Ongoing Screening Summary Report 2018 Inspection Year

Illicit Discharge Detection and Elimination Program

City of Oshkosh

January 25, 2019

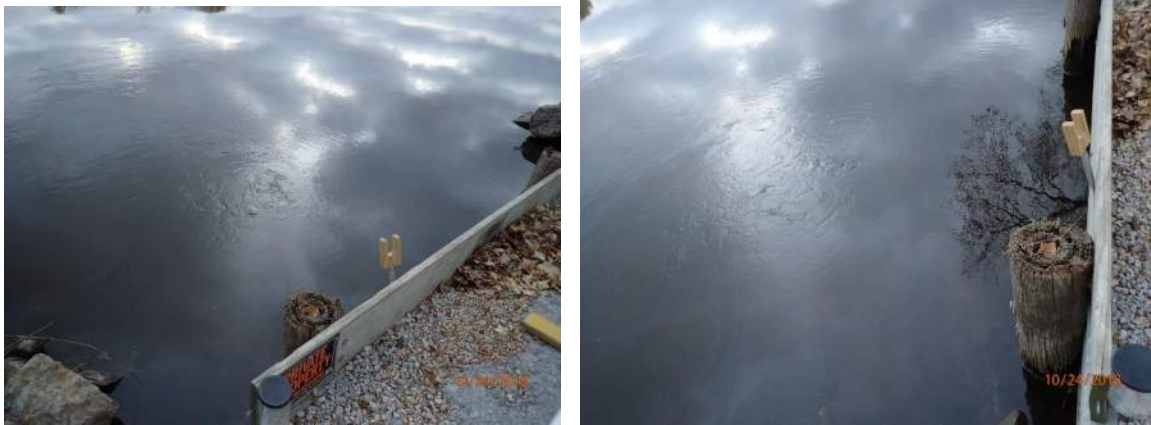
Figure 14 - Outfall 06-253 (2018)

Outfall 06-253 consists of a 34x53 inch reinforced concrete pipe (RCP) that discharges into the Fox River at the end of the extension of Campbell Road. The pipe may be the effluent pipe for the wastewater treatment plant. The pipe is fully submerged.

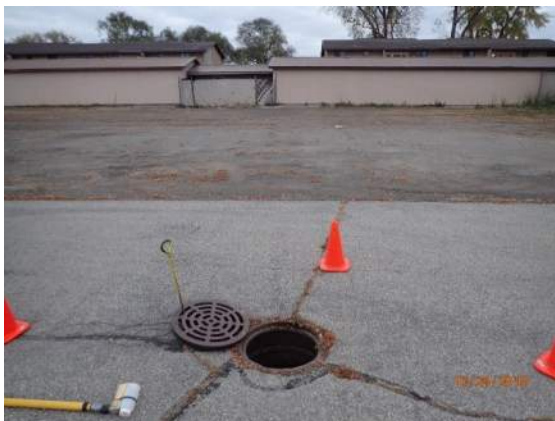
Figure 15 – Upstream manhole 06-253 US1 (2018)

Because the outfall is fully submerged, it is screened at the upstream manhole (06-253 US1) located approximately 266 feet upstream of the outfall, in the senior center parking lot.

During the 2017 screening, the sample collected from manhole 06-253 US1 had an elevated level of ammonia. No other parameters were outside of the normal range, although conductivity was approaching the 2,000 $\mu\text{S}/\text{cm}$ action level.

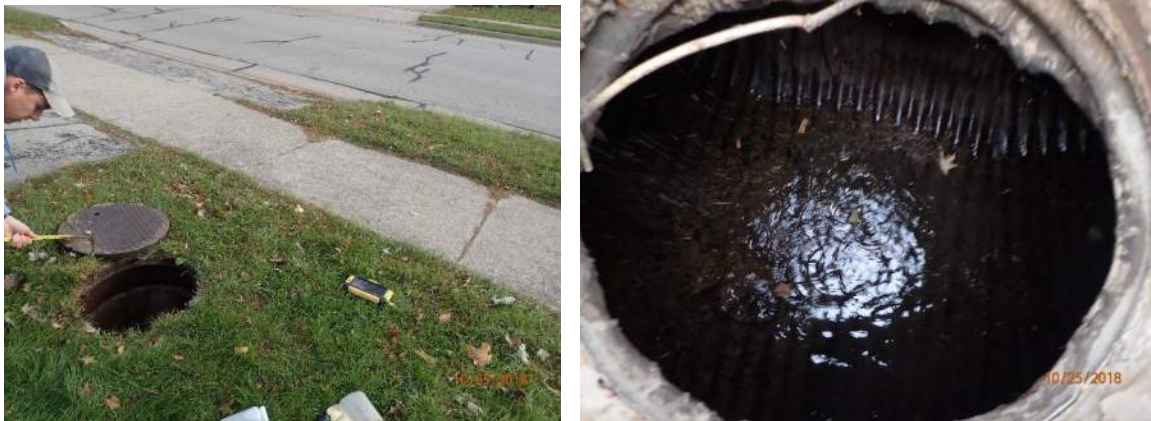
Figure 16 - Outfall 06-473 (2018)

A large metal box culvert runs from 9th Avenue (Franklin Elementary School) to Witzel Avenue (east of Lourdes High School). Because this culvert diverts a stream, it is considered a Water of the State, and outfalls are located wherever storm sewer lines discharge to it. Outfall 06-473 is located where the 24" storm sewer from Mason Street discharges to the culvert from the south, just south of W. 5th Avenue. Because it was not possible to screen at the actual junction, the outfall was screened at the nearest manhole.

During the 10/25/2018 screening, the outfall was partially submerged with a slight flow. Detergent was detected in the sample that was collected. Because of this, a second sample was collected on 10/26/2018, which also contained detergent.

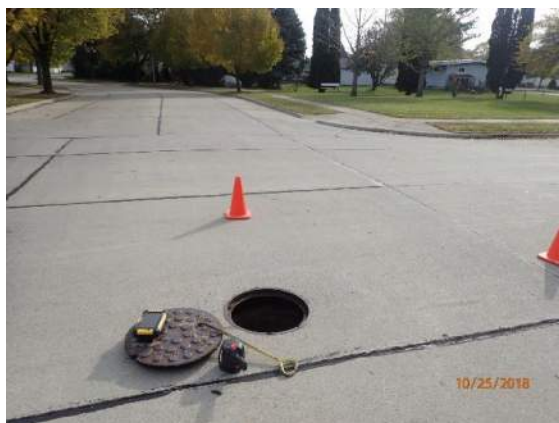
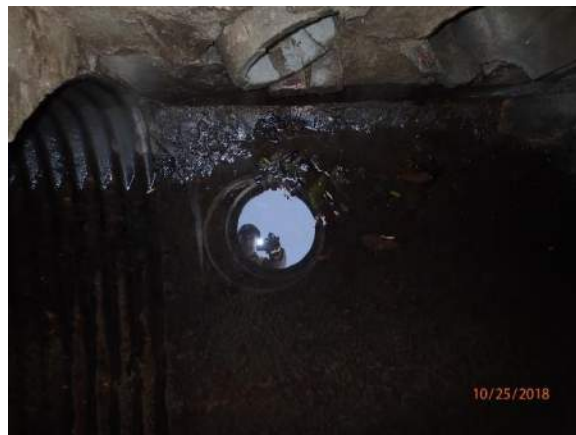
Figure 17 - Outfall 06-494 US1 (2018)

A large metal box culvert runs from 9th Avenue (Franklin Elementary School) to Witzel Avenue (east of Lourdes High School). Because this culvert diverts a stream, it is considered a Water of the State, and outfalls are located wherever storm sewer lines discharge to it. Outfall 06-494 is located where the 36x58" storm sewer from W. 4th Avenue discharges to the culvert from the west, between Mason Street and Sawyer Street. Because it was not possible to screen at the actual junction, the outfall was screened at the nearest manhole, at the intersection of W. 4th Avenue and Mason Street.

During the 10/25/2018 screening, the outfall was partially submerged with indeterminate flow. Detergent was detected in the sample that was collected. Because of this, a second sample was collected on 10/26/2018, which also contained detergent.

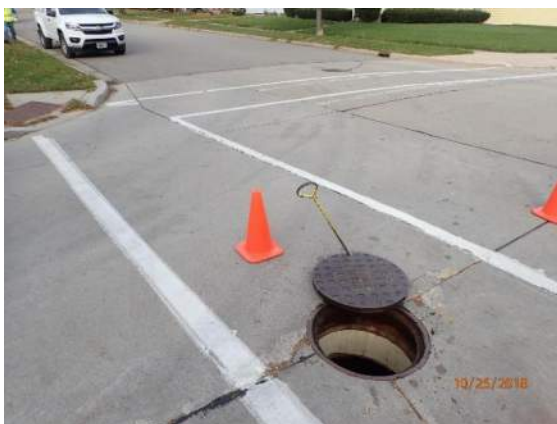
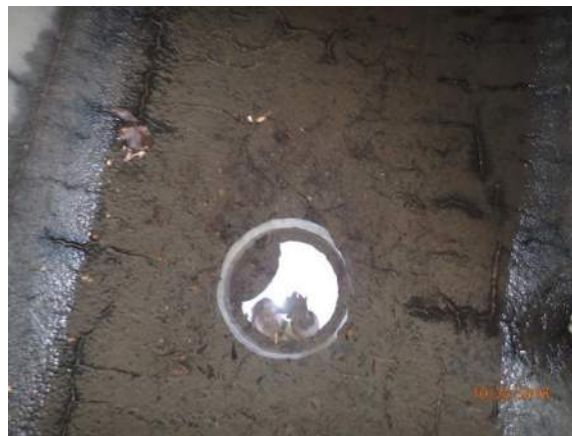
Figure 18 - Outfall 06-610 (2018)

A large metal box culvert runs from 9th Avenue (Franklin Elementary School) to Witzel Avenue (east of Lourdes High School). Because this culvert diverts a stream, it is considered a Water of the State, and outfalls are located wherever storm sewer lines discharge to it. Outfall 06-610 is located where the 15" storm sewer from W. 5th Avenue discharges to the culvert from the west. Because it was not possible to screen at the actual junction, the outfall was screened at the nearest manhole, at the intersection of W. 5th Avenue and Mason Street.

During the 10/25/2018 screening, the outfall was partially submerged with indeterminate flow. Detergent was detected in the sample that was collected. Because of this, a second sample was collected on 10/26/2018, which also contained detergent.

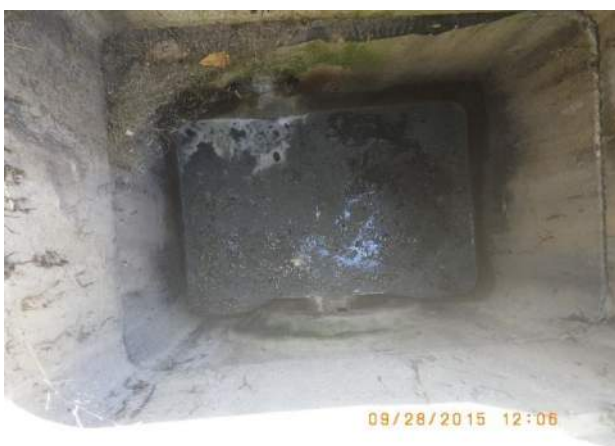
Figure 21 – Pipe discharging into inlet 582A (9/28/2015)

The Illicit Discharge Coordinator was notified of this pipe on September 28, 2015, and OMNNI and City personnel met with a representative of Carew Concrete on September 29, 2015 to attempt to identify the source of the discharge. No upstream inlets or catchbasins were located on the property. City personnel inserted a temporary plug in the end of the pipe to stop the discharge.

During the 2016 screening on October 10, 2016, it was observed that the pipe in the upstream catchbasin had been permanently plugged.

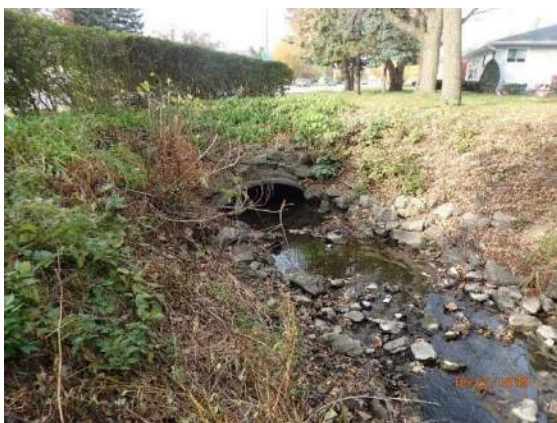
Figure 22 - Outfall 13-471 (2018)

Outfall 13-471 consists of a 48x76 elliptical concrete pipe that discharges to a channel north of W. 9th Avenue. After flowing approximately 400 feet, the channel enters the large metal box culvert that flows north to Witzel Avenue and discharges east of Lourdes High School.

During the 10/25/2018 screening, the outfall was partially submerged with significant flow. A sample was collected from the flow, which tested positive for detergent. Because of this, a second sample was collected on 10/26/2018, which also contained detergent.

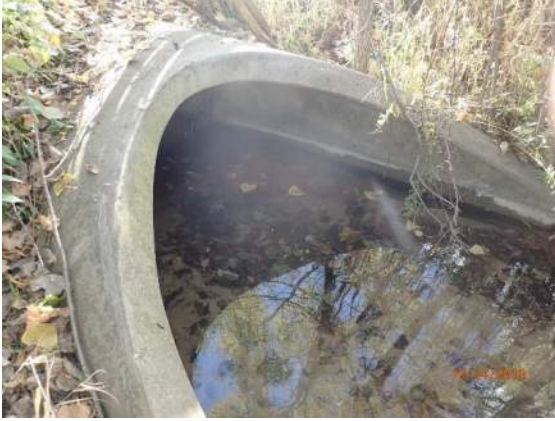
Figure 23 - Outfall 13-2332 (2018)

Outfall 13-2332 consists of a 33x60 elliptical concrete pipe that discharges to a channel north of Fox Tail Lane, near Traeger Middle School.

During the 10/24/2018 screening, the outfall was partially submerged with slight flow. A sample was collected from the flow, which tested positive for detergent. Because of this, a second sample was collected on 10/26/2018, which also contained detergent.

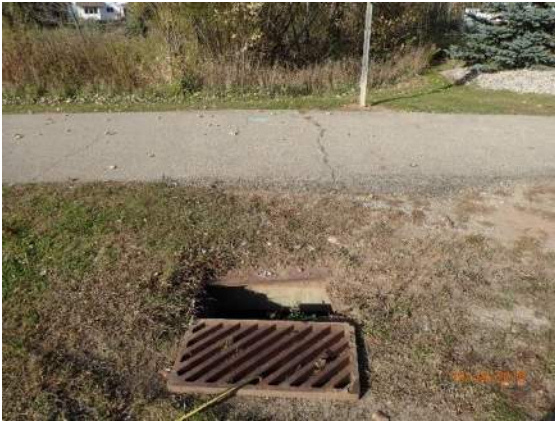
Figure 24 – Upstream manhole 13-2332 US1 (2018)

Because the outfall was partially submerged during the 10/24/2018 screening, it was screened at the upstream catchbasin (13-2332 US1) located approximately 30 feet upstream of the outfall.

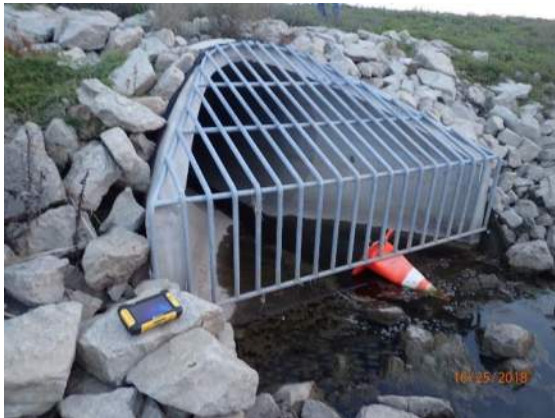
Figure 25 - Outfall 13-3774 (2018)

Outfall 13-3774 consists of a 66" reinforced concrete pipe that discharges to the west side of the recently-constructed Armory pond, near the end of Menard Drive. The drainage area for this outfall consists primarily of the commercial area east of S. Koeller Street, between 9th Street and 2th Street.

A sample was collected from the trickle flow from the outfall on 10/25/2018. Detergent was detected in this sample at 0.45 mg/L. Because of this detection, the outfall flow was resampled on 10/26/2018, and the detergent concentration was 0.85 mg/L. No other indicator parameters were above action limits.

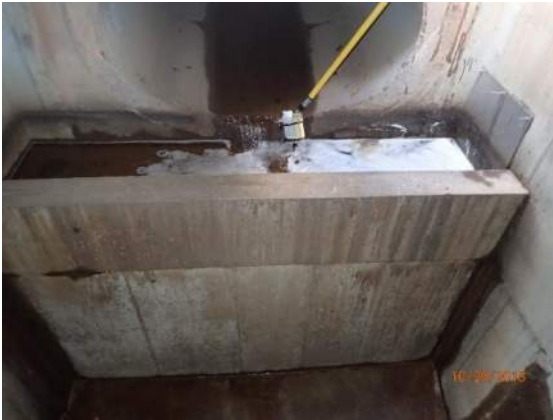
Figure 28 – Sample from west – manhole 13-3774 (2018)

Additional upstream manholes in the Shopko parking lot and on Menard Drive were also screened. If any flows were present, they were not sufficient to collect a sample for detergent testing. As a result, no suspected source or direction was determined for the detergent in the flow.

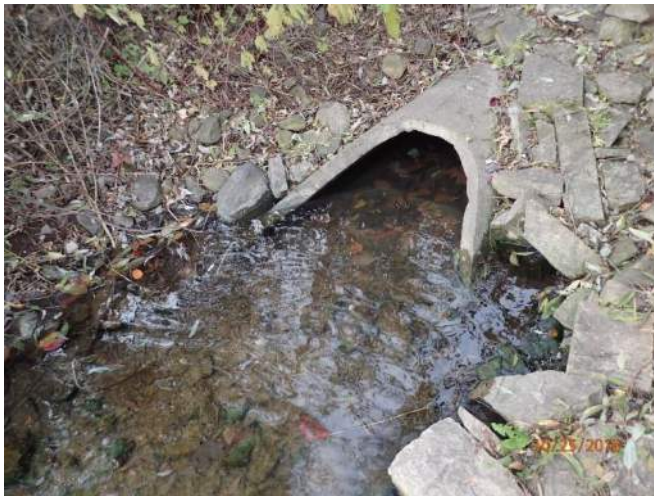
Figure 29 - Outfall 16-660 (2018)

Outfall 16-660 consists of a 21-inch RCP that discharges into the south end of a detention basin between Westhaven Drive and Sawyer Creek. The drainage basin for the storm sewer is primarily a residential area.

This outfall tested positive for detergent (0.55 mg/L) in 2017, so it was rescreened in 2018.

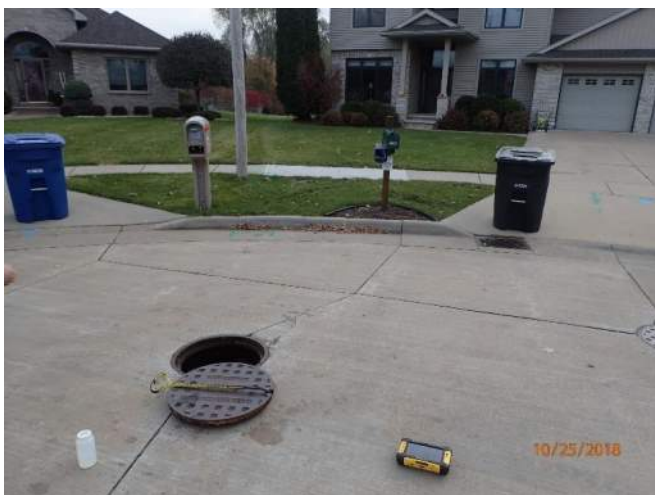
Figure 30 – Upstream manhole 16-660 US1 (2018)

Detergent was detected in the 10/25/2018 sample, as well as the 10/26/2018 follow-up sample.

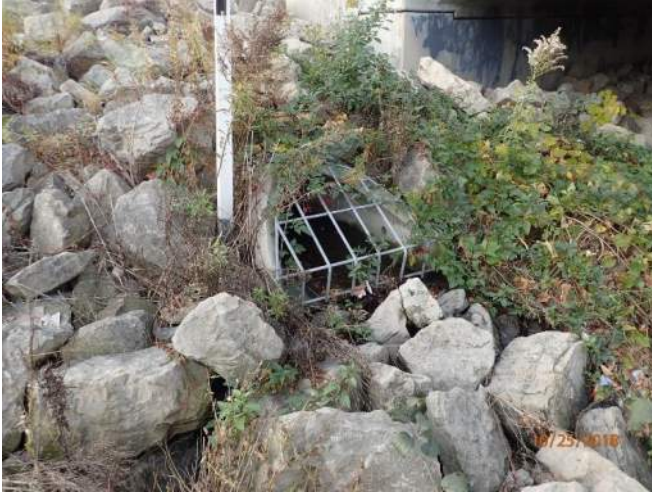
Figure 31 - Outfall 16-844 (2018)

Detergent and elevated conductivity was detected in the 10/25/2018 sample, as well as the 10/26/2018 follow-up sample.

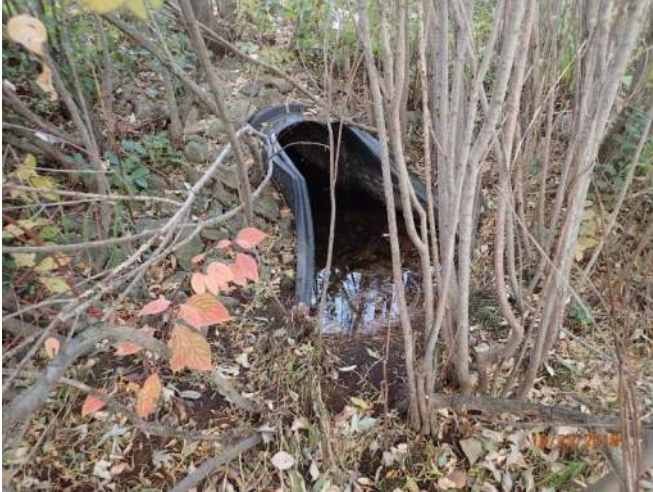
Figure 32 - Outfall 16-995 (2018)

This outfall tested positive for detergent (1.3 mg/L) in 2017, so it was rescreened in 2018.

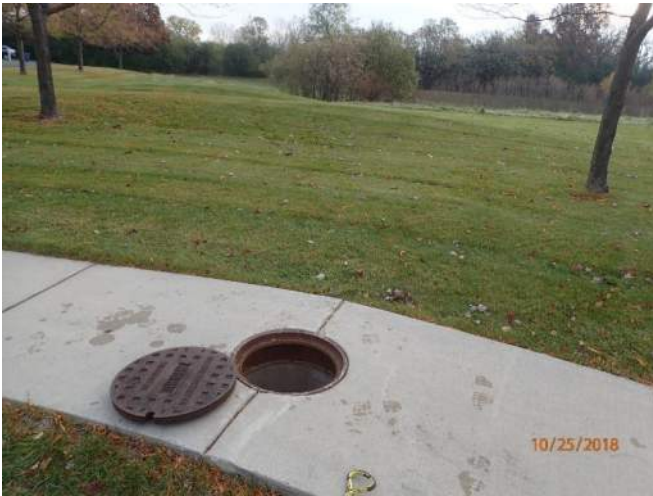
Figure 33 – Upstream manhole 16-995 US1 (2018)

Detergent was detected in the 10/25/2018 sample, as well as the 10/26/2018 follow-up sample.

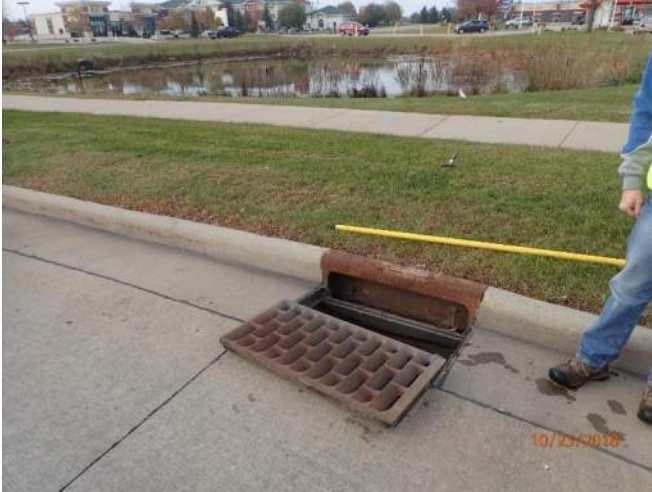
Figure 35 – Upstream manhole 16-1205 US1 (2018)

Detergent was detected in the 10/25/2018 sample, as well as the 10/26/2018 follow-up sample. The pool in the curb inlet was below the invert of the outfall pipe, so the sample was collected from the sump. Because the curb inlet is the only storm sewer component in the drainage basin, no additional tracking was possible.

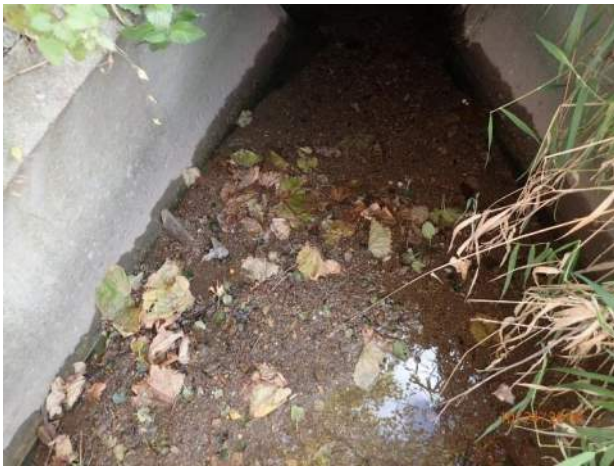
Figure 40 – Minor deposition at outfall 13-1588

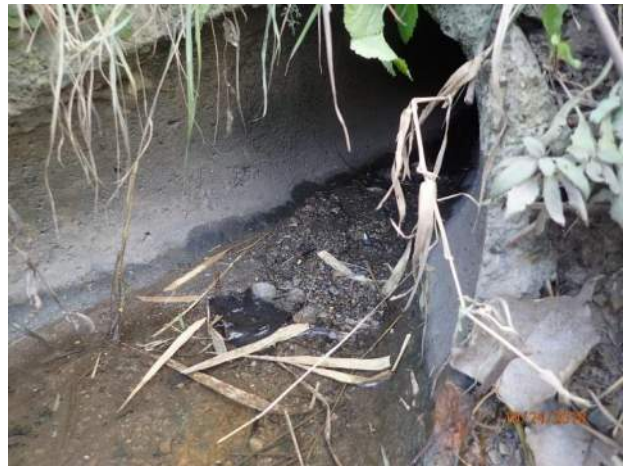
Figure 41 – Minor deposition at outfall 13-2611

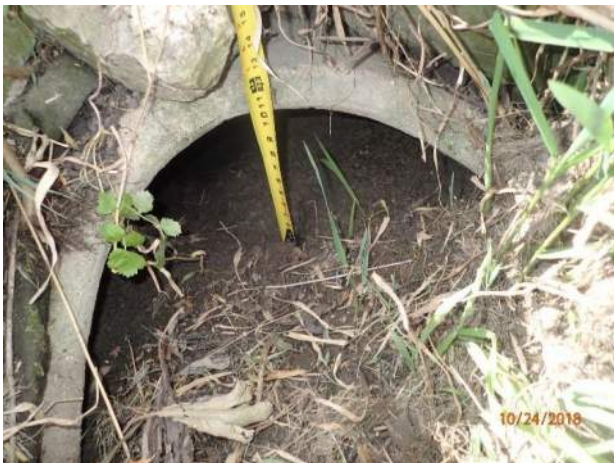
Figure 42 – Moderate deposition at outfall 13-2860

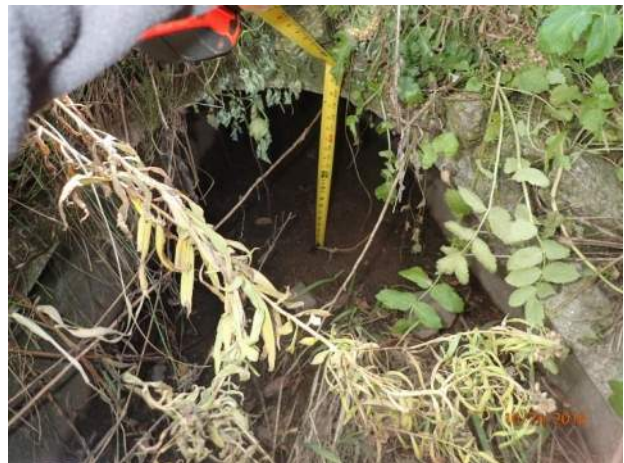
Figure 43 – Minor deposition at outfall 13-2867

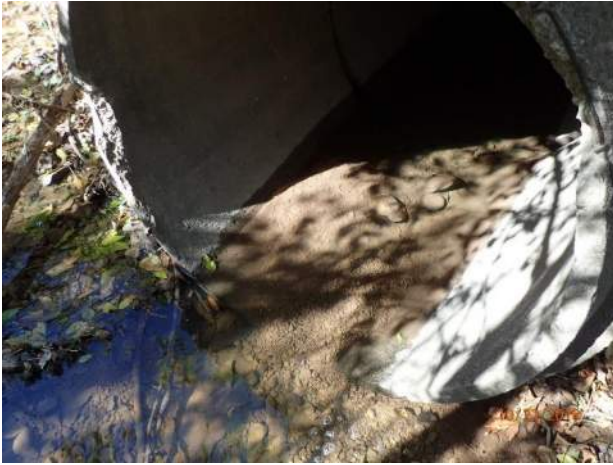
Figure 44 – Minor deposition at outfall 14-999

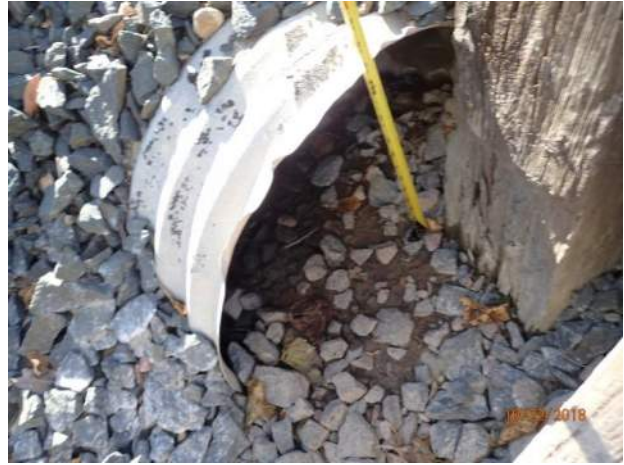
Figure 45 – Moderate deposition at outfall 14-1514

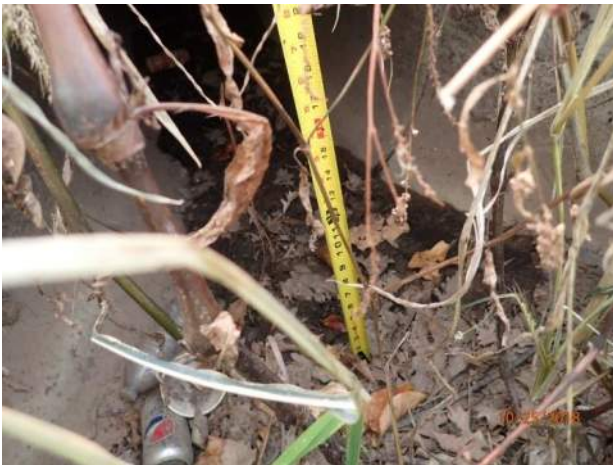
Figure 46 – Minor deposition at outfall 15-2409

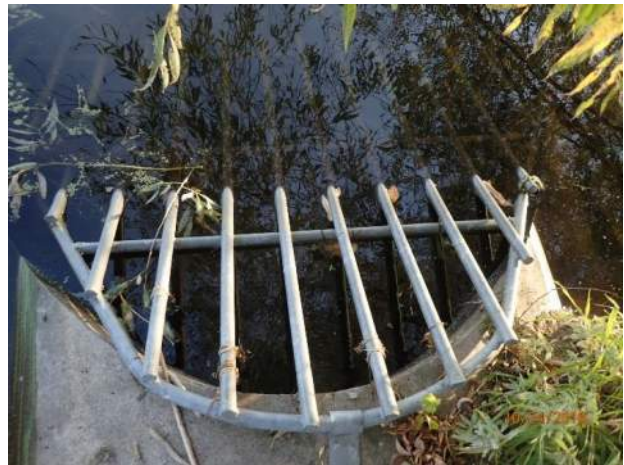
Figure 47 – Minor deposition at outfall 15-2477

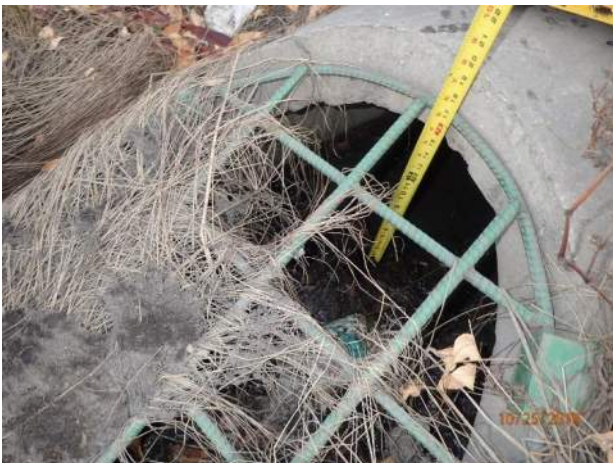
Figure 48 – Minor deposition at outfall 16-1205

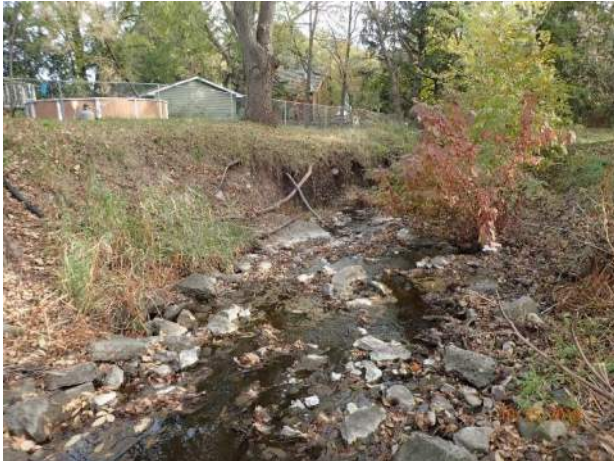
Outfall	Severity	Description
13-471	Moderate	Bank erosion downstream from pipe.

Figure 49 – Bank erosion downstream of outfall 13-471

One of the outfalls showed signs of erosion at the end of the outfall pipe or channel. Most of the outfalls with minor erosion could be repaired with minor landscaping repairs. Those outfalls

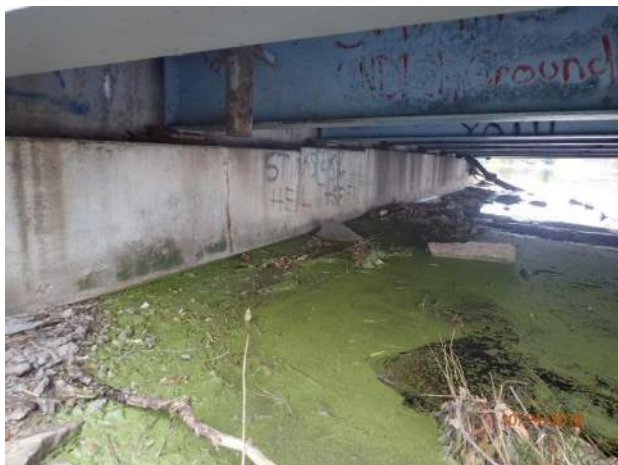
Graffiti was observed in or around one outfall. The graffiti was not severe but should probably be monitored to make sure that it does not become more severe.

Outfall	Severity	Description
12-569	Moderate	Graffiti on bridge abutment adjacent to outfall.

Figure 50 – Graffiti near outfall 12-569

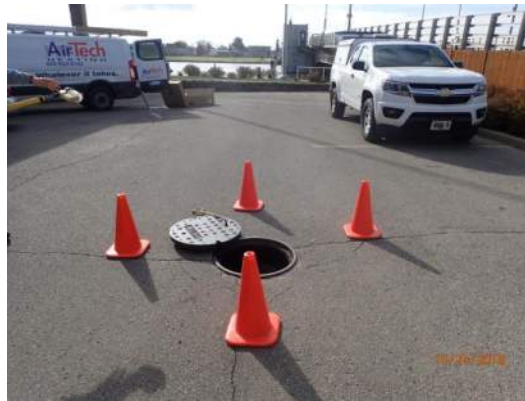
o20181024105512.JPG

Upstream manhole located approx 72 ft N of outfall 01-35. Intermediate area consists of paved parking area with no observed inlets.

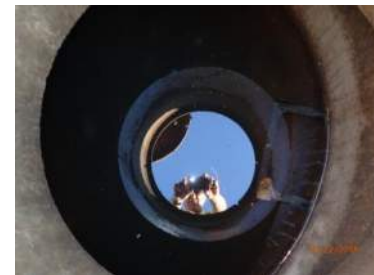
o20181022165512.JPG

Sample Location:	Pool																																					
Total Chlorine:	0 ppm																																					
Free Chlorine:	0 ppm																																					
Ammonia:	0 ppm																																					
pH:	7.55 units																																					
Temperature:	66 °F																																					
Conductivity:	229 µS/cm																																					
Detergents:	0 mg/L																																					
Floatables:	None																																					
Odor:	None																																					
Turbidity:	None																																					
Color:	None																																					
Gross Solids:	None																																					
Vegetation:	None																																					
Benthic Growth:	None																																					
Stains:	None																																					
Non-illicit:	None

Notes Sample collected from submerged pool in manhole.																																				
		Condition Assessment <table border="1" style="width:100%; border-collapse: collapse;"> <tr><td>Graffiti:</td><td>None</td></tr> <tr><td>Erosion:</td><td>None</td></tr> <tr><td>Deposition:</td><td>None in.</td></tr> <tr><td>Damage:</td><td>None</td></tr> </table>			Graffiti:	None	Erosion:	None	Deposition:	None in.	Damage:	None																										
Graffiti:	None																																					
Erosion:	None																																					
Deposition:	None in.																																					
Damage:	None

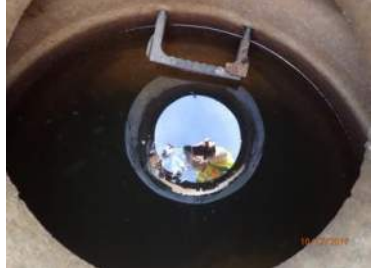
o20171017152922.JPG 2017

Sample Location:	Pool																																					
Total Chlorine:	0 ppm																																					
Free Chlorine:	0 ppm																																					
Ammonia:	0 ppm																																					
pH:	7.34 units																																					
Temperature:	67 °F																																					
Conductivity:	978 µS/cm																																					
Detergents:	0 mg/L																																					
Floatables:	None																																					
Odor:	None																																					
Turbidity:	None																																					
Color:	None																																					
Gross Solids:	Slight																																					
Vegetation:	None																																					
Benthic Growth:	None																																					
Stains:	None																																					
Non-illicit:	None

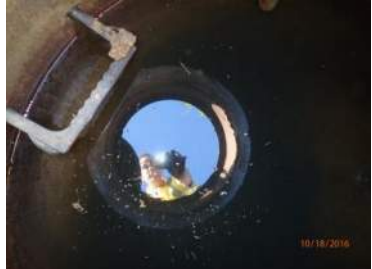
o20161018151736.JPG 2016

Sample Location:	Pool																																					
Total Chlorine:	0 ppm																																					
Free Chlorine:	0 ppm																																					
Ammonia:	0 ppm																																					
pH:	7.76 units																																					
Temperature:	75 °F																																					
Conductivity:	541 µS/cm																																					
Detergents:	0 mg/L																																					
Floatables:	None																																					
Odor:	None																																					
Turbidity:	None																																					
Color:	None																																					
Gross Solids:	None																																					
Vegetation:	None																																					
Benthic Growth:	Slight																																					
Stains:	None																																					
Non-illicit:	None

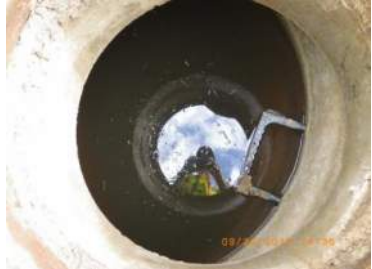
o20150922133640.JPG 2015

Sample Location:	Pool																																					
Total Chlorine:	0 ppm																																					
Free Chlorine:	0 ppm																																					
Ammonia:	0 ppm																																					
pH:	7.6 units																																					
Temperature:	72 °F																																					
Conductivity:	-- µS/cm																																					
Detergents:	0 mg/L																																					
Floatables:	None																																					
Odor:	None																																					
Turbidity:	None																																					
Color:	None																																					
Gross Solids:	None																																					
Vegetation:	None																																					
Benthic Growth:	Slight																																					
Stains:	None																																					
Non-illicit:	None

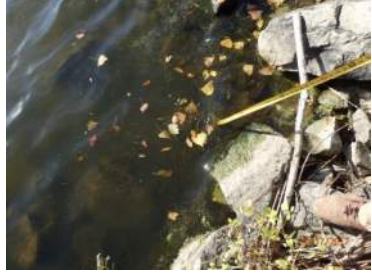
<p style="text-align: center;">o20171017151448.JPG</p> <p style="text-align: center; font-size: 24pt; font-weight: bold;">2017</p>	
Submerged: Fully		Depth (in): 39		Condition Assessment Graffiti: None Erosion: None Deposition: None in. Damage: None			
Sampling Results Sample Location: Total Chlorine: -- ppm Free Chlorine: -- ppm Ammonia: -- ppm pH: -- units Temperature -- ° F Conductivity: -- µS/cm Detergents: -- mg/L		Floatables: None Odor: None Turbidity: None Color: None Gross Solids: None Vegetation: None Benthic Growth: None Stains: None Non-illicit: None

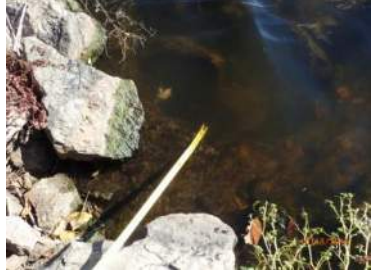
<p style="text-align: center;">o20161018153652.JPG</p> <p style="text-align: center; font-size: 24pt; font-weight: bold;">2016</p>	
Submerged: Fully		Depth (in): 33		Condition Assessment Graffiti: None Erosion: None Deposition: None in. Damage: None			
Sampling Results Sample Location: Total Chlorine: -- ppm Free Chlorine: -- ppm Ammonia: -- ppm pH: -- units Temperature -- ° F Conductivity: -- µS/cm Detergents: -- mg/L		Floatables: None Odor: None Turbidity: None Color: None Gross Solids: None Vegetation: None Benthic Growth: Severe Stains: None Non-illicit: None

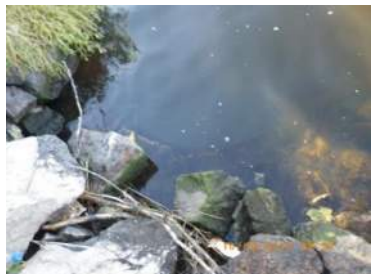
<p style="text-align: center;">o20141009073704.JPG</p> <p style="text-align: center; font-size: 24pt; font-weight: bold;">2014</p>	
Submerged: Fully		Depth (in): 56		Condition Assessment Graffiti: None Erosion: None Deposition: None in. Damage: None			
Sampling Results Sample Location: Total Chlorine: -- ppm Free Chlorine: -- ppm Ammonia: -- ppm pH: -- units Temperature -- ° F Conductivity: -- µS/cm Detergents: -- mg/L		Floatables: None Odor: None Turbidity: None Color: None Gross Solids: None Vegetation: None Benthic Growth: Moderate Stains: None Non-illicit: None

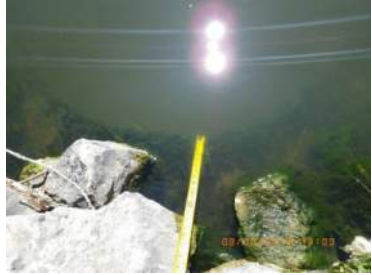
o20130905120336.JPG

Inspection Date: 9/5/2013 12:59:39 PM		Type: Ongoing	Flow: Submerged, indeterminate	Previous Rainfall (hrs): 72+
Illicit Discharge Potential: Potential		Inspector: JCW	Notes	
Submerged: Fully Depth (in): 49			Outfall fully submerged. Outfall screened upstream at 01-520 US1. 2012 screening follow-up. Gross solids in upstream mh.	
Sampling Results			Condition Assessment	
Sample Location:	Floatables:	None	Graffiti:	None
Total Chlorine: -- ppm	Odor:	None	Erosion:	None
Free Chlorine: -- ppm	Turbidity:	None	Deposition:	None in.
Ammonia: -- ppm	Color:	None	Damage:	None
pH: -- units	Gross Solids:	None		
Temperature -- °F	Vegetation:	None		
Conductivity: -- µS/cm	Benthic Growth:	Moderate		
Detergents: -- mg/L	Stains:	None		
	Non-illicit:	None

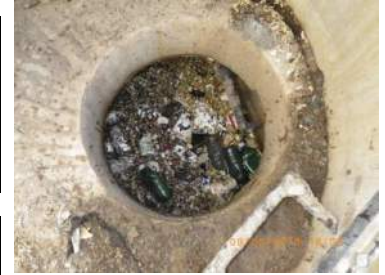
o20130905120924.JPG

Inspection Date: 9/5/2013 1:02:45 PM		Type: Ongoing	Flow: Submerged, indeterminate	Previous Rainfall (hrs): 72+								
Illicit Discharge Potential: Potential		Inspector: JCW	Notes									
Submerged: Fully		Depth (in): 69	2012 screening follow-up. Significant gross solids in manhole - similar to previous years.									
Sampling Results		Floatables: None	Condition Assessment									
Sample Location: Pool		Odor: None

Graffiti:	None	Erosion:	None	Deposition:	None in.	Damage:	None
Graffiti:	None											
Erosion:	None											
Deposition:	None in.											
Damage:	None											
Total Chlorine: 0 ppm		Turbidity: None										
Free Chlorine: 0 ppm		Color: None										
Ammonia: 0 ppm		Gross Solids: Severe										
pH: 8.51 units		Vegetation: None										
Temperature 76 °F		Benthic Growth: None										
Conductivity: 424 µS/cm		Stains: None										
Detergents: 0 mg/L		Non-illicit: None

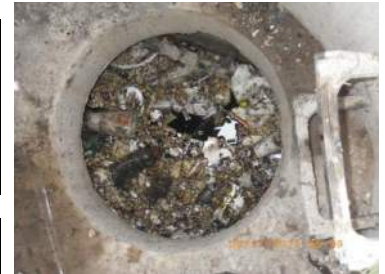
o20120927085918.JPG

Inspection Date: 9/27/2012 9:57:25 AM		Type: Ongoing	Flow: Submerged, indeterminate	Previous Rainfall (hrs): 72+								
Illicit Discharge Potential: Potential		Inspector: JCW	Notes									
Submerged: Fully		Depth (in): 69	2011 gross solids follow-up.									
Sampling Results		Floatables: None	Condition Assessment									
Sample Location: Pool		Odor: None

Graffiti:	None	Erosion:	None	Deposition:	None in.	Damage:	None
Graffiti:	None											
Erosion:	None											
Deposition:	None in.											
Damage:	None											
Total Chlorine: 0 ppm		Turbidity: None										
Free Chlorine: 0 ppm		Color: None										
Ammonia: 0.5 ppm		Gross Solids: Severe										
pH: 7.77 units		Vegetation: None										
Temperature 60 °F		Benthic Growth: None										
Conductivity: 542 µS/cm		Stains: Slight										
Detergents: 0 mg/L		Non-illicit: None

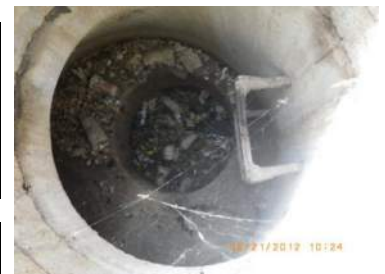
o20120621092424.JPG

Inspection Date: 6/21/2012 10:34:01 AM		Type: Other	Flow: Submerged, indeterminate	Previous Rainfall (hrs): 0-24								
Illicit Discharge Potential: Potential		Inspector: JCW	Notes									
Submerged: Fully		Depth (in): 70	Gross solids pre-screening.									
Sampling Results		Floatables: None	Condition Assessment									
Sample Location: Pool		Odor: None

Graffiti:	None	Erosion:	None	Deposition:	None in.	Damage:	None
Graffiti:	None											
Erosion:	None											
Deposition:	None in.											
Damage:	None											
Total Chlorine: -- ppm		Turbidity: None										
Free Chlorine: -- ppm		Color: None										
Ammonia: -- ppm		Gross Solids: Severe										
pH: -- units		Vegetation: None										
Temperature -- °F		Benthic Growth: None										
Conductivity: -- µS/cm		Stains: Moderate										
Detergents: -- mg/L		Non-illicit: None

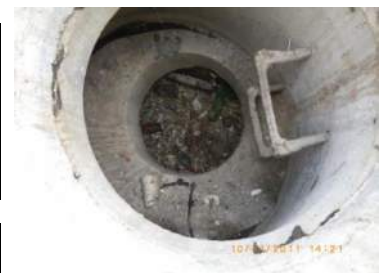
o20111011142110.JPG

Inspection Date: 10/11/2011 2:24:37 PM		Type: Ongoing	Flow: Submerged, indeterminate	Previous Rainfall (hrs): 72+								
Illicit Discharge Potential: Potential		Inspector: JCW	Notes									
Submerged: Fully		Depth (in): 64	2010 screening follow-up. Floatable debris still present.									
Sampling Results		Floatables: None	Condition Assessment									
Sample Location: Pool		Odor: None

Graffiti:	None	Erosion:	None	Deposition:	None 0 in.	Damage:	None
Graffiti:	None											
Erosion:	None											
Deposition:	None 0 in.											
Damage:	None											
Total Chlorine: 0 ppm		Turbidity: None										
Free Chlorine: 0 ppm		Color: None										
Ammonia: 0 ppm		Gross Solids: Severe										
pH: 8.49 units		Vegetation: None										
Temperature 71 °F		Benthic Growth: None										
Conductivity: -- µS/cm		Stains: None										
Detergents: -- mg/L		Non-illicit: None

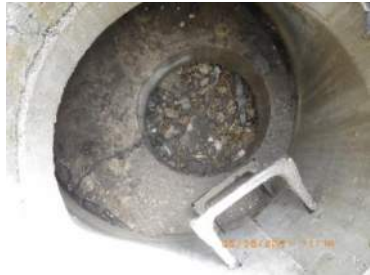
o20110526111400.JPG

Inspection Date: 5/26/2011 11:13:00 AM		Type: Other	Flow: Submerged, indeterminate	Previous Rainfall (hrs): 72+
Illicit Discharge Potential: Potential		Inspector: JCW	Notes	
Submerged: Fully		Depth (in):	Limited screening conducted to check for floatable debris.	
Sampling Results				
Sample Location:	Floatables:	None		
Total Chlorine: -- ppm	Odor:			
Free Chlorine: -- ppm	Turbidity:			
Ammonia: -- ppm	Color:			
pH: -- units	Gross Solids:	Severe		
Temperature -- °F	Vegetation:			
Conductivity: -- µS/cm	Benthic Growth:			
Detergents: -- mg/L	Stains:			
	Non-illicit:	None		
		Condition Assessment		
		Graffiti:	None	
		Erosion:	None	
		Deposition:	None 0 in.	
		Damage:	None

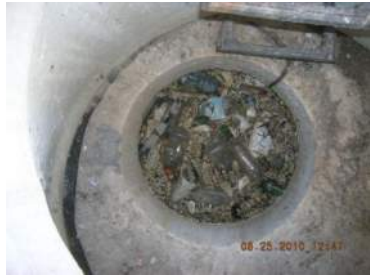
o20100825124708.JPG

Inspection Date: 8/25/2010 12:53:35 PM		Type: Ongoing	Flow: Submerged, indeterminate	Previous Rainfall (hrs): 72+
Illicit Discharge Potential: Potential		Inspector: JCW	Notes	
Submerged: Fully		Depth (in): 72	Significant floatable debris in manhole.	
Sampling Results				
Sample Location: Pool	Floatables:	None		
Total Chlorine: 0 ppm	Odor:	None		
Free Chlorine: 0 ppm	Turbidity:	None		
Ammonia: 0 ppm	Color:	Faint in bottle		
pH: 8.18 units	Gross Solids:	Severe		
Temperature 73 °F	Vegetation:	None		
Conductivity: -- µS/cm	Benthic Growth:	None		
Detergents: 0 mg/L	Stains:	None		
	Non-illicit:	None		
		Condition Assessment		
		Graffiti:	None	
		Erosion:	None	
		Deposition:	None 0 in.	
		Damage:	None

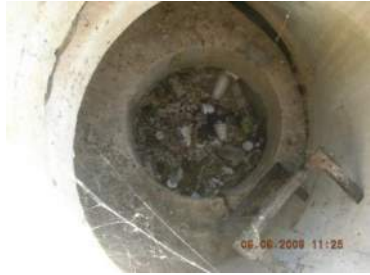
Osh09_DSCN6718.JPG

Inspection Date: 9/9/2009		Type: Initial	Flow: Submerged, indeterminate	Previous Rainfall (hrs): 72+
Illicit Discharge Potential: Potential		Inspector: JCW	Notes	
Submerged: Fully		Depth (in): 61	Abnormal detergent analysis result (bubbles). Significant floatables in manhole. Brown color.	
Sampling Results				
Sample Location: Pool	Floatables:	None		
Total Chlorine: 0 ppm	Odor:	None		
Free Chlorine: 0 ppm	Turbidity:	None		
Ammonia: -- ppm	Color:	Clearly visible in bottl		
pH: 8.6 units	Gross Solids:	Severe		
Temperature 78 °F	Vegetation:	None		
Conductivity: -- µS/cm	Benthic Growth:	None		
Detergents: 0 mg/L	Stains:	None		
	Non-illicit:	None		
		Condition Assessment		
		Graffiti:	None	
		Erosion:	None	
		Deposition:	None 0 in.	
		Damage:	None

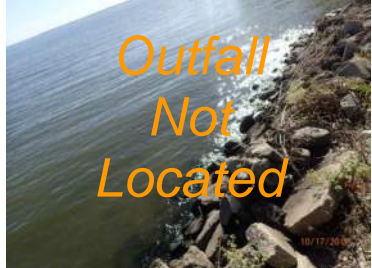
o20171017133948.JPG <div style="text-align: center; font-size: 24pt; font-weight: bold;">2017</div>

Inspection Date: 10/17/2017 1:41:46 PM		Type: Ongoing	Flow: Submerged (not located)	Previous Rainfall (hrs): 48-72
Illicit Discharge Potential: Potential		Inspector: JCW		
Submerged: Fully		Depth (in):		
Sampling Results Sample Location: _____ Total Chlorine: -- ppm Free Chlorine: -- ppm Ammonia: -- ppm pH: -- units Temperature: -- °F Conductivity: -- µS/cm Detergents: -- mg/L		Floatables: None Odor: None Turbidity: None Color: None Gross Solids: None Vegetation: None Benthic Growth: None Stains: None Non-illicit: None		
		Notes Outfall fully submerged and not located - screened upstream at 02-309 US1. Floating gross solids (litter) in manhole.		
		Condition Assessment Graffiti: None Erosion: None Deposition: None in. Damage: None

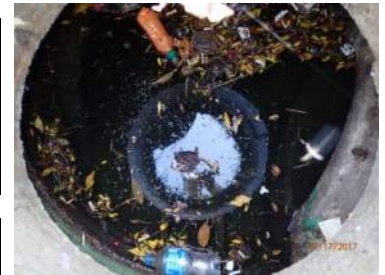
o20171017134106.JPG

Inspection Date: 10/17/2017 1:45:07 PM		Type: Ongoing	Flow: Submerged, indeterminate	Previous Rainfall (hrs): 48-72
Illicit Discharge Potential: Potential		Inspector: JCW		
Submerged: Fully		Depth (in): 31		
Sampling Results		Notes Sample collected from submerged pool in manhole. Floating gross solids (litter) in manhole.		
Sample Location: Pool	Floatables: None	Condition Assessment Graffiti: None Erosion: None Deposition: None in. Damage: None		
Total Chlorine: 0 ppm	Odor: None			
Free Chlorine: 0 ppm	Turbidity: None			
Ammonia: 0 ppm	Color: None			
pH: 7.74 units	Gross Solids: Moderate			
Temperature 69 °F	Vegetation: None			
Conductivity: 644 µS/cm	Benthic Growth: Moderate			
Detergents: 0 mg/L	Stains: None			
	Non-illicit: None

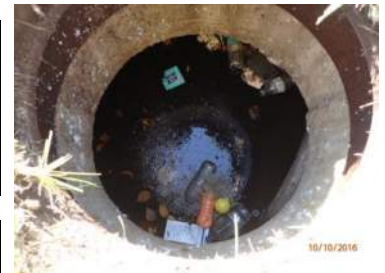
o20161010103236.JPG

Inspection Date: 10/10/2016 10:35:02 AM		Type: Ongoing	Flow: Submerged, indeterminate	Previous Rainfall (hrs): 72+
Illicit Discharge Potential: Potential		Inspector: JCW		
Submerged: Fully		Depth (in): 28		
Sampling Results		Notes Potential illicit discharge due to gross solids.		
Sample Location: Pool	Floatables: None	Condition Assessment Graffiti: None Erosion: None Deposition: None in. Damage: None		
Total Chlorine: 0 ppm	Odor: None			
Free Chlorine: 0 ppm	Turbidity: None			
Ammonia: 0 ppm	Color: None			
pH: 7.54 units	Gross Solids: Moderate			
Temperature 64 °F	Vegetation: None			
Conductivity: 592 µS/cm	Benthic Growth: None			
Detergents: 0 mg/L	Stains: None			
	Non-illicit: None

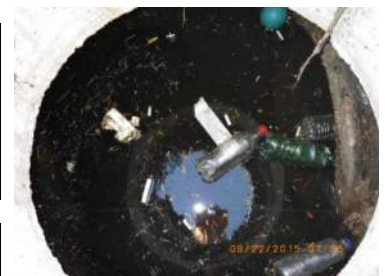
o20150922065636.JPG

Inspection Date: 9/22/2015 7:50:50 AM		Type: Ongoing	Flow: Submerged, indeterminate	Previous Rainfall (hrs): 72+
Illicit Discharge Potential: Potential		Inspector: JCW		
Submerged: Fully		Depth (in): 28		
Sampling Results		Notes Floating gross solids (litter) in manhole.		
Sample Location: Pool	Floatables: None	Condition Assessment Graffiti: None Erosion: None Deposition: None in. Damage: None		
Total Chlorine: 0 ppm	Odor: None			
Free Chlorine: 0 ppm	Turbidity: None			
Ammonia: 0 ppm	Color: None			
pH: 7.74 units	Gross Solids: Slight			
Temperature 66 °F	Vegetation: None			
Conductivity: 853 µS/cm	Benthic Growth: Slight			
Detergents: 0 mg/L	Stains: Slight			
	Non-illicit: None

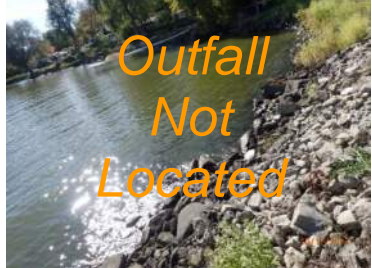
o20171017133026.JPG 2017

Inspection Date: 10/17/2017 1:32:28 PM		Type: Ongoing	Flow: Submerged (not located)	Previous Rainfall (hrs): 48-72
Illicit Discharge Potential: Potential		Inspector: JCW		
Submerged: Fully		Depth (in):		
Sampling Results Sample Location: _____ Total Chlorine: -- ppm Free Chlorine: -- ppm Ammonia: -- ppm pH: -- units Temperature: -- °F Conductivity: -- µS/cm Detergents: -- mg/L		Floatables: None Odor: None Turbidity: None Color: None Gross Solids: None Vegetation: None Benthic Growth: None Stains: None Non-illicit: None		
		Notes Outfall fully submerged and not located - screened upstream at 02-357 US1. Floating gross solids (litter) in manhole.		
		Condition Assessment Graffiti: None Erosion: None Deposition: None in. Damage: None

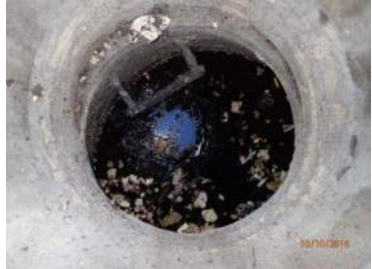
o20161010105436.JPG 2016

Inspection Date: 10/10/2016 10:57:04 AM		Type: Ongoing	Flow: Submerged, indeterminate	Previous Rainfall (hrs): 72+																		
Illicit Discharge Potential: Potential		Inspector: JCW																				
Submerged: Fully		Depth (in): 37																				
Sampling Results		<div style="float: right; border: 1px solid black; padding: 5px; width: 200px;"> Notes Potential illicit discharge due to gross solids. </div> <table border="1" style="width:100%; border-collapse: collapse;"> <tr><td>Floatables:</td><td>None</td></tr> <tr><td>Odor:</td><td>None</td></tr> <tr><td>Turbidity:</td><td>None</td></tr> <tr><td>Color:</td><td>None</td></tr> <tr><td>Gross Solids:</td><td>Moderate</td></tr> <tr><td>Vegetation:</td><td>None</td></tr> <tr><td>Benthic Growth:</td><td>None</td></tr> <tr><td>Stains:</td><td>None</td></tr> <tr><td>Non-illicit:</td><td>None</td></tr> </table>			Floatables:	None	Odor:	None	Turbidity:	None	Color:	None	Gross Solids:	Moderate	Vegetation:	None	Benthic Growth:	None	Stains:	None	Non-illicit:	None

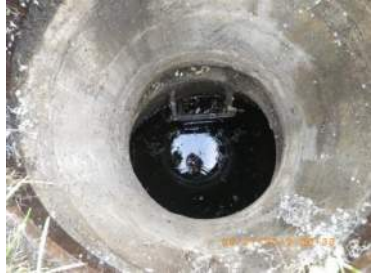
o20120927073352.JPG <div style="text-align: center; font-size: 24pt; font-weight: bold;">2012</div>

Inspection Date: 6/20/2012 8:08:37 AM		Type: Other	Flow: Submerged, indeterminate	Previous Rainfall (hrs): 24-48																																				
Illicit Discharge Potential: Unlikely		Inspector: JCW	Notes																																					
Submerged: Fully		Depth (in): 43	Gross solids pre-screening.

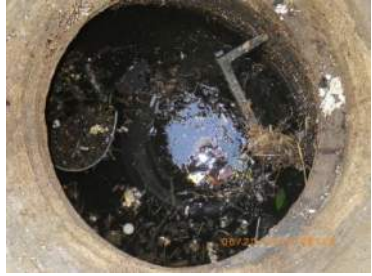
o20120620070908.JPG <div style="text-align: center; font-size: 24pt; font-weight: bold;">2012</div>

Inspection Date: 10/3/2011 10:30:08 AM		Type: Ongoing	Flow: Submerged, indeterminate	Previous Rainfall (hrs): 72+																																				
Illicit Discharge Potential: Potential		Inspector: JCW	Notes																																					
Submerged: Fully		Depth (in): 39	Significant floatable debris in manhole.

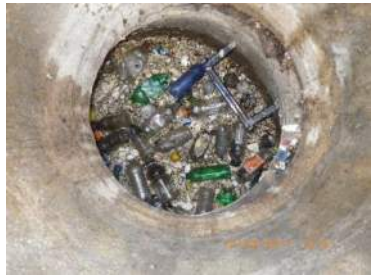
o20111003103104.JPG <div style="text-align: center; font-size: 24pt; font-weight: bold;">2011</div>

Inspection Date: 5/10/2011 8:51:00 AM		Type: Other	Flow: Submerged, indeterminate	Previous Rainfall (hrs): 0-24																																				
Illicit Discharge Potential: Potential		Inspector: JCW	Notes																																					
Submerged: Fully		Depth (in):	Limited screening conducted for upstream manhole prescreening.

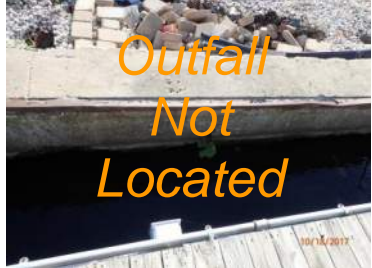
Inspection Date: 10/18/2017 3:22:08 PM		Type: Ongoing	Flow: Submerged (not located)	Previous Rainfall (hrs): 72+
Illicit Discharge Potential: Potential		Inspector: JCW		
Submerged: Fully		Depth (in):		
Sampling Results Sample Location: _____ Total Chlorine: -- ppm Free Chlorine: -- ppm Ammonia: -- ppm pH: -- units Temperature: -- °F Conductivity: -- µS/cm Detergents: -- mg/L		Floatables: None Odor: None Turbidity: None Color: None Gross Solids: None Vegetation: None Benthic Growth: None Stains: None Non-illicit: None	Notes Outfall fully submerged and not located - screened upstream at 03-22 US1. Floating gross solids (litter) in manhole.

o20171018151946.JPG 2017
		Condition Assessment Graffiti: None Erosion: None Deposition: None in. Damage: None

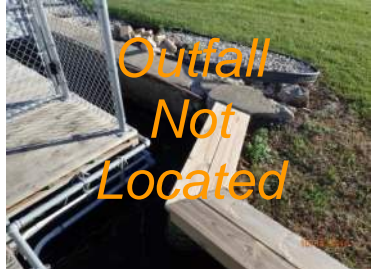
Inspection Date: 10/18/2016 4:04:35 PM		Type: Ongoing	Flow: Submerged (not located)	Previous Rainfall (hrs): 72+
Illicit Discharge Potential: Potential		Inspector: JCW		
Submerged: Fully		Depth (in):		
Sampling Results Sample Location: _____ Total Chlorine: -- ppm Free Chlorine: -- ppm Ammonia: -- ppm pH: -- units Temperature: -- °F Conductivity: -- µS/cm Detergents: -- mg/L		Floatables: None Odor: None Turbidity: None Color: None Gross Solids: None Vegetation: None Benthic Growth: None Stains: None Non-illicit: None	Notes Outfall not located and assumed submerged - screened upstream at 03-22 US1.

o20161018160304.JPG 2016
		Condition Assessment Graffiti: None Erosion: None Deposition: None in. Damage: None

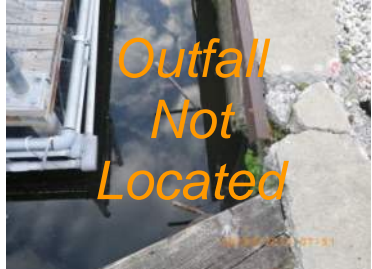
Inspection Date: 9/23/2015 7:47:01 AM		Type: Ongoing	Flow: Submerged (not located)	Previous Rainfall (hrs): 72+
Illicit Discharge Potential: Potential		Inspector: JCW		
Submerged: Fully		Depth (in):		
Sampling Results Sample Location: _____ Total Chlorine: -- ppm Free Chlorine: -- ppm Ammonia: -- ppm pH: -- units Temperature: -- °F Conductivity: -- µS/cm Detergents: -- mg/L		Floatables: None Odor: None Turbidity: None Color: None Gross Solids: None Vegetation: None Benthic Growth: None Stains: None Non-illicit: None	Notes Significant sinking above suspected pipe. Outfall not located - screened at 03-22 US1.

o20150923065132.JPG 2015
		Condition Assessment Graffiti: None Erosion: None Deposition: None in. Damage: Severe

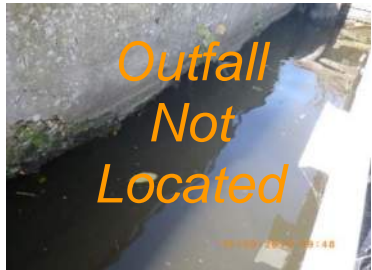
Inspection Date: 10/9/2014 9:47:52 AM		Type: Ongoing	Flow: Submerged (not located)	Previous Rainfall (hrs): 72+
Illicit Discharge Potential: Potential		Inspector: JCW		
Submerged: Fully		Depth (in):		
Sampling Results Sample Location: _____ Total Chlorine: -- ppm Free Chlorine: -- ppm Ammonia: -- ppm pH: -- units Temperature: -- °F Conductivity: -- µS/cm Detergents: -- mg/L		Floatables: None Odor: None Turbidity: None Color: None Gross Solids: None Vegetation: None Benthic Growth: None Stains: None Non-illicit: None	Notes Outfall fully submerged and not located - screened upstream at 03-22 US1.

o20141009084834.JPG 2014
		Condition Assessment Graffiti: None Erosion: None Deposition: None in. Damage: None

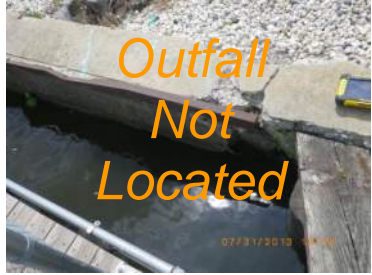
Notes 2012 screening follow-up. Outfall not located. Outfall screened upstream at 03-22 US1. Gross solids in upstream mh. Condition Assessment <table border="1" style="width:100%; border-collapse: collapse;"> <tr><td>Graffiti:</td><td>None</td></tr> <tr><td>Erosion:</td><td>None</td></tr> <tr><td>Deposition:</td><td>None in.</td></tr> <tr><td>Damage:</td><td>None</td></tr> </table>		Graffiti:	None	Erosion:	None	Deposition:	None in.	Damage:	None																											
Graffiti:	None																																					
Erosion:	None																																					
Deposition:	None in.																																					
Damage:	None

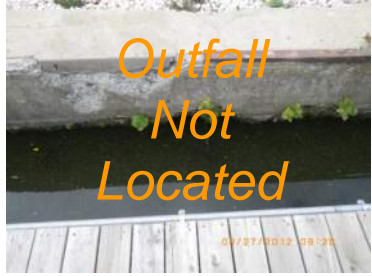
Notes Outfall fully submerged; screened upstream at 03-22 US1. Condition Assessment <table border="1" style="width:100%; border-collapse: collapse;"> <tr><td>Graffiti:</td><td>None</td></tr> <tr><td>Erosion:</td><td>None</td></tr> <tr><td>Deposition:</td><td>None in.</td></tr> <tr><td>Damage:</td><td>None</td></tr> </table>		Graffiti:	None	Erosion:	None	Deposition:	None in.	Damage:	None																											
Graffiti:	None																																					
Erosion:	None																																					
Deposition:	None in.																																					
Damage:	None

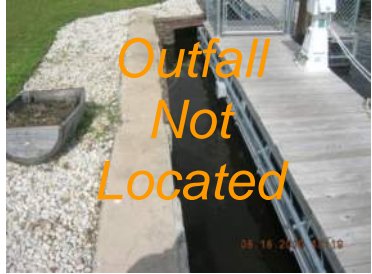
o20100818101918.JPG

Inspection Date: 8/18/2010 10:26:01 AM		Type: Ongoing	Flow: Submerged (not located)	Previous Rainfall (hrs): 72+
Illicit Discharge Potential: Potential		Inspector: JCW	Notes	
Submerged: Fully Depth (in):			Outfall fully submerged and not physically located. Outfall screened upstream at 03-22 US1.	
Sampling Results			Condition Assessment	
Sample Location:	Floatables:	None	Graffiti: None Erosion: None Deposition: None 0 in. Damage: None	
Total Chlorine: -- ppm	Odor:	None		
Free Chlorine: -- ppm	Turbidity:	None		
Ammonia: -- ppm	Color:	None		
pH: -- units	Gross Solids:	None		
Temperature -- °F	Vegetation:	None		
Conductivity: -- µS/cm	Benthic Growth:	None		
Detergents: -- mg/L	Stains:	None		
	Non-illicit:	None

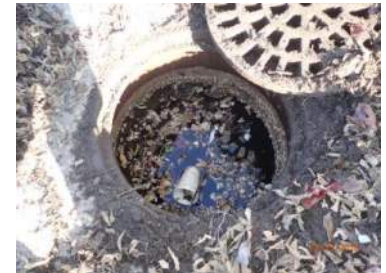
o20181022155408.JPG

**Inspection Date:** 10/22/2018 3:58:28 PM**Inspector:** JCW**Inspection Type:** Ongoing**Previous Rainfall (hrs):** 48-72**Flow Description:** Submerged, indeterminate

Damage: None ☐ Displacement ☐ Undercut ☐ Crushed☐ Corrosion ☐ Cracks/Structural Damage

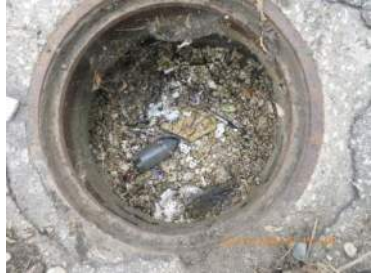
o20130731114610.JPG

Inspection Date: 7/31/2013 12:42:35 PM		Type: Ongoing		Flow: Submerged, indeterminate		Previous Rainfall (hrs): 72+	
Illicit Discharge Potential: Potential		Inspector: JCW		Notes 2012 screening follow-up. Significant gross solids - similar to previous years.

Submerged: Fully		Depth (in): 44					
Sampling Results		Floatables:		None		Condition Assessment Graffiti: None Erosion: None Deposition: None in. Damage: None	
Sample Location: Pool		Odor:		Faint			
Total Chlorine: 0 ppm		Turbidity:		None			
Free Chlorine: 0 ppm		Color:		Faint in bottle			
Ammonia: 0 ppm		Gross Solids:		Severe			
pH: 7.95 units		Vegetation:		None			
Temperature 76 °F		Benthic Growth:		None			
Conductivity: 450 µS/cm		Stains:		None			
Detergents: 0 mg/L		Non-illicit:		None

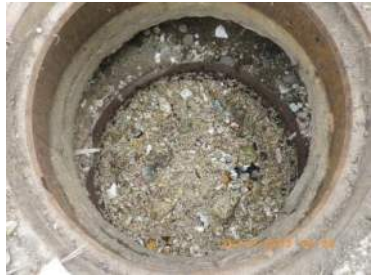
o20120927082922.JPG

Inspection Date: 9/27/2012 9:27:45 AM		Type: Ongoing		Flow: Submerged, indeterminate		Previous Rainfall (hrs): 72+	
Illicit Discharge Potential: Potential		Inspector: JCW		Notes 2011 gross solids follow-up.

Submerged: Fully		Depth (in): 39					
Sampling Results		Floatables:		None		Condition Assessment Graffiti: None Erosion: None Deposition: None in. Damage: None	
Sample Location: Pool		Odor:		None			
Total Chlorine: 0 ppm		Turbidity:		None			
Free Chlorine: 0 ppm		Color:		None			
Ammonia: 0 ppm		Gross Solids:		Severe			
pH: 8.32 units		Vegetation:		None			
Temperature 59 °F		Benthic Growth:		None			
Conductivity: 398 µS/cm		Stains:		None			
Detergents: 0 mg/L		Non-illicit:		None

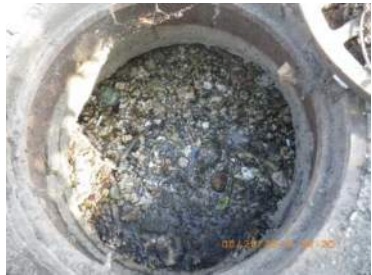
o20120620082508.JPG

Inspection Date: 6/20/2012 9:24:19 AM		Type: Other		Flow: Submerged, indeterminate		Previous Rainfall (hrs): 24-48	
Illicit Discharge Potential: Potential		Inspector: JCW		Notes Gross solids pre-screening.

Submerged: Fully		Depth (in): 46					
Sampling Results		Floatables:		None		Condition Assessment Graffiti: None Erosion: None Deposition: None in. Damage: None	
Sample Location:		Odor:		None			
Total Chlorine: -- ppm		Turbidity:		None			
Free Chlorine: -- ppm		Color:		None			
Ammonia: -- ppm		Gross Solids:		Severe			
pH: -- units		Vegetation:		None			
Temperature -- °F		Benthic Growth:		None			
Conductivity: -- µS/cm		Stains:		None			
Detergents: -- mg/L		Non-illicit:		None
