Ongoing Screening Summary Report 2018 Inspection Year

Illicit Discharge Detection and Elimination Program

City of Oshkosh

January 25, 2019

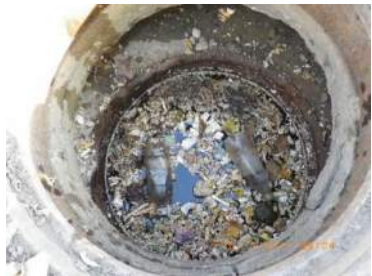
o20111011090446.JPG

Inspection Date: 10/11/2011 9:05:50 AM		Type: Ongoing		Flow: Submerged, indeterminate		Previous Rainfall (hrs): 72+	
Illicit Discharge Potential: Potential		Inspector: JCW		Notes 2010 screening follow-up. No significant change in volume of floatable debris.

Submerged: Fully		Depth (in): 37					
Sampling Results		Floatables:		None		Condition Assessment Graffiti: None Erosion: None Deposition: None 0 in. Damage: None	
Sample Location: Pool		Odor:		None			
Total Chlorine: 0 ppm		Turbidity:		None			
Free Chlorine: 0 ppm		Color:		None			
Ammonia: 0 ppm		Gross Solids:		Moderate			
pH: 8.13 units		Vegetation:		None			
Temperature 70 °F		Benthic Growth:		None			
Conductivity: -- µS/cm		Stains:		None			
Detergents: -- mg/L		Non-illicit:		None

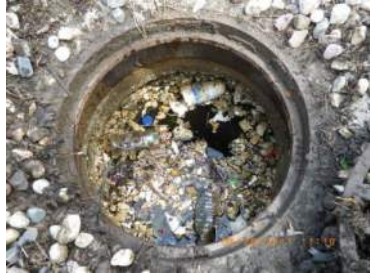
o20110526111930.JPG

Inspection Date: 5/26/2011 11:19:00 AM		Type: Other	Flow: Submerged, indeterminate	Previous Rainfall (hrs): 72+
Illicit Discharge Potential: Potential		Inspector: JCW	Notes	
Submerged: Fully		Depth (in):	Limited screening conducted to check for floatable debris.	
Sampling Results		Floatables:	Condition Assessment Graffiti: None Erosion: None Deposition: None 0 in. Damage: None	
Sample Location:		Odor:		
Total Chlorine: -- ppm		Turbidity:		
Free Chlorine: -- ppm		Color:		
Ammonia: -- ppm		Gross Solids: Moderate		
pH: -- units		Vegetation:		
Temperature -- °F		Benthic Growth:		
Conductivity: -- µS/cm		Stains:		
Detergents: -- mg/L		Non-illicit: None

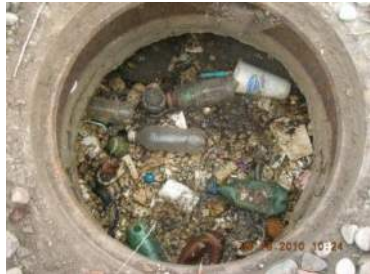
o20100818102410.JPG

Inspection Date: 8/18/2010 10:29:59 AM		Type: Ongoing	Flow: Submerged, indeterminate	Previous Rainfall (hrs): 72+
Illicit Discharge Potential: Potential		Inspector: JCW	Notes	
Submerged: Fully		Depth (in): 44	Severe floatable debris in catchbasin.	
Sampling Results		Floatables:	Condition Assessment Graffiti: None Erosion: None Deposition: None 0 in. Damage: None	
Sample Location: Pool		Odor:		
Total Chlorine: 0 ppm		Turbidity:		
Free Chlorine: 0 ppm		Color:		
Ammonia: 0 ppm		Gross Solids: Severe		
pH: 7.38 units		Vegetation:		
Temperature 76 °F		Benthic Growth:		
Conductivity: -- µS/cm		Stains:		
Detergents: 0 mg/L		Non-illicit: None

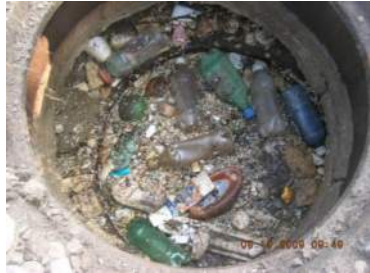
Osh09_DSCN6768.JPG

Inspection Date: 9/10/2009		Type: Initial	Flow: Submerged, indeterminate	Previous Rainfall (hrs): 72+
Illicit Discharge Potential: Potential		Inspector: JCW	Notes	
Submerged: Fully		Depth (in): 44	Abnormal detergent analysis result (bubbles). Significant floatables in manhole.	
Sampling Results		Floatables:	Condition Assessment Graffiti: None Erosion: None Deposition: None 0 in. Damage: None	
Sample Location: Pool		Odor:		
Total Chlorine: 0 ppm		Turbidity:		
Free Chlorine: 0 ppm		Color:		
Ammonia: -- ppm		Gross Solids: Severe		
pH: 8.3 units		Vegetation:		
Temperature 75 °F		Benthic Growth:		
Conductivity: -- µS/cm		Stains:		
Detergents: 0 mg/L		Non-illicit: None

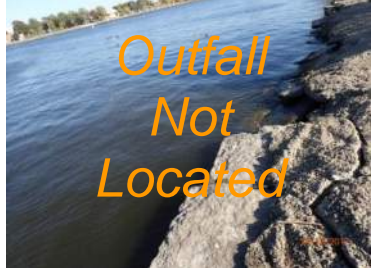
o20171018150844.JPG <div style="text-align: center; font-size: 24pt; font-weight: bold;">2017</div>

Inspection Date: 10/18/2017 3:15:43 PM		Type: Ongoing	Flow: Submerged (not located)	Previous Rainfall (hrs): 72+
Illicit Discharge Potential: Potential		Inspector: JCW		
Submerged: Fully		Depth (in):		
Sampling Results Sample Location: _____ Total Chlorine: -- ppm Free Chlorine: -- ppm Ammonia: -- ppm pH: -- units Temperature: -- °F Conductivity: -- µS/cm Detergents: -- mg/L		Floatables: None Odor: None Turbidity: None Color: None Gross Solids: None Vegetation: None Benthic Growth: None Stains: None Non-illicit: None	Notes Outfall fully submerged and not located - screened upstream at 03-35 US1. Floating gross solids (litter) in manhole. Condition Assessment Graffiti: None Erosion: None Deposition: None in. Damage: None

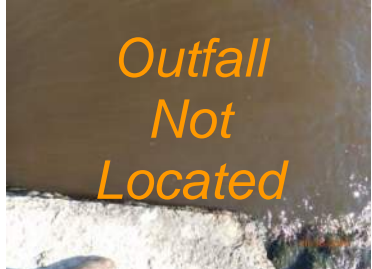
o20161010094930.JPG <div style="text-align: center; font-size: 24pt; font-weight: bold;">2016</div>

Inspection Date: 10/10/2016 9:52:05 AM		Type: Ongoing	Flow: Submerged (not located)	Previous Rainfall (hrs): 72+
Illicit Discharge Potential: Potential		Inspector: JCW		
Submerged: Fully		Depth (in):		
Sampling Results Sample Location: _____ Total Chlorine: -- ppm Free Chlorine: -- ppm Ammonia: -- ppm pH: -- units Temperature: -- °F Conductivity: -- µS/cm Detergents: -- mg/L		Floatables: None Odor: None Turbidity: None Color: None Gross Solids: None Vegetation: None Benthic Growth: None Stains: None Non-illicit: None	Notes Outfall fully submerged and not located - screened upstream at 03-35 US1. Condition Assessment Graffiti: None Erosion: None Deposition: None in. Damage: None

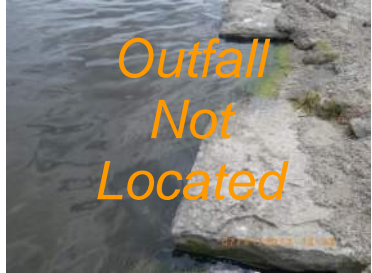
o20130731113304.JPG

Inspection Date: 7/31/2013 12:30:28 PM		Type: Ongoing	Flow: Submerged (not located)	Previous Rainfall (hrs): 72+
Illicit Discharge Potential: Potential		Inspector: JCW	Notes	
Submerged: Fully Depth (in):			2012 screening follow-up. Outfall not located. Outfall screened upstream at 03-35 US1. Gross solids in upstream mh.	
Sampling Results			Condition Assessment	
Sample Location:	Floatables:	None	Graffiti: None Erosion: None Deposition: None in. Damage: None	
Total Chlorine: -- ppm	Odor:	None		
Free Chlorine: -- ppm	Turbidity:	None		
Ammonia: -- ppm	Color:	None		
pH: -- units	Gross Solids:	None		
Temperature -- °F	Vegetation:	None		
Conductivity: -- µS/cm	Benthic Growth:	None		
Detergents: -- mg/L	Stains:	None		
	Non-illicit:	None

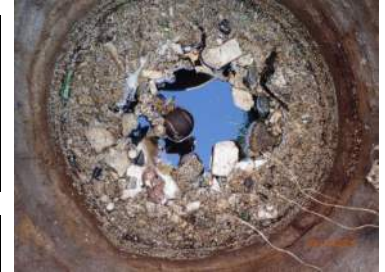
o20171018151012.JPG

Inspection Date: 10/18/2017 3:16:37 PM		Type: Ongoing	Flow: Submerged, indeterminate	Previous Rainfall (hrs): 72+
Illicit Discharge Potential: Potential		Inspector: JCW		
Submerged: Fully		Depth (in): 35		
Sampling Results		Notes Sample collected from submerged pool in manhole. Floating gross solids (litter) in manhole.		
Sample Location: Pool	Floatables: None	Condition Assessment Graffiti: None Erosion: None Deposition: None in. Damage: None		
Total Chlorine: 0 ppm	Odor: None			
Free Chlorine: 0 ppm	Turbidity: None			
Ammonia: 0 ppm	Color: None			
pH: 7.94 units	Gross Solids: Severe			
Temperature 66 °F	Vegetation: None			
Conductivity: 554 µS/cm	Benthic Growth: None			
Detergents: 0 mg/L	Stains: None			
	Non-illicit: None

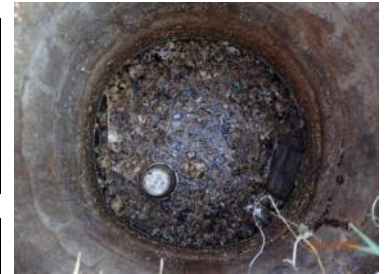
o20161010094958.JPG

Inspection Date: 10/10/2016 9:52:43 AM		Type: Ongoing	Flow: Submerged, indeterminate	Previous Rainfall (hrs): 72+
Illicit Discharge Potential: Potential		Inspector: JCW		
Submerged: Fully		Depth (in): 32		
Sampling Results		Notes Potential illicit discharge due to gross solids.		
Sample Location: Pool	Floatables: None	Condition Assessment Graffiti: None Erosion: None Deposition: None in. Damage: None		
Total Chlorine: 0 ppm	Odor: Faint			
Free Chlorine: 0 ppm	Turbidity: None			
Ammonia: 0 ppm	Color: None			
pH: 7.54 units	Gross Solids: Moderate			
Temperature 63 °F	Vegetation: None			
Conductivity: 391 µS/cm	Benthic Growth: None			
Detergents: 0 mg/L	Stains: None			
	Non-illicit: None

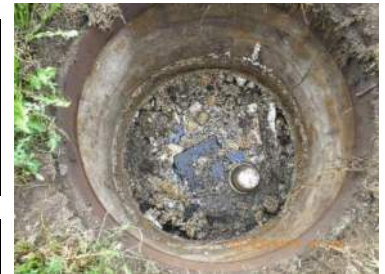
o20150923063950.JPG

Inspection Date: 9/23/2015 7:36:00 AM		Type: Ongoing	Flow: Submerged, indeterminate	Previous Rainfall (hrs): 72+
Illicit Discharge Potential: Potential		Inspector: JCW		
Submerged: Fully		Depth (in): 30		
Sampling Results		Notes Floating gross solids (litter) in manhole.		
Sample Location: Pool	Floatables: None	Condition Assessment Graffiti: None Erosion: None Deposition: Minor 1 in. Damage: None		
Total Chlorine: 0 ppm	Odor: None			
Free Chlorine: 0 ppm	Turbidity: None			
Ammonia: 0 ppm	Color: Faint in bottle			
pH: 8.64 units	Gross Solids: Moderate			
Temperature 69 °F	Vegetation: None			
Conductivity: 359 µS/cm	Benthic Growth: None			
Detergents: 0 mg/L	Stains: None			
	Non-illicit: None

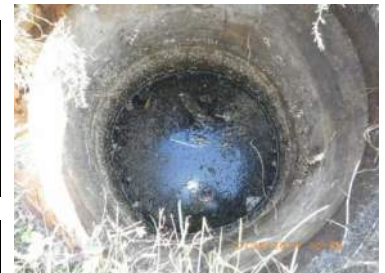
o20141009093356.JPG

Inspection Date: 10/9/2014 10:35:52 AM		Type: Ongoing	Flow: Submerged, indeterminate	Previous Rainfall (hrs): 72+
Illicit Discharge Potential: Unlikely		Inspector: JCW		
Submerged: Fully		Depth (in): 32		
Sampling Results		Notes Vegetative debris in photo from opening lid.		
Sample Location: Pool	Floatables: None	Condition Assessment Graffiti: None Erosion: None Deposition: Minor 1 in. Damage: None		
Total Chlorine: 0 ppm	Odor: None			
Free Chlorine: 0 ppm	Turbidity: None			
Ammonia: 0 ppm	Color: Faint in bottle			
pH: 7.86 units	Gross Solids: Slight			
Temperature 58 °F	Vegetation: None			
Conductivity: 476 µS/cm	Benthic Growth: None			
Detergents: 0 mg/L	Stains: None			
	Non-illicit: None

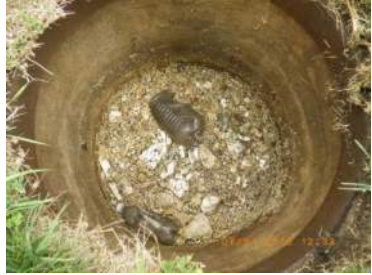
Inspection Date: 7/31/2013 12:31:00 PM		Type: Ongoing		Flow: Submerged, indeterminate		Previous Rainfall (hrs): 72+																											
Illicit Discharge Potential: Potential		Inspector: JCW		Notes 2012 screening follow-up. Significant gross solids. Similar to previous years.

Submerged: Fully		Depth (in): 33																															
Sampling Results		<table border="1" style="width:100%; border-collapse: collapse;"> <tr><td>Floatables:</td><td>None</td></tr> <tr><td>Odor:</td><td>None</td></tr> <tr><td>Turbidity:</td><td>None</td></tr> <tr><td>Color:</td><td>Faint in bottle</td></tr> <tr><td>Gross Solids:</td><td>Severe</td></tr> <tr><td>Vegetation:</td><td>None</td></tr> <tr><td>Benthic Growth:</td><td>None</td></tr> <tr><td>Stains:</td><td>Moderate</td></tr> <tr><td>Non-illicit:</td><td>None</td></tr> </table>		Floatables:	None	Odor:	None	Turbidity:	None	Color:	Faint in bottle	Gross Solids:	Severe	Vegetation:	None	Benthic Growth:	None	Stains:	Moderate	Non-illicit:	None	Condition Assessment		<table border="1" style="width:100%; border-collapse: collapse;"> <tr><td>Graffiti:</td><td>None</td></tr> <tr><td>Erosion:</td><td>None</td></tr> <tr><td>Deposition:</td><td>None in.</td></tr> <tr><td>Damage:</td><td>None</td></tr> </table>		Graffiti:	None	Erosion:	None	Deposition:	None in.	Damage:	None

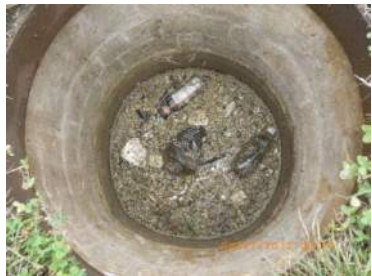
Inspection Date: 9/27/2012 9:13:54 AM		Type: Ongoing		Flow: Submerged, indeterminate		Previous Rainfall (hrs): 72+																											
Illicit Discharge Potential: Potential		Inspector: JCW		Notes 2011 gross solids follow-up.

Submerged: Fully		Depth (in): 31																															
Sampling Results		<table border="1" style="width:100%; border-collapse: collapse;"> <tr><td>Floatables:</td><td>None</td></tr> <tr><td>Odor:</td><td>None</td></tr> <tr><td>Turbidity:</td><td>None</td></tr> <tr><td>Color:</td><td>None</td></tr> <tr><td>Gross Solids:</td><td>Severe</td></tr> <tr><td>Vegetation:</td><td>None</td></tr> <tr><td>Benthic Growth:</td><td>None</td></tr> <tr><td>Stains:</td><td>Slight</td></tr> <tr><td>Non-illicit:</td><td>None</td></tr> </table>		Floatables:	None	Odor:	None	Turbidity:	None	Color:	None	Gross Solids:	Severe	Vegetation:	None	Benthic Growth:	None	Stains:	Slight	Non-illicit:	None	Condition Assessment		<table border="1" style="width:100%; border-collapse: collapse;"> <tr><td>Graffiti:</td><td>None</td></tr> <tr><td>Erosion:</td><td>None</td></tr> <tr><td>Deposition:</td><td>Minor 3 in.</td></tr> <tr><td>Damage:</td><td>None</td></tr> </table>		Graffiti:	None	Erosion:	None	Deposition:	Minor 3 in.	Damage:	None

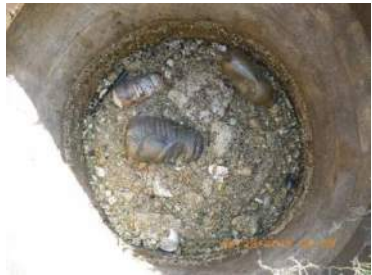
Inspection Date: 6/20/2012 9:08:12 AM		Type: Other		Flow: Submerged, indeterminate		Previous Rainfall (hrs): 24-48																											
Illicit Discharge Potential: Potential		Inspector: JCW		Notes Gross solids pre-screening.

Submerged: Fully		Depth (in): 39																															
Sampling Results		<table border="1" style="width:100%; border-collapse: collapse;"> <tr><td>Floatables:</td><td>None</td></tr> <tr><td>Odor:</td><td>None</td></tr> <tr><td>Turbidity:</td><td>None</td></tr> <tr><td>Color:</td><td>None</td></tr> <tr><td>Gross Solids:</td><td>Severe</td></tr> <tr><td>Vegetation:</td><td>None</td></tr> <tr><td>Benthic Growth:</td><td>None</td></tr> <tr><td>Stains:</td><td>None</td></tr> <tr><td>Non-illicit:</td><td>None</td></tr> </table>		Floatables:	None	Odor:	None	Turbidity:	None	Color:	None	Gross Solids:	Severe	Vegetation:	None	Benthic Growth:	None	Stains:	None	Non-illicit:	None	Condition Assessment		<table border="1" style="width:100%; border-collapse: collapse;"> <tr><td>Graffiti:</td><td>None</td></tr> <tr><td>Erosion:</td><td>None</td></tr> <tr><td>Deposition:</td><td>None in.</td></tr> <tr><td>Damage:</td><td>None</td></tr> </table>		Graffiti:	None	Erosion:	None	Deposition:	None in.	Damage:	None

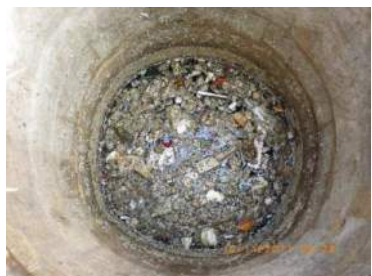
Inspection Date: 10/11/2011 9:29:50 AM		Type: Ongoing		Flow: Submerged, indeterminate		Previous Rainfall (hrs): 72+																											
Illicit Discharge Potential: Potential		Inspector: JCW		Notes 2010 screening follow-up. Floatable debris still present. Slight petroleum sheen.

Submerged: Fully		Depth (in): 19																															
Sampling Results		<table border="1" style="width:100%; border-collapse: collapse;"> <tr><td>Floatables:</td><td>Severe</td></tr> <tr><td>Odor:</td><td>None</td></tr> <tr><td>Turbidity:</td><td>None</td></tr> <tr><td>Color:</td><td>None</td></tr> <tr><td>Gross Solids:</td><td>Severe</td></tr> <tr><td>Vegetation:</td><td>None</td></tr> <tr><td>Benthic Growth:</td><td>None</td></tr> <tr><td>Stains:</td><td>None</td></tr> <tr><td>Non-illicit:</td><td>None</td></tr> </table>		Floatables:	Severe	Odor:	None	Turbidity:	None	Color:	None	Gross Solids:	Severe	Vegetation:	None	Benthic Growth:	None	Stains:	None	Non-illicit:	None	Condition Assessment		<table border="1" style="width:100%; border-collapse: collapse;"> <tr><td>Graffiti:</td><td>None</td></tr> <tr><td>Erosion:</td><td>None</td></tr> <tr><td>Deposition:</td><td>None 0 in.</td></tr> <tr><td>Damage:</td><td>None</td></tr> </table>		Graffiti:	None	Erosion:	None	Deposition:	None 0 in.	Damage:	None

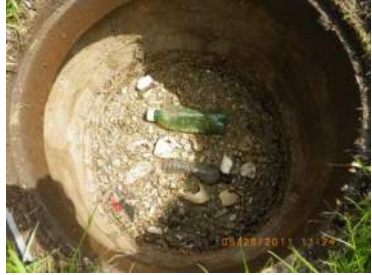
o20110526112400.JPG
2011

Inspection Date: 5/26/2011 11:23:00 AM		Type: Other	Flow: Submerged, indeterminate	Previous Rainfall (hrs): 72+
Illicit Discharge Potential: Potential		Inspector: JCW	Notes	
Submerged: Fully		Depth (in):	Limited screening conducted to check for floatable debris.	
Sampling Results		Floatables:	Condition Assessment Graffiti: None Erosion: None Deposition: None 0 in. Damage: None	
Sample Location:		Odor:		
Total Chlorine: -- ppm		Turbidity:		
Free Chlorine: -- ppm		Color:		
Ammonia: -- ppm		Gross Solids: Severe		
pH: -- units		Vegetation:		
Temperature -- °F		Benthic Growth:		
Conductivity: -- µS/cm		Stains:		
Detergents: -- mg/L		Non-illicit: None

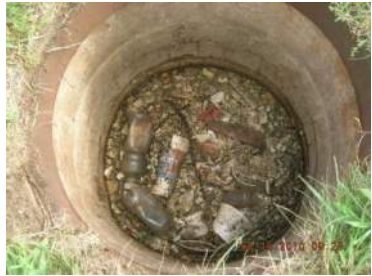
o20100818092304.JPG
2010

Inspection Date: 8/18/2010 9:32:06 AM		Type: Ongoing	Flow: Submerged, indeterminate	Previous Rainfall (hrs): 72+
Illicit Discharge Potential: Potential		Inspector: JCW	Notes	
Submerged: Fully		Depth (in): 34	Severe floatable debris in catchbasin.	
Sampling Results		Floatables:	Condition Assessment Graffiti: None Erosion: None Deposition: None 0 in. Damage: None	
Sample Location: Pool		Odor:		
Total Chlorine: 0 ppm		Turbidity:		
Free Chlorine: 0 ppm		Color:		
Ammonia: 0.5 ppm		Gross Solids: Severe		
pH: 7.46 units		Vegetation:		
Temperature 73 °F		Benthic Growth:		
Conductivity: -- µS/cm		Stains:		
Detergents: 0 mg/L		Non-illicit: None

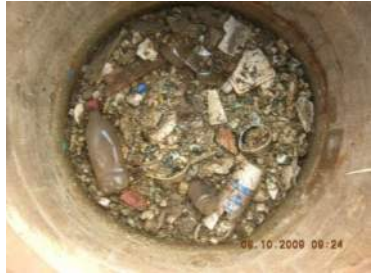
Osh09_DSCN6763.JPG
2009

Inspection Date: 9/10/2009		Type: Initial	Flow: Submerged, indeterminate	Previous Rainfall (hrs): 72+
Illicit Discharge Potential: Potential		Inspector: JCW	Notes	
Submerged: Fully		Depth (in): 33	Abnormal detergent analysis result (bubbles). Significant floatables in manhole.	
Sampling Results		Floatables:	Condition Assessment Graffiti: None Erosion: None Deposition: None 0 in. Damage: None	
Sample Location: Pool		Odor:		
Total Chlorine: 0 ppm		Turbidity:		
Free Chlorine: 0 ppm		Color:		
Ammonia: -- ppm		Gross Solids: Severe		
pH: 8.23 units		Vegetation:		
Temperature 73 °F		Benthic Growth:		
Conductivity: -- µS/cm		Stains:		
Detergents: 0 mg/L		Non-illicit: None

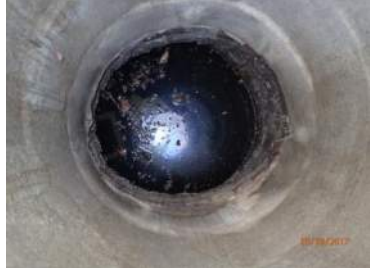
<p style="text-align: center;">o20171018145016.JPG</p> <p style="text-align: center; font-size: 24pt; font-weight: bold;">2017</p>

Sample Location:	Pool																																					
Total Chlorine:	0 ppm																																					
Free Chlorine:	0 ppm																																					
Ammonia:	1 ppm																																					
pH:	7.22 units																																					
Temperature:	66 °F																																					
Conductivity:	1020 µS/cm																																					
Detergents:	0.8 mg/L																																					
Floatables:	Moderate																																					
Odor:	None																																					
Turbidity:	None																																					
Color:	Faint in bottle																																					
Gross Solids:	Slight																																					
Vegetation:	None																																					
Benthic Growth:	None																																					
Stains:	None																																					
Non-illicit:	None

<div style="display: flex;"> <div style="flex: 1;"> <p>Notes</p> <p>Elevated ammonia and detergent in sample from manhole pool. Slight sheen observed on surface.</p> </div> <div style="flex: 1;"> <p>Condition Assessment</p> <table border="1" style="width:100%; border-collapse: collapse;"> <tr><td>Graffiti:</td><td>None</td></tr> <tr><td>Erosion:</td><td>None</td></tr> <tr><td>Deposition:</td><td>None in.</td></tr> <tr><td>Damage:</td><td>None</td></tr> </table> </div> </div>			Graffiti:	None	Erosion:	None	Deposition:	None in.	Damage:	None																										
Graffiti:	None																																					
Erosion:	None																																					
Deposition:	None in.																																					
Damage:	None

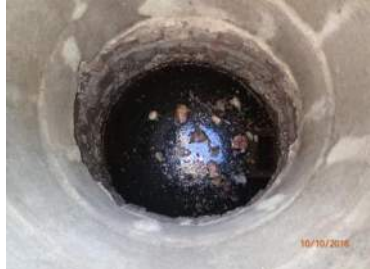
<p style="text-align: center;">o20161010090136.JPG</p> <p style="text-align: center; font-size: 24pt; font-weight: bold;">2016</p>

Sample Location:	Pool																																					
Total Chlorine:	0 ppm																																					
Free Chlorine:	0 ppm																																					
Ammonia:	1 ppm																																					
pH:	7.41 units																																					
Temperature:	63 °F																																					
Conductivity:	565 µS/cm																																					
Detergents:	0 mg/L																																					
Floatables:	Moderate																																					
Odor:	Faint																																					
Turbidity:	None																																					
Color:	Faint in bottle																																					
Gross Solids:	Slight																																					
Vegetation:	None																																					
Benthic Growth:	None																																					
Stains:	None																																					
Non-illicit:	None

<div style="display: flex;"> <div style="flex: 1;"> <p>Notes</p> <p>Potential illicit discharge due to gross solids and petroleum odor and sheen and elevated ammonia.</p> </div> <div style="flex: 1;"> <p>Condition Assessment</p> <table border="1" style="width:100%; border-collapse: collapse;"> <tr><td>Graffiti:</td><td>None</td></tr> <tr><td>Erosion:</td><td>None</td></tr> <tr><td>Deposition:</td><td>None in.</td></tr> <tr><td>Damage:</td><td>None</td></tr> </table> </div> </div>			Graffiti:	None	Erosion:	None	Deposition:	None in.	Damage:	None																										
Graffiti:	None																																					
Erosion:	None																																					
Deposition:	None in.																																					
Damage:	None

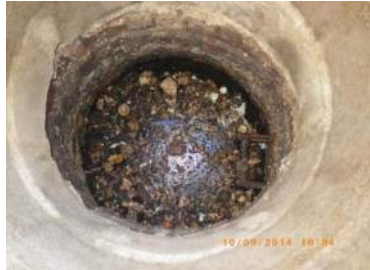
<p style="text-align: center;">o20141009090404.JPG</p> <p style="text-align: center; font-size: 24pt; font-weight: bold;">2014</p>

Sample Location:	Pool																																					
Total Chlorine:	0 ppm																																					
Free Chlorine:	0 ppm																																					
Ammonia:	0.5 ppm																																					
pH:	7.58 units																																					
Temperature:	58 °F																																					
Conductivity:	679 µS/cm																																					
Detergents:	0 mg/L																																					
Floatables:	Moderate																																					
Odor:	Faint																																					
Turbidity:	None																																					
Color:	None																																					
Gross Solids:	Severe																																					
Vegetation:	None																																					
Benthic Growth:	None																																					
Stains:	None																																					
Non-illicit:	None

<div style="display: flex;"> <div style="flex: 1;"> <p>Notes</p> <p>Petroleum odor and sheen on surface.</p> </div> <div style="flex: 1;"> <p>Condition Assessment</p> <table border="1" style="width:100%; border-collapse: collapse;"> <tr><td>Graffiti:</td><td>None</td></tr> <tr><td>Erosion:</td><td>None</td></tr> <tr><td>Deposition:</td><td>Minor 2 in.</td></tr> <tr><td>Damage:</td><td>None</td></tr> </table> </div> </div>			Graffiti:	None	Erosion:	None	Deposition:	Minor 2 in.	Damage:	None																										
Graffiti:	None																																					
Erosion:	None																																					
Deposition:	Minor 2 in.																																					
Damage:	None

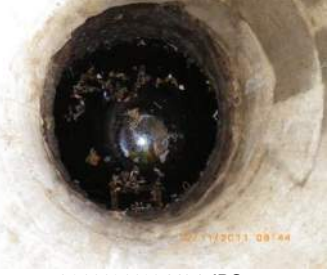
No apparent sources were readily identified during the field screening. This detergent discharge may be related to the detections at downstream outfalls 06-473, 06-494 and 06-610.

Table 10 - Sample results from outfall 13-471

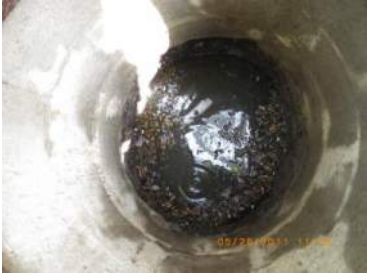
Additional information related to the investigation of this outfall is contained in Appendix D.

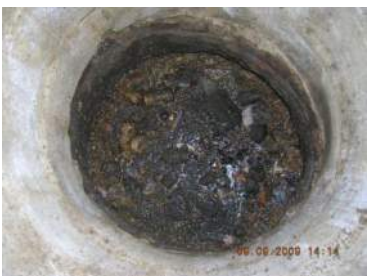
Because this outfall is a non-priority non-major outfall, it would normally be scheduled to be screened in 10 years. However, because of the potential illicit discharge, it will be scheduled to be rescreened in 2019. If the detergent is still present, and additional tracking will be performed.

Date	Location	Ammonia (ppm)	Detergent (mg/L)	pH	Conductivity (µS/cm)
9/3/2009	Manhole	N/A	0	8.04	N/A
6/12/2012	Manhole	0	0	7.64	982
10/24/2018	Manhole	0	0.3	7.56	1,107
10/26/2018	Manhole	0	0.35	7.66	1,082

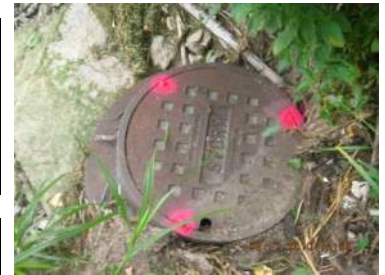
o20100817135854.JPG

Inspection Date: 8/17/2010 2:07:11 PM		Type: Ongoing	Flow: Submerged, indeterminate	Previous Rainfall (hrs): 72+
Illicit Discharge Potential: Potential		Inspector: JCW		
Submerged: Fully		Depth (in):		
Sampling Results		Notes Lid bolts rusted tight - could not access. Screened upstream at 03-173 US2.		
Sample Location:	Floatables:	None		
Total Chlorine: -- ppm	Odor:	None		
Free Chlorine: -- ppm	Turbidity:	None		
Ammonia: -- ppm	Color:	None		
pH: -- units	Gross Solids:	None		
Temperature -- °F	Vegetation:	None		
Conductivity: -- µS/cm	Benthic Growth:	None		
Detergents: -- mg/L	Stains:	None		
	Non-illicit:	None		
		Condition Assessment Graffiti: None Erosion: None Deposition: None 0 in. Damage: Moderate

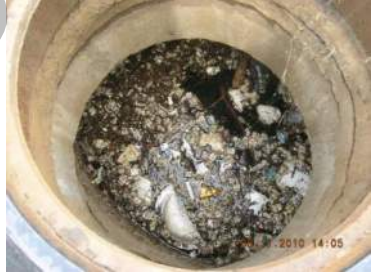
o20100817140504.JPG

Inspection Date: 8/17/2010 2:11:27 PM		Type: Ongoing	Flow: Submerged, indeterminate	Previous Rainfall (hrs): 72+
Illicit Discharge Potential: Potential		Inspector: JCW	Notes	
Submerged: Fully		Depth (in): 42	Floatable debris in manhole.	
Sampling Results				
Sample Location: Pool	Floatables:	None		
Total Chlorine: 0 ppm	Odor:	None		
Free Chlorine: 0 ppm	Turbidity:	None		
Ammonia: 0 ppm	Color:	None		
pH: 7.69 units	Gross Solids:	Moderate		
Temperature 77 °F	Vegetation:	None		
Conductivity: -- µS/cm	Benthic Growth:	None		
Detergents: 0 mg/L	Stains:	None		
	Non-illicit:	None		
			Condition Assessment	
			Graffiti:	None
			Erosion:	None
			Deposition:	None 0 in.
			Damage:	None

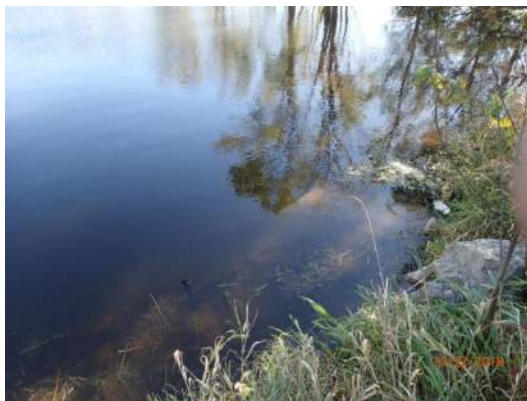
o20181022133904.JPG

Storm sewer from E 15th Ave discharges to lake from west. Original 27" CMP replaced prior to 2018 screening.

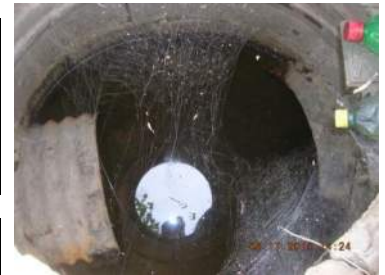
o20100817142402.JPG

Inspection Date: 8/17/2010 2:28:30 PM		Type: Ongoing	Flow: Submerged, indeterminate	Previous Rainfall (hrs): 72+
Illicit Discharge Potential: Unlikely		Inspector: JCW		
Submerged: Partially		Depth (in): 13		
Sampling Results				
Sample Location: Pool		Floatables:	None	
Total Chlorine: 0 ppm		Odor:	None	
Free Chlorine: 0 ppm		Turbidity:	None	
Ammonia: 0 ppm		Color:	None	
pH: 7.55 units		Gross Solids:	None	
Temperature: 76 °F		Vegetation:	None	
Conductivity: -- µS/cm		Benthic Growth:	None	
Detergents: 0 mg/L		Stains:	Slight	
		Non-illicit:	None	
Notes				
Broken manhole rings allow materials to enter manhole below casting.				
Condition Assessment				
Graffiti: None				
Erosion: None				
Deposition: None		0 in.		
Damage: Minor

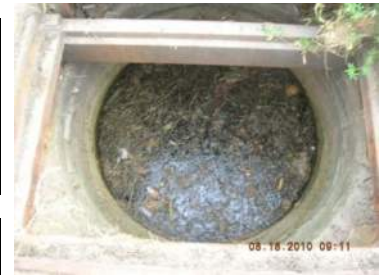
o20100818091114.JPG

Inspection Date: 8/18/2010 9:18:35 AM		Type: Ongoing	Flow: Submerged, indeterminate	Previous Rainfall (hrs): 72+								
Illicit Discharge Potential: Unlikely		Inspector: JCW										
Submerged: Fully		Depth (in): 25										
Sampling Results		Notes										
Sample Location: Pool	Floatables:	<table border="1"> <tr><td>Slight</td></tr> <tr><td>None</td></tr> <tr><td>None</td></tr> <tr><td>Faint in bottle</td></tr> <tr><td>None</td></tr> <tr><td>None</td></tr> <tr><td>None</td></tr> <tr><td>None</td></tr> </table>			Slight	None	None	Faint in bottle	None	None	None	None
Slight												
None												
None												
Faint in bottle												
None												
None												
None												
None												
Total Chlorine: 0 ppm	Odor:											
Free Chlorine: 0 ppm	Turbidity:											
Ammonia: 0 ppm	Color:											
pH: 7.37 units	Gross Solids:											
Temperature: 76 °F	Vegetation:

Conductivity: -- µS/cm	Benthic Growth:											
Detergents: 0 mg/L	Stains:	<table border="1"> <tr><td colspan="2">Condition Assessment</td></tr> <tr> <td>Graffiti: None</td> <td rowspan="3">0 in.</td> </tr> <tr> <td>Erosion: None</td> </tr> <tr> <td>Deposition: None</td> </tr> <tr> <td>Damage: None</td> <td></td> </tr> </table>			Condition Assessment		Graffiti: None	0 in.	Erosion: None	Deposition: None	Damage: None	
Condition Assessment												
Graffiti: None	0 in.											
Erosion: None												
Deposition: None												
Damage: None												
	Non-illicit:

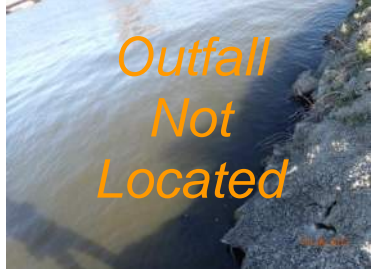
o20171018150108.JPG 2017

Inspection Date: 10/18/2017 3:02:59 PM		Type: Ongoing	Flow: Submerged (not located)	Previous Rainfall (hrs): 72+
Illicit Discharge Potential: Potential		Inspector: JCW		
Submerged: Fully		Depth (in):		
Sampling Results Sample Location: _____ Total Chlorine: -- ppm Free Chlorine: -- ppm Ammonia: -- ppm pH: -- units Temperature: -- °F Conductivity: -- µS/cm Detergents: -- mg/L		Floatables: None Odor: None Turbidity: None Color: None Gross Solids: None Vegetation: None Benthic Growth: None Stains: None Non-illicit: None	Notes Outfall fully submerged and not located - screened upstream at 03-381 US1. Floating gross solids (litter) in manhole. Condition Assessment Graffiti: None Erosion: None Deposition: None in. Damage: None

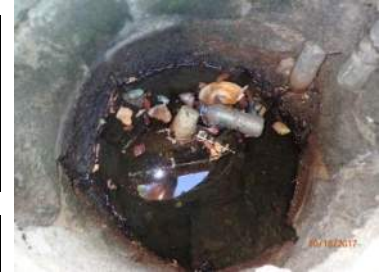
POTENTIAL ILLICIT DISCHARGES

Outfall	Detergent (mg/L)	IDDE Potential	Reason
13-2332 US1	0.3	Potential	Detergent detected in upstream manhole flow.
06-494 US1	0.3	Potential	Detergent detected in upstream manhole pool.
16-660 US1	0.35	Potential	Detergent detected in upstream manhole flow.
16-995 US1	0.4	Potential	Detergent detected in upstream manhole pool.
16-844	0.45	Potential	Detergent and elevated conductivity in flow from outfall.
13-3774	0.45	Potential	Detergent detected in flow from outfall.
06-610	0.5	Potential	Detergent detected in flow in manhole.
13-471	0.5	Potential	Detergent detected in flow from outfall.
06-473	0.5	Potential	Detergent detected in flow in manhole.
16-1205 US1	0.55	Potential	Detergent detected in upstream manhole pool.

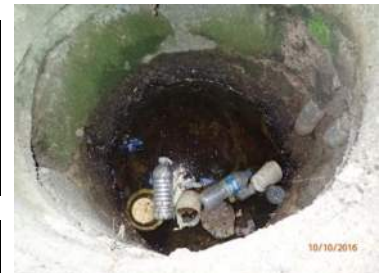
Table 4 – Outfalls with elevated illicit discharge classifications

- Unlikely – no significant physical or chemical evidence of current or past illicit discharge
- Potential – presence of physical and/or chemical indicators, but no strong visible evidence
- Obvious – visible and/or strong chemical evidence of current or past illicit discharge

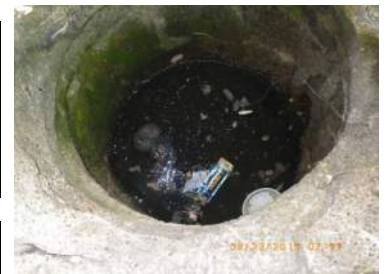
03-381	Potential	Persistent gross solids in upstream manhole (also present in 2010, 2011, 2014, 2015, 2016 and 2017).
05-14	Potential	Persistent gross solids in upstream manhole (also present in 2015, 2016 and 2017).
06-52	Potential	Persistent gross solids in upstream manhole (also present in 2010, 2011, 2014, 2015, 2016 and 2017).
06-216	Potential	Persistent gross solids in upstream manhole (also present in 2010).
06-221	Potential	Persistent gross solids in upstream manhole (also present in 2010, 2011, 2014, 2016 and 2017).
06-253	Potential	Elevated ammonia in upstream manhole sample (also present in 2017).
06-473	Potential	Detergent detected in manhole (outfall).
06-494	Potential	Detergent detected in manhole (outfall).

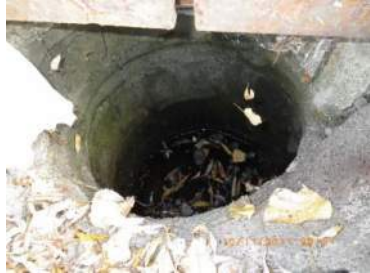
Inspection Date: 10/11/2011 9:52:43 AM		Type: Ongoing		Flow: Submerged, indeterminate		Previous Rainfall (hrs): 72+	
Illicit Discharge Potential: Unlikely		Inspector: JCW		Notes 2010 screening follow-up. Floatable debris significantly reduced.

o20111011095140.JPG	
Submerged: Fully		Depth (in): 12					
Sampling Results		Floatables: None Odor: Faint Turbidity: None Color: None Gross Solids: None Vegetation: None Benthic Growth: None Stains: None Non-illicit: None		Condition Assessment Graffiti: None Erosion: None Deposition: None 0 in. Damage: None		2011	
Sample Location: Pool Total Chlorine: 0 ppm Free Chlorine: 0 ppm Ammonia: 0 ppm pH: 7.1 units Temperature: 71 °F Conductivity: -- µS/cm Detergents: -- mg/L

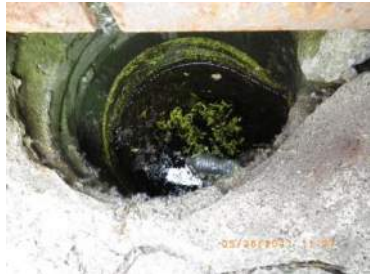
Inspection Date: 5/26/2011 11:27:00 AM		Type: Other		Flow: Submerged, indeterminate		Previous Rainfall (hrs): 72+	
Illicit Discharge Potential: Unlikely		Inspector: JCW		Notes Limited screening conducted to check for floatable debris.

o20110526112736.JPG	
Submerged: Fully		Depth (in):					
Sampling Results		Floatables: None Odor: Turbidity: Color: Gross Solids: Slight Vegetation: Benthic Growth: Stains: Non-illicit: None		Condition Assessment Graffiti: None Erosion: None Deposition: None 0 in. Damage: None		2011	
Sample Location: Total Chlorine: -- ppm Free Chlorine: -- ppm Ammonia: -- ppm pH: -- units Temperature: -- °F Conductivity: -- µS/cm Detergents: -- mg/L

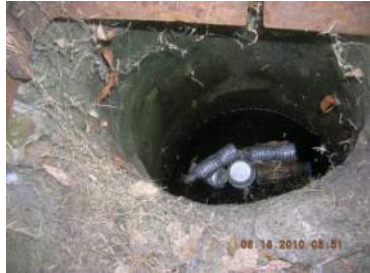
Inspection Date: 8/18/2010 9:03:59 AM		Type: Ongoing		Flow: Submerged, indeterminate		Previous Rainfall (hrs): 72+	
Illicit Discharge Potential: Potential		Inspector: JCW		Notes Floating debris, slight oil sheen in manhole.

o20100818085124.JPG	
Submerged: Fully		Depth (in): 13					
Sampling Results		Floatables: Moderate Odor: Faint Turbidity: None Color: Faint in bottle Gross Solids: Moderate Vegetation: None Benthic Growth: None Stains: None Non-illicit: None		Condition Assessment Graffiti: None Erosion: None Deposition: None 0 in. Damage: None		2010	
Sample Location: Pool Total Chlorine: 0 ppm Free Chlorine: 0 ppm Ammonia: 0 ppm pH: 7.13 units Temperature: 72 °F Conductivity: -- µS/cm Detergents: 0 mg/L

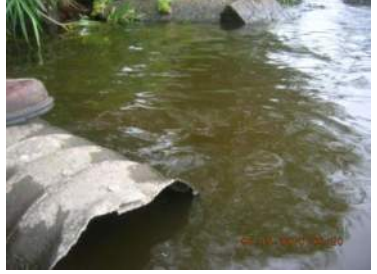
<p>o20100818082054.JPG</p> <p>2010</p>

Inspection Date: 8/18/2010 8:25:27 AM		Type: Ongoing	Flow: Submerged, indeterminate	Previous Rainfall (hrs): 72+
Illicit Discharge Potential: Unlikely		Inspector: JCW		
Submerged: Partially		Depth (in): 9		
Sampling Results		Notes Outfall partially submerged. Outfall screened upstream at 03-382 US1.		
Sample Location: Total Chlorine: -- ppm Free Chlorine: -- ppm Ammonia: -- ppm pH: -- units Temperature: -- °F Conductivity: -- µS/cm Detergents: -- mg/L		Condition Assessment Graffiti: None Erosion: None Deposition: None 0 in. Damage: None		
Floatables: None Odor: None Turbidity: None Color: None Gross Solids: None Vegetation: None Benthic Growth: Moderate Stains: Moderate Non-illicit: None

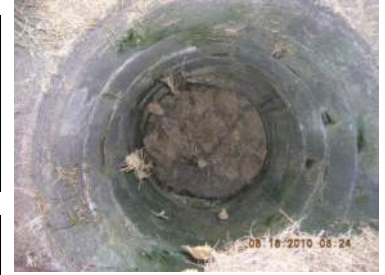
o20100818082432.JPG

Inspection Date: 8/18/2010 8:34:04 AM		Type: Ongoing	Flow: None	Previous Rainfall (hrs): 72+
Illicit Discharge Potential: Unlikely		Inspector: JCW		
Submerged: None		Depth (in):		
Sampling Results		Notes Dry bottom. Grass clipping build up.		
Sample Location:	Floatables:	None		
Total Chlorine: -- ppm	Odor:	None		
Free Chlorine: -- ppm	Turbidity:	None		
Ammonia: -- ppm	Color:	None		
pH: -- units	Gross Solids:	None		
Temperature -- °F	Vegetation:	None		
Conductivity: -- µS/cm	Benthic Growth:	None		
Detergents: -- mg/L	Stains:	None		
	Non-illicit:	None		
		Condition Assessment Graffiti: None Erosion: None Deposition: None 0 in. Damage: None

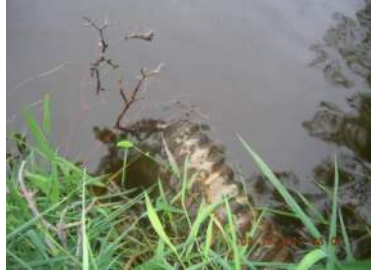
Inspection Date: 8/18/2010 8:10:24 AM		Type: Ongoing		Flow: Submerged, indeterminate		Previous Rainfall (hrs): 72+	
Illicit Discharge Potential: Unlikely		Inspector: JCW		Notes

<p>o20100818080520.JPG</p>	
Submerged: Fully		Depth (in): 10		Outfall fully submerged. Outfall screened upstream at 03-385 US1.			
Sampling Results				Condition Assessment			
Sample Location:		Floatables:	None	Graffiti:		None	0 in.
Total Chlorine: -- ppm		Odor:	None	Erosion:		None	
Free Chlorine: -- ppm		Turbidity:	None	Deposition:		None	
Ammonia: -- ppm		Color:	None	Damage:		None	
pH: -- units		Gross Solids:	None				
Temperature -- °F		Vegetation:	None				
Conductivity: -- µS/cm		Benthic Growth:	None				
Detergents: -- mg/L		Stains:	None				
		Non-illicit:	None

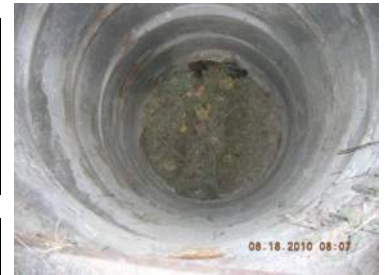
o20100818080728.JPG

Inspection Date: 8/18/2010 8:15:59 AM		Type: Ongoing	Flow: None	Previous Rainfall (hrs): 72+
Illicit Discharge Potential: Unlikely		Inspector: JCW		
Submerged: None		Depth (in):		
Sampling Results		Notes Dry bottom.		
Sample Location: Total Chlorine: -- ppm Free Chlorine: -- ppm Ammonia: -- ppm pH: -- units Temperature: -- °F Conductivity: -- µS/cm Detergents: -- mg/L		Floatables: None Odor: None Turbidity: None Color: None Gross Solids: None Vegetation: None Benthic Growth: None Stains: None Non-illicit: None		
		Condition Assessment Graffiti: None Erosion: None Deposition: None 0 in. Damage: None

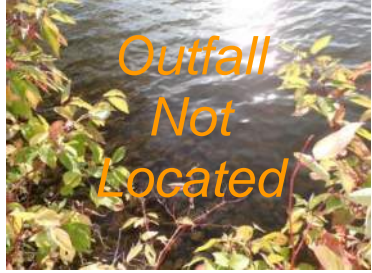
o20171017155038.JPG <div style="text-align: center; font-size: 24pt; font-weight: bold;">2017</div>

Inspection Date: 10/17/2017 3:57:26 PM		Type: Ongoing	Flow: Submerged (not located)	Previous Rainfall (hrs): 48-72
Illicit Discharge Potential: Potential		Inspector: JCW		
Submerged: Fully		Depth (in):		
Sampling Results Sample Location: _____ Total Chlorine: -- ppm Free Chlorine: -- ppm Ammonia: -- ppm pH: -- units Temperature: -- °F Conductivity: -- µS/cm Detergents: -- mg/L		Floatables: None Odor: None Turbidity: None Color: None Gross Solids: None Vegetation: None Benthic Growth: None Stains: None Non-illicit: None		
		Notes Outfall fully submerged and not located - screened upstream at 05-14 US1. Floating gross solids (litter) in manhole.		
		Condition Assessment Graffiti: None Erosion: None Deposition: None in. Damage: None

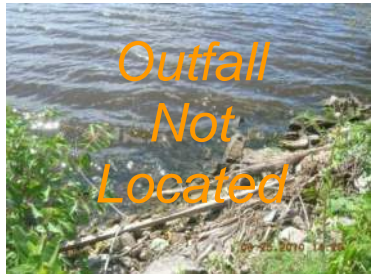
o20100825142900.JPG <div style="text-align: center; font-size: 24pt; font-weight: bold;">2010</div>

Inspection Date: 8/25/2010 2:37:24 PM		Type: Ongoing	Flow: Submerged (not located)	Previous Rainfall (hrs): 72+
Illicit Discharge Potential: Unlikely		Inspector: JCW		
Submerged: Fully		Depth (in):		
Sampling Results Sample Location: _____ Total Chlorine: -- ppm Free Chlorine: -- ppm Ammonia: -- ppm pH: -- units Temperature: -- °F Conductivity: -- µS/cm Detergents: -- mg/L		Floatables: None Odor: None Turbidity: None Color: None Gross Solids: None Vegetation: None Benthic Growth: None Stains: None Non-illicit: None		
		Notes Outfall fully submerged and not physically located. Outfall screened upstream at 05-14 US2.		
		Condition Assessment Graffiti: None Erosion: None Deposition: None 0 in. Damage: None

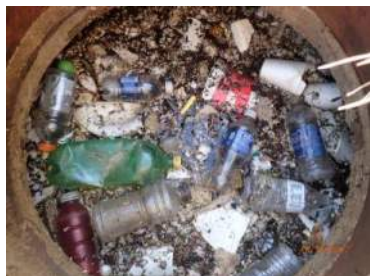
o20171017155256.JPG
2017

Inspection Date: 10/17/2017 3:58:36 PM		Type: Ongoing	Flow: Submerged, indeterminate	Previous Rainfall (hrs): 48-72
Illicit Discharge Potential: Potential		Inspector: JCW		
Submerged: Fully		Depth (in): 40		
Sampling Results		Notes Sample collected from submerged pool in manhole. Floating gross solids (litter) in manhole.		
Sample Location: Pool	Floatables: None	Condition Assessment Graffiti: None Erosion: None Deposition: None in. Damage: None		
Total Chlorine: 0 ppm	Odor: None			
Free Chlorine: 0 ppm	Turbidity: None			
Ammonia: 0 ppm	Color: None			
pH: 7.93 units	Gross Solids: Severe			
Temperature 66 °F	Vegetation: None			
Conductivity: 886 µS/cm	Benthic Growth: None			
Detergents: 0 mg/L	Stains: None			
	Non-illicit: None

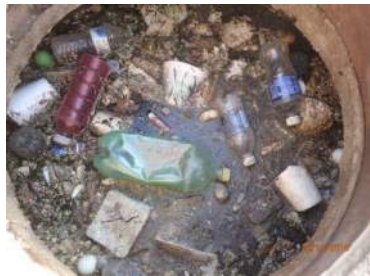
o20161010154428.JPG
2016

Inspection Date: 10/10/2016 3:46:48 PM		Type: Ongoing	Flow: Submerged, indeterminate	Previous Rainfall (hrs): 72+
Illicit Discharge Potential: Potential		Inspector: JCW		
Submerged: Fully		Depth (in): 41		
Sampling Results		Notes Potential illicit discharge due to gross solids.		
Sample Location: Pool	Floatables: None	Condition Assessment Graffiti: None Erosion: None Deposition: None in. Damage: None		
Total Chlorine: 0 ppm	Odor: None			
Free Chlorine: 0 ppm	Turbidity: None			
Ammonia: 0 ppm	Color: None			
pH: 7.69 units	Gross Solids: Severe			
Temperature 70 °F	Vegetation: None			
Conductivity: 660 µS/cm	Benthic Growth: None			
Detergents: 0 mg/L	Stains: None			
	Non-illicit: None

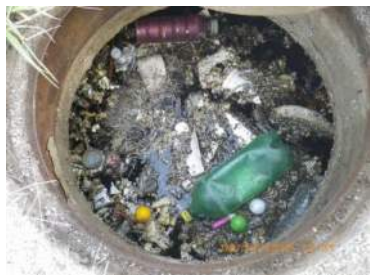
o20150924093714.JPG
2015

Inspection Date: 9/24/2015 10:36:18 AM		Type: Ongoing	Flow: Submerged, indeterminate	Previous Rainfall (hrs): 72+
Illicit Discharge Potential: Potential		Inspector: JCW		
Submerged: Fully		Depth (in): 44		
Sampling Results		Notes Floating gross solids (litter) in manhole.		
Sample Location: Pool	Floatables: None	Condition Assessment Graffiti: None Erosion: None Deposition: None in. Damage: None		
Total Chlorine: 0 ppm	Odor: None			
Free Chlorine: 0 ppm	Turbidity: None			
Ammonia: 0 ppm	Color: None			
pH: 7.98 units	Gross Solids: Severe			
Temperature 70 °F	Vegetation: None			
Conductivity: 424 µS/cm	Benthic Growth: None			
Detergents: 0 mg/L	Stains: None			
	Non-illicit: None

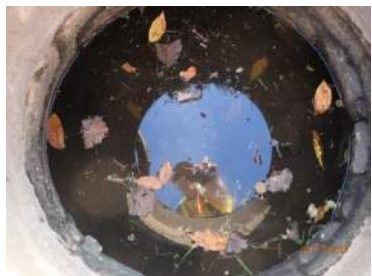
o20171017155840.JPG <div style="text-align: center; font-size: 24pt; font-weight: bold;">2017</div>

<div style="display: flex;"> <div style="flex: 1;"> <p>Notes</p> <p>Detergent detected in sample collected from submerged pool in manhole.</p> </div> <div style="flex: 1;"> <p>Condition Assessment</p> <table border="1" style="width:100%; border-collapse: collapse;"> <tr><td>Graffiti:</td><td>None</td></tr> <tr><td>Erosion:</td><td>None</td></tr> <tr><td>Deposition:</td><td>None in.</td></tr> <tr><td>Damage:</td><td>None</td></tr> </table> </div> </div>			Graffiti:	None	Erosion:	None	Deposition:	None in.	Damage:	None																										
Graffiti:	None																																					
Erosion:	None																																					
Deposition:	None in.																																					
Damage:	None

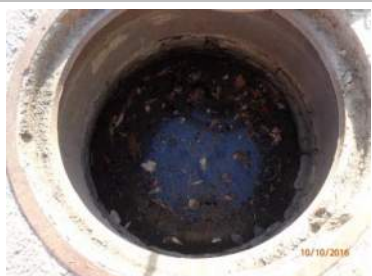
o20161010154822.JPG <div style="text-align: center; font-size: 24pt; font-weight: bold;">2016</div>

Sample Location:	Pool																																					
Total Chlorine:	0 ppm																																					
Free Chlorine:	0 ppm																																					
Ammonia:	0 ppm																																					
pH:	7.59 units																																					
Temperature:	69 °F																																					
Conductivity:	1551 µS/cm																																					
Detergents:	0 mg/L																																					
Floatables:	None																																					
Odor:	None																																					
Turbidity:	None																																					
Color:	None																																					
Gross Solids:	Moderate																																					
Vegetation:	None																																					
Benthic Growth:	None																																					
Stains:	None																																					
Non-illicit:	Slight

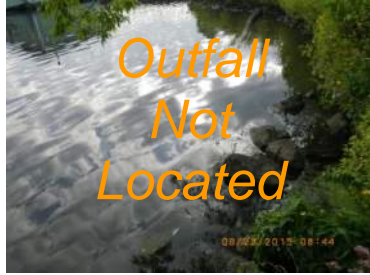
<div style="margin-left: 10px;"> <h2 style="color: orange; margin: 0;">Outfall Not Located</h2> <p style="color: black; font-size: 0.8em; margin: 0;">o20150923074404.JPG</p> <p style="color: black; font-size: 1.5em; font-weight: bold; margin: 0;">2015</p> </div> </div>

Inspection Date: 9/23/2015 8:40:05 AM		Type: Ongoing	Flow: Submerged (not located)	Previous Rainfall (hrs): 72+																		
Illicit Discharge Potential: Potential		Inspector: JCW	<div style="border: 1px solid black; padding: 5px;"> Notes Outfall fully submerged and not located - screened at 06-52 US1. </div>																			
Submerged: Fully Depth (in):																						
<div style="border: 1px solid black; padding: 5px;"> Sampling Results Sample Location: _____ Total Chlorine: -- ppm Free Chlorine: -- ppm Ammonia: -- ppm pH: -- units Temperature -- ° F Conductivity: -- µS/cm Detergents: -- mg/L </div>

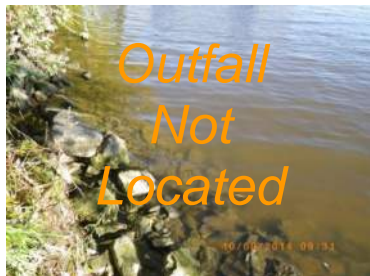
<div style="margin-left: 10px;"> <h2 style="color: orange; margin: 0;">Outfall Not Located</h2> <p style="color: black; font-size: 0.8em; margin: 0;">o20141009083144.JPG</p> <p style="color: black; font-size: 1.5em; font-weight: bold; margin: 0;">2014</p> </div> </div>

Inspection Date: 10/9/2014 9:32:21 AM		Type: Ongoing	Flow: Submerged (not located)	Previous Rainfall (hrs): 72+																		
Illicit Discharge Potential: Potential		Inspector: JCW	<div style="border: 1px solid black; padding: 5px;"> Notes Outfall fully submerged and not located - screened upstream at 06-52 US1. </div>																			
Submerged: Fully Depth (in):																						
<div style="border: 1px solid black; padding: 5px;"> Sampling Results Sample Location: _____ Total Chlorine: -- ppm Free Chlorine: -- ppm Ammonia: -- ppm pH: -- units Temperature -- ° F Conductivity: -- µS/cm Detergents: -- mg/L </div>

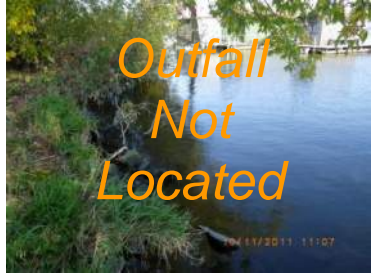
<p style="text-align: center;">o20111011110724.JPG</p> <p style="text-align: center; font-size: 24pt; font-weight: bold;">2011</p>

Inspection Date: 10/11/2011 11:06:46 AM		Type: Ongoing	Flow: Submerged (not located)	Previous Rainfall (hrs): 72+																																		
Illicit Discharge Potential: Unlikely		Inspector: JCW	Notes 2010 screening follow-up. Outfall fully submerged and not physically located. Outfall screened upstream at 06-52 US1.																																			
Submerged: Fully Depth (in):																																						
Sampling Results <table border="1" style="width: 100%; border-collapse: collapse;"> <tr> <td style="width: 50%;">Sample Location:</td> <td style="width: 50%;">Floatables:</td> <td>None</td> </tr> <tr> <td>Total Chlorine: -- ppm</td> <td>Odor:</td> <td>None</td> </tr> <tr> <td>Free Chlorine: -- ppm</td> <td>Turbidity:</td> <td>None</td> </tr> <tr> <td>Ammonia: -- ppm</td> <td>Color:</td> <td>None</td> </tr> <tr> <td>pH: -- units</td> <td>Gross Solids:</td> <td>None</td> </tr> <tr> <td>Temperature -- °F</td> <td>Vegetation:</td> <td>None</td> </tr> <tr> <td>Conductivity: -- µS/cm</td> <td>Benthic Growth:</td> <td>None</td> </tr> <tr> <td>Detergents: -- mg/L</td> <td>Stains:</td> <td>None</td> </tr> <tr> <td></td> <td>Non-illicit:</td> <td>None</td> </tr> </table>		Sample Location:	Floatables:	None	Total Chlorine: -- ppm	Odor:	None	Free Chlorine: -- ppm	Turbidity:	None	Ammonia: -- ppm	Color:	None	pH: -- units	Gross Solids:	None	Temperature -- °F	Vegetation:	None	Conductivity: -- µS/cm	Benthic Growth:	None	Detergents: -- mg/L	Stains:	None		Non-illicit:	None	Condition Assessment <table border="1" style="width: 100%; border-collapse: collapse;"> <tr> <td>Graffiti:</td> <td>None</td> </tr> <tr> <td>Erosion:</td> <td>None</td> </tr> <tr> <td>Deposition:</td> <td>None 0 in.</td> </tr> <tr> <td>Damage:</td> <td>None</td> </tr> </table>		Graffiti:	None	Erosion:	None	Deposition:	None 0 in.	Damage:	None

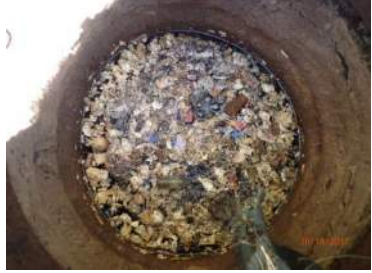
<p style="text-align: center;">o20171018112938.JPG</p> <p style="text-align: center; font-size: 24pt; font-weight: bold;">2017</p>	
Submerged: Fully		Depth (in): 40		Sample collected from submerged pool in manhole. Floating gross solids (litter) in manhole.			
Sampling Results							
Sample Location: Pool		Floatables:	None	Condition Assessment		Graffiti: None Erosion: None Deposition: None in. Damage: None	
Total Chlorine: 0 ppm		Odor:	None				
Free Chlorine: 0 ppm		Turbidity:	None				
Ammonia: 0 ppm		Color:	None				
pH: 8.39 units		Gross Solids:	Severe				
Temperature 65 °F		Vegetation:	None				
Conductivity: 403 µS/cm		Benthic Growth:	None				
Detergents: 0 mg/L		Stains:	None				
		Non-illicit:	None

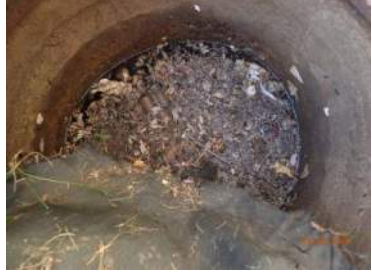
<p style="text-align: center;">o20161018145924.JPG</p> <p style="text-align: center; font-size: 24pt; font-weight: bold;">2016</p>	
Submerged: Fully		Depth (in):		Potential illicit discharge due to gross solids.			
Sampling Results							
Sample Location: Pool		Floatables:	None	Condition Assessment		Graffiti: None Erosion: None Deposition: None 0 in. Damage: None	
Total Chlorine: 0 ppm		Odor:	None				
Free Chlorine: 0 ppm		Turbidity:	None				
Ammonia: 0 ppm		Color:	None				
pH: 8.02 units		Gross Solids:	Moderate				
Temperature 67 °F		Vegetation:	None				
Conductivity: 418 µS/cm		Benthic Growth:	None				
Detergents: 0 mg/L		Stains:	None				
		Non-illicit:	None

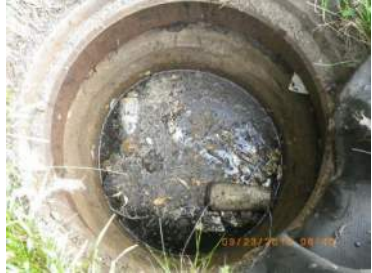
<p style="text-align: center;">o20150923074542.JPG</p> <p style="text-align: center; font-size: 24pt; font-weight: bold;">2015</p>	
Submerged: Fully		Depth (in): 44		Floating gross solids (litter) in manhole.			
Sampling Results							
Sample Location: Pool		Floatables:	None	Condition Assessment		Graffiti: None Erosion: None Deposition: None in. Damage: None	
Total Chlorine: 0 ppm		Odor:	None				
Free Chlorine: 0 ppm		Turbidity:	None				
Ammonia: 0 ppm		Color:	None				
pH: 8.74 units		Gross Solids:	Moderate				
Temperature 70 °F		Vegetation:	None				
Conductivity: 351 µS/cm		Benthic Growth:	None				
Detergents: 0 mg/L		Stains:	None				
		Non-illicit:	None

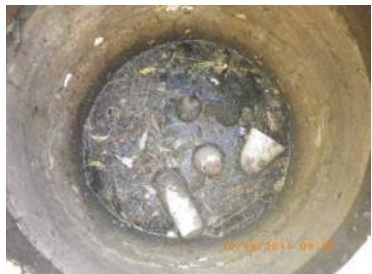
<p style="text-align: center;">o20141009083526.JPG</p> <p style="text-align: center; font-size: 24pt; font-weight: bold;">2014</p>	
Submerged: Fully		Depth (in): 35		Floating gross solids (litter) in manhole. Filter fabric installed in inlet.			
Sampling Results							
Sample Location: Pool		Floatables:	None	Condition Assessment		Graffiti: None Erosion: None Deposition: None in. Damage: None	
Total Chlorine: 0 ppm		Odor:	None				
Free Chlorine: 0 ppm		Turbidity:	Slight cloudiness				
Ammonia: 0 ppm		Color:	None				
pH: 7.82 units		Gross Solids:	Severe				
Temperature 56 °F		Vegetation:	None				
Conductivity: 471 µS/cm		Benthic Growth:	Slight				
Detergents: 0 mg/L		Stains:	None				
		Non-illicit:	None

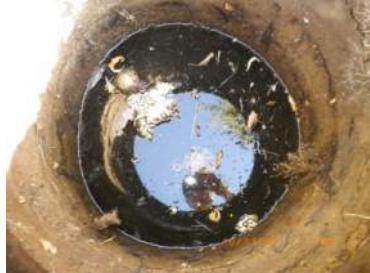
o20111011110824.JPG <div style="text-align: center; font-size: 24pt; font-weight: bold;">2011</div>

Inspection Date: 10/11/2011 11:09:29 AM		Type: Ongoing	Flow: Submerged, indeterminate	Previous Rainfall (hrs): 72+																											
Illicit Discharge Potential: Unlikely		Inspector: JCW	Notes 2010 screening follow-up. Floatable debris significantly reduced.																												
Submerged: Fully Depth (in): 35																															
Sampling Results

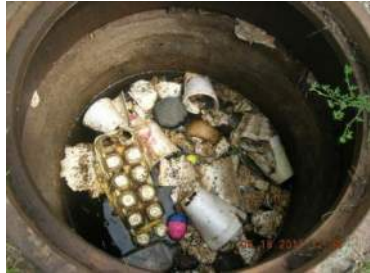
o20100818125018.JPG <div style="text-align: center; font-size: 24pt; font-weight: bold;">2010</div>

Inspection Date: 8/18/2010 1:00:07 PM		Type: Ongoing	Flow: Submerged, indeterminate	Previous Rainfall (hrs): 72+																											
Illicit Discharge Potential: Potential		Inspector: JCW	Notes Significant floatable debris in manhole.																												
Submerged: Fully Depth (in): 41																															
Sampling Results

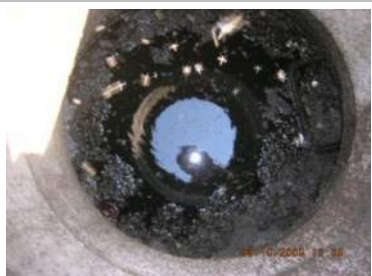
Osh09_DSCN6788.JPG 2009

Notes <div style="border: 1px solid black; height: 80px; width: 100%;"> River fly swarm inside manhole. </div>																																				
		Condition Assessment <table border="1" style="width: 100%; border-collapse: collapse;"> <tr> <td>Graffiti:</td> <td>None</td> </tr> <tr> <td>Erosion:</td> <td>None</td> </tr> <tr> <td>Deposition:</td> <td>None 0 in.</td> </tr> <tr> <td>Damage:</td> <td>None</td> </tr> </table>			Graffiti:	None	Erosion:	None	Deposition:	None 0 in.	Damage:	None																										
Graffiti:	None																																					
Erosion:	None																																					
Deposition:	None 0 in.																																					
Damage:	None

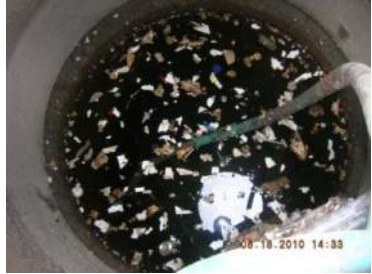
Inspection Date: 8/18/2010 2:43:51 PM		Type: Ongoing	Flow: Submerged, indeterminate	Previous Rainfall (hrs): 72+																																
Illicit Discharge Potential: Potential		Inspector: JCW	Notes Torn paper and other floatable debris in manhole.																																	
Submerged: Fully		Depth (in): 36

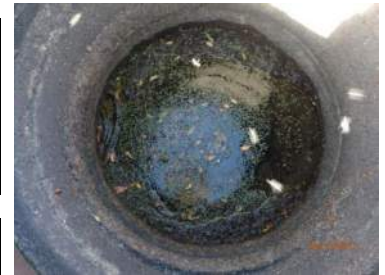
o20171019131708.JPG

Inspection Date: 10/19/2017 1:19:57 PM		Type: Ongoing	Flow: Submerged, slight flow	Previous Rainfall (hrs): 72+
Illicit Discharge Potential: Potential		Inspector: JCW		
Submerged: Fully		Depth (in): 40		
Sampling Results		Notes Sample collected from submerged flow in manhole. Elevated ammonia.		
Sample Location: Flow	Floatables: None	Condition Assessment Graffiti: None Erosion: None Deposition: None in. Damage: None		
Total Chlorine: 0 ppm	Odor: None			
Free Chlorine: 0 ppm	Turbidity: None			
Ammonia: 3 ppm	Color: None			
pH: 7.15 units	Gross Solids: None			
Temperature 68 °F	Vegetation: None			
Conductivity: 1990 µS/cm	Benthic Growth: None			
Detergents: 0 mg/L	Stains: None			
	Non-illicit: None

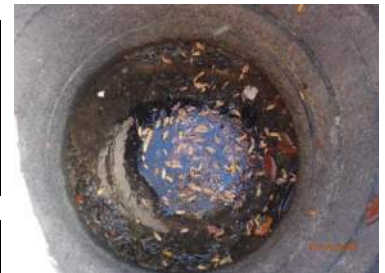
o20161018140148.JPG

Inspection Date: 10/18/2016 2:03:25 PM		Type: Ongoing	Flow: Submerged, significant flow	Previous Rainfall (hrs): 72+
Illicit Discharge Potential: Unlikely		Inspector: JCW		
Submerged: Fully		Depth (in): 40		
Sampling Results		Notes Strong current; significant flies in manhole.		
Sample Location: Flow	Floatables: None	Condition Assessment Graffiti: None Erosion: None Deposition: None in. Damage: None		
Total Chlorine: 0 ppm	Odor: Faint			
Free Chlorine: 0 ppm	Turbidity: None			
Ammonia: 0 ppm	Color: None			
pH: 7.01 units	Gross Solids: None			
Temperature 70 °F	Vegetation: None			
Conductivity: 1228 µS/cm	Benthic Growth: None			
Detergents: 0 mg/L	Stains: None			
	Non-illicit: None

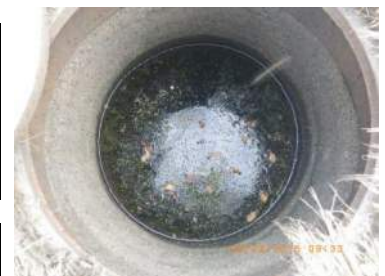
o20150923083310.JPG

Inspection Date: 9/23/2015 9:31:39 AM		Type: Ongoing	Flow: Submerged, significant flow	Previous Rainfall (hrs): 72+
Illicit Discharge Potential: Unlikely		Inspector: JCW		
Submerged: Fully		Depth (in): 42		
Sampling Results		Notes Significant current detected in pool. Many flies emerging from water.		
Sample Location: Pool	Floatables: None	Condition Assessment Graffiti: None Erosion: None Deposition: None in. Damage: None		
Total Chlorine: 0 ppm	Odor: None			
Free Chlorine: 0 ppm	Turbidity: None			
Ammonia: 0 ppm	Color: None			
pH: 7.53 units	Gross Solids: Slight			
Temperature 70 °F	Vegetation: None			
Conductivity: 1220 µS/cm	Benthic Growth: Slight			
Detergents: 0 mg/L	Stains: None			
	Non-illicit: None

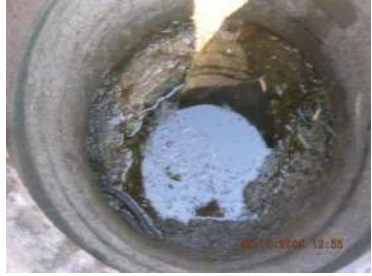
Inspection Date: 9/10/2009		Type: Initial		Flow: Submerged, slight flow		Previous Rainfall (hrs): 72+	
Illicit Discharge Potential: Unlikely		Inspector: JCW		Notes River fly swarm inside manhole.

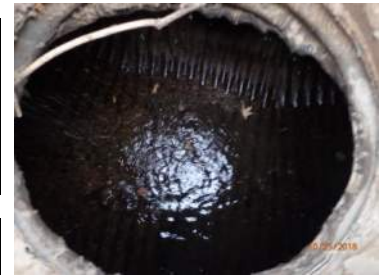
o20181025100244.JPG

Inspection Date: 10/25/2018 10:02:44 AM		Type: Ongoing	Flow: Submerged, slight flow	Previous Rainfall (hrs): 72+
Illicit Discharge Potential: Potential		Inspector: JCW		
Submerged: Partially		Depth (in): 2		
Sampling Results		Notes Sample collected from submerged pool in manhole. Detergent detected in sample.		
Sample Location: Flow	Floatables: None	Condition Assessment Graffiti: None Erosion: None Deposition: None in. Damage: None		
Total Chlorine: 0 ppm	Odor: None			
Free Chlorine: 0 ppm	Turbidity: None			
Ammonia: 0 ppm	Color: None			
pH: 8.15 units	Gross Solids: None			
Temperature 52 °F	Vegetation: None			
Conductivity: 1289 µS/cm	Benthic Growth: None			
Detergents: 0.5 mg/L	Stains: None			
	Non-illicit: None

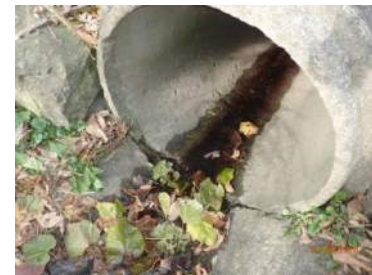
o20181025094334.JPG

Damage: Minor ☒ Displacement ☐ Undercut ☐ Crushed☐ Corrosion ☐ Cracks/Structural Damage

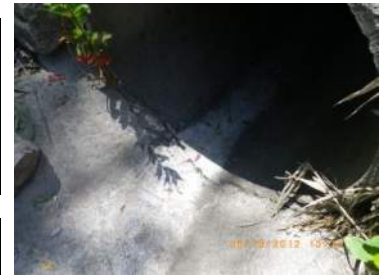
o20120613122416.JPG

Inspection Date: 6/13/2012 1:23:15 PM		Type: Ongoing	Flow: None	Previous Rainfall (hrs): 72+
Illicit Discharge Potential: Unlikely		Inspector: JCW		
Submerged: None		Depth (in):		
Sampling Results		Notes Pipe and downstream channel dry.		
Sample Location: Total Chlorine: -- ppm Free Chlorine: -- ppm Ammonia: -- ppm pH: -- units Temperature: -- °F Conductivity: -- µS/cm Detergents: -- mg/L		Floatables: None Odor: None Turbidity: None Color: None Gross Solids: None Vegetation: None Benthic Growth: None Stains: Moderate Non-illicit: None		
		Condition Assessment Graffiti: None Erosion: None Deposition: None in. Damage: None

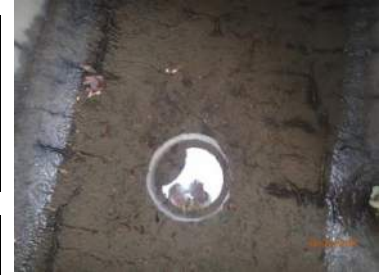
o20181025095732.JPG

Inspection Date: 10/25/2018 9:59:28 AM		Type: Ongoing	Flow: Submerged, indeterminate	Previous Rainfall (hrs): 72+
Illicit Discharge Potential: Potential		Inspector: JCW		
Submerged: Partially		Depth (in): 2		
Sampling Results		Notes Sample collected from submerged pool in manhole. Detergent detected in sample.		
Sample Location:	Pool	Floatables:	None	
Total Chlorine:	0 ppm	Odor:	None	
Free Chlorine:	0 ppm	Turbidity:	None	
Ammonia:	0 ppm	Color:	None	
pH:	8.09 units	Gross Solids:	None	
Temperature:	51 °F	Vegetation:	None	
Conductivity:	1272 µS/cm	Benthic Growth:	None	
Detergents:	0.5 mg/L	Stains:	None	
		Non-illicit:	None	
		Condition Assessment Graffiti: None Erosion: None Deposition: None in. Damage: None

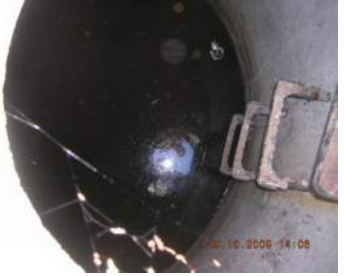
Osh09_DSCN6801.JPG

Inspection Date: 9/10/2009		Type: Initial		Flow: Submerged, indeterminate		Previous Rainfall (hrs): 72+	
Illicit Discharge Potential: Potential		Inspector: JCW		Notes Abnormal detergent analysis result (bubbles)
