Ongoing Screening Summary Report 2018 Inspection Year

Illicit Discharge Detection and Elimination Program

City of Oshkosh

January 25, 2019

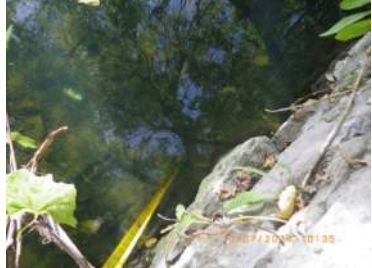
o20141007093522.JPG

Inspection Date: 10/7/2014 10:34:09 AM		Type: Ongoing	Flow: Submerged, indeterminate	Previous Rainfall (hrs): 48-72																																		
Illicit Discharge Potential: Unlikely		Inspector: JCW																																				
Submerged: Fully		Depth (in): 42																																				
Sampling Results <table border="1" style="width:100%; border-collapse: collapse;"> <tr><td>Sample Location:</td><td></td></tr> <tr><td>Total Chlorine:</td><td>-- ppm</td></tr> <tr><td>Free Chlorine:</td><td>-- ppm</td></tr> <tr><td>Ammonia:</td><td>-- ppm</td></tr> <tr><td>pH:</td><td>-- units</td></tr> <tr><td>Temperature:</td><td>-- °F</td></tr> <tr><td>Conductivity:</td><td>-- µS/cm</td></tr> <tr><td>Detergents:</td><td>-- mg/L</td></tr> </table>		Sample Location:		Total Chlorine:	-- ppm	Free Chlorine:	-- ppm	Ammonia:	-- ppm	pH:	-- units	Temperature:	-- °F	Conductivity:	-- µS/cm	Detergents:	-- mg/L	<table border="1" style="width:100%; border-collapse: collapse;"> <tr><td>Floatables:</td><td>None</td></tr> <tr><td>Odor:</td><td>None</td></tr> <tr><td>Turbidity:</td><td>None</td></tr> <tr><td>Color:</td><td>None</td></tr> <tr><td>Gross Solids:</td><td>None</td></tr> <tr><td>Vegetation:</td><td>None</td></tr> <tr><td>Benthic Growth:</td><td>Slight</td></tr> <tr><td>Stains:</td><td>None</td></tr> <tr><td>Non-illicit:</td><td>None</td></tr> </table>	Floatables:	None	Odor:	None	Turbidity:	None	Color:	None	Gross Solids:	None	Vegetation:	None	Benthic Growth:	Slight	Stains:	None	Non-illicit:	None	Notes Outfall fully submerged - screened upstream at 06-829 US1. Manhole lid in water near end of pipe.

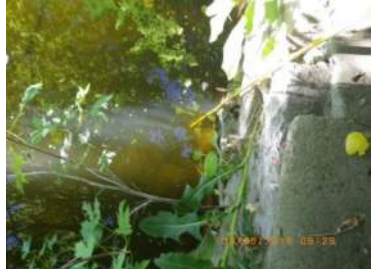
o20130905082920.JPG

Inspection Date: 9/5/2013 9:25:55 AM		Type: Ongoing	Flow: Submerged, indeterminate	Previous Rainfall (hrs): 72+																																		
Illicit Discharge Potential: Potential		Inspector: JCW																																				
Submerged: Fully		Depth (in): 45																																				
Sampling Results <table border="1" style="width:100%; border-collapse: collapse;"> <tr><td>Sample Location:</td><td></td></tr> <tr><td>Total Chlorine:</td><td>-- ppm</td></tr> <tr><td>Free Chlorine:</td><td>-- ppm</td></tr> <tr><td>Ammonia:</td><td>-- ppm</td></tr> <tr><td>pH:</td><td>-- units</td></tr> <tr><td>Temperature:</td><td>-- °F</td></tr> <tr><td>Conductivity:</td><td>-- µS/cm</td></tr> <tr><td>Detergents:</td><td>-- mg/L</td></tr> </table>		Sample Location:		Total Chlorine:	-- ppm	Free Chlorine:	-- ppm	Ammonia:	-- ppm	pH:	-- units	Temperature:	-- °F	Conductivity:	-- µS/cm	Detergents:	-- mg/L	<table border="1" style="width:100%; border-collapse: collapse;"> <tr><td>Floatables:</td><td>None</td></tr> <tr><td>Odor:</td><td>None</td></tr> <tr><td>Turbidity:</td><td>None</td></tr> <tr><td>Color:</td><td>None</td></tr> <tr><td>Gross Solids:</td><td>None</td></tr> <tr><td>Vegetation:</td><td>None</td></tr> <tr><td>Benthic Growth:</td><td>None</td></tr> <tr><td>Stains:</td><td>None</td></tr> <tr><td>Non-illicit:</td><td>None</td></tr> </table>	Floatables:	None	Odor:	None	Turbidity:	None	Color:	None	Gross Solids:	None	Vegetation:	None	Benthic Growth:	None	Stains:	None	Non-illicit:	None	Notes 2012 screening follow-up. Outfall fully submerged. Outfall screened upstream at 06-829 US1. Gross solids in upstream mh.

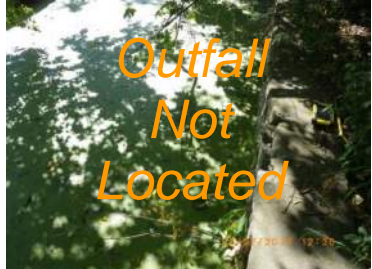
o20120927113654.JPG

Inspection Date: 9/27/2012 12:33:16 PM		Type: Ongoing	Flow: Submerged (not located)	Previous Rainfall (hrs): 72+																																		
Illicit Discharge Potential: Potential		Inspector: JCW																																				
Submerged: Fully		Depth (in):																																				
Sampling Results <table border="1" style="width:100%; border-collapse: collapse;"> <tr><td>Sample Location:</td><td></td></tr> <tr><td>Total Chlorine:</td><td>-- ppm</td></tr> <tr><td>Free Chlorine:</td><td>-- ppm</td></tr> <tr><td>Ammonia:</td><td>-- ppm</td></tr> <tr><td>pH:</td><td>-- units</td></tr> <tr><td>Temperature:</td><td>-- °F</td></tr> <tr><td>Conductivity:</td><td>-- µS/cm</td></tr> <tr><td>Detergents:</td><td>-- mg/L</td></tr> </table>		Sample Location:		Total Chlorine:	-- ppm	Free Chlorine:	-- ppm	Ammonia:	-- ppm	pH:	-- units	Temperature:	-- °F	Conductivity:	-- µS/cm	Detergents:	-- mg/L	<table border="1" style="width:100%; border-collapse: collapse;"> <tr><td>Floatables:</td><td>None</td></tr> <tr><td>Odor:</td><td>None</td></tr> <tr><td>Turbidity:</td><td>None</td></tr> <tr><td>Color:</td><td>None</td></tr> <tr><td>Gross Solids:</td><td>None</td></tr> <tr><td>Vegetation:</td><td>None</td></tr> <tr><td>Benthic Growth:</td><td>None</td></tr> <tr><td>Stains:</td><td>None</td></tr> <tr><td>Non-illicit:</td><td>None</td></tr> </table>	Floatables:	None	Odor:	None	Turbidity:	None	Color:	None	Gross Solids:	None	Vegetation:	None	Benthic Growth:	None	Stains:	None	Non-illicit:	None	Notes Outfall fully submerged; screened upstream at 06-829 US1.

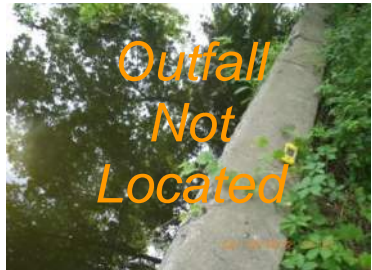
o20120613132730.JPG

Inspection Date: 6/13/2012 2:26:38 PM		Type: Other	Flow: Submerged (not located)	Previous Rainfall (hrs): 72+																																		
Illicit Discharge Potential: Potential		Inspector: JCW																																				
Submerged: Fully		Depth (in):																																				
Sampling Results <table border="1" style="width:100%; border-collapse: collapse;"> <tr><td>Sample Location:</td><td></td></tr> <tr><td>Total Chlorine:</td><td>-- ppm</td></tr> <tr><td>Free Chlorine:</td><td>-- ppm</td></tr> <tr><td>Ammonia:</td><td>-- ppm</td></tr> <tr><td>pH:</td><td>-- units</td></tr> <tr><td>Temperature:</td><td>-- °F</td></tr> <tr><td>Conductivity:</td><td>-- µS/cm</td></tr> <tr><td>Detergents:</td><td>-- mg/L</td></tr> </table>		Sample Location:		Total Chlorine:	-- ppm	Free Chlorine:	-- ppm	Ammonia:	-- ppm	pH:	-- units	Temperature:	-- °F	Conductivity:	-- µS/cm	Detergents:	-- mg/L	<table border="1" style="width:100%; border-collapse: collapse;"> <tr><td>Floatables:</td><td>None</td></tr> <tr><td>Odor:</td><td>None</td></tr> <tr><td>Turbidity:</td><td>None</td></tr> <tr><td>Color:</td><td>None</td></tr> <tr><td>Gross Solids:</td><td>None</td></tr> <tr><td>Vegetation:</td><td>None</td></tr> <tr><td>Benthic Growth:</td><td>None</td></tr> <tr><td>Stains:</td><td>None</td></tr> <tr><td>Non-illicit:</td><td>None</td></tr> </table>	Floatables:	None	Odor:	None	Turbidity:	None	Color:	None	Gross Solids:	None	Vegetation:	None	Benthic Growth:	None	Stains:	None	Non-illicit:	None	Notes Gross solids pre-screening.

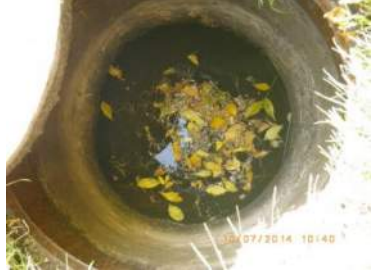
o20141007094030.JPG 2014

Notes Vegetative debris from opening lid.																																				
		Condition Assessment <table border="1" style="width:100%; border-collapse: collapse;"> <tr><td>Graffiti:</td><td>None</td></tr> <tr><td>Erosion:</td><td>None</td></tr> <tr><td>Deposition:</td><td>None in.</td></tr> <tr><td>Damage:</td><td>None</td></tr> </table>			Graffiti:	None	Erosion:	None	Deposition:	None in.	Damage:	None																										
Graffiti:	None																																					
Erosion:	None																																					
Deposition:	None in.																																					
Damage:	None

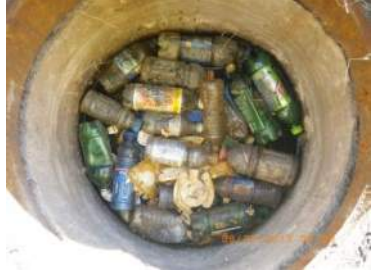
o20130905082002.JPG 2013

Notes 2012 screening follow-up. Significant gross solids in manhole - similar to previous years.																																				
		Condition Assessment <table border="1" style="width:100%; border-collapse: collapse;"> <tr><td>Graffiti:</td><td>None</td></tr> <tr><td>Erosion:</td><td>None</td></tr> <tr><td>Deposition:</td><td>None in.</td></tr> <tr><td>Damage:</td><td>None</td></tr> </table>			Graffiti:	None	Erosion:	None	Deposition:	None in.	Damage:	None																										
Graffiti:	None																																					
Erosion:	None																																					
Deposition:	None in.																																					
Damage:	None

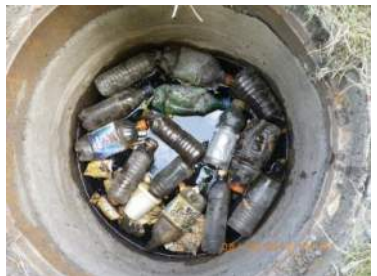
o20120613133100.JPG 2012

Notes Gross solids pre-screening. Bottles in manhole.																																				
		Condition Assessment <table border="1" style="width:100%; border-collapse: collapse;"> <tr><td>Graffiti:</td><td>None</td></tr> <tr><td>Erosion:</td><td>None</td></tr> <tr><td>Deposition:</td><td>None in.</td></tr> <tr><td>Damage:</td><td>None</td></tr> </table>			Graffiti:	None	Erosion:	None	Deposition:	None in.	Damage:	None																										
Graffiti:	None																																					
Erosion:	None																																					
Deposition:	None in.																																					
Damage:	None

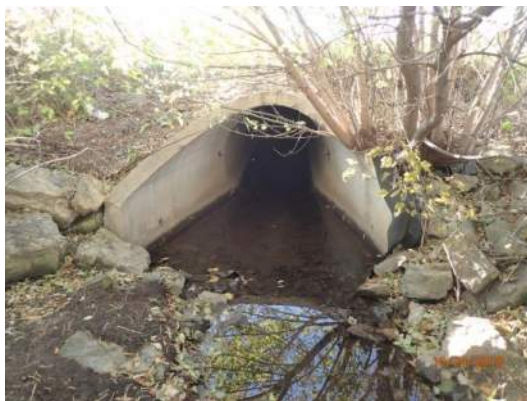
o20181024154708.JPG

Storm sewer from Witzel Ave discharges to stream from west via riprap channel.

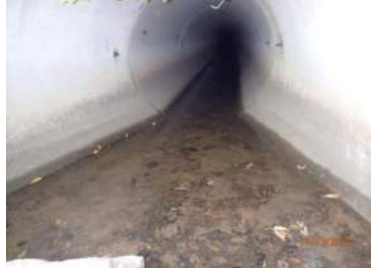
o20171003132032.JPG <div style="text-align: center; font-size: 24pt; font-weight: bold;">2017</div>

Inspection Date: 10/3/2017 1:22:33 PM		Type: Ongoing	Flow: Submerged, indeterminate	Previous Rainfall (hrs): 72+
Illicit Discharge Potential: Potential		Inspector: JCW		
Submerged: Partially		Depth (in): 2		
Sampling Results Sample Location: Pool Total Chlorine: 0 ppm Free Chlorine: 0 ppm Ammonia: 0 ppm pH: 7.55 units Temperature: 74 °F Conductivity: 623 µS/cm Detergents: 1 mg/L		Floatables: None Odor: None Turbidity: None Color: None Gross Solids: None Vegetation: None Benthic Growth: Slight Stains: Slight Non-illicit: None		
		Notes Outfall partially submerged - screened upstream at 06-1746 US1. Sample collected from outfall pool - detergent detected.		
		Condition Assessment Graffiti: None Erosion: None Deposition: None in. Damage: None

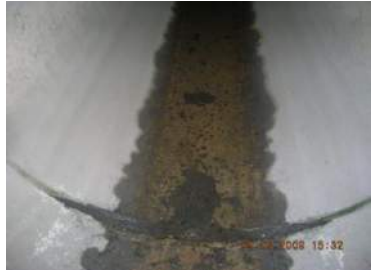
Osh09_DSCN6473.JPG <div style="text-align: center; font-size: 24pt; font-weight: bold;">2009</div>

Inspection Date: 9/3/2009		Type: Initial	Flow: None	Previous Rainfall (hrs): 72+
Illicit Discharge Potential: Unlikely		Inspector: JCW		
Submerged: None		Depth (in): 0		
Sampling Results Sample Location: Total Chlorine: -- ppm Free Chlorine: -- ppm Ammonia: -- ppm pH: -- units Temperature: -- °F Conductivity: -- µS/cm Detergents: -- mg/L		Floatables: Odor: Turbidity: Color: Gross Solids: Vegetation: Benthic Growth: Stains: Non-illicit: None		
		Notes Wet, no flow.		
		Condition Assessment Graffiti: None Erosion: None Deposition: None 0 in. Damage: None

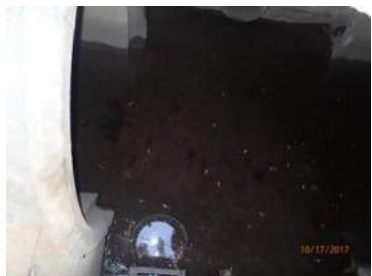
o20171017090542.JPG <div style="text-align: center; font-size: 24pt; font-weight: bold;">2017</div>
		Condition Assessment Graffiti: None Erosion: None Deposition: None in. Damage: None

Inspection Date: 10/17/2017 9:12:10 AM		Type: Repeat	Flow: Submerged, indeterminate	Previous Rainfall (hrs): 48-72
Illicit Discharge Potential: Unlikely		Inspector: JCW		
Submerged: Partially		Depth (in): 9		
Sampling Results Sample Location: Pool Total Chlorine: 0 ppm Free Chlorine: 0 ppm Ammonia: 0 ppm pH: 7.9 units Temperature: 60 °F Conductivity: 989 µS/cm Detergents: 0 mg/L		Floatables: None Odor: None Turbidity: None Color: None Gross Solids: None Vegetation: None Benthic Growth: Slight Stains: None Non-illicit: None	Notes Repeat inspection due to detergent. No detergent detected in manhole sample.

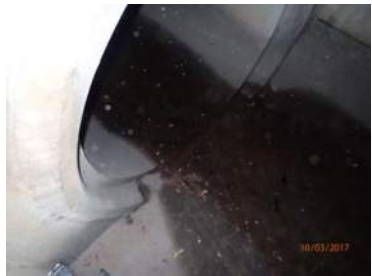
o20171003132832.JPG <div style="text-align: center; font-size: 24pt; font-weight: bold;">2017</div>
		Condition Assessment Graffiti: None Erosion: None Deposition: None in. Damage: None

Inspection Date: 10/3/2017 1:32:29 PM		Type: Ongoing	Flow: None	Previous Rainfall (hrs): 72+
Illicit Discharge Potential: Potential		Inspector: JCW		
Submerged: None		Depth (in):		
Sampling Results Sample Location: Total Chlorine: -- ppm Free Chlorine: -- ppm Ammonia: -- ppm pH: -- units Temperature: -- °F Conductivity: -- µS/cm Detergents: -- mg/L		Floatables: None Odor: None Turbidity: None Color: None Gross Solids: None Vegetation: None Benthic Growth: None Stains: Slight Non-illicit: None	Notes Flowline wet, but no flow at time of inspection. Detergent detected in sample from outfall pool.

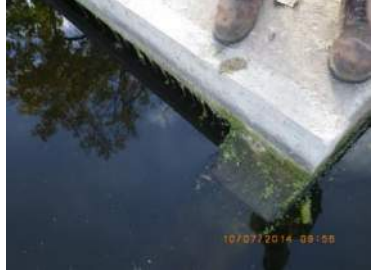
o20141007085606.JPG <div style="text-align: center; font-size: 24pt; font-weight: bold;">2014</div>
			Condition Assessment Graffiti: None Erosion: None Deposition: None in. Damage: None

Inspection Date: 10/7/2014 9:58:05 AM		Type: Ongoing	Flow: Submerged, indeterminate	Previous Rainfall (hrs): 48-72
Illicit Discharge Potential: Unlikely		Inspector: JCW		
Submerged: Partially		Depth (in): 46		
Sampling Results Sample Location: Total Chlorine: -- ppm Free Chlorine: -- ppm Ammonia: -- ppm pH: -- units Temperature: -- °F Conductivity: -- µS/cm Detergents: -- mg/L		Floatables: None Odor: None Turbidity: None Color: None Gross Solids: None Vegetation: None Benthic Growth: Moderate Stains: None Non-illicit: None	Notes Outfall partially submerged - screened upstream at 06-2241 US1.

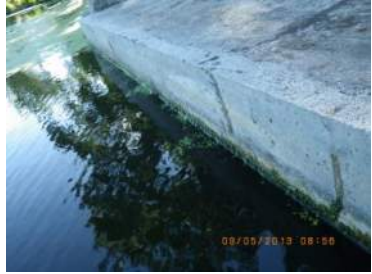
Inspection Date: 9/5/2013 8:49:36 AM		Type: Ongoing	Flow: Submerged, indeterminate	Previous Rainfall (hrs): 72+
Illicit Discharge Potential: Unlikely		Inspector: JCW		
Submerged: Fully		Depth (in): 44		
Sampling Results Sample Location: Total Chlorine: -- ppm Free Chlorine: -- ppm Ammonia: -- ppm pH: -- units Temperature: -- °F Conductivity: -- µS/cm Detergents: -- mg/L		Floatables: None Odor: None Turbidity: None Color: None Gross Solids: None Vegetation: None Benthic Growth: Severe Stains: None Non-illicit: None	Notes 2012 screening follow-up. Outfall fully submerged. Outfall screened upstream at 06-2241 US1.

o20130905075650.JPG <div style="text-align: center; font-size: 24pt; font-weight: bold;">2013</div>
			Condition Assessment Graffiti: None Erosion: None Deposition: None in. Damage: None

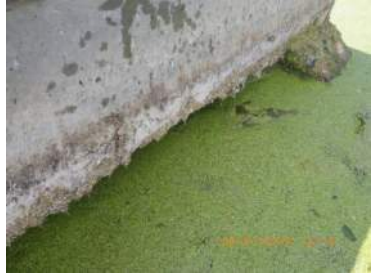
Inspection Date: 9/27/2012 12:15:16 PM		Type: Repeat	Flow: Submerged, indeterminate	Previous Rainfall (hrs): 72+
Illicit Discharge Potential: Unlikely		Inspector: JCW		
Submerged: Partially		Depth (in): 36		
Sampling Results Sample Location: Total Chlorine: -- ppm Free Chlorine: -- ppm Ammonia: -- ppm pH: -- units Temperature: -- °F Conductivity: -- µS/cm Detergents: -- mg/L		Floatables: None Odor: None Turbidity: None Color: None Gross Solids: None Vegetation: None Benthic Growth: None Stains: None Non-illicit: None	Notes Outfall partially submerged; screened upstream at 06-2241.

o20120927111938.JPG <div style="text-align: center; font-size: 24pt; font-weight: bold;">2012</div>
			Condition Assessment Graffiti: None Erosion: None Deposition: None in. Damage: None

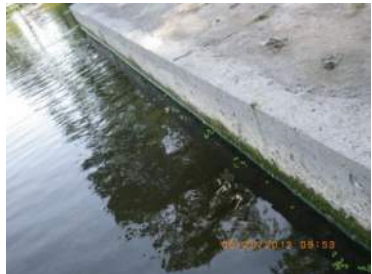
Inspection Date: 6/20/2012 9:50:33 AM		Type: Ongoing	Flow: Submerged, indeterminate	Previous Rainfall (hrs): 24-48
Illicit Discharge Potential: Potential		Inspector: JCW		
Submerged: Fully		Depth (in): 45		
Sampling Results Sample Location: Total Chlorine: -- ppm Free Chlorine: -- ppm Ammonia: -- ppm pH: -- units Temperature: -- °F Conductivity: -- µS/cm Detergents: -- mg/L		Floatables: None Odor: None Turbidity: None Color: None Gross Solids: None Vegetation: None Benthic Growth: Moderate Stains: None Non-illicit: None	Notes Outfall partially submerged; screened upstream at 06-2241 US1.

o20120620085346.JPG <div style="text-align: center; font-size: 24pt; font-weight: bold;">2012</div>
			Condition Assessment Graffiti: None Erosion: None Deposition: None in. Damage: None

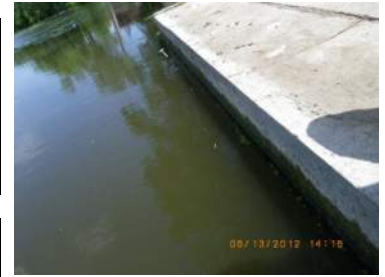
o20120613131558.JPG

Inspection Date: 6/13/2012 2:13:03 PM		Type: Other	Flow: Submerged, indeterminate	Previous Rainfall (hrs): 72+
Illicit Discharge Potential: Potential		Inspector: JCW		Notes Gross solids pre-screening.
Submerged: Fully		Depth (in): 45		
Sampling Results				
Sample Location:		Floatables:	None	
Total Chlorine:	-- ppm	Odor:	None	
Free Chlorine:	-- ppm	Turbidity:	None	
Ammonia:	-- ppm	Color:	None	
pH:	-- units	Gross Solids:	None	
Temperature	-- °F	Vegetation:	None	
Conductivity:	-- µS/cm	Benthic Growth:	None	
Detergents:	-- mg/L	Stains:	None	
		Non-illicit:	None	
Condition Assessment				
Graffiti:		None		
Erosion:		None		
Deposition:		None in.		
Damage:		None

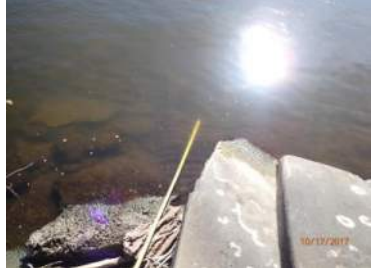
Inspection Date: 10/17/2017 1:56:02 PM		Type: Ongoing	Flow: Submerged, indeterminate	Previous Rainfall (hrs): 48-72
Illicit Discharge Potential: Potential		Inspector: JCW		
Submerged: Fully		Depth (in): 36		
Sampling Results Sample Location: _____ Total Chlorine: -- ppm Free Chlorine: -- ppm Ammonia: -- ppm pH: -- units Temperature: -- °F Conductivity: -- µS/cm Detergents: -- mg/L		Floatables: None Odor: None Turbidity: None Color: None Gross Solids: None Vegetation: None Benthic Growth: None Stains: None Non-illicit: None	Notes Outfall fully submerged with approx 9" of water over crown of pipe - screened upstream at 08-284 US1. Floating gross solids (litter) in manhole. Condition Assessment Graffiti: None Erosion: None Deposition: None in. Damage: None

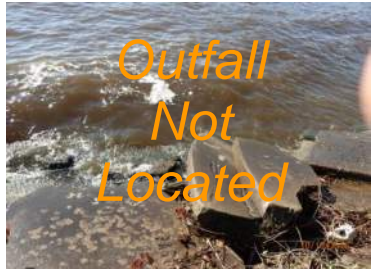
Inspection Date: 10/10/2016 10:18:48 AM		Type: Ongoing	Flow: Submerged (not located)	Previous Rainfall (hrs): 72+
Illicit Discharge Potential: Potential		Inspector: JCW		
Submerged: Fully		Depth (in):		
Sampling Results Sample Location: _____ Total Chlorine: -- ppm Free Chlorine: -- ppm Ammonia: -- ppm pH: -- units Temperature: -- °F Conductivity: -- µS/cm Detergents: -- mg/L		Floatables: None Odor: None Turbidity: None Color: None Gross Solids: None Vegetation: None Benthic Growth: None Stains: None Non-illicit: None	Notes Outfall fully submerged and not located - screened upstream at 08-284 US1. Condition Assessment Graffiti: None Erosion: None Deposition: None in. Damage: None

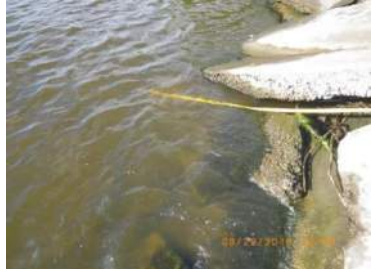
Inspection Date: 9/22/2015 10:04:59 AM		Type: Ongoing	Flow: Submerged, indeterminate	Previous Rainfall (hrs): 72+
Illicit Discharge Potential: Potential		Inspector: JCW		
Submerged: Fully		Depth (in): 30		
Sampling Results Sample Location: _____ Total Chlorine: -- ppm Free Chlorine: -- ppm Ammonia: -- ppm pH: -- units Temperature: -- °F Conductivity: -- µS/cm Detergents: -- mg/L		Floatables: None Odor: None Turbidity: None Color: None Gross Solids: None Vegetation: None Benthic Growth: Moderate Stains: None Non-illicit: None	Notes Outfall fully submerged - screened at 08-284 US1. Condition Assessment Graffiti: None Erosion: None Deposition: None in. Damage: None

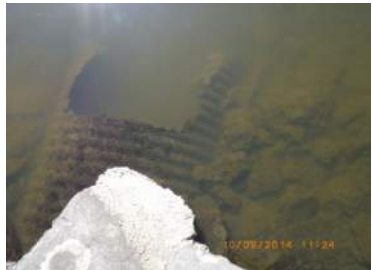
Inspection Date: 10/9/2014 11:24:44 AM		Type: Ongoing	Flow: Submerged, indeterminate	Previous Rainfall (hrs): 72+
Illicit Discharge Potential: Potential		Inspector: JCW		
Submerged: Fully		Depth (in): 29		
Sampling Results Sample Location: _____ Total Chlorine: -- ppm Free Chlorine: -- ppm Ammonia: -- ppm pH: -- units Temperature: -- °F Conductivity: -- µS/cm Detergents: -- mg/L		Floatables: None Odor: None Turbidity: None Color: None Gross Solids: None Vegetation: None Benthic Growth: None Stains: None Non-illicit: None	Notes Outfall fully submerged - screened upstream at 08-284 US1. Condition Assessment Graffiti: None Erosion: None Deposition: Minor 3 in. Damage: Minor

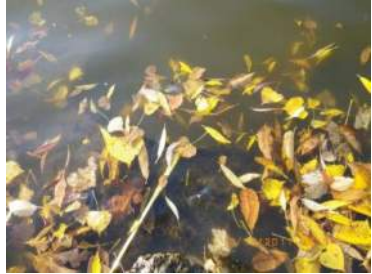
Inspection Date: 10/11/2011 8:37:04 AM		Type: Ongoing		Flow: Submerged, indeterminate		Previous Rainfall (hrs): 72+	
Illicit Discharge Potential: Unlikely		Inspector: JCW		Notes 2010 screening follow-up. Outfall fully submerged. Outfall screened upstream at 08-284 US1.

o20111011083728.JPG	
Submerged: Fully		Depth (in): 25					
Sampling Results Sample Location: _____ Total Chlorine: -- ppm Free Chlorine: -- ppm Ammonia: -- ppm pH: -- units Temperature: -- °F Conductivity: -- µS/cm Detergents: -- mg/L		Floatables: None Odor: None Turbidity: None Color: None Gross Solids: None Vegetation: None Benthic Growth: None Stains: None Non-illicit: None		Condition Assessment Graffiti: None Erosion: None Deposition: None 0 in. Damage: None		<div style="text-align: center; font-size: 24pt; font-weight: bold;">2011</div>

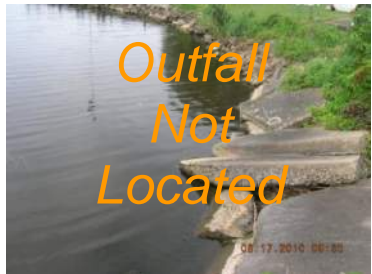
Inspection Date: 8/17/2010 9:35:00 AM		Type: Ongoing		Flow: Submerged (not located)		Previous Rainfall (hrs): 72+	
Illicit Discharge Potential: Potential		Inspector: JCW		Notes Outfall fully submerged and not physically located. Outfall screened upstream at 08-284 US1.

o20100817093554.JPG	
Submerged: Fully		Depth (in):					
Sampling Results Sample Location: _____ Total Chlorine: -- ppm Free Chlorine: -- ppm Ammonia: -- ppm pH: -- units Temperature: -- °F Conductivity: -- µS/cm Detergents: -- mg/L		Floatables: None Odor: None Turbidity: None Color: None Gross Solids: None Vegetation: None Benthic Growth: None Stains: None Non-illicit: None		Condition Assessment Graffiti: None Erosion: None Deposition: None 0 in. Damage: None		<div style="text-align: center; font-size: 24pt; font-weight: bold;">2010</div>

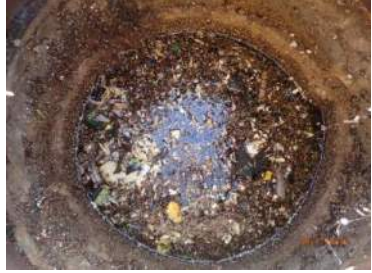
o20171017135518.JPG 2017

Sample Location:	Pool																																					
Total Chlorine:	0 ppm																																					
Free Chlorine:	0 ppm																																					
Ammonia:	0 ppm																																					
pH:	8.67 units																																					
Temperature:	66 °F																																					
Conductivity:	352 µS/cm																																					
Detergents:	0 mg/L																																					
Floatables:	None																																					
Odor:	None																																					
Turbidity:	None																																					
Color:	None																																					
Gross Solids:	Moderate																																					
Vegetation:	None																																					
Benthic Growth:	None																																					
Stains:	None																																					
Non-illicit:	None

<div style="display: flex; justify-content: space-between;"> <div style="width: 45%;"> <p>Notes</p> <p>Sample collected from submerged pool in outfall. Floating gross solids (litter) in manhole.</p> </div> <div style="width: 45%;"> <p>Condition Assessment</p> <table border="1" style="width:100%; border-collapse: collapse;"> <tr><td>Graffiti:</td><td>None</td></tr> <tr><td>Erosion:</td><td>None</td></tr> <tr><td>Deposition:</td><td>None in.</td></tr> <tr><td>Damage:</td><td>None</td></tr> </table> </div> </div>			Graffiti:	None	Erosion:	None	Deposition:	None in.	Damage:	None																										
Graffiti:	None																																					
Erosion:	None																																					
Deposition:	None in.																																					
Damage:	None

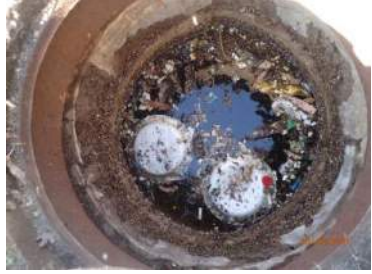
o20161010101916.JPG 2016

Sample Location:	Pool																																					
Total Chlorine:	0 ppm																																					
Free Chlorine:	0 ppm																																					
Ammonia:	0 ppm																																					
pH:	8.15 units																																					
Temperature:	63 °F																																					
Conductivity:	369 µS/cm																																					
Detergents:	0 mg/L																																					
Floatables:	None																																					
Odor:	None																																					
Turbidity:	None																																					
Color:	Clearly visible in bottle																																					
Gross Solids:	Moderate																																					
Vegetation:	None																																					
Benthic Growth:	None																																					
Stains:	None																																					
Non-illicit:	None

<div style="display: flex; justify-content: space-between;"> <div style="width: 45%;"> <p>Notes</p> <p>Potential illicit discharge due to gross solids.</p> </div> <div style="width: 45%;"> <p>Condition Assessment</p> <table border="1" style="width:100%; border-collapse: collapse;"> <tr><td>Graffiti:</td><td>None</td></tr> <tr><td>Erosion:</td><td>None</td></tr> <tr><td>Deposition:</td><td>None in.</td></tr> <tr><td>Damage:</td><td>None</td></tr> </table> </div> </div>			Graffiti:	None	Erosion:	None	Deposition:	None in.	Damage:	None																										
Graffiti:	None																																					
Erosion:	None																																					
Deposition:	None in.																																					
Damage:	None

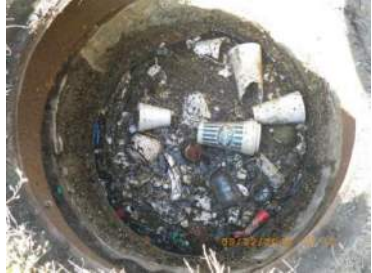
o20150922091040.JPG 2015

Sample Location:	Pool																																					
Total Chlorine:	0 ppm																																					
Free Chlorine:	0 ppm																																					
Ammonia:	0 ppm																																					
pH:	8.8 units																																					
Temperature:	70 °F																																					
Conductivity:	335 µS/cm																																					
Detergents:	0 mg/L																																					
Floatables:	None																																					
Odor:	None																																					
Turbidity:	None																																					
Color:	None																																					
Gross Solids:	Severe																																					
Vegetation:	None																																					
Benthic Growth:	None																																					
Stains:	None																																					
Non-illicit:	None

<div style="display: flex; justify-content: space-between;"> <div style="width: 45%;"> <p>Notes</p> <p>Floating gross solids (litter) in manhole.</p> </div> <div style="width: 45%;"> <p>Condition Assessment</p> <table border="1" style="width:100%; border-collapse: collapse;"> <tr><td>Graffiti:</td><td>None</td></tr> <tr><td>Erosion:</td><td>None</td></tr> <tr><td>Deposition:</td><td>None in.</td></tr> <tr><td>Damage:</td><td>None</td></tr> </table> </div> </div>			Graffiti:	None	Erosion:	None	Deposition:	None in.	Damage:	None																										
Graffiti:	None																																					
Erosion:	None																																					
Deposition:	None in.																																					
Damage:	None

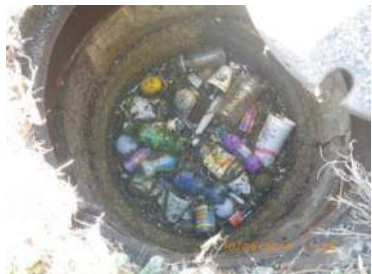
o20141009102622.JPG 2014

Sample Location:	Pool																																					
Total Chlorine:	0 ppm																																					
Free Chlorine:	0 ppm																																					
Ammonia:	0 ppm																																					
pH:	8.34 units																																					
Temperature:	57 °F																																					
Conductivity:	400 µS/cm																																					
Detergents:	0 mg/L																																					
Floatables:	None																																					
Odor:	None																																					
Turbidity:	None																																					
Color:	Faint in bottle																																					
Gross Solids:	Severe																																					
Vegetation:	None																																					
Benthic Growth:	None																																					
Stains:	None																																					
Non-illicit:	None

<div style="display: flex; justify-content: space-between;"> <div style="width: 45%;"> <p>Notes</p> <p>Floating gross solids (litter) in manhole.</p> </div> <div style="width: 45%;"> <p>Condition Assessment</p> <table border="1" style="width:100%; border-collapse: collapse;"> <tr><td>Graffiti:</td><td>None</td></tr> <tr><td>Erosion:</td><td>None</td></tr> <tr><td>Deposition:</td><td>None in.</td></tr> <tr><td>Damage:</td><td>None</td></tr> </table> </div> </div>			Graffiti:	None	Erosion:	None	Deposition:	None in.	Damage:	None																										
Graffiti:	None																																					
Erosion:	None																																					
Deposition:	None in.																																					
Damage:	None

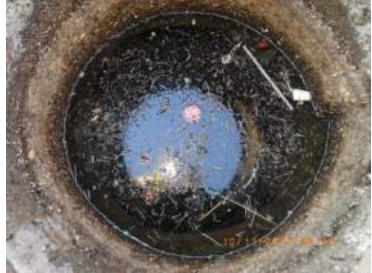
Inspection Date: 10/11/2011 8:41:22 AM		Type: Ongoing		Flow: Submerged, indeterminate		Previous Rainfall (hrs): 72+	
Illicit Discharge Potential: Unlikely		Inspector: JCW		Notes 2010 screening follow-up. Floatable debris significantly reduced.

o20111011084038.JPG	
Submerged: Fully		Depth (in): 18					
Sampling Results		Floatables: None Odor: None Turbidity: None Color: None Gross Solids: Slight Vegetation: None Benthic Growth: None Stains: None Non-illicit: None		Condition Assessment Graffiti: None Erosion: None Deposition: None 0 in. Damage: None		2011	
Sample Location: Pool Total Chlorine: 0 ppm Free Chlorine: 0 ppm Ammonia: 0 ppm pH: 8.11 units Temperature: 72 °F Conductivity: -- µS/cm Detergents: -- mg/L

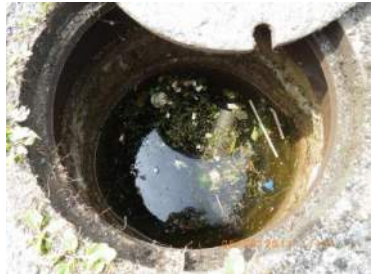
Inspection Date: 5/26/2011 11:01:00 AM		Type: Other		Flow: Submerged, indeterminate		Previous Rainfall (hrs): 72+	
Illicit Discharge Potential: Potential		Inspector: JCW		Notes Limited screening conducted to check for floatable debris.

o20110526110156.JPG	
Submerged: Fully		Depth (in):					
Sampling Results		Floatables: None Odor: Turbidity: Color: Gross Solids: Moderate Vegetation: Benthic Growth: Stains: Non-illicit: None		Condition Assessment Graffiti: None Erosion: None Deposition: None 0 in. Damage: None		2011	
Sample Location: Total Chlorine: -- ppm Free Chlorine: -- ppm Ammonia: -- ppm pH: -- units Temperature: -- °F Conductivity: -- µS/cm Detergents: -- mg/L

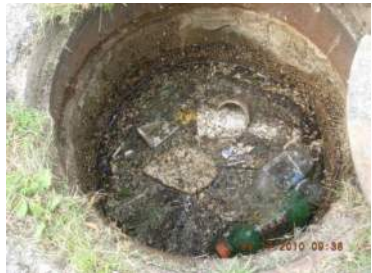
Inspection Date: 8/17/2010 9:47:15 AM		Type: Ongoing		Flow: Submerged, indeterminate		Previous Rainfall (hrs): 72+	
Illicit Discharge Potential: Potential		Inspector: JCW		Notes Significant floatable debris in manhole.

o20100817093838.JPG	
Submerged: Fully		Depth (in): 31					
Sampling Results		Floatables: None Odor: None Turbidity: None Color: Faint in bottle Gross Solids: Severe Vegetation: None Benthic Growth: None Stains: None Non-illicit: None		Condition Assessment Graffiti: None Erosion: None Deposition: None 0 in. Damage: None		2010	
Sample Location: Pool Total Chlorine: 0 ppm Free Chlorine: 0 ppm Ammonia: 0 ppm pH: 7.64 units Temperature: 74 °F Conductivity: -- µS/cm Detergents: 0 mg/L

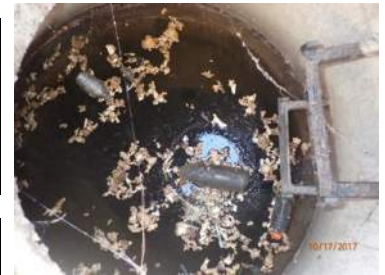
o20171017140304.JPG

Inspection Date: 10/17/2017 2:07:18 PM		Type: Ongoing	Flow: Submerged, indeterminate	Previous Rainfall (hrs): 48-72
Illicit Discharge Potential: Potential		Inspector: JCW		
Submerged: Fully		Depth (in): 46		
Sampling Results		Notes Sample collected from submerged pool in manhole. Floating gross solids (litter) in manhole.		
Sample Location: Pool	Floatables: None	Condition Assessment Graffiti: None Erosion: None Deposition: None in. Damage: None		
Total Chlorine: 0 ppm	Odor: None			
Free Chlorine: 0 ppm	Turbidity: None			
Ammonia: 0 ppm	Color: None			
pH: 8.29 units	Gross Solids: Moderate			
Temperature 66 °F	Vegetation: None			
Conductivity: 346 µS/cm	Benthic Growth: None			
Detergents: 0 mg/L	Stains: None			
	Non-illicit: None

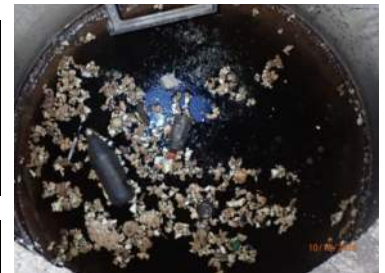
o20161018170248.JPG

Inspection Date: 10/18/2016 5:02:56 PM		Type: Ongoing	Flow: Submerged, indeterminate	Previous Rainfall (hrs): 72+
Illicit Discharge Potential: Potential		Inspector: JCW		
Submerged: Partially		Depth (in): 46		
Sampling Results		Notes Potential illicit discharge due to gross solids.		
Sample Location: Pool	Floatables: None	Condition Assessment Graffiti: None Erosion: None Deposition: None in. Damage: None		
Total Chlorine: 0 ppm	Odor: None			
Free Chlorine: 0 ppm	Turbidity: None			
Ammonia: 0 ppm	Color: Faint in bottle			
pH: 8.18 units	Gross Solids: Severe			
Temperature 66 °F	Vegetation: None			
Conductivity: 361 µS/cm	Benthic Growth: None			
Detergents: 0 mg/L	Stains: None			
	Non-illicit: None

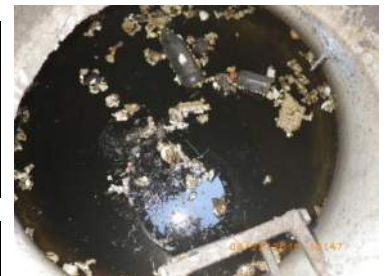
o20150922094746.JPG

Inspection Date: 9/22/2015 10:46:05 AM		Type: Ongoing	Flow: Submerged, indeterminate	Previous Rainfall (hrs): 72+
Illicit Discharge Potential: Potential		Inspector: JCW		
Submerged: Fully		Depth (in): 48		
Sampling Results		Notes Floating gross solids (litter) in manhole.		
Sample Location: Pool	Floatables: None	Condition Assessment Graffiti: None Erosion: None Deposition: None in. Damage: None		
Total Chlorine: 0 ppm	Odor: None			
Free Chlorine: 0 ppm	Turbidity: None			
Ammonia: 0 ppm	Color: None			
pH: 8.33 units	Gross Solids: Moderate			
Temperature 73 °F	Vegetation: None			
Conductivity: 352 µS/cm	Benthic Growth: None			
Detergents: 0 mg/L	Stains: None			
	Non-illicit: None

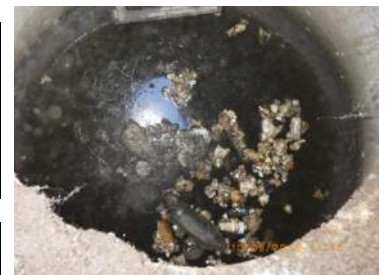
o20141009101552.JPG

Inspection Date: 10/9/2014 11:17:38 AM		Type: Ongoing	Flow: Submerged, indeterminate	Previous Rainfall (hrs): 72+
Illicit Discharge Potential: Potential		Inspector: JCW		
Submerged: Fully		Depth (in): 43		
Sampling Results		Notes Floating gross solids (litter) in manhole.		
Sample Location: Pool	Floatables: None	Condition Assessment Graffiti: None Erosion: None Deposition: None in. Damage: None		
Total Chlorine: 0 ppm	Odor: None			
Free Chlorine: 0 ppm	Turbidity: None			
Ammonia: 0 ppm	Color: None			
pH: 7.67 units	Gross Solids: Moderate			
Temperature 59 °F	Vegetation: None			
Conductivity: 422 µS/cm	Benthic Growth: None			
Detergents: 0 mg/L	Stains: None			
	Non-illicit: None

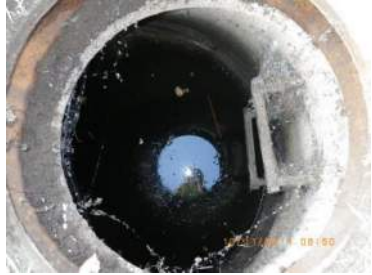
o20111011085018.JPG 2011
Submerged: Fully		Depth (in): 43		
Sampling Results Sample Location: Pool Total Chlorine: 0 ppm Free Chlorine: 0 ppm Ammonia: 0 ppm pH: 7.87 units Temperature: 71 °F Conductivity: -- µS/cm Detergents: -- mg/L		Notes 2010 screening follow-up. Floatable debris significantly reduced. Condition Assessment Graffiti: None Erosion: None Deposition: None 0 in. Damage: None		
Floatables: None Odor: None Turbidity: None Color: Faint in bottle Gross Solids: Slight Vegetation: None Benthic Growth: None Stains: None Non-illicit: None

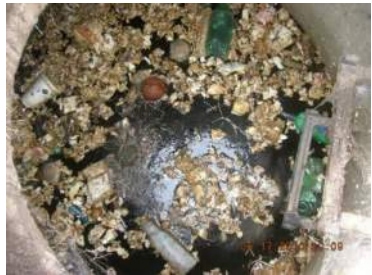
o20100817100950.JPG 2010
Submerged: Fully		Depth (in): 48		
Sampling Results Sample Location: Pool Total Chlorine: 0 ppm Free Chlorine: 0 ppm Ammonia: 0 ppm pH: 7.71 units Temperature: 74 °F Conductivity: -- µS/cm Detergents: 0 mg/L		Notes Significant floatable debris in manhole. Condition Assessment Graffiti: None Erosion: None Deposition: None 0 in. Damage: None		
Floatables: None Odor: None Turbidity: None Color: None Gross Solids: Severe Vegetation: None Benthic Growth: None Stains: None Non-illicit: None

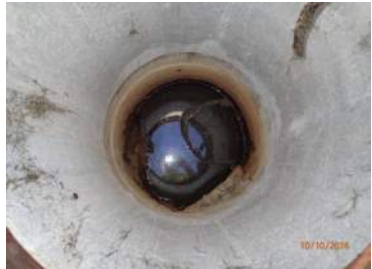
o20161010100336.JPG 2016

Inspection Date: 10/10/2016 10:06:06 AM		Type: Ongoing	Flow: Submerged, indeterminate	Previous Rainfall (hrs): 72+
Illicit Discharge Potential: Unlikely		Inspector: JCW		
Submerged: Partially		Depth (in): 12		
Sampling Results		Notes		
Sample Location:	Pool	Floatables:	Slight	
Total Chlorine:	0 ppm	Odor:	None	
Free Chlorine:	0 ppm	Turbidity:	None	
Ammonia:	1 ppm	Color:	Clearly visible in flow	
pH:	6.94 units	Gross Solids:	None	
Temperature	64 °F	Vegetation:	None	
Conductivity:	752 µS/cm	Benthic Growth:	None	
Detergents:	0 mg/L	Stains:	Slight	
		Non-illicit:	Moderate	
		Condition Assessment		
		Graffiti:	None	
		Erosion:	None	
		Deposition:	None in.	
		Damage:	None

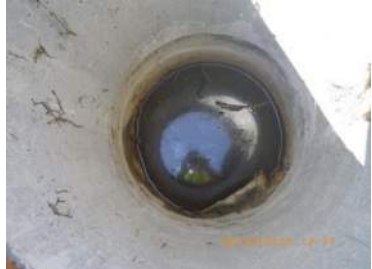
o20150922111710.JPG 2015

Inspection Date: 9/22/2015 12:16:00 PM		Type: Ongoing	Flow: Submerged, indeterminate	Previous Rainfall (hrs): 72+
Illicit Discharge Potential: Unlikely		Inspector: JCW		
Submerged: Fully		Depth (in): 16		
Sampling Results		Notes		
Sample Location:	Pool	Floatables:	Moderate	
Total Chlorine:	0 ppm	Odor:	None	
Free Chlorine:	0 ppm	Turbidity:	None	
Ammonia:	0 ppm	Color:	None	
pH:	7.48 units	Gross Solids:	None	
Temperature	75 °F	Vegetation:	None	
Conductivity:	499 µS/cm	Benthic Growth:	None	
Detergents:	0 mg/L	Stains:	Slight	
		Non-illicit:	None	
		Condition Assessment		
		Graffiti:	None	
		Erosion:	None	
		Deposition:	None in.	
		Damage:	None

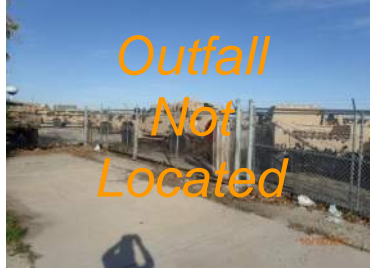
o20171018152942.JPG 2017
		Condition Assessment Graffiti: None Erosion: None Deposition: None in. Damage: None

Inspection Date: 10/18/2017 3:36:30 PM		Type: Ongoing	Flow: Submerged (not located)	Previous Rainfall (hrs): 72+
Illicit Discharge Potential: Unlikely		Inspector: JCW		
Submerged: Fully		Depth (in):		
Sampling Results Sample Location: _____ Total Chlorine: -- ppm Free Chlorine: -- ppm Ammonia: -- ppm pH: -- units Temperature: -- °F Conductivity: -- µS/cm Detergents: -- mg/L		Floatables: None Odor: None Turbidity: None Color: None Gross Solids: None Vegetation: None Benthic Growth: None Stains: None Non-illicit: None	Notes Outfall behind locked gate. Screened upstream at 09-101a US1.

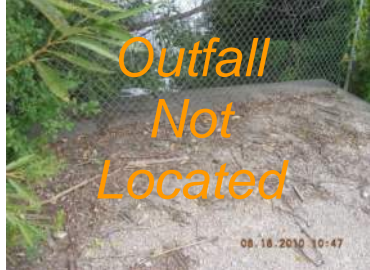
o20100818104726.JPG 2010
		Condition Assessment Graffiti: None Erosion: None Deposition: None 0 in. Damage: None

Inspection Date: 8/18/2010 10:55:07 AM		Type: Ongoing	Flow: Submerged (not located)	Previous Rainfall (hrs): 72+
Illicit Discharge Potential: Unlikely		Inspector: JCW		
Submerged: Partially		Depth (in):		
Sampling Results Sample Location: _____ Total Chlorine: -- ppm Free Chlorine: -- ppm Ammonia: -- ppm pH: -- units Temperature: -- °F Conductivity: -- µS/cm Detergents: -- mg/L		Floatables: None Odor: None Turbidity: None Color: None Gross Solids: None Vegetation: None Benthic Growth: None Stains: None Non-illicit: None	Notes Outfall fully submerged and not physically located. Outfall screened upstream at 09-101a US1.

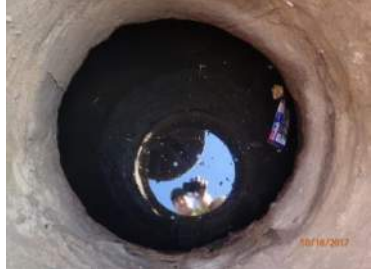
o20171018153026.JPG <div style="text-align: center; font-size: 24pt; font-weight: bold;">2017</div>

Sample Location:	Pool																																					
Total Chlorine:	0 ppm																																					
Free Chlorine:	0 ppm																																					
Ammonia:	0 ppm																																					
pH:	7.85 units																																					
Temperature:	66 °F																																					
Conductivity:	1169 µS/cm																																					
Detergents:	0 mg/L																																					
Floatables:	None																																					
Odor:	Faint																																					
Turbidity:	Slight cloudiness																																					
Color:	None																																					
Gross Solids:	Slight																																					
Vegetation:	None																																					
Benthic Growth:	None																																					
Stains:	None																																					
Non-illicit:	None

Notes Sample collected from submerged pool in manhole.																																				
		Condition Assessment <table border="1" style="width:100%; border-collapse: collapse;"> <tr><td>Graffiti:</td><td>None</td></tr> <tr><td>Erosion:</td><td>None</td></tr> <tr><td>Deposition:</td><td>None in.</td></tr> <tr><td>Damage:</td><td>None</td></tr> </table>			Graffiti:	None	Erosion:	None	Deposition:	None in.	Damage:	None																										
Graffiti:	None																																					
Erosion:	None																																					
Deposition:	None in.																																					
Damage:	None

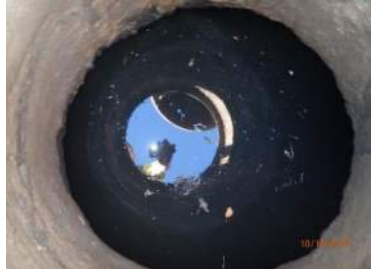
o20161018161534.JPG <div style="text-align: center; font-size: 24pt; font-weight: bold;">2016</div>

Inspection Date: 10/18/2016 4:18:25 PM		Type: Ongoing	Flow: Submerged, indeterminate	Previous Rainfall (hrs): 72+																																		
Illicit Discharge Potential: Unlikely		Inspector: JCW																																				
Submerged: Fully		Depth (in): 28																																				
Sampling Results <table border="1" style="width:100%; border-collapse: collapse;"> <tr><td>Sample Location:</td><td>Pool</td></tr> <tr><td>Total Chlorine:</td><td>0 ppm</td></tr> <tr><td>Free Chlorine:</td><td>0 ppm</td></tr> <tr><td>Ammonia:</td><td>0 ppm</td></tr> <tr><td>pH:</td><td>7.93 units</td></tr> <tr><td>Temperature:</td><td>67 °F</td></tr> <tr><td>Conductivity:</td><td>1231 µS/cm</td></tr> <tr><td>Detergents:</td><td>0 mg/L</td></tr> </table>		Sample Location:	Pool	Total Chlorine:	0 ppm	Free Chlorine:	0 ppm	Ammonia:	0 ppm	pH:	7.93 units	Temperature:	67 °F	Conductivity:	1231 µS/cm	Detergents:	0 mg/L	<table border="1" style="width:100%; border-collapse: collapse;"> <tr><td>Floatables:</td><td>None</td></tr> <tr><td>Odor:</td><td>None</td></tr> <tr><td>Turbidity:</td><td>Cloudy</td></tr> <tr><td>Color:</td><td>None</td></tr> <tr><td>Gross Solids:</td><td>None</td></tr> <tr><td>Vegetation:</td><td>None</td></tr> <tr><td>Benthic Growth:</td><td>None</td></tr> <tr><td>Stains:</td><td>None</td></tr> <tr><td>Non-illicit:</td><td>None</td></tr> </table>			Floatables:	None	Odor:	None	Turbidity:	Cloudy	Color:	None	Gross Solids:	None	Vegetation:	None	Benthic Growth:	None	Stains:	None	Non-illicit:	None

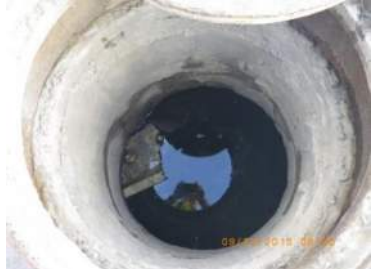
o20150923070520.JPG <div style="text-align: center; font-size: 24pt; font-weight: bold;">2015</div>

Inspection Date: 9/23/2015 8:04:12 AM		Type: Ongoing	Flow: Submerged, indeterminate	Previous Rainfall (hrs): 72+																																		
Illicit Discharge Potential: Unlikely		Inspector: JCW																																				
Submerged: Fully		Depth (in): 24																																				
Sampling Results <table border="1" style="width:100%; border-collapse: collapse;"> <tr><td>Sample Location:</td><td>Pool</td></tr> <tr><td>Total Chlorine:</td><td>0 ppm</td></tr> <tr><td>Free Chlorine:</td><td>0 ppm</td></tr> <tr><td>Ammonia:</td><td>0 ppm</td></tr> <tr><td>pH:</td><td>7.93 units</td></tr> <tr><td>Temperature:</td><td>70 °F</td></tr> <tr><td>Conductivity:</td><td>1112 µS/cm</td></tr> <tr><td>Detergents:</td><td>0 mg/L</td></tr> </table>		Sample Location:	Pool	Total Chlorine:	0 ppm	Free Chlorine:	0 ppm	Ammonia:	0 ppm	pH:	7.93 units	Temperature:	70 °F	Conductivity:	1112 µS/cm	Detergents:	0 mg/L	<table border="1" style="width:100%; border-collapse: collapse;"> <tr><td>Floatables:</td><td>None</td></tr> <tr><td>Odor:</td><td>None</td></tr> <tr><td>Turbidity:</td><td>Slight cloudiness</td></tr> <tr><td>Color:</td><td>None</td></tr> <tr><td>Gross Solids:</td><td>Slight</td></tr> <tr><td>Vegetation:</td><td>None</td></tr> <tr><td>Benthic Growth:</td><td>None</td></tr> <tr><td>Stains:</td><td>None</td></tr> <tr><td>Non-illicit:</td><td>None</td></tr> </table>			Floatables:	None	Odor:	None	Turbidity:	Slight cloudiness	Color:	None	Gross Solids:	Slight	Vegetation:	None	Benthic Growth:	None	Stains:	None	Non-illicit:	None

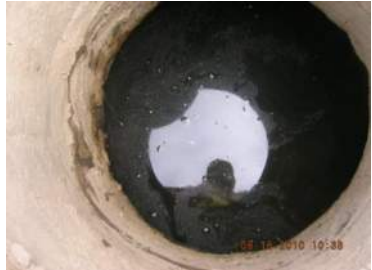
o20100818103836.JPG <div style="text-align: center; font-size: 24pt; font-weight: bold;">2010</div>

Inspection Date: 8/18/2010 10:47:15 AM		Type: Ongoing	Flow: Submerged, indeterminate	Previous Rainfall (hrs): 72+																																		
Illicit Discharge Potential: Unlikely		Inspector: JCW																																				
Submerged: Fully		Depth (in): 24																																				
Sampling Results <table border="1" style="width:100%; border-collapse: collapse;"> <tr><td>Sample Location:</td><td>Pool</td></tr> <tr><td>Total Chlorine:</td><td>0 ppm</td></tr> <tr><td>Free Chlorine:</td><td>0 ppm</td></tr> <tr><td>Ammonia:</td><td>0 ppm</td></tr> <tr><td>pH:</td><td>7.65 units</td></tr> <tr><td>Temperature:</td><td>76 °F</td></tr> <tr><td>Conductivity:</td><td>-- µS/cm</td></tr> <tr><td>Detergents:</td><td>0 mg/L</td></tr> </table>		Sample Location:	Pool	Total Chlorine:	0 ppm	Free Chlorine:	0 ppm	Ammonia:	0 ppm	pH:	7.65 units	Temperature:	76 °F	Conductivity:	-- µS/cm	Detergents:	0 mg/L	<table border="1" style="width:100%; border-collapse: collapse;"> <tr><td>Floatables:</td><td>None</td></tr> <tr><td>Odor:</td><td>None</td></tr> <tr><td>Turbidity:</td><td>None</td></tr> <tr><td>Color:</td><td>None</td></tr> <tr><td>Gross Solids:</td><td>None</td></tr> <tr><td>Vegetation:</td><td>None</td></tr> <tr><td>Benthic Growth:</td><td>None</td></tr> <tr><td>Stains:</td><td>None</td></tr> <tr><td>Non-illicit:</td><td>None</td></tr> </table>			Floatables:	None	Odor:	None	Turbidity:	None	Color:	None	Gross Solids:	None	Vegetation:	None	Benthic Growth:	None	Stains:	None	Non-illicit:	None

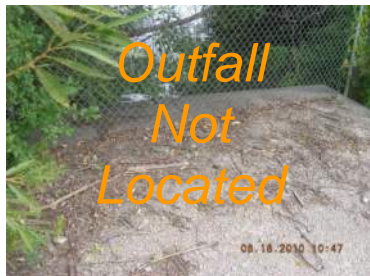
o20100818104726.JPG 2010

Inspection Date: 8/18/2010 10:58:06 AM		Type: Ongoing	Flow: Submerged (not located)	Previous Rainfall (hrs): 72+
Illicit Discharge Potential: Unlikely		Inspector: JCW		
Submerged: Partially		Depth (in):		
Sampling Results Sample Location: _____ Total Chlorine: -- ppm Free Chlorine: -- ppm Ammonia: -- ppm pH: -- units Temperature -- °F Conductivity: -- µS/cm Detergents: -- mg/L		Floatables: None Odor: None Turbidity: None Color: None Gross Solids: None Vegetation: None Benthic Growth: None Stains: None Non-illicit: None	Notes Outfall fully submerged and not physically located. Outfall screened upstream at 09-101b US1. Condition Assessment Graffiti: None Erosion: None Deposition: None 0 in. Damage: None

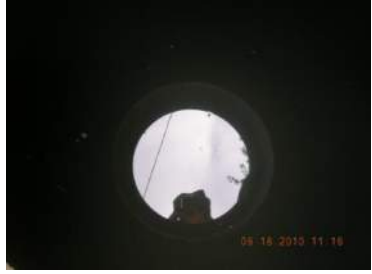
o20100818111616.JPG <div style="font-size: 24pt; font-weight: bold; text-align: center;">2010</div>

Inspection Date: 8/18/2010 11:20:42 AM		Type: Ongoing	Flow: Submerged, slight flow	Previous Rainfall (hrs): 72+
Illicit Discharge Potential: Unlikely		Inspector: JCW		
Submerged: Partially		Depth (in): 30		
Sampling Results Sample Location: Pool Total Chlorine: 0 ppm Free Chlorine: 0 ppm Ammonia: 0 ppm pH: 7.88 units Temperature: 73 °F Conductivity: -- µS/cm Detergents: 0 mg/L		Floatables: None Odor: None Turbidity: None Color: None Gross Solids: None Vegetation: None Benthic Growth: None Stains: None Non-illicit: None	Notes Condition Assessment Graffiti: None Erosion: None Deposition: None 0 in. Damage: None

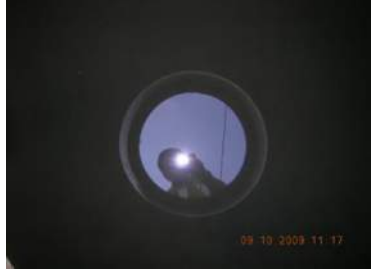
Osh09_DSCN6780.JPG <div style="font-size: 24pt; font-weight: bold; text-align: center;">2009</div>

Inspection Date: 9/10/2009		Type: Initial	Flow: Submerged, slight flow	Previous Rainfall (hrs): 72+
Illicit Discharge Potential: Unlikely		Inspector: JCW		
Submerged: Partially		Depth (in): 28		
Sampling Results Sample Location: Flow Total Chlorine: 0 ppm Free Chlorine: 0 ppm Ammonia: -- ppm pH: 8.21 units Temperature: 78 °F Conductivity: -- µS/cm Detergents: 0 mg/L		Floatables: None Odor: None Turbidity: None Color: None Gross Solids: None Vegetation: None Benthic Growth: None Stains: None Non-illicit: None	Notes Condition Assessment Graffiti: None Erosion: None Deposition: None 0 in. Damage: None

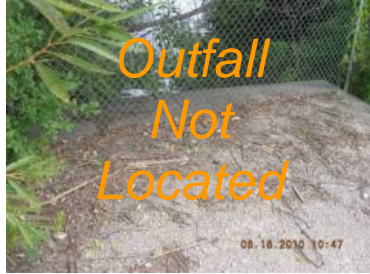
o20100818104726.JPG

Inspection Date: 8/18/2010 11:01:01 AM		Type: Ongoing	Flow: Submerged (not located)	Previous Rainfall (hrs): 72+
Illicit Discharge Potential: Potential		Inspector: JCW	Notes	
Submerged: Partially Depth (in):			Outfall fully submerged and not physically located. Outfall screened upstream at 09-101c US1.	
Sampling Results			Condition Assessment	
Sample Location:	Floatables:	None	Graffiti: None Erosion: None Deposition: None 0 in. Damage: None	
Total Chlorine: -- ppm	Odor:	None		
Free Chlorine: -- ppm	Turbidity:	None		
Ammonia: -- ppm	Color:	None		
pH: -- units	Gross Solids:	None		
Temperature -- °F	Vegetation:	None		
Conductivity: -- µS/cm	Benthic Growth:	None		
Detergents: -- mg/L	Stains:	None		
	Non-illicit:	None

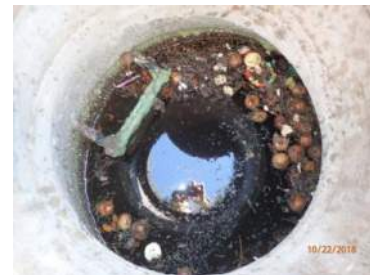
o20181022100114.JPG

<div style="display: flex;"> <div style="flex: 1;"> <p>Notes</p> <p>Sample collected from submerged pool in manhole. Floating gross solids (litter) in manhole.</p> </div> <div style="flex: 1;"> <p>Condition Assessment</p> <table border="1" style="width:100%; border-collapse: collapse;"> <tr><td>Graffiti:</td><td>None</td></tr> <tr><td>Erosion:</td><td>None</td></tr> <tr><td>Deposition:</td><td>None in.</td></tr> <tr><td>Damage:</td><td>None</td></tr> </table> </div> </div>			Graffiti:	None	Erosion:	None	Deposition:	None in.	Damage:	None																										
Graffiti:	None																																					
Erosion:	None																																					
Deposition:	None in.																																					
Damage:	None

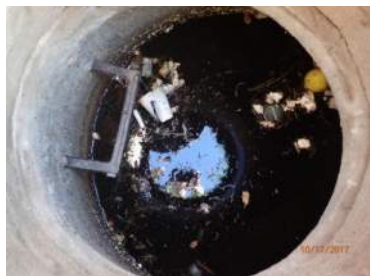
<p style="text-align: center;">o20171017131930.JPG</p> <p style="text-align: center; font-size: 24pt; font-weight: bold;">2017</p>

<div style="display: flex;"> <div style="flex: 1;"> <p>Notes</p> <p>Potential illicit discharge due to gross solids.</p> </div> <div style="flex: 1;"> <p>Condition Assessment</p> <table border="1" style="width:100%; border-collapse: collapse;"> <tr><td>Graffiti:</td><td>None</td></tr> <tr><td>Erosion:</td><td>None</td></tr> <tr><td>Deposition:</td><td>None in.</td></tr> <tr><td>Damage:</td><td>None</td></tr> </table> </div> </div>			Graffiti:	None	Erosion:	None	Deposition:	None in.	Damage:	None																										
Graffiti:	None																																					
Erosion:	None																																					
Deposition:	None in.																																					
Damage:	None

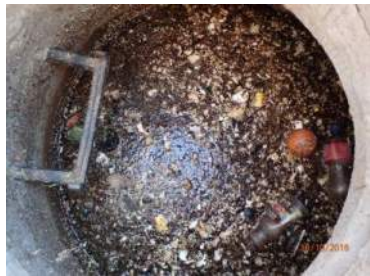
<p style="text-align: center;">o20161010110444.JPG</p> <p style="text-align: center; font-size: 24pt; font-weight: bold;">2016</p>

<div style="display: flex;"> <div style="flex: 1;"> <p>Notes</p> <p>Floating gross solids (litter) in manhole.</p> </div> <div style="flex: 1;"> <p>Condition Assessment</p> <table border="1" style="width:100%; border-collapse: collapse;"> <tr><td>Graffiti:</td><td>None</td></tr> <tr><td>Erosion:</td><td>None</td></tr> <tr><td>Deposition:</td><td>None in.</td></tr> <tr><td>Damage:</td><td>None</td></tr> </table> </div> </div>			Graffiti:	None	Erosion:	None	Deposition:	None in.	Damage:	None																										
Graffiti:	None																																					
Erosion:	None																																					
Deposition:	None in.																																					
Damage:	None

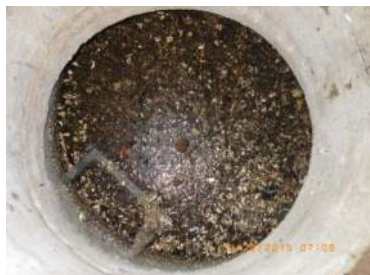
<p style="text-align: center;">o20150922060832.JPG</p> <p style="text-align: center; font-size: 24pt; font-weight: bold;">2015</p>

<div style="display: flex;"> <div style="flex: 1;"> <p>Notes</p> <p>Floating gross solids (litter) in manhole.</p> </div> <div style="flex: 1;"> <p>Condition Assessment</p> <table border="1" style="width:100%; border-collapse: collapse;"> <tr><td>Graffiti:</td><td>None</td></tr> <tr><td>Erosion:</td><td>None</td></tr> <tr><td>Deposition:</td><td>None in.</td></tr> <tr><td>Damage:</td><td>None</td></tr> </table> </div> </div>			Graffiti:	None	Erosion:	None	Deposition:	None in.	Damage:	None																										
Graffiti:	None																																					
Erosion:	None																																					
Deposition:	None in.																																					
Damage:	None

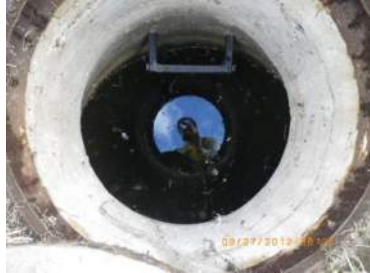
o20120927072438.JPG <div style="text-align: center; font-size: 24pt; font-weight: bold;">2012</div>

Inspection Date: 9/27/2012 8:22:20 AM		Type: Ongoing	Flow: Submerged, indeterminate	Previous Rainfall (hrs): 72+																																				
Illicit Discharge Potential: Unlikely		Inspector: JCW	Notes																																					
Submerged: Fully		Depth (in): 34	2011 gross solids follow-up.

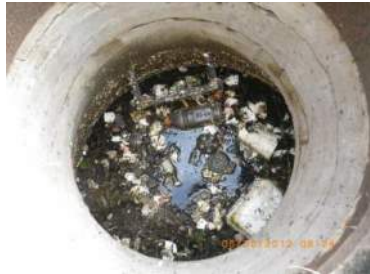
o20120620072408.JPG <div style="text-align: center; font-size: 24pt; font-weight: bold;">2012</div>

Inspection Date: 6/20/2012 8:24:06 AM		Type: Other	Flow: Submerged, indeterminate	Previous Rainfall (hrs): 24-48																																				
Illicit Discharge Potential: Potential		Inspector: JCW	Notes																																					
Submerged: Fully		Depth (in): 40	Gross solids pre-screening.

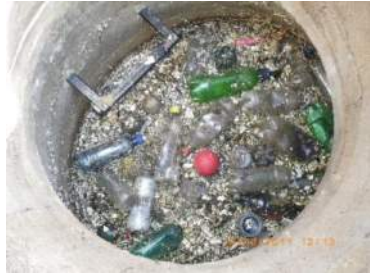
o20111003121302.JPG <div style="text-align: center; font-size: 24pt; font-weight: bold;">2011</div>

Inspection Date: 10/3/2011 12:13:00 PM		Type: Ongoing	Flow: Submerged, indeterminate	Previous Rainfall (hrs): 72+																																				
Illicit Discharge Potential: Potential		Inspector: JCW	Notes																																					
Submerged: Fully		Depth (in): 36	Significant floatable debris in manhole.

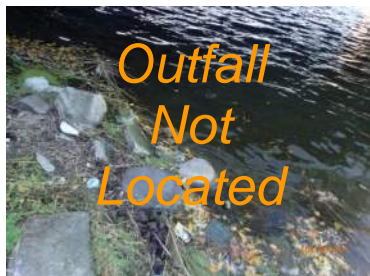
o20171018101412.JPG 2017

Inspection Date: 10/18/2017 10:17:17 AM		Type: Ongoing	Flow: Submerged (not located)	Previous Rainfall (hrs): 72+
Illicit Discharge Potential: Potential		Inspector: JCW		
Submerged: Fully		Depth (in):		
Sampling Results Sample Location: _____ Total Chlorine: -- ppm Free Chlorine: -- ppm Ammonia: -- ppm pH: -- units Temperature: -- °F Conductivity: -- µS/cm Detergents: -- mg/L		Floatables: None Odor: None Turbidity: None Color: None Gross Solids: None Vegetation: None Benthic Growth: None Stains: None Non-illicit: None	Notes Outfall fully submerged and not located - screened upstream at 12-569 US1. Graffiti on nearby bridge abutment. Floating gross solids (litter) in MH. Condition Assessment Graffiti: Minor Erosion: None Deposition: None in. Damage: None

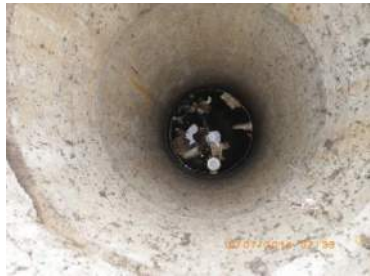
o20141007063948.JPG <div style="text-align: center; font-size: 24pt; font-weight: bold;">2014</div>

Inspection Date: 10/7/2014 7:39:34 AM		Type: Ongoing	Flow: Submerged, indeterminate	Previous Rainfall (hrs): 48-72
Illicit Discharge Potential: Potential		Inspector: JCW		
Submerged: Fully		Depth (in): 34		
Sampling Results		<div style="display: flex; justify-content: space-between;"> <div> <p>Sample Location: Pool</p> <p>Total Chlorine: 0 ppm</p> <p>Free Chlorine: 0 ppm</p> <p>Ammonia: 0 ppm</p> <p>pH: 7.66 units</p> <p>Temperature: 59 °F</p> <p>Conductivity: 771 µS/cm</p> <p>Detergents: 0 mg/L</p> </div> <div> <p>Floatables: None</p> <p>Odor: None</p> <p>Turbidity: None</p> <p>Color: None</p> <p>Gross Solids: Moderate</p> <p>Vegetation: None</p> <p>Benthic Growth: None</p> <p>Stains: None</p> <p>Non-illicit: None</p> </div> </div>		
		<div style="display: flex; justify-content: space-between;"> <div> <p>Notes</p> <p>Floating gross solids (litter) in manhole.</p> </div> <div> <p>Condition Assessment</p> <p>Graffiti: None</p> <p>Erosion: None</p> <p>Deposition: None in.</p> <p>Damage: None</p> </div> </div>

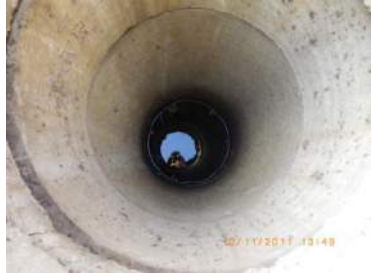
o20111011134946.JPG

Inspection Date: 10/11/2011 1:51:24 PM		Type: Ongoing	Flow: Submerged, indeterminate	Previous Rainfall (hrs): 72+
Illicit Discharge Potential: Unlikely		Inspector: JCW	Notes	
Submerged: Fully		Depth (in): 32	2010 screening follow-up. Floatable debris significantly reduced.	
Sampling Results		Condition Assessment		
Sample Location: Pool	Floatables:	None		
Total Chlorine: 0 ppm	Odor:	None		
Free Chlorine: 0 ppm	Turbidity:	None		
Ammonia: 0 ppm	Color:	None		
pH: 8.63 units	Gross Solids:	None		
Temperature 73 °F	Vegetation:	None		
Conductivity: -- µS/cm	Benthic Growth:	None		
Detergents: -- mg/L	Stains:	None		
	Non-illicit:	None		
		Graffiti:	None	
		Erosion:	None	
		Deposition:	None	0 in.
		Damage:	None

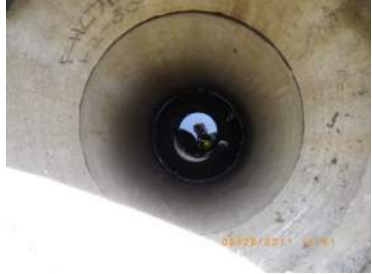
o20110526144100.JPG

Inspection Date: 5/26/2011 2:40:00 PM		Type: Other	Flow: Submerged, indeterminate	Previous Rainfall (hrs): 72+
Illicit Discharge Potential: Unlikely		Inspector: JCW	Notes	
Submerged: Fully		Depth (in):	Limited screening conducted to check for floatable debris.	
Sampling Results		Condition Assessment		
Sample Location:	Floatables:	None		
Total Chlorine: -- ppm	Odor:			
Free Chlorine: -- ppm	Turbidity:			
Ammonia: -- ppm	Color:			
pH: -- units	Gross Solids:	None		
Temperature -- °F	Vegetation:			
Conductivity: -- µS/cm	Benthic Growth:			
Detergents: -- mg/L	Stains:			
	Non-illicit:	None		
		Graffiti:	None	
		Erosion:	None	
		Deposition:	None	0 in.
		Damage:	None

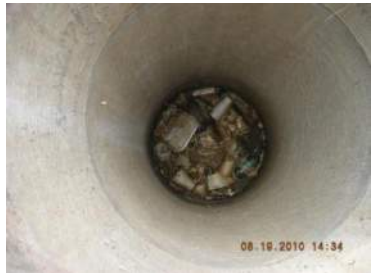
o20100819143434.JPG

Inspection Date: 8/19/2010 2:41:43 PM		Type: Ongoing	Flow: Submerged, indeterminate	Previous Rainfall (hrs): 72+
Illicit Discharge Potential: Potential		Inspector: JCW	Notes	
Submerged: Fully		Depth (in): 38	Severe floatable debris	
Sampling Results		Condition Assessment		
Sample Location: Pool	Floatables:	None		
Total Chlorine: 0 ppm	Odor:	None		
Free Chlorine: 0 ppm	Turbidity:	None		
Ammonia: 0 ppm	Color:	Faint in bottle		
pH: 7.59 units	Gross Solids:	Severe		
Temperature 79 °F	Vegetation:	None		
Conductivity: -- µS/cm	Benthic Growth:	None		
Detergents: 0 mg/L	Stains:	Slight		
	Non-illicit:	None		
		Graffiti:	None	
		Erosion:	None	
		Deposition:	None	0 in.
		Damage:	None

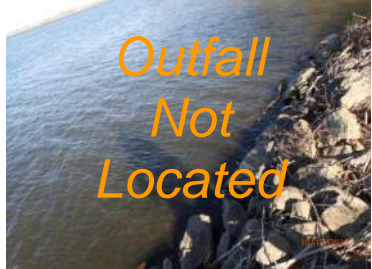
Inspection Date: 10/18/2017 10:05:54 AM		Type: Ongoing	Flow: Submerged (not located)	Previous Rainfall (hrs): 72+
Illicit Discharge Potential: Unlikely		Inspector: JCW		
Submerged: Fully		Depth (in):		
Sampling Results Sample Location: _____ Total Chlorine: -- ppm Free Chlorine: -- ppm Ammonia: -- ppm pH: -- units Temperature: -- °F Conductivity: -- µS/cm Detergents: -- mg/L		Floatables: None Odor: None Turbidity: None Color: None Gross Solids: None Vegetation: None Benthic Growth: None Stains: None Non-illicit: None	Notes Outfall fully submerged and not located - screened upstream at 12-576 US1.

o20171018100254.JPG 2017
		Condition Assessment Graffiti: None Erosion: None Deposition: None in. Damage: None
