Ongoing Screening Summary Report 2018 Inspection Year

Illicit Discharge Detection and Elimination Program

City of Oshkosh

January 25, 2019

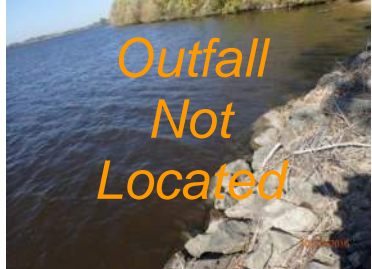
Inspection Date: 10/10/2016 1:14:55 PM		Type: Ongoing	Flow: Submerged (not located)	Previous Rainfall (hrs): 72+
Illicit Discharge Potential: Unlikely		Inspector: JCW		
Submerged: Fully		Depth (in):		
Sampling Results Sample Location: _____ Total Chlorine: -- ppm Free Chlorine: -- ppm Ammonia: -- ppm pH: -- units Temperature: -- °F Conductivity: -- µS/cm Detergents: -- mg/L		Floatables: None Odor: None Turbidity: None Color: None Gross Solids: None Vegetation: None Benthic Growth: None Stains: None Non-illicit: None	Notes Outfall fully submerged and not located - screened upstream at 12-576 US1.

o20161010131430.JPG 2016
		Condition Assessment Graffiti: None Erosion: None Deposition: None in. Damage: None

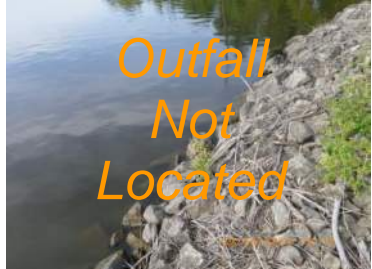
Inspection Date: 9/23/2015 3:11:43 PM		Type: Ongoing	Flow: Submerged (not located)	Previous Rainfall (hrs): 72+
Illicit Discharge Potential: Unlikely		Inspector: JCW		
Submerged: Fully		Depth (in):		
Sampling Results Sample Location: _____ Total Chlorine: -- ppm Free Chlorine: -- ppm Ammonia: -- ppm pH: -- units Temperature: -- °F Conductivity: -- µS/cm Detergents: -- mg/L		Floatables: None Odor: None Turbidity: None Color: None Gross Solids: None Vegetation: None Benthic Growth: None Stains: None Non-illicit: None	Notes Outfall fully submerged and not located- screened at 12-576 US1

o20150923141532.JPG 2015
		Condition Assessment Graffiti: None Erosion: None Deposition: None in. Damage: None

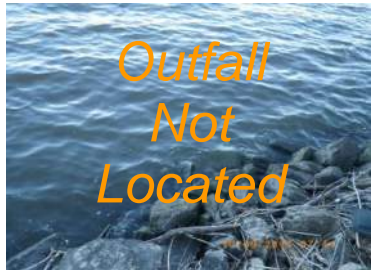
Inspection Date: 10/9/2014 7:43:34 AM		Type: Ongoing	Flow: Submerged (not located)	Previous Rainfall (hrs): 72+
Illicit Discharge Potential: Potential		Inspector: JCW		
Submerged: Fully		Depth (in):		
Sampling Results Sample Location: _____ Total Chlorine: -- ppm Free Chlorine: -- ppm Ammonia: -- ppm pH: -- units Temperature: -- °F Conductivity: -- µS/cm Detergents: -- mg/L		Floatables: None Odor: None Turbidity: None Color: None Gross Solids: None Vegetation: None Benthic Growth: None Stains: None Non-illicit: None	Notes Outfall fully submerged and not located - screened upstream at 12-576 US1.

o20141009064412.JPG 2014
		Condition Assessment Graffiti: None Erosion: None Deposition: None in. Damage: None

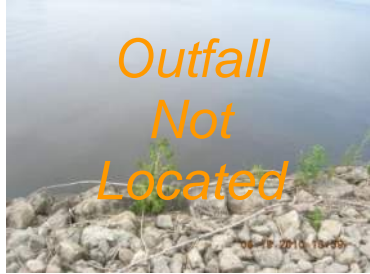
o20100819133944.JPG

Inspection Date: 8/19/2010 1:47:19 PM		Type: Ongoing	Flow: Submerged (not located)	Previous Rainfall (hrs): 72+																									
Illicit Discharge Potential: Unlikely		Inspector: JCW	Notes																										
Submerged: Fully		Depth (in):	<div style="border: 1px solid black; padding: 5px;"> Outfall fully submerged and not physically located. Outfall screened upstream at 12-576 US1. </div>																										
Sampling Results			<div style="border: 1px solid black; padding: 5px;"> Condition Assessment Graffiti: None Erosion: None Deposition: None 0 in. Damage: None </div>

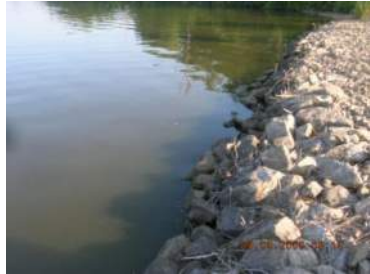
Osh09_DSCN6673.JPG

Inspection Date: 9/9/2009		Type: Initial	Flow: Submerged, indeterminate	Previous Rainfall (hrs): 72+																									
Illicit Discharge Potential: Potential		Inspector: JCW	Notes																										
Submerged: Fully		Depth (in):	<div style="border: 1px solid black; padding: 5px;"> </div>																										
Sampling Results			<div style="border: 1px solid black; padding: 5px;"> Condition Assessment Graffiti: None Erosion: None Deposition: None 0 in. Damage: None </div>

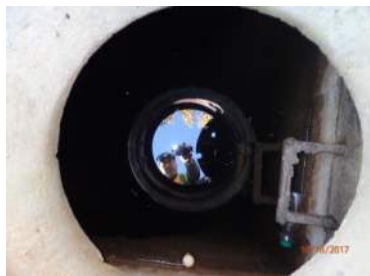
<p style="text-align: center;">o20171018100406.JPG</p> <p style="text-align: center; font-size: 24pt; font-weight: bold;">2017</p>

Inspection Date: 10/18/2017 10:08:19 AM		Type: Ongoing	Flow: Submerged, indeterminate	Previous Rainfall (hrs): 72+
Illicit Discharge Potential: Unlikely		Inspector: JCW		
Submerged: Fully		Depth (in): 69		
Sampling Results		<div style="display: flex; justify-content: space-between;"> <div> <p>Sample Location: Pool</p> <p>Total Chlorine: 0 ppm</p> <p>Free Chlorine: 0 ppm</p> <p>Ammonia: 0 ppm</p> <p>pH: 7.94 units</p> <p>Temperature: 65 °F</p> <p>Conductivity: 650 µS/cm</p> <p>Detergents: 0 mg/L</p> </div> <div> <p>Floatables: None</p> <p>Odor: None</p> <p>Turbidity: None</p> <p>Color: None</p> <p>Gross Solids: Slight</p> <p>Vegetation: None</p> <p>Benthic Growth: Slight</p> <p>Stains: None</p> <p>Non-illicit: None</p> </div> </div>		
		<div style="display: flex; justify-content: space-between;"> <div> <p>Notes</p> <p>Sample collected from submerged pool in manhole.</p> </div> <div> <p>Condition Assessment</p> <p>Graffiti: None</p> <p>Erosion: None</p> <p>Deposition: None in.</p> <p>Damage: None</p> </div> </div>

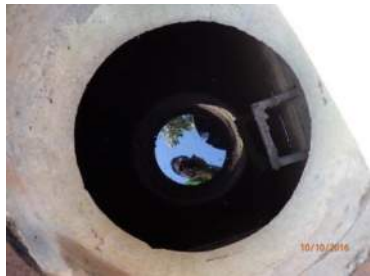
<p style="text-align: center;">o20161010131500.JPG</p> <p style="text-align: center; font-size: 24pt; font-weight: bold;">2016</p>

Inspection Date: 10/10/2016 1:17:02 PM		Type: Ongoing	Flow: Submerged, indeterminate	Previous Rainfall (hrs): 72+
Illicit Discharge Potential: Unlikely		Inspector: JCW		
Submerged: Fully		Depth (in): 69		
Sampling Results		<div style="display: flex; justify-content: space-between;"> <div> <p>Sample Location: Pool</p> <p>Total Chlorine: 0 ppm</p> <p>Free Chlorine: 0 ppm</p> <p>Ammonia: 0 ppm</p> <p>pH: 7.67 units</p> <p>Temperature: 67 °F</p> <p>Conductivity: 496 µS/cm</p> <p>Detergents: 0 mg/L</p> </div> <div> <p>Floatables: None</p> <p>Odor: None</p> <p>Turbidity: None</p> <p>Color: None</p> <p>Gross Solids: None</p> <p>Vegetation: None</p> <p>Benthic Growth: Slight</p> <p>Stains: Slight</p> <p>Non-illicit: None</p> </div> </div>		
		<div style="display: flex; justify-content: space-between;"> <div> <p>Notes</p> </div> <div> <p>Condition Assessment</p> <p>Graffiti: None</p> <p>Erosion: None</p> <p>Deposition: None in.</p> <p>Damage: None</p> </div> </div>

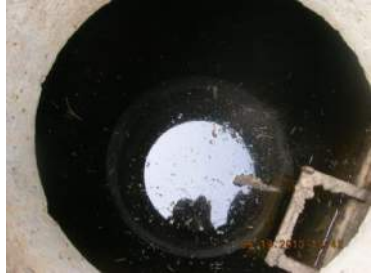
Inspection Date: 8/19/2010 1:50:40 PM		Type: Ongoing	Flow: Submerged, indeterminate	Previous Rainfall (hrs): 72+	
Illicit Discharge Potential: Unlikely		Inspector: JCW	Notes		
Submerged: Fully		Depth (in): 72

o20100819134200.JPG <div style="text-align: center; font-weight: bold; font-size: 1.2em;">2010</div>		
Sampling Results					
Sample Location:	Pool	Floatables:			None
Total Chlorine:	0 ppm	Odor:			None
Free Chlorine:	0 ppm	Turbidity:			None
Ammonia:	0 ppm	Color:			Faint in bottle
pH:	7.85 units	Gross Solids:			None
Temperature	76 °F	Vegetation:			None
Conductivity:	-- µS/cm	Benthic Growth:			Moderate
Detergents:	0 mg/L	Stains:			Slight
		Non-illicit:	None	Condition Assessment Graffiti: None Erosion: None Deposition: None 0 in. Damage: None

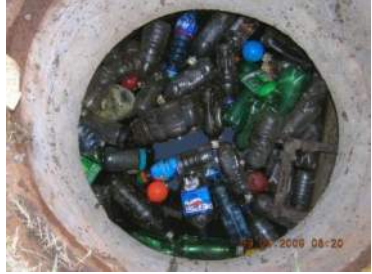
Inspection Date: 9/9/2009		Type: Initial	Flow: Submerged, indeterminate	Previous Rainfall (hrs): 72+	
Illicit Discharge Potential: Potential		Inspector: JCW	Notes		
Submerged: Fully		Depth (in): 68

Osh09_DSCN6675.JPG <div style="text-align: center; font-weight: bold; font-size: 1.2em;">2009</div>		
Sampling Results					
Sample Location:	Pool	Floatables:			None
Total Chlorine:	0 ppm	Odor:			None
Free Chlorine:	0 ppm	Turbidity:			None
Ammonia:	-- ppm	Color:			None
pH:	8.46 units	Gross Solids:			Severe
Temperature	69 °F	Vegetation:			None
Conductivity:	-- µS/cm	Benthic Growth:			None
Detergents:	0 mg/L	Stains:			None
		Non-illicit:	None	Condition Assessment Graffiti: None Erosion: None Deposition: None 0 in. Damage: None

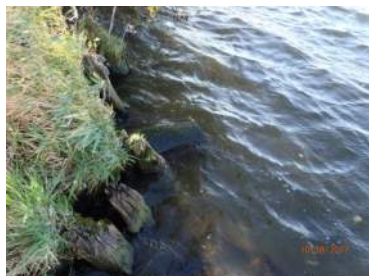
Inspection Date: 10/18/2017 9:51:15 AM		Type: Ongoing	Flow: Submerged, indeterminate	Previous Rainfall (hrs): 72+
Illicit Discharge Potential: Unlikely		Inspector: JCW		
Submerged: Partially		Depth (in): 15		
Sampling Results Sample Location: _____ Total Chlorine: -- ppm Free Chlorine: -- ppm Ammonia: -- ppm pH: -- units Temperature: -- °F Conductivity: -- µS/cm Detergents: -- mg/L		Floatables: None Odor: None Turbidity: None Color: None Gross Solids: None Vegetation: None Benthic Growth: None Stains: None Non-illicit: None	Notes Outfall partially submerged - screened upstream at 12-1313 US1.

o20171018094812.JPG <div style="text-align: center; font-size: 24pt; font-weight: bold;">2017</div>
			Condition Assessment Graffiti: None Erosion: None Deposition: None in. Damage: None

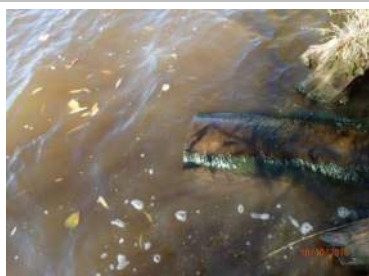
Inspection Date: 10/10/2016 12:50:26 PM		Type: Ongoing	Flow: Submerged, indeterminate	Previous Rainfall (hrs): 72+
Illicit Discharge Potential: Unlikely		Inspector: JCW		
Submerged: Partially		Depth (in): 17		
Sampling Results Sample Location: _____ Total Chlorine: -- ppm Free Chlorine: -- ppm Ammonia: -- ppm pH: -- units Temperature: -- °F Conductivity: -- µS/cm Detergents: -- mg/L		Floatables: None Odor: None Turbidity: None Color: None Gross Solids: None Vegetation: None Benthic Growth: Severe Stains: None Non-illicit: None	Notes Submerged depth estimated. Outfall partially submerged - screened upstream at 12-1313 US1.

o20161010124844.JPG <div style="text-align: center; font-size: 24pt; font-weight: bold;">2016</div>
			Condition Assessment Graffiti: None Erosion: None Deposition: None in. Damage: None

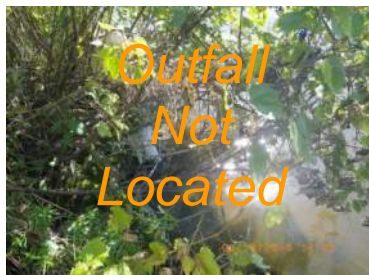
Inspection Date: 9/23/2015 2:02:54 PM		Type: Ongoing	Flow: Submerged (not located)	Previous Rainfall (hrs): 72+
Illicit Discharge Potential: Unlikely		Inspector: JCW		
Submerged: Fully		Depth (in):		
Sampling Results Sample Location: _____ Total Chlorine: -- ppm Free Chlorine: -- ppm Ammonia: -- ppm pH: -- units Temperature: -- °F Conductivity: -- µS/cm Detergents: -- mg/L		Floatables: None Odor: None Turbidity: None Color: None Gross Solids: None Vegetation: None Benthic Growth: None Stains: None Non-illicit: None	Notes Outfall fully submerged and not located - screened at 12-1313 US1.

o20150923130558.JPG <div style="text-align: center; font-size: 24pt; font-weight: bold;">2015</div>
			Condition Assessment Graffiti: None Erosion: None Deposition: None in. Damage: None

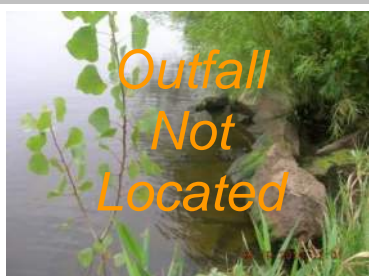
Inspection Date: 8/19/2010 12:09:32 PM		Type: Ongoing	Flow: Submerged (not located)	Previous Rainfall (hrs): 72+
Illicit Discharge Potential: Unlikely		Inspector: JCW		
Submerged: Fully		Depth (in):		
Sampling Results Sample Location: _____ Total Chlorine: -- ppm Free Chlorine: -- ppm Ammonia: -- ppm pH: -- units Temperature: -- °F Conductivity: -- µS/cm Detergents: -- mg/L		Floatables: None Odor: None Turbidity: None Color: None Gross Solids: None Vegetation: None Benthic Growth: None Stains: None Non-illicit: None	Notes Outfall fully submerged and not physically located. Outfall screened upstream at 12-1313 US1.

o20100819120152.JPG <div style="text-align: center; font-size: 24pt; font-weight: bold;">2010</div>
			Condition Assessment Graffiti: None Erosion: None Deposition: None 0 in. Damage: None

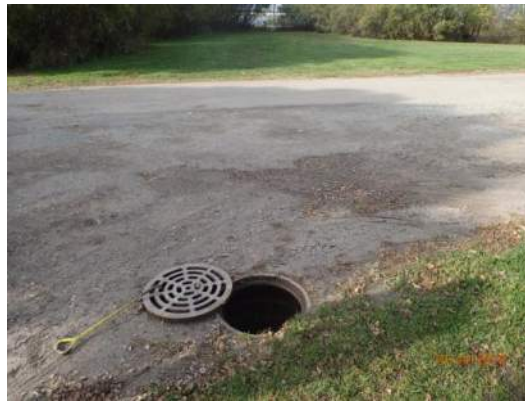
o20181024095214.JPG

Upstream catchbasin located approx 252 ft ENE of outfall 12-1313. Intermediate area consists of open space and cemetery road.

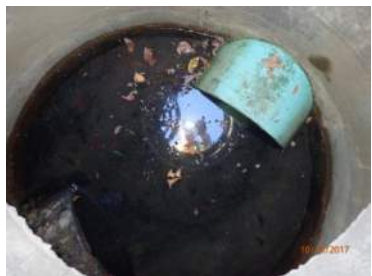
o20171018095044.JPG <div style="font-size: 24pt; font-weight: bold;">2017</div>

Inspection Date: 10/18/2017 9:55:58 AM		Type: Ongoing	Flow: Submerged, indeterminate	Previous Rainfall (hrs): 72+																																		
Illicit Discharge Potential: Unlikely		Inspector: JCW																																				
Submerged: Partially		Depth (in): 12																																				
Sampling Results		<div style="float: right; border: 1px solid black; padding: 5px; width: 200px;"> Notes Sample collected from submerged pool in manhole. </div> <table border="1" style="width:100%; border-collapse: collapse;"> <tr><td>Sample Location:</td><td>Pool</td></tr> <tr><td>Total Chlorine:</td><td>0 ppm</td></tr> <tr><td>Free Chlorine:</td><td>0 ppm</td></tr> <tr><td>Ammonia:</td><td>0 ppm</td></tr> <tr><td>pH:</td><td>7.8 units</td></tr> <tr><td>Temperature:</td><td>65 °F</td></tr> <tr><td>Conductivity:</td><td>797 µS/cm</td></tr> <tr><td>Detergents:</td><td>0 mg/L</td></tr> </table> <table border="1" style="width:100%; border-collapse: collapse;"> <tr><td>Floatables:</td><td>None</td></tr> <tr><td>Odor:</td><td>None</td></tr> <tr><td>Turbidity:</td><td>None</td></tr> <tr><td>Color:</td><td>None</td></tr> <tr><td>Gross Solids:</td><td>None</td></tr> <tr><td>Vegetation:</td><td>None</td></tr> <tr><td>Benthic Growth:</td><td>Moderate</td></tr> <tr><td>Stains:</td><td>None</td></tr> <tr><td>Non-illicit:</td><td>None</td></tr> </table> <div style="float: right; border: 1px solid black; padding: 5px; width: 200px;"> Condition Assessment Graffiti: None Erosion: None Deposition: None in. Damage: None </div>			Sample Location:	Pool	Total Chlorine:	0 ppm	Free Chlorine:	0 ppm	Ammonia:	0 ppm	pH:	7.8 units	Temperature:	65 °F	Conductivity:	797 µS/cm	Detergents:	0 mg/L	Floatables:	None	Odor:	None	Turbidity:	None	Color:	None	Gross Solids:	None	Vegetation:	None	Benthic Growth:	Moderate	Stains:	None	Non-illicit:	None

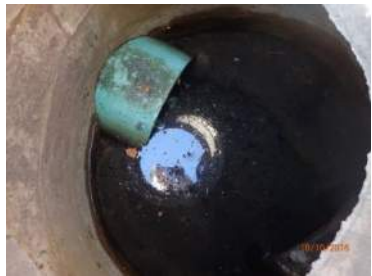
o20161010125134.JPG <div style="font-size: 24pt; font-weight: bold;">2016</div>

Inspection Date: 10/10/2016 12:53:53 PM		Type: Ongoing	Flow: Submerged, indeterminate	Previous Rainfall (hrs): 72+																																		
Illicit Discharge Potential: Unlikely		Inspector: JCW																																				
Submerged: Partially		Depth (in): 13																																				
Sampling Results		<div style="float: right; border: 1px solid black; padding: 5px; width: 200px;"> Notes </div> <table border="1" style="width:100%; border-collapse: collapse;"> <tr><td>Sample Location:</td><td>Pool</td></tr> <tr><td>Total Chlorine:</td><td>0 ppm</td></tr> <tr><td>Free Chlorine:</td><td>0 ppm</td></tr> <tr><td>Ammonia:</td><td>0 ppm</td></tr> <tr><td>pH:</td><td>7.42 units</td></tr> <tr><td>Temperature:</td><td>67 °F</td></tr> <tr><td>Conductivity:</td><td>759 µS/cm</td></tr> <tr><td>Detergents:</td><td>0 mg/L</td></tr> </table> <table border="1" style="width:100%; border-collapse: collapse;"> <tr><td>Floatables:</td><td>None</td></tr> <tr><td>Odor:</td><td>Faint</td></tr> <tr><td>Turbidity:</td><td>None</td></tr> <tr><td>Color:</td><td>None</td></tr> <tr><td>Gross Solids:</td><td>None</td></tr> <tr><td>Vegetation:</td><td>None</td></tr> <tr><td>Benthic Growth:</td><td>Slight</td></tr> <tr><td>Stains:</td><td>None</td></tr> <tr><td>Non-illicit:</td><td>None</td></tr> </table> <div style="float: right; border: 1px solid black; padding: 5px; width: 200px;"> Condition Assessment Graffiti: None Erosion: None Deposition: None in. Damage: None </div>			Sample Location:	Pool	Total Chlorine:	0 ppm	Free Chlorine:	0 ppm	Ammonia:	0 ppm	pH:	7.42 units	Temperature:	67 °F	Conductivity:	759 µS/cm	Detergents:	0 mg/L	Floatables:	None	Odor:	Faint	Turbidity:	None	Color:	None	Gross Solids:	None	Vegetation:	None	Benthic Growth:	Slight	Stains:	None	Non-illicit:	None

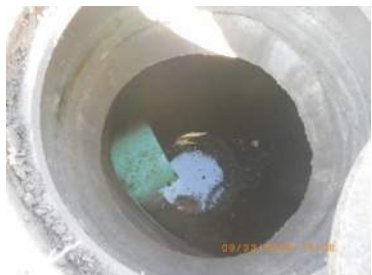
o20150923130846.JPG <div style="font-size: 24pt; font-weight: bold;">2015</div>

Inspection Date: 9/23/2015 2:07:15 PM		Type: Ongoing	Flow: Submerged, indeterminate	Previous Rainfall (hrs): 72+																																		
Illicit Discharge Potential: Unlikely		Inspector: JCW																																				
Submerged: Partially		Depth (in): 16																																				
Sampling Results		<div style="float: right; border: 1px solid black; padding: 5px; width: 200px;"> Notes </div> <table border="1" style="width:100%; border-collapse: collapse;"> <tr><td>Sample Location:</td><td>Pool</td></tr> <tr><td>Total Chlorine:</td><td>0 ppm</td></tr> <tr><td>Free Chlorine:</td><td>0 ppm</td></tr> <tr><td>Ammonia:</td><td>0 ppm</td></tr> <tr><td>pH:</td><td>7.8 units</td></tr> <tr><td>Temperature:</td><td>76 °F</td></tr> <tr><td>Conductivity:</td><td>413 µS/cm</td></tr> <tr><td>Detergents:</td><td>0 mg/L</td></tr> </table> <table border="1" style="width:100%; border-collapse: collapse;"> <tr><td>Floatables:</td><td>None</td></tr> <tr><td>Odor:</td><td>None</td></tr> <tr><td>Turbidity:</td><td>None</td></tr> <tr><td>Color:</td><td>None</td></tr> <tr><td>Gross Solids:</td><td>None</td></tr> <tr><td>Vegetation:</td><td>None</td></tr> <tr><td>Benthic Growth:</td><td>Slight</td></tr> <tr><td>Stains:</td><td>None</td></tr> <tr><td>Non-illicit:</td><td>None</td></tr> </table> <div style="float: right; border: 1px solid black; padding: 5px; width: 200px;"> Condition Assessment Graffiti: None Erosion: None Deposition: None in. Damage: None </div>			Sample Location:	Pool	Total Chlorine:	0 ppm	Free Chlorine:	0 ppm	Ammonia:	0 ppm	pH:	7.8 units	Temperature:	76 °F	Conductivity:	413 µS/cm	Detergents:	0 mg/L	Floatables:	None	Odor:	None	Turbidity:	None	Color:	None	Gross Solids:	None	Vegetation:	None	Benthic Growth:	Slight	Stains:	None	Non-illicit:	None

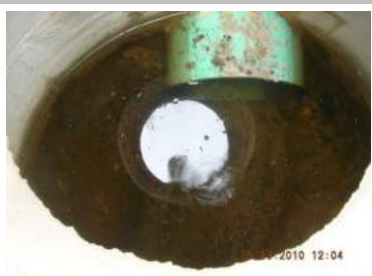
o20100819120420.JPG <div style="font-size: 24pt; font-weight: bold;">2010</div>

Inspection Date: 8/19/2010 12:12:14 PM		Type: Ongoing	Flow: Submerged, indeterminate	Previous Rainfall (hrs): 72+																																		
Illicit Discharge Potential: Unlikely		Inspector: JCW																																				
Submerged: Partially		Depth (in): 15																																				
Sampling Results		<div style="float: right; border: 1px solid black; padding: 5px; width: 200px;"> Notes </div> <table border="1" style="width:100%; border-collapse: collapse;"> <tr><td>Sample Location:</td><td>Pool</td></tr> <tr><td>Total Chlorine:</td><td>0 ppm</td></tr> <tr><td>Free Chlorine:</td><td>0 ppm</td></tr> <tr><td>Ammonia:</td><td>0 ppm</td></tr> <tr><td>pH:</td><td>7.38 units</td></tr> <tr><td>Temperature:</td><td>78 °F</td></tr> <tr><td>Conductivity:</td><td>-- µS/cm</td></tr> <tr><td>Detergents:</td><td>0 mg/L</td></tr> </table> <table border="1" style="width:100%; border-collapse: collapse;"> <tr><td>Floatables:</td><td>None</td></tr> <tr><td>Odor:</td><td>None</td></tr> <tr><td>Turbidity:</td><td>None</td></tr> <tr><td>Color:</td><td>Faint in bottle</td></tr> <tr><td>Gross Solids:</td><td>None</td></tr> <tr><td>Vegetation:</td><td>None</td></tr> <tr><td>Benthic Growth:</td><td>Slight</td></tr> <tr><td>Stains:</td><td>None</td></tr> <tr><td>Non-illicit:</td><td>None</td></tr> </table> <div style="float: right; border: 1px solid black; padding: 5px; width: 200px;"> Condition Assessment Graffiti: None Erosion: None Deposition: None 0 in. Damage: None </div>			Sample Location:	Pool	Total Chlorine:	0 ppm	Free Chlorine:	0 ppm	Ammonia:	0 ppm	pH:	7.38 units	Temperature:	78 °F	Conductivity:	-- µS/cm	Detergents:	0 mg/L	Floatables:	None	Odor:	None	Turbidity:	None	Color:	Faint in bottle	Gross Solids:	None	Vegetation:	None	Benthic Growth:	Slight	Stains:	None	Non-illicit:	None

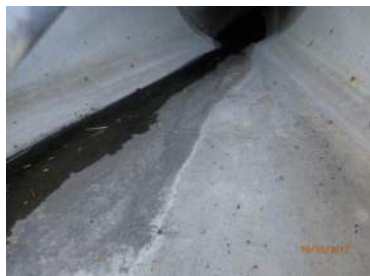
o20171018093128.JPG
2017

Inspection Date: 10/18/2017 9:40:26 AM		Type: Ongoing	Flow: Trickle	Previous Rainfall (hrs): 72+
Illicit Discharge Potential: Potential		Inspector: JCW		
Submerged: None		Depth (in):		
Sampling Results		Notes		
Sample Location: Flow	Floatables: None	Elevated pH in sample from trickle flow. No flow in upstream curb inlet at time of inspection.		
Total Chlorine: 0 ppm	Odor: None			
Free Chlorine: 0 ppm	Turbidity: None			
Ammonia: 0 ppm	Color: None			
pH: 9.23 units	Gross Solids: None			
Temperature 65 °F	Vegetation: None			
Conductivity: 1563 µS/cm	Benthic Growth: None			
Detergents: 0 mg/L	Stains:			
	Non-illicit: None			
		Graffiti: None Erosion: None Deposition: None in. Damage: None

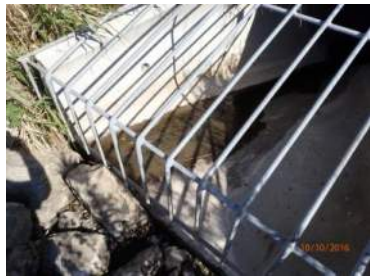
o20161010122036.JPG
2016

Inspection Date: 10/10/2016 12:26:38 PM		Type: Ongoing	Flow: Trickle	Previous Rainfall (hrs): 72+
Illicit Discharge Potential: Potential		Inspector: JCW		
Submerged: None		Depth (in):		
Sampling Results		Notes		
Sample Location: Flow	Floatables: None	Elevated pH, but not as high as 2015 screening. Possible residual in upstream pipe.		
Total Chlorine: 0 ppm	Odor: None			
Free Chlorine: 0 ppm	Turbidity: None			
Ammonia: 0 ppm	Color: None			
pH: 9.45 units	Gross Solids: None			
Temperature 64 °F	Vegetation: None			
Conductivity: 880 µS/cm	Benthic Growth: Moderate			
Detergents: 0 mg/L	Stains: Slight			
	Non-illicit: None			
		Graffiti: None Erosion: None Deposition: None in. Damage: None

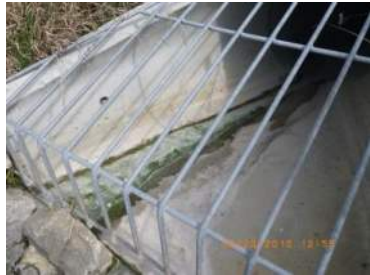
o20150923115508.JPG
2015

Inspection Date: 9/23/2015 12:56:15 PM		Type: Ongoing	Flow: Trickle	Previous Rainfall (hrs): 72+
Illicit Discharge Potential: Obvious		Inspector: JCW		
Submerged: None		Depth (in):		
Sampling Results		Notes		
Sample Location: Flow	Floatables: None	White silty discharge. Chlorine patches turned yellow (not on scale). Elevated pH and conductivity.		
Total Chlorine: -- ppm	Odor: None			
Free Chlorine: -- ppm	Turbidity: None			
Ammonia: 1 ppm	Color: None			
pH: 11.66 units	Gross Solids: Slight			
Temperature 73 °F	Vegetation: None			
Conductivity: 2470 µS/cm	Benthic Growth: Moderate			
Detergents: 0 mg/L	Stains: Moderate			
	Non-illicit: None			
		Graffiti: None Erosion: None Deposition: None in. Damage: None

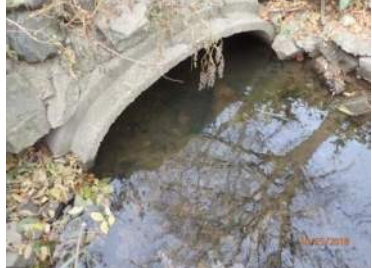
o20181025093132.JPG
2018

Inspection Date: 10/25/2018 9:33:47 AM		Type: Ongoing	Flow: Submerged, significant flow	Previous Rainfall (hrs): 72+
Illicit Discharge Potential: Potential		Inspector: JCW		
Submerged: Partially		Depth (in): 26		
Sampling Results		Notes Downstream bank erosion. Sample collected from submerged flow in pipe. Detergent detected.		
Sample Location: Flow	Floatables: None	Condition Assessment Graziti: None Erosion: Moderate Deposition: None in. Damage: None		
Total Chlorine: 0 ppm	Odor: None			
Free Chlorine: 0 ppm	Turbidity: None			
Ammonia: 0 ppm	Color: None			
pH: 8.16 units	Gross Solids: Slight			
Temperature 51 °F	Vegetation: None			
Conductivity: 1209 µS/cm	Benthic Growth: Moderate			
Detergents: 0.5 mg/L	Stains: None			
	Non-illicit: None

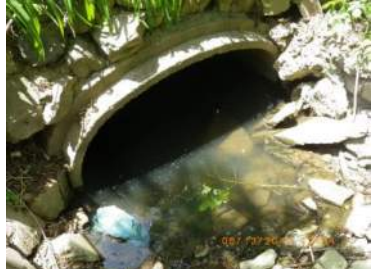
o20120613115412.JPG
2012

Inspection Date: 6/13/2012 12:53:24 PM		Type: Ongoing	Flow: Submerged, no flow	Previous Rainfall (hrs): 72+
Illicit Discharge Potential: Unlikely		Inspector: JCW		
Submerged: Partially		Depth (in): 19		
Sampling Results		Notes No flow leaving pool on apron. Downstream channel dry. Sample collected from apron pool.		
Sample Location: Pool	Floatables: None	Condition Assessment Graziti: None Erosion: None Deposition: None in. Damage: None		
Total Chlorine: 0 ppm	Odor: None			
Free Chlorine: 0 ppm	Turbidity: Slight cloudiness			
Ammonia: 0 ppm	Color: None			
pH: 7.91 units	Gross Solids: Slight			
Temperature 74 °F	Vegetation: None			
Conductivity: 1579 µS/cm	Benthic Growth: Slight			
Detergents: 0 mg/L	Stains: None			
	Non-illicit: None

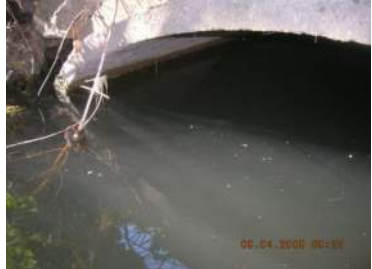
Osh09_DSCN6503.JPG
2009

Inspection Date: 9/4/2009		Type: Initial	Flow: Submerged, slight flow	Previous Rainfall (hrs): 72+
Illicit Discharge Potential: Unlikely		Inspector: JCW		
Submerged: Partially		Depth (in): 38		
Sampling Results		Notes		
Sample Location: Pool	Floatables: None	Condition Assessment Graziti: None Erosion: None Deposition: None 0 in. Damage: None		
Total Chlorine: 0 ppm	Odor: None			
Free Chlorine: 0 ppm	Turbidity: Slight cloudiness			
Ammonia: -- ppm	Color: None			
pH: 8.38 units	Gross Solids: None			
Temperature 66 °F	Vegetation:			
Conductivity: -- µS/cm	Benthic Growth: Slight			
Detergents: 0 mg/L	Stains:			
	Non-illicit: None

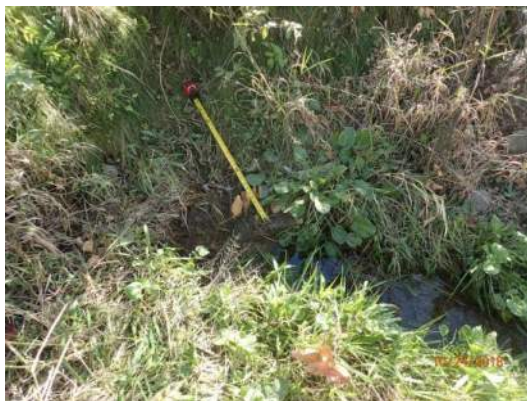
o20181024150404.JPG

Storm sewer discharges to channel from south.

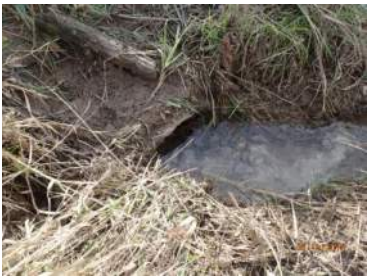
o20161019150326.JPG 2016

Inspection Date: 10/19/2016 3:04:11 PM		Type: Ongoing	Flow: Submerged, slight flow	Previous Rainfall (hrs): 72+
Illicit Discharge Potential: Unlikely		Inspector: JCW		
Submerged: Partially		Depth (in): 22		
Sampling Results Sample Location: -- Total Chlorine: -- ppm Free Chlorine: -- ppm Ammonia: -- ppm pH: -- units Temperature: -- °F Conductivity: -- µS/cm Detergents: -- mg/L		Floatables: None Odor: None Turbidity: None Color: None Gross Solids: None Vegetation: None Benthic Growth: None Stains: None Non-illicit: None	Notes Outfall partially submerged - screened upstream at 13-1098 US1. End of pipe recently excavated. Condition Assessment Graffiti: None Erosion: None Deposition: Severe 16 in. Damage: None

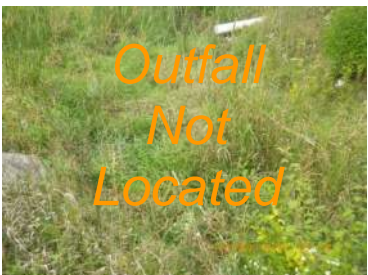
o20150924141536.JPG 2015

Inspection Date: 9/24/2015 3:10:53 PM		Type: Ongoing	Flow: Submerged (not located)	Previous Rainfall (hrs): 72+
Illicit Discharge Potential: Unlikely		Inspector: JCW		
Submerged: None		Depth (in):		
Sampling Results Sample Location: -- Total Chlorine: -- ppm Free Chlorine: -- ppm Ammonia: -- ppm pH: -- units Temperature: -- °F Conductivity: -- µS/cm Detergents: -- mg/L		Floatables: None Odor: None Turbidity: None Color: None Gross Solids: None Vegetation: None Benthic Growth: None Stains: None Non-illicit: None	Notes Outfall not located - screened at 13-1098 US1. Condition Assessment Graffiti: None Erosion: None Deposition: None in. Damage: None

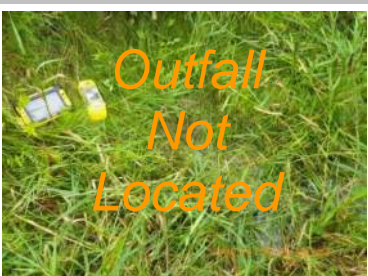
o20130730070410.JPG 2013

Inspection Date: 7/30/2013 7:57:44 AM		Type: Ongoing	Flow: Submerged (not located)	Previous Rainfall (hrs): 72+
Illicit Discharge Potential: Unlikely		Inspector: JCW		
Submerged: Fully		Depth (in):		
Sampling Results Sample Location: -- Total Chlorine: -- ppm Free Chlorine: -- ppm Ammonia: -- ppm pH: -- units Temperature: -- °F Conductivity: -- µS/cm Detergents: -- mg/L		Floatables: None Odor: None Turbidity: None Color: None Gross Solids: None Vegetation: None Benthic Growth: None Stains: None Non-illicit: None	Notes Pipe not located in grassy stream bank. Screened upstream at 13-1098 US1. Condition Assessment Graffiti: None Erosion: None Deposition: None in. Damage: None

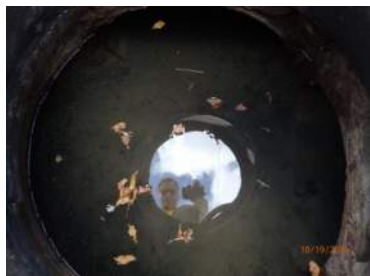
o20161019150612.JPG <div style="text-align: center; font-size: 24pt; font-weight: bold;">2016</div>

Inspection Date: 10/19/2016 3:08:52 PM		Type: Ongoing	Flow: Submerged, indeterminate	Previous Rainfall (hrs): 72+
Illicit Discharge Potential: Unlikely		Inspector: JCW		
Submerged: Partially		Depth (in): 16		
Sampling Results Sample Location: Pool Total Chlorine: 0 ppm Free Chlorine: 0 ppm Ammonia: 0 ppm pH: 7.27 units Temperature: 67 °F Conductivity: 1550 µS/cm Detergents: 0 mg/L		Floatables: None Odor: None Turbidity: None Color: None Gross Solids: None Vegetation: None Benthic Growth: None Stains: None Non-illicit: None	Notes Condition Assessment Graffiti: None Erosion: None Deposition: None in. Damage: None

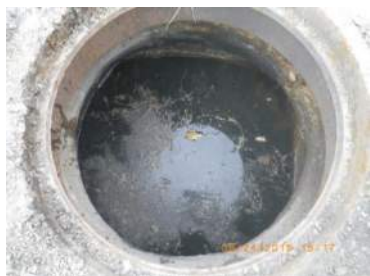
o20150924141732.JPG <div style="text-align: center; font-size: 24pt; font-weight: bold;">2015</div>

Inspection Date: 9/24/2015 3:16:16 PM		Type: Ongoing	Flow: Submerged, indeterminate	Previous Rainfall (hrs): 72+
Illicit Discharge Potential: Unlikely		Inspector: JCW		
Submerged: Partially		Depth (in): 20		
Sampling Results Sample Location: Pool Total Chlorine: 0 ppm Free Chlorine: 0 ppm Ammonia: 0 ppm pH: 7.1 units Temperature: 70 °F Conductivity: 1386 µS/cm Detergents: 0 mg/L		Floatables: None Odor: None Turbidity: None Color: None Gross Solids: Slight Vegetation: None Benthic Growth: Slight Stains: None Non-illicit: None	Notes Trash around inlet grate, but none in storm sewer. Condition Assessment Graffiti: None Erosion: None Deposition: None in. Damage: None

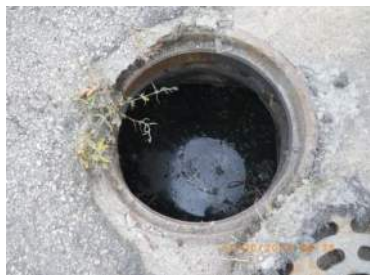
o20130730073636.JPG <div style="text-align: center; font-size: 24pt; font-weight: bold;">2013</div>

Inspection Date: 7/30/2013 8:33:34 AM		Type: Ongoing	Flow: Submerged, indeterminate	Previous Rainfall (hrs): 72+
Illicit Discharge Potential: Unlikely		Inspector: JCW		
Submerged: Partially		Depth (in): 22		
Sampling Results Sample Location: Pool Total Chlorine: 0 ppm Free Chlorine: 0 ppm Ammonia: 0 ppm pH: 7.4 units Temperature: 65 °F Conductivity: 1654 µS/cm Detergents: 0 mg/L		Floatables: None Odor: None Turbidity: None Color: None Gross Solids: Slight Vegetation: None Benthic Growth: None Stains: None Non-illicit: None	Notes Condition Assessment Graffiti: None Erosion: None Deposition: Minor 2 in. Damage: None

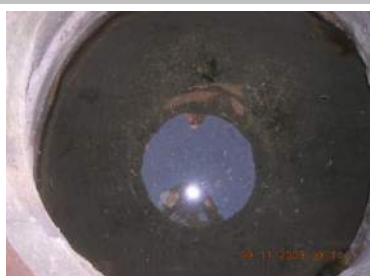
Osh09_DSCN6853.JPG <div style="text-align: center; font-size: 24pt; font-weight: bold;">2009</div>

Inspection Date: 9/3/2009		Type: Initial	Flow: Submerged, indeterminate	Previous Rainfall (hrs): 72+
Illicit Discharge Potential: Unlikely		Inspector: JCW		
Submerged: Partially		Depth (in): 13		
Sampling Results Sample Location: Pool Total Chlorine: 0 ppm Free Chlorine: 0 ppm Ammonia: -- ppm pH: 7.09 units Temperature: 70 °F Conductivity: -- µS/cm Detergents: 0 mg/L		Floatables: Odor: Turbidity: Color: Gross Solids: Vegetation: Benthic Growth: Stains: Non-illicit: None	Notes Condition Assessment Graffiti: None Erosion: None Deposition: None 0 in. Damage: None

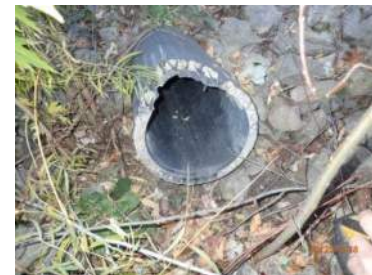
o20181025073036.JPG

Damage: Minor ☐ Displacement ☐ Undercut ☐ Crushed☐ Corrosion ☒ Cracks/Structural Damage

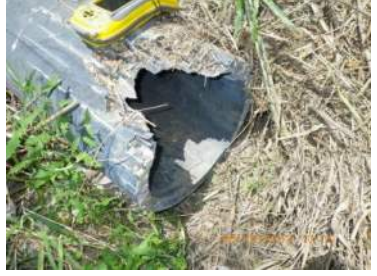
<p>o20120613121044.JPG</p> <p>2012</p>

Inspection Date: 6/13/2012 1:08:33 PM		Type: Ongoing	Flow: None	Previous Rainfall (hrs): 72+																		
Illicit Discharge Potential: Unlikely		Inspector: JCW																				
Submerged: None		Depth (in):																				
Sampling Results		Notes Pipe dry at time of inspection. Minor damage to top of pipe.																				
Sample Location: Total Chlorine: -- ppm Free Chlorine: -- ppm Ammonia: -- ppm pH: -- units Temperature: -- °F Conductivity: -- µS/cm Detergents: -- mg/L

Floatables:	None	Odor:	None	Turbidity:	None	Color:	None	Gross Solids:	None	Vegetation:	None	Benthic Growth:	None	Stains:	None	Non-illicit:	None
Floatables:	None																					
Odor:	None																					
Turbidity:	None																					
Color:	None																					
Gross Solids:	None																					
Vegetation:	None																					
Benthic Growth:	None																					
Stains:	None																					
Non-illicit:	None																					
		Condition Assessment Graffiti: None Erosion: None Deposition: None in. Damage: Minor

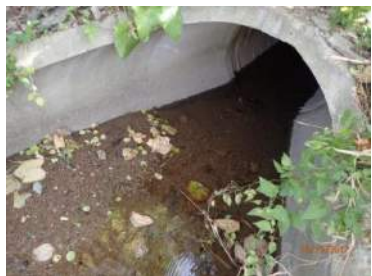
o20171019110648.JPG <div style="text-align: center; font-size: 24pt; font-weight: bold;">2017</div>

Notes Sample collected from flow from end of pipe.																																				
		Condition Assessment <table border="1" style="width:100%; border-collapse: collapse;"> <tr><td>Graffiti:</td><td>None</td></tr> <tr><td>Erosion:</td><td>None</td></tr> <tr><td>Deposition:</td><td>Minor 1 in.</td></tr> <tr><td>Damage:</td><td>None</td></tr> </table>			Graffiti:	None	Erosion:	None	Deposition:	Minor 1 in.	Damage:	None																										
Graffiti:	None																																					
Erosion:	None																																					
Deposition:	Minor 1 in.																																					
Damage:	None

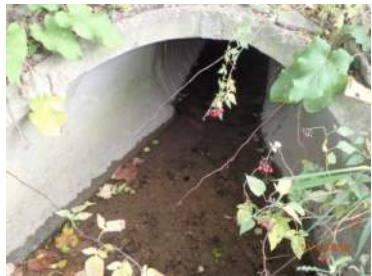
o20161019145234.JPG <div style="text-align: center; font-size: 24pt; font-weight: bold;">2016</div>

Inspection Date: 10/19/2016 2:54:11 PM		Type: Ongoing	Flow: Submerged, slight flow	Previous Rainfall (hrs): 72+																																		
Illicit Discharge Potential: Unlikely		Inspector: JCW																																				
Submerged: Partially		Depth (in): 2																																				
Sampling Results <table border="1" style="width:100%; border-collapse: collapse;"> <tr><td>Sample Location:</td><td>Flow</td></tr> <tr><td>Total Chlorine:</td><td>0 ppm</td></tr> <tr><td>Free Chlorine:</td><td>0 ppm</td></tr> <tr><td>Ammonia:</td><td>0 ppm</td></tr> <tr><td>pH:</td><td>7.3 units</td></tr> <tr><td>Temperature:</td><td>66 °F</td></tr> <tr><td>Conductivity:</td><td>1979 µS/cm</td></tr> <tr><td>Detergents:</td><td>0 mg/L</td></tr> </table>		Sample Location:	Flow	Total Chlorine:	0 ppm	Free Chlorine:	0 ppm	Ammonia:	0 ppm	pH:	7.3 units	Temperature:	66 °F	Conductivity:	1979 µS/cm	Detergents:	0 mg/L	<table border="1" style="width:100%; border-collapse: collapse;"> <tr><td>Floatables:</td><td>None</td></tr> <tr><td>Odor:</td><td>None</td></tr> <tr><td>Turbidity:</td><td>None</td></tr> <tr><td>Color:</td><td>None</td></tr> <tr><td>Gross Solids:</td><td>None</td></tr> <tr><td>Vegetation:</td><td>None</td></tr> <tr><td>Benthic Growth:</td><td>Moderate</td></tr> <tr><td>Stains:</td><td>None</td></tr> <tr><td>Non-illicit:</td><td>None</td></tr> </table>			Floatables:	None	Odor:	None	Turbidity:	None	Color:	None	Gross Solids:	None	Vegetation:	None	Benthic Growth:	Moderate	Stains:	None	Non-illicit:	None

Notes Sample collected from area of concentrated flow immediately downstream from outfall.																																				
		Condition Assessment <table border="1" style="width:100%; border-collapse: collapse;"> <tr><td>Graffiti:</td><td>None</td></tr> <tr><td>Erosion:</td><td>None</td></tr> <tr><td>Deposition:</td><td>None in.</td></tr> <tr><td>Damage:</td><td>None</td></tr> </table>			Graffiti:	None	Erosion:	None	Deposition:	None in.	Damage:	None																										
Graffiti:	None																																					
Erosion:	None																																					
Deposition:	None in.																																					
Damage:	None

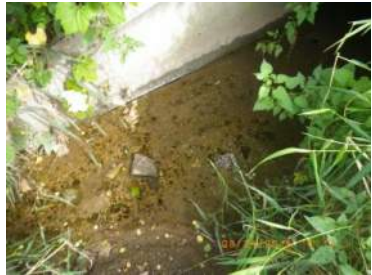
o20150924131716.JPG <div style="text-align: center; font-size: 24pt; font-weight: bold;">2015</div>

Inspection Date: 9/24/2015 2:14:57 PM		Type: Ongoing	Flow: Moderate	Previous Rainfall (hrs): 72+																																		
Illicit Discharge Potential: Unlikely		Inspector: JCW																																				
Submerged: None		Depth (in):																																				
Sampling Results <table border="1" style="width:100%; border-collapse: collapse;"> <tr><td>Sample Location:</td><td>Flow</td></tr> <tr><td>Total Chlorine:</td><td>0 ppm</td></tr> <tr><td>Free Chlorine:</td><td>0 ppm</td></tr> <tr><td>Ammonia:</td><td>0 ppm</td></tr> <tr><td>pH:</td><td>7.31 units</td></tr> <tr><td>Temperature:</td><td>70 °F</td></tr> <tr><td>Conductivity:</td><td>1648 µS/cm</td></tr> <tr><td>Detergents:</td><td>0 mg/L</td></tr> </table>		Sample Location:	Flow	Total Chlorine:	0 ppm	Free Chlorine:	0 ppm	Ammonia:	0 ppm	pH:	7.31 units	Temperature:	70 °F	Conductivity:	1648 µS/cm	Detergents:	0 mg/L	<table border="1" style="width:100%; border-collapse: collapse;"> <tr><td>Floatables:</td><td>None</td></tr> <tr><td>Odor:</td><td>None</td></tr> <tr><td>Turbidity:</td><td>None</td></tr> <tr><td>Color:</td><td>None</td></tr> <tr><td>Gross Solids:</td><td>None</td></tr> <tr><td>Vegetation:</td><td>None</td></tr> <tr><td>Benthic Growth:</td><td>Moderate</td></tr> <tr><td>Stains:</td><td>Slight</td></tr> <tr><td>Non-illicit:</td><td>None</td></tr> </table>			Floatables:	None	Odor:	None	Turbidity:	None	Color:	None	Gross Solids:	None	Vegetation:	None	Benthic Growth:	Moderate	Stains:	Slight	Non-illicit:	None

Notes Moderate flow into detention basin.																																				
		Condition Assessment <table border="1" style="width:100%; border-collapse: collapse;"> <tr><td>Graffiti:</td><td>None</td></tr> <tr><td>Erosion:</td><td>None</td></tr> <tr><td>Deposition:</td><td>None in.</td></tr> <tr><td>Damage:</td><td>None</td></tr> </table>			Graffiti:	None	Erosion:	None	Deposition:	None in.	Damage:	None																										
Graffiti:	None																																					
Erosion:	None																																					
Deposition:	None in.																																					
Damage:	None

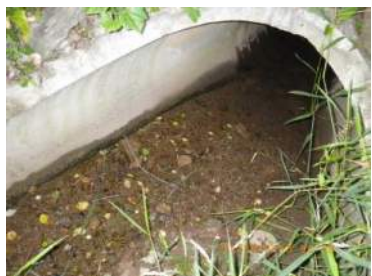
o20130730053908.JPG <div style="text-align: center; font-size: 24pt; font-weight: bold;">2013</div>

Inspection Date: 7/30/2013 6:33:19 AM		Type: Ongoing	Flow: Trickle	Previous Rainfall (hrs): 72+																																		
Illicit Discharge Potential: Unlikely		Inspector: JCW																																				
Submerged: None		Depth (in):																																				
Sampling Results <table border="1" style="width:100%; border-collapse: collapse;"> <tr><td>Sample Location:</td><td>Flow</td></tr> <tr><td>Total Chlorine:</td><td>0 ppm</td></tr> <tr><td>Free Chlorine:</td><td>0 ppm</td></tr> <tr><td>Ammonia:</td><td>0 ppm</td></tr> <tr><td>pH:</td><td>7.38 units</td></tr> <tr><td>Temperature:</td><td>63 °F</td></tr> <tr><td>Conductivity:</td><td>1764 µS/cm</td></tr> <tr><td>Detergents:</td><td>0 mg/L</td></tr> </table>		Sample Location:	Flow	Total Chlorine:	0 ppm	Free Chlorine:	0 ppm	Ammonia:	0 ppm	pH:	7.38 units	Temperature:	63 °F	Conductivity:	1764 µS/cm	Detergents:	0 mg/L	<table border="1" style="width:100%; border-collapse: collapse;"> <tr><td>Floatables:</td><td>None</td></tr> <tr><td>Odor:</td><td>None</td></tr> <tr><td>Turbidity:</td><td>None</td></tr> <tr><td>Color:</td><td>None</td></tr> <tr><td>Gross Solids:</td><td>None</td></tr> <tr><td>Vegetation:</td><td>None</td></tr> <tr><td>Benthic Growth:</td><td>Slight</td></tr> <tr><td>Stains:</td><td>Moderate</td></tr> <tr><td>Non-illicit:</td><td>None</td></tr> </table>			Floatables:	None	Odor:	None	Turbidity:	None	Color:	None	Gross Solids:	None	Vegetation:	None	Benthic Growth:	Slight	Stains:	Moderate	Non-illicit:	None

Notes 																																				
		Condition Assessment <table border="1" style="width:100%; border-collapse: collapse;"> <tr><td>Graffiti:</td><td>None</td></tr> <tr><td>Erosion:</td><td>None</td></tr> <tr><td>Deposition:</td><td>Minor 3 in.</td></tr> <tr><td>Damage:</td><td>None</td></tr> </table>			Graffiti:	None	Erosion:	None	Deposition:	Minor 3 in.	Damage:	None																										
Graffiti:	None																																					
Erosion:	None																																					
Deposition:	Minor 3 in.																																					
Damage:	None

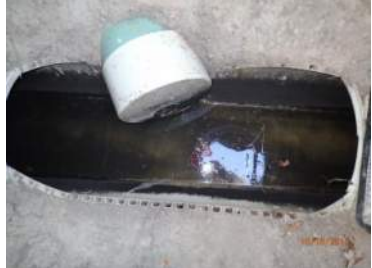
o20171018160304.JPG <div style="text-align: right; font-size: 1.5em; font-weight: bold;">2017</div>

Inspection Date: 10/18/2017 4:09:29 PM		Type: Ongoing	Flow: Submerged, indeterminate	Previous Rainfall (hrs): 72+
Illicit Discharge Potential: Potential		Inspector: JCW		
Submerged: Partially		Depth (in): 2		
Sampling Results		Notes Sample collected from submerged flow near orifice on inlet pipe. Elevated ammonia in sample.		
Sample Location: Pool	Floatables:	Slight		
Total Chlorine: 0 ppm	Odor:	None		
Free Chlorine: 0 ppm	Turbidity:	None		
Ammonia: 3 ppm	Color:	Faint in bottle		
pH: 7.69 units	Gross Solids:	None		
Temperature 66 °F	Vegetation:	None		
Conductivity: 488 µS/cm	Benthic Growth:	Moderate		
Detergents: 0 mg/L	Stains:	Severe		
	Non-illicit:	None		
		Condition Assessment Graffiti: None Erosion: None Deposition: None in. Damage: None

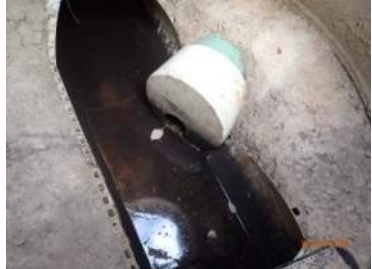
o20161019135400.JPG <div style="text-align: right; font-size: 1.5em; font-weight: bold;">2016</div>

Inspection Date: 10/19/2016 1:54:34 PM		Type: Ongoing	Flow: Submerged, slight flow	Previous Rainfall (hrs): 72+
Illicit Discharge Potential: Unlikely		Inspector: JCW		
Submerged: Partially		Depth (in): 3		
Sampling Results		Notes Sample collected from area where car wash pipe enters manhole.		
Sample Location: Flow	Floatables:	None		
Total Chlorine: 0 ppm	Odor:	None		
Free Chlorine: 0 ppm	Turbidity:	Cloudy		
Ammonia: 0 ppm	Color:	None		
pH: 7.91 units	Gross Solids:	None		
Temperature 67 °F	Vegetation:	None		
Conductivity: 649 µS/cm	Benthic Growth:	Slight		
Detergents: 0 mg/L	Stains:	Severe		
	Non-illicit:	Slight		
		Condition Assessment Graffiti: None Erosion: None Deposition: None in. Damage: None

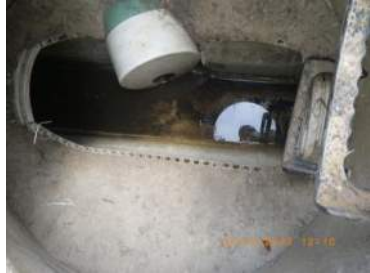
Inspection Date: 7/31/2013 12:07:12 PM		Type: Ongoing	Flow: Submerged, indeterminate	Previous Rainfall (hrs): 72+	
Illicit Discharge Potential: Unlikely		Inspector: JCW	Notes		
Submerged: Partially		Depth (in): 2

o20130731111022.JPG <div style="text-align: center; font-size: 1.5em; font-weight: bold;">2013</div>		
Sampling Results					
Sample Location:	Pool	Floatables:			None
Total Chlorine:	0 ppm	Odor:			None
Free Chlorine:	0 ppm	Turbidity:			Slight cloudiness
Ammonia:	1 ppm	Color:			None
pH:	7.81 units	Gross Solids:			None
Temperature	75 °F	Vegetation:			None
Conductivity:	632 µS/cm	Benthic Growth:			Slight
Detergents:	0 mg/L	Stains:			Moderate
		Non-illicit:	None		
			Condition Assessment Graffiti: None Erosion: None Deposition: None in. Damage: None

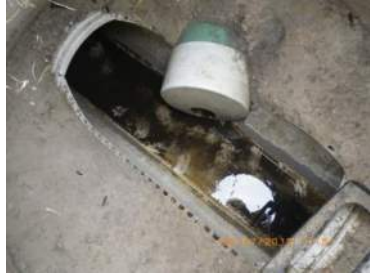
Inspection Date: 9/27/2012 10:59:11 AM		Type: Repeat	Flow: Submerged, indeterminate	Previous Rainfall (hrs): 72+	
Illicit Discharge Potential: Potential		Inspector: JCW	Notes		
Submerged: Partially		Depth (in): 2

o20120927100116.JPG <div style="text-align: center; font-size: 1.5em; font-weight: bold;">2012</div>		
Sampling Results					
Sample Location:	Pool	Floatables:			None
Total Chlorine:	0 ppm	Odor:			None
Free Chlorine:	0 ppm	Turbidity:			Slight cloudiness
Ammonia:	0 ppm	Color:			Faint in bottle
pH:	7.88 units	Gross Solids:			None
Temperature	64 °F	Vegetation:			None
Conductivity:	686 µS/cm	Benthic Growth:			Slight
Detergents:	0 mg/L	Stains:			Slight
		Non-illicit:	None		
			Condition Assessment Graffiti: None Erosion: None Deposition: None in. Damage: None

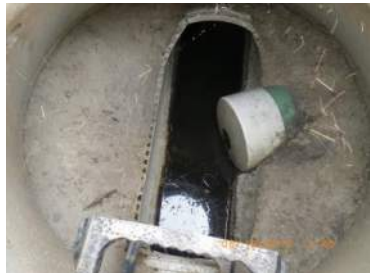
Inspection Date: 6/12/2012 11:42:38 AM		Type: Ongoing	Flow: Submerged, indeterminate	Previous Rainfall (hrs): 72+	
Illicit Discharge Potential: Potential		Inspector: JCW	Notes		
Submerged: Partially		Depth (in): 2

o20120612104548.JPG <div style="text-align: center; font-size: 1.5em; font-weight: bold;">2012</div>		
Sampling Results					
Sample Location:	Pool	Floatables:			None
Total Chlorine:	0 ppm	Odor:			Faint
Free Chlorine:	0 ppm	Turbidity:			Cloudy
Ammonia:	3 ppm	Color:			Clearly visible in bottl
pH:	7.89 units	Gross Solids:			Slight
Temperature	64 °F	Vegetation:			None
Conductivity:	1011 µS/cm	Benthic Growth:			None
Detergents:	1.3 mg/L	Stains:			Moderate
		Non-illicit:	Moderate		
			Condition Assessment Graffiti: None Erosion: None Deposition: None in. Damage: None

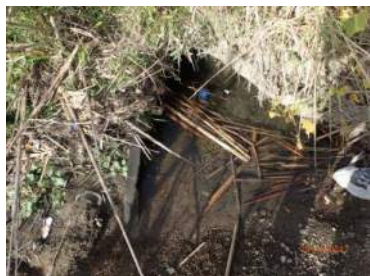
o20171019103654.JPG <div style="text-align: center; font-size: 24pt; font-weight: bold;">2017</div>

Inspection Date: 10/19/2017 10:43:36 AM		Type: Ongoing	Flow: Submerged, indeterminate	Previous Rainfall (hrs): 72+
Illicit Discharge Potential: Unlikely		Inspector: JCW		
Submerged: Partially		Depth (in): 12		
Sampling Results Sample Location: _____ Total Chlorine: -- ppm Free Chlorine: -- ppm Ammonia: -- ppm pH: -- units Temperature: -- °F Conductivity: -- µS/cm Detergents: -- mg/L		Floatables: None Odor: None Turbidity: None Color: None Gross Solids: Slight Vegetation: None Benthic Growth: Moderate Stains: Moderate Non-illicit: None	Notes Outfall partially submerged - screened upstream at 13-1758 US1. Condition Assessment Graffiti: None Erosion: None Deposition: Moderate 8 in. Damage: None

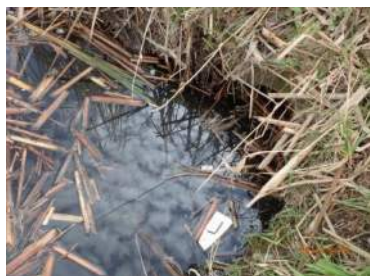
o20161019142738.JPG <div style="text-align: center; font-size: 24pt; font-weight: bold;">2016</div>

Inspection Date: 10/19/2016 2:28:19 PM		Type: Ongoing	Flow: Submerged, indeterminate	Previous Rainfall (hrs): 72+
Illicit Discharge Potential: Unlikely		Inspector: JCW		
Submerged: Partially		Depth (in): 24		
Sampling Results Sample Location: _____ Total Chlorine: -- ppm Free Chlorine: -- ppm Ammonia: -- ppm pH: -- units Temperature: -- °F Conductivity: -- µS/cm Detergents: -- mg/L		Floatables: None Odor: Easily detected Turbidity: None Color: None Gross Solids: Slight Vegetation: None Benthic Growth: None Stains: None Non-illicit: None	Notes Outfall partially submerged - screened upstream at 13-1758 US1. Condition Assessment Graffiti: None Erosion: None Deposition: Moderate 13 in. Damage: None

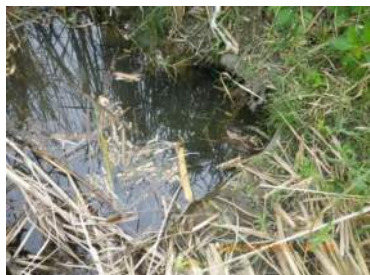
o20150924125956.JPG <div style="text-align: center; font-size: 24pt; font-weight: bold;">2015</div>

Inspection Date: 9/24/2015 1:57:20 PM		Type: Ongoing	Flow: Submerged, indeterminate	Previous Rainfall (hrs): 72+
Illicit Discharge Potential: Unlikely		Inspector: JCW		
Submerged: Partially		Depth (in): 24		
Sampling Results Sample Location: _____ Total Chlorine: -- ppm Free Chlorine: -- ppm Ammonia: -- ppm pH: -- units Temperature: -- °F Conductivity: -- µS/cm Detergents: -- mg/L		Floatables: None Odor: None Turbidity: None Color: None Gross Solids: Slight Vegetation: None Benthic Growth: Moderate Stains: None Non-illicit: None	Notes Outfall partially submerged - screened at 13-1758 US1. Condition Assessment Graffiti: None Erosion: None Deposition: Moderate 8 in. Damage: None

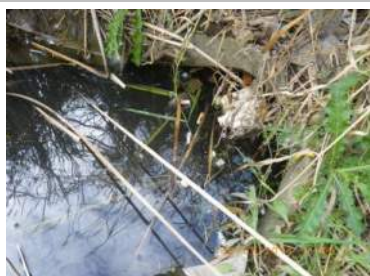
o20141007105524.JPG <div style="text-align: center; font-size: 24pt; font-weight: bold;">2014</div>

Inspection Date: 10/7/2014 11:57:15 AM		Type: Ongoing	Flow: Submerged, indeterminate	Previous Rainfall (hrs): 48-72
Illicit Discharge Potential: Potential		Inspector: JCW		
Submerged: Partially		Depth (in): 26		
Sampling Results Sample Location: _____ Total Chlorine: -- ppm Free Chlorine: -- ppm Ammonia: -- ppm pH: -- units Temperature: -- °F Conductivity: -- µS/cm Detergents: -- mg/L		Floatables: None Odor: None Turbidity: None Color: None Gross Solids: Slight Vegetation: None Benthic Growth: Slight Stains: None Non-illicit: None	Notes Outfall partially submerged - screened upstream at 13-1758 US1. Condition Assessment Graffiti: None Erosion: None Deposition: Moderate 8 in. Damage: None

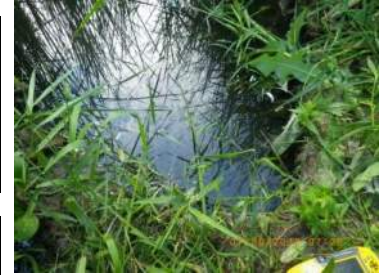
o20130730062618.JPG

Inspection Date: 7/30/2013 7:19:09 AM		Type: Ongoing	Flow: Submerged, indeterminate	Previous Rainfall (hrs): 72+
Illicit Discharge Potential: Potential		Inspector: JCW		
Submerged: Fully		Depth (in): 30		
Sampling Results		Notes Oil containment booms still present in downstream pool. Outfall fully submerged. Screened upstream at 13-1758 US1.		
Sample Location:	Floatables:	Slight		
Total Chlorine: -- ppm	Odor:	Faint		
Free Chlorine: -- ppm	Turbidity:	None		
Ammonia: -- ppm	Color:	None		
pH: -- units	Gross Solids:	Slight		
Temperature -- °F	Vegetation:	None		
Conductivity: -- µS/cm	Benthic Growth:	None		
Detergents: -- mg/L	Stains:	None		
	Non-illicit:	None		
		Condition Assessment Graffiti: None Erosion: None Deposition: Moderate 10 in. Damage: None

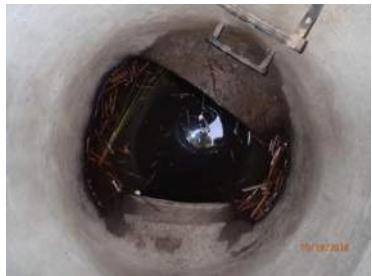
o20161019143020.JPG <div style="text-align: center; font-size: 24pt; font-weight: bold;">2016</div>

<div style="float: right; border: 1px solid black; padding: 5px; width: 200px;"> Condition Assessment Graffiti: None Erosion: None Deposition: None in. Damage: None </div>			Floatables:	None	Odor:	None	Turbidity:	None	Color:	None	Gross Solids:	Moderate	Vegetation:	None	Benthic Growth:	None	Stains:	Moderate	Non-illicit:	None
Floatables:	None																					
Odor:	None																					
Turbidity:	None																					
Color:	None																					
Gross Solids:	Moderate																					
Vegetation:	None																					
Benthic Growth:	None																					
Stains:	Moderate																					
Non-illicit:	None																					
Sample Location: Pool Total Chlorine: 0 ppm Free Chlorine: 0 ppm Ammonia: 0 ppm pH: 7.72 units Temperature: 67 °F Conductivity: 1270 µS/cm Detergents: 0 mg/L

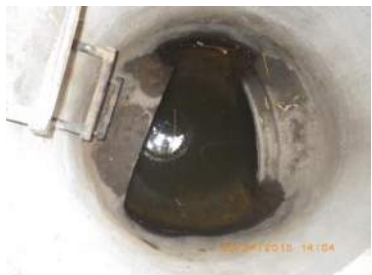
o20150924130406.JPG <div style="text-align: center; font-size: 24pt; font-weight: bold;">2015</div>

Inspection Date: 9/24/2015 2:02:47 PM		Type: Ongoing	Flow: Submerged, indeterminate	Previous Rainfall (hrs): 72+																		
Illicit Discharge Potential: Unlikely		Inspector: JCW																				
Submerged: Partially		Depth (in): 22																				
Sampling Results		<div style="float: right; border: 1px solid black; padding: 5px; width: 200px;"> Notes No remaining evidence of former petroleum discharge. </div>

<div style="float: right; border: 1px solid black; padding: 5px; width: 200px;"> Condition Assessment Graffiti: None Erosion: None Deposition: None in. Damage: None </div>			Floatables:	None	Odor:	None	Turbidity:	Slight cloudiness	Color:	None	Gross Solids:	None	Vegetation:	None	Benthic Growth:	Slight	Stains:	Moderate	Non-illicit:	Slight
Floatables:	None																					
Odor:	None																					
Turbidity:	Slight cloudiness																					
Color:	None																					
Gross Solids:	None																					
Vegetation:	None																					
Benthic Growth:	Slight																					
Stains:	Moderate																					
Non-illicit:	Slight																					
Sample Location: Pool Total Chlorine: 0 ppm Free Chlorine: 0 ppm Ammonia: 0 ppm pH: 7.66 units Temperature: 72 °F Conductivity: 1138 µS/cm Detergents: 0 mg/L

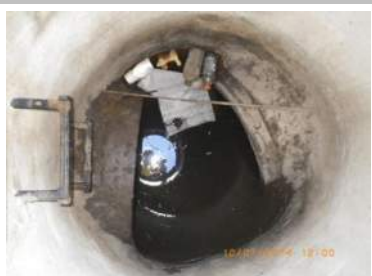
o20141007110058.JPG <div style="text-align: center; font-size: 24pt; font-weight: bold;">2014</div>

Inspection Date: 10/7/2014 12:02:49 PM		Type: Ongoing	Flow: Submerged, indeterminate	Previous Rainfall (hrs): 48-72																		
Illicit Discharge Potential: Potential		Inspector: JCW																				
Submerged: Partially		Depth (in): 22																				
Sampling Results		<div style="float: right; border: 1px solid black; padding: 5px; width: 200px;"> Notes Floating gross solids (litter) in manhole. </div>

<div style="float: right; border: 1px solid black; padding: 5px; width: 200px;"> Condition Assessment Graffiti: None Erosion: None Deposition: None in. Damage: None </div>			Floatables:	None	Odor:	None	Turbidity:	None	Color:	None	Gross Solids:	Moderate	Vegetation:	None	Benthic Growth:	Slight	Stains:	Moderate	Non-illicit:	None
Floatables:	None																					
Odor:	None																					
Turbidity:	None																					
Color:	None																					
Gross Solids:	Moderate																					
Vegetation:	None																					
Benthic Growth:	Slight																					
Stains:	Moderate																					
Non-illicit:	None																					
Sample Location: Pool Total Chlorine: 0 ppm Free Chlorine: 0 ppm Ammonia: 0 ppm pH: 7.72 units Temperature: -- °F Conductivity: 1629 µS/cm Detergents: 0 mg/L

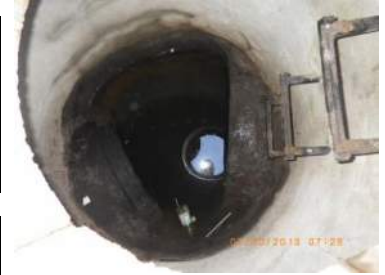
o20130730062844.JPG

Inspection Date: 7/30/2013 7:22:47 AM		Type: Ongoing	Flow: Submerged, indeterminate	Previous Rainfall (hrs): 72+
Illicit Discharge Potential: Potential		Inspector: JCW		
Submerged: Partially		Depth (in): 27		
Sampling Results		Notes Petroleum odor still present. Slight sheen observed.		
Sample Location: Pool	Floatables:	Moderate		
Total Chlorine: 0 ppm	Odor:	Easily detected		
Free Chlorine: 0 ppm	Turbidity:	None		
Ammonia: 0 ppm	Color:	None		
pH: 7.6 units	Gross Solids:	Slight		
Temperature 67 °F	Vegetation:	None		
Conductivity: 1071 µS/cm	Benthic Growth:	None		
Detergents: 0 mg/L	Stains:	Severe		
	Non-illicit:	None		
		Condition Assessment Graffiti: None Erosion: None Deposition: None in. Damage: None

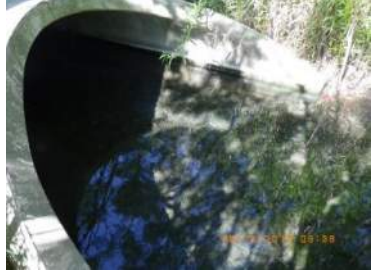
o20120612083850.JPG

Inspection Date: 6/12/2012 9:35:59 AM		Type: Ongoing	Flow: Submerged, slight flow	Previous Rainfall (hrs): 72+
Illicit Discharge Potential: Unlikely		Inspector: JCW		
Submerged: Partially		Depth (in): 14		
Sampling Results		Notes		
Sample Location:		Outfall partially submerged; screened upstream at 13-2332 US1.		
Total Chlorine:	-- ppm	Floatables:	None	
Free Chlorine:	-- ppm	Odor:	None	
Ammonia:	-- ppm	Turbidity:	None	
pH:	-- units	Color:	None	
Temperature:	-- °F	Gross Solids:	Slight	
Conductivity:	-- µS/cm	Vegetation:	None	
Detergents:	-- mg/L	Benthic Growth:	Moderate	
		Stains:	None	
		Non-illicit:	None	
		Condition Assessment		
		Graffiti:	None	
		Erosion:	None	
		Deposition:	None in.	
		Damage:	None

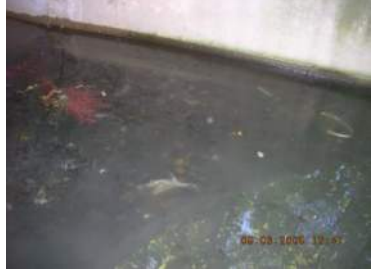
Osh09_DSCN6437.JPG

Inspection Date: 9/3/2009		Type: Initial	Flow: Submerged, slight flow	Previous Rainfall (hrs): 72+
Illicit Discharge Potential: Unlikely		Inspector: JCW		
Submerged: Partially		Depth (in): 15		
Sampling Results		Notes		
Sample Location:				
Total Chlorine:	-- ppm	Floatables:	None	
Free Chlorine:	-- ppm	Odor:	Faint	
Ammonia:	-- ppm	Turbidity:	None	
pH:	-- units	Color:	None	
Temperature:	-- °F	Gross Solids:	None	
Conductivity:	-- µS/cm	Vegetation:		
Detergents:	-- mg/L	Benthic Growth:	Slight	
		Stains:		
		Non-illicit:	None	
		Condition Assessment		
		Graffiti:	None	
		Erosion:	None	
		Deposition:	8 in.	
		Damage:	None

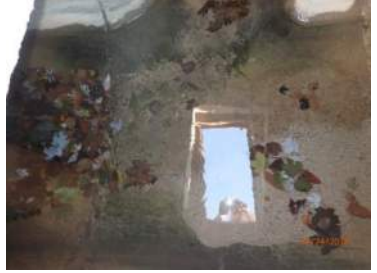
o20181024151936.JPG 2018

Inspection Date: 10/24/2018 3:21:30 PM		Type: Ongoing	Flow: Submerged, slight flow	Previous Rainfall (hrs): 72+
Illicit Discharge Potential: Potential		Inspector: JCW		
Submerged: Partially		Depth (in): 6		
Sampling Results		Notes		
Sample Location: Pool	Floatables: None	<div style="border: 1px solid black; padding: 5px;"> Sample collected from submerged pool in manhole. Detergent detected in sample. </div>		
Total Chlorine: 0 ppm	Odor: None			
Free Chlorine: 0 ppm	Turbidity: None			
Ammonia: 0 ppm	Color: None			
pH: 7.56 units	Gross Solids: None			
Temperature 55 °F	Vegetation: None			
Conductivity: 1107 µS/cm	Benthic Growth: None			
Detergents: 0.3 mg/L	Stains: Slight			
	Non-illicit: None			
		Graffiti: None Erosion: None Deposition: None in. Damage: None

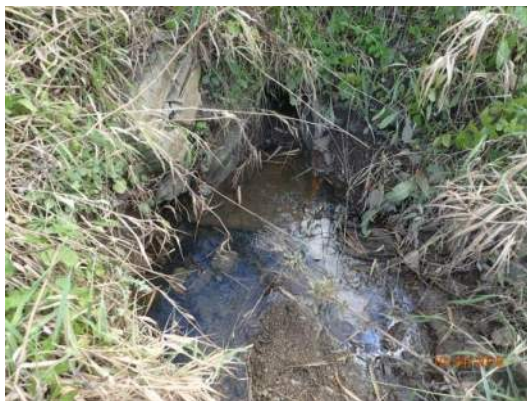
o20181024124534.JPG

STH 44 curb inlets discharge to stream from south. Possible outfall pool located, but actual pipe not found. Encountered rock/riprap.

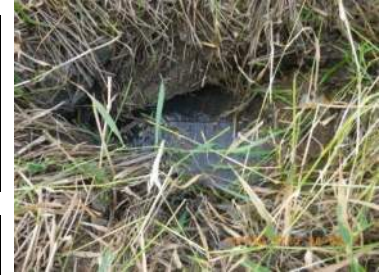
o20130730055304.JPG

Inspection Date: 7/30/2013 6:46:29 AM		Type: Ongoing	Flow: Submerged, indeterminate	Previous Rainfall (hrs): 72+
Illicit Discharge Potential: Unlikely		Inspector: JCW		
Submerged: Fully		Depth (in): 12		
Sampling Results		Notes Outfall not positively identified. Outfall screened upstream at 13-2611 US1.		
Sample Location:	Floatables:	None		
Total Chlorine: -- ppm	Odor:	None		
Free Chlorine: -- ppm	Turbidity:	None		
Ammonia: -- ppm	Color:	None		
pH: -- units	Gross Solids:	Slight		
Temperature -- °F	Vegetation:	None		
Conductivity: -- µS/cm	Benthic Growth:	None		
Detergents: -- mg/L	Stains:	None		
	Non-illicit:	None		
		Condition Assessment Graffiti: None Erosion: None Deposition: Moderate 2 in. Damage: None

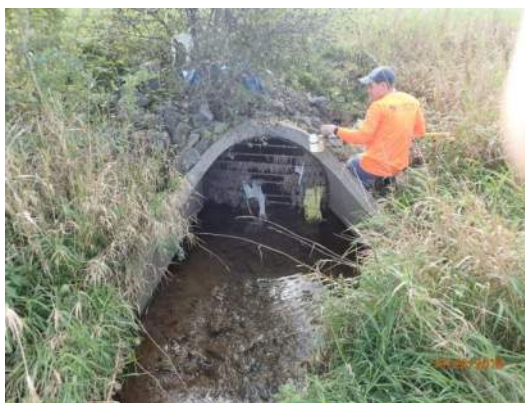
o20181024124742.JPG

STH 44 storm sewer discharges to stream from west.

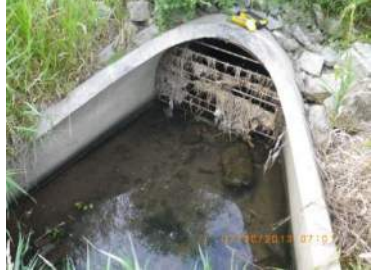
<p style="text-align: center;">o20130730060140.JPG</p> <p style="text-align: center; font-size: 24pt; font-weight: bold;">2013</p>

Inspection Date: 7/30/2013 6:54:23 AM		Type: Ongoing	Flow: Submerged, indeterminate	Previous Rainfall (hrs): 72+
Illicit Discharge Potential: Unlikely		Inspector: JCW		
Submerged: Partially		Depth (in): 5		
Sampling Results		Notes Outfall partially submerged. Outfall screened upstream at 13-2613 US1.		
Sample Location: --- Total Chlorine: -- ppm Free Chlorine: -- ppm Ammonia: -- ppm pH: -- units Temperature: -- °F Conductivity: -- µS/cm Detergents: -- mg/L		Condition Assessment Graffiti: None Erosion: None Deposition: None in. Damage: None		
Floatables: None Odor: None Turbidity: None Color: None Gross Solids: Moderate Vegetation: None Benthic Growth: Moderate Stains: Moderate Non-illicit: None

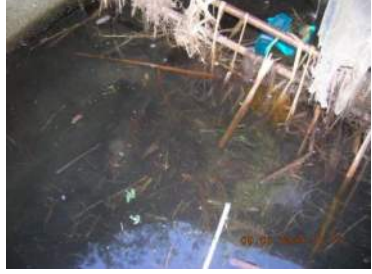
<p style="text-align: center;">Osh09_DSCN6430.JPG</p> <p style="text-align: center; font-size: 24pt; font-weight: bold;">2009</p>

Inspection Date: 9/3/2009		Type: Initial	Flow: Submerged, slight flow	Previous Rainfall (hrs): 72+
Illicit Discharge Potential: Unlikely		Inspector: JCW		
Submerged: Partially		Depth (in): 6		
Sampling Results		Notes Thick layer of grass clippings in pipe and pool.		
Sample Location: Pool Total Chlorine: 0 ppm Free Chlorine: 0 ppm Ammonia: -- ppm pH: 7.77 units Temperature: 69 °F Conductivity: -- µS/cm Detergents: 0 mg/L		Condition Assessment Graffiti: None Erosion: None Deposition: None 0 in. Damage: None		
Floatables: Moderate Odor: None Turbidity: None Color: None Gross Solids: None Vegetation: --- Benthic Growth: Slight Stains: --- Non-illicit: None
