Ongoing Screening Summary Report 2018 Inspection Year

Illicit Discharge Detection and Elimination Program

City of Oshkosh

January 25, 2019

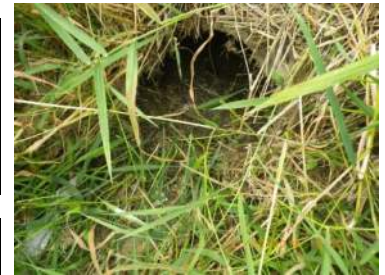
o20130730095052.JPG

Inspection Date: 7/30/2013 10:43:10 AM		Type: Ongoing	Flow: None	Previous Rainfall (hrs): 72+
Illicit Discharge Potential: Unlikely		Inspector: JCW		
Submerged: None		Depth (in):		
Sampling Results		Notes		
Sample Location:		Apron sediment wet, but no collectable flow at time of inspection.		
Total Chlorine:	-- ppm	Floatables:	None	
Free Chlorine:	-- ppm	Odor:	None	
Ammonia:	-- ppm	Turbidity:	None	
pH:	-- units	Color:	None	
Temperature	-- °F	Gross Solids:	None	
Conductivity:	-- µS/cm	Vegetation:	None	
Detergents:	-- mg/L	Benthic Growth:	Slight	
		Stains:	None	
		Non-illicit:	None	
		Condition Assessment		
		Graffiti:	None	
		Erosion:	None	
		Deposition:	Minor	2 in.
		Damage:	None

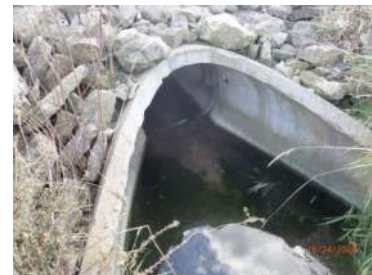
o20181024130804.JPG

Damage: Minor ☒ Displacement ☐ Undercut ☐ Crushed☐ Corrosion ☐ Cracks/Structural Damage

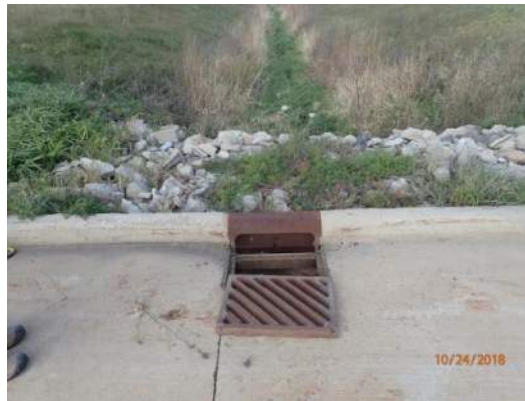
o20181024131134.JPG

Upstream curb inlet located approx 11 ft SE of outfall 13-2872a. Intermediate area consists of street right-of-way.

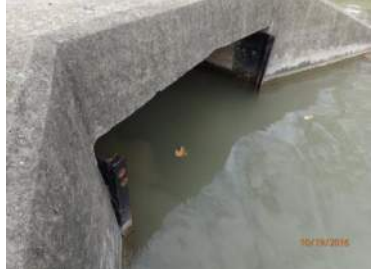
o20161019134018.JPG <div style="text-align: right; font-size: 1.5em; font-weight: bold;">2016</div>

Inspection Date: 10/19/2016 1:42:21 PM		Type: Ongoing	Flow: Submerged, indeterminate	Previous Rainfall (hrs): 72+
Illicit Discharge Potential: Unlikely		Inspector: JCW		
Submerged: Partially		Depth (in): 19		
Sampling Results		Notes Outfall partially submerged - screened upstream at 13-2957 US1.		
Sample Location:	Floatables:	None		
Total Chlorine: -- ppm	Odor:	None		
Free Chlorine: -- ppm	Turbidity:	Cloudy		
Ammonia: -- ppm	Color:	None		
pH: -- units	Gross Solids:	None		
Temperature -- °F	Vegetation:	None		
Conductivity: -- µS/cm	Benthic Growth:	Moderate		
Detergents: -- mg/L	Stains:	Moderate		
	Non-illicit:	None		
		Condition Assessment Graffiti: None Erosion: None Deposition: None in. Damage: None

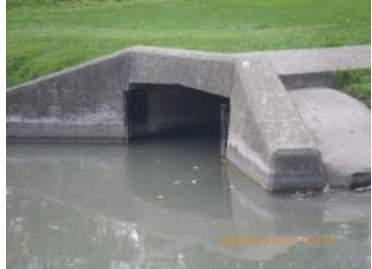
o20150924121536.JPG <div style="text-align: right; font-size: 1.5em; font-weight: bold;">2015</div>

Inspection Date: 9/24/2015 1:12:45 PM		Type: Ongoing	Flow: Submerged, indeterminate	Previous Rainfall (hrs): 72+
Illicit Discharge Potential: Unlikely		Inspector: JCW		
Submerged: Partially		Depth (in): 17		
Sampling Results		Notes Outfall partially submerged - screened at 13-2957 US1.		
Sample Location:	Floatables:	None		
Total Chlorine: -- ppm	Odor:	None		
Free Chlorine: -- ppm	Turbidity:	Cloudy		
Ammonia: -- ppm	Color:	None		
pH: -- units	Gross Solids:	None		
Temperature -- °F	Vegetation:	None		
Conductivity: -- µS/cm	Benthic Growth:	Moderate		
Detergents: -- mg/L	Stains:	None		
	Non-illicit:	None		
		Condition Assessment Graffiti: None Erosion: None Deposition: None in. Damage: None

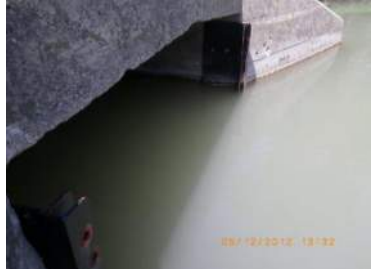
o20120612123258.JPG <div style="text-align: right; font-size: 1.5em; font-weight: bold;">2012</div>

Inspection Date: 6/12/2012 1:30:43 PM		Type: Ongoing	Flow: Submerged, indeterminate	Previous Rainfall (hrs): 72+
Illicit Discharge Potential: Unlikely		Inspector: JCW		
Submerged: Partially		Depth (in): 21		
Sampling Results		Notes Outfall partially submerged; screened upstream at 13-2957 US1.		
Sample Location:	Floatables:	None		
Total Chlorine: -- ppm	Odor:	None		
Free Chlorine: -- ppm	Turbidity:	None		
Ammonia: -- ppm	Color:	None		
pH: -- units	Gross Solids:	None		
Temperature -- °F	Vegetation:	None		
Conductivity: -- µS/cm	Benthic Growth:	Moderate		
Detergents: -- mg/L	Stains:	Moderate		
	Non-illicit:	None		
		Condition Assessment Graffiti: Minor Erosion: None Deposition: None in. Damage: None

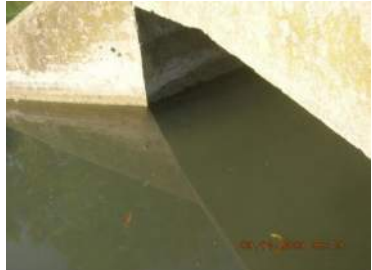
Osh09_DSCN6483.JPG <div style="text-align: right; font-size: 1.5em; font-weight: bold;">2009</div>

Inspection Date: 9/4/2009		Type: Initial	Flow: Submerged, slight flow	Previous Rainfall (hrs): 72+
Illicit Discharge Potential: Unlikely		Inspector: JCW		
Submerged: None		Depth (in): 16		
Sampling Results		Notes		
Sample Location:	Floatables:	None		
Total Chlorine: -- ppm	Odor:	None		
Free Chlorine: -- ppm	Turbidity:	None		
Ammonia: -- ppm	Color:	None		
pH: -- units	Gross Solids:	None		
Temperature -- °F	Vegetation:			
Conductivity: -- µS/cm	Benthic Growth:	Slight		
Detergents: -- mg/L	Stains:			
	Non-illicit:	None		
		Condition Assessment Graffiti: None Erosion: None Deposition: None 0 in. Damage: None

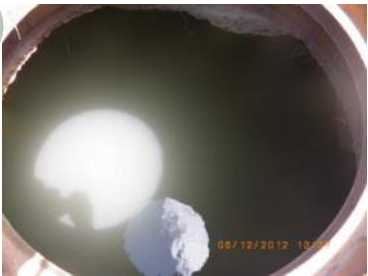
Inspection Date: 6/12/2012 1:36:29 PM		Type: Ongoing	Flow: Submerged, indeterminate	Previous Rainfall (hrs): 72+
Illicit Discharge Potential: Unlikely		Inspector: JCW		
Submerged: Partially		Depth (in): 23		
Sampling Results Sample Location: Pool Total Chlorine: 0 ppm Free Chlorine: 0 ppm Ammonia: 0 ppm pH: 8.35 units Temperature: 71 °F Conductivity: 1336 µS/cm Detergents: 0 mg/L		Floatables: None Odor: None Turbidity: Slight cloudiness Color: None Gross Solids: None Vegetation: None Benthic Growth: None Stains: None Non-illicit: None	Notes

o20120612123728.JPG 2012
		Condition Assessment Graffiti: None Erosion: None Deposition: None in. Damage: None

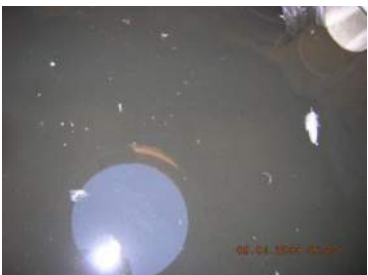
Inspection Date: 9/4/2009		Type: Initial	Flow: Submerged, slight flow	Previous Rainfall (hrs): 72+
Illicit Discharge Potential: Unlikely		Inspector: JCW		
Submerged: Fully		Depth (in):		
Sampling Results Sample Location: Pool Total Chlorine: 0 ppm Free Chlorine: 0 ppm Ammonia: -- ppm pH: 8.1 units Temperature: 66 °F Conductivity: -- µS/cm Detergents: 0 mg/L		Floatables: None Odor: None Turbidity: None Color: None Gross Solids: None Vegetation: Benthic Growth: Stains: Non-illicit: None	Notes

Osh09_DSCN6486.JPG 2009
		Condition Assessment Graffiti: None Erosion: None Deposition: None 0 in. Damage: None

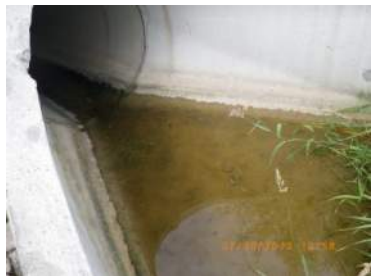
o20130730095856.JPG
2013

Inspection Date: 7/30/2013 10:52:09 AM		Type: Ongoing	Flow: Submerged, indeterminate	Previous Rainfall (hrs): 72+
Illicit Discharge Potential: Unlikely		Inspector: JCW		
Submerged: Partially		Depth (in): 1		
Sampling Results		Notes		
Sample Location:	Floatables:	Outfall partially submerged. Outfall screened upstream at 13-3204 US1.		
Total Chlorine: -- ppm	Odor:			
Free Chlorine: -- ppm	Turbidity:			
Ammonia: -- ppm	Color:			
pH: -- units	Gross Solids:			
Temperature -- °F	Vegetation:			
Conductivity: -- µS/cm	Benthic Growth:			
Detergents: -- mg/L	Stains:			
	Non-illicit:	Condition Assessment Graffiti: None Erosion: None Deposition: None in. Damage: None

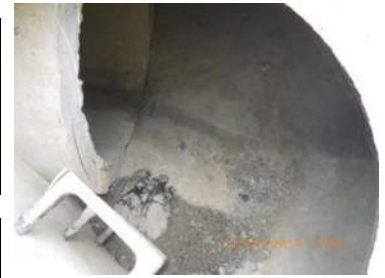
o20130730100236.JPG

Inspection Date: 7/30/2013 11:00:01 AM		Type: Ongoing	Flow: None	Previous Rainfall (hrs): 72+
Illicit Discharge Potential: Unlikely		Inspector: JCW		
Submerged: None		Depth (in):		
Sampling Results		Notes		
Sample Location:		Manhole dry and clean at time of inspection.		
Total Chlorine:	-- ppm	Floatables:	None	
Free Chlorine:	-- ppm	Odor:	None	
Ammonia:	-- ppm	Turbidity:	None	
pH:	-- units	Color:	None	
Temperature:	-- °F	Gross Solids:	None	
Conductivity:	-- µS/cm	Vegetation:	None	
Detergents:	-- mg/L	Benthic Growth:	None	
		Stains:	None	
		Non-illicit:	None	
		Condition Assessment		
		Graffiti:	None	
		Erosion:	None	
		Deposition:	None in.	
		Damage:	None

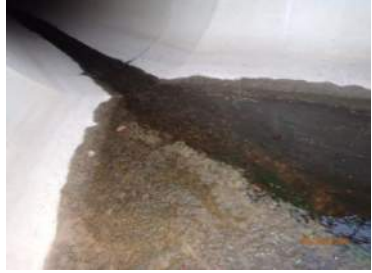
o20150922133514.JPG 2015

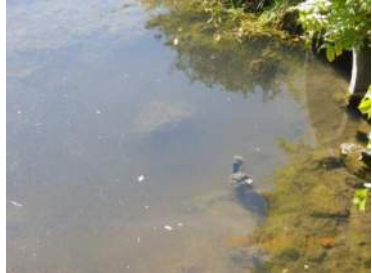
classification indicates that the color can be observed in the actual flow or pool, outside of the sample bottle.

Inspection Date: 10/5/2011 12:26:00 PM		Type: Repeat	Flow: Submerged, indeterminate	Previous Rainfall (hrs): 72+
Illicit Discharge Potential: Obvious		Inspector: JCW	Notes Complaint follow-up. Outfall partially submerged. Outfall screened upstream at 14-585 US7. Limited screening conducted.	
Submerged: Partially Depth (in):				
Sampling Results Sample Location: _____ Total Chlorine: -- ppm Free Chlorine: -- ppm Ammonia: -- ppm pH: -- units Temperature -- °F Conductivity: -- µS/cm Detergents: -- mg/L		Floatables: _____ Odor: _____ Turbidity: _____ Color: _____ Gross Solids: _____ Vegetation: _____ Benthic Growth: _____ Stains: _____ Non-illicit: None	Condition Assessment Graffiti: _____ Erosion: _____ Deposition: in. Damage: _____

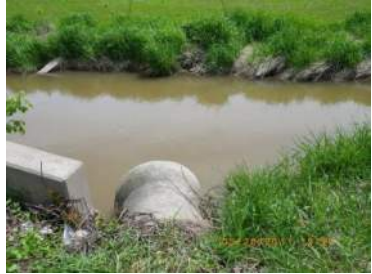
o20110526112114.jpg <div style="font-size: 24pt; font-weight: bold;">2011</div>

Inspection Date: 5/26/2011 12:21:00 PM		Type: Repeat	Flow: Submerged, indeterminate	Previous Rainfall (hrs): 72+
Illicit Discharge Potential: Obvious		Inspector: JCW	Notes Complaint follow-up. Strong chlorine smell inside pipe. Chemical interference with chlorine test. Limited screening conducted.	
Submerged: Partially Depth (in):				
Sampling Results Sample Location: Pool Total Chlorine: -- ppm Free Chlorine: -- ppm Ammonia: -- ppm pH: -- units Temperature -- °F Conductivity: -- µS/cm Detergents: -- mg/L		Floatables: _____ Odor: Noticeable from a dist Turbidity: _____ Color: _____ Gross Solids: _____ Vegetation: _____ Benthic Growth: _____ Stains: _____ Non-illicit: _____	Condition Assessment Graffiti: _____ Erosion: _____ Deposition: in. Damage: _____

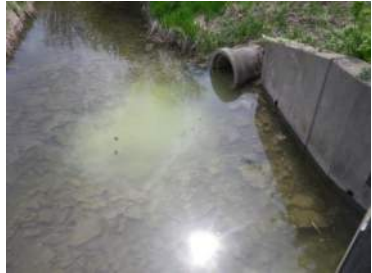
o20110512133142.jpg <div style="font-size: 24pt; font-weight: bold;">2011</div>

Inspection Date: 5/12/2011 1:03:00 PM		Type: Complaint	Flow: Submerged, indeterminate	Previous Rainfall (hrs): 72+
Illicit Discharge Potential: Obvious		Inspector: JCW	Notes Responded to complaint about discharge from pipe. Outfall partially submerged. Yellow pool at end of pipe. Chemical smell inside pipe.	
Submerged: Partially Depth (in):				
Sampling Results Sample Location: Pool Total Chlorine: 2 ppm Free Chlorine: 2 ppm Ammonia: 2 ppm pH: -- units Temperature -- °F Conductivity: -- µS/cm Detergents: -- mg/L		Floatables: _____ Odor: Noticeable from a dist Turbidity: _____ Color: Clearly visible in flow Gross Solids: _____ Vegetation: _____ Benthic Growth: _____ Stains: _____ Non-illicit: None	Condition Assessment Graffiti: _____ Erosion: _____ Deposition: in. Damage: _____

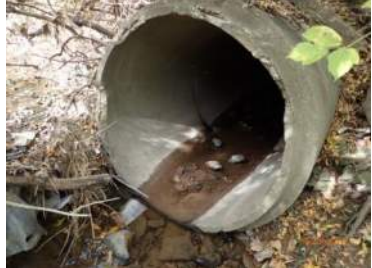
Damage: Moderate ☒ Displacement ☐ Undercut ☐ Crushed☐ Corrosion ☐ Cracks/Structural Damage

o20171019115316.JPG <div style="text-align: center; font-size: 24pt; font-weight: bold;">2017</div>																										
Graffiti:	None																																					
Erosion:	None																																					
Deposition:	None in.																																					
Damage:	Moderate

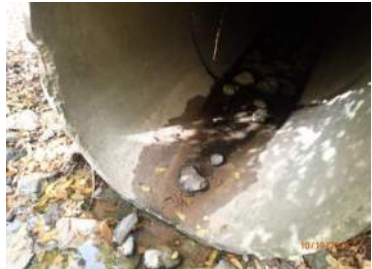
Inspection Date: 10/19/2016 1:11:20 PM		Type: Ongoing	Flow: Trickle	Previous Rainfall (hrs): 72+																																		
Illicit Discharge Potential: Unlikely		Inspector: JCW																																				
Submerged: None		Depth (in):																																				
Sampling Results <table border="1" style="width:100%; border-collapse: collapse;"> <tr><td>Sample Location:</td><td>Flow</td></tr> <tr><td>Total Chlorine:</td><td>0 ppm</td></tr> <tr><td>Free Chlorine:</td><td>0 ppm</td></tr> <tr><td>Ammonia:</td><td>0 ppm</td></tr> <tr><td>pH:</td><td>8.24 units</td></tr> <tr><td>Temperature:</td><td>65 °F</td></tr> <tr><td>Conductivity:</td><td>765 µS/cm</td></tr> <tr><td>Detergents:</td><td>0 mg/L</td></tr> </table>		Sample Location:	Flow	Total Chlorine:	0 ppm	Free Chlorine:	0 ppm	Ammonia:	0 ppm	pH:	8.24 units	Temperature:	65 °F	Conductivity:	765 µS/cm	Detergents:	0 mg/L	<table border="1" style="width:100%; border-collapse: collapse;"> <tr><td>Floatables:</td><td>None</td></tr> <tr><td>Odor:</td><td>None</td></tr> <tr><td>Turbidity:</td><td>None</td></tr> <tr><td>Color:</td><td>Faint in bottle</td></tr> <tr><td>Gross Solids:</td><td>None</td></tr> <tr><td>Vegetation:</td><td>None</td></tr> <tr><td>Benthic Growth:</td><td>Slight</td></tr> <tr><td>Stains:</td><td>None</td></tr> <tr><td>Non-illicit:</td><td>None</td></tr> </table>	Floatables:	None	Odor:	None	Turbidity:	None	Color:	Faint in bottle	Gross Solids:	None	Vegetation:	None	Benthic Growth:	Slight	Stains:	None	Non-illicit:	None	Notes Last pipe segment displaced 4" at joint.

o20161019130908.JPG <div style="text-align: center; font-size: 24pt; font-weight: bold;">2016</div>																										
Graffiti:	None																																					
Erosion:	None																																					
Deposition:	None in.																																					
Damage:	Minor

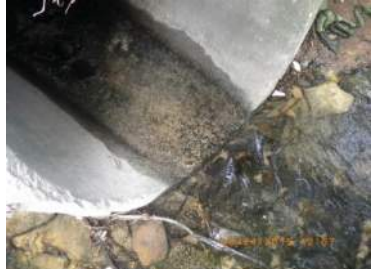
Inspection Date: 9/24/2015 12:55:30 PM		Type: Ongoing	Flow: Moderate	Previous Rainfall (hrs): 72+																																		
Illicit Discharge Potential: Unlikely		Inspector: JCW																																				
Submerged: None		Depth (in):																																				
Sampling Results <table border="1" style="width:100%; border-collapse: collapse;"> <tr><td>Sample Location:</td><td>Flow</td></tr> <tr><td>Total Chlorine:</td><td>0 ppm</td></tr> <tr><td>Free Chlorine:</td><td>0 ppm</td></tr> <tr><td>Ammonia:</td><td>0 ppm</td></tr> <tr><td>pH:</td><td>8.17 units</td></tr> <tr><td>Temperature:</td><td>72 °F</td></tr> <tr><td>Conductivity:</td><td>1595 µS/cm</td></tr> <tr><td>Detergents:</td><td>0 mg/L</td></tr> </table>		Sample Location:	Flow	Total Chlorine:	0 ppm	Free Chlorine:	0 ppm	Ammonia:	0 ppm	pH:	8.17 units	Temperature:	72 °F	Conductivity:	1595 µS/cm	Detergents:	0 mg/L	<table border="1" style="width:100%; border-collapse: collapse;"> <tr><td>Floatables:</td><td>None</td></tr> <tr><td>Odor:</td><td>None</td></tr> <tr><td>Turbidity:</td><td>None</td></tr> <tr><td>Color:</td><td>None</td></tr> <tr><td>Gross Solids:</td><td>None</td></tr> <tr><td>Vegetation:</td><td>None</td></tr> <tr><td>Benthic Growth:</td><td>None</td></tr> <tr><td>Stains:</td><td>Slight</td></tr> <tr><td>Non-illicit:</td><td>None</td></tr> </table>	Floatables:	None	Odor:	None	Turbidity:	None	Color:	None	Gross Solids:	None	Vegetation:	None	Benthic Growth:	None	Stains:	Slight	Non-illicit:	None	Notes 4" joint displacement.

o20150924115728.JPG <div style="text-align: center; font-size: 24pt; font-weight: bold;">2015</div>																										
Graffiti:	None																																					
Erosion:	None																																					
Deposition:	None in.																																					
Damage:	Moderate

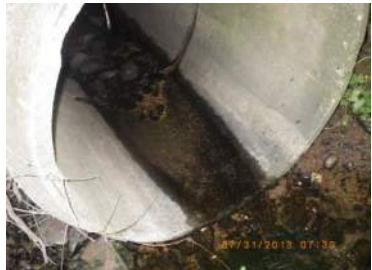
Inspection Date: 7/31/2013 7:27:16 AM		Type: Ongoing	Flow: Trickle	Previous Rainfall (hrs): 72+																																		
Illicit Discharge Potential: Unlikely		Inspector: JCW																																				
Submerged: None		Depth (in):																																				
Sampling Results <table border="1" style="width:100%; border-collapse: collapse;"> <tr><td>Sample Location:</td><td>Flow</td></tr> <tr><td>Total Chlorine:</td><td>0 ppm</td></tr> <tr><td>Free Chlorine:</td><td>0 ppm</td></tr> <tr><td>Ammonia:</td><td>0 ppm</td></tr> <tr><td>pH:</td><td>8.05 units</td></tr> <tr><td>Temperature:</td><td>71 °F</td></tr> <tr><td>Conductivity:</td><td>1865 µS/cm</td></tr> <tr><td>Detergents:</td><td>0 mg/L</td></tr> </table>		Sample Location:	Flow	Total Chlorine:	0 ppm	Free Chlorine:	0 ppm	Ammonia:	0 ppm	pH:	8.05 units	Temperature:	71 °F	Conductivity:	1865 µS/cm	Detergents:	0 mg/L	<table border="1" style="width:100%; border-collapse: collapse;"> <tr><td>Floatables:</td><td>None</td></tr> <tr><td>Odor:</td><td>None</td></tr> <tr><td>Turbidity:</td><td>None</td></tr> <tr><td>Color:</td><td>None</td></tr> <tr><td>Gross Solids:</td><td>None</td></tr> <tr><td>Vegetation:</td><td>None</td></tr> <tr><td>Benthic Growth:</td><td>None</td></tr> <tr><td>Stains:</td><td>Moderate</td></tr> <tr><td>Non-illicit:</td><td>None</td></tr> </table>	Floatables:	None	Odor:	None	Turbidity:	None	Color:	None	Gross Solids:	None	Vegetation:	None	Benthic Growth:	None	Stains:	Moderate	Non-illicit:	None	Notes End section displaced 4".

o20130731063036.JPG <div style="text-align: center; font-size: 24pt; font-weight: bold;">2013</div>																										
Graffiti:	None																																					
Erosion:	None																																					
Deposition:	None in.																																					
Damage:	Minor

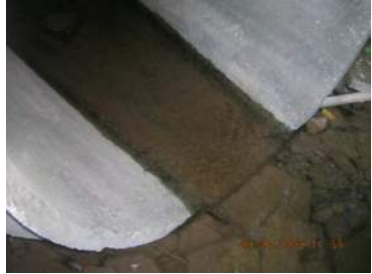
<p>Osh09_DSCN6570.JPG</p> <p>2009</p>	
Submerged: Partially		Depth (in): 1		End section of pipe separated.			
Sampling Results		Floatables:		None		Condition Assessment Graffiti: None Erosion: None Deposition: None 0 in. Damage: Moderate	
Sample Location: Pool		Odor:		None			
Total Chlorine: 0 ppm		Turbidity:		None			
Free Chlorine: 0 ppm		Color:		None			
Ammonia: -- ppm		Gross Solids:		None			
pH: 7.82 units		Vegetation:					
Temperature 73 °F		Benthic Growth:		Slight			
Conductivity: -- µS/cm		Stains:					
Detergents: 0 mg/L		Non-illicit:		None

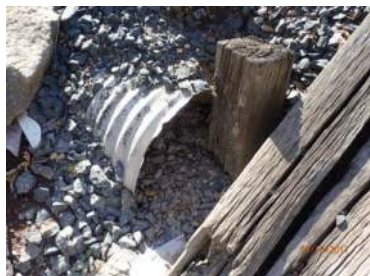
Inspection Date: 10/18/2017 1:17:40 PM		Type: Ongoing	Flow: None	Previous Rainfall (hrs): 72+
Illicit Discharge Potential: Unlikely		Inspector: JCW		
Submerged: None		Depth (in):		
Sampling Results Sample Location: _____ Total Chlorine: -- ppm Free Chlorine: -- ppm Ammonia: -- ppm pH: -- units Temperature -- °F Conductivity: -- µS/cm Detergents: -- mg/L		Floatables: None Odor: None Turbidity: None Color: None Gross Solids: None Vegetation: None Benthic Growth: None Stains: None Non-illicit: None	Notes Dry railroad ballast inside pipe. No flow observed at time of inspection.

o20171018131410.JPG <div style="text-align: center; font-size: 24pt; font-weight: bold;">2017</div>
		Condition Assessment Graffiti: None Erosion: None Deposition: Moderate 11 in. Damage: None

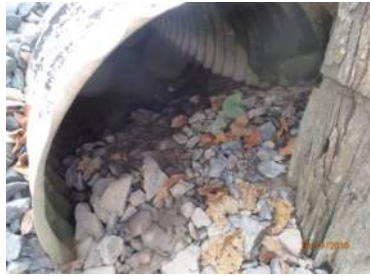
Inspection Date: 10/19/2016 12:41:44 PM		Type: Ongoing	Flow: None	Previous Rainfall (hrs): 72+
Illicit Discharge Potential: Unlikely		Inspector: JCW		
Submerged: None		Depth (in):		
Sampling Results Sample Location: _____ Total Chlorine: -- ppm Free Chlorine: -- ppm Ammonia: -- ppm pH: -- units Temperature -- °F Conductivity: -- µS/cm Detergents: -- mg/L		Floatables: None Odor: None Turbidity: None Color: None Gross Solids: None Vegetation: None Benthic Growth: Slight Stains: None Non-illicit: None	Notes Corrugations wet, but no flow. 10" of stone in end of pipe. RR ties obstructing end.

o20161019124104.JPG <div style="text-align: center; font-size: 24pt; font-weight: bold;">2016</div>
		Condition Assessment Graffiti: None Erosion: None Deposition: Moderate 10 in. Damage: None

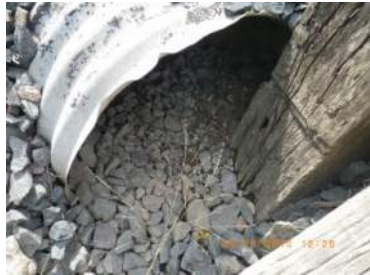
Inspection Date: 9/24/2015 12:22:34 PM		Type: Ongoing	Flow: None	Previous Rainfall (hrs): 72+
Illicit Discharge Potential: Unlikely		Inspector: JCW		
Submerged: None		Depth (in):		
Sampling Results Sample Location: _____ Total Chlorine: -- ppm Free Chlorine: -- ppm Ammonia: -- ppm pH: -- units Temperature -- °F Conductivity: -- µS/cm Detergents: -- mg/L		Floatables: None Odor: None Turbidity: None Color: None Gross Solids: None Vegetation: None Benthic Growth: None Stains: None Non-illicit: None	Notes Partially filled with stone.

o20150924112622.JPG <div style="text-align: center; font-size: 24pt; font-weight: bold;">2015</div>
		Condition Assessment Graffiti: None Erosion: None Deposition: Moderate 10 in. Damage: None

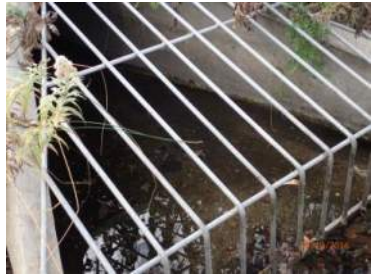
Inspection Date: 10/19/2016 12:09:41 PM		Type: Ongoing	Flow: Submerged, slight flow	Previous Rainfall (hrs): 72+
Illicit Discharge Potential: Unlikely		Inspector: JCW		
Submerged: Partially		Depth (in): 7		
Sampling Results Sample Location: Flow Total Chlorine: 0 ppm Free Chlorine: 0 ppm Ammonia: 0 ppm pH: 7.57 units Temperature: 66 °F Conductivity: 1099 µS/cm Detergents: 0 mg/L		Floatables: None Odor: None Turbidity: None Color: None Gross Solids: Moderate Vegetation: None Benthic Growth: Slight Stains: Slight Non-illicit: None	Notes Sample collected from concentrated flow in outfall pool.

o20161019120708.JPG <div style="text-align: center; font-size: 24pt; font-weight: bold;">2016</div>
			Condition Assessment Graffiti: None Erosion: None Deposition: None in. Damage: None

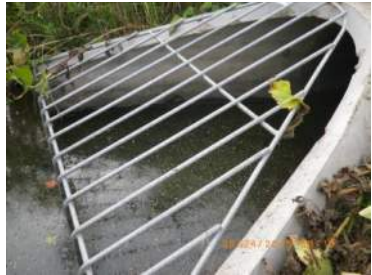
Inspection Date: 9/24/2015 8:10:48 AM		Type: Ongoing	Flow: Submerged, indeterminate	Previous Rainfall (hrs): 72+
Illicit Discharge Potential: Unlikely		Inspector: JCW		
Submerged: Partially		Depth (in): 8		
Sampling Results Sample Location: Pool Total Chlorine: 0 ppm Free Chlorine: 0 ppm Ammonia: 0 ppm pH: 7.99 units Temperature: 67 °F Conductivity: 1153 µS/cm Detergents: 0 mg/L		Floatables: None Odor: None Turbidity: None Color: None Gross Solids: None Vegetation: None Benthic Growth: Moderate Stains: Moderate Non-illicit: None	Notes Construction and traffic prevented screening at US1. Sample collected from outfall pool.

o20150924071336.JPG <div style="text-align: center; font-size: 24pt; font-weight: bold;">2015</div>
			Condition Assessment Graffiti: None Erosion: None Deposition: None in. Damage: None

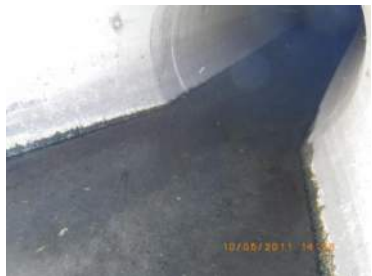
Inspection Date: 10/6/2011 2:30:02 PM		Type: Ongoing	Flow: Submerged, indeterminate	Previous Rainfall (hrs): 72+
Illicit Discharge Potential: Unlikely		Inspector: JCW		
Submerged: Partially		Depth (in): 6		
Sampling Results Sample Location: _____ Total Chlorine: -- ppm Free Chlorine: -- ppm Ammonia: -- ppm pH: -- units Temperature: -- °F Conductivity: -- µS/cm Detergents: -- mg/L		Floatables: Moderate Odor: None Turbidity: None Color: None Gross Solids: None Vegetation: None Benthic Growth: Slight Stains: Slight Non-illicit: Moderate	Notes Outfall partially submerged. Outfall screened upstream at 15-143 US1.

o20111006142826.JPG <div style="text-align: center; font-size: 24pt; font-weight: bold;">2011</div>
			Condition Assessment Graffiti: None Erosion: None Deposition: None 0 in. Damage: None

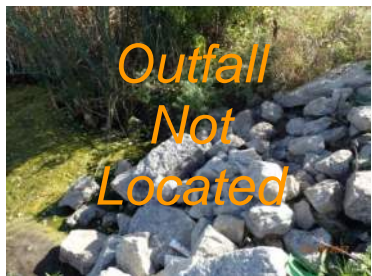
Inspection Date: 10/19/2017 2:32:42 PM		Type: Ongoing		Flow: Submerged (not located)		Previous Rainfall (hrs): 72+	
Illicit Discharge Potential: Unlikely		Inspector: JCW		Notes Outfall fully submerged and not located - screened upstream at 15-1093 US1.

o20171019143036.JPG	
Submerged: Fully		Depth (in):					
Sampling Results		Floatables: None Odor: None Turbidity: None Color: None Gross Solids: None Vegetation: None Benthic Growth: None Stains: None Non-illicit: None		Condition Assessment Graffiti: None Erosion: None Deposition: None in. Damage: None		2017	
Sample Location: Total Chlorine: -- ppm Free Chlorine: -- ppm Ammonia: -- ppm pH: -- units Temperature: -- °F Conductivity: -- µS/cm Detergents: -- mg/L

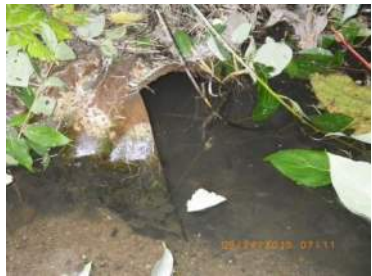
Inspection Date: 9/24/2015 7:09:54 AM		Type: Ongoing		Flow: Submerged, indeterminate		Previous Rainfall (hrs): 72+	
Illicit Discharge Potential: Unlikely		Inspector: JCW		Notes Outfall partially submerged - screened at 15-1093 US1.

o20150924061136.JPG	
Submerged: Partially		Depth (in): 14					
Sampling Results		Floatables: None Odor: None Turbidity: None Color: None Gross Solids: None Vegetation: None Benthic Growth: Moderate Stains: None Non-illicit: None		Condition Assessment Graffiti: None Erosion: None Deposition: Moderate 6 in. Damage: None		2015	
Sample Location: Total Chlorine: -- ppm Free Chlorine: -- ppm Ammonia: -- ppm pH: -- units Temperature: -- °F Conductivity: -- µS/cm Detergents: -- mg/L

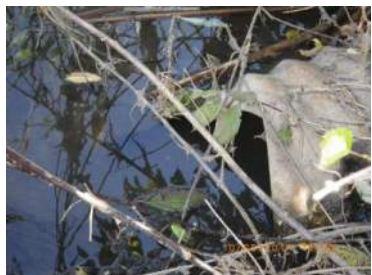
Inspection Date: 10/9/2014 1:54:00 PM		Type: Ongoing		Flow: Submerged, indeterminate		Previous Rainfall (hrs): 72+	
Illicit Discharge Potential: Unlikely		Inspector: JCW		Notes Outfall partially submerged - screened upstream at 15-1093 US1.

o20141009125326.JPG	
Submerged: Partially		Depth (in): 9					
Sampling Results		Floatables: None Odor: None Turbidity: None Color: None Gross Solids: None Vegetation: None Benthic Growth: None Stains: None Non-illicit: None		Condition Assessment Graffiti: None Erosion: None Deposition: None in. Damage: None		2014	
Sample Location: Total Chlorine: -- ppm Free Chlorine: -- ppm Ammonia: -- ppm pH: -- units Temperature: -- °F Conductivity: -- µS/cm Detergents: -- mg/L

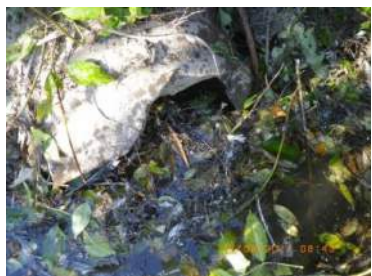
Inspection Date: 10/6/2011 8:44:09 AM		Type: Ongoing		Flow: Submerged, indeterminate		Previous Rainfall (hrs): 72+	
Illicit Discharge Potential: Unlikely		Inspector: JCW		Notes Outfall partially submerged. Outfall screened upstream at 15-1093 US1.

o20111006084300.JPG	
Submerged: Partially		Depth (in): 9					
Sampling Results		Floatables: None Odor: None Turbidity: None Color: None Gross Solids: None Vegetation: None Benthic Growth: None Stains: None Non-illicit: None		Condition Assessment Graffiti: None Erosion: None Deposition: None 0 in. Damage: Minor		2011	
Sample Location: Total Chlorine: -- ppm Free Chlorine: -- ppm Ammonia: -- ppm pH: -- units Temperature: -- °F Conductivity: -- µS/cm Detergents: -- mg/L

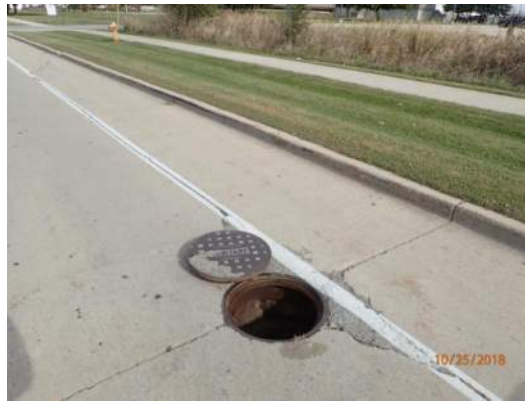
o20181025121656.JPG

Upstream manhole located approx 88 ft SSW of outfall 15-1093. Intermediate area consists of Main Street and right-of-way.

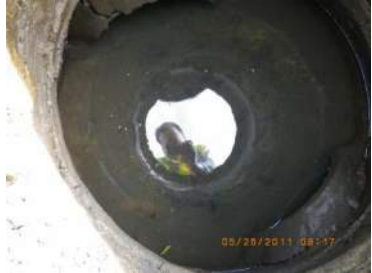
o20110526091718.JPG 2011

Inspection Date: 5/26/2011 9:17:00 AM		Type: Other	Flow: Submerged, indeterminate	Previous Rainfall (hrs): 72+
Illicit Discharge Potential: Unlikely		Inspector: JCW	Notes Limited screening conducted for upstream manhole prescreening.	
Submerged: Partially Depth (in):				
Sampling Results Sample Location: _____ Total Chlorine: -- ppm Free Chlorine: -- ppm Ammonia: -- ppm pH: -- units Temperature: -- °F Conductivity: -- µS/cm Detergents: -- mg/L		Floatables: _____ Odor: _____ Turbidity: _____ Color: _____ Gross Solids: _____ Vegetation: _____ Benthic Growth: _____ Stains: _____ Non-illicit: None	Condition Assessment Graffiti: None Erosion: None Deposition: None 0 in. Damage: None

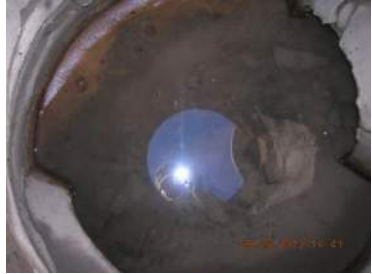
o20100826144124.JPG 2010

Inspection Date: 8/26/2010 2:49:55 PM		Type: Ongoing	Flow: Submerged, slight flow	Previous Rainfall (hrs): 72+
Illicit Discharge Potential: Unlikely		Inspector: JCW	Notes 	
Submerged: Partially Depth (in): 2				
Sampling Results Sample Location: Pool Total Chlorine: 0 ppm Free Chlorine: 0 ppm Ammonia: 0 ppm pH: 7.95 units Temperature: 79 °F Conductivity: -- µS/cm Detergents: 0 mg/L		Floatables: None Odor: None Turbidity: None Color: None Gross Solids: None Vegetation: None Benthic Growth: None Stains: Slight Non-illicit: None	Condition Assessment Graffiti: None Erosion: None Deposition: None 0 in. Damage: None

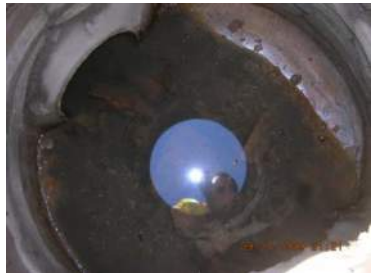
Osh09_DSCN6366.JPG 2009

Inspection Date: 9/2/2009		Type: Initial	Flow: Submerged, indeterminate	Previous Rainfall (hrs): 72+
Illicit Discharge Potential: Potential		Inspector: JCW	Notes Ammonia test = 0 mg/L	
Submerged: Partially Depth (in):				
Sampling Results Sample Location: Pool Total Chlorine: 0 ppm Free Chlorine: 0 ppm Ammonia: -- ppm pH: 7.79 units Temperature: 76 °F Conductivity: -- µS/cm Detergents: 0 mg/L		Floatables: None Odor: Faint Turbidity: None Color: None Gross Solids: None Vegetation: None Benthic Growth: None Stains: None Non-illicit: None	Condition Assessment Graffiti: None Erosion: None Deposition: None 0 in. Damage: None

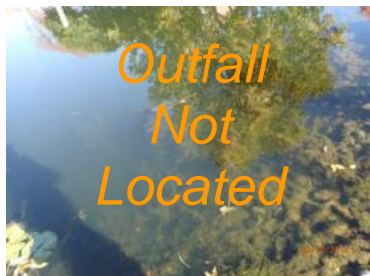
o20171019141152.JPG <div style="text-align: center; font-weight: bold; font-size: 1.2em;">2017</div>

Inspection Date: 10/19/2017 2:13:56 PM		Type: Ongoing	Flow: Submerged (not located)	Previous Rainfall (hrs): 72+
Illicit Discharge Potential: Unlikely		Inspector: JCW		
Submerged: Fully		Depth (in):		
Sampling Results Sample Location: _____ Total Chlorine: -- ppm Free Chlorine: -- ppm Ammonia: -- ppm pH: -- units Temperature: -- °F Conductivity: -- µS/cm Detergents: -- mg/L		Floatables: None Odor: None Turbidity: None Color: None Gross Solids: None Vegetation: None Benthic Growth: None Stains: None Non-illicit: None		
		Notes Outfall fully submerged and not located - screened upstream at 15-1108 US1.		
		Condition Assessment Graffiti: None Erosion: None Deposition: None in. Damage: None

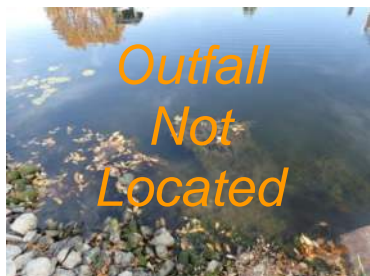
o20161019092756.JPG <div style="text-align: center; font-weight: bold; font-size: 1.2em;">2016</div>

Inspection Date: 10/19/2016 9:29:15 AM		Type: Ongoing	Flow: Submerged (not located)	Previous Rainfall (hrs): 72+
Illicit Discharge Potential: Unlikely		Inspector: JCW		
Submerged: Fully		Depth (in):		
Sampling Results Sample Location: _____ Total Chlorine: -- ppm Free Chlorine: -- ppm Ammonia: -- ppm pH: -- units Temperature: -- °F Conductivity: -- µS/cm Detergents: -- mg/L		Floatables: None Odor: None Turbidity: None Color: None Gross Solids: None Vegetation: None Benthic Growth: None Stains: None Non-illicit: None		
		Notes Outfall fully submerged and not located - screened upstream at 15-1108 US1.		
		Condition Assessment Graffiti: None Erosion: None Deposition: None in. Damage: None

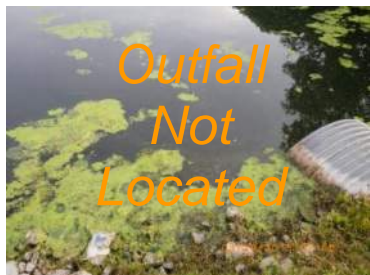
o20150924063632.JPG <div style="text-align: center; font-weight: bold; font-size: 1.2em;">2015</div>

Inspection Date: 9/24/2015 7:35:11 AM		Type: Ongoing	Flow: Submerged (not located)	Previous Rainfall (hrs): 72+
Illicit Discharge Potential: Unlikely		Inspector: JCW		
Submerged: Fully		Depth (in):		
Sampling Results Sample Location: _____ Total Chlorine: -- ppm Free Chlorine: -- ppm Ammonia: -- ppm pH: -- units Temperature: -- °F Conductivity: -- µS/cm Detergents: -- mg/L		Floatables: None Odor: None Turbidity: None Color: None Gross Solids: None Vegetation: None Benthic Growth: None Stains: None Non-illicit: None		
		Notes Outfall fully submerged and not located - screened at 15-1108 US1.		
		Condition Assessment Graffiti: None Erosion: None Deposition: None in. Damage: None

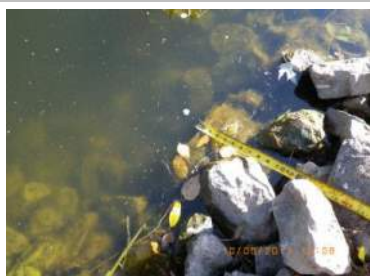
o20111005100840.JPG <div style="text-align: center; font-weight: bold; font-size: 1.2em;">2011</div>

Inspection Date: 10/5/2011 10:07:32 AM		Type: Ongoing	Flow: Submerged, indeterminate	Previous Rainfall (hrs): 72+
Illicit Discharge Potential: Unlikely		Inspector: JCW		
Submerged: Fully		Depth (in): 16		
Sampling Results Sample Location: _____ Total Chlorine: -- ppm Free Chlorine: -- ppm Ammonia: -- ppm pH: -- units Temperature: -- °F Conductivity: -- µS/cm Detergents: -- mg/L		Floatables: None Odor: None Turbidity: None Color: None Gross Solids: None Vegetation: None Benthic Growth: None Stains: None Non-illicit: None		
		Notes Outfall fully submerged. Outfall screened upstream at 15-1108 US1.		
		Condition Assessment Graffiti: None Erosion: None Deposition: None 0 in. Damage: None

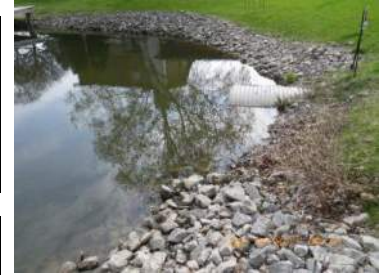
o20110512093128.JPG

Inspection Date: 5/12/2011 9:38:00 AM		Type: Other	Flow: Submerged, indeterminate	Previous Rainfall (hrs): 48-72
Illicit Discharge Potential: Unlikely		Inspector: JCW		
Submerged: Fully		Depth (in):		
Sampling Results		Notes Outfall fully submerged. Outfall screened upstream at 15-1108 US1.		
Sample Location:	Floatables:	Condition Assessment Graffiti: None Erosion: None Deposition: None 0 in. Damage: None		
Total Chlorine: -- ppm	Odor:			
Free Chlorine: -- ppm	Turbidity:			
Ammonia: -- ppm	Color:			
pH: -- units	Gross Solids:			
Temperature -- °F	Vegetation:			
Conductivity: -- µS/cm	Benthic Growth:			
Detergents: -- mg/L	Stains:			
	Non-illicit:	None

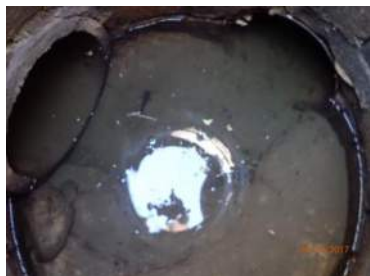
o20171019141326.JPG <div style="text-align: center; font-size: 24pt; font-weight: bold;">2017</div>

Inspection Date: 10/19/2017 2:15:28 PM		Type: Ongoing	Flow: Submerged, indeterminate	Previous Rainfall (hrs): 72+
Illicit Discharge Potential: Unlikely		Inspector: JCW		
Submerged: Partially		Depth (in): 11		
Sampling Results Sample Location: _____ Total Chlorine: 0 ppm Free Chlorine: 0 ppm Ammonia: 0 ppm pH: 7.85 units Temperature: 66 °F Conductivity: 412 µS/cm Detergents: 0 mg/L		Floatables: None Odor: None Turbidity: None Color: None Gross Solids: None Vegetation: None Benthic Growth: None Stains: None Non-illicit: None		
		Notes Sample collected from submerged pool in manhole.		
		Condition Assessment Graffiti: None Erosion: None Deposition: None in. Damage: None

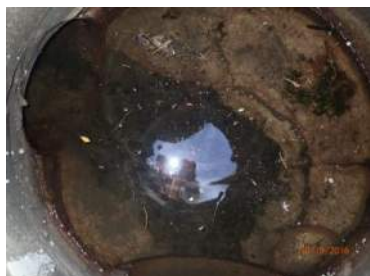
o20161019092942.JPG <div style="text-align: center; font-size: 24pt; font-weight: bold;">2016</div>

Inspection Date: 10/19/2016 9:33:09 AM		Type: Ongoing	Flow: Submerged, indeterminate	Previous Rainfall (hrs): 72+
Illicit Discharge Potential: Unlikely		Inspector: JCW		
Submerged: Partially		Depth (in): 9		
Sampling Results Sample Location: Pool Total Chlorine: 0 ppm Free Chlorine: 0 ppm Ammonia: 0 ppm pH: 7.78 units Temperature: 63 °F Conductivity: 413 µS/cm Detergents: 0 mg/L		Floatables: None Odor: None Turbidity: None Color: None Gross Solids: None Vegetation: None Benthic Growth: Moderate Stains: Slight Non-illicit: None		
		Notes		
		Condition Assessment Graffiti: None Erosion: None Deposition: None in. Damage: None

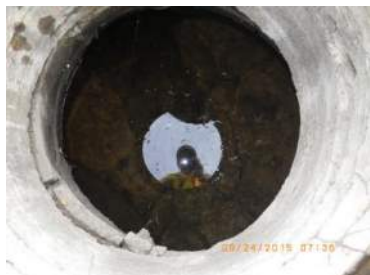
o20150924063654.JPG <div style="text-align: center; font-size: 24pt; font-weight: bold;">2015</div>

Inspection Date: 9/24/2015 7:35:59 AM		Type: Ongoing	Flow: Submerged, indeterminate	Previous Rainfall (hrs): 72+
Illicit Discharge Potential: Unlikely		Inspector: JCW		
Submerged: Partially		Depth (in): 7		
Sampling Results Sample Location: Pool Total Chlorine: 0 ppm Free Chlorine: 0 ppm Ammonia: 0 ppm pH: 7.88 units Temperature: 68 °F Conductivity: 384 µS/cm Detergents: 0 mg/L		Floatables: None Odor: None Turbidity: None Color: None Gross Solids: None Vegetation: None Benthic Growth: Moderate Stains: None Non-illicit: Slight		
		Notes		
		Condition Assessment Graffiti: None Erosion: None Deposition: None in. Damage: None

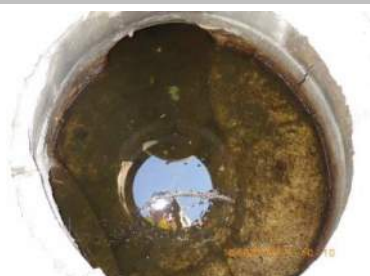
o20111005101010.JPG <div style="text-align: center; font-size: 24pt; font-weight: bold;">2011</div>

Inspection Date: 10/5/2011 10:10:59 AM		Type: Ongoing	Flow: Submerged, indeterminate	Previous Rainfall (hrs): 72+
Illicit Discharge Potential: Unlikely		Inspector: JCW		
Submerged: Partially		Depth (in): 8		
Sampling Results Sample Location: Pool Total Chlorine: 0 ppm Free Chlorine: 0 ppm Ammonia: 0 ppm pH: 7.25 units Temperature: 62 °F Conductivity: -- µS/cm Detergents: 0 mg/L		Floatables: None Odor: None Turbidity: None Color: None Gross Solids: None Vegetation: None Benthic Growth: None Stains: None Non-illicit: None		
		Notes		
		Condition Assessment Graffiti: None Erosion: None Deposition: None 0 in. Damage: None

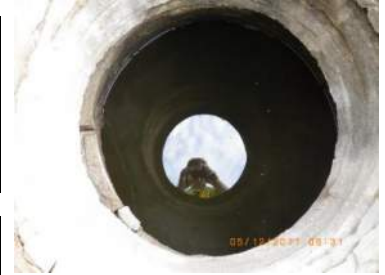
o20110512093152.JPG

Inspection Date: 5/12/2011 9:31:00 AM		Type: Other	Flow: Submerged, indeterminate	Previous Rainfall (hrs): 48-72
Illicit Discharge Potential: Unlikely		Inspector: JCW		
Submerged: Fully		Depth (in):		
Sampling Results		Notes Limited screening conducted for upstream manhole prescreening.		
Sample Location:	Floatables:	Condition Assessment Graffiti: None Erosion: None Deposition: None 0 in. Damage: None		
Total Chlorine: -- ppm	Odor:			
Free Chlorine: -- ppm	Turbidity:			
Ammonia: -- ppm	Color:			
pH: -- units	Gross Solids:			
Temperature -- °F	Vegetation:			
Conductivity: -- µS/cm	Benthic Growth:			
Detergents: -- mg/L	Stains:			
	Non-illicit:	None

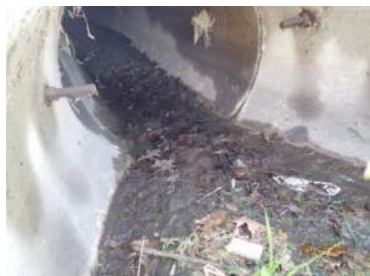
o20171017123304.JPG <div style="text-align: center; font-size: 24pt; font-weight: bold;">2017</div>

Inspection Date: 10/17/2017 12:36:42 PM		Type: Ongoing	Flow: Submerged, indeterminate	Previous Rainfall (hrs): 48-72
Illicit Discharge Potential: Unlikely		Inspector: JCW		
Submerged: Partially		Depth (in): 1		
Sampling Results Sample Location: _____ Total Chlorine: -- ppm Free Chlorine: -- ppm Ammonia: -- ppm pH: -- units Temperature: -- °F Conductivity: -- µS/cm Detergents: -- mg/L		Floatables: None Odor: None Turbidity: None Color: None Gross Solids: Moderate Vegetation: None Benthic Growth: None Stains: Slight Non-illicit: None		
		Notes Saturated sediment on apron. Outfall partially submerged - screened upstream at 15-2409 US1.		
		Condition Assessment Graffiti: None Erosion: None Deposition: Minor 2 in. Damage: None

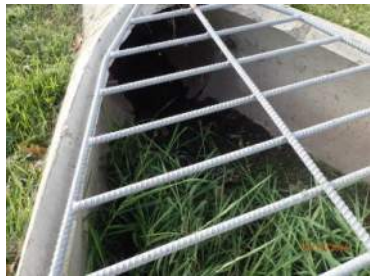
o20161019122450.JPG <div style="text-align: center; font-size: 24pt; font-weight: bold;">2016</div>

Inspection Date: 10/19/2016 12:25:36 PM		Type: Ongoing	Flow: None	Previous Rainfall (hrs): 72+
Illicit Discharge Potential: Unlikely		Inspector: JCW		
Submerged: None		Depth (in):		
Sampling Results Sample Location: _____ Total Chlorine: -- ppm Free Chlorine: -- ppm Ammonia: -- ppm pH: -- units Temperature: -- °F Conductivity: -- µS/cm Detergents: -- mg/L		Floatables: None Odor: None Turbidity: None Color: None Gross Solids: None Vegetation: None Benthic Growth: Slight Stains: None Non-illicit: None		
		Notes Sediment wet, but no flow at time of inspection.		
		Condition Assessment Graffiti: None Erosion: None Deposition: Minor 1 in. Damage: None

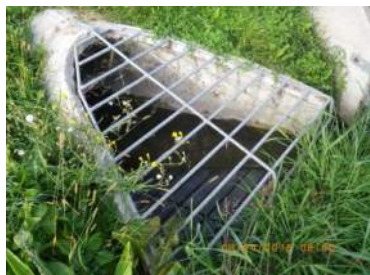
o20150924075004.JPG <div style="text-align: center; font-size: 24pt; font-weight: bold;">2015</div>

Inspection Date: 9/24/2015 8:45:17 AM		Type: Ongoing	Flow: Submerged, indeterminate	Previous Rainfall (hrs): 72+
Illicit Discharge Potential: Unlikely		Inspector: JCW		
Submerged: Partially		Depth (in): 2		
Sampling Results Sample Location: _____ Total Chlorine: -- ppm Free Chlorine: -- ppm Ammonia: -- ppm pH: -- units Temperature: -- °F Conductivity: -- µS/cm Detergents: -- mg/L		Floatables: None Odor: None Turbidity: None Color: None Gross Solids: None Vegetation: None Benthic Growth: Slight Stains: None Non-illicit: None		
		Notes Outfall partially submerged - screened at 15-2409 US1.		
		Condition Assessment Graffiti: None Erosion: None Deposition: None in. Damage: None

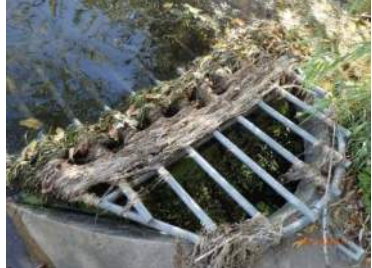
o20171019145658.JPG <div style="text-align: center; font-size: 24pt; font-weight: bold;">2017</div>

Inspection Date: 10/19/2017 2:59:13 PM		Type: Ongoing	Flow: Submerged, indeterminate	Previous Rainfall (hrs): 72+
Illicit Discharge Potential: Unlikely		Inspector: JCW		
Submerged: Partially		Depth (in): 38		
Sampling Results Sample Location: _____ Total Chlorine: -- ppm Free Chlorine: -- ppm Ammonia: -- ppm pH: -- units Temperature: -- °F Conductivity: -- µS/cm Detergents: -- mg/L		Floatables: None Odor: None Turbidity: None Color: None Gross Solids: None Vegetation: None Benthic Growth: None Stains: None Non-illicit: None	Notes Outfall partially submerged - screened upstream at 15-2477 US2. Condition Assessment Graffiti: None Erosion: None Deposition: Minor 8 in. Damage: None

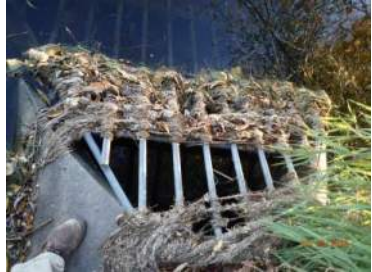
o20161018173020.JPG <div style="text-align: center; font-size: 24pt; font-weight: bold;">2016</div>

Inspection Date: 10/18/2016 5:32:01 PM		Type: Ongoing	Flow: Submerged, indeterminate	Previous Rainfall (hrs): 72+
Illicit Discharge Potential: Unlikely		Inspector: JCW		
Submerged: Partially		Depth (in): 30		
Sampling Results Sample Location: _____ Total Chlorine: -- ppm Free Chlorine: -- ppm Ammonia: -- ppm pH: -- units Temperature: -- °F Conductivity: -- µS/cm Detergents: -- mg/L		Floatables: None Odor: None Turbidity: None Color: None Gross Solids: None Vegetation: None Benthic Growth: Slight Stains: Slight Non-illicit: None	Notes Vegetation accumulating on outside of grate. Outfall partially submerged - screened upstream at 15-2477 US2. Condition Assessment Graffiti: None Erosion: None Deposition: None in. Damage: None

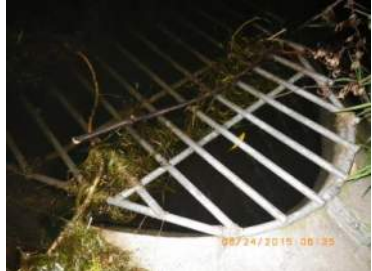
o20150924053500.JPG <div style="text-align: center; font-size: 24pt; font-weight: bold;">2015</div>

Inspection Date: 9/24/2015 6:32:39 AM		Type: Ongoing	Flow: Submerged, indeterminate	Previous Rainfall (hrs): 72+
Illicit Discharge Potential: Unlikely		Inspector: JCW		
Submerged: Fully		Depth (in): 43		
Sampling Results Sample Location: _____ Total Chlorine: -- ppm Free Chlorine: -- ppm Ammonia: -- ppm pH: -- units Temperature: -- °F Conductivity: -- µS/cm Detergents: -- mg/L		Floatables: None Odor: None Turbidity: None Color: None Gross Solids: None Vegetation: None Benthic Growth: Slight Stains: None Non-illicit: None	Notes Outfall partially submerged - screened at 15-2477 US2. First upstream manhole in parking area not located in gravel. Condition Assessment Graffiti: None Erosion: None Deposition: Minor 7 in. Damage: None

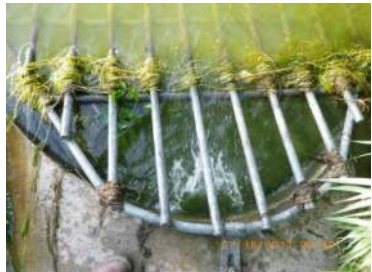
o20130716074040.JPG <div style="text-align: center; font-size: 24pt; font-weight: bold;">2013</div>

Inspection Date: 7/16/2013 8:34:01 AM		Type: Ongoing	Flow: Submerged, indeterminate	Previous Rainfall (hrs): 72+
Illicit Discharge Potential: Unlikely		Inspector: JCW		
Submerged: Partially		Depth (in): 41		
Sampling Results Sample Location: _____ Total Chlorine: -- ppm Free Chlorine: -- ppm Ammonia: -- ppm pH: -- units Temperature: -- °F Conductivity: -- µS/cm Detergents: -- mg/L		Floatables: None Odor: None Turbidity: None Color: None Gross Solids: None Vegetation: None Benthic Growth: Moderate Stains: None Non-illicit: None	Notes Outfall partially submerged. Outfall screened upstream at 15-2477 US2. Condition Assessment Graffiti: None Erosion: None Deposition: Moderate 9 in. Damage: None

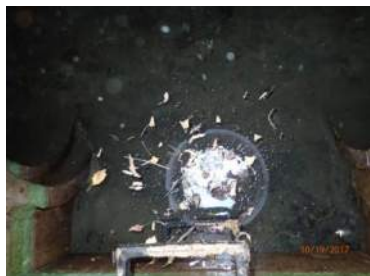
o20171019145130.JPG <div style="text-align: center; font-size: 24pt; font-weight: bold;">2017</div>

Inspection Date: 10/19/2017 2:53:35 PM		Type: Ongoing	Flow: Submerged, indeterminate	Previous Rainfall (hrs): 72+
Illicit Discharge Potential: Unlikely		Inspector: JCW		
Submerged: Partially		Depth (in): 16		
Sampling Results Sample Location: _____ Total Chlorine: 0 ppm Free Chlorine: 0 ppm Ammonia: 0 ppm pH: 7.8 units Temperature: 65 °F Conductivity: 900 µS/cm Detergents: 0 mg/L		Floatables: None Odor: None Turbidity: None Color: None Gross Solids: None Vegetation: None Benthic Growth: Moderate Stains: None Non-illicit: None	Notes Sample collected from submerged pool in manhole. Condition Assessment Graffiti: None Erosion: None Deposition: Minor 2 in. Damage: None

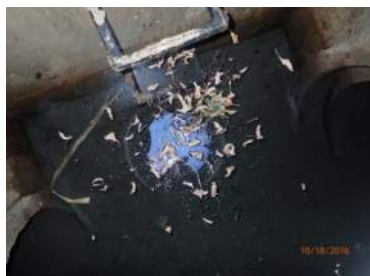
o20161018172406.JPG <div style="text-align: center; font-size: 24pt; font-weight: bold;">2016</div>

Inspection Date: 9/24/2015 6:43:24 AM		Type: Ongoing	Flow: Submerged, indeterminate	Previous Rainfall (hrs): 72+
Illicit Discharge Potential: Unlikely		Inspector: JCW		
Submerged: Partially		Depth (in): 19		
Sampling Results Sample Location: Pool Total Chlorine: 0 ppm Free Chlorine: 0 ppm Ammonia: 0 ppm pH: 8.11 units Temperature: 67 °F Conductivity: 438 µS/cm Detergents: 0 mg/L		Floatables: None Odor: None Turbidity: None Color: None Gross Solids: None Vegetation: None Benthic Growth: Slight Stains: None Non-illicit: None	Notes Condition Assessment Graffiti: None Erosion: None Deposition: None in. Damage: None

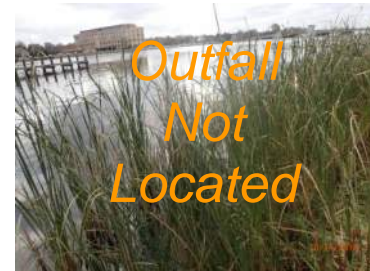
o20181024085930.JPG

Flow Description: Submerged (not located)

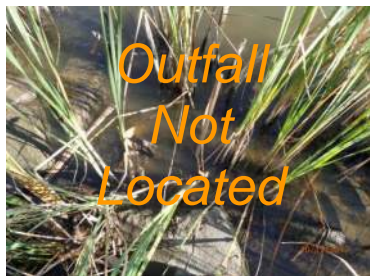
o20171017110742.JPG <div style="text-align: center; font-weight: bold; font-size: 1.2em;">2017</div>

Inspection Date: 10/17/2017 11:10:52 AM		Type: Ongoing	Flow: Submerged (not located)	Previous Rainfall (hrs): 48-72
Illicit Discharge Potential: Unlikely		Inspector: JCW		
Submerged: Fully		Depth (in):		
Sampling Results Sample Location: _____ Total Chlorine: -- ppm Free Chlorine: -- ppm Ammonia: -- ppm pH: -- units Temperature: -- °F Conductivity: -- µS/cm Detergents: -- mg/L		Floatables: None Odor: None Turbidity: None Color: None Gross Solids: None Vegetation: None Benthic Growth: None Stains: None Non-illicit: None		
		Notes Outfall fully submerged and not located - screened upstream at 16-142 US1.		
		Condition Assessment Graffiti: None Erosion: None Deposition: None in. Damage: None

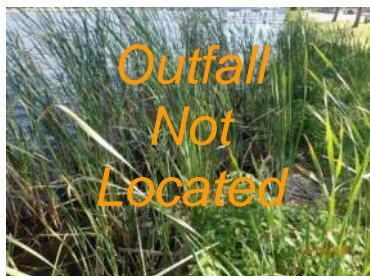
o20161010133812.JPG <div style="text-align: center; font-weight: bold; font-size: 1.2em;">2016</div>

Inspection Date: 10/10/2016 1:39:08 PM		Type: Ongoing	Flow: Submerged (not located)	Previous Rainfall (hrs): 72+
Illicit Discharge Potential: Potential		Inspector: JCW		
Submerged: Fully		Depth (in):		
Sampling Results Sample Location: _____ Total Chlorine: -- ppm Free Chlorine: -- ppm Ammonia: -- ppm pH: -- units Temperature: -- °F Conductivity: -- µS/cm Detergents: -- mg/L		Floatables: None Odor: None Turbidity: None Color: None Gross Solids: None Vegetation: None Benthic Growth: None Stains: None Non-illicit: None		
		Notes Outfall fully submerged and not located - screened upstream at 16-142 US1.		
		Condition Assessment Graffiti: None Erosion: None Deposition: None in. Damage: None

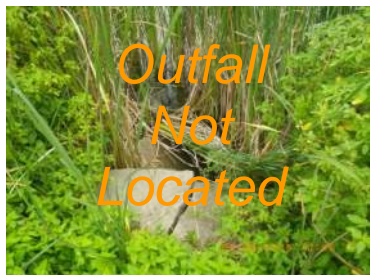
o20150923094512.JPG <div style="text-align: center; font-weight: bold; font-size: 1.2em;">2015</div>

Inspection Date: 9/23/2015 10:42:40 AM		Type: Ongoing	Flow: Submerged (not located)	Previous Rainfall (hrs): 72+
Illicit Discharge Potential: Potential		Inspector: JCW		
Submerged: Fully		Depth (in):		
Sampling Results Sample Location: _____ Total Chlorine: -- ppm Free Chlorine: -- ppm Ammonia: -- ppm pH: -- units Temperature: -- °F Conductivity: -- µS/cm Detergents: -- mg/L		Floatables: None Odor: None Turbidity: None Color: None Gross Solids: None Vegetation: None Benthic Growth: None Stains: None Non-illicit: None		
		Notes Outfall fully submerged and not located - screened at 16-142 US1.		
		Condition Assessment Graffiti: None Erosion: None Deposition: None in. Damage: None

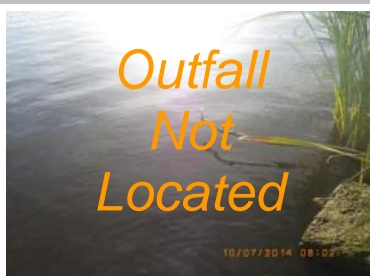
o20141007070234.JPG <div style="text-align: center; font-weight: bold; font-size: 1.2em;">2014</div>

Inspection Date: 10/7/2014 8:03:04 AM		Type: Ongoing	Flow: Submerged (not located)	Previous Rainfall (hrs): 48-72
Illicit Discharge Potential: Potential		Inspector: JCW		
Submerged: Fully		Depth (in):		
Sampling Results Sample Location: _____ Total Chlorine: -- ppm Free Chlorine: -- ppm Ammonia: -- ppm pH: -- units Temperature: -- °F Conductivity: -- µS/cm Detergents: -- mg/L		Floatables: None Odor: None Turbidity: None Color: None Gross Solids: None Vegetation: None Benthic Growth: None Stains: None Non-illicit: None		
		Notes Outfall fully submerged and not located - screened upstream at 16-142 US1.		
		Condition Assessment Graffiti: None Erosion: None Deposition: None in. Damage: None

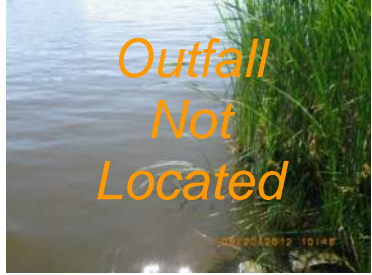
o20120620094610.JPG

Inspection Date: 6/20/2012 10:45:54 AM		Type: Ongoing	Flow: Submerged (not located)	Previous Rainfall (hrs): 24-48
Illicit Discharge Potential: Unlikely		Inspector: JCW	Notes	
Submerged: Fully Depth (in):			Outfall fully submerged; screened upstream at 16-142 US1.	
Sampling Results			Condition Assessment	
Sample Location:	Floatables:	None	Graffiti: None	
Total Chlorine: -- ppm	Odor:	None	Erosion: None	
Free Chlorine: -- ppm	Turbidity:	None	Deposition: None in.	
Ammonia: -- ppm	Color:	None	Damage: None	
pH: -- units	Gross Solids:	None		
Temperature -- °F	Vegetation:	None		
Conductivity: -- µS/cm	Benthic Growth:	None		
Detergents: -- mg/L	Stains:	None		
	Non-illicit:	None

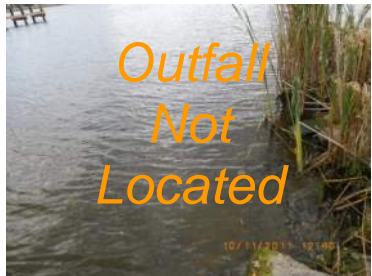
o20111011124048.JPG

Inspection Date: 10/11/2011 12:41:17 PM		Type: Ongoing	Flow: Submerged (not located)	Previous Rainfall (hrs): 72+
Illicit Discharge Potential: Potential		Inspector: JCW	Notes	
Submerged: Fully Depth (in):			2010 screening follow-up. Outfall fully submerged and not physically located. Outfall screened upstream at 16-142 US1.	
Sampling Results			Condition Assessment	
Sample Location:	Floatables:	None	Graffiti: None	
Total Chlorine: -- ppm	Odor:	None	Erosion: None	
Free Chlorine: -- ppm	Turbidity:	None	Deposition: None 0 in.	
Ammonia: -- ppm	Color:	None	Damage: None	
pH: -- units	Gross Solids:	None		
Temperature -- °F	Vegetation:	None		
Conductivity: -- µS/cm	Benthic Growth:	None		
Detergents: -- mg/L	Stains:	None		
	Non-illicit:	None

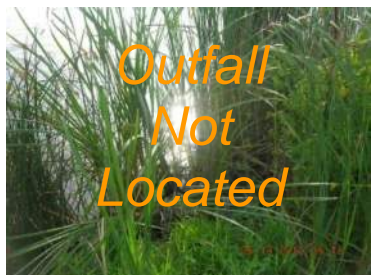
o20100819081820.JPG

Inspection Date: 8/19/2010 8:26:01 AM		Type: Ongoing	Flow: Submerged (not located)	Previous Rainfall (hrs): 72+
Illicit Discharge Potential: Potential		Inspector: JCW	Notes	
Submerged: Fully Depth (in):			Outfall fully submerged and not physically located. Outfall screened upstream at 16-142 US1.	
Sampling Results			Condition Assessment	
Sample Location:	Floatables:	None	Graffiti: None	
Total Chlorine: -- ppm	Odor:	None	Erosion: None	
Free Chlorine: -- ppm	Turbidity:	None	Deposition: None 0 in.	
Ammonia: -- ppm	Color:	None	Damage: None	
pH: -- units	Gross Solids:	None		
Temperature -- °F	Vegetation:	None		
Conductivity: -- µS/cm	Benthic Growth:	None		
Detergents: -- mg/L	Stains:	None		
	Non-illicit:	None

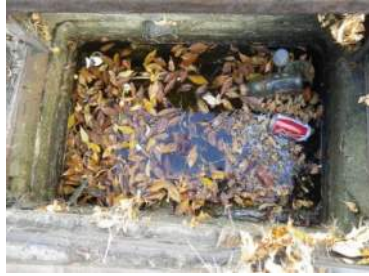
o20111011124148.JPG <div style="text-align: right; font-size: 24pt; font-weight: bold;">2011</div>

Inspection Date: 10/11/2011 12:44:57 PM		Type: Ongoing	Flow: Submerged, indeterminate	Previous Rainfall (hrs): 72+																																				
Illicit Discharge Potential: Potential		Inspector: JCW	Notes																																					
Submerged: Fully		Depth (in): 16	2010 screening follow-up. Floatable debris still present.																																					
<table border="1" style="width:100%; border-collapse: collapse;"> <tr> <td colspan="2">Sampling Results</td> <td>Floatables:</td> <td>None</td> </tr> <tr> <td colspan="2">Sample Location: Pool</td> <td>Odor:</td> <td>None</td> </tr> <tr> <td>Total Chlorine:</td> <td>0 ppm</td> <td>Turbidity:</td> <td>None</td> </tr> <tr> <td>Free Chlorine:</td> <td>0 ppm</td> <td>Color:</td> <td>None</td> </tr> <tr> <td>Ammonia:</td> <td>0 ppm</td> <td>Gross Solids:</td> <td>Slight</td> </tr> <tr> <td>pH:</td> <td>8.15 units</td> <td>Vegetation:</td> <td>None</td> </tr> <tr> <td>Temperature</td> <td>71 °F</td> <td>Benthic Growth:</td> <td>None</td> </tr> <tr> <td>Conductivity:</td> <td>-- µS/cm</td> <td>Stains:</td> <td>None</td> </tr> <tr> <td>Detergents:</td> <td>-- mg/L</td> <td>Non-illicit:</td> <td>None</td> </tr> </table>					Sampling Results		Floatables:	None	Sample Location: Pool		Odor:	None	Total Chlorine:	0 ppm	Turbidity:	None	Free Chlorine:	0 ppm	Color:	None	Ammonia:	0 ppm	Gross Solids:	Slight	pH:	8.15 units	Vegetation:	None	Temperature	71 °F	Benthic Growth:	None	Conductivity:	-- µS/cm	Stains:	None	Detergents:	-- mg/L	Non-illicit:	None

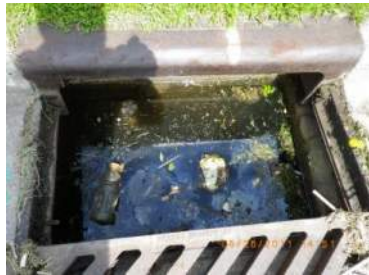
o20110526145102.JPG <div style="text-align: right; font-size: 24pt; font-weight: bold;">2011</div>

Inspection Date: 5/26/2011 2:50:00 PM		Type: Other	Flow: Submerged, indeterminate	Previous Rainfall (hrs): 72+																																				
Illicit Discharge Potential: Potential		Inspector: JCW	Notes																																					
Submerged: Fully		Depth (in):	Limited screening conducted to check for floatable debris.																																					
<table border="1" style="width:100%; border-collapse: collapse;"> <tr> <td colspan="2">Sampling Results</td> <td>Floatables:</td> <td>Moderate</td> </tr> <tr> <td colspan="2">Sample Location:</td> <td>Odor:</td> <td></td> </tr> <tr> <td>Total Chlorine:</td> <td>-- ppm</td> <td>Turbidity:</td> <td></td> </tr> <tr> <td>Free Chlorine:</td> <td>-- ppm</td> <td>Color:</td> <td></td> </tr> <tr> <td>Ammonia:</td> <td>-- ppm</td> <td>Gross Solids:</td> <td>None</td> </tr> <tr> <td>pH:</td> <td>-- units</td> <td>Vegetation:</td> <td></td> </tr> <tr> <td>Temperature</td> <td>-- °F</td> <td>Benthic Growth:</td> <td></td> </tr> <tr> <td>Conductivity:</td> <td>-- µS/cm</td> <td>Stains:</td> <td></td> </tr> <tr> <td>Detergents:</td> <td>-- mg/L</td> <td>Non-illicit:</td> <td>Moderate</td> </tr> </table>					Sampling Results		Floatables:	Moderate	Sample Location:		Odor:		Total Chlorine:	-- ppm	Turbidity:		Free Chlorine:	-- ppm	Color:		Ammonia:	-- ppm	Gross Solids:	None	pH:	-- units	Vegetation:		Temperature	-- °F	Benthic Growth:		Conductivity:	-- µS/cm	Stains:		Detergents:	-- mg/L	Non-illicit:	Moderate

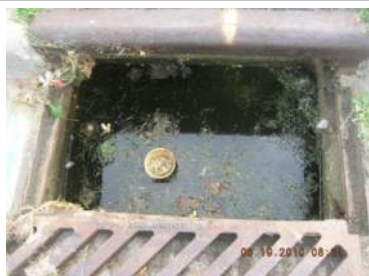
o20100819082134.JPG <div style="text-align: right; font-size: 24pt; font-weight: bold;">2010</div>

Inspection Date: 8/19/2010 8:30:49 AM		Type: Ongoing	Flow: Submerged, indeterminate	Previous Rainfall (hrs): 72+																																				
Illicit Discharge Potential: Potential		Inspector: JCW	Notes																																					
Submerged: Fully		Depth (in): 22	Floatable debris in catchbasin.																																					
<table border="1" style="width:100%; border-collapse: collapse;"> <tr> <td colspan="2">Sampling Results</td> <td>Floatables:</td> <td>None</td> </tr> <tr> <td colspan="2">Sample Location: Pool</td> <td>Odor:</td> <td>None</td> </tr> <tr> <td>Total Chlorine:</td> <td>0 ppm</td> <td>Turbidity:</td> <td>Slight cloudiness</td> </tr> <tr> <td>Free Chlorine:</td> <td>0 ppm</td> <td>Color:</td> <td>Faint in bottle</td> </tr> <tr> <td>Ammonia:</td> <td>0 ppm</td> <td>Gross Solids:</td> <td>Moderate</td> </tr> <tr> <td>pH:</td> <td>7.84 units</td> <td>Vegetation:</td> <td>None</td> </tr> <tr> <td>Temperature</td> <td>73 °F</td> <td>Benthic Growth:</td> <td>Slight</td> </tr> <tr> <td>Conductivity:</td> <td>-- µS/cm</td> <td>Stains:</td> <td>None</td> </tr> <tr> <td>Detergents:</td> <td>0 mg/L</td> <td>Non-illicit:</td> <td>None</td> </tr> </table>					Sampling Results		Floatables:	None	Sample Location: Pool		Odor:	None	Total Chlorine:	0 ppm	Turbidity:	Slight cloudiness	Free Chlorine:	0 ppm	Color:	Faint in bottle	Ammonia:	0 ppm	Gross Solids:	Moderate	pH:	7.84 units	Vegetation:	None	Temperature	73 °F	Benthic Growth:	Slight	Conductivity:	-- µS/cm	Stains:	None	Detergents:	0 mg/L	Non-illicit:	None

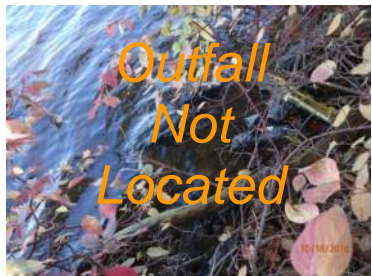
o20161018124936.JPG <div style="text-align: center; font-size: 24pt; font-weight: bold;">2016</div>
		Condition Assessment Graffiti: None Erosion: None Deposition: None in. Damage: None

Inspection Date: 10/18/2016 12:50:50 PM		Type: Ongoing	Flow: Submerged (not located)	Previous Rainfall (hrs): 72+
Illicit Discharge Potential: Unlikely		Inspector: JCW		
Submerged: Fully		Depth (in):		
Sampling Results Sample Location: _____ Total Chlorine: -- ppm Free Chlorine: -- ppm Ammonia: -- ppm pH: -- units Temperature: -- °F Conductivity: -- µS/cm Detergents: -- mg/L		Floatables: None Odor: None Turbidity: None Color: None Gross Solids: None Vegetation: None Benthic Growth: None Stains: None Non-illicit: None	Notes Outfall fully submerged and not located - screened upstream at 16-164 US1.

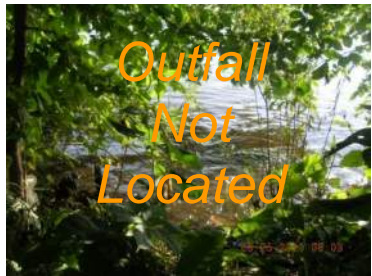
o20100825080326.JPG <div style="text-align: center; font-size: 24pt; font-weight: bold;">2010</div>
		Condition Assessment Graffiti: None Erosion: None Deposition: None 0 in. Damage: None

Inspection Date: 8/25/2010 8:11:03 AM		Type: Ongoing	Flow: Submerged (not located)	Previous Rainfall (hrs): 72+
Illicit Discharge Potential: Unlikely		Inspector: JCW		
Submerged: Fully		Depth (in):		
Sampling Results Sample Location: _____ Total Chlorine: -- ppm Free Chlorine: -- ppm Ammonia: -- ppm pH: -- units Temperature: -- °F Conductivity: -- µS/cm Detergents: -- mg/L		Floatables: None Odor: None Turbidity: None Color: None Gross Solids: None Vegetation: None Benthic Growth: None Stains: None Non-illicit: None	Notes Outfall fully submerged and not physically located. Outfall screened upstream at 16-164 US1.
