Ongoing Screening Summary Report 2018 Inspection Year

Illicit Discharge Detection and Elimination Program

City of Oshkosh

January 25, 2019

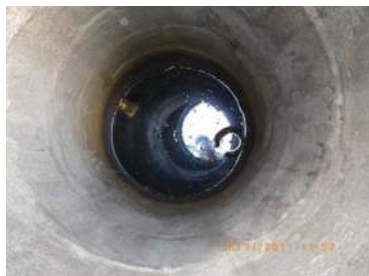
o20111011115206.JPG <div style="text-align: center; font-size: 24pt; font-weight: bold;">2011</div>

Inspection Date: 10/11/2011 11:54:56 AM		Type: Ongoing	Flow: Submerged, indeterminate	Previous Rainfall (hrs): 72+																																											
Illicit Discharge Potential: Unlikely		Inspector: JCW	Notes 2010 screening follow-up. Floatable debris significantly reduced.																																												
Submerged: Fully Depth (in): 30																																															
Sampling Results <table border="1" style="width: 100%; border-collapse: collapse;"> <tr> <td>Sample Location:</td> <td>Pool</td> <td>Floatables:</td> <td>Moderate</td> </tr> <tr> <td>Total Chlorine:</td> <td>0 ppm</td> <td>Odor:</td> <td>None</td> </tr> <tr> <td>Free Chlorine:</td> <td>0 ppm</td> <td>Turbidity:</td> <td>None</td> </tr> <tr> <td>Ammonia:</td> <td>0.5 ppm</td> <td>Color:</td> <td>None</td> </tr> <tr> <td>pH:</td> <td>7.34 units</td> <td>Gross Solids:</td> <td>Moderate</td> </tr> <tr> <td>Temperature:</td> <td>71 °F</td> <td>Vegetation:</td> <td>None</td> </tr> <tr> <td>Conductivity:</td> <td>-- µS/cm</td> <td>Benthic Growth:</td> <td>None</td> </tr> <tr> <td>Detergents:</td> <td>-- mg/L</td> <td>Stains:</td> <td>Moderate</td> </tr> <tr> <td></td> <td></td> <td>Non-illicit:</td> <td>Moderate</td> </tr> </table>		Sample Location:	Pool	Floatables:	Moderate	Total Chlorine:	0 ppm	Odor:	None	Free Chlorine:	0 ppm	Turbidity:	None	Ammonia:	0.5 ppm	Color:	None	pH:	7.34 units	Gross Solids:	Moderate	Temperature:	71 °F	Vegetation:	None	Conductivity:	-- µS/cm	Benthic Growth:	None	Detergents:	-- mg/L	Stains:	Moderate			Non-illicit:	Moderate	Condition Assessment <table border="1" style="width: 100%; border-collapse: collapse;"> <tr> <td>Graffiti:</td> <td>None</td> </tr> <tr> <td>Erosion:</td> <td>None</td> </tr> <tr> <td>Deposition:</td> <td>None 0 in.</td> </tr> <tr> <td>Damage:</td> <td>None</td> </tr> </table>		Graffiti:	None	Erosion:	None	Deposition:	None 0 in.	Damage:	None

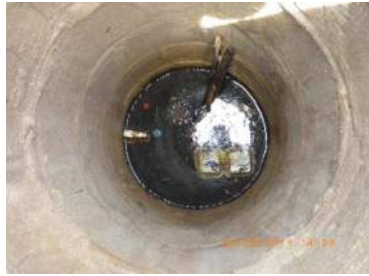
o20110526142310.JPG <div style="text-align: center; font-size: 24pt; font-weight: bold;">2011</div>

Inspection Date: 5/26/2011 2:23:00 PM		Type: Other	Flow: Submerged, indeterminate	Previous Rainfall (hrs): 72+																																											
Illicit Discharge Potential: Potential		Inspector: JCW	Notes Limited screening conducted to check for floatable debris.																																												
Submerged: Fully Depth (in):																																															
Sampling Results <table border="1" style="width: 100%; border-collapse: collapse;"> <tr> <td>Sample Location:</td> <td></td> <td>Floatables:</td> <td>Moderate</td> </tr> <tr> <td>Total Chlorine:</td> <td>-- ppm</td> <td>Odor:</td> <td></td> </tr> <tr> <td>Free Chlorine:</td> <td>-- ppm</td> <td>Turbidity:</td> <td></td> </tr> <tr> <td>Ammonia:</td> <td>-- ppm</td> <td>Color:</td> <td></td> </tr> <tr> <td>pH:</td> <td>-- units</td> <td>Gross Solids:</td> <td>Moderate</td> </tr> <tr> <td>Temperature:</td> <td>-- °F</td> <td>Vegetation:</td> <td></td> </tr> <tr> <td>Conductivity:</td> <td>-- µS/cm</td> <td>Benthic Growth:</td> <td></td> </tr> <tr> <td>Detergents:</td> <td>-- mg/L</td> <td>Stains:</td> <td></td> </tr> <tr> <td></td> <td></td> <td>Non-illicit:</td> <td>None</td> </tr> </table>		Sample Location:		Floatables:	Moderate	Total Chlorine:	-- ppm	Odor:		Free Chlorine:	-- ppm	Turbidity:		Ammonia:	-- ppm	Color:		pH:	-- units	Gross Solids:	Moderate	Temperature:	-- °F	Vegetation:		Conductivity:	-- µS/cm	Benthic Growth:		Detergents:	-- mg/L	Stains:				Non-illicit:	None	Condition Assessment <table border="1" style="width: 100%; border-collapse: collapse;"> <tr> <td>Graffiti:</td> <td>None</td> </tr> <tr> <td>Erosion:</td> <td>None</td> </tr> <tr> <td>Deposition:</td> <td>None 0 in.</td> </tr> <tr> <td>Damage:</td> <td>None</td> </tr> </table>		Graffiti:	None	Erosion:	None	Deposition:	None 0 in.	Damage:	None

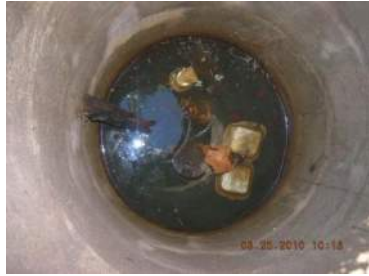
o20100825101302.JPG <div style="text-align: center; font-size: 24pt; font-weight: bold;">2010</div>

Inspection Date: 8/25/2010 10:22:31 AM		Type: Ongoing	Flow: Submerged, indeterminate	Previous Rainfall (hrs): 72+																																											
Illicit Discharge Potential: Potential		Inspector: JCW	Notes Floatable debris in manhole.																																												
Submerged: Fully Depth (in): 37																																															
Sampling Results <table border="1" style="width: 100%; border-collapse: collapse;"> <tr> <td>Sample Location:</td> <td>Pool</td> <td>Floatables:</td> <td>None</td> </tr> <tr> <td>Total Chlorine:</td> <td>0 ppm</td> <td>Odor:</td> <td>None</td> </tr> <tr> <td>Free Chlorine:</td> <td>0 ppm</td> <td>Turbidity:</td> <td>None</td> </tr> <tr> <td>Ammonia:</td> <td>0 ppm</td> <td>Color:</td> <td>Faint in bottle</td> </tr> <tr> <td>pH:</td> <td>7.31 units</td> <td>Gross Solids:</td> <td>Moderate</td> </tr> <tr> <td>Temperature:</td> <td>71 °F</td> <td>Vegetation:</td> <td>None</td> </tr> <tr> <td>Conductivity:</td> <td>-- µS/cm</td> <td>Benthic Growth:</td> <td>Slight</td> </tr> <tr> <td>Detergents:</td> <td>0 mg/L</td> <td>Stains:</td> <td>Slight</td> </tr> <tr> <td></td> <td></td> <td>Non-illicit:</td> <td>None</td> </tr> </table>		Sample Location:	Pool	Floatables:	None	Total Chlorine:	0 ppm	Odor:	None	Free Chlorine:	0 ppm	Turbidity:	None	Ammonia:	0 ppm	Color:	Faint in bottle	pH:	7.31 units	Gross Solids:	Moderate	Temperature:	71 °F	Vegetation:	None	Conductivity:	-- µS/cm	Benthic Growth:	Slight	Detergents:	0 mg/L	Stains:	Slight			Non-illicit:	None	Condition Assessment <table border="1" style="width: 100%; border-collapse: collapse;"> <tr> <td>Graffiti:</td> <td>None</td> </tr> <tr> <td>Erosion:</td> <td>None</td> </tr> <tr> <td>Deposition:</td> <td>None 0 in.</td> </tr> <tr> <td>Damage:</td> <td>None</td> </tr> </table>		Graffiti:	None	Erosion:	None	Deposition:	None 0 in.	Damage:	None

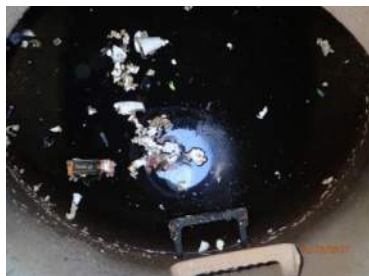
o20171019133054.JPG <div style="text-align: center; font-size: 24pt; font-weight: bold;">2017</div>

<div style="display: flex;"> <div style="flex: 1;"> <p>Notes</p> <p>Sample collected from submerged pool in manhole.</p> </div> <div style="flex: 1;"> <p>Condition Assessment</p> <table border="1" style="width:100%; border-collapse: collapse;"> <tr><td>Graffiti:</td><td>None</td></tr> <tr><td>Erosion:</td><td>None</td></tr> <tr><td>Deposition:</td><td>None in.</td></tr> <tr><td>Damage:</td><td>None</td></tr> </table> </div> </div>			Graffiti:	None	Erosion:	None	Deposition:	None in.	Damage:	None																										
Graffiti:	None																																					
Erosion:	None																																					
Deposition:	None in.																																					
Damage:	None

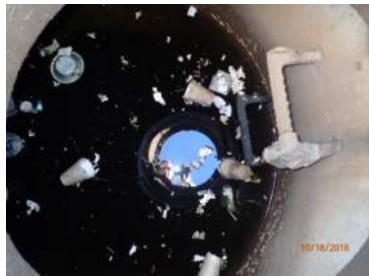
o20161018092516.JPG <div style="text-align: center; font-size: 24pt; font-weight: bold;">2016</div>

<div style="display: flex;"> <div style="flex: 1;"> <p>Notes</p> <p>Potential illicit discharge due to gross solids.</p> </div> <div style="flex: 1;"> <p>Condition Assessment</p> <table border="1" style="width:100%; border-collapse: collapse;"> <tr><td>Graffiti:</td><td>None</td></tr> <tr><td>Erosion:</td><td>None</td></tr> <tr><td>Deposition:</td><td>None in.</td></tr> <tr><td>Damage:</td><td>None</td></tr> </table> </div> </div>			Graffiti:	None	Erosion:	None	Deposition:	None in.	Damage:	None																										
Graffiti:	None																																					
Erosion:	None																																					
Deposition:	None in.																																					
Damage:	None

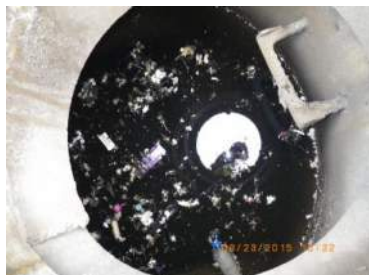
o20150923093204.JPG <div style="text-align: center; font-size: 24pt; font-weight: bold;">2015</div>

<div style="display: flex;"> <div style="flex: 1;"> <p>Notes</p> <p>Floating gross solids (litter) - including syringe - in manhole.</p> </div> <div style="flex: 1;"> <p>Condition Assessment</p> <table border="1" style="width:100%; border-collapse: collapse;"> <tr><td>Graffiti:</td><td>None</td></tr> <tr><td>Erosion:</td><td>None</td></tr> <tr><td>Deposition:</td><td>None in.</td></tr> <tr><td>Damage:</td><td>None</td></tr> </table> </div> </div>			Graffiti:	None	Erosion:	None	Deposition:	None in.	Damage:	None																										
Graffiti:	None																																					
Erosion:	None																																					
Deposition:	None in.																																					
Damage:	None

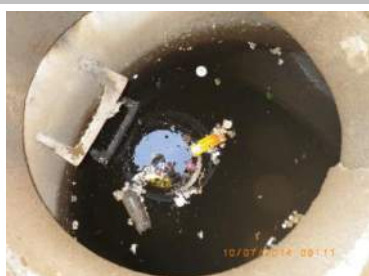
o20141007081140.JPG <div style="text-align: center; font-size: 24pt; font-weight: bold;">2014</div>

<div style="display: flex;"> <div style="flex: 1;"> <p>Notes</p> <p>Floating gross solids (litter) in manhole.</p> </div> <div style="flex: 1;"> <p>Condition Assessment</p> <table border="1" style="width:100%; border-collapse: collapse;"> <tr><td>Graffiti:</td><td>None</td></tr> <tr><td>Erosion:</td><td>None</td></tr> <tr><td>Deposition:</td><td>None in.</td></tr> <tr><td>Damage:</td><td>None</td></tr> </table> </div> </div>			Graffiti:	None	Erosion:	None	Deposition:	None in.	Damage:	None																										
Graffiti:	None																																					
Erosion:	None																																					
Deposition:	None in.																																					
Damage:	None

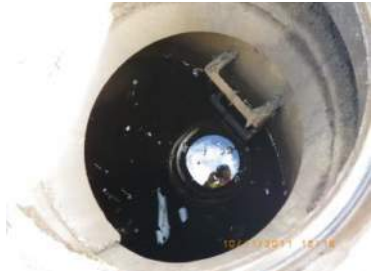
Inspection Date: 10/11/2011 12:22:21 PM		Type: Ongoing		Flow: Submerged, indeterminate		Previous Rainfall (hrs): 72+	
Illicit Discharge Potential: Unlikely		Inspector: JCW		Notes 2010 screening follow-up. Floatable debris significantly reduced.

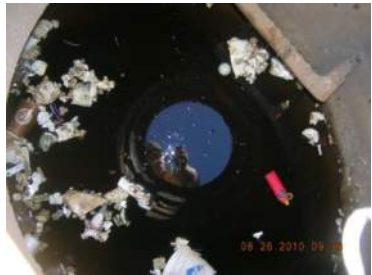
Inspection Date: 8/26/2010 10:01:38 AM		Type: Ongoing		Flow: Submerged, indeterminate		Previous Rainfall (hrs): 72+	
Illicit Discharge Potential: Potential		Inspector: JCW		Notes Floatable debris in manhole.

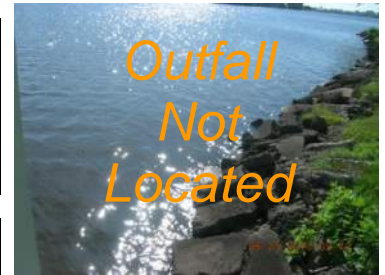
o20100825094258.JPG

Inspection Date: 8/25/2010 9:49:38 AM		Type: Ongoing	Flow: Submerged (not located)	Previous Rainfall (hrs): 72+
Illicit Discharge Potential: Unlikely		Inspector: JCW		
Submerged: Fully		Depth (in):		
Sampling Results		Notes Outfall fully submerged and not physically located. Upstream manhole not accessible.		
Sample Location:	Floatables:	None		
Total Chlorine: -- ppm	Odor:	None		
Free Chlorine: -- ppm	Turbidity:	None		
Ammonia: -- ppm	Color:	None		
pH: -- units	Gross Solids:	None		
Temperature -- °F	Vegetation:	None		
Conductivity: -- µS/cm	Benthic Growth:	None		
Detergents: -- mg/L	Stains:	None		
	Non-illicit:	None		
		Condition Assessment Graffiti: None Erosion: None Deposition: None 0 in. Damage: None

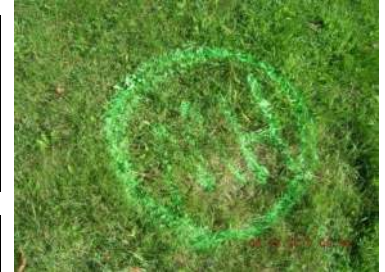
Inspection Date: 8/25/2010 9:54:50 AM		Type: Ongoing	Flow: None	Previous Rainfall (hrs): 72+
Illicit Discharge Potential: Unlikely		Inspector: JCW		
Submerged: None		Depth (in):		
Sampling Results		Notes Only upstream manhole appears to be buried.		
Sample Location:	Floatables:	Condition Assessment Graffiti: None Erosion: None Deposition: None 0 in. Damage: None		
Total Chlorine: -- ppm	Odor:			
Free Chlorine: -- ppm	Turbidity:			
Ammonia: -- ppm	Color:			
pH: -- units	Gross Solids:			
Temperature -- °F	Vegetation:			
Conductivity: -- µS/cm	Benthic Growth:			
Detergents: -- mg/L	Stains:			
	Non-illicit:

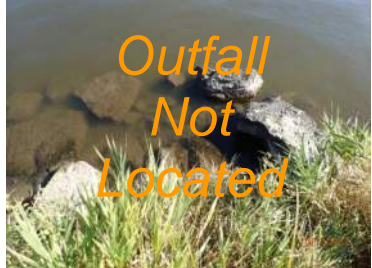
Inspection Date: 10/17/2017 11:24:35 AM		Type: Ongoing	Flow: Submerged (not located)	Previous Rainfall (hrs): 48-72
Illicit Discharge Potential: Potential		Inspector: JCW		
Submerged: Fully		Depth (in):		
Sampling Results Sample Location: _____ Total Chlorine: -- ppm Free Chlorine: -- ppm Ammonia: -- ppm pH: -- units Temperature: -- °F Conductivity: -- µS/cm Detergents: -- mg/L		Floatables: None Odor: None Turbidity: None Color: None Gross Solids: None Vegetation: None Benthic Growth: None Stains: None Non-illicit: None		
		Notes Outfall fully submerged and not located - screened upstream at 16-594 US1. Floating gross solids (litter) in manhole.		
		Condition Assessment Graffiti: None Erosion: None Deposition: None in. Damage: None

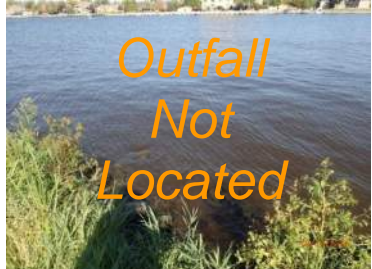
Inspection Date: 10/10/2016 2:04:49 PM		Type: Ongoing	Flow: Submerged (not located)	Previous Rainfall (hrs): 72+
Illicit Discharge Potential: Potential		Inspector: JCW		
Submerged: Fully		Depth (in):		
Sampling Results Sample Location: _____ Total Chlorine: -- ppm Free Chlorine: -- ppm Ammonia: -- ppm pH: -- units Temperature: -- °F Conductivity: -- µS/cm Detergents: -- mg/L		Floatables: None Odor: None Turbidity: None Color: None Gross Solids: None Vegetation: None Benthic Growth: None Stains: None Non-illicit: None		
		Notes Outfall fully submerged and not located -screened upstream at 16-594 US1.		
		Condition Assessment Graffiti: None Erosion: None Deposition: None in. Damage: None

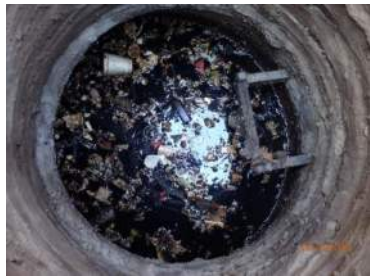
Inspection Date: 10/10/2016 2:07:20 PM		Type: Ongoing	Flow: Submerged, indeterminate	Previous Rainfall (hrs): 72+
Illicit Discharge Potential: Potential		Inspector: JCW		
Submerged: Fully		Depth (in): 51		
Sampling Results		Notes		
Sample Location: Pool	Floatables: Slight	Potential illicit discharge due to gross solids.		
Total Chlorine: 0 ppm	Odor: Easily detected			
Free Chlorine: 0 ppm	Turbidity: None	Condition Assessment		
Ammonia: 0.25 ppm	Color: None			
pH: 7.17 units	Gross Solids: Moderate	Graffiti: None	in.	
Temperature: 71 °F	Vegetation: None	Erosion: None		
Conductivity: 831 µS/cm	Benthic Growth: None	Deposition: None		
Detergents: 0 mg/L	Stains: None	Damage: None		
	Non-illicit: None

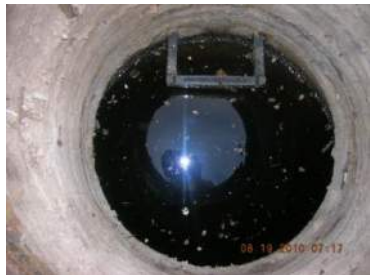
Inspection Date: 8/19/2010 7:26:35 AM		Type: Ongoing	Flow: Submerged, indeterminate	Previous Rainfall (hrs): 72+
Illicit Discharge Potential: Unlikely		Inspector: JCW		
Submerged: Fully		Depth (in): 51		
Sampling Results		Notes		
Sample Location: Pool	Floatables: Slight	2 small oil drops, likely from Oshkosh Ave runoff.		
Total Chlorine: 0 ppm	Odor: None			
Free Chlorine: 0 ppm	Turbidity: None	Condition Assessment		
Ammonia: 0 ppm	Color: Faint in bottle			
pH: 7.44 units	Gross Solids: Slight	Graffiti: None	0 in.	
Temperature: 75 °F	Vegetation: None	Erosion: None		
Conductivity: -- µS/cm	Benthic Growth: None	Deposition: None		
Detergents: 0 mg/L	Stains: None	Damage: None		
	Non-illicit: None

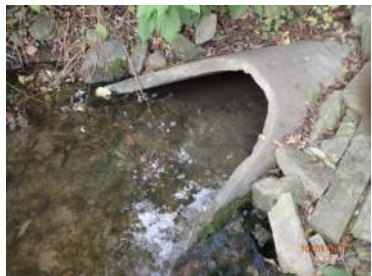
Inspection Date: 10/3/2017 11:03:37 AM		Type: Ongoing	Flow: Submerged, indeterminate	Previous Rainfall (hrs): 72+
Illicit Discharge Potential: Potential		Inspector: JCW		
Submerged: Partially		Depth (in): 12		
Sampling Results Sample Location: Total Chlorine: -- ppm Free Chlorine: -- ppm Ammonia: -- ppm pH: -- units Temperature -- °F Conductivity: -- µS/cm Detergents: -- mg/L		Floatables: None Odor: None Turbidity: None Color: None Gross Solids: None Vegetation: None Benthic Growth: Moderate Stains: Moderate Non-illicit: None		
		Notes Outfall partially submerged - screened upstream at 16-660 US1. Detergent detected in sample.		
		Condition Assessment Graffiti: None Erosion: None Deposition: None in. Damage: None

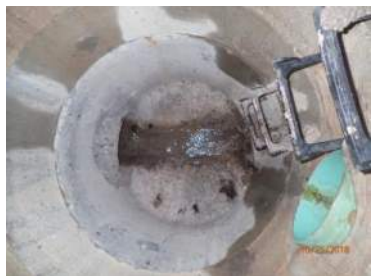
<div style="display: flex;"> <div style="flex: 1;"> <p>Notes</p> <p>Sample collected from flow in manhole. Detergent detected in sample.</p> </div> <div style="flex: 1;"> <p>Condition Assessment</p> <table border="1" style="width:100%; border-collapse: collapse;"> <tr><td>Graffiti:</td><td>None</td></tr> <tr><td>Erosion:</td><td>None</td></tr> <tr><td>Deposition:</td><td>None in.</td></tr> <tr><td>Damage:</td><td>None</td></tr> </table> </div> </div>			Graffiti:	None	Erosion:	None	Deposition:	None in.	Damage:	None																										
Graffiti:	None																																					
Erosion:	None																																					
Deposition:	None in.																																					
Damage:	None

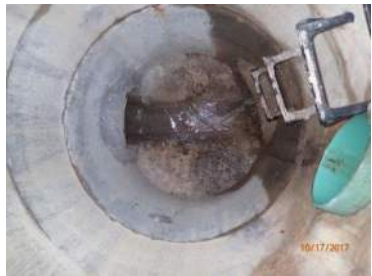
<div style="display: flex;"> <div style="flex: 1;"> <p>Notes</p> <p>Repeat inspection due to detergent. No detergent detected in manhole sample.</p> </div> <div style="flex: 1;"> <p>Condition Assessment</p> <table border="1" style="width:100%; border-collapse: collapse;"> <tr><td>Graffiti:</td><td>None</td></tr> <tr><td>Erosion:</td><td>None</td></tr> <tr><td>Deposition:</td><td>None in.</td></tr> <tr><td>Damage:</td><td>None</td></tr> </table> </div> </div>			Graffiti:	None	Erosion:	None	Deposition:	None in.	Damage:	None																										
Graffiti:	None																																					
Erosion:	None																																					
Deposition:	None in.																																					
Damage:	None

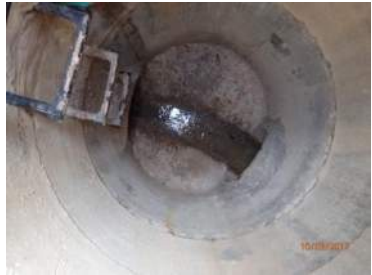
<div style="display: flex;"> <div style="flex: 1;"> <p>Notes</p> <p>Sample collected from flow in manhole. Detergent detected in sample.</p> </div> <div style="flex: 1;"> <p>Condition Assessment</p> <table border="1" style="width:100%; border-collapse: collapse;"> <tr><td>Graffiti:</td><td>None</td></tr> <tr><td>Erosion:</td><td>None</td></tr> <tr><td>Deposition:</td><td>None in.</td></tr> <tr><td>Damage:</td><td>None</td></tr> </table> </div> </div>			Graffiti:	None	Erosion:	None	Deposition:	None in.	Damage:	None																										
Graffiti:	None																																					
Erosion:	None																																					
Deposition:	None in.																																					
Damage:	None

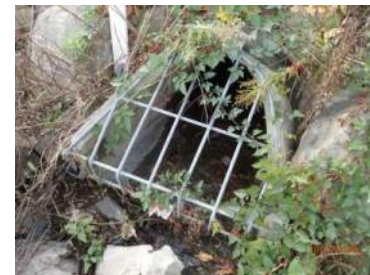
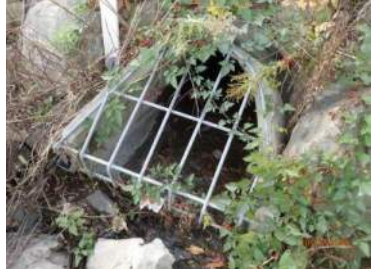
o20181025085152.JPG

Inspection Date: 10/25/2018 8:55:36 AM		Type: Ongoing	Flow: Trickle	Previous Rainfall (hrs): 72+																																		
Illicit Discharge Potential: Potential		Inspector: JCW																																				
Submerged: None		Depth (in):																																				
Sampling Results		<div style="float: right; border: 1px solid black; padding: 5px; width: 200px;"> Notes Sample collected from pipe flow. Detergent and elevated conductivity in sample. </div> <table border="1" style="width:100%; border-collapse: collapse;"> <tr><td>Sample Location:</td><td>Flow</td></tr> <tr><td>Total Chlorine:</td><td>0 ppm</td></tr> <tr><td>Free Chlorine:</td><td>0 ppm</td></tr> <tr><td>Ammonia:</td><td>0 ppm</td></tr> <tr><td>pH:</td><td>8.22 units</td></tr> <tr><td>Temperature:</td><td>52 °F</td></tr> <tr><td>Conductivity:</td><td>3300 µS/cm</td></tr> <tr><td>Detergents:</td><td>0.45 mg/L</td></tr> </table> <table border="1" style="width:100%; border-collapse: collapse;"> <tr><td>Floatables:</td><td>None</td></tr> <tr><td>Odor:</td><td>None</td></tr> <tr><td>Turbidity:</td><td>None</td></tr> <tr><td>Color:</td><td>None</td></tr> <tr><td>Gross Solids:</td><td>None</td></tr> <tr><td>Vegetation:</td><td>None</td></tr> <tr><td>Benthic Growth:</td><td>Moderate</td></tr> <tr><td>Stains:</td><td>None</td></tr> <tr><td>Non-illicit:</td><td>None</td></tr> </table> <div style="float: right; border: 1px solid black; padding: 5px; width: 200px;"> Condition Assessment Graffiti: None Erosion: None Deposition: None in. Damage: None </div>			Sample Location:	Flow	Total Chlorine:	0 ppm	Free Chlorine:	0 ppm	Ammonia:	0 ppm	pH:	8.22 units	Temperature:	52 °F	Conductivity:	3300 µS/cm	Detergents:	0.45 mg/L	Floatables:	None	Odor:	None	Turbidity:	None	Color:	None	Gross Solids:	None	Vegetation:	None	Benthic Growth:	Moderate	Stains:	None	Non-illicit:	None

Sample Location:	Flow																																					
Total Chlorine:	0 ppm																																					
Free Chlorine:	0 ppm																																					
Ammonia:	0 ppm																																					
pH:	8.22 units																																					
Temperature:	52 °F																																					
Conductivity:	3300 µS/cm																																					
Detergents:	0.45 mg/L																																					
Floatables:	None																																					
Odor:	None																																					
Turbidity:	None																																					
Color:	None																																					
Gross Solids:	None																																					
Vegetation:	None																																					
Benthic Growth:	Moderate																																					
Stains:	None																																					
Non-illicit:	None

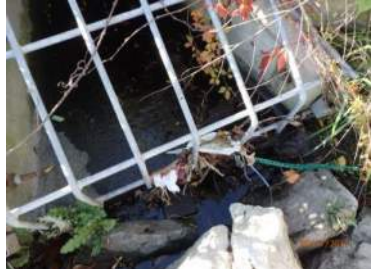
o20171017102814.JPG <div style="font-size: 24pt; font-weight: bold; text-align: center;">2017</div>

Inspection Date: 10/17/2017 10:32:21 AM		Type: Ongoing	Flow: Trickle	Previous Rainfall (hrs): 48-72																																		
Illicit Discharge Potential: Unlikely		Inspector: JCW																																				
Submerged: None		Depth (in):																																				
Sampling Results		<div style="float: right; border: 1px solid black; padding: 5px; width: 200px;"> Notes Sample collected from pipe flow. </div> <table border="1" style="width:100%; border-collapse: collapse;"> <tr><td>Sample Location:</td><td>Flow</td></tr> <tr><td>Total Chlorine:</td><td>0 ppm</td></tr> <tr><td>Free Chlorine:</td><td>0 ppm</td></tr> <tr><td>Ammonia:</td><td>0 ppm</td></tr> <tr><td>pH:</td><td>8.35 units</td></tr> <tr><td>Temperature:</td><td>65 °F</td></tr> <tr><td>Conductivity:</td><td>1704 µS/cm</td></tr> <tr><td>Detergents:</td><td>0 mg/L</td></tr> </table> <table border="1" style="width:100%; border-collapse: collapse;"> <tr><td>Floatables:</td><td>None</td></tr> <tr><td>Odor:</td><td>None</td></tr> <tr><td>Turbidity:</td><td>None</td></tr> <tr><td>Color:</td><td>None</td></tr> <tr><td>Gross Solids:</td><td>Slight</td></tr> <tr><td>Vegetation:</td><td>None</td></tr> <tr><td>Benthic Growth:</td><td>Slight</td></tr> <tr><td>Stains:</td><td>None</td></tr> <tr><td>Non-illicit:</td><td>None</td></tr> </table> <div style="float: right; border: 1px solid black; padding: 5px; width: 200px;"> Condition Assessment Graffiti: None Erosion: None Deposition: None in. Damage: None </div>			Sample Location:	Flow	Total Chlorine:	0 ppm	Free Chlorine:	0 ppm	Ammonia:	0 ppm	pH:	8.35 units	Temperature:	65 °F	Conductivity:	1704 µS/cm	Detergents:	0 mg/L	Floatables:	None	Odor:	None	Turbidity:	None	Color:	None	Gross Solids:	Slight	Vegetation:	None	Benthic Growth:	Slight	Stains:	None	Non-illicit:	None

Sample Location:	Flow																																					
Total Chlorine:	0 ppm																																					
Free Chlorine:	0 ppm																																					
Ammonia:	0 ppm																																					
pH:	8.35 units																																					
Temperature:	65 °F																																					
Conductivity:	1704 µS/cm																																					
Detergents:	0 mg/L																																					
Floatables:	None																																					
Odor:	None																																					
Turbidity:	None																																					
Color:	None																																					
Gross Solids:	Slight																																					
Vegetation:	None																																					
Benthic Growth:	Slight																																					
Stains:	None																																					
Non-illicit:	None

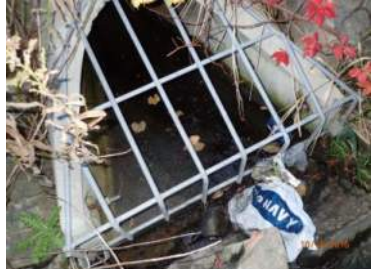
o20161018071712.JPG <div style="font-size: 24pt; font-weight: bold; text-align: center;">2016</div>

Inspection Date: 10/18/2016 7:21:24 AM		Type: Ongoing	Flow: Trickle	Previous Rainfall (hrs): 72+																																		
Illicit Discharge Potential: Unlikely		Inspector: JCW																																				
Submerged: None		Depth (in):																																				
Sampling Results		<div style="float: right; border: 1px solid black; padding: 5px; width: 200px;"> Notes Elevated conductivity, but no other parameters out of range. </div> <table border="1" style="width:100%; border-collapse: collapse;"> <tr><td>Sample Location:</td><td>Flow</td></tr> <tr><td>Total Chlorine:</td><td>0 ppm</td></tr> <tr><td>Free Chlorine:</td><td>0 ppm</td></tr> <tr><td>Ammonia:</td><td>0 ppm</td></tr> <tr><td>pH:</td><td>8.29 units</td></tr> <tr><td>Temperature:</td><td>64 °F</td></tr> <tr><td>Conductivity:</td><td>3880 µS/cm</td></tr> <tr><td>Detergents:</td><td>0 mg/L</td></tr> </table> <table border="1" style="width:100%; border-collapse: collapse;"> <tr><td>Floatables:</td><td>None</td></tr> <tr><td>Odor:</td><td>Faint</td></tr> <tr><td>Turbidity:</td><td>None</td></tr> <tr><td>Color:</td><td>None</td></tr> <tr><td>Gross Solids:</td><td>Slight</td></tr> <tr><td>Vegetation:</td><td>None</td></tr> <tr><td>Benthic Growth:</td><td>Moderate</td></tr> <tr><td>Stains:</td><td>None</td></tr> <tr><td>Non-illicit:</td><td>None</td></tr> </table> <div style="float: right; border: 1px solid black; padding: 5px; width: 200px;"> Condition Assessment Graffiti: None Erosion: None Deposition: None in. Damage: None </div>			Sample Location:	Flow	Total Chlorine:	0 ppm	Free Chlorine:	0 ppm	Ammonia:	0 ppm	pH:	8.29 units	Temperature:	64 °F	Conductivity:	3880 µS/cm	Detergents:	0 mg/L	Floatables:	None	Odor:	Faint	Turbidity:	None	Color:	None	Gross Solids:	Slight	Vegetation:	None	Benthic Growth:	Moderate	Stains:	None	Non-illicit:	None

Sample Location:	Flow																																					
Total Chlorine:	0 ppm																																					
Free Chlorine:	0 ppm																																					
Ammonia:	0 ppm																																					
pH:	8.29 units																																					
Temperature:	64 °F																																					
Conductivity:	3880 µS/cm																																					
Detergents:	0 mg/L																																					
Floatables:	None																																					
Odor:	Faint																																					
Turbidity:	None																																					
Color:	None																																					
Gross Solids:	Slight																																					
Vegetation:	None																																					
Benthic Growth:	Moderate																																					
Stains:	None																																					
Non-illicit:	None

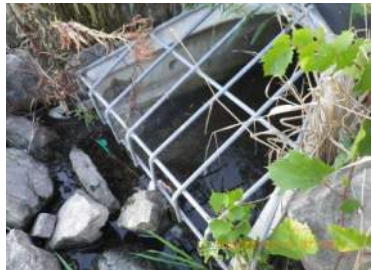
o20150928062340.JPG <div style="font-size: 24pt; font-weight: bold; text-align: center;">2015</div>

Inspection Date: 9/28/2015 7:20:55 AM		Type: Ongoing	Flow: None	Previous Rainfall (hrs): 72+																																		
Illicit Discharge Potential: Unlikely		Inspector: JCW																																				
Submerged: None		Depth (in):																																				
Sampling Results		<div style="float: right; border: 1px solid black; padding: 5px; width: 200px;"> Notes Flowline wet, but no flow at time of inspection. </div> <table border="1" style="width:100%; border-collapse: collapse;"> <tr><td>Sample Location:</td><td></td></tr> <tr><td>Total Chlorine:</td><td>-- ppm</td></tr> <tr><td>Free Chlorine:</td><td>-- ppm</td></tr> <tr><td>Ammonia:</td><td>-- ppm</td></tr> <tr><td>pH:</td><td>-- units</td></tr> <tr><td>Temperature:</td><td>-- °F</td></tr> <tr><td>Conductivity:</td><td>-- µS/cm</td></tr> <tr><td>Detergents:</td><td>-- mg/L</td></tr> </table> <table border="1" style="width:100%; border-collapse: collapse;"> <tr><td>Floatables:</td><td>None</td></tr> <tr><td>Odor:</td><td>None</td></tr> <tr><td>Turbidity:</td><td>None</td></tr> <tr><td>Color:</td><td>None</td></tr> <tr><td>Gross Solids:</td><td>Slight</td></tr> <tr><td>Vegetation:</td><td>None</td></tr> <tr><td>Benthic Growth:</td><td>Moderate</td></tr> <tr><td>Stains:</td><td>None</td></tr> <tr><td>Non-illicit:</td><td>None</td></tr> </table> <div style="float: right; border: 1px solid black; padding: 5px; width: 200px;"> Condition Assessment Graffiti: None Erosion: None Deposition: None in. Damage: None </div>			Sample Location:		Total Chlorine:	-- ppm	Free Chlorine:	-- ppm	Ammonia:	-- ppm	pH:	-- units	Temperature:	-- °F	Conductivity:	-- µS/cm	Detergents:	-- mg/L	Floatables:	None	Odor:	None	Turbidity:	None	Color:	None	Gross Solids:	Slight	Vegetation:	None	Benthic Growth:	Moderate	Stains:	None	Non-illicit:	None

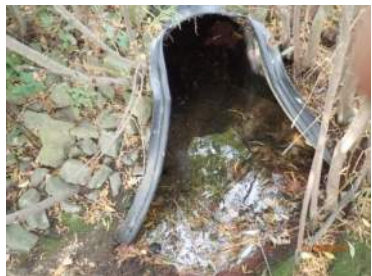
o20171003101614.JPG <div style="text-align: right; font-size: 24pt; font-weight: bold;">2017</div>

Inspection Date: 10/3/2017 10:18:12 AM		Type: Ongoing	Flow: Submerged, indeterminate	Previous Rainfall (hrs): 72+
Illicit Discharge Potential: Potential		Inspector: JCW		
Submerged: Partially		Depth (in): 8		
Sampling Results		Notes Outfall partially submerged - screened upstream at 16-995 US1. Detergent detected in sample.		
Sample Location:	Floatables:	None		
Total Chlorine: -- ppm	Odor:	None		
Free Chlorine: -- ppm	Turbidity:	None		
Ammonia: -- ppm	Color:	None		
pH: -- units	Gross Solids:	None		
Temperature -- °F	Vegetation:	None		
Conductivity: -- µS/cm	Benthic Growth:	Slight		
Detergents: -- mg/L	Stains:	None		
	Non-illicit:	None		
		Condition Assessment Graffiti: None Erosion: None Deposition: Minor 1 in. Damage: None

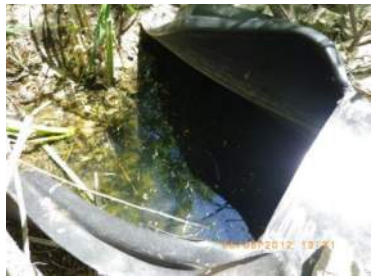
o20120606122140.JPG <div style="text-align: right; font-size: 24pt; font-weight: bold;">2012</div>

Inspection Date: 6/6/2012 1:21:40 PM		Type: Ongoing	Flow: Submerged, indeterminate	Previous Rainfall (hrs): 72+
Illicit Discharge Potential: Unlikely		Inspector: JCW		
Submerged: Partially		Depth (in): 9		
Sampling Results		Notes No flow leaving pool at end of outfall. Deposition in swale downstream. Screened upstream at 16-995 US1.		
Sample Location:	Floatables:	None		
Total Chlorine: -- ppm	Odor:	None		
Free Chlorine: -- ppm	Turbidity:	None		
Ammonia: -- ppm	Color:	None		
pH: -- units	Gross Solids:	Slight		
Temperature -- °F	Vegetation:	None		
Conductivity: -- µS/cm	Benthic Growth:	Slight		
Detergents: -- mg/L	Stains:	Slight		
	Non-illicit:	None		
		Condition Assessment Graffiti: None Erosion: None Deposition: Moderate 8 in. Damage: None

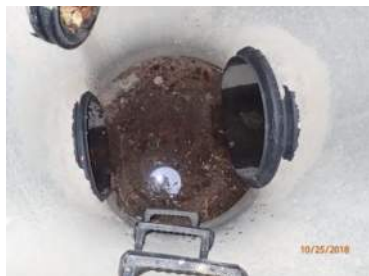
<p style="text-align: center;">o20181025082910.JPG</p> <p style="text-align: center; font-size: 24pt; font-weight: bold;">2018</p>

Sample Location:	Pool																																					
Total Chlorine:	0 ppm																																					
Free Chlorine:	0 ppm																																					
Ammonia:	0 ppm																																					
pH:	7.86 units																																					
Temperature:	50 °F																																					
Conductivity:	1011 µS/cm																																					
Detergents:	0.4 mg/L																																					
Floatables:	None																																					
Odor:	None																																					
Turbidity:	None																																					
Color:	None																																					
Gross Solids:	Slight																																					
Vegetation:	None																																					
Benthic Growth:	None																																					
Stains:	None																																					
Non-illicit:	None

<div style="display: flex;"> <div style="flex: 1;"> <p>Notes</p> <p>Sample collected from submerged pool in outfall. Detergent detected in sample.</p> </div> <div style="flex: 1;"> <p>Condition Assessment</p> <table border="1" style="width:100%; border-collapse: collapse;"> <tr><td>Graffiti:</td><td>None</td></tr> <tr><td>Erosion:</td><td>None</td></tr> <tr><td>Deposition:</td><td>None in.</td></tr> <tr><td>Damage:</td><td>None</td></tr> </table> </div> </div>			Graffiti:	None	Erosion:	None	Deposition:	None in.	Damage:	None																										
Graffiti:	None																																					
Erosion:	None																																					
Deposition:	None in.																																					
Damage:	None

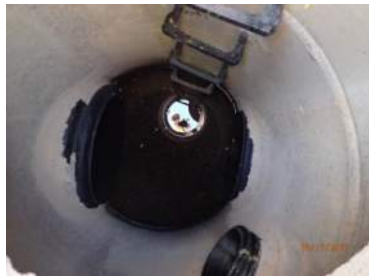
<p style="text-align: center;">o20171017084622.JPG</p> <p style="text-align: center; font-size: 24pt; font-weight: bold;">2017</p>

Sample Location:	Pool																																					
Total Chlorine:	0 ppm																																					
Free Chlorine:	0 ppm																																					
Ammonia:	0 ppm																																					
pH:	7.54 units																																					
Temperature:	61 °F																																					
Conductivity:	582 µS/cm																																					
Detergents:	0.8 mg/L																																					
Floatables:	None																																					
Odor:	None																																					
Turbidity:	None																																					
Color:	None																																					
Gross Solids:	None																																					
Vegetation:	None																																					
Benthic Growth:	None																																					
Stains:	None																																					
Non-illicit:	None

<div style="display: flex;"> <div style="flex: 1;"> <p>Notes</p> <p>Repeat inspection due to detergent. Detergent detected in manhole sample.</p> </div> <div style="flex: 1;"> <p>Condition Assessment</p> <table border="1" style="width:100%; border-collapse: collapse;"> <tr><td>Graffiti:</td><td>None</td></tr> <tr><td>Erosion:</td><td>None</td></tr> <tr><td>Deposition:</td><td>None in.</td></tr> <tr><td>Damage:</td><td>None</td></tr> </table> </div> </div>			Graffiti:	None	Erosion:	None	Deposition:	None in.	Damage:	None																										
Graffiti:	None																																					
Erosion:	None																																					
Deposition:	None in.																																					
Damage:	None

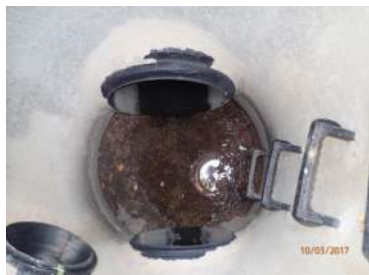
<p style="text-align: center;">o20171003101932.JPG</p> <p style="text-align: center; font-size: 24pt; font-weight: bold;">2017</p>

Sample Location:	Pool																																					
Total Chlorine:	0 ppm																																					
Free Chlorine:	0 ppm																																					
Ammonia:	0 ppm																																					
pH:	7.45 units																																					
Temperature:	72 °F																																					
Conductivity:	333 µS/cm																																					
Detergents:	1.3 mg/L																																					
Floatables:	None																																					
Odor:	None																																					
Turbidity:	None																																					
Color:	None																																					
Gross Solids:	None																																					
Vegetation:	None																																					
Benthic Growth:	None																																					
Stains:	None																																					
Non-illicit:	None

<div style="display: flex;"> <div style="flex: 1;"> <p>Notes</p> <p>Sample collected from submerged pool in outfall. Detergent detected in sample.</p> </div> <div style="flex: 1;"> <p>Condition Assessment</p> <table border="1" style="width:100%; border-collapse: collapse;"> <tr><td>Graffiti:</td><td>None</td></tr> <tr><td>Erosion:</td><td>None</td></tr> <tr><td>Deposition:</td><td>None in.</td></tr> <tr><td>Damage:</td><td>None</td></tr> </table> </div> </div>			Graffiti:	None	Erosion:	None	Deposition:	None in.	Damage:	None																										
Graffiti:	None																																					
Erosion:	None																																					
Deposition:	None in.																																					
Damage:	None

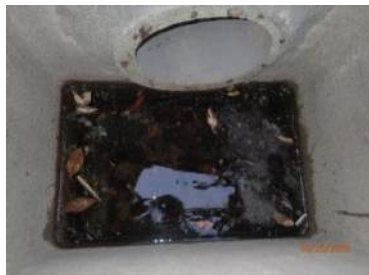
Detergents: 0.5 mg/L

Inspection Date: 10/25/2018 8:41:51 AM		Type: Ongoing	Flow: None	Previous Rainfall (hrs): 72+
Illicit Discharge Potential: Potential Submerged: None Depth (in):		Inspector: JCW	Notes

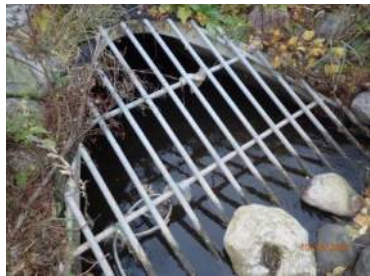
o20161018072836.JPG																																			
2016

Notes Graffiti on south bridge abutment. Outfall partially submerged - screened upstream at 16-1508 US1.																																				
		Condition Assessment <table border="1" style="width:100%; border-collapse: collapse;"> <tr><td>Graffiti:</td><td>Moderate</td></tr> <tr><td>Erosion:</td><td>None</td></tr> <tr><td>Deposition:</td><td>None in.</td></tr> <tr><td>Damage:</td><td>None</td></tr> </table>			Graffiti:	Moderate	Erosion:	None	Deposition:	None in.	Damage:	None																										
Graffiti:	Moderate																																					
Erosion:	None																																					
Deposition:	None in.																																					
Damage:	None

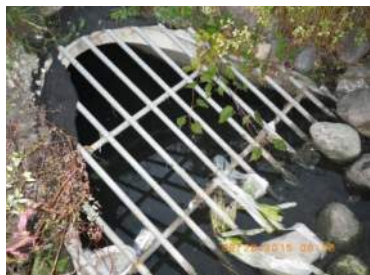
o20150928055850.JPG																																			
2015

Notes Outfall partially submerged - screened at 16-1508 US1. Elevated ammonia.																																				
		Condition Assessment <table border="1" style="width:100%; border-collapse: collapse;"> <tr><td>Graffiti:</td><td>None</td></tr> <tr><td>Erosion:</td><td>None</td></tr> <tr><td>Deposition:</td><td>None in.</td></tr> <tr><td>Damage:</td><td>None</td></tr> </table>			Graffiti:	None	Erosion:	None	Deposition:	None in.	Damage:	None																										
Graffiti:	None																																					
Erosion:	None																																					
Deposition:	None in.																																					
Damage:	None

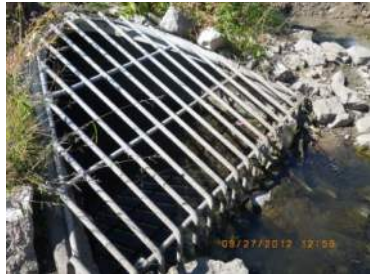
o20120927115922.JPG <div style="text-align: center; font-size: 24pt; font-weight: bold;">2012</div>

Inspection Date: 9/27/2012 12:57:15 PM		Type: Repeat	Flow: Submerged, indeterminate	Previous Rainfall (hrs): 72+																									
Illicit Discharge Potential: Potential		Inspector: JCW	Notes Construction around outfall. Screened upstream at 16-1508 US1.																										
Submerged: Partially Depth (in): 15																													
Sampling Results <table border="1" style="width:100%; border-collapse: collapse;"> <tr> <td style="width:50%;">Sample Location:</td> <td style="width:50%;">Floatables:</td> </tr> <tr> <td>Total Chlorine: -- ppm</td> <td>Odor:</td> </tr> <tr> <td>Free Chlorine: -- ppm</td> <td>Turbidity:</td> </tr> <tr> <td>Ammonia: -- ppm</td> <td>Color:</td> </tr> <tr> <td>pH: -- units</td> <td>Gross Solids:</td> </tr> <tr> <td>Temperature -- °F</td> <td>Vegetation:</td> </tr> <tr> <td>Conductivity: -- µS/cm</td> <td>Benthic Growth:</td> </tr> <tr> <td>Detergents: -- mg/L</td> <td>Stains:</td> </tr> <tr> <td></td> <td>Non-illicit:</td> </tr> </table>		Sample Location:	Floatables:	Total Chlorine: -- ppm	Odor:	Free Chlorine: -- ppm	Turbidity:	Ammonia: -- ppm	Color:	pH: -- units	Gross Solids:	Temperature -- °F	Vegetation:	Conductivity: -- µS/cm	Benthic Growth:	Detergents: -- mg/L	Stains:		Non-illicit:	Condition Assessment <table border="1" style="width:100%; border-collapse: collapse;"> <tr> <td>Graffiti:</td> <td>None</td> </tr> <tr> <td>Erosion:</td> <td>None</td> </tr> <tr> <td>Deposition:</td> <td>Moderate 9 in.</td> </tr> <tr> <td>Damage:</td> <td>None</td> </tr> </table>		Graffiti:	None	Erosion:	None	Deposition:	Moderate 9 in.	Damage:	None

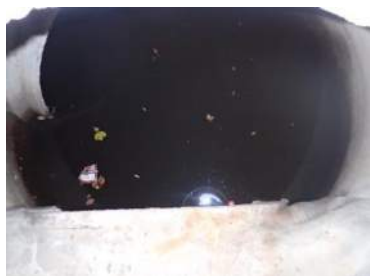
o20161018073934.JPG <div style="text-align: right; font-size: 1.5em; font-weight: bold;">2016</div>

Inspection Date: 10/18/2016 7:44:01 AM		Type: Ongoing	Flow: Submerged, indeterminate	Previous Rainfall (hrs): 72+
Illicit Discharge Potential: Unlikely		Inspector: JCW		
Submerged: Partially		Depth (in): 29		
Sampling Results Sample Location: Pool Total Chlorine: 0 ppm Free Chlorine: 0 ppm Ammonia: 0 ppm pH: 8.11 units Temperature: 64 °F Conductivity: 1020 µS/cm Detergents: 0 mg/L		Floatables: None Odor: None Turbidity: Slight cloudiness Color: None Gross Solids: None Vegetation: None Benthic Growth: Moderate Stains: None Non-illicit: None	Notes	
		Condition Assessment Graffiti: None Erosion: None Deposition: None in. Damage: None

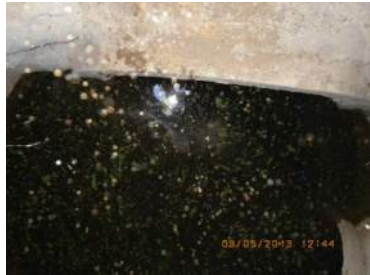
o20130905114422.JPG <div style="text-align: right; font-weight: bold; font-size: 1.2em;">2013</div>

Inspection Date: 9/5/2013 12:37:35 PM		Type: Ongoing	Flow: Submerged, indeterminate	Previous Rainfall (hrs): 72+																																											
Illicit Discharge Potential: Unlikely		Inspector: JCW	Notes 2012 ammonia detection follow-up.																																												
Submerged: Partially Depth (in): 27																																															
Sampling Results <table border="1" style="width:100%; border-collapse: collapse;"> <tr> <td>Sample Location:</td> <td>Pool</td> <td>Floatables:</td> <td>None</td> </tr> <tr> <td>Total Chlorine:</td> <td>0 ppm</td> <td>Odor:</td> <td>None</td> </tr> <tr> <td>Free Chlorine:</td> <td>0 ppm</td> <td>Turbidity:</td> <td>None</td> </tr> <tr> <td>Ammonia:</td> <td>0.5 ppm</td> <td>Color:</td> <td>None</td> </tr> <tr> <td>pH:</td> <td>7.82 units</td> <td>Gross Solids:</td> <td>None</td> </tr> <tr> <td>Temperature</td> <td>86 °F</td> <td>Vegetation:</td> <td>None</td> </tr> <tr> <td>Conductivity:</td> <td>754 µS/cm</td> <td>Benthic Growth:</td> <td>None</td> </tr> <tr> <td>Detergents:</td> <td>0 mg/L</td> <td>Stains:</td> <td>None</td> </tr> <tr> <td></td> <td></td> <td>Non-illicit:</td> <td>None</td> </tr> </table>		Sample Location:	Pool	Floatables:	None	Total Chlorine:	0 ppm	Odor:	None	Free Chlorine:	0 ppm	Turbidity:	None	Ammonia:	0.5 ppm	Color:	None	pH:	7.82 units	Gross Solids:	None	Temperature	86 °F	Vegetation:	None	Conductivity:	754 µS/cm	Benthic Growth:	None	Detergents:	0 mg/L	Stains:	None			Non-illicit:	None	Condition Assessment <table border="1" style="width:100%; border-collapse: collapse;"> <tr> <td>Graffiti:</td> <td>None</td> </tr> <tr> <td>Erosion:</td> <td>None</td> </tr> <tr> <td>Deposition:</td> <td>None in.</td> </tr> <tr> <td>Damage:</td> <td>None</td> </tr> </table>		Graffiti:	None	Erosion:	None	Deposition:	None in.	Damage:	None

Sample Location:	Pool	Floatables:	None																																												
Total Chlorine:	0 ppm	Odor:	None																																												
Free Chlorine:	0 ppm	Turbidity:	None																																												
Ammonia:	0.5 ppm	Color:	None																																												
pH:	7.82 units	Gross Solids:	None																																												
Temperature	86 °F	Vegetation:	None																																												
Conductivity:	754 µS/cm	Benthic Growth:	None																																												
Detergents:	0 mg/L	Stains:	None																																												
		Non-illicit:	None																																												
Graffiti:	None																																														
Erosion:	None																																														
Deposition:	None in.																																														
Damage:	None

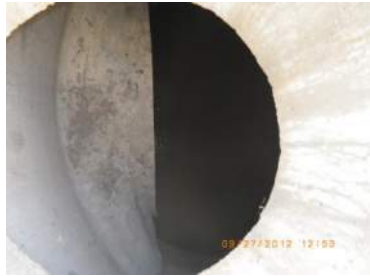
o20120927115358.JPG <div style="text-align: right; font-weight: bold; font-size: 1.2em;">2012</div>

Inspection Date: 9/27/2012 12:51:46 PM		Type: Repeat	Flow: Submerged, indeterminate	Previous Rainfall (hrs): 72+																																											
Illicit Discharge Potential: Potential		Inspector: JCW	Notes Ammonia detection follow-up.																																												
Submerged: Partially Depth (in): 9																																															
Sampling Results <table border="1" style="width:100%; border-collapse: collapse;"> <tr> <td>Sample Location:</td> <td>Pool</td> <td>Floatables:</td> <td>None</td> </tr> <tr> <td>Total Chlorine:</td> <td>0 ppm</td> <td>Odor:</td> <td>None</td> </tr> <tr> <td>Free Chlorine:</td> <td>0 ppm</td> <td>Turbidity:</td> <td>None</td> </tr> <tr> <td>Ammonia:</td> <td>3 ppm</td> <td>Color:</td> <td>None</td> </tr> <tr> <td>pH:</td> <td>7.8 units</td> <td>Gross Solids:</td> <td>None</td> </tr> <tr> <td>Temperature</td> <td>65 °F</td> <td>Vegetation:</td> <td>None</td> </tr> <tr> <td>Conductivity:</td> <td>1408 µS/cm</td> <td>Benthic Growth:</td> <td>None</td> </tr> <tr> <td>Detergents:</td> <td>0 mg/L</td> <td>Stains:</td> <td>None</td> </tr> <tr> <td></td> <td></td> <td>Non-illicit:</td> <td>None</td> </tr> </table>		Sample Location:	Pool	Floatables:	None	Total Chlorine:	0 ppm	Odor:	None	Free Chlorine:	0 ppm	Turbidity:	None	Ammonia:	3 ppm	Color:	None	pH:	7.8 units	Gross Solids:	None	Temperature	65 °F	Vegetation:	None	Conductivity:	1408 µS/cm	Benthic Growth:	None	Detergents:	0 mg/L	Stains:	None			Non-illicit:	None	Condition Assessment <table border="1" style="width:100%; border-collapse: collapse;"> <tr> <td>Graffiti:</td> <td>None</td> </tr> <tr> <td>Erosion:</td> <td>None</td> </tr> <tr> <td>Deposition:</td> <td>None in.</td> </tr> <tr> <td>Damage:</td> <td>None</td> </tr> </table>		Graffiti:	None	Erosion:	None	Deposition:	None in.	Damage:	None

Sample Location:	Pool	Floatables:	None																																												
Total Chlorine:	0 ppm	Odor:	None																																												
Free Chlorine:	0 ppm	Turbidity:	None																																												
Ammonia:	3 ppm	Color:	None																																												
pH:	7.8 units	Gross Solids:	None																																												
Temperature	65 °F	Vegetation:	None																																												
Conductivity:	1408 µS/cm	Benthic Growth:	None																																												
Detergents:	0 mg/L	Stains:	None																																												
		Non-illicit:	None																																												
Graffiti:	None																																														
Erosion:	None																																														
Deposition:	None in.																																														
Damage:	None

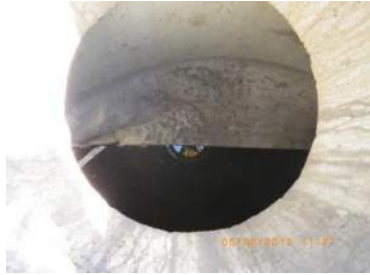
o20120606102704.JPG <div style="text-align: right; font-weight: bold; font-size: 1.2em;">2012</div>

Inspection Date: 6/6/2012 11:27:15 AM		Type: Repeat	Flow: Submerged, indeterminate	Previous Rainfall (hrs): 72+																																											
Illicit Discharge Potential: Potential		Inspector: JCW	Notes Ammonia detection follow-up. Limited screening conducted.																																												
Submerged: Partially Depth (in):																																															
Sampling Results <table border="1" style="width:100%; border-collapse: collapse;"> <tr> <td>Sample Location:</td> <td>Pool</td> <td>Floatables:</td> <td>None</td> </tr> <tr> <td>Total Chlorine:</td> <td>0 ppm</td> <td>Odor:</td> <td>None</td> </tr> <tr> <td>Free Chlorine:</td> <td>0 ppm</td> <td>Turbidity:</td> <td>None</td> </tr> <tr> <td>Ammonia:</td> <td>0 ppm</td> <td>Color:</td> <td>None</td> </tr> <tr> <td>pH:</td> <td>8.21 units</td> <td>Gross Solids:</td> <td>None</td> </tr> <tr> <td>Temperature</td> <td>72 °F</td> <td>Vegetation:</td> <td>None</td> </tr> <tr> <td>Conductivity:</td> <td>1088 µS/cm</td> <td>Benthic Growth:</td> <td>None</td> </tr> <tr> <td>Detergents:</td> <td>0 mg/L</td> <td>Stains:</td> <td>None</td> </tr> <tr> <td></td> <td></td> <td>Non-illicit:</td> <td>None</td> </tr> </table>		Sample Location:	Pool	Floatables:	None	Total Chlorine:	0 ppm	Odor:	None	Free Chlorine:	0 ppm	Turbidity:	None	Ammonia:	0 ppm	Color:	None	pH:	8.21 units	Gross Solids:	None	Temperature	72 °F	Vegetation:	None	Conductivity:	1088 µS/cm	Benthic Growth:	None	Detergents:	0 mg/L	Stains:	None			Non-illicit:	None	Condition Assessment <table border="1" style="width:100%; border-collapse: collapse;"> <tr> <td>Graffiti:</td> <td>None</td> </tr> <tr> <td>Erosion:</td> <td>None</td> </tr> <tr> <td>Deposition:</td> <td>None in.</td> </tr> <tr> <td>Damage:</td> <td>None</td> </tr> </table>		Graffiti:	None	Erosion:	None	Deposition:	None in.	Damage:	None

Sample Location:	Pool	Floatables:	None																																												
Total Chlorine:	0 ppm	Odor:	None																																												
Free Chlorine:	0 ppm	Turbidity:	None																																												
Ammonia:	0 ppm	Color:	None																																												
pH:	8.21 units	Gross Solids:	None																																												
Temperature	72 °F	Vegetation:	None																																												
Conductivity:	1088 µS/cm	Benthic Growth:	None																																												
Detergents:	0 mg/L	Stains:	None																																												
		Non-illicit:	None																																												
Graffiti:	None																																														
Erosion:	None																																														
Deposition:	None in.																																														
Damage:	None

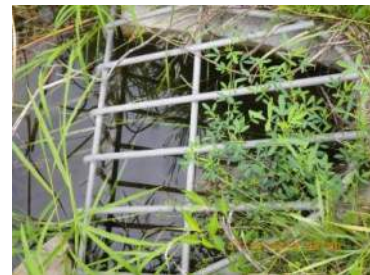
o20130730085048.JPG

Inspection Date: 7/30/2013 9:47:56 AM		Type: Ongoing	Flow: Submerged, indeterminate	Previous Rainfall (hrs): 72+
Illicit Discharge Potential: Unlikely		Inspector: JCW		
Submerged: Partially		Depth (in): 5		
Sampling Results		Notes No upstream screening point - sample collected from outfall pool.		
Sample Location: Pool	Floatables: None	Condition Assessment Graffiti: None Erosion: None Deposition: None in. Damage: None		
Total Chlorine: 0 ppm	Odor: None			
Free Chlorine: 0 ppm	Turbidity: None			
Ammonia: 0 ppm	Color: None			
pH: 8.46 units	Gross Solids: None			
Temperature 72 °F	Vegetation: None			
Conductivity: 804 µS/cm	Benthic Growth: Moderate			
Detergents: 0 mg/L	Stains: Slight			
	Non-illicit: None
