Ongoing Screening Summary Report 2019 Inspection Year

Illicit Discharge Detection and Elimination Program

City of Oshkosh

January 3, 2020

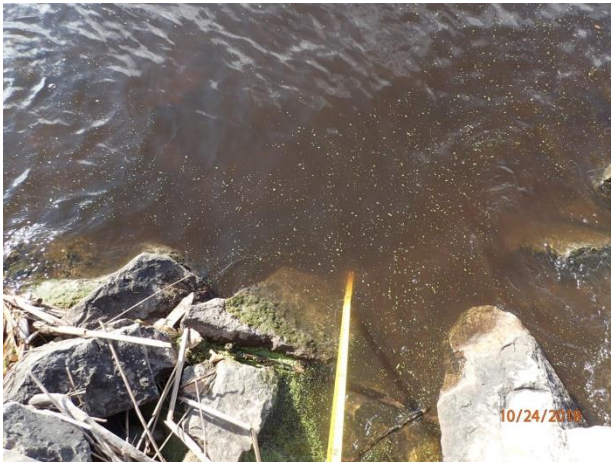
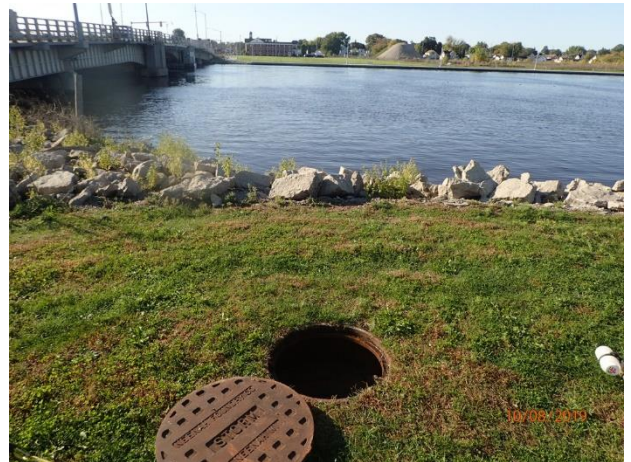
Outfall 01-520 (Jackson Street)

Outfall 01-520 consists of a 54-inch reinforced concrete pipe (RCP) that discharges to the Fox River, just west of the Jackson Street bridge. Because the outfall is typically fully submerged, it is screened at the upstream manhole (01-520 US1) located approximately 25 feet upstream of the outfall.

This outfall is classified as a Priority Outfall due to the persistent floating gross solids in the upstream manhole.

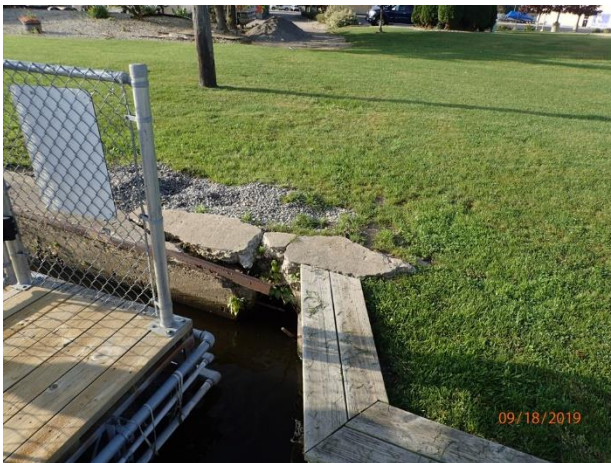
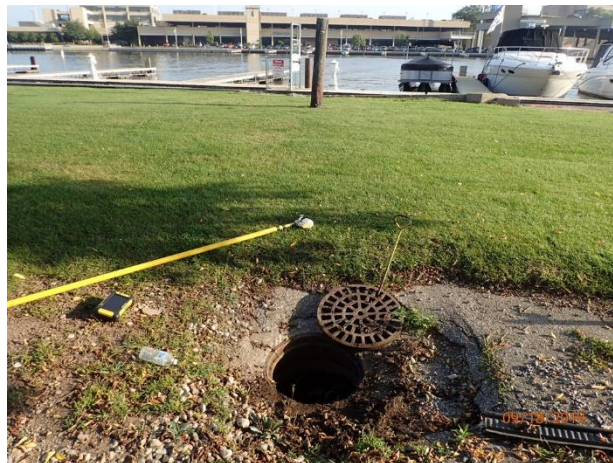
Outfall 03-22 (Nebraska Street)

Outfall 03-22 consists of a 36x58-inch RCP that discharges to the Fox River at the north end of Nebraska Street. Because the outfall is fully submerged and has not been located, it is screened at the upstream manhole (03-22 US1) located approximately 55 feet upstream of the outfall.

This outfall is classified as a Priority Outfall due to the persistent floating gross solids in the upstream manhole.

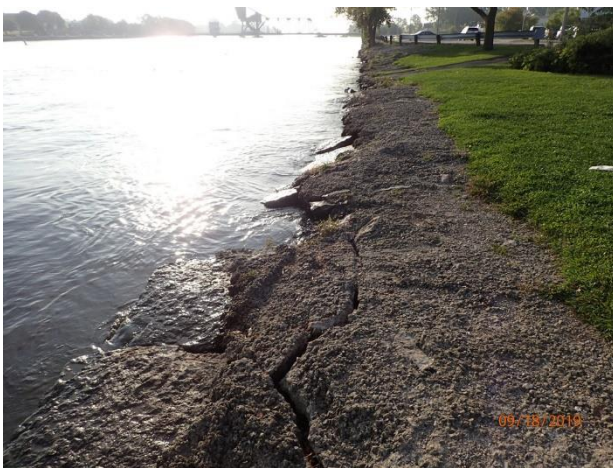
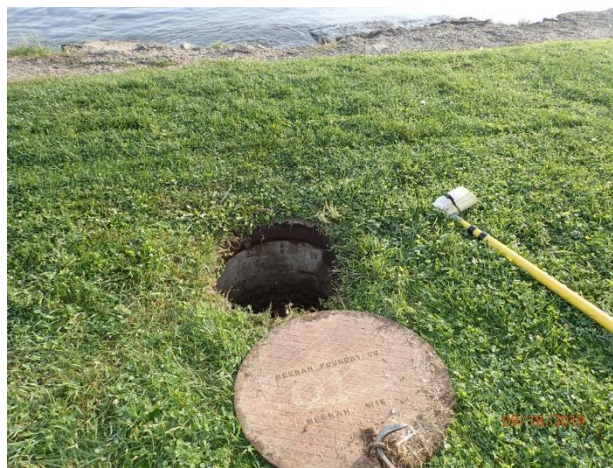
Outfall 03-35 (Pioneer Drive)

Outfall 03-35 consists of a 30-inch RCP that discharges to the Fox River immediately east of the Main Street bridge. Because the outfall is fully submerged and has not been located, it is screened at the upstream manhole (03-35 US1) located approximately 20 feet upstream of the outfall.

This outfall is classified as a Priority Outfall due to the persistent floating gross solids in the upstream manhole.

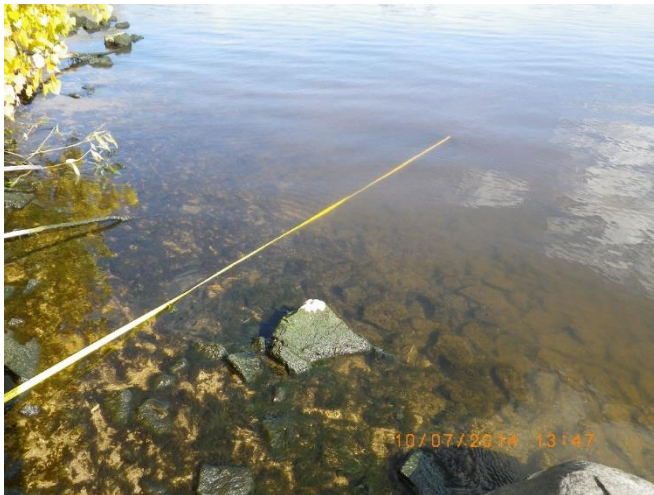
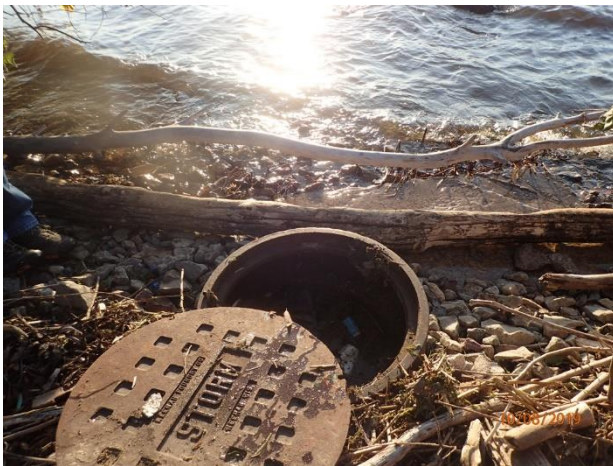
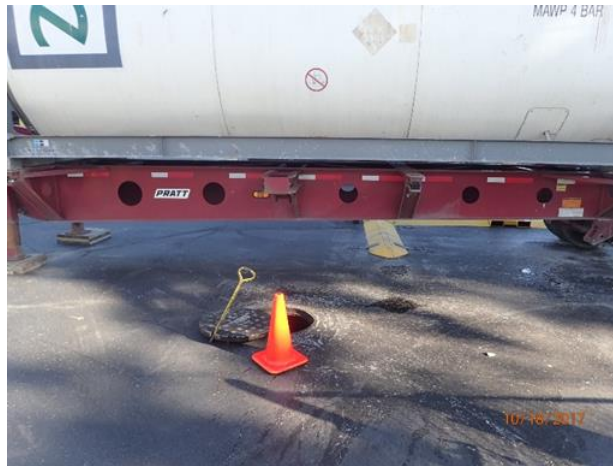
Outfall 03-173 (Blended Waxes)

Outfall 03-173 consists of a 36-inch reinforced concrete pipe (RCP) that discharges to Lake Winnebago. The outfall is fully submerged, and the pipe is only visible in calm conditions.

Floating gross solids were observed in the upstream manhole(s) in 2010, 2011, 2014, 2015-2018, and the outfall was listed as a potential illicit discharge for this reason. During the 2017 screening, wax stains were observed on the pavement around manhole 03-173 US2, which also contributed to the potential illicit discharge status that year.

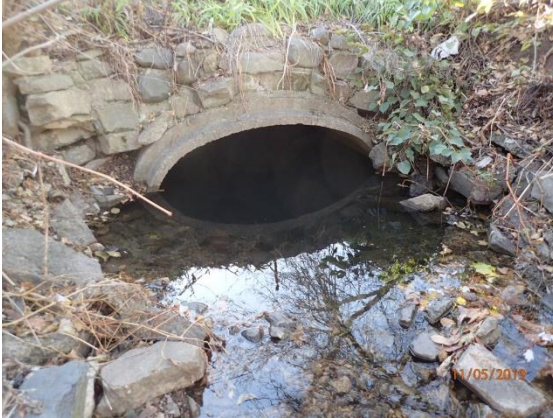
Figure 22 - Outfall 13-471 (2019)

The pH values ranged from 6.91 to 9.27. One sample (13-471) was outside of the 6.0-9.0 normal range. Because this outfall also had a detergent detection in the follow-up sample, it was classified as a potential illicit discharge.

Outfall 13-471 consists of a 48x76-inch elliptical concrete pipe that discharges to a channel north of W. 9th Avenue. After flowing approximately 400 feet, the channel enters the large metal box culvert that flows north to Witzel Avenue and discharges east of Lourdes High School.

Detergent was detected at the outfall during the 2018 screening. As a result, it was scheduled to be rescreened in 2019.

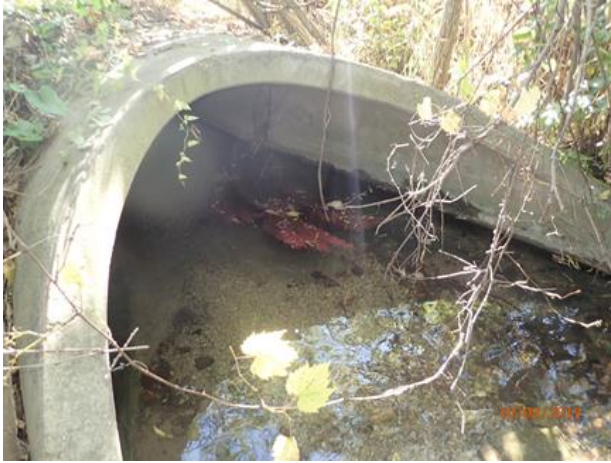
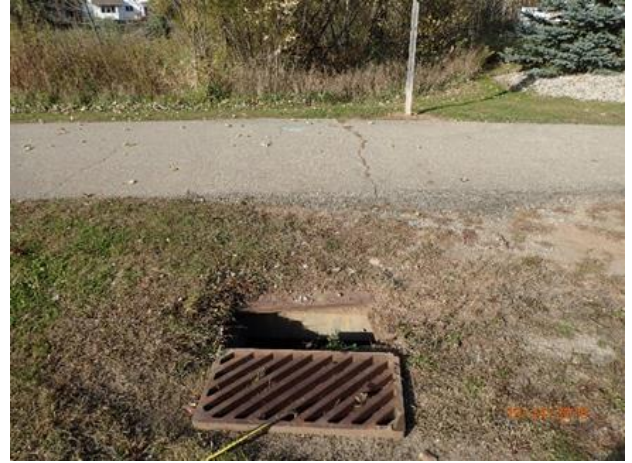
Outfall 13-2332 (Fox Tail Ln)

Outfall 13-2332 consists of a 33x60-inch elliptical concrete pipe that discharges to a channel north of Fox Tail Lane, near Traeger Middle School. Because the outfall is typically partially submerged, it is screened at the upstream catchbasin (13-2332 US1) located approximately 30 feet upstream of the outfall.

Detergent was detected at the outfall during the 2018 screening. As a result, it was scheduled to be rescreened in 2019.

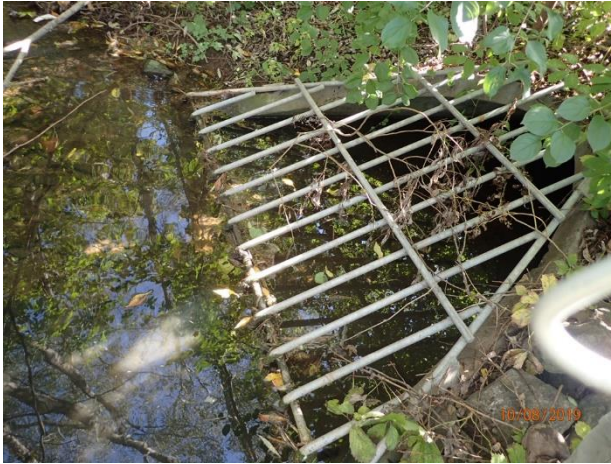
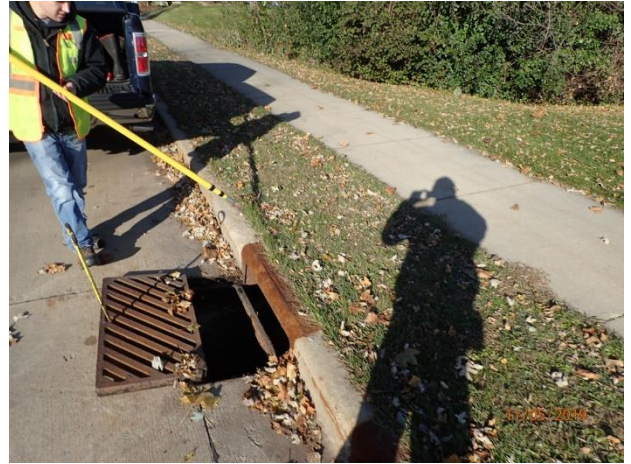
Figure 25 – Outfall 13-2736 (2019)

Outfall 13-2736 consists of a 29x45-inch RCP that discharges into Sawyer Creek on the east side of S. Oakwood Road. The drainage basin for the storm sewer is primarily a residential area along Homestead Drive. The storm sewer may also receive the discharge from outfalls 13-3097 and 13-3099, near Pheasant Creek Drive. The outfall is typically partially submerged, so screening is conducted at an upstream location. The first upstream manhole is located in the center of S. Oakwood Road. Due to the heavy traffic on the street, the screening was conducted at the curb

During the 10/8/2019 screening, detergent was detected in the upstream curb inlet (1.1 mg/L). The outfall was rescreened on 11/5/2019, and the sample from the curb inlet had a detergent concentration of 1.3 mg/L. An additional sample was collected from a manhole near the middle of Homestead Drive, which showed no detergent.

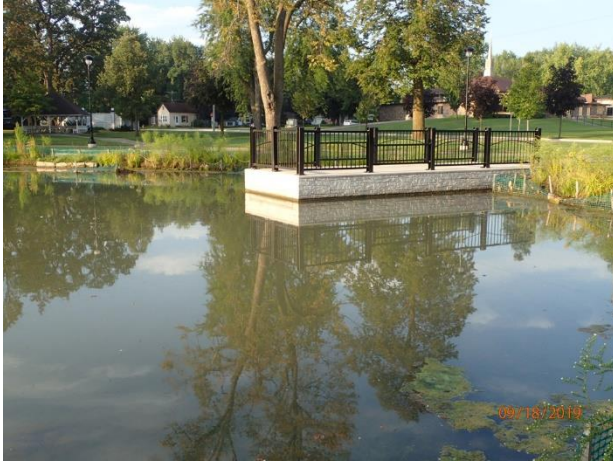
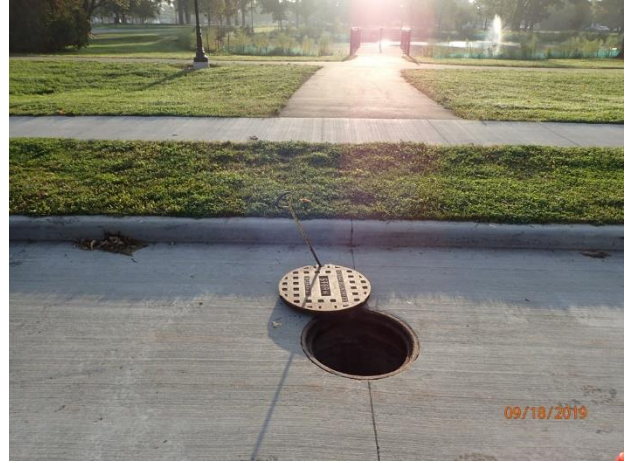
Outfall 13-2957 (South Park)

Outfall 13-2957 consists of a 36x60-inch concrete box culvert that discharges to the west end of the west pond in South Park. The outfall was reconstructed prior to the 2018 field screening and incorporated several of the adjacent outfalls on the pond. Because the outfall is typically partially- or fully-submerged, it is screened at the first upstream manhole, located in Georgia Street.

During the 9/18/2019 screening, detergent was detected in the upstream manhole (0.75 mg/L). The outfall was rescreened on 10/8/2019, and detergent was not detected. The outfall was rescreened on 11/5/2019, and detergent was once again detected in the upstream manhole (0.6 mg/L). Samples from Osborn Avenue and South Park Avenue showed trace or no detergent (see Appendix D for locations and results).

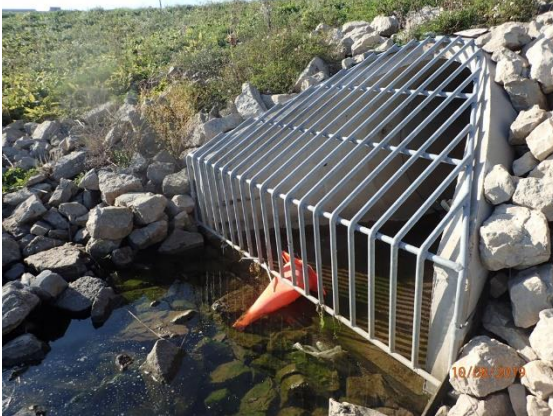
Figure 29 - Outfall 13-3774 (2019)

Outfall 13-3774 consists of a 66-inch RCP that discharges to the west side of the Armory pond, near the end of Menard Drive. The drainage area for this outfall consists primarily of the commercial area east of S. Koeller Street, between 9th Street and 2th Street.

Detergent was detected at the outfall during the 2018 screening. The flow was traced upstream, but no definitive source was identified. Because the outfall is a Priority Outfall, it was automatically scheduled for screening in 2019.

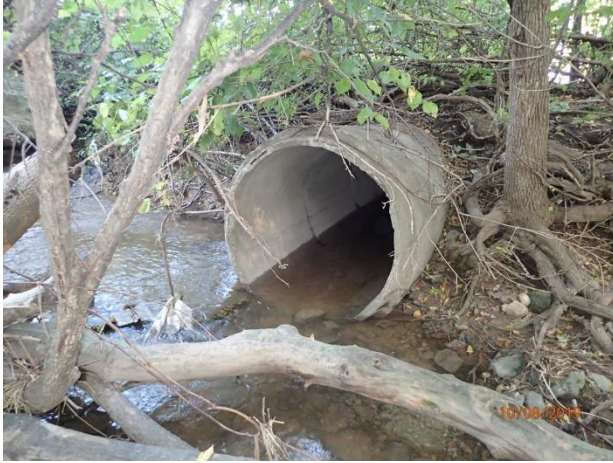
Figure 32 – Outfall 14-999 (2019)

During the 10/8/2019 screening, detergent was detected in the flow from the outfall (1.0 mg/L). The outfall was rescreened on 11/5/2019, and no detergent was detected. Additional screenings were conducted at upstream locations (see Appendix D for locations and results).

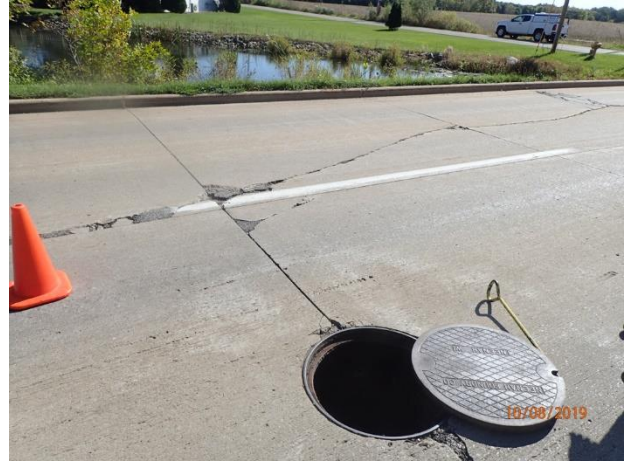
Figure 34 – Upstream manhole 15-2243 US1 (2019)

During the 10/8/2019 screening, the outfall was fully submerged and not located. Detergent was detected in the upstream manhole (1.0 mg/L). The outfall was rescreened on 11/5/2019, and the sample from the manhole had a detergent concentration of 0.6 mg/L. Additional samples were collected from other upstream manholes (see Appendix D for locations and results).

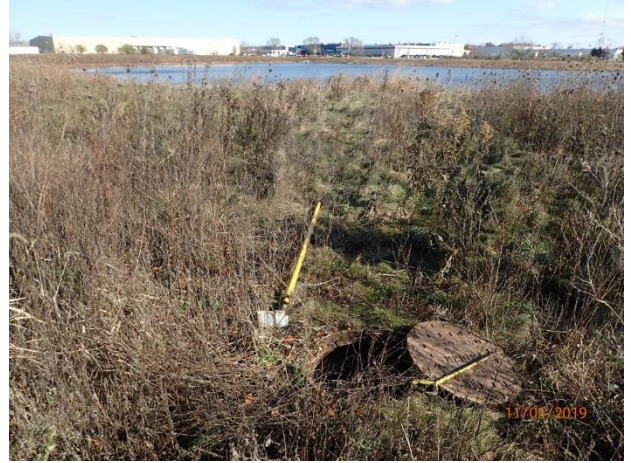
Figure 36 – Upstream manhole 15-3211 US1 (2019)

During the 11/5/2019 screening, the outfall was partially submerged. Detergent was detected in the upstream manhole (0.4 mg/L). No additional upstream sampling was conducted at that time.

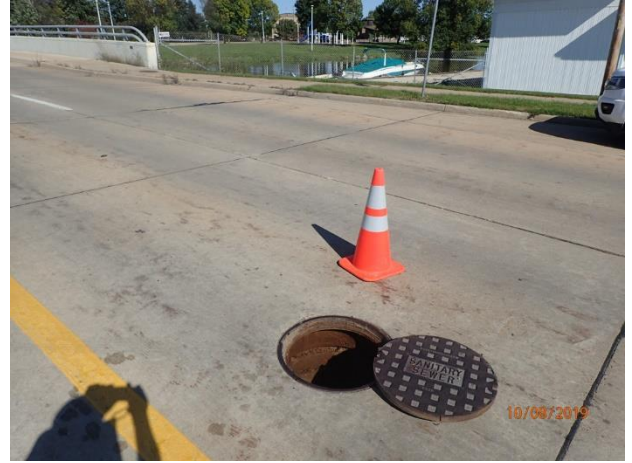
Figure 38 – Upstream manhole 16-533 US1 (2019)

During the 10/8/2019 screening, the outfall was fully submerged and not located. Detergent was detected in the upstream manhole (0.5 mg/L). The outfall was rescreened on 11/5/2019, and no detergent was detected in the sample from the manhole. Additional screenings were conducted at other upstream manholes (see Appendix D for locations and results).

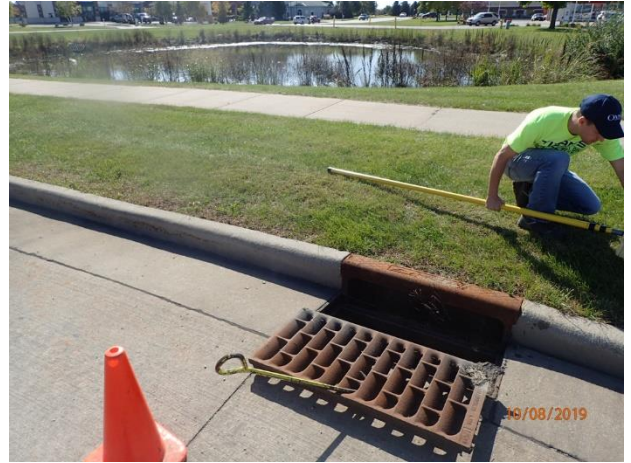
Figure 45 – Upstream curb inlet 16-1205 US1 (2019)

During the 2018 screening, a sample collected from the sump of the curb inlet had a detergent concentration of 0.5 mg/L. No water was leaving the curb inlet through the outlet pipe.

During the 2019 screening, the same condition was observed – water was present in the sump, but no water was leaving through the outlet pipe. A sample collected from the sump had a detergent concentration of 0.6 mg/L. Because the curb inlet is the only storm sewer component in the drainage basin, no additional tracking was possible.

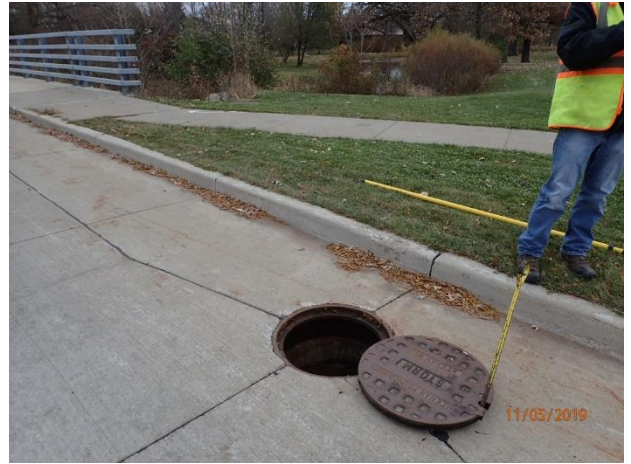
Figure 47 – Upstream manhole 16-1508 US1 (2019)

During the 10/8/2019 screening, detergent (0.6 mg/L) and ammonia (1 ppm) were detected in the upstream manhole. The outfall was rescreened on 11/5/2019, and the sample from the manhole had a detergent concentration of 0.5 mg/L and an ammonia concentration of 1 ppm. Additional samples were collected from upstream manholes (see Appendix D for locations and results).

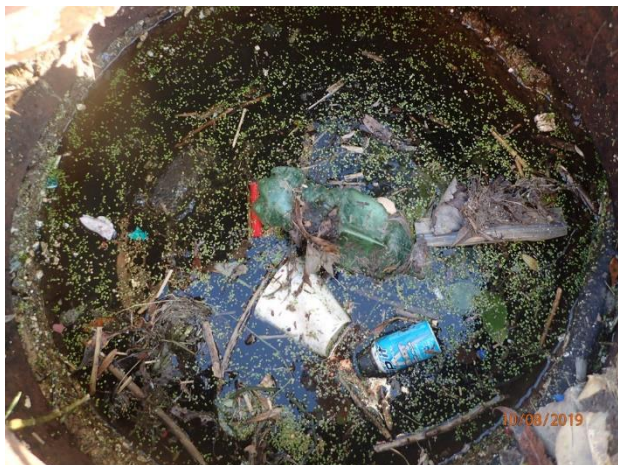
Figure 53 – Minor deposition in manhole 03-173 US1

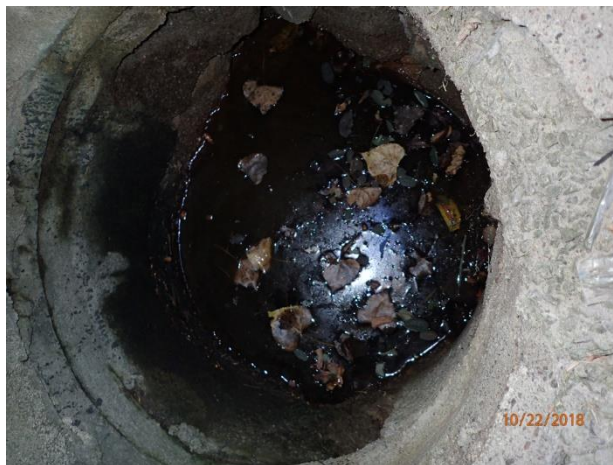
Figure 54 – Moderate deposition in manhole 03-381 US1

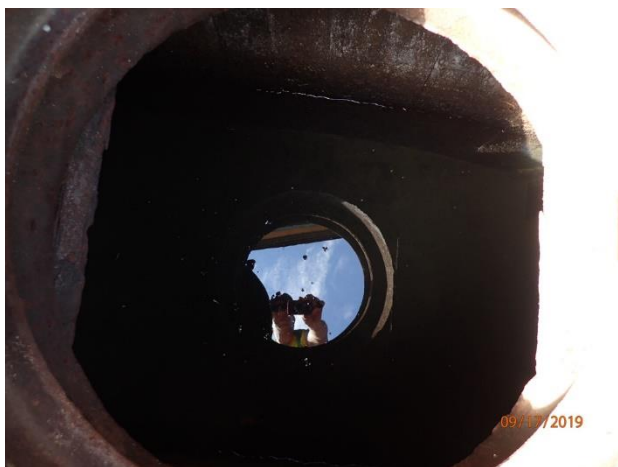
Figure 55 – Minor deposition in manhole 11-225 US2

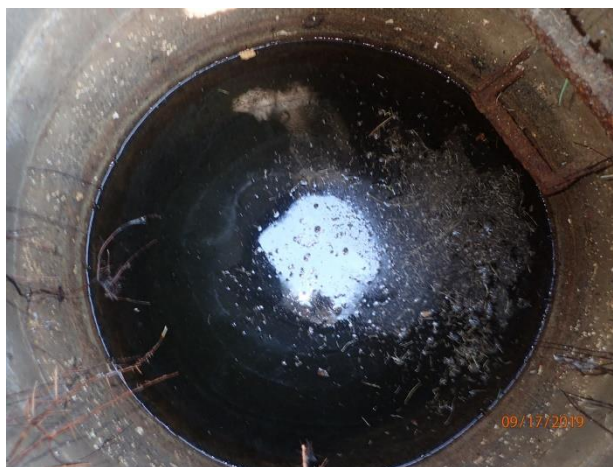
Figure 56 – Moderate deposition in manhole 11-71 US1

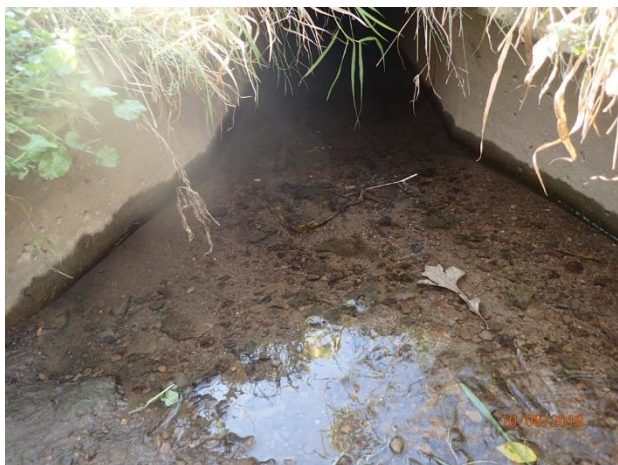
Figure 57 – Minor deposition at outfall 13-1758

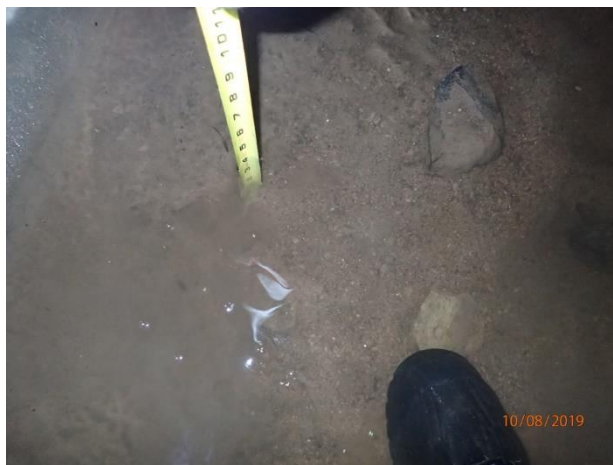
Figure 58 – Minor deposition at outfall 14-999

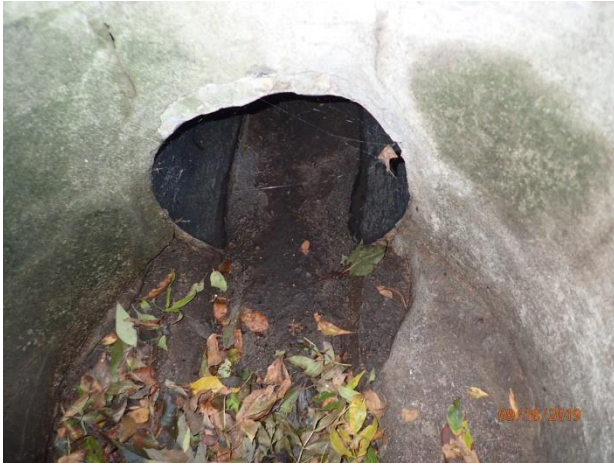
Figure 59 – Minor deposition in manhole 15-1137 US1

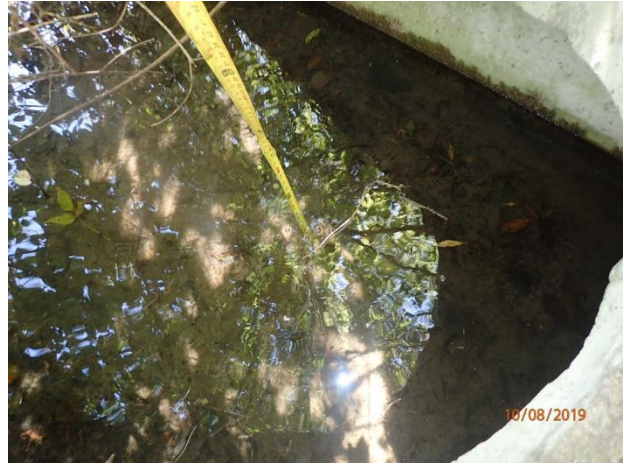
Figure 60 – Minor deposition at outfall 15-2108

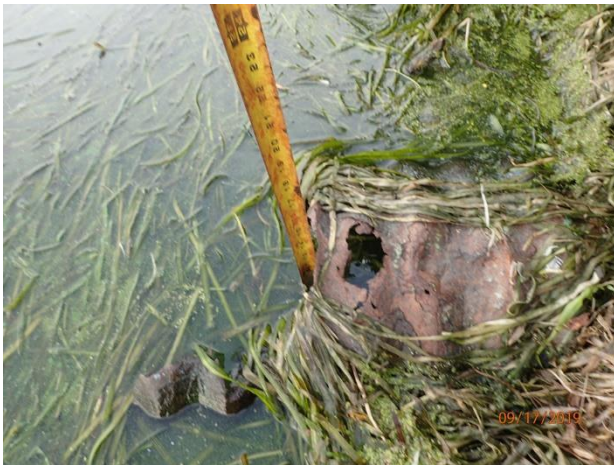
Figure 61 – Minor deposition at outfall 15-690

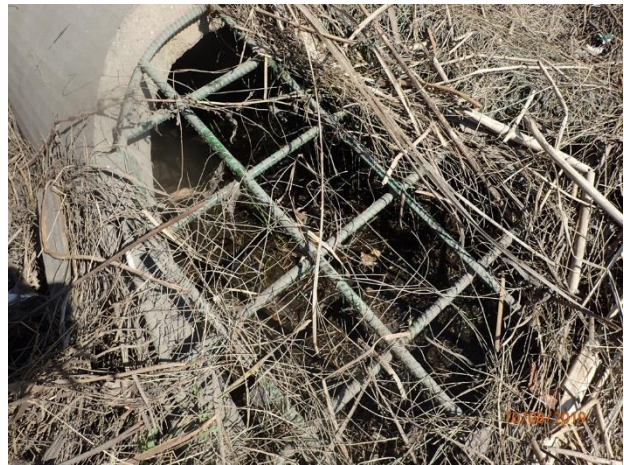
Figure 62 – Minor deposition at outfall 16-1205

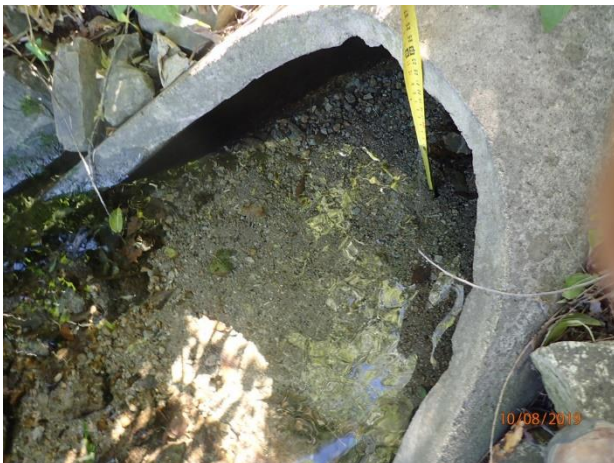
Figure 63 – Minor deposition at outfall 16-660

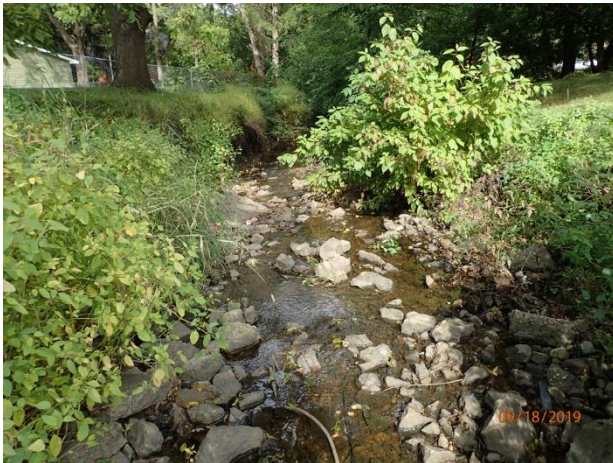
Outfall	Severity	Description
13-471	Severe	Bank erosion downstream from pipe.

Figure 64 – Bank erosion downstream of outfall 13-471

One of the outfalls showed signs of erosion at the end of the outfall pipe or channel. Most of the outfalls with minor erosion could be repaired with minor landscaping repairs. Those outfalls

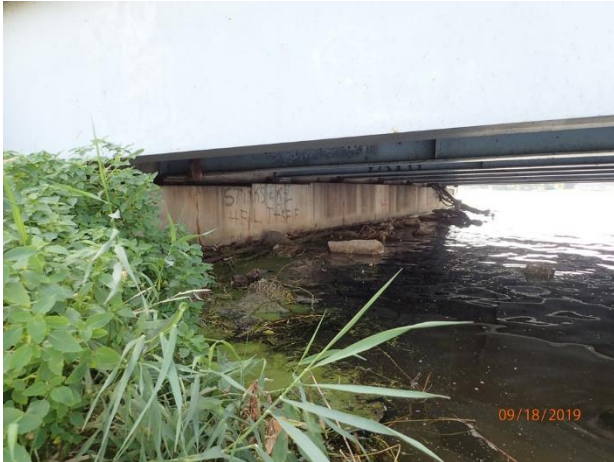
Graffiti was observed in or around one outfall. The graffiti was not severe but should probably be monitored to make sure that it does not become more severe.

Outfall	Severity	Description
12-569	Moderate	Graffiti on bridge abutment adjacent to outfall.

Figure 65 – Graffiti near outfall 12-569

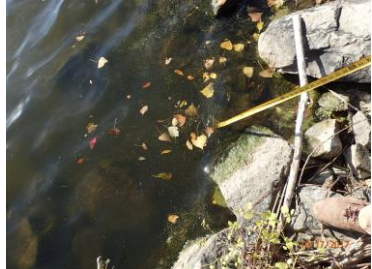
o20171017151448.JPG <div style="text-align: center; font-size: 24pt; font-weight: bold;">2017</div>

Inspection Date: 10/17/2017 3:18:17 PM		Type: Ongoing	Flow: Submerged, indeterminate	Previous Rainfall (hrs): 48-72
Illicit Discharge Potential: Potential		Inspector: JCW		
Submerged: Fully		Depth (in): 39		
Sampling Results Sample Location: Total Chlorine: -- ppm Free Chlorine: -- ppm Ammonia: -- ppm pH: -- units Temperature: -- °F Conductivity: -- µS/cm Detergents: -- mg/L		Floatables: None Odor: None Turbidity: None Color: None Gross Solids: None Vegetation: None Benthic Growth: None Stains: None Non-illicit: None	Notes Outfall fully submerged - screened upstream at 01-520 US1. Floating gross solids (litter) in manhole. Condition Assessment Graffiti: None Erosion: None Deposition: None in. Damage: None

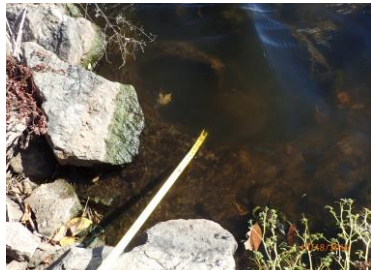
o20161018153652.JPG <div style="text-align: center; font-size: 24pt; font-weight: bold;">2016</div>

Inspection Date: 10/18/2016 3:38:45 PM		Type: Ongoing	Flow: Submerged, indeterminate	Previous Rainfall (hrs): 72+
Illicit Discharge Potential: Potential		Inspector: JCW		
Submerged: Fully		Depth (in): 33		
Sampling Results Sample Location: Total Chlorine: -- ppm Free Chlorine: -- ppm Ammonia: -- ppm pH: -- units Temperature: -- °F Conductivity: -- µS/cm Detergents: -- mg/L		Floatables: None Odor: None Turbidity: None Color: None Gross Solids: None Vegetation: None Benthic Growth: Severe Stains: None Non-illicit: None	Notes Outfall fully submerged - screened upstream at 01-520 US1. Condition Assessment Graffiti: None Erosion: None Deposition: None in. Damage: None

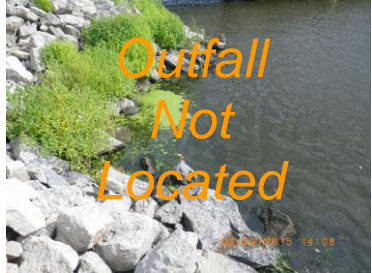
o20150922130830.JPG

Inspection Date: 9/22/2015 2:05:49 PM		Type: Ongoing	Flow: Submerged (not located)	Previous Rainfall (hrs): 72+
Illicit Discharge Potential: Potential		Inspector: JCW	Notes	
Submerged: Fully		Depth (in):	Outfall fully submerged and not located during this screening - screened at 01-520 US1.	
Sampling Results		Floatables:	Condition Assessment	
Sample Location:		None	Graffiti: None	
Total Chlorine: -- ppm		None	Erosion: None	
Free Chlorine: -- ppm		None	Deposition: None in.	
Ammonia: -- ppm		None	Damage: None	
pH: -- units		None		
Temperature -- °F		None		
Conductivity: -- µS/cm		None		
Detergents: -- mg/L		None

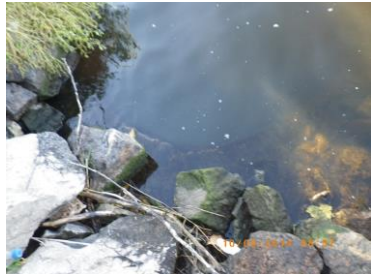
o20141009073704.JPG

Inspection Date: 10/9/2014 8:38:02 AM		Type: Ongoing	Flow: Submerged, indeterminate	Previous Rainfall (hrs): 72+
Illicit Discharge Potential: Potential		Inspector: JCW	Notes	
Submerged: Fully		Depth (in): 56	Outfall fully submerged - screened upstream at 01-520 US1.	
Sampling Results		Floatables:	Condition Assessment	
Sample Location:		None	Graffiti: None	
Total Chlorine: -- ppm		None	Erosion: None	
Free Chlorine: -- ppm		None	Deposition: None in.	
Ammonia: -- ppm		None	Damage: None	
pH: -- units		None		
Temperature -- °F		Moderate		
Conductivity: -- µS/cm		None		
Detergents: -- mg/L		None

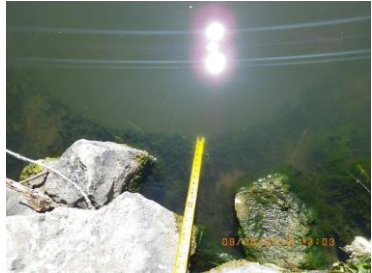
o20130905120336.JPG

Inspection Date: 9/5/2013 12:59:39 PM		Type: Ongoing	Flow: Submerged, indeterminate	Previous Rainfall (hrs): 72+
Illicit Discharge Potential: Potential		Inspector: JCW	Notes	
Submerged: Fully		Depth (in): 49	Outfall fully submerged. Outfall screened upstream at 01-520 US1. 2012 screening follow-up. Gross solids in upstream mh.	
Sampling Results		Floatables:	Condition Assessment	
Sample Location:		None	Graffiti: None	
Total Chlorine: -- ppm		None	Erosion: None	
Free Chlorine: -- ppm		None	Deposition: None in.	
Ammonia: -- ppm		None	Damage: None	
pH: -- units		None		
Temperature -- °F		Moderate		
Conductivity: -- µS/cm		None		
Detergents: -- mg/L		None

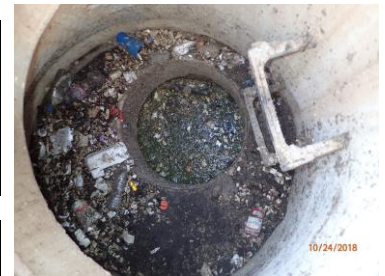
o20181024110538.JPG

Inspection Date: 10/24/2018 11:07:34 AM		Type: Ongoing	Flow: Submerged, indeterminate	Previous Rainfall (hrs): 72+
Illicit Discharge Potential: Potential		Inspector: JCW		
Submerged: Partially		Depth (in): 70		
Sampling Results		Notes Sample collected from submerged pool in manhole. Floating gross solids (litter) in manhole.		
Sample Location: Pool	Floatables: None	Condition Assessment Graffiti: None Erosion: None Deposition: None in. Damage: None		
Total Chlorine: 0 ppm	Odor: None			
Free Chlorine: 0 ppm	Turbidity: None			
Ammonia: 0 ppm	Color: None			
pH: 8.02 units	Gross Solids: Severe			
Temperature 49 °F	Vegetation: None			
Conductivity: 336 µS/cm	Benthic Growth: None			
Detergents: 0 mg/L	Stains: None			
	Non-illicit: None

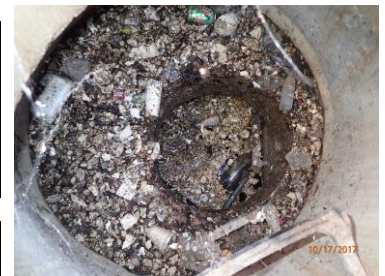
o20171017151640.JPG

Inspection Date: 10/17/2017 3:21:22 PM		Type: Ongoing	Flow: Submerged, indeterminate	Previous Rainfall (hrs): 48-72
Illicit Discharge Potential: Potential		Inspector: JCW		
Submerged: Fully		Depth (in): 67		
Sampling Results		Notes Sample collected from submerged pool in manhole. Floating gross solids (litter) in manhole.		
Sample Location: Pool	Floatables: None	Condition Assessment Graffiti: None Erosion: None Deposition: None in. Damage: None		
Total Chlorine: 0 ppm	Odor: None			
Free Chlorine: 0 ppm	Turbidity: None			
Ammonia: 0 ppm	Color: None			
pH: 7.72 units	Gross Solids: Severe			
Temperature 67 °F	Vegetation: None			
Conductivity: 896 µS/cm	Benthic Growth: None			
Detergents: 0 mg/L	Stains: None			
	Non-illicit: None

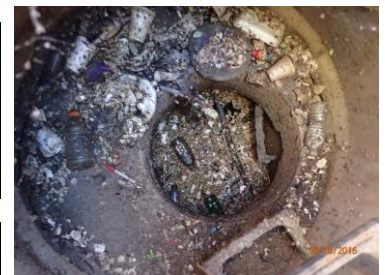
o20161018153916.JPG

Inspection Date: 10/18/2016 3:42:40 PM		Type: Ongoing	Flow: Submerged, indeterminate	Previous Rainfall (hrs): 72+
Illicit Discharge Potential: Potential		Inspector: JCW		
Submerged: Fully		Depth (in): 67		
Sampling Results		Notes Potential illicit discharge due to gross solids.		
Sample Location: Pool	Floatables: None	Condition Assessment Graffiti: None Erosion: None Deposition: None in. Damage: None		
Total Chlorine: 0 ppm	Odor: None			
Free Chlorine: 0 ppm	Turbidity: None			
Ammonia: 0 ppm	Color: Faint in bottle			
pH: 8.16 units	Gross Solids: Severe			
Temperature 66 °F	Vegetation: None			
Conductivity: 531 µS/cm	Benthic Growth: None			
Detergents: 0 mg/L	Stains: None			
	Non-illicit: None

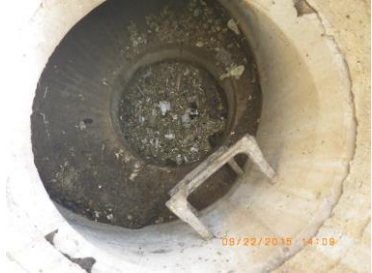
o20150922130946.JPG

Inspection Date: 9/22/2015 2:08:37 PM		Type: Ongoing	Flow: Submerged, indeterminate	Previous Rainfall (hrs): 72+
Illicit Discharge Potential: Potential		Inspector: JCW	Notes	
Submerged: Fully		Depth (in): 70	Floating gross solids (litter) in manhole.	
Sampling Results				
Sample Location:	Pool	Floatables:	None	
Total Chlorine:	0 ppm	Odor:	None	
Free Chlorine:	0 ppm	Turbidity:	None	
Ammonia:	0 ppm	Color:	None	
pH:	8.1 units	Gross Solids:	Severe	
Temperature	76 °F	Vegetation:	None	
Conductivity:	917 µS/cm	Benthic Growth:	None	
Detergents:	0 mg/L	Stains:	None	
		Non-illicit:	None	
			Condition Assessment	
			Graffiti:	None
			Erosion:	None
			Deposition:	None in.
			Damage:	None

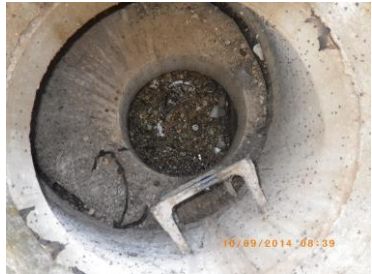
o20141009073910.JPG

Inspection Date: 10/9/2014 8:42:09 AM		Type: Ongoing	Flow: Submerged, indeterminate	Previous Rainfall (hrs): 72+
Illicit Discharge Potential: Potential		Inspector: JCW	Notes	
Submerged: Fully		Depth (in): 64	Floating gross solids (litter) inside manhole.	
Sampling Results				
Sample Location:	Pool	Floatables:	None	
Total Chlorine:	0 ppm	Odor:	Faint	
Free Chlorine:	0 ppm	Turbidity:	None	
Ammonia:	0 ppm	Color:	None	
pH:	7.84 units	Gross Solids:	Severe	
Temperature	57 °F	Vegetation:	None	
Conductivity:	1318 µS/cm	Benthic Growth:	Slight	
Detergents:	0 mg/L	Stains:	None	
		Non-illicit:	None	
			Condition Assessment	
			Graffiti:	None
			Erosion:	None
			Deposition:	None in.
			Damage:	None

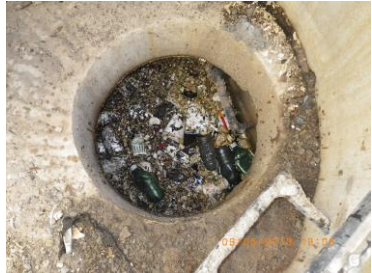
o20130905120924.JPG

Inspection Date: 9/5/2013 1:02:45 PM		Type: Ongoing	Flow: Submerged, indeterminate	Previous Rainfall (hrs): 72+
Illicit Discharge Potential: Potential		Inspector: JCW	Notes	
Submerged: Fully		Depth (in): 69	2012 screening follow-up. Significant gross solids in manhole - similar to previous years.	
Sampling Results				
Sample Location:	Pool	Floatables:	None	
Total Chlorine:	0 ppm	Odor:	None	
Free Chlorine:	0 ppm	Turbidity:	None	
Ammonia:	0 ppm	Color:	None	
pH:	8.51 units	Gross Solids:	Severe	
Temperature	76 °F	Vegetation:	None	
Conductivity:	424 µS/cm	Benthic Growth:	None	
Detergents:	0 mg/L	Stains:	None	
		Non-illicit:	None	
			Condition Assessment	
			Graffiti:	None
			Erosion:	None
			Deposition:	None in.
			Damage:	None

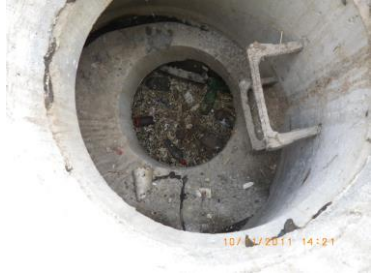
o20111011142110.JPG

Inspection Date: 10/11/2011 2:24:37 PM		Type: Ongoing	Flow: Submerged, indeterminate	Previous Rainfall (hrs): 72+
Illicit Discharge Potential: Potential		Inspector: JCW	Notes	
Submerged: Fully		Depth (in): 64	2010 screening follow-up. Floatable debris still present.	
Sampling Results				
Sample Location: Pool	Floatables:	None		
Total Chlorine: 0 ppm	Odor:	None		
Free Chlorine: 0 ppm	Turbidity:	None		
Ammonia: 0 ppm	Color:	None		
pH: 8.49 units	Gross Solids:	Severe		
Temperature 71 °F	Vegetation:	None		
Conductivity: -- µS/cm	Benthic Growth:	None		
Detergents: -- mg/L	Stains:	None		
	Non-illicit:	None		
			Condition Assessment	
			Graffiti:	None
			Erosion:	None
			Deposition:	None 0 in.
			Damage:	None

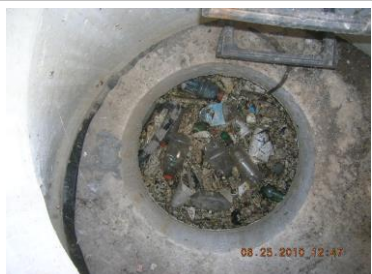
o20100825124708.JPG

Inspection Date: 8/25/2010 12:53:35 PM		Type: Ongoing	Flow: Submerged, indeterminate	Previous Rainfall (hrs): 72+
Illicit Discharge Potential: Potential		Inspector: JCW	Notes	
Submerged: Fully		Depth (in): 72	Significant floatable debris in manhole.	
Sampling Results				
Sample Location: Pool	Floatables:	None		
Total Chlorine: 0 ppm	Odor:	None		
Free Chlorine: 0 ppm	Turbidity:	None		
Ammonia: 0 ppm	Color:	Faint in bottle		
pH: 8.18 units	Gross Solids:	Severe		
Temperature 73 °F	Vegetation:	None		
Conductivity: -- µS/cm	Benthic Growth:	None		
Detergents: 0 mg/L	Stains:	None		
	Non-illicit:	None		
			Condition Assessment	
			Graffiti:	None
			Erosion:	None
			Deposition:	None 0 in.
			Damage:	None

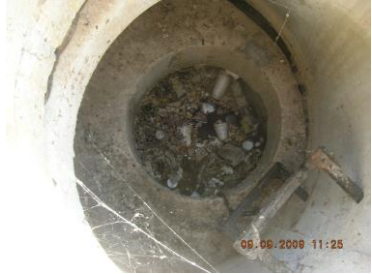
Inspection Date: 9/9/2009		Type: Initial		Flow: Submerged, indeterminate		Previous Rainfall (hrs): 72+	
Illicit Discharge Potential: Potential		Inspector: JCW		Notes Abnormal detergent analysis result (bubbles). Significant floatables in manhole. Brown color.

Submerged: Fully		Depth (in): 61					
Sampling Results		Floatables: None Odor: None Turbidity: None Color: Clearly visible in bottl Gross Solids: Severe Vegetation: None Benthic Growth: None Stains: None Non-illicit: None		Condition Assessment Graffiti: None Erosion: None Deposition: None 0 in. Damage: None		Osh09_DSCN6718.JPG 2009	
Sample Location: Pool Total Chlorine: 0 ppm Free Chlorine: 0 ppm Ammonia: -- ppm pH: 8.6 units Temperature: 78 °F Conductivity: -- µS/cm Detergents: 0 mg/L

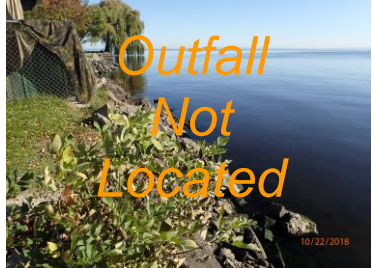
o20181022102328.JPG <div style="text-align: center; font-size: 24pt; font-weight: bold;">2018</div>

Inspection Date: 10/22/2018 10:23:45 AM		Type: Ongoing	Flow: Submerged (not located)	Previous Rainfall (hrs): 48-72
Illicit Discharge Potential: Potential		Inspector: JCW		
Submerged: Fully		Depth (in):		
Sampling Results Sample Location: _____ Total Chlorine: -- ppm Free Chlorine: -- ppm Ammonia: -- ppm pH: -- units Temperature: -- °F Conductivity: -- µS/cm Detergents: -- mg/L		Floatables: None Odor: None Turbidity: None Color: None Gross Solids: None Vegetation: None Benthic Growth: None Stains: None Non-illicit: None		
		Notes Outfall fully submerged and not located - screened upstream at 02-309 US1. Floating gross solids (litter) in manhole.		
		Condition Assessment Graffiti: None Erosion: None Deposition: None in. Damage: None

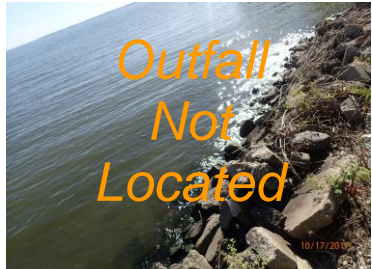
o20171017133948.JPG <div style="text-align: center; font-size: 24pt; font-weight: bold;">2017</div>

Inspection Date: 10/17/2017 1:41:46 PM		Type: Ongoing	Flow: Submerged (not located)	Previous Rainfall (hrs): 48-72
Illicit Discharge Potential: Potential		Inspector: JCW		
Submerged: Fully		Depth (in):		
Sampling Results Sample Location: _____ Total Chlorine: -- ppm Free Chlorine: -- ppm Ammonia: -- ppm pH: -- units Temperature: -- °F Conductivity: -- µS/cm Detergents: -- mg/L		Floatables: None Odor: None Turbidity: None Color: None Gross Solids: None Vegetation: None Benthic Growth: None Stains: None Non-illicit: None		
		Notes Outfall fully submerged and not located - screened upstream at 02-309 US1. Floating gross solids (litter) in manhole.		
		Condition Assessment Graffiti: None Erosion: None Deposition: None in. Damage: None

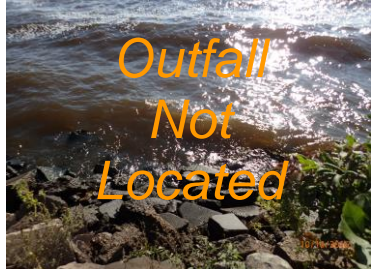
o20161010102916.JPG <div style="text-align: center; font-size: 24pt; font-weight: bold;">2016</div>

Inspection Date: 10/10/2016 10:29:27 AM		Type: Ongoing	Flow: Submerged (not located)	Previous Rainfall (hrs): 72+
Illicit Discharge Potential: Potential		Inspector: JCW		
Submerged: Fully		Depth (in):		
Sampling Results Sample Location: _____ Total Chlorine: -- ppm Free Chlorine: -- ppm Ammonia: -- ppm pH: -- units Temperature: -- °F Conductivity: -- µS/cm Detergents: -- mg/L		Floatables: None Odor: None Turbidity: None Color: None Gross Solids: None Vegetation: None Benthic Growth: None Stains: None Non-illicit: None		
		Notes Outfall fully submerged and not located - screened upstream at 02-309 US1.		
		Condition Assessment Graffiti: None Erosion: None Deposition: None in. Damage: None

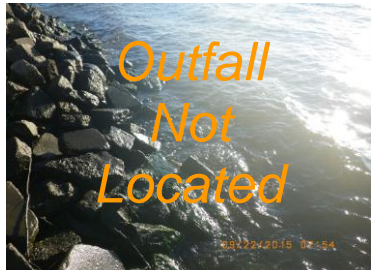
o20150922065432.JPG <div style="text-align: center; font-size: 24pt; font-weight: bold;">2015</div>

Inspection Date: 9/22/2015 7:50:13 AM		Type: Ongoing	Flow: Submerged (not located)	Previous Rainfall (hrs): 72+
Illicit Discharge Potential: Potential		Inspector: JCW		
Submerged: Fully		Depth (in):		
Sampling Results Sample Location: _____ Total Chlorine: -- ppm Free Chlorine: -- ppm Ammonia: -- ppm pH: -- units Temperature: -- °F Conductivity: -- µS/cm Detergents: -- mg/L		Floatables: None Odor: None Turbidity: None Color: None Gross Solids: None Vegetation: None Benthic Growth: None Stains: None Non-illicit: None		
		Notes Outfall fully submerged and not physically located - screened upstream at 02-309 US1.		
		Condition Assessment Graffiti: None Erosion: None Deposition: None in. Damage: None

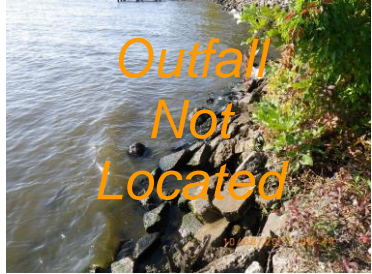
o20111003094448.JPG

Sample Location:	Floatables:	Total Chlorine: -- ppm	Odor:	Free Chlorine: -- ppm	Turbidity:	Ammonia: -- ppm	Color:	pH: -- units	Gross Solids:	Temperature -- °F	Vegetation:	Conductivity: -- µS/cm	Benthic Growth:	Detergents: -- mg/L	Stains:		Non-illicit:	Notes Outfall fully submerged and not physically located. Outfall screened upstream at 02-309 US1.		
Sample Location:	Floatables:																					
Total Chlorine: -- ppm	Odor:																					
Free Chlorine: -- ppm	Turbidity:																					
Ammonia: -- ppm	Color:																					
pH: -- units	Gross Solids:																					
Temperature -- °F	Vegetation:																					
Conductivity: -- µS/cm	Benthic Growth:																					
Detergents: -- mg/L	Stains:																					
	Non-illicit:																					
		Condition Assessment Graffiti: None Erosion: None Deposition: None 0 in. Damage: None

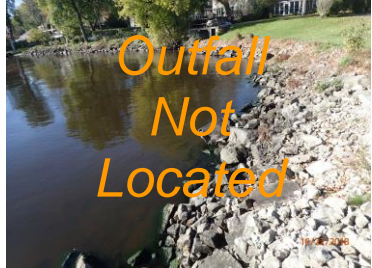
o20181022101158.JPG <div style="text-align: center; font-size: 24pt; font-weight: bold;">2018</div>

Inspection Date: 10/22/2018 10:13:07 AM		Type: Ongoing	Flow: Submerged (not located)	Previous Rainfall (hrs): 48-72
Illicit Discharge Potential: Potential		Inspector: JCW		
Submerged: Fully		Depth (in):		
Sampling Results Sample Location: _____ Total Chlorine: -- ppm Free Chlorine: -- ppm Ammonia: -- ppm pH: -- units Temperature: -- °F Conductivity: -- µS/cm Detergents: -- mg/L		Floatables: None Odor: None Turbidity: None Color: None Gross Solids: None Vegetation: None Benthic Growth: None Stains: None Non-illicit: None	Notes Outfall fully submerged and not located - screened upstream at 02-357 US1. Floating gross solids (litter) in manhole. Condition Assessment Graffiti: None Erosion: None Deposition: None in. Damage: None

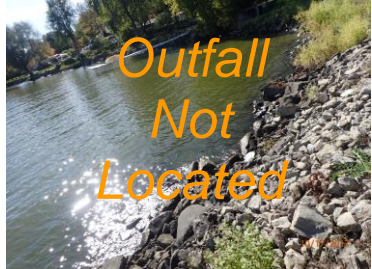
o20171017133026.JPG <div style="text-align: center; font-size: 24pt; font-weight: bold;">2017</div>

Inspection Date: 10/17/2017 1:32:28 PM		Type: Ongoing	Flow: Submerged (not located)	Previous Rainfall (hrs): 48-72
Illicit Discharge Potential: Potential		Inspector: JCW		
Submerged: Fully		Depth (in):		
Sampling Results Sample Location: _____ Total Chlorine: -- ppm Free Chlorine: -- ppm Ammonia: -- ppm pH: -- units Temperature: -- °F Conductivity: -- µS/cm Detergents: -- mg/L		Floatables: None Odor: None Turbidity: None Color: None Gross Solids: None Vegetation: None Benthic Growth: None Stains: None Non-illicit: None	Notes Outfall fully submerged and not located - screened upstream at 02-357 US1. Floating gross solids (litter) in manhole. Condition Assessment Graffiti: None Erosion: None Deposition: None in. Damage: None

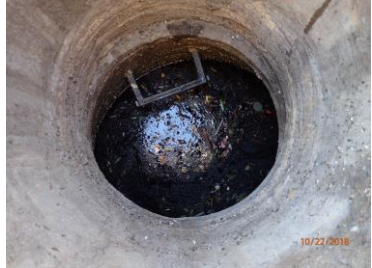
o20181022101258.JPG

Inspection Date: 10/22/2018 10:15:43 AM		Type: Ongoing	Flow: Submerged, indeterminate	Previous Rainfall (hrs): 48-72
Illicit Discharge Potential: Potential		Inspector: JCW		
Submerged: Fully		Depth (in): 43		
Sampling Results		Notes Sample collected from submerged pool in manhole. Floating gross solids (litter) in manhole.		
Sample Location: Pool	Floatables: None	Condition Assessment Graffiti: None Erosion: None Deposition: None in. Damage: None		
Total Chlorine: 0 ppm	Odor: None			
Free Chlorine: 0 ppm	Turbidity: None			
Ammonia: 0 ppm	Color: None			
pH: 7.17 units	Gross Solids: Slight			
Temperature 60 °F	Vegetation: None			
Conductivity: 506 µS/cm	Benthic Growth: None			
Detergents: 0 mg/L	Stains: None			
	Non-illicit: None

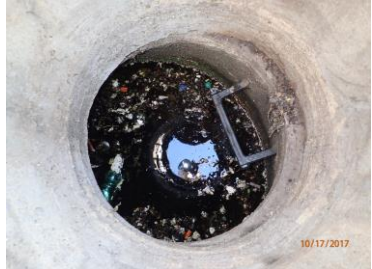
o20171017133104.JPG

Inspection Date: 10/17/2017 1:35:20 PM		Type: Ongoing	Flow: Submerged, indeterminate	Previous Rainfall (hrs): 48-72
Illicit Discharge Potential: Potential		Inspector: JCW		
Submerged: Fully		Depth (in): 39		
Sampling Results		Notes Sample collected from submerged pool in manhole. Floating gross solids (litter) in manhole.		
Sample Location: Pool	Floatables: None	Condition Assessment Graffiti: None Erosion: None Deposition: None in. Damage: None		
Total Chlorine: 0 ppm	Odor: None			
Free Chlorine: 0 ppm	Turbidity: None			
Ammonia: 0 ppm	Color: None			
pH: 7.57 units	Gross Solids: Moderate			
Temperature 67 °F	Vegetation: None			
Conductivity: 537 µS/cm	Benthic Growth: None			
Detergents: 0 mg/L	Stains: None			
	Non-illicit: None

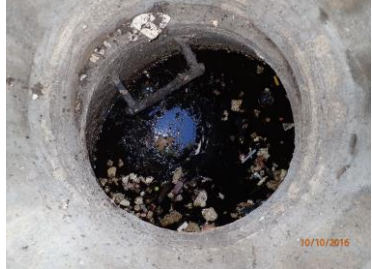
o20161010105436.JPG

Inspection Date: 10/10/2016 10:57:04 AM		Type: Ongoing	Flow: Submerged, indeterminate	Previous Rainfall (hrs): 72+
Illicit Discharge Potential: Potential		Inspector: JCW		
Submerged: Fully		Depth (in): 37		
Sampling Results		Notes Potential illicit discharge due to gross solids.		
Sample Location: Pool	Floatables: None	Condition Assessment Graffiti: None Erosion: None Deposition: None in. Damage: None		
Total Chlorine: 0 ppm	Odor: None			
Free Chlorine: 0 ppm	Turbidity: None			
Ammonia: 0 ppm	Color: None			
pH: 7.54 units	Gross Solids: Moderate			
Temperature 65 °F	Vegetation: None			
Conductivity: 654 µS/cm	Benthic Growth: None			
Detergents: 0 mg/L	Stains: None			
	Non-illicit: None

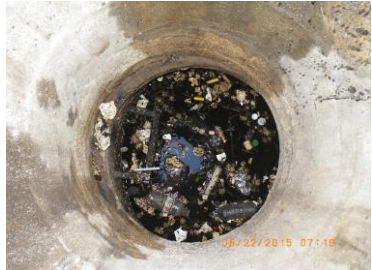
o20150922061944.JPG

Inspection Date: 9/22/2015 7:15:12 AM		Type: Ongoing	Flow: Submerged, indeterminate	Previous Rainfall (hrs): 72+
Illicit Discharge Potential: Potential		Inspector: JCW		
Submerged: Fully		Depth (in): 39		
Sampling Results		Notes Floating gross solids (litter) in manhole.		
Sample Location: Pool	Floatables: None	Condition Assessment Graffiti: None Erosion: None Deposition: None in. Damage: None		
Total Chlorine: 0 ppm	Odor: None			
Free Chlorine: 0 ppm	Turbidity: None			
Ammonia: 0 ppm	Color: None			
pH: 7.84 units	Gross Solids: Moderate			
Temperature 65 °F	Vegetation: None			
Conductivity: 459 µS/cm	Benthic Growth: None			
Detergents: 0 mg/L	Stains: None			
	Non-illicit: None

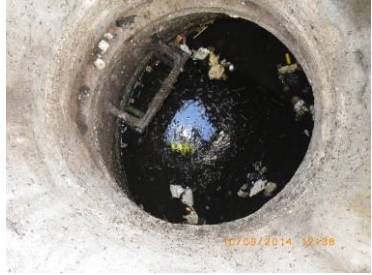
o20141009113842.JPG 2014

Inspection Date: 10/9/2014 12:40:37 PM		Type: Ongoing	Flow: Submerged, indeterminate	Previous Rainfall (hrs): 72+
Illicit Discharge Potential: Potential		Inspector: JCW	Notes	
Submerged: Fully		Depth (in): 35	Floating gross solids (litter) in manhole.	
Sampling Results				
Sample Location:	Pool	Floatables:	None	
Total Chlorine:	0 ppm	Odor:	None	
Free Chlorine:	0 ppm	Turbidity:	None	
Ammonia:	0 ppm	Color:	None	
pH:	7.58 units	Gross Solids:	Moderate	
Temperature:	62 °F	Vegetation:	None	
Conductivity:	707 µS/cm	Benthic Growth:	None	
Detergents:	0 mg/L	Stains:	None	
		Non-illicit:	None	
			Condition Assessment	
			Graffiti:	None
			Erosion:	None
			Deposition:	None in.
			Damage:	None

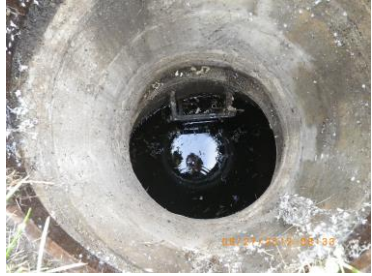
o20120927073352.JPG 2012

Inspection Date: 9/27/2012 8:31:15 AM		Type: Ongoing	Flow: Submerged, indeterminate	Previous Rainfall (hrs): 72+
Illicit Discharge Potential: Unlikely		Inspector: JCW	Notes	
Submerged: Fully		Depth (in): 36	2011 gross solids follow-up.	
Sampling Results				
Sample Location:	Pool	Floatables:	None	
Total Chlorine:	0 ppm	Odor:	None	
Free Chlorine:	0 ppm	Turbidity:	None	
Ammonia:	0 ppm	Color:	None	
pH:	7.73 units	Gross Solids:	Slight	
Temperature:	60 °F	Vegetation:	None	
Conductivity:	518 µS/cm	Benthic Growth:	None	
Detergents:	0 mg/L	Stains:	None	
		Non-illicit:	None	
			Condition Assessment	
			Graffiti:	None
			Erosion:	None
			Deposition:	None in.
			Damage:	None

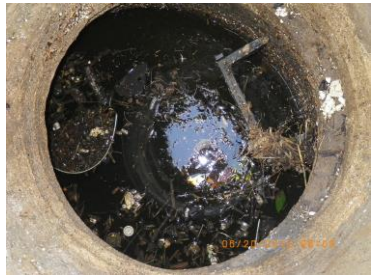
o20120620070908.JPG 2012

Inspection Date: 6/20/2012 8:08:37 AM		Type: Other	Flow: Submerged, indeterminate	Previous Rainfall (hrs): 24-48
Illicit Discharge Potential: Unlikely		Inspector: JCW	Notes	
Submerged: Fully		Depth (in): 43	Gross solids pre-screening.	
Sampling Results				
Sample Location:		Floatables:	None	
Total Chlorine:	-- ppm	Odor:	None	
Free Chlorine:	-- ppm	Turbidity:	None	
Ammonia:	-- ppm	Color:	None	
pH:	-- units	Gross Solids:	Moderate	
Temperature:	-- °F	Vegetation:	None	
Conductivity:	-- µS/cm	Benthic Growth:	Slight	
Detergents:	-- mg/L	Stains:	None	
		Non-illicit:	None	
			Condition Assessment	
			Graffiti:	None
			Erosion:	None
			Deposition:	None in.
			Damage:	None

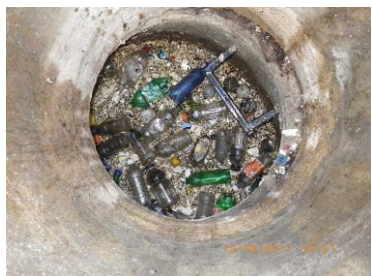
o20111003103104.JPG 2011

Inspection Date: 10/3/2011 10:30:08 AM		Type: Ongoing	Flow: Submerged, indeterminate	Previous Rainfall (hrs): 72+
Illicit Discharge Potential: Potential		Inspector: JCW	Notes	
Submerged: Fully		Depth (in): 39	Significant floatable debris in manhole.	
Sampling Results				
Sample Location:	Pool	Floatables:	None	
Total Chlorine:	0 ppm	Odor:	None	
Free Chlorine:	0 ppm	Turbidity:	None	
Ammonia:	0 ppm	Color:	None	
pH:	7.1 units	Gross Solids:	Severe	
Temperature:	61 °F	Vegetation:	None	
Conductivity:	-- µS/cm	Benthic Growth:	None	
Detergents:	0 mg/L	Stains:	None	
		Non-illicit:	None	
			Condition Assessment	
			Graffiti:	None
			Erosion:	None
			Deposition:	None 0 in.
			Damage:	None

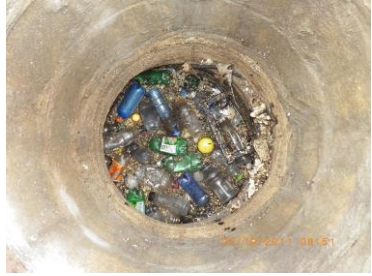
<p>o20110510085154.JPG</p> <p style="font-size: 24pt; font-weight: bold;">2011</p>

Inspection Date: 5/10/2011 8:51:00 AM		Type: Other	Flow: Submerged, indeterminate	Previous Rainfall (hrs): 0-24
Illicit Discharge Potential: Potential		Inspector: JCW		Notes Limited screening conducted for upstream manhole prescreening.
Submerged: Fully		Depth (in):		
Sampling Results Sample Location:		Floatables: None		
Total Chlorine: -- ppm Free Chlorine: -- ppm Ammonia: -- ppm pH: -- units Temperature: -- °F Conductivity: -- µS/cm Detergents: -- mg/L		Odor: Turbidity: Color: Gross Solids: Severe Vegetation: Benthic Growth: Stains: Non-illicit: None		
		Condition Assessment Graffiti: None Erosion: None Deposition: None 0 in. Damage: None
