Ongoing Screening Summary Report 2019 Inspection Year

Illicit Discharge Detection and Elimination Program

City of Oshkosh

January 3, 2020

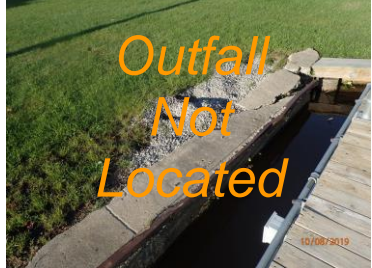
o20191008073428.jpg
2019

Inspection Date: 10/8/2019 8:34:00 AM		Type: Repeat	Flow: Submerged (not located)	Previous Rainfall (hrs): 48-72
Illicit Discharge Potential: Potential		Inspector: JCW		
Submerged: Fully		Depth (in):		
Sampling Results Sample Location: _____ Total Chlorine: -- ppm Free Chlorine: -- ppm Ammonia: -- ppm pH: -- units Temperature: -- °F Conductivity: -- µS/cm Detergents: -- mg/L		Floatables: None Odor: None Turbidity: None Color: None Gross Solids: None Vegetation: None Benthic Growth: None Stains: None Non-illicit: None	Notes Outfall fully submerged and not located - screened upstream at 03-22 US1. Follow-up inspection for sampling - limited screening conducted. Condition Assessment Graffiti: None Erosion: None Deposition: None in. Damage: None

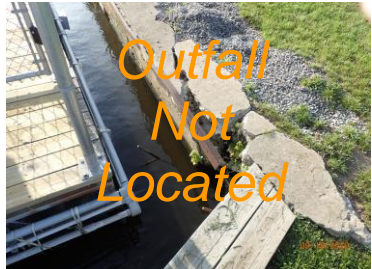
o20190918071544.JPG
2019

Inspection Date: 9/18/2019 8:16:51 AM		Type: Ongoing	Flow: Submerged (not located)	Previous Rainfall (hrs): 72+
Illicit Discharge Potential: Potential		Inspector: JCW		
Submerged: Fully		Depth (in):		
Sampling Results Sample Location: _____ Total Chlorine: -- ppm Free Chlorine: -- ppm Ammonia: -- ppm pH: -- units Temperature: -- °F Conductivity: -- µS/cm Detergents: -- mg/L		Floatables: None Odor: None Turbidity: None Color: None Gross Solids: None Vegetation: None Benthic Growth: None Stains: None Non-illicit: None	Notes Outfall fully submerged and not located - screened upstream at 03-22 US1. Floating gross solids (litter) and detergent in manhole. Condition Assessment Graffiti: None Erosion: None Deposition: None in. Damage: None

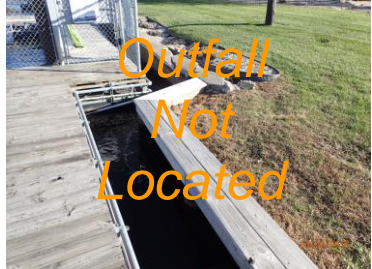
o20181022155222.JPG
2018

Inspection Date: 10/22/2018 3:53:56 PM		Type: Ongoing	Flow: Submerged (not located)	Previous Rainfall (hrs): 48-72
Illicit Discharge Potential: Potential		Inspector: JCW		
Submerged: Fully		Depth (in):		
Sampling Results Sample Location: _____ Total Chlorine: -- ppm Free Chlorine: -- ppm Ammonia: -- ppm pH: -- units Temperature: -- °F Conductivity: -- µS/cm Detergents: -- mg/L		Floatables: None Odor: None Turbidity: None Color: None Gross Solids: None Vegetation: None Benthic Growth: None Stains: None Non-illicit: None	Notes Outfall fully submerged and not located - screened upstream at 03-22 US1. Floating gross solids (litter) in manhole. Condition Assessment Graffiti: None Erosion: None Deposition: None in. Damage: None

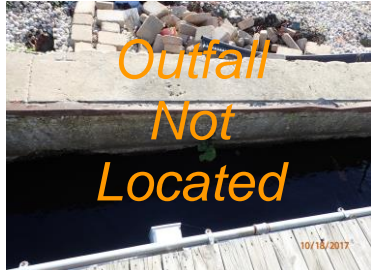
o20171018151946.JPG
2017

Inspection Date: 10/18/2017 3:22:08 PM		Type: Ongoing	Flow: Submerged (not located)	Previous Rainfall (hrs): 72+
Illicit Discharge Potential: Potential		Inspector: JCW		
Submerged: Fully		Depth (in):		
Sampling Results Sample Location: _____ Total Chlorine: -- ppm Free Chlorine: -- ppm Ammonia: -- ppm pH: -- units Temperature: -- °F Conductivity: -- µS/cm Detergents: -- mg/L		Floatables: None Odor: None Turbidity: None Color: None Gross Solids: None Vegetation: None Benthic Growth: None Stains: None Non-illicit: None	Notes Outfall fully submerged and not located - screened upstream at 03-22 US1. Floating gross solids (litter) in manhole. Condition Assessment Graffiti: None Erosion: None Deposition: None in. Damage: None

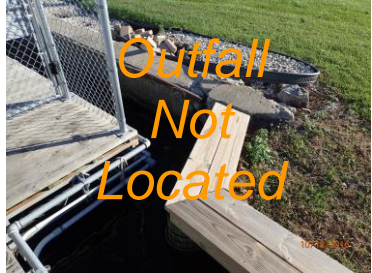
<p style="text-align: center;">o20161018160304.JPG</p> <p style="text-align: center; font-size: 1.5em; font-weight: bold;">2016</p>	
Submerged: Fully		Depth (in):		Outfall not located and assumed submerged - screened upstream at 03-22 US1.			
Sampling Results				Condition Assessment			
Sample Location:		Floatables:	None	Graftiti:		None	in.
Total Chlorine: -- ppm		Odor:	None	Erosion:		None	
Free Chlorine: -- ppm		Turbidity:	None	Deposition:		None	
Ammonia: -- ppm		Color:	None	Damage:		None	
pH: -- units		Gross Solids:	None				
Temperature -- °F		Vegetation:	None				
Conductivity: -- µS/cm		Benthic Growth:	None				
Detergents: -- mg/L		Stains:	None				
		Non-illicit:	None

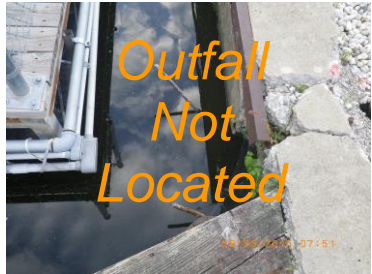
<p style="text-align: center;">o20150923065132.JPG</p> <p style="text-align: center; font-size: 1.5em; font-weight: bold;">2015</p>	
Submerged: Fully		Depth (in):		Significant sinking above suspected pipe. Outfall not located - screened at 03-22 US1.			
Sampling Results				Condition Assessment			
Sample Location:		Floatables:	None	Graftiti:		None	in.
Total Chlorine: -- ppm		Odor:	None	Erosion:		None	
Free Chlorine: -- ppm		Turbidity:	None	Deposition:		None	
Ammonia: -- ppm		Color:	None	Damage:		Severe	
pH: -- units		Gross Solids:	None				
Temperature -- °F		Vegetation:	None				
Conductivity: -- µS/cm		Benthic Growth:	None				
Detergents: -- mg/L		Stains:	None				
		Non-illicit:	None

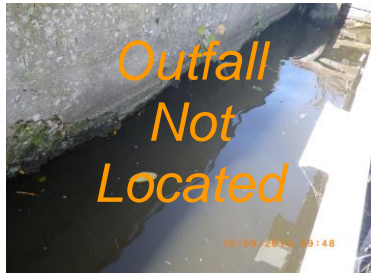
<p style="text-align: center;">o20141009084834.JPG</p> <p style="text-align: center; font-size: 1.5em; font-weight: bold;">2014</p>	
Submerged: Fully		Depth (in):		Outfall fully submerged and not located - screened upstream at 03-22 US1.			
Sampling Results				Condition Assessment			
Sample Location:		Floatables:	None	Graftiti:		None	in.
Total Chlorine: -- ppm		Odor:	None	Erosion:		None	
Free Chlorine: -- ppm		Turbidity:	None	Deposition:		None	
Ammonia: -- ppm		Color:	None	Damage:		None	
pH: -- units		Gross Solids:	None				
Temperature -- °F		Vegetation:	None				
Conductivity: -- µS/cm		Benthic Growth:	None				
Detergents: -- mg/L		Stains:	None				
		Non-illicit:	None

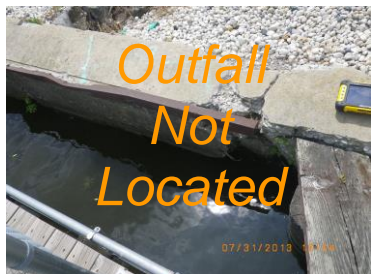
<p style="text-align: center;">o20130731114434.JPG</p> <p style="text-align: center; font-size: 1.5em; font-weight: bold;">2013</p>	
Submerged: Fully		Depth (in):		2012 screening follow-up. Outfall not located. Outfall screened upstream at 03-22 US1. Gross solids in upstream mh.			
Sampling Results				Condition Assessment			
Sample Location:		Floatables:	None	Graftiti:		None	in.
Total Chlorine: -- ppm		Odor:	None	Erosion:		None	
Free Chlorine: -- ppm		Turbidity:	None	Deposition:		None	
Ammonia: -- ppm		Color:	None	Damage:		None	
pH: -- units		Gross Solids:	None				
Temperature -- °F		Vegetation:	None				
Conductivity: -- µS/cm		Benthic Growth:	None				
Detergents: -- mg/L		Stains:	None				
		Non-illicit:	None

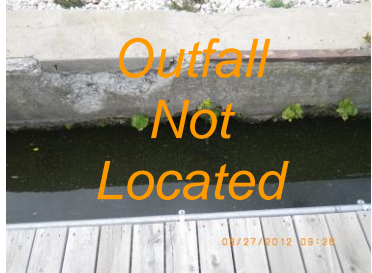
o20120927082846.JPG <div style="text-align: center; font-size: 24pt; font-weight: bold;">2012</div>

Inspection Date: 9/27/2012 9:26:54 AM		Type: Ongoing	Flow: Submerged (not located)	Previous Rainfall (hrs): 72+
Illicit Discharge Potential: Potential		Inspector: JCW		
Submerged: Fully		Depth (in):		
Sampling Results		Notes Outfall fully submerged; screened upstream at 03-22 US1.		
Sample Location: Total Chlorine: -- ppm Free Chlorine: -- ppm Ammonia: -- ppm pH: -- units Temperature: -- °F Conductivity: -- µS/cm Detergents: -- mg/L		Floatables: None Odor: None Turbidity: None Color: None Gross Solids: None Vegetation: None Benthic Growth: None Stains: None Non-illicit: None		
		Condition Assessment Graffiti: None Erosion: None Deposition: None in. Damage: None

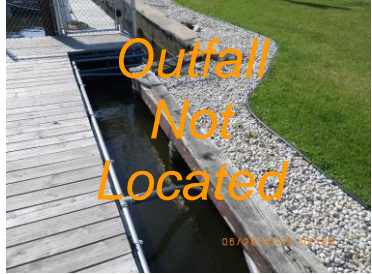
o20120620082248.JPG <div style="text-align: center; font-size: 24pt; font-weight: bold;">2012</div>

Inspection Date: 6/20/2012 9:22:09 AM		Type: Other	Flow: Submerged (not located)	Previous Rainfall (hrs): 24-48
Illicit Discharge Potential: Potential		Inspector: JCW		
Submerged: Fully		Depth (in):		
Sampling Results		Notes Gross solids pre-screening.		
Sample Location: Total Chlorine: -- ppm Free Chlorine: -- ppm Ammonia: -- ppm pH: -- units Temperature: -- °F Conductivity: -- µS/cm Detergents: -- mg/L		Floatables: None Odor: None Turbidity: None Color: None Gross Solids: None Vegetation: None Benthic Growth: None Stains: None Non-illicit: None		
		Condition Assessment Graffiti: None Erosion: None Deposition: None in. Damage: None

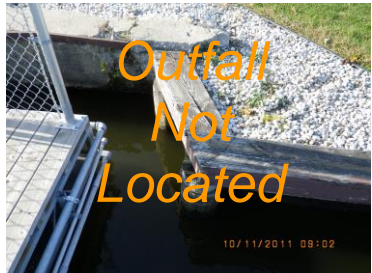
o20111011090250.JPG <div style="text-align: center; font-size: 24pt; font-weight: bold;">2011</div>

Inspection Date: 10/11/2011 9:03:10 AM		Type: Ongoing	Flow: Submerged (not located)	Previous Rainfall (hrs): 72+
Illicit Discharge Potential: Potential		Inspector: JCW		
Submerged: Fully		Depth (in):		
Sampling Results		Notes 2010 screening follow-up. Outfall fully submerged and not physically located. Outfall screened upstream at 03-22 US1.		
Sample Location: Total Chlorine: -- ppm Free Chlorine: -- ppm Ammonia: -- ppm pH: -- units Temperature: -- °F Conductivity: -- µS/cm Detergents: -- mg/L		Floatables: None Odor: None Turbidity: None Color: None Gross Solids: None Vegetation: None Benthic Growth: None Stains: None Non-illicit: None		
		Condition Assessment Graffiti: None Erosion: None Deposition: None 0 in. Damage: None

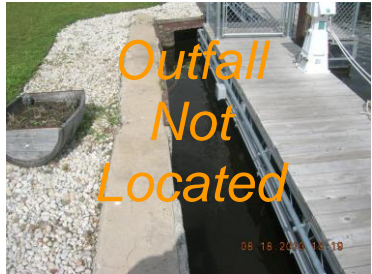
o20100818101918.JPG <div style="text-align: center; font-size: 24pt; font-weight: bold;">2010</div>

Inspection Date: 8/18/2010 10:26:01 AM		Type: Ongoing	Flow: Submerged (not located)	Previous Rainfall (hrs): 72+
Illicit Discharge Potential: Potential		Inspector: JCW		
Submerged: Fully		Depth (in):		
Sampling Results		Notes Outfall fully submerged and not physically located. Outfall screened upstream at 03-22 US1.		
Sample Location: Total Chlorine: -- ppm Free Chlorine: -- ppm Ammonia: -- ppm pH: -- units Temperature: -- °F Conductivity: -- µS/cm Detergents: -- mg/L		Floatables: None Odor: None Turbidity: None Color: None Gross Solids: None Vegetation: None Benthic Growth: None Stains: None Non-illicit: None		
		Condition Assessment Graffiti: None Erosion: None Deposition: None 0 in. Damage: None

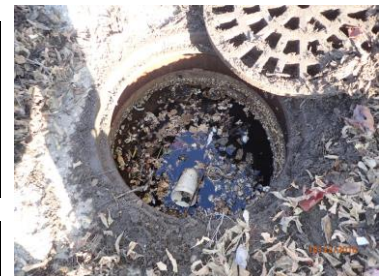
o20181022155408.JPG

Inspection Date: 10/22/2018 3:58:28 PM		Type: Ongoing	Flow: Submerged, indeterminate	Previous Rainfall (hrs): 48-72
Illicit Discharge Potential: Potential		Inspector: JCW		
Submerged: Fully		Depth (in): 49		
Sampling Results		Notes Sample collected from submerged pool in manhole. Floating gross solids (litter) in manhole.		
Sample Location: Pool	Floatables: None	Condition Assessment Graffiti: None Erosion: None Deposition: None in. Damage: None		
Total Chlorine: 0 ppm	Odor: None			
Free Chlorine: 0 ppm	Turbidity: None			
Ammonia: 0 ppm	Color: None			
pH: 7.68 units	Gross Solids: Moderate			
Temperature 55 °F	Vegetation: None			
Conductivity: 355 µS/cm	Benthic Growth: None			
Detergents: 0 mg/L	Stains: None			
	Non-illicit: None

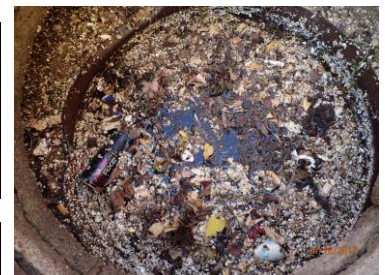
o20171018152158.JPG

Inspection Date: 10/18/2017 3:25:56 PM		Type: Ongoing	Flow: Submerged, indeterminate	Previous Rainfall (hrs): 72+
Illicit Discharge Potential: Potential		Inspector: JCW		
Submerged: Fully		Depth (in): 44		
Sampling Results		Notes Sample collected from submerged pool in manhole. Floating gross solids (litter) in manhole.		
Sample Location: Pool	Floatables: None	Condition Assessment Graffiti: None Erosion: None Deposition: None in. Damage: None		
Total Chlorine: 0 ppm	Odor: None			
Free Chlorine: 0 ppm	Turbidity: None			
Ammonia: 0 ppm	Color: None			
pH: 8.32 units	Gross Solids: Moderate			
Temperature 66 °F	Vegetation: None			
Conductivity: 422 µS/cm	Benthic Growth: None			
Detergents: 0 mg/L	Stains: None			
	Non-illicit: None

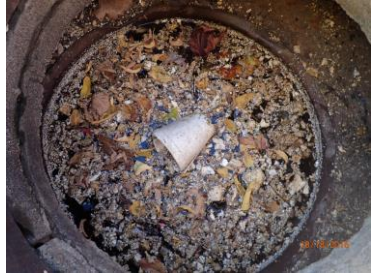
o20161018160430.JPG

Inspection Date: 10/18/2016 4:06:54 PM		Type: Ongoing	Flow: Submerged, indeterminate	Previous Rainfall (hrs): 72+
Illicit Discharge Potential: Potential		Inspector: JCW	Notes	
Submerged: Fully		Depth (in): 44	Potential illicit discharge due to gross solids.	
Sampling Results		Floatables: None	Condition Assessment Graffiti: None Erosion: None Deposition: None in. Damage: None	
Sample Location: Pool	Odor: None			
Total Chlorine: 0 ppm	Turbidity: None			
Free Chlorine: 0 ppm	Color: Faint in bottle			
Ammonia: 0 ppm	Gross Solids: Severe			
pH: 8.15 units	Vegetation: None			
Temperature 66 °F	Benthic Growth: None			
Conductivity: 403 µS/cm	Stains: None			
Detergents: 0 mg/L	Non-illicit: None

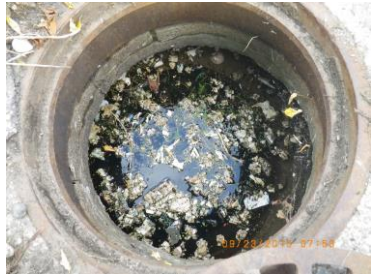
o20150923065324.JPG

Inspection Date: 9/23/2015 7:51:33 AM		Type: Ongoing	Flow: Submerged, indeterminate	Previous Rainfall (hrs): 72+
Illicit Discharge Potential: Potential		Inspector: JCW	Notes	
Submerged: Fully		Depth (in): 46	Floating gross solids (litter) in manhole.	
Sampling Results		Floatables: None	Condition Assessment Graffiti: None Erosion: None Deposition: None in. Damage: None	
Sample Location: Pool	Odor: None			
Total Chlorine: 0 ppm	Turbidity: None			
Free Chlorine: 0 ppm	Color: None			
Ammonia: 0 ppm	Gross Solids: Moderate			
pH: 8.44 units	Vegetation: None			
Temperature 70 °F	Benthic Growth: None			
Conductivity: 354 µS/cm	Stains: None			
Detergents: 0 mg/L	Non-illicit: None

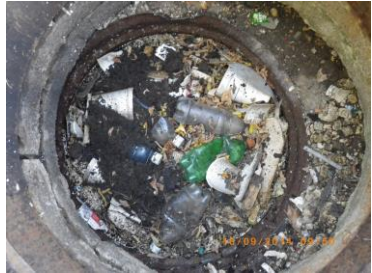
o20141009085040.JPG

Inspection Date: 10/9/2014 9:52:24 AM		Type: Ongoing	Flow: Submerged, indeterminate	Previous Rainfall (hrs): 72+
Illicit Discharge Potential: Potential		Inspector: JCW	Notes	
Submerged: Fully		Depth (in): 40	Floatable litter in catchbasin.	
Sampling Results		Floatables: None	Condition Assessment Graffiti: None Erosion: None Deposition: None in. Damage: None	
Sample Location: Pool	Odor: None			
Total Chlorine: 0 ppm	Turbidity: None			
Free Chlorine: 0 ppm	Color: Faint in bottle			
Ammonia: 0 ppm	Gross Solids: Severe			
pH: 7.79 units	Vegetation: None			
Temperature 57 °F	Benthic Growth: None			
Conductivity: 442 µS/cm	Stains: None			
Detergents: 0 mg/L	Non-illicit: None

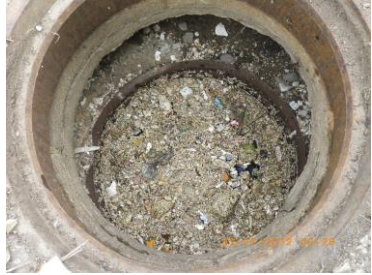
o20120927082922.JPG

Inspection Date: 9/27/2012 9:27:45 AM		Type: Ongoing	Flow: Submerged, indeterminate	Previous Rainfall (hrs): 72+
Illicit Discharge Potential: Potential		Inspector: JCW	Notes	
Submerged: Fully		Depth (in): 39	2011 gross solids follow-up.	
Sampling Results				
Sample Location:	Pool	Floatables:	None	
Total Chlorine:	0 ppm	Odor:	None	
Free Chlorine:	0 ppm	Turbidity:	None	
Ammonia:	0 ppm	Color:	None	
pH:	8.32 units	Gross Solids:	Severe	
Temperature:	59 °F	Vegetation:	None	
Conductivity:	398 µS/cm	Benthic Growth:	None	
Detergents:	0 mg/L	Stains:	None	
		Non-illicit:	None	
			Condition Assessment	
			Graffiti:	None
			Erosion:	None
			Deposition:	None in.
			Damage:	None

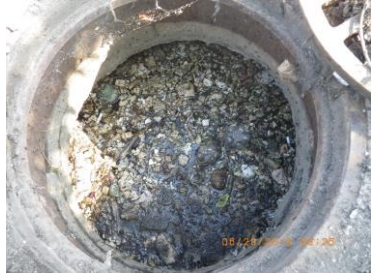
o20120620082508.JPG

Inspection Date: 6/20/2012 9:24:19 AM		Type: Other	Flow: Submerged, indeterminate	Previous Rainfall (hrs): 24-48
Illicit Discharge Potential: Potential		Inspector: JCW	Notes	
Submerged: Fully		Depth (in): 46	Gross solids pre-screening.	
Sampling Results				
Sample Location:		Floatables:	None	
Total Chlorine:	-- ppm	Odor:	None	
Free Chlorine:	-- ppm	Turbidity:	None	
Ammonia:	-- ppm	Color:	None	
pH:	-- units	Gross Solids:	Severe	
Temperature:	-- °F	Vegetation:	None	
Conductivity:	-- µS/cm	Benthic Growth:	None	
Detergents:	-- mg/L	Stains:	None	
		Non-illicit:	None	
			Condition Assessment	
			Graffiti:	None
			Erosion:	None
			Deposition:	None in.
			Damage:	None

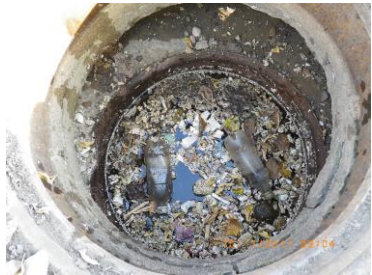
o20111011090446.JPG

Inspection Date: 10/11/2011 9:05:50 AM		Type: Ongoing	Flow: Submerged, indeterminate	Previous Rainfall (hrs): 72+
Illicit Discharge Potential: Potential		Inspector: JCW	Notes	
Submerged: Fully		Depth (in): 37	2010 screening follow-up. No significant change in volume of floatable debris.	
Sampling Results				
Sample Location:	Pool	Floatables:	None	
Total Chlorine:	0 ppm	Odor:	None	
Free Chlorine:	0 ppm	Turbidity:	None	
Ammonia:	0 ppm	Color:	None	
pH:	8.13 units	Gross Solids:	Moderate	
Temperature:	70 °F	Vegetation:	None	
Conductivity:	-- µS/cm	Benthic Growth:	None	
Detergents:	-- mg/L	Stains:	None	
		Non-illicit:	None	
			Condition Assessment	
			Graffiti:	None
			Erosion:	None
			Deposition:	None 0 in.
			Damage:	None

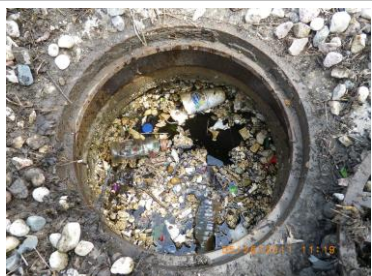
o20110526111930.JPG

Inspection Date: 5/26/2011 11:19:00 AM		Type: Other	Flow: Submerged, indeterminate	Previous Rainfall (hrs): 72+
Illicit Discharge Potential: Potential		Inspector: JCW	Notes	
Submerged: Fully		Depth (in):	Limited screening conducted to check for floatable debris.	
Sampling Results				
Sample Location:		Floatables:	None	
Total Chlorine:	-- ppm	Odor:		
Free Chlorine:	-- ppm	Turbidity:		
Ammonia:	-- ppm	Color:		
pH:	-- units	Gross Solids:	Moderate	
Temperature:	-- °F	Vegetation:		
Conductivity:	-- µS/cm	Benthic Growth:		
Detergents:	-- mg/L	Stains:		
		Non-illicit:	None	
			Condition Assessment	
			Graffiti:	None
			Erosion:	None
			Deposition:	None 0 in.
			Damage:	None

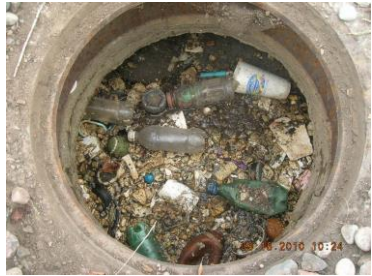
o20100818102410.JPG

Inspection Date: 8/18/2010 10:29:59 AM		Type: Ongoing	Flow: Submerged, indeterminate	Previous Rainfall (hrs): 72+
Illicit Discharge Potential: Potential		Inspector: JCW	Notes	
Submerged: Fully Depth (in): 44			Severe floatable debris in catchbasin.	
Sampling Results			Condition Assessment	
Sample Location: Pool	Floatables: None		Graffiti: None Erosion: None Deposition: None 0 in. Damage: None	
Total Chlorine: 0 ppm	Odor: None			
Free Chlorine: 0 ppm	Turbidity: None			
Ammonia: 0 ppm	Color: Faint in bottle			
pH: 7.38 units	Gross Solids: Severe			
Temperature 76 °F	Vegetation: None			
Conductivity: -- µS/cm	Benthic Growth: None			
Detergents: 0 mg/L	Stains: None			
	Non-illicit: None

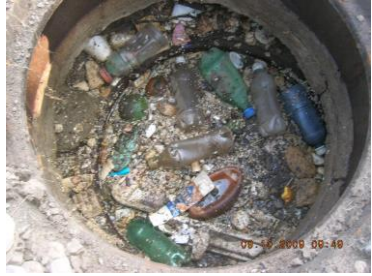
Osh09_DSCN6768.JPG

Inspection Date: 9/10/2009		Type: Initial	Flow: Submerged, indeterminate	Previous Rainfall (hrs): 72+
Illicit Discharge Potential: Potential		Inspector: JCW	Notes	
Submerged: Fully Depth (in): 44			Abnormal detergent analysis result (bubbles). Significant floatables in manhole.	
Sampling Results			Condition Assessment	
Sample Location: Pool	Floatables: None		Graffiti: None Erosion: None Deposition: None 0 in. Damage: None	
Total Chlorine: 0 ppm	Odor: None			
Free Chlorine: 0 ppm	Turbidity: None			
Ammonia: -- ppm	Color: None			
pH: 8.3 units	Gross Solids: Severe			
Temperature 75 °F	Vegetation: None			
Conductivity: -- µS/cm	Benthic Growth: None			
Detergents: 0 mg/L	Stains: None			
	Non-illicit: None

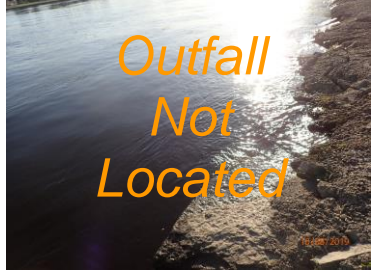
<p style="text-align: center;">o20191008072714.JPG</p> <p style="text-align: center; font-size: 1.2em;">2019</p>	
Submerged: Fully		Depth (in):		Detergent detection follow-up. Limited screening conducted beyond sampling.			
Sampling Results				Condition Assessment			
Sample Location:		Floatables:	None	Graffiti:	None		
Total Chlorine:	-- ppm	Odor:	None	Erosion:	None		
Free Chlorine:	-- ppm	Turbidity:	None	Deposition:	None in.		
Ammonia:	-- ppm	Color:	None	Damage:	None		
pH:	-- units	Gross Solids:	None				
Temperature:	-- °F	Vegetation:	None				
Conductivity:	-- µS/cm	Benthic Growth:	None				
Detergents:	-- mg/L	Stains:	None				
		Non-illicit:	None

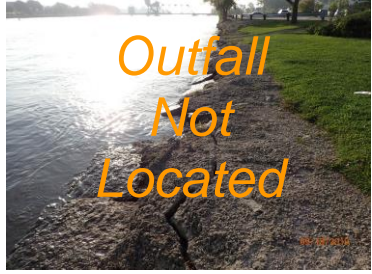
<p style="text-align: center;">o20190918070310.JPG</p> <p style="text-align: center; font-size: 1.2em;">2019</p>	
Submerged: Fully		Depth (in):		Outfall fully submerged and not located - screened upstream at 03-35 US1. Floating gross solids (litter) and detergent in manhole.			
Sampling Results				Condition Assessment			
Sample Location:		Floatables:	None	Graffiti:	None		
Total Chlorine:	-- ppm	Odor:	None	Erosion:	None		
Free Chlorine:	-- ppm	Turbidity:	None	Deposition:	None in.		
Ammonia:	-- ppm	Color:	None	Damage:	None		
pH:	-- units	Gross Solids:	None				
Temperature:	-- °F	Vegetation:	None				
Conductivity:	-- µS/cm	Benthic Growth:	None				
Detergents:	-- mg/L	Stains:	None				
		Non-illicit:	None

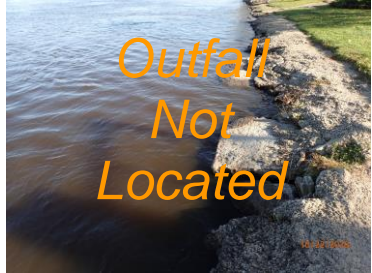
<p style="text-align: center;">o20181022152608.JPG</p> <p style="text-align: center; font-size: 1.2em;">2018</p>	
Submerged: Fully		Depth (in):		Outfall fully submerged and not located - screened upstream at 03-35 US1. Floating gross solids (litter) in manhole.			
Sampling Results				Condition Assessment			
Sample Location:		Floatables:	None	Graffiti:	None		
Total Chlorine:	-- ppm	Odor:	None	Erosion:	None		
Free Chlorine:	-- ppm	Turbidity:	None	Deposition:	None in.		
Ammonia:	-- ppm	Color:	None	Damage:	None		
pH:	-- units	Gross Solids:	None				
Temperature:	-- °F	Vegetation:	None				
Conductivity:	-- µS/cm	Benthic Growth:	None				
Detergents:	-- mg/L	Stains:	None				
		Non-illicit:	None

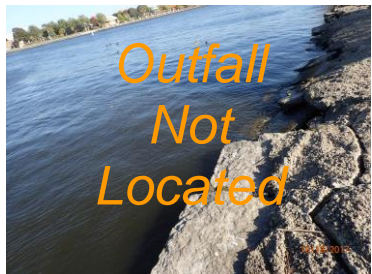
<p style="text-align: center;">o20171018150844.JPG</p> <p style="text-align: center; font-size: 1.2em;">2017</p>	
Submerged: Fully		Depth (in):		Outfall fully submerged and not located - screened upstream at 03-35 US1. Floating gross solids (litter) in manhole.			
Sampling Results				Condition Assessment			
Sample Location:		Floatables:	None	Graffiti:	None		
Total Chlorine:	-- ppm	Odor:	None	Erosion:	None		
Free Chlorine:	-- ppm	Turbidity:	None	Deposition:	None in.		
Ammonia:	-- ppm	Color:	None	Damage:	None		
pH:	-- units	Gross Solids:	None				
Temperature:	-- °F	Vegetation:	None				
Conductivity:	-- µS/cm	Benthic Growth:	None				
Detergents:	-- mg/L	Stains:	None				
		Non-illicit:	None

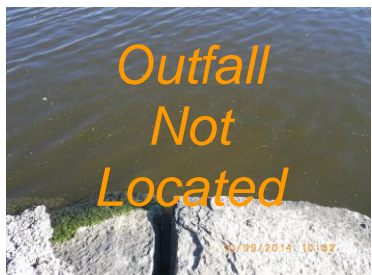
o20141009093222.JPG

Inspection Date: 10/9/2014 10:33:07 AM		Type: Ongoing	Flow: Submerged (not located)	Previous Rainfall (hrs): 72+
Illicit Discharge Potential: Unlikely		Inspector: JCW	Notes	
Submerged: Fully		Depth (in):	Outfall fully submerged and not located - screened upstream at 03-35 US1	
Sampling Results		Floatables:	Condition Assessment Graffiti: None Erosion: None Deposition: None in. Damage: None	
Sample Location:		Odor:		
Total Chlorine: -- ppm		Turbidity:		
Free Chlorine: -- ppm		Color:		
Ammonia: -- ppm		Gross Solids:		
pH: -- units		Vegetation:		
Temperature -- °F		Benthic Growth:		
Conductivity: -- µS/cm		Stains:		
Detergents: -- mg/L		Non-illicit:

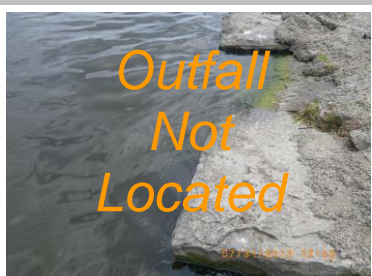
o20130731113304.JPG

Inspection Date: 7/31/2013 12:30:28 PM		Type: Ongoing	Flow: Submerged (not located)	Previous Rainfall (hrs): 72+
Illicit Discharge Potential: Potential		Inspector: JCW	Notes	
Submerged: Fully		Depth (in):	2012 screening follow-up. Outfall not located. Outfall screened upstream at 03-35 US1. Gross solids in upstream mh.	
Sampling Results		Floatables:	Condition Assessment Graffiti: None Erosion: None Deposition: None in. Damage: None	
Sample Location:		Odor:		
Total Chlorine: -- ppm		Turbidity:		
Free Chlorine: -- ppm		Color:		
Ammonia: -- ppm		Gross Solids:		
pH: -- units		Vegetation:		
Temperature -- °F		Benthic Growth:		
Conductivity: -- µS/cm		Stains:		
Detergents: -- mg/L		Non-illicit:

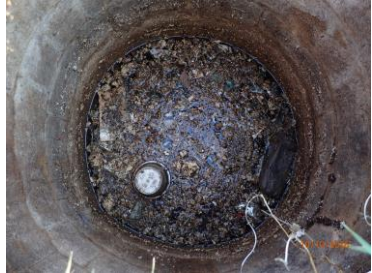
o20161010094958.JPG

Inspection Date: 10/10/2016 9:52:43 AM		Type: Ongoing	Flow: Submerged, indeterminate	Previous Rainfall (hrs): 72+
Illicit Discharge Potential: Potential		Inspector: JCW	Notes	
Submerged: Fully		Depth (in): 32	Potential illicit discharge due to gross solids.	
Sampling Results		Floatables: None	Condition Assessment Graffiti: None Erosion: None Deposition: None in. Damage: None	
Sample Location: Pool	Odor: Faint			
Total Chlorine: 0 ppm	Turbidity: None			
Free Chlorine: 0 ppm	Color: None			
Ammonia: 0 ppm	Gross Solids: Moderate			
pH: 7.54 units	Vegetation: None			
Temperature 63 °F	Benthic Growth: None			
Conductivity: 391 µS/cm	Stains: None			
Detergents: 0 mg/L	Non-illicit: None

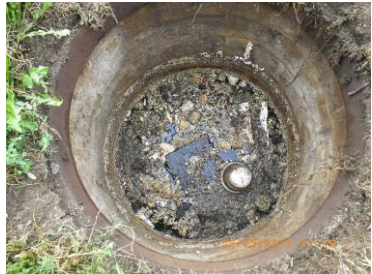
o20150923063950.JPG

Inspection Date: 9/23/2015 7:36:00 AM		Type: Ongoing	Flow: Submerged, indeterminate	Previous Rainfall (hrs): 72+
Illicit Discharge Potential: Potential		Inspector: JCW	Notes	
Submerged: Fully		Depth (in): 30	Floating gross solids (litter) in manhole.	
Sampling Results		Floatables: None	Condition Assessment Graffiti: None Erosion: None Deposition: Minor 1 in. Damage: None	
Sample Location: Pool	Odor: None			
Total Chlorine: 0 ppm	Turbidity: None			
Free Chlorine: 0 ppm	Color: Faint in bottle			
Ammonia: 0 ppm	Gross Solids: Moderate			
pH: 8.64 units	Vegetation: None			
Temperature 69 °F	Benthic Growth: None			
Conductivity: 359 µS/cm	Stains: None			
Detergents: 0 mg/L	Non-illicit: None

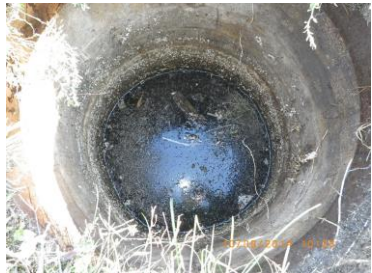
o20141009093356.JPG

Inspection Date: 10/9/2014 10:35:52 AM		Type: Ongoing	Flow: Submerged, indeterminate	Previous Rainfall (hrs): 72+
Illicit Discharge Potential: Unlikely		Inspector: JCW	Notes	
Submerged: Fully		Depth (in): 32	Vegetative debris in photo from opening lid.	
Sampling Results		Floatables: None	Condition Assessment Graffiti: None Erosion: None Deposition: Minor 1 in. Damage: None	
Sample Location: Pool	Odor: None			
Total Chlorine: 0 ppm	Turbidity: None			
Free Chlorine: 0 ppm	Color: Faint in bottle			
Ammonia: 0 ppm	Gross Solids: Slight			
pH: 7.86 units	Vegetation: None			
Temperature 58 °F	Benthic Growth: None			
Conductivity: 476 µS/cm	Stains: None			
Detergents: 0 mg/L	Non-illicit: None

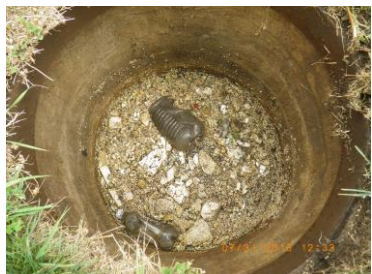
o20130731113346.JPG

Inspection Date: 7/31/2013 12:31:00 PM		Type: Ongoing	Flow: Submerged, indeterminate	Previous Rainfall (hrs): 72+
Illicit Discharge Potential: Potential		Inspector: JCW	Notes	
Submerged: Fully		Depth (in): 33	2012 screening follow-up. Significant gross solids. Similar to previous years.	
Sampling Results		Floatables: None	Condition Assessment Graffiti: None Erosion: None Deposition: None in. Damage: None	
Sample Location: Pool	Odor: None			
Total Chlorine: 0 ppm	Turbidity: None			
Free Chlorine: 0 ppm	Color: Faint in bottle			
Ammonia: 0 ppm	Gross Solids: Severe			
pH: 8.47 units	Vegetation: None			
Temperature 75 °F	Benthic Growth: None			
Conductivity: 425 µS/cm	Stains: Moderate			
Detergents: 0 mg/L	Non-illicit: None

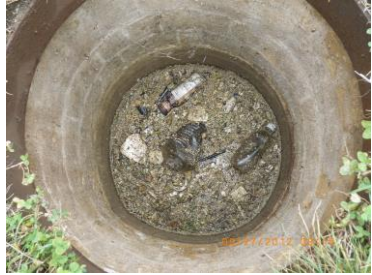
o20120927081522.JPG

Inspection Date: 9/27/2012 9:13:54 AM		Type: Ongoing	Flow: Submerged, indeterminate	Previous Rainfall (hrs): 72+
Illicit Discharge Potential: Potential		Inspector: JCW	Notes	
Submerged: Fully		Depth (in): 31	2011 gross solids follow-up.	
Sampling Results				
Sample Location:	Pool	Floatables:	None	
Total Chlorine:	0 ppm	Odor:	None	
Free Chlorine:	0 ppm	Turbidity:	None	
Ammonia:	0 ppm	Color:	None	
pH:	8.42 units	Gross Solids:	Severe	
Temperature:	59 °F	Vegetation:	None	
Conductivity:	723 µS/cm	Benthic Growth:	None	
Detergents:	0 mg/L	Stains:	Slight	
		Non-illicit:	None	
			Condition Assessment	
			Graffiti:	None
			Erosion:	None
			Deposition:	Minor 3 in.
			Damage:	None

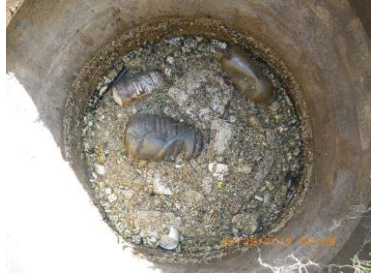
o20120620080918.JPG

Inspection Date: 6/20/2012 9:08:12 AM		Type: Other	Flow: Submerged, indeterminate	Previous Rainfall (hrs): 24-48
Illicit Discharge Potential: Potential		Inspector: JCW	Notes	
Submerged: Fully		Depth (in): 39	Gross solids pre-screening.	
Sampling Results				
Sample Location:		Floatables:	None	
Total Chlorine:	-- ppm	Odor:	None	
Free Chlorine:	-- ppm	Turbidity:	None	
Ammonia:	-- ppm	Color:	None	
pH:	-- units	Gross Solids:	Severe	
Temperature:	-- °F	Vegetation:	None	
Conductivity:	-- µS/cm	Benthic Growth:	None	
Detergents:	-- mg/L	Stains:	None	
		Non-illicit:	None	
			Condition Assessment	
			Graffiti:	None
			Erosion:	None
			Deposition:	None in.
			Damage:	None

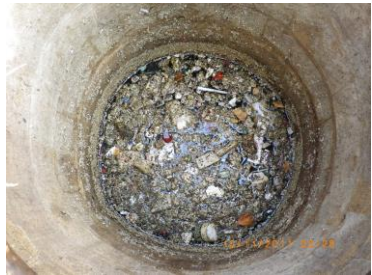
o20111011092832.JPG

Inspection Date: 10/11/2011 9:29:50 AM		Type: Ongoing	Flow: Submerged, indeterminate	Previous Rainfall (hrs): 72+
Illicit Discharge Potential: Potential		Inspector: JCW	Notes	
Submerged: Fully		Depth (in): 19	2010 screening follow-up. Floatable debris still present. Slight petroleum sheen.	
Sampling Results				
Sample Location:	Pool	Floatables:	Severe	
Total Chlorine:	0 ppm	Odor:	None	
Free Chlorine:	0 ppm	Turbidity:	None	
Ammonia:	0 ppm	Color:	None	
pH:	8.01 units	Gross Solids:	Severe	
Temperature:	71 °F	Vegetation:	None	
Conductivity:	-- µS/cm	Benthic Growth:	None	
Detergents:	-- mg/L	Stains:	None	
		Non-illicit:	None	
			Condition Assessment	
			Graffiti:	None
			Erosion:	None
			Deposition:	None 0 in.
			Damage:	None

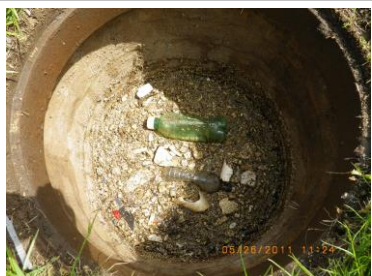
o20110526112400.JPG

Inspection Date: 5/26/2011 11:23:00 AM		Type: Other	Flow: Submerged, indeterminate	Previous Rainfall (hrs): 72+
Illicit Discharge Potential: Potential		Inspector: JCW	Notes	
Submerged: Fully		Depth (in):	Limited screening conducted to check for floatable debris.	
Sampling Results				
Sample Location:		Floatables:	None	
Total Chlorine:	-- ppm	Odor:		
Free Chlorine:	-- ppm	Turbidity:		
Ammonia:	-- ppm	Color:		
pH:	-- units	Gross Solids:	Severe	
Temperature:	-- °F	Vegetation:		
Conductivity:	-- µS/cm	Benthic Growth:		
Detergents:	-- mg/L	Stains:		
		Non-illicit:	None	
			Condition Assessment	
			Graffiti:	None
			Erosion:	None
			Deposition:	None 0 in.
			Damage:	None

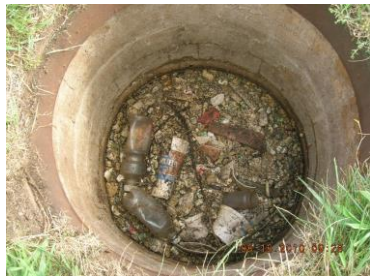
o20100818092304.JPG

Inspection Date: 8/18/2010 9:32:06 AM		Type: Ongoing	Flow: Submerged, indeterminate	Previous Rainfall (hrs): 72+
Illicit Discharge Potential: Potential		Inspector: JCW	Notes	
Submerged: Fully Depth (in): 34			Severe floatable debris in catchbasin.	
Sampling Results			Condition Assessment	
Sample Location: Pool	Floatables: None		Graffiti: None	
Total Chlorine: 0 ppm	Odor: Faint		Erosion: None	
Free Chlorine: 0 ppm	Turbidity: None		Deposition: None 0 in.	
Ammonia: 0.5 ppm	Color: Faint in bottle		Damage: None	
pH: 7.46 units	Gross Solids: Severe			
Temperature 73 °F	Vegetation: None			
Conductivity: -- µS/cm	Benthic Growth: None			
Detergents: 0 mg/L	Stains: None			
	Non-illicit: None

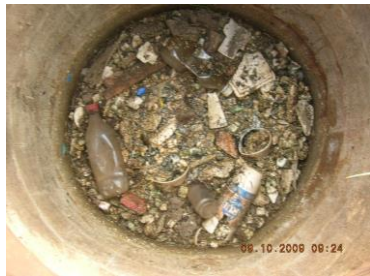
Osh09_DSCN6763.JPG

Inspection Date: 9/10/2009		Type: Initial	Flow: Submerged, indeterminate	Previous Rainfall (hrs): 72+
Illicit Discharge Potential: Potential		Inspector: JCW	Notes	
Submerged: Fully Depth (in): 33			Abnormal detergent analysis result (bubbles). Significant floatables in manhole.	
Sampling Results			Condition Assessment	
Sample Location: Pool	Floatables: None		Graffiti: None	
Total Chlorine: 0 ppm	Odor: None		Erosion: None	
Free Chlorine: 0 ppm	Turbidity: None		Deposition: None 0 in.	
Ammonia: -- ppm	Color: None		Damage: None	
pH: 8.23 units	Gross Solids: Severe			
Temperature 73 °F	Vegetation: None			
Conductivity: -- µS/cm	Benthic Growth: None			
Detergents: 0 mg/L	Stains: None			
	Non-illicit: None

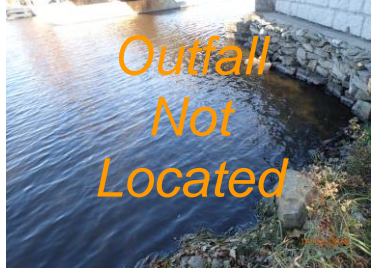
o20181022151216.JPG <div style="text-align: center; font-size: 24pt; font-weight: bold;">2018</div>

Inspection Date: 10/22/2018 3:13:39 PM		Type: Ongoing	Flow: Submerged (not located)	Previous Rainfall (hrs): 48-72
Illicit Discharge Potential: Potential		Inspector: JCW		
Submerged: Fully		Depth (in):		
Sampling Results Sample Location: _____ Total Chlorine: -- ppm Free Chlorine: -- ppm Ammonia: -- ppm pH: -- units Temperature: -- °F Conductivity: -- µS/cm Detergents: -- mg/L		Floatables: None Odor: None Turbidity: None Color: None Gross Solids: None Vegetation: None Benthic Growth: None Stains: None Non-illicit: None	Notes Outfall fully submerged and not located - screened upstream at 03-81 US1. Floating gross solids (litter) in manhole. Condition Assessment Graffiti: None Erosion: None Deposition: None in. Damage: None

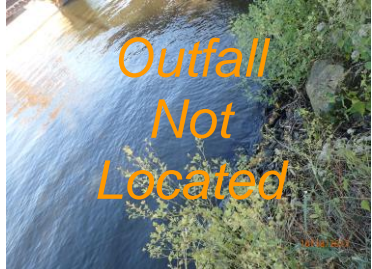
o20171018144750.JPG <div style="text-align: center; font-size: 24pt; font-weight: bold;">2017</div>

Inspection Date: 10/18/2017 2:50:50 PM		Type: Ongoing	Flow: Submerged (not located)	Previous Rainfall (hrs): 72+
Illicit Discharge Potential: Potential		Inspector: JCW		
Submerged: Fully		Depth (in):		
Sampling Results Sample Location: _____ Total Chlorine: -- ppm Free Chlorine: -- ppm Ammonia: -- ppm pH: -- units Temperature: -- °F Conductivity: -- µS/cm Detergents: -- mg/L		Floatables: None Odor: None Turbidity: None Color: None Gross Solids: None Vegetation: None Benthic Growth: None Stains: None Non-illicit: None	Notes Outfall fully submerged and not located - screened upstream at 03-81 US1. Ammonia, detergent and sheen in upstream manhole. Condition Assessment Graffiti: None Erosion: None Deposition: None in. Damage: None

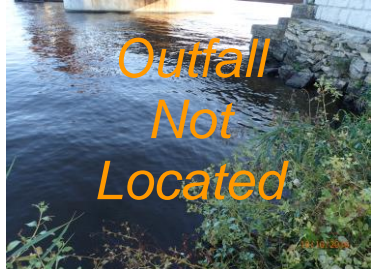
o20161010085808.JPG <div style="text-align: center; font-size: 24pt; font-weight: bold;">2016</div>

Inspection Date: 10/10/2016 8:59:12 AM		Type: Ongoing	Flow: Submerged (not located)	Previous Rainfall (hrs): 72+
Illicit Discharge Potential: Potential		Inspector: JCW		
Submerged: Fully		Depth (in):		
Sampling Results Sample Location: _____ Total Chlorine: -- ppm Free Chlorine: -- ppm Ammonia: -- ppm pH: -- units Temperature: -- °F Conductivity: -- µS/cm Detergents: -- mg/L		Floatables: None Odor: None Turbidity: None Color: None Gross Solids: None Vegetation: None Benthic Growth: None Stains: None Non-illicit: None	Notes Outfall fully submerged and not located - screened upstream at 03-81 US1. Condition Assessment Graffiti: None Erosion: None Deposition: None in. Damage: None

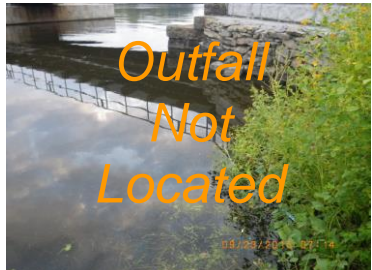
o20150923061430.JPG <div style="text-align: center; font-size: 24pt; font-weight: bold;">2015</div>

Inspection Date: 9/23/2015 7:10:20 AM		Type: Ongoing	Flow: Submerged (not located)	Previous Rainfall (hrs): 72+
Illicit Discharge Potential: Unlikely		Inspector: JCW		
Submerged: Fully		Depth (in):		
Sampling Results Sample Location: _____ Total Chlorine: -- ppm Free Chlorine: -- ppm Ammonia: -- ppm pH: -- units Temperature: -- °F Conductivity: -- µS/cm Detergents: -- mg/L		Floatables: None Odor: None Turbidity: None Color: None Gross Solids: None Vegetation: None Benthic Growth: None Stains: None Non-illicit: None	Notes Outfall fully submerged and not located - screened at 03-81 US1. Condition Assessment Graffiti: None Erosion: None Deposition: None in. Damage: None

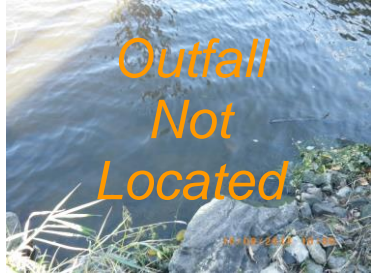
o20141009090032.JPG 2014

Inspection Date: 10/9/2014 10:00:10 AM		Type: Ongoing	Flow: Submerged (not located)	Previous Rainfall (hrs): 72+
Illicit Discharge Potential: Obvious		Inspector: JCW		
Submerged: Fully		Depth (in):		
Sampling Results				
Sample Location:	Floatables:	None		
Total Chlorine: -- ppm	Odor:	None		
Free Chlorine: -- ppm	Turbidity:	None		
Ammonia: -- ppm	Color:	None		
pH: -- units	Gross Solids:	None		
Temperature -- °F	Vegetation:	None		
Conductivity: -- µS/cm	Benthic Growth:	None		
Detergents: -- mg/L	Stains:	None		
	Non-illicit:	None		
		Notes Outfall fully submerged and not located - screened upstream at 03-81 US1.		
		Condition Assessment Graffiti: None Erosion: None Deposition: None in. Damage: None

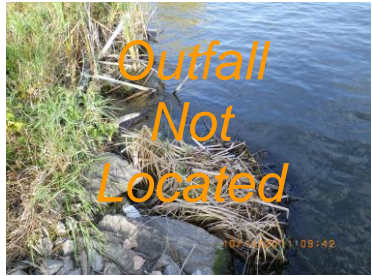
o20111011094236.JPG 2011

Inspection Date: 10/11/2011 9:42:33 AM		Type: Ongoing	Flow: Submerged (not located)	Previous Rainfall (hrs): 72+
Illicit Discharge Potential: Unlikely		Inspector: JCW		
Submerged: Fully		Depth (in):		
Sampling Results				
Sample Location:	Floatables:	None		
Total Chlorine: -- ppm	Odor:	None		
Free Chlorine: -- ppm	Turbidity:	None		
Ammonia: -- ppm	Color:	None		
pH: -- units	Gross Solids:	None		
Temperature -- °F	Vegetation:	None		
Conductivity: -- µS/cm	Benthic Growth:	None		
Detergents: -- mg/L	Stains:	None		
	Non-illicit:	None		
		Notes 2010 screening follow-up. Outfall fully submerged and not physically located. Outfall screened upstream at 03-81 US1.		
		Condition Assessment Graffiti: None Erosion: None Deposition: None 0 in. Damage: None

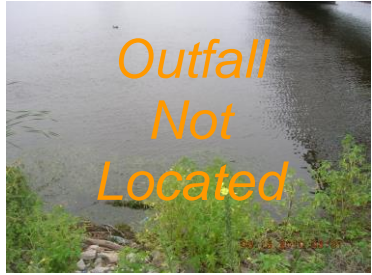
o20100818083116.JPG 2010

Inspection Date: 8/18/2010 8:38:23 AM		Type: Ongoing	Flow: Submerged (not located)	Previous Rainfall (hrs): 72+
Illicit Discharge Potential: Potential		Inspector: JCW		
Submerged: Fully		Depth (in):		
Sampling Results				
Sample Location:	Floatables:	None		
Total Chlorine: -- ppm	Odor:	None		
Free Chlorine: -- ppm	Turbidity:	None		
Ammonia: -- ppm	Color:	None		
pH: -- units	Gross Solids:	None		
Temperature -- °F	Vegetation:	None		
Conductivity: -- µS/cm	Benthic Growth:	None		
Detergents: -- mg/L	Stains:	None		
	Non-illicit:	None		
		Notes Outfall fully submerged and not physically located. Outfall screened upstream at 03-81 US1.		
		Condition Assessment Graffiti: None Erosion: None Deposition: None 0 in. Damage: None

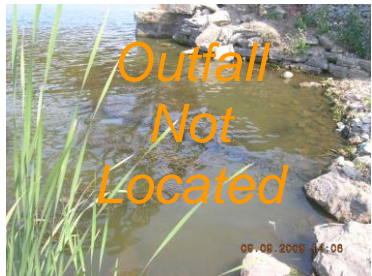
Osh09_DSCN6745.JPG 2009

Inspection Date: 9/9/2009		Type: Initial	Flow: Submerged (not located)	Previous Rainfall (hrs): 72+
Illicit Discharge Potential: Obvious		Inspector: JCW		
Submerged: Fully		Depth (in):		
Sampling Results				
Sample Location:	Floatables:	None		
Total Chlorine: -- ppm	Odor:	None		
Free Chlorine: -- ppm	Turbidity:	None		
Ammonia: -- ppm	Color:	None		
pH: -- units	Gross Solids:	None		
Temperature -- °F	Vegetation:	None		
Conductivity: -- µS/cm	Benthic Growth:	None		
Detergents: -- mg/L	Stains:	None		
	Non-illicit:	None		
		Notes Outfall fully submerged and not physically located. Outfall screened upstream at 03-81 US1.		
		Condition Assessment Graffiti: None Erosion: None Deposition: None 0 in. Damage: None

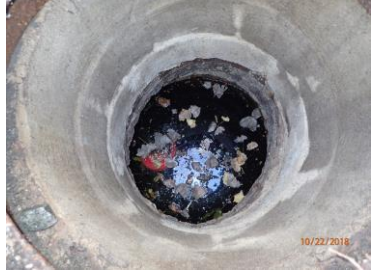
o20181022151626.JPG

Inspection Date: 10/22/2018 3:18:57 PM		Type: Ongoing	Flow: Submerged, indeterminate	Previous Rainfall (hrs): 48-72
Illicit Discharge Potential: Potential		Inspector: JCW		
Submerged: Fully		Depth (in): 57		
Sampling Results		Notes Floating gross solids (litter) in manhole.		
Sample Location: Pool	Floatables: None	Condition Assessment Graffiti: None Erosion: None Deposition: None in. Damage: None		
Total Chlorine: 0 ppm	Odor: None			
Free Chlorine: 0 ppm	Turbidity: None			
Ammonia: 0 ppm	Color: None			
pH: 7.62 units	Gross Solids: Moderate			
Temperature 57 °F	Vegetation: None			
Conductivity: 357 µS/cm	Benthic Growth: None			
Detergents: 0 mg/L	Stains: None			
	Non-illicit: None

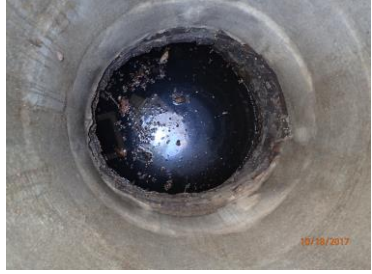
o20171018145016.JPG

Inspection Date: 10/18/2017 2:55:07 PM		Type: Ongoing	Flow: Submerged, indeterminate	Previous Rainfall (hrs): 72+
Illicit Discharge Potential: Potential		Inspector: JCW		
Submerged: Fully		Depth (in): 50		
Sampling Results		Notes Elevated ammonia and detergent in sample from manhole pool. Slight sheen observed on surface.		
Sample Location: Pool	Floatables: Moderate	Condition Assessment Graffiti: None Erosion: None Deposition: None in. Damage: None		
Total Chlorine: 0 ppm	Odor: None			
Free Chlorine: 0 ppm	Turbidity: None			
Ammonia: 1 ppm	Color: Faint in bottle			
pH: 7.22 units	Gross Solids: Slight			
Temperature 66 °F	Vegetation: None			
Conductivity: 1020 µS/cm	Benthic Growth: None			
Detergents: 0.8 mg/L	Stains: None			
	Non-illicit: None

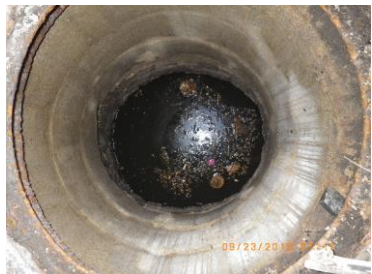
o20150923061754.JPG

Inspection Date: 9/23/2015 7:16:22 AM		Type: Ongoing	Flow: Submerged, indeterminate	Previous Rainfall (hrs): 72+
Illicit Discharge Potential: Unlikely		Inspector: JCW		
Submerged: Fully		Depth (in): 52		
Sampling Results		Notes		
Sample Location: Pool	Floatables: None	Condition Assessment Graffiti: None Erosion: None Deposition: None in. Damage: None		
Total Chlorine: 0 ppm	Odor: None			
Free Chlorine: 0 ppm	Turbidity: None			
Ammonia: 1 ppm	Color: Faint in bottle			
pH: 7.32 units	Gross Solids: Slight			
Temperature 69 °F	Vegetation: None			
Conductivity: 638 µS/cm	Benthic Growth: None			
Detergents: 0 mg/L	Stains: Slight			
	Non-illicit: None

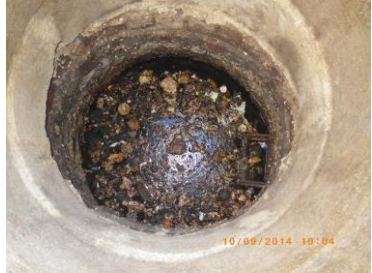
o20141009090404.JPG

Inspection Date: 10/9/2014 10:07:49 AM		Type: Ongoing	Flow: Submerged, indeterminate	Previous Rainfall (hrs): 72+
Illicit Discharge Potential: Obvious		Inspector: JCW	Notes	
Submerged: Fully		Depth (in): 44	Petroleum odor and sheen on surface.	
Sampling Results				
Sample Location:	Pool	Floatables:	Moderate	
Total Chlorine:	0 ppm	Odor:	Faint	
Free Chlorine:	0 ppm	Turbidity:	None	
Ammonia:	0.5 ppm	Color:	None	
pH:	7.58 units	Gross Solids:	Severe	
Temperature	58 °F	Vegetation:	None	
Conductivity:	679 µS/cm	Benthic Growth:	None	
Detergents:	0 mg/L	Stains:	None	
		Non-illicit:	None	
			Condition Assessment	
			Graffiti:	None
			Erosion:	None
			Deposition:	Minor 2 in.
			Damage:	None

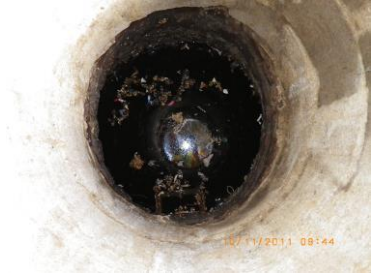
o20111011094434.JPG

Inspection Date: 10/11/2011 9:46:04 AM		Type: Ongoing	Flow: Submerged, indeterminate	Previous Rainfall (hrs): 72+
Illicit Discharge Potential: Unlikely		Inspector: JCW	Notes	
Submerged: Fully		Depth (in): 38	2010 screening follow-up. Floatable debris significantly reduced.	
Sampling Results				
Sample Location:	Pool	Floatables:	None	
Total Chlorine:	0 ppm	Odor:	None	
Free Chlorine:	0 ppm	Turbidity:	None	
Ammonia:	0.25 ppm	Color:	None	
pH:	7.68 units	Gross Solids:	Slight	
Temperature	71 °F	Vegetation:	None	
Conductivity:	-- µS/cm	Benthic Growth:	None	
Detergents:	-- mg/L	Stains:	None	
		Non-illicit:	None	
			Condition Assessment	
			Graffiti:	None
			Erosion:	None
			Deposition:	None 0 in.
			Damage:	None

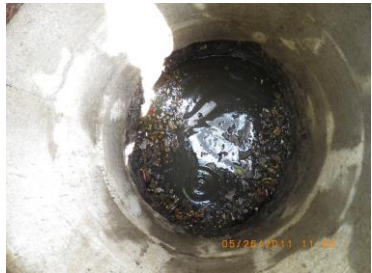
o20110526112952.JPG

Inspection Date: 5/26/2011 11:29:00 AM		Type: Other	Flow: Submerged, indeterminate	Previous Rainfall (hrs): 72+
Illicit Discharge Potential: Unlikely		Inspector: JCW	Notes	
Submerged: Fully		Depth (in):	Limited screening conducted to check for floatable debris.	
Sampling Results				
Sample Location:		Floatables:	None	
Total Chlorine:	-- ppm	Odor:		
Free Chlorine:	-- ppm	Turbidity:		
Ammonia:	-- ppm	Color:		
pH:	-- units	Gross Solids:	Slight	
Temperature	-- °F	Vegetation:		
Conductivity:	-- µS/cm	Benthic Growth:		
Detergents:	-- mg/L	Stains:		
		Non-illicit:	None	
			Condition Assessment	
			Graffiti:	None
			Erosion:	None
			Deposition:	None 0 in.
			Damage:	None

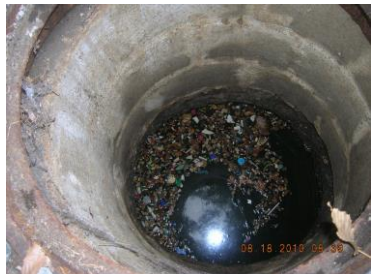
o20100818083958.JPG

Inspection Date: 8/18/2010 8:43:09 AM		Type: Ongoing	Flow: Submerged, indeterminate	Previous Rainfall (hrs): 72+
Illicit Discharge Potential: Potential		Inspector: JCW	Notes	
Submerged: Fully		Depth (in): 47	Petroleum odor likely from residual petroleum in pipes after 2009 jetting.	
Sampling Results				
Sample Location:	Pool	Floatables:	None	
Total Chlorine:	0 ppm	Odor:	Faint	
Free Chlorine:	0 ppm	Turbidity:	None	
Ammonia:	0 ppm	Color:	None	
pH:	6.63 units	Gross Solids:	Moderate	
Temperature	71 °F	Vegetation:	None	
Conductivity:	-- µS/cm	Benthic Growth:	None	
Detergents:	0 mg/L	Stains:	Moderate	
		Non-illicit:	None	
			Condition Assessment	
			Graffiti:	None
			Erosion:	None
			Deposition:	None 0 in.
			Damage:	None

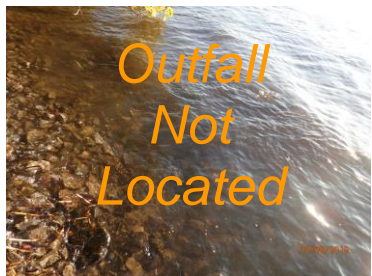
o20191008065912.JPG

Inspection Date: 10/8/2019 8:00:16 AM		Type: Ongoing	Flow: Submerged (not located)	Previous Rainfall (hrs): 48-72
Illicit Discharge Potential: Potential		Inspector: JCW	Notes	
Submerged: Fully		Depth (in):	Outfall fully submerged and not located - screened upstream at 03-173 US1. Floating gross solids (litter) in manhole. Detergent detected.	
Sampling Results		Floatables:	Condition Assessment	
Sample Location:		Odor:		
Total Chlorine: -- ppm		Turbidity:	Gross Solids: None	
Free Chlorine: -- ppm		Color:	Vegetation: None	
Ammonia: -- ppm		Gross Solids:	Benthic Growth: None	
pH: -- units		Stains:	Deposition: None in.	
Temperature -- °F		Non-illicit:	Damage: None	
Conductivity: -- µS/cm				
Detergents: -- mg/L

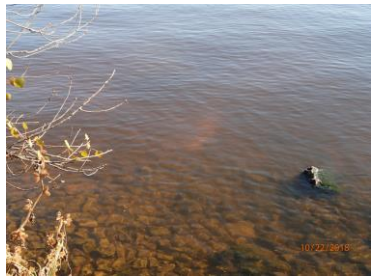
o20181022131820.JPG

Inspection Date: 10/22/2018 1:18:45 PM		Type: Ongoing	Flow: Submerged, indeterminate	Previous Rainfall (hrs): 48-72
Illicit Discharge Potential: Potential		Inspector: JCW	Notes	
Submerged: Fully		Depth (in):	Outfall fully submerged and not located - screened upstream at 03-173 US1. Floating gross solids (litter) in manhole.	
Sampling Results		Floatables:	Condition Assessment	
Sample Location:		Odor:		
Total Chlorine: -- ppm		Turbidity:	Gross Solids: None	
Free Chlorine: -- ppm		Color:	Vegetation: None	
Ammonia: -- ppm		Gross Solids:	Benthic Growth: None	
pH: -- units		Stains:	Deposition: None in.	
Temperature -- °F		Non-illicit:	Damage: None	
Conductivity: -- µS/cm				
Detergents: -- mg/L

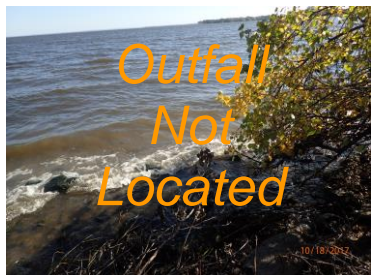
o20171018142348.JPG

Inspection Date: 10/18/2017 2:27:05 PM		Type: Ongoing	Flow: Submerged (not located)	Previous Rainfall (hrs): 72+
Illicit Discharge Potential: Potential		Inspector: JCW	Notes	
Submerged: Fully		Depth (in):	Outfall fully submerged and not located - screened upstream at 03-173 US2. Floating gross solids (litter) in manhole.	
Sampling Results		Floatables:	Condition Assessment	
Sample Location:		Odor:		
Total Chlorine: -- ppm		Turbidity:	Gross Solids: None	
Free Chlorine: -- ppm		Color:	Vegetation: None	
Ammonia: -- ppm		Gross Solids:	Benthic Growth: None	
pH: -- units		Stains:	Deposition: None in.	
Temperature -- °F		Non-illicit:	Damage: None	
Conductivity: -- µS/cm				
Detergents: -- mg/L

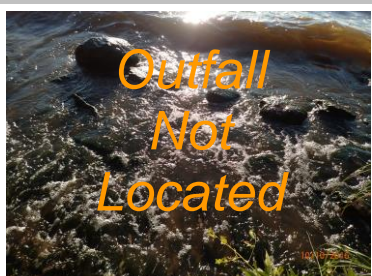
o20161010082552.JPG

Inspection Date: 10/10/2016 8:27:25 AM		Type: Ongoing	Flow: Submerged (not located)	Previous Rainfall (hrs): 72+
Illicit Discharge Potential: Potential		Inspector: JCW	Notes	
Submerged: Fully		Depth (in):	Outfall fully submerged and not located - screened upstream at 03-173 US2.	
Sampling Results		Floatables:	Condition Assessment	
Sample Location:		Odor:		
Total Chlorine: -- ppm		Turbidity:	Gross Solids: None	
Free Chlorine: -- ppm		Color:	Vegetation: None	
Ammonia: -- ppm		Gross Solids:	Benthic Growth: None	
pH: -- units		Stains:	Deposition: None in.	
Temperature -- °F		Non-illicit:	Damage: None	
Conductivity: -- µS/cm				
Detergents: -- mg/L

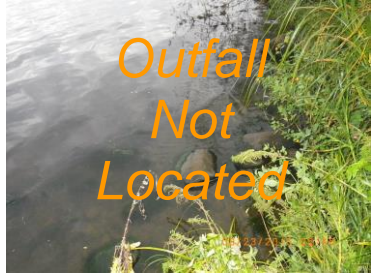
Inspection Date: 9/23/2015 6:48:56 AM		Type: Ongoing		Flow: Submerged (not located)		Previous Rainfall (hrs): 72+	
Illicit Discharge Potential: Potential		Inspector: JCW		Notes Outfall fully submerged and not located during this screening - screened at 13-173 US2.

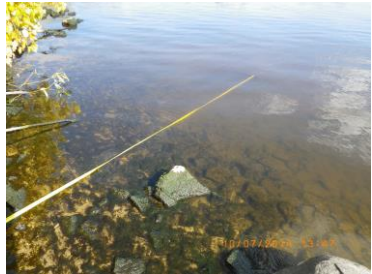
Inspection Date: 10/7/2014 1:47:08 PM		Type: Ongoing		Flow: Submerged, indeterminate		Previous Rainfall (hrs): 48-72	
Illicit Discharge Potential: Potential		Inspector: JCW		Notes Outfall fully submerged - screened upstream at 13-173 US2. Pipe approx 5" below water surface.

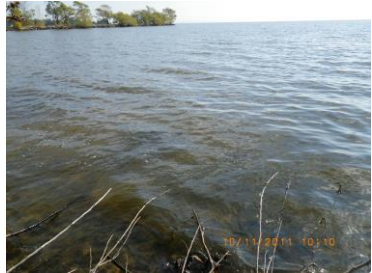
Inspection Date: 10/11/2011 10:11:07 AM		Type: Ongoing		Flow: Submerged, indeterminate		Previous Rainfall (hrs): 72+	
Illicit Discharge Potential: Unlikely		Inspector: JCW		Notes 2010 screening follow-up. Outfall fully submerged. Outfall screened upstream at 03-173 US2.

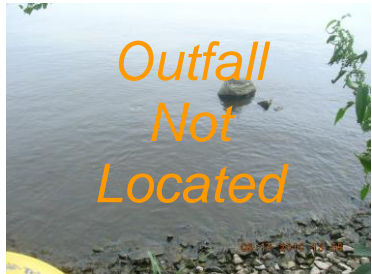
Inspection Date: 8/17/2010 2:04:29 PM		Type: Ongoing		Flow: Submerged (not located)		Previous Rainfall (hrs): 72+	
Illicit Discharge Potential: Potential		Inspector: JCW		Notes Outfall fully submerged and not physically located. Outfall screened upstream at 03-173 US2.

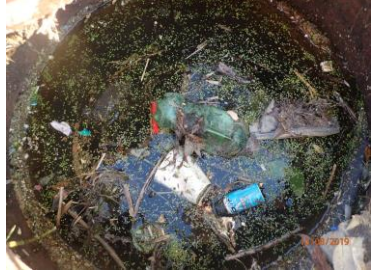
o20191008070022.JPG		
2019

Inspection Date: 10/8/2019 8:01:54 AM		Type: Ongoing	Flow: Submerged, indeterminate	Previous Rainfall (hrs): 48-72
Illicit Discharge Potential: Potential		Inspector: JCW		
Submerged: Partially		Depth (in): 38		
Sampling Results		Notes Manhole 03-173 US2 inaccessible (behind locked gate). Floating gross solids (litter) in manhole. Detergent detected.		
Sample Location: Pool Total Chlorine: 0 ppm Free Chlorine: 0 ppm Ammonia: 0 ppm pH: 7.64 units Temperature: 53 °F Conductivity: 592 µS/cm Detergents: 1 mg/L		Condition Assessment Graffiti: None Erosion: None Deposition: Minor 4 in. Damage: None		
Floatables: Moderate Odor: None Turbidity: None Color: None Gross Solids: Moderate Vegetation: None Benthic Growth: Slight Stains: None Non-illicit: None

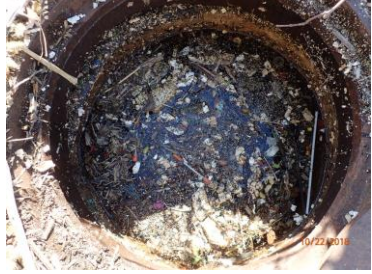
o20181022132154.JPG		
2018

Inspection Date: 10/22/2018 1:24:38 PM		Type: Ongoing	Flow: Submerged, indeterminate	Previous Rainfall (hrs): 48-72
Illicit Discharge Potential: Potential		Inspector: JCW		
Submerged: Fully		Depth (in): 40		
Sampling Results		Notes Manhole 03-173 US2 inaccessible (behind locked gate). Floating gross solids (litter) in manhole, including 2 syringes.		
Sample Location: Pool Total Chlorine: 0 ppm Free Chlorine: 0 ppm Ammonia: 0 ppm pH: 7.18 units Temperature: 59 °F Conductivity: 1229 µS/cm Detergents: 0 mg/L		Condition Assessment Graffiti: None Erosion: None Deposition: None in. Damage: None		
Floatables: None Odor: None Turbidity: None Color: None Gross Solids: Moderate Vegetation: None Benthic Growth: None Stains: None Non-illicit: None

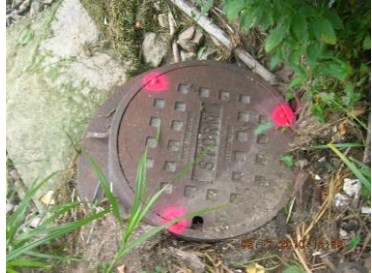
o20100817135854.JPG		
2010

Inspection Date: 8/17/2010 2:07:11 PM		Type: Ongoing	Flow: Submerged, indeterminate	Previous Rainfall (hrs): 72+
Illicit Discharge Potential: Potential		Inspector: JCW		
Submerged: Fully		Depth (in):		
Sampling Results		Notes Lid bolts rusted tight - could not access. Screened upstream at 03-173 US2.		
Sample Location: -- Total Chlorine: -- ppm Free Chlorine: -- ppm Ammonia: -- ppm pH: -- units Temperature: -- °F Conductivity: -- µS/cm Detergents: -- mg/L		Condition Assessment Graffiti: None Erosion: None Deposition: None 0 in. Damage: Moderate		
Floatables: None Odor: None Turbidity: None Color: None Gross Solids: None Vegetation: None Benthic Growth: None Stains: None Non-illicit: None

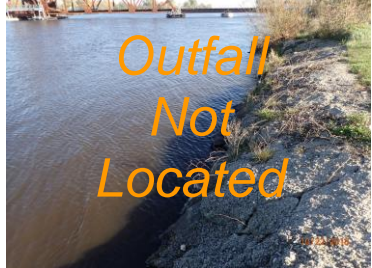
Inspection Date: 10/22/2018 3:03:58 PM		Type: Ongoing	Flow: Submerged (not located)	Previous Rainfall (hrs): 48-72
Illicit Discharge Potential: Potential		Inspector: JCW		
Submerged: Fully		Depth (in):		
Sampling Results Sample Location: _____ Total Chlorine: -- ppm Free Chlorine: -- ppm Ammonia: -- ppm pH: -- units Temperature: -- °F Conductivity: -- µS/cm Detergents: -- mg/L		Floatables: None Odor: None Turbidity: None Color: None Gross Solids: None Vegetation: None Benthic Growth: None Stains: None Non-illicit: None	Notes Outfall fully submerged and not located - screened upstream at 03-381 US1. Floating gross solids (litter) in manhole.

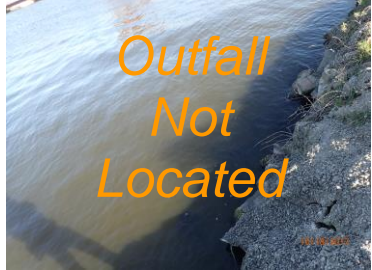
Inspection Date: 10/18/2017 3:02:59 PM		Type: Ongoing	Flow: Submerged (not located)	Previous Rainfall (hrs): 72+
Illicit Discharge Potential: Potential		Inspector: JCW		
Submerged: Fully		Depth (in):		
Sampling Results Sample Location: _____ Total Chlorine: -- ppm Free Chlorine: -- ppm Ammonia: -- ppm pH: -- units Temperature: -- °F Conductivity: -- µS/cm Detergents: -- mg/L		Floatables: None Odor: None Turbidity: None Color: None Gross Solids: None Vegetation: None Benthic Growth: None Stains: None Non-illicit: None	Notes Outfall fully submerged and not located - screened upstream at 03-381 US1. Floating gross solids (litter) in manhole.

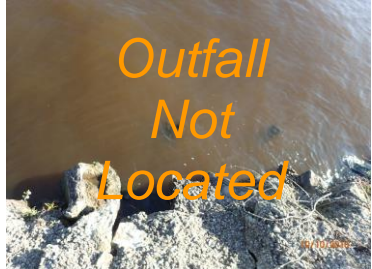
Inspection Date: 10/10/2016 9:18:11 AM		Type: Ongoing	Flow: Submerged (not located)	Previous Rainfall (hrs): 72+
Illicit Discharge Potential: Potential		Inspector: JCW		
Submerged: Fully		Depth (in):		
Sampling Results Sample Location: _____ Total Chlorine: -- ppm Free Chlorine: -- ppm Ammonia: -- ppm pH: -- units Temperature: -- °F Conductivity: -- µS/cm Detergents: -- mg/L		Floatables: None Odor: None Turbidity: None Color: None Gross Solids: None Vegetation: None Benthic Growth: None Stains: None Non-illicit: None	Notes Outfall fully submerged and not located - screened upstream at 03-381 US1.

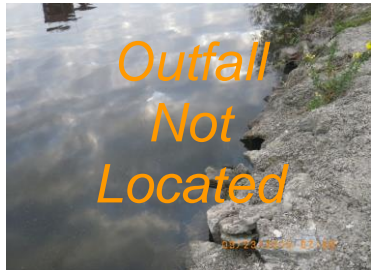
Inspection Date: 9/23/2015 7:22:24 AM		Type: Ongoing	Flow: Submerged (not located)	Previous Rainfall (hrs): 72+
Illicit Discharge Potential: Potential		Inspector: JCW		
Submerged: Fully		Depth (in):		
Sampling Results Sample Location: _____ Total Chlorine: -- ppm Free Chlorine: -- ppm Ammonia: -- ppm pH: -- units Temperature: -- °F Conductivity: -- µS/cm Detergents: -- mg/L		Floatables: None Odor: None Turbidity: None Color: None Gross Solids: None Vegetation: None Benthic Growth: None Stains: None Non-illicit: None	Notes Outfall fully submerged and not located - screened at 03-381 US1.

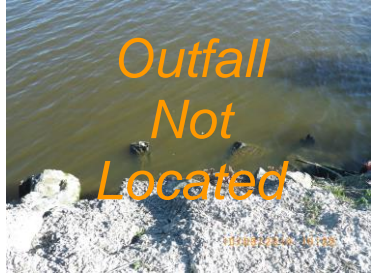
o20141009092246.JPG 2014

Inspection Date: 10/9/2014 10:22:12 AM		Type: Ongoing	Flow: Submerged (not located)	Previous Rainfall (hrs): 72+
Illicit Discharge Potential: Unlikely		Inspector: JCW		
Submerged: Fully		Depth (in):		
Sampling Results				
Sample Location:	Floatables:	None		
Total Chlorine: -- ppm	Odor:	None		
Free Chlorine: -- ppm	Turbidity:	None		
Ammonia: -- ppm	Color:	None		
pH: -- units	Gross Solids:	None		
Temperature -- °F	Vegetation:	None		
Conductivity: -- µS/cm	Benthic Growth:	None		
Detergents: -- mg/L	Stains:	None		
	Non-illicit:	None		
		Notes Outfall fully submerged and not located - screened upstream at 03-381 US1.		
		Condition Assessment Graffiti: None Erosion: None Deposition: None in. Damage: None

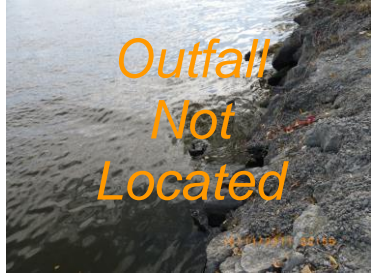
o20111011095540.JPG 2011

Inspection Date: 10/11/2011 9:56:37 AM		Type: Ongoing	Flow: Submerged (not located)	Previous Rainfall (hrs): 72+
Illicit Discharge Potential: Unlikely		Inspector: JCW		
Submerged: Fully		Depth (in):		
Sampling Results				
Sample Location:	Floatables:	None		
Total Chlorine: -- ppm	Odor:	None		
Free Chlorine: -- ppm	Turbidity:	None		
Ammonia: -- ppm	Color:	None		
pH: -- units	Gross Solids:	None		
Temperature -- °F	Vegetation:	None		
Conductivity: -- µS/cm	Benthic Growth:	None		
Detergents: -- mg/L	Stains:	None		
	Non-illicit:	None		
		Notes 2010 screening follow-up. Outfall fully submerged and not physically located. Outfall screened upstream at 03-381 US1.		
		Condition Assessment Graffiti: None Erosion: None Deposition: None 0 in. Damage: None

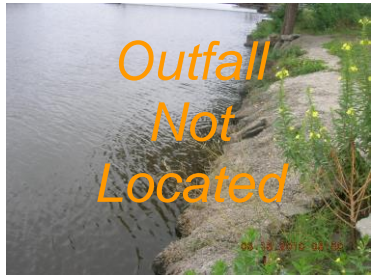
o20100818085058.JPG 2010

Inspection Date: 8/18/2010 8:59:26 AM		Type: Ongoing	Flow: Submerged (not located)	Previous Rainfall (hrs): 72+
Illicit Discharge Potential: Potential		Inspector: JCW		
Submerged: Fully		Depth (in):		
Sampling Results				
Sample Location:	Floatables:	None		
Total Chlorine: -- ppm	Odor:	None		
Free Chlorine: -- ppm	Turbidity:	None		
Ammonia: -- ppm	Color:	None		
pH: -- units	Gross Solids:	None		
Temperature -- °F	Vegetation:	None		
Conductivity: -- µS/cm	Benthic Growth:	None		
Detergents: -- mg/L	Stains:	None		
	Non-illicit:	None		
		Notes Outfall fully submerged and not physically located. Outfall screened upstream at 03-381 US1.		
		Condition Assessment Graffiti: None Erosion: None Deposition: None 0 in. Damage: None
