Ongoing Screening Summary Report 2019 Inspection Year

Illicit Discharge Detection and Elimination Program

City of Oshkosh

January 3, 2020

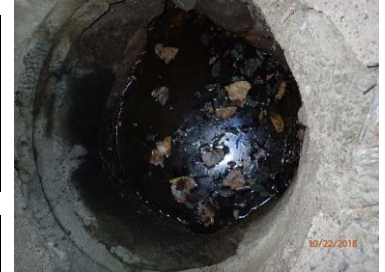
o20181022150350.JPG

Inspection Date: 10/22/2018 3:06:47 PM		Type: Ongoing	Flow: Submerged, indeterminate	Previous Rainfall (hrs): 48-72
Illicit Discharge Potential: Potential		Inspector: JCW		
Submerged: Fully		Depth (in): 14		
Sampling Results		Notes Sample collected from submerged pool in manhole. Floating gross solids (litter) in manhole.		
Sample Location: Pool	Floatables: None	Condition Assessment Graffiti: None Erosion: None Deposition: None in. Damage: None		
Total Chlorine: 0 ppm	Odor: None			
Free Chlorine: 0 ppm	Turbidity: None			
Ammonia: 0 ppm	Color: None			
pH: 6.73 units	Gross Solids: Slight			
Temperature 59 °F	Vegetation: None			
Conductivity: 877 µS/cm	Benthic Growth: Slight			
Detergents: 0 mg/L	Stains: None			
	Non-illicit: Slight

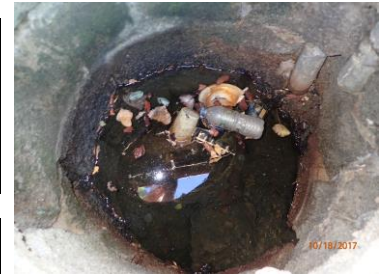
o20171018150142.JPG

Inspection Date: 10/18/2017 3:05:57 PM		Type: Ongoing	Flow: Submerged, indeterminate	Previous Rainfall (hrs): 72+
Illicit Discharge Potential: Potential		Inspector: JCW		
Submerged: Fully		Depth (in): 16		
Sampling Results		Notes Sample collected from submerged pool in manhole. Floating gross solids (litter) in manhole.		
Sample Location: Pool	Floatables: None	Condition Assessment Graffiti: None Erosion: None Deposition: None in. Damage: None		
Total Chlorine: 0 ppm	Odor: None			
Free Chlorine: 0 ppm	Turbidity: None			
Ammonia: 0 ppm	Color: None			
pH: 7.71 units	Gross Solids: Moderate			
Temperature 66 °F	Vegetation: None			
Conductivity: 317 µS/cm	Benthic Growth: None			
Detergents: 0 mg/L	Stains: None			
	Non-illicit: None

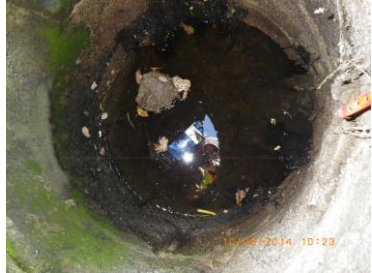
Inspection Date: 10/9/2014 10:25:59 AM		Type: Ongoing	Flow: Submerged, indeterminate	Previous Rainfall (hrs): 72+	
Illicit Discharge Potential: Unlikely		Inspector: JCW	Notes		
Submerged: Fully		Depth (in): 14

<p style="text-align: center;">o20141009092338.JPG</p> <p style="text-align: center; font-size: 24pt; font-weight: bold;">2014</p>		
Sampling Results					
Sample Location:	Pool	Floatables:			None
Total Chlorine:	0 ppm	Odor:			None
Free Chlorine:	0 ppm	Turbidity:			None
Ammonia:	0 ppm	Color:			Faint in bottle
pH:	7.79 units	Gross Solids:			Slight
Temperature	57 °F	Vegetation:			None
Conductivity:	408 µS/cm	Benthic Growth:			Slight
Detergents:	0 mg/L	Stains:			Moderate
		Non-illicit:	None		
			Condition Assessment Graffiti: None Erosion: None Deposition: Minor 2 in. Damage: None

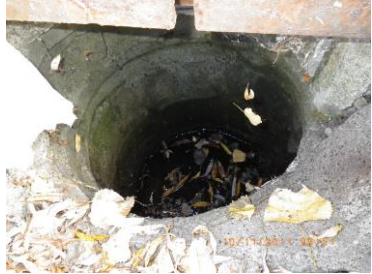
Inspection Date: 10/11/2011 9:52:43 AM		Type: Ongoing	Flow: Submerged, indeterminate	Previous Rainfall (hrs): 72+	
Illicit Discharge Potential: Unlikely		Inspector: JCW	Notes		
Submerged: Fully		Depth (in): 12

<p style="text-align: center;">o20111011095140.JPG</p> <p style="text-align: center; font-size: 24pt; font-weight: bold;">2011</p>		
Sampling Results					
Sample Location:	Pool	Floatables:			None
Total Chlorine:	0 ppm	Odor:			Faint
Free Chlorine:	0 ppm	Turbidity:			None
Ammonia:	0 ppm	Color:			None
pH:	7.1 units	Gross Solids:			None
Temperature	71 °F	Vegetation:			None
Conductivity:	-- µS/cm	Benthic Growth:			None
Detergents:	-- mg/L	Stains:			None
		Non-illicit:	None		
			Condition Assessment Graffiti: None Erosion: None Deposition: None 0 in. Damage: None

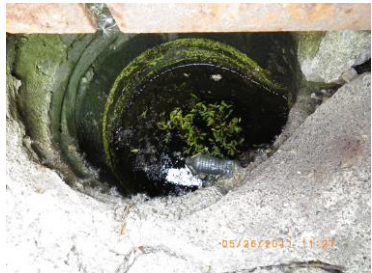
Inspection Date: 5/26/2011 11:27:00 AM		Type: Other	Flow: Submerged, indeterminate	Previous Rainfall (hrs): 72+	
Illicit Discharge Potential: Unlikely		Inspector: JCW	Notes		
Submerged: Fully		Depth (in):

<p style="text-align: center;">o20110526112736.JPG</p> <p style="text-align: center; font-size: 24pt; font-weight: bold;">2011</p>		
Sampling Results					
Sample Location:		Floatables:			None
Total Chlorine:	-- ppm	Odor:			
Free Chlorine:	-- ppm	Turbidity:			
Ammonia:	-- ppm	Color:			
pH:	-- units	Gross Solids:			Slight
Temperature	-- °F	Vegetation:			
Conductivity:	-- µS/cm	Benthic Growth:			
Detergents:	-- mg/L	Stains:			
		Non-illicit:	None		
			Condition Assessment Graffiti: None Erosion: None Deposition: None 0 in. Damage: None

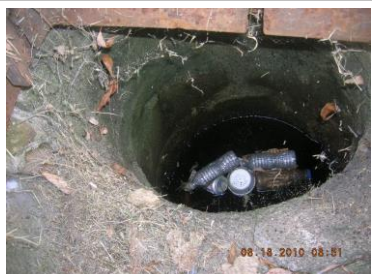
Inspection Date: 8/18/2010 9:03:59 AM		Type: Ongoing	Flow: Submerged, indeterminate	Previous Rainfall (hrs): 72+	
Illicit Discharge Potential: Potential		Inspector: JCW	Notes		
Submerged: Fully		Depth (in): 13

<p style="text-align: center;">o20100818085124.JPG</p> <p style="text-align: center; font-size: 24pt; font-weight: bold;">2010</p>		
Sampling Results					
Sample Location:	Pool	Floatables:			Moderate
Total Chlorine:	0 ppm	Odor:			Faint
Free Chlorine:	0 ppm	Turbidity:			None
Ammonia:	0 ppm	Color:			Faint in bottle
pH:	7.13 units	Gross Solids:			Moderate
Temperature	72 °F	Vegetation:			None
Conductivity:	-- µS/cm	Benthic Growth:			None
Detergents:	0 mg/L	Stains:			None
		Non-illicit:	None		
			Condition Assessment Graffiti: None Erosion: None Deposition: None 0 in. Damage: None

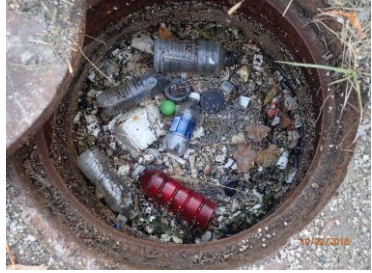
o20181022171308.JPG

Inspection Date: 10/22/2018 5:15:36 PM		Type: Ongoing	Flow: Submerged, indeterminate	Previous Rainfall (hrs): 48-72
Illicit Discharge Potential: Potential		Inspector: JCW		
Submerged: Fully		Depth (in): 47		
Sampling Results		Notes Sample collected from submerged pool in manhole. Floating gross solids (litter) in manhole.		
Sample Location: Pool	Floatables: None	Condition Assessment Graffiti: None Erosion: None Deposition: None in. Damage: None		
Total Chlorine: 0 ppm	Odor: None			
Free Chlorine: 0 ppm	Turbidity: Cloudy			
Ammonia: 0 ppm	Color: None			
pH: 7.59 units	Gross Solids: Severe			
Temperature 56 °F	Vegetation: None			
Conductivity: 361 µS/cm	Benthic Growth: None			
Detergents: 0 mg/L	Stains: None			
	Non-illicit: None

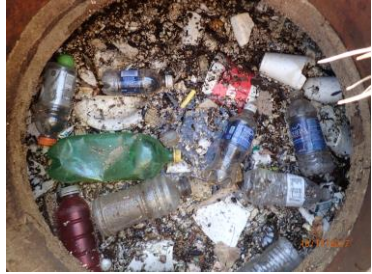
o20171017155256.JPG

Inspection Date: 10/17/2017 3:58:36 PM		Type: Ongoing	Flow: Submerged, indeterminate	Previous Rainfall (hrs): 48-72
Illicit Discharge Potential: Potential		Inspector: JCW		
Submerged: Fully		Depth (in): 40		
Sampling Results		Notes Sample collected from submerged pool in manhole. Floating gross solids (litter) in manhole.		
Sample Location: Pool	Floatables: None	Condition Assessment Graffiti: None Erosion: None Deposition: None in. Damage: None		
Total Chlorine: 0 ppm	Odor: None			
Free Chlorine: 0 ppm	Turbidity: None			
Ammonia: 0 ppm	Color: None			
pH: 7.93 units	Gross Solids: Severe			
Temperature 66 °F	Vegetation: None			
Conductivity: 886 µS/cm	Benthic Growth: None			
Detergents: 0 mg/L	Stains: None			
	Non-illicit: None

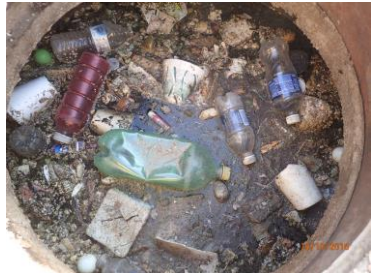
o20161010154428.JPG

Inspection Date: 10/10/2016 3:46:48 PM		Type: Ongoing	Flow: Submerged, indeterminate	Previous Rainfall (hrs): 72+
Illicit Discharge Potential: Potential		Inspector: JCW		
Submerged: Fully		Depth (in): 41		
Sampling Results		Notes Potential illicit discharge due to gross solids.		
Sample Location: Pool	Floatables: None	Condition Assessment Graffiti: None Erosion: None Deposition: None in. Damage: None		
Total Chlorine: 0 ppm	Odor: None			
Free Chlorine: 0 ppm	Turbidity: None			
Ammonia: 0 ppm	Color: None			
pH: 7.69 units	Gross Solids: Severe			
Temperature 70 °F	Vegetation: None			
Conductivity: 660 µS/cm	Benthic Growth: None			
Detergents: 0 mg/L	Stains: None			
	Non-illicit: None

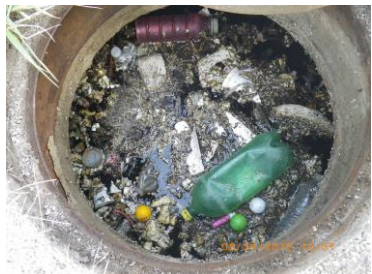
o20150924093714.JPG

Inspection Date: 9/24/2015 10:36:18 AM		Type: Ongoing	Flow: Submerged, indeterminate	Previous Rainfall (hrs): 72+
Illicit Discharge Potential: Potential		Inspector: JCW		
Submerged: Fully		Depth (in): 44		
Sampling Results		Notes Floating gross solids (litter) in manhole.		
Sample Location: Pool	Floatables: None	Condition Assessment Graffiti: None Erosion: None Deposition: None in. Damage: None		
Total Chlorine: 0 ppm	Odor: None			
Free Chlorine: 0 ppm	Turbidity: None			
Ammonia: 0 ppm	Color: None			
pH: 7.98 units	Gross Solids: Severe			
Temperature 70 °F	Vegetation: None			
Conductivity: 424 µS/cm	Benthic Growth: None			
Detergents: 0 mg/L	Stains: None			
	Non-illicit: None

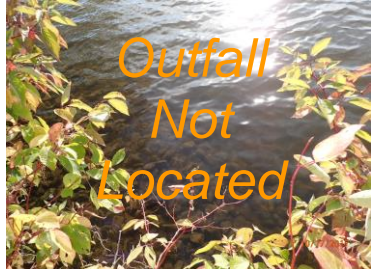
Inspection Date: 10/17/2017 3:57:59 PM		Type: Ongoing	Flow: Submerged (not located)	Previous Rainfall (hrs): 48-72
Illicit Discharge Potential: Potential		Inspector: JCW		
Submerged: Fully		Depth (in):		
Sampling Results Sample Location: _____ Total Chlorine: -- ppm Free Chlorine: -- ppm Ammonia: -- ppm pH: -- units Temperature: -- °F Conductivity: -- µS/cm Detergents: -- mg/L		Floatables: None Odor: None Turbidity: None Color: None Gross Solids: None Vegetation: None Benthic Growth: None Stains: None Non-illicit: None	Notes Outfall fully submerged and not located - screened upstream at 05-241 US1. Detergent detected in upstream manhole.

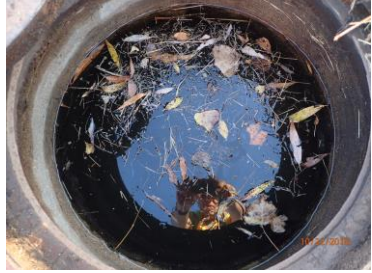
Sample Location:	Pool																																					
Total Chlorine:	0 ppm																																					
Free Chlorine:	0 ppm																																					
Ammonia:	0 ppm																																					
pH:	7.55 units																																					
Temperature:	55 °F																																					
Conductivity:	410 µS/cm																																					
Detergents:	0 mg/L																																					
Floatables:	None																																					
Odor:	None																																					
Turbidity:	None																																					
Color:	None																																					
Gross Solids:	None																																					
Vegetation:	None																																					
Benthic Growth:	None																																					
Stains:	None																																					
Non-illicit:	None

Notes Sample collected from submerged pool in manhole.																																				
		Condition Assessment <table border="1" style="width:100%; border-collapse: collapse;"> <tr><td>Graffiti:</td><td>None</td></tr> <tr><td>Erosion:</td><td>None</td></tr> <tr><td>Deposition:</td><td>None in.</td></tr> <tr><td>Damage:</td><td>None</td></tr> </table>			Graffiti:	None	Erosion:	None	Deposition:	None in.	Damage:	None																										
Graffiti:	None																																					
Erosion:	None																																					
Deposition:	None in.																																					
Damage:	None

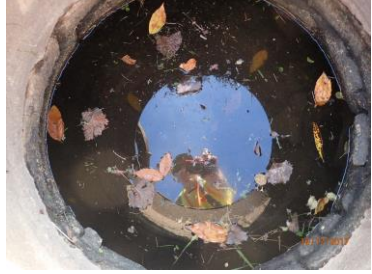
o20171017155840.JPG <div style="text-align: center; font-size: 24pt; font-weight: bold;">2017</div>

Notes Detergent detected in sample collected from submerged pool in manhole.																																				
		Condition Assessment <table border="1" style="width:100%; border-collapse: collapse;"> <tr><td>Graffiti:</td><td>None</td></tr> <tr><td>Erosion:</td><td>None</td></tr> <tr><td>Deposition:</td><td>None in.</td></tr> <tr><td>Damage:</td><td>None</td></tr> </table>			Graffiti:	None	Erosion:	None	Deposition:	None in.	Damage:	None																										
Graffiti:	None																																					
Erosion:	None																																					
Deposition:	None in.																																					
Damage:	None

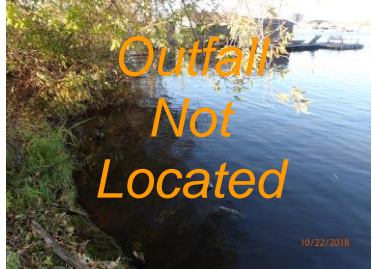
o20181022163054.JPG <div style="text-align: center; font-size: 24pt; font-weight: bold;">2018</div>

Inspection Date: 10/22/2018 4:31:59 PM		Type: Ongoing	Flow: Submerged (not located)	Previous Rainfall (hrs): 48-72
Illicit Discharge Potential: Potential		Inspector: JCW		
Submerged: Fully		Depth (in):		
Sampling Results Sample Location: _____ Total Chlorine: -- ppm Free Chlorine: -- ppm Ammonia: -- ppm pH: -- units Temperature: -- °F Conductivity: -- µS/cm Detergents: -- mg/L		Floatables: None Odor: None Turbidity: None Color: None Gross Solids: None Vegetation: None Benthic Growth: None Stains: None Non-illicit: None	Notes Outfall fully submerged and not located - screened upstream at 06-52 US1. Floating gross solids (litter) in manhole. Condition Assessment Graffiti: None Erosion: None Deposition: None in. Damage: None

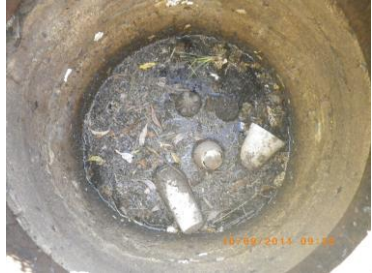
<p style="text-align: center;">o20141009083526.JPG</p> <p style="text-align: center; font-size: 24pt; font-weight: bold;">2014</p>	
Submerged: Fully		Depth (in): 35		Condition Assessment Graffiti: None Erosion: None Deposition: None in. Damage: None			
Sampling Results Sample Location: Pool Total Chlorine: 0 ppm Free Chlorine: 0 ppm Ammonia: 0 ppm pH: 7.82 units Temperature: 56 °F Conductivity: 471 µS/cm Detergents: 0 mg/L		Floatables: None Odor: None Turbidity: Slight cloudiness Color: None Gross Solids: Severe Vegetation: None Benthic Growth: Slight Stains: None Non-illicit: None

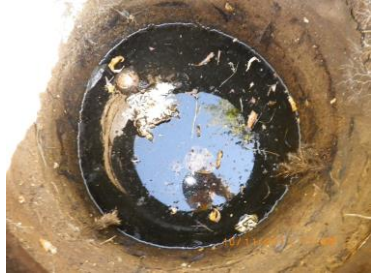
<p style="text-align: center;">o20111011110824.JPG</p> <p style="text-align: center; font-size: 24pt; font-weight: bold;">2011</p>	
Submerged: Fully		Depth (in): 35		Condition Assessment Graffiti: None Erosion: None Deposition: None 0 in. Damage: None			
Sampling Results Sample Location: Pool Total Chlorine: 0 ppm Free Chlorine: 0 ppm Ammonia: 0 ppm pH: 8.13 units Temperature: 70 °F Conductivity: -- µS/cm Detergents: -- mg/L		Floatables: None Odor: None Turbidity: None Color: None Gross Solids: Moderate Vegetation: None Benthic Growth: None Stains: None Non-illicit: None

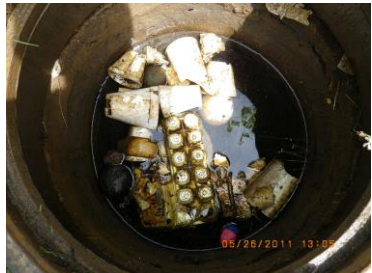
<p style="text-align: center;">o20110526130522.JPG</p> <p style="text-align: center; font-size: 24pt; font-weight: bold;">2011</p>	
Submerged: Fully		Depth (in):		Condition Assessment Graffiti: None Erosion: None Deposition: None 0 in. Damage: None			
Sampling Results Sample Location: -- Total Chlorine: -- ppm Free Chlorine: -- ppm Ammonia: -- ppm pH: -- units Temperature: -- °F Conductivity: -- µS/cm Detergents: -- mg/L		Floatables: None Odor: -- Turbidity: -- Color: -- Gross Solids: Moderate Vegetation: -- Benthic Growth: -- Stains: -- Non-illicit: None

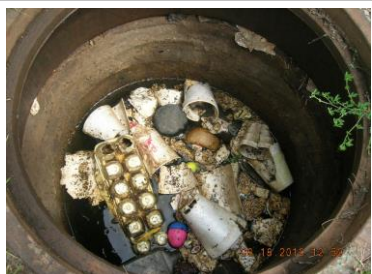
<p style="text-align: center;">o20100818125018.JPG</p> <p style="text-align: center; font-size: 24pt; font-weight: bold;">2010</p>	
Submerged: Fully		Depth (in): 41		Condition Assessment Graffiti: None Erosion: None Deposition: None 0 in. Damage: None			
Sampling Results Sample Location: Pool Total Chlorine: 0 ppm Free Chlorine: 0 ppm Ammonia: 0 ppm pH: 7.98 units Temperature: 76 °F Conductivity: -- µS/cm Detergents: 0 mg/L		Floatables: None Odor: None Turbidity: Slight cloudiness Color: Faint in bottle Gross Solids: Severe Vegetation: None Benthic Growth: None Stains: None Non-illicit: None

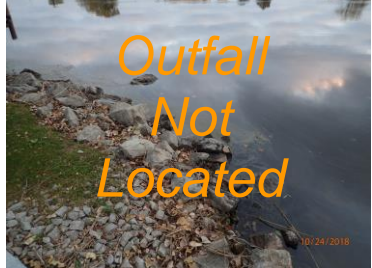
o20181024073028.JPG	
			2018

Inspection Date: 10/24/2018 7:31:02 AM		Type: Ongoing	Flow: Submerged (not located)	Previous Rainfall (hrs): 72+
Illicit Discharge Potential: Potential		Inspector: JCW		
Submerged: Fully		Depth (in):		
Sampling Results Sample Location: _____ Total Chlorine: -- ppm Free Chlorine: -- ppm Ammonia: -- ppm pH: -- units Temperature: -- °F Conductivity: -- µS/cm Detergents: -- mg/L		Floatables: None Odor: None Turbidity: None Color: None Gross Solids: None Vegetation: None Benthic Growth: None Stains: None Non-illicit: None		
		Notes Outfall fully submerged and not located - screened upstream at 06-216 US1. Floating gross solids (litter) in manhole.		
		Condition Assessment Graffiti: None Erosion: None Deposition: None in. Damage: None

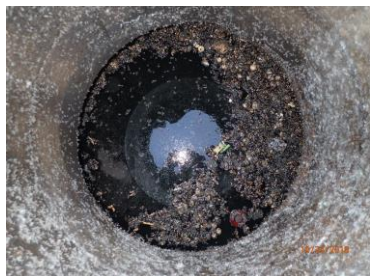
o20181024073322.JPG
2018

Inspection Date: 10/24/2018 7:36:44 AM		Type: Ongoing	Flow: Submerged, indeterminate	Previous Rainfall (hrs): 72+
Illicit Discharge Potential: Potential		Inspector: JCW		
Submerged: Fully		Depth (in): 108		
Sampling Results		Notes Sample collected from submerged pool in manhole. Floating gross solids (litter) in manhole.		
Sample Location: Pool	Floatables: None	Condition Assessment Graffiti: None Erosion: None Deposition: None in. Damage: None		
Total Chlorine: 0 ppm	Odor: None			
Free Chlorine: 0 ppm	Turbidity: None			
Ammonia: 0 ppm	Color: None			
pH: 7.31 units	Gross Solids: Slight			
Temperature 53 °F	Vegetation: None			
Conductivity: 1242 µS/cm	Benthic Growth: None			
Detergents: 0 mg/L	Stains: None			
	Non-illicit: None

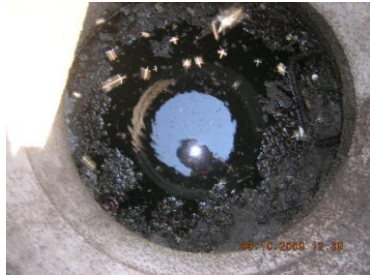
Osh09_DSCN6788.JPG
2009

Inspection Date: 9/10/2009		Type: Initial	Flow: Submerged, indeterminate	Previous Rainfall (hrs): 72+
Illicit Discharge Potential: Unlikely		Inspector: JCW		
Submerged: Fully		Depth (in): 100		
Sampling Results		Notes River fly swarm inside manhole.		
Sample Location: Pool	Floatables: None	Condition Assessment Graffiti: None Erosion: None Deposition: None 0 in. Damage: None		
Total Chlorine: 0 ppm	Odor: None			
Free Chlorine: 0 ppm	Turbidity: None			
Ammonia: -- ppm	Color: None			
pH: 6.96 units	Gross Solids: None			
Temperature 79 °F	Vegetation: None			
Conductivity: -- µS/cm	Benthic Growth: None			
Detergents: 0 mg/L	Stains: None			
	Non-illicit: None

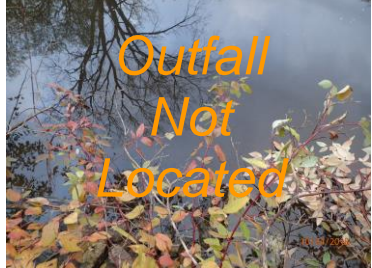
o20181024074402.JPG <div style="text-align: center; font-size: 24pt; font-weight: bold;">2018</div>

Inspection Date: 10/24/2018 7:45:30 AM		Type: Ongoing	Flow: Submerged (not located)	Previous Rainfall (hrs): 72+
Illicit Discharge Potential: Potential		Inspector: JCW		
Submerged: Fully		Depth (in):		
Sampling Results Sample Location: _____ Total Chlorine: -- ppm Free Chlorine: -- ppm Ammonia: -- ppm pH: -- units Temperature: -- °F Conductivity: -- µS/cm Detergents: -- mg/L		Floatables: None Odor: None Turbidity: None Color: None Gross Solids: None Vegetation: None Benthic Growth: None Stains: None Non-illicit: None	Notes Outfall fully submerged and not located - screened upstream at 06-221 US1. Floating gross solids (litter) in manhole. Condition Assessment Graffiti: None Erosion: None Deposition: None in. Damage: None

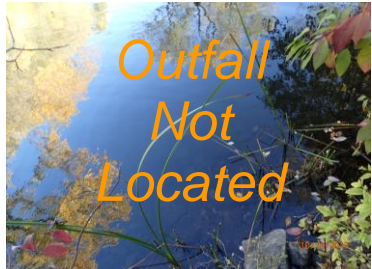
o20171018105502.JPG <div style="text-align: center; font-size: 24pt; font-weight: bold;">2017</div>

Inspection Date: 10/18/2017 10:56:45 AM		Type: Ongoing	Flow: Submerged (not located)	Previous Rainfall (hrs): 72+
Illicit Discharge Potential: Potential		Inspector: JCW		
Submerged: Fully		Depth (in):		
Sampling Results Sample Location: _____ Total Chlorine: -- ppm Free Chlorine: -- ppm Ammonia: -- ppm pH: -- units Temperature: -- °F Conductivity: -- µS/cm Detergents: -- mg/L		Floatables: None Odor: None Turbidity: None Color: None Gross Solids: None Vegetation: None Benthic Growth: None Stains: None Non-illicit: None	Notes Outfall fully submerged and not located - screened upstream at 06-221 US1. Floating gross solids (litter) in manhole. Condition Assessment Graffiti: None Erosion: None Deposition: None in. Damage: None

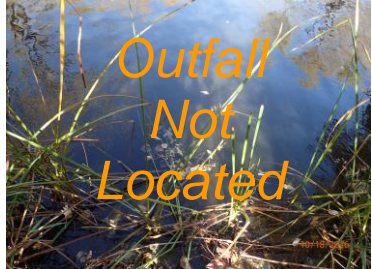
o20161018133940.JPG <div style="text-align: center; font-size: 24pt; font-weight: bold;">2016</div>

Inspection Date: 10/18/2016 1:40:09 PM		Type: Ongoing	Flow: Submerged (not located)	Previous Rainfall (hrs): 72+
Illicit Discharge Potential: Potential		Inspector: JCW		
Submerged: Fully		Depth (in):		
Sampling Results Sample Location: _____ Total Chlorine: -- ppm Free Chlorine: -- ppm Ammonia: -- ppm pH: -- units Temperature: -- °F Conductivity: -- µS/cm Detergents: -- mg/L		Floatables: None Odor: None Turbidity: None Color: None Gross Solids: None Vegetation: None Benthic Growth: None Stains: None Non-illicit: None	Notes Outfall fully submerged and not located - screened upstream at 06-221 US1. Condition Assessment Graffiti: None Erosion: None Deposition: None in. Damage: None

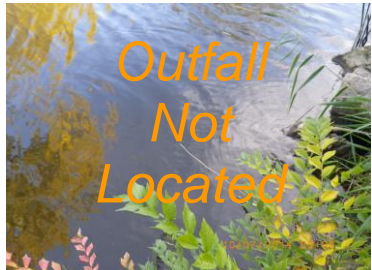
o20141007083652.JPG <div style="text-align: center; font-size: 24pt; font-weight: bold;">2014</div>

Inspection Date: 10/7/2014 9:37:56 AM		Type: Ongoing	Flow: Submerged (not located)	Previous Rainfall (hrs): 48-72
Illicit Discharge Potential: Unlikely		Inspector: JCW		
Submerged: Fully		Depth (in):		
Sampling Results Sample Location: _____ Total Chlorine: -- ppm Free Chlorine: -- ppm Ammonia: -- ppm pH: -- units Temperature: -- °F Conductivity: -- µS/cm Detergents: -- mg/L		Floatables: None Odor: None Turbidity: None Color: None Gross Solids: None Vegetation: None Benthic Growth: None Stains: None Non-illicit: None	Notes Outfall partially submerged and not located - screened upstream at 06-221 US1. Condition Assessment Graffiti: None Erosion: None Deposition: None in. Damage: None

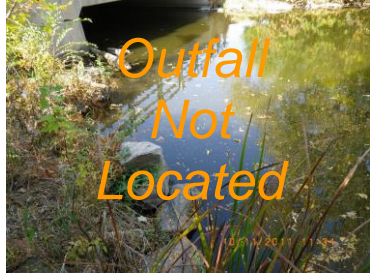
o20111011113446.JPG

Inspection Date: 10/11/2011 11:34:32 AM		Type: Ongoing	Flow: Submerged (not located)	Previous Rainfall (hrs): 72+
Illicit Discharge Potential: Potential		Inspector: JCW	Notes	
Submerged: Fully Depth (in):			2010 screening follow-up. Outfall fully submerged and not physically located. Outfall screened upstream at 06-221 US1.	
Sampling Results			Condition Assessment	
Sample Location:	Floatables:	None	Graffiti:	None
Total Chlorine: -- ppm	Odor:	None	Erosion:	None
Free Chlorine: -- ppm	Turbidity:	None	Deposition:	None 0 in.
Ammonia: -- ppm	Color:	None	Damage:	None
pH: -- units	Gross Solids:	None		
Temperature -- °F	Vegetation:	None		
Conductivity: -- µS/cm	Benthic Growth:	None		
Detergents: -- mg/L	Stains:	None		
	Non-illicit:	None

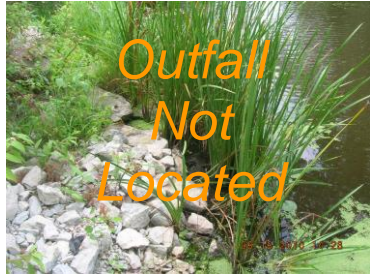
o20100818142820.JPG

Inspection Date: 8/18/2010 2:38:53 PM		Type: Ongoing	Flow: Submerged (not located)	Previous Rainfall (hrs): 72+
Illicit Discharge Potential: Potential		Inspector: JCW	Notes	
Submerged: Fully Depth (in):			Outfall fully submerged and not physically located. Outfall screened upstream at 06-221 US1.	
Sampling Results			Condition Assessment	
Sample Location:	Floatables:	None	Graffiti:	None
Total Chlorine: -- ppm	Odor:	None	Erosion:	None
Free Chlorine: -- ppm	Turbidity:	None	Deposition:	None 0 in.
Ammonia: -- ppm	Color:	None	Damage:	None
pH: -- units	Gross Solids:	None		
Temperature -- °F	Vegetation:	None		
Conductivity: -- µS/cm	Benthic Growth:	None		
Detergents: -- mg/L	Stains:	None		
	Non-illicit:	None

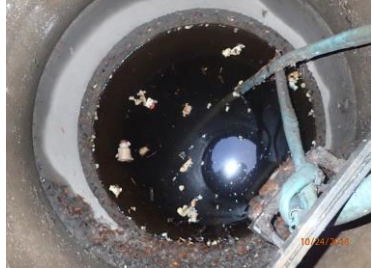
o20181024074456.JPG

Inspection Date: 10/24/2018 7:47:19 AM		Type: Ongoing	Flow: Submerged, indeterminate	Previous Rainfall (hrs): 72+
Illicit Discharge Potential: Potential		Inspector: JCW		
Submerged: Fully		Depth (in): 40		
Sampling Results		Notes Sample collected from submerged pool in manhole. Floating gross solids (litter) in manhole.		
Sample Location: Pool	Floatables: None	Condition Assessment Graffiti: None Erosion: None Deposition: None in. Damage: None		
Total Chlorine: 0 ppm	Odor: None			
Free Chlorine: 0 ppm	Turbidity: None			
Ammonia: 0 ppm	Color: None			
pH: 7.59 units	Gross Solids: Slight			
Temperature 52 °F	Vegetation: None			
Conductivity: 575 µS/cm	Benthic Growth: None			
Detergents: 0 mg/L	Stains: None			
	Non-illicit: None

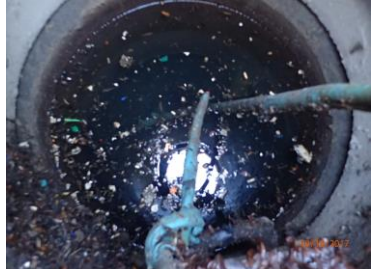
o20171018105550.JPG

Inspection Date: 10/18/2017 11:00:06 AM		Type: Ongoing	Flow: Submerged, indeterminate	Previous Rainfall (hrs): 72+
Illicit Discharge Potential: Potential		Inspector: JCW		
Submerged: Fully		Depth (in): 32		
Sampling Results		Notes Sample collected from submerged pool in manhole. Floating gross solids (litter) in manhole.		
Sample Location: Pool	Floatables: None	Condition Assessment Graffiti: None Erosion: None Deposition: None in. Damage: None		
Total Chlorine: 0 ppm	Odor: None			
Free Chlorine: 0 ppm	Turbidity: None			
Ammonia: 0 ppm	Color: None			
pH: 7.24 units	Gross Solids: Moderate			
Temperature 66 °F	Vegetation: None			
Conductivity: 379 µS/cm	Benthic Growth: None			
Detergents: 0 mg/L	Stains: None			
	Non-illicit: None

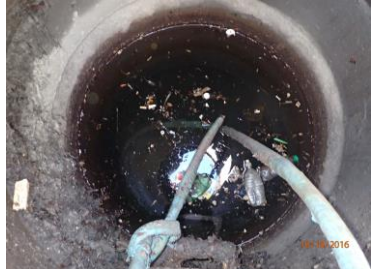
o20161018134038.JPG

Inspection Date: 10/18/2016 1:43:57 PM		Type: Ongoing	Flow: Submerged, indeterminate	Previous Rainfall (hrs): 72+
Illicit Discharge Potential: Potential		Inspector: JCW		
Submerged: Fully		Depth (in): 35		
Sampling Results		Notes Casting displaced 2". Potential illicit discharge due to gross solids.		
Sample Location: Pool	Floatables: None	Condition Assessment Graffiti: None Erosion: None Deposition: None in. Damage: Minor		
Total Chlorine: 0 ppm	Odor: None			
Free Chlorine: 0 ppm	Turbidity: None			
Ammonia: 0 ppm	Color: None			
pH: 7.06 units	Gross Solids: Moderate			
Temperature 68 °F	Vegetation: None			
Conductivity: 460 µS/cm	Benthic Growth: None			
Detergents: 0 mg/L	Stains: None			
	Non-illicit: None

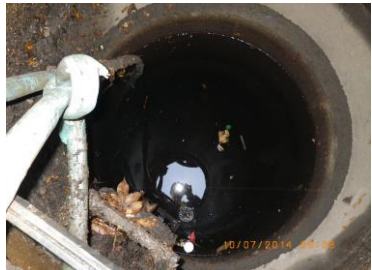
o20141007083848.JPG

Inspection Date: 10/7/2014 9:38:38 AM		Type: Ongoing	Flow: Submerged, indeterminate	Previous Rainfall (hrs): 48-72
Illicit Discharge Potential: Unlikely		Inspector: JCW		
Submerged: Fully		Depth (in): 32		
Sampling Results		Notes		
Sample Location: Pool	Floatables: None	Condition Assessment Graffiti: None Erosion: None Deposition: Minor 3 in. Damage: None		
Total Chlorine: 0 ppm	Odor: None			
Free Chlorine: 0 ppm	Turbidity: None			
Ammonia: 0 ppm	Color: None			
pH: 7.78 units	Gross Solids: Slight			
Temperature -- °F	Vegetation: None			
Conductivity: 351 µS/cm	Benthic Growth: None			
Detergents: 0 mg/L	Stains: None			
	Non-illicit: None

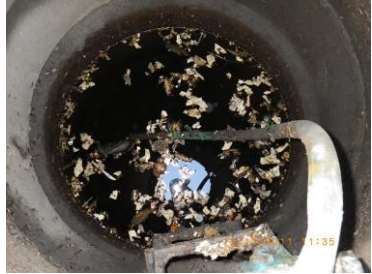
o20111011113522.JPG

Inspection Date: 10/11/2011 11:37:34 AM		Type: Ongoing	Flow: Submerged, indeterminate	Previous Rainfall (hrs): 72+
Illicit Discharge Potential: Potential		Inspector: JCW	Notes	
Submerged: Fully Depth (in): 32			2010 screening follow-up. Floatable debris still present.	
Sampling Results		Condition Assessment		
Sample Location: Pool	Floatables: None	Graffiti: None Erosion: None Deposition: None 0 in. Damage: None		
Total Chlorine: 0 ppm	Odor: None			
Free Chlorine: 0 ppm	Turbidity: None			
Ammonia: 0 ppm	Color: None			
pH: 7.5 units	Gross Solids: Moderate			
Temperature 71 °F	Vegetation: None			
Conductivity: -- µS/cm	Benthic Growth: None			
Detergents: -- mg/L	Stains: None			
	Non-illicit: None

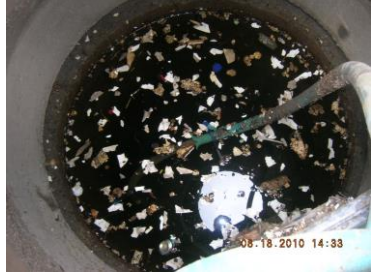
o20100818143354.JPG

Inspection Date: 8/18/2010 2:43:51 PM		Type: Ongoing	Flow: Submerged, indeterminate	Previous Rainfall (hrs): 72+
Illicit Discharge Potential: Potential		Inspector: JCW	Notes	
Submerged: Fully Depth (in): 36			Torn paper and other floatable debris in manhole.	
Sampling Results		Condition Assessment		
Sample Location: Pool	Floatables: None	Graffiti: None Erosion: None Deposition: None 0 in. Damage: None		
Total Chlorine: 0 ppm	Odor: None			
Free Chlorine: 0 ppm	Turbidity: None			
Ammonia: 0 ppm	Color: None			
pH: 7.21 units	Gross Solids: Moderate			
Temperature 79 °F	Vegetation: None			
Conductivity: -- µS/cm	Benthic Growth: None			
Detergents: 0 mg/L	Stains: None			
	Non-illicit: None

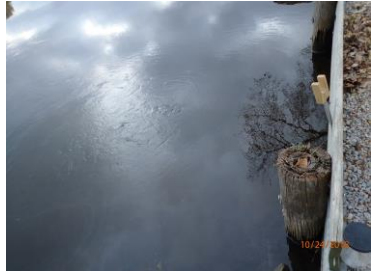
o20181024072834.JPG
2018

Inspection Date: 10/24/2018 7:29:02 AM		Type: Ongoing	Flow: Submerged, significant flow	Previous Rainfall (hrs): 72+
Illicit Discharge Potential: Potential		Inspector: JCW		
Submerged: Fully		Depth (in):		
Sampling Results		Notes Outfall fully submerged, significant flow causing surface disturbance. Screened upstream at 06-253 US1. Elevated ammonia and conductivity in manhole.		
Sample Location:	Floatables:	Condition Assessment Graffiti: None Erosion: None Deposition: None in. Damage: None		
Total Chlorine: -- ppm	Odor:			
Free Chlorine: -- ppm	Turbidity:			
Ammonia: -- ppm	Color:			
pH: -- units	Gross Solids:			
Temperature -- °F	Vegetation:			
Conductivity: -- µS/cm	Benthic Growth:			
Detergents: -- mg/L	Stains:			
	Non-illicit:

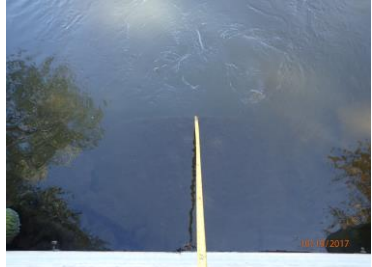
o20171019131334.JPG
2017

Inspection Date: 10/19/2017 1:14:17 PM		Type: Ongoing	Flow: Submerged, significant flow	Previous Rainfall (hrs): 72+
Illicit Discharge Potential: Potential		Inspector: JCW		
Submerged: Fully		Depth (in):		
Sampling Results		Notes Outfall fully submerged with significant flow causing surface disturbance. Screened upstream at 06-253 US1. Elevated ammonia in manhole.		
Sample Location:	Floatables:	Condition Assessment Graffiti: None Erosion: None Deposition: None in. Damage: None		
Total Chlorine: -- ppm	Odor:			
Free Chlorine: -- ppm	Turbidity:			
Ammonia: -- ppm	Color:			
pH: -- units	Gross Solids:			
Temperature -- °F	Vegetation:			
Conductivity: -- µS/cm	Benthic Growth:			
Detergents: -- mg/L	Stains:			
	Non-illicit:

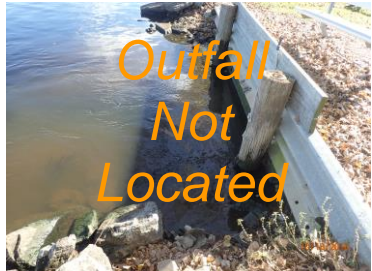
o20161018135746.JPG
2016

Inspection Date: 10/18/2016 1:59:02 PM		Type: Ongoing	Flow: Submerged (not located)	Previous Rainfall (hrs): 72+
Illicit Discharge Potential: Unlikely		Inspector: JCW		
Submerged: Fully		Depth (in):		
Sampling Results		Notes Outfall fully submerged and not located - screened upstream at 06-253 US1.		
Sample Location:	Floatables:	Condition Assessment Graffiti: None Erosion: None Deposition: None in. Damage: None		
Total Chlorine: -- ppm	Odor:			
Free Chlorine: -- ppm	Turbidity:			
Ammonia: -- ppm	Color:			
pH: -- units	Gross Solids:			
Temperature -- °F	Vegetation:			
Conductivity: -- µS/cm	Benthic Growth:			
Detergents: -- mg/L	Stains:			
	Non-illicit:

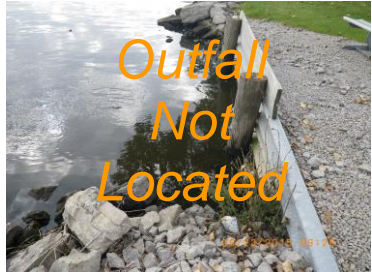
o20150923082910.JPG
2015

Inspection Date: 9/23/2015 9:26:08 AM		Type: Ongoing	Flow: Submerged (not located)	Previous Rainfall (hrs): 72+
Illicit Discharge Potential: Unlikely		Inspector: JCW		
Submerged: Fully		Depth (in):		
Sampling Results		Notes Outfall fully submerged and not located - screened at 06-253 US1.		
Sample Location:	Floatables:	Condition Assessment Graffiti: None Erosion: None Deposition: None in. Damage: None		
Total Chlorine: -- ppm	Odor:			
Free Chlorine: -- ppm	Turbidity:			
Ammonia: -- ppm	Color:			
pH: -- units	Gross Solids:			
Temperature -- °F	Vegetation:			
Conductivity: -- µS/cm	Benthic Growth:			
Detergents: -- mg/L	Stains:			
	Non-illicit:

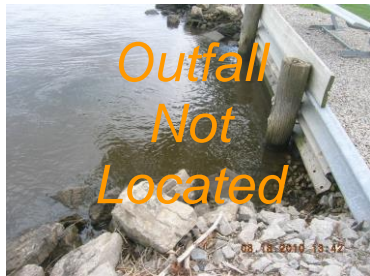
<p style="text-align: center;">o20100818134248.JPG</p> <p style="text-align: center; font-size: 1.5em; font-weight: bold;">2010</p>

Inspection Date: 8/18/2010 1:51:34 PM		Type: Ongoing	Flow: Submerged (not located)	Previous Rainfall (hrs): 72+
Illicit Discharge Potential: Unlikely		Inspector: JCW		
Submerged: Fully		Depth (in):		
Sampling Results				
Sample Location:	Floatables:	None		
Total Chlorine: -- ppm	Odor:	None		
Free Chlorine: -- ppm	Turbidity:	None		
Ammonia: -- ppm	Color:	None		
pH: -- units	Gross Solids:	None		
Temperature -- °F	Vegetation:	None		
Conductivity: -- µS/cm	Benthic Growth:	None		
Detergents: -- mg/L	Stains:	None		
	Non-illicit:	None		
		Notes Outfall fully submerged and not physically located. Outfall screened upstream at 06-263 US1.		
		Condition Assessment Graffiti: None Erosion: None Deposition: None 0 in. Damage: None

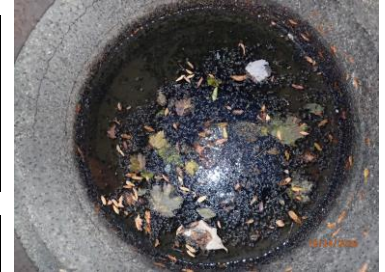
o20181024071720.JPG

Inspection Date: 10/24/2018 7:21:30 AM		Type: Ongoing	Flow: Submerged, indeterminate	Previous Rainfall (hrs): 72+
Illicit Discharge Potential: Potential		Inspector: JCW		
Submerged: Fully		Depth (in): 46		
Sampling Results		Notes Sample collected from submerged flow in manhole. Elevated ammonia and conductivity in sample.		
Sample Location: Pool	Floatables: None	Condition Assessment Graffiti: None Erosion: None Deposition: None in. Damage: None		
Total Chlorine: 0 ppm	Odor: None			
Free Chlorine: 0 ppm	Turbidity: None			
Ammonia: 3 ppm	Color: None			
pH: 7.27 units	Gross Solids: Slight			
Temperature 52 °F	Vegetation: None			
Conductivity: 2280 µS/cm	Benthic Growth: None			
Detergents: 0 mg/L	Stains: None			
	Non-illicit: None

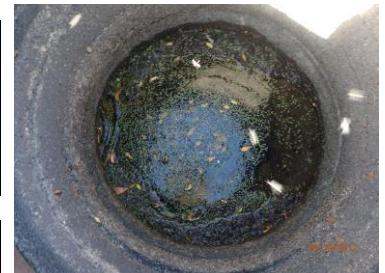
o20171019131708.JPG

Inspection Date: 10/19/2017 1:19:57 PM		Type: Ongoing	Flow: Submerged, slight flow	Previous Rainfall (hrs): 72+
Illicit Discharge Potential: Potential		Inspector: JCW		
Submerged: Fully		Depth (in): 40		
Sampling Results		Notes Sample collected from submerged flow in manhole. Elevated ammonia.		
Sample Location: Flow	Floatables: None	Condition Assessment Graffiti: None Erosion: None Deposition: None in. Damage: None		
Total Chlorine: 0 ppm	Odor: None			
Free Chlorine: 0 ppm	Turbidity: None			
Ammonia: 3 ppm	Color: None			
pH: 7.15 units	Gross Solids: None			
Temperature 68 °F	Vegetation: None			
Conductivity: 1990 µS/cm	Benthic Growth: None			
Detergents: 0 mg/L	Stains: None			
	Non-illicit: None

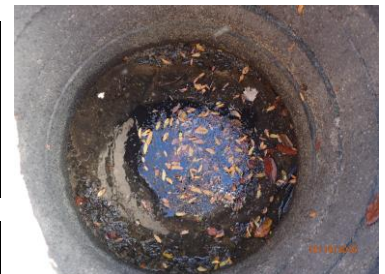
o20161018140148.JPG

Inspection Date: 10/18/2016 2:03:25 PM		Type: Ongoing	Flow: Submerged, significant flow	Previous Rainfall (hrs): 72+
Illicit Discharge Potential: Unlikely		Inspector: JCW		
Submerged: Fully		Depth (in): 40		
Sampling Results		Notes Strong current; significant flies in manhole.		
Sample Location: Flow	Floatables: None	Condition Assessment Graffiti: None Erosion: None Deposition: None in. Damage: None		
Total Chlorine: 0 ppm	Odor: Faint			
Free Chlorine: 0 ppm	Turbidity: None			
Ammonia: 0 ppm	Color: None			
pH: 7.01 units	Gross Solids: None			
Temperature 70 °F	Vegetation: None			
Conductivity: 1228 µS/cm	Benthic Growth: None			
Detergents: 0 mg/L	Stains: None			
	Non-illicit: None

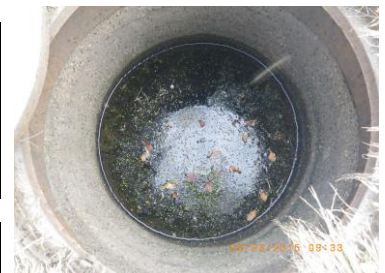
o20150923083310.JPG

Inspection Date: 9/23/2015 9:31:39 AM		Type: Ongoing	Flow: Submerged, significant flow	Previous Rainfall (hrs): 72+
Illicit Discharge Potential: Unlikely		Inspector: JCW		
Submerged: Fully		Depth (in): 42		
Sampling Results		Notes Significant current detected in pool. Many flies emerging from water.		
Sample Location: Pool	Floatables: None	Condition Assessment Graffiti: None Erosion: None Deposition: None in. Damage: None		
Total Chlorine: 0 ppm	Odor: None			
Free Chlorine: 0 ppm	Turbidity: None			
Ammonia: 0 ppm	Color: None			
pH: 7.53 units	Gross Solids: Slight			
Temperature 70 °F	Vegetation: None			
Conductivity: 1220 µS/cm	Benthic Growth: Slight			
Detergents: 0 mg/L	Stains: None			
	Non-illicit: None

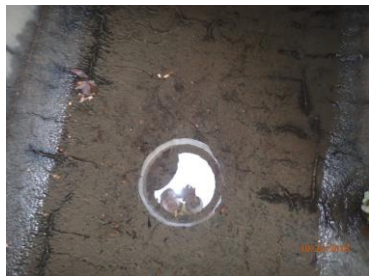
o20181025095732.JPG <div style="text-align: center; font-size: 24pt; font-weight: bold;">2018</div>

Sample Location:	Flow																																					
Total Chlorine:	0 ppm																																					
Free Chlorine:	0 ppm																																					
Ammonia:	0 ppm																																					
pH:	8.17 units																																					
Temperature:	55 °F																																					
Conductivity:	1215 µS/cm																																					
Detergents:	0.45 mg/L																																					
Floatables:	None																																					
Odor:	None																																					
Turbidity:	None																																					
Color:	None																																					
Gross Solids:	None																																					
Vegetation:	None																																					
Benthic Growth:	None																																					
Stains:	None																																					
Non-illicit:	None

<div style="display: flex; justify-content: space-between;"> <div style="width: 45%;"> <p>Notes</p> <p>Detergent detection follow-up. Limited screening conducted beyond sampling.</p> </div> <div style="width: 45%;"> <p>Condition Assessment</p> <table border="1" style="width:100%; border-collapse: collapse;"> <tr><td>Graffiti:</td><td>None</td></tr> <tr><td>Erosion:</td><td>None</td></tr> <tr><td>Deposition:</td><td>None in.</td></tr> <tr><td>Damage:</td><td>None</td></tr> </table> </div> </div>			Graffiti:	None	Erosion:	None	Deposition:	None in.	Damage:	None																										
Graffiti:	None																																					
Erosion:	None																																					
Deposition:	None in.																																					
Damage:	None

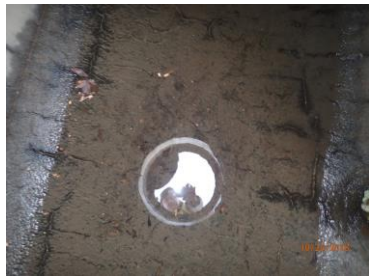
o20181025095732.JPG <div style="text-align: center; font-size: 24pt; font-weight: bold;">2018</div>

Sample Location:	Pool																																					
Total Chlorine:	0 ppm																																					
Free Chlorine:	0 ppm																																					
Ammonia:	0 ppm																																					
pH:	8.09 units																																					
Temperature:	51 °F																																					
Conductivity:	1272 µS/cm																																					
Detergents:	0.5 mg/L																																					
Floatables:	None																																					
Odor:	None																																					
Turbidity:	None																																					
Color:	None																																					
Gross Solids:	None																																					
Vegetation:	None																																					
Benthic Growth:	None																																					
Stains:	None																																					
Non-illicit:	None

<div style="display: flex; justify-content: space-between;"> <div style="width: 45%;"> <p>Notes</p> <p>Sample collected from submerged pool in manhole. Detergent detected in sample.</p> </div> <div style="width: 45%;"> <p>Condition Assessment</p> <table border="1" style="width:100%; border-collapse: collapse;"> <tr><td>Graffiti:</td><td>None</td></tr> <tr><td>Erosion:</td><td>None</td></tr> <tr><td>Deposition:</td><td>None in.</td></tr> <tr><td>Damage:</td><td>None</td></tr> </table> </div> </div>			Graffiti:	None	Erosion:	None	Deposition:	None in.	Damage:	None																										
Graffiti:	None																																					
Erosion:	None																																					
Deposition:	None in.																																					
Damage:	None

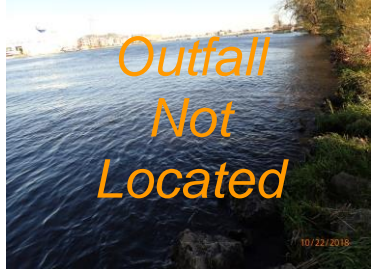
o20181022164110.JPG <div style="text-align: center; font-size: 24pt; font-weight: bold;">2018</div>

Inspection Date: 10/22/2018 4:42:27 PM		Type: Ongoing	Flow: Submerged (not located)	Previous Rainfall (hrs): 48-72
Illicit Discharge Potential: Potential		Inspector: JCW		
Submerged: Fully		Depth (in):		
Sampling Results Sample Location: _____ Total Chlorine: -- ppm Free Chlorine: -- ppm Ammonia: -- ppm pH: -- units Temperature: -- °F Conductivity: -- µS/cm Detergents: -- mg/L		Floatables: None Odor: None Turbidity: None Color: None Gross Solids: None Vegetation: None Benthic Growth: None Stains: None Non-illicit: None		
		Notes Outfall fully submerged and not located - screened upstream at 06-810 US1. Floating gross solids (litter) in manhole.		
		Condition Assessment Graffiti: None Erosion: None Deposition: None in. Damage: None

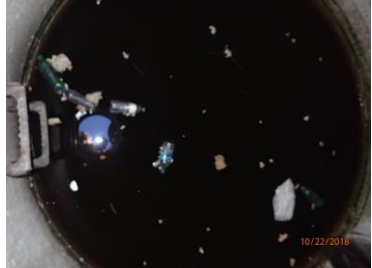
o20181022164226.JPG

Inspection Date: 10/22/2018 4:45:48 PM		Type: Ongoing	Flow: Submerged, indeterminate	Previous Rainfall (hrs): 48-72
Illicit Discharge Potential: Potential		Inspector: JCW		
Submerged: Fully		Depth (in): 58		
Sampling Results		Notes Sample collected from submerged pool in manhole. Floating gross solids (litter) in manhole.		
Sample Location: Pool	Floatables: None	Condition Assessment Graffiti: None Erosion: None Deposition: None in. Damage: None		
Total Chlorine: 0 ppm	Odor: None			
Free Chlorine: 0 ppm	Turbidity: None			
Ammonia: 0 ppm	Color: None			
pH: 7.7 units	Gross Solids: Slight			
Temperature 55 °F	Vegetation: None			
Conductivity: 370 µS/cm	Benthic Growth: None			
Detergents: 0 mg/L	Stains: None			
	Non-illicit: None

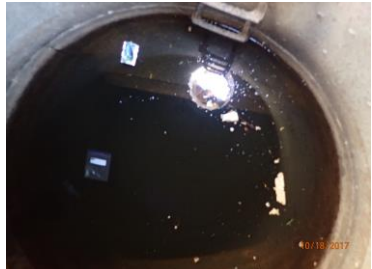
o20171018111612.JPG

Inspection Date: 10/18/2017 11:23:20 AM		Type: Ongoing	Flow: Submerged, indeterminate	Previous Rainfall (hrs): 72+
Illicit Discharge Potential: Unlikely		Inspector: JCW		
Submerged: Fully		Depth (in): 50		
Sampling Results		Notes Sample collected from submerged pool in manhole.		
Sample Location: Pool	Floatables: None	Condition Assessment Graffiti: None Erosion: None Deposition: None in. Damage: None		
Total Chlorine: 0 ppm	Odor: None			
Free Chlorine: 0 ppm	Turbidity: None			
Ammonia: 0 ppm	Color: None			
pH: 7.85 units	Gross Solids: Slight			
Temperature 65 °F	Vegetation: None			
Conductivity: 174 µS/cm	Benthic Growth: Moderate			
Detergents: 0 mg/L	Stains: None			
	Non-illicit: None

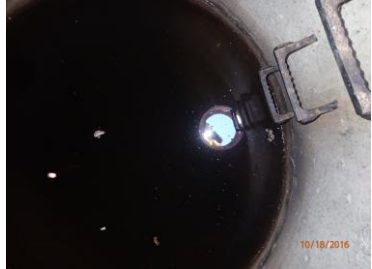
o20161018144430.JPG

Inspection Date: 10/18/2016 2:47:47 PM		Type: Ongoing	Flow: Submerged, indeterminate	Previous Rainfall (hrs): 72+
Illicit Discharge Potential: Unlikely		Inspector: JCW		
Submerged: Fully		Depth (in): 52		
Sampling Results		Notes		
Sample Location: Pool	Floatables: None	Condition Assessment Graffiti: None Erosion: None Deposition: None in. Damage: None		
Total Chlorine: 0 ppm	Odor: None			
Free Chlorine: 0 ppm	Turbidity: None			
Ammonia: 0 ppm	Color: None			
pH: 7.93 units	Gross Solids: None			
Temperature 67 °F	Vegetation: None			
Conductivity: 400 µS/cm	Benthic Growth: Slight			
Detergents: 0 mg/L	Stains: None			
	Non-illicit: None

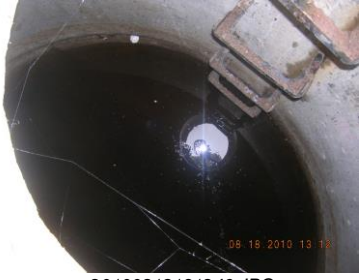
Inspection Date: 8/18/2010 1:18:51 PM		Type: Ongoing	Flow: Submerged, indeterminate	Previous Rainfall (hrs): 72+	
Illicit Discharge Potential: Unlikely		Inspector: JCW	Notes		
Submerged: Fully		Depth (in): 55

<p style="text-align: center;">o20100818131246.JPG</p> <p style="text-align: center; font-size: 1.5em; font-weight: bold;">2010</p>		
Sampling Results					
Sample Location:	Pool	Floatables:			None
Total Chlorine:	0 ppm	Odor:			Faint
Free Chlorine:	0 ppm	Turbidity:			None
Ammonia:	0.5 ppm	Color:			Faint in bottle
pH:	7.68 units	Gross Solids:			None
Temperature	78 °F	Vegetation:			None
Conductivity:	-- µS/cm	Benthic Growth:			None
Detergents:	0 mg/L	Stains:			None
		Non-illicit:	None		
			Condition Assessment Graffiti: None Erosion: None Deposition: None 0 in. Damage: None

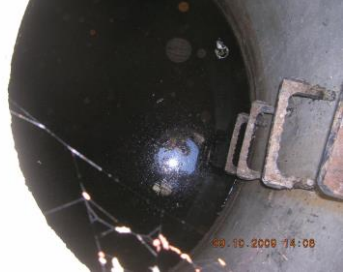
Inspection Date: 9/10/2009		Type: Initial	Flow: Submerged, indeterminate	Previous Rainfall (hrs): 72+	
Illicit Discharge Potential: Potential		Inspector: JCW	Notes		
Submerged: Partially		Depth (in): 6

<p style="text-align: center;">Osh09_DSCN6801.JPG</p> <p style="text-align: center; font-size: 1.5em; font-weight: bold;">2009</p>		
Sampling Results					
Sample Location:	Pool	Floatables:			None
Total Chlorine:	0 ppm	Odor:			None
Free Chlorine:	0 ppm	Turbidity:			None
Ammonia:	-- ppm	Color:			None
pH:	8.42 units	Gross Solids:			None
Temperature	82 °F	Vegetation:			None
Conductivity:	-- µS/cm	Benthic Growth:			None
Detergents:	0 mg/L	Stains:			None
		Non-illicit:	None		
			Condition Assessment Graffiti: None Erosion: None Deposition: None 0 in. Damage: None

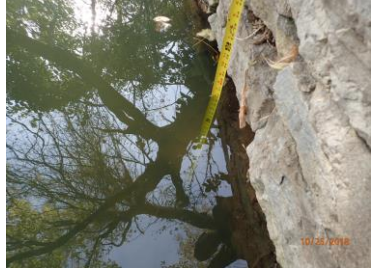
o20181025133432.JPG
2018

Inspection Date: 10/25/2018 1:36:22 PM		Type: Ongoing	Flow: Submerged, indeterminate	Previous Rainfall (hrs): 72+
Illicit Discharge Potential: Potential		Inspector: JCW	Notes	
Submerged: Fully		Depth (in):	Outfall fully submerged - screened upstream at 06-829 US1. Floating gross solids (litter) in manhole.	
Sampling Results		Floatables:	Condition Assessment Graffiti: None Erosion: None Deposition: None in. Damage: None	
Sample Location:		Odor:		
Total Chlorine: -- ppm		Turbidity:		
Free Chlorine: -- ppm		Color:		
Ammonia: -- ppm		Gross Solids:		
pH: -- units		Vegetation:		
Temperature -- °F		Benthic Growth:		
Conductivity: -- µS/cm		Stains:		
Detergents: -- mg/L		Non-illicit:

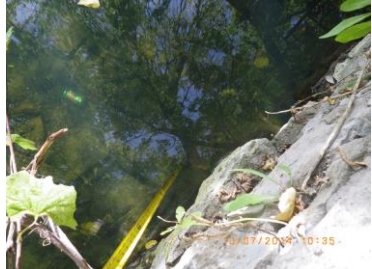
o20141007093522.JPG
2014

Inspection Date: 10/7/2014 10:34:09 AM		Type: Ongoing	Flow: Submerged, indeterminate	Previous Rainfall (hrs): 48-72
Illicit Discharge Potential: Unlikely		Inspector: JCW	Notes	
Submerged: Fully		Depth (in): 42	Outfall fully submerged - screened upstream at 06-829 US1. Manhole lid in water near end of pipe.	
Sampling Results		Floatables:	Condition Assessment Graffiti: None Erosion: None Deposition: None in. Damage: None	
Sample Location:		Odor:		
Total Chlorine: -- ppm		Turbidity:		
Free Chlorine: -- ppm		Color:		
Ammonia: -- ppm		Gross Solids:		
pH: -- units		Vegetation:		
Temperature -- °F		Benthic Growth:		
Conductivity: -- µS/cm		Stains:		
Detergents: -- mg/L		Non-illicit:

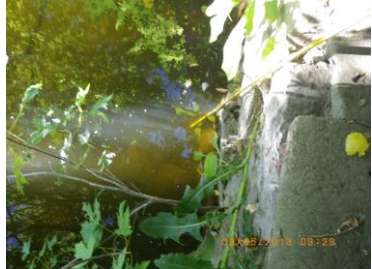
o20130905082920.JPG
2013

Inspection Date: 9/5/2013 9:25:55 AM		Type: Ongoing	Flow: Submerged, indeterminate	Previous Rainfall (hrs): 72+
Illicit Discharge Potential: Potential		Inspector: JCW	Notes	
Submerged: Fully		Depth (in): 45	2012 screening follow-up. Outfall fully submerged. Outfall screened upstream at 06-829 US1. Gross solids in upstream mh.	
Sampling Results		Floatables:	Condition Assessment Graffiti: None Erosion: None Deposition: None in. Damage: None	
Sample Location:		Odor:		
Total Chlorine: -- ppm		Turbidity:		
Free Chlorine: -- ppm		Color:		
Ammonia: -- ppm		Gross Solids:		
pH: -- units		Vegetation:		
Temperature -- °F		Benthic Growth:		
Conductivity: -- µS/cm		Stains:		
Detergents: -- mg/L		Non-illicit:

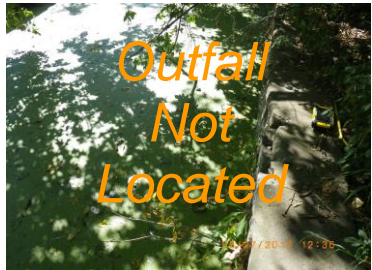
o20120927113654.JPG
2012

Inspection Date: 9/27/2012 12:33:16 PM		Type: Ongoing	Flow: Submerged (not located)	Previous Rainfall (hrs): 72+
Illicit Discharge Potential: Potential		Inspector: JCW	Notes	
Submerged: Fully		Depth (in):	Outfall fully submerged; screened upstream at 06-829 US1.	
Sampling Results		Floatables:	Condition Assessment Graffiti: None Erosion: None Deposition: None in. Damage: None	
Sample Location:		Odor:		
Total Chlorine: -- ppm		Turbidity:		
Free Chlorine: -- ppm		Color:		
Ammonia: -- ppm		Gross Solids:		
pH: -- units		Vegetation:		
Temperature -- °F		Benthic Growth:		
Conductivity: -- µS/cm		Stains:		
Detergents: -- mg/L		Non-illicit:

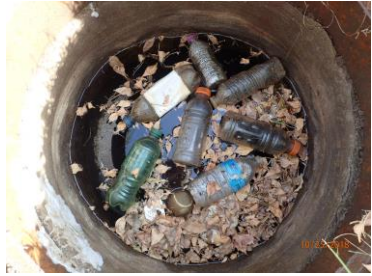
o20181025133814.JPG

Inspection Date: 10/25/2018 1:40:19 PM		Type: Ongoing	Flow: Submerged, indeterminate	Previous Rainfall (hrs): 72+
Illicit Discharge Potential: Potential		Inspector: JCW		
Submerged: Fully		Depth (in): 39		
Sampling Results		Notes Sample collected from submerged pool in manhole. Floating gross solids (litter) in manhole.		
Sample Location: Pool	Floatables: None	Condition Assessment Graffiti: None Erosion: None Deposition: None in. Damage: None		
Total Chlorine: 0 ppm	Odor: None			
Free Chlorine: 0 ppm	Turbidity: None			
Ammonia: 0 ppm	Color: None			
pH: 7.64 units	Gross Solids: Moderate			
Temperature 58 °F	Vegetation: None			
Conductivity: 1550 µS/cm	Benthic Growth: Slight			
Detergents: 0 mg/L	Stains: None			
	Non-illicit: None

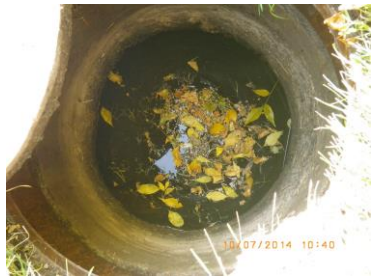
o20141007094030.JPG

Inspection Date: 10/7/2014 10:41:53 AM		Type: Ongoing	Flow: Submerged, indeterminate	Previous Rainfall (hrs): 48-72
Illicit Discharge Potential: Unlikely		Inspector: JCW		
Submerged: Fully		Depth (in): 30		
Sampling Results		Notes Vegetative debris from opening lid.		
Sample Location: Pool	Floatables: None	Condition Assessment Graffiti: None Erosion: None Deposition: None in. Damage: None		
Total Chlorine: 0 ppm	Odor: None			
Free Chlorine: 0 ppm	Turbidity: None			
Ammonia: 0 ppm	Color: None			
pH: 7.82 units	Gross Solids: None			
Temperature -- °F	Vegetation: None			
Conductivity: 1715 µS/cm	Benthic Growth: Slight			
Detergents: 0 mg/L	Stains: None			
	Non-illicit: None

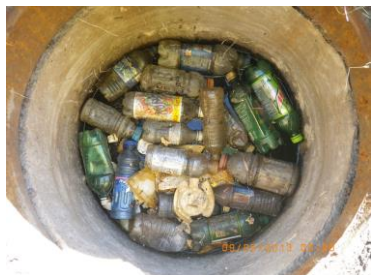
o20130905082002.JPG

Inspection Date: 9/5/2013 9:16:05 AM		Type: Ongoing	Flow: Submerged, indeterminate	Previous Rainfall (hrs): 72+
Illicit Discharge Potential: Potential		Inspector: JCW		
Submerged: Fully		Depth (in): 35		
Sampling Results		Notes 2012 screening follow-up. Significant gross solids in manhole - similar to previous years.		
Sample Location: Pool	Floatables: None	Condition Assessment Graffiti: None Erosion: None Deposition: None in. Damage: None		
Total Chlorine: 0 ppm	Odor: None			
Free Chlorine: 0 ppm	Turbidity: None			
Ammonia: 0 ppm	Color: None			
pH: 7.7 units	Gross Solids: Severe			
Temperature 71 °F	Vegetation: None			
Conductivity: 1666 µS/cm	Benthic Growth: None			
Detergents: 0 mg/L	Stains: Slight			
	Non-illicit: None

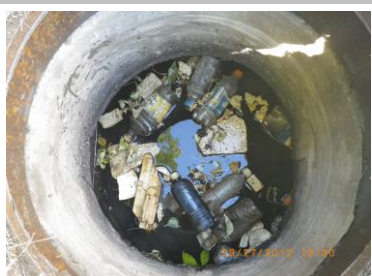
o20120927113044.JPG

Inspection Date: 9/27/2012 12:28:37 PM		Type: Ongoing	Flow: Submerged, indeterminate	Previous Rainfall (hrs): 72+
Illicit Discharge Potential: Potential		Inspector: JCW		
Submerged: Fully		Depth (in): 30		
Sampling Results		Notes		
Sample Location: Pool	Floatables: None	Condition Assessment Graffiti: None Erosion: None Deposition: None in. Damage: None		
Total Chlorine: 0 ppm	Odor: None			
Free Chlorine: 0 ppm	Turbidity: None			
Ammonia: 0 ppm	Color: None			
pH: 7.72 units	Gross Solids: Moderate			
Temperature 64 °F	Vegetation: None			
Conductivity: 1583 µS/cm	Benthic Growth: None			
Detergents: 0 mg/L	Stains: Slight			
	Non-illicit: None

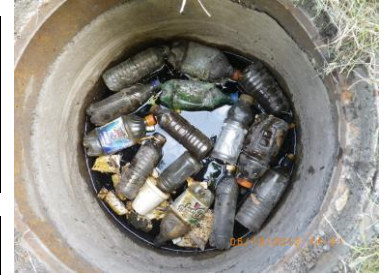
o20120613133100.JPG

Inspection Date: 6/13/2012 2:30:25 PM		Type: Other	Flow: Submerged, indeterminate	Previous Rainfall (hrs): 72+
Illicit Discharge Potential: Potential		Inspector: JCW	Notes	
Submerged: Fully		Depth (in): 37	Gross solids pre-screening. Bottles in manhole.	
Sampling Results			Condition Assessment	
Sample Location:	Pool	Floatables:	None	
Total Chlorine:	0 ppm	Odor:	None	
Free Chlorine:	0 ppm	Turbidity:	None	
Ammonia:	0 ppm	Color:	None	
pH:	7.58 units	Gross Solids:	Severe	
Temperature:	70 °F	Vegetation:	None	
Conductivity:	1765 µS/cm	Benthic Growth:	Slight	
Detergents:	0 mg/L	Stains:	None	
		Non-illicit:	None	
			Graffiti:	None
			Erosion:	None
			Deposition:	None in.
			Damage:	None

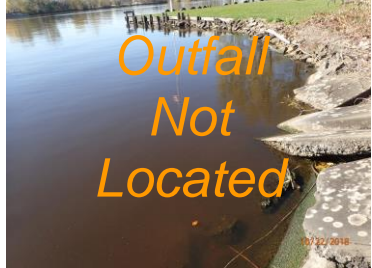
o20181022105100.JPG <div style="text-align: center; font-size: 24pt; font-weight: bold;">2018</div>

Inspection Date: 10/22/2018 10:51:14 AM		Type: Ongoing	Flow: Submerged (not located)	Previous Rainfall (hrs): 48-72
Illicit Discharge Potential: Potential		Inspector: JCW		
Submerged: Fully		Depth (in):		
Sampling Results Sample Location: Total Chlorine: -- ppm Free Chlorine: -- ppm Ammonia: -- ppm pH: -- units Temperature: -- °F Conductivity: -- µS/cm Detergents: -- mg/L		Floatables: None Odor: None Turbidity: None Color: None Gross Solids: None Vegetation: None Benthic Growth: None Stains: None Non-illicit: None		
		Notes Outfall fully submerged and not located - screened upstream at 08-284 US1. Floating gross solids (litter) in manhole.		
		Condition Assessment Graffiti: None Erosion: None Deposition: None in. Damage: None

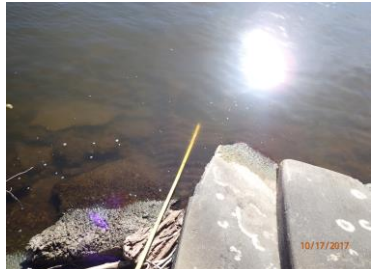
o20171017135302.JPG <div style="text-align: center; font-size: 24pt; font-weight: bold;">2017</div>

Inspection Date: 10/17/2017 1:56:02 PM		Type: Ongoing	Flow: Submerged, indeterminate	Previous Rainfall (hrs): 48-72
Illicit Discharge Potential: Potential		Inspector: JCW		
Submerged: Fully		Depth (in): 36		
Sampling Results Sample Location: Total Chlorine: -- ppm Free Chlorine: -- ppm Ammonia: -- ppm pH: -- units Temperature: -- °F Conductivity: -- µS/cm Detergents: -- mg/L		Floatables: None Odor: None Turbidity: None Color: None Gross Solids: None Vegetation: None Benthic Growth: None Stains: None Non-illicit: None		
		Notes Outfall fully submerged with approx 9" of water over crown of pipe - screened upstream at 08-284 US1. Floating gross solids (litter) in manhole.		
		Condition Assessment Graffiti: None Erosion: None Deposition: None in. Damage: None

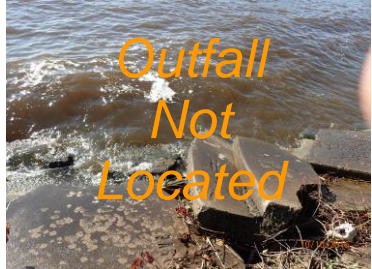
o20161010101832.JPG <div style="text-align: center; font-size: 24pt; font-weight: bold;">2016</div>

Inspection Date: 10/10/2016 10:18:48 AM		Type: Ongoing	Flow: Submerged (not located)	Previous Rainfall (hrs): 72+
Illicit Discharge Potential: Potential		Inspector: JCW		
Submerged: Fully		Depth (in):		
Sampling Results Sample Location: Total Chlorine: -- ppm Free Chlorine: -- ppm Ammonia: -- ppm pH: -- units Temperature: -- °F Conductivity: -- µS/cm Detergents: -- mg/L		Floatables: None Odor: None Turbidity: None Color: None Gross Solids: None Vegetation: None Benthic Growth: None Stains: None Non-illicit: None		
		Notes Outfall fully submerged and not located - screened upstream at 08-284 US1.		
		Condition Assessment Graffiti: None Erosion: None Deposition: None in. Damage: None

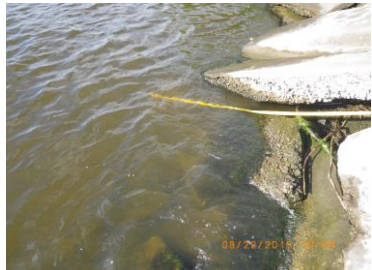
o20150922090932.JPG <div style="text-align: center; font-size: 24pt; font-weight: bold;">2015</div>

Inspection Date: 9/22/2015 10:04:59 AM		Type: Ongoing	Flow: Submerged, indeterminate	Previous Rainfall (hrs): 72+
Illicit Discharge Potential: Potential		Inspector: JCW		
Submerged: Fully		Depth (in): 30		
Sampling Results Sample Location: Total Chlorine: -- ppm Free Chlorine: -- ppm Ammonia: -- ppm pH: -- units Temperature: -- °F Conductivity: -- µS/cm Detergents: -- mg/L		Floatables: None Odor: None Turbidity: None Color: None Gross Solids: None Vegetation: None Benthic Growth: Moderate Stains: None Non-illicit: None		
		Notes Outfall fully submerged - screened at 08-284 US1.		
		Condition Assessment Graffiti: None Erosion: None Deposition: None in. Damage: None

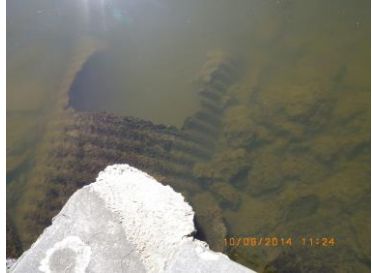
o20141009102400.JPG

Inspection Date: 10/9/2014 11:24:44 AM		Type: Ongoing	Flow: Submerged, indeterminate	Previous Rainfall (hrs): 72+
Illicit Discharge Potential: Potential		Inspector: JCW	Notes	
Submerged: Fully Depth (in): 29			Outfall fully submerged - screened upstream at 08-284 US1.	
Sampling Results			Condition Assessment	
Sample Location:	Floatables:	None		
Total Chlorine: -- ppm	Odor:	None		
Free Chlorine: -- ppm	Turbidity:	None		
Ammonia: -- ppm	Color:	None		
pH: -- units	Gross Solids:	None		
Temperature -- °F	Vegetation:	None		
Conductivity: -- µS/cm	Benthic Growth:	None		
Detergents: -- mg/L	Stains:	None		
	Non-illicit:	None		
			Graffiti: None Erosion: None Deposition: Minor 3 in. Damage: Minor

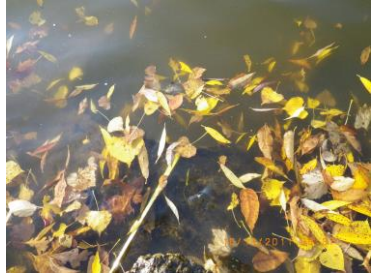
o20111011083728.JPG

Inspection Date: 10/11/2011 8:37:04 AM		Type: Ongoing	Flow: Submerged, indeterminate	Previous Rainfall (hrs): 72+
Illicit Discharge Potential: Unlikely		Inspector: JCW	Notes	
Submerged: Fully Depth (in): 25			2010 screening follow-up. Outfall fully submerged. Outfall screened upstream at 08-284 US1.	
Sampling Results			Condition Assessment	
Sample Location:	Floatables:	None		
Total Chlorine: -- ppm	Odor:	None		
Free Chlorine: -- ppm	Turbidity:	None		
Ammonia: -- ppm	Color:	None		
pH: -- units	Gross Solids:	None		
Temperature -- °F	Vegetation:	None		
Conductivity: -- µS/cm	Benthic Growth:	None		
Detergents: -- mg/L	Stains:	None		
	Non-illicit:	None		
			Graffiti: None Erosion: None Deposition: None 0 in. Damage: None

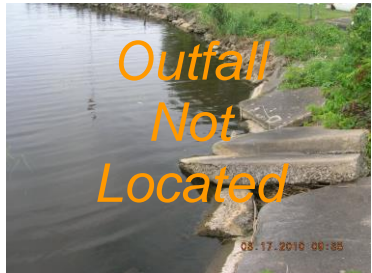
o20100817093554.JPG

Inspection Date: 8/17/2010 9:35:00 AM		Type: Ongoing	Flow: Submerged (not located)	Previous Rainfall (hrs): 72+
Illicit Discharge Potential: Potential		Inspector: JCW	Notes	
Submerged: Fully Depth (in):			Outfall fully submerged and not physically located. Outfall screened upstream at 08-284 US1.	
Sampling Results			Condition Assessment	
Sample Location:	Floatables:	None		
Total Chlorine: -- ppm	Odor:	None		
Free Chlorine: -- ppm	Turbidity:	None		
Ammonia: -- ppm	Color:	None		
pH: -- units	Gross Solids:	None		
Temperature -- °F	Vegetation:	None		
Conductivity: -- µS/cm	Benthic Growth:	None		
Detergents: -- mg/L	Stains:	None		
	Non-illicit:	None		
			Graffiti: None Erosion: None Deposition: None 0 in. Damage: None

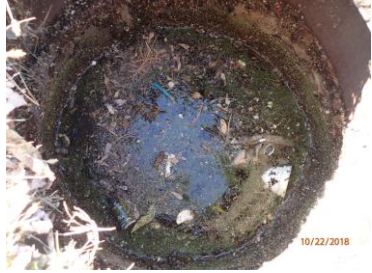
o20181022105156.JPG

Inspection Date: 10/22/2018 10:54:41 AM		Type: Ongoing	Flow: Submerged, indeterminate	Previous Rainfall (hrs): 48-72
Illicit Discharge Potential: Potential		Inspector: JCW		
Submerged: Fully		Depth (in): 34		
Sampling Results		Notes Sample collected from submerged pool in outfall. Floating gross solids (litter) in manhole.		
Sample Location: Pool	Floatables: None	Condition Assessment Graffiti: None Erosion: None Deposition: None in. Damage: None		
Total Chlorine: 0 ppm	Odor: None			
Free Chlorine: 0 ppm	Turbidity: None			
Ammonia: 0 ppm	Color: Faint in bottle			
pH: 7.5 units	Gross Solids: Moderate			
Temperature 54 °F	Vegetation: None			
Conductivity: 314 µS/cm	Benthic Growth: Moderate			
Detergents: 0 mg/L	Stains: None			
	Non-illicit: None
