Ongoing Screening Summary Report 2019 Inspection Year

Illicit Discharge Detection and Elimination Program

City of Oshkosh

January 3, 2020

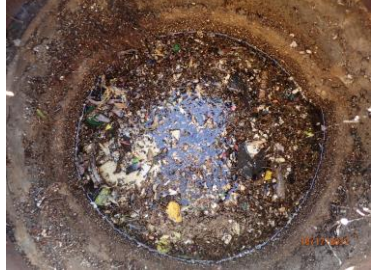
o20171017135518.JPG

Inspection Date: 10/17/2017 1:59:35 PM		Type: Ongoing	Flow: Submerged, indeterminate	Previous Rainfall (hrs): 48-72
Illicit Discharge Potential: Potential		Inspector: JCW		
Submerged: Fully		Depth (in): 30		
Sampling Results		Notes Sample collected from submerged pool in outfall. Floating gross solids (litter) in manhole.		
Sample Location: Pool	Floatables: None	Condition Assessment Graffiti: None Erosion: None Deposition: None in. Damage: None		
Total Chlorine: 0 ppm	Odor: None			
Free Chlorine: 0 ppm	Turbidity: None			
Ammonia: 0 ppm	Color: None			
pH: 8.67 units	Gross Solids: Moderate			
Temperature 66 °F	Vegetation: None			
Conductivity: 352 µS/cm	Benthic Growth: None			
Detergents: 0 mg/L	Stains: None			
	Non-illicit: None

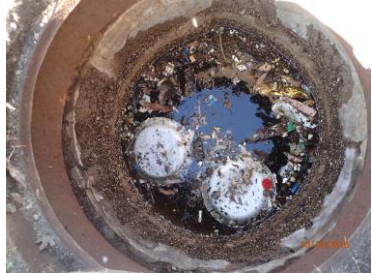
o20161010101916.JPG

Inspection Date: 10/10/2016 10:21:35 AM		Type: Ongoing	Flow: Submerged, indeterminate	Previous Rainfall (hrs): 72+
Illicit Discharge Potential: Potential		Inspector: JCW		
Submerged: Fully		Depth (in): 32		
Sampling Results		Notes Potential illicit discharge due to gross solids.		
Sample Location: Pool	Floatables: None	Condition Assessment Graffiti: None Erosion: None Deposition: None in. Damage: None		
Total Chlorine: 0 ppm	Odor: None			
Free Chlorine: 0 ppm	Turbidity: None			
Ammonia: 0 ppm	Color: Clearly visible in bottl			
pH: 8.15 units	Gross Solids: Moderate			
Temperature 63 °F	Vegetation: None			
Conductivity: 369 µS/cm	Benthic Growth: None			
Detergents: 0 mg/L	Stains: None			
	Non-illicit: None

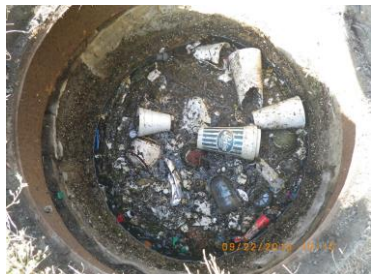
o20150922091040.JPG

Inspection Date: 9/22/2015 10:09:39 AM		Type: Ongoing	Flow: Submerged, indeterminate	Previous Rainfall (hrs): 72+
Illicit Discharge Potential: Potential		Inspector: JCW		
Submerged: Fully		Depth (in): 34		
Sampling Results		Notes Floating gross solids (litter) in manhole.		
Sample Location: Pool	Floatables: None	Condition Assessment Graffiti: None Erosion: None Deposition: None in. Damage: None		
Total Chlorine: 0 ppm	Odor: None			
Free Chlorine: 0 ppm	Turbidity: None			
Ammonia: 0 ppm	Color: None			
pH: 8.8 units	Gross Solids: Severe			
Temperature 70 °F	Vegetation: None			
Conductivity: 335 µS/cm	Benthic Growth: None			
Detergents: 0 mg/L	Stains: None			
	Non-illicit: None

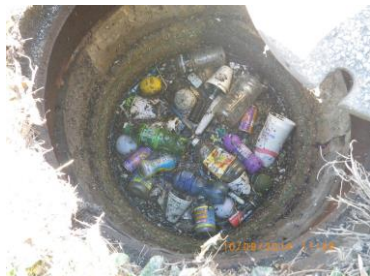
o20141009102622.JPG

Inspection Date: 10/9/2014 11:28:19 AM		Type: Ongoing	Flow: Submerged, indeterminate	Previous Rainfall (hrs): 72+
Illicit Discharge Potential: Potential		Inspector: JCW	Notes	
Submerged: Fully		Depth (in): 29	Floating gross solids (litter) in manhole.	
Sampling Results				
Sample Location:	Pool	Floatables:	None	
Total Chlorine:	0 ppm	Odor:	None	
Free Chlorine:	0 ppm	Turbidity:	None	
Ammonia:	0 ppm	Color:	Faint in bottle	
pH:	8.34 units	Gross Solids:	Severe	
Temperature	57 °F	Vegetation:	None	
Conductivity:	400 µS/cm	Benthic Growth:	None	
Detergents:	0 mg/L	Stains:	None	
		Non-illicit:	None	
			Condition Assessment	
			Graffiti:	None
			Erosion:	None
			Deposition:	None in.
			Damage:	None

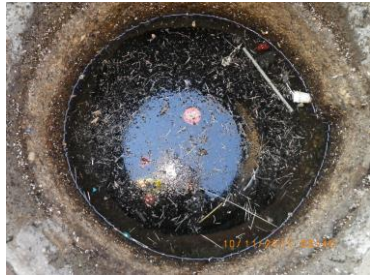
o20111011084038.JPG

Inspection Date: 10/11/2011 8:41:22 AM		Type: Ongoing	Flow: Submerged, indeterminate	Previous Rainfall (hrs): 72+
Illicit Discharge Potential: Unlikely		Inspector: JCW	Notes	
Submerged: Fully		Depth (in): 18	2010 screening follow-up. Floatable debris significantly reduced.	
Sampling Results				
Sample Location:	Pool	Floatables:	None	
Total Chlorine:	0 ppm	Odor:	None	
Free Chlorine:	0 ppm	Turbidity:	None	
Ammonia:	0 ppm	Color:	None	
pH:	8.11 units	Gross Solids:	Slight	
Temperature	72 °F	Vegetation:	None	
Conductivity:	-- µS/cm	Benthic Growth:	None	
Detergents:	-- mg/L	Stains:	None	
		Non-illicit:	None	
			Condition Assessment	
			Graffiti:	None
			Erosion:	None
			Deposition:	None 0 in.
			Damage:	None

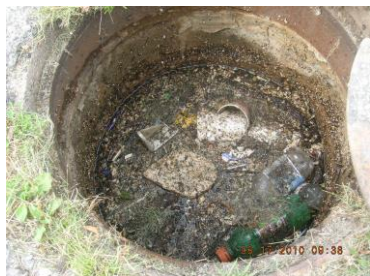
o20100817093838.JPG

Inspection Date: 8/17/2010 9:47:15 AM		Type: Ongoing	Flow: Submerged, indeterminate	Previous Rainfall (hrs): 72+
Illicit Discharge Potential: Potential		Inspector: JCW	Notes	
Submerged: Fully		Depth (in): 31	Significant floatable debris in manhole.	
Sampling Results				
Sample Location:	Pool	Floatables:	None	
Total Chlorine:	0 ppm	Odor:	None	
Free Chlorine:	0 ppm	Turbidity:	None	
Ammonia:	0 ppm	Color:	Faint in bottle	
pH:	7.64 units	Gross Solids:	Severe	
Temperature	74 °F	Vegetation:	None	
Conductivity:	-- µS/cm	Benthic Growth:	None	
Detergents:	0 mg/L	Stains:	None	
		Non-illicit:	None	
			Condition Assessment	
			Graffiti:	None
			Erosion:	None
			Deposition:	None 0 in.
			Damage:	None

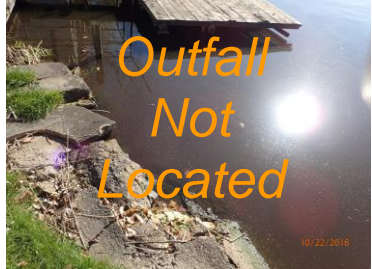
o20181022105820.JPG <div style="text-align: center; font-size: 24pt; font-weight: bold;">2018</div>

Inspection Date: 10/22/2018 10:59:46 AM		Type: Ongoing	Flow: Submerged (not located)	Previous Rainfall (hrs): 48-72
Illicit Discharge Potential: Potential		Inspector: JCW		
Submerged: Fully		Depth (in):		
Sampling Results Sample Location: _____ Total Chlorine: -- ppm Free Chlorine: -- ppm Ammonia: -- ppm pH: -- units Temperature: -- °F Conductivity: -- µS/cm Detergents: -- mg/L		Floatables: None Odor: None Turbidity: None Color: None Gross Solids: None Vegetation: None Benthic Growth: None Stains: None Non-illicit: None	Notes Outfall fully submerged and not located - screened upstream at 08-347 US1. Floating gross solids (litter) in manhole. Condition Assessment Graffiti: None Erosion: None Deposition: None in. Damage: None

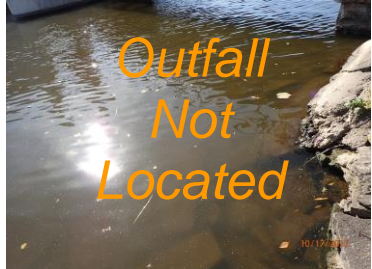
o20171017140150.JPG <div style="text-align: center; font-size: 24pt; font-weight: bold;">2017</div>

Inspection Date: 10/17/2017 2:04:43 PM		Type: Ongoing	Flow: Submerged (not located)	Previous Rainfall (hrs): 48-72
Illicit Discharge Potential: Potential		Inspector: JCW		
Submerged: Fully		Depth (in):		
Sampling Results Sample Location: _____ Total Chlorine: -- ppm Free Chlorine: -- ppm Ammonia: -- ppm pH: -- units Temperature: -- °F Conductivity: -- µS/cm Detergents: -- mg/L		Floatables: None Odor: None Turbidity: None Color: None Gross Solids: None Vegetation: None Benthic Growth: None Stains: None Non-illicit: None	Notes Outfall fully submerged and not located - screened upstream at 08-347 US1. Floating gross solids (litter) in manhole. Condition Assessment Graffiti: None Erosion: None Deposition: None in. Damage: None

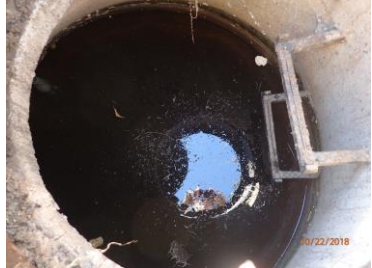
o20181022110036.JPG

Inspection Date: 10/22/2018 11:02:59 AM		Type: Ongoing	Flow: Submerged, indeterminate	Previous Rainfall (hrs): 48-72
Illicit Discharge Potential: Potential		Inspector: JCW		
Submerged: Fully		Depth (in): 53		
Sampling Results		Notes Sample collected from submerged pool in manhole. Floating gross solids (litter) in manhole.		
Sample Location: Pool	Floatables: None	Condition Assessment Graffiti: None Erosion: None Deposition: None in. Damage: None		
Total Chlorine: 0 ppm	Odor: None			
Free Chlorine: 0 ppm	Turbidity: None			
Ammonia: 0 ppm	Color: Faint in bottle			
pH: 7.49 units	Gross Solids: Slight			
Temperature 55 °F	Vegetation: None			
Conductivity: 321 µS/cm	Benthic Growth: Slight			
Detergents: 0 mg/L	Stains: None			
	Non-illicit: None

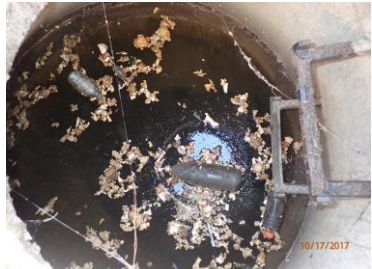
o20171017140304.JPG

Inspection Date: 10/17/2017 2:07:18 PM		Type: Ongoing	Flow: Submerged, indeterminate	Previous Rainfall (hrs): 48-72
Illicit Discharge Potential: Potential		Inspector: JCW		
Submerged: Fully		Depth (in): 46		
Sampling Results		Notes Sample collected from submerged pool in manhole. Floating gross solids (litter) in manhole.		
Sample Location: Pool	Floatables: None	Condition Assessment Graffiti: None Erosion: None Deposition: None in. Damage: None		
Total Chlorine: 0 ppm	Odor: None			
Free Chlorine: 0 ppm	Turbidity: None			
Ammonia: 0 ppm	Color: None			
pH: 8.29 units	Gross Solids: Moderate			
Temperature 66 °F	Vegetation: None			
Conductivity: 346 µS/cm	Benthic Growth: None			
Detergents: 0 mg/L	Stains: None			
	Non-illicit: None

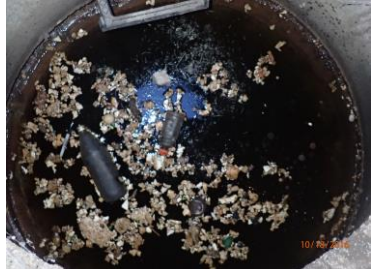
o20161018170248.JPG

Inspection Date: 10/18/2016 5:02:56 PM		Type: Ongoing	Flow: Submerged, indeterminate	Previous Rainfall (hrs): 72+
Illicit Discharge Potential: Potential		Inspector: JCW		
Submerged: Partially		Depth (in): 46		
Sampling Results		Notes Potential illicit discharge due to gross solids.		
Sample Location: Pool	Floatables: None	Condition Assessment Graffiti: None Erosion: None Deposition: None in. Damage: None		
Total Chlorine: 0 ppm	Odor: None			
Free Chlorine: 0 ppm	Turbidity: None			
Ammonia: 0 ppm	Color: Faint in bottle			
pH: 8.18 units	Gross Solids: Severe			
Temperature 66 °F	Vegetation: None			
Conductivity: 361 µS/cm	Benthic Growth: None			
Detergents: 0 mg/L	Stains: None			
	Non-illicit: None

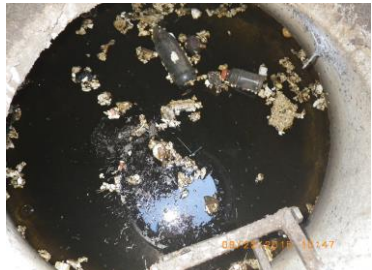
o20150922094746.JPG

Inspection Date: 9/22/2015 10:46:05 AM		Type: Ongoing	Flow: Submerged, indeterminate	Previous Rainfall (hrs): 72+
Illicit Discharge Potential: Potential		Inspector: JCW		
Submerged: Fully		Depth (in): 48		
Sampling Results		Notes Floating gross solids (litter) in manhole.		
Sample Location: Pool	Floatables: None	Condition Assessment Graffiti: None Erosion: None Deposition: None in. Damage: None		
Total Chlorine: 0 ppm	Odor: None			
Free Chlorine: 0 ppm	Turbidity: None			
Ammonia: 0 ppm	Color: None			
pH: 8.33 units	Gross Solids: Moderate			
Temperature 73 °F	Vegetation: None			
Conductivity: 352 µS/cm	Benthic Growth: None			
Detergents: 0 mg/L	Stains: None			
	Non-illicit: None

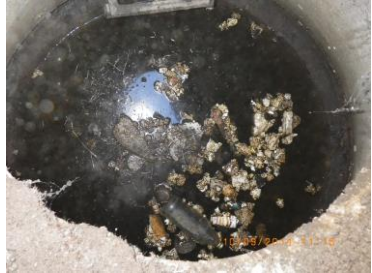
o20141009101552.JPG

Inspection Date: 10/9/2014 11:17:38 AM		Type: Ongoing	Flow: Submerged, indeterminate	Previous Rainfall (hrs): 72+
Illicit Discharge Potential: Potential		Inspector: JCW	Notes	
Submerged: Fully		Depth (in): 43	Floating gross solids (litter) in manhole.	
Sampling Results				
Sample Location:	Pool	Floatables:	None	
Total Chlorine:	0 ppm	Odor:	None	
Free Chlorine:	0 ppm	Turbidity:	None	
Ammonia:	0 ppm	Color:	None	
pH:	7.67 units	Gross Solids:	Moderate	
Temperature	59 °F	Vegetation:	None	
Conductivity:	422 µS/cm	Benthic Growth:	None	
Detergents:	0 mg/L	Stains:	None	
		Non-illicit:	None	
			Condition Assessment	
			Graffiti:	None
			Erosion:	None
			Deposition:	None in.
			Damage:	None

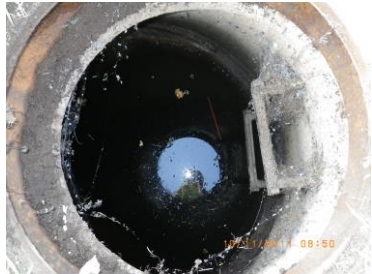
o20111011085018.JPG

Inspection Date: 10/11/2011 8:51:38 AM		Type: Ongoing	Flow: Submerged, indeterminate	Previous Rainfall (hrs): 72+
Illicit Discharge Potential: Unlikely		Inspector: JCW	Notes	
Submerged: Fully		Depth (in): 43	2010 screening follow-up. Floatable debris significantly reduced.	
Sampling Results				
Sample Location:	Pool	Floatables:	None	
Total Chlorine:	0 ppm	Odor:	None	
Free Chlorine:	0 ppm	Turbidity:	None	
Ammonia:	0 ppm	Color:	Faint in bottle	
pH:	7.87 units	Gross Solids:	Slight	
Temperature	71 °F	Vegetation:	None	
Conductivity:	-- µS/cm	Benthic Growth:	None	
Detergents:	-- mg/L	Stains:	None	
		Non-illicit:	None	
			Condition Assessment	
			Graffiti:	None
			Erosion:	None
			Deposition:	None 0 in.
			Damage:	None

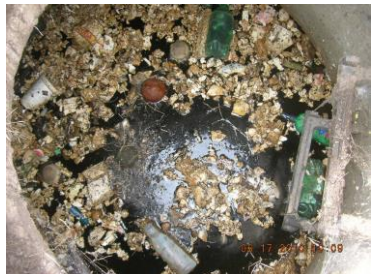
o20100817100950.JPG

Inspection Date: 8/17/2010 10:17:46 AM		Type: Ongoing	Flow: Submerged, indeterminate	Previous Rainfall (hrs): 72+
Illicit Discharge Potential: Potential		Inspector: JCW	Notes	
Submerged: Fully		Depth (in): 48	Significant floatable debris in manhole.	
Sampling Results				
Sample Location:	Pool	Floatables:	None	
Total Chlorine:	0 ppm	Odor:	None	
Free Chlorine:	0 ppm	Turbidity:	None	
Ammonia:	0 ppm	Color:	None	
pH:	7.71 units	Gross Solids:	Severe	
Temperature	74 °F	Vegetation:	None	
Conductivity:	-- µS/cm	Benthic Growth:	None	
Detergents:	0 mg/L	Stains:	None	
		Non-illicit:	None	
			Condition Assessment	
			Graffiti:	None
			Erosion:	None
			Deposition:	None 0 in.
			Damage:	None

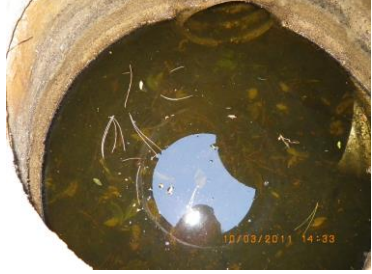
o20111003143300.JPG 2011 </div>

Inspection Date: 10/3/2011 2:33:22 PM		Type: Ongoing	Flow: Submerged, indeterminate	Previous Rainfall (hrs): 72+																															
Illicit Discharge Potential: Unlikely		Inspector: JCW																																	
Submerged: Fully		Depth (in): 12																																	
Sampling Results		<div style="border: 1px solid black; padding: 5px;">Notes</div> <div style="border: 1px solid black; padding: 5px; margin-top: 10px;"> Condition Assessment Graffiti: None Erosion: None Deposition: None 0 in. Damage: None </div>																																	
<table border="1" style="width:100%; border-collapse: collapse;"> <tr><td>Sample Location:</td><td>Pool</td></tr> <tr><td>Total Chlorine:</td><td>0 ppm</td></tr> <tr><td>Free Chlorine:</td><td>0 ppm</td></tr> <tr><td>Ammonia:</td><td>0.5 ppm</td></tr> <tr><td>pH:</td><td>7.16 units</td></tr> <tr><td>Temperature:</td><td>70 °F</td></tr> <tr><td>Conductivity:</td><td>-- µS/cm</td></tr> <tr><td>Detergents:</td><td>0 mg/L</td></tr> </table> <table border="1" style="width:100%; border-collapse: collapse;"> <tr><td>Floatables:</td><td>None</td></tr> <tr><td>Odor:</td><td>Faint</td></tr> <tr><td>Turbidity:</td><td>None</td></tr> <tr><td>Color:</td><td>None</td></tr> <tr><td>Gross Solids:</td><td>None</td></tr> <tr><td>Vegetation:</td><td>None</td></tr> <tr><td>Benthic Growth:</td><td>None</td></tr> <tr><td>Stains:</td><td>None</td></tr> <tr><td>Non-illicit:</td><td>None</td></tr> </table>					Sample Location:	Pool	Total Chlorine:	0 ppm	Free Chlorine:	0 ppm	Ammonia:	0.5 ppm	pH:	7.16 units	Temperature:	70 °F	Conductivity:	-- µS/cm	Detergents:	0 mg/L	Floatables:	None	Odor:	Faint	Turbidity:	None	Color:	None	Gross Solids:	None	Vegetation:	None	Benthic Growth:	None	Stains:

Sample Location:	Pool																																		
Total Chlorine:	0 ppm																																		
Free Chlorine:	0 ppm																																		
Ammonia:	0.5 ppm																																		
pH:	7.16 units																																		
Temperature:	70 °F																																		
Conductivity:	-- µS/cm																																		
Detergents:	0 mg/L																																		
Floatables:	None																																		
Odor:	Faint																																		
Turbidity:	None																																		
Color:	None																																		
Gross Solids:	None																																		
Vegetation:	None																																		
Benthic Growth:	None																																		
Stains:	None																																		
Non-illicit:	None																																		
		<div style="text-align: center;">

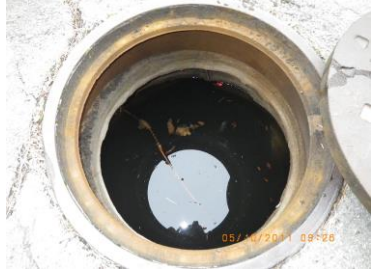
o20110510092630.JPG 2011 </div>

Inspection Date: 5/10/2011 9:26:00 AM		Type: Other	Flow: Submerged, indeterminate	Previous Rainfall (hrs): 0-24																															
Illicit Discharge Potential: Unlikely		Inspector: JCW																																	
Submerged: Fully		Depth (in):																																	
Sampling Results		<div style="border: 1px solid black; padding: 5px;">Notes</div> <div style="border: 1px solid black; padding: 5px; margin-top: 10px;"> Limited screening conducted for upstream manhole prescreening. </div> <div style="border: 1px solid black; padding: 5px; margin-top: 10px;"> Condition Assessment Graffiti: None Erosion: None Deposition: None 0 in. Damage: None </div>																																	
<table border="1" style="width:100%; border-collapse: collapse;"> <tr><td>Sample Location:</td><td></td></tr> <tr><td>Total Chlorine:</td><td>-- ppm</td></tr> <tr><td>Free Chlorine:</td><td>-- ppm</td></tr> <tr><td>Ammonia:</td><td>-- ppm</td></tr> <tr><td>pH:</td><td>-- units</td></tr> <tr><td>Temperature:</td><td>-- °F</td></tr> <tr><td>Conductivity:</td><td>-- µS/cm</td></tr> <tr><td>Detergents:</td><td>-- mg/L</td></tr> </table> <table border="1" style="width:100%; border-collapse: collapse;"> <tr><td>Floatables:</td><td>None</td></tr> <tr><td>Odor:</td><td></td></tr> <tr><td>Turbidity:</td><td></td></tr> <tr><td>Color:</td><td></td></tr> <tr><td>Gross Solids:</td><td>None</td></tr> <tr><td>Vegetation:</td><td></td></tr> <tr><td>Benthic Growth:</td><td></td></tr> <tr><td>Stains:</td><td></td></tr> <tr><td>Non-illicit:</td><td>None</td></tr> </table>					Sample Location:		Total Chlorine:	-- ppm	Free Chlorine:	-- ppm	Ammonia:	-- ppm	pH:	-- units	Temperature:	-- °F	Conductivity:	-- µS/cm	Detergents:	-- mg/L	Floatables:	None	Odor:		Turbidity:		Color:		Gross Solids:	None	Vegetation:		Benthic Growth:		Stains:

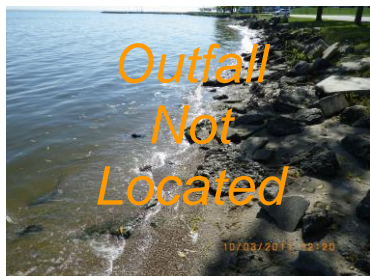
Inspection Date: 10/3/2011 12:20:26 PM		Type: Ongoing	Flow: Submerged (not located)	Previous Rainfall (hrs): 72+
Illicit Discharge Potential: Unlikely		Inspector: JCW		
Submerged: Fully		Depth (in):		
Sampling Results Sample Location: Total Chlorine: -- ppm Free Chlorine: -- ppm Ammonia: -- ppm pH: -- units Temperature -- °F Conductivity: -- µS/cm Detergents: -- mg/L		Floatables: None Odor: None Turbidity: None Color: None Gross Solids: None Vegetation: None Benthic Growth: None Stains: None Non-illicit: None	Notes Outfall fully submerged and not physically located. Outfall screened upstream at 11-64 US1.

o20111003122000.JPG 2011
		Condition Assessment Graffiti: None Erosion: None Deposition: None 0 in. Damage: None

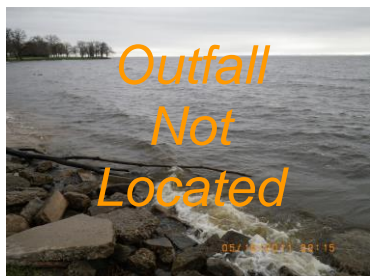
Inspection Date: 5/10/2011 9:14:00 AM		Type: Other	Flow: Submerged (not located)	Previous Rainfall (hrs): 0-24
Illicit Discharge Potential: Unlikely		Inspector: JCW		
Submerged: Fully		Depth (in):		
Sampling Results Sample Location: Total Chlorine: -- ppm Free Chlorine: -- ppm Ammonia: -- ppm pH: -- units Temperature -- °F Conductivity: -- µS/cm Detergents: -- mg/L		Floatables: Odor: Turbidity: Color: Gross Solids: Vegetation: Benthic Growth: Stains: Non-illicit: None	Notes Outfall fully submerged and not physically located. Outfall screened upstream at 11-64 US1.

o20110510091510.JPG 2011
		Condition Assessment Graffiti: None Erosion: None Deposition: None 0 in. Damage: None

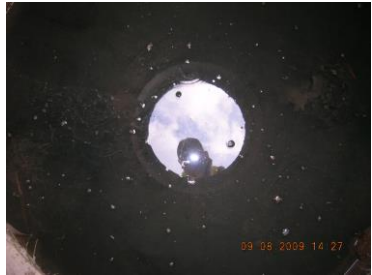
Osh09_DSCN6653.JPG <div style="text-align: center; font-size: 24pt; font-weight: bold;">2009</div>

Sample Location:	Pool																																					
Total Chlorine:	0 ppm																																					
Free Chlorine:	0 ppm																																					
Ammonia:	-- ppm																																					
pH:	7.61 units																																					
Temperature:	77 °F																																					
Conductivity:	-- µS/cm																																					
Detergents:	0 mg/L																																					
Floatables:																																						
Odor:																																						
Turbidity:																																						
Color:																																						
Gross Solids:																																						
Vegetation:																																						
Benthic Growth:																																						
Stains:																																						
Non-illicit:	None																																					
		Notes Slight sulfide odor.

Condition Assessment <table border="1" style="width:100%; border-collapse: collapse;"> <tr> <td>Graffiti:</td> <td>None</td> </tr> <tr> <td>Erosion:</td> <td>None</td> </tr> <tr> <td>Deposition:</td> <td>5 in.</td> </tr> <tr> <td>Damage:</td> <td>None</td> </tr> </table>			Graffiti:	None	Erosion:	None	Deposition:	5 in.	Damage:	None																										
Graffiti:	None																																					
Erosion:	None																																					
Deposition:	5 in.																																					
Damage:	None

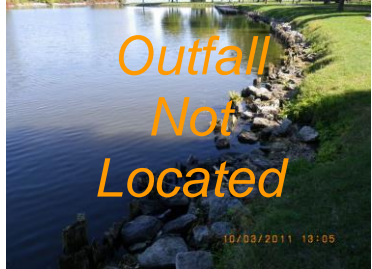
Inspection Date: 10/3/2011 1:04:57 PM		Type: Ongoing	Flow: Submerged (not located)	Previous Rainfall (hrs): 72+
Illicit Discharge Potential: Unlikely		Inspector: JCW		
Submerged: Fully		Depth (in):		
Sampling Results Sample Location: Total Chlorine: -- ppm Free Chlorine: -- ppm Ammonia: -- ppm pH: -- units Temperature -- °F Conductivity: -- µS/cm Detergents: -- mg/L		Floatables: None Odor: None Turbidity: None Color: None Gross Solids: None Vegetation: None Benthic Growth: None Stains: None Non-illicit: None		
		Notes Outfall fully submerged and not physically located. Outfall screened upstream at 11-71 US1.		
		Condition Assessment Graffiti: None Erosion: None Deposition: None 0 in. Damage: None

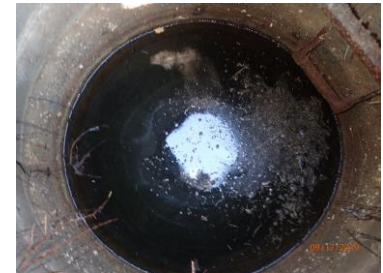
o20190917115714.JPG

Submerged: Fully Depth (in): 40

Illicit Discharge Potential: Unlikely**Notes:** Sample collected from submerged pool in manhole.Floatables: ☐ Petrol. Sheen ☐ Suds ☐ Sewage ☐ Algae ☐ OtherOdor: ☐ Petroleum ☐ Musty ☐ Sewage ☐ Chlorine ☐ Other☐ VOC/Solvent ☐ Fishy ☐ Sulfur ☐ FragrantTurbidity: Color: Gross Solids: ☐ Litter ☐ Veg. Debris ☐ Sediment ☐ OtherVegetation: ☐ Inhibited ☐ ExcessiveBenthic Growth: ☐ Green ☐ BrownStains: ☐ Flow Line ☐ Oil ☐ Rust Stains☐ Paint ☐ OtherNon-illicit: ☐ Natural Sheen ☐ Natural Suds/Foam**Physical Condition Assessment**

Deposition: Moderate Depth (in): 9

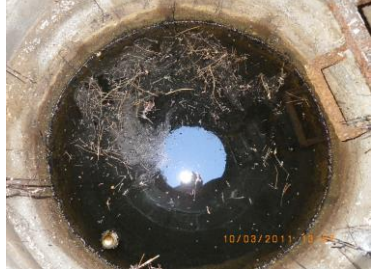
o20111003130758.JPG <div style="text-align: center; font-size: 24pt; font-weight: bold;">2011</div>

Sample Location:	Pool																																					
Total Chlorine:	0 ppm																																					
Free Chlorine:	0 ppm																																					
Ammonia:	0 ppm																																					
pH:	7.31 units																																					
Temperature:	67 °F																																					
Conductivity:	-- µS/cm																																					
Detergents:	0 mg/L																																					
Floatables:	None																																					
Odor:	None																																					
Turbidity:	None																																					
Color:	None																																					
Gross Solids:	Slight																																					
Vegetation:	None																																					
Benthic Growth:	None																																					
Stains:	None																																					
Non-illicit:	None

Notes <div style="border: 1px solid black; height: 80px; width: 100%;"></div>																																				
		Condition Assessment <table border="1" style="width:100%; border-collapse: collapse;"> <tr> <td>Graffiti:</td> <td>None</td> </tr> <tr> <td>Erosion:</td> <td>None</td> </tr> <tr> <td>Deposition:</td> <td>Minor 6 in.</td> </tr> <tr> <td>Damage:</td> <td>None</td> </tr> </table>			Graffiti:	None	Erosion:	None	Deposition:	Minor 6 in.	Damage:	None																										
Graffiti:	None																																					
Erosion:	None																																					
Deposition:	Minor 6 in.																																					
Damage:	None

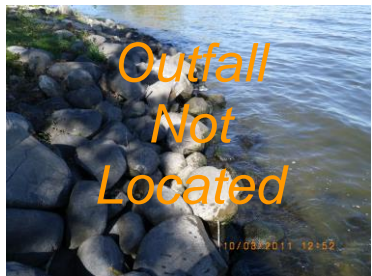
Inspection Date: 10/3/2011 12:52:36 PM		Type: Ongoing	Flow: Submerged (not located)	Previous Rainfall (hrs): 72+
Illicit Discharge Potential: Unlikely		Inspector: JCW		
Submerged: Fully		Depth (in):		
Sampling Results Sample Location: _____ Total Chlorine: -- ppm Free Chlorine: -- ppm Ammonia: -- ppm pH: -- units Temperature -- °F Conductivity: -- µS/cm Detergents: -- mg/L		Floatables: None Odor: None Turbidity: None Color: None Gross Solids: None Vegetation: None Benthic Growth: None Stains: None Non-illicit: None		
		Notes Outfall fully submerged and not physically located. Outfall screened upstream at 11-75 US1.		
		Condition Assessment Graffiti: None Erosion: None Deposition: None 0 in. Damage: None

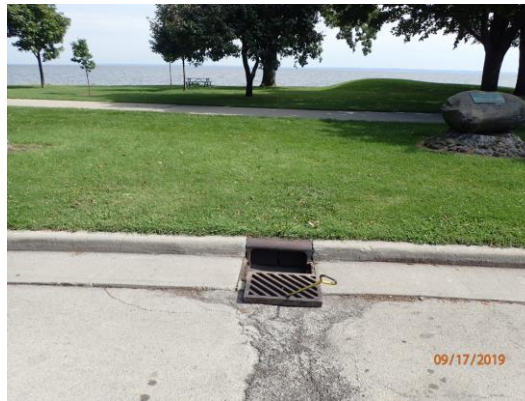
o20190917112646.JPG

Upstream curb inlet located approx 165 ft WSW of outfall 11-75. Intermediate area consists of open space in park.

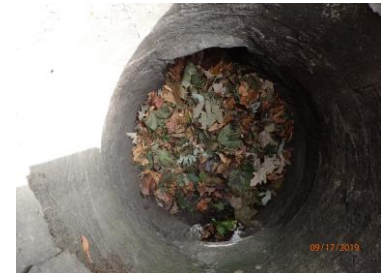
o20190917112654.JPG

Sample Location:																																		
Total Chlorine:	-- ppm																																	
Free Chlorine:	-- ppm																																	
Ammonia:	-- ppm																																	
pH:	-- units																																	
Temperature:	-- °F																																	
Conductivity:	-- µS/cm																																	
Detergents:	-- mg/L																																	
Notes																																		
Curb inlet dry at time of inspection. Some leaves on bottom.																																		
Condition Assessment																																		
Graffiti:	None																																	
Erosion:	None																																	
Deposition:	None 0 in.																																	
Damage:	None

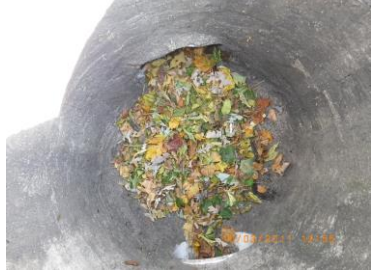
<p style="text-align: center;">o20111003125508.JPG</p> <p style="text-align: center; font-size: 24pt; font-weight: bold;">2011</p>

Sample Location:																																		
Total Chlorine:	-- ppm																																	
Free Chlorine:	-- ppm																																	
Ammonia:	-- ppm																																	
pH:	-- units																																	
Temperature:	-- °F																																	
Conductivity:	-- µS/cm																																	
Detergents:	-- mg/L																																	
Notes																																		
Limited screening conducted for upstream manhole prescreening.																																		
Condition Assessment																																		
Graffiti:	None																																	
Erosion:	None																																	
Deposition:	None 0 in.																																	
Damage:	None

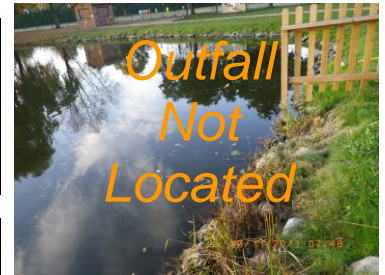
o20111011074830.JPG

Sample Location:																																		
Total Chlorine:	-- ppm																																	
Free Chlorine:	-- ppm																																	
Ammonia:	-- ppm																																	
pH:	-- units																																	
Temperature:	-- °F																																	
Conductivity:	-- µS/cm																																	
Detergents:	-- mg/L																																	
Notes																																		
Outfall fully submerged and not physically located. Outfall screened upstream at 11-79 US1.																																		
Condition Assessment																																		
Graffiti:	None																																	
Erosion:	None																																	
Deposition:	None 0 in.																																	
Damage:	None

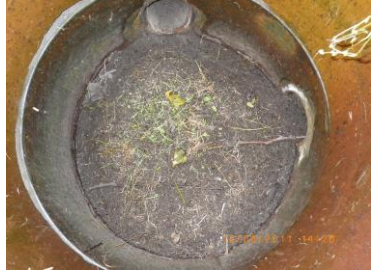
o20111003142638.JPG <div style="text-align: right; font-size: 24pt; font-weight: bold;">2011</div>

Inspection Date: 10/3/2011 2:26:22 PM		Type: Ongoing	Flow: None	Previous Rainfall (hrs): 72+
Illicit Discharge Potential: Unlikely		Inspector: JCW		
Submerged: None		Depth (in):		
Sampling Results Sample Location: _____ Total Chlorine: -- ppm Free Chlorine: -- ppm Ammonia: -- ppm pH: -- units Temperature -- °F Conductivity: -- µS/cm Detergents: -- mg/L		Floatables: None Odor: None Turbidity: None Color: None Gross Solids: None Vegetation: None Benthic Growth: None Stains: None Non-illicit: None		
		Notes Catchbasin dry at time of inspection.		
		Condition Assessment Graffiti: None Erosion: None Deposition: Minor 1 in. Damage: None

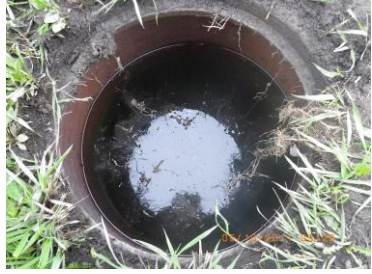
o20110510092930.JPG <div style="text-align: right; font-size: 24pt; font-weight: bold;">2011</div>

Inspection Date: 5/10/2011 9:26:00 AM		Type: Other	Flow: Submerged, indeterminate	Previous Rainfall (hrs): 0-24
Illicit Discharge Potential: Unlikely		Inspector: JCW		
Submerged: Fully		Depth (in):		
Sampling Results Sample Location: _____ Total Chlorine: -- ppm Free Chlorine: -- ppm Ammonia: -- ppm pH: -- units Temperature -- °F Conductivity: -- µS/cm Detergents: -- mg/L		Floatables: None Odor: _____ Turbidity: _____ Color: _____ Gross Solids: None Vegetation: _____ Benthic Growth: _____ Stains: _____ Non-illicit: None		
		Notes Limited screening conducted for upstream manhole prescreening.		
		Condition Assessment Graffiti: None Erosion: None Deposition: None 0 in. Damage: None

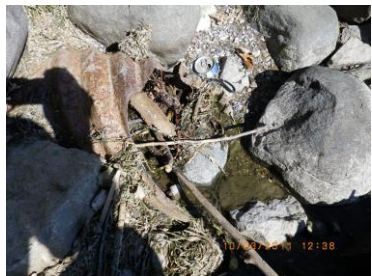
o20111003123802.JPG <div style="text-align: center; font-size: 24pt; font-weight: bold;">2011</div>

Inspection Date: 10/3/2011 12:37:11 PM		Type: Ongoing	Flow: Submerged, indeterminate	Previous Rainfall (hrs): 72+
Illicit Discharge Potential: Unlikely		Inspector: JCW		
Submerged: Partially		Depth (in): 5		
Sampling Results Sample Location: _____ Total Chlorine: -- ppm Free Chlorine: -- ppm Ammonia: -- ppm pH: -- units Temperature: -- °F Conductivity: -- µS/cm Detergents: -- mg/L		Floatables: None Odor: None Turbidity: None Color: None Gross Solids: Slight Vegetation: None Benthic Growth: None Stains: None Non-illicit: None		
		Notes Outfall partially submerged. Outfall screened upstream at 11-118 US1.		
		Condition Assessment Graffiti: None Erosion: None Deposition: Moderate 4 in. Damage: Minor

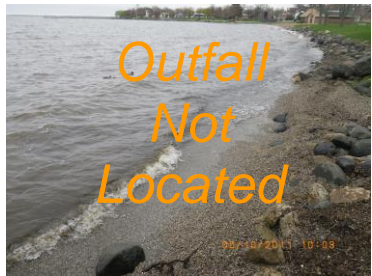
o20110510100308.JPG <div style="text-align: center; font-size: 24pt; font-weight: bold;">2011</div>

Inspection Date: 5/10/2011 10:02:00 AM		Type: Other	Flow: Submerged (not located)	Previous Rainfall (hrs): 0-24
Illicit Discharge Potential: Unlikely		Inspector: JCW		
Submerged: Fully		Depth (in):		
Sampling Results Sample Location: _____ Total Chlorine: -- ppm Free Chlorine: -- ppm Ammonia: -- ppm pH: -- units Temperature: -- °F Conductivity: -- µS/cm Detergents: -- mg/L		Floatables: _____ Odor: _____ Turbidity: _____ Color: _____ Gross Solids: _____ Vegetation: _____ Benthic Growth: _____ Stains: _____ Non-illicit: None		
		Notes Outfall fully submerged and not physically located. Outfall screened upstream at 11-118 US1.		
		Condition Assessment Graffiti: None Erosion: None Deposition: None 0 in. Damage: None

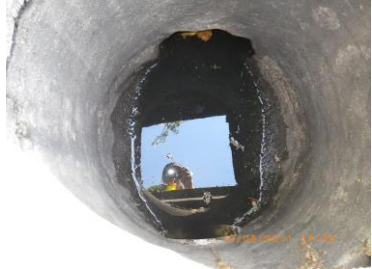
<small>o20111003124056.JPG</small> <div style="font-size: 24pt; font-weight: bold;">2011</div>

Inspection Date: 10/3/2011 12:41:20 PM		Type: Ongoing	Flow: Submerged, indeterminate	Previous Rainfall (hrs): 72+																															
Illicit Discharge Potential: Unlikely		Inspector: JCW																																	
Submerged: Partially		Depth (in): 3																																	
Sampling Results		<div style="border: 1px solid black; padding: 5px;">Notes</div> <div style="border: 1px solid black; padding: 5px; margin-top: 10px;"> Condition Assessment Graffiti: None Erosion: None Deposition: None 0 in. Damage: None </div>																																	
<table border="1" style="width:100%; border-collapse: collapse;"> <tr><td>Sample Location:</td><td>Pool</td></tr> <tr><td>Total Chlorine:</td><td>0 ppm</td></tr> <tr><td>Free Chlorine:</td><td>0 ppm</td></tr> <tr><td>Ammonia:</td><td>0.5 ppm</td></tr> <tr><td>pH:</td><td>6.99 units</td></tr> <tr><td>Temperature:</td><td>68 °F</td></tr> <tr><td>Conductivity:</td><td>-- µS/cm</td></tr> <tr><td>Detergents:</td><td>0 mg/L</td></tr> </table> <table border="1" style="width:100%; border-collapse: collapse;"> <tr><td>Floatables:</td><td>None</td></tr> <tr><td>Odor:</td><td>Faint</td></tr> <tr><td>Turbidity:</td><td>None</td></tr> <tr><td>Color:</td><td>None</td></tr> <tr><td>Gross Solids:</td><td>None</td></tr> <tr><td>Vegetation:</td><td>None</td></tr> <tr><td>Benthic Growth:</td><td>None</td></tr> <tr><td>Stains:</td><td>None</td></tr> <tr><td>Non-illicit:</td><td>None</td></tr> </table>					Sample Location:	Pool	Total Chlorine:	0 ppm	Free Chlorine:	0 ppm	Ammonia:	0.5 ppm	pH:	6.99 units	Temperature:	68 °F	Conductivity:	-- µS/cm	Detergents:	0 mg/L	Floatables:	None	Odor:	Faint	Turbidity:	None	Color:	None	Gross Solids:	None	Vegetation:	None	Benthic Growth:	None	Stains:

Sample Location:	Pool																																		
Total Chlorine:	0 ppm																																		
Free Chlorine:	0 ppm																																		
Ammonia:	0.5 ppm																																		
pH:	6.99 units																																		
Temperature:	68 °F																																		
Conductivity:	-- µS/cm																																		
Detergents:	0 mg/L																																		
Floatables:	None																																		
Odor:	Faint																																		
Turbidity:	None																																		
Color:	None																																		
Gross Solids:	None																																		
Vegetation:	None																																		
Benthic Growth:	None																																		
Stains:	None																																		
Non-illicit:	None

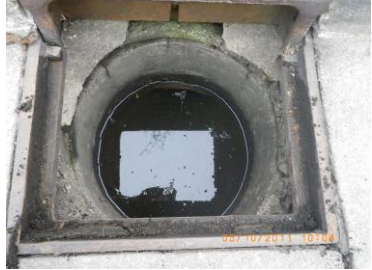
<small>o20110510100406.JPG</small> <div style="font-size: 24pt; font-weight: bold;">2011</div>

Inspection Date: 5/10/2011 10:03:00 AM		Type: Other	Flow: Submerged, indeterminate	Previous Rainfall (hrs): 0-24																															
Illicit Discharge Potential: Unlikely		Inspector: JCW																																	
Submerged: Fully		Depth (in):																																	
Sampling Results		<div style="border: 1px solid black; padding: 5px;">Notes</div> <div style="border: 1px solid black; padding: 5px; margin-top: 10px;"> Limited screening conducted for upstream manhole prescreening. </div> <div style="border: 1px solid black; padding: 5px; margin-top: 10px;"> Condition Assessment Graffiti: None Erosion: None Deposition: None 0 in. Damage: None </div>																																	
<table border="1" style="width:100%; border-collapse: collapse;"> <tr><td>Sample Location:</td><td></td></tr> <tr><td>Total Chlorine:</td><td>-- ppm</td></tr> <tr><td>Free Chlorine:</td><td>-- ppm</td></tr> <tr><td>Ammonia:</td><td>-- ppm</td></tr> <tr><td>pH:</td><td>-- units</td></tr> <tr><td>Temperature:</td><td>-- °F</td></tr> <tr><td>Conductivity:</td><td>-- µS/cm</td></tr> <tr><td>Detergents:</td><td>-- mg/L</td></tr> </table> <table border="1" style="width:100%; border-collapse: collapse;"> <tr><td>Floatables:</td><td>None</td></tr> <tr><td>Odor:</td><td></td></tr> <tr><td>Turbidity:</td><td></td></tr> <tr><td>Color:</td><td></td></tr> <tr><td>Gross Solids:</td><td>None</td></tr> <tr><td>Vegetation:</td><td></td></tr> <tr><td>Benthic Growth:</td><td></td></tr> <tr><td>Stains:</td><td></td></tr> <tr><td>Non-illicit:</td><td>None</td></tr> </table>					Sample Location:		Total Chlorine:	-- ppm	Free Chlorine:	-- ppm	Ammonia:	-- ppm	pH:	-- units	Temperature:	-- °F	Conductivity:	-- µS/cm	Detergents:	-- mg/L	Floatables:	None	Odor:		Turbidity:		Color:		Gross Solids:	None	Vegetation:		Benthic Growth:		Stains:

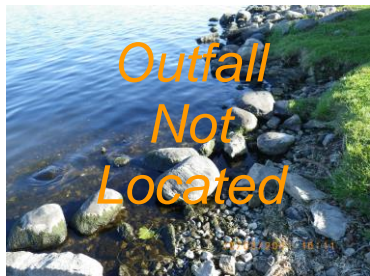
o20111003161156.JPG <div style="text-align: center; font-weight: bold; font-size: 1.2em;">2011</div>

Inspection Date: 10/3/2011 4:12:24 PM		Type: Ongoing	Flow: Submerged (not located)	Previous Rainfall (hrs): 72+
Illicit Discharge Potential: Unlikely		Inspector: JCW		
Submerged: Fully		Depth (in):		
Sampling Results Sample Location: _____ Total Chlorine: -- ppm Free Chlorine: -- ppm Ammonia: -- ppm pH: -- units Temperature: -- °F Conductivity: -- µS/cm Detergents: -- mg/L		Floatables: None Odor: None Turbidity: None Color: None Gross Solids: None Vegetation: None Benthic Growth: None Stains: None Non-illicit: None	Notes Outfall fully submerged and not physically located. Outfall screened upstream at 11-177 US1. Condition Assessment Graffiti: None Erosion: None Deposition: None 0 in. Damage: None

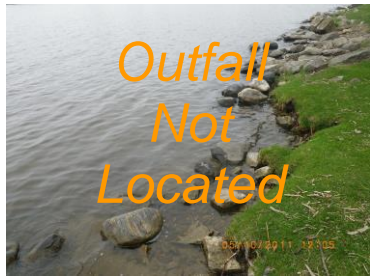
o20110510120530.JPG <div style="text-align: center; font-weight: bold; font-size: 1.2em;">2011</div>

Inspection Date: 5/10/2011 12:05:00 PM		Type: Other	Flow: Submerged (not located)	Previous Rainfall (hrs): 0-24
Illicit Discharge Potential: Potential		Inspector: JCW		
Submerged: Fully		Depth (in):		
Sampling Results Sample Location: _____ Total Chlorine: -- ppm Free Chlorine: -- ppm Ammonia: -- ppm pH: -- units Temperature: -- °F Conductivity: -- µS/cm Detergents: -- mg/L		Floatables: _____ Odor: _____ Turbidity: _____ Color: _____ Gross Solids: _____ Vegetation: _____ Benthic Growth: _____ Stains: _____ Non-illicit: None	Notes Outfall fully submerged and not physically located. Outfall screened upstream at 11-177 US1. Condition Assessment Graffiti: None Erosion: None Deposition: None 0 in. Damage: None

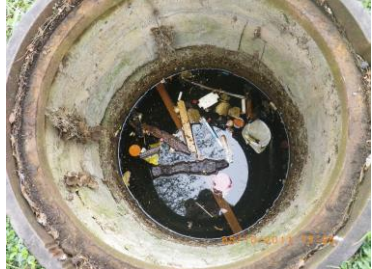
o20110510120546.JPG <div style="text-align: center; font-size: 24pt; font-weight: bold;">2011</div>

Sample Location:																																						
Total Chlorine:	-- ppm																																					
Free Chlorine:	-- ppm																																					
Ammonia:	-- ppm																																					
pH:	-- units																																					
Temperature:	-- °F																																					
Conductivity:	-- µS/cm																																					
Detergents:	-- mg/L																																					
Floatables:	None																																					
Odor:																																						
Turbidity:																																						
Color:																																						
Gross Solids:	Moderate																																					
Vegetation:																																						
Benthic Growth:																																						
Stains:																																						
Non-illicit:	None																																					
		Notes <div style="border: 1px solid black; padding: 5px;"> Limited screening conducted for upstream manhole prescreening. </div>

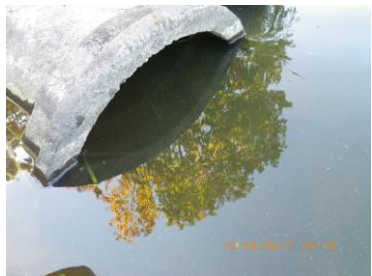
o20111003131358.JPG <div style="text-align: right; font-size: 24pt; font-weight: bold;">2011</div>

Inspection Date: 10/3/2011 1:12:53 PM		Type: Ongoing	Flow: Submerged, indeterminate	Previous Rainfall (hrs): 72+
Illicit Discharge Potential: Unlikely		Inspector: JCW		
Submerged: Partially		Depth (in): 13		
Sampling Results Sample Location: Total Chlorine: -- ppm Free Chlorine: -- ppm Ammonia: -- ppm pH: -- units Temperature -- °F Conductivity: -- µS/cm Detergents: -- mg/L		Floatables: None Odor: None Turbidity: None Color: None Gross Solids: None Vegetation: None Benthic Growth: Slight Stains: None Non-illicit: None		
		Notes Outfall partially submerged. Outfall screened upstream at 11-225 US2.		
		Condition Assessment Graffiti: None Erosion: None Deposition: None 0 in. Damage: None

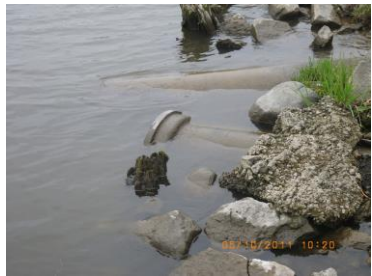
o20110510102022.JPG <div style="text-align: right; font-size: 24pt; font-weight: bold;">2011</div>

Inspection Date: 5/10/2011 10:20:00 AM		Type: Other	Flow: Submerged, indeterminate	Previous Rainfall (hrs): 0-24
Illicit Discharge Potential: Unlikely		Inspector: JCW		
Submerged: Fully		Depth (in):		
Sampling Results Sample Location: Total Chlorine: -- ppm Free Chlorine: -- ppm Ammonia: -- ppm pH: -- units Temperature -- °F Conductivity: -- µS/cm Detergents: -- mg/L		Floatables: Odor: Turbidity: Color: Gross Solids: Vegetation: Benthic Growth: Stains: Non-illicit: None		
		Notes Outfall fully submerged. Outfall screened upstream at 11-225 US1.		
		Condition Assessment Graffiti: None Erosion: None Deposition: None 0 in. Damage: None

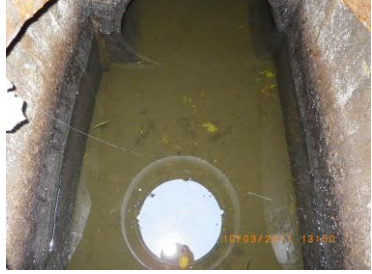
o20111003135020.JPG

Sample Location: Pool	Floatables: None																		
Total Chlorine: 0 ppm	Odor: None																		
Free Chlorine: 0 ppm	Turbidity: None																		
Ammonia: 0 ppm	Color: None																		
pH: 7.43 units	Gross Solids: None																		
Temperature: 67 °F	Vegetation: None																		
Conductivity: -- µS/cm	Benthic Growth: None																		
Detergents: 0 mg/L	Stains: Slight																		
	Non-illicit: None																		
		Condition Assessment																	
		<table border="1" style="width: 100%; border-collapse: collapse;"> <tr> <td style="width: 50%;">Graffiti: None</td> <td style="width: 50%;"></td> </tr> <tr> <td>Erosion: None</td> <td></td> </tr> <tr> <td>Deposition: Minor</td> <td>2 in.</td> </tr> <tr> <td>Damage: None</td> <td></td> </tr> </table>			Graffiti: None		Erosion: None		Deposition: Minor	2 in.	Damage: None								
Graffiti: None

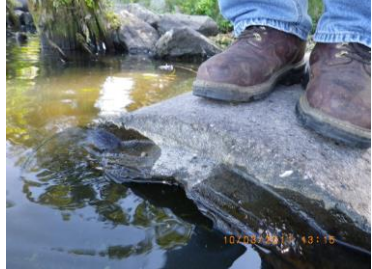
o20111003131556.JPG <div style="text-align: right; font-size: 1.5em; font-weight: bold;">2011</div>

Inspection Date: 10/3/2011 1:19:01 PM		Type: Ongoing	Flow: Submerged, indeterminate	Previous Rainfall (hrs): 72+
Illicit Discharge Potential: Unlikely		Inspector: JCW		
Submerged: Fully		Depth (in):		
Sampling Results Sample Location: Total Chlorine: -- ppm Free Chlorine: -- ppm Ammonia: -- ppm pH: -- units Temperature -- °F Conductivity: -- µS/cm Detergents: -- mg/L		Floatables: None Odor: None Turbidity: None Color: None Gross Solids: None Vegetation: None Benthic Growth: Slight Stains: None Non-illicit: None		
		Notes End section of pipe displaced. Outfall fully submerged. Outfall screened upstream at 11-244 US1.		
		Condition Assessment Graffiti: None Erosion: None Deposition: None 0 in. Damage: Minor

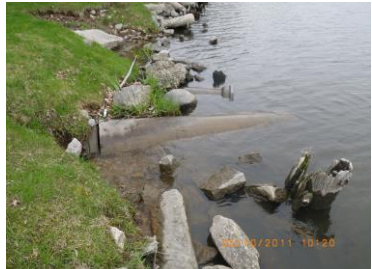
o20110510102050.JPG <div style="text-align: right; font-size: 1.5em; font-weight: bold;">2011</div>

Inspection Date: 5/10/2011 10:20:00 AM		Type: Other	Flow: Submerged, indeterminate	Previous Rainfall (hrs): 0-24
Illicit Discharge Potential: Unlikely		Inspector: JCW		
Submerged: Fully		Depth (in):		
Sampling Results Sample Location: Total Chlorine: -- ppm Free Chlorine: -- ppm Ammonia: -- ppm pH: -- units Temperature -- °F Conductivity: -- µS/cm Detergents: -- mg/L		Floatables: Odor: Turbidity: Color: Gross Solids: Vegetation: Benthic Growth: Stains: Non-illicit: None		
		Notes Outfall fully submerged. Outfall screened upstream at 11-244 US1.		
		Condition Assessment Graffiti: None Erosion: None Deposition: None 0 in. Damage: Minor

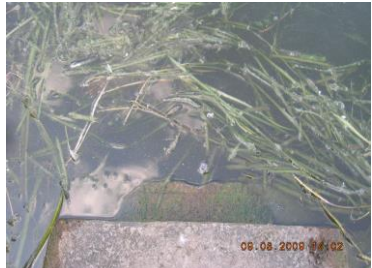
Osh09_DSCN6645.JPG <div style="text-align: right; font-size: 1.5em; font-weight: bold;">2009</div>

Inspection Date: 9/8/2009		Type: Initial	Flow: Submerged, indeterminate	Previous Rainfall (hrs): 72+
Illicit Discharge Potential: Unlikely		Inspector: JCW		
Submerged: Fully		Depth (in): 27		
Sampling Results Sample Location: Total Chlorine: -- ppm Free Chlorine: -- ppm Ammonia: -- ppm pH: -- units Temperature -- °F Conductivity: -- µS/cm Detergents: -- mg/L		Floatables: Odor: Turbidity: Color: Gross Solids: Vegetation: Benthic Growth: Stains: Non-illicit: None		
		Notes Pipe separation		
		Condition Assessment Graffiti: None Erosion: None Deposition: in. Damage: Moderate

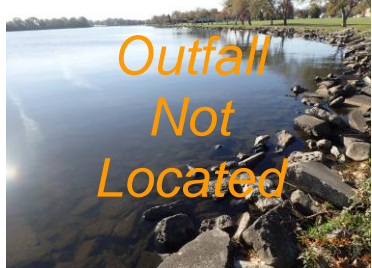
o20181022094126.JPG

Inspection Date: 10/22/2018 9:42:07 AM		Type: Ongoing	Flow: Submerged (not located)	Previous Rainfall (hrs): 48-72
Illicit Discharge Potential: Potential		Inspector: JCW		
Submerged: Fully		Depth (in):		
Sampling Results Sample Location: _____ Total Chlorine: -- ppm Free Chlorine: -- ppm Ammonia: -- ppm pH: -- units Temperature: -- °F Conductivity: -- µS/cm Detergents: -- mg/L		Floatables: None Odor: None Turbidity: None Color: None Gross Solids: None Vegetation: None Benthic Growth: None Stains: None Non-illicit: None	Notes Outfall fully submerged and not located - screened upstream at 11-376 US1. Floating gross solids (litter) in manhole. Condition Assessment Graffiti: None Erosion: None Deposition: None in. Damage: None

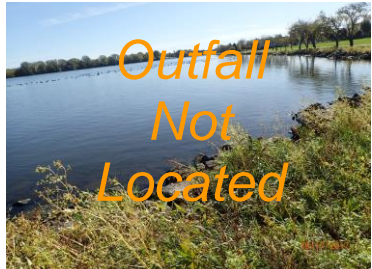
o20171017130204.JPG

Inspection Date: 10/17/2017 1:03:56 PM		Type: Ongoing	Flow: Submerged (not located)	Previous Rainfall (hrs): 48-72
Illicit Discharge Potential: Potential		Inspector: JCW		
Submerged: Fully		Depth (in):		
Sampling Results Sample Location: _____ Total Chlorine: -- ppm Free Chlorine: -- ppm Ammonia: -- ppm pH: -- units Temperature: -- °F Conductivity: -- µS/cm Detergents: -- mg/L		Floatables: None Odor: None Turbidity: None Color: None Gross Solids: None Vegetation: None Benthic Growth: None Stains: None Non-illicit: None	Notes Outfall fully submerged and not located - screened upstream at 11-376 US1. Floating gross solids (litter) in manhole. Condition Assessment Graffiti: None Erosion: None Deposition: None in. Damage: None

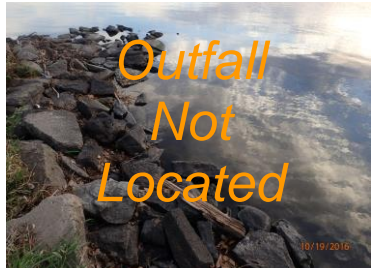
o20161019074246.JPG

Inspection Date: 10/19/2016 7:43:58 AM		Type: Ongoing	Flow: Submerged (not located)	Previous Rainfall (hrs): 72+
Illicit Discharge Potential: Potential		Inspector: JCW		
Submerged: Fully		Depth (in):		
Sampling Results Sample Location: _____ Total Chlorine: -- ppm Free Chlorine: -- ppm Ammonia: -- ppm pH: -- units Temperature: -- °F Conductivity: -- µS/cm Detergents: -- mg/L		Floatables: None Odor: None Turbidity: None Color: None Gross Solids: None Vegetation: None Benthic Growth: None Stains: None Non-illicit: None	Notes Outfall fully submerged and not located - screened upstream at 11-376 US1. Condition Assessment Graffiti: None Erosion: None Deposition: None in. Damage: None

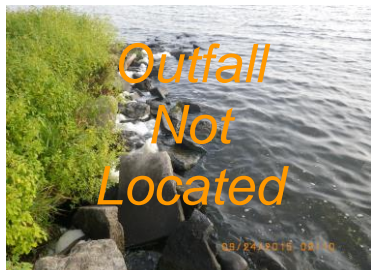
o20150924081044.JPG

Inspection Date: 9/24/2015 9:06:24 AM		Type: Ongoing	Flow: Submerged (not located)	Previous Rainfall (hrs): 72+
Illicit Discharge Potential: Potential		Inspector: JCW		
Submerged: Fully		Depth (in):		
Sampling Results Sample Location: _____ Total Chlorine: -- ppm Free Chlorine: -- ppm Ammonia: -- ppm pH: -- units Temperature: -- °F Conductivity: -- µS/cm Detergents: -- mg/L		Floatables: None Odor: None Turbidity: None Color: None Gross Solids: None Vegetation: None Benthic Growth: None Stains: None Non-illicit: Moderate	Notes Outfall fully submerged and not located - screened at 11-376 US1. Condition Assessment Graffiti: None Erosion: None Deposition: None in. Damage: None

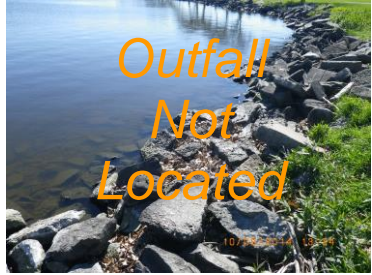
o20141009123438.JPG

Inspection Date: 10/9/2014 1:35:21 PM		Type: Ongoing	Flow: Submerged (not located)	Previous Rainfall (hrs): 72+
Illicit Discharge Potential: Potential		Inspector: JCW	Notes	
Submerged: Fully		Depth (in):	Outfall fully submerged and not located - screened upstream at 11-376 US1.	
Sampling Results		Floatables:	Condition Assessment Graffiti: None Erosion: None Deposition: None in. Damage: None	
Sample Location:		Odor:		
Total Chlorine: -- ppm		Turbidity:		
Free Chlorine: -- ppm		Color:		
Ammonia: -- ppm		Gross Solids:		
pH: -- units		Vegetation:		
Temperature -- °F		Benthic Growth:		
Conductivity: -- µS/cm		Stains:		
Detergents: -- mg/L		Non-illicit:

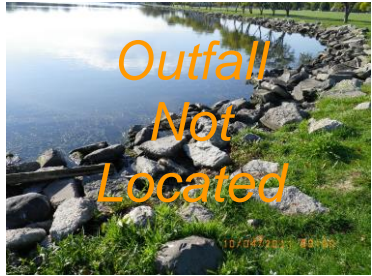
o20111004092048.JPG

Inspection Date: 10/4/2011 9:20:16 AM		Type: Ongoing	Flow: Submerged (not located)	Previous Rainfall (hrs): 72+
Illicit Discharge Potential: Unlikely		Inspector: JCW	Notes	
Submerged: Fully		Depth (in):	Outfall fully submerged and not physically located. Outfall screened upstream at 11-376 US1.	
Sampling Results		Floatables:	Condition Assessment Graffiti: None Erosion: None Deposition: None 0 in. Damage: None	
Sample Location:		Odor:		
Total Chlorine: -- ppm		Turbidity:		
Free Chlorine: -- ppm		Color:		
Ammonia: -- ppm		Gross Solids:		
pH: -- units		Vegetation:		
Temperature -- °F		Benthic Growth:		
Conductivity: -- µS/cm		Stains:		
Detergents: -- mg/L		Non-illicit:

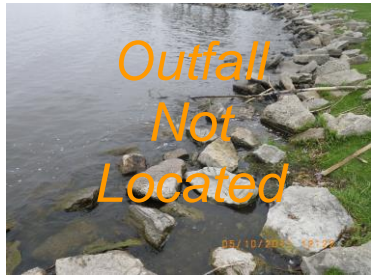
o20110510122252.JPG

Inspection Date: 5/10/2011 12:22:00 PM		Type: Other	Flow: Submerged (not located)	Previous Rainfall (hrs): 0-24
Illicit Discharge Potential: Potential		Inspector: JCW	Notes	
Submerged: Fully		Depth (in):	Outfall fully submerged and not physically located. Outfall screened upstream at 11-376 US1.	
Sampling Results		Floatables:	Condition Assessment Graffiti: None Erosion: None Deposition: None 0 in. Damage: None	
Sample Location:		Odor:		
Total Chlorine: -- ppm		Turbidity:		
Free Chlorine: -- ppm		Color:		
Ammonia: -- ppm		Gross Solids:		
pH: -- units		Vegetation:		
Temperature -- °F		Benthic Growth:		
Conductivity: -- µS/cm		Stains:		
Detergents: -- mg/L		Non-illicit:

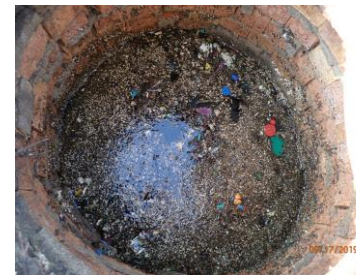
o20190917074432.JPG

Sample Location:	Pool																																					
Total Chlorine:	0 ppm																																					
Free Chlorine:	0 ppm																																					
Ammonia:	0 ppm																																					
pH:	7.52 units																																					
Temperature:	55 °F																																					
Conductivity:	575 µS/cm																																					
Detergents:	0 mg/L																																					
Floatables:	None																																					
Odor:	None																																					
Turbidity:	None																																					
Color:	None																																					
Gross Solids:	Moderate																																					
Vegetation:	None																																					
Benthic Growth:	None																																					
Stains:	None																																					
Non-illicit:	None

<div style="display: flex;"> <div style="flex: 1;"> <p>Notes</p> <p>Sample collected from submerged pool in manhole. Floating gross solids (litter) in manhole.</p> </div> <div style="flex: 1;"> <p>Condition Assessment</p> <table border="1" style="width:100%; border-collapse: collapse;"> <tr><td>Graffiti:</td><td>None</td></tr> <tr><td>Erosion:</td><td>None</td></tr> <tr><td>Deposition:</td><td>None in.</td></tr> <tr><td>Damage:</td><td>None</td></tr> </table> </div> </div>			Graffiti:	None	Erosion:	None	Deposition:	None in.	Damage:	None																										
Graffiti:	None																																					
Erosion:	None																																					
Deposition:	None in.																																					
Damage:	None

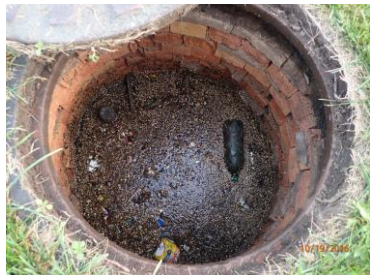
o20161019074410.JPG <div style="text-align: center; font-size: 24pt; font-weight: bold;">2016</div>

Inspection Date: 9/24/2015 9:10:22 AM		Type: Ongoing	Flow: Submerged, indeterminate	Previous Rainfall (hrs): 72+																																		
Illicit Discharge Potential: Potential		Inspector: JCW																																				
Submerged: Fully		Depth (in): 81																																				
Sampling Results		<div style="display: flex;"> <div style="flex: 1;"> <table border="1" style="width:100%; border-collapse: collapse;"> <tr><td>Sample Location:</td><td>Pool</td></tr> <tr><td>Total Chlorine:</td><td>0 ppm</td></tr> <tr><td>Free Chlorine:</td><td>0 ppm</td></tr> <tr><td>Ammonia:</td><td>0 ppm</td></tr> <tr><td>pH:</td><td>7.88 units</td></tr> <tr><td>Temperature:</td><td>68 °F</td></tr> <tr><td>Conductivity:</td><td>397 µS/cm</td></tr> <tr><td>Detergents:</td><td>0 mg/L</td></tr> </table> </div> <div style="flex: 1;"> <table border="1" style="width:100%; border-collapse: collapse;"> <tr><td>Floatables:</td><td>None</td></tr> <tr><td>Odor:</td><td>Faint</td></tr> <tr><td>Turbidity:</td><td>None</td></tr> <tr><td>Color:</td><td>None</td></tr> <tr><td>Gross Solids:</td><td>Severe</td></tr> <tr><td>Vegetation:</td><td>None</td></tr> <tr><td>Benthic Growth:</td><td>None</td></tr> <tr><td>Stains:</td><td>None</td></tr> <tr><td>Non-illicit:</td><td>None</td></tr> </table> </div> </div>			Sample Location:	Pool	Total Chlorine:	0 ppm	Free Chlorine:	0 ppm	Ammonia:	0 ppm	pH:	7.88 units	Temperature:	68 °F	Conductivity:	397 µS/cm	Detergents:	0 mg/L	Floatables:	None	Odor:	Faint	Turbidity:	None	Color:	None	Gross Solids:	Severe	Vegetation:	None	Benthic Growth:	None	Stains:	None	Non-illicit:	None

<div style="display: flex;"> <div style="flex: 1;"> <p>Notes</p> <p>Floating gross solids (litter) in manhole.</p> </div> <div style="flex: 1;"> <p>Condition Assessment</p> <table border="1" style="width:100%; border-collapse: collapse;"> <tr><td>Graffiti:</td><td>None</td></tr> <tr><td>Erosion:</td><td>None</td></tr> <tr><td>Deposition:</td><td>None in.</td></tr> <tr><td>Damage:</td><td>None</td></tr> </table> </div> </div>			Graffiti:	None	Erosion:	None	Deposition:	None in.	Damage:	None																										
Graffiti:	None																																					
Erosion:	None																																					
Deposition:	None in.																																					
Damage:	None

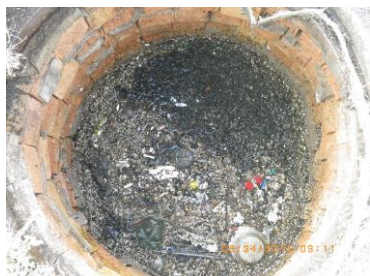
o20150924081150.JPG <div style="text-align: center; font-size: 24pt; font-weight: bold;">2015</div>

Inspection Date: 10/9/2014 1:36:18 PM		Type: Ongoing	Flow: Submerged, indeterminate	Previous Rainfall (hrs): 72+
Illicit Discharge Potential: Potential		Inspector: JCW	Notes	
Submerged: Fully		Depth (in): 74	Floating gross solids (litter) in manhole.	
Sampling Results				
Sample Location:	Pool	Floatables:	None	
Total Chlorine:	0 ppm	Odor:	None	
Free Chlorine:	0 ppm	Turbidity:	None	
Ammonia:	0 ppm	Color:	Faint in bottle	
pH:	7.76 units	Gross Solids:	Severe	
Temperature	59 °F	Vegetation:	None	
Conductivity:	381 µS/cm	Benthic Growth:	None	
Detergents:	0 mg/L	Stains:	None	
		Non-illicit:	None	
			Condition Assessment	
			Graffiti:	None
			Erosion:	None
			Deposition:	None in.
			Damage:	None

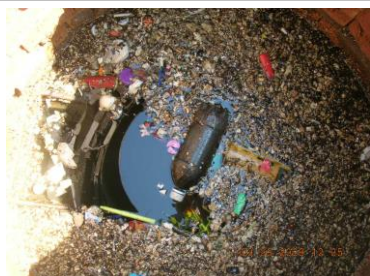
Osh09_DSCN6622.JPG

Inspection Date: 9/8/2009		Type: Initial	Flow: Submerged, indeterminate	Previous Rainfall (hrs): 72+
Illicit Discharge Potential: Potential		Inspector: JCW	Notes	
Submerged: Fully		Depth (in): 81	Abnormal detergent analysis result (bubbles). Significant floating debris in manhole.	
Sampling Results				
Sample Location:	Pool	Floatables:	None	
Total Chlorine:	0 ppm	Odor:		
Free Chlorine:	0 ppm	Turbidity:		
Ammonia:	-- ppm	Color:		
pH:	7.82 units	Gross Solids:	Severe	
Temperature	76 °F	Vegetation:		
Conductivity:	-- µS/cm	Benthic Growth:		
Detergents:	0 mg/L	Stains:		
		Non-illicit:	None	
			Condition Assessment	
			Graffiti:	None
			Erosion:	None
			Deposition:	None 0 in.
			Damage:	None

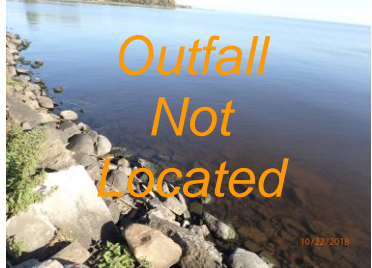
o20181022095658.JPG <div style="text-align: center; font-size: 24pt; font-weight: bold;">2018</div>

Inspection Date: 10/22/2018 9:59:38 AM		Type: Ongoing	Flow: Submerged (not located)	Previous Rainfall (hrs): 48-72
Illicit Discharge Potential: Potential		Inspector: JCW		
Submerged: Fully		Depth (in):		
Sampling Results Sample Location: _____ Total Chlorine: -- ppm Free Chlorine: -- ppm Ammonia: -- ppm pH: -- units Temperature: -- °F Conductivity: -- µS/cm Detergents: -- mg/L		Floatables: None Odor: None Turbidity: None Color: None Gross Solids: None Vegetation: None Benthic Growth: None Stains: None Non-illicit: None		
		Notes Outfall fully submerged and not located - screened upstream at 11-512 US1. Floating gross solids (litter) in manhole.		
		Condition Assessment Graffiti: None Erosion: None Deposition: None in. Damage: None

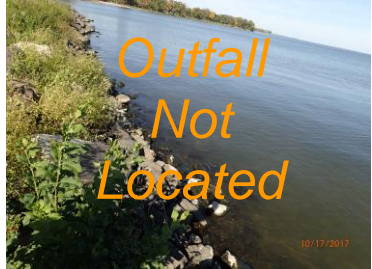
o20171017131910.JPG <div style="text-align: center; font-size: 24pt; font-weight: bold;">2017</div>

Inspection Date: 10/17/2017 1:20:48 PM		Type: Ongoing	Flow: Submerged (not located)	Previous Rainfall (hrs): 48-72
Illicit Discharge Potential: Potential		Inspector: JCW		
Submerged: Fully		Depth (in):		
Sampling Results Sample Location: _____ Total Chlorine: -- ppm Free Chlorine: -- ppm Ammonia: -- ppm pH: -- units Temperature: -- °F Conductivity: -- µS/cm Detergents: -- mg/L		Floatables: None Odor: None Turbidity: None Color: None Gross Solids: None Vegetation: None Benthic Growth: None Stains: None Non-illicit: None		
		Notes Outfall fully submerged and not located - screened upstream at 11-512 US1. Floating gross solids (litter) in manhole.		
		Condition Assessment Graffiti: None Erosion: None Deposition: None in. Damage: None

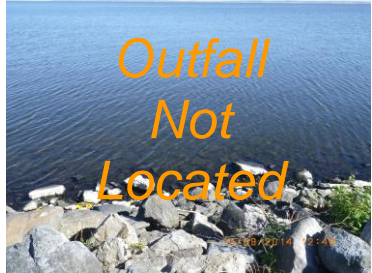
o20141009114820.JPG

Inspection Date: 10/9/2014 12:48:49 PM		Type: Ongoing	Flow: Submerged (not located)	Previous Rainfall (hrs): 72+
Illicit Discharge Potential: Potential		Inspector: JCW	Notes	
Submerged: Fully Depth (in):			Outfall fully submerged and not located - screened upstream at 11-512 US1.	
Sampling Results			Condition Assessment	
Sample Location:	Floatables:	None	Graffiti: None Erosion: None Deposition: None in. Damage: None	
Total Chlorine: -- ppm	Odor:	None		
Free Chlorine: -- ppm	Turbidity:	None		
Ammonia: -- ppm	Color:	None		
pH: -- units	Gross Solids:	None		
Temperature -- °F	Vegetation:	None		
Conductivity: -- µS/cm	Benthic Growth:	None		
Detergents: -- mg/L	Stains:	None		
	Non-illicit:	None

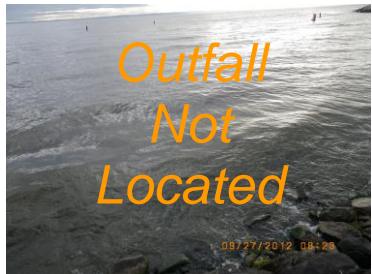
o20120927072324.JPG

Inspection Date: 9/27/2012 8:21:03 AM		Type: Ongoing	Flow: Submerged (not located)	Previous Rainfall (hrs): 72+
Illicit Discharge Potential: Unlikely		Inspector: JCW	Notes	
Submerged: Fully Depth (in):			Outfall fully submerged; screened upstream at 11-512 US1.	
Sampling Results			Condition Assessment	
Sample Location:	Floatables:	None	Graffiti: None Erosion: None Deposition: None in. Damage: None	
Total Chlorine: -- ppm	Odor:	None		
Free Chlorine: -- ppm	Turbidity:	None		
Ammonia: -- ppm	Color:	None		
pH: -- units	Gross Solids:	None		
Temperature -- °F	Vegetation:	None		
Conductivity: -- µS/cm	Benthic Growth:	None		
Detergents: -- mg/L	Stains:	None		
	Non-illicit:	None

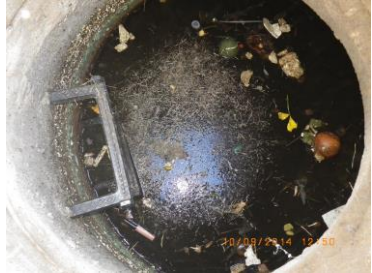
o20141009115024.JPG

Inspection Date: 10/9/2014 12:52:08 PM		Type: Ongoing	Flow: Submerged, indeterminate	Previous Rainfall (hrs): 72+
Illicit Discharge Potential: Potential		Inspector: JCW	Notes	
Submerged: Fully		Depth (in): 39	Floating gross solids (litter) in manhole.	
Sampling Results		Condition Assessment		
Sample Location: Pool	Floatables: None	Graffiti: None	Erosion: None	in.
Total Chlorine: 0 ppm	Odor: None	Deposition: None	Damage: None	
Free Chlorine: 0 ppm	Turbidity: Slight cloudiness			
Ammonia: 0 ppm	Color: None			
pH: 7.57 units	Gross Solids: Moderate			
Temperature 62 °F	Vegetation: None			
Conductivity: 548 µS/cm	Benthic Growth: Slight			
Detergents: 0 mg/L	Stains: None			
	Non-illicit: None
