Ongoing Screening Summary Report 2019 Inspection Year

Illicit Discharge Detection and Elimination Program

City of Oshkosh

January 3, 2020

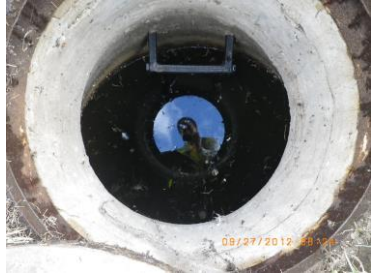
o20120927072438.JPG

Inspection Date: 9/27/2012 8:22:20 AM		Type: Ongoing	Flow: Submerged, indeterminate	Previous Rainfall (hrs): 72+
Illicit Discharge Potential: Unlikely		Inspector: JCW	Notes	
Submerged: Fully		Depth (in): 34	2011 gross solids follow-up.	
Sampling Results		Condition Assessment		
Sample Location: Pool	Floatables: None	Graffiti: None	Erosion: None	in.
Total Chlorine: 0 ppm	Odor: None	Deposition: None	Damage: None	
Free Chlorine: 0 ppm	Turbidity: None			
Ammonia: 0 ppm	Color: None			
pH: 8.73 units	Gross Solids: Slight			
Temperature 59 °F	Vegetation: None			
Conductivity: 416 µS/cm	Benthic Growth: Slight			
Detergents: 0 mg/L	Stains: Slight			
	Non-illicit: None

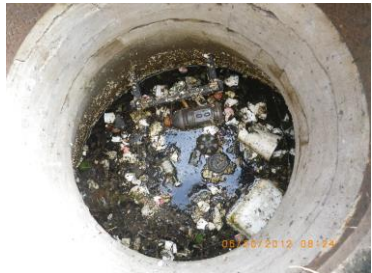
o20120620072408.JPG

Inspection Date: 6/20/2012 8:24:06 AM		Type: Other	Flow: Submerged, indeterminate	Previous Rainfall (hrs): 24-48
Illicit Discharge Potential: Potential		Inspector: JCW	Notes	
Submerged: Fully		Depth (in): 40	Gross solids pre-screening.	
Sampling Results		Condition Assessment		
Sample Location: Pool	Floatables: None	Graffiti: None	Erosion: None	in.
Total Chlorine: -- ppm	Odor: None	Deposition: None	Damage: None	
Free Chlorine: -- ppm	Turbidity: None			
Ammonia: -- ppm	Color: None			
pH: -- units	Gross Solids: Severe			
Temperature -- °F	Vegetation: None			
Conductivity: -- µS/cm	Benthic Growth: None			
Detergents: -- mg/L	Stains: None			
	Non-illicit: None

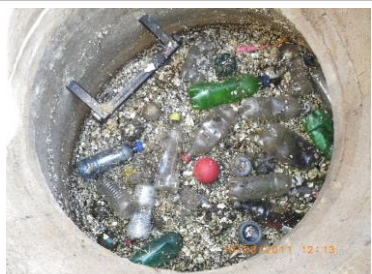
o20111003121302.JPG

Inspection Date: 10/3/2011 12:13:00 PM		Type: Ongoing	Flow: Submerged, indeterminate	Previous Rainfall (hrs): 72+
Illicit Discharge Potential: Potential		Inspector: JCW	Notes	
Submerged: Fully		Depth (in): 36	Significant floatable debris in manhole.	
Sampling Results		Condition Assessment		
Sample Location: Pool	Floatables: None	Graffiti: None	Erosion: None	0 in.
Total Chlorine: 0 ppm	Odor: None	Deposition: None	Damage: None	
Free Chlorine: 0 ppm	Turbidity: None			
Ammonia: 0 ppm	Color: None			
pH: 7.39 units	Gross Solids: Severe			
Temperature 67 °F	Vegetation: None			
Conductivity: -- µS/cm	Benthic Growth: None			
Detergents: 0 mg/L	Stains: None			
	Non-illicit: None

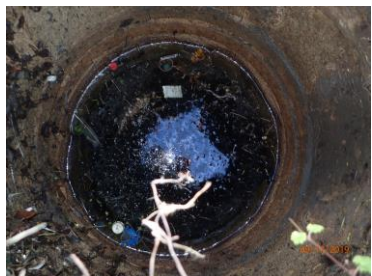
o20190917080056.JPG
2019

Inspection Date: 9/17/2019 9:03:20 AM		Type: Ongoing	Flow: Submerged, indeterminate	Previous Rainfall (hrs): 48-72
Illicit Discharge Potential: Unlikely		Inspector: JCW		
Submerged: Fully		Depth (in): 17		
Sampling Results		Notes Sample collected from submerged pool in manhole. Ammonia detected on initial screening but no detection on follow-up screening on 11/5/19.		
Sample Location: Pool	Floatables: None	Condition Assessment Graffiti: None Erosion: None Deposition: None in. Damage: None		
Total Chlorine: 0 ppm	Odor: Faint			
Free Chlorine: 0 ppm	Turbidity: None			
Ammonia: 1 ppm	Color: None			
pH: 7.27 units	Gross Solids: Slight			
Temperature 71 °F	Vegetation: None			
Conductivity: 1160 µS/cm	Benthic Growth: None			
Detergents: 0 mg/L	Stains: None			
	Non-illicit: None

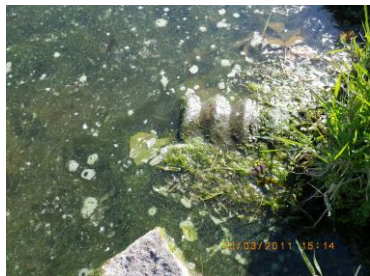
o20111003151448.JPG <div style="text-align: center; font-size: 24pt; font-weight: bold;">2011</div>

Inspection Date: 10/3/2011 3:14:35 PM		Type: Ongoing	Flow: Submerged, indeterminate	Previous Rainfall (hrs): 72+
Illicit Discharge Potential: Unlikely		Inspector: JCW		
Submerged: Fully		Depth (in): 12		
Sampling Results Sample Location: Total Chlorine: -- ppm Free Chlorine: -- ppm Ammonia: -- ppm pH: -- units Temperature -- °F Conductivity: -- µS/cm Detergents: -- mg/L		Floatables: None Odor: None Turbidity: None Color: None Gross Solids: None Vegetation: None Benthic Growth: Moderate Stains: None Non-illicit: None		
		Notes Outfall fully submerged. Outfall screened upstream at 11-801 US1.		
		Condition Assessment Graffiti: None Erosion: None Deposition: Minor 3 in. Damage: None

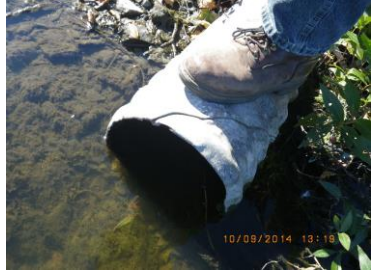
2014

Inspection Date: 10/9/2014 1:19:06 PM		Type: Ongoing	Flow: Submerged, indeterminate	Previous Rainfall (hrs): 72+
Illicit Discharge Potential: Unlikely		Inspector: JCW		
Submerged: Partially		Depth (in): 5		
Sampling Results Sample Location: _____ Total Chlorine: -- ppm Free Chlorine: -- ppm Ammonia: -- ppm pH: -- units Temperature: -- °F Conductivity: -- µS/cm Detergents: -- mg/L		Floatables: None Odor: None Turbidity: None Color: None Gross Solids: None Vegetation: None Benthic Growth: Moderate Stains: None Non-illicit: None	Notes Outfall partially submerged - screened upstream at 11-803 US1.

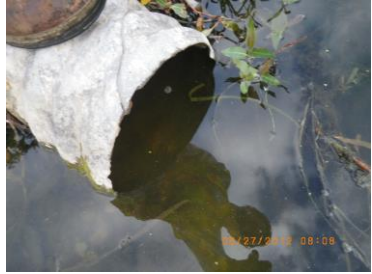
2012

Inspection Date: 9/27/2012 8:05:18 AM		Type: Ongoing	Flow: Submerged, indeterminate	Previous Rainfall (hrs): 72+
Illicit Discharge Potential: Unlikely		Inspector: JCW		
Submerged: Partially		Depth (in): 7		
Sampling Results Sample Location: _____ Total Chlorine: -- ppm Free Chlorine: -- ppm Ammonia: -- ppm pH: -- units Temperature: -- °F Conductivity: -- µS/cm Detergents: -- mg/L		Floatables: None Odor: None Turbidity: None Color: None Gross Solids: None Vegetation: None Benthic Growth: Slight Stains: Slight Non-illicit: None	Notes 2011 ammonia follow-up. Outfall partially submerged; screened upstream at 11-803 US1.

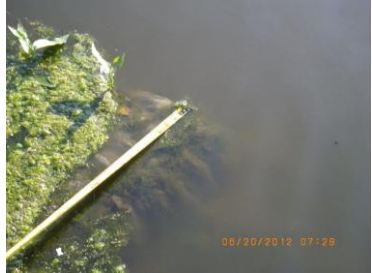
2012

Inspection Date: 6/20/2012 7:26:32 AM		Type: Other	Flow: Submerged, indeterminate	Previous Rainfall (hrs): 24-48
Illicit Discharge Potential: Unlikely		Inspector: JCW		
Submerged: Fully		Depth (in): 13		
Sampling Results Sample Location: _____ Total Chlorine: -- ppm Free Chlorine: -- ppm Ammonia: -- ppm pH: -- units Temperature: -- °F Conductivity: -- µS/cm Detergents: -- mg/L		Floatables: None Odor: None Turbidity: None Color: None Gross Solids: None Vegetation: None Benthic Growth: None Stains: None Non-illicit: None	Notes Gross solids pre-screen. Outfall fully submerged; screened upstream at 11-803 US1.

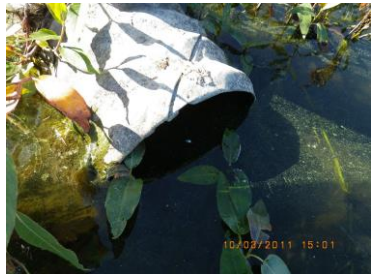
o20111003150102.JPG
			Condition Assessment Graffiti: None Erosion: None Deposition: None 0 in. Damage: None

Inspection Date: 10/3/2011 3:01:24 PM		Type: Ongoing	Flow: Submerged, indeterminate	Previous Rainfall (hrs): 72+
Illicit Discharge Potential: Potential		Inspector: JCW		
Submerged: Partially		Depth (in): 9		
Sampling Results Sample Location: _____ Total Chlorine: -- ppm Free Chlorine: -- ppm Ammonia: -- ppm pH: -- units Temperature: -- °F Conductivity: -- µS/cm Detergents: -- mg/L		Floatables: None Odor: None Turbidity: None Color: None Gross Solids: None Vegetation: None Benthic Growth: Moderate Stains: None Non-illicit: None	Notes Outfall fully submerged. Outfall screened upstream at 11-400 US2.

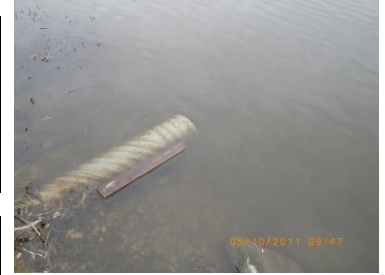
o20110510094732.JPG

Inspection Date: 5/10/2011 9:39:00 AM		Type: Other	Flow: Submerged, indeterminate	Previous Rainfall (hrs): 0-24
Illicit Discharge Potential: Unlikely		Inspector: JCW		
Submerged: Fully		Depth (in):		
Sampling Results		Notes Outfall fully submerged. Outfall screened upstream at 11-400 US2. Pipe info from MS4 map.		
Sample Location:	Floatables:	Condition Assessment Graffiti: None Erosion: None Deposition: None 0 in. Damage: None		
Total Chlorine: -- ppm	Odor:			
Free Chlorine: -- ppm	Turbidity:			
Ammonia: -- ppm	Color:			
pH: -- units	Gross Solids:			
Temperature -- °F	Vegetation:			
Conductivity: -- µS/cm	Benthic Growth:			
Detergents: -- mg/L	Stains:			
	Non-illicit:	None

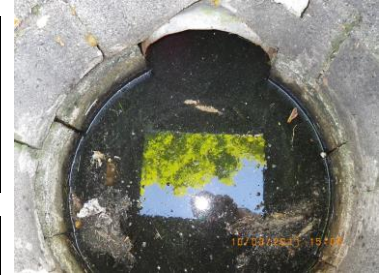
o20111003150602.JPG

Inspection Date: 10/3/2011 3:04:34 PM		Type: Ongoing	Flow: Submerged, indeterminate	Previous Rainfall (hrs): 72+																																			
Illicit Discharge Potential: Potential		Inspector: JCW	Notes Elevated ammonia concentration in sample.																																				
Submerged: Partially Depth (in): 4																																							
Sampling Results

Sample Location:	Pool	Floatables:	None	Total Chlorine:	0 ppm	Odor:	Faint	Free Chlorine:	0 ppm	Turbidity:	Cloudy	Ammonia:	3 ppm	Color:	Clearly visible in bottl	pH:	7.35 units	Gross Solids:	None	Temperature	70 °F	Vegetation:	None	Conductivity:	-- µS/cm	Benthic Growth:	None	Detergents:	0 mg/L	Stains:	Slight			Non-illicit:	None	Condition Assessment Graffiti: None Erosion: None Deposition: None 0 in. Damage: None	
Sample Location:	Pool	Floatables:	None																																				
Total Chlorine:	0 ppm	Odor:	Faint																																				
Free Chlorine:	0 ppm	Turbidity:	Cloudy																																				
Ammonia:	3 ppm	Color:	Clearly visible in bottl																																				
pH:	7.35 units	Gross Solids:	None																																				
Temperature	70 °F	Vegetation:	None																																				
Conductivity:	-- µS/cm	Benthic Growth:	None																																				
Detergents:	0 mg/L	Stains:	Slight																																				
		Non-illicit:	None

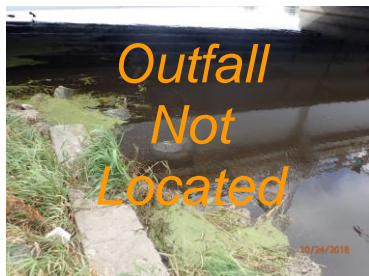
o20181024092154.JPG <div style="text-align: center; font-size: 24pt; font-weight: bold;">2018</div>

Inspection Date: 10/24/2018 9:23:56 AM		Type: Ongoing	Flow: Submerged (not located)	Previous Rainfall (hrs): 72+
Illicit Discharge Potential: Potential		Inspector: JCW		
Submerged: Fully		Depth (in):		
Sampling Results Sample Location: _____ Total Chlorine: -- ppm Free Chlorine: -- ppm Ammonia: -- ppm pH: -- units Temperature: -- °F Conductivity: -- µS/cm Detergents: -- mg/L		Floatables: None Odor: None Turbidity: None Color: None Gross Solids: None Vegetation: None Benthic Growth: None Stains: None Non-illicit: None	Notes Outfall fully submerged and not located - screened upstream at 12-569 US1. Graffiti on nearby bridge abutment. Floating gross solids (litter) in MH. Condition Assessment Graffiti: Moderate Erosion: None Deposition: None in. Damage: None

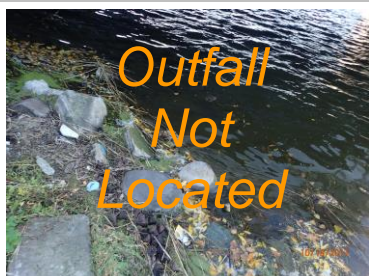
o20171018101412.JPG <div style="text-align: center; font-size: 24pt; font-weight: bold;">2017</div>

Inspection Date: 10/18/2017 10:17:17 AM		Type: Ongoing	Flow: Submerged (not located)	Previous Rainfall (hrs): 72+
Illicit Discharge Potential: Potential		Inspector: JCW		
Submerged: Fully		Depth (in):		
Sampling Results Sample Location: _____ Total Chlorine: -- ppm Free Chlorine: -- ppm Ammonia: -- ppm pH: -- units Temperature: -- °F Conductivity: -- µS/cm Detergents: -- mg/L		Floatables: None Odor: None Turbidity: None Color: None Gross Solids: None Vegetation: None Benthic Growth: None Stains: None Non-illicit: None	Notes Outfall fully submerged and not located - screened upstream at 12-569 US1. Graffiti on nearby bridge abutment. Floating gross solids (litter) in MH. Condition Assessment Graffiti: Minor Erosion: None Deposition: None in. Damage: None

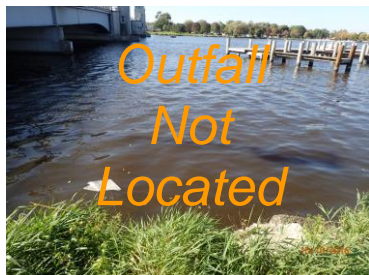
o20161010132600.JPG <div style="text-align: center; font-size: 24pt; font-weight: bold;">2016</div>

Inspection Date: 10/10/2016 1:26:15 PM		Type: Ongoing	Flow: Submerged (not located)	Previous Rainfall (hrs): 72+
Illicit Discharge Potential: Potential		Inspector: JCW		
Submerged: Fully		Depth (in):		
Sampling Results Sample Location: _____ Total Chlorine: -- ppm Free Chlorine: -- ppm Ammonia: -- ppm pH: -- units Temperature: -- °F Conductivity: -- µS/cm Detergents: -- mg/L		Floatables: None Odor: None Turbidity: None Color: None Gross Solids: None Vegetation: None Benthic Growth: None Stains: None Non-illicit: None	Notes Graffiti on east bridge abutment. Outfall fully submerged and not located - screened upstream at 12-569 US1. Condition Assessment Graffiti: Minor Erosion: None Deposition: None in. Damage: None

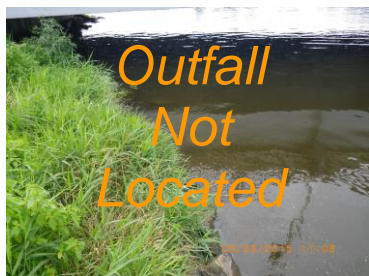
o20150923100828.JPG <div style="text-align: center; font-size: 24pt; font-weight: bold;">2015</div>

Inspection Date: 9/23/2015 11:06:02 AM		Type: Ongoing	Flow: Submerged (not located)	Previous Rainfall (hrs): 72+
Illicit Discharge Potential: Potential		Inspector: JCW		
Submerged: Fully		Depth (in):		
Sampling Results Sample Location: _____ Total Chlorine: -- ppm Free Chlorine: -- ppm Ammonia: -- ppm pH: -- units Temperature: -- °F Conductivity: -- µS/cm Detergents: -- mg/L		Floatables: None Odor: None Turbidity: None Color: None Gross Solids: None Vegetation: None Benthic Growth: None Stains: None Non-illicit: None	Notes Outfall fully submerged and not located - screened at 12-569 US1. Condition Assessment Graffiti: Moderate Erosion: None Deposition: None in. Damage: None

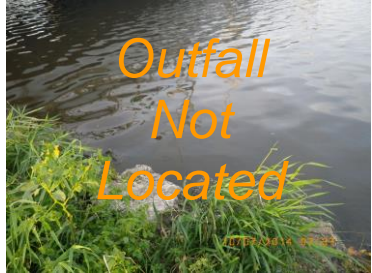
o20141007063712.JPG

Inspection Date: 10/7/2014 7:38:26 AM		Type: Ongoing	Flow: Submerged (not located)	Previous Rainfall (hrs): 48-72
Illicit Discharge Potential: Potential		Inspector: JCW		
Submerged: Fully		Depth (in):		
Sampling Results		Notes		
Sample Location:	Floatables:	None		
Total Chlorine: -- ppm	Odor:	None		
Free Chlorine: -- ppm	Turbidity:	None		
Ammonia: -- ppm	Color:	None		
pH: -- units	Gross Solids:	None		
Temperature -- °F	Vegetation:	None		
Conductivity: -- µS/cm	Benthic Growth:	None		
Detergents: -- mg/L	Stains:	None		
	Non-illicit:	None		
		Condition Assessment		
		Graffiti:	Moderate	
		Erosion:	None	
		Deposition:	None	in.
		Damage:	None

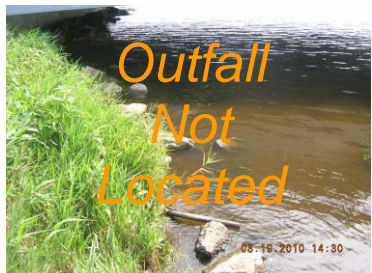
o20100819143022.JPG

Inspection Date: 8/19/2010 2:37:50 PM		Type: Ongoing	Flow: Submerged (not located)	Previous Rainfall (hrs): 72+
Illicit Discharge Potential: Potential		Inspector: JCW		
Submerged: Fully		Depth (in):		
Sampling Results		Notes		
Sample Location:	Floatables:	None		
Total Chlorine: -- ppm	Odor:	None		
Free Chlorine: -- ppm	Turbidity:	None		
Ammonia: -- ppm	Color:	None		
pH: -- units	Gross Solids:	None		
Temperature -- °F	Vegetation:	None		
Conductivity: -- µS/cm	Benthic Growth:	None		
Detergents: -- mg/L	Stains:	None		
	Non-illicit:	None		
		Condition Assessment		
		Graffiti:	None	
		Erosion:	None	
		Deposition:	None	0 in.
		Damage:	None

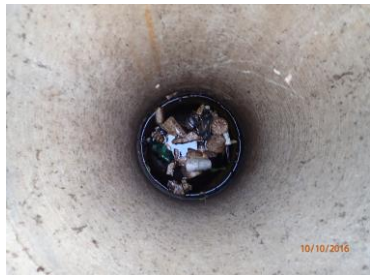
<p style="text-align: center;">o20161010132718.JPG</p> <p style="text-align: center; font-size: 24pt; font-weight: bold;">2016</p>

<div style="display: flex; justify-content: space-between;"> <div style="width: 45%;"> <p>Notes</p> <p>Floating gross solids (litter) in manhole.</p> </div> <div style="width: 45%;"> <p>Condition Assessment</p> <table border="1" style="width:100%; border-collapse: collapse;"> <tr><td>Graffiti:</td><td>None</td></tr> <tr><td>Erosion:</td><td>None</td></tr> <tr><td>Deposition:</td><td>None in.</td></tr> <tr><td>Damage:</td><td>None</td></tr> </table> </div> </div>			Graffiti:	None	Erosion:	None	Deposition:	None in.	Damage:	None																										
Graffiti:	None																																					
Erosion:	None																																					
Deposition:	None in.																																					
Damage:	None

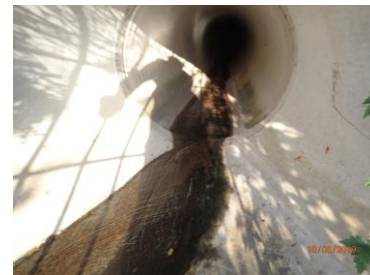
o20191008160300.JPG

<div style="display: flex;"> <div style="flex: 1;"> <p>Notes</p> <p>Elevated pH in sample from trickle flow. No flow in upstream curb inlet at time of inspection.</p> </div> <div style="flex: 1;"> <p>Condition Assessment</p> <table border="1" style="width:100%; border-collapse: collapse;"> <tr><td>Graffiti:</td><td>None</td></tr> <tr><td>Erosion:</td><td>None</td></tr> <tr><td>Deposition:</td><td>None in.</td></tr> <tr><td>Damage:</td><td>None</td></tr> </table> </div> </div>			Graffiti:	None	Erosion:	None	Deposition:	None in.	Damage:	None																										
Graffiti:	None																																					
Erosion:	None																																					
Deposition:	None in.																																					
Damage:	None

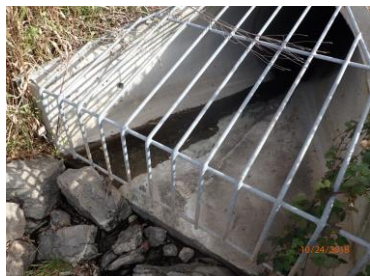
o20181024103144.JPG <div style="text-align: center; font-size: 24pt; font-weight: bold;">2018</div>

<div style="display: flex;"> <div style="flex: 1;"> <p>Notes</p> <p>Elevated pH in sample from trickle flow. No flow in upstream curb inlet at time of inspection.</p> </div> <div style="flex: 1;"> <p>Condition Assessment</p> <table border="1" style="width:100%; border-collapse: collapse;"> <tr><td>Graffiti:</td><td>None</td></tr> <tr><td>Erosion:</td><td>None</td></tr> <tr><td>Deposition:</td><td>None in.</td></tr> <tr><td>Damage:</td><td>None</td></tr> </table> </div> </div>			Graffiti:	None	Erosion:	None	Deposition:	None in.	Damage:	None																										
Graffiti:	None																																					
Erosion:	None																																					
Deposition:	None in.																																					
Damage:	None

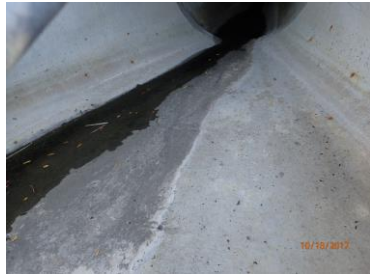
o20171018093128.JPG <div style="text-align: center; font-size: 24pt; font-weight: bold;">2017</div>

<div style="display: flex;"> <div style="flex: 1;"> <p>Notes</p> <p>Elevated pH, but not as high as 2015 screening. Possible residual in upstream pipe.</p> </div> <div style="flex: 1;"> <p>Condition Assessment</p> <table border="1" style="width:100%; border-collapse: collapse;"> <tr><td>Graffiti:</td><td>None</td></tr> <tr><td>Erosion:</td><td>None</td></tr> <tr><td>Deposition:</td><td>None in.</td></tr> <tr><td>Damage:</td><td>None</td></tr> </table> </div> </div>			Graffiti:	None	Erosion:	None	Deposition:	None in.	Damage:	None																										
Graffiti:	None																																					
Erosion:	None																																					
Deposition:	None in.																																					
Damage:	None

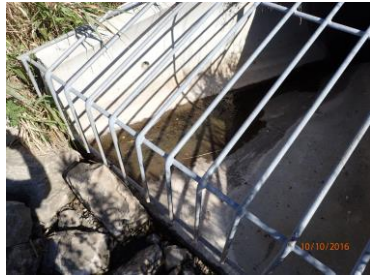
o20161010122036.JPG <div style="text-align: center; font-size: 24pt; font-weight: bold;">2016</div>

<div style="display: flex;"> <div style="flex: 1;"> <p>Notes</p> <p>White silty discharge. Chlorine patches turned yellow (not on scale). Elevated pH and conductivity.</p> </div> <div style="flex: 1;"> <p>Condition Assessment</p> <table border="1" style="width:100%; border-collapse: collapse;"> <tr><td>Graffiti:</td><td>None</td></tr> <tr><td>Erosion:</td><td>None</td></tr> <tr><td>Deposition:</td><td>None in.</td></tr> <tr><td>Damage:</td><td>None</td></tr> </table> </div> </div>			Graffiti:	None	Erosion:	None	Deposition:	None in.	Damage:	None																										
Graffiti:	None																																					
Erosion:	None																																					
Deposition:	None in.																																					
Damage:	None

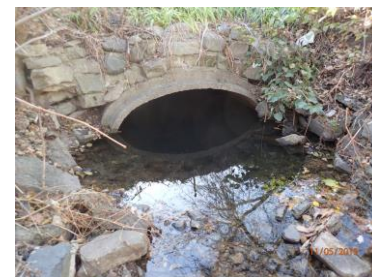
o20191105142746.JPG

Odor:	None																					
Turbidity:	None																					
Color:	None																					
Gross Solids:	None																					
Vegetation:	None																					
Benthic Growth:	Moderate																					
Stains:	Slight																					
Non-illicit:	None																					
<table border="1" style="width:100%; border-collapse: collapse;"> <tr><td>Sample Location:</td><td>Flow</td></tr> <tr><td>Total Chlorine:</td><td>0 ppm</td></tr> <tr><td>Free Chlorine:</td><td>0 ppm</td></tr> <tr><td>Ammonia:</td><td>0 ppm</td></tr> <tr><td>pH:</td><td>9.27 units</td></tr> <tr><td>Temperature:</td><td>77 °F</td></tr> <tr><td>Conductivity:</td><td>368 µS/cm</td></tr> <tr><td>Detergents:</td><td>0 mg/L</td></tr> </table>		Sample Location:	Flow	Total Chlorine:	0 ppm	Free Chlorine:	0 ppm	Ammonia:	0 ppm	pH:	9.27 units	Temperature:	77 °F	Conductivity:	368 µS/cm	Detergents:	0 mg/L	Notes Downstream bank erosion. Sample collected from submerged flow in pipe. High pH detected.

Sample Location:	Flow																					
Total Chlorine:	0 ppm																					
Free Chlorine:	0 ppm																					
Ammonia:	0 ppm																					
pH:	9.27 units																					
Temperature:	77 °F																					
Conductivity:	368 µS/cm																					
Detergents:	0 mg/L																					
		Condition Assessment <table border="1" style="width:100%; border-collapse: collapse;"> <tr><td>Graffiti:</td><td>None</td></tr> <tr><td>Erosion:</td><td>Severe</td></tr> <tr><td>Deposition:</td><td>None in.</td></tr> <tr><td>Damage:</td><td>None</td></tr> </table>			Graffiti:	None	Erosion:	Severe	Deposition:	None in.	Damage:	None										
Graffiti:	None																					
Erosion:	Severe																					
Deposition:	None in.																					
Damage:	None

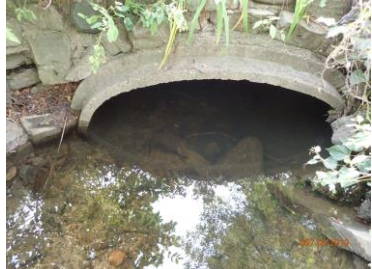
o20190918141444.JPG <div style="text-align: center; font-size: 24pt; font-weight: bold;">2019</div>

Odor:	None																					
Turbidity:	None																					
Color:	None																					
Gross Solids:	Slight																					
Vegetation:	None																					
Benthic Growth:	Slight																					
Stains:	None																					
Non-illicit:	None																					
<table border="1" style="width:100%; border-collapse: collapse;"> <tr><td>Sample Location:</td><td>Flow</td></tr> <tr><td>Total Chlorine:</td><td>0 ppm</td></tr> <tr><td>Free Chlorine:</td><td>0 ppm</td></tr> <tr><td>Ammonia:</td><td>0 ppm</td></tr> <tr><td>pH:</td><td>8.18 units</td></tr> <tr><td>Temperature:</td><td>54 °F</td></tr> <tr><td>Conductivity:</td><td>1183 µS/cm</td></tr> <tr><td>Detergents:</td><td>0.4 mg/L</td></tr> </table>		Sample Location:	Flow	Total Chlorine:	0 ppm	Free Chlorine:	0 ppm	Ammonia:	0 ppm	pH:	8.18 units	Temperature:	54 °F	Conductivity:	1183 µS/cm	Detergents:	0.4 mg/L	Notes Detergent detection follow-up. Limited screening conducted beyond sampling.

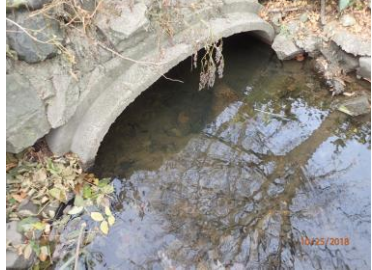
o20181025093132.JPG <div style="text-align: center; font-size: 24pt; font-weight: bold;">2018</div>

Odor:	None																					
Turbidity:	None																					
Color:	None																					
Gross Solids:	Slight																					
Vegetation:	None																					
Benthic Growth:	Moderate																					
Stains:	None																					
Non-illicit:	None																					
<table border="1" style="width:100%; border-collapse: collapse;"> <tr><td>Sample Location:</td><td>Flow</td></tr> <tr><td>Total Chlorine:</td><td>0 ppm</td></tr> <tr><td>Free Chlorine:</td><td>0 ppm</td></tr> <tr><td>Ammonia:</td><td>0 ppm</td></tr> <tr><td>pH:</td><td>8.16 units</td></tr> <tr><td>Temperature:</td><td>51 °F</td></tr> <tr><td>Conductivity:</td><td>1209 µS/cm</td></tr> <tr><td>Detergents:</td><td>0.5 mg/L</td></tr> </table>		Sample Location:	Flow	Total Chlorine:	0 ppm	Free Chlorine:	0 ppm	Ammonia:	0 ppm	pH:	8.16 units	Temperature:	51 °F	Conductivity:	1209 µS/cm	Detergents:	0.5 mg/L	Notes Downstream bank erosion. Sample collected from submerged flow in pipe. Detergent detected.

Sample Location:	Flow																					
Total Chlorine:	0 ppm																					
Free Chlorine:	0 ppm																					
Ammonia:	0 ppm																					
pH:	8.16 units																					
Temperature:	51 °F																					
Conductivity:	1209 µS/cm																					
Detergents:	0.5 mg/L																					
		Condition Assessment <table border="1" style="width:100%; border-collapse: collapse;"> <tr><td>Graffiti:</td><td>None</td></tr> <tr><td>Erosion:</td><td>Moderate</td></tr> <tr><td>Deposition:</td><td>None in.</td></tr> <tr><td>Damage:</td><td>None</td></tr> </table>			Graffiti:	None	Erosion:	Moderate	Deposition:	None in.	Damage:	None										
Graffiti:	None																					
Erosion:	Moderate																					
Deposition:	None in.																					
Damage:	None

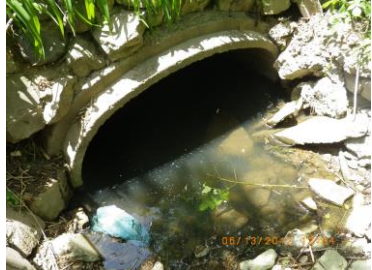
o20120613115412.JPG <div style="text-align: center; font-size: 24pt; font-weight: bold;">2012</div>

Inspection Date: 6/13/2012 12:53:24 PM		Type: Ongoing	Flow: Submerged, no flow	Previous Rainfall (hrs): 72+																		
Illicit Discharge Potential: Unlikely		Inspector: JCW																				
Submerged: Partially		Depth (in): 19																				
Sampling Results		<table border="1" style="width:100%; border-collapse: collapse;"> <tr><td>Floatables:</td><td>None</td></tr> <tr><td>Odor:</td><td>None</td></tr> <tr><td>Turbidity:</td><td>Slight cloudiness</td></tr> <tr><td>Color:</td><td>None</td></tr> <tr><td>Gross Solids:</td><td>Slight</td></tr> <tr><td>Vegetation:</td><td>None</td></tr> <tr><td>Benthic Growth:</td><td>Slight</td></tr> <tr><td>Stains:</td><td>None</td></tr> <tr><td>Non-illicit:</td><td>None</td></tr> </table>			Floatables:	None	Odor:	None	Turbidity:	Slight cloudiness	Color:	None	Gross Solids:	Slight	Vegetation:	None	Benthic Growth:	Slight	Stains:	None	Non-illicit:	None

Floatables:	None																					
Odor:	None																					
Turbidity:	Slight cloudiness																					
Color:	None																					
Gross Solids:	Slight																					
Vegetation:	None																					
Benthic Growth:	Slight																					
Stains:	None																					
Non-illicit:	None																					
<table border="1" style="width:100%; border-collapse: collapse;"> <tr><td>Sample Location:</td><td>Pool</td></tr> <tr><td>Total Chlorine:</td><td>0 ppm</td></tr> <tr><td>Free Chlorine:</td><td>0 ppm</td></tr> <tr><td>Ammonia:</td><td>0 ppm</td></tr> <tr><td>pH:</td><td>7.91 units</td></tr> <tr><td>Temperature:</td><td>74 °F</td></tr> <tr><td>Conductivity:</td><td>1579 µS/cm</td></tr> <tr><td>Detergents:</td><td>0 mg/L</td></tr> </table>		Sample Location:	Pool	Total Chlorine:	0 ppm	Free Chlorine:	0 ppm	Ammonia:	0 ppm	pH:	7.91 units	Temperature:	74 °F	Conductivity:	1579 µS/cm	Detergents:	0 mg/L	Notes No flow leaving pool on apron. Downstream channel dry. Sample collected from apron pool.

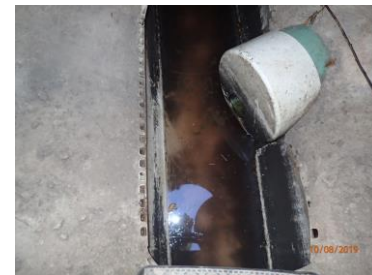
o20191008145002.JPG

☐ Petrol. Sheen ☐ Suds ☐ Sewage ☐ Algae ☐ Other☐ Petroleum ☐ Musty ☒ Sewage ☐ Chlorine ☐ Other☐ VOC/Solvent ☐ Fishy ☐ Sulfur ☐ Fragrant☐ Litter ☐ Veg. Debris ☐ Sediment ☐ Other☐ Inhibited ☐ Excessive☐ Green ☐ Brown☒ Flow Line ☐ Oil ☐ Rust Stains☐ Paint ☐ Other☐ Natural Sheen ☐ Natural Suds/Foam

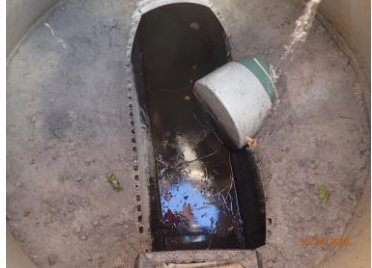
<p style="text-align: center;">o20181024115924.JPG</p>																		
		<p>Condition Assessment</p> <p>Graffiti: None</p> <p>Erosion: None</p> <p>Deposition: None in.</p> <p>Damage: None</p>																				
2018

</div> </div>					Floatables:	None	Odor:	Faint	Turbidity:	Cloudy	Color:	Clearly visible in bottl	Gross Solids:	None	Vegetation:	None	Benthic Growth:	None	Stains:	None	Non-illicit:	None
Floatables:	None																					
Odor:	Faint																					
Turbidity:	Cloudy																					
Color:	Clearly visible in bottl																					
Gross Solids:	None																					
Vegetation:	None																					
Benthic Growth:	None																					
Stains:	None																					
Non-illicit:	None																					
		<p>Notes</p> <p>Sample collected from submerged pool near orifice on inlet pipe.</p>

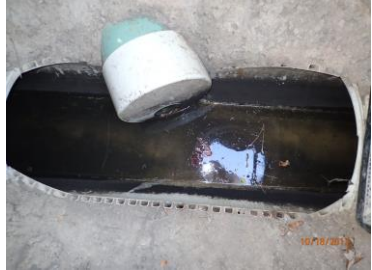
<p style="text-align: center;">o20171018160304.JPG</p>																		
		<p>Condition Assessment</p> <p>Graffiti: None</p> <p>Erosion: None</p> <p>Deposition: None in.</p> <p>Damage: None</p>																				
2017

</div> </div>					Floatables:	Slight	Odor:	None	Turbidity:	None	Color:	Faint in bottle	Gross Solids:	None	Vegetation:	None	Benthic Growth:	Moderate	Stains:	Severe	Non-illicit:	None
Floatables:	Slight																					
Odor:	None																					
Turbidity:	None																					
Color:	Faint in bottle																					
Gross Solids:	None																					
Vegetation:	None																					
Benthic Growth:	Moderate																					
Stains:	Severe																					
Non-illicit:	None																					
		<p>Notes</p> <p>Sample collected from submerged flow near orifice on inlet pipe. Elevated ammonia in sample.</p>

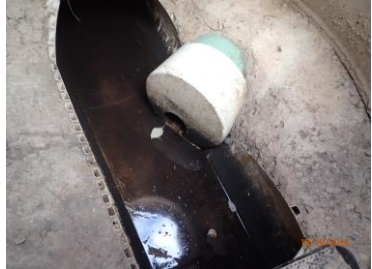
<p style="text-align: center;">o20161019135400.JPG</p>																		
		<p>Condition Assessment</p> <p>Graffiti: None</p> <p>Erosion: None</p> <p>Deposition: None in.</p> <p>Damage: None</p>																				
2016

</div> </div>					Floatables:	None	Odor:	None	Turbidity:	Cloudy	Color:	None	Gross Solids:	None	Vegetation:	None	Benthic Growth:	Slight	Stains:	Severe	Non-illicit:	Slight
Floatables:	None																					
Odor:	None																					
Turbidity:	Cloudy																					
Color:	None																					
Gross Solids:	None																					
Vegetation:	None																					
Benthic Growth:	Slight																					
Stains:	Severe																					
Non-illicit:	Slight																					
		<p>Notes</p> <p>Sample collected from area where car wash pipe enters manhole.</p>

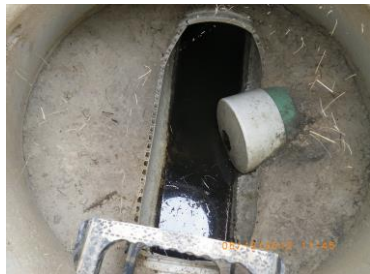
o20120612104548.JPG <div style="text-align: right; font-size: 1.5em; font-weight: bold;">2012</div>

Inspection Date: 6/12/2012 11:42:38 AM		Type: Ongoing	Flow: Submerged, indeterminate	Previous Rainfall (hrs): 72+																																				
Illicit Discharge Potential: Potential		Inspector: JCW	Notes																																					
Submerged: Partially		Depth (in): 2	Black pool on flowline with petroleum odor.

Sampling Results		Floatables:	None	Sample Location:	Pool	Odor:	Faint	Total Chlorine:	0 ppm	Turbidity:	Cloudy	Free Chlorine:	0 ppm	Color:	Clearly visible in bottl	Ammonia:	3 ppm	Gross Solids:	Slight	pH:	7.89 units	Vegetation:	None	Temperature	64 °F	Benthic Growth:	None	Conductivity:	1011 µS/cm	Stains:	Moderate	Detergents:	1.3 mg/L	Non-illicit:	Moderate
Sampling Results		Floatables:	None																																					
Sample Location:	Pool	Odor:	Faint																																					
Total Chlorine:	0 ppm	Turbidity:	Cloudy																																					
Free Chlorine:	0 ppm	Color:	Clearly visible in bottl																																					
Ammonia:	3 ppm	Gross Solids:	Slight																																					
pH:	7.89 units	Vegetation:	None																																					
Temperature	64 °F	Benthic Growth:	None																																					
Conductivity:	1011 µS/cm	Stains:	Moderate																																					
Detergents:	1.3 mg/L	Non-illicit:	Moderate																																					
			Condition Assessment Graffiti: None Erosion: None Deposition: None in. Damage: None

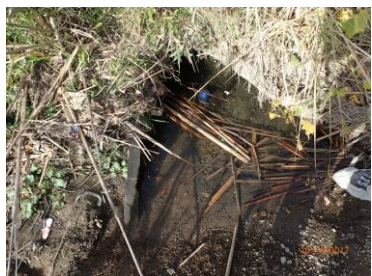
o20171019103654.JPG		
2017

Inspection Date: 10/19/2017 10:43:36 AM		Type: Ongoing	Flow: Submerged, indeterminate	Previous Rainfall (hrs): 72+
Illicit Discharge Potential: Unlikely		Inspector: JCW		
Submerged: Partially		Depth (in): 12		
Sampling Results		Notes Outfall partially submerged - screened upstream at 13-1758 US1.		
Sample Location:	Floatables:	None		
Total Chlorine: -- ppm	Odor:	None		
Free Chlorine: -- ppm	Turbidity:	None		
Ammonia: -- ppm	Color:	None		
pH: -- units	Gross Solids:	Slight		
Temperature -- °F	Vegetation:	None		
Conductivity: -- µS/cm	Benthic Growth:	Moderate		
Detergents: -- mg/L	Stains:	Moderate		
	Non-illicit:	None		
		Condition Assessment Graffiti: None Erosion: None Deposition: Moderate 8 in. Damage: None

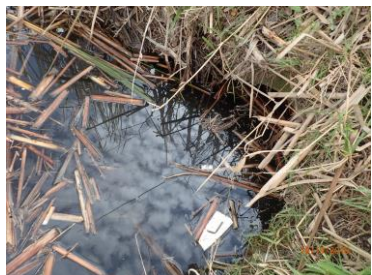
o20161019142738.JPG		
2016

Inspection Date: 10/19/2016 2:28:19 PM		Type: Ongoing	Flow: Submerged, indeterminate	Previous Rainfall (hrs): 72+
Illicit Discharge Potential: Unlikely		Inspector: JCW		
Submerged: Partially		Depth (in): 24		
Sampling Results		Notes Outfall partially submerged - screened upstream at 13-1758 US1.		
Sample Location:	Floatables:	None		
Total Chlorine: -- ppm	Odor:	Easily detected		
Free Chlorine: -- ppm	Turbidity:	None		
Ammonia: -- ppm	Color:	None		
pH: -- units	Gross Solids:	Slight		
Temperature -- °F	Vegetation:	None		
Conductivity: -- µS/cm	Benthic Growth:	None		
Detergents: -- mg/L	Stains:	None		
	Non-illicit:	None		
		Condition Assessment Graffiti: None Erosion: None Deposition: Moderate 13 in. Damage: None

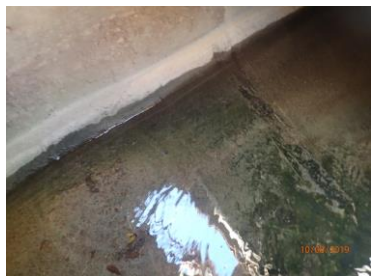
Stains

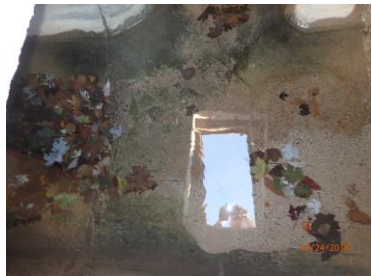
Gross Solids

Stains are useful indicators, since they tend to be persistent, and can often be used to trace the flow path upstream to a source, even after the original illicit discharge has ended. By screening outfalls on a regular basis and documenting the stains with photographs, it is possible to compare the severity of the stains to determine if a discharge is ongoing.

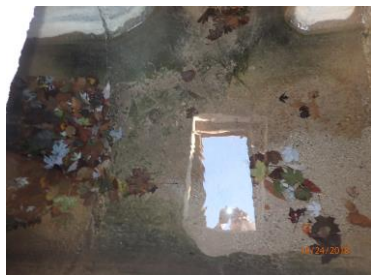
The *Center for Watershed Protection* adopted the concept of Gross Solids regarding illicit discharge detections. Gross solids are materials that are larger than fine solids (silt and clay) and coarse solids (fine sand, fine gravel, and detritus). Gross solids consist primarily of *litter* (human derived trash larger than 4.75 mm), *organic debris* (leaves, branches, seeds, twigs and grass clippings larger than 4.75 mm), and *coarse sediments* (inorganic breakdown products from soils, pavement or building materials greater than 0.075 mm).

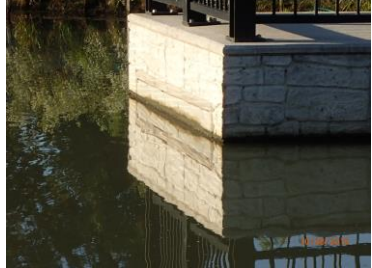
Figure 30 – Outfall 14-582 (2019)

Outfall 14-582 consists of a 27-inch RCP that discharges into the stream that crosses W. 28th Avenue. The drainage basin for this outfall consists primarily of industrial and commercial properties on W. 28th Avenue and Oregon Street between W. 28th Avenue and W. 29th Avenue. Because this outfall is typically partially submerged, the screening is conducted at the first upstream manhole, located 27 feet upstream of the outfall.

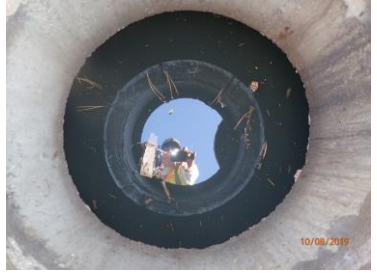
Outfall 16-1205 (Westowne Avenue)

If the source of the detergent was “individual residential car washing,” the MS4 permit does not consider this an illicit discharge. However, because the exact source of the detergent was not identified, it cannot be considered exempt at this time.

Because this outfall is a non-priority non-major outfall, it would normally be scheduled to be screened in 10 years. However, because of the potential illicit discharge, it will be scheduled to be rescreened in 2020. If the detergent is still present, additional tracking should be conducted.

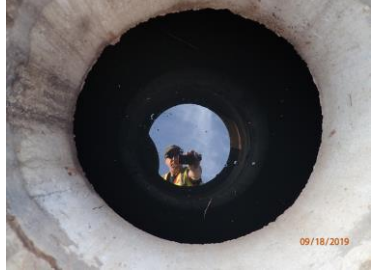
o20190918063424.JPG <div style="text-align: center; font-size: 24pt; font-weight: bold;">2019</div>

Notes Sample collected from submerged pool in manhole. Detergent detected in sample.																																				
		Condition Assessment <table border="1" style="width: 100%; border-collapse: collapse;"> <tr> <td>Graffiti:</td> <td>None</td> </tr> <tr> <td>Erosion:</td> <td>None</td> </tr> <tr> <td>Deposition:</td> <td>None in.</td> </tr> <tr> <td>Damage:</td> <td>None</td> </tr> </table>			Graffiti:	None	Erosion:	None	Deposition:	None in.	Damage:	None																										
Graffiti:	None																																					
Erosion:	None																																					
Deposition:	None in.																																					
Damage:	None

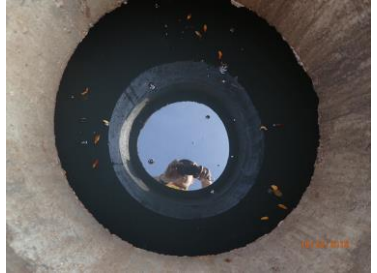
o20181025131952.JPG <div style="text-align: center; font-size: 24pt; font-weight: bold;">2018</div>

Notes Sample collected from submerged pool in manhole.																																				
		Condition Assessment <table border="1" style="width: 100%; border-collapse: collapse;"> <tr> <td>Graffiti:</td> <td>None</td> </tr> <tr> <td>Erosion:</td> <td>None</td> </tr> <tr> <td>Deposition:</td> <td>None in.</td> </tr> <tr> <td>Damage:</td> <td>None</td> </tr> </table>			Graffiti:	None	Erosion:	None	Deposition:	None in.	Damage:	None																										
Graffiti:	None																																					
Erosion:	None																																					
Deposition:	None in.																																					
Damage:	None

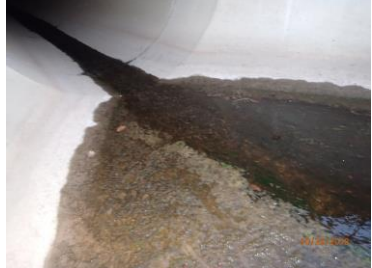
o20181025072226.JPG
2018

Inspection Date: 10/26/2018 12:50:27 PM		Type: Repeat	Flow: Trickle	Previous Rainfall (hrs): 72+
Illicit Discharge Potential: Potential		Inspector: KMK		
Submerged: None		Depth (in):		
Sampling Results		Notes Detergent detection follow-up. Limited screening conducted beyond sampling.		
Sample Location: Flow	Floatables: Slight	Condition Assessment Graffiti: None Erosion: None Deposition: None in. Damage: None		
Total Chlorine: 0 ppm	Odor: None			
Free Chlorine: 0 ppm	Turbidity: None			
Ammonia: 0 ppm	Color: None			
pH: 7.91 units	Gross Solids: None			
Temperature 56 °F	Vegetation: None			
Conductivity: 1745 µS/cm	Benthic Growth: None			
Detergents: 0.85 mg/L	Stains: Slight			
	Non-illicit: None

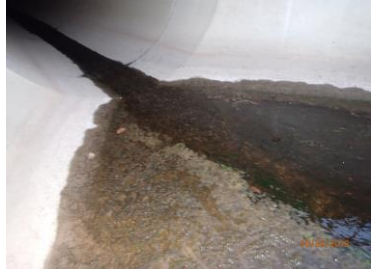
o20181025072226.JPG
2018

Inspection Date: 10/25/2018 7:24:13 AM		Type: Ongoing	Flow: Trickle	Previous Rainfall (hrs): 72+
Illicit Discharge Potential: Potential		Inspector: JCW		
Submerged: None		Depth (in):		
Sampling Results		Notes Sample collected from submerged flow at end of pipe. Detergent detected.		
Sample Location: Flow	Floatables: Slight	Condition Assessment Graffiti: None Erosion: None Deposition: None in. Damage: None		
Total Chlorine: 0 ppm	Odor: None			
Free Chlorine: 0 ppm	Turbidity: None			
Ammonia: 0 ppm	Color: None			
pH: 7.94 units	Gross Solids: None			
Temperature 49 °F	Vegetation: None			
Conductivity: 1865 µS/cm	Benthic Growth: Moderate			
Detergents: 0.45 mg/L	Stains: Slight			
	Non-illicit: None

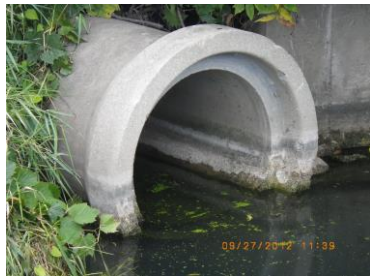
<p style="text-align: center;">o20120927103918.JPG</p> <p style="text-align: center; font-size: 24pt; font-weight: bold;">2012</p>

Inspection Date: 9/27/2012 11:43:23 AM		Type: Repeat	Flow: Submerged, slight flow	Previous Rainfall (hrs): 72+																																				
Illicit Discharge Potential: Potential		Inspector: JCW	Notes																																					
Submerged: Partially Depth (in): 6			Gel-like sheen on surface of stream. Outfall partially submerged; additional screening upstream at 14-582 US7.																																					
<table border="1" style="width:100%; border-collapse: collapse;"> <tr> <td colspan="2">Sampling Results</td> <td>Floatables:</td> <td>None</td> </tr> <tr> <td colspan="2">Sample Location: Pool</td> <td>Odor:</td> <td>None</td> </tr> <tr> <td>Total Chlorine:</td> <td>0 ppm</td> <td>Turbidity:</td> <td>None</td> </tr> <tr> <td>Free Chlorine:</td> <td>0 ppm</td> <td>Color:</td> <td>None</td> </tr> <tr> <td>Ammonia:</td> <td>0 ppm</td> <td>Gross Solids:</td> <td>None</td> </tr> <tr> <td>pH:</td> <td>7.77 units</td> <td>Vegetation:</td> <td>None</td> </tr> <tr> <td>Temperature:</td> <td>64 °F</td> <td>Benthic Growth:</td> <td>Moderate</td> </tr> <tr> <td>Conductivity:</td> <td>1077 µS/cm</td> <td>Stains:</td> <td>Severe</td> </tr> <tr> <td>Detergents:</td> <td>0 mg/L</td> <td>Non-illicit:</td> <td>None</td> </tr> </table>					Sampling Results		Floatables:	None	Sample Location: Pool		Odor:	None	Total Chlorine:	0 ppm	Turbidity:	None	Free Chlorine:	0 ppm	Color:	None	Ammonia:	0 ppm	Gross Solids:	None	pH:	7.77 units	Vegetation:	None	Temperature:	64 °F	Benthic Growth:	Moderate	Conductivity:	1077 µS/cm	Stains:	Severe	Detergents:	0 mg/L	Non-illicit:	None

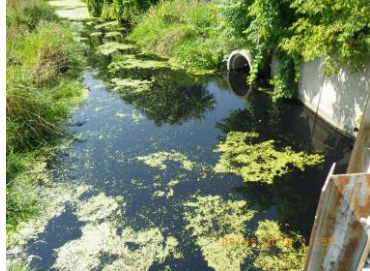
o20120905105212.JPG

Inspection Date: 9/5/2012 11:52:00 AM		Type: Complaint	Flow: Submerged, indeterminate	Previous Rainfall (hrs): 72+
Illicit Discharge Potential: Potential		Inspector: JCW	Notes	
Submerged: Partially Depth (in): 12			Dark black substance in water around outfall and bridge. Sample collected from stream.	
Sampling Results		Floatables: None	Condition Assessment	
Sample Location: Pool		Odor: Noticeable from a dist	Graftiti: None	
Total Chlorine: 0 ppm		Turbidity: Cloudy	Erosion: None	
Free Chlorine: 0 ppm		Color: Clearly visible in flow	Deposition: None in.	
Ammonia: 0 ppm		Gross Solids: None	Damage: None	
pH: 75 units		Vegetation: None		
Temperature -- °F		Benthic Growth: Moderate		
Conductivity: 1419 µS/cm		Stains: None		
Detergents: 0 mg/L		Non-illicit: None

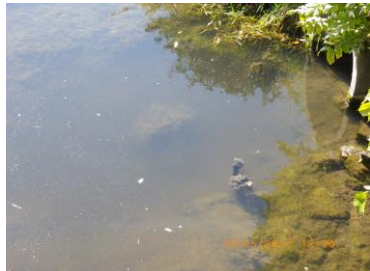
o20111005122620.JPG

Inspection Date: 10/5/2011 12:26:00 PM		Type: Repeat	Flow: Submerged, indeterminate	Previous Rainfall (hrs): 72+
Illicit Discharge Potential: Obvious		Inspector: JCW	Notes	
Submerged: Partially Depth (in):			Complaint follow-up. Outfall partially submerged. Outfall screened upstream at 14-585 US7. Limited screening conducted.	
Sampling Results		Floatables:	Condition Assessment	
Sample Location:		Odor:	Graftiti:	
Total Chlorine: -- ppm		Turbidity:	Erosion:	
Free Chlorine: -- ppm		Color:	Deposition: in.	
Ammonia: -- ppm		Gross Solids:	Damage:	
pH: -- units		Vegetation:		
Temperature -- °F		Benthic Growth:		
Conductivity: -- µS/cm		Stains:		
Detergents: -- mg/L		Non-illicit: None

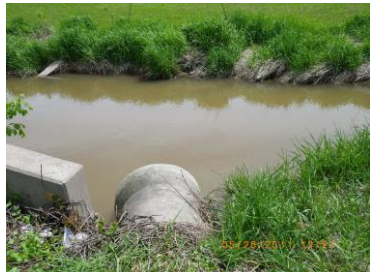
o20110526112114.jpg

Inspection Date: 5/26/2011 12:21:00 PM		Type: Repeat	Flow: Submerged, indeterminate	Previous Rainfall (hrs): 72+
Illicit Discharge Potential: Obvious		Inspector: JCW	Notes	
Submerged: Partially Depth (in):			Complaint follow-up. Strong chlorine smell inside pipe. Chemical interference with chlorine test. Limited screening conducted.	
Sampling Results		Floatables:	Condition Assessment	
Sample Location: Pool		Odor: Noticeable from a dist	Graftiti:	
Total Chlorine: -- ppm		Turbidity:	Erosion:	
Free Chlorine: -- ppm		Color:	Deposition: in.	
Ammonia: -- ppm		Gross Solids:	Damage:	
pH: -- units		Vegetation:		
Temperature -- °F		Benthic Growth:		
Conductivity: -- µS/cm		Stains:		
Detergents: -- mg/L		Non-illicit:

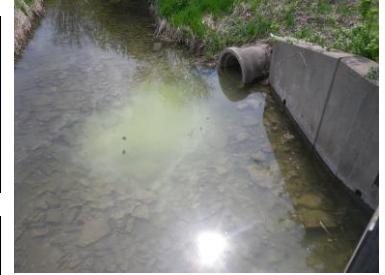
o20110512133142.jpg

Inspection Date: 5/12/2011 1:03:00 PM		Type: Complaint	Flow: Submerged, indeterminate	Previous Rainfall (hrs): 72+
Illicit Discharge Potential: Obvious		Inspector: JCW		
Submerged: Partially		Depth (in):		
Sampling Results		Notes Responded to complaint about discharge from pipe. Outfall partially submerged. Yellow pool at end of pipe. Chemical smell inside pipe.		
Sample Location:	Pool	Floatables:		
Total Chlorine:	2 ppm	Odor:	Noticeable from a dist	
Free Chlorine:	2 ppm	Turbidity:		
Ammonia:	2 ppm	Color:	Clearly visible in flow	
pH:	-- units	Gross Solids:		
Temperature	-- °F	Vegetation:		
Conductivity:	-- µS/cm	Benthic Growth:		
Detergents:	-- mg/L	Stains:		
		Non-illicit:	None	
		Condition Assessment Graffiti: Erosion: Deposition: in. Damage:

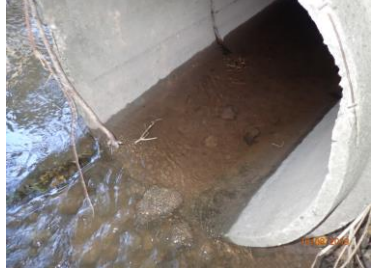
o20191008064438.JPG <div style="text-align: center; font-size: 24pt; font-weight: bold;">2019</div>

Damage: Minor ☐ Displacement ☐ Undercut ☐ Crushed☐ Corrosion ☒ Cracks/Structural Damage

Sample Location: Flow																																		
Total Chlorine:	0 ppm																																	
Free Chlorine:	0 ppm																																	
Ammonia:	0 ppm																																	
pH:	7.85 units																																	
Temperature:	51 °F																																	
Conductivity:	741 µS/cm																																	
Detergents:	1 mg/L																																	
Notes																																		
Sample collected from submerged flow at end of pipe. 2" joint displacement. Detergent detected.																																		
Condition Assessment																																		
Graffiti:	None																																	
Erosion:	None																																	
Deposition:	Minor 1 in.																																	
Damage:	Minor

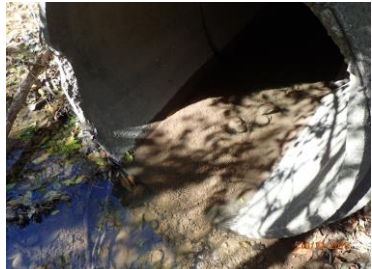
o20181022130156.JPG <div style="text-align: center; font-size: 24pt; font-weight: bold;">2018</div>

Sample Location: Flow																																		
Total Chlorine:	0 ppm																																	
Free Chlorine:	0 ppm																																	
Ammonia:	0 ppm																																	
pH:	7.62 units																																	
Temperature:	57 °F																																	
Conductivity:	811 µS/cm																																	
Detergents:	0 mg/L																																	
Notes																																		
Sample collected from submerged flow at end of pipe. 4" joint displacement.																																		
Condition Assessment																																		
Graffiti:	None																																	
Erosion:	None																																	
Deposition:	Minor 1 in.																																	
Damage:	Moderate

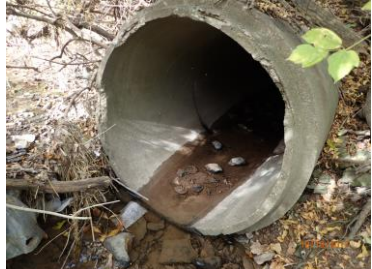
o20171019115316.JPG <div style="text-align: center; font-size: 24pt; font-weight: bold;">2017</div>

Sample Location: Flow																																		
Total Chlorine:	0 ppm																																	
Free Chlorine:	0 ppm																																	
Ammonia:	0 ppm																																	
pH:	8.1 units																																	
Temperature:	62 °F																																	
Conductivity:	725 µS/cm																																	
Detergents:	0 mg/L																																	
Notes																																		
Upstream manhole dry - sample collected from submerged pool at end of pipe. 3" joint displacement and damaged concrete.																																		
Condition Assessment																																		
Graffiti:	None																																	
Erosion:	None																																	
Deposition:	None in.																																	
Damage:	Moderate

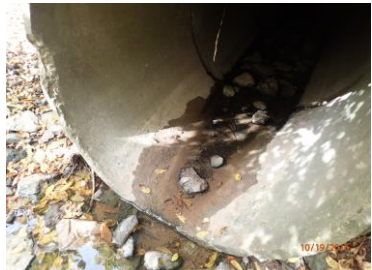
o20161019130908.JPG <div style="text-align: center; font-size: 24pt; font-weight: bold;">2016</div>

Sample Location: Flow																																		
Total Chlorine:	0 ppm																																	
Free Chlorine:	0 ppm																																	
Ammonia:	0 ppm																																	
pH:	8.24 units																																	
Temperature:	65 °F																																	
Conductivity:	765 µS/cm																																	
Detergents:	0 mg/L																																	
Notes																																		
Last pipe segment displaced 4" at joint.																																		
Condition Assessment																																		
Graffiti:	None																																	
Erosion:	None																																	
Deposition:	None in.																																	
Damage:	Minor

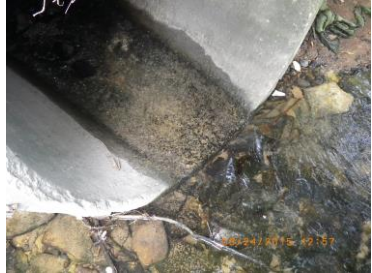
o20150924115728.JPG 2015

Inspection Date: 9/24/2015 12:55:30 PM		Type: Ongoing	Flow: Moderate	Previous Rainfall (hrs): 72+
Illicit Discharge Potential: Unlikely		Inspector: JCW	Notes 4" joint displacement.	
Submerged: None Depth (in):				
Sampling Results Sample Location: Flow Total Chlorine: 0 ppm Free Chlorine: 0 ppm Ammonia: 0 ppm pH: 8.17 units Temperature: 72 °F Conductivity: 1595 µS/cm Detergents: 0 mg/L		Floatables: None Odor: None Turbidity: None Color: None Gross Solids: None Vegetation: None Benthic Growth: None Stains: Slight Non-illicit: None	Condition Assessment Graffiti: None Erosion: None Deposition: None in. Damage: Moderate

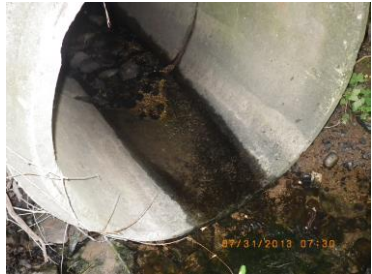
o20130731063036.JPG 2013

Inspection Date: 7/31/2013 7:27:16 AM		Type: Ongoing	Flow: Trickle	Previous Rainfall (hrs): 72+
Illicit Discharge Potential: Unlikely		Inspector: JCW	Notes End section displaced 4".	
Submerged: None Depth (in):				
Sampling Results Sample Location: Flow Total Chlorine: 0 ppm Free Chlorine: 0 ppm Ammonia: 0 ppm pH: 8.05 units Temperature: 71 °F Conductivity: 1865 µS/cm Detergents: 0 mg/L		Floatables: None Odor: None Turbidity: None Color: None Gross Solids: None Vegetation: None Benthic Growth: None Stains: Moderate Non-illicit: None	Condition Assessment Graffiti: None Erosion: None Deposition: None in. Damage: Minor

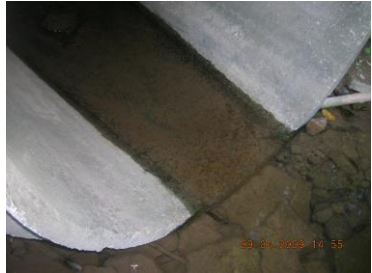
Osh09_DSCN6570.JPG 2009

Inspection Date: 9/4/2009		Type: Initial	Flow: Submerged, slight flow	Previous Rainfall (hrs): 72+
Illicit Discharge Potential: Unlikely		Inspector: JCW	Notes End section of pipe separated.	
Submerged: Partially Depth (in): 1				
Sampling Results Sample Location: Pool Total Chlorine: 0 ppm Free Chlorine: 0 ppm Ammonia: -- ppm pH: 7.82 units Temperature: 73 °F Conductivity: -- µS/cm Detergents: 0 mg/L		Floatables: None Odor: None Turbidity: None Color: None Gross Solids: None Vegetation: Benthic Growth: Slight Stains: Non-illicit: None	Condition Assessment Graffiti: None Erosion: None Deposition: None 0 in. Damage: Moderate

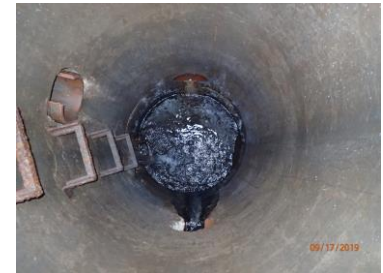
020190917071502.JPG

Notes: Main flow from north (lower). Black stains under west pipe.

Stains: Severe

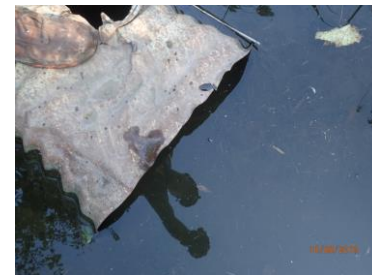
o20191008085136.JPG

Notes: Outfall partially submerged. Outfall screened upstream at 15-1067 US1. Damaged metal pipe with holes.

Damage: Moderate ☐ Displacement ☐ Undercut ☒ Crushed☐ Corrosion ☒ Cracks/Structural Damage

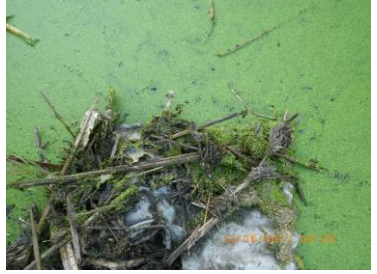
o20111006080206.JPG 2011

Inspection Date: 10/6/2011 8:01:50 AM		Type: Ongoing	Flow: Submerged, indeterminate	Previous Rainfall (hrs): 72+
Illicit Discharge Potential: Unlikely		Inspector: JCW		
Submerged: Partially		Depth (in): 22		
Sampling Results Sample Location: Total Chlorine: -- ppm Free Chlorine: -- ppm Ammonia: -- ppm pH: -- units Temperature: -- °F Conductivity: -- µS/cm Detergents: -- mg/L		Floatables: None Odor: None Turbidity: None Color: None Gross Solids: None Vegetation: None Benthic Growth: None Stains: None Non-illicit: None		
		Notes Outfall partially submerged. Outfall screened upstream at 15-1067 US1.		
		Condition Assessment Graffiti: None Erosion: None Deposition: Severe 16 in. Damage: Moderate

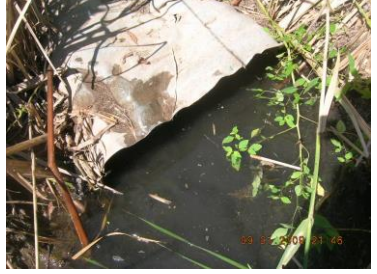
Osh09_DSCN6372.JPG 2009

Inspection Date: 9/2/2009		Type: Initial	Flow: Submerged, slight flow	Previous Rainfall (hrs): 72+
Illicit Discharge Potential: Unlikely		Inspector: JCW		
Submerged: Partially		Depth (in): 14		
Sampling Results Sample Location: Total Chlorine: -- ppm Free Chlorine: -- ppm Ammonia: -- ppm pH: -- units Temperature: -- °F Conductivity: -- µS/cm Detergents: -- mg/L		Floatables: Odor: Turbidity: Color: Gross Solids: Vegetation: Benthic Growth: Stains: Non-illicit: None		
		Notes Crushed pipe.		
		Condition Assessment Graffiti: None Erosion: None Deposition: 5 in. Damage: Minor

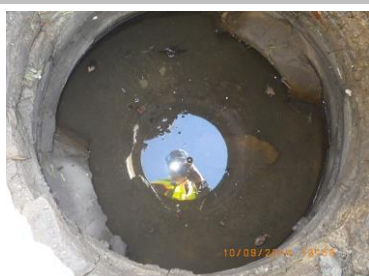
Benthic Growth: None

Gross Solids: None

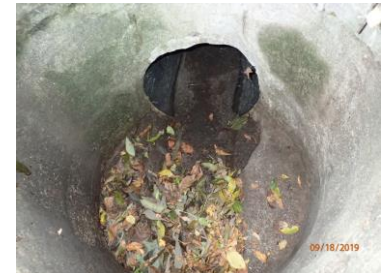
Upstream Manholes with Significant Floatable Debris

During the 10/8/2019 screening, detergent was detected in the upstream manhole (0.9 mg/L). When the manhole was rescreened on 11/5/2019, along with upstream locations, no detergent was detected, so no upstream tracking could be performed.

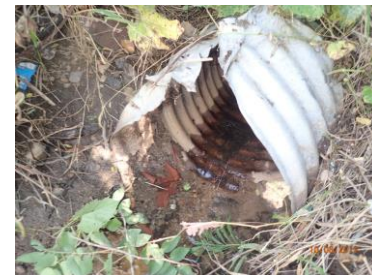
The samples collected from the outfall and upstream manhole are summarized in Table 10:

During the 10/8/2019 screening, detergent was detected in the upstream manhole (0.8 mg/L). An additional sample was collected from the upstream storm sewer at W. 20th Avenue. This upstream sample had a detergent concentration of 0.6, indicating that the detergent source was likely upstream of W. 20th Avenue.

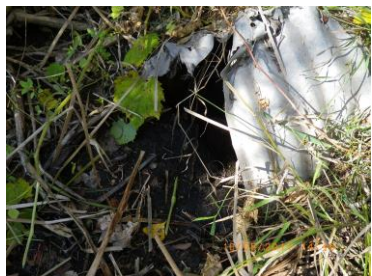
The samples collected from the outfall and upstream manhole are summarized in Table 11:

Date	Location	Ammonia (ppm)	Detergent (mg/L)	pH	Conductivity (μS/cm)
10/8/2019	13-2736 US2	0	1.1	7.74	799
11/5/2019	13-2736 US2	N/A	1.3	N/A	N/A

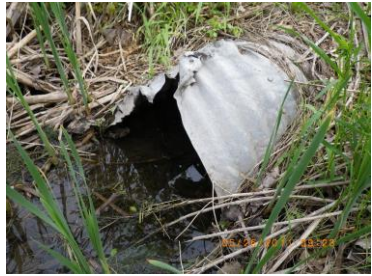
Because this outfall is a non-priority non-major outfall, it would normally be scheduled to be screened in 10 years. However, because of the potential illicit discharge, it will be scheduled to be rescreened in 2020. If the detergent is still present, additional tracking should be conducted.

Outfall 13-2957 (South Park)

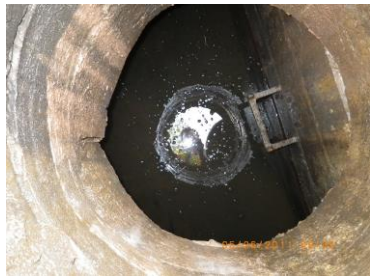
o20110526093522.JPG <div style="text-align: center; font-size: 24pt; font-weight: bold;">2011</div>

Inspection Date: 9/2/2009		Type: Initial	Flow: Submerged, slight flow	Previous Rainfall (hrs): 72+																																		
Illicit Discharge Potential: Unlikely		Inspector: JCW																																				
Submerged: None		Depth (in): 0																																				
Sampling Results <table border="1" style="width:100%; border-collapse: collapse;"> <tr> <td>Sample Location:</td> <td>Pool</td> </tr> <tr> <td>Total Chlorine:</td> <td>0 ppm</td> </tr> <tr> <td>Free Chlorine:</td> <td>0 ppm</td> </tr> <tr> <td>Ammonia:</td> <td>-- ppm</td> </tr> <tr> <td>pH:</td> <td>8.1 units</td> </tr> <tr> <td>Temperature:</td> <td>72 °F</td> </tr> <tr> <td>Conductivity:</td> <td>-- µS/cm</td> </tr> <tr> <td>Detergents:</td> <td>0 mg/L</td> </tr> </table>		Sample Location:	Pool	Total Chlorine:	0 ppm	Free Chlorine:	0 ppm	Ammonia:	-- ppm	pH:	8.1 units	Temperature:	72 °F	Conductivity:	-- µS/cm	Detergents:	0 mg/L	<table border="1" style="width:100%; border-collapse: collapse;"> <tr> <td>Floatables:</td> <td>None</td> </tr> <tr> <td>Odor:</td> <td>None</td> </tr> <tr> <td>Turbidity:</td> <td>None</td> </tr> <tr> <td>Color:</td> <td>None</td> </tr> <tr> <td>Gross Solids:</td> <td>None</td> </tr> <tr> <td>Vegetation:</td> <td></td> </tr> <tr> <td>Benthic Growth:</td> <td></td> </tr> <tr> <td>Stains:</td> <td></td> </tr> <tr> <td>Non-illicit:</td> <td>None</td> </tr> </table>			Floatables:	None	Odor:	None	Turbidity:	None	Color:	None	Gross Solids:	None	Vegetation:		Benthic Growth:		Stains:		Non-illicit:	None

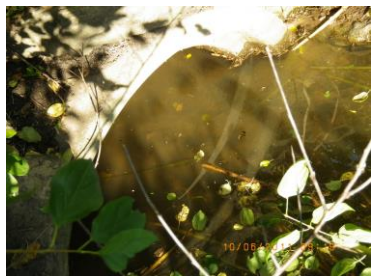
o20111006091914.JPG <div style="text-align: right; font-size: 24pt; font-weight: bold;">2011</div>

Inspection Date: 10/6/2011 9:21:36 AM		Type: Ongoing	Flow: Submerged, indeterminate	Previous Rainfall (hrs): 72+
Illicit Discharge Potential: Unlikely		Inspector: JCW		
Submerged: Partially		Depth (in): 20		
Sampling Results Sample Location: _____ Total Chlorine: -- ppm Free Chlorine: -- ppm Ammonia: -- ppm pH: -- units Temperature: -- °F Conductivity: -- µS/cm Detergents: -- mg/L		Floatables: None Odor: None Turbidity: None Color: None Gross Solids: None Vegetation: None Benthic Growth: Slight Stains: Slight Non-illicit: None	Notes Outfall partially submerged. Outfall screened upstream at 15-1263 US1.	
		Condition Assessment Graffiti: None Erosion: None Deposition: Moderate 16 in. Damage: None

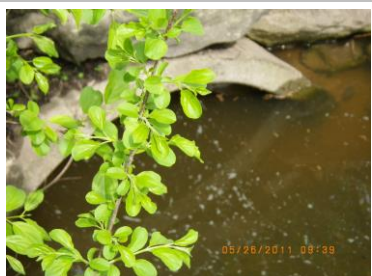
o20110526093900.JPG <div style="text-align: right; font-size: 24pt; font-weight: bold;">2011</div>

Inspection Date: 5/26/2011 9:38:00 AM		Type: Other	Flow: Submerged, indeterminate	Previous Rainfall (hrs): 72+
Illicit Discharge Potential: Unlikely		Inspector: JCW		
Submerged: Partially		Depth (in):		
Sampling Results Sample Location: _____ Total Chlorine: -- ppm Free Chlorine: -- ppm Ammonia: -- ppm pH: -- units Temperature: -- °F Conductivity: -- µS/cm Detergents: -- mg/L		Floatables: _____ Odor: _____ Turbidity: _____ Color: _____ Gross Solids: _____ Vegetation: _____ Benthic Growth: _____ Stains: _____ Non-illicit: None	Notes Outfall partially submerged. Outfall screened upstream at 15-1263 US1.	
		Condition Assessment Graffiti: None Erosion: None Deposition: None 0 in. Damage: None

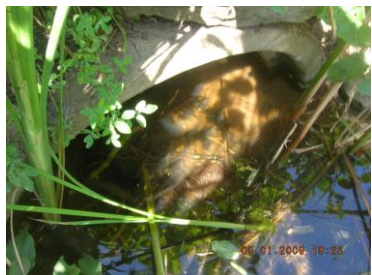
Osh09_DSCN6332.JPG <div style="text-align: right; font-size: 24pt; font-weight: bold;">2009</div>

Inspection Date: 9/2/2009		Type: Initial	Flow: Submerged, no flow	Previous Rainfall (hrs): 72+
Illicit Discharge Potential: Unlikely		Inspector: JCW		
Submerged: Partially		Depth (in): 18		
Sampling Results Sample Location: _____ Total Chlorine: -- ppm Free Chlorine: -- ppm Ammonia: -- ppm pH: -- units Temperature: -- °F Conductivity: -- µS/cm Detergents: -- mg/L		Floatables: _____ Odor: _____ Turbidity: _____ Color: _____ Gross Solids: _____ Vegetation: _____ Benthic Growth: Slight Stains: _____ Non-illicit: None	Notes _____	
		Condition Assessment Graffiti: None Erosion: None Deposition: 10 in. Damage: None

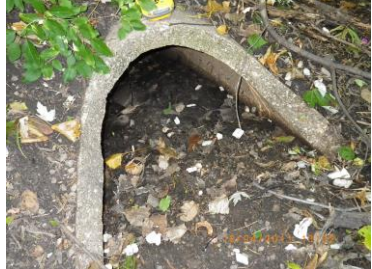
o20111004130230.JPG <div style="text-align: center; font-size: 24pt; font-weight: bold;">2011</div>

Inspection Date: 10/4/2011 1:01:53 PM		Type: Ongoing	Flow: None	Previous Rainfall (hrs): 72+
Illicit Discharge Potential: Unlikely		Inspector: JCW		
Submerged: None		Depth (in):		
Sampling Results Sample Location: Total Chlorine: -- ppm Free Chlorine: -- ppm Ammonia: -- ppm pH: -- units Temperature: -- °F Conductivity: -- µS/cm Detergents: -- mg/L		Floatables: None Odor: None Turbidity: None Color: None Gross Solids: Slight Vegetation: None Benthic Growth: None Stains: None Non-illicit: None	Notes Condition Assessment Graffiti: None Erosion: None Deposition: Moderate 6 in. Damage: None
