Ongoing Screening Summary Report 2019 Inspection Year

Illicit Discharge Detection and Elimination Program

City of Oshkosh

January 3, 2020

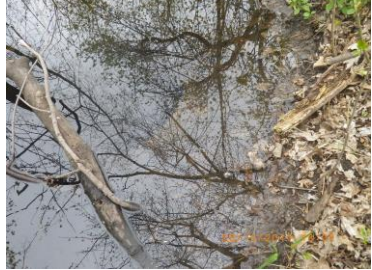
o20110510133204.JPG <div style="text-align: center; font-size: 24pt; font-weight: bold;">2011</div>

Inspection Date: 5/10/2011 1:31:00 PM		Type: Other	Flow: Submerged, indeterminate	Previous Rainfall (hrs): 0-24
Illicit Discharge Potential: Unlikely		Inspector: JCW		
Submerged: Fully		Depth (in):		
Sampling Results Sample Location: Total Chlorine: -- ppm Free Chlorine: -- ppm Ammonia: -- ppm pH: -- units Temperature: -- °F Conductivity: -- µS/cm Detergents: -- mg/L		Floatables: Odor: Turbidity: Color: Gross Solids: Vegetation: Benthic Growth: Stains: Non-illicit: None	Notes Outfall fully submerged. Outfall screened upstream at 15-1494 US1.	
		Condition Assessment Graffiti: None Erosion: None Deposition: None 0 in. Damage: None

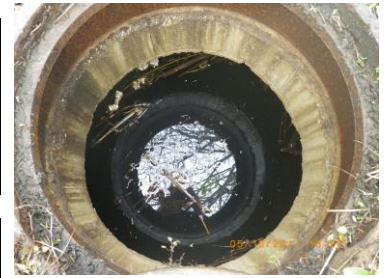
o20110510133350.JPG

Inspection Date: 5/10/2011 1:33:00 PM		Type: Other	Flow: Submerged, indeterminate	Previous Rainfall (hrs): 0-24
Illicit Discharge Potential: Unlikely		Inspector: JCW		
Submerged: Fully		Depth (in):		
Sampling Results		Notes Limited screening conducted for upstream manhole prescreening.		
Sample Location:	Floatables:	None		
Total Chlorine: -- ppm	Odor:			
Free Chlorine: -- ppm	Turbidity:			
Ammonia: -- ppm	Color:			
pH: -- units	Gross Solids:	None		
Temperature -- °F	Vegetation:			
Conductivity: -- µS/cm	Benthic Growth:			
Detergents: -- mg/L	Stains:			
	Non-illicit:	None		
		Condition Assessment Graffiti: None Erosion: None Deposition: None 0 in. Damage: None

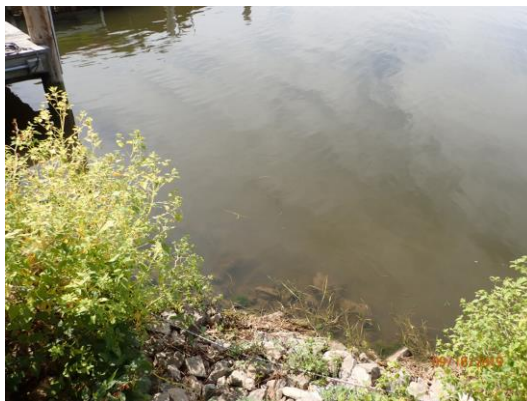
o20190918122744.JPG

Storm sewer from Hickory Ct discharges to lake from east. Outfall fully submerged.

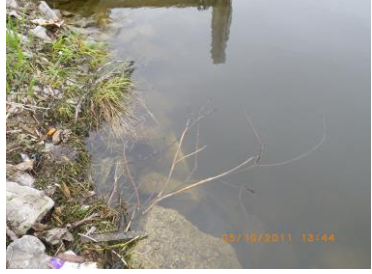
o20110510134454.JPG <div style="text-align: right; font-size: 24pt; font-weight: bold;">2011</div>

Inspection Date: 5/10/2011 1:44:00 PM		Type: Other	Flow: Submerged, indeterminate	Previous Rainfall (hrs): 0-24																		
Illicit Discharge Potential: Unlikely		Inspector: JCW																				
Submerged: Fully		Depth (in):																				
Sampling Results		<table border="1" style="width: 100%; border-collapse: collapse;"> <tr><td>Floatables:</td><td></td></tr> <tr><td>Odor:</td><td></td></tr> <tr><td>Turbidity:</td><td></td></tr> <tr><td>Color:</td><td></td></tr> <tr><td>Gross Solids:</td><td></td></tr> <tr><td>Vegetation:</td><td></td></tr> <tr><td>Benthic Growth:</td><td></td></tr> <tr><td>Stains:</td><td></td></tr> <tr><td>Non-illicit:</td><td>None</td></tr> </table>			Floatables:		Odor:		Turbidity:		Color:		Gross Solids:		Vegetation:		Benthic Growth:		Stains:		Non-illicit:	None
Floatables:																						
Odor:																						
Turbidity:																						
Color:

Gross Solids:																						
Vegetation:																						
Benthic Growth:																						
Stains:																						
Non-illicit:	None																					
<table border="1" style="width: 100%; border-collapse: collapse;"> <tr><td colspan="2">Sample Location:</td></tr> <tr><td>Total Chlorine:</td><td>-- ppm</td></tr> <tr><td>Free Chlorine:</td><td>-- ppm</td></tr> <tr><td>Ammonia:</td><td>-- ppm</td></tr> <tr><td>pH:</td><td>-- units</td></tr> <tr><td>Temperature:</td><td>-- °F</td></tr> <tr><td>Conductivity:</td><td>-- µS/cm</td></tr> <tr><td>Detergents:</td><td>-- mg/L</td></tr> </table>		Sample Location:		Total Chlorine:	-- ppm	Free Chlorine:	-- ppm	Ammonia:	-- ppm	pH:	-- units	Temperature:	-- °F	Conductivity:	-- µS/cm	Detergents:	-- mg/L	Notes Outfall fully submerged. Outfall screened upstream at 15-1983 US1.				
Sample Location:																						
Total Chlorine:	-- ppm

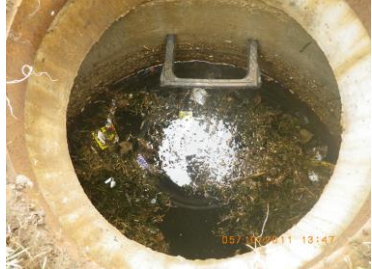
<p style="text-align: center;">o20110510134702.JPG</p> <p style="text-align: center; font-size: 24pt; font-weight: bold;">2011</p>

Sample Location:																																						
Total Chlorine:	-- ppm																																					
Free Chlorine:	-- ppm																																					
Ammonia:	-- ppm																																					
pH:	-- units																																					
Temperature:	-- °F																																					
Conductivity:	-- µS/cm																																					
Detergents:	-- mg/L																																					
Floatables:	None																																					
Odor:																																						
Turbidity:																																						
Color:																																						
Gross Solids:	Slight																																					
Vegetation:																																						
Benthic Growth:																																						
Stains:																																						
Non-illicit:	None																																					
		Notes <div style="border: 1px solid black; padding: 5px;"> Limited screening conducted for upstream manhole prescreening. </div>

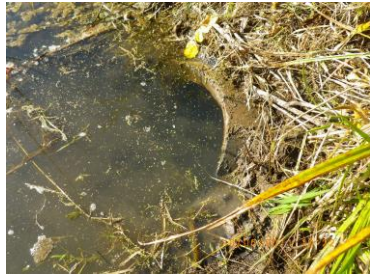
o20111006102246.JPG

Inspection Date: 10/6/2011 10:18:45 AM		Type: Ongoing	Flow: Submerged, indeterminate	Previous Rainfall (hrs): 72+
Illicit Discharge Potential: Unlikely		Inspector: JCW	Notes Outfall partially submerged. Outfall screened upstream at 15-2243 US1.	
Submerged: Fully Depth (in): 20				
Sampling Results Sample Location: Total Chlorine: -- ppm Free Chlorine: -- ppm Ammonia: -- ppm pH: -- units Temperature -- °F Conductivity: -- µS/cm Detergents: -- mg/L		Floatables: None Odor: None Turbidity: None Color: None Gross Solids: None Vegetation: None Benthic Growth: None Stains: None Non-illicit: None	Condition Assessment Graffiti: None Erosion: None Deposition: None 0 in. Damage: None

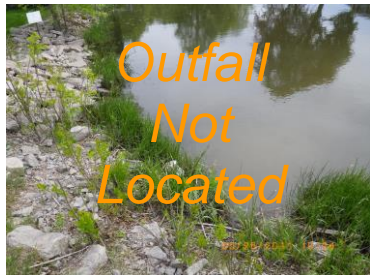
o20110526102404.JPG

Inspection Date: 5/26/2011 10:24:00 AM		Type: Other	Flow: Submerged (not located)	Previous Rainfall (hrs): 72+
Illicit Discharge Potential: Unlikely		Inspector: JCW	Notes Outfall fully submerged and not physically located. Outfall screened upstream at 15-2243 US1.	
Submerged: Fully Depth (in):				
Sampling Results Sample Location: Total Chlorine: -- ppm Free Chlorine: -- ppm Ammonia: -- ppm pH: -- units Temperature -- °F Conductivity: -- µS/cm Detergents: -- mg/L		Floatables: Odor: Turbidity: Color: Gross Solids: Vegetation: Benthic Growth: Stains: Non-illicit: None	Condition Assessment Graffiti: None Erosion: None Deposition: None 0 in. Damage: None

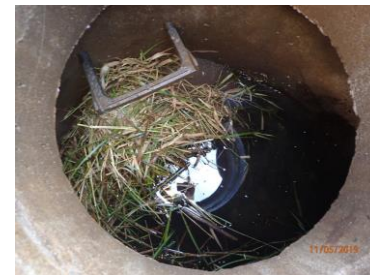
o20191105102140.JPG

Notes Sample collected from submerged pool in manhole. Detergent detected.																																				
		Condition Assessment <table border="1" style="width:100%; border-collapse: collapse;"> <tr><td>Graffiti:</td><td>None</td></tr> <tr><td>Erosion:</td><td>None</td></tr> <tr><td>Deposition:</td><td>None in.</td></tr> <tr><td>Damage:</td><td>None</td></tr> </table>			Graffiti:	None	Erosion:	None	Deposition:	None in.	Damage:	None																										
Graffiti:	None																																					
Erosion:	None																																					
Deposition:	None in.																																					
Damage:	None

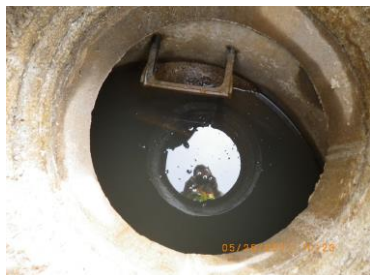
o20110526102324.JPG 2011

Sample Location:																																						
Total Chlorine:	-- ppm																																					
Free Chlorine:	-- ppm																																					
Ammonia:	-- ppm																																					
pH:	-- units																																					
Temperature:	-- °F																																					
Conductivity:	-- µS/cm																																					
Detergents:	-- mg/L																																					
Floatables:																																						
Odor:																																						
Turbidity:																																						
Color:																																						
Gross Solids:																																						
Vegetation:																																						
Benthic Growth:																																						
Stains:																																						
Non-illicit:	None																																					
		Notes Limited screening conducted for upstream manhole prescreening.

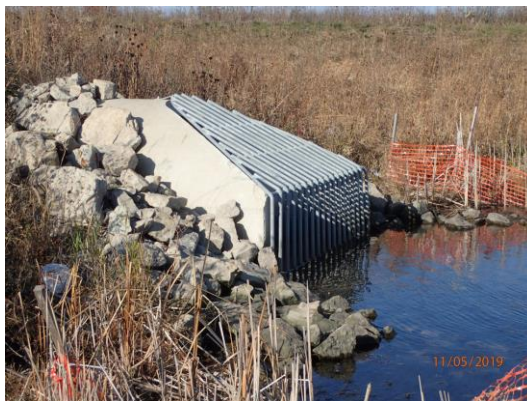
o20191105095938.JPG

Storm sewer from Jackson Street discharges to SW corner of detention basin. Constructed 2016 - replaces outfall 15-1889.

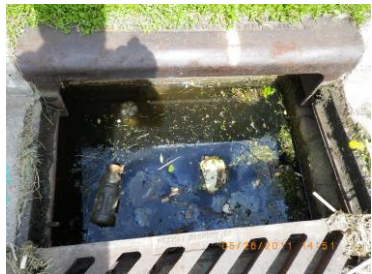
Height/Depth (in): 24

Dimensions

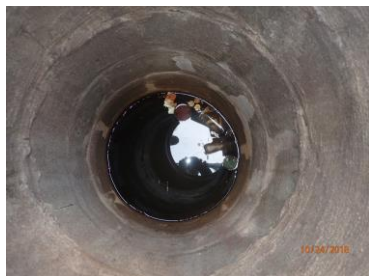
o20150922061944.JPG

Inspection Date: 10/9/2014 12:40:37 PM		Type: Ongoing	Flow: Submerged, indeterminate	Previous Rainfall (hrs): 72+
Illicit Discharge Potential: Potential		Inspector: JCW	Notes	
Submerged: Fully		Depth (in): 35	Floating gross solids (litter) in manhole.	
Sampling Results				
Sample Location:	Pool	Floatables:	None	
Total Chlorine:	0 ppm	Odor:	None	
Free Chlorine:	0 ppm	Turbidity:	None	
Ammonia:	0 ppm	Color:	None	
pH:	7.58 units	Gross Solids:	Moderate	
Temperature:	62 °F	Vegetation:	None	
Conductivity:	707 µS/cm	Benthic Growth:	None	
Detergents:	0 mg/L	Stains:	None	
		Non-illicit:	None	
			Condition Assessment	
			Graffiti:	None
			Erosion:	None
			Deposition:	None in.
			Damage:	None

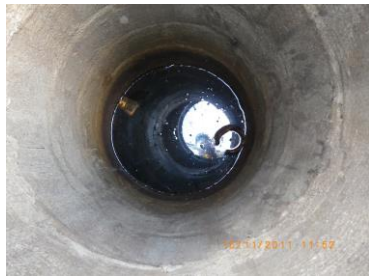
<p>o20111011115206.JPG</p> <p style="font-size: 24pt; font-weight: bold;">2011</p> </div>

<p>2010 screening follow-up. Floatable debris significantly reduced.</p> </div>		
Total Chlorine: 0 ppm	Odor: None			
Free Chlorine: 0 ppm	Turbidity: None			
Ammonia: 0.5 ppm	Color: None			
pH: 7.34 units	Gross Solids: Moderate			
Temperature 71 °F	Vegetation: None			
Conductivity: -- µS/cm	Benthic Growth: None			
Detergents: -- mg/L	Stains: Moderate			
	Non-illicit: Moderate			
		<div style="text-align: center;">

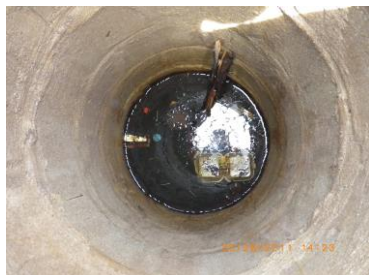
<p>o20110526142310.JPG</p> <p style="font-size: 24pt; font-weight: bold;">2011</p> </div>

<p>Limited screening conducted to check for floatable debris.</p> </div>		
Total Chlorine: -- ppm	Odor:			
Free Chlorine: -- ppm	Turbidity:			
Ammonia: -- ppm	Color:			
pH: -- units	Gross Solids: Moderate			
Temperature -- °F	Vegetation:			
Conductivity: -- µS/cm	Benthic Growth:			
Detergents: -- mg/L	Stains:			
	Non-illicit: None			
		<div style="text-align: center;">

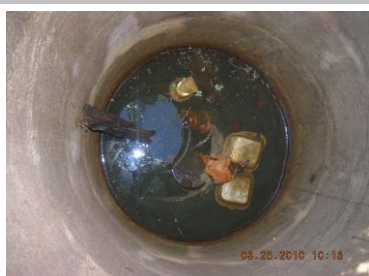
<p>Floatable debris in manhole.</p> </div>		
Total Chlorine: 0 ppm	Odor: None			
Free Chlorine: 0 ppm	Turbidity: None			
Ammonia: 0 ppm	Color: Faint in bottle			
pH: 7.31 units	Gross Solids: Moderate			
Temperature 71 °F	Vegetation: None			
Conductivity: -- µS/cm	Benthic Growth: Slight			
Detergents: 0 mg/L	Stains: Slight			
	Non-illicit: None			
		<div style="text-align: center;">

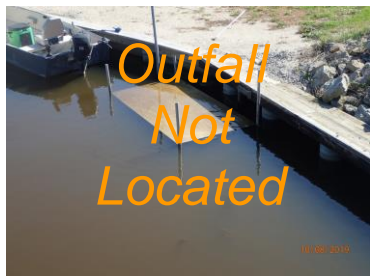
o20191008123600.JPG <div style="text-align: center; font-size: 24pt; font-weight: bold;">2019</div>

Inspection Date: 10/8/2019 1:37:40 PM		Type: Ongoing	Flow: Submerged (not located)	Previous Rainfall (hrs): 48-72
Illicit Discharge Potential: Potential		Inspector: JCW		
Submerged: Fully		Depth (in):		
Sampling Results		Notes Outfall fully submerged and not located - screened upstream at 16-533 US1. Floating gross solids (litter) and detergent in manhole.		
Sample Location:	Floatables:	None		
Total Chlorine: -- ppm	Odor:	None		
Free Chlorine: -- ppm	Turbidity:	None		
Ammonia: -- ppm	Color:	None		
pH: -- units	Gross Solids:	None		
Temperature -- °F	Vegetation:	None		
Conductivity: -- µS/cm	Benthic Growth:	None		
Detergents: -- mg/L	Stains:	None		
	Non-illicit:	None		
		Condition Assessment Graffiti: None Erosion: None Deposition: None in. Damage: None

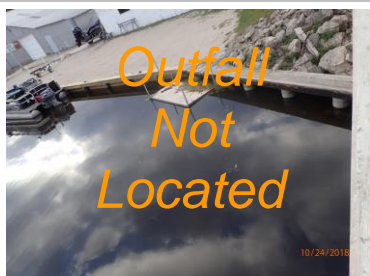
o20181024084514.JPG <div style="text-align: center; font-size: 24pt; font-weight: bold;">2018</div>

Inspection Date: 10/24/2018 8:46:55 AM		Type: Ongoing	Flow: Submerged (not located)	Previous Rainfall (hrs): 72+
Illicit Discharge Potential: Potential		Inspector: JCW		
Submerged: Fully		Depth (in):		
Sampling Results		Notes Outfall fully submerged and not located - screened upstream at 16-533 US1. Floating gross solids (litter) in manhole.		
Sample Location:	Floatables:	None		
Total Chlorine: -- ppm	Odor:	None		
Free Chlorine: -- ppm	Turbidity:	None		
Ammonia: -- ppm	Color:	None		
pH: -- units	Gross Solids:	None		
Temperature -- °F	Vegetation:	None		
Conductivity: -- µS/cm	Benthic Growth:	None		
Detergents: -- mg/L	Stains:	None		
	Non-illicit:	None		
		Condition Assessment Graffiti: None Erosion: None Deposition: None in. Damage: None

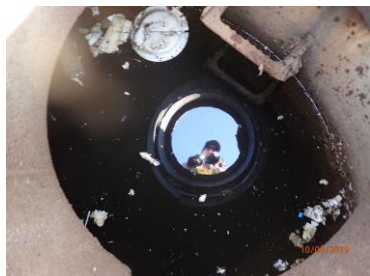
o20191008123830.JPG

Inspection Date: 10/8/2019 1:38:32 PM		Type: Ongoing	Flow: Submerged, indeterminate	Previous Rainfall (hrs): 48-72
Illicit Discharge Potential: Potential		Inspector: JCW		
Submerged: Partially		Depth (in): 38		
Sampling Results		Notes		
Sample Location: Pool	Floatables: None	Sample collected from submerged pool in manhole. Floating gross solids (litter) in manhole. Detergent detected in sample.		
Total Chlorine: 0 ppm	Odor: None			
Free Chlorine: 0 ppm	Turbidity: None			
Ammonia: 0 ppm	Color: None			
pH: 7.34 units	Gross Solids: Moderate			
Temperature 66 °F	Vegetation: None			
Conductivity: 449 µS/cm	Benthic Growth: None			
Detergents: 0.5 mg/L	Stains: None			
	Non-illicit: None	Condition Assessment		
		Graffiti: None		
		Erosion: None		
		Deposition: None in.		
		Damage: None

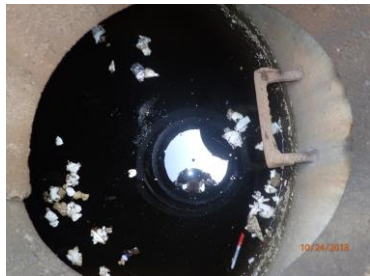
o20181024084850.JPG

Inspection Date: 10/24/2018 8:51:52 AM		Type: Ongoing	Flow: Submerged, indeterminate	Previous Rainfall (hrs): 72+
Illicit Discharge Potential: Potential		Inspector: JCW		
Submerged: Partially		Depth (in): 46		
Sampling Results		Notes		
Sample Location: Pool	Floatables: None	Sample collected from submerged pool in manhole. Floating gross solids (litter) in manhole.		
Total Chlorine: 0 ppm	Odor: None			
Free Chlorine: 0 ppm	Turbidity: None			
Ammonia: 0 ppm	Color: None			
pH: 7.75 units	Gross Solids: Slight			
Temperature 48 °F	Vegetation: None			
Conductivity: 485 µS/cm	Benthic Growth: None			
Detergents: 0 mg/L	Stains: None			
	Non-illicit: None	Condition Assessment		
		Graffiti: None		
		Erosion: None		
		Deposition: None in.		
		Damage: None

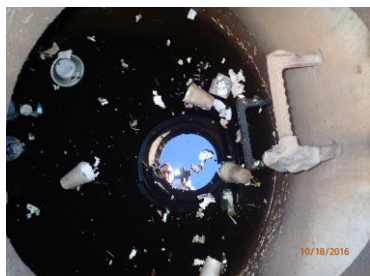
o20161018092516.JPG

Inspection Date: 10/18/2016 9:29:17 AM		Type: Ongoing	Flow: Submerged, indeterminate	Previous Rainfall (hrs): 72+
Illicit Discharge Potential: Potential		Inspector: JCW		
Submerged: Fully		Depth (in): 40		
Sampling Results		Notes		
Sample Location: Pool	Floatables: None	Potential illicit discharge due to gross solids.		
Total Chlorine: 0 ppm	Odor: None			
Free Chlorine: 0 ppm	Turbidity: None			
Ammonia: 0 ppm	Color: None			
pH: 7.94 units	Gross Solids: Moderate			
Temperature 63 °F	Vegetation: None			
Conductivity: 482 µS/cm	Benthic Growth: None			
Detergents: 0 mg/L	Stains: None			
	Non-illicit: None	Condition Assessment		
		Graffiti: None		
		Erosion: None		
		Deposition: None in.		
		Damage: None

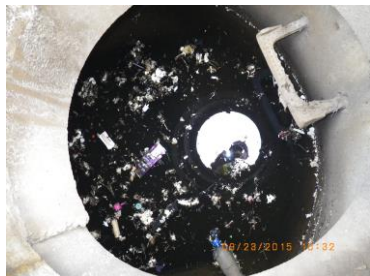
o20150923093204.JPG

Inspection Date: 9/23/2015 10:32:59 AM		Type: Ongoing	Flow: Submerged, indeterminate	Previous Rainfall (hrs): 72+
Illicit Discharge Potential: Potential		Inspector: JCW	Notes	
Submerged: Fully		Depth (in): 36	Floating gross solids (litter) - including syringe - in manhole.	
Sampling Results		Floatables: None	Condition Assessment	
Sample Location:	Pool	Odor: None	Graffiti: None Erosion: None Deposition: None in. Damage: None	
Total Chlorine:	0 ppm	Turbidity: None		
Free Chlorine:	0 ppm	Color: None		
Ammonia:	0 ppm	Gross Solids: Moderate		
pH:	7.95 units	Vegetation: None		
Temperature	71 °F	Benthic Growth: Slight		
Conductivity:	363 µS/cm	Stains: None		
Detergents:	0 mg/L	Non-illicit: None

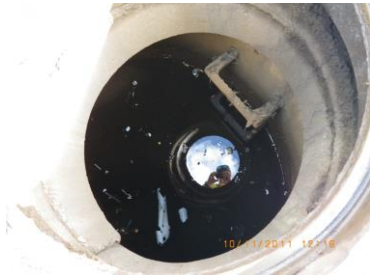
o20111011121924.JPG

Inspection Date: 10/11/2011 12:22:21 PM		Type: Ongoing	Flow: Submerged, indeterminate	Previous Rainfall (hrs): 72+
Illicit Discharge Potential: Unlikely		Inspector: JCW	Notes	
Submerged: Fully		Depth (in): 16	2010 screening follow-up. Floatable debris significantly reduced.	
Sampling Results		Floatables: None	Condition Assessment	
Sample Location:	Pool	Odor: None	Graffiti: None Erosion: None Deposition: None 0 in. Damage: None	
Total Chlorine:	0 ppm	Turbidity: None		
Free Chlorine:	0 ppm	Color: None		
Ammonia:	0 ppm	Gross Solids: Moderate		
pH:	7.9 units	Vegetation: None		
Temperature	70 °F	Benthic Growth: None		
Conductivity:	-- µS/cm	Stains: None		
Detergents:	-- mg/L	Non-illicit: None

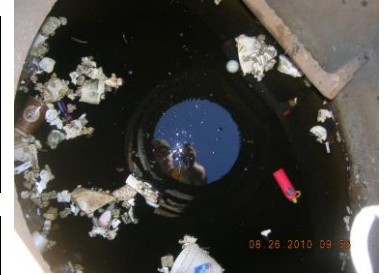
o20100826095640.JPG

Inspection Date: 8/26/2010 10:01:38 AM		Type: Ongoing	Flow: Submerged, indeterminate	Previous Rainfall (hrs): 72+
Illicit Discharge Potential: Potential		Inspector: JCW	Notes Floatable debris in manhole.	
Submerged: Fully		Depth (in): 36		
Sampling Results				
Sample Location:	Pool	Floatables:	None	
Total Chlorine:	0 ppm	Odor:	None	
Free Chlorine:	0 ppm	Turbidity:	None	
Ammonia:	0 ppm	Color:	Faint in bottle	
pH:	7.23 units	Gross Solids:	Moderate	
Temperature	76 °F	Vegetation:	None	
Conductivity:	-- µS/cm	Benthic Growth:	Slight	
Detergents:	0 mg/L	Stains:	None	
		Non-illicit:	None	
		Condition Assessment		
		Graffiti:	None	
		Erosion:	None	
		Deposition:	None 0 in.	
		Damage:	None

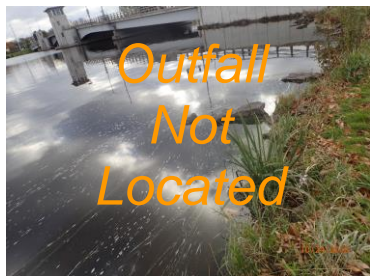
o20181024090620.JPG <div style="text-align: center; font-size: 24pt; font-weight: bold;">2018</div>
		Condition Assessment Graffiti: None Erosion: None Deposition: None in. Damage: None

Inspection Date: 10/24/2018 9:07:36 AM		Type: Ongoing	Flow: Submerged (not located)	Previous Rainfall (hrs): 72+
Illicit Discharge Potential: Potential		Inspector: JCW		
Submerged: Fully		Depth (in):		
Sampling Results Sample Location: _____ Total Chlorine: -- ppm Free Chlorine: -- ppm Ammonia: -- ppm pH: -- units Temperature: -- °F Conductivity: -- µS/cm Detergents: -- mg/L		Floatables: None Odor: None Turbidity: None Color: None Gross Solids: None Vegetation: None Benthic Growth: None Stains: None Non-illicit: None	Notes Outfall fully submerged and not located - screened upstream at 16-594 US1. Floating gross solids (litter) in manhole.

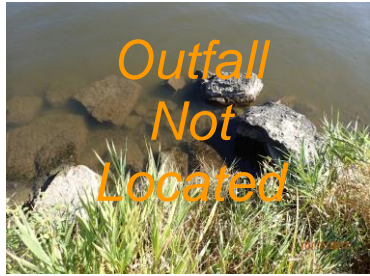
o20171017112242.JPG <div style="text-align: center; font-size: 24pt; font-weight: bold;">2017</div>
		Condition Assessment Graffiti: None Erosion: None Deposition: None in. Damage: None

Inspection Date: 10/17/2017 11:24:35 AM		Type: Ongoing	Flow: Submerged (not located)	Previous Rainfall (hrs): 48-72
Illicit Discharge Potential: Potential		Inspector: JCW		
Submerged: Fully		Depth (in):		
Sampling Results Sample Location: _____ Total Chlorine: -- ppm Free Chlorine: -- ppm Ammonia: -- ppm pH: -- units Temperature: -- °F Conductivity: -- µS/cm Detergents: -- mg/L		Floatables: None Odor: None Turbidity: None Color: None Gross Solids: None Vegetation: None Benthic Growth: None Stains: None Non-illicit: None	Notes Outfall fully submerged and not located - screened upstream at 16-594 US1. Floating gross solids (litter) in manhole.

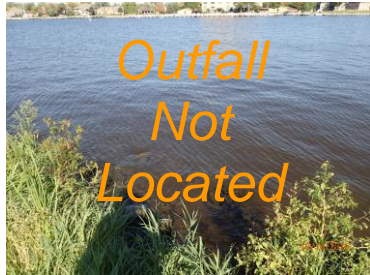
o20161010140356.JPG <div style="text-align: center; font-size: 24pt; font-weight: bold;">2016</div>
		Condition Assessment Graffiti: None Erosion: None Deposition: None in. Damage: None

Inspection Date: 10/10/2016 2:04:49 PM		Type: Ongoing	Flow: Submerged (not located)	Previous Rainfall (hrs): 72+
Illicit Discharge Potential: Potential		Inspector: JCW		
Submerged: Fully		Depth (in):		
Sampling Results Sample Location: _____ Total Chlorine: -- ppm Free Chlorine: -- ppm Ammonia: -- ppm pH: -- units Temperature: -- °F Conductivity: -- µS/cm Detergents: -- mg/L		Floatables: None Odor: None Turbidity: None Color: None Gross Solids: None Vegetation: None Benthic Growth: None Stains: None Non-illicit: None	Notes Outfall fully submerged and not located -screened upstream at 16-594 US1.

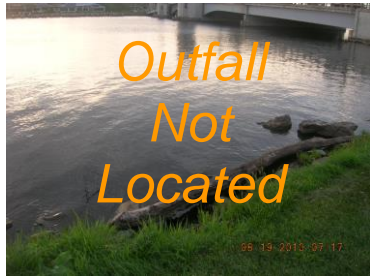
o20100819071708.JPG <div style="text-align: center; font-size: 24pt; font-weight: bold;">2010</div>
		Condition Assessment Graffiti: None Erosion: None Deposition: None 0 in. Damage: None

Inspection Date: 8/19/2010 7:23:24 AM		Type: Ongoing	Flow: Submerged (not located)	Previous Rainfall (hrs): 72+
Illicit Discharge Potential: Unlikely		Inspector: JCW		
Submerged: Fully		Depth (in):		
Sampling Results Sample Location: _____ Total Chlorine: -- ppm Free Chlorine: -- ppm Ammonia: -- ppm pH: -- units Temperature: -- °F Conductivity: -- µS/cm Detergents: -- mg/L		Floatables: None Odor: None Turbidity: None Color: None Gross Solids: None Vegetation: None Benthic Growth: None Stains: None Non-illicit: None	Notes Outfall fully submerged and not physically located. Outfall screened upstream at 16-594 US1.

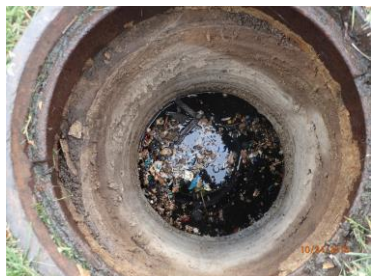
o20181024090720.JPG <div style="text-align: center; font-size: 24pt; font-weight: bold;">2018</div>

Inspection Date: 10/24/2018 9:08:57 AM		Type: Ongoing	Flow: Submerged, indeterminate	Previous Rainfall (hrs): 72+
Illicit Discharge Potential: Potential		Inspector: JCW		
Submerged: Fully		Depth (in): 57		
Sampling Results		Notes Sample collected from submerged pool in manhole. Floating gross solids (litter) in manhole.		
Sample Location: Pool Total Chlorine: 0 ppm Free Chlorine: 0 ppm Ammonia: 0 ppm pH: 7.35 units Temperature: 50 °F Conductivity: 456 µS/cm Detergents: 0 mg/L		Condition Assessment Graffiti: None Erosion: None Deposition: None in. Damage: None		
Floatables: None Odor: None Turbidity: None Color: None Gross Solids: Moderate Vegetation: None Benthic Growth: None Stains: None Non-illicit: None

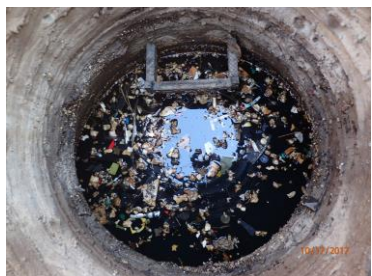
o20171017112318.JPG <div style="text-align: center; font-size: 24pt; font-weight: bold;">2017</div>

Inspection Date: 10/17/2017 11:27:30 AM		Type: Ongoing	Flow: Submerged, indeterminate	Previous Rainfall (hrs): 48-72
Illicit Discharge Potential: Potential		Inspector: JCW		
Submerged: Fully		Depth (in): 51		
Sampling Results		Notes Sample collected from submerged pool in manhole. Floating gross solids (litter) in manhole.		
Sample Location: Pool Total Chlorine: 0 ppm Free Chlorine: 0 ppm Ammonia: 0 ppm pH: 6.98 units Temperature: 68 °F Conductivity: 741 µS/cm Detergents: 0 mg/L		Condition Assessment Graffiti: None Erosion: None Deposition: None in. Damage: None		
Floatables: None Odor: None Turbidity: None Color: None Gross Solids: Moderate Vegetation: None Benthic Growth: None Stains: None Non-illicit: None

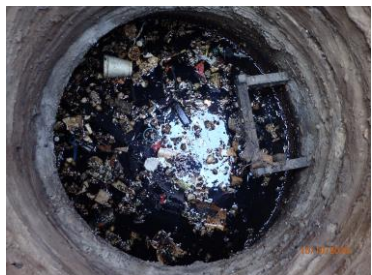
o20161010140454.JPG <div style="text-align: center; font-size: 24pt; font-weight: bold;">2016</div>

Inspection Date: 10/10/2016 2:07:20 PM		Type: Ongoing	Flow: Submerged, indeterminate	Previous Rainfall (hrs): 72+
Illicit Discharge Potential: Potential		Inspector: JCW		
Submerged: Fully		Depth (in): 51		
Sampling Results		Notes Potential illicit discharge due to gross solids.		
Sample Location: Pool Total Chlorine: 0 ppm Free Chlorine: 0 ppm Ammonia: 0.25 ppm pH: 7.17 units Temperature: 71 °F Conductivity: 831 µS/cm Detergents: 0 mg/L		Condition Assessment Graffiti: None Erosion: None Deposition: None in. Damage: None		
Floatables: Slight Odor: Easily detected Turbidity: None Color: None Gross Solids: Moderate Vegetation: None Benthic Growth: None Stains: None Non-illicit: None

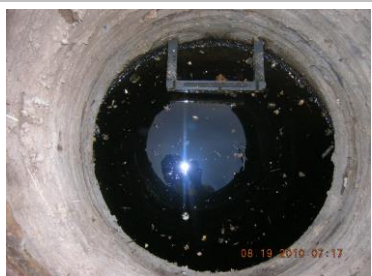
o20100819071738.JPG <div style="text-align: center; font-size: 24pt; font-weight: bold;">2010</div>

Inspection Date: 8/19/2010 7:26:35 AM		Type: Ongoing	Flow: Submerged, indeterminate	Previous Rainfall (hrs): 72+
Illicit Discharge Potential: Unlikely		Inspector: JCW		
Submerged: Fully		Depth (in): 51		
Sampling Results		Notes 2 small oil drops, likely from Oshkosh Ave runoff.		
Sample Location: Pool Total Chlorine: 0 ppm Free Chlorine: 0 ppm Ammonia: 0 ppm pH: 7.44 units Temperature: 75 °F Conductivity: -- µS/cm Detergents: 0 mg/L		Condition Assessment Graffiti: None Erosion: None Deposition: None 0 in. Damage: None		
Floatables: Slight Odor: None Turbidity: None Color: Faint in bottle Gross Solids: Slight Vegetation: None Benthic Growth: None Stains: None Non-illicit: None

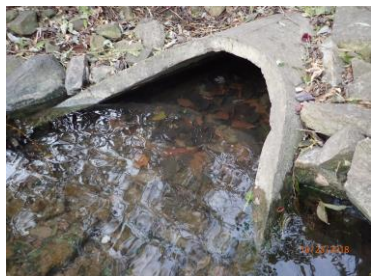
o20181025081252.JPG <div style="text-align: right; font-size: 1.5em; font-weight: bold;">2018</div>

Sample Location:																																						
Total Chlorine:	-- ppm																																					
Free Chlorine:	-- ppm																																					
Ammonia:	-- ppm																																					
pH:	-- units																																					
Temperature:	-- °F																																					
Conductivity:	-- µS/cm																																					
Detergents:	-- mg/L																																					
Floatables:	None																																					
Odor:	None																																					
Turbidity:	None																																					
Color:	None																																					
Gross Solids:	Slight																																					
Vegetation:	None																																					
Benthic Growth:	Moderate																																					
Stains:	Moderate																																					
Non-illicit:	None

Notes Outfall partially submerged - screened upstream at 16-660 US1. Detergent detected in sample.																																				
		Condition Assessment <table border="1" style="width:100%; border-collapse: collapse;"> <tr><td>Graffiti:</td><td>None</td></tr> <tr><td>Erosion:</td><td>None</td></tr> <tr><td>Deposition:</td><td>None in.</td></tr> <tr><td>Damage:</td><td>None</td></tr> </table>			Graffiti:	None	Erosion:	None	Deposition:	None in.	Damage:	None																										
Graffiti:	None																																					
Erosion:	None																																					
Deposition:	None in.																																					
Damage:	None

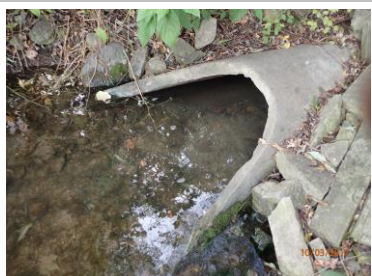
o20171003110156.JPG <div style="text-align: right; font-size: 1.5em; font-weight: bold;">2017</div>

Sample Location:																																						
Total Chlorine:	-- ppm																																					
Free Chlorine:	-- ppm																																					
Ammonia:	-- ppm																																					
pH:	-- units																																					
Temperature:	-- °F																																					
Conductivity:	-- µS/cm																																					
Detergents:	-- mg/L																																					
Floatables:	None																																					
Odor:	None																																					
Turbidity:	None																																					
Color:	None																																					
Gross Solids:	None																																					
Vegetation:	None																																					
Benthic Growth:	Moderate																																					
Stains:	Moderate																																					
Non-illicit:	None

Notes Outfall partially submerged - screened upstream at 16-660 US1. Detergent detected in sample.																																				
		Condition Assessment <table border="1" style="width:100%; border-collapse: collapse;"> <tr><td>Graffiti:</td><td>None</td></tr> <tr><td>Erosion:</td><td>None</td></tr> <tr><td>Deposition:</td><td>None in.</td></tr> <tr><td>Damage:</td><td>None</td></tr> </table>			Graffiti:	None	Erosion:	None	Deposition:	None in.	Damage:	None																										
Graffiti:	None																																					
Erosion:	None																																					
Deposition:	None in.																																					
Damage:	None

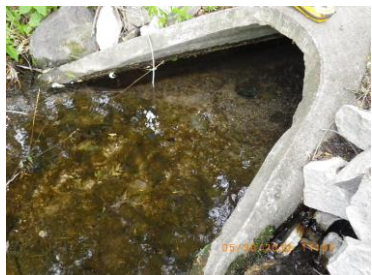
o20120530100048.JPG <div style="text-align: right; font-size: 1.5em; font-weight: bold;">2012</div>

Sample Location:																																						
Total Chlorine:	-- ppm																																					
Free Chlorine:	-- ppm																																					
Ammonia:	-- ppm																																					
pH:	-- units																																					
Temperature:	-- °F																																					
Conductivity:	-- µS/cm																																					
Detergents:	-- mg/L																																					
Floatables:	None																																					
Odor:	None																																					
Turbidity:	None																																					
Color:	None																																					
Gross Solids:	Slight																																					
Vegetation:	None																																					
Benthic Growth:	Moderate																																					
Stains:	Slight																																					
Non-illicit:	None

Notes Outfall partially submerged. Outfall screened upstream at 16-660.																																				
		Condition Assessment <table border="1" style="width:100%; border-collapse: collapse;"> <tr><td>Graffiti:</td><td>None</td></tr> <tr><td>Erosion:</td><td>None</td></tr> <tr><td>Deposition:</td><td>Minor 1 in.</td></tr> <tr><td>Damage:</td><td>None</td></tr> </table>			Graffiti:	None	Erosion:	None	Deposition:	Minor 1 in.	Damage:	None																										
Graffiti:	None																																					
Erosion:	None																																					
Deposition:	Minor 1 in.																																					
Damage:	None

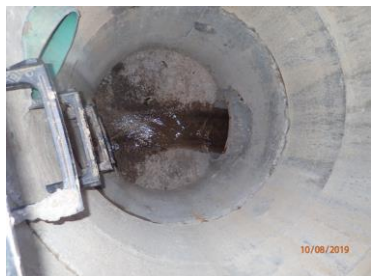
o20191008134416.JPG

Inspection Date: 10/8/2019 2:44:41 PM		Type: Ongoing	Flow: Moderate	Previous Rainfall (hrs): 48-72
Illicit Discharge Potential: Potential		Inspector: JCW		
Submerged: None		Depth (in):		
Sampling Results		Notes		
Sample Location: Flow	Floatables: None	Sample collected from flow in manhole. Detergent detected in sample.		
Total Chlorine: 0 ppm	Odor: None			
Free Chlorine: 0 ppm	Turbidity: None			
Ammonia: 0 ppm	Color: None			
pH: 7.68 units	Gross Solids: None			
Temperature 65 °F	Vegetation: None			
Conductivity: 943 µS/cm	Benthic Growth: None			
Detergents: 0.5 mg/L	Stains: None			
	Non-illicit: None			
		Graffiti: None		
		Erosion: None		
		Deposition: None in.		
		Damage: None

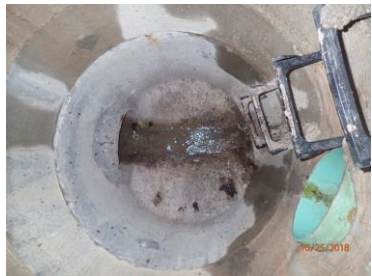
o20181025081632.JPG

Inspection Date: 10/26/2018 12:20:38 PM		Type: Repeat	Flow: Trickle	Previous Rainfall (hrs): 72+
Illicit Discharge Potential: Potential		Inspector: KMK		
Submerged: None		Depth (in):		
Sampling Results		Notes		
Sample Location: Flow	Floatables: None	Detergent detection follow-up. Limited screening conducted beyond sampling.		
Total Chlorine: 0 ppm	Odor: None			
Free Chlorine: 0 ppm	Turbidity: None			
Ammonia: 0 ppm	Color: None			
pH: 7.83 units	Gross Solids: None			
Temperature 56 °F	Vegetation: None			
Conductivity: 1063 µS/cm	Benthic Growth: None			
Detergents: 0.7 mg/L	Stains: None			
	Non-illicit: None			
		Graffiti: None		
		Erosion: None		
		Deposition: None in.		
		Damage: None

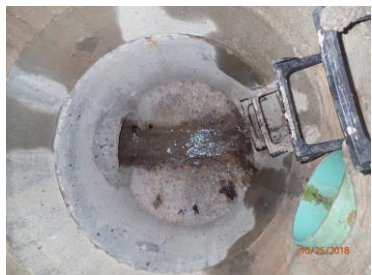
o20181025081632.JPG

Inspection Date: 10/25/2018 8:16:19 AM		Type: Ongoing	Flow: Trickle	Previous Rainfall (hrs): 72+
Illicit Discharge Potential: Potential		Inspector: JCW		
Submerged: None		Depth (in):		
Sampling Results		Notes		
Sample Location: Flow	Floatables: None	Sample collected from flow in manhole. Detergent detected in sample.		
Total Chlorine: 0 ppm	Odor: None			
Free Chlorine: 0 ppm	Turbidity: None			
Ammonia: 0 ppm	Color: None			
pH: 7.9 units	Gross Solids: None			
Temperature 52 °F	Vegetation: None			
Conductivity: 1037 µS/cm	Benthic Growth: None			
Detergents: 0.35 mg/L	Stains: None			
	Non-illicit: None			
		Graffiti: None		
		Erosion: None		
		Deposition: None in.		
		Damage: None

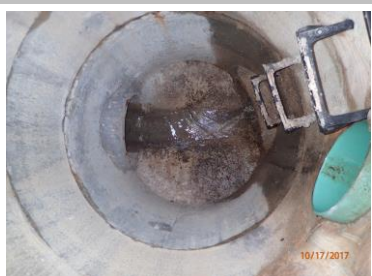
o20171017085628.JPG

Inspection Date: 10/17/2017 9:02:21 AM		Type: Repeat	Flow: Moderate	Previous Rainfall (hrs): 48-72
Illicit Discharge Potential: Unlikely		Inspector: JCW		
Submerged: None		Depth (in):		
Sampling Results		Notes		
Sample Location: Flow	Floatables: None	Repeat inspection due to detergent. No detergent detected in manhole sample.		
Total Chlorine: 0 ppm	Odor: None			
Free Chlorine: 0 ppm	Turbidity: None			
Ammonia: 0 ppm	Color: None			
pH: 7.78 units	Gross Solids: None			
Temperature 61 °F	Vegetation: None			
Conductivity: 926 µS/cm	Benthic Growth: Slight			
Detergents: 0 mg/L	Stains: None			
	Non-illicit: None			
		Graffiti: None		
		Erosion: None		
		Deposition: None in.		
		Damage: None

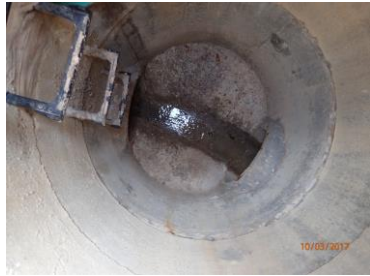
o20171003110702.JPG

Inspection Date: 10/3/2017 11:12:57 AM		Type: Ongoing	Flow: Trickle	Previous Rainfall (hrs): 72+
Illicit Discharge Potential: Potential		Inspector: JCW	Notes	
Submerged: None		Depth (in):	Sample collected from flow in manhole. Detergent detected in sample.	
Sampling Results		Floatables:	Condition Assessment	
Sample Location: Flow		Odor:	Graffiti: None	
Total Chlorine: 0 ppm		Turbidity:	Erosion: None	
Free Chlorine: 0 ppm		Color:	Deposition: None in.	
Ammonia: 0 ppm		Gross Solids:	Damage: None	
pH: 8.26 units		Vegetation:		
Temperature: 76 °F		Benthic Growth:		
Conductivity: 845 µS/cm		Stains:		
Detergents: 0.55 mg/L		Non-illicit:

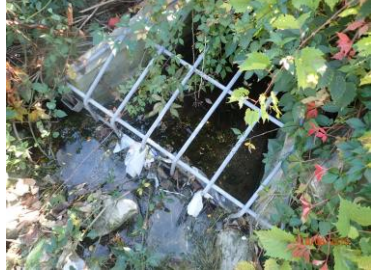
o20191008125814.JPG <div style="text-align: center; font-size: 24pt; font-weight: bold;">2019</div>

Sample Location:	Flow																																					
Total Chlorine:	0 ppm																																					
Free Chlorine:	0 ppm																																					
Ammonia:	0 ppm																																					
pH:	8.09 units																																					
Temperature:	66 °F																																					
Conductivity:	2640 µS/cm																																					
Detergents:	0.5 mg/L																																					
Floatables:	None																																					
Odor:	None																																					
Turbidity:	None																																					
Color:	None																																					
Gross Solids:	Slight																																					
Vegetation:	None																																					
Benthic Growth:	Slight																																					
Stains:	None																																					
Non-illicit:	None

<div style="display: flex;"> <div style="flex: 1;"> <p>Notes</p> <p>Sample collected from pipe flow. Detergent and elevated conductivity in sample.</p> </div> <div style="flex: 1;"> <p>Condition Assessment</p> <table border="1" style="width:100%; border-collapse: collapse;"> <tr><td>Graffiti:</td><td>None</td></tr> <tr><td>Erosion:</td><td>None</td></tr> <tr><td>Deposition:</td><td>None in.</td></tr> <tr><td>Damage:</td><td>None</td></tr> </table> </div> </div>			Graffiti:	None	Erosion:	None	Deposition:	None in.	Damage:	None																										
Graffiti:	None																																					
Erosion:	None																																					
Deposition:	None in.																																					
Damage:	None

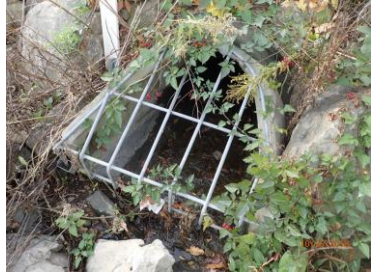
o20181025085152.JPG <div style="text-align: center; font-size: 24pt; font-weight: bold;">2018</div>

Sample Location:	Flow																																					
Total Chlorine:	0 ppm																																					
Free Chlorine:	0 ppm																																					
Ammonia:	0 ppm																																					
pH:	8.19 units																																					
Temperature:	56 °F																																					
Conductivity:	3550 µS/cm																																					
Detergents:	0.5 mg/L																																					
Floatables:	None																																					
Odor:	None																																					
Turbidity:	None																																					
Color:	None																																					
Gross Solids:	None																																					
Vegetation:	None																																					
Benthic Growth:	Moderate																																					
Stains:	None																																					
Non-illicit:	None

<div style="display: flex;"> <div style="flex: 1;"> <p>Notes</p> <p>Detergent detection follow-up. Limited screening conducted beyond sampling.</p> </div> <div style="flex: 1;"> <p>Condition Assessment</p> <table border="1" style="width:100%; border-collapse: collapse;"> <tr><td>Graffiti:</td><td>None</td></tr> <tr><td>Erosion:</td><td>None</td></tr> <tr><td>Deposition:</td><td>None in.</td></tr> <tr><td>Damage:</td><td>None</td></tr> </table> </div> </div>			Graffiti:	None	Erosion:	None	Deposition:	None in.	Damage:	None																										
Graffiti:	None																																					
Erosion:	None																																					
Deposition:	None in.																																					
Damage:	None

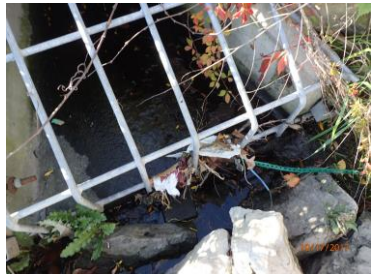
o20171017102814.JPG <div style="text-align: center; font-size: 24pt; font-weight: bold;">2017</div>

Inspection Date: 10/17/2017 10:32:21 AM		Type: Ongoing	Flow: Trickle	Previous Rainfall (hrs): 48-72																																		
Illicit Discharge Potential: Unlikely		Inspector: JCW																																				
Submerged: None		Depth (in):																																				
Sampling Results		<div style="display: flex;"> <div style="flex: 1;"> <table border="1" style="width:100%; border-collapse: collapse;"> <tr><td>Sample Location:</td><td>Flow</td></tr> <tr><td>Total Chlorine:</td><td>0 ppm</td></tr> <tr><td>Free Chlorine:</td><td>0 ppm</td></tr> <tr><td>Ammonia:</td><td>0 ppm</td></tr> <tr><td>pH:</td><td>8.35 units</td></tr> <tr><td>Temperature:</td><td>65 °F</td></tr> <tr><td>Conductivity:</td><td>1704 µS/cm</td></tr> <tr><td>Detergents:</td><td>0 mg/L</td></tr> </table> </div> <div style="flex: 1;"> <table border="1" style="width:100%; border-collapse: collapse;"> <tr><td>Floatables:</td><td>None</td></tr> <tr><td>Odor:</td><td>None</td></tr> <tr><td>Turbidity:</td><td>None</td></tr> <tr><td>Color:</td><td>None</td></tr> <tr><td>Gross Solids:</td><td>Slight</td></tr> <tr><td>Vegetation:</td><td>None</td></tr> <tr><td>Benthic Growth:</td><td>Slight</td></tr> <tr><td>Stains:</td><td>None</td></tr> <tr><td>Non-illicit:</td><td>None</td></tr> </table> </div> </div>			Sample Location:	Flow	Total Chlorine:	0 ppm	Free Chlorine:	0 ppm	Ammonia:	0 ppm	pH:	8.35 units	Temperature:	65 °F	Conductivity:	1704 µS/cm	Detergents:	0 mg/L	Floatables:	None	Odor:	None	Turbidity:	None	Color:	None	Gross Solids:	Slight	Vegetation:	None	Benthic Growth:	Slight	Stains:	None	Non-illicit:	None

<div style="display: flex;"> <div style="flex: 1;"> <p>Notes</p> <p>Sample collected from pipe flow.</p> </div> <div style="flex: 1;"> <p>Condition Assessment</p> <table border="1" style="width:100%; border-collapse: collapse;"> <tr><td>Graffiti:</td><td>None</td></tr> <tr><td>Erosion:</td><td>None</td></tr> <tr><td>Deposition:</td><td>None in.</td></tr> <tr><td>Damage:</td><td>None</td></tr> </table> </div> </div>			Graffiti:	None	Erosion:	None	Deposition:	None in.	Damage:	None																										
Graffiti:	None																																					
Erosion:	None																																					
Deposition:	None in.																																					
Damage:	None

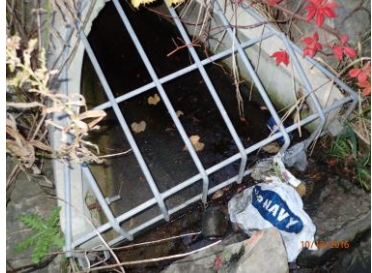
o20161018071712.JPG

Inspection Date: 10/18/2016 7:21:24 AM		Type: Ongoing	Flow: Trickle	Previous Rainfall (hrs): 72+
Illicit Discharge Potential: Unlikely		Inspector: JCW		
Submerged: None		Depth (in):		
Sampling Results		Notes		
Sample Location: Flow		Elevated conductivity, but no other parameters out of range.		
Total Chlorine:	0 ppm	Floatables:	None	
Free Chlorine:	0 ppm	Odor:	Faint	
Ammonia:	0 ppm	Turbidity:	None	
pH:	8.29 units	Color:	None	
Temperature:	64 °F	Gross Solids:	Slight	
Conductivity:	3880 µS/cm	Vegetation:	None	
Detergents:	0 mg/L	Benthic Growth:	Moderate	
		Stains:	None	
		Non-illicit:	None	
		Condition Assessment		
		Graffiti:	None	
		Erosion:	None	
		Deposition:	None	in.
		Damage:	None

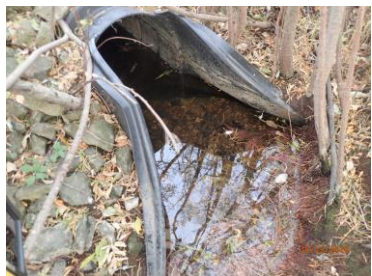
o20181025082506.JPG <div style="text-align: right; font-size: 1.5em; font-weight: bold;">2018</div>

Inspection Date: 10/25/2018 8:27:19 AM		Type: Ongoing	Flow: Submerged, indeterminate	Previous Rainfall (hrs): 72+
Illicit Discharge Potential: Potential		Inspector: JCW		
Submerged: Partially		Depth (in): 12		
Sampling Results Sample Location: Total Chlorine: -- ppm Free Chlorine: -- ppm Ammonia: -- ppm pH: -- units Temperature -- °F Conductivity: -- µS/cm Detergents: -- mg/L		Floatables: None Odor: None Turbidity: None Color: None Gross Solids: Slight Vegetation: None Benthic Growth: None Stains: None Non-illicit: None		
		Notes Outfall partially submerged - screened upstream at 16-995 US1. Detergent detected in sample.		
		Condition Assessment Graffiti: None Erosion: None Deposition: None in. Damage: None

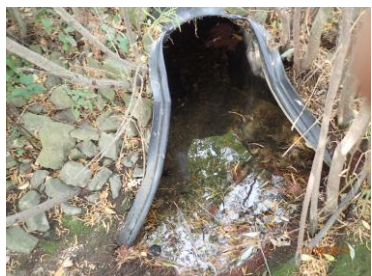
o20171003101614.JPG <div style="text-align: right; font-size: 1.5em; font-weight: bold;">2017</div>

Inspection Date: 10/3/2017 10:18:12 AM		Type: Ongoing	Flow: Submerged, indeterminate	Previous Rainfall (hrs): 72+
Illicit Discharge Potential: Potential		Inspector: JCW		
Submerged: Partially		Depth (in): 8		
Sampling Results Sample Location: Total Chlorine: -- ppm Free Chlorine: -- ppm Ammonia: -- ppm pH: -- units Temperature -- °F Conductivity: -- µS/cm Detergents: -- mg/L		Floatables: None Odor: None Turbidity: None Color: None Gross Solids: None Vegetation: None Benthic Growth: Slight Stains: None Non-illicit: None		
		Notes Outfall partially submerged - screened upstream at 16-995 US1. Detergent detected in sample.		
		Condition Assessment Graffiti: None Erosion: None Deposition: Minor 1 in. Damage: None

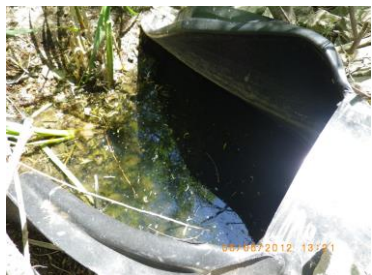
o20120606122140.JPG <div style="text-align: right; font-size: 1.5em; font-weight: bold;">2012</div>

Inspection Date: 6/6/2012 1:21:40 PM		Type: Ongoing	Flow: Submerged, indeterminate	Previous Rainfall (hrs): 72+
Illicit Discharge Potential: Unlikely		Inspector: JCW		
Submerged: Partially		Depth (in): 9		
Sampling Results Sample Location: Total Chlorine: -- ppm Free Chlorine: -- ppm Ammonia: -- ppm pH: -- units Temperature -- °F Conductivity: -- µS/cm Detergents: -- mg/L		Floatables: None Odor: None Turbidity: None Color: None Gross Solids: Slight Vegetation: None Benthic Growth: Slight Stains: Slight Non-illicit: None		
		Notes No flow leaving pool at end of outfall. Deposition in swale downstream. Screened upstream at 16-995 US1.		
		Condition Assessment Graffiti: None Erosion: None Deposition: Moderate 8 in. Damage: None

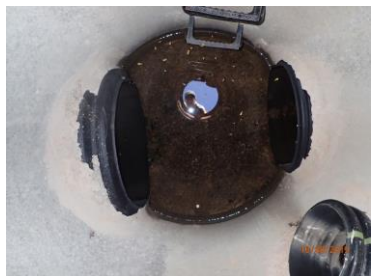
o20191008133058.JPG
2019

Inspection Date: 10/8/2019 2:32:34 PM		Type: Ongoing	Flow: Submerged, indeterminate	Previous Rainfall (hrs): 48-72
Illicit Discharge Potential: Potential		Inspector: JCW		
Submerged: Partially		Depth (in): 9		
Sampling Results		Notes Sample collected from submerged pool in outfall. Detergent detected in sample.		
Sample Location: Pool	Floatables: None	Condition Assessment Graffiti: None Erosion: None Deposition: None in. Damage: None		
Total Chlorine: 0 ppm	Odor: None			
Free Chlorine: 0 ppm	Turbidity: None			
Ammonia: 0 ppm	Color: None			
pH: 7.45 units	Gross Solids: None			
Temperature 65 °F	Vegetation: None			
Conductivity: 731 µS/cm	Benthic Growth: None			
Detergents: 1 mg/L	Stains: None			
	Non-illicit: None

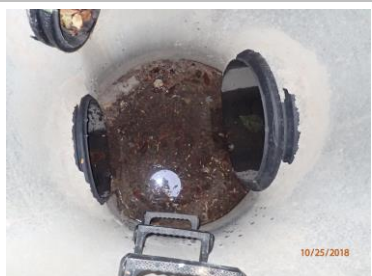
o20181025082910.JPG
2018

Inspection Date: 10/26/2018 12:12:28 PM		Type: Repeat	Flow: Submerged, no flow	Previous Rainfall (hrs): 72+
Illicit Discharge Potential: Potential		Inspector: KMK		
Submerged: Partially		Depth (in):		
Sampling Results		Notes Detergent detection follow-up. Limited screening conducted beyond sampling.		
Sample Location: Pool	Floatables: None	Condition Assessment Graffiti: None Erosion: None Deposition: None in. Damage: None		
Total Chlorine: 0 ppm	Odor: None			
Free Chlorine: 0 ppm	Turbidity: None			
Ammonia: 0 ppm	Color: None			
pH: 8.02 units	Gross Solids: None			
Temperature 54 °F	Vegetation: None			
Conductivity: 1143 µS/cm	Benthic Growth: None			
Detergents: 0.85 mg/L	Stains: None			
	Non-illicit: None

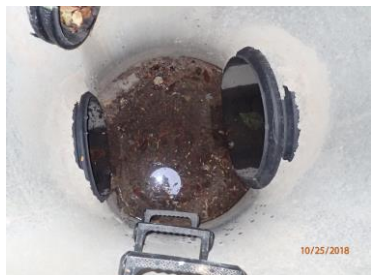
o20181025082910.JPG
2018

Inspection Date: 10/25/2018 8:28:36 AM		Type: Ongoing	Flow: Submerged, indeterminate	Previous Rainfall (hrs): 72+
Illicit Discharge Potential: Potential		Inspector: JCW		
Submerged: Partially		Depth (in): 2		
Sampling Results		Notes Sample collected from submerged pool in outfall. Detergent detected in sample.		
Sample Location: Pool	Floatables: None	Condition Assessment Graffiti: None Erosion: None Deposition: None in. Damage: None		
Total Chlorine: 0 ppm	Odor: None			
Free Chlorine: 0 ppm	Turbidity: None			
Ammonia: 0 ppm	Color: None			
pH: 7.86 units	Gross Solids: Slight			
Temperature 50 °F	Vegetation: None			
Conductivity: 1011 µS/cm	Benthic Growth: None			
Detergents: 0.4 mg/L	Stains: None			
	Non-illicit: None

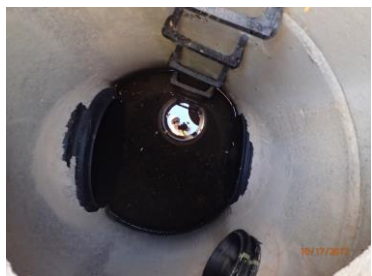
o20171017084622.JPG
2017

Inspection Date: 10/17/2017 8:51:34 AM		Type: Repeat	Flow: Submerged, indeterminate	Previous Rainfall (hrs): 48-72
Illicit Discharge Potential: Potential		Inspector: JCW		
Submerged: Partially		Depth (in): 7		
Sampling Results		Notes Repeat inspection due to detergent. Detergent detected in manhole sample.		
Sample Location: Pool	Floatables: None	Condition Assessment Graffiti: None Erosion: None Deposition: None in. Damage: None		
Total Chlorine: 0 ppm	Odor: None			
Free Chlorine: 0 ppm	Turbidity: None			
Ammonia: 0 ppm	Color: None			
pH: 7.54 units	Gross Solids: None			
Temperature 61 °F	Vegetation: None			
Conductivity: 582 µS/cm	Benthic Growth: None			
Detergents: 0.8 mg/L	Stains: None			
	Non-illicit: None

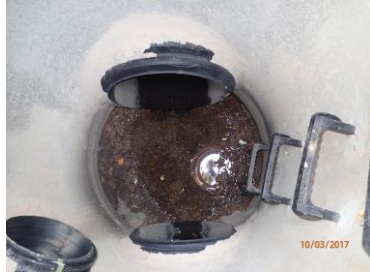
o20171003101932.JPG

Inspection Date: 10/3/2017 10:22:53 AM		Type: Ongoing	Flow: Submerged, indeterminate	Previous Rainfall (hrs): 72+
Illicit Discharge Potential: Potential		Inspector: JCW	Notes	
Submerged: Partially Depth (in): 3			Sample collected from submerged pool in outfall. Detergent detected in sample.	
Sampling Results			Condition Assessment	
Sample Location:	Pool	Floatables:	None	
Total Chlorine:	0 ppm	Odor:	None	
Free Chlorine:	0 ppm	Turbidity:	None	
Ammonia:	0 ppm	Color:	None	
pH:	7.45 units	Gross Solids:	None	
Temperature:	72 °F	Vegetation:	None	
Conductivity:	333 µS/cm	Benthic Growth:	None	
Detergents:	1.3 mg/L	Stains:	None	
		Non-illicit:	None	
			Graffiti:	None
			Erosion:	None
			Deposition:	None in.
			Damage:	None

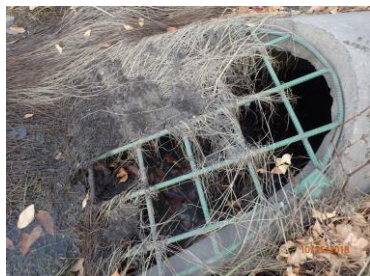
o20181025083538.JPG 2018

Inspection Date: 10/25/2018 8:41:00 AM		Type: Ongoing	Flow: Submerged, indeterminate	Previous Rainfall (hrs): 72+
Illicit Discharge Potential: Potential		Inspector: JCW		
Submerged: Partially		Depth (in): 5		
Sampling Results		Notes Outfall partially submerged - screened upstream at 16-1205 US1. Detergent detected in upstream manhole.		
Sample Location:	Floatables:	None		
Total Chlorine: -- ppm	Odor:	None		
Free Chlorine: -- ppm	Turbidity:	None		
Ammonia: -- ppm	Color:	None		
pH: -- units	Gross Solids:	Slight		
Temperature -- °F	Vegetation:	None		
Conductivity: -- µS/cm	Benthic Growth:	None		
Detergents: -- mg/L	Stains:	None		
	Non-illicit:	None		
		Condition Assessment Graffiti: None Erosion: None Deposition: Minor 2 in. Damage: None

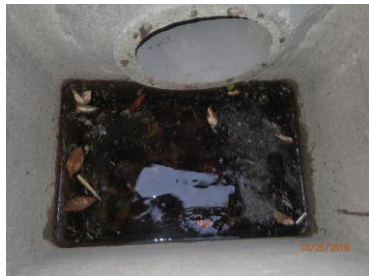
o20181025083908.JPG 2018

Sample Location:	Pool																																					
Total Chlorine:	0 ppm																																					
Free Chlorine:	0 ppm																																					
Ammonia:	0 ppm																																					
pH:	7.68 units																																					
Temperature:	50 °F																																					
Conductivity:	661 µS/cm																																					
Detergents:	0.55 mg/L																																					
Floatables:	None																																					
Odor:	None																																					
Turbidity:	None																																					
Color:	None																																					
Gross Solids:	Slight																																					
Vegetation:	None																																					
Benthic Growth:	None																																					
Stains:	None																																					
Non-illicit:	None

Notes Water below outlet pipe. Sample collected from sump. Detergent detected.																																				
		Condition Assessment <table border="1" style="width:100%; border-collapse: collapse;"> <tr><td>Graffiti:</td><td>None</td></tr> <tr><td>Erosion:</td><td>None</td></tr> <tr><td>Deposition:</td><td>None in.</td></tr> <tr><td>Damage:</td><td>None</td></tr> </table>			Graffiti:	None	Erosion:	None	Deposition:	None in.	Damage:	None																										
Graffiti:	None																																					
Erosion:	None																																					
Deposition:	None in.																																					
Damage:	None

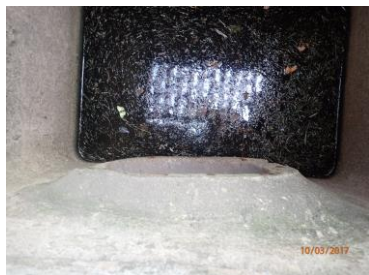
o20171003090254.JPG 2017

Notes Outlet pipe dry - no sample collected.																																				
		Condition Assessment <table border="1" style="width:100%; border-collapse: collapse;"> <tr><td>Graffiti:</td><td>None</td></tr> <tr><td>Erosion:</td><td>None</td></tr> <tr><td>Deposition:</td><td>None in.</td></tr> <tr><td>Damage:</td><td>None</td></tr> </table>			Graffiti:	None	Erosion:	None	Deposition:	None in.	Damage:	None																										
Graffiti:	None																																					
Erosion:	None																																					
Deposition:	None in.																																					
Damage:	None

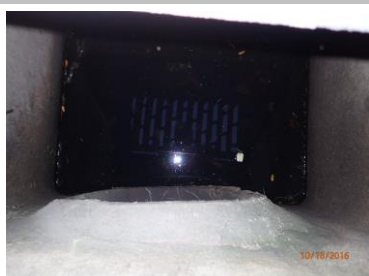
o20161018070720.JPG 2016

Notes Water in sump, but no flow entering pipe. No sample collected from sump.																																				
		Condition Assessment <table border="1" style="width:100%; border-collapse: collapse;"> <tr><td>Graffiti:</td><td>None</td></tr> <tr><td>Erosion:</td><td>None</td></tr> <tr><td>Deposition:</td><td>None in.</td></tr> <tr><td>Damage:</td><td>None</td></tr> </table>			Graffiti:	None	Erosion:	None	Deposition:	None in.	Damage:	None																										
Graffiti:	None																																					
Erosion:	None																																					
Deposition:	None in.																																					
Damage:	None

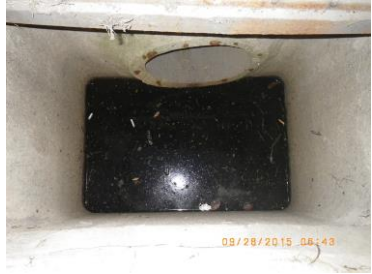
<p style="text-align: center;">o20150928054310.JPG</p> <p style="text-align: center; font-size: 24pt; font-weight: bold;">2015</p>

Inspection Date: 9/28/2015 6:42:48 AM		Type: Ongoing	Flow: None	Previous Rainfall (hrs): 72+
Illicit Discharge Potential: Unlikely		Inspector: JCW		<div style="border: 1px solid black; padding: 5px;"> Notes Water level below outlet pipe - no sample collected. 18" of water in sump, 2" of sediment. </div> <div style="border: 1px solid black; padding: 5px; margin-top: 10px;"> Condition Assessment Graffiti: None Erosion: None Deposition: None in. Damage: None </div>
Submerged: None		Depth (in):		
<div style="border: 1px solid black; padding: 5px;"> Sampling Results Sample Location: _____ Total Chlorine: -- ppm Free Chlorine: -- ppm Ammonia: -- ppm pH: -- units Temperature -- °F Conductivity: -- µS/cm Detergents: -- mg/L </div>		<div style="border: 1px solid black; padding: 5px;"> Floatables: None Odor: None Turbidity: None Color: None Gross Solids: None Vegetation: None Benthic Growth: None Stains: None Non-illicit: None </div>

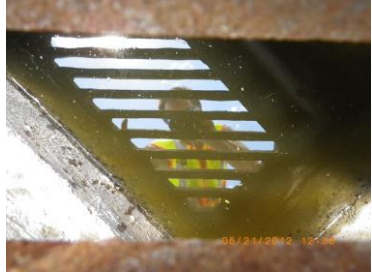
<p style="text-align: center;">o20120621113808.JPG</p> <p style="text-align: center; font-size: 24pt; font-weight: bold;">2012</p>

Inspection Date: 6/21/2012 12:35:14 PM		Type: Ongoing	Flow: Submerged, indeterminate	Previous Rainfall (hrs): 0-24
Illicit Discharge Potential: Unlikely		Inspector: JCW		<div style="border: 1px solid black; padding: 5px;"> Notes Grate could not be removed for sample. </div> <div style="border: 1px solid black; padding: 5px; margin-top: 10px;"> Condition Assessment Graffiti: None Erosion: None Deposition: None in. Damage: None </div>
Submerged: Fully		Depth (in): 32		
<div style="border: 1px solid black; padding: 5px;"> Sampling Results Sample Location: _____ Total Chlorine: -- ppm Free Chlorine: -- ppm Ammonia: -- ppm pH: -- units Temperature -- °F Conductivity: -- µS/cm Detergents: -- mg/L </div>		<div style="border: 1px solid black; padding: 5px;"> Floatables: None Odor: None Turbidity: None Color: None Gross Solids: None Vegetation: None Benthic Growth: None Stains: None Non-illicit: None </div>

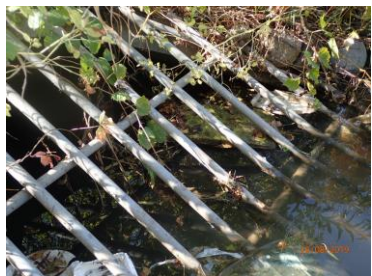
o20191008124948.JPG

Inspection Date: 10/8/2019 1:50:30 PM		Type: Ongoing	Flow: Submerged, indeterminate	Previous Rainfall (hrs): 48-72																																		
Illicit Discharge Potential: Potential		Inspector: JCW																																				
Submerged: Partially		Depth (in): 25																																				
Sampling Results <table border="1" style="width:100%; border-collapse: collapse;"> <tr><td>Sample Location:</td><td></td></tr> <tr><td>Total Chlorine:</td><td>-- ppm</td></tr> <tr><td>Free Chlorine:</td><td>-- ppm</td></tr> <tr><td>Ammonia:</td><td>-- ppm</td></tr> <tr><td>pH:</td><td>-- units</td></tr> <tr><td>Temperature:</td><td>-- °F</td></tr> <tr><td>Conductivity:</td><td>-- µS/cm</td></tr> <tr><td>Detergents:</td><td>-- mg/L</td></tr> </table>		Sample Location:		Total Chlorine:	-- ppm	Free Chlorine:	-- ppm	Ammonia:	-- ppm	pH:	-- units	Temperature:	-- °F	Conductivity:	-- µS/cm	Detergents:	-- mg/L	<table border="1" style="width:100%; border-collapse: collapse;"> <tr><td>Floatables:</td><td>None</td></tr> <tr><td>Odor:</td><td>None</td></tr> <tr><td>Turbidity:</td><td>None</td></tr> <tr><td>Color:</td><td>None</td></tr> <tr><td>Gross Solids:</td><td>Slight</td></tr> <tr><td>Vegetation:</td><td>None</td></tr> <tr><td>Benthic Growth:</td><td>None</td></tr> <tr><td>Stains:</td><td>None</td></tr> <tr><td>Non-illicit:</td><td>None</td></tr> </table>	Floatables:	None	Odor:	None	Turbidity:	None	Color:	None	Gross Solids:	Slight	Vegetation:	None	Benthic Growth:	None	Stains:	None	Non-illicit:	None	Notes Outfall partially submerged. Outfall screened upstream at 16-1508 US1. Detergent and ammonia in manhole.

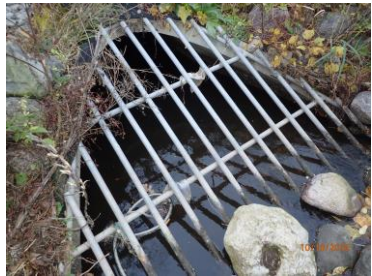
o20161018072836.JPG

Inspection Date: 10/18/2016 7:30:34 AM		Type: Ongoing	Flow: Submerged, indeterminate	Previous Rainfall (hrs): 72+																																		
Illicit Discharge Potential: Unlikely		Inspector: JCW																																				
Submerged: Partially		Depth (in): 21																																				
Sampling Results <table border="1" style="width:100%; border-collapse: collapse;"> <tr><td>Sample Location:</td><td></td></tr> <tr><td>Total Chlorine:</td><td>-- ppm</td></tr> <tr><td>Free Chlorine:</td><td>-- ppm</td></tr> <tr><td>Ammonia:</td><td>-- ppm</td></tr> <tr><td>pH:</td><td>-- units</td></tr> <tr><td>Temperature:</td><td>-- °F</td></tr> <tr><td>Conductivity:</td><td>-- µS/cm</td></tr> <tr><td>Detergents:</td><td>-- mg/L</td></tr> </table>		Sample Location:		Total Chlorine:	-- ppm	Free Chlorine:	-- ppm	Ammonia:	-- ppm	pH:	-- units	Temperature:	-- °F	Conductivity:	-- µS/cm	Detergents:	-- mg/L	<table border="1" style="width:100%; border-collapse: collapse;"> <tr><td>Floatables:</td><td>None</td></tr> <tr><td>Odor:</td><td>None</td></tr> <tr><td>Turbidity:</td><td>None</td></tr> <tr><td>Color:</td><td>None</td></tr> <tr><td>Gross Solids:</td><td>Slight</td></tr> <tr><td>Vegetation:</td><td>None</td></tr> <tr><td>Benthic Growth:</td><td>Moderate</td></tr> <tr><td>Stains:</td><td>Slight</td></tr> <tr><td>Non-illicit:</td><td>None</td></tr> </table>	Floatables:	None	Odor:	None	Turbidity:	None	Color:	None	Gross Solids:	Slight	Vegetation:	None	Benthic Growth:	Moderate	Stains:	Slight	Non-illicit:	None	Notes Graffiti on south bridge abutment. Outfall partially submerged - screened upstream at 16-1508 US1.

Condition Assessment <table border="1" style="width:100%; border-collapse: collapse;"> <tr><td>Graffiti:</td><td>Moderate</td></tr> <tr><td>Erosion:</td><td>None</td></tr> <tr><td>Deposition:</td><td>None in.</td></tr> <tr><td>Damage:</td><td>None</td></tr> </table>	Graffiti:	Moderate	Erosion:	None	Deposition:	None in.	Damage:	None	2016																											
Graffiti:	Moderate																																					
Erosion:	None																																					
Deposition:	None in.																																					
Damage:	None

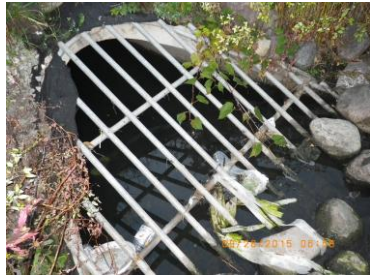
o20150928055850.JPG

Inspection Date: 9/28/2015 6:56:23 AM		Type: Ongoing	Flow: Submerged, indeterminate	Previous Rainfall (hrs): 72+
Illicit Discharge Potential: Potential		Inspector: JCW	Notes	
Submerged: Partially Depth (in): 27			Outfall partially submerged - screened at 16-1508 US1. Elevated ammonia.	
Sampling Results			Condition Assessment	
Sample Location:	Floatables:	None	Graffiti:	None
Total Chlorine: -- ppm	Odor:	None	Erosion:	None
Free Chlorine: -- ppm	Turbidity:	None	Deposition:	None in.
Ammonia: -- ppm	Color:	None	Damage:	None
pH: -- units	Gross Solids:	Slight		
Temperature -- °F	Vegetation:	None		
Conductivity: -- µS/cm	Benthic Growth:	Moderate		
Detergents: -- mg/L	Stains:	Moderate		
	Non-illicit:	None
