Ongoing Screening Summary Report 2019 Inspection Year

Illicit Discharge Detection and Elimination Program

City of Oshkosh

January 3, 2020

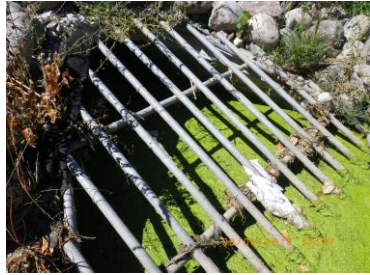
o20130905113702.JPG

Inspection Date: 9/5/2013 12:32:55 PM		Type: Ongoing	Flow: Submerged, indeterminate	Previous Rainfall (hrs): 72+
Illicit Discharge Potential: Unlikely		Inspector: JCW	Notes	
Submerged: Partially Depth (in): 28			Significant duckweed. Outfall partially submerged. Outfall screened upstream at 16-1508 US1.	
Sampling Results			Condition Assessment	
Sample Location:	Floatables:	None	Graffiti:	None
Total Chlorine: -- ppm	Odor:	None	Erosion:	None
Free Chlorine: -- ppm	Turbidity:	None	Deposition:	None in.
Ammonia: -- ppm	Color:	None	Damage:	None
pH: -- units	Gross Solids:	Moderate		
Temperature -- °F	Vegetation:	None		
Conductivity: -- µS/cm	Benthic Growth:	Moderate		
Detergents: -- mg/L	Stains:	Moderate		
	Non-illicit:	None

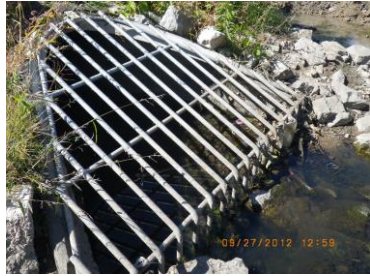
o20120927115922.JPG

Inspection Date: 9/27/2012 12:57:15 PM		Type: Repeat	Flow: Submerged, indeterminate	Previous Rainfall (hrs): 72+
Illicit Discharge Potential: Potential		Inspector: JCW	Notes	
Submerged: Partially Depth (in): 15			Construction around outfall. Screened upstream at 16-1508 US1.	
Sampling Results			Condition Assessment	
Sample Location:	Floatables:	None	Graffiti:	None
Total Chlorine: -- ppm	Odor:	None	Erosion:	None
Free Chlorine: -- ppm	Turbidity:	None	Deposition:	Moderate 9 in.
Ammonia: -- ppm	Color:	None	Damage:	None
pH: -- units	Gross Solids:	Slight		
Temperature -- °F	Vegetation:	None		
Conductivity: -- µS/cm	Benthic Growth:	Slight		
Detergents: -- mg/L	Stains:	Slight		
	Non-illicit:	None

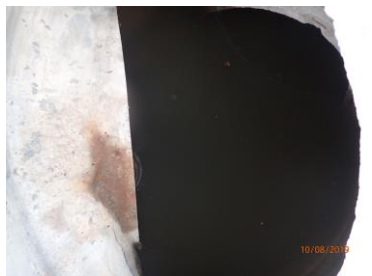
o20191008125050.JPG <div style="text-align: center; font-size: 24pt; font-weight: bold;">2019</div>
		Condition Assessment Graffiti: None Erosion: None Deposition: None in. Damage: None

Inspection Date: 10/8/2019 1:52:05 PM		Type: Ongoing	Flow: Submerged, indeterminate	Previous Rainfall (hrs): 48-72
Illicit Discharge Potential: Potential		Inspector: JCW		
Submerged: Partially		Depth (in): 34		
Sampling Results Sample Location: Pool Total Chlorine: 0 ppm Free Chlorine: 0 ppm Ammonia: 1 ppm pH: 7.76 units Temperature: 66 °F Conductivity: 465 µS/cm Detergents: 0.6 mg/L		Floatables: None Odor: None Turbidity: None Color: None Gross Solids: None Vegetation: None Benthic Growth: None Stains: None Non-illicit: None	Notes Sample collected from submerged pool in manhole. Detergent and ammonia detections.

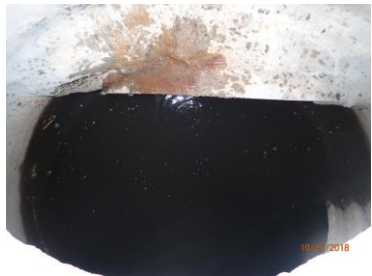
o20181025090232.JPG <div style="text-align: center; font-size: 24pt; font-weight: bold;">2018</div>
		Condition Assessment Graffiti: None Erosion: None Deposition: None in. Damage: None

Inspection Date: 10/25/2018 9:04:43 AM		Type: Ongoing	Flow: Submerged, indeterminate	Previous Rainfall (hrs): 72+
Illicit Discharge Potential: Unlikely		Inspector: JCW		
Submerged: Partially		Depth (in): 39		
Sampling Results Sample Location: Pool Total Chlorine: 0 ppm Free Chlorine: 0 ppm Ammonia: 0 ppm pH: 8.01 units Temperature: 51 °F Conductivity: 1305 µS/cm Detergents: 0 mg/L		Floatables: None Odor: None Turbidity: None Color: None Gross Solids: None Vegetation: None Benthic Growth: None Stains: None Non-illicit: None	Notes Sample collected from submerged pool in manhole. Detergent and ammonia detections.

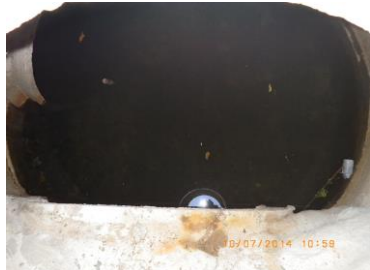
o20141007095952.JPG 2014

o20150928060258.JPG 2015
Sampling Results Sample Location: Pool Total Chlorine: 0 ppm Free Chlorine: 0 ppm Ammonia: 3 ppm pH: 7.28 units Temperature: 69 °F Conductivity: 1032 µS/cm Detergents: 0 mg/L		Floatables: None Odor: None Turbidity: Slight cloudiness Color: None Gross Solids: Slight Vegetation: None Benthic Growth: Moderate Stains: Moderate Non-illicit: None	Condition Assessment Graffiti: None Erosion: None Deposition: None in. Damage: None	
Inspection Date: 10/7/2014 11:02:53 AM		Type: Ongoing	Flow: Submerged, indeterminate	Previous Rainfall (hrs): 48-72
Illicit Discharge Potential: Potential Submerged: Partially Depth (in): 22		Inspector: JCW	Notes Elevated ammonia. Park restrooms shut down for season.

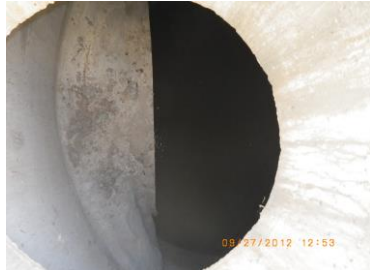
Inspection Date: 9/27/2012 12:51:46 PM		Type: Repeat	Flow: Submerged, indeterminate	Previous Rainfall (hrs): 72+
Illicit Discharge Potential: Potential Submerged: Partially Depth (in): 9		Inspector: JCW	Notes Ammonia detection follow-up.

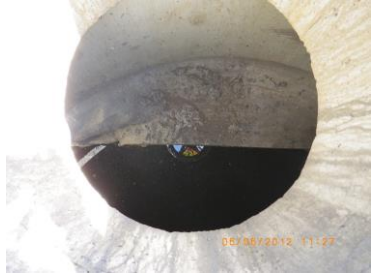
Inspection Date: 6/6/2012 11:27:15 AM		Type: Repeat	Flow: Submerged, indeterminate	Previous Rainfall (hrs): 72+																
Illicit Discharge Potential: Potential		Inspector: JCW	Notes Ammonia detection follow-up. Limited screening conducted.																	
Submerged: Partially Depth (in):

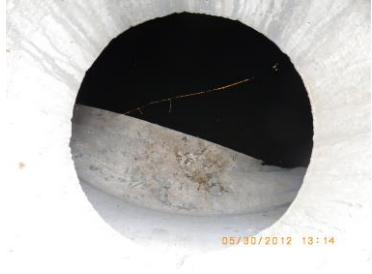
Inspection Date: 5/30/2012 1:14:06 PM		Type: Ongoing	Flow: Submerged, indeterminate	Previous Rainfall (hrs): 72+																
Illicit Discharge Potential: Potential		Inspector: JCW	Notes																	
Submerged: Partially Depth (in): 29

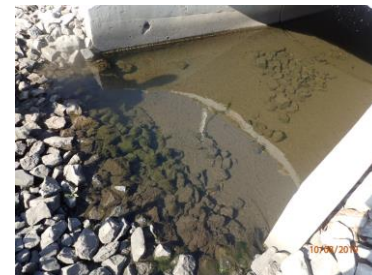
o20191008131926.JPG

Notes: Apron submerged, but no upstream flow observed. Sampled from STH 21 apron pool.

Stains: Moderate

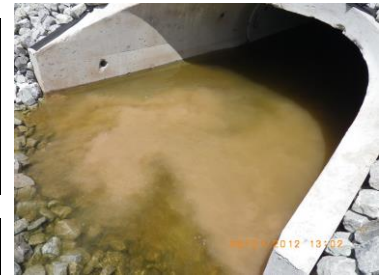
o20120621120240.JPG

Inspection Date: 6/21/2012 12:59:23 PM		Type: Ongoing	Flow: Submerged, no flow	Previous Rainfall (hrs): 0-24
Illicit Discharge Potential: Unlikely		Inspector: JCW		
Submerged: Partially		Depth (in): 12		
Sampling Results		Notes Apron submerged, but no upstream flow observed.		
Sample Location:	Floatables:	None		
Total Chlorine: -- ppm	Odor:	None		
Free Chlorine: -- ppm	Turbidity:	None		
Ammonia: -- ppm	Color:	None		
pH: -- units	Gross Solids:	None		
Temperature -- °F	Vegetation:	None		
Conductivity: -- µS/cm	Benthic Growth:	None		
Detergents: -- mg/L	Stains:	None		
	Non-illicit:	None		
		Condition Assessment Graffiti: None Erosion: None Deposition: Minor 3 in. Damage: None
