IDDE Ongoing Screening Summary Report

2021 Inspection Year

City of Oshkosh

Westwood

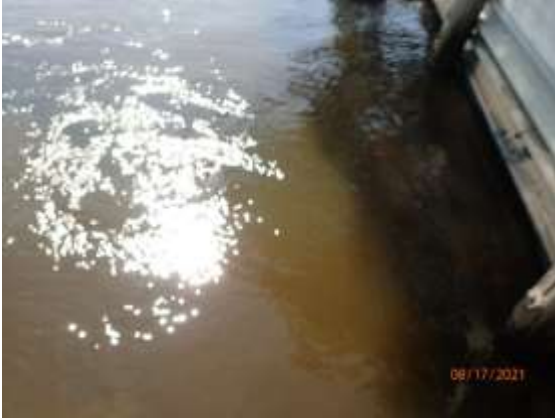
Outfall 06-1709 consists of a 34x53 inch reinforced concrete pipe (RCP) that discharges into the Fox River at the end of the extension of Campbell Road. The outfall was formerly classified as 06-253. The pipe may be the effluent pipe for the wastewater treatment plant. The pipe is fully submerged.

Figure 12 - Outfall 06-1709 (2021)

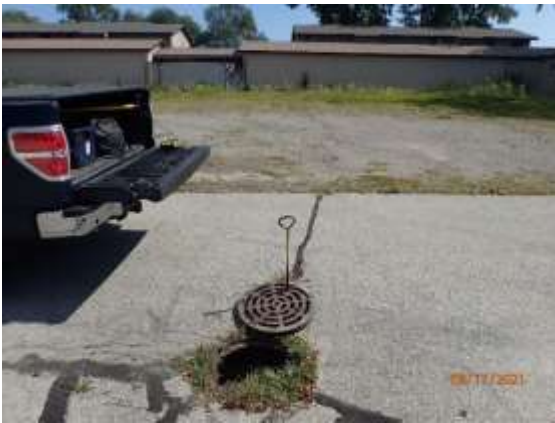
Figure 13 – Upstream manhole 06-1709 US1 (2021)

During previous screenings, the sample collected from the flow in the upstream manhole has had elevated conductivity and ammonia, along with slight gross solids. During the 8/17/2021 screening, the sample collected from the flow in the upstream manhole had a detergent concentration of 0.4 mg/L. During a follow-up screening on 8/31/2021, no detergent was detected.

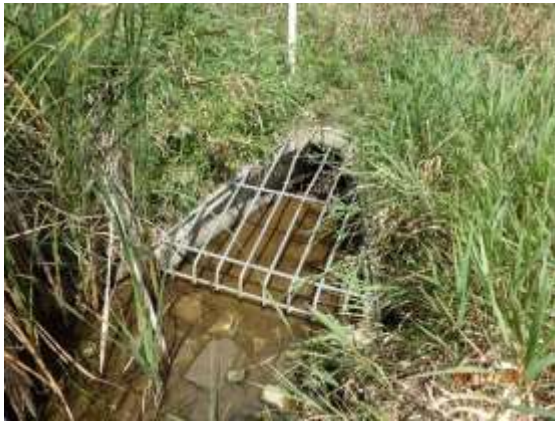
**Figure 14 - Outfall 12-2484 (2021)**

During the 8/17/2021 screening, detergent was detected in the sample that was collected from the submerged flow immediately downstream from the pipe. During a follow-up screening on 8/31/2021, no detergent was detected.

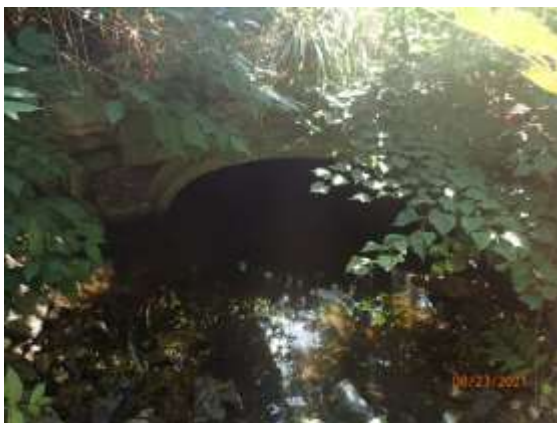
Figure 15 - Outfall 13-471 (2021)

During the 8/23/2021 screening, detergent was detected in the sample that was collected from the submerged pool at the end of the pipe. During a follow-up screening on 8/31/2021, no detergent was detected.

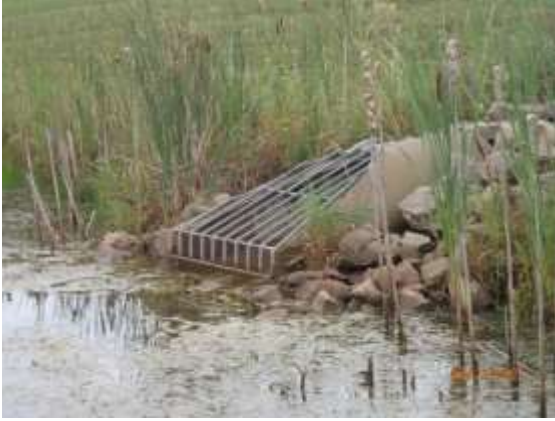
Figure 16 - Outfall 13-3921 (2021)

During the 8/23/2021 screening, detergent was detected in the sample that was collected from the flow in the pipe. During a follow-up screening on 8/31/2021, no detergent was detected.

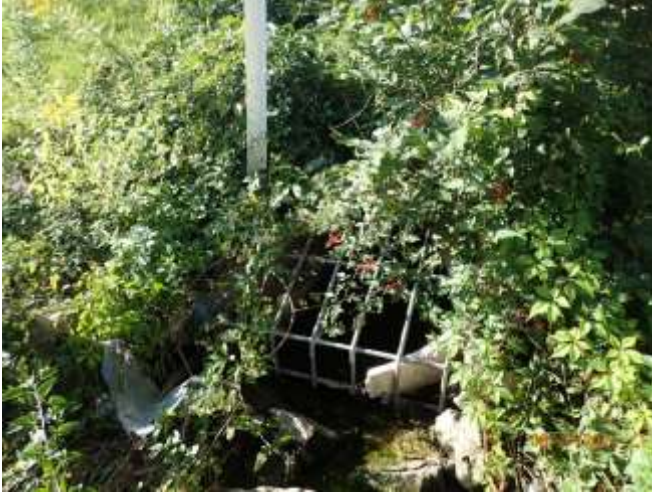
Figure 17 - Outfall 16-844 (2021)

During previous screenings, the sample collected from the outfall flow has had elevated conductivity and detergent. During the 8/17/2021 screening, the sample collected from the flow had a detergent concentration of 0.65 mg/L. During a follow-up screening on 8/31/2021, no detergent was detected, but conductivity was slightly elevated.

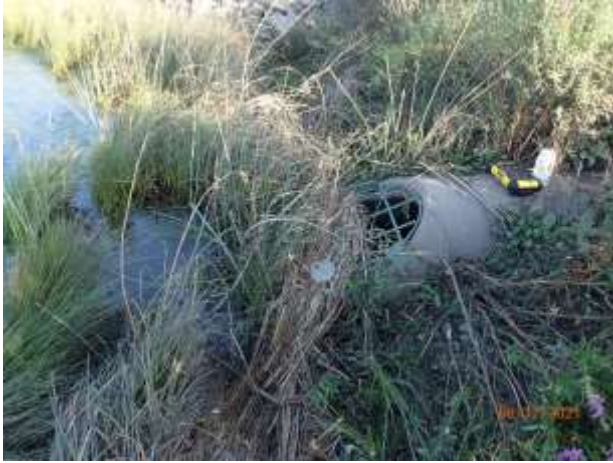
Figure 18 – Outfall 16-1205 (2021)

During previous screenings, the sample collected from the upstream curb inlet sump has tested positive for detergent. During the 8/17/2021 screening, heavy traffic on Washburn Street prevented a sample from being collected from the curb inlet, so the sample was collected from the submerged pool at the end of the outfall pipe. This sample had 0.6 mg/L detergent and elevated conductivity. During a follow-up screening on 8/31/2021, the water level in the curb inlet sump was three inches below the outlet pipe, so there was no flow. A sample was collected from the detention basin for comparison. No detergent was detected in the sample.

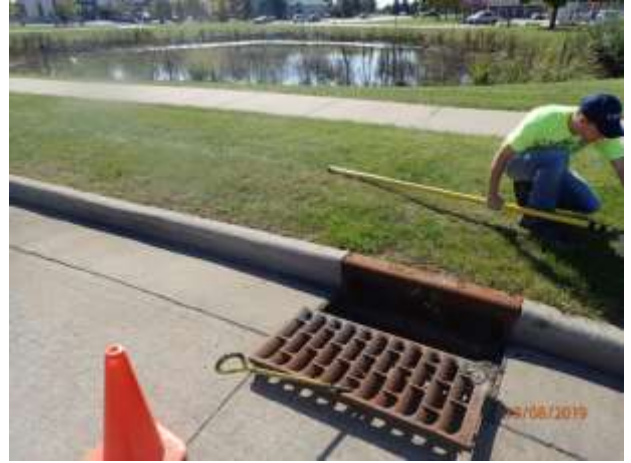
Figure 19 – Upstream curb inlet 16-1205 US1 (2019)

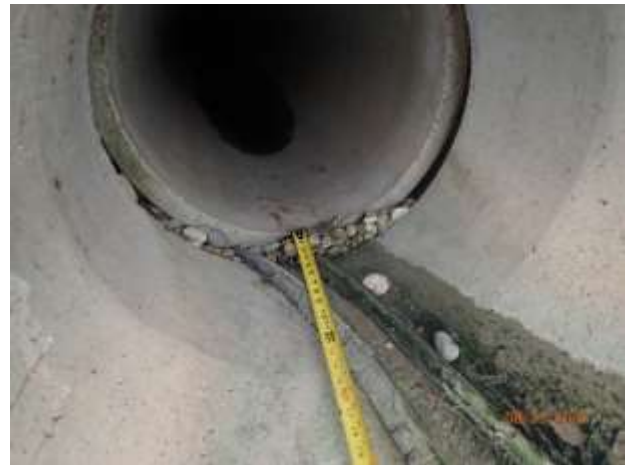
Figure 23 – Displaced apron at outfall 13-3636

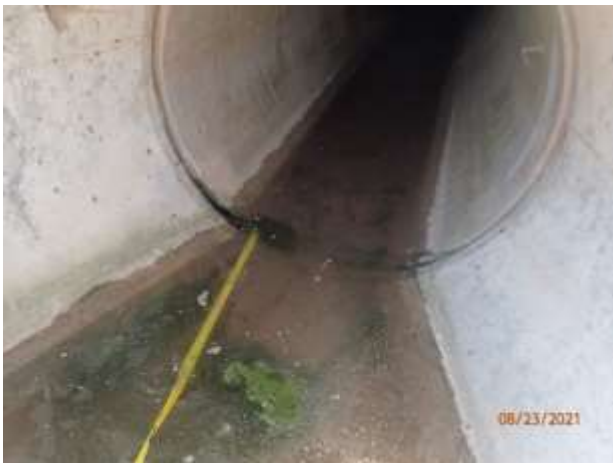
Figure 24 – Displaced apron at outfall 13-3861

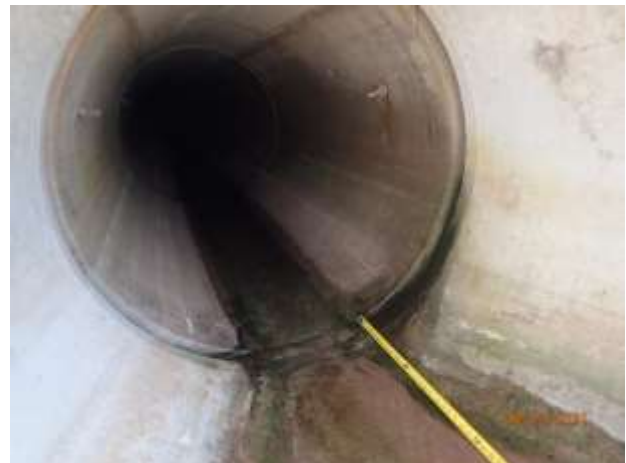
Figure 25 – Displaced apron at outfall 13-3869

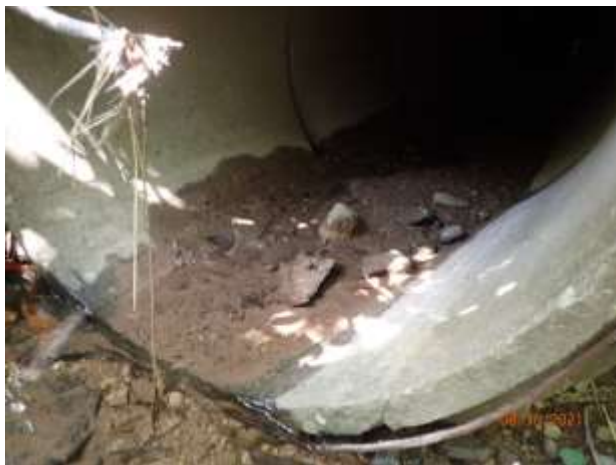
Figure 26 – Displaced pipe at outfall 14-999

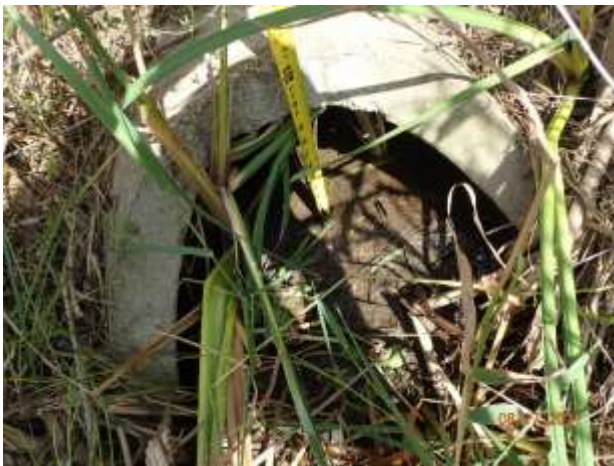
Figure 30 – Moderate deposition at outfall 12-2126

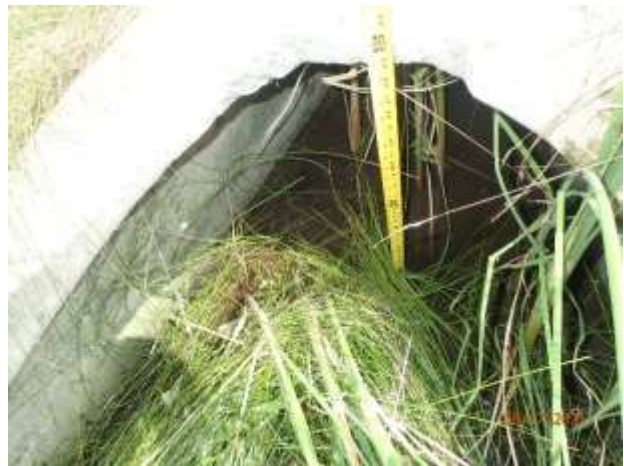
Figure 31 – Minor deposition at outfall 12-2128

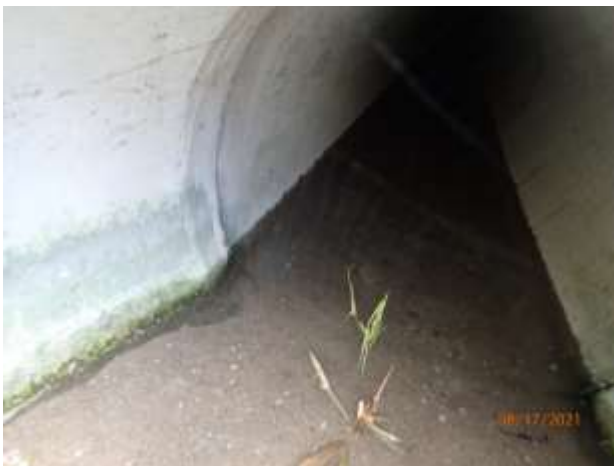
Figure 32 – Minor deposition at outfall 12-2538

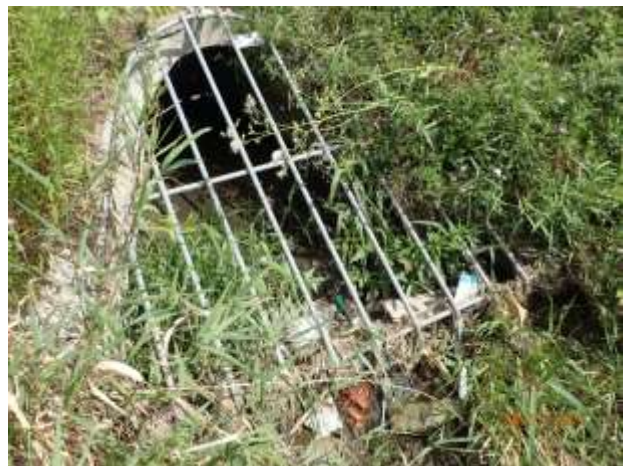
Figure 33 – Minor deposition at outfall 12-2551

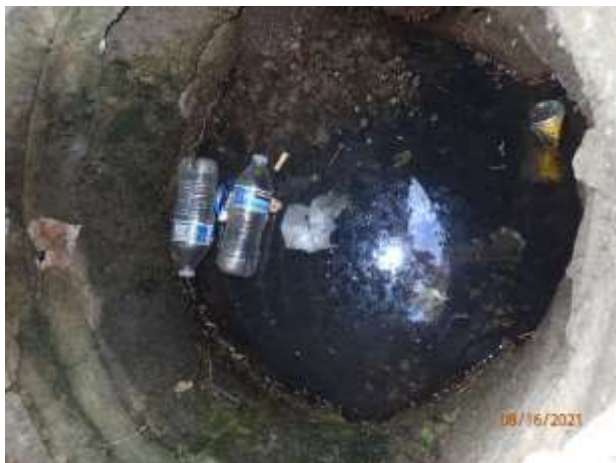
Figure 34 – Minor deposition in manhole 03-381 US1

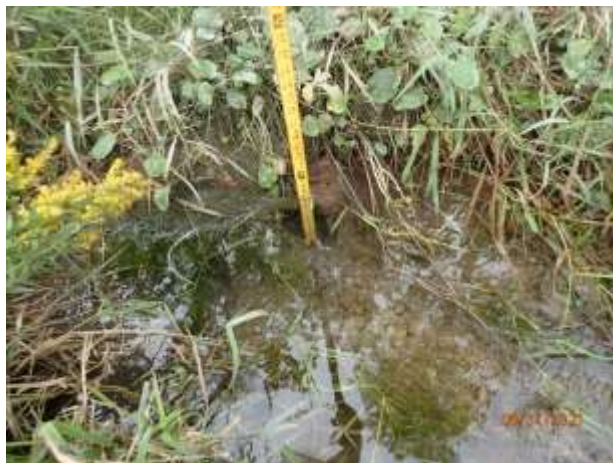
Outfall	Severity	Description
13-1098	Moderate	16" of sediment in submerged pipe.
13-1769	Minor	1" of sediment on apron.
13-2371	Minor	1" of sediment and vegetation on apron.
13-3021	Moderate	10" of sediment in pipe and on apron.
13-4107	Minor	1" of sediment and vegetation in pipe and on apron.
14-999	Minor	1" of sediment in pipe.
15-1217	Minor	2" of sediment in pipe.
15-2409	Minor	2" of sediment in pipe and on apron.
15-2412	Minor	2" of sediment in pipe and on side of apron.
15-571	Minor	2" of sediment on apron.
16-660	Minor	1" of sediment on apron.

Figure 35 – Moderate deposition at outfall 13-1098

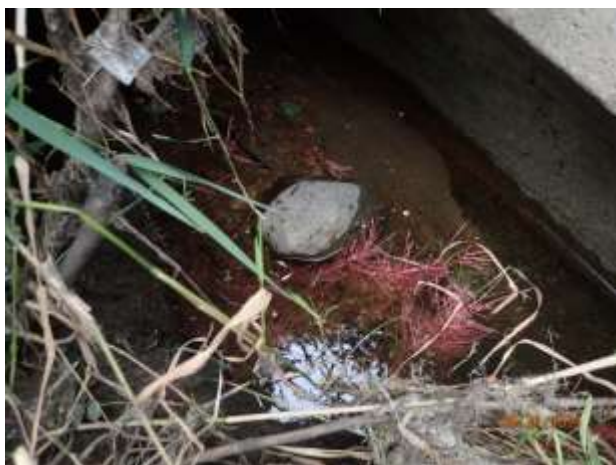
Figure 36 – Minor deposition at outfall 13-1769

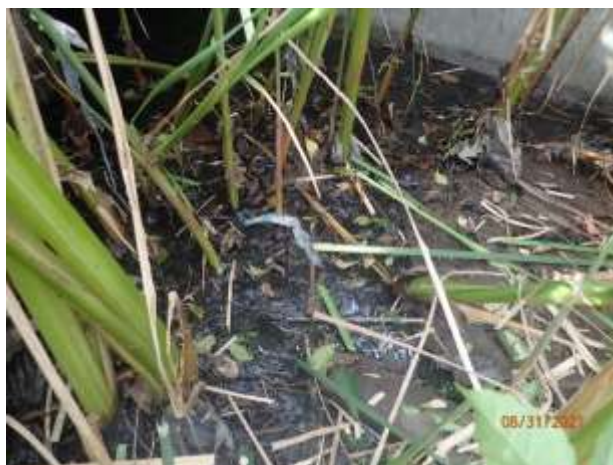
Figure 37 – Minor deposition at outfall 13-2371

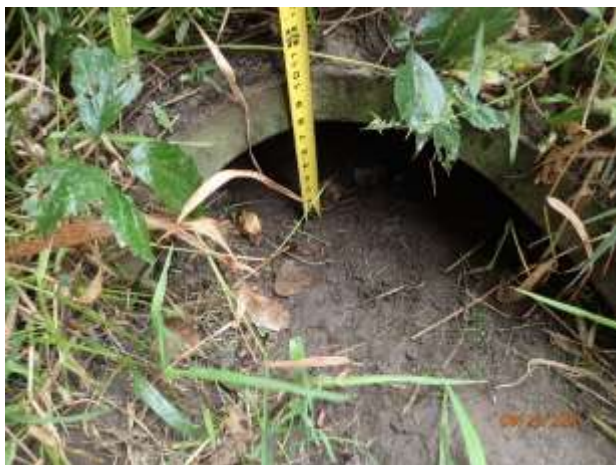
Figure 38 – Moderate deposition at outfall 13-3021

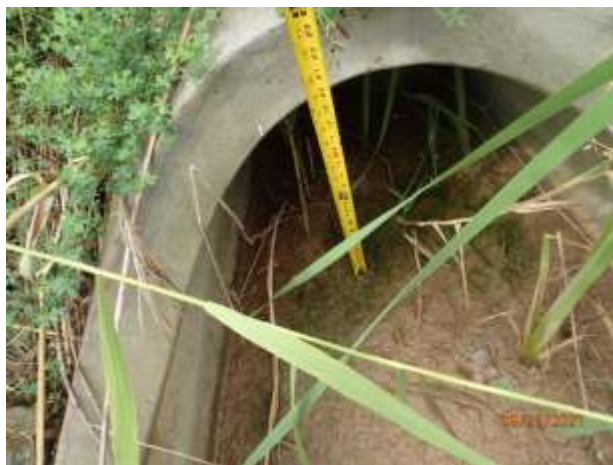
Figure 39 – Minor deposition at outfall 13-4107

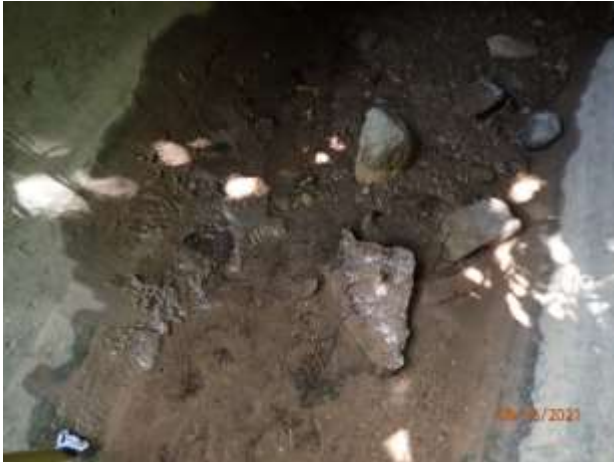
Figure 40 – Minor deposition at outfall 14-999

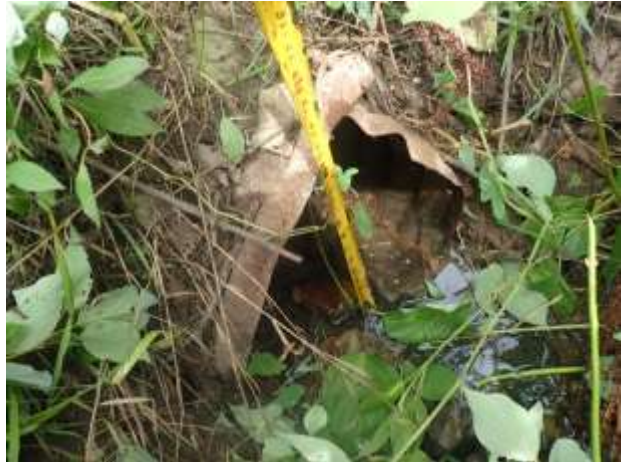
Figure 41 – Minor deposition at outfall 15-1217

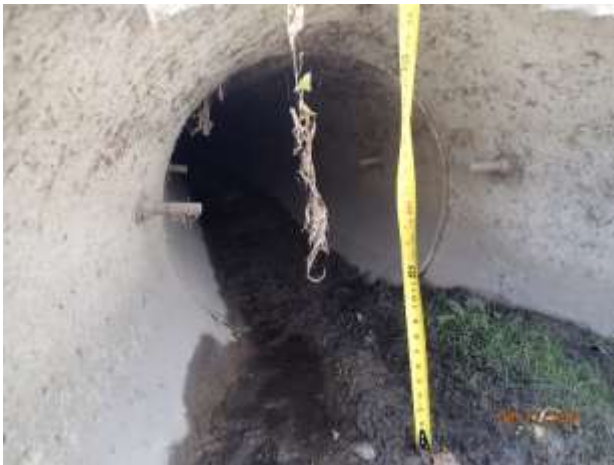
Figure 42 – Minor deposition at outfall 15-2409

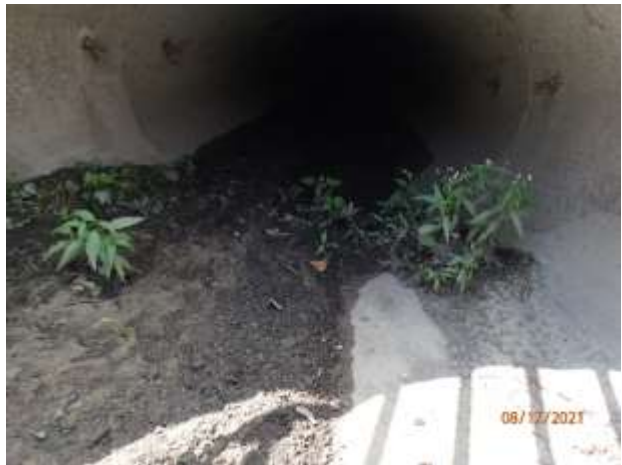
Figure 43 – Minor deposition at outfall 15-2412

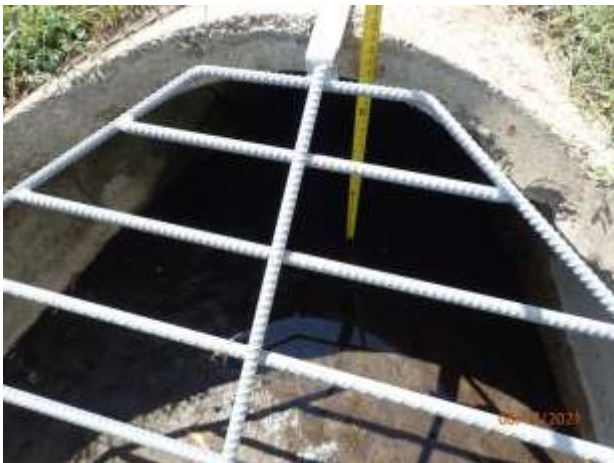
Figure 44 – Minor deposition at outfall 15-571

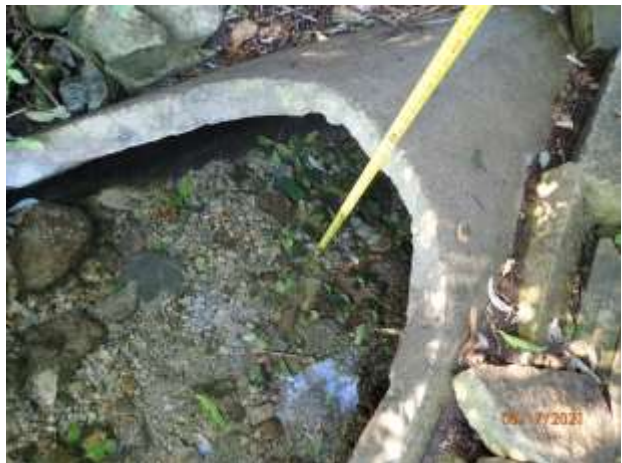
Figure 45 – Minor deposition at outfall 16-660

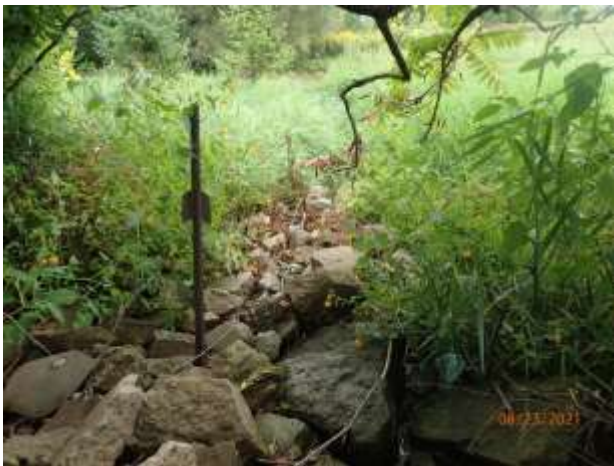
Outfall	Severity	Description
13-2135	Minor	Minor erosion downstream of outfall (past riprap).
13-3130	Minor	Erosion downstream of outfall pipe.
13-471	Severe	Streambank erosion downstream from pipe.

Figure 46 – Erosion downstream of outfall 13-2135

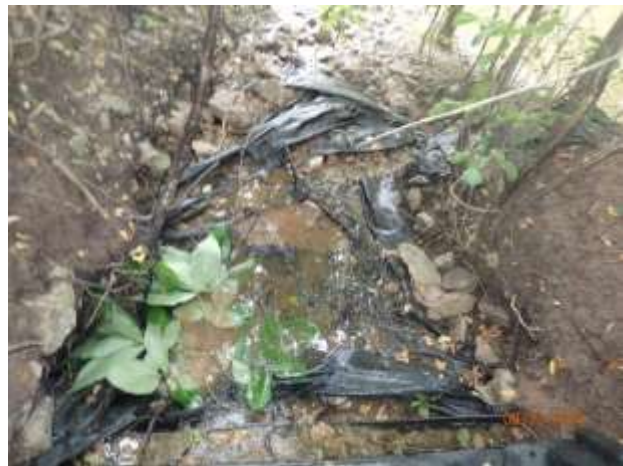
Figure 47 – Erosion downstream of outfall 13-3130

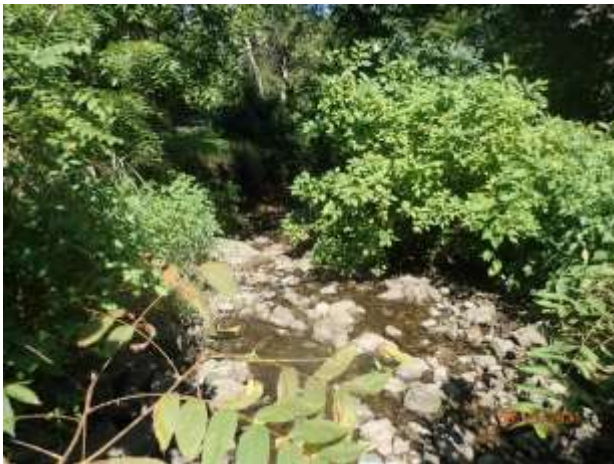
Figure 48 – Bank erosion downstream of outfall 13-471

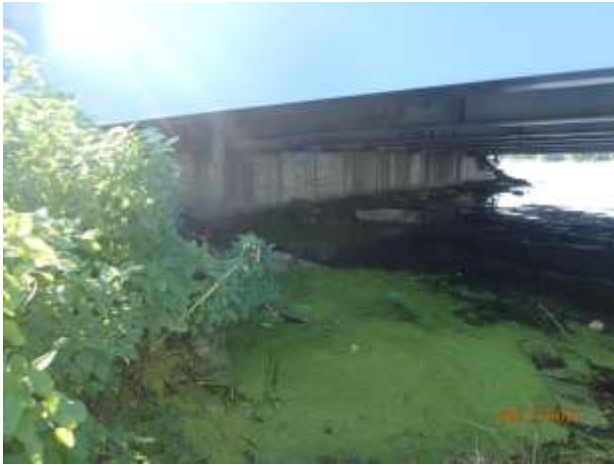
Graffiti was observed in or around one outfall. The graffiti was not severe but should probably be monitored to make sure that it does not become more severe.

Outfall	Severity	Description
12-569	Moderate	Graffiti on bridge abutment adjacent to outfall.

Figure 49 – Graffiti near outfall 12-569

The ongoing screening also identified nine outfalls with visible structural damage, 16 with deposition, three with erosion, and one with graffiti. While none of these posed an immediate danger, the City may want to address these issues as part of the regular storm sewer system maintenance.

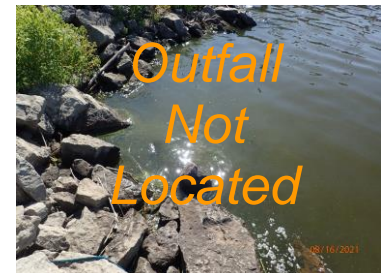
o20210816101510.JPG

Inspection Date: 8/19/2020 1:19:20 PM		Type: Ongoing	Flow: Submerged (not located)	Previous Rainfall (hrs): 72+
Illicit Discharge Potential: Potential		Inspector: JCW		
Submerged: Fully		Depth (in):		
Sampling Results		Notes Outfall fully submerged and not located - screened upstream at 01-520 US1. Floating gross solids (litter) in upstream manhole.		
Sample Location:	Floatables:	None		
Total Chlorine: -- ppm	Odor:	None		
Free Chlorine: -- ppm	Turbidity:	None		
Ammonia: -- ppm	Color:	None		
pH: -- units	Gross Solids:	None		
Temperature -- °F	Vegetation:	None		
Conductivity: -- µS/cm	Benthic Growth:	None		
Detergents: -- mg/L	Stains:	None		
	Non-illicit:	None		
		Condition Assessment Graffiti: None Erosion: None Deposition: None in. Damage: None

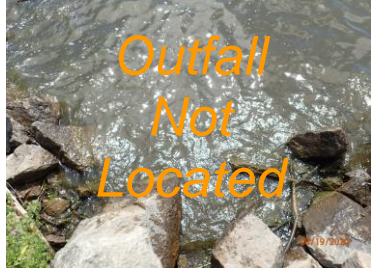
o20200819131544.JPG <div style="text-align: center; font-weight: bold; font-size: 1.2em;">2020</div>

Inspection Date: 11/5/2019 11:04:00 AM		Type: Repeat	Flow: Submerged (not located)	Previous Rainfall (hrs): 48-72
Illicit Discharge Potential: Potential		Inspector: JCW		
Submerged: Fully		Depth (in):		
Sampling Results		Notes Outfall fully submerged - screened upstream at 01-520 US1. Follow-up inspection for sampling - limited screening conducted.		
Sample Location:	Floatables:	None		
Total Chlorine: -- ppm	Odor:	None		
Free Chlorine: -- ppm	Turbidity:	None		
Ammonia: -- ppm	Color:	None		
pH: -- units	Gross Solids:	None		
Temperature -- °F	Vegetation:	None		
Conductivity: -- µS/cm	Benthic Growth:	None		
Detergents: -- mg/L	Stains:	None		
	Non-illicit:	None		
		Condition Assessment Graffiti: None Erosion: None Deposition: None in. Damage: None

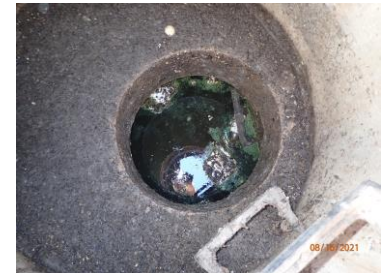
o20210816101558.JPG

Inspection Date: 8/19/2020 1:20:07 PM		Type: Ongoing	Flow: Submerged, indeterminate	Previous Rainfall (hrs): 72+
Illicit Discharge Potential: Potential		Inspector: JCW		
Submerged: Fully		Depth (in): 68		
Sampling Results		Notes Sample collected from submerged pool in manhole. Floating gross solids (litter) in manhole. Elevated pH seemed widespread in river.		
Sample Location: Pool	Floatables: None	Condition Assessment Graffiti: None Erosion: None Deposition: None in. Damage: None		
Total Chlorine: 0 ppm	Odor: None			
Free Chlorine: 0 ppm	Turbidity: None			
Ammonia: 0 ppm	Color: None			
pH: 9.11 units	Gross Solids: Severe			
Temperature: 85 °F	Vegetation: None			
Conductivity: 372 µS/cm	Benthic Growth: None			
Detergents: 0 mg/L	Stains: None			
	Non-illicit: None

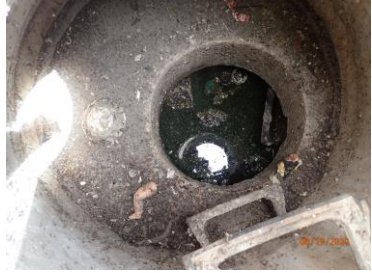
o20200819131610.JPG
2020

Inspection Date: 11/5/2019 11:05:04 AM		Type: Repeat	Flow: Submerged, indeterminate	Previous Rainfall (hrs): 48-72
Illicit Discharge Potential: Potential		Inspector: JCW		
Submerged: Partially		Depth (in): 67		
Sampling Results		Notes Detergent detection follow-up. Limited screening conducted.		
Sample Location: Pool	Floatables:	Condition Assessment Graffiti: None Erosion: None Deposition: None in. Damage: None		
Total Chlorine: -- ppm	Odor: None			
Free Chlorine: -- ppm	Turbidity: None			
Ammonia: -- ppm	Color: None			
pH: -- units	Gross Solids: Severe			
Temperature: -- °F	Vegetation: None			
Conductivity: -- µS/cm	Benthic Growth: None			
Detergents: 0 mg/L	Stains: None			
	Non-illicit: None

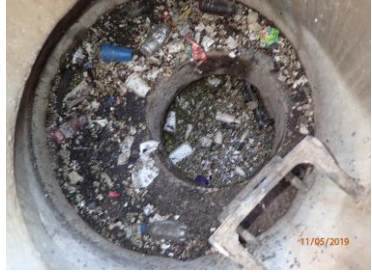
o20191105110322.JPG
2019

Inspection Date: 10/8/2019 9:18:01 AM		Type: Ongoing	Flow: Submerged, indeterminate	Previous Rainfall (hrs): 48-72
Illicit Discharge Potential: Potential		Inspector: JCW		
Submerged: Partially		Depth (in): 73		
Sampling Results		Notes Sample collected from submerged pool in manhole. Floating gross solids (litter) in manhole. Detergent detected.		
Sample Location: Pool	Floatables: None	Condition Assessment Graffiti: None Erosion: None Deposition: None in. Damage: None		
Total Chlorine: 0 ppm	Odor: None			
Free Chlorine: 0 ppm	Turbidity: None			
Ammonia: 0 ppm	Color: None			
pH: 7.28 units	Gross Solids: Severe			
Temperature: 61 °F	Vegetation: None			
Conductivity: 381 µS/cm	Benthic Growth: None			
Detergents: 0.9 mg/L	Stains: None			
	Non-illicit: None

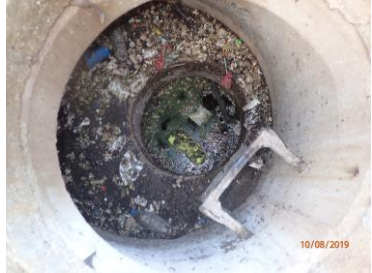
o20191008081524.JPG
2019

Inspection Date: 10/24/2018 11:07:34 AM		Type: Ongoing	Flow: Submerged, indeterminate	Previous Rainfall (hrs): 72+
Illicit Discharge Potential: Potential		Inspector: JCW		
Submerged: Partially		Depth (in): 70		
Sampling Results		Notes Sample collected from submerged pool in manhole. Floating gross solids (litter) in manhole.		
Sample Location: Pool	Floatables: None	Condition Assessment Graffiti: None Erosion: None Deposition: None in. Damage: None		
Total Chlorine: 0 ppm	Odor: None			
Free Chlorine: 0 ppm	Turbidity: None			
Ammonia: 0 ppm	Color: None			
pH: 8.02 units	Gross Solids: Severe			
Temperature: 49 °F	Vegetation: None			
Conductivity: 336 µS/cm	Benthic Growth: None			
Detergents: 0 mg/L	Stains: None			
	Non-illicit: None

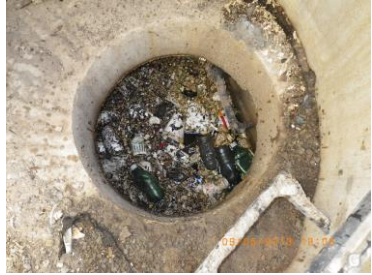
Inspection Date: 9/5/2013 1:02:45 PM		Type: Ongoing	Flow: Submerged, indeterminate	Previous Rainfall (hrs): 72+
Illicit Discharge Potential: Potential		Inspector: JCW	Notes	
Submerged: Fully		Depth (in): 69	2012 screening follow-up. Significant gross solids in manhole - similar to previous years.	
Sampling Results		Floatables: None	Condition Assessment	
Sample Location: Pool		Odor: None

o20130905120924.JPG 2013	
Total Chlorine: 0 ppm		Turbidity: None		
Free Chlorine: 0 ppm		Color: None		
Ammonia: 0 ppm		Gross Solids: Severe		
pH: 8.51 units		Vegetation: None		
Temperature: 76 °F		Benthic Growth: None		
Conductivity: 424 µS/cm		Stains: None		
Detergents: 0 mg/L		Non-illicit: None		
			Graffiti: None Erosion: None Deposition: None in. Damage: None

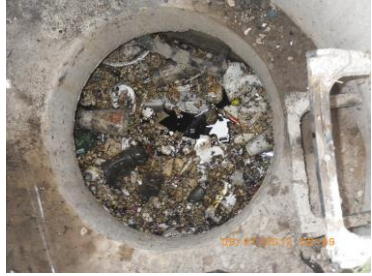
Inspection Date: 9/27/2012 9:57:25 AM		Type: Ongoing	Flow: Submerged, indeterminate	Previous Rainfall (hrs): 72+
Illicit Discharge Potential: Potential		Inspector: JCW	Notes	
Submerged: Fully		Depth (in): 69	2011 gross solids follow-up.	
Sampling Results		Floatables: None	Condition Assessment	
Sample Location: Pool		Odor: None

o20120927085918.JPG 2012	
Total Chlorine: 0 ppm		Turbidity: None		
Free Chlorine: 0 ppm		Color: None		
Ammonia: 0.5 ppm		Gross Solids: Severe		
pH: 7.77 units		Vegetation: None		
Temperature: 60 °F		Benthic Growth: None		
Conductivity: 542 µS/cm		Stains: Slight		
Detergents: 0 mg/L		Non-illicit: None		
			Graffiti: None Erosion: None Deposition: None in. Damage: None

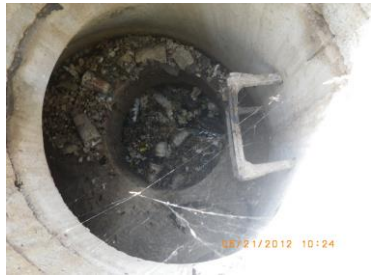
Inspection Date: 6/21/2012 10:34:01 AM		Type: Other	Flow: Submerged, indeterminate	Previous Rainfall (hrs): 0-24
Illicit Discharge Potential: Potential		Inspector: JCW	Notes	
Submerged: Fully		Depth (in): 70	Gross solids pre-screening.	
Sampling Results		Floatables: None	Condition Assessment	
Sample Location: --		Odor: None

o20120621092424.JPG 2012	
Total Chlorine: -- ppm		Turbidity: None		
Free Chlorine: -- ppm		Color: None		
Ammonia: -- ppm		Gross Solids: Severe		
pH: -- units		Vegetation: None		
Temperature: -- °F		Benthic Growth: None		
Conductivity: -- µS/cm		Stains: Moderate		
Detergents: -- mg/L		Non-illicit: None		
			Graffiti: None Erosion: None Deposition: None in. Damage: None

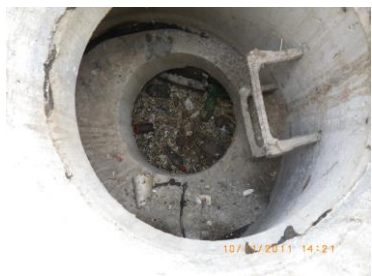
Inspection Date: 10/11/2011 2:24:37 PM		Type: Ongoing	Flow: Submerged, indeterminate	Previous Rainfall (hrs): 72+
Illicit Discharge Potential: Potential		Inspector: JCW	Notes	
Submerged: Fully		Depth (in): 64	2010 screening follow-up. Floatable debris still present.	
Sampling Results		Floatables: None	Condition Assessment	
Sample Location: Pool		Odor: None

o20111011142110.JPG 2011	
Total Chlorine: 0 ppm		Turbidity: None		
Free Chlorine: 0 ppm		Color: None		
Ammonia: 0 ppm		Gross Solids: Severe		
pH: 8.49 units		Vegetation: None		
Temperature: 71 °F		Benthic Growth: None		
Conductivity: -- µS/cm		Stains: None		
Detergents: -- mg/L		Non-illicit: None		
			Graffiti: None Erosion: None Deposition: None 0 in. Damage: None

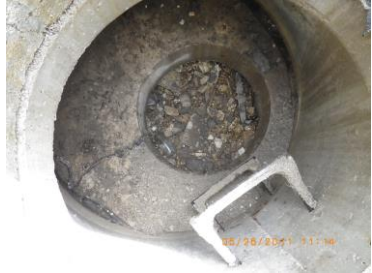
Inspection Date: 5/26/2011 11:13:00 AM		Type: Other	Flow: Submerged, indeterminate	Previous Rainfall (hrs): 72+
Illicit Discharge Potential: Potential		Inspector: JCW	Notes Limited screening conducted to check for floatable debris.	
Submerged: Fully		Depth (in):

o20110526111400.JPG <div style="font-size: 24pt; font-weight: bold; text-align: center;">2011</div>	
Sampling Results		Floatables: None		
Sample Location:		Odor:		
Total Chlorine: -- ppm		Turbidity:		
Free Chlorine: -- ppm		Color:		
Ammonia: -- ppm		Gross Solids: Severe		
pH: -- units		Vegetation:		
Temperature -- °F		Benthic Growth:		
Conductivity: -- µS/cm		Stains:		
Detergents: -- mg/L		Non-illicit: None		
Condition Assessment			Graffiti: None Erosion: None Deposition: None 0 in. Damage: None

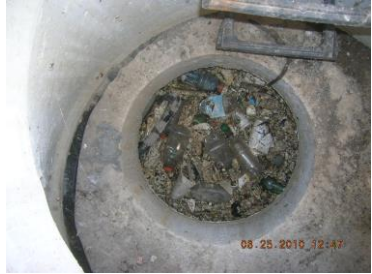
Inspection Date: 8/25/2010 12:53:35 PM		Type: Ongoing	Flow: Submerged, indeterminate	Previous Rainfall (hrs): 72+
Illicit Discharge Potential: Potential		Inspector: JCW	Notes Significant floatable debris in manhole.	
Submerged: Fully		Depth (in): 72

o20100825124708.JPG <div style="font-size: 24pt; font-weight: bold; text-align: center;">2010</div>	
Sampling Results		Floatables: None		
Sample Location: Pool		Odor: None		
Total Chlorine: 0 ppm		Turbidity: None		
Free Chlorine: 0 ppm		Color: Faint in bottle		
Ammonia: 0 ppm		Gross Solids: Severe		
pH: 8.18 units		Vegetation: None		
Temperature 73 °F		Benthic Growth: None		
Conductivity: -- µS/cm		Stains: None		
Detergents: 0 mg/L		Non-illicit: None		
Condition Assessment			Graffiti: None Erosion: None Deposition: None 0 in. Damage: None

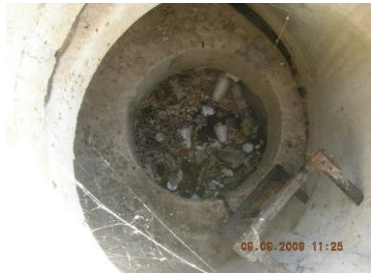
Inspection Date: 9/9/2009		Type: Initial	Flow: Submerged, indeterminate	Previous Rainfall (hrs): 72+
Illicit Discharge Potential: Potential		Inspector: JCW	Notes Abnormal detergent analysis result (bubbles). Significant floatables in manhole. Brown color.	
Submerged: Fully		Depth (in): 61

Osh09_DSCN6718.JPG <div style="font-size: 24pt; font-weight: bold; text-align: center;">2009</div>	
Sampling Results		Floatables: None		
Sample Location: Pool		Odor: None		
Total Chlorine: 0 ppm		Turbidity: None		
Free Chlorine: 0 ppm		Color: Clearly visible in bottl		
Ammonia: -- ppm		Gross Solids: Severe		
pH: 8.6 units		Vegetation: None		
Temperature 78 °F		Benthic Growth: None		
Conductivity: -- µS/cm		Stains: None		
Detergents: 0 mg/L		Non-illicit: None		
Condition Assessment			Graffiti: None Erosion: None Deposition: None 0 in. Damage: None

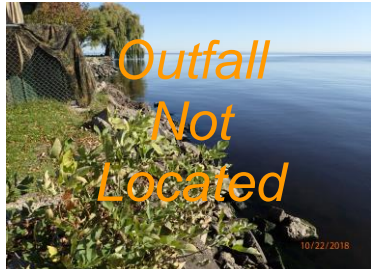
o20181022102328.JPG 2018

Inspection Date: 10/22/2018 10:23:45 AM		Type: Ongoing	Flow: Submerged (not located)	Previous Rainfall (hrs): 48-72
Illicit Discharge Potential: Potential		Inspector: JCW		
Submerged: Fully		Depth (in):		
Sampling Results Sample Location: _____ Total Chlorine: -- ppm Free Chlorine: -- ppm Ammonia: -- ppm pH: -- units Temperature: -- °F Conductivity: -- µS/cm Detergents: -- mg/L		Floatables: None Odor: None Turbidity: None Color: None Gross Solids: None Vegetation: None Benthic Growth: None Stains: None Non-illicit: None		
		Notes Outfall fully submerged and not located - screened upstream at 02-309 US1. Floating gross solids (litter) in manhole.		
		Condition Assessment Graffiti: None Erosion: None Deposition: None in. Damage: None

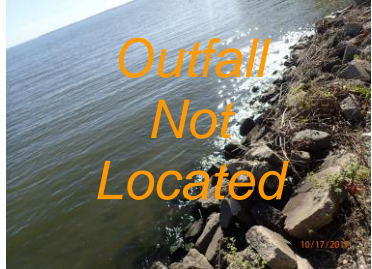
o20171017133948.JPG 2017

Inspection Date: 10/17/2017 1:41:46 PM		Type: Ongoing	Flow: Submerged (not located)	Previous Rainfall (hrs): 48-72
Illicit Discharge Potential: Potential		Inspector: JCW		
Submerged: Fully		Depth (in):		
Sampling Results Sample Location: _____ Total Chlorine: -- ppm Free Chlorine: -- ppm Ammonia: -- ppm pH: -- units Temperature: -- °F Conductivity: -- µS/cm Detergents: -- mg/L		Floatables: None Odor: None Turbidity: None Color: None Gross Solids: None Vegetation: None Benthic Growth: None Stains: None Non-illicit: None		
		Notes Outfall fully submerged and not located - screened upstream at 02-309 US1. Floating gross solids (litter) in manhole.		
		Condition Assessment Graffiti: None Erosion: None Deposition: None in. Damage: None

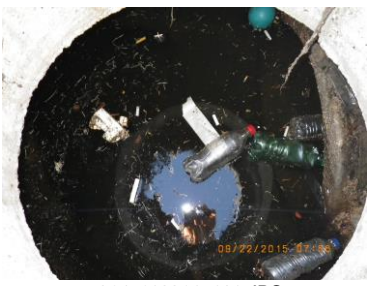
o20150922065636.JPG

Inspection Date: 9/22/2015 7:50:50 AM		Type: Ongoing	Flow: Submerged, indeterminate	Previous Rainfall (hrs): 72+
Illicit Discharge Potential: Potential		Inspector: JCW	Notes	
Submerged: Fully		Depth (in): 28	Floating gross solids (litter) in manhole.	
Sampling Results				
Sample Location:	Pool	Floatables:	None	
Total Chlorine:	0 ppm	Odor:	None	
Free Chlorine:	0 ppm	Turbidity:	None	
Ammonia:	0 ppm	Color:	None	
pH:	7.74 units	Gross Solids:	Slight	
Temperature	66 °F	Vegetation:	None	
Conductivity:	853 µS/cm	Benthic Growth:	Slight	
Detergents:	0 mg/L	Stains:	Slight	
		Non-illicit:	None	
			Condition Assessment	
			Graffiti:	None
			Erosion:	None
			Deposition:	None in.
			Damage:	None

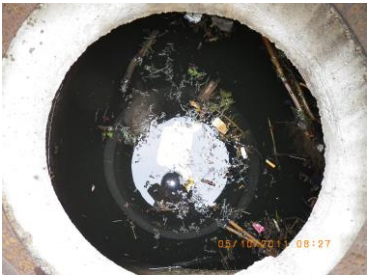
o20110510082708.JPG

Inspection Date: 5/10/2011 8:27:00 AM		Type: Other	Flow: Submerged, indeterminate	Previous Rainfall (hrs): 0-24
Illicit Discharge Potential: Potential		Inspector: JCW	Notes	
Submerged: Fully		Depth (in):	Limited screening conducted for upstream manhole prescreening.	
Sampling Results				
Sample Location:		Floatables:	None	
Total Chlorine:	-- ppm	Odor:		
Free Chlorine:	-- ppm	Turbidity:		
Ammonia:	-- ppm	Color:		
pH:	-- units	Gross Solids:	Slight	
Temperature	-- °F	Vegetation:		
Conductivity:	-- µS/cm	Benthic Growth:		
Detergents:	-- mg/L	Stains:		
		Non-illicit:	None	
			Condition Assessment	
			Graffiti:	None
			Erosion:	None
			Deposition:	None 0 in.
			Damage:	None

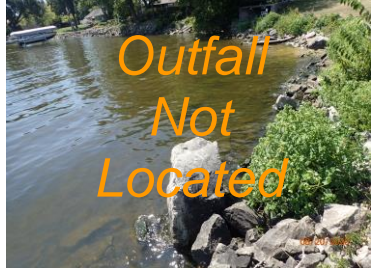
o20200820130304.JPG <div style="text-align: center; font-weight: bold; font-size: 1.2em;">2020</div>

Inspection Date: 8/20/2020 1:04:00 PM		Type: Ongoing	Flow: Submerged (not located)	Previous Rainfall (hrs): 72+
Illicit Discharge Potential: Potential		Inspector: JCW		
Submerged: Fully		Depth (in):		
Sampling Results Sample Location: _____ Total Chlorine: -- ppm Free Chlorine: -- ppm Ammonia: -- ppm pH: -- units Temperature: -- °F Conductivity: -- µS/cm Detergents: -- mg/L		Floatables: None Odor: None Turbidity: None Color: None Gross Solids: None Vegetation: None Benthic Growth: None Stains: None Non-illicit: None	Notes Outfall fully submerged and not located - screened upstream at 02-357 US1. Floating gross solids (litter) in upstream manhole. Condition Assessment Graffiti: None Erosion: None Deposition: None in. Damage: None

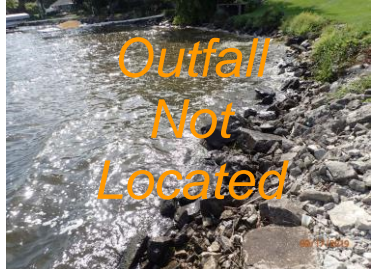
o20190917131538.JPG <div style="text-align: center; font-weight: bold; font-size: 1.2em;">2019</div>

Inspection Date: 9/17/2019 2:15:46 PM		Type: Ongoing	Flow: Submerged (not located)	Previous Rainfall (hrs): 48-72
Illicit Discharge Potential: Potential		Inspector: JCW		
Submerged: Fully		Depth (in):		
Sampling Results Sample Location: _____ Total Chlorine: -- ppm Free Chlorine: -- ppm Ammonia: -- ppm pH: -- units Temperature: -- °F Conductivity: -- µS/cm Detergents: -- mg/L		Floatables: None Odor: None Turbidity: None Color: None Gross Solids: None Vegetation: None Benthic Growth: None Stains: None Non-illicit: None	Notes Outfall fully submerged and not located - screened upstream at 02-357 US1. Floating gross solids (litter) in manhole. Condition Assessment Graffiti: None Erosion: None Deposition: None in. Damage: None

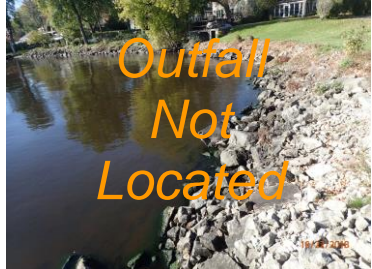
o20181022101158.JPG <div style="text-align: center; font-weight: bold; font-size: 1.2em;">2018</div>

Inspection Date: 10/22/2018 10:13:07 AM		Type: Ongoing	Flow: Submerged (not located)	Previous Rainfall (hrs): 48-72
Illicit Discharge Potential: Potential		Inspector: JCW		
Submerged: Fully		Depth (in):		
Sampling Results Sample Location: _____ Total Chlorine: -- ppm Free Chlorine: -- ppm Ammonia: -- ppm pH: -- units Temperature: -- °F Conductivity: -- µS/cm Detergents: -- mg/L		Floatables: None Odor: None Turbidity: None Color: None Gross Solids: None Vegetation: None Benthic Growth: None Stains: None Non-illicit: None	Notes Outfall fully submerged and not located - screened upstream at 02-357 US1. Floating gross solids (litter) in manhole. Condition Assessment Graffiti: None Erosion: None Deposition: None in. Damage: None

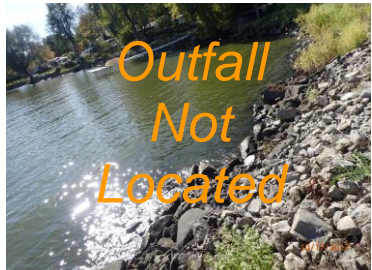
o20171017133026.JPG <div style="text-align: center; font-weight: bold; font-size: 1.2em;">2017</div>

Inspection Date: 10/17/2017 1:32:28 PM		Type: Ongoing	Flow: Submerged (not located)	Previous Rainfall (hrs): 48-72
Illicit Discharge Potential: Potential		Inspector: JCW		
Submerged: Fully		Depth (in):		
Sampling Results Sample Location: _____ Total Chlorine: -- ppm Free Chlorine: -- ppm Ammonia: -- ppm pH: -- units Temperature: -- °F Conductivity: -- µS/cm Detergents: -- mg/L		Floatables: None Odor: None Turbidity: None Color: None Gross Solids: None Vegetation: None Benthic Growth: None Stains: None Non-illicit: None	Notes Outfall fully submerged and not located - screened upstream at 02-357 US1. Floating gross solids (litter) in manhole. Condition Assessment Graffiti: None Erosion: None Deposition: None in. Damage: None

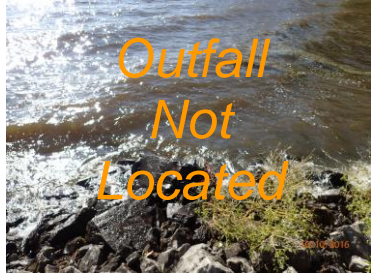
Inspection Date: 10/10/2016 10:53:43 AM		Type: Ongoing		Flow: Submerged (not located)		Previous Rainfall (hrs): 72+																															
Illicit Discharge Potential: Potential		Inspector: JCW		Notes Outfall fully submerged and not located - screened upstream at 02-357 US1.

<p style="text-align: center;">o20161010105240.JPG</p> <p style="text-align: center; font-size: 1.2em; font-weight: bold;">2016</p>																															
Submerged: Fully		Depth (in):																																			
Sampling Results				Condition Assessment		Graffiti: None Erosion: None Deposition: None in. Damage: None																															
<table border="1" style="width:100%; border-collapse: collapse;"> <tr><td>Sample Location:</td><td></td></tr> <tr><td>Total Chlorine:</td><td>-- ppm</td></tr> <tr><td>Free Chlorine:</td><td>-- ppm</td></tr> <tr><td>Ammonia:</td><td>-- ppm</td></tr> <tr><td>pH:</td><td>-- units</td></tr> <tr><td>Temperature:</td><td>-- °F</td></tr> <tr><td>Conductivity:</td><td>-- µS/cm</td></tr> <tr><td>Detergents:</td><td>-- mg/L</td></tr> </table>		Sample Location:						Total Chlorine:	-- ppm	Free Chlorine:	-- ppm	Ammonia:	-- ppm	pH:	-- units	Temperature:	-- °F	Conductivity:	-- µS/cm	Detergents:	-- mg/L	<table border="1" style="width:100%; border-collapse: collapse;"> <tr><td>Floatables:</td><td>None</td></tr> <tr><td>Odor:</td><td>None</td></tr> <tr><td>Turbidity:</td><td>None</td></tr> <tr><td>Color:</td><td>None</td></tr> <tr><td>Gross Solids:</td><td>None</td></tr> <tr><td>Vegetation:</td><td>None</td></tr> <tr><td>Benthic Growth:</td><td>None</td></tr> <tr><td>Stains:</td><td>None</td></tr> <tr><td>Non-illicit:</td><td>None</td></tr> </table>		Floatables:	None	Odor:	None	Turbidity:	None	Color:	None	Gross Solids:	None	Vegetation:	None	Benthic Growth:	None

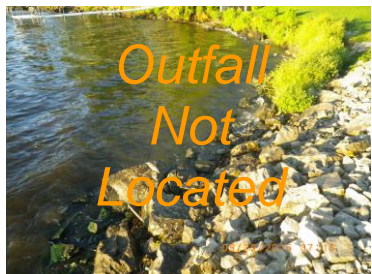
Inspection Date: 9/22/2015 7:14:30 AM		Type: Ongoing		Flow: Submerged (not located)		Previous Rainfall (hrs): 72+																															
Illicit Discharge Potential: Potential		Inspector: JCW		Notes Outfall fully submerged and not located - screened upstream at 02-357 US1.

<p style="text-align: center;">o20150922061856.JPG</p> <p style="text-align: center; font-size: 1.2em; font-weight: bold;">2015</p>																															
Submerged: Fully		Depth (in):																																			
Sampling Results				Condition Assessment		Graffiti: None Erosion: None Deposition: None in. Damage: None																															
<table border="1" style="width:100%; border-collapse: collapse;"> <tr><td>Sample Location:</td><td></td></tr> <tr><td>Total Chlorine:</td><td>-- ppm</td></tr> <tr><td>Free Chlorine:</td><td>-- ppm</td></tr> <tr><td>Ammonia:</td><td>-- ppm</td></tr> <tr><td>pH:</td><td>-- units</td></tr> <tr><td>Temperature:</td><td>-- °F</td></tr> <tr><td>Conductivity:</td><td>-- µS/cm</td></tr> <tr><td>Detergents:</td><td>-- mg/L</td></tr> </table>		Sample Location:						Total Chlorine:	-- ppm	Free Chlorine:	-- ppm	Ammonia:	-- ppm	pH:	-- units	Temperature:	-- °F	Conductivity:	-- µS/cm	Detergents:	-- mg/L	<table border="1" style="width:100%; border-collapse: collapse;"> <tr><td>Floatables:</td><td>None</td></tr> <tr><td>Odor:</td><td>None</td></tr> <tr><td>Turbidity:</td><td>None</td></tr> <tr><td>Color:</td><td>None</td></tr> <tr><td>Gross Solids:</td><td>None</td></tr> <tr><td>Vegetation:</td><td>None</td></tr> <tr><td>Benthic Growth:</td><td>None</td></tr> <tr><td>Stains:</td><td>None</td></tr> <tr><td>Non-illicit:</td><td>None</td></tr> </table>		Floatables:	None	Odor:	None	Turbidity:	None	Color:	None	Gross Solids:	None	Vegetation:	None	Benthic Growth:	None

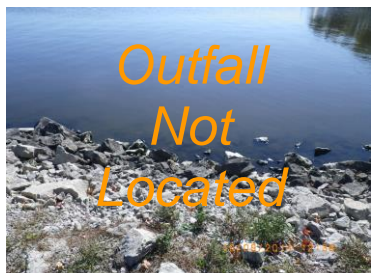
Inspection Date: 10/9/2014 12:37:08 PM		Type: Ongoing		Flow: Submerged (not located)		Previous Rainfall (hrs): 72+																															
Illicit Discharge Potential: Potential		Inspector: JCW		Notes Outfall fully submerged and not located - screened upstream at 02-357 US1.

<p style="text-align: center;">o20141009113806.JPG</p> <p style="text-align: center; font-size: 1.2em; font-weight: bold;">2014</p>																															
Submerged: Fully		Depth (in):																																			
Sampling Results				Condition Assessment		Graffiti: None Erosion: None Deposition: None in. Damage: None																															
<table border="1" style="width:100%; border-collapse: collapse;"> <tr><td>Sample Location:</td><td></td></tr> <tr><td>Total Chlorine:</td><td>-- ppm</td></tr> <tr><td>Free Chlorine:</td><td>-- ppm</td></tr> <tr><td>Ammonia:</td><td>-- ppm</td></tr> <tr><td>pH:</td><td>-- units</td></tr> <tr><td>Temperature:</td><td>-- °F</td></tr> <tr><td>Conductivity:</td><td>-- µS/cm</td></tr> <tr><td>Detergents:</td><td>-- mg/L</td></tr> </table>		Sample Location:						Total Chlorine:	-- ppm	Free Chlorine:	-- ppm	Ammonia:	-- ppm	pH:	-- units	Temperature:	-- °F	Conductivity:	-- µS/cm	Detergents:	-- mg/L	<table border="1" style="width:100%; border-collapse: collapse;"> <tr><td>Floatables:</td><td>None</td></tr> <tr><td>Odor:</td><td>None</td></tr> <tr><td>Turbidity:</td><td>None</td></tr> <tr><td>Color:</td><td>None</td></tr> <tr><td>Gross Solids:</td><td>None</td></tr> <tr><td>Vegetation:</td><td>None</td></tr> <tr><td>Benthic Growth:</td><td>None</td></tr> <tr><td>Stains:</td><td>None</td></tr> <tr><td>Non-illicit:</td><td>None</td></tr> </table>		Floatables:	None	Odor:	None	Turbidity:	None	Color:	None	Gross Solids:	None	Vegetation:	None	Benthic Growth:	None

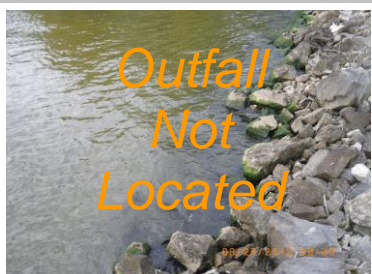
Inspection Date: 9/27/2012 8:29:10 AM		Type: Ongoing		Flow: Submerged (not located)		Previous Rainfall (hrs): 72+																															
Illicit Discharge Potential: Unlikely		Inspector: JCW		Notes Outfall fully submerged; screened upstream at 02-357 US1.

<p style="text-align: center;">o20120927073330.JPG</p> <p style="text-align: center; font-size: 1.2em; font-weight: bold;">2012</p>																															
Submerged: Fully		Depth (in):																																			
Sampling Results				Condition Assessment		Graffiti: None Erosion: None Deposition: None in. Damage: None																															
<table border="1" style="width:100%; border-collapse: collapse;"> <tr><td>Sample Location:</td><td></td></tr> <tr><td>Total Chlorine:</td><td>-- ppm</td></tr> <tr><td>Free Chlorine:</td><td>-- ppm</td></tr> <tr><td>Ammonia:</td><td>-- ppm</td></tr> <tr><td>pH:</td><td>-- units</td></tr> <tr><td>Temperature:</td><td>-- °F</td></tr> <tr><td>Conductivity:</td><td>-- µS/cm</td></tr> <tr><td>Detergents:</td><td>-- mg/L</td></tr> </table>		Sample Location:						Total Chlorine:	-- ppm	Free Chlorine:	-- ppm	Ammonia:	-- ppm	pH:	-- units	Temperature:	-- °F	Conductivity:	-- µS/cm	Detergents:	-- mg/L	<table border="1" style="width:100%; border-collapse: collapse;"> <tr><td>Floatables:</td><td>None</td></tr> <tr><td>Odor:</td><td>None</td></tr> <tr><td>Turbidity:</td><td>None</td></tr> <tr><td>Color:</td><td>None</td></tr> <tr><td>Gross Solids:</td><td>None</td></tr> <tr><td>Vegetation:</td><td>None</td></tr> <tr><td>Benthic Growth:</td><td>None</td></tr> <tr><td>Stains:</td><td>None</td></tr> <tr><td>Non-illicit:</td><td>None</td></tr> </table>		Floatables:	None	Odor:	None	Turbidity:	None	Color:	None	Gross Solids:	None	Vegetation:	None	Benthic Growth:	None

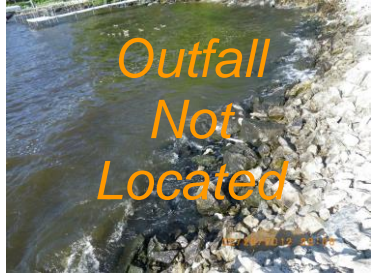
o20120620070830.JPG

Inspection Date: 6/20/2012 8:05:53 AM		Type: Other	Flow: Submerged (not located)	Previous Rainfall (hrs): 24-48
Illicit Discharge Potential: Unlikely		Inspector: JCW		
Submerged: Fully		Depth (in):		
Sampling Results		Notes		
Sample Location:		Gross solids pre-screening. Outfall fully submerged; screened upstream at 02-357 US1.		
Total Chlorine: -- ppm	Floatables: None	Condition Assessment Graffiti: None Erosion: None Deposition: None in. Damage: None		
Free Chlorine: -- ppm	Odor: None			
Ammonia: -- ppm	Turbidity: None			
pH: -- units	Color: None			
Temperature -- °F	Gross Solids: None			
Conductivity: -- µS/cm	Vegetation: None			
Detergents: -- mg/L	Benthic Growth: None			
	Stains: None			
	Non-illicit: None

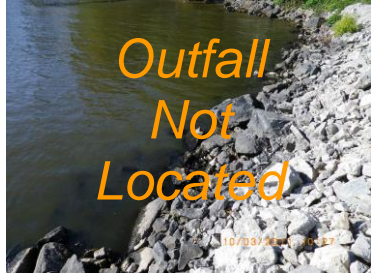
o20111003102714.JPG

Inspection Date: 10/3/2011 10:26:14 AM		Type: Ongoing	Flow: Submerged (not located)	Previous Rainfall (hrs): 72+
Illicit Discharge Potential: Potential		Inspector: JCW		
Submerged: Fully		Depth (in):		
Sampling Results		Notes		
Sample Location:		Outfall fully submerged and not physically located. Outfall screened upstream at 02-357 US1.		
Total Chlorine: -- ppm	Floatables: None	Condition Assessment Graffiti: None Erosion: None Deposition: None 0 in. Damage: None		
Free Chlorine: -- ppm	Odor: None			
Ammonia: -- ppm	Turbidity: None			
pH: -- units	Color: None			
Temperature -- °F	Gross Solids: None			
Conductivity: -- µS/cm	Vegetation: None			
Detergents: -- mg/L	Benthic Growth: None			
	Stains: None			
	Non-illicit: None

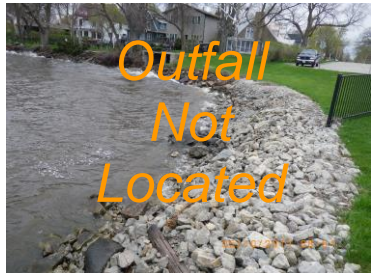
o20110510085116.JPG

Inspection Date: 5/10/2011 8:51:00 AM		Type: Other	Flow: Submerged (not located)	Previous Rainfall (hrs): 0-24
Illicit Discharge Potential: Potential		Inspector: JCW		
Submerged: Fully		Depth (in):		
Sampling Results		Notes		
Sample Location:		Outfall fully submerged and not physically located. Outfall screened upstream at 02-357 US1.		
Total Chlorine: -- ppm	Floatables:	Condition Assessment Graffiti: None Erosion: None Deposition: None 0 in. Damage: None		
Free Chlorine: -- ppm	Odor:			
Ammonia: -- ppm	Turbidity:			
pH: -- units	Color:			
Temperature -- °F	Gross Solids:			
Conductivity: -- µS/cm	Vegetation:			
Detergents: -- mg/L	Benthic Growth:			
	Stains:			
	Non-illicit: None

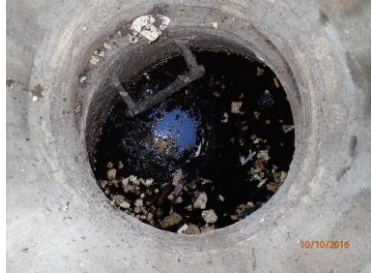
o20161010105436.JPG 2016

Inspection Date: 10/10/2016 10:57:04 AM		Type: Ongoing	Flow: Submerged, indeterminate	Previous Rainfall (hrs): 72+
Illicit Discharge Potential: Potential		Inspector: JCW	Notes	
Submerged: Fully		Depth (in): 37	Potential illicit discharge due to gross solids.	
Sampling Results				
Sample Location:	Pool	Floatables:	None	
Total Chlorine:	0 ppm	Odor:	None	
Free Chlorine:	0 ppm	Turbidity:	None	
Ammonia:	0 ppm	Color:	None	
pH:	7.54 units	Gross Solids:	Moderate	
Temperature	65 °F	Vegetation:	None	
Conductivity:	654 µS/cm	Benthic Growth:	None	
Detergents:	0 mg/L	Stains:	None	
		Non-illicit:	None	
			Condition Assessment	
			Graffiti:	None
			Erosion:	None
			Deposition:	None in.
			Damage:	None

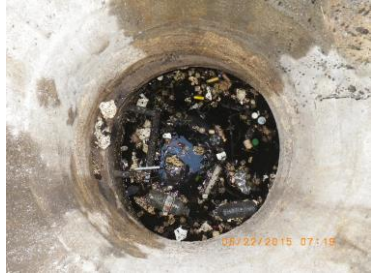
o20150922061944.JPG 2015

Inspection Date: 9/22/2015 7:15:12 AM		Type: Ongoing	Flow: Submerged, indeterminate	Previous Rainfall (hrs): 72+
Illicit Discharge Potential: Potential		Inspector: JCW	Notes	
Submerged: Fully		Depth (in): 39	Floating gross solids (litter) in manhole.	
Sampling Results				
Sample Location:	Pool	Floatables:	None	
Total Chlorine:	0 ppm	Odor:	None	
Free Chlorine:	0 ppm	Turbidity:	None	
Ammonia:	0 ppm	Color:	None	
pH:	7.84 units	Gross Solids:	Moderate	
Temperature	65 °F	Vegetation:	None	
Conductivity:	459 µS/cm	Benthic Growth:	None	
Detergents:	0 mg/L	Stains:	None	
		Non-illicit:	None	
			Condition Assessment	
			Graffiti:	None
			Erosion:	None
			Deposition:	None in.
			Damage:	None

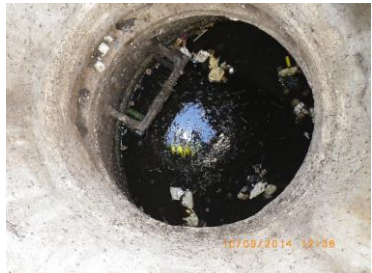
o20141009113842.JPG 2014

Inspection Date: 10/9/2014 12:40:37 PM		Type: Ongoing	Flow: Submerged, indeterminate	Previous Rainfall (hrs): 72+
Illicit Discharge Potential: Potential		Inspector: JCW	Notes	
Submerged: Fully		Depth (in): 35	Floating gross solids (litter) in manhole.	
Sampling Results				
Sample Location:	Pool	Floatables:	None	
Total Chlorine:	0 ppm	Odor:	None	
Free Chlorine:	0 ppm	Turbidity:	None	
Ammonia:	0 ppm	Color:	None	
pH:	7.58 units	Gross Solids:	Moderate	
Temperature	62 °F	Vegetation:	None	
Conductivity:	707 µS/cm	Benthic Growth:	None	
Detergents:	0 mg/L	Stains:	None	
		Non-illicit:	None	
			Condition Assessment	
			Graffiti:	None
			Erosion:	None
			Deposition:	None in.
			Damage:	None

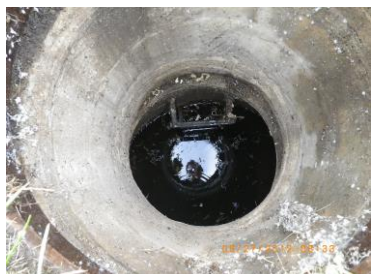
o20120927073352.JPG 2012

Inspection Date: 9/27/2012 8:31:15 AM		Type: Ongoing	Flow: Submerged, indeterminate	Previous Rainfall (hrs): 72+
Illicit Discharge Potential: Unlikely		Inspector: JCW	Notes	
Submerged: Fully		Depth (in): 36	2011 gross solids follow-up.	
Sampling Results				
Sample Location:	Pool	Floatables:	None	
Total Chlorine:	0 ppm	Odor:	None	
Free Chlorine:	0 ppm	Turbidity:	None	
Ammonia:	0 ppm	Color:	None	
pH:	7.73 units	Gross Solids:	Slight	
Temperature	60 °F	Vegetation:	None	
Conductivity:	518 µS/cm	Benthic Growth:	None	
Detergents:	0 mg/L	Stains:	None	
		Non-illicit:	None	
			Condition Assessment	
			Graffiti:	None
			Erosion:	None
			Deposition:	None in.
			Damage:	None

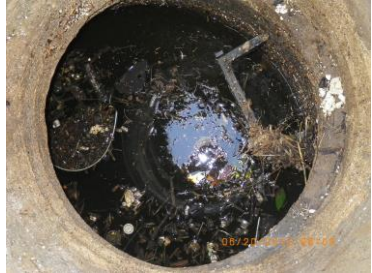
o20120620070908.JPG

Inspection Date: 6/20/2012 8:08:37 AM		Type: Other	Flow: Submerged, indeterminate	Previous Rainfall (hrs): 24-48
Illicit Discharge Potential: Unlikely		Inspector: JCW	Notes	
Submerged: Fully		Depth (in): 43	Gross solids pre-screening.	
Sampling Results				
Sample Location:	Floatables:	None		
Total Chlorine: -- ppm	Odor:	None		
Free Chlorine: -- ppm	Turbidity:	None		
Ammonia: -- ppm	Color:	None		
pH: -- units	Gross Solids:	Moderate		
Temperature -- °F	Vegetation:	None		
Conductivity: -- µS/cm	Benthic Growth:	Slight		
Detergents: -- mg/L	Stains:	None		
	Non-illicit:	None		
			Condition Assessment	
			Graffiti:	None
			Erosion:	None
			Deposition:	None in.
			Damage:	None

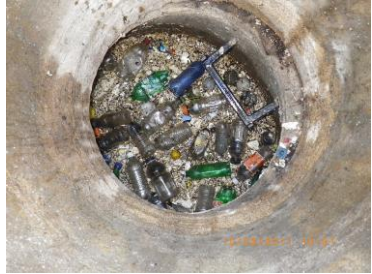
o20111003103104.JPG

Inspection Date: 10/3/2011 10:30:08 AM		Type: Ongoing	Flow: Submerged, indeterminate	Previous Rainfall (hrs): 72+
Illicit Discharge Potential: Potential		Inspector: JCW	Notes	
Submerged: Fully		Depth (in): 39	Significant floatable debris in manhole.	
Sampling Results				
Sample Location: Pool	Floatables:	None		
Total Chlorine: 0 ppm	Odor:	None		
Free Chlorine: 0 ppm	Turbidity:	None		
Ammonia: 0 ppm	Color:	None		
pH: 7.1 units	Gross Solids:	Severe		
Temperature 61 °F	Vegetation:	None		
Conductivity: -- µS/cm	Benthic Growth:	None		
Detergents: 0 mg/L	Stains:	None		
	Non-illicit:	None		
			Condition Assessment	
			Graffiti:	None
			Erosion:	None
			Deposition:	None 0 in.
			Damage:	None
