IDDE Ongoing Screening Summary Report

2021 Inspection Year

City of Oshkosh

Westwood

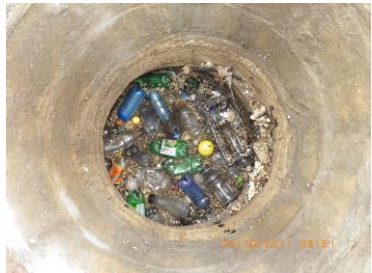
o20110510085154.JPG

Inspection Date: 5/10/2011 8:51:00 AM		Type: Other	Flow: Submerged, indeterminate	Previous Rainfall (hrs): 0-24
Illicit Discharge Potential: Potential		Inspector: JCW	Notes	
Submerged: Fully		Depth (in):	Limited screening conducted for upstream manhole prescreening.	
Sampling Results				
Sample Location:	Floatables:	None		
Total Chlorine: -- ppm	Odor:			
Free Chlorine: -- ppm	Turbidity:			
Ammonia: -- ppm	Color:			
pH: -- units	Gross Solids:	Severe		
Temperature -- °F	Vegetation:			
Conductivity: -- µS/cm	Benthic Growth:			
Detergents: -- mg/L	Stains:			
	Non-illicit:	None		
			Condition Assessment	
			Graffiti:	None
			Erosion:	None
			Deposition:	None 0 in.
			Damage:	None

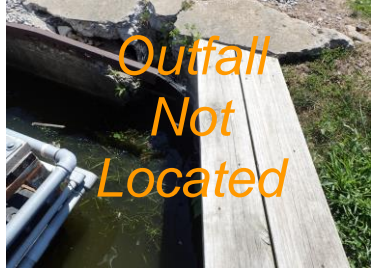
o20200819140018.JPG

Inspection Date: 8/19/2020 2:03:43 PM		Type: Ongoing	Flow: Submerged (not located)	Previous Rainfall (hrs): 72+
Illicit Discharge Potential: Potential		Inspector: JCW	Notes	
Submerged: Fully		Depth (in):	Outfall fully submerged and not located - screened upstream at 03-22 US1. Floating gross solids (litter) in upstream manhole.	
Sampling Results		Floatables:	Condition Assessment Graffiti: None Erosion: None Deposition: None in. Damage: None	
Sample Location:		Odor:		
Total Chlorine: -- ppm		Turbidity:		
Free Chlorine: -- ppm		Color:		
Ammonia: -- ppm		Gross Solids:		
pH: -- units		Vegetation:		
Temperature -- °F		Benthic Growth:		
Conductivity: -- µS/cm		Stains:		
Detergents: -- mg/L		Non-illicit:

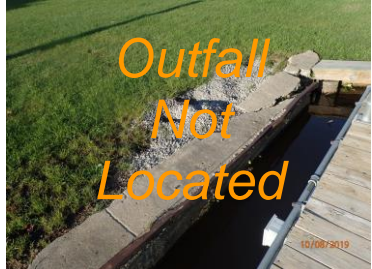
o20191008073428.jpg

Inspection Date: 10/8/2019 8:34:00 AM		Type: Repeat	Flow: Submerged (not located)	Previous Rainfall (hrs): 48-72
Illicit Discharge Potential: Potential		Inspector: JCW	Notes	
Submerged: Fully		Depth (in):	Outfall fully submerged and not located - screened upstream at 03-22 US1. Follow-up inspection for sampling - limited screening conducted.	
Sampling Results		Floatables:	Condition Assessment Graffiti: None Erosion: None Deposition: None in. Damage: None	
Sample Location:		Odor:		
Total Chlorine: -- ppm		Turbidity:		
Free Chlorine: -- ppm		Color:		
Ammonia: -- ppm		Gross Solids:		
pH: -- units		Vegetation:		
Temperature -- °F		Benthic Growth:		
Conductivity: -- µS/cm		Stains:		
Detergents: -- mg/L		Non-illicit:

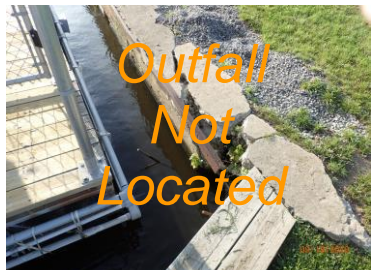
o20190918071544.JPG

Inspection Date: 9/18/2019 8:16:51 AM		Type: Ongoing	Flow: Submerged (not located)	Previous Rainfall (hrs): 72+
Illicit Discharge Potential: Potential		Inspector: JCW	Notes	
Submerged: Fully		Depth (in):	Outfall fully submerged and not located - screened upstream at 03-22 US1. Floating gross solids (litter) and detergent in manhole.	
Sampling Results		Floatables:	Condition Assessment Graffiti: None Erosion: None Deposition: None in. Damage: None	
Sample Location:		Odor:		
Total Chlorine: -- ppm		Turbidity:		
Free Chlorine: -- ppm		Color:		
Ammonia: -- ppm		Gross Solids:		
pH: -- units		Vegetation:		
Temperature -- °F		Benthic Growth:		
Conductivity: -- µS/cm		Stains:		
Detergents: -- mg/L		Non-illicit:

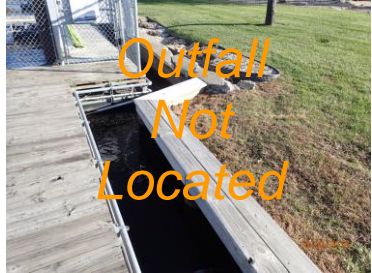
o20181022155222.JPG

Inspection Date: 10/22/2018 3:53:56 PM		Type: Ongoing	Flow: Submerged (not located)	Previous Rainfall (hrs): 48-72
Illicit Discharge Potential: Potential		Inspector: JCW	Notes	
Submerged: Fully		Depth (in):	Outfall fully submerged and not located - screened upstream at 03-22 US1. Floating gross solids (litter) in manhole.	
Sampling Results		Floatables:	Condition Assessment Graffiti: None Erosion: None Deposition: None in. Damage: None	
Sample Location:		Odor:		
Total Chlorine: -- ppm		Turbidity:		
Free Chlorine: -- ppm		Color:		
Ammonia: -- ppm		Gross Solids:		
pH: -- units		Vegetation:		
Temperature -- °F		Benthic Growth:		
Conductivity: -- µS/cm		Stains:		
Detergents: -- mg/L		Non-illicit:

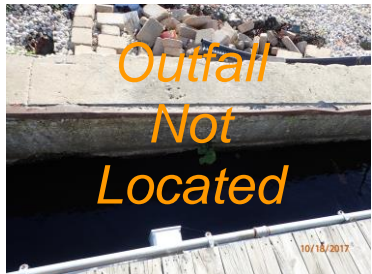
o20171018151946.JPG

Inspection Date: 10/18/2017 3:22:08 PM		Type: Ongoing	Flow: Submerged (not located)	Previous Rainfall (hrs): 72+
Illicit Discharge Potential: Potential		Inspector: JCW	Notes	
Submerged: Fully		Depth (in):	Outfall fully submerged and not located - screened upstream at 03-22 US1. Floating gross solids (litter) in manhole.	
Sampling Results		Floatables:	Condition Assessment Graffiti: None Erosion: None Deposition: None in. Damage: None	
Sample Location:		Odor:		
Total Chlorine: -- ppm		Turbidity:		
Free Chlorine: -- ppm		Color:		
Ammonia: -- ppm		Gross Solids:		
pH: -- units		Vegetation:		
Temperature -- °F		Benthic Growth:		
Conductivity: -- µS/cm		Stains:		
Detergents: -- mg/L		Non-illicit:

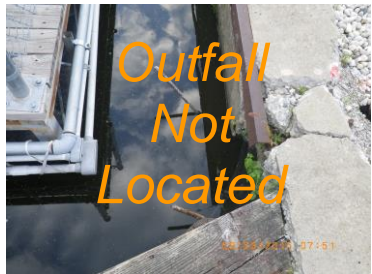
o20150923065132.JPG

Inspection Date: 9/23/2015 7:47:01 AM		Type: Ongoing	Flow: Submerged (not located)	Previous Rainfall (hrs): 72+
Illicit Discharge Potential: Potential		Inspector: JCW	Notes	
Submerged: Fully		Depth (in):	Significant sinking above suspected pipe. Outfall not located - screened at 03-22 US1.	
Sampling Results		Floatables:	Condition Assessment Graffiti: None Erosion: None Deposition: None in. Damage: Severe	
Sample Location:		Odor:		
Total Chlorine: -- ppm		Turbidity:		
Free Chlorine: -- ppm		Color:		
Ammonia: -- ppm		Gross Solids:		
pH: -- units		Vegetation:		
Temperature -- °F		Benthic Growth:		
Conductivity: -- µS/cm		Stains:		
Detergents: -- mg/L		Non-illicit:

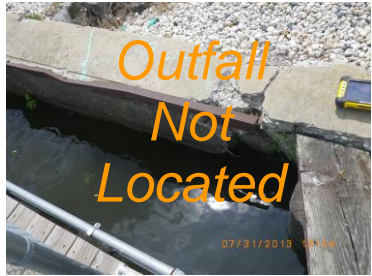
<p style="text-align: center; font-weight: bold; font-size: 1.2em;">2013</p>																																									
Submerged: Fully		Depth (in):		2012 screening follow-up. Outfall not located. Outfall screened upstream at 03-22 US1. Gross solids in upstream mh.																																											
Sampling Results <table border="1" style="width:100%; border-collapse: collapse;"> <tr><td colspan="2">Sample Location:</td></tr> <tr><td>Total Chlorine:</td><td>-- ppm</td></tr> <tr><td>Free Chlorine:</td><td>-- ppm</td></tr> <tr><td>Ammonia:</td><td>-- ppm</td></tr> <tr><td>pH:</td><td>-- units</td></tr> <tr><td>Temperature:</td><td>-- °F</td></tr> <tr><td>Conductivity:</td><td>-- µS/cm</td></tr> <tr><td>Detergents:</td><td>-- mg/L</td></tr> </table>		Sample Location:		Total Chlorine:	-- ppm			Free Chlorine:	-- ppm	Ammonia:	-- ppm	pH:	-- units	Temperature:	-- °F	Conductivity:	-- µS/cm	Detergents:	-- mg/L	<table border="1" style="width:100%; border-collapse: collapse;"> <tr><td>Floatables:</td><td>None</td></tr> <tr><td>Odor:</td><td>None</td></tr> <tr><td>Turbidity:</td><td>None</td></tr> <tr><td>Color:</td><td>None</td></tr> <tr><td>Gross Solids:</td><td>None</td></tr> <tr><td>Vegetation:</td><td>None</td></tr> <tr><td>Benthic Growth:</td><td>None</td></tr> <tr><td>Stains:</td><td>None</td></tr> <tr><td>Non-illicit:</td><td>None</td></tr> </table>		Floatables:	None	Odor:	None	Turbidity:	None	Color:	None	Gross Solids:	None	Vegetation:	None	Benthic Growth:	None	Stains:	None	Non-illicit:	None	Condition Assessment <table border="1" style="width:100%; border-collapse: collapse;"> <tr><td>Graffiti:</td><td>None</td></tr> <tr><td>Erosion:</td><td>None</td></tr> <tr><td>Deposition:</td><td>None in.</td></tr> <tr><td>Damage:</td><td>None</td></tr> </table>		Graffiti:	None	Erosion:	None	Deposition:	None in.

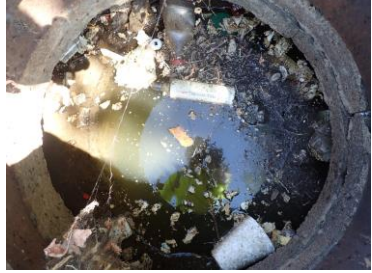
o20200819140108.JPG

Inspection Date: 8/19/2020 2:04:58 PM		Type: Ongoing	Flow: Submerged, indeterminate	Previous Rainfall (hrs): 72+
Illicit Discharge Potential: Potential		Inspector: JCW		
Submerged: Fully		Depth (in): 47		
Sampling Results		Notes Sample collected from submerged pool in manhole. Floating gross solids (litter) in manhole. Elevated pH seemed widespread in river.		
Sample Location: Pool	Floatables: None	Condition Assessment Graffiti: None Erosion: None Deposition: None in. Damage: None		
Total Chlorine: 0 ppm	Odor: None			
Free Chlorine: 0 ppm	Turbidity: None			
Ammonia: 0 ppm	Color: None			
pH: 9.13 units	Gross Solids: Severe			
Temperature 84 °F	Vegetation: None			
Conductivity: 338 µS/cm	Benthic Growth: None			
Detergents: 0 mg/L	Stains: None			
	Non-illicit: None

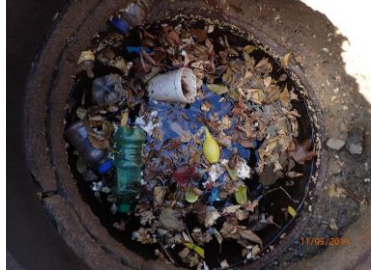
o20191105112834.JPG

Inspection Date: 11/5/2019 11:28:50 AM		Type: Repeat	Flow: Submerged, indeterminate	Previous Rainfall (hrs): 48-72
Illicit Discharge Potential: Potential		Inspector: JCW		
Submerged: Partially		Depth (in): 47		
Sampling Results		Notes Follow-up inspection for sampling - limited screening conducted. Floating gross solids (litter) in manhole.		
Sample Location: Pool	Floatables: None	Condition Assessment Graffiti: None Erosion: None Deposition: None in. Damage: None		
Total Chlorine: -- ppm	Odor: None			
Free Chlorine: -- ppm	Turbidity: None			
Ammonia: -- ppm	Color: None			
pH: -- units	Gross Solids: Severe			
Temperature -- °F	Vegetation: None			
Conductivity: -- µS/cm	Benthic Growth: None			
Detergents: 0 mg/L	Stains: None			
	Non-illicit: None

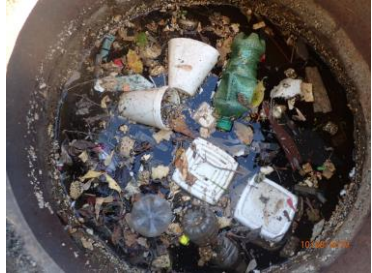
o20191008073520.jpg

Inspection Date: 10/8/2019 8:35:00 AM		Type: Repeat	Flow: Submerged, indeterminate	Previous Rainfall (hrs): 48-72
Illicit Discharge Potential: Potential		Inspector: JCW		
Submerged: Partially		Depth (in): 47		
Sampling Results		Notes Follow-up inspection for sampling - limited screening conducted. Floating gross solids (litter) in manhole.		
Sample Location: Pool	Floatables: None	Condition Assessment Graffiti: None Erosion: None Deposition: None in. Damage: None		
Total Chlorine: 0 ppm	Odor: None			
Free Chlorine: 0 ppm	Turbidity: None			
Ammonia: 0 ppm	Color: None			
pH: 7.58 units	Gross Solids: Severe			
Temperature 56 °F	Vegetation: None			
Conductivity: 381 µS/cm	Benthic Growth: None			
Detergents: 1.2 mg/L	Stains: None			
	Non-illicit: None

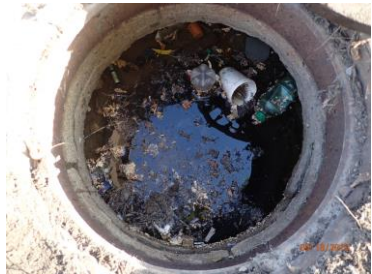
o20190918071726.JPG

Inspection Date: 9/18/2019 8:19:32 AM		Type: Ongoing	Flow: Submerged, indeterminate	Previous Rainfall (hrs): 72+
Illicit Discharge Potential: Potential		Inspector: JCW		
Submerged: Fully		Depth (in): 49		
Sampling Results		Notes Sample collected from submerged pool in manhole. Floating gross solids (litter) and detergent in manhole.		
Sample Location: Pool	Floatables: None	Condition Assessment Graffiti: None Erosion: None Deposition: None in. Damage: None		
Total Chlorine: 0 ppm	Odor: None			
Free Chlorine: 0 ppm	Turbidity: None			
Ammonia: 0 ppm	Color: None			
pH: 8.64 units	Gross Solids: Moderate			
Temperature 71 °F	Vegetation: None			
Conductivity: 372 µS/cm	Benthic Growth: None			
Detergents: 1 mg/L	Stains: None			
	Non-illicit: None

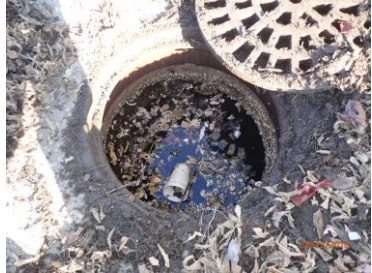
o20181022155408.JPG

Inspection Date: 10/22/2018 3:58:28 PM		Type: Ongoing	Flow: Submerged, indeterminate	Previous Rainfall (hrs): 48-72
Illicit Discharge Potential: Potential		Inspector: JCW	Notes	
Submerged: Fully		Depth (in): 49	Sample collected from submerged pool in manhole. Floating gross solids (litter) in manhole.	
Sampling Results		Floatables: None	Condition Assessment Graffiti: None Erosion: None Deposition: None in. Damage: None	
Sample Location: Pool	Odor: None			
Total Chlorine: 0 ppm	Turbidity: None			
Free Chlorine: 0 ppm	Color: None			
Ammonia: 0 ppm	Gross Solids: Moderate			
pH: 7.68 units	Vegetation: None			
Temperature 55 °F	Benthic Growth: None			
Conductivity: 355 µS/cm	Stains: None			
Detergents: 0 mg/L	Non-illicit: None

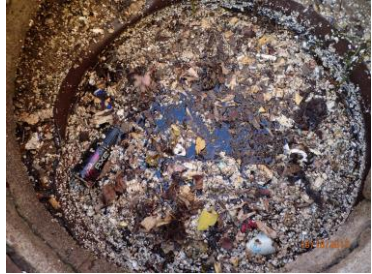
o20171018152158.JPG

Inspection Date: 10/18/2017 3:25:56 PM		Type: Ongoing	Flow: Submerged, indeterminate	Previous Rainfall (hrs): 72+
Illicit Discharge Potential: Potential		Inspector: JCW	Notes	
Submerged: Fully		Depth (in): 44	Sample collected from submerged pool in manhole. Floating gross solids (litter) in manhole.	
Sampling Results		Floatables: None	Condition Assessment Graffiti: None Erosion: None Deposition: None in. Damage: None	
Sample Location: Pool	Odor: None			
Total Chlorine: 0 ppm	Turbidity: None			
Free Chlorine: 0 ppm	Color: None			
Ammonia: 0 ppm	Gross Solids: Moderate			
pH: 8.32 units	Vegetation: None			
Temperature 66 °F	Benthic Growth: None			
Conductivity: 422 µS/cm	Stains: None			
Detergents: 0 mg/L	Non-illicit: None

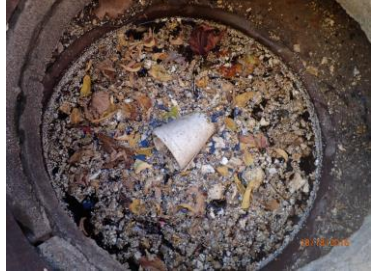
o20161018160430.JPG

Inspection Date: 10/18/2016 4:06:54 PM		Type: Ongoing	Flow: Submerged, indeterminate	Previous Rainfall (hrs): 72+
Illicit Discharge Potential: Potential		Inspector: JCW	Notes	
Submerged: Fully		Depth (in): 44	Potential illicit discharge due to gross solids.	
Sampling Results		Floatables: None	Condition Assessment Graffiti: None Erosion: None Deposition: None in. Damage: None	
Sample Location: Pool	Odor: None			
Total Chlorine: 0 ppm	Turbidity: None			
Free Chlorine: 0 ppm	Color: Faint in bottle			
Ammonia: 0 ppm	Gross Solids: Severe			
pH: 8.15 units	Vegetation: None			
Temperature 66 °F	Benthic Growth: None			
Conductivity: 403 µS/cm	Stains: None			
Detergents: 0 mg/L	Non-illicit: None

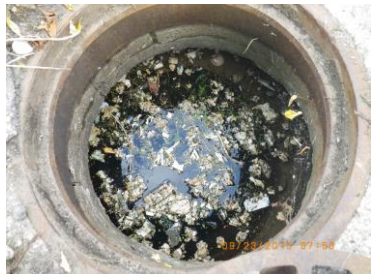
o20150923065324.JPG

Inspection Date: 9/23/2015 7:51:33 AM		Type: Ongoing	Flow: Submerged, indeterminate	Previous Rainfall (hrs): 72+
Illicit Discharge Potential: Potential		Inspector: JCW	Notes	
Submerged: Fully		Depth (in): 46	Floating gross solids (litter) in manhole.	
Sampling Results		Floatables: None	Condition Assessment Graffiti: None Erosion: None Deposition: None in. Damage: None	
Sample Location: Pool	Odor: None			
Total Chlorine: 0 ppm	Turbidity: None			
Free Chlorine: 0 ppm	Color: None			
Ammonia: 0 ppm	Gross Solids: Moderate			
pH: 8.44 units	Vegetation: None			
Temperature 70 °F	Benthic Growth: None			
Conductivity: 354 µS/cm	Stains: None			
Detergents: 0 mg/L	Non-illicit: None

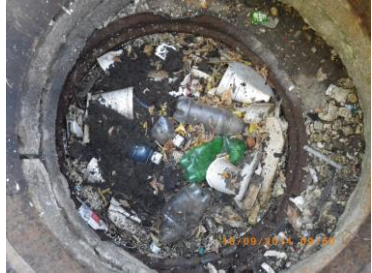
o20141009085040.JPG

Inspection Date: 10/9/2014 9:52:24 AM		Type: Ongoing	Flow: Submerged, indeterminate	Previous Rainfall (hrs): 72+
Illicit Discharge Potential: Potential		Inspector: JCW	Notes	
Submerged: Fully		Depth (in): 40	Floatable litter in catchbasin.	
Sampling Results				
Sample Location:	Pool	Floatables:	None	
Total Chlorine:	0 ppm	Odor:	None	
Free Chlorine:	0 ppm	Turbidity:	None	
Ammonia:	0 ppm	Color:	Faint in bottle	
pH:	7.79 units	Gross Solids:	Severe	
Temperature	57 °F	Vegetation:	None	
Conductivity:	442 µS/cm	Benthic Growth:	None	
Detergents:	0 mg/L	Stains:	None	
		Non-illicit:	None	
			Condition Assessment	
			Graffiti:	None
			Erosion:	None
			Deposition:	None in.
			Damage:	None

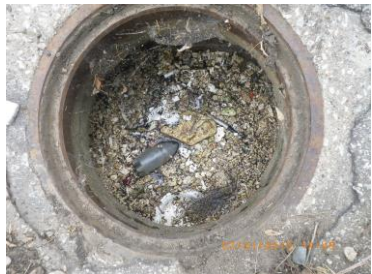
o20130731114610.JPG

Inspection Date: 7/31/2013 12:42:35 PM		Type: Ongoing	Flow: Submerged, indeterminate	Previous Rainfall (hrs): 72+
Illicit Discharge Potential: Potential		Inspector: JCW	Notes	
Submerged: Fully		Depth (in): 44	2012 screening follow-up. Significant gross solids - similar to previous years.	
Sampling Results				
Sample Location:	Pool	Floatables:	None	
Total Chlorine:	0 ppm	Odor:	Faint	
Free Chlorine:	0 ppm	Turbidity:	None	
Ammonia:	0 ppm	Color:	Faint in bottle	
pH:	7.95 units	Gross Solids:	Severe	
Temperature	76 °F	Vegetation:	None	
Conductivity:	450 µS/cm	Benthic Growth:	None	
Detergents:	0 mg/L	Stains:	None	
		Non-illicit:	None	
			Condition Assessment	
			Graffiti:	None
			Erosion:	None
			Deposition:	None in.
			Damage:	None

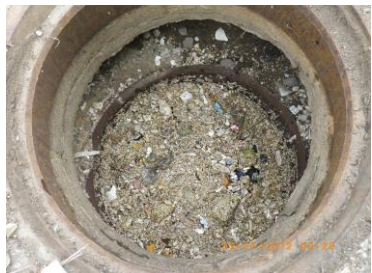
o20120927082922.JPG

Inspection Date: 9/27/2012 9:27:45 AM		Type: Ongoing	Flow: Submerged, indeterminate	Previous Rainfall (hrs): 72+
Illicit Discharge Potential: Potential		Inspector: JCW	Notes	
Submerged: Fully		Depth (in): 39	2011 gross solids follow-up.	
Sampling Results				
Sample Location:	Pool	Floatables:	None	
Total Chlorine:	0 ppm	Odor:	None	
Free Chlorine:	0 ppm	Turbidity:	None	
Ammonia:	0 ppm	Color:	None	
pH:	8.32 units	Gross Solids:	Severe	
Temperature	59 °F	Vegetation:	None	
Conductivity:	398 µS/cm	Benthic Growth:	None	
Detergents:	0 mg/L	Stains:	None	
		Non-illicit:	None	
			Condition Assessment	
			Graffiti:	None
			Erosion:	None
			Deposition:	None in.
			Damage:	None

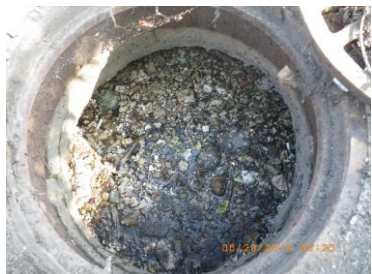
o20120620082508.JPG

Inspection Date: 6/20/2012 9:24:19 AM		Type: Other	Flow: Submerged, indeterminate	Previous Rainfall (hrs): 24-48
Illicit Discharge Potential: Potential		Inspector: JCW	Notes	
Submerged: Fully		Depth (in): 46	Gross solids pre-screening.	
Sampling Results				
Sample Location:		Floatables:	None	
Total Chlorine:	-- ppm	Odor:	None	
Free Chlorine:	-- ppm	Turbidity:	None	
Ammonia:	-- ppm	Color:	None	
pH:	-- units	Gross Solids:	Severe	
Temperature	-- °F	Vegetation:	None	
Conductivity:	-- µS/cm	Benthic Growth:	None	
Detergents:	-- mg/L	Stains:	None	
		Non-illicit:	None	
			Condition Assessment	
			Graffiti:	None
			Erosion:	None
			Deposition:	None in.
			Damage:	None

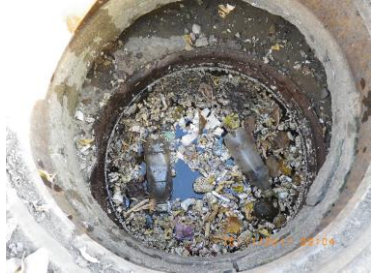
o20111011090446.JPG

Inspection Date: 10/11/2011 9:05:50 AM		Type: Ongoing	Flow: Submerged, indeterminate	Previous Rainfall (hrs): 72+
Illicit Discharge Potential: Potential		Inspector: JCW	Notes	
Submerged: Fully		Depth (in): 37	2010 screening follow-up. No significant change in volume of floatable debris.	
Sampling Results		Floatables: None	Condition Assessment	
Sample Location:	Pool	Odor: None	Graffiti: None	
Total Chlorine:	0 ppm	Turbidity: None	Erosion: None	
Free Chlorine:	0 ppm	Color: None	Deposition: None 0 in.	
Ammonia:	0 ppm	Gross Solids: Moderate	Damage: None	
pH:	8.13 units	Vegetation: None		
Temperature:	70 °F	Benthic Growth: None		
Conductivity:	-- µS/cm	Stains: None		
Detergents:	-- mg/L	Non-illicit: None

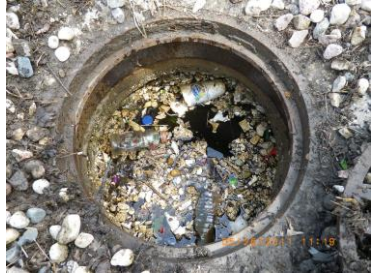
o20110526111930.JPG

Inspection Date: 5/26/2011 11:19:00 AM		Type: Other	Flow: Submerged, indeterminate	Previous Rainfall (hrs): 72+
Illicit Discharge Potential: Potential		Inspector: JCW	Notes	
Submerged: Fully		Depth (in):	Limited screening conducted to check for floatable debris.	
Sampling Results		Floatables: None	Condition Assessment	
Sample Location:		Odor:	Graffiti: None	
Total Chlorine:	-- ppm	Turbidity:	Erosion: None	
Free Chlorine:	-- ppm	Color:	Deposition: None 0 in.	
Ammonia:	-- ppm	Gross Solids: Moderate	Damage: None	
pH:	-- units	Vegetation:		
Temperature:	-- °F	Benthic Growth:		
Conductivity:	-- µS/cm	Stains:		
Detergents:	-- mg/L	Non-illicit: None

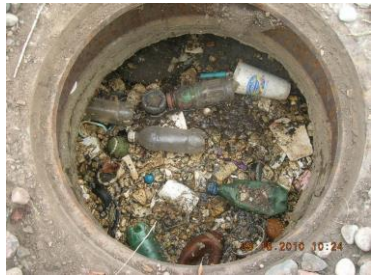
o20100818102410.JPG

Inspection Date: 8/18/2010 10:29:59 AM		Type: Ongoing	Flow: Submerged, indeterminate	Previous Rainfall (hrs): 72+
Illicit Discharge Potential: Potential		Inspector: JCW	Notes	
Submerged: Fully		Depth (in): 44	Severe floatable debris in catchbasin.	
Sampling Results		Floatables: None	Condition Assessment	
Sample Location:	Pool	Odor: None	Graffiti: None	
Total Chlorine:	0 ppm	Turbidity: None	Erosion: None	
Free Chlorine:	0 ppm	Color: Faint in bottle	Deposition: None 0 in.	
Ammonia:	0 ppm	Gross Solids: Severe	Damage: None	
pH:	7.38 units	Vegetation: None		
Temperature:	76 °F	Benthic Growth: None		
Conductivity:	-- µS/cm	Stains: None		
Detergents:	0 mg/L	Non-illicit: None

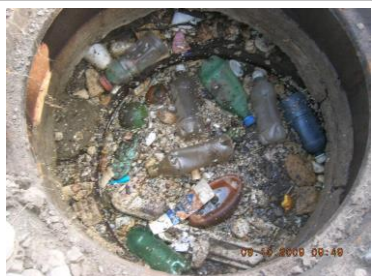
Osh09_DSCN6768.JPG

Inspection Date: 9/10/2009		Type: Initial	Flow: Submerged, indeterminate	Previous Rainfall (hrs): 72+
Illicit Discharge Potential: Potential		Inspector: JCW	Notes	
Submerged: Fully		Depth (in): 44	Abnormal detergent analysis result (bubbles). Significant floatables in manhole.	
Sampling Results		Floatables: None	Condition Assessment	
Sample Location:	Pool	Odor: None	Graffiti: None	
Total Chlorine:	0 ppm	Turbidity: None	Erosion: None	
Free Chlorine:	0 ppm	Color: None	Deposition: None 0 in.	
Ammonia:	-- ppm	Gross Solids: Severe	Damage: None	
pH:	8.3 units	Vegetation: None		
Temperature:	75 °F	Benthic Growth: None		
Conductivity:	-- µS/cm	Stains: None		
Detergents:	0 mg/L	Non-illicit: None

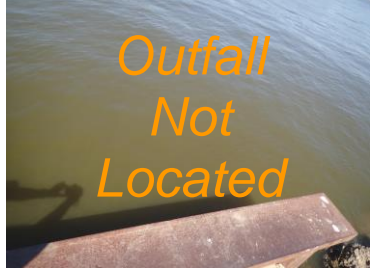
o20200819143634.JPG <div style="text-align: center; font-size: 24pt; font-weight: bold;">2020</div>

Inspection Date: 8/19/2020 2:40:57 PM		Type: Ongoing	Flow: Submerged (not located)	Previous Rainfall (hrs): 72+
Illicit Discharge Potential: Potential		Inspector: JCW		
Submerged: Fully		Depth (in):		
Sampling Results Sample Location: _____ Total Chlorine: -- ppm Free Chlorine: -- ppm Ammonia: -- ppm pH: -- units Temperature: -- °F Conductivity: -- µS/cm Detergents: -- mg/L		Floatables: None Odor: None Turbidity: None Color: None Gross Solids: None Vegetation: None Benthic Growth: None Stains: None Non-illicit: None	Notes Outfall fully submerged and not located - screened upstream at 03-35 US1. Floating gross solids (litter) in upstream manhole. Condition Assessment Graffiti: None Erosion: None Deposition: None in. Damage: None

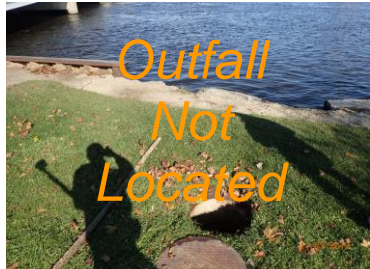
o20191105114512.JPG <div style="text-align: center; font-size: 24pt; font-weight: bold;">2019</div>

Inspection Date: 11/5/2019 11:44:00 AM		Type: Repeat	Flow: Submerged (not located)	Previous Rainfall (hrs): 48-72
Illicit Discharge Potential: Potential		Inspector: JCW		
Submerged: Fully		Depth (in):		
Sampling Results Sample Location: _____ Total Chlorine: -- ppm Free Chlorine: -- ppm Ammonia: -- ppm pH: -- units Temperature: -- °F Conductivity: -- µS/cm Detergents: -- mg/L		Floatables: None Odor: None Turbidity: None Color: None Gross Solids: None Vegetation: None Benthic Growth: None Stains: None Non-illicit: None	Notes Follow-up inspection for sampling - limited screening conducted. Floating gross solids (litter) and detergent in manhole. Condition Assessment Graffiti: None Erosion: None Deposition: None in. Damage: None

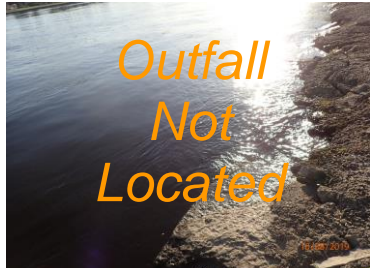
o20191008072714.JPG <div style="text-align: center; font-size: 24pt; font-weight: bold;">2019</div>

Inspection Date: 10/8/2019 8:29:12 AM		Type: Repeat	Flow: Submerged (not located)	Previous Rainfall (hrs): 48-72
Illicit Discharge Potential: Potential		Inspector: JCW		
Submerged: Fully		Depth (in):		
Sampling Results Sample Location: _____ Total Chlorine: -- ppm Free Chlorine: -- ppm Ammonia: -- ppm pH: -- units Temperature: -- °F Conductivity: -- µS/cm Detergents: -- mg/L		Floatables: None Odor: None Turbidity: None Color: None Gross Solids: None Vegetation: None Benthic Growth: None Stains: None Non-illicit: None	Notes Detergent detection follow-up. Limited screening conducted beyond sampling. Condition Assessment Graffiti: None Erosion: None Deposition: None in. Damage: None

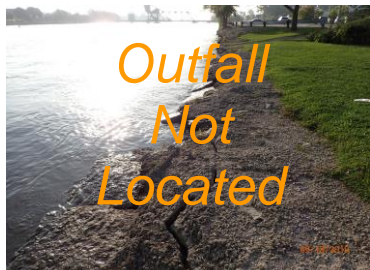
o20190918070310.JPG <div style="text-align: center; font-size: 24pt; font-weight: bold;">2019</div>

Inspection Date: 9/18/2019 8:05:22 AM		Type: Ongoing	Flow: Submerged (not located)	Previous Rainfall (hrs): 72+
Illicit Discharge Potential: Potential		Inspector: JCW		
Submerged: Fully		Depth (in):		
Sampling Results Sample Location: _____ Total Chlorine: -- ppm Free Chlorine: -- ppm Ammonia: -- ppm pH: -- units Temperature: -- °F Conductivity: -- µS/cm Detergents: -- mg/L		Floatables: None Odor: None Turbidity: None Color: None Gross Solids: None Vegetation: None Benthic Growth: None Stains: None Non-illicit: None	Notes Outfall fully submerged and not located - screened upstream at 03-35 US1. Floating gross solids (litter) and detergent in manhole. Condition Assessment Graffiti: None Erosion: None Deposition: None in. Damage: None

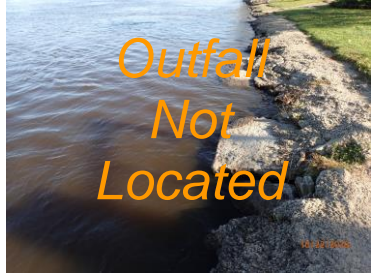
o20181022152608.JPG

Inspection Date: 10/22/2018 3:27:47 PM		Type: Ongoing	Flow: Submerged (not located)	Previous Rainfall (hrs): 48-72
Illicit Discharge Potential: Potential		Inspector: JCW	Notes	
Submerged: Fully Depth (in):			Outfall fully submerged and not located - screened upstream at 03-35 US1. Floating gross solids (litter) in manhole.	
Sampling Results			Condition Assessment	
Sample Location:	Floatables:	None	Graffiti: None Erosion: None Deposition: None in. Damage: None	
Total Chlorine: -- ppm	Odor:	None		
Free Chlorine: -- ppm	Turbidity:	None		
Ammonia: -- ppm	Color:	None		
pH: -- units	Gross Solids:	None		
Temperature -- °F	Vegetation:	None		
Conductivity: -- µS/cm	Benthic Growth:	None		
Detergents: -- mg/L	Stains:	None		
	Non-illicit:	None

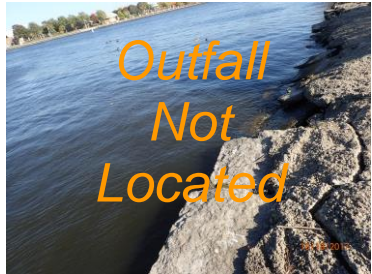
o20171018150844.JPG

Inspection Date: 10/18/2017 3:15:43 PM		Type: Ongoing	Flow: Submerged (not located)	Previous Rainfall (hrs): 72+
Illicit Discharge Potential: Potential		Inspector: JCW	Notes	
Submerged: Fully Depth (in):			Outfall fully submerged and not located - screened upstream at 03-35 US1. Floating gross solids (litter) in manhole.	
Sampling Results			Condition Assessment	
Sample Location:	Floatables:	None	Graffiti: None Erosion: None Deposition: None in. Damage: None	
Total Chlorine: -- ppm	Odor:	None		
Free Chlorine: -- ppm	Turbidity:	None		
Ammonia: -- ppm	Color:	None		
pH: -- units	Gross Solids:	None		
Temperature -- °F	Vegetation:	None		
Conductivity: -- µS/cm	Benthic Growth:	None		
Detergents: -- mg/L	Stains:	None		
	Non-illicit:	None

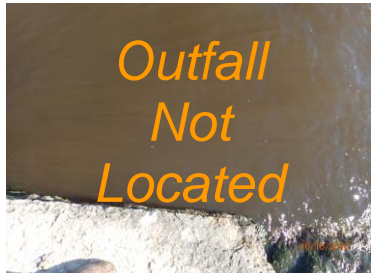
o20161010094930.JPG

Inspection Date: 10/10/2016 9:52:05 AM		Type: Ongoing	Flow: Submerged (not located)	Previous Rainfall (hrs): 72+
Illicit Discharge Potential: Potential		Inspector: JCW	Notes	
Submerged: Fully Depth (in):			Outfall fully submerged and not located - screened upstream at 03-35 US1.	
Sampling Results			Condition Assessment	
Sample Location:	Floatables:	None	Graffiti: None Erosion: None Deposition: None in. Damage: None	
Total Chlorine: -- ppm	Odor:	None		
Free Chlorine: -- ppm	Turbidity:	None		
Ammonia: -- ppm	Color:	None		
pH: -- units	Gross Solids:	None		
Temperature -- °F	Vegetation:	None		
Conductivity: -- µS/cm	Benthic Growth:	None		
Detergents: -- mg/L	Stains:	None		
	Non-illicit:	None

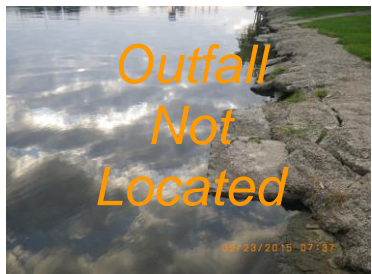
o20150923063720.JPG

Inspection Date: 9/23/2015 7:34:32 AM		Type: Ongoing	Flow: Submerged (not located)	Previous Rainfall (hrs): 72+
Illicit Discharge Potential: Potential		Inspector: JCW	Notes	
Submerged: Fully Depth (in):			Outfall fully submerged and not located - screened at 03-35 US1.	
Sampling Results			Condition Assessment	
Sample Location:	Floatables:	None	Graffiti: None Erosion: None Deposition: None in. Damage: None	
Total Chlorine: -- ppm	Odor:	None		
Free Chlorine: -- ppm	Turbidity:	None		
Ammonia: -- ppm	Color:	None		
pH: -- units	Gross Solids:	None		
Temperature -- °F	Vegetation:	None		
Conductivity: -- µS/cm	Benthic Growth:	None		
Detergents: -- mg/L	Stains:	None		
	Non-illicit:	None

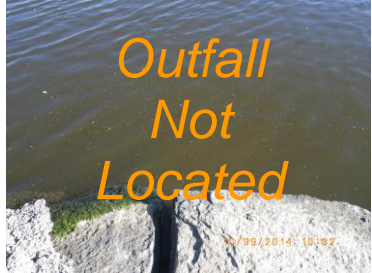
Inspection Date: 10/9/2014 10:33:07 AM		Type: Ongoing		Flow: Submerged (not located)		Previous Rainfall (hrs): 72+	
Illicit Discharge Potential: Unlikely		Inspector: JCW		Notes

<p style="text-align: center;">o20141009093222.JPG</p> <p style="text-align: center; font-size: 1.5em; font-weight: bold;">2014</p>	
Submerged: Fully		Depth (in):		Outfall fully submerged and not located - screened upstream at 03-35 US1			
Sampling Results				Condition Assessment			
Sample Location:		Floatables:	None	Gross solids pre-screening.			
Total Chlorine: -- ppm		Odor:	None				
Free Chlorine: -- ppm		Turbidity:	None	Condition Assessment			
Ammonia: -- ppm		Color:	None				
pH: -- units		Gross Solids:	None	Gross Solids: None		in.	
Temperature -- °F		Vegetation:	None				
Conductivity: -- µS/cm		Benthic Growth:	None	Erosion: None			
Detergents: -- mg/L		Stains:	None				
		Non-illicit:	None	Deposition: None			
				Damage: None

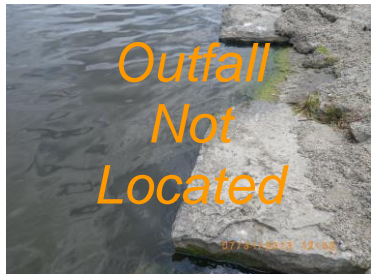
Inspection Date: 7/31/2013 12:30:28 PM		Type: Ongoing		Flow: Submerged (not located)		Previous Rainfall (hrs): 72+	
Illicit Discharge Potential: Potential		Inspector: JCW		Notes

<p style="text-align: center;">o20130731113304.JPG</p> <p style="text-align: center; font-size: 1.5em; font-weight: bold;">2013</p>	
Submerged: Fully		Depth (in):		2012 screening follow-up. Outfall not located. Outfall screened upstream at 03-35 US1. Gross solids in upstream mh.			
Sampling Results				Condition Assessment			
Sample Location:		Floatables:	None	Gross solids pre-screening.			
Total Chlorine: -- ppm		Odor:	None				
Free Chlorine: -- ppm		Turbidity:	None	Condition Assessment			
Ammonia: -- ppm		Color:	None				
pH: -- units		Gross Solids:	None	Gross Solids: None		in.	
Temperature -- °F		Vegetation:	None				
Conductivity: -- µS/cm		Benthic Growth:	None	Erosion: None			
Detergents: -- mg/L		Stains:	None				
		Non-illicit:	None	Deposition: None

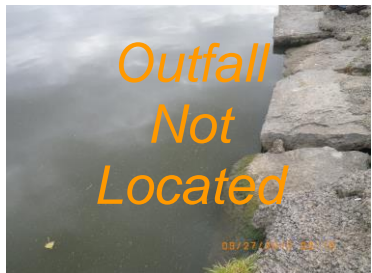
Inspection Date: 9/27/2012 9:13:17 AM		Type: Ongoing		Flow: Submerged (not located)		Previous Rainfall (hrs): 72+	
Illicit Discharge Potential: Potential		Inspector: JCW		Notes

<p style="text-align: center;">o20120927081506.JPG</p> <p style="text-align: center; font-size: 1.5em; font-weight: bold;">2012</p>	
Submerged: Fully		Depth (in):		Outfall fully submerged; screened upstream at 03-35 US1.			
Sampling Results				Condition Assessment			
Sample Location:		Floatables:	None	Gross solids pre-screening.			
Total Chlorine: -- ppm		Odor:	None				
Free Chlorine: -- ppm		Turbidity:	None	Condition Assessment			
Ammonia: -- ppm		Color:	None				
pH: -- units		Gross Solids:	None	Gross Solids: None		in.	
Temperature -- °F		Vegetation:	None				
Conductivity: -- µS/cm		Benthic Growth:	None	Erosion: None			
Detergents: -- mg/L		Stains:	None				
		Non-illicit:	None	Deposition: None			
				Damage: None

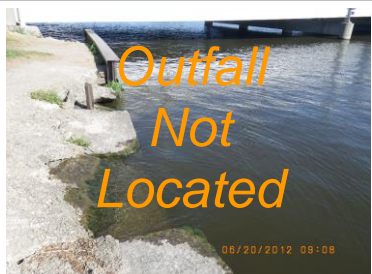
Inspection Date: 6/20/2012 9:06:10 AM		Type: Other		Flow: Submerged (not located)		Previous Rainfall (hrs): 24-48	
Illicit Discharge Potential: Potential		Inspector: JCW		Notes

<p style="text-align: center;">o20120620080844.JPG</p> <p style="text-align: center; font-size: 1.5em; font-weight: bold;">2012</p>	
Submerged: Fully		Depth (in):		Gross solids pre-screening.			
Sampling Results				Condition Assessment			
Sample Location:		Floatables:	None	Gross solids pre-screening.			
Total Chlorine: -- ppm		Odor:	None				
Free Chlorine: -- ppm		Turbidity:	None	Condition Assessment			
Ammonia: -- ppm		Color:	None				
pH: -- units		Gross Solids:	None	Gross Solids: None		in.	
Temperature -- °F		Vegetation:	None				
Conductivity: -- µS/cm		Benthic Growth:	None	Erosion: None			
Detergents: -- mg/L		Stains:	None				
		Non-illicit:	None	Deposition: None			
				Damage: None

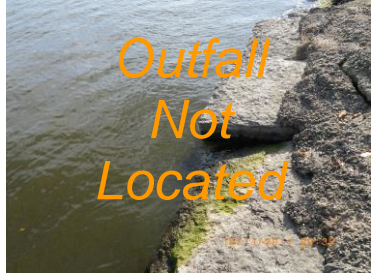
o20111011093254.JPG

Inspection Date: 10/11/2011 9:36:03 AM		Type: Ongoing	Flow: Submerged (not located)	Previous Rainfall (hrs): 72+
Illicit Discharge Potential: Potential		Inspector: JCW		
Submerged: Fully		Depth (in):		
Sampling Results		Notes		
Sample Location:	Floatables:	2010 screening follow-up. Outfall fully submerged and not physically located. Outfall screened upstream at 03-35 US1.		
Total Chlorine: -- ppm	Odor:			
Free Chlorine: -- ppm	Turbidity:			
Ammonia: -- ppm	Color:			
pH: -- units	Gross Solids:			
Temperature -- °F	Vegetation:			
Conductivity: -- µS/cm	Benthic Growth:			
Detergents: -- mg/L	Stains:			
	Non-illicit:	Graffiti: None Erosion: None Deposition: None 0 in. Damage: None

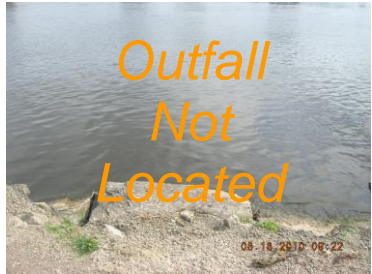
o20100818092204.JPG

Inspection Date: 8/18/2010 9:27:46 AM		Type: Ongoing	Flow: Submerged (not located)	Previous Rainfall (hrs): 72+
Illicit Discharge Potential: Potential		Inspector: JCW		
Submerged: Fully		Depth (in):		
Sampling Results		Notes		
Sample Location:	Floatables:	Outfall fully submerged and not physically located. Outfall screened upstream at 03-35 US1.		
Total Chlorine: -- ppm	Odor:			
Free Chlorine: -- ppm	Turbidity:			
Ammonia: -- ppm	Color:			
pH: -- units	Gross Solids:			
Temperature -- °F	Vegetation:			
Conductivity: -- µS/cm	Benthic Growth:			
Detergents: -- mg/L	Stains:			
	Non-illicit:	Graffiti: None Erosion: None Deposition: None 0 in. Damage: None

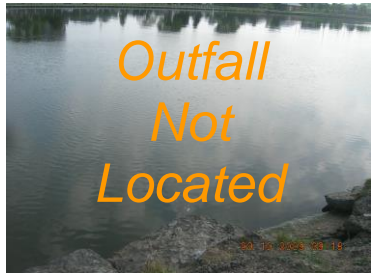
Osh09_DSCN6761.JPG

Inspection Date: 9/10/2009		Type: Initial	Flow: Submerged (not located)	Previous Rainfall (hrs): 72+
Illicit Discharge Potential: Potential		Inspector: JCW		
Submerged: Fully		Depth (in):		
Sampling Results		Notes		
Sample Location:	Floatables:	Outfall fully submerged and not physically located. Outfall screened upstream at 03-35 US1.		
Total Chlorine: -- ppm	Odor:			
Free Chlorine: -- ppm	Turbidity:			
Ammonia: -- ppm	Color:			
pH: -- units	Gross Solids:			
Temperature -- °F	Vegetation:			
Conductivity: -- µS/cm	Benthic Growth:			
Detergents: -- mg/L	Stains:			
	Non-illicit:	Graffiti: None Erosion: None Deposition: None 0 in. Damage: None

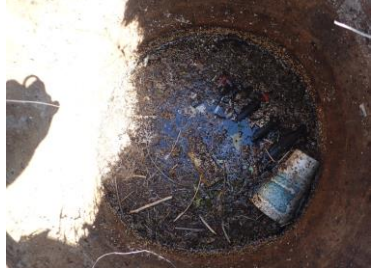
o20200819143804.JPG

Inspection Date: 8/19/2020 2:41:48 PM		Type: Ongoing	Flow: Submerged, indeterminate	Previous Rainfall (hrs): 72+
Illicit Discharge Potential: Potential		Inspector: JCW		
Submerged: Fully		Depth (in): 36		
Sampling Results		Notes		
Sample Location: Pool	Floatables: None	Sample collected from submerged pool in manhole. Floating gross solids (litter) in manhole. Slightly elevated ammonia.		
Total Chlorine: 0 ppm	Odor: None			
Free Chlorine: 0 ppm	Turbidity: None	Condition Assessment		
Ammonia: 0.5 ppm	Color: None			
pH: 8.44 units	Gross Solids: Severe	Graffiti: None	in.	
Temperature 85 °F	Vegetation: None	Erosion: None		
Conductivity: 346 µS/cm	Benthic Growth: None	Deposition: None		
Detergents: 0 mg/L	Stains: None	Damage: None		
	Non-illicit: None

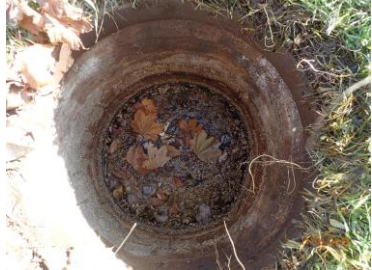
o20191105114518.JPG

Inspection Date: 11/5/2019 11:45:22 AM		Type: Repeat	Flow: Submerged, indeterminate	Previous Rainfall (hrs): 48-72
Illicit Discharge Potential: Potential		Inspector: JCW		
Submerged: Partially		Depth (in): 30		
Sampling Results		Notes		
Sample Location: Pool	Floatables: None	Detergent detection follow-up. Limited screening conducted. Floating gross solids (litter) and detergent in manhole.		
Total Chlorine: -- ppm	Odor: None			
Free Chlorine: -- ppm	Turbidity: None	Condition Assessment		
Ammonia: -- ppm	Color: None			
pH: -- units	Gross Solids: Severe	Graffiti: None	in.	
Temperature -- °F	Vegetation: None	Erosion: None		
Conductivity: -- µS/cm	Benthic Growth: None	Deposition: None		
Detergents: 0 mg/L	Stains: None	Damage: None		
	Non-illicit: None

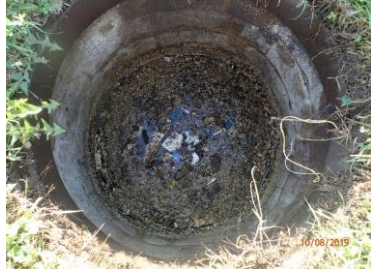
o20191008072724.JPG

Inspection Date: 10/8/2019 8:30:16 AM		Type: Repeat	Flow: Submerged, indeterminate	Previous Rainfall (hrs): 48-72
Illicit Discharge Potential: Potential		Inspector: JCW		
Submerged: Partially		Depth (in): 42		
Sampling Results		Notes		
Sample Location: Pool	Floatables: None	Detergent detection follow-up. Limited screening conducted beyond sampling.		
Total Chlorine: 0 ppm	Odor: None			
Free Chlorine: 0 ppm	Turbidity: None	Condition Assessment		
Ammonia: 0 ppm	Color: None			
pH: 7.68 units	Gross Solids: Severe	Graffiti: None	in.	
Temperature 55 °F	Vegetation: None	Erosion: None		
Conductivity: 415 µS/cm	Benthic Growth: None	Deposition: None		
Detergents: 1.3 mg/L	Stains: None	Damage: None		
	Non-illicit: None

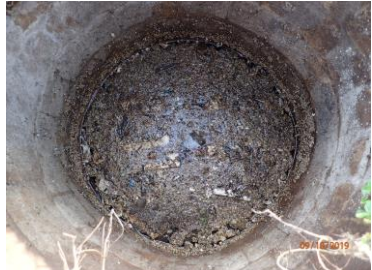
o20190918070320.JPG

Inspection Date: 9/18/2019 8:06:15 AM		Type: Ongoing	Flow: Submerged, indeterminate	Previous Rainfall (hrs): 72+
Illicit Discharge Potential: Potential		Inspector: JCW		
Submerged: Fully		Depth (in): 38		
Sampling Results		Notes		
Sample Location: Pool	Floatables: None	Sample collected from submerged pool in manhole. Floating gross solids (litter) and detergent in manhole.		
Total Chlorine: 0 ppm	Odor: None			
Free Chlorine: 0 ppm	Turbidity: None	Condition Assessment		
Ammonia: 0 ppm	Color: None			
pH: 8.47 units	Gross Solids: Severe	Graffiti: None	in.	
Temperature 70 °F	Vegetation: None	Erosion: None		
Conductivity: 389 µS/cm	Benthic Growth: None	Deposition: None		
Detergents: 1.3 mg/L	Stains: None	Damage: None		
	Non-illicit: None

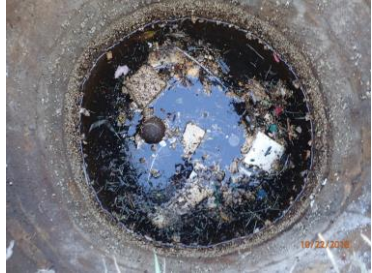
o20181022152746.JPG

Inspection Date: 10/22/2018 3:30:12 PM		Type: Ongoing	Flow: Submerged, indeterminate	Previous Rainfall (hrs): 48-72
Illicit Discharge Potential: Potential		Inspector: JCW	Notes	
Submerged: Fully		Depth (in): 41	Sample collected from submerged pool in manhole. Floating gross solids (litter) in manhole.	
Sampling Results		Floatables: None	Condition Assessment	
Sample Location:	Pool	Odor: None	Graffiti: None	
Total Chlorine:	0 ppm	Turbidity: None	Erosion: None	
Free Chlorine:	0 ppm	Color: None	Deposition: None in.	
Ammonia:	0 ppm	Gross Solids: Moderate	Damage: None	
pH:	7.81 units	Vegetation: None		
Temperature:	56 °F	Benthic Growth: None		
Conductivity:	338 µS/cm	Stains: None		
Detergents:	0 mg/L	Non-illicit: None

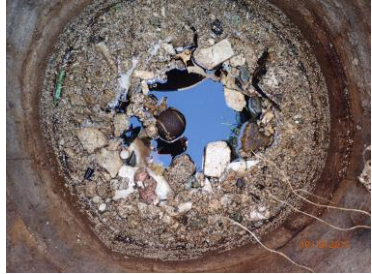
o20171018151012.JPG

Inspection Date: 10/18/2017 3:16:37 PM		Type: Ongoing	Flow: Submerged, indeterminate	Previous Rainfall (hrs): 72+
Illicit Discharge Potential: Potential		Inspector: JCW	Notes	
Submerged: Fully		Depth (in): 35	Sample collected from submerged pool in manhole. Floating gross solids (litter) in manhole.	
Sampling Results		Floatables: None	Condition Assessment	
Sample Location:	Pool	Odor: None	Graffiti: None	
Total Chlorine:	0 ppm	Turbidity: None	Erosion: None	
Free Chlorine:	0 ppm	Color: None	Deposition: None in.	
Ammonia:	0 ppm	Gross Solids: Severe	Damage: None	
pH:	7.94 units	Vegetation: None		
Temperature:	66 °F	Benthic Growth: None		
Conductivity:	554 µS/cm	Stains: None		
Detergents:	0 mg/L	Non-illicit: None

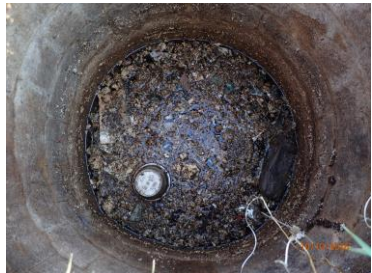
o20161010094958.JPG

Inspection Date: 10/10/2016 9:52:43 AM		Type: Ongoing	Flow: Submerged, indeterminate	Previous Rainfall (hrs): 72+
Illicit Discharge Potential: Potential		Inspector: JCW	Notes	
Submerged: Fully		Depth (in): 32	Potential illicit discharge due to gross solids.	
Sampling Results		Floatables: None	Condition Assessment	
Sample Location:	Pool	Odor: Faint	Graffiti: None	
Total Chlorine:	0 ppm	Turbidity: None	Erosion: None	
Free Chlorine:	0 ppm	Color: None	Deposition: None in.	
Ammonia:	0 ppm	Gross Solids: Moderate	Damage: None	
pH:	7.54 units	Vegetation: None		
Temperature:	63 °F	Benthic Growth: None		
Conductivity:	391 µS/cm	Stains: None		
Detergents:	0 mg/L	Non-illicit: None

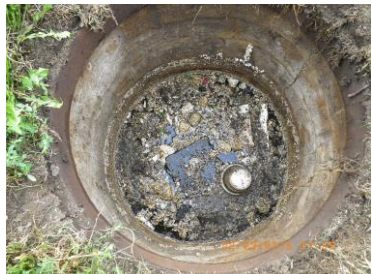
o20150923063950.JPG

Inspection Date: 9/23/2015 7:36:00 AM		Type: Ongoing	Flow: Submerged, indeterminate	Previous Rainfall (hrs): 72+
Illicit Discharge Potential: Potential		Inspector: JCW	Notes	
Submerged: Fully		Depth (in): 30	Floating gross solids (litter) in manhole.	
Sampling Results		Floatables: None	Condition Assessment	
Sample Location:	Pool	Odor: None	Graffiti: None	
Total Chlorine:	0 ppm	Turbidity: None	Erosion: None	
Free Chlorine:	0 ppm	Color: Faint in bottle	Deposition: Minor 1 in.	
Ammonia:	0 ppm	Gross Solids: Moderate	Damage: None	
pH:	8.64 units	Vegetation: None		
Temperature:	69 °F	Benthic Growth: None		
Conductivity:	359 µS/cm	Stains: None		
Detergents:	0 mg/L	Non-illicit: None

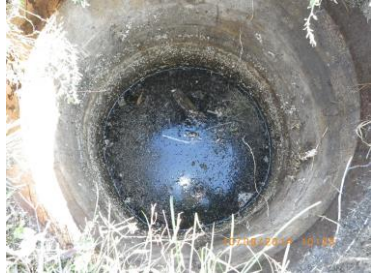
<p style="text-align: center;">o20141009093356.JPG</p> <p style="text-align: center; font-size: 1.5em; font-weight: bold;">2014</p>	
Submerged: Fully		Depth (in): 32		Vegetative debris in photo from opening lid.			
Sampling Results				Condition Assessment			
Sample Location: Pool		Floatables: None		Gross Solids: Slight		Gross Solids: Slight	
Total Chlorine: 0 ppm		Odor: None		Vegetation: None		Vegetation: None	
Free Chlorine: 0 ppm		Turbidity: None		Benthic Growth: None		Benthic Growth: None	
Ammonia: 0 ppm		Color: Faint in bottle		Stains: None		Stains: None	
pH: 7.86 units		Gross Solids: Slight		Non-illicit: None		Non-illicit: None	
Temperature 58 °F		Vegetation: None		Gross Solids: Slight		Gross Solids: Slight	
Conductivity: 476 µS/cm		Benthic Growth: None		Vegetation: None		Vegetation: None

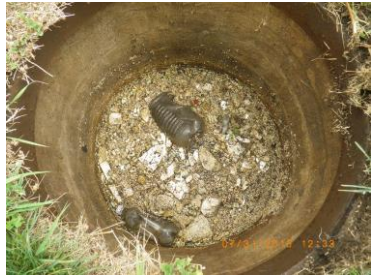
<p style="text-align: center;">o20130731113346.JPG</p> <p style="text-align: center; font-size: 1.5em; font-weight: bold;">2013</p>	
Submerged: Fully		Depth (in): 33		2012 screening follow-up. Significant gross solids. Similar to previous years.			
Sampling Results				Condition Assessment			
Sample Location: Pool		Floatables: None		Gross Solids: Severe		Gross Solids: Severe	
Total Chlorine: 0 ppm		Odor: None		Vegetation: None		Vegetation: None	
Free Chlorine: 0 ppm		Turbidity: None		Benthic Growth: None		Benthic Growth: None	
Ammonia: 0 ppm		Color: Faint in bottle		Stains: Moderate		Stains: Moderate	
pH: 8.47 units		Gross Solids: Severe		Non-illicit: None		Non-illicit: None	
Temperature 75 °F		Vegetation: None		Gross Solids: Severe		Gross Solids: Severe

Conductivity: 425 µS/cm		Benthic Growth: None		Vegetation: None		Vegetation: None	
Detergents: 0 mg/L		Stains: Moderate		Benthic Growth: None		Benthic Growth: None	
		Non-illicit: None		Stains: Moderate		Stains: Moderate	
				Damage: None		Damage: None

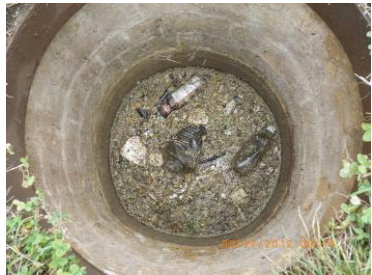
<p style="text-align: center;">o20120927081522.JPG</p> <p style="text-align: center; font-size: 1.5em; font-weight: bold;">2012</p>	
Submerged: Fully		Depth (in): 31		2011 gross solids follow-up.			
Sampling Results				Condition Assessment			
Sample Location: Pool		Floatables: None		Gross Solids: Severe		Gross Solids: Severe	
Total Chlorine: 0 ppm		Odor: None		Vegetation: None		Vegetation: None	
Free Chlorine: 0 ppm		Turbidity: None		Benthic Growth: None		Benthic Growth: None	
Ammonia: 0 ppm		Color: None		Stains: Slight		Stains: Slight	
pH: 8.42 units		Gross Solids: Severe		Non-illicit: None		Non-illicit: None	
Temperature 59 °F		Vegetation: None		Gross Solids: Severe		Gross Solids: Severe	
Conductivity: 723 µS/cm		Benthic Growth: None		Vegetation: None		Vegetation: None

Detergents: 0 mg/L		Stains: Slight		Benthic Growth: None		Benthic Growth: None	
		Non-illicit: None		Stains: Slight		Stains: Slight	
				Damage: None		Damage: None

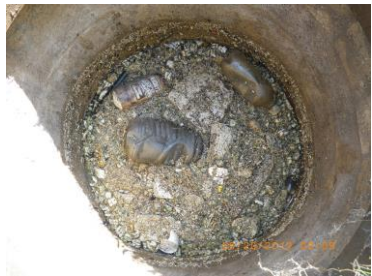
<p style="text-align: center;">o20120620080918.JPG</p> <p style="text-align: center; font-size: 1.5em; font-weight: bold;">2012</p>	
Submerged: Fully		Depth (in): 39		Gross solids pre-screening.			
Sampling Results				Condition Assessment			
Sample Location: Pool		Floatables: None		Gross Solids: Severe		Gross Solids: Severe	
Total Chlorine: -- ppm		Odor: None		Vegetation: None		Vegetation: None	
Free Chlorine: -- ppm		Turbidity: None		Benthic Growth: None		Benthic Growth: None	
Ammonia: -- ppm		Color: None		Stains: None		Stains: None	
pH: -- units		Gross Solids: Severe		Non-illicit: None		Non-illicit: None	
Temperature -- °F		Vegetation: None		Gross Solids: Severe		Gross Solids: Severe	
Conductivity: -- µS/cm		Benthic Growth: None		Vegetation: None		Vegetation: None

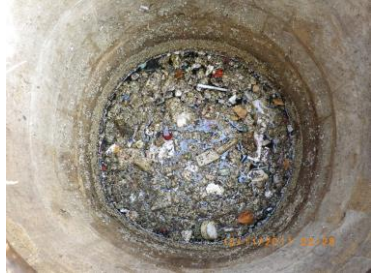
o20111011092832.JPG

Inspection Date: 10/11/2011 9:29:50 AM		Type: Ongoing	Flow: Submerged, indeterminate	Previous Rainfall (hrs): 72+
Illicit Discharge Potential: Potential		Inspector: JCW	Notes	
Submerged: Fully		Depth (in): 19	2010 screening follow-up. Floatable debris still present. Slight petroleum sheen.	
Sampling Results		Floatables: Severe	Condition Assessment	
Sample Location:	Pool	Odor: None	Graffiti: None	
Total Chlorine:	0 ppm	Turbidity: None	Erosion: None	
Free Chlorine:	0 ppm	Color: None	Deposition: None 0 in.	
Ammonia:	0 ppm	Gross Solids: Severe	Damage: None	
pH:	8.01 units	Vegetation: None		
Temperature:	71 °F	Benthic Growth: None		
Conductivity:	-- µS/cm	Stains: None		
Detergents:	-- mg/L	Non-illicit: None

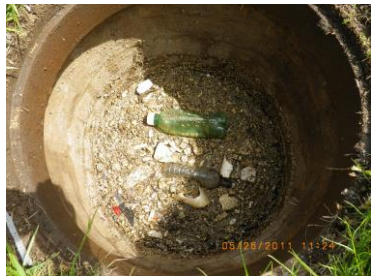
o20110526112400.JPG

Inspection Date: 5/26/2011 11:23:00 AM		Type: Other	Flow: Submerged, indeterminate	Previous Rainfall (hrs): 72+
Illicit Discharge Potential: Potential		Inspector: JCW	Notes	
Submerged: Fully		Depth (in):	Limited screening conducted to check for floatable debris.	
Sampling Results		Floatables: None	Condition Assessment	
Sample Location:		Odor:	Graffiti: None	
Total Chlorine:	-- ppm	Turbidity:	Erosion: None	
Free Chlorine:	-- ppm	Color:	Deposition: None 0 in.	
Ammonia:	-- ppm	Gross Solids: Severe	Damage: None	
pH:	-- units	Vegetation:		
Temperature:	-- °F	Benthic Growth:		
Conductivity:	-- µS/cm	Stains:		
Detergents:	-- mg/L	Non-illicit: None

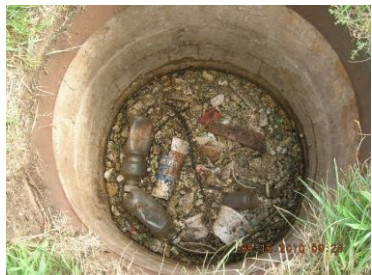
o20100818092304.JPG

Inspection Date: 8/18/2010 9:32:06 AM		Type: Ongoing	Flow: Submerged, indeterminate	Previous Rainfall (hrs): 72+
Illicit Discharge Potential: Potential		Inspector: JCW	Notes	
Submerged: Fully		Depth (in): 34	Severe floatable debris in catchbasin.	
Sampling Results		Floatables: None	Condition Assessment	
Sample Location:	Pool	Odor: Faint	Graffiti: None	
Total Chlorine:	0 ppm	Turbidity: None	Erosion: None	
Free Chlorine:	0 ppm	Color: Faint in bottle	Deposition: None 0 in.	
Ammonia:	0.5 ppm	Gross Solids: Severe	Damage: None	
pH:	7.46 units	Vegetation: None		
Temperature:	73 °F	Benthic Growth: None		
Conductivity:	-- µS/cm	Stains: None		
Detergents:	0 mg/L	Non-illicit: None

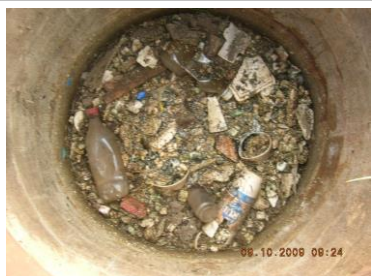
Osh09_DSCN6763.JPG

Inspection Date: 9/10/2009		Type: Initial	Flow: Submerged, indeterminate	Previous Rainfall (hrs): 72+
Illicit Discharge Potential: Potential		Inspector: JCW	Notes	
Submerged: Fully		Depth (in): 33	Abnormal detergent analysis result (bubbles). Significant floatables in manhole.	
Sampling Results		Floatables: None	Condition Assessment	
Sample Location:	Pool	Odor: None	Graffiti: None	
Total Chlorine:	0 ppm	Turbidity: None	Erosion: None	
Free Chlorine:	0 ppm	Color: None	Deposition: None 0 in.	
Ammonia:	-- ppm	Gross Solids: Severe	Damage: None	
pH:	8.23 units	Vegetation: None		
Temperature:	73 °F	Benthic Growth: None		
Conductivity:	-- µS/cm	Stains: None		
Detergents:	0 mg/L	Non-illicit: None

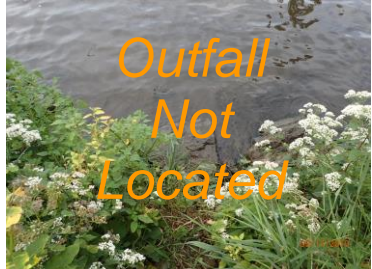
Inspection Date: 9/17/2019 3:00:32 PM		Type: Ongoing	Flow: Submerged (not located)	Previous Rainfall (hrs): 48-72
Illicit Discharge Potential: Potential		Inspector: JCW		
Submerged: Fully		Depth (in):		
Sampling Results Sample Location: _____ Total Chlorine: -- ppm Free Chlorine: -- ppm Ammonia: -- ppm pH: -- units Temperature: -- °F Conductivity: -- µS/cm Detergents: -- mg/L		Floatables: None Odor: None Turbidity: None Color: None Gross Solids: None Vegetation: None Benthic Growth: None Stains: None Non-illicit: None	Notes Outfall fully submerged and not located - screened upstream at 03-81 US1. Floating gross solids (litter) in manhole. Condition Assessment Graffiti: None Erosion: None Deposition: None in. Damage: None

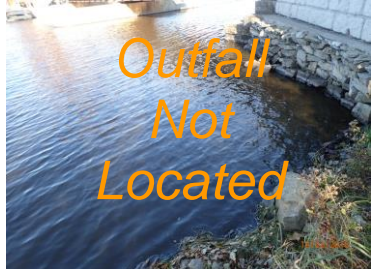
Inspection Date: 10/22/2018 3:13:39 PM		Type: Ongoing	Flow: Submerged (not located)	Previous Rainfall (hrs): 48-72
Illicit Discharge Potential: Potential		Inspector: JCW		
Submerged: Fully		Depth (in):		
Sampling Results Sample Location: _____ Total Chlorine: -- ppm Free Chlorine: -- ppm Ammonia: -- ppm pH: -- units Temperature: -- °F Conductivity: -- µS/cm Detergents: -- mg/L		Floatables: None Odor: None Turbidity: None Color: None Gross Solids: None Vegetation: None Benthic Growth: None Stains: None Non-illicit: None	Notes Outfall fully submerged and not located - screened upstream at 03-81 US1. Floating gross solids (litter) in manhole. Condition Assessment Graffiti: None Erosion: None Deposition: None in. Damage: None

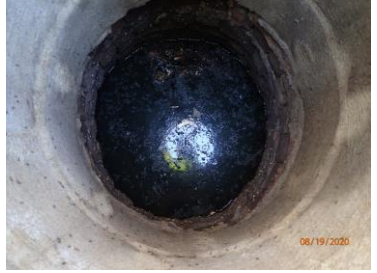
Inspection Date: 8/19/2020 2:19:30 PM		Type: Ongoing	Flow: Submerged, indeterminate	Previous Rainfall (hrs): 72+
Illicit Discharge Potential: Potential Submerged: Fully Depth (in): 50		Inspector: JCW	Notes Sample collected from submerged pool in manhole. Floating gross solids (litter) in manhole. Elevated pH seemed widespread in river.	
Sampling Results Sample Location: Pool Total Chlorine: 0 ppm Free Chlorine: 0 ppm Ammonia: 0 ppm pH: 9.09 units Temperature: 84 °F Conductivity: 327 µS/cm Detergents: 0 mg/L		Floatables: None Odor: None Turbidity: None Color: Faint in bottle Gross Solids: Moderate Vegetation: None Benthic Growth: None Stains: None Non-illicit: None	Condition Assessment Graffiti: None Erosion: None Deposition: None in. Damage: None

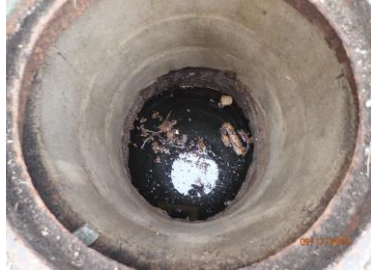
Inspector: JCW Sampling Results Sample Location: Pool Total Chlorine: 0 ppm Free Chlorine: 0 ppm Ammonia: 0 ppm pH: 8.07 units Temperature: 75 °F Conductivity: 399 µS/cm Detergents: 0 mg/L		Floatables: None Odor: None Turbidity: None Color: None Gross Solids: Moderate Vegetation: None Benthic Growth: None Stains: None Non-illicit: None	Notes Sample collected from submerged pool in manhole. Floating gross solids (litter) in manhole.	
			Condition Assessment Graffiti: None Erosion: None Deposition: None in. Damage: None

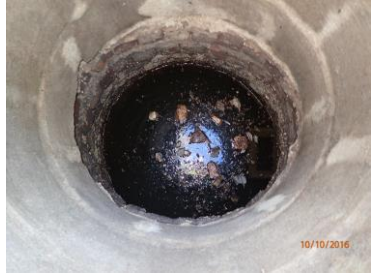
o20161010090136.JPG

Inspection Date: 10/10/2016 9:04:32 AM		Type: Ongoing	Flow: Submerged, indeterminate	Previous Rainfall (hrs): 72+
Illicit Discharge Potential: Potential		Inspector: JCW	Notes	
Submerged: Fully		Depth (in): 46	Potential illicit discharge due to gross solids and petroleum odor and sheen and elevated ammonia.	
Sampling Results		Floatables: Moderate	Condition Assessment	
Sample Location: Pool		Odor: Faint	Graffiti: None	
Total Chlorine: 0 ppm		Turbidity: None	Erosion: None	
Free Chlorine: 0 ppm		Color: Faint in bottle	Deposition: None in.	
Ammonia: 1 ppm		Gross Solids: Slight	Damage: None	
pH: 7.41 units		Vegetation: None		
Temperature 63 °F		Benthic Growth: None		
Conductivity: 565 µS/cm		Stains: None		
Detergents: 0 mg/L		Non-illicit: None

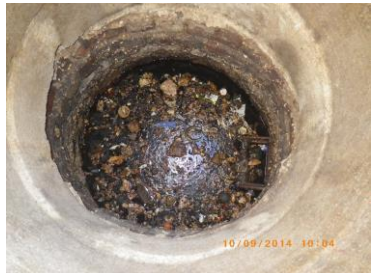
o20141009090404.JPG

Inspection Date: 10/9/2014 10:07:49 AM		Type: Ongoing	Flow: Submerged, indeterminate	Previous Rainfall (hrs): 72+
Illicit Discharge Potential: Obvious		Inspector: JCW	Notes	
Submerged: Fully		Depth (in): 44	Petroleum odor and sheen on surface.	
Sampling Results		Floatables: Moderate	Condition Assessment	
Sample Location: Pool		Odor: Faint	Graffiti: None	
Total Chlorine: 0 ppm		Turbidity: None	Erosion: None	
Free Chlorine: 0 ppm		Color: None	Deposition: Minor 2 in.	
Ammonia: 0.5 ppm		Gross Solids: Severe	Damage: None	
pH: 7.58 units		Vegetation: None		
Temperature 58 °F		Benthic Growth: None		
Conductivity: 679 µS/cm		Stains: None		
Detergents: 0 mg/L		Non-illicit: None

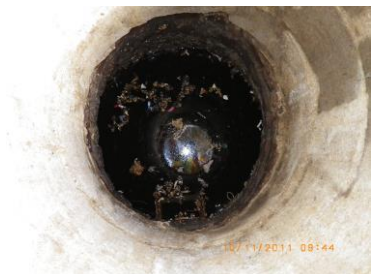
o20111011094434.JPG

Inspection Date: 10/11/2011 9:46:04 AM		Type: Ongoing	Flow: Submerged, indeterminate	Previous Rainfall (hrs): 72+
Illicit Discharge Potential: Unlikely		Inspector: JCW	Notes	
Submerged: Fully		Depth (in): 38	2010 screening follow-up. Floatable debris significantly reduced.	
Sampling Results		Floatables: None	Condition Assessment	
Sample Location: Pool		Odor: None	Graffiti: None	
Total Chlorine: 0 ppm		Turbidity: None	Erosion: None	
Free Chlorine: 0 ppm		Color: None	Deposition: None 0 in.	
Ammonia: 0.25 ppm		Gross Solids: Slight	Damage: None	
pH: 7.68 units		Vegetation: None		
Temperature 71 °F		Benthic Growth: None		
Conductivity: -- µS/cm		Stains: None		
Detergents: -- mg/L		Non-illicit: None

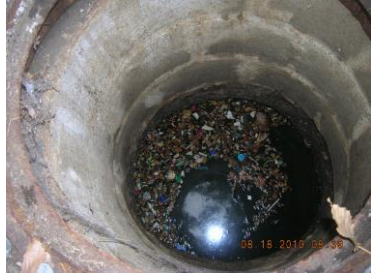
o20100818083958.JPG <div style="text-align: center; font-size: 24pt; font-weight: bold;">2010</div>

Inspection Date: 8/18/2010 8:43:09 AM		Type: Ongoing	Flow: Submerged, indeterminate	Previous Rainfall (hrs): 72+																																				
Illicit Discharge Potential: Potential		Inspector: JCW	Notes																																					
Submerged: Fully		Depth (in): 47	Petroleum odor likely from residual petroleum in pipes after 2009 jetting.

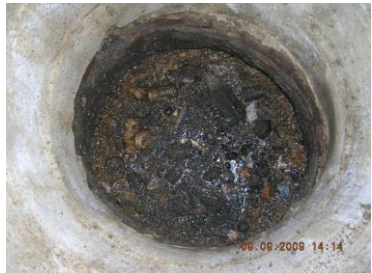
Osh09_DSCN6747.JPG <div style="text-align: center; font-size: 24pt; font-weight: bold;">2009</div>

Inspection Date: 9/9/2009		Type: Initial	Flow: Submerged, indeterminate	Previous Rainfall (hrs): 72+																																				
Illicit Discharge Potential: Obvious		Inspector: JCW	Notes																																					
Submerged: Fully		Depth (in): 44	Diesel/oil odor, sheen on surface. Floatables with grease. Brown/gray color.

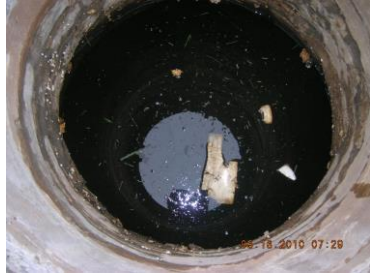
<p style="text-align: center;">o20100818072942.JPG</p> <p style="text-align: center; font-size: 24pt; font-weight: bold;">2010</p>		
Sampling Results					
Sample Location:	Pool	Floatables:			Slight
Total Chlorine:	0 ppm	Odor:			Faint
Free Chlorine:	0 ppm	Turbidity:			None
Ammonia:	0.5 ppm	Color:			Faint in bottle
pH:	7.06 units	Gross Solids:			Slight
Temperature	71 °F	Vegetation:			None
Conductivity:	-- µS/cm	Benthic Growth:			None
Detergents:	0 mg/L	Stains:			None
		Non-illicit:	Slight		
			Condition Assessment Graffiti: None Erosion: None Deposition: None 0 in. Damage: None

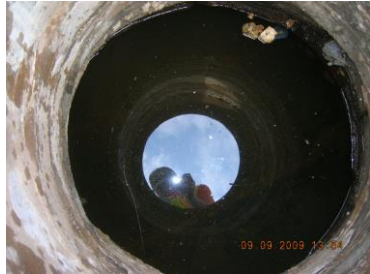
<p style="text-align: center;">Osh09_DSCN6743.JPG</p> <p style="text-align: center; font-size: 24pt; font-weight: bold;">2009</p>		
Sampling Results					
Sample Location:	Pool	Floatables:			None
Total Chlorine:	0 ppm	Odor:			None
Free Chlorine:	0 ppm	Turbidity:			None
Ammonia:	-- ppm	Color:			None
pH:	7.87 units	Gross Solids:			None
Temperature	76 °F	Vegetation:			None
Conductivity:	-- µS/cm	Benthic Growth:			None
Detergents:	0 mg/L	Stains:			None
		Non-illicit:	None		
			Condition Assessment Graffiti: None Erosion: None Deposition: None 0 in. Damage: None

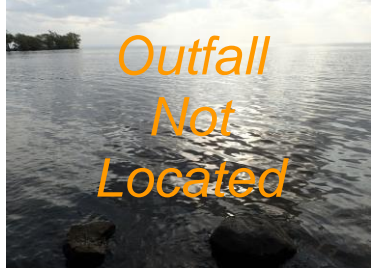
o20200924090116.JPG 2020

Inspection Date: 9/24/2020 8:57:20 AM		Type: Ongoing	Flow: Submerged (not located)	Previous Rainfall (hrs): 72+
Illicit Discharge Potential: Potential		Inspector: QAL		
Submerged: Fully		Depth (in):		
Sampling Results Sample Location: _____ Total Chlorine: -- ppm Free Chlorine: -- ppm Ammonia: -- ppm pH: -- units Temperature: -- °F Conductivity: -- µS/cm Detergents: -- mg/L		Floatables: None Odor: None Turbidity: None Color: None Gross Solids: None Vegetation: None Benthic Growth: None Stains: None Non-illicit: None		
		Notes Outfall fully submerged and not located - screened upstream at 03-173 US1. Floating gross solids (litter) in upstream manhole.		
		Condition Assessment Graffiti: None Erosion: None Deposition: None in. Damage: None

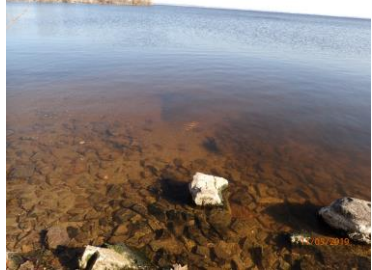
o20191105131408.JPG 2019

Inspection Date: 11/5/2019 1:14:00 PM		Type: Repeat	Flow: Submerged, indeterminate	Previous Rainfall (hrs): 48-72
Illicit Discharge Potential: Potential		Inspector: JCW		
Submerged: Fully		Depth (in):		
Sampling Results Sample Location: _____ Total Chlorine: -- ppm Free Chlorine: -- ppm Ammonia: -- ppm pH: -- units Temperature: -- °F Conductivity: -- µS/cm Detergents: -- mg/L		Floatables: None Odor: None Turbidity: None Color: None Gross Solids: None Vegetation: None Benthic Growth: None Stains: None Non-illicit: None		
		Notes Outfall fully submerged - screened upstream at 03-173 US1. Follow-up inspection for sampling - limited screening conducted.		
		Condition Assessment Graffiti: None Erosion: None Deposition: None in. Damage: None

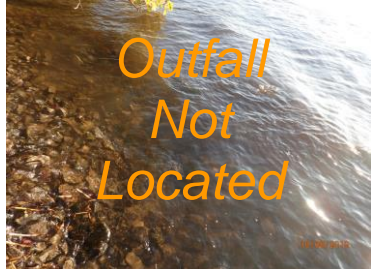
o20191008065912.JPG 2019

Inspection Date: 10/8/2019 8:00:16 AM		Type: Ongoing	Flow: Submerged (not located)	Previous Rainfall (hrs): 48-72
Illicit Discharge Potential: Potential		Inspector: JCW		
Submerged: Fully		Depth (in):		
Sampling Results Sample Location: _____ Total Chlorine: -- ppm Free Chlorine: -- ppm Ammonia: -- ppm pH: -- units Temperature: -- °F Conductivity: -- µS/cm Detergents: -- mg/L		Floatables: None Odor: None Turbidity: None Color: None Gross Solids: None Vegetation: None Benthic Growth: None Stains: None Non-illicit: None		
		Notes Outfall fully submerged and not located - screened upstream at 03-173 US1. Floating gross solids (litter) in manhole. Detergent detected.		
		Condition Assessment Graffiti: None Erosion: None Deposition: None in. Damage: None
