IDDE Ongoing Screening Summary Report

2021 Inspection Year

City of Oshkosh

Westwood

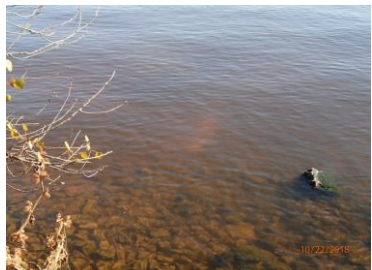
o20181022131820.JPG 2018

Inspection Date: 10/22/2018 1:18:45 PM		Type: Ongoing	Flow: Submerged, indeterminate	Previous Rainfall (hrs): 48-72
Illicit Discharge Potential: Potential		Inspector: JCW		
Submerged: Fully		Depth (in):		
Sampling Results Sample Location: _____ Total Chlorine: -- ppm Free Chlorine: -- ppm Ammonia: -- ppm pH: -- units Temperature: -- °F Conductivity: -- µS/cm Detergents: -- mg/L		Floatables: None Odor: None Turbidity: None Color: None Gross Solids: None Vegetation: None Benthic Growth: None Stains: None Non-illicit: None		
		Notes Outfall fully submerged and not located - screened upstream at 03-173 US1. Floating gross solids (litter) in manhole.		
		Condition Assessment Graffiti: None Erosion: None Deposition: None in. Damage: None

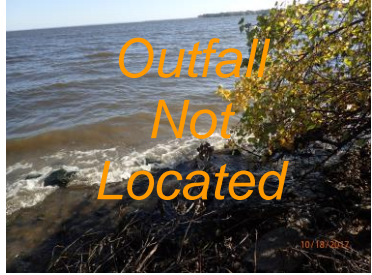
<p style="text-align: center;">o20171018142348.JPG</p> <p style="text-align: center; font-size: 1.5em; font-weight: bold;">2017</p>	
Submerged: Fully		Depth (in):		Outfall fully submerged and not located - screened upstream at 03-173 US2. Floating gross solids (litter) in manhole.			
Sampling Results				Condition Assessment			
Sample Location:		Floatables:	None	Graftiti:		None	in.
Total Chlorine: -- ppm		Odor:	None	Erosion:		None	
Free Chlorine: -- ppm		Turbidity:	None	Deposition:		None	
Ammonia: -- ppm		Color:	None	Damage:		None	
pH: -- units		Gross Solids:	None				
Temperature -- °F		Vegetation:	None				
Conductivity: -- µS/cm		Benthic Growth:	None				
Detergents: -- mg/L		Stains:	None				
		Non-illicit:	None

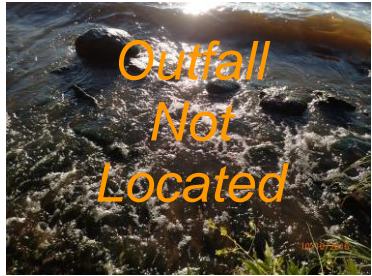
<p style="text-align: center;">o20161010082552.JPG</p> <p style="text-align: center; font-size: 1.5em; font-weight: bold;">2016</p>	
Submerged: Fully		Depth (in):		Outfall fully submerged and not located - screened upstream at 03-173 US2.			
Sampling Results				Condition Assessment			
Sample Location:		Floatables:	None	Graftiti:		None	in.
Total Chlorine: -- ppm		Odor:	None	Erosion:		None	
Free Chlorine: -- ppm		Turbidity:	None	Deposition:		None	
Ammonia: -- ppm		Color:	None	Damage:		None	
pH: -- units		Gross Solids:	None				
Temperature -- °F		Vegetation:	None				
Conductivity: -- µS/cm		Benthic Growth:	None				
Detergents: -- mg/L		Stains:	None				
		Non-illicit:	None

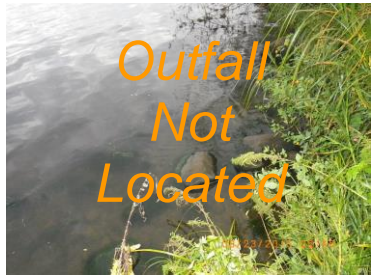
<p style="text-align: center;">o20150923054658.JPG</p> <p style="text-align: center; font-size: 1.5em; font-weight: bold;">2015</p>	
Submerged: Fully		Depth (in):		Outfall fully submerged and not located during this screening - screened at 13-173 US2.			
Sampling Results				Condition Assessment			
Sample Location:		Floatables:	None	Graftiti:		None	in.
Total Chlorine: -- ppm		Odor:	None	Erosion:		None	
Free Chlorine: -- ppm		Turbidity:	None	Deposition:		None	
Ammonia: -- ppm		Color:	None	Damage:		None	
pH: -- units		Gross Solids:	None				
Temperature -- °F		Vegetation:	None				
Conductivity: -- µS/cm		Benthic Growth:	None				
Detergents: -- mg/L		Stains:	None				
		Non-illicit:	None

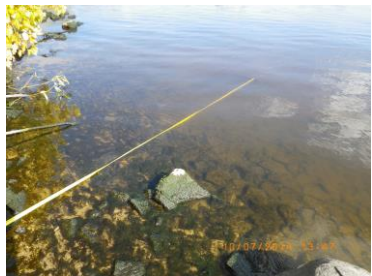
<p style="text-align: center;">o20141007124746.JPG</p> <p style="text-align: center; font-size: 1.5em; font-weight: bold;">2014</p>	
Submerged: Fully		Depth (in):		Outfall fully submerged - screened upstream at 13-173 US2. Pipe approx 5" below water surface.			
Sampling Results				Condition Assessment			
Sample Location:		Floatables:	None	Graftiti:		None	in.
Total Chlorine: -- ppm		Odor:	None	Erosion:		None	
Free Chlorine: -- ppm		Turbidity:	None	Deposition:		None	
Ammonia: -- ppm		Color:	None	Damage:		None	
pH: -- units		Gross Solids:	None				
Temperature -- °F		Vegetation:	None				
Conductivity: -- µS/cm		Benthic Growth:	None				
Detergents: -- mg/L		Stains:	None				
		Non-illicit:	None

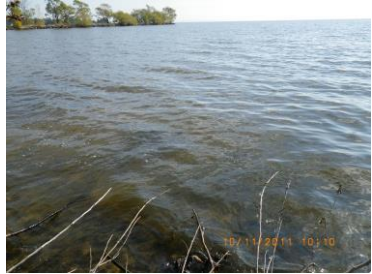
o20111011101022.JPG

Inspection Date: 10/11/2011 10:11:07 AM		Type: Ongoing	Flow: Submerged, indeterminate	Previous Rainfall (hrs): 72+
Illicit Discharge Potential: Unlikely		Inspector: JCW	Notes	
Submerged: Fully		Depth (in):	2010 screening follow-up. Outfall fully submerged. Outfall screened upstream at 03-173 US2.	
Sampling Results		Floatables:	Condition Assessment Graffiti: None Erosion: None Deposition: None 0 in. Damage: None	
Sample Location:		Odor:		
Total Chlorine: -- ppm		Turbidity:		
Free Chlorine: -- ppm		Color:		
Ammonia: -- ppm		Gross Solids:		
pH: -- units		Vegetation:		
Temperature -- °F		Benthic Growth:		
Conductivity: -- µS/cm		Stains:		
Detergents: -- mg/L		Non-illicit:

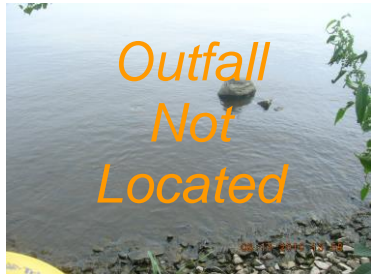
o20100817135838.JPG

Inspection Date: 8/17/2010 2:04:29 PM		Type: Ongoing	Flow: Submerged (not located)	Previous Rainfall (hrs): 72+
Illicit Discharge Potential: Potential		Inspector: JCW	Notes	
Submerged: Fully		Depth (in):	Outfall fully submerged and not physically located. Outfall screened upstream at 03-173 US2.	
Sampling Results		Floatables:	Condition Assessment Graffiti: None Erosion: None Deposition: None 0 in. Damage: None	
Sample Location:		Odor:		
Total Chlorine: -- ppm		Turbidity:		
Free Chlorine: -- ppm		Color:		
Ammonia: -- ppm		Gross Solids:		
pH: -- units		Vegetation:		
Temperature -- °F		Benthic Growth:		
Conductivity: -- µS/cm		Stains:		
Detergents: -- mg/L		Non-illicit:

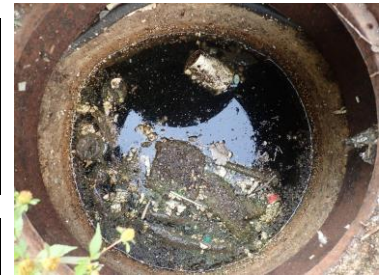
o20200924090226.JPG

Inspection Date: 9/24/2020 8:58:24 AM		Type: Ongoing	Flow: Submerged, no flow	Previous Rainfall (hrs): 72+
Illicit Discharge Potential: Potential		Inspector: QAL		
Submerged: Fully		Depth (in): 36		
Sampling Results		Notes Sample collected from submerged pool in manhole. Floating gross solids (litter) in manhole.		
Sample Location: Pool	Floatables: None	Condition Assessment Graffiti: None Erosion: None Deposition: None in. Damage: None		
Total Chlorine: 0 ppm	Odor: None			
Free Chlorine: 0 ppm	Turbidity: None			
Ammonia: 0 ppm	Color: Faint in bottle			
pH: 8.54 units	Gross Solids: Severe			
Temperature 68 °F	Vegetation: None			
Conductivity: 405 µS/cm	Benthic Growth: None			
Detergents: 0 mg/L	Stains: None			
	Non-illicit: None

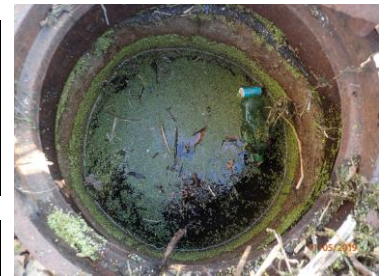
o20191105131426.JPG

Inspection Date: 11/5/2019 1:15:28 PM		Type: Repeat	Flow: Submerged, indeterminate	Previous Rainfall (hrs): 48-72
Illicit Discharge Potential: Potential		Inspector: JCW		
Submerged: Partially		Depth (in): 32		
Sampling Results		Notes Detergent detection follow-up. Limited screening conducted.		
Sample Location: Pool	Floatables: None	Condition Assessment Graffiti: None Erosion: None Deposition: None in. Damage: None		
Total Chlorine: -- ppm	Odor: None			
Free Chlorine: -- ppm	Turbidity: None			
Ammonia: -- ppm	Color: None			
pH: -- units	Gross Solids: None			
Temperature -- °F	Vegetation: None			
Conductivity: -- µS/cm	Benthic Growth: None			
Detergents: 0 mg/L	Stains: None			
	Non-illicit: None

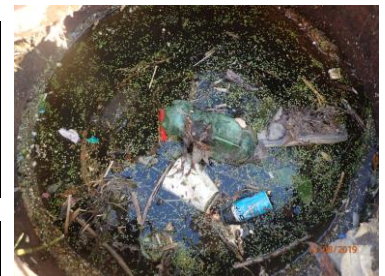
o20191008070022.JPG

Inspection Date: 10/8/2019 8:01:54 AM		Type: Ongoing	Flow: Submerged, indeterminate	Previous Rainfall (hrs): 48-72
Illicit Discharge Potential: Potential		Inspector: JCW		
Submerged: Partially		Depth (in): 38		
Sampling Results		Notes Manhole 03-173 US2 inaccessible (behind locked gate). Floating gross solids (litter) in manhole. Detergent detected.		
Sample Location: Pool	Floatables: Moderate	Condition Assessment Graffiti: None Erosion: None Deposition: Minor 4 in. Damage: None		
Total Chlorine: 0 ppm	Odor: None			
Free Chlorine: 0 ppm	Turbidity: None			
Ammonia: 0 ppm	Color: None			
pH: 7.64 units	Gross Solids: Moderate			
Temperature 53 °F	Vegetation: None			
Conductivity: 592 µS/cm	Benthic Growth: Slight			
Detergents: 1 mg/L	Stains: None			
	Non-illicit: None

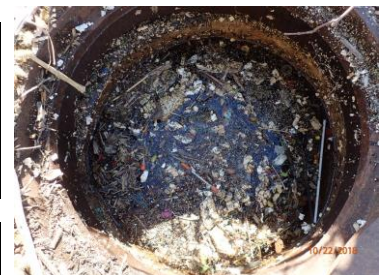
o20181022132154.JPG

Inspection Date: 10/22/2018 1:24:38 PM		Type: Ongoing	Flow: Submerged, indeterminate	Previous Rainfall (hrs): 48-72
Illicit Discharge Potential: Potential		Inspector: JCW		
Submerged: Fully		Depth (in): 40		
Sampling Results		Notes Manhole 03-173 US2 inaccessible (behind locked gate). Floating gross solids (litter) in manhole, including 2 syringes.		
Sample Location: Pool	Floatables: None	Condition Assessment Graffiti: None Erosion: None Deposition: None in. Damage: None		
Total Chlorine: 0 ppm	Odor: None			
Free Chlorine: 0 ppm	Turbidity: None			
Ammonia: 0 ppm	Color: None			
pH: 7.18 units	Gross Solids: Moderate			
Temperature 59 °F	Vegetation: None			
Conductivity: 1229 µS/cm	Benthic Growth: None			
Detergents: 0 mg/L	Stains: None			
	Non-illicit: None

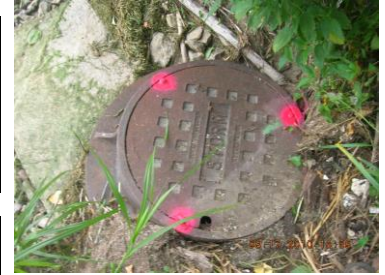
o20100817135854.JPG

Inspection Date: 8/17/2010 2:07:11 PM		Type: Ongoing	Flow: Submerged, indeterminate	Previous Rainfall (hrs): 72+
Illicit Discharge Potential: Potential		Inspector: JCW	Notes	
Submerged: Fully		Depth (in):	Lid bolts rusted tight - could not access. Screened upstream at 03-173 US2.	
Sampling Results		Floatables:	Condition Assessment	
Sample Location:		Odor:	Graffiti: None	
Total Chlorine:	-- ppm	Turbidity:	Erosion: None	
Free Chlorine:	-- ppm	Color:	Deposition: None 0 in.	
Ammonia:	-- ppm	Gross Solids:	Damage: Moderate	
pH:	-- units	Vegetation:		
Temperature	-- °F	Benthic Growth:		
Conductivity:	-- µS/cm	Stains:		
Detergents:	-- mg/L	Non-illicit:

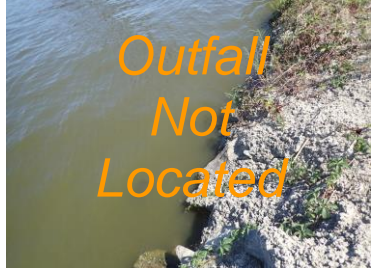
Inspection Date: 8/19/2020 2:27:01 PM		Type: Ongoing	Flow: Submerged (not located)	Previous Rainfall (hrs): 72+
Illicit Discharge Potential: Potential		Inspector: JCW		
Submerged: Fully		Depth (in):		
Sampling Results Sample Location: _____ Total Chlorine: -- ppm Free Chlorine: -- ppm Ammonia: -- ppm pH: -- units Temperature: -- °F Conductivity: -- µS/cm Detergents: -- mg/L		Floatables: None Odor: None Turbidity: None Color: None Gross Solids: None Vegetation: None Benthic Growth: None Stains: None Non-illicit: None	Notes Outfall fully submerged and not located - screened upstream at 03-381 US1. Floating gross solids (litter) in upstream manhole.

o20200819142502.JPG <div style="text-align: center; font-size: 24pt; font-weight: bold;">2020</div>
		Condition Assessment Graffiti: None Erosion: None Deposition: None in. Damage: None

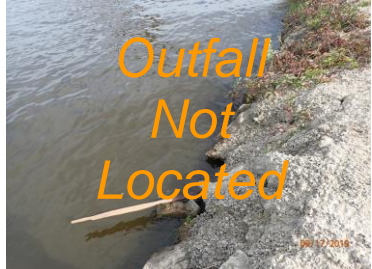
Inspection Date: 9/17/2019 3:09:53 PM		Type: Ongoing	Flow: Submerged (not located)	Previous Rainfall (hrs): 48-72
Illicit Discharge Potential: Potential		Inspector: JCW		
Submerged: Fully		Depth (in):		
Sampling Results Sample Location: _____ Total Chlorine: -- ppm Free Chlorine: -- ppm Ammonia: -- ppm pH: -- units Temperature: -- °F Conductivity: -- µS/cm Detergents: -- mg/L		Floatables: None Odor: None Turbidity: None Color: None Gross Solids: None Vegetation: None Benthic Growth: None Stains: None Non-illicit: None	Notes Outfall fully submerged and not located - screened upstream at 03-381 US1. Floating gross solids (litter) in manhole.

o20190917140942.JPG <div style="text-align: center; font-size: 24pt; font-weight: bold;">2019</div>
		Condition Assessment Graffiti: None Erosion: None Deposition: None in. Damage: None

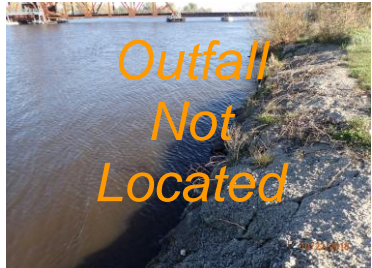
Inspection Date: 10/22/2018 3:03:58 PM		Type: Ongoing	Flow: Submerged (not located)	Previous Rainfall (hrs): 48-72
Illicit Discharge Potential: Potential		Inspector: JCW		
Submerged: Fully		Depth (in):		
Sampling Results Sample Location: _____ Total Chlorine: -- ppm Free Chlorine: -- ppm Ammonia: -- ppm pH: -- units Temperature: -- °F Conductivity: -- µS/cm Detergents: -- mg/L		Floatables: None Odor: None Turbidity: None Color: None Gross Solids: None Vegetation: None Benthic Growth: None Stains: None Non-illicit: None	Notes Outfall fully submerged and not located - screened upstream at 03-381 US1. Floating gross solids (litter) in manhole.

o20181022150212.JPG <div style="text-align: center; font-size: 24pt; font-weight: bold;">2018</div>
		Condition Assessment Graffiti: None Erosion: None Deposition: None in. Damage: None

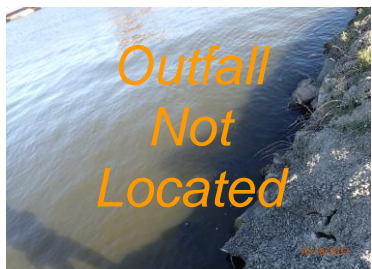
Inspection Date: 10/18/2017 3:02:59 PM		Type: Ongoing	Flow: Submerged (not located)	Previous Rainfall (hrs): 72+
Illicit Discharge Potential: Potential		Inspector: JCW		
Submerged: Fully		Depth (in):		
Sampling Results Sample Location: _____ Total Chlorine: -- ppm Free Chlorine: -- ppm Ammonia: -- ppm pH: -- units Temperature: -- °F Conductivity: -- µS/cm Detergents: -- mg/L		Floatables: None Odor: None Turbidity: None Color: None Gross Solids: None Vegetation: None Benthic Growth: None Stains: None Non-illicit: None	Notes Outfall fully submerged and not located - screened upstream at 03-381 US1. Floating gross solids (litter) in manhole.

o20171018150108.JPG <div style="text-align: center; font-size: 24pt; font-weight: bold;">2017</div>
		Condition Assessment Graffiti: None Erosion: None Deposition: None in. Damage: None

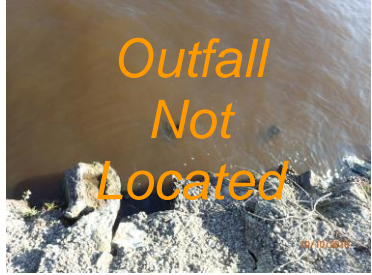
o20161010091656.JPG

Inspection Date: 10/10/2016 9:18:11 AM		Type: Ongoing	Flow: Submerged (not located)	Previous Rainfall (hrs): 72+
Illicit Discharge Potential: Potential		Inspector: JCW	Notes	
Submerged: Fully		Depth (in):	Outfall fully submerged and not located - screened upstream at 03-381 US1.	
Sampling Results		Floatables:	Condition Assessment Graffiti: None Erosion: None Deposition: None in. Damage: None	
Sample Location:		Odor:		
Total Chlorine: -- ppm		Turbidity:		
Free Chlorine: -- ppm		Color:		
Ammonia: -- ppm		Gross Solids:		
pH: -- units		Vegetation:		
Temperature -- °F		Benthic Growth:		
Conductivity: -- µS/cm		Stains:		
Detergents: -- mg/L		Non-illicit:

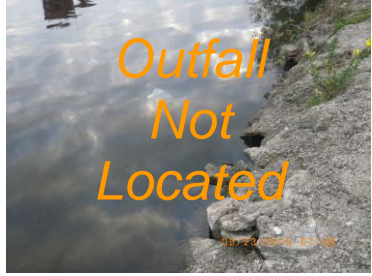
o20150923062656.JPG

Inspection Date: 9/23/2015 7:22:24 AM		Type: Ongoing	Flow: Submerged (not located)	Previous Rainfall (hrs): 72+
Illicit Discharge Potential: Potential		Inspector: JCW	Notes	
Submerged: Fully		Depth (in):	Outfall fully submerged and not located - screened at 03-381 US1.	
Sampling Results		Floatables:	Condition Assessment Graffiti: None Erosion: None Deposition: None in. Damage: None	
Sample Location:		Odor:		
Total Chlorine: -- ppm		Turbidity:		
Free Chlorine: -- ppm		Color:		
Ammonia: -- ppm		Gross Solids:		
pH: -- units		Vegetation:		
Temperature -- °F		Benthic Growth:		
Conductivity: -- µS/cm		Stains:		
Detergents: -- mg/L		Non-illicit:

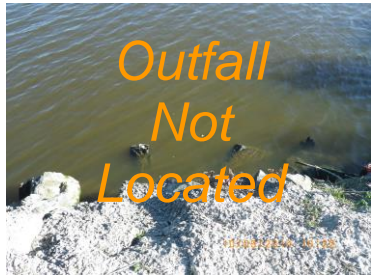
o20141009092246.JPG

Inspection Date: 10/9/2014 10:22:12 AM		Type: Ongoing	Flow: Submerged (not located)	Previous Rainfall (hrs): 72+
Illicit Discharge Potential: Unlikely		Inspector: JCW	Notes	
Submerged: Fully		Depth (in):	Outfall fully submerged and not located - screened upstream at 03-381 US1.	
Sampling Results		Floatables:	Condition Assessment Graffiti: None Erosion: None Deposition: None in. Damage: None	
Sample Location:		Odor:		
Total Chlorine: -- ppm		Turbidity:		
Free Chlorine: -- ppm		Color:		
Ammonia: -- ppm		Gross Solids:		
pH: -- units		Vegetation:		
Temperature -- °F		Benthic Growth:		
Conductivity: -- µS/cm		Stains:		
Detergents: -- mg/L		Non-illicit:

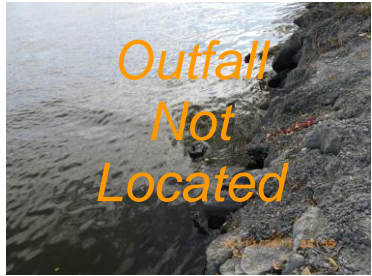
o20111011095540.JPG

Inspection Date: 10/11/2011 9:56:37 AM		Type: Ongoing	Flow: Submerged (not located)	Previous Rainfall (hrs): 72+
Illicit Discharge Potential: Unlikely		Inspector: JCW	Notes	
Submerged: Fully		Depth (in):	2010 screening follow-up. Outfall fully submerged and not physically located. Outfall screened upstream at 03-381 US1.	
Sampling Results		Floatables:	Condition Assessment Graffiti: None Erosion: None Deposition: None 0 in. Damage: None	
Sample Location:		Odor:		
Total Chlorine: -- ppm		Turbidity:		
Free Chlorine: -- ppm		Color:		
Ammonia: -- ppm		Gross Solids:		
pH: -- units		Vegetation:		
Temperature -- °F		Benthic Growth:		
Conductivity: -- µS/cm		Stains:		
Detergents: -- mg/L		Non-illicit:

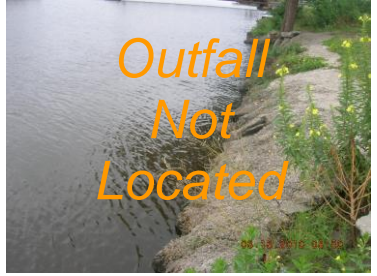
o20100818085058.JPG

Inspection Date: 8/18/2010 8:59:26 AM		Type: Ongoing	Flow: Submerged (not located)	Previous Rainfall (hrs): 72+
Illicit Discharge Potential: Potential		Inspector: JCW		
Submerged: Fully		Depth (in):		
Sampling Results Sample Location: Total Chlorine: -- ppm Free Chlorine: -- ppm Ammonia: -- ppm pH: -- units Temperature: -- °F Conductivity: -- µS/cm Detergents: -- mg/L		Floatables: None Odor: None Turbidity: None Color: None Gross Solids: None Vegetation: None Benthic Growth: None Stains: None Non-illicit: None		
		Notes Outfall fully submerged and not physically located. Outfall screened upstream at 03-381 US1.		
		Condition Assessment Graffiti: None Erosion: None Deposition: None 0 in. Damage: None

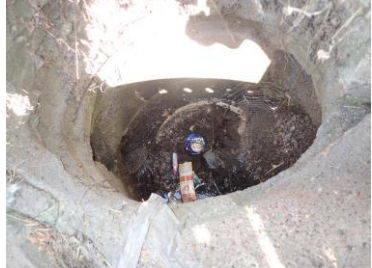
o20200819142524.JPG

Inspection Date: 8/19/2020 2:28:06 PM		Type: Ongoing	Flow: Submerged, indeterminate	Previous Rainfall (hrs): 72+
Illicit Discharge Potential: Potential		Inspector: JCW		
Submerged: Fully		Depth (in):		
Sampling Results		Notes		
Sample Location: Pool	Floatables: None	Pipe full of sediment/mud. Floating gross solids (litter) in manhole. Elevated ammonia - no incoming pipes.		
Total Chlorine: 0 ppm	Odor: None			
Free Chlorine: 0 ppm	Turbidity: None			
Ammonia: 3 ppm	Color: Clearly visible in bottl			
pH: 7.43 units	Gross Solids: Moderate			
Temperature 85 °F	Vegetation: None			
Conductivity: 374 µS/cm	Benthic Growth: None			
Detergents: 0 mg/L	Stains: None			
Non-illicit: None		Condition Assessment		
		Graffiti: None		
		Erosion: None		
		Deposition: Severe in.		
		Damage: None

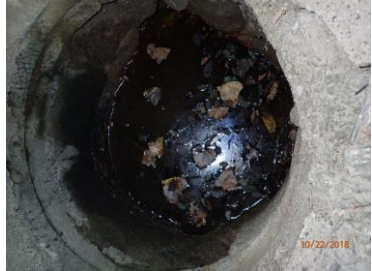
o20181022150350.JPG

Inspection Date: 10/22/2018 3:06:47 PM		Type: Ongoing	Flow: Submerged, indeterminate	Previous Rainfall (hrs): 48-72
Illicit Discharge Potential: Potential		Inspector: JCW		
Submerged: Fully		Depth (in): 14		
Sampling Results		Notes		
Sample Location: Pool	Floatables: None	Sample collected from submerged pool in manhole. Floating gross solids (litter) in manhole.		
Total Chlorine: 0 ppm	Odor: None			
Free Chlorine: 0 ppm	Turbidity: None			
Ammonia: 0 ppm	Color: None			
pH: 6.73 units	Gross Solids: Slight			
Temperature 59 °F	Vegetation: None			
Conductivity: 877 µS/cm	Benthic Growth: Slight			
Detergents: 0 mg/L	Stains: None			
Non-illicit: Slight		Condition Assessment		
		Graffiti: None		
		Erosion: None		
		Deposition: None in.		
		Damage: None

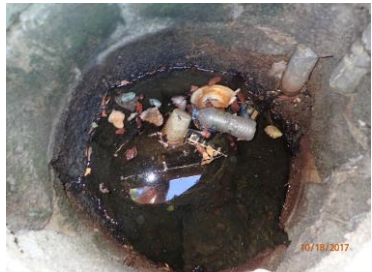
o20171018150142.JPG

Inspection Date: 10/18/2017 3:05:57 PM		Type: Ongoing	Flow: Submerged, indeterminate	Previous Rainfall (hrs): 72+
Illicit Discharge Potential: Potential		Inspector: JCW		
Submerged: Fully		Depth (in): 16		
Sampling Results		Notes		
Sample Location: Pool	Floatables: None	Sample collected from submerged pool in manhole. Floating gross solids (litter) in manhole.		
Total Chlorine: 0 ppm	Odor: None			
Free Chlorine: 0 ppm	Turbidity: None			
Ammonia: 0 ppm	Color: None			
pH: 7.71 units	Gross Solids: Moderate			
Temperature 66 °F	Vegetation: None			
Conductivity: 317 µS/cm	Benthic Growth: None			
Detergents: 0 mg/L	Stains: None			
Non-illicit: None		Condition Assessment		
		Graffiti: None		
		Erosion: None		
		Deposition: None in.		
		Damage: None

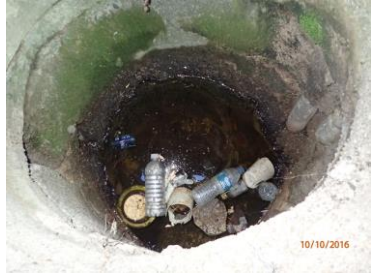
10/10/2016
o20161010091822.JPG

Inspection Date: 10/10/2016 9:20:59 AM		Type: Ongoing	Flow: Submerged, indeterminate	Previous Rainfall (hrs): 72+
Illicit Discharge Potential: Potential		Inspector: JCW	Notes	
Submerged: Fully		Depth (in): 14	Potential illicit discharge due to gross solids.	
Sampling Results				
Sample Location:	Pool	Floatables:	None	
Total Chlorine:	0 ppm	Odor:	None	
Free Chlorine:	0 ppm	Turbidity:	None	
Ammonia:	0 ppm	Color:	Faint in bottle	
pH:	7.57 units	Gross Solids:	Slight	
Temperature	65 °F	Vegetation:	None	
Conductivity:	365 µS/cm	Benthic Growth:	Moderate	
Detergents:	0 mg/L	Stains:	None	
		Non-illicit:	None	
			Condition Assessment	
			Graffiti:	None
			Erosion:	None
			Deposition:	None in.
			Damage:	None

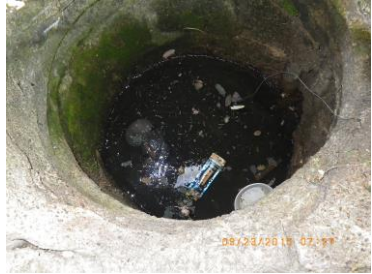
09/23/2015 07:27
o20150923062728.JPG

Inspection Date: 9/23/2015 7:26:11 AM		Type: Ongoing	Flow: Submerged, indeterminate	Previous Rainfall (hrs): 72+
Illicit Discharge Potential: Potential		Inspector: JCW	Notes	
Submerged: Fully		Depth (in): 20	Floating gross solids (litter) in manhole.	
Sampling Results				
Sample Location:	Pool	Floatables:	None	
Total Chlorine:	0 ppm	Odor:	Faint	
Free Chlorine:	0 ppm	Turbidity:	None	
Ammonia:	1 ppm	Color:	None	
pH:	7.69 units	Gross Solids:	Slight	
Temperature	70 °F	Vegetation:	None	
Conductivity:	352 µS/cm	Benthic Growth:	Slight	
Detergents:	0 mg/L	Stains:	None	
		Non-illicit:	None	
			Condition Assessment	
			Graffiti:	None
			Erosion:	None
			Deposition:	None in.
			Damage:	None

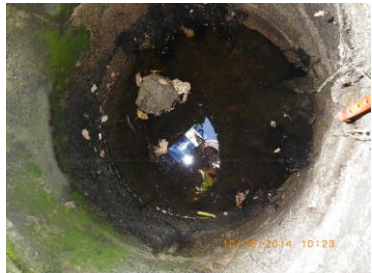
10/09/2014 10:23
o20141009092338.JPG

Inspection Date: 10/9/2014 10:25:59 AM		Type: Ongoing	Flow: Submerged, indeterminate	Previous Rainfall (hrs): 72+
Illicit Discharge Potential: Unlikely		Inspector: JCW	Notes	
Submerged: Fully		Depth (in): 14		
Sampling Results				
Sample Location:	Pool	Floatables:	None	
Total Chlorine:	0 ppm	Odor:	None	
Free Chlorine:	0 ppm	Turbidity:	None	
Ammonia:	0 ppm	Color:	Faint in bottle	
pH:	7.79 units	Gross Solids:	Slight	
Temperature	57 °F	Vegetation:	None	
Conductivity:	408 µS/cm	Benthic Growth:	Slight	
Detergents:	0 mg/L	Stains:	Moderate	
		Non-illicit:	None	
			Condition Assessment	
			Graffiti:	None
			Erosion:	None
			Deposition:	Minor 2 in.
			Damage:	None

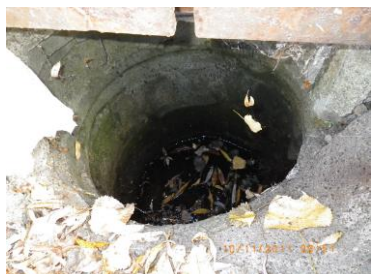
10/11/2011 09:52
o20111011095140.JPG

Inspection Date: 10/11/2011 9:52:43 AM		Type: Ongoing	Flow: Submerged, indeterminate	Previous Rainfall (hrs): 72+
Illicit Discharge Potential: Unlikely		Inspector: JCW	Notes	
Submerged: Fully		Depth (in): 12	2010 screening follow-up. Floatable debris significantly reduced.	
Sampling Results				
Sample Location:	Pool	Floatables:	None	
Total Chlorine:	0 ppm	Odor:	Faint	
Free Chlorine:	0 ppm	Turbidity:	None	
Ammonia:	0 ppm	Color:	None	
pH:	7.1 units	Gross Solids:	None	
Temperature	71 °F	Vegetation:	None	
Conductivity:	-- µS/cm	Benthic Growth:	None	
Detergents:	-- mg/L	Stains:	None	
		Non-illicit:	None	
			Condition Assessment	
			Graffiti:	None
			Erosion:	None
			Deposition:	None 0 in.
			Damage:	None

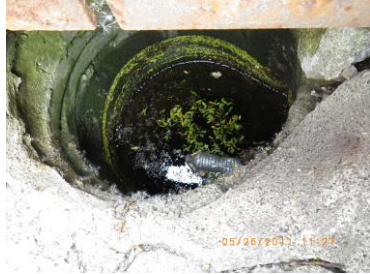
Inspection Date: 5/26/2011 11:27:00 AM		Type: Other	Flow: Submerged, indeterminate	Previous Rainfall (hrs): 72+
Illicit Discharge Potential: Unlikely		Inspector: JCW		
Submerged: Fully		Depth (in):		
Sampling Results		Notes Limited screening conducted to check for floatable debris.		
Sample Location: _____ Total Chlorine: -- ppm Free Chlorine: -- ppm Ammonia: -- ppm pH: -- units Temperature: -- °F Conductivity: -- µS/cm Detergents: -- mg/L		Floatables: None Odor: _____ Turbidity: _____ Color: _____ Gross Solids: Slight Vegetation: _____ Benthic Growth: _____ Stains: _____ Non-illicit: None		
		Condition Assessment Graffiti: None Erosion: None Deposition: None 0 in. Damage: None

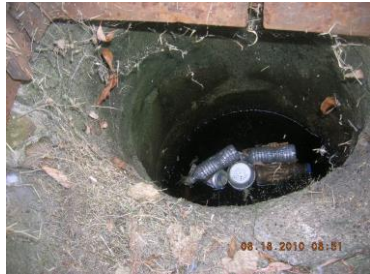
Inspection Date: 8/18/2010 9:03:59 AM		Type: Ongoing	Flow: Submerged, indeterminate	Previous Rainfall (hrs): 72+
Illicit Discharge Potential: Potential		Inspector: JCW		
Submerged: Fully		Depth (in): 13		
Sampling Results		Notes Floating debris, slight oil sheen in manhole.		
Sample Location: Pool Total Chlorine: 0 ppm Free Chlorine: 0 ppm Ammonia: 0 ppm pH: 7.13 units Temperature: 72 °F Conductivity: -- µS/cm Detergents: 0 mg/L		Floatables: Moderate Odor: Faint Turbidity: None Color: Faint in bottle Gross Solids: Moderate Vegetation: None Benthic Growth: None Stains: None Non-illicit: None		
		Condition Assessment Graffiti: None Erosion: None Deposition: None 0 in. Damage: None

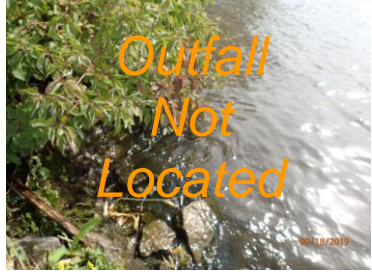
Odor:	None																					
Turbidity:	None																					
Color:	None																					
Gross Solids:	None																					
Vegetation:	None																					
Benthic Growth:	None																					
Stains:	None																					
Non-illicit:	None																					
<table border="1" style="width:100%; border-collapse: collapse;"> <tr><td colspan="2">Sample Location:</td></tr> <tr><td>Total Chlorine:</td><td>-- ppm</td></tr> <tr><td>Free Chlorine:</td><td>-- ppm</td></tr> <tr><td>Ammonia:</td><td>-- ppm</td></tr> <tr><td>pH:</td><td>-- units</td></tr> <tr><td>Temperature:</td><td>-- ° F</td></tr> <tr><td>Conductivity:</td><td>-- µS/cm</td></tr> <tr><td>Detergents:</td><td>-- mg/L</td></tr> </table>		Sample Location:		Total Chlorine:	-- ppm	Free Chlorine:	-- ppm	Ammonia:	-- ppm	pH:	-- units	Temperature:	-- ° F	Conductivity:	-- µS/cm	Detergents:	-- mg/L	Notes Outfall fully submerged and not located - screened upstream at 05-14 US1. Floating gross solids (litter) in manhole.

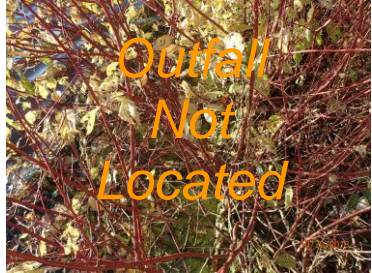
Odor:	None																					
Turbidity:	None																					
Color:	None																					
Gross Solids:	None																					
Vegetation:	None																					
Benthic Growth:	None																					
Stains:	None																					
Non-illicit:	None																					
<table border="1" style="width:100%; border-collapse: collapse;"> <tr><td colspan="2">Sample Location:</td></tr> <tr><td>Total Chlorine:</td><td>-- ppm</td></tr> <tr><td>Free Chlorine:</td><td>-- ppm</td></tr> <tr><td>Ammonia:</td><td>-- ppm</td></tr> <tr><td>pH:</td><td>-- units</td></tr> <tr><td>Temperature:</td><td>-- ° F</td></tr> <tr><td>Conductivity:</td><td>-- µS/cm</td></tr> <tr><td>Detergents:</td><td>-- mg/L</td></tr> </table>		Sample Location:		Total Chlorine:	-- ppm	Free Chlorine:	-- ppm	Ammonia:	-- ppm	pH:	-- units	Temperature:	-- ° F	Conductivity:	-- µS/cm	Detergents:	-- mg/L	Notes Outfall fully submerged and not located - screened upstream at 05-14 US1. Floating gross solids (litter) in manhole.

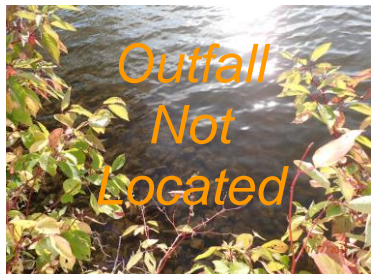
Odor:	None																					
Turbidity:	None																					
Color:	None																					
Gross Solids:	None																					
Vegetation:	None																					
Benthic Growth:	None																					
Stains:	None																					
Non-illicit:	None																					
<table border="1" style="width:100%; border-collapse: collapse;"> <tr><td colspan="2">Sample Location:</td></tr> <tr><td>Total Chlorine:</td><td>-- ppm</td></tr> <tr><td>Free Chlorine:</td><td>-- ppm</td></tr> <tr><td>Ammonia:</td><td>-- ppm</td></tr> <tr><td>pH:</td><td>-- units</td></tr> <tr><td>Temperature:</td><td>-- ° F</td></tr> <tr><td>Conductivity:</td><td>-- µS/cm</td></tr> <tr><td>Detergents:</td><td>-- mg/L</td></tr> </table>		Sample Location:		Total Chlorine:	-- ppm	Free Chlorine:	-- ppm	Ammonia:	-- ppm	pH:	-- units	Temperature:	-- ° F	Conductivity:	-- µS/cm	Detergents:	-- mg/L	Notes Outfall fully submerged and not located - screened upstream at 05-14 US1. Floating gross solids (litter) in manhole.

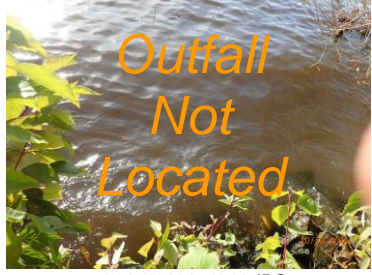
<p style="text-align: center;">o20161010154044.JPG</p> <p style="text-align: center; font-size: 1.2em; font-weight: bold;">2016</p>	
Submerged: Fully		Depth (in):		Outfall fully submerged and not located - screened upstream at 05-14 US1.			
Sampling Results				Condition Assessment			
Sample Location:		Floatables:	None	Graffiti: None			
Total Chlorine: -- ppm		Odor:	None	Erosion: None			
Free Chlorine: -- ppm		Turbidity:	None	Deposition: None in.			
Ammonia: -- ppm		Color:	None	Damage: None			
pH: -- units		Gross Solids:	None				
Temperature -- °F		Vegetation:	None				
Conductivity: -- µS/cm		Benthic Growth:	None				
Detergents: -- mg/L		Stains:	None				
		Non-illicit:	None

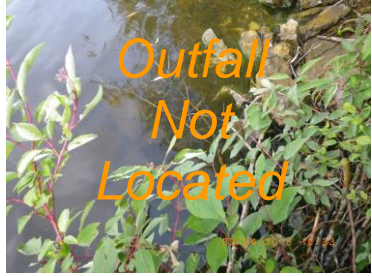
<p style="text-align: center;">o20150924093340.JPG</p> <p style="text-align: center; font-size: 1.2em; font-weight: bold;">2015</p>	
Submerged: Fully		Depth (in):		Outfall fully submerged and not located - screened at 05-14 US1.			
Sampling Results				Condition Assessment			
Sample Location:		Floatables:	None	Graffiti: None			
Total Chlorine: -- ppm		Odor:	None	Erosion: None			
Free Chlorine: -- ppm		Turbidity:	None	Deposition: None in.			
Ammonia: -- ppm		Color:	None	Damage: None			
pH: -- units		Gross Solids:	None				
Temperature -- °F		Vegetation:	None				
Conductivity: -- µS/cm		Benthic Growth:	None				
Detergents: -- mg/L		Stains:	None				
		Non-illicit:	None

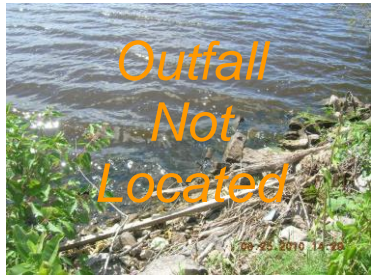
<p style="text-align: center;">o20100825142900.JPG</p> <p style="text-align: center; font-size: 1.2em; font-weight: bold;">2010</p>	
Submerged: Fully		Depth (in):		Outfall fully submerged and not physically located. Outfall screened upstream at 05-14 US2.			
Sampling Results				Condition Assessment			
Sample Location:		Floatables:	None	Graffiti: None			
Total Chlorine: -- ppm		Odor:	None	Erosion: None			
Free Chlorine: -- ppm		Turbidity:	None	Deposition: None 0 in.			
Ammonia: -- ppm		Color:	None	Damage: None			
pH: -- units		Gross Solids:	None				
Temperature -- °F		Vegetation:	None				
Conductivity: -- µS/cm		Benthic Growth:	None				
Detergents: -- mg/L		Stains:	None				
		Non-illicit:	None

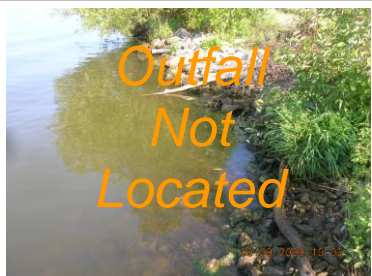
<p style="text-align: center;">Osh09_DSCN6696.JPG</p> <p style="text-align: center; font-size: 1.2em; font-weight: bold;">2009</p>	
Submerged: Fully		Depth (in):		Outfall fully submerged and not physically located. Outfall screened upstream at 05-14 US2.			
Sampling Results				Condition Assessment			
Sample Location:		Floatables:	None	Graffiti: None			
Total Chlorine: -- ppm		Odor:	None	Erosion: None			
Free Chlorine: -- ppm		Turbidity:	None	Deposition: None 0 in.			
Ammonia: -- ppm		Color:	None	Damage: None			
pH: -- units		Gross Solids:	None				
Temperature -- °F		Vegetation:	None				
Conductivity: -- µS/cm		Benthic Growth:	None				
Detergents: -- mg/L		Stains:	None				
		Non-illicit:	None

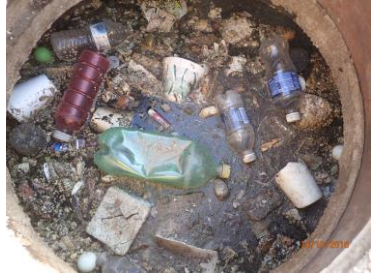
o20161010154428.JPG 2016

Inspection Date: 10/10/2016 3:46:48 PM		Type: Ongoing	Flow: Submerged, indeterminate	Previous Rainfall (hrs): 72+																																													
Illicit Discharge Potential: Potential		Inspector: JCW	Notes																																														
Submerged: Fully		Depth (in): 41	Potential illicit discharge due to gross solids.																																														
Sampling Results		Condition Assessment																																															
<table border="1" style="width:100%; border-collapse: collapse;"> <tr> <td>Sample Location:</td> <td>Pool</td> <td>Floatables:</td> <td>None</td> </tr> <tr> <td>Total Chlorine:</td> <td>0 ppm</td> <td>Odor:</td> <td>None</td> </tr> <tr> <td>Free Chlorine:</td> <td>0 ppm</td> <td>Turbidity:</td> <td>None</td> </tr> <tr> <td>Ammonia:</td> <td>0 ppm</td> <td>Color:</td> <td>None</td> </tr> <tr> <td>pH:</td> <td>7.69 units</td> <td>Gross Solids:</td> <td>Severe</td> </tr> <tr> <td>Temperature</td> <td>70 °F</td> <td>Vegetation:</td> <td>None</td> </tr> <tr> <td>Conductivity:</td> <td>660 µS/cm</td> <td>Benthic Growth:</td> <td>None</td> </tr> <tr> <td>Detergents:</td> <td>0 mg/L</td> <td>Stains:</td> <td>None</td> </tr> <tr> <td></td> <td></td> <td>Non-illicit:</td> <td>None</td> </tr> </table>		Sample Location:	Pool	Floatables:	None	Total Chlorine:	0 ppm	Odor:	None	Free Chlorine:	0 ppm	Turbidity:	None	Ammonia:	0 ppm	Color:	None	pH:	7.69 units	Gross Solids:	Severe	Temperature	70 °F	Vegetation:	None	Conductivity:	660 µS/cm	Benthic Growth:	None	Detergents:	0 mg/L	Stains:	None			Non-illicit:	None	<table border="1" style="width:100%; border-collapse: collapse;"> <tr> <td>Graffiti:</td> <td>None</td> <td rowspan="4" style="text-align: center; vertical-align: middle;">in.</td> </tr> <tr> <td>Erosion:</td> <td>None</td> </tr> <tr> <td>Deposition:</td> <td>None</td> </tr> <tr> <td>Damage:</td> <td>None</td> </tr> </table>			Graffiti:	None	in.	Erosion:	None	Deposition:	None	Damage:	None

Sample Location:	Pool	Floatables:	None																																														
Total Chlorine:	0 ppm	Odor:	None																																														
Free Chlorine:	0 ppm	Turbidity:	None																																														
Ammonia:	0 ppm	Color:	None																																														
pH:	7.69 units	Gross Solids:	Severe																																														
Temperature	70 °F	Vegetation:	None																																														
Conductivity:	660 µS/cm	Benthic Growth:	None																																														
Detergents:	0 mg/L	Stains:	None																																														
		Non-illicit:	None																																														
Graffiti:	None	in.																																															
Erosion:	None																																																
Deposition:	None																																																
Damage:	None

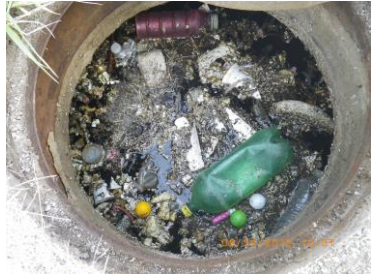
o20150924093714.JPG 2015

Inspection Date: 9/24/2015 10:36:18 AM		Type: Ongoing	Flow: Submerged, indeterminate	Previous Rainfall (hrs): 72+																																													
Illicit Discharge Potential: Potential		Inspector: JCW	Notes																																														
Submerged: Fully		Depth (in): 44	Floating gross solids (litter) in manhole.																																														
Sampling Results		Condition Assessment																																															
<table border="1" style="width:100%; border-collapse: collapse;"> <tr> <td>Sample Location:</td> <td>Pool</td> <td>Floatables:</td> <td>None</td> </tr> <tr> <td>Total Chlorine:</td> <td>0 ppm</td> <td>Odor:</td> <td>None</td> </tr> <tr> <td>Free Chlorine:</td> <td>0 ppm</td> <td>Turbidity:</td> <td>None</td> </tr> <tr> <td>Ammonia:</td> <td>0 ppm</td> <td>Color:</td> <td>None</td> </tr> <tr> <td>pH:</td> <td>7.98 units</td> <td>Gross Solids:</td> <td>Severe</td> </tr> <tr> <td>Temperature</td> <td>70 °F</td> <td>Vegetation:</td> <td>None</td> </tr> <tr> <td>Conductivity:</td> <td>424 µS/cm</td> <td>Benthic Growth:</td> <td>None</td> </tr> <tr> <td>Detergents:</td> <td>0 mg/L</td> <td>Stains:</td> <td>None</td> </tr> <tr> <td></td> <td></td> <td>Non-illicit:</td> <td>None</td> </tr> </table>		Sample Location:	Pool	Floatables:	None	Total Chlorine:	0 ppm	Odor:	None	Free Chlorine:	0 ppm	Turbidity:	None	Ammonia:	0 ppm	Color:	None	pH:	7.98 units	Gross Solids:	Severe	Temperature	70 °F	Vegetation:	None	Conductivity:	424 µS/cm	Benthic Growth:	None	Detergents:	0 mg/L	Stains:	None			Non-illicit:	None	<table border="1" style="width:100%; border-collapse: collapse;"> <tr> <td>Graffiti:</td> <td>None</td> <td rowspan="4" style="text-align: center; vertical-align: middle;">in.</td> </tr> <tr> <td>Erosion:</td> <td>None</td> </tr> <tr> <td>Deposition:</td> <td>None</td> </tr> <tr> <td>Damage:</td> <td>None</td> </tr> </table>			Graffiti:	None	in.	Erosion:	None	Deposition:	None	Damage:	None

Sample Location:	Pool	Floatables:	None																																														
Total Chlorine:	0 ppm	Odor:	None																																														
Free Chlorine:	0 ppm	Turbidity:	None																																														
Ammonia:	0 ppm	Color:	None																																														
pH:	7.98 units	Gross Solids:	Severe																																														
Temperature	70 °F	Vegetation:	None																																														
Conductivity:	424 µS/cm	Benthic Growth:	None																																														
Detergents:	0 mg/L	Stains:	None																																														
		Non-illicit:	None																																														
Graffiti:	None	in.																																															
Erosion:	None																																																
Deposition:	None																																																
Damage:	None

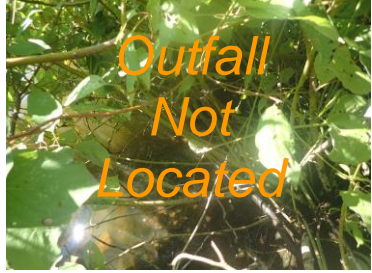
Inspection Date: 8/19/2020 3:45:30 PM		Type: Ongoing	Flow: Submerged (not located)	Previous Rainfall (hrs): 72+
Illicit Discharge Potential: Unlikely		Inspector: JCW		
Submerged: Fully		Depth (in):		
Sampling Results Sample Location: _____ Total Chlorine: -- ppm Free Chlorine: -- ppm Ammonia: -- ppm pH: -- units Temperature: -- °F Conductivity: -- µS/cm Detergents: -- mg/L		Floatables: None Odor: None Turbidity: None Color: None Gross Solids: None Vegetation: None Benthic Growth: None Stains: None Non-illicit: None	Notes Outfall fully submerged and not located - screened upstream at 05-241 US1.

o20200819153632.JPG <div style="text-align: center; font-weight: bold; font-size: 1.2em;">2020</div>
		Condition Assessment Graffiti: None Erosion: None Deposition: None in. Damage: None

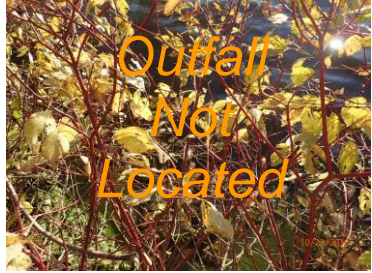
Inspection Date: 10/22/2018 5:11:27 PM		Type: Ongoing	Flow: Submerged (not located)	Previous Rainfall (hrs): 48-72
Illicit Discharge Potential: Unlikely		Inspector: JCW		
Submerged: Fully		Depth (in):		
Sampling Results Sample Location: _____ Total Chlorine: -- ppm Free Chlorine: -- ppm Ammonia: -- ppm pH: -- units Temperature: -- °F Conductivity: -- µS/cm Detergents: -- mg/L		Floatables: None Odor: None Turbidity: None Color: None Gross Solids: None Vegetation: None Benthic Growth: None Stains: None Non-illicit: None	Notes Outfall fully submerged and not located - screened upstream at 05-241 US1.

o20181022170952.JPG <div style="text-align: center; font-weight: bold; font-size: 1.2em;">2018</div>
		Condition Assessment Graffiti: None Erosion: None Deposition: None in. Damage: None

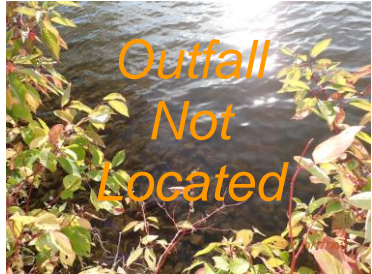
o20171017155038.JPG <div style="text-align: center; font-weight: bold; font-size: 1.2em;">2017</div>
		Condition Assessment Graffiti: None Erosion: None Deposition: None in. Damage: None

Inspection Date: 10/17/2017 3:57:59 PM		Type: Ongoing	Flow: Submerged (not located)	Previous Rainfall (hrs): 48-72
Illicit Discharge Potential: Potential		Inspector: JCW		
Submerged: Fully		Depth (in):		
Sampling Results Sample Location: _____ Total Chlorine: -- ppm Free Chlorine: -- ppm Ammonia: -- ppm pH: -- units Temperature: -- °F Conductivity: -- µS/cm Detergents: -- mg/L		Floatables: None Odor: None Turbidity: None Color: None Gross Solids: None Vegetation: None Benthic Growth: None Stains: None Non-illicit: None	Notes Outfall fully submerged and not located - screened upstream at 05-241 US1. Detergent detected in upstream manhole.

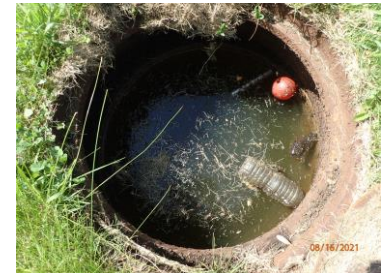
o20210816145144.JPG

☐ Petrol. Sheen ☐ Suds ☐ Sewage ☐ Algae ☐ Other☐ Petroleum ☐ Musty ☐ Sewage ☐ Chlorine ☐ Other☐ VOC/Solvent ☐ Fishy ☐ Sulfur ☐ Fragrant☒ Litter ☒ Veg. Debris ☐ Sediment ☐ Other☐ Inhibited ☐ Excessive☒ Green ☐ Brown☐ Flow Line ☐ Oil ☐ Rust Stains☐ Paint ☐ Other☐ Natural Sheen ☐ Natural Suds/Foam**Physical Condition Assessment**

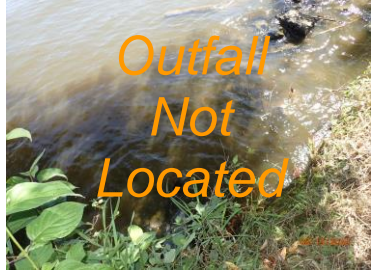
o20200819113108.JPG <div style="text-align: center; font-size: 24pt; font-weight: bold;">2020</div>
		Condition Assessment Graffiti: None Erosion: None Deposition: None in. Damage: None

Inspection Date: 8/19/2020 11:32:11 AM		Type: Ongoing	Flow: Submerged (not located)	Previous Rainfall (hrs): 72+
Illicit Discharge Potential: Potential		Inspector: JCW		
Submerged: Fully		Depth (in):		
Sampling Results Sample Location: _____ Total Chlorine: -- ppm Free Chlorine: -- ppm Ammonia: -- ppm pH: -- units Temperature: -- °F Conductivity: -- µS/cm Detergents: -- mg/L		Floatables: None Odor: None Turbidity: None Color: None Gross Solids: None Vegetation: None Benthic Growth: None Stains: None Non-illicit: None	Notes Outfall fully submerged and not located - screened upstream at 06-52 US1. Floating gross solids (litter) in upstream manhole.

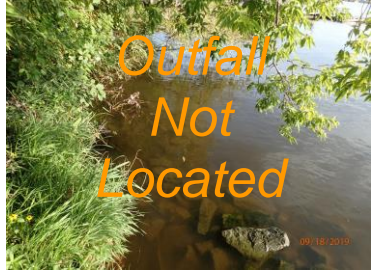
o20190918074208.JPG <div style="text-align: center; font-size: 24pt; font-weight: bold;">2019</div>
		Condition Assessment Graffiti: None Erosion: None Deposition: None in. Damage: None

Inspection Date: 9/18/2019 8:43:23 AM		Type: Ongoing	Flow: Submerged (not located)	Previous Rainfall (hrs): 72+
Illicit Discharge Potential: Potential		Inspector: JCW		
Submerged: Fully		Depth (in):		
Sampling Results Sample Location: _____ Total Chlorine: -- ppm Free Chlorine: -- ppm Ammonia: -- ppm pH: -- units Temperature: -- °F Conductivity: -- µS/cm Detergents: -- mg/L		Floatables: None Odor: None Turbidity: None Color: None Gross Solids: None Vegetation: None Benthic Growth: None Stains: None Non-illicit: None	Notes Outfall fully submerged and not located - screened upstream at 06-52 US1. Floating gross solids (litter) in manhole.

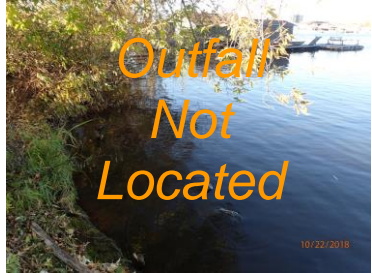
o20181022163054.JPG <div style="text-align: center; font-size: 24pt; font-weight: bold;">2018</div>
		Condition Assessment Graffiti: None Erosion: None Deposition: None in. Damage: None

Inspection Date: 10/22/2018 4:31:59 PM		Type: Ongoing	Flow: Submerged (not located)	Previous Rainfall (hrs): 48-72
Illicit Discharge Potential: Potential		Inspector: JCW		
Submerged: Fully		Depth (in):		
Sampling Results Sample Location: _____ Total Chlorine: -- ppm Free Chlorine: -- ppm Ammonia: -- ppm pH: -- units Temperature: -- °F Conductivity: -- µS/cm Detergents: -- mg/L		Floatables: None Odor: None Turbidity: None Color: None Gross Solids: None Vegetation: None Benthic Growth: None Stains: None Non-illicit: None	Notes Outfall fully submerged and not located - screened upstream at 06-52 US1. Floating gross solids (litter) in manhole.

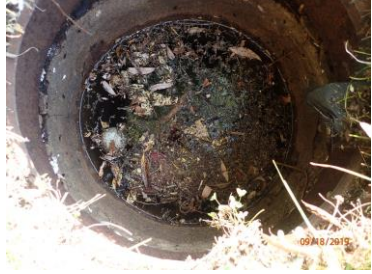
o20190918074352.JPG

Inspection Date: 9/18/2019 8:45:58 AM		Type: Ongoing	Flow: Submerged, no flow	Previous Rainfall (hrs): 72+
Illicit Discharge Potential: Potential		Inspector: JCW		
Submerged: Fully		Depth (in): 44		
Sampling Results		Notes		
Sample Location: Pool	Floatables: None	Sample collected from submerged pool in manhole. Floating gross solids (litter) in manhole.		
Total Chlorine: 0 ppm	Odor: None			
Free Chlorine: 0 ppm	Turbidity: None			
Ammonia: 0 ppm	Color: None			
pH: 8.4 units	Gross Solids: Moderate			
Temperature 70 °F	Vegetation: None			
Conductivity: 391 µS/cm	Benthic Growth: None			
Detergents: 0 mg/L	Stains: None			
	Non-illicit: None	Condition Assessment		
		Graffiti: None	in.	
		Erosion: None		
		Deposition: None		
		Damage: None

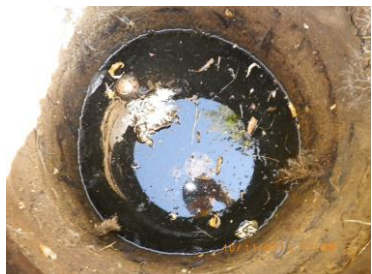
The outfall deposition is shown in the photos that follow. The locations of the outfalls with deposition are shown on the map in Appendix C.

Outfall	Severity	Description
12-2126	Moderate	3" of sediment and vegetation on apron.
12-2128	Minor	1" of sediment and vegetation on apron.
12-2538	Minor	1" of sediment in pipe and on apron.
12-2551	Minor	1" of sediment and vegetation on apron.
03-381 US1	Moderate	3" of sediment in bottom of manhole.

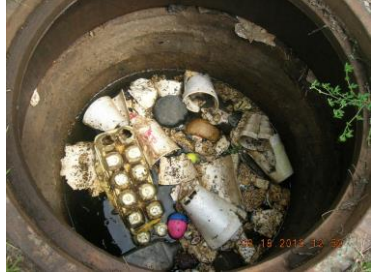
Inspection Date: 8/18/2010 1:00:07 PM		Type: Ongoing	Flow: Submerged, indeterminate	Previous Rainfall (hrs): 72+	
Illicit Discharge Potential: Potential		Inspector: JCW	Notes Significant floatable debris in manhole.		
Submerged: Fully		Depth (in): 41

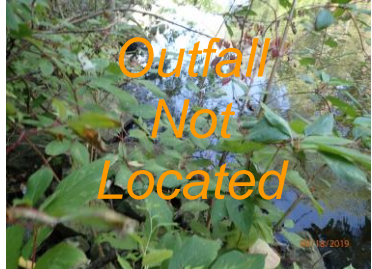
Inspection Date: 9/18/2019 9:37:57 AM		Type: Ongoing	Flow: Submerged (not located)	Previous Rainfall (hrs): 72+
Illicit Discharge Potential: Unlikely		Inspector: JCW		
Submerged: Fully		Depth (in):		
Sampling Results Sample Location: _____ Total Chlorine: -- ppm Free Chlorine: -- ppm Ammonia: -- ppm pH: -- units Temperature: -- °F Conductivity: -- µS/cm Detergents: -- mg/L		Floatables: None Odor: None Turbidity: None Color: None Gross Solids: None Vegetation: None Benthic Growth: None Stains: None Non-illicit: None	Notes Outfall fully submerged and not located - screened upstream at 06-221 US1. Floating gross solids (litter) in manhole.

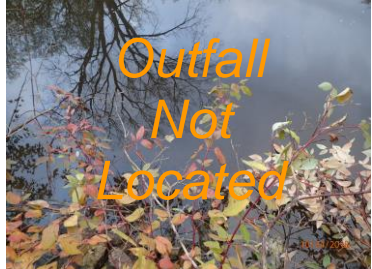
Inspection Date: 10/24/2018 7:45:30 AM		Type: Ongoing	Flow: Submerged (not located)	Previous Rainfall (hrs): 72+
Illicit Discharge Potential: Potential		Inspector: JCW		
Submerged: Fully		Depth (in):		
Sampling Results Sample Location: _____ Total Chlorine: -- ppm Free Chlorine: -- ppm Ammonia: -- ppm pH: -- units Temperature: -- °F Conductivity: -- µS/cm Detergents: -- mg/L		Floatables: None Odor: None Turbidity: None Color: None Gross Solids: None Vegetation: None Benthic Growth: None Stains: None Non-illicit: None	Notes Outfall fully submerged and not located - screened upstream at 06-221 US1. Floating gross solids (litter) in manhole.

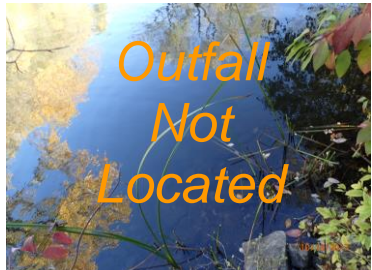
Inspection Date: 10/18/2017 10:56:45 AM		Type: Ongoing	Flow: Submerged (not located)	Previous Rainfall (hrs): 72+
Illicit Discharge Potential: Potential		Inspector: JCW		
Submerged: Fully		Depth (in):		
Sampling Results Sample Location: _____ Total Chlorine: -- ppm Free Chlorine: -- ppm Ammonia: -- ppm pH: -- units Temperature: -- °F Conductivity: -- µS/cm Detergents: -- mg/L		Floatables: None Odor: None Turbidity: None Color: None Gross Solids: None Vegetation: None Benthic Growth: None Stains: None Non-illicit: None	Notes Outfall fully submerged and not located - screened upstream at 06-221 US1. Floating gross solids (litter) in manhole.

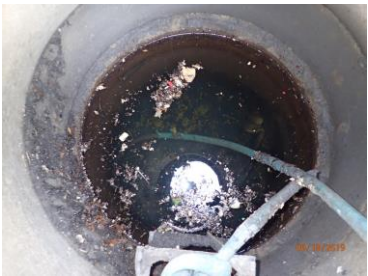
<div style="display: flex; justify-content: space-between;"> <div style="width: 45%;"> <p>Notes</p> <p>Sample collected from submerged pool in manhole. Floating gross solids (litter) in manhole.</p> </div> <div style="width: 45%;"> <p>Condition Assessment</p> <table border="1" style="width:100%; border-collapse: collapse;"> <tr><td>Graffiti:</td><td>None</td></tr> <tr><td>Erosion:</td><td>None</td></tr> <tr><td>Deposition:</td><td>None in.</td></tr> <tr><td>Damage:</td><td>None</td></tr> </table> </div> </div>			Graffiti:	None	Erosion:	None	Deposition:	None in.	Damage:	None																										
Graffiti:	None																																					
Erosion:	None																																					
Deposition:	None in.																																					
Damage:	None																																					
		<div style="display: flex; justify-content: space-between; align-items: center;">

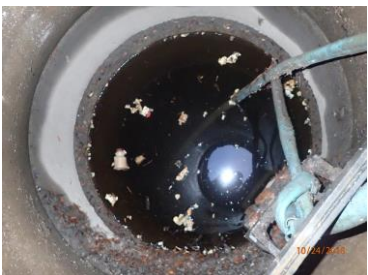
<div style="text-align: right;"> <p>o20181024074456.JPG</p> <p>2018</p> </div> </div>

<div style="display: flex; justify-content: space-between;"> <div style="width: 45%;"> <p>Notes</p> <p>Sample collected from submerged pool in manhole. Floating gross solids (litter) in manhole.</p> </div> <div style="width: 45%;"> <p>Condition Assessment</p> <table border="1" style="width:100%; border-collapse: collapse;"> <tr><td>Graffiti:</td><td>None</td></tr> <tr><td>Erosion:</td><td>None</td></tr> <tr><td>Deposition:</td><td>None in.</td></tr> <tr><td>Damage:</td><td>None</td></tr> </table> </div> </div>			Graffiti:	None	Erosion:	None	Deposition:	None in.	Damage:	None																										
Graffiti:	None																																					
Erosion:	None																																					
Deposition:	None in.																																					
Damage:	None																																					
		<div style="display: flex; justify-content: space-between; align-items: center;">

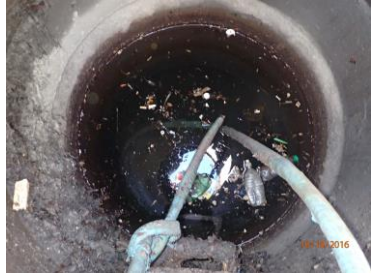
o20161018134038.JPG

Inspection Date: 10/18/2016 1:43:57 PM		Type: Ongoing	Flow: Submerged, indeterminate	Previous Rainfall (hrs): 72+
Illicit Discharge Potential: Potential		Inspector: JCW	Notes	
Submerged: Fully		Depth (in): 35	Casting displaced 2". Potential illicit discharge due to gross solids.	
Sampling Results		Condition Assessment		
Sample Location: Pool	Floatables: None	Graffiti: None	Erosion: None	in.
Total Chlorine: 0 ppm	Odor: None	Deposition: None	Damage: Minor	
Free Chlorine: 0 ppm	Turbidity: None			
Ammonia: 0 ppm	Color: None			
pH: 7.06 units	Gross Solids: Moderate			
Temperature 68 °F	Vegetation: None			
Conductivity: 460 µS/cm	Benthic Growth: None			
Detergents: 0 mg/L	Stains: None			
	Non-illicit: None

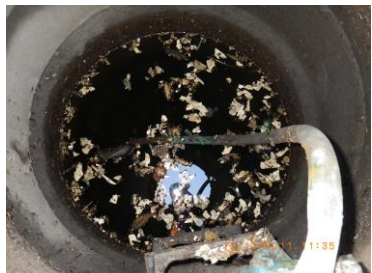
o20111011113522.JPG

Inspection Date: 10/11/2011 11:37:34 AM		Type: Ongoing	Flow: Submerged, indeterminate	Previous Rainfall (hrs): 72+
Illicit Discharge Potential: Potential		Inspector: JCW	Notes	
Submerged: Fully		Depth (in): 32	2010 screening follow-up. Floatable debris still present.	
Sampling Results		Condition Assessment		
Sample Location: Pool	Floatables: None	Graffiti: None	Erosion: None	0 in.
Total Chlorine: 0 ppm	Odor: None	Deposition: None	Damage: None	
Free Chlorine: 0 ppm	Turbidity: None			
Ammonia: 0 ppm	Color: None			
pH: 7.5 units	Gross Solids: Moderate			
Temperature 71 °F	Vegetation: None			
Conductivity: -- µS/cm	Benthic Growth: None			
Detergents: -- mg/L	Stains: None			
	Non-illicit: None

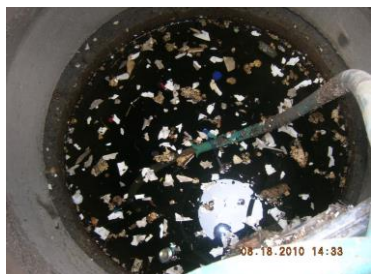
o20100818143354.JPG

Inspection Date: 8/18/2010 2:43:51 PM		Type: Ongoing	Flow: Submerged, indeterminate	Previous Rainfall (hrs): 72+
Illicit Discharge Potential: Potential		Inspector: JCW	Notes	
Submerged: Fully		Depth (in): 36	Torn paper and other floatable debris in manhole.	
Sampling Results		Condition Assessment		
Sample Location: Pool	Floatables: None	Graffiti: None	Erosion: None	0 in.
Total Chlorine: 0 ppm	Odor: None	Deposition: None	Damage: None	
Free Chlorine: 0 ppm	Turbidity: None			
Ammonia: 0 ppm	Color: None			
pH: 7.21 units	Gross Solids: Moderate			
Temperature 79 °F	Vegetation: None			
Conductivity: -- µS/cm	Benthic Growth: None			
Detergents: 0 mg/L	Stains: None			
	Non-illicit: None

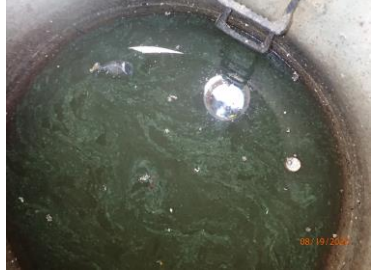
o20200819111844.JPG

Inspection Date: 8/19/2020 11:21:56 AM		Type: Ongoing	Flow: Submerged, indeterminate	Previous Rainfall (hrs): 72+
Illicit Discharge Potential: Unlikely		Inspector: JCW		
Submerged: Fully		Depth (in): 36		
Sampling Results		Notes Sample collected from submerged pool in manhole. Floating gross solids (litter) in manhole.		
Sample Location: Pool	Floatables: None	Condition Assessment Graffiti: None Erosion: None Deposition: None in. Damage: None		
Total Chlorine: 0 ppm	Odor: None			
Free Chlorine: 0 ppm	Turbidity: None			
Ammonia: 0 ppm	Color: None			
pH: 8.99 units	Gross Solids: Slight			
Temperature 80 °F	Vegetation: None			
Conductivity: 343 µS/cm	Benthic Growth: None			
Detergents: 0 mg/L	Stains: None			
	Non-illicit: None

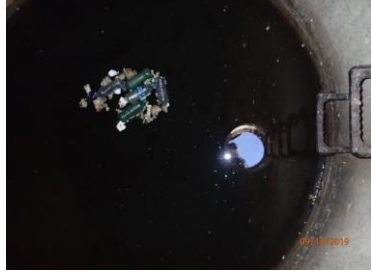
o20190918080922.JPG

Inspection Date: 9/18/2019 9:12:03 AM		Type: Ongoing	Flow: Submerged, indeterminate	Previous Rainfall (hrs): 72+
Illicit Discharge Potential: Potential		Inspector: JCW		
Submerged: Fully		Depth (in): 57		
Sampling Results		Notes Sample collected from submerged pool in manhole. Floating gross solids (litter) in manhole.		
Sample Location: Pool	Floatables: None	Condition Assessment Graffiti: None Erosion: None Deposition: None in. Damage: None		
Total Chlorine: 0 ppm	Odor: None			
Free Chlorine: 0 ppm	Turbidity: None			
Ammonia: 0 ppm	Color: None			
pH: 8.62 units	Gross Solids: Slight			
Temperature 71 °F	Vegetation: None			
Conductivity: 387 µS/cm	Benthic Growth: None			
Detergents: 0 mg/L	Stains: None			
	Non-illicit: None

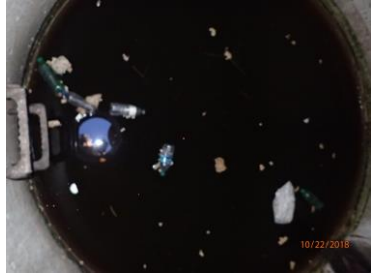
o20181022164226.JPG

Inspection Date: 10/22/2018 4:45:48 PM		Type: Ongoing	Flow: Submerged, indeterminate	Previous Rainfall (hrs): 48-72
Illicit Discharge Potential: Potential		Inspector: JCW		
Submerged: Fully		Depth (in): 58		
Sampling Results		Notes Sample collected from submerged pool in manhole. Floating gross solids (litter) in manhole.		
Sample Location: Pool	Floatables: None	Condition Assessment Graffiti: None Erosion: None Deposition: None in. Damage: None		
Total Chlorine: 0 ppm	Odor: None			
Free Chlorine: 0 ppm	Turbidity: None			
Ammonia: 0 ppm	Color: None			
pH: 7.7 units	Gross Solids: Slight			
Temperature 55 °F	Vegetation: None			
Conductivity: 370 µS/cm	Benthic Growth: None			
Detergents: 0 mg/L	Stains: None			
	Non-illicit: None

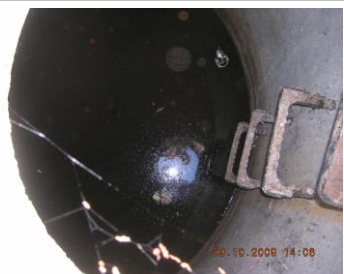
<p style="text-align: center;">Osh09_DSCN6801.JPG</p> <p style="text-align: center; font-size: 24pt; font-weight: bold;">2009</p>

<div style="display: flex; justify-content: space-between;"> <div style="width: 45%;"> <p>Notes</p> <p>Abnormal detergent analysis result (bubbles)</p> </div> <div style="width: 45%;"> <p>Condition Assessment</p> <table border="1" style="width:100%; border-collapse: collapse;"> <tr><td>Graffiti:</td><td>None</td></tr> <tr><td>Erosion:</td><td>None</td></tr> <tr><td>Deposition:</td><td>None 0 in.</td></tr> <tr><td>Damage:</td><td>None</td></tr> </table> </div> </div>			Graffiti:	None	Erosion:	None	Deposition:	None 0 in.	Damage:	None																										
Graffiti:	None																																					
Erosion:	None																																					
Deposition:	None 0 in.																																					
Damage:	None

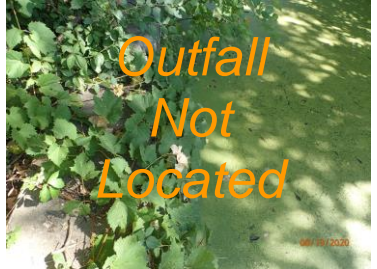
Inspection Date: 8/19/2020 10:50:40 AM		Type: Ongoing	Flow: Submerged (not located)	Previous Rainfall (hrs): 72+
Illicit Discharge Potential: Unlikely		Inspector: JCW		
Submerged: Fully		Depth (in):		
Sampling Results Sample Location: Total Chlorine: -- ppm Free Chlorine: -- ppm Ammonia: -- ppm pH: -- units Temperature: -- °F Conductivity: -- µS/cm Detergents: -- mg/L		Floatables: None Odor: None Turbidity: None Color: None Gross Solids: None Vegetation: None Benthic Growth: None Stains: None Non-illicit: None	Notes Outfall fully submerged and not located - screened upstream at 06-829 US1.

o20200819105038.JPG 2020
		Condition Assessment Graffiti: None Erosion: None Deposition: None in. Damage: None

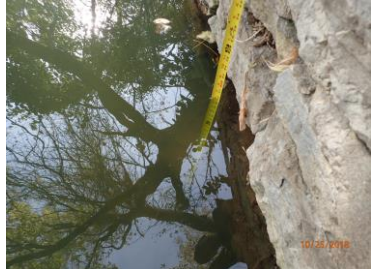
Inspection Date: 10/25/2018 1:36:22 PM		Type: Ongoing	Flow: Submerged, indeterminate	Previous Rainfall (hrs): 72+
Illicit Discharge Potential: Potential		Inspector: JCW		
Submerged: Fully		Depth (in):		
Sampling Results Sample Location: Total Chlorine: -- ppm Free Chlorine: -- ppm Ammonia: -- ppm pH: -- units Temperature: -- °F Conductivity: -- µS/cm Detergents: -- mg/L		Floatables: None Odor: None Turbidity: None Color: None Gross Solids: None Vegetation: None Benthic Growth: None Stains: None Non-illicit: None	Notes Outfall fully submerged - screened upstream at 06-829 US1. Floating gross solids (litter) in manhole.

o20181025133432.JPG 2018
		Condition Assessment Graffiti: None Erosion: None Deposition: None in. Damage: None

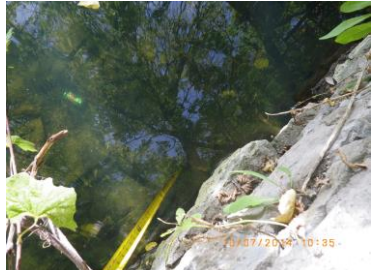
Inspection Date: 10/7/2014 10:34:09 AM		Type: Ongoing	Flow: Submerged, indeterminate	Previous Rainfall (hrs): 48-72
Illicit Discharge Potential: Unlikely		Inspector: JCW		
Submerged: Fully		Depth (in): 42		
Sampling Results Sample Location: Total Chlorine: -- ppm Free Chlorine: -- ppm Ammonia: -- ppm pH: -- units Temperature: -- °F Conductivity: -- µS/cm Detergents: -- mg/L		Floatables: None Odor: None Turbidity: None Color: None Gross Solids: None Vegetation: None Benthic Growth: Slight Stains: None Non-illicit: None	Notes Outfall fully submerged - screened upstream at 06-829 US1. Manhole lid in water near end of pipe.

o20141007093522.JPG 2014
		Condition Assessment Graffiti: None Erosion: None Deposition: None in. Damage: None

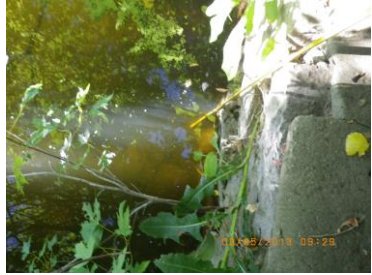
o20130905082920.JPG

Inspection Date: 9/5/2013 9:25:55 AM		Type: Ongoing	Flow: Submerged, indeterminate	Previous Rainfall (hrs): 72+
Illicit Discharge Potential: Potential		Inspector: JCW	Notes	
Submerged: Fully Depth (in): 45			2012 screening follow-up. Outfall fully submerged. Outfall screened upstream at 06-829 US1. Gross solids in upstream mh.	
Sampling Results			Condition Assessment	
Sample Location:	Floatables:	None	Graffiti:	None
Total Chlorine: -- ppm	Odor:	None	Erosion:	None
Free Chlorine: -- ppm	Turbidity:	None	Deposition:	None in.
Ammonia: -- ppm	Color:	None	Damage:	None
pH: -- units	Gross Solids:	None		
Temperature -- °F	Vegetation:	None		
Conductivity: -- µS/cm	Benthic Growth:	None		
Detergents: -- mg/L	Stains:	None		
	Non-illicit:	None

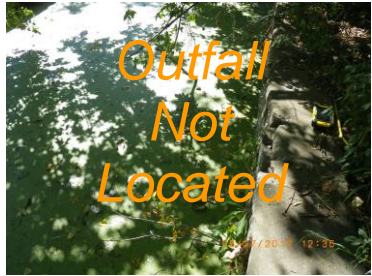
o20120927113654.JPG

Inspection Date: 9/27/2012 12:33:16 PM		Type: Ongoing	Flow: Submerged (not located)	Previous Rainfall (hrs): 72+
Illicit Discharge Potential: Potential		Inspector: JCW	Notes	
Submerged: Fully Depth (in):			Outfall fully submerged; screened upstream at 06-829 US1.	
Sampling Results			Condition Assessment	
Sample Location:	Floatables:	None	Graffiti:	None
Total Chlorine: -- ppm	Odor:	None	Erosion:	None
Free Chlorine: -- ppm	Turbidity:	None	Deposition:	None in.
Ammonia: -- ppm	Color:	None	Damage:	None
pH: -- units	Gross Solids:	None		
Temperature -- °F	Vegetation:	None		
Conductivity: -- µS/cm	Benthic Growth:	None		
Detergents: -- mg/L	Stains:	None		
	Non-illicit:	None
