IDDE Ongoing Screening Summary Report

2021 Inspection Year

City of Oshkosh

Westwood

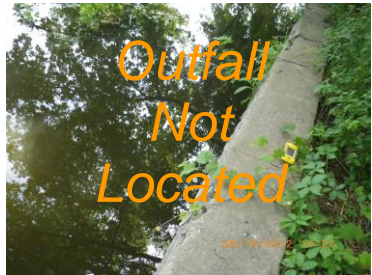
o20120613132730.JPG

Inspection Date: 6/13/2012 2:26:38 PM		Type: Other	Flow: Submerged (not located)	Previous Rainfall (hrs): 72+
Illicit Discharge Potential: Potential		Inspector: JCW	Notes	
Submerged: Fully Depth (in):			Gross solids pre-screening.	
Sampling Results			Condition Assessment	
Sample Location:	Floatables:	None	Graffiti:	None
Total Chlorine: -- ppm	Odor:	None	Erosion:	None
Free Chlorine: -- ppm	Turbidity:	None	Deposition:	None in.
Ammonia: -- ppm	Color:	None	Damage:	None
pH: -- units	Gross Solids:	None		
Temperature -- °F	Vegetation:	None		
Conductivity: -- µS/cm	Benthic Growth:	None		
Detergents: -- mg/L	Stains:	None		
	Non-illicit:	None

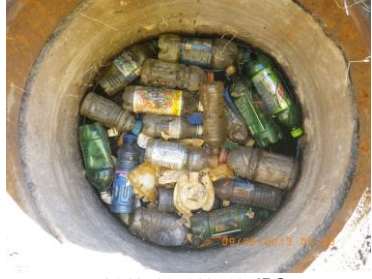
o20130905082002.JPG

Inspection Date: 9/5/2013 9:16:05 AM		Type: Ongoing	Flow: Submerged, indeterminate	Previous Rainfall (hrs): 72+
Illicit Discharge Potential: Potential		Inspector: JCW	Notes	
Submerged: Fully		Depth (in): 35	2012 screening follow-up. Significant gross solids in manhole - similar to previous years.	
Sampling Results		Condition Assessment		
Sample Location: Pool	Floatables: None	Graffiti: None	Erosion: None	in.
Total Chlorine: 0 ppm	Odor: None	Deposition: None	Damage: None	
Free Chlorine: 0 ppm	Turbidity: None			
Ammonia: 0 ppm	Color: None			
pH: 7.7 units	Gross Solids: Severe			
Temperature 71 °F	Vegetation: None			
Conductivity: 1666 µS/cm	Benthic Growth: None			
Detergents: 0 mg/L	Stains: Slight			
	Non-illicit: None

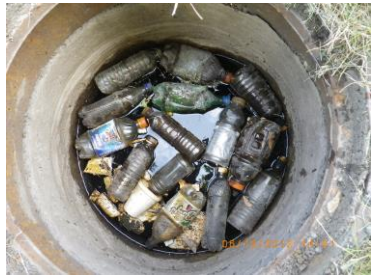
o20120613133100.JPG

Inspection Date: 6/13/2012 2:30:25 PM		Type: Other	Flow: Submerged, indeterminate	Previous Rainfall (hrs): 72+
Illicit Discharge Potential: Potential		Inspector: JCW	Notes	
Submerged: Fully		Depth (in): 37	Gross solids pre-screening. Bottles in manhole.	
Sampling Results		Condition Assessment		
Sample Location: Pool	Floatables: None	Graffiti: None	Erosion: None	in.
Total Chlorine: 0 ppm	Odor: None	Deposition: None	Damage: None	
Free Chlorine: 0 ppm	Turbidity: None			
Ammonia: 0 ppm	Color: None			
pH: 7.58 units	Gross Solids: Severe			
Temperature 70 °F	Vegetation: None			
Conductivity: 1765 µS/cm	Benthic Growth: Slight			
Detergents: 0 mg/L	Stains: None			
	Non-illicit: None

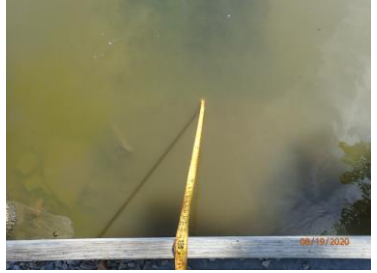
Inspection Date: 8/19/2020 10:22:53 AM		Type: Ongoing	Flow: Submerged, significant flow	Previous Rainfall (hrs): 72+
Illicit Discharge Potential: Unlikely		Inspector: JCW		
Submerged: Fully		Depth (in): 38		
Sampling Results Sample Location: _____ Total Chlorine: -- ppm Free Chlorine: -- ppm Ammonia: -- ppm pH: -- units Temperature: -- °F Conductivity: -- µS/cm Detergents: -- mg/L		Floatables: None Odor: None Turbidity: None Color: None Gross Solids: None Vegetation: None Benthic Growth: None Stains: None Non-illicit: None	Notes Outfall fully submerged - screened upstream at 06-253 US1.

o20200819102052.JPG <div style="text-align: center; font-size: 24pt; font-weight: bold;">2020</div>
			Condition Assessment Graffiti: None Erosion: None Deposition: None in. Damage: None

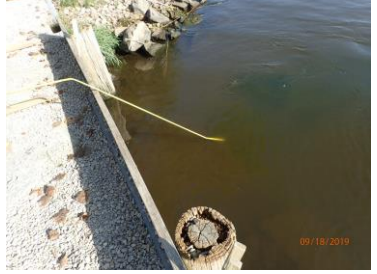
Inspection Date: 9/18/2019 9:25:08 AM		Type: Ongoing	Flow: Submerged, significant flow	Previous Rainfall (hrs): 72+
Illicit Discharge Potential: Unlikely		Inspector: JCW		
Submerged: Fully		Depth (in):		
Sampling Results Sample Location: _____ Total Chlorine: -- ppm Free Chlorine: -- ppm Ammonia: -- ppm pH: -- units Temperature: -- °F Conductivity: -- µS/cm Detergents: -- mg/L		Floatables: None Odor: None Turbidity: None Color: None Gross Solids: None Vegetation: None Benthic Growth: None Stains: None Non-illicit: None	Notes Outfall fully submerged, significant flow causing surface disturbance. Screened upstream at 06-253 US1.

o20190918082324.JPG <div style="text-align: center; font-size: 24pt; font-weight: bold;">2019</div>
			Condition Assessment Graffiti: None Erosion: None Deposition: None in. Damage: None

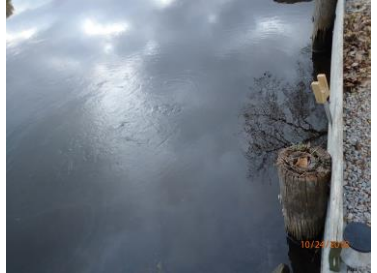
Inspection Date: 10/24/2018 7:29:02 AM		Type: Ongoing	Flow: Submerged, significant flow	Previous Rainfall (hrs): 72+
Illicit Discharge Potential: Potential		Inspector: JCW		
Submerged: Fully		Depth (in):		
Sampling Results Sample Location: _____ Total Chlorine: -- ppm Free Chlorine: -- ppm Ammonia: -- ppm pH: -- units Temperature: -- °F Conductivity: -- µS/cm Detergents: -- mg/L		Floatables: None Odor: None Turbidity: None Color: None Gross Solids: None Vegetation: None Benthic Growth: None Stains: None Non-illicit: None	Notes Outfall fully submerged, significant flow causing surface disturbance. Screened upstream at 06-253 US1. Elevated ammonia and conductivity in manhole.

o20181024072834.JPG <div style="text-align: center; font-size: 24pt; font-weight: bold;">2018</div>
			Condition Assessment Graffiti: None Erosion: None Deposition: None in. Damage: None

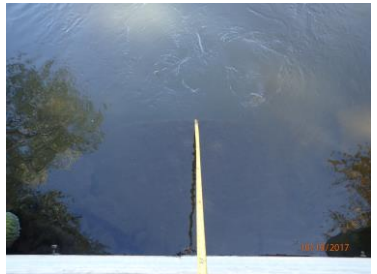
Inspection Date: 10/19/2017 1:14:17 PM		Type: Ongoing	Flow: Submerged, significant flow	Previous Rainfall (hrs): 72+
Illicit Discharge Potential: Potential		Inspector: JCW		
Submerged: Fully		Depth (in):		
Sampling Results Sample Location: _____ Total Chlorine: -- ppm Free Chlorine: -- ppm Ammonia: -- ppm pH: -- units Temperature: -- °F Conductivity: -- µS/cm Detergents: -- mg/L		Floatables: None Odor: None Turbidity: None Color: None Gross Solids: None Vegetation: None Benthic Growth: None Stains: None Non-illicit: None	Notes Outfall fully submerged with significant flow causing surface disturbance. Screened upstream at 06-253 US1. Elevated ammonia in manhole.

o20171019131334.JPG <div style="text-align: center; font-size: 24pt; font-weight: bold;">2017</div>
			Condition Assessment Graffiti: None Erosion: None Deposition: None in. Damage: None

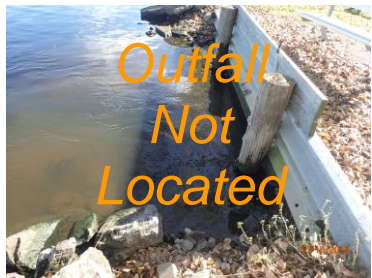
o20161018135746.JPG <div style="text-align: right; font-weight: bold; font-size: 1.2em;">2016</div>

Inspection Date: 10/18/2016 1:59:02 PM		Type: Ongoing	Flow: Submerged (not located)	Previous Rainfall (hrs): 72+
Illicit Discharge Potential: Unlikely		Inspector: JCW		
Submerged: Fully		Depth (in):		
Sampling Results				
Sample Location:	Floatables:	None		
Total Chlorine: -- ppm	Odor:	None		
Free Chlorine: -- ppm	Turbidity:	None		
Ammonia: -- ppm	Color:	None		
pH: -- units	Gross Solids:	None		
Temperature -- °F	Vegetation:	None		
Conductivity: -- µS/cm	Benthic Growth:	None		
Detergents: -- mg/L	Stains:	None		
	Non-illicit:	None		
		Notes Outfall fully submerged and not located - screened upstream at 06-253 US1.		
		Condition Assessment Graffiti: None Erosion: None Deposition: None in. Damage: None

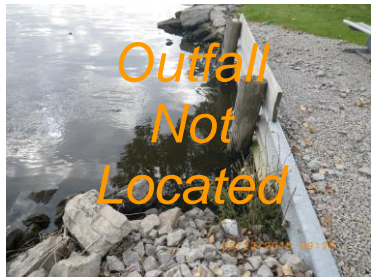
o20150923082910.JPG <div style="text-align: right; font-weight: bold; font-size: 1.2em;">2015</div>

Inspection Date: 9/23/2015 9:26:08 AM		Type: Ongoing	Flow: Submerged (not located)	Previous Rainfall (hrs): 72+
Illicit Discharge Potential: Unlikely		Inspector: JCW		
Submerged: Fully		Depth (in):		
Sampling Results				
Sample Location:	Floatables:	None		
Total Chlorine: -- ppm	Odor:	None		
Free Chlorine: -- ppm	Turbidity:	None		
Ammonia: -- ppm	Color:	None		
pH: -- units	Gross Solids:	None		
Temperature -- °F	Vegetation:	None		
Conductivity: -- µS/cm	Benthic Growth:	None		
Detergents: -- mg/L	Stains:	None		
	Non-illicit:	None		
		Notes Outfall fully submerged and not located - screened at 06-253 US1.		
		Condition Assessment Graffiti: None Erosion: None Deposition: None in. Damage: None

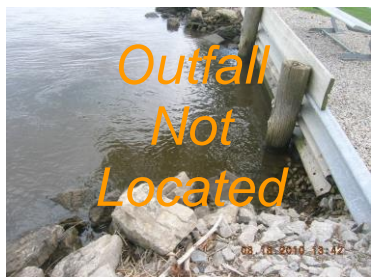
o20100818134248.JPG <div style="text-align: right; font-weight: bold; font-size: 1.2em;">2010</div>

Inspection Date: 8/18/2010 1:51:34 PM		Type: Ongoing	Flow: Submerged (not located)	Previous Rainfall (hrs): 72+
Illicit Discharge Potential: Unlikely		Inspector: JCW		
Submerged: Fully		Depth (in):		
Sampling Results				
Sample Location:	Floatables:	None		
Total Chlorine: -- ppm	Odor:	None		
Free Chlorine: -- ppm	Turbidity:	None		
Ammonia: -- ppm	Color:	None		
pH: -- units	Gross Solids:	None		
Temperature -- °F	Vegetation:	None		
Conductivity: -- µS/cm	Benthic Growth:	None		
Detergents: -- mg/L	Stains:	None		
	Non-illicit:	None		
		Notes Outfall fully submerged and not physically located. Outfall screened upstream at 06-263 US1.		
		Condition Assessment Graffiti: None Erosion: None Deposition: None 0 in. Damage: None

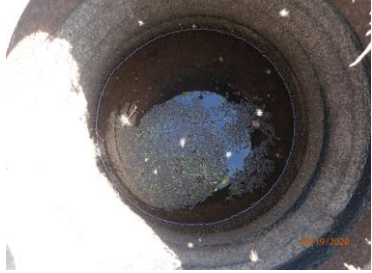
A *slight* severity for floatables indicates isolated occurrences of the substance in the pool or flow. A *moderate* severity indicates a broader coverage, including distinct pockets of the substance. A *severe* classification typically describes total coverage of the water surface.

Odor

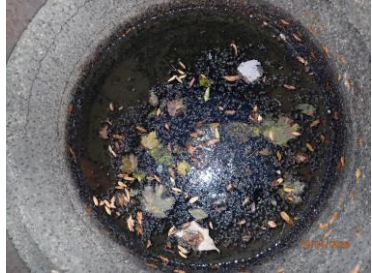
Color is most easily assessed in the sample bottle. The sample bottle can be compared to a bottle of deionized water as a standard. The general color of the sample is noted, along with the relative severity. A *slight* severity for color indicates that the color is faint in the sample bottle. A *moderate* severity indicates that the color is easily detected in the sample bottle. A *severe* classification indicates that the color can be observed in the actual flow or pool, outside of the sample bottle.

Vegetation

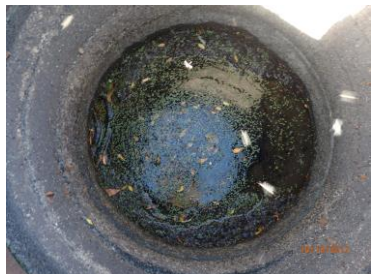
Vegetation effects were classified as either “inhibited” or “excessive.” The severity was subjectively assigned based on the extent of the vegetation impact that was observed, ranging from *slight* to *severe*.

Benthic Growth

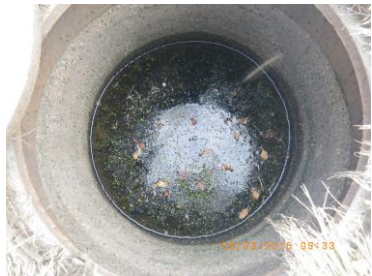
important to distinguish between actual iron discharges and normal pipe corrosion, which can occur in metal pipes, and is not an illicit discharge. Corrosion typically occurs along the invert of the pipe, where water may collect and corrode the pipe. Rust stains are typically darker streaks, often originating from a lateral or other incoming pipe.

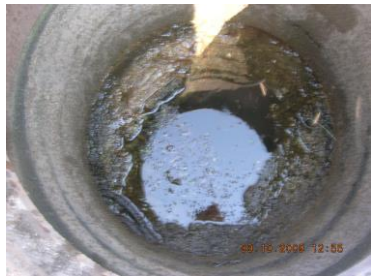
Vegetative debris, including leaves and grass clippings, can also enter the storm sewer through catchbasins and inlets and travel to the outfall. As with litter, an attempt is made to determine if the vegetative debris traveled through the storm sewer or was deposited at the outfall in another manner.

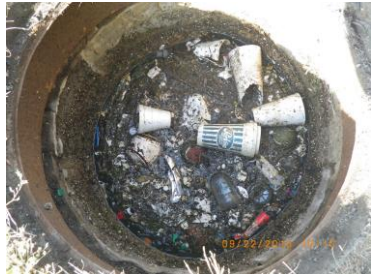
o20150922091040.JPG

Inspection Date: 9/22/2015 10:09:39 AM		Type: Ongoing	Flow: Submerged, indeterminate	Previous Rainfall (hrs): 72+
Illicit Discharge Potential: Potential		Inspector: JCW	Notes	
Submerged: Fully		Depth (in): 34	Floating gross solids (litter) in manhole.	
Sampling Results		Condition Assessment		
Sample Location: Pool	Floatables: None	Graffiti: None Erosion: None Deposition: None in. Damage: None		
Total Chlorine: 0 ppm	Odor: None			
Free Chlorine: 0 ppm	Turbidity: None			
Ammonia: 0 ppm	Color: None			
pH: 8.8 units	Gross Solids: Severe			
Temperature 70 °F	Vegetation: None			
Conductivity: 335 µS/cm	Benthic Growth: None			
Detergents: 0 mg/L	Stains: None			
	Non-illicit: None

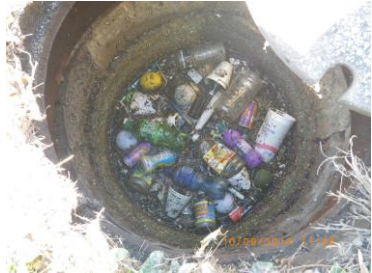
o20141009102622.JPG

Inspection Date: 10/9/2014 11:28:19 AM		Type: Ongoing	Flow: Submerged, indeterminate	Previous Rainfall (hrs): 72+
Illicit Discharge Potential: Potential		Inspector: JCW	Notes	
Submerged: Fully		Depth (in): 29	Floating gross solids (litter) in manhole.	
Sampling Results		Condition Assessment		
Sample Location: Pool	Floatables: None	Graffiti: None Erosion: None Deposition: None in. Damage: None		
Total Chlorine: 0 ppm	Odor: None			
Free Chlorine: 0 ppm	Turbidity: None			
Ammonia: 0 ppm	Color: Faint in bottle			
pH: 8.34 units	Gross Solids: Severe			
Temperature 57 °F	Vegetation: None			
Conductivity: 400 µS/cm	Benthic Growth: None			
Detergents: 0 mg/L	Stains: None			
	Non-illicit: None

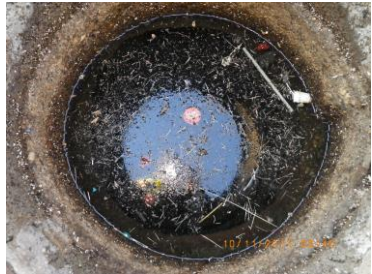
o20111011084038.JPG

Inspection Date: 10/11/2011 8:41:22 AM		Type: Ongoing	Flow: Submerged, indeterminate	Previous Rainfall (hrs): 72+
Illicit Discharge Potential: Unlikely		Inspector: JCW	Notes	
Submerged: Fully		Depth (in): 18	2010 screening follow-up. Floatable debris significantly reduced.	
Sampling Results		Condition Assessment		
Sample Location: Pool	Floatables: None	Graffiti: None Erosion: None Deposition: None 0 in. Damage: None		
Total Chlorine: 0 ppm	Odor: None			
Free Chlorine: 0 ppm	Turbidity: None			
Ammonia: 0 ppm	Color: None			
pH: 8.11 units	Gross Solids: Slight			
Temperature 72 °F	Vegetation: None			
Conductivity: -- µS/cm	Benthic Growth: None			
Detergents: -- mg/L	Stains: None			
	Non-illicit: None

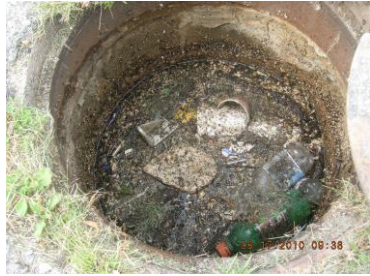
Inspection Date: 8/17/2010 9:47:15 AM		Type: Ongoing	Flow: Submerged, indeterminate	Previous Rainfall (hrs): 72+		
Illicit Discharge Potential: Potential		Inspector: JCW	Notes Significant floatable debris in manhole.			
Submerged: Fully		Depth (in): 31

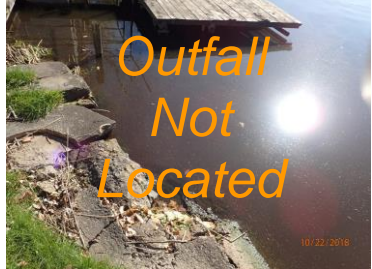
o20181022105820.JPG <div style="text-align: center; font-size: 24pt; font-weight: bold;">2018</div>

Inspection Date: 10/22/2018 10:59:46 AM		Type: Ongoing	Flow: Submerged (not located)	Previous Rainfall (hrs): 48-72
Illicit Discharge Potential: Potential		Inspector: JCW		
Submerged: Fully		Depth (in):		
Sampling Results Sample Location: _____ Total Chlorine: -- ppm Free Chlorine: -- ppm Ammonia: -- ppm pH: -- units Temperature: -- °F Conductivity: -- µS/cm Detergents: -- mg/L		Floatables: None Odor: None Turbidity: None Color: None Gross Solids: None Vegetation: None Benthic Growth: None Stains: None Non-illicit: None		
		Notes Outfall fully submerged and not located - screened upstream at 08-347 US1. Floating gross solids (litter) in manhole.		
		Condition Assessment Graffiti: None Erosion: None Deposition: None in. Damage: None

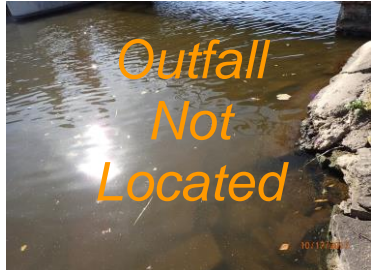
o20171017140150.JPG <div style="text-align: center; font-size: 24pt; font-weight: bold;">2017</div>

Inspection Date: 10/17/2017 2:04:43 PM		Type: Ongoing	Flow: Submerged (not located)	Previous Rainfall (hrs): 48-72
Illicit Discharge Potential: Potential		Inspector: JCW		
Submerged: Fully		Depth (in):		
Sampling Results Sample Location: _____ Total Chlorine: -- ppm Free Chlorine: -- ppm Ammonia: -- ppm pH: -- units Temperature: -- °F Conductivity: -- µS/cm Detergents: -- mg/L		Floatables: None Odor: None Turbidity: None Color: None Gross Solids: None Vegetation: None Benthic Growth: None Stains: None Non-illicit: None		
		Notes Outfall fully submerged and not located - screened upstream at 08-347 US1. Floating gross solids (litter) in manhole.		
		Condition Assessment Graffiti: None Erosion: None Deposition: None in. Damage: None

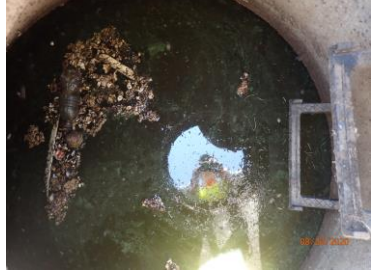
Inspection Date: 8/20/2020 12:45:49 PM		Type: Ongoing	Flow: Submerged, indeterminate	Previous Rainfall (hrs): 72+
Illicit Discharge Potential: Potential Submerged: Fully Depth (in): 48		Inspector: JCW	Notes Sample collected from submerged pool in manhole. Floating gross solids (litter) in manhole.	
Sampling Results Sample Location: Pool Total Chlorine: 0 ppm Free Chlorine: 0 ppm Ammonia: 0 ppm pH: 8.95 units Temperature: 82 °F Conductivity: 340 µS/cm Detergents: 0 mg/L		Floatables: None Odor: None Turbidity: None Color: None Gross Solids: Moderate Vegetation: None Benthic Growth: None Stains: None Non-illicit: None	Condition Assessment Graffiti: None Erosion: None Deposition: None in. Damage: None

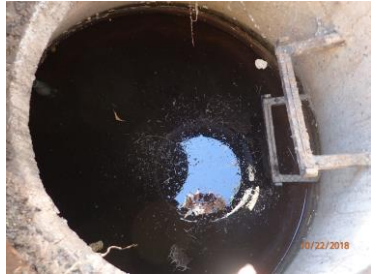
o20190917134722.JPG 2019	
Inspection Date: 10/22/2018 11:02:59 AM Illicit Discharge Potential: Potential Submerged: Fully Depth (in): 53		Type: Ongoing	Flow: Submerged, indeterminate	Previous Rainfall (hrs): 48-72
Inspector: JCW Sampling Results Sample Location: Pool Total Chlorine: 0 ppm Free Chlorine: 0 ppm Ammonia: 0 ppm pH: 7.49 units Temperature: 55 °F Conductivity: 321 µS/cm Detergents: 0 mg/L		Floatables: None Odor: None Turbidity: None Color: Faint in bottle Gross Solids: Slight Vegetation: None Benthic Growth: Slight Stains: None Non-illicit: None	Notes Sample collected from submerged pool in manhole. Floating gross solids (litter) in manhole.

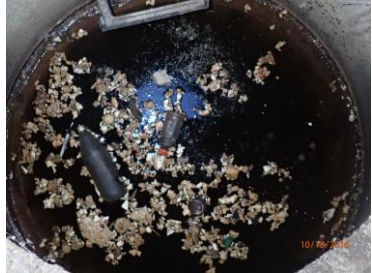
o20161018170248.JPG

Inspection Date: 10/18/2016 5:02:56 PM		Type: Ongoing	Flow: Submerged, indeterminate	Previous Rainfall (hrs): 72+
Illicit Discharge Potential: Potential		Inspector: JCW	Notes	
Submerged: Partially Depth (in): 46			Potential illicit discharge due to gross solids.	
Sampling Results		Floatables: None	Condition Assessment	
Sample Location: Pool		Odor: None	Graffiti: None Erosion: None Deposition: None in. Damage: None	
Total Chlorine: 0 ppm		Turbidity: None		
Free Chlorine: 0 ppm		Color: Faint in bottle		
Ammonia: 0 ppm		Gross Solids: Severe		
pH: 8.18 units		Vegetation: None		
Temperature 66 °F		Benthic Growth: None		
Conductivity: 361 µS/cm		Stains: None		
Detergents: 0 mg/L		Non-illicit: None

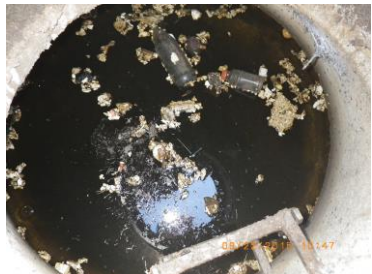
o20150922094746.JPG

Inspection Date: 9/22/2015 10:46:05 AM		Type: Ongoing	Flow: Submerged, indeterminate	Previous Rainfall (hrs): 72+
Illicit Discharge Potential: Potential		Inspector: JCW	Notes	
Submerged: Fully Depth (in): 48			Floating gross solids (litter) in manhole.	
Sampling Results		Floatables: None	Condition Assessment	
Sample Location: Pool		Odor: None	Graffiti: None Erosion: None Deposition: None in. Damage: None	
Total Chlorine: 0 ppm		Turbidity: None		
Free Chlorine: 0 ppm		Color: None		
Ammonia: 0 ppm		Gross Solids: Moderate		
pH: 8.33 units		Vegetation: None		
Temperature 73 °F		Benthic Growth: None		
Conductivity: 352 µS/cm		Stains: None		
Detergents: 0 mg/L		Non-illicit: None

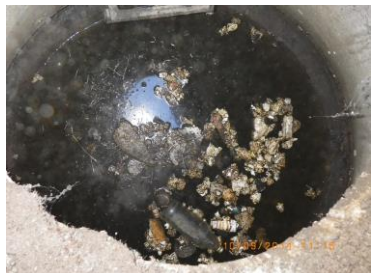
o20141009101552.JPG

Inspection Date: 10/9/2014 11:17:38 AM		Type: Ongoing	Flow: Submerged, indeterminate	Previous Rainfall (hrs): 72+
Illicit Discharge Potential: Potential		Inspector: JCW	Notes	
Submerged: Fully Depth (in): 43			Floating gross solids (litter) in manhole.	
Sampling Results		Floatables: None	Condition Assessment	
Sample Location: Pool		Odor: None	Graffiti: None Erosion: None Deposition: None in. Damage: None	
Total Chlorine: 0 ppm		Turbidity: None		
Free Chlorine: 0 ppm		Color: None		
Ammonia: 0 ppm		Gross Solids: Moderate		
pH: 7.67 units		Vegetation: None		
Temperature 59 °F		Benthic Growth: None		
Conductivity: 422 µS/cm		Stains: None		
Detergents: 0 mg/L		Non-illicit: None

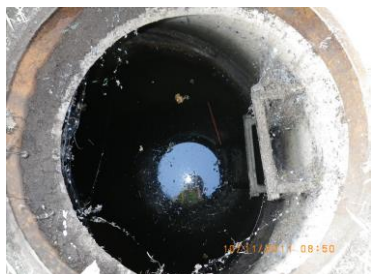
o20111011085018.JPG

Inspection Date: 10/11/2011 8:51:38 AM		Type: Ongoing	Flow: Submerged, indeterminate	Previous Rainfall (hrs): 72+
Illicit Discharge Potential: Unlikely		Inspector: JCW	Notes	
Submerged: Fully Depth (in): 43			2010 screening follow-up. Floatable debris significantly reduced.	
Sampling Results		Floatables: None	Condition Assessment	
Sample Location: Pool		Odor: None	Graffiti: None Erosion: None Deposition: None 0 in. Damage: None	
Total Chlorine: 0 ppm		Turbidity: None		
Free Chlorine: 0 ppm		Color: Faint in bottle		
Ammonia: 0 ppm		Gross Solids: Slight		
pH: 7.87 units		Vegetation: None		
Temperature 71 °F		Benthic Growth: None		
Conductivity: -- µS/cm		Stains: None		
Detergents: -- mg/L		Non-illicit: None

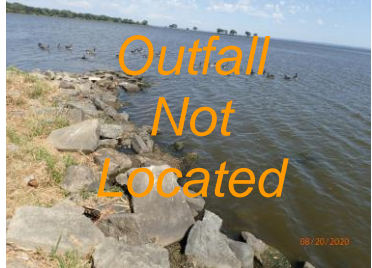
Free Chlorine (field): 0 ppm

Time Collected: 09:17

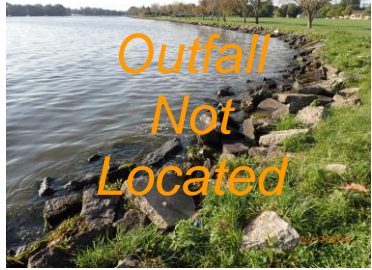
Temperature (field): 72 °F

Ammonia (field): 0 ppm

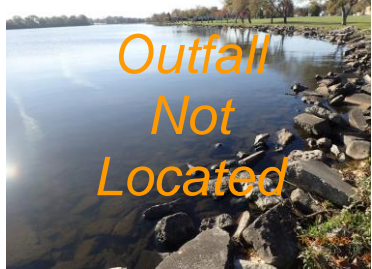
Conductivity (field): 493 µS/cm

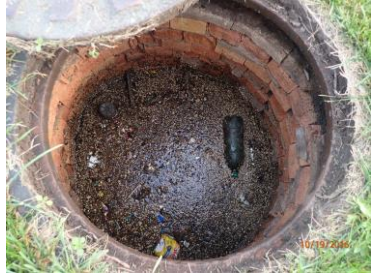
o20161019074410.JPG

Inspection Date: 10/19/2016 7:46:56 AM		Type: Ongoing	Flow: Submerged, indeterminate	Previous Rainfall (hrs): 72+
Illicit Discharge Potential: Potential		Inspector: JCW	Notes	
Submerged: Fully		Depth (in): 79	Potential illicit discharge due to gross solids.	
Sampling Results		Condition Assessment		
Sample Location: Pool	Floatables: None	Graffiti: None	Erosion: None	in.
Total Chlorine: 0 ppm	Odor: Faint	Deposition: None	Damage: None	
Free Chlorine: 0 ppm	Turbidity: None			
Ammonia: 0 ppm	Color: Faint in bottle			
pH: 7.89 units	Gross Solids: Severe			
Temperature 58 °F	Vegetation: None			
Conductivity: 357 µS/cm	Benthic Growth: None			
Detergents: 0 mg/L	Stains: None			
	Non-illicit: None

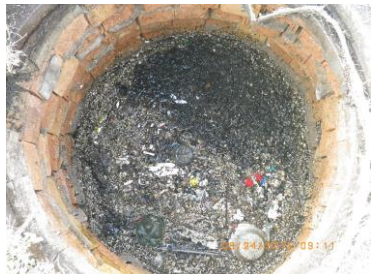
o20150924081150.JPG

Inspection Date: 9/24/2015 9:10:22 AM		Type: Ongoing	Flow: Submerged, indeterminate	Previous Rainfall (hrs): 72+
Illicit Discharge Potential: Potential		Inspector: JCW	Notes	
Submerged: Fully		Depth (in): 81	Floating gross solids (litter) in manhole.	
Sampling Results		Condition Assessment		
Sample Location: Pool	Floatables: None	Graffiti: None	Erosion: None	in.
Total Chlorine: 0 ppm	Odor: Faint	Deposition: None	Damage: None	
Free Chlorine: 0 ppm	Turbidity: None			
Ammonia: 0 ppm	Color: None			
pH: 7.88 units	Gross Solids: Severe			
Temperature 68 °F	Vegetation: None			
Conductivity: 397 µS/cm	Benthic Growth: None			
Detergents: 0 mg/L	Stains: None			
	Non-illicit: None

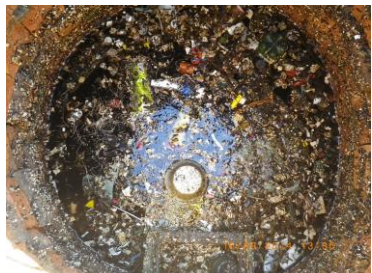
o20141009123616.JPG

Inspection Date: 10/9/2014 1:36:18 PM		Type: Ongoing	Flow: Submerged, indeterminate	Previous Rainfall (hrs): 72+
Illicit Discharge Potential: Potential		Inspector: JCW	Notes	
Submerged: Fully		Depth (in): 74	Floating gross solids (litter) in manhole.	
Sampling Results		Condition Assessment		
Sample Location: Pool	Floatables: None	Graffiti: None	Erosion: None	in.
Total Chlorine: 0 ppm	Odor: None	Deposition: None	Damage: None	
Free Chlorine: 0 ppm	Turbidity: None			
Ammonia: 0 ppm	Color: Faint in bottle			
pH: 7.76 units	Gross Solids: Severe			
Temperature 59 °F	Vegetation: None			
Conductivity: 381 µS/cm	Benthic Growth: None			
Detergents: 0 mg/L	Stains: None			
	Non-illicit: None

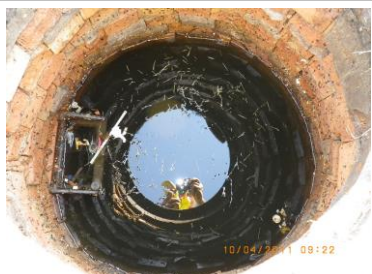
90 outfalls screened, with 18 potential illicit discharges identified.

City of Oshkosh Ongoing Screening Summary Report – 2019 Inspection Year (January 3, 2020)

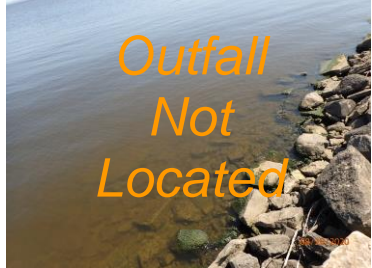
Gross solid severity is similar to the method used for floatables. A *slight* severity for gross solids indicates isolated occurrences of the substance in the pool or flow. A *moderate* severity indicates a broader coverage, including distinct pockets of the substance. A *severe* classification typically describes total coverage of the water surface or manhole.

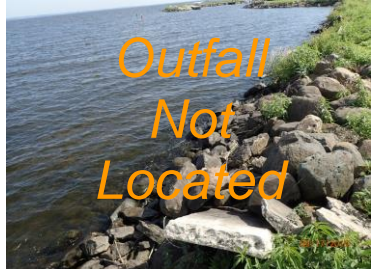
Physical indicators can also be valuable aids when tracing a suspected illicit discharge upstream to the source. Certain physical indicators – pipe and channel stains in particular – are persistent and can be used to trace the flow well after the actual flow has stopped.

years, some of the parameters included in the current year's inspections may not have been evaluated in previous years, and those parameters may appear as blank or missing data on earlier reports.)

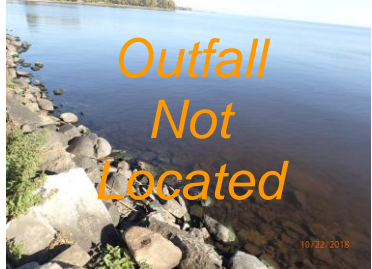
Figure 3 – Physical indicator observations

The physical indicators observed during the outfall inspections are summarized in Figure 3.

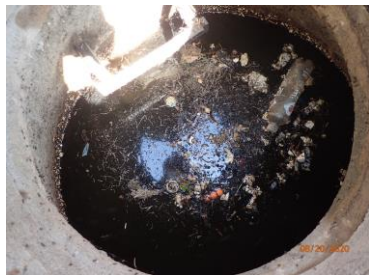
Inspection Date: 8/20/2020 1:21:12 PM		Type: Ongoing	Flow: Submerged, indeterminate	Previous Rainfall (hrs): 72+
Illicit Discharge Potential: Potential Submerged: Fully Depth (in): 39		Inspector: JCW	Notes Sample collected from submerged pool in manhole. Floating gross solids (litter) in manhole. Elevated pH seemed widespread in river/lake.	
Sampling Results Sample Location: Pool Total Chlorine: 0 ppm Free Chlorine: 0 ppm Ammonia: 0 ppm pH: 9.07 units Temperature: 84 °F Conductivity: 347 µS/cm Detergents: 0 mg/L		Floatables: None Odor: None Turbidity: None Color: None Gross Solids: Moderate Vegetation: None Benthic Growth: Moderate Stains: None Non-illicit: None	Condition Assessment Graffiti: None Erosion: None Deposition: None in. Damage: None

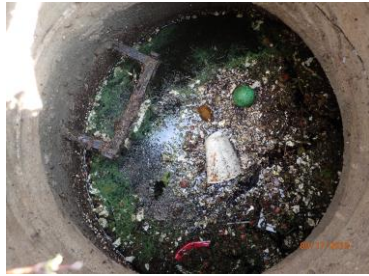
Inspector: JCW Sampling Results Sample Location: Pool Total Chlorine: 0 ppm Free Chlorine: 0 ppm Ammonia: 0 ppm pH: 8.23 units Temperature: 76 °F Conductivity: 333 µS/cm Detergents: 0 mg/L		Floatables: None Odor: None Turbidity: None Color: None Gross Solids: Severe Vegetation: None Benthic Growth: None Stains: None Non-illicit: None	Notes Sample collected from submerged pool in manhole. Floating gross solids (litter) in manhole.	
			Condition Assessment Graffiti: None Erosion: None Deposition: None in. Damage: None

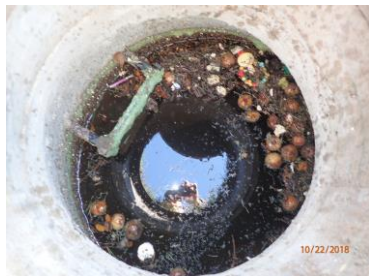
o20190917130614.JPG 2019	
Inspection Date: 10/22/2018 10:00:30 AM Illicit Discharge Potential: Potential Submerged: Fully Depth (in): 42		Type: Ongoing	Flow: Submerged, indeterminate	Previous Rainfall (hrs): 48-72
Inspector: JCW Sampling Results Sample Location: Pool Total Chlorine: 0 ppm Free Chlorine: 0 ppm Ammonia: 0 ppm pH: 7.35 units Temperature: 57 °F Conductivity: 470 µS/cm Detergents: 0 mg/L		Floatables: None Odor: None Turbidity: None Color: None Gross Solids: Moderate Vegetation: None Benthic Growth: Slight Stains: None Non-illicit: None	Notes Sample collected from submerged pool in manhole. Floating gross solids (litter) in manhole.

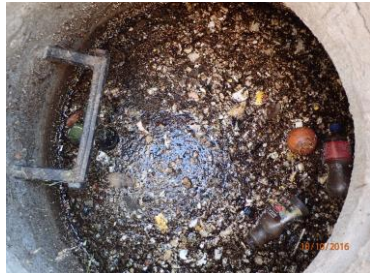
o20161010110444.JPG

Inspection Date: 10/10/2016 11:07:16 AM		Type: Ongoing	Flow: Submerged, indeterminate	Previous Rainfall (hrs): 72+
Illicit Discharge Potential: Potential		Inspector: JCW	Notes	
Submerged: Fully		Depth (in): 35	Potential illicit discharge due to gross solids.	
Sampling Results				
Sample Location:	Pool	Floatables:	None	
Total Chlorine:	0 ppm	Odor:	None	
Free Chlorine:	0 ppm	Turbidity:	None	
Ammonia:	0 ppm	Color:	None	
pH:	7.63 units	Gross Solids:	Severe	
Temperature	65 °F	Vegetation:	None	
Conductivity:	514 µS/cm	Benthic Growth:	None	
Detergents:	0 mg/L	Stains:	None	
		Non-illicit:	None	
			Condition Assessment	
			Graffiti:	None
			Erosion:	None
			Deposition:	None in.
			Damage:	None

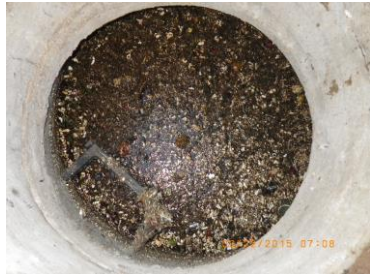
o20150922060832.JPG

Inspection Date: 9/22/2015 7:04:46 AM		Type: Ongoing	Flow: Submerged, indeterminate	Previous Rainfall (hrs): 72+
Illicit Discharge Potential: Potential		Inspector: JCW	Notes	
Submerged: Fully		Depth (in): 37	Floating gross solids (litter) in manhole.	
Sampling Results				
Sample Location:	Pool	Floatables:	None	
Total Chlorine:	0 ppm	Odor:	None	
Free Chlorine:	0 ppm	Turbidity:	None	
Ammonia:	0 ppm	Color:	None	
pH:	7.93 units	Gross Solids:	Moderate	
Temperature	65 °F	Vegetation:	None	
Conductivity:	1055 µS/cm	Benthic Growth:	None	
Detergents:	0 mg/L	Stains:	None	
		Non-illicit:	None	
			Condition Assessment	
			Graffiti:	None
			Erosion:	None
			Deposition:	None in.
			Damage:	None

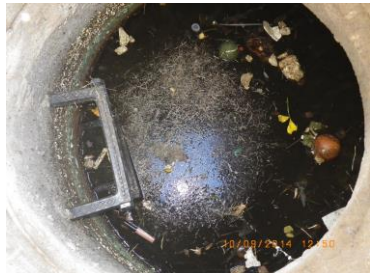
o20141009115024.JPG

Inspection Date: 10/9/2014 12:52:08 PM		Type: Ongoing	Flow: Submerged, indeterminate	Previous Rainfall (hrs): 72+
Illicit Discharge Potential: Potential		Inspector: JCW	Notes	
Submerged: Fully		Depth (in): 39	Floating gross solids (litter) in manhole.	
Sampling Results				
Sample Location:	Pool	Floatables:	None	
Total Chlorine:	0 ppm	Odor:	None	
Free Chlorine:	0 ppm	Turbidity:	Slight cloudiness	
Ammonia:	0 ppm	Color:	None	
pH:	7.57 units	Gross Solids:	Moderate	
Temperature	62 °F	Vegetation:	None	
Conductivity:	548 µS/cm	Benthic Growth:	Slight	
Detergents:	0 mg/L	Stains:	None	
		Non-illicit:	None	
			Condition Assessment	
			Graffiti:	None
			Erosion:	None
			Deposition:	None in.
			Damage:	None

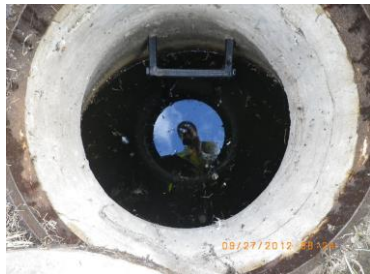
o20120927072438.JPG

Inspection Date: 9/27/2012 8:22:20 AM		Type: Ongoing	Flow: Submerged, indeterminate	Previous Rainfall (hrs): 72+
Illicit Discharge Potential: Unlikely		Inspector: JCW	Notes	
Submerged: Fully		Depth (in): 34	2011 gross solids follow-up.	
Sampling Results				
Sample Location:	Pool	Floatables:	None	
Total Chlorine:	0 ppm	Odor:	None	
Free Chlorine:	0 ppm	Turbidity:	None	
Ammonia:	0 ppm	Color:	None	
pH:	8.73 units	Gross Solids:	Slight	
Temperature	59 °F	Vegetation:	None	
Conductivity:	416 µS/cm	Benthic Growth:	Slight	
Detergents:	0 mg/L	Stains:	Slight	
		Non-illicit:	None	
			Condition Assessment	
			Graffiti:	None
			Erosion:	None
			Deposition:	None in.
			Damage:	None

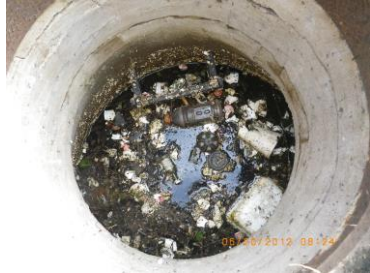
o20120620072408.JPG

Inspection Date: 6/20/2012 8:24:06 AM		Type: Other	Flow: Submerged, indeterminate	Previous Rainfall (hrs): 24-48
Illicit Discharge Potential: Potential		Inspector: JCW	Notes	
Submerged: Fully Depth (in): 40			Gross solids pre-screening.	
Sampling Results				
Sample Location:	Floatables:	None		
Total Chlorine: -- ppm	Odor:	None		
Free Chlorine: -- ppm	Turbidity:	None		
Ammonia: -- ppm	Color:	None		
pH: -- units	Gross Solids:	Severe		
Temperature -- °F	Vegetation:	None		
Conductivity: -- µS/cm	Benthic Growth:	None		
Detergents: -- mg/L	Stains:	None		
	Non-illicit:	None		
		Condition Assessment		
		Graffiti:	None	
		Erosion:	None	
		Deposition:	None	in.
		Damage:	None

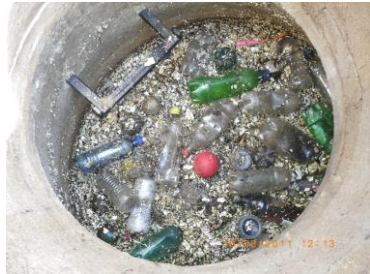
o20111003121302.JPG

Inspection Date: 10/3/2011 12:13:00 PM		Type: Ongoing	Flow: Submerged, indeterminate	Previous Rainfall (hrs): 72+
Illicit Discharge Potential: Potential		Inspector: JCW	Notes	
Submerged: Fully Depth (in): 36			Significant floatable debris in manhole.	
Sampling Results				
Sample Location: Pool	Floatables:	None		
Total Chlorine: 0 ppm	Odor:	None		
Free Chlorine: 0 ppm	Turbidity:	None		
Ammonia: 0 ppm	Color:	None		
pH: 7.39 units	Gross Solids:	Severe		
Temperature 67 °F	Vegetation:	None		
Conductivity: -- µS/cm	Benthic Growth:	None		
Detergents: 0 mg/L	Stains:	None		
	Non-illicit:	None		
		Condition Assessment		
		Graffiti:	None	
		Erosion:	None	
		Deposition:	None	0 in.
		Damage:	None

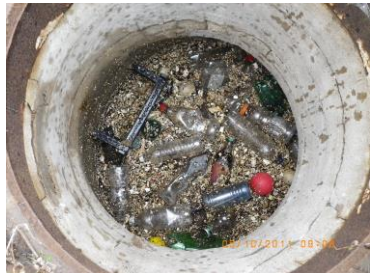
o20110510090830.JPG

Inspection Date: 5/10/2011 9:08:00 AM		Type: Other	Flow: Submerged, indeterminate	Previous Rainfall (hrs): 0-24
Illicit Discharge Potential: Potential		Inspector: JCW	Notes	
Submerged: Fully Depth (in):			Limited screening conducted for upstream manhole prescreening.	
Sampling Results				
Sample Location:	Floatables:	None		
Total Chlorine: -- ppm	Odor:			
Free Chlorine: -- ppm	Turbidity:			
Ammonia: -- ppm	Color:			
pH: -- units	Gross Solids:	Severe		
Temperature -- °F	Vegetation:			
Conductivity: -- µS/cm	Benthic Growth:			
Detergents: -- mg/L	Stains:			
	Non-illicit:	None		
		Condition Assessment		
		Graffiti:	None	
		Erosion:	None	
		Deposition:	None	0 in.
		Damage:	None

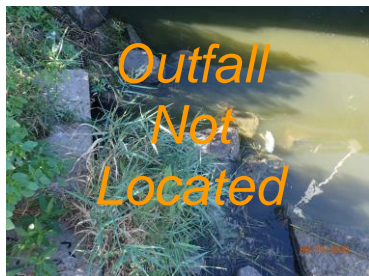
o20200819084114.JPG <div style="text-align: center; font-weight: bold; font-size: 1.2em;">2020</div>

Inspection Date: 8/19/2020 8:41:26 AM		Type: Ongoing	Flow: Submerged (not located)	Previous Rainfall (hrs): 72+
Illicit Discharge Potential: Unlikely		Inspector: JCW		
Submerged: Fully		Depth (in):		
Sampling Results		Notes Outfall fully submerged and not physically located - screened upstream at 12-569 US1. Graffiti on bridge abutment.		
Sample Location:	Floatables:	None		
Total Chlorine: -- ppm	Odor:	None		
Free Chlorine: -- ppm	Turbidity:	None		
Ammonia: -- ppm	Color:	None		
pH: -- units	Gross Solids:	None		
Temperature -- °F	Vegetation:	None		
Conductivity: -- µS/cm	Benthic Growth:	None		
Detergents: -- mg/L	Stains:	None		
	Non-illicit:	None		
		Condition Assessment Graffiti: Moderate Erosion: None Deposition: None in. Damage: None

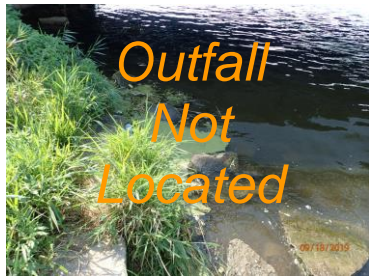
o20190918101816.JPG <div style="text-align: center; font-weight: bold; font-size: 1.2em;">2019</div>

Inspection Date: 9/18/2019 11:19:35 AM		Type: Ongoing	Flow: Submerged (not located)	Previous Rainfall (hrs): 72+
Illicit Discharge Potential: Potential		Inspector: JCW		
Submerged: Fully		Depth (in):		
Sampling Results		Notes Outfall fully submerged and not located - screened upstream at 12-569 US1. Graffiti on nearby bridge abutment. Floating gross solids (litter) in MH.		
Sample Location:	Floatables:	None		
Total Chlorine: -- ppm	Odor:	None		
Free Chlorine: -- ppm	Turbidity:	None		
Ammonia: -- ppm	Color:	None		
pH: -- units	Gross Solids:	None		
Temperature -- °F	Vegetation:	None		
Conductivity: -- µS/cm	Benthic Growth:	None		
Detergents: -- mg/L	Stains:	None		
	Non-illicit:	None		
		Condition Assessment Graffiti: Moderate Erosion: None Deposition: None in. Damage: None

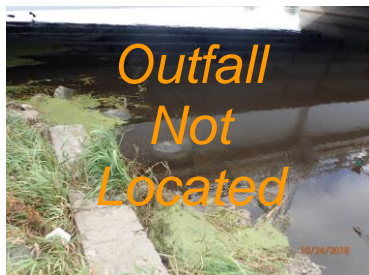
o20181024092154.JPG <div style="text-align: center; font-weight: bold; font-size: 1.2em;">2018</div>

Inspection Date: 10/24/2018 9:23:56 AM		Type: Ongoing	Flow: Submerged (not located)	Previous Rainfall (hrs): 72+
Illicit Discharge Potential: Potential		Inspector: JCW		
Submerged: Fully		Depth (in):		
Sampling Results		Notes Outfall fully submerged and not located - screened upstream at 12-569 US1. Graffiti on nearby bridge abutment. Floating gross solids (litter) in MH.		
Sample Location:	Floatables:	None		
Total Chlorine: -- ppm	Odor:	None		
Free Chlorine: -- ppm	Turbidity:	None		
Ammonia: -- ppm	Color:	None		
pH: -- units	Gross Solids:	None		
Temperature -- °F	Vegetation:	None		
Conductivity: -- µS/cm	Benthic Growth:	None		
Detergents: -- mg/L	Stains:	None		
	Non-illicit:	None		
		Condition Assessment Graffiti: Moderate Erosion: None Deposition: None in. Damage: None

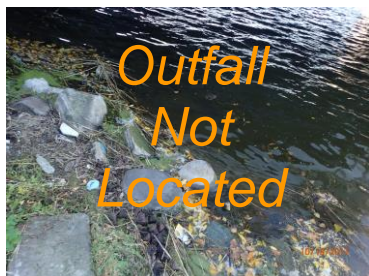
o20171018101412.JPG <div style="text-align: center; font-weight: bold; font-size: 1.2em;">2017</div>

Inspection Date: 10/18/2017 10:17:17 AM		Type: Ongoing	Flow: Submerged (not located)	Previous Rainfall (hrs): 72+
Illicit Discharge Potential: Potential		Inspector: JCW		
Submerged: Fully		Depth (in):		
Sampling Results		Notes Outfall fully submerged and not located - screened upstream at 12-569 US1. Graffiti on nearby bridge abutment. Floating gross solids (litter) in MH.		
Sample Location:	Floatables:	None		
Total Chlorine: -- ppm	Odor:	None		
Free Chlorine: -- ppm	Turbidity:	None		
Ammonia: -- ppm	Color:	None		
pH: -- units	Gross Solids:	None		
Temperature -- °F	Vegetation:	None		
Conductivity: -- µS/cm	Benthic Growth:	None		
Detergents: -- mg/L	Stains:	None		
	Non-illicit:	None		
		Condition Assessment Graffiti: Minor Erosion: None Deposition: None in. Damage: None

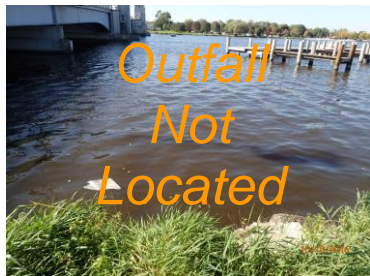
o20161010132600.JPG

Inspection Date: 10/10/2016 1:26:15 PM		Type: Ongoing	Flow: Submerged (not located)	Previous Rainfall (hrs): 72+
Illicit Discharge Potential: Potential		Inspector: JCW	Notes	
Submerged: Fully Depth (in):			Graffiti on east bridge abutment. Outfall fully submerged and not located - screened upstream at 12-569 US1.	
Sampling Results			Condition Assessment	
Sample Location:	Floatables:	None	Graffiti: Minor	
Total Chlorine: -- ppm	Odor:	None	Erosion: None	
Free Chlorine: -- ppm	Turbidity:	None	Deposition: None in.	
Ammonia: -- ppm	Color:	None	Damage: None	
pH: -- units	Gross Solids:	None		
Temperature -- °F	Vegetation:	None		
Conductivity: -- µS/cm	Benthic Growth:	None		
Detergents: -- mg/L	Stains:	None		
	Non-illicit:	None

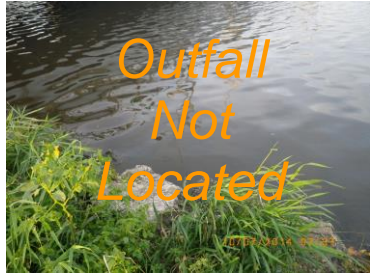
o20141007063712.JPG

Inspection Date: 10/7/2014 7:38:26 AM		Type: Ongoing	Flow: Submerged (not located)	Previous Rainfall (hrs): 48-72
Illicit Discharge Potential: Potential		Inspector: JCW	Notes	
Submerged: Fully Depth (in):			Outfall fully submerged and not located - screened upstream at 12-569 US1. Graffiti on east abutment.	
Sampling Results			Condition Assessment	
Sample Location:	Floatables:	None	Graffiti: Moderate	
Total Chlorine: -- ppm	Odor:	None	Erosion: None	
Free Chlorine: -- ppm	Turbidity:	None	Deposition: None in.	
Ammonia: -- ppm	Color:	None	Damage: None	
pH: -- units	Gross Solids:	None		
Temperature -- °F	Vegetation:	None		
Conductivity: -- µS/cm	Benthic Growth:	None		
Detergents: -- mg/L	Stains:	None		
	Non-illicit:	None

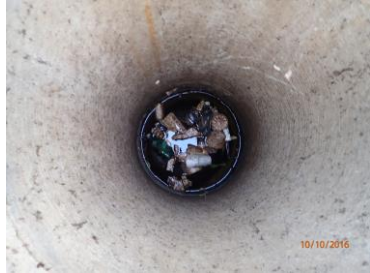
o20161010132718.JPG

Inspection Date: 10/10/2016 1:30:04 PM		Type: Ongoing	Flow: Submerged, indeterminate	Previous Rainfall (hrs): 72+
Illicit Discharge Potential: Potential		Inspector: JCW	Notes	
Submerged: Fully		Depth (in): 38	Potential illicit discharge due to gross solids.	
Sampling Results				
Sample Location:	Pool	Floatables:	None	
Total Chlorine:	0 ppm	Odor:	None	
Free Chlorine:	0 ppm	Turbidity:	Slight cloudiness	
Ammonia:	0 ppm	Color:	Clearly visible in bottl	
pH:	7.41 units	Gross Solids:	Moderate	
Temperature	69 °F	Vegetation:	None	
Conductivity:	616 µS/cm	Benthic Growth:	None	
Detergents:	0 mg/L	Stains:	None	
		Non-illicit:	None	
			Condition Assessment	
			Graffiti:	None
			Erosion:	None
			Deposition:	None in.
			Damage:	None

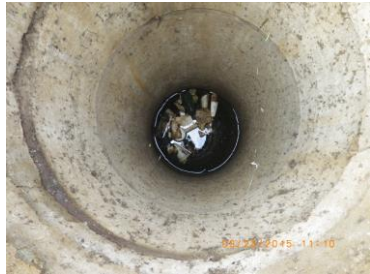
o20150923101026.JPG

Inspection Date: 9/23/2015 11:06:51 AM		Type: Ongoing	Flow: Submerged, indeterminate	Previous Rainfall (hrs): 72+
Illicit Discharge Potential: Potential		Inspector: JCW	Notes	
Submerged: Fully		Depth (in): 40	Floating gross solids (litter) in manhole.	
Sampling Results				
Sample Location:	Pool	Floatables:	None	
Total Chlorine:	0 ppm	Odor:	None	
Free Chlorine:	0 ppm	Turbidity:	None	
Ammonia:	0 ppm	Color:	None	
pH:	7.5 units	Gross Solids:	Moderate	
Temperature	76 °F	Vegetation:	None	
Conductivity:	441 µS/cm	Benthic Growth:	Slight	
Detergents:	0 mg/L	Stains:	None	
		Non-illicit:	None	
			Condition Assessment	
			Graffiti:	None
			Erosion:	None
			Deposition:	None in.
			Damage:	None

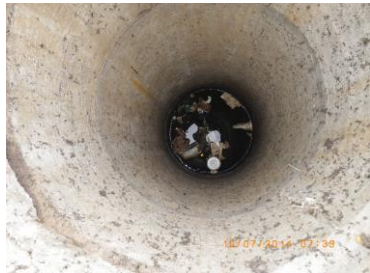
o20141007063948.JPG

Inspection Date: 10/7/2014 7:39:34 AM		Type: Ongoing	Flow: Submerged, indeterminate	Previous Rainfall (hrs): 48-72
Illicit Discharge Potential: Potential		Inspector: JCW	Notes	
Submerged: Fully		Depth (in): 34	Floating gross solids (litter) in manhole.	
Sampling Results				
Sample Location:	Pool	Floatables:	None	
Total Chlorine:	0 ppm	Odor:	None	
Free Chlorine:	0 ppm	Turbidity:	None	
Ammonia:	0 ppm	Color:	None	
pH:	7.66 units	Gross Solids:	Moderate	
Temperature	59 °F	Vegetation:	None	
Conductivity:	771 µS/cm	Benthic Growth:	None	
Detergents:	0 mg/L	Stains:	None	
		Non-illicit:	None	
			Condition Assessment	
			Graffiti:	None
			Erosion:	None
			Deposition:	None in.
			Damage:	None

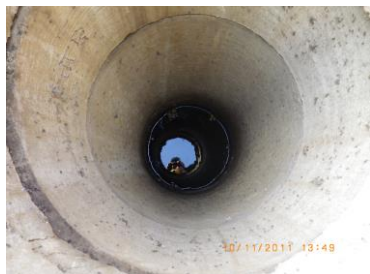
o20111011134946.JPG

Inspection Date: 10/11/2011 1:51:24 PM		Type: Ongoing	Flow: Submerged, indeterminate	Previous Rainfall (hrs): 72+
Illicit Discharge Potential: Unlikely		Inspector: JCW	Notes	
Submerged: Fully		Depth (in): 32	2010 screening follow-up. Floatable debris significantly reduced.	
Sampling Results				
Sample Location:	Pool	Floatables:	None	
Total Chlorine:	0 ppm	Odor:	None	
Free Chlorine:	0 ppm	Turbidity:	None	
Ammonia:	0 ppm	Color:	None	
pH:	8.63 units	Gross Solids:	None	
Temperature	73 °F	Vegetation:	None	
Conductivity:	-- µS/cm	Benthic Growth:	None	
Detergents:	-- mg/L	Stains:	None	
		Non-illicit:	None	
			Condition Assessment	
			Graffiti:	None
			Erosion:	None
			Deposition:	None 0 in.
			Damage:	None

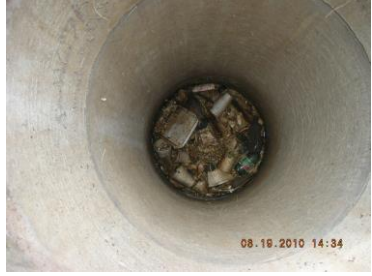
Inspection Date: 8/19/2010 2:41:43 PM		Type: Ongoing	Flow: Submerged, indeterminate	Previous Rainfall (hrs): 72+
Illicit Discharge Potential: Potential		Inspector: JCW	Notes Severe floatable debris	
Submerged: Fully Depth (in): 38				
Sampling Results Sample Location: Pool Total Chlorine: 0 ppm Free Chlorine: 0 ppm Ammonia: 0 ppm pH: 7.59 units Temperature: 79 °F Conductivity: -- µS/cm Detergents: 0 mg/L		Floatables: None Odor: None Turbidity: None Color: Faint in bottle Gross Solids: Severe Vegetation: None Benthic Growth: None Stains: Slight Non-illicit: None	Condition Assessment Graffiti: None Erosion: None Deposition: None 0 in. Damage: None

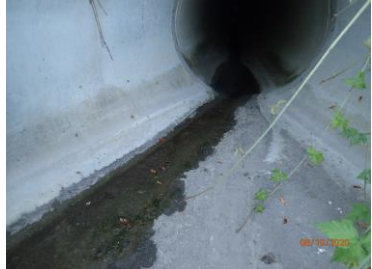
o20200819072022.JPG <div style="text-align: center; font-size: 24pt; font-weight: bold;">2020</div>
		Condition Assessment Graffiti: None Erosion: None Deposition: None in. Damage: None

Inspection Date: 8/19/2020 7:19:45 AM		Type: Ongoing	Flow: None	Previous Rainfall (hrs): 72+
Illicit Discharge Potential: Unlikely		Inspector: JCW		
Submerged: None		Depth (in):		
Sampling Results Sample Location: _____ Total Chlorine: -- ppm Free Chlorine: -- ppm Ammonia: -- ppm pH: -- units Temperature: -- °F Conductivity: -- µS/cm Detergents: -- mg/L		Floatables: None Odor: None Turbidity: None Color: None Gross Solids: None Vegetation: None Benthic Growth: Slight Stains: None Non-illicit: None	Notes Pipe wet, but no collectable flow at time of inspection.

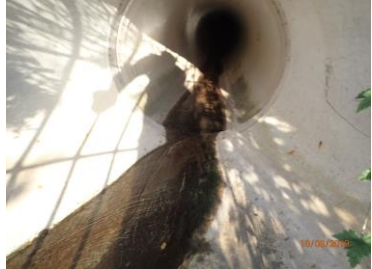
o20191008160300.JPG <div style="text-align: center; font-size: 24pt; font-weight: bold;">2019</div>
		Condition Assessment Graffiti: None Erosion: None Deposition: None in. Damage: None

Inspection Date: 10/8/2019 5:07:04 PM		Type: Ongoing	Flow: Moderate	Previous Rainfall (hrs): 48-72
Illicit Discharge Potential: Unlikely		Inspector: JCW		
Submerged: None		Depth (in):		
Sampling Results Sample Location: Flow Total Chlorine: 0 ppm Free Chlorine: 0 ppm Ammonia: 0 ppm pH: 8.16 units Temperature: 65 °F Conductivity: 1014 µS/cm Detergents: 0 mg/L		Floatables: None Odor: None Turbidity: None Color: None Gross Solids: None Vegetation: None Benthic Growth: Moderate Stains: None Non-illicit: Slight	Notes Outfall sampled from moderate flow.

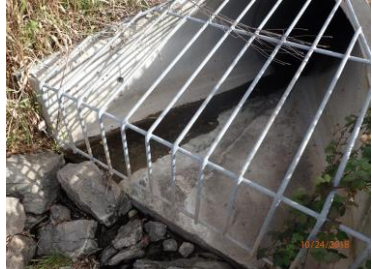
o20181024103144.JPG <div style="text-align: center; font-size: 24pt; font-weight: bold;">2018</div>
		Condition Assessment Graffiti: None Erosion: None Deposition: None in. Damage: None

Inspection Date: 10/24/2018 10:34:16 AM		Type: Ongoing	Flow: Trickle	Previous Rainfall (hrs): 72+
Illicit Discharge Potential: Potential		Inspector: JCW		
Submerged: None		Depth (in):		
Sampling Results Sample Location: Flow Total Chlorine: 0 ppm Free Chlorine: 0 ppm Ammonia: 0 ppm pH: 9.04 units Temperature: 50 °F Conductivity: 792 µS/cm Detergents: 0 mg/L		Floatables: None Odor: None Turbidity: None Color: None Gross Solids: None Vegetation: None Benthic Growth: Moderate Stains: Slight Non-illicit: None	Notes Elevated pH in sample from trickle flow. No flow in upstream curb inlet at time of inspection.

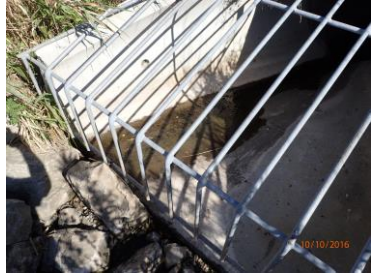
Inspection Date: 10/10/2016 12:26:38 PM		Type: Ongoing	Flow: Trickle	Previous Rainfall (hrs): 72+																																		
Illicit Discharge Potential: Potential		Inspector: JCW

<p style="text-align: center;">o20161010122036.JPG</p> <p style="text-align: center; font-size: 24pt; font-weight: bold;">2016</p>																																		
Submerged: None		Depth (in):																																				
Sampling Results <table border="1" style="width: 100%; border-collapse: collapse;"> <tr> <td>Sample Location:</td> <td>Flow</td> </tr> <tr> <td>Total Chlorine:</td> <td>0 ppm</td> </tr> <tr> <td>Free Chlorine:</td> <td>0 ppm</td> </tr> <tr> <td>Ammonia:</td> <td>0 ppm</td> </tr> <tr> <td>pH:</td> <td>9.45 units</td> </tr> <tr> <td>Temperature:</td> <td>64 °F</td> </tr> <tr> <td>Conductivity:</td> <td>880 µS/cm</td> </tr> <tr> <td>Detergents:</td> <td>0 mg/L</td> </tr> </table>		Sample Location:	Flow		Total Chlorine:	0 ppm	Free Chlorine:	0 ppm	Ammonia:	0 ppm	pH:	9.45 units	Temperature:	64 °F	Conductivity:	880 µS/cm	Detergents:	0 mg/L	<table border="1" style="width: 100%; border-collapse: collapse;"> <tr> <td>Floatables:</td> <td>None</td> </tr> <tr> <td>Odor:</td> <td>None</td> </tr> <tr> <td>Turbidity:</td> <td>None</td> </tr> <tr> <td>Color:</td> <td>None</td> </tr> <tr> <td>Gross Solids:</td> <td>None</td> </tr> <tr> <td>Vegetation:</td> <td>None</td> </tr> <tr> <td>Benthic Growth:</td> <td>Moderate</td> </tr> <tr> <td>Stains:</td> <td>Slight</td> </tr> <tr> <td>Non-illicit:</td> <td>None</td> </tr> </table>		Floatables:	None	Odor:	None	Turbidity:	None	Color:	None	Gross Solids:	None	Vegetation:	None	Benthic Growth:	Moderate	Stains:	Slight	Non-illicit:	None

Notes Elevated pH, but not as high as 2015 screening. Possible residual in upstream pipe.																																				
		Condition Assessment <table border="1" style="width: 100%; border-collapse: collapse;"> <tr> <td>Graffiti:</td> <td>None</td> </tr> <tr> <td>Erosion:</td> <td>None</td> </tr> <tr> <td>Deposition:</td> <td>None in.</td> </tr> <tr> <td>Damage:</td> <td>None</td> </tr> </table>		Graffiti:	None	Erosion:	None	Deposition:	None in.	Damage:	None																											
Graffiti:	None																																					
Erosion:	None																																					
Deposition:	None in.																																					
Damage:	None

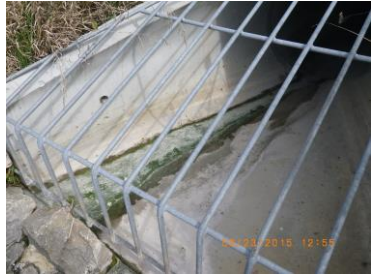
Inspection Date: 9/23/2015 12:56:15 PM		Type: Ongoing	Flow: Trickle	Previous Rainfall (hrs): 72+																																		
Illicit Discharge Potential: Obvious		Inspector: JCW

<p style="text-align: center;">o20150923115508.JPG</p> <p style="text-align: center; font-size: 24pt; font-weight: bold;">2015</p>																																		
Submerged: None		Depth (in):																																				
Sampling Results <table border="1" style="width: 100%; border-collapse: collapse;"> <tr> <td>Sample Location:</td> <td>Flow</td> </tr> <tr> <td>Total Chlorine:</td> <td>-- ppm</td> </tr> <tr> <td>Free Chlorine:</td> <td>-- ppm</td> </tr> <tr> <td>Ammonia:</td> <td>1 ppm</td> </tr> <tr> <td>pH:</td> <td>11.66 units</td> </tr> <tr> <td>Temperature:</td> <td>73 °F</td> </tr> <tr> <td>Conductivity:</td> <td>2470 µS/cm</td> </tr> <tr> <td>Detergents:</td> <td>0 mg/L</td> </tr> </table>		Sample Location:	Flow		Total Chlorine:	-- ppm	Free Chlorine:	-- ppm	Ammonia:	1 ppm	pH:	11.66 units	Temperature:	73 °F	Conductivity:	2470 µS/cm	Detergents:	0 mg/L	<table border="1" style="width: 100%; border-collapse: collapse;"> <tr> <td>Floatables:</td> <td>None</td> </tr> <tr> <td>Odor:</td> <td>None</td> </tr> <tr> <td>Turbidity:</td> <td>None</td> </tr> <tr> <td>Color:</td> <td>None</td> </tr> <tr> <td>Gross Solids:</td> <td>Slight</td> </tr> <tr> <td>Vegetation:</td> <td>None</td> </tr> <tr> <td>Benthic Growth:</td> <td>Moderate</td> </tr> <tr> <td>Stains:</td> <td>Moderate</td> </tr> <tr> <td>Non-illicit:</td> <td>None</td> </tr> </table>		Floatables:	None	Odor:	None	Turbidity:	None	Color:	None	Gross Solids:	Slight	Vegetation:	None	Benthic Growth:	Moderate	Stains:	Moderate	Non-illicit:	None

Notes White silty discharge. Chlorine patches turned yellow (not on scale). Elevated pH and conductivity.																																				
		Condition Assessment <table border="1" style="width: 100%; border-collapse: collapse;"> <tr> <td>Graffiti:</td> <td>None</td> </tr> <tr> <td>Erosion:</td> <td>None</td> </tr> <tr> <td>Deposition:</td> <td>None in.</td> </tr> <tr> <td>Damage:</td> <td>None</td> </tr> </table>		Graffiti:	None	Erosion:	None	Deposition:	None in.	Damage:	None																											
Graffiti:	None																																					
Erosion:	None																																					
Deposition:	None in.																																					
Damage:	None

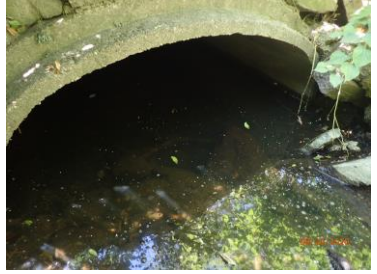
Inspection Date: 8/20/2020 12:09:18 PM		Type: Ongoing		Flow: Submerged, no flow		Previous Rainfall (hrs): 72+	
Illicit Discharge Potential: Potential		Inspector: JCW		Notes No flow appears to be leaving pool at end of outfall. Sample collected from pool -detergent detected.

o20200820121004.JPG	
Submerged: Partially Depth (in): 24							
Sampling Results Sample Location: Pool Total Chlorine: 0 ppm Free Chlorine: 0 ppm Ammonia: 0 ppm pH: 7.76 units Temperature: 81 °F Conductivity: 453 µS/cm Detergents: 0.6 mg/L		Floatables: Moderate Odor: None Turbidity: None Color: None Gross Solids: None Vegetation: None Benthic Growth: Moderate Stains: None Non-illicit: None		Condition Assessment Graffiti: None Erosion: Moderate Deposition: Moderate 12 in. Damage: None		<div style="text-align: center; font-size: 24pt; font-weight: bold;">2020</div>

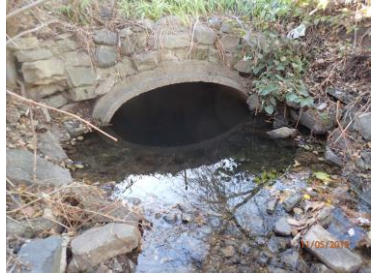
Inspection Date: 11/5/2019 2:27:14 PM		Type: Repeat		Flow: Submerged, indeterminate		Previous Rainfall (hrs): 48-72	
Illicit Discharge Potential: Potential		Inspector: JCW		Notes Follow-up inspection for sampling - limited screening conducted. pH in normal range; detergent detected.

o20191105142746.JPG	
Submerged: Partially Depth (in): 20							
Sampling Results Sample Location: Pool Total Chlorine: -- ppm Free Chlorine: -- ppm Ammonia: -- ppm pH: 8.18 units Temperature: 45 °F Conductivity: 680 µS/cm Detergents: 0.8 mg/L		Floatables: None Odor: None Turbidity: None Color: None Gross Solids: None Vegetation: None Benthic Growth: None Stains: None Non-illicit: None		Condition Assessment Graffiti: None Erosion: None Deposition: None in. Damage: None		<div style="text-align: center; font-size: 24pt; font-weight: bold;">2019</div>

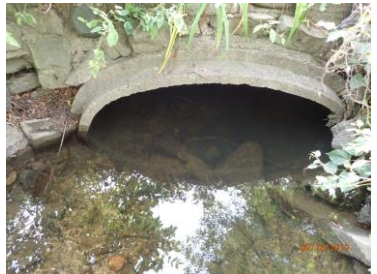
Inspection Date: 9/18/2019 3:16:56 PM		Type: Ongoing		Flow: Submerged, slight flow		Previous Rainfall (hrs): 72+	
Illicit Discharge Potential: Potential		Inspector: JCW		Notes Downstream bank erosion. Sample collected from submerged flow in pipe. High pH detected.

o20190918141444.JPG	
Submerged: Partially Depth (in): 20							
Sampling Results Sample Location: Flow Total Chlorine: 0 ppm Free Chlorine: 0 ppm Ammonia: 0 ppm pH: 9.27 units Temperature: 77 °F Conductivity: 368 µS/cm Detergents: 0 mg/L		Floatables: None Odor: None Turbidity: None Color: None Gross Solids: None Vegetation: None Benthic Growth: Moderate Stains: Slight Non-illicit: None		Condition Assessment Graffiti: None Erosion: Severe Deposition: None in. Damage: None		<div style="text-align: center; font-size: 24pt; font-weight: bold;">2019</div>

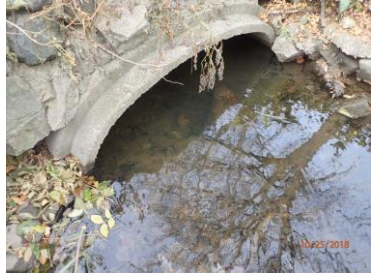
<p style="text-align: center;">o20181025093132.JPG</p> <p style="text-align: center; font-size: 24pt; font-weight: bold;">2018</p>

Inspection Date: 10/26/2018 1:26:25 PM		Type: Repeat	Flow: Submerged, significant flow	Previous Rainfall (hrs): 72+
Illicit Discharge Potential: Potential		Inspector: KMK		
Submerged: Partially		Depth (in): 26		
<div style="display: flex; justify-content: space-between;"> <div style="width: 45%;"> <p>Sampling Results</p> <p>Sample Location: Flow</p> <p>Total Chlorine: 0 ppm</p> <p>Free Chlorine: 0 ppm</p> <p>Ammonia: 0 ppm</p> <p>pH: 8.18 units</p> <p>Temperature: 54 °F</p> <p>Conductivity: 1183 µS/cm</p> <p>Detergents: 0.4 mg/L</p> </div> <div style="width: 45%;"> <p>Floatables: None</p> <p>Odor: None</p> <p>Turbidity: None</p> <p>Color: None</p> <p>Gross Solids: Slight</p> <p>Vegetation: None</p> <p>Benthic Growth: Slight</p> <p>Stains: None</p> <p>Non-illicit: None</p> </div> </div>				
		<p>Notes</p> <p>Detergent detection follow-up. Limited screening conducted beyond sampling.</p>		
		<p>Condition Assessment</p> <p>Graffiti: None</p> <p>Erosion: None</p> <p>Deposition: None in.</p> <p>Damage: None</p>

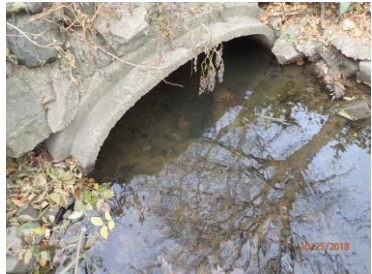
<p style="text-align: center;">o20181025093132.JPG</p> <p style="text-align: center; font-size: 24pt; font-weight: bold;">2018</p>

Inspection Date: 10/25/2018 9:33:47 AM		Type: Ongoing	Flow: Submerged, significant flow	Previous Rainfall (hrs): 72+
Illicit Discharge Potential: Potential		Inspector: JCW		
Submerged: Partially		Depth (in): 26		
<div style="display: flex; justify-content: space-between;"> <div style="width: 45%;"> <p>Sampling Results</p> <p>Sample Location: Flow</p> <p>Total Chlorine: 0 ppm</p> <p>Free Chlorine: 0 ppm</p> <p>Ammonia: 0 ppm</p> <p>pH: 8.16 units</p> <p>Temperature: 51 °F</p> <p>Conductivity: 1209 µS/cm</p> <p>Detergents: 0.5 mg/L</p> </div> <div style="width: 45%;"> <p>Floatables: None</p> <p>Odor: None</p> <p>Turbidity: None</p> <p>Color: None</p> <p>Gross Solids: Slight</p> <p>Vegetation: None</p> <p>Benthic Growth: Moderate</p> <p>Stains: None</p> <p>Non-illicit: None</p> </div> </div>				
		<p>Notes</p> <p>Downstream bank erosion. Sample collected from submerged flow in pipe. Detergent detected.</p>

<p>Condition Assessment</p> <p>Graffiti: None</p> <p>Erosion: Moderate</p> <p>Deposition: None in.</p> <p>Damage: None</p>

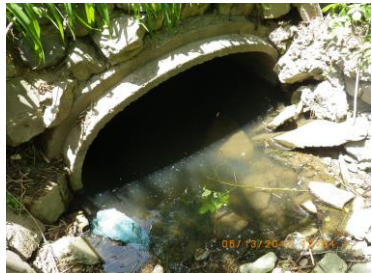
<p style="text-align: center;">o20120613115412.JPG</p> <p style="text-align: center; font-size: 24pt; font-weight: bold;">2012</p>

Inspection Date: 6/13/2012 12:53:24 PM		Type: Ongoing	Flow: Submerged, no flow	Previous Rainfall (hrs): 72+
Illicit Discharge Potential: Unlikely		Inspector: JCW		
Submerged: Partially		Depth (in): 19		
<div style="display: flex; justify-content: space-between;"> <div style="width: 45%;"> <p>Sampling Results</p> <p>Sample Location: Pool</p> <p>Total Chlorine: 0 ppm</p> <p>Free Chlorine: 0 ppm</p> <p>Ammonia: 0 ppm</p> <p>pH: 7.91 units</p> <p>Temperature: 74 °F</p> <p>Conductivity: 1579 µS/cm</p> <p>Detergents: 0 mg/L</p> </div> <div style="width: 45%;"> <p>Floatables: None</p> <p>Odor: None</p> <p>Turbidity: Slight cloudiness</p> <p>Color: None</p> <p>Gross Solids: Slight</p> <p>Vegetation: None</p> <p>Benthic Growth: Slight</p> <p>Stains: None</p> <p>Non-illicit: None</p> </div> </div>				
		<p>Notes</p> <p>No flow leaving pool on apron. Downstream channel dry. Sample collected from apron pool.</p>

<p>Condition Assessment</p> <p>Graffiti: None</p> <p>Erosion: None</p> <p>Deposition: None in.</p> <p>Damage: None</p>

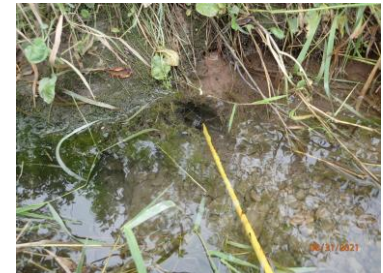
o20210831074728.JPG

Deposition: Moderate Depth (in): 16

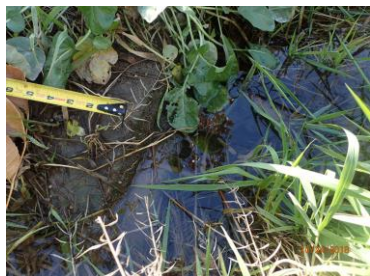
o20181024150410.JPG <div style="text-align: center; font-size: 24pt; font-weight: bold;">2018</div>

Notes Outfall partially submerged - screened upstream at 13-1098 US1.																																				
		Condition Assessment <table border="1" style="width:100%; border-collapse: collapse;"> <tr><td>Graffiti:</td><td>None</td></tr> <tr><td>Erosion:</td><td>None</td></tr> <tr><td>Deposition:</td><td>None in.</td></tr> <tr><td>Damage:</td><td>None</td></tr> </table>			Graffiti:	None	Erosion:	None	Deposition:	None in.	Damage:	None																										
Graffiti:	None																																					
Erosion:	None																																					
Deposition:	None in.																																					
Damage:	None

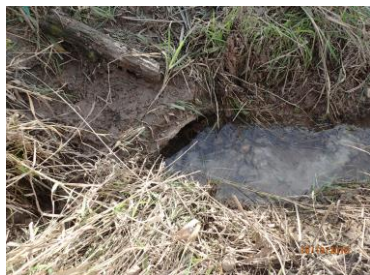
o20161019150326.JPG <div style="text-align: center; font-size: 24pt; font-weight: bold;">2016</div>

Notes Outfall partially submerged - screened upstream at 13-1098 US1. End of pipe recently excavated.																																				
		Condition Assessment <table border="1" style="width:100%; border-collapse: collapse;"> <tr><td>Graffiti:</td><td>None</td></tr> <tr><td>Erosion:</td><td>None</td></tr> <tr><td>Deposition:</td><td>Severe 16 in.</td></tr> <tr><td>Damage:</td><td>None</td></tr> </table>			Graffiti:	None	Erosion:	None	Deposition:	Severe 16 in.	Damage:	None																										
Graffiti:	None																																					
Erosion:	None																																					
Deposition:	Severe 16 in.																																					
Damage:	None
