IDDE Ongoing Screening Summary Report

2021 Inspection Year

City of Oshkosh

Westwood

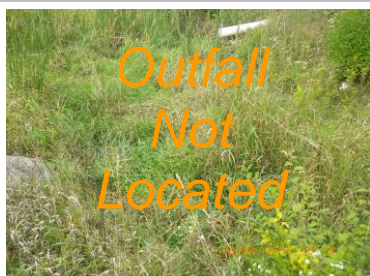
o20150924141536.JPG <div style="text-align: center; font-size: 24pt; font-weight: bold;">2015</div>

Notes Outfall not located - screened at 13-1098 US1.																																				
		Condition Assessment <table border="1" style="width:100%; border-collapse: collapse;"> <tr><td>Graffiti:</td><td>None</td></tr> <tr><td>Erosion:</td><td>None</td></tr> <tr><td>Deposition:</td><td>None in.</td></tr> <tr><td>Damage:</td><td>None</td></tr> </table>			Graffiti:	None	Erosion:	None	Deposition:	None in.	Damage:	None																										
Graffiti:	None																																					
Erosion:	None																																					
Deposition:	None in.																																					
Damage:	None

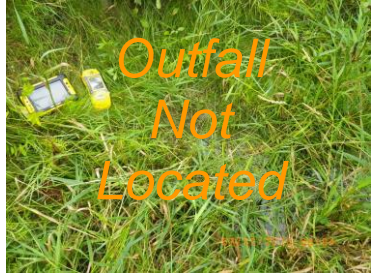
o20130730070410.JPG

Inspection Date: 7/30/2013 7:57:44 AM		Type: Ongoing	Flow: Submerged (not located)	Previous Rainfall (hrs): 72+
Illicit Discharge Potential: Unlikely		Inspector: JCW	Notes	
Submerged: Fully		Depth (in):	Pipe not located in grassy stream bank. Screened upstream at 13-1098 US1.	
Sampling Results		Floatables:	Condition Assessment Graffiti: None Erosion: None Deposition: None in. Damage: None	
Sample Location:		Odor:		
Total Chlorine: -- ppm		Turbidity:		
Free Chlorine: -- ppm		Color:		
Ammonia: -- ppm		Gross Solids:		
pH: -- units		Vegetation:		
Temperature -- °F		Benthic Growth:		
Conductivity: -- µS/cm		Stains:		
Detergents: -- mg/L		Non-illicit:

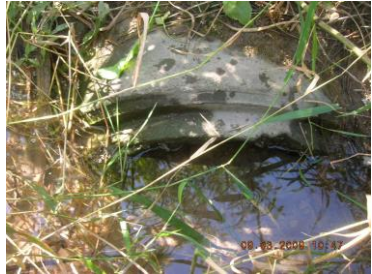
Osh09_DSCN6427.JPG

Inspection Date: 9/3/2009		Type: Initial	Flow: Submerged, indeterminate	Previous Rainfall (hrs): 72+
Illicit Discharge Potential: Unlikely		Inspector: JCW	Notes	
Submerged: Partially		Depth (in): 23		
Sampling Results		Floatables:	Condition Assessment Graffiti: None Erosion: None Deposition: 18 in. Damage: None	
Sample Location:		Odor:		
Total Chlorine: -- ppm		Turbidity:		
Free Chlorine: -- ppm		Color:		
Ammonia: -- ppm		Gross Solids:		
pH: -- units		Vegetation:		
Temperature -- °F		Benthic Growth:		
Conductivity: -- µS/cm		Stains:		
Detergents: -- mg/L		Non-illicit:

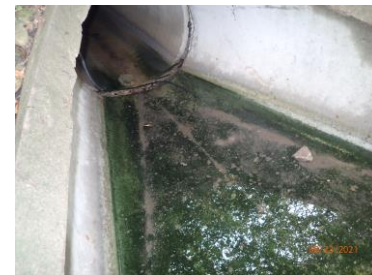
o20210823095816.JPG

Damage: Minor ☒ Displacement ☐ Undercut ☐ Crushed☐ Corrosion ☒ Cracks/Structural Damage

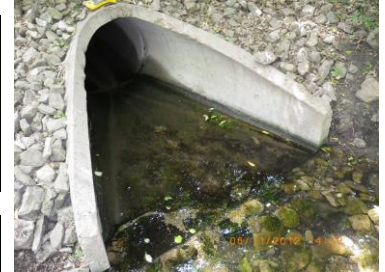
o20120611131320.JPG

Inspection Date: 6/11/2012 2:12:41 PM		Type: Ongoing	Flow: Submerged, indeterminate	Previous Rainfall (hrs): 72+
Illicit Discharge Potential: Unlikely		Inspector: JCW		
Submerged: Partially		Depth (in): 3		
Sampling Results		Notes Outfall partially submerged; screened upstream at 13-1673 US1.		
Sample Location:	Floatables:	None		
Total Chlorine: -- ppm	Odor:	None		
Free Chlorine: -- ppm	Turbidity:	None		
Ammonia: -- ppm	Color:	None		
pH: -- units	Gross Solids:	None		
Temperature -- °F	Vegetation:	None		
Conductivity: -- µS/cm	Benthic Growth:	Moderate		
Detergents: -- mg/L	Stains:	Moderate		
	Non-illicit:	None		
		Condition Assessment Graffiti: None Erosion: None Deposition: None in. Damage: None

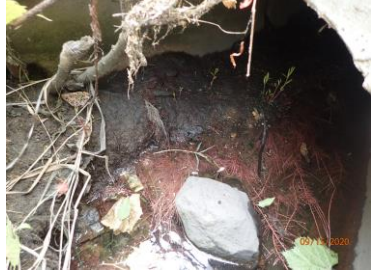
Inspection Date: 9/15/2020 11:07:57 AM		Type: Ongoing		Flow: Submerged, indeterminate		Previous Rainfall (hrs): 72+	
Illicit Discharge Potential: Unlikely		Inspector: JCW		Notes Deposition on half of apron; clear on other half. Outfall partially submerged - screened upstream at 13-1769 US1.

o20200915110530.JPG	
Submerged: Partially		Depth (in): 4					
Sampling Results Sample Location: Total Chlorine: -- ppm Free Chlorine: -- ppm Ammonia: -- ppm pH: -- units Temperature: -- °F Conductivity: -- µS/cm Detergents: -- mg/L		Floatables: None Odor: None Turbidity: None Color: None Gross Solids: None Vegetation: None Benthic Growth: Slight Stains: Slight Non-illicit: None		Condition Assessment Graffiti: None Erosion: None Deposition: Moderate 8 in. Damage: None		2020

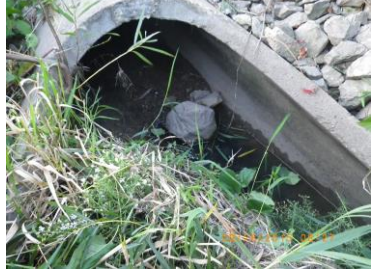
Inspection Date: 9/28/2015 8:25:30 AM		Type: Ongoing		Flow: Submerged, indeterminate		Previous Rainfall (hrs): 72+	
Illicit Discharge Potential: Unlikely		Inspector: JCW		Notes 3-4" of sediment in pipe, apron full and channelized. Screened at 13-1769 US1.

o20150928072730.JPG	
Submerged: Partially		Depth (in): 2					
Sampling Results Sample Location: Total Chlorine: -- ppm Free Chlorine: -- ppm Ammonia: -- ppm pH: -- units Temperature: -- °F Conductivity: -- µS/cm Detergents: -- mg/L		Floatables: None Odor: None Turbidity: None Color: None Gross Solids: None Vegetation: None Benthic Growth: Slight Stains: None Non-illicit: Moderate		Condition Assessment Graffiti: None Erosion: None Deposition: Severe 4 in. Damage: None		2015

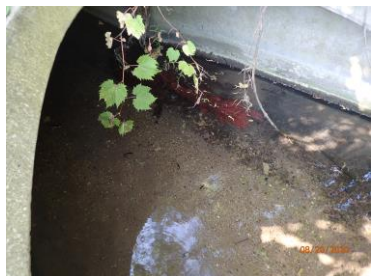
o20200820104754.JPG

Inspection Date: 8/20/2020 10:49:39 AM		Type: Ongoing	Flow: Submerged, slight flow	Previous Rainfall (hrs): 72+
Illicit Discharge Potential: Unlikely		Inspector: JCW		
Submerged: Partially		Depth (in): 3		
Sampling Results		Notes Sample collected from concentrated flow immediately downstream from outfall.		
Sample Location: Flow	Floatables: None	Condition Assessment Graffiti: None Erosion: None Deposition: None in. Damage: None		
Total Chlorine: 0 ppm	Odor: None			
Free Chlorine: 0 ppm	Turbidity: None			
Ammonia: 0 ppm	Color: None			
pH: 8.18 units	Gross Solids: None			
Temperature 76 °F	Vegetation: None			
Conductivity: 1219 µS/cm	Benthic Growth: Moderate			
Detergents: 0 mg/L	Stains: Slight			
	Non-illicit: None

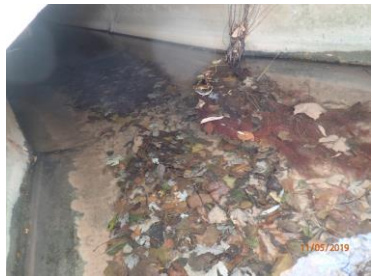
o20191105140404.JPG

Inspection Date: 11/5/2019 2:05:00 PM		Type: Repeat	Flow: Submerged, indeterminate	Previous Rainfall (hrs): 48-72
Illicit Discharge Potential: Potential		Inspector: JCW		
Submerged: Partially		Depth (in): 19		
Sampling Results		Notes Outfall partially submerged - screened upstream at 13-2332 US1. Follow-up inspection for sampling - limited screening conducted.		
Sample Location: --	Floatables: None	Condition Assessment Graffiti: None Erosion: None Deposition: None in. Damage: None		
Total Chlorine: -- ppm	Odor: None			
Free Chlorine: -- ppm	Turbidity: None			
Ammonia: -- ppm	Color: None			
pH: -- units	Gross Solids: None			
Temperature -- °F	Vegetation: None			
Conductivity: -- µS/cm	Benthic Growth: Slight			
Detergents: -- mg/L	Stains: None			
	Non-illicit: Slight

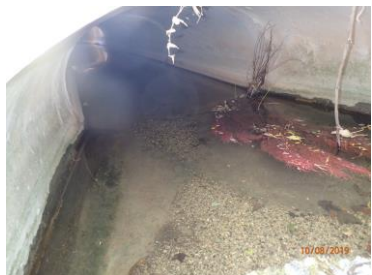
o20191008140758.jpg

Inspection Date: 10/8/2019 3:09:23 PM		Type: Ongoing	Flow: Submerged, indeterminate	Previous Rainfall (hrs): 48-72
Illicit Discharge Potential: Potential		Inspector: JCW		
Submerged: Partially		Depth (in): 19		
Sampling Results		Notes Outfall partially submerged - screened upstream at 13-2332 US1. Detergent detected in upstream manhole.		
Sample Location: --	Floatables: None	Condition Assessment Graffiti: None Erosion: None Deposition: None in. Damage: None		
Total Chlorine: -- ppm	Odor: None			
Free Chlorine: -- ppm	Turbidity: None			
Ammonia: -- ppm	Color: None			
pH: -- units	Gross Solids: None			
Temperature -- °F	Vegetation: None			
Conductivity: -- µS/cm	Benthic Growth: Slight			
Detergents: -- mg/L	Stains: None			
	Non-illicit: Slight

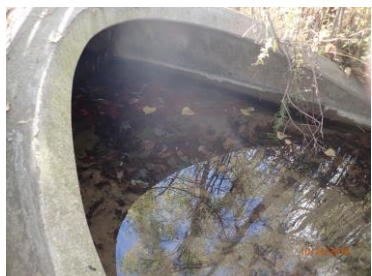
o20181024151710.JPG

Inspection Date: 10/24/2018 3:19:11 PM		Type: Ongoing	Flow: Submerged, slight flow	Previous Rainfall (hrs): 72+
Illicit Discharge Potential: Potential		Inspector: JCW		
Submerged: Partially		Depth (in): 11		
Sampling Results		Notes Outfall partially submerged - screened upstream at 13-2332 US1. Detergent detected in upstream manhole.		
Sample Location: --	Floatables: None	Condition Assessment Graffiti: None Erosion: None Deposition: None in. Damage: None		
Total Chlorine: -- ppm	Odor: Faint			
Free Chlorine: -- ppm	Turbidity: None			
Ammonia: -- ppm	Color: None			
pH: -- units	Gross Solids: Moderate			
Temperature -- °F	Vegetation: None			
Conductivity: -- µS/cm	Benthic Growth: Slight			
Detergents: -- mg/L	Stains: Moderate			
	Non-illicit: None

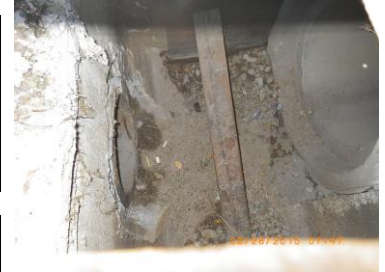
o20150928064714.JPG

Inspection Date: 9/28/2015 7:45:00 AM		Type: Ongoing	Flow: None	Previous Rainfall (hrs): 72+
Illicit Discharge Potential: Unlikely		Inspector: JCW		
Submerged: None		Depth (in):		
Sampling Results		Notes		
Sample Location:		Flowline dry. 2x4 in bottom of inlet.		
Total Chlorine:	-- ppm	Floatables:	None	
Free Chlorine:	-- ppm	Odor:	None	
Ammonia:	-- ppm	Turbidity:	None	
pH:	-- units	Color:	None	
Temperature:	-- °F	Gross Solids:	None	
Conductivity:	-- µS/cm	Vegetation:	None	
Detergents:	-- mg/L	Benthic Growth:	None	
		Stains:	None	
		Non-illicit:	None	
		Condition Assessment		
		Graffiti:	None	
		Erosion:	None	
		Deposition:	None in.	
		Damage:	None

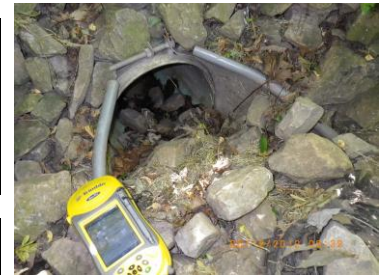
o20120612073224.JPG

Inspection Date: 6/12/2012 8:33:10 AM		Type: Ongoing	Flow: None	Previous Rainfall (hrs): 72+
Illicit Discharge Potential: Unlikely		Inspector: JCW		
Submerged: None		Depth (in):		
Sampling Results		Notes		
Sample Location:		Flowline damp. Riprap blocking end of pipe.		
Total Chlorine:	-- ppm	Floatables:	None	
Free Chlorine:	-- ppm	Odor:	None	
Ammonia:	-- ppm	Turbidity:	None	
pH:	-- units	Color:	None	
Temperature	-- °F	Gross Solids:	Slight	
Conductivity:	-- µS/cm	Vegetation:	None	
Detergents:	-- mg/L	Benthic Growth:	None	
		Stains:	None	
		Non-illicit:	None	
		Condition Assessment		
		Graffiti:	None	
		Erosion:	None	
		Deposition:	Moderate	6 in.
		Damage:	None

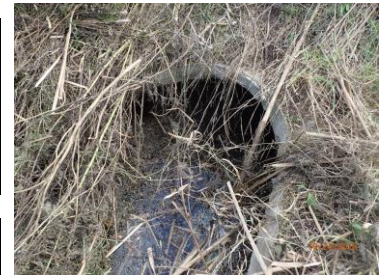
o20181024125924.JPG

Inspection Date: 10/24/2018 1:01:16 PM		Type: Ongoing	Flow: Submerged, indeterminate	Previous Rainfall (hrs): 72+
Illicit Discharge Potential: Unlikely		Inspector: JCW		
Submerged: Partially		Depth (in): 8		
Sampling Results		Notes Outfall partially submerged - screened upstream at 13-2822 US1.		
Sample Location:	Floatables:	None		
Total Chlorine: -- ppm	Odor:	None		
Free Chlorine: -- ppm	Turbidity:	None		
Ammonia: -- ppm	Color:	None		
pH: -- units	Gross Solids:	None		
Temperature -- °F	Vegetation:	None		
Conductivity: -- µS/cm	Benthic Growth:	Slight		
Detergents: -- mg/L	Stains:	None		
	Non-illicit:	None		
		Condition Assessment Graffiti: None Erosion: None Deposition: None in. Damage: None

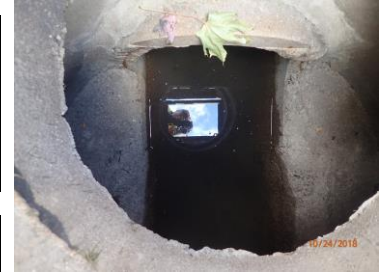
o20181024130224.JPG

Inspection Date: 10/24/2018 1:04:01 PM		Type: Ongoing	Flow: Submerged, indeterminate	Previous Rainfall (hrs): 72+
Illicit Discharge Potential: Unlikely		Inspector: JCW		
Submerged: Partially		Depth (in): 7		
Sampling Results				
Sample Location: Pool		Floatables:	None	
Total Chlorine: 0 ppm		Odor:	None	
Free Chlorine: 0 ppm		Turbidity:	None	
Ammonia: 0 ppm		Color:	None	
pH: 7.71 units		Gross Solids:	None	
Temperature: 54 °F		Vegetation:	None	
Conductivity: 1446 µS/cm		Benthic Growth:	None	
Detergents: 0 mg/L		Stains:	None	
		Non-illicit:	None	
Notes				
Sample collected from submerged pool in manhole.				
Condition Assessment				
Graffiti: None				
Erosion: None				
Deposition: None		in.		
Damage: None

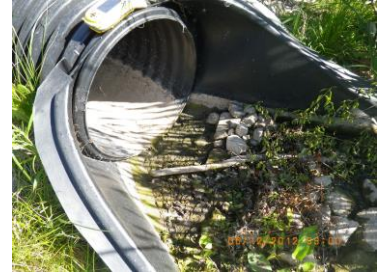
o20120612080046.JPG

Inspection Date: 6/12/2012 8:58:32 AM		Type: Ongoing	Flow: None	Previous Rainfall (hrs): 72+
Illicit Discharge Potential: Unlikely		Inspector: JCW	Notes	
Submerged: None		Depth (in):	Dry. Flowline sediment	
Sampling Results				
Sample Location:		Floatables:	None	
Total Chlorine: -- ppm		Odor:	None	
Free Chlorine: -- ppm		Turbidity:	None	
Ammonia: -- ppm		Color:	None	
pH: -- units		Gross Solids:	Slight	
Temperature -- °F		Vegetation:	None	
Conductivity: -- µS/cm		Benthic Growth:	Slight	
Detergents: -- mg/L		Stains:	None	
		Non-illicit:	None	
		Condition Assessment		
		Graffiti:	None	
		Erosion:	None	
		Deposition:	None in.	
		Damage:	None

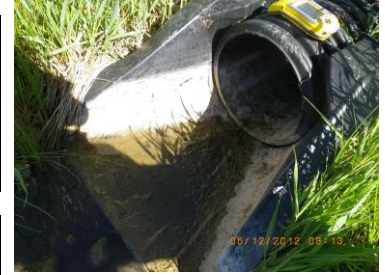
o20120612081300.JPG

Sample Location:																																		
Total Chlorine:	-- ppm																																	
Free Chlorine:	-- ppm																																	
Ammonia:	-- ppm																																	
pH:	-- units																																	
Temperature:	-- °F																																	
Conductivity:	-- µS/cm																																	
Detergents:	-- mg/L																																	
Notes																																		
Dry sediment and dry algae on apron.																																		
Condition Assessment																																		
Graffiti:	None																																	
Erosion:	None																																	
Deposition:	None in.																																	
Damage:	None

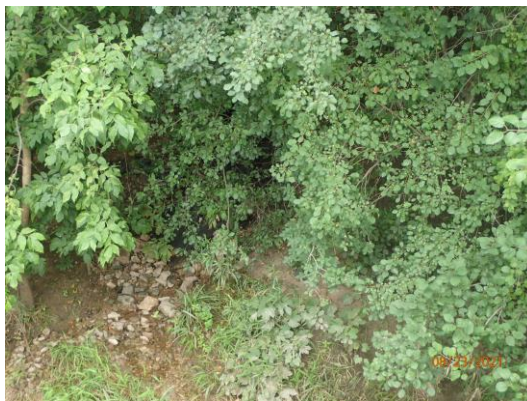
o20210823101628.JPG

Outlet pipe from detention basin discharges to stream from north via riprap channel.

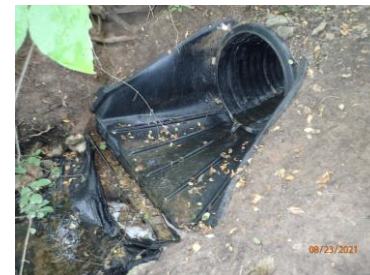
o20210823101724.JPG

Damage: Minor ☐ Displacement ☒ Undercut ☐ Crushed☐ Corrosion ☐ Cracks/Structural Damage

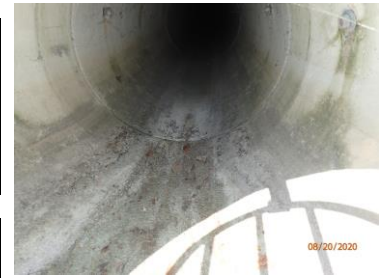
o20200820111920.JPG

Inspection Date: 8/20/2020 11:21:03 AM		Type: Ongoing	Flow: None	Previous Rainfall (hrs): 72+
Illicit Discharge Potential: Unlikely		Inspector: JCW		
Submerged: None		Depth (in):		
Sampling Results		Notes Pipe dry at time of inspection.		
Sample Location:	Floatables:	None		
Total Chlorine: -- ppm	Odor:	None		
Free Chlorine: -- ppm	Turbidity:	None		
Ammonia: -- ppm	Color:	None		
pH: -- units	Gross Solids:	None		
Temperature -- °F	Vegetation:	None		
Conductivity: -- µS/cm	Benthic Growth:	Slight		
Detergents: -- mg/L	Stains:	Slight		
	Non-illicit:	None		
		Condition Assessment Graffiti: None Erosion: None Deposition: None in. Damage: None

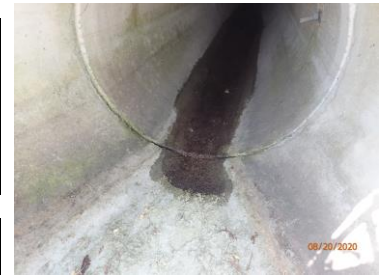
o20200820111526.JPG

Inspection Date: 8/20/2020 11:15:59 AM		Type: Ongoing	Flow: None	Previous Rainfall (hrs): 72+
Illicit Discharge Potential: Unlikely		Inspector: JCW		
Submerged: None		Depth (in):		
Sampling Results		Notes		
Sample Location:		Pipe wet, but no collectable flow at time of inspection.		
Total Chlorine:	-- ppm	Floatables:	None	
Free Chlorine:	-- ppm	Odor:	None	
Ammonia:	-- ppm	Turbidity:	None	
pH:	-- units	Color:	None	
Temperature	-- °F	Gross Solids:	None	
Conductivity:	-- µS/cm	Vegetation:	None	
Detergents:	-- mg/L	Benthic Growth:	None	
		Stains:	Slight	
		Non-illicit:	None	
		Condition Assessment		
		Graffiti:	None	
		Erosion:	None	
		Deposition:	None in.	
		Damage:	None

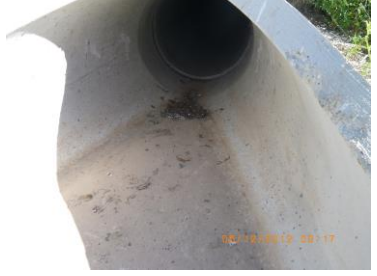
Damage: Moderate ☒ Displacement ☐ Undercut ☐ Crushed
☐ Corrosion ☐ Cracks/Structural Damage

<p>o20120612081748.JPG</p> <p>2012</p>	
Submerged: None		Depth (in):		Pipe dry at time of inspection. Apron slightly displaced from pipe.			
Sampling Results				Condition Assessment			
Sample Location:		Floatables:	None	Graffiti:		None	in.
Total Chlorine: -- ppm		Odor:	None	Erosion:		None	
Free Chlorine: -- ppm		Turbidity:	None	Deposition:		None	
Ammonia: -- ppm		Color:	None	Damage:		Minor	
pH: -- units		Gross Solids:	None				
Temperature -- °F		Vegetation:	None				
Conductivity: -- µS/cm		Benthic Growth:	None				
Detergents: -- mg/L		Stains:	None				
		Non-illicit:	None

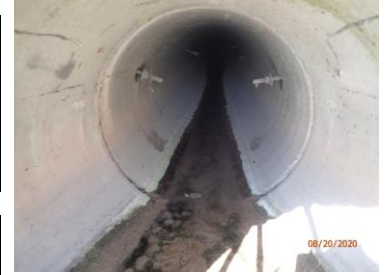
o20200820100338.JPG

Inspection Date: 8/20/2020 10:05:37 AM		Type: Ongoing	Flow: None	Previous Rainfall (hrs): 72+
Illicit Discharge Potential: Unlikely		Inspector: JCW		
Submerged: None		Depth (in):		
Sampling Results		Notes		
Sample Location:		Sediment in pipe wet, but no flow at time of inspection. Blue pond dye.		
Total Chlorine:	-- ppm	Floatables:	None	
Free Chlorine:	-- ppm	Odor:	None	
Ammonia:	-- ppm	Turbidity:	None	
pH:	-- units	Color:	None	
Temperature:	-- °F	Gross Solids:	Slight	
Conductivity:	-- µS/cm	Vegetation:	None	
Detergents:	-- mg/L	Benthic Growth:	Moderate	
		Stains:	None	
		Non-illicit:	None	
		Condition Assessment		
		Graffiti:	None	
		Erosion:	None	
		Deposition:	Minor	1 in.
		Damage:	None

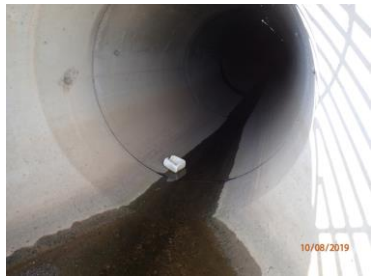
o20191008145924.JPG 2019

Inspection Date: 10/8/2019 4:01:14 PM		Type: Ongoing	Flow: Moderate	Previous Rainfall (hrs): 48-72
Illicit Discharge Potential: Potential		Inspector: JCW		
Submerged: None		Depth (in):		
Sampling Results		Notes		
Sample Location: Flow		Sample collected from submerged flow at end of pipe. Elevated conductivity.		
Total Chlorine:	0 ppm	Floatables:	None	
Free Chlorine:	0 ppm	Odor:	None	
Ammonia:	0 ppm	Turbidity:	None	
pH:	7.66 units	Color:	None	
Temperature:	65 °F	Gross Solids:	None	
Conductivity:	2470 µS/cm	Vegetation:	None	
Detergents:	0 mg/L	Benthic Growth:	Moderate	
		Stains:	None	
		Non-illicit:	None	
		Condition Assessment		
		Graffiti:	None	
		Erosion:	None	
		Deposition:	None in.	
		Damage:	None

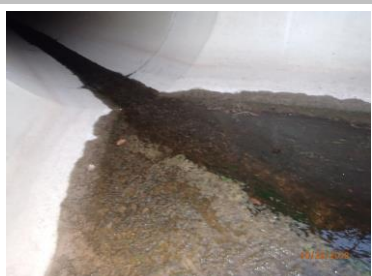
o20181025072226.JPG 2018

Inspection Date: 10/25/2018 7:24:13 AM		Type: Ongoing	Flow: Trickle	Previous Rainfall (hrs): 72+
Illicit Discharge Potential: Potential		Inspector: JCW		
Submerged: None		Depth (in):		
Sampling Results		Notes		
Sample Location: Flow		Sample collected from submerged flow at end of pipe. Detergent detected.		
Total Chlorine:	0 ppm	Floatables:	Slight	
Free Chlorine:	0 ppm	Odor:	None	
Ammonia:	0 ppm	Turbidity:	None	
pH:	7.94 units	Color:	None	
Temperature:	49 °F	Gross Solids:	None	
Conductivity:	1865 µS/cm	Vegetation:	None	
Detergents:	0.45 mg/L	Benthic Growth:	Moderate	
		Stains:	Slight	
		Non-illicit:	None	
		Condition Assessment		
		Graffiti:	None	
		Erosion:	None	
		Deposition:	None in.	
		Damage:	None

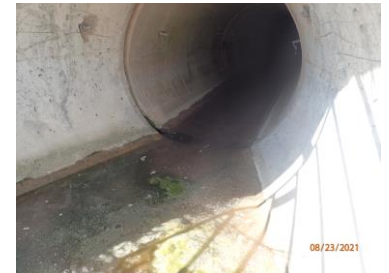
o20210823133324.JPG

Damage: Minor ☒ Displacement ☐ Undercut ☐ Crushed☐ Corrosion ☐ Cracks/Structural Damage

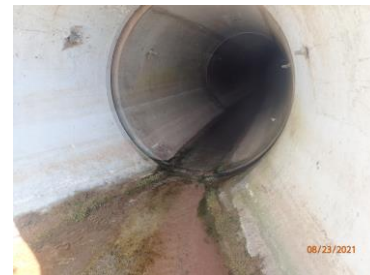
o20210823130936.JPG

Damage: Moderate ☒ Displacement ☐ Undercut ☐ Crushed☐ Corrosion ☐ Cracks/Structural Damage

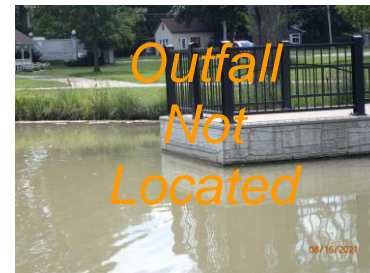
Damage: None ☐ Displacement ☐ Undercut ☐ Crushed☐ Corrosion ☐ Cracks/Structural Damage

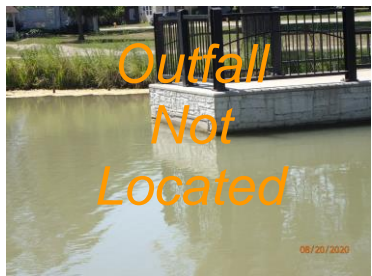
o20200820122132.JPG
2020

Inspection Date: 8/20/2020 12:23:12 PM		Type: Ongoing	Flow: Submerged (not located)	Previous Rainfall (hrs): 72+
Illicit Discharge Potential: Unlikely		Inspector: JCW		
Submerged: Fully		Depth (in):		
Sampling Results		Notes		
Sample Location:	Floatables:	<div style="border: 1px solid black; padding: 5px;"> <p>Outfall fully submerged and not located - screened upstream at 13-2957 US1.</p> </div>		
Total Chlorine: -- ppm	Odor:			
Free Chlorine: -- ppm	Turbidity:			
Ammonia: -- ppm	Color:			
pH: -- units	Gross Solids:			
Temperature -- °F	Vegetation:			
Conductivity: -- µS/cm	Benthic Growth:			
Detergents: -- mg/L	Stains:			
	Non-illicit:	Condition Assessment Graffiti: None Erosion: None Deposition: None in. Damage: None

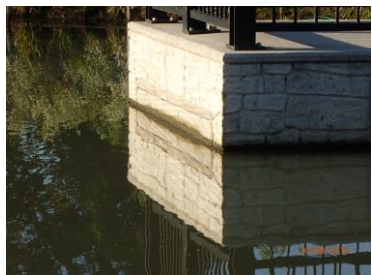
o20191008071216.JPG
2019

Inspection Date: 10/8/2019 8:14:46 AM		Type: Repeat	Flow: Submerged, indeterminate	Previous Rainfall (hrs): 48-72
Illicit Discharge Potential: Unlikely		Inspector: JCW		
Submerged: Fully		Depth (in):		
Sampling Results		Notes		
Sample Location:	Floatables:	<div style="border: 1px solid black; padding: 5px;"> <p>Detergent detection follow-up. Limited screening conducted beyond sampling. No detergent in follow-up sample.</p> </div>		
Total Chlorine: -- ppm	Odor:			
Free Chlorine: -- ppm	Turbidity:			
Ammonia: -- ppm	Color:			
pH: -- units	Gross Solids:			
Temperature -- °F	Vegetation:			
Conductivity: -- µS/cm	Benthic Growth:			
Detergents: -- mg/L	Stains:			
	Non-illicit:	Condition Assessment Graffiti: None Erosion: None Deposition: None in. Damage: None

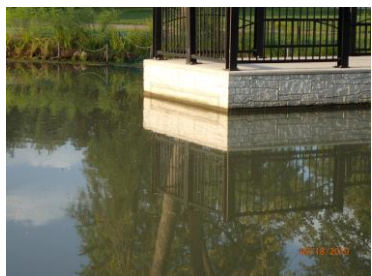
o20190918063134.JPG
2019

Inspection Date: 9/18/2019 7:32:53 AM		Type: Ongoing	Flow: Submerged, indeterminate	Previous Rainfall (hrs): 72+
Illicit Discharge Potential: Potential		Inspector: JCW		
Submerged: Fully		Depth (in):		
Sampling Results		Notes		
Sample Location:	Floatables:	<div style="border: 1px solid black; padding: 5px;"> <p>Outfall inaccessible - screened upstream at 13-2957 US1a. Detergent in upstream manhole.</p> </div>		
Total Chlorine: -- ppm	Odor:			
Free Chlorine: -- ppm	Turbidity:			
Ammonia: -- ppm	Color:			
pH: -- units	Gross Solids:			
Temperature -- °F	Vegetation:			
Conductivity: -- µS/cm	Benthic Growth:			
Detergents: -- mg/L	Stains:			
	Non-illicit:	Condition Assessment Graffiti: None Erosion: None Deposition: None in. Damage: None

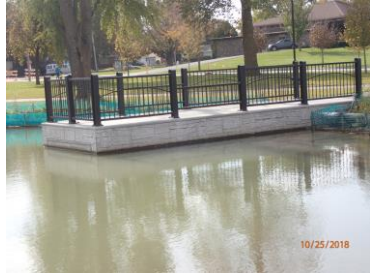
Inspection Date: 10/25/2018 1:17:00 PM		Type: Ongoing	Flow: Submerged, indeterminate	Previous Rainfall (hrs): 72+																																		
Illicit Discharge Potential: Unlikely		Inspector: JCW	Notes																																			
Submerged: Partially		Depth (in):	Outfall inaccessible - screened upstream at 13-2957 US1a.																																			
<div style="display: flex; justify-content: space-between;"> <div style="width: 45%;"> Sampling Results <table border="1" style="width:100%; border-collapse: collapse;"> <tr><td>Sample Location:</td><td></td></tr> <tr><td>Total Chlorine:</td><td>-- ppm</td></tr> <tr><td>Free Chlorine:</td><td>-- ppm</td></tr> <tr><td>Ammonia:</td><td>-- ppm</td></tr> <tr><td>pH:</td><td>-- units</td></tr> <tr><td>Temperature:</td><td>-- °F</td></tr> <tr><td>Conductivity:</td><td>-- µS/cm</td></tr> <tr><td>Detergents:</td><td>-- mg/L</td></tr> </table> </div> <div style="width: 45%;"> <table border="1" style="width:100%; border-collapse: collapse;"> <tr><td>Floatables:</td><td>None</td></tr> <tr><td>Odor:</td><td>None</td></tr> <tr><td>Turbidity:</td><td>None</td></tr> <tr><td>Color:</td><td>None</td></tr> <tr><td>Gross Solids:</td><td>None</td></tr> <tr><td>Vegetation:</td><td>None</td></tr> <tr><td>Benthic Growth:</td><td>None</td></tr> <tr><td>Stains:</td><td>None</td></tr> <tr><td>Non-illicit:</td><td>None</td></tr> </table> </div> </div>					Sample Location:		Total Chlorine:	-- ppm	Free Chlorine:	-- ppm	Ammonia:	-- ppm	pH:	-- units	Temperature:	-- °F	Conductivity:	-- µS/cm	Detergents:	-- mg/L	Floatables:	None	Odor:	None	Turbidity:	None	Color:	None	Gross Solids:	None	Vegetation:	None	Benthic Growth:	None	Stains:	None	Non-illicit:	None

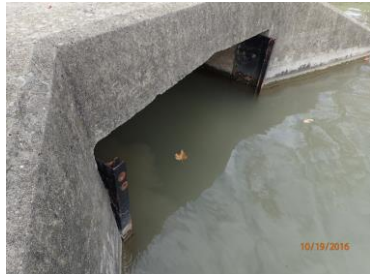
Inspection Date: 10/19/2016 1:42:21 PM		Type: Ongoing	Flow: Submerged, indeterminate	Previous Rainfall (hrs): 72+																																		
Illicit Discharge Potential: Unlikely		Inspector: JCW	Notes																																			
Submerged: Partially		Depth (in): 19	Outfall partially submerged - screened upstream at 13-2957 US1.																																			
<div style="display: flex; justify-content: space-between;"> <div style="width: 45%;"> Sampling Results <table border="1" style="width:100%; border-collapse: collapse;"> <tr><td>Sample Location:</td><td></td></tr> <tr><td>Total Chlorine:</td><td>-- ppm</td></tr> <tr><td>Free Chlorine:</td><td>-- ppm</td></tr> <tr><td>Ammonia:</td><td>-- ppm</td></tr> <tr><td>pH:</td><td>-- units</td></tr> <tr><td>Temperature:</td><td>-- °F</td></tr> <tr><td>Conductivity:</td><td>-- µS/cm</td></tr> <tr><td>Detergents:</td><td>-- mg/L</td></tr> </table> </div> <div style="width: 45%;"> <table border="1" style="width:100%; border-collapse: collapse;"> <tr><td>Floatables:</td><td>None</td></tr> <tr><td>Odor:</td><td>None</td></tr> <tr><td>Turbidity:</td><td>Cloudy</td></tr> <tr><td>Color:</td><td>None</td></tr> <tr><td>Gross Solids:</td><td>None</td></tr> <tr><td>Vegetation:</td><td>None</td></tr> <tr><td>Benthic Growth:</td><td>Moderate</td></tr> <tr><td>Stains:</td><td>Moderate</td></tr> <tr><td>Non-illicit:</td><td>None</td></tr> </table> </div> </div>					Sample Location:		Total Chlorine:	-- ppm	Free Chlorine:	-- ppm	Ammonia:	-- ppm	pH:	-- units	Temperature:	-- °F	Conductivity:	-- µS/cm	Detergents:	-- mg/L	Floatables:	None	Odor:	None	Turbidity:	Cloudy	Color:	None	Gross Solids:	None	Vegetation:	None	Benthic Growth:	Moderate	Stains:	Moderate	Non-illicit:	None

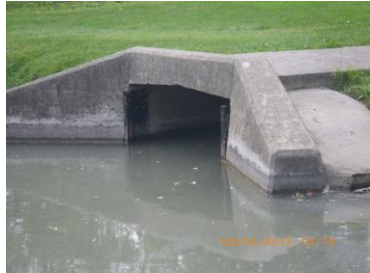
Inspection Date: 9/24/2015 1:12:45 PM		Type: Ongoing	Flow: Submerged, indeterminate	Previous Rainfall (hrs): 72+																																		
Illicit Discharge Potential: Unlikely		Inspector: JCW	Notes																																			
Submerged: Partially		Depth (in): 17	Outfall partially submerged - screened at 13-2957 US1.																																			
<div style="display: flex; justify-content: space-between;"> <div style="width: 45%;"> Sampling Results <table border="1" style="width:100%; border-collapse: collapse;"> <tr><td>Sample Location:</td><td></td></tr> <tr><td>Total Chlorine:</td><td>-- ppm</td></tr> <tr><td>Free Chlorine:</td><td>-- ppm</td></tr> <tr><td>Ammonia:</td><td>-- ppm</td></tr> <tr><td>pH:</td><td>-- units</td></tr> <tr><td>Temperature:</td><td>-- °F</td></tr> <tr><td>Conductivity:</td><td>-- µS/cm</td></tr> <tr><td>Detergents:</td><td>-- mg/L</td></tr> </table> </div> <div style="width: 45%;"> <table border="1" style="width:100%; border-collapse: collapse;"> <tr><td>Floatables:</td><td>None</td></tr> <tr><td>Odor:</td><td>None</td></tr> <tr><td>Turbidity:</td><td>Cloudy</td></tr> <tr><td>Color:</td><td>None</td></tr> <tr><td>Gross Solids:</td><td>None</td></tr> <tr><td>Vegetation:</td><td>None</td></tr> <tr><td>Benthic Growth:</td><td>Moderate</td></tr> <tr><td>Stains:</td><td>None</td></tr> <tr><td>Non-illicit:</td><td>None</td></tr> </table> </div> </div>					Sample Location:		Total Chlorine:	-- ppm	Free Chlorine:	-- ppm	Ammonia:	-- ppm	pH:	-- units	Temperature:	-- °F	Conductivity:	-- µS/cm	Detergents:	-- mg/L	Floatables:	None	Odor:	None	Turbidity:	Cloudy	Color:	None	Gross Solids:	None	Vegetation:	None	Benthic Growth:	Moderate	Stains:	None	Non-illicit:	None

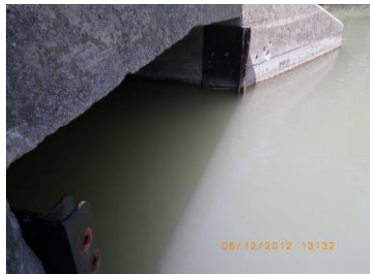
Inspection Date: 6/12/2012 1:30:43 PM		Type: Ongoing	Flow: Submerged, indeterminate	Previous Rainfall (hrs): 72+																																		
Illicit Discharge Potential: Unlikely		Inspector: JCW	Notes																																			
Submerged: Partially		Depth (in): 21	Outfall partially submerged; screened upstream at 13-2957 US1.																																			
<div style="display: flex; justify-content: space-between;"> <div style="width: 45%;"> Sampling Results <table border="1" style="width:100%; border-collapse: collapse;"> <tr><td>Sample Location:</td><td></td></tr> <tr><td>Total Chlorine:</td><td>-- ppm</td></tr> <tr><td>Free Chlorine:</td><td>-- ppm</td></tr> <tr><td>Ammonia:</td><td>-- ppm</td></tr> <tr><td>pH:</td><td>-- units</td></tr> <tr><td>Temperature:</td><td>-- °F</td></tr> <tr><td>Conductivity:</td><td>-- µS/cm</td></tr> <tr><td>Detergents:</td><td>-- mg/L</td></tr> </table> </div> <div style="width: 45%;"> <table border="1" style="width:100%; border-collapse: collapse;"> <tr><td>Floatables:</td><td>None</td></tr> <tr><td>Odor:</td><td>None</td></tr> <tr><td>Turbidity:</td><td>None</td></tr> <tr><td>Color:</td><td>None</td></tr> <tr><td>Gross Solids:</td><td>None</td></tr> <tr><td>Vegetation:</td><td>None</td></tr> <tr><td>Benthic Growth:</td><td>Moderate</td></tr> <tr><td>Stains:</td><td>Moderate</td></tr> <tr><td>Non-illicit:</td><td>None</td></tr> </table> </div> </div>					Sample Location:		Total Chlorine:	-- ppm	Free Chlorine:	-- ppm	Ammonia:	-- ppm	pH:	-- units	Temperature:	-- °F	Conductivity:	-- µS/cm	Detergents:	-- mg/L	Floatables:	None	Odor:	None	Turbidity:	None	Color:	None	Gross Solids:	None	Vegetation:	None	Benthic Growth:	Moderate	Stains:	Moderate	Non-illicit:	None

<div style="display: flex; justify-content: space-between;"> <div style="width: 45%;"> Condition Assessment <table border="1" style="width:100%; border-collapse: collapse;"> <tr><td>Graffiti:</td><td>Minor</td></tr> <tr><td>Erosion:</td><td>None</td></tr> <tr><td>Deposition:</td><td>None in.</td></tr> <tr><td>Damage:</td><td>None</td></tr> </table> </div> <div style="width: 45%; text-align: center;">

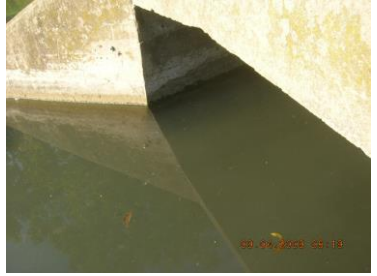
Osh09_DSCN6483.JPG

Inspection Date: 9/4/2009		Type: Initial		Flow: Submerged, slight flow		Previous Rainfall (hrs): 72+	
Illicit Discharge Potential: Unlikely		Inspector: JCW		Notes

Submerged: None		Depth (in): 16					
Sampling Results				Condition Assessment			
Sample Location:		Floatables:		Graffiti:		None	
Total Chlorine: -- ppm		Odor:		Erosion:		None	
Free Chlorine: -- ppm		Turbidity:		Deposition:		None 0 in.	
Ammonia: -- ppm		Color:		Damage:		None	
pH: -- units		Gross Solids:					
Temperature -- °F		Vegetation:					
Conductivity: -- µS/cm		Benthic Growth:					
Detergents: -- mg/L		Stains:					
		Non-illicit:

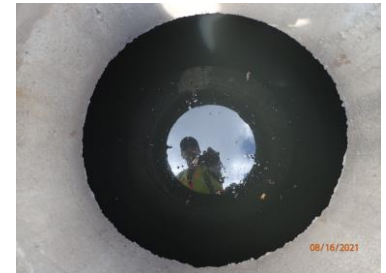
o20210816134742.JPG

Submerged: Fully Depth (in): 72

Damage: None ☐ Displacement ☐ Undercut ☐ Crushed☐ Corrosion ☐ Cracks/Structural Damage

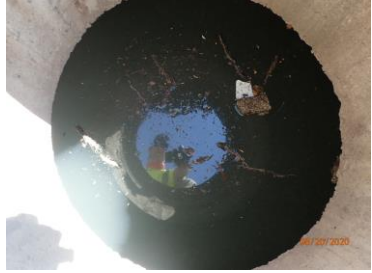
<p style="text-align: center;">o20200820122308.JPG</p> <p style="text-align: center; font-size: 24pt; font-weight: bold;">2020</p>

Inspection Date: 8/20/2020 12:29:26 PM		Type: Ongoing	Flow: Submerged, indeterminate	Previous Rainfall (hrs): 72+
Illicit Discharge Potential: Unlikely		Inspector: JCW		
Submerged: Fully		Depth (in): 57		
Sampling Results		<div style="display: flex; justify-content: space-between;"> <div> <p>Floatables: None</p> <p>Odor: None</p> <p>Turbidity: None</p> <p>Color: None</p> <p>Gross Solids: Slight</p> <p>Vegetation: None</p> <p>Benthic Growth: None</p> <p>Stains: None</p> <p>Non-illicit: None</p> </div> <div> <p>Sample Location: Pool</p> <p>Total Chlorine: 0 ppm</p> <p>Free Chlorine: 0 ppm</p> <p>Ammonia: 0 ppm</p> <p>pH: 7.88 units</p> <p>Temperature: 81 °F</p> <p>Conductivity: 1350 µS/cm</p> <p>Detergents: 0 mg/L</p> </div> </div>		
		<div style="display: flex; justify-content: space-between;"> <div> <p>Notes</p> <p>Sample collected from submerged pool in manhole.</p> </div> <div> <p>Condition Assessment</p> <p>Graffiti: None</p> <p>Erosion: None</p> <p>Deposition: None in.</p> <p>Damage: None</p> </div> </div>

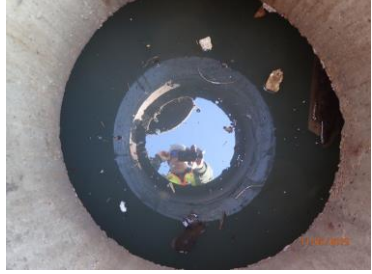
<p style="text-align: center;">o20191105133254.JPG</p> <p style="text-align: center; font-size: 24pt; font-weight: bold;">2019</p>

Inspection Date: 11/5/2019 1:33:38 PM		Type: Repeat	Flow: Submerged, indeterminate	Previous Rainfall (hrs): 48-72
Illicit Discharge Potential: Potential		Inspector: JCW		
Submerged: Partially		Depth (in): 71		
Sampling Results		<div style="display: flex; justify-content: space-between;"> <div> <p>Floatables: None</p> <p>Odor: None</p> <p>Turbidity: None</p> <p>Color: None</p> <p>Gross Solids: None</p> <p>Vegetation: None</p> <p>Benthic Growth: None</p> <p>Stains: None</p> <p>Non-illicit: None</p> </div> <div> <p>Sample Location: Pool</p> <p>Total Chlorine: -- ppm</p> <p>Free Chlorine: -- ppm</p> <p>Ammonia: -- ppm</p> <p>pH: -- units</p> <p>Temperature: -- °F</p> <p>Conductivity: -- µS/cm</p> <p>Detergents: 0.6 mg/L</p> </div> </div>		
		<div style="display: flex; justify-content: space-between;"> <div> <p>Notes</p> <p>Follow-up inspection for sampling - limited screening conducted. Detergent in follow-up sample.</p> </div> <div> <p>Condition Assessment</p> <p>Graffiti: None</p> <p>Erosion: None</p> <p>Deposition: None in.</p> <p>Damage: None</p> </div> </div>

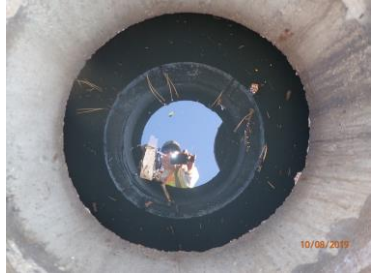
<p style="text-align: center;">o20191008071514.JPG</p> <p style="text-align: center; font-size: 24pt; font-weight: bold;">2019</p>

Inspection Date: 10/8/2019 8:16:29 AM		Type: Repeat	Flow: Submerged, indeterminate	Previous Rainfall (hrs): 48-72
Illicit Discharge Potential: Unlikely		Inspector: JCW		
Submerged: Partially		Depth (in): 72		
Sampling Results		<div style="display: flex; justify-content: space-between;"> <div> <p>Floatables:</p> <p>Odor: None</p> <p>Turbidity: None</p> <p>Color: None</p> <p>Gross Solids: Slight</p> <p>Vegetation: None</p> <p>Benthic Growth: None</p> <p>Stains: None</p> <p>Non-illicit: None</p> </div> <div> <p>Sample Location: Flow</p> <p>Total Chlorine: 0 ppm</p> <p>Free Chlorine: 0 ppm</p> <p>Ammonia: 0 ppm</p> <p>pH: 7.65 units</p> <p>Temperature: 55 °F</p> <p>Conductivity: 1354 µS/cm</p> <p>Detergents: 0 mg/L</p> </div> </div>		
		<div style="display: flex; justify-content: space-between;"> <div> <p>Notes</p> <p>Detergent detection follow-up. Limited screening conducted beyond sampling. No detergent in follow-up sample.</p> </div> <div> <p>Condition Assessment</p> <p>Graffiti: None</p> <p>Erosion: None</p> <p>Deposition: None in.</p> <p>Damage: None</p> </div> </div>

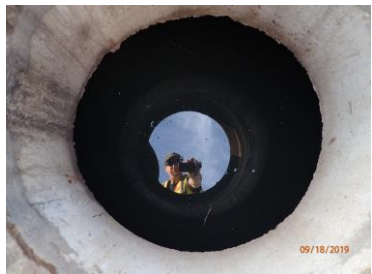
<p style="text-align: center;">o20190918063424.JPG</p> <p style="text-align: center; font-size: 24pt; font-weight: bold;">2019</p>

Inspection Date: 9/18/2019 7:36:33 AM		Type: Ongoing	Flow: Submerged, indeterminate	Previous Rainfall (hrs): 72+
Illicit Discharge Potential: Potential		Inspector: JCW		
Submerged: Fully		Depth (in): 71		
Sampling Results		<div style="display: flex; justify-content: space-between;"> <div> <p>Floatables: None</p> <p>Odor: None</p> <p>Turbidity: None</p> <p>Color: None</p> <p>Gross Solids: None</p> <p>Vegetation: None</p> <p>Benthic Growth: None</p> <p>Stains: None</p> <p>Non-illicit: None</p> </div> <div> <p>Sample Location: Pool</p> <p>Total Chlorine: 0 ppm</p> <p>Free Chlorine: 0 ppm</p> <p>Ammonia: 0 ppm</p> <p>pH: 7.9 units</p> <p>Temperature: 70 °F</p> <p>Conductivity: 1265 µS/cm</p> <p>Detergents: 0.75 mg/L</p> </div> </div>		
		<div style="display: flex; justify-content: space-between;"> <div> <p>Notes</p> <p>Sample collected from submerged pool in manhole. Detergent detected in sample.</p> </div> <div> <p>Condition Assessment</p> <p>Graffiti: None</p> <p>Erosion: None</p> <p>Deposition: None in.</p> <p>Damage: None</p> </div> </div>

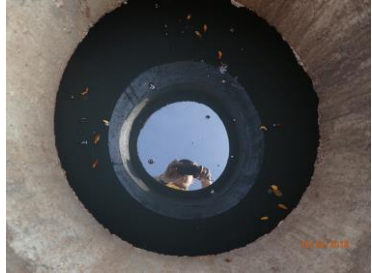
o20181025131952.JPG <div style="text-align: center; font-size: 24pt; font-weight: bold;">2018</div>

Inspection Date: 10/25/2018 1:21:51 PM		Type: Ongoing	Flow: Submerged, indeterminate	Previous Rainfall (hrs): 72+																																				
Illicit Discharge Potential: Unlikely		Inspector: JCW	Notes																																					
Submerged: Fully		Depth (in): 72	Sample collected from submerged pool in manhole.																																					
<table border="1" style="width:100%; border-collapse: collapse;"> <tr> <td colspan="2">Sampling Results</td> <td>Floatables:</td> <td>None</td> </tr> <tr> <td>Sample Location:</td> <td>Pool</td> <td>Odor:</td> <td>None</td> </tr> <tr> <td>Total Chlorine:</td> <td>0 ppm</td> <td>Turbidity:</td> <td>None</td> </tr> <tr> <td>Free Chlorine:</td> <td>0 ppm</td> <td>Color:</td> <td>None</td> </tr> <tr> <td>Ammonia:</td> <td>0 ppm</td> <td>Gross Solids:</td> <td>None</td> </tr> <tr> <td>pH:</td> <td>7.81 units</td> <td>Vegetation:</td> <td>None</td> </tr> <tr> <td>Temperature</td> <td>56 °F</td> <td>Benthic Growth:</td> <td>None</td> </tr> <tr> <td>Conductivity:</td> <td>1178 µS/cm</td> <td>Stains:</td> <td>None</td> </tr> <tr> <td>Detergents:</td> <td>0 mg/L</td> <td>Non-illicit:</td> <td>None</td> </tr> </table>					Sampling Results		Floatables:	None	Sample Location:	Pool	Odor:	None	Total Chlorine:	0 ppm	Turbidity:	None	Free Chlorine:	0 ppm	Color:	None	Ammonia:	0 ppm	Gross Solids:	None	pH:	7.81 units	Vegetation:	None	Temperature	56 °F	Benthic Growth:	None	Conductivity:	1178 µS/cm	Stains:	None	Detergents:	0 mg/L	Non-illicit:	None

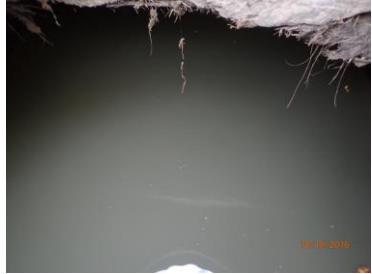
o20161019134250_1.JPG <div style="text-align: center; font-size: 24pt; font-weight: bold;">2016</div>

Inspection Date: 10/19/2016 1:45:38 PM		Type: Ongoing	Flow: Submerged, slight flow	Previous Rainfall (hrs): 72+																																				
Illicit Discharge Potential: Unlikely		Inspector: JCW	Notes																																					
Submerged: Partially		Depth (in): 22	Screened at old location (13-2957 US1).																																					
<table border="1" style="width:100%; border-collapse: collapse;"> <tr> <td colspan="2">Sampling Results</td> <td>Floatables:</td> <td>None</td> </tr> <tr> <td>Sample Location:</td> <td>Flow</td> <td>Odor:</td> <td>None</td> </tr> <tr> <td>Total Chlorine:</td> <td>0 ppm</td> <td>Turbidity:</td> <td>Slight cloudiness</td> </tr> <tr> <td>Free Chlorine:</td> <td>0 ppm</td> <td>Color:</td> <td>None</td> </tr> <tr> <td>Ammonia:</td> <td>0 ppm</td> <td>Gross Solids:</td> <td>None</td> </tr> <tr> <td>pH:</td> <td>7.98 units</td> <td>Vegetation:</td> <td>None</td> </tr> <tr> <td>Temperature</td> <td>65 °F</td> <td>Benthic Growth:</td> <td>None</td> </tr> <tr> <td>Conductivity:</td> <td>1234 µS/cm</td> <td>Stains:</td> <td>None</td> </tr> <tr> <td>Detergents:</td> <td>0 mg/L</td> <td>Non-illicit:</td> <td>None</td> </tr> </table>					Sampling Results		Floatables:	None	Sample Location:	Flow	Odor:	None	Total Chlorine:	0 ppm	Turbidity:	Slight cloudiness	Free Chlorine:	0 ppm	Color:	None	Ammonia:	0 ppm	Gross Solids:	None	pH:	7.98 units	Vegetation:	None	Temperature	65 °F	Benthic Growth:	None	Conductivity:	1234 µS/cm	Stains:	None	Detergents:	0 mg/L	Non-illicit:	None

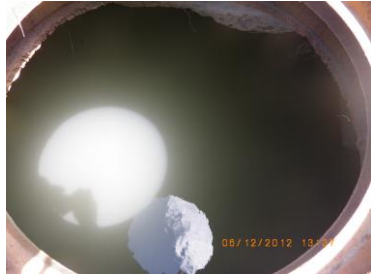
o20120612123728.JPG <div style="text-align: center; font-size: 24pt; font-weight: bold;">2012</div>

Sampling Results		Floatables:	None																																					
Sample Location:	Pool	Odor:	None																																					
Total Chlorine:	0 ppm	Turbidity:	Slight cloudiness																																					
Free Chlorine:	0 ppm	Color:	None																																					
Ammonia:	0 ppm	Gross Solids:	None																																					
pH:	8.35 units	Vegetation:	None																																					
Temperature	71 °F	Benthic Growth:	None																																					
Conductivity:	1336 µS/cm	Stains:	None																																					
Detergents:	0 mg/L	Non-illicit:	None																																					
<table border="1" style="width:100%; border-collapse: collapse;"> <tr> <td colspan="2">Condition Assessment</td> </tr> <tr> <td>Graffiti:</td> <td>None</td> </tr> <tr> <td>Erosion:</td> <td>None</td> </tr> <tr> <td>Deposition:</td> <td>None in.</td> </tr> <tr> <td>Damage:</td> <td>None</td> </tr> </table>					Condition Assessment		Graffiti:	None	Erosion:	None	Deposition:	None in.	Damage:	None

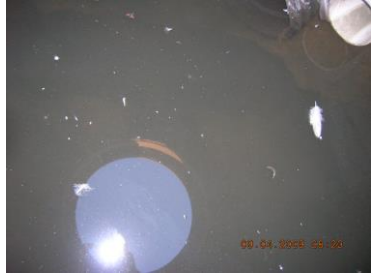
Inspection Date: 9/4/2009		Type: Initial		Flow: Submerged, slight flow		Previous Rainfall (hrs): 72+	
Illicit Discharge Potential: Unlikely		Inspector: JCW		Notes Screened at old location (13-2957 US1).

Submerged: Fully		Depth (in):					
Sampling Results		Floatables: None Odor: None Turbidity: None Color: None Gross Solids: None Vegetation: Benthic Growth: Stains: Non-illicit: None		Condition Assessment Graffiti: None Erosion: None Deposition: None 0 in. Damage: None

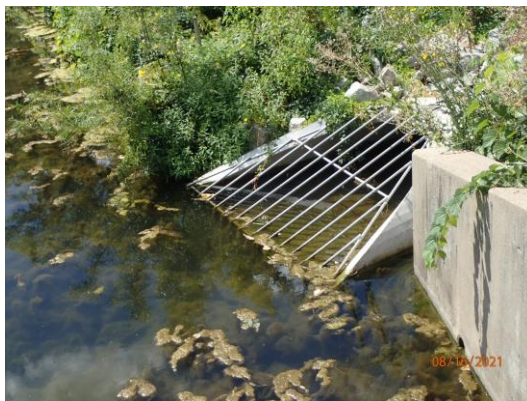
o20210816122950.JPG

Storm sewer from W 28th Ave discharges to stream from west. Reconstructed prior to 2020 inspection. 27" RCP replaced with HECP.

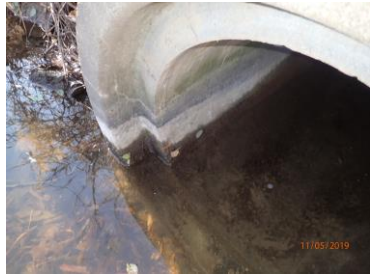
o20191105125024.JPG <div style="text-align: center; font-size: 24pt; font-weight: bold;">2019</div>
			Condition Assessment Graffiti: None Erosion: None Deposition: None in. Damage: None

Inspection Date: 11/5/2019 12:50:00 PM		Type: Repeat	Flow: Submerged, indeterminate	Previous Rainfall (hrs): 48-72
Illicit Discharge Potential: Potential		Inspector: JCW		
Submerged: Partially		Depth (in): 14		
Sampling Results Sample Location: _____ Total Chlorine: -- ppm Free Chlorine: -- ppm Ammonia: -- ppm pH: -- units Temperature: -- °F Conductivity: -- µS/cm Detergents: -- mg/L		Floatables: None Odor: None Turbidity: None Color: None Gross Solids: None Vegetation: None Benthic Growth: Moderate Stains: Slight Non-illicit: None	Notes Follow-up inspection for sampling - limited screening conducted. Detergent detected in manhole.

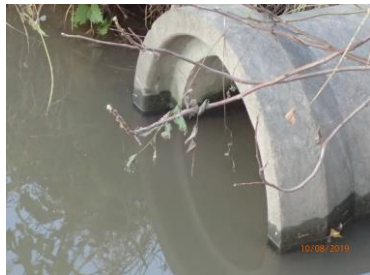
o20191008062428.JPG <div style="text-align: center; font-size: 24pt; font-weight: bold;">2019</div>
			Condition Assessment Graffiti: None Erosion: None Deposition: None in. Damage: None

Inspection Date: 10/8/2019 7:28:07 AM		Type: Ongoing	Flow: Submerged, indeterminate	Previous Rainfall (hrs): 48-72
Illicit Discharge Potential: Potential		Inspector: JCW		
Submerged: Partially		Depth (in): 14		
Sampling Results Sample Location: _____ Total Chlorine: -- ppm Free Chlorine: -- ppm Ammonia: -- ppm pH: -- units Temperature: -- °F Conductivity: -- µS/cm Detergents: -- mg/L		Floatables: None Odor: None Turbidity: None Color: None Gross Solids: None Vegetation: None Benthic Growth: Moderate Stains: Slight Non-illicit: None	Notes Outfall partially submerged - screened upstream at 14-582 US1. Detergent detected in manhole.

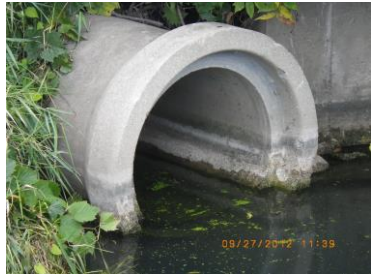
o20120927103918.JPG

Inspection Date: 9/27/2012 11:43:23 AM		Type: Repeat	Flow: Submerged, slight flow	Previous Rainfall (hrs): 72+
Illicit Discharge Potential: Potential		Inspector: JCW	Notes	
Submerged: Partially Depth (in): 6			Gel-like sheen on surface of stream. Outfall partially submerged; additional screening upstream at 14-582 US7.	
Sampling Results			Condition Assessment	
Sample Location: Pool	Floatables:	None	Graffiti:	None
Total Chlorine: 0 ppm	Odor:	None	Erosion:	None
Free Chlorine: 0 ppm	Turbidity:	None	Deposition:	None in.
Ammonia: 0 ppm	Color:	None	Damage:	None
pH: 7.77 units	Gross Solids:	None		
Temperature 64 °F	Vegetation:	None		
Conductivity: 1077 µS/cm	Benthic Growth:	Moderate		
Detergents: 0 mg/L	Stains:	Severe		
	Non-illicit:	None

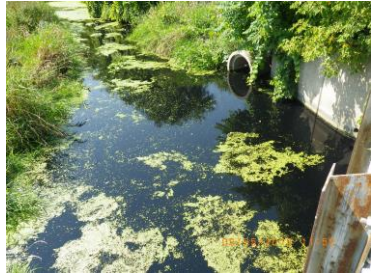
o20120905105212.JPG

Inspection Date: 9/5/2012 11:52:00 AM		Type: Complaint	Flow: Submerged, indeterminate	Previous Rainfall (hrs): 72+
Illicit Discharge Potential: Potential		Inspector: JCW	Notes	
Submerged: Partially Depth (in): 12			Dark black substance in water around outfall and bridge. Sample collected from stream.	
Sampling Results			Condition Assessment	
Sample Location: Pool	Floatables:	None	Graffiti:	None
Total Chlorine: 0 ppm	Odor:	Noticeable from a dist	Erosion:	None
Free Chlorine: 0 ppm	Turbidity:	Cloudy	Deposition:	None in.
Ammonia: 0 ppm	Color:	Clearly visible in flow	Damage:	None
pH: 75 units	Gross Solids:	None		
Temperature -- °F	Vegetation:	None		
Conductivity: 1419 µS/cm	Benthic Growth:	Moderate		
Detergents: 0 mg/L	Stains:	None		
	Non-illicit:	None

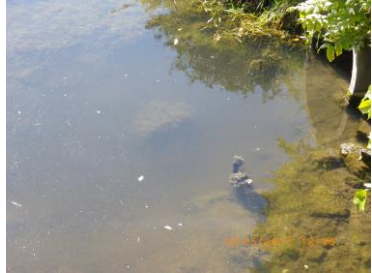
o20111005122620.JPG

Inspection Date: 10/5/2011 12:26:00 PM		Type: Repeat	Flow: Submerged, indeterminate	Previous Rainfall (hrs): 72+
Illicit Discharge Potential: Obvious		Inspector: JCW	Notes	
Submerged: Partially Depth (in):			Complaint follow-up. Outfall partially submerged. Outfall screened upstream at 14-585 US7. Limited screening conducted.	
Sampling Results			Condition Assessment	
Sample Location:	Floatables:		Graffiti:	
Total Chlorine: -- ppm	Odor:		Erosion:	
Free Chlorine: -- ppm	Turbidity:		Deposition: in.	
Ammonia: -- ppm	Color:		Damage:	
pH: -- units	Gross Solids:			
Temperature -- °F	Vegetation:			
Conductivity: -- µS/cm	Benthic Growth:			
Detergents: -- mg/L	Stains:			
	Non-illicit:	None

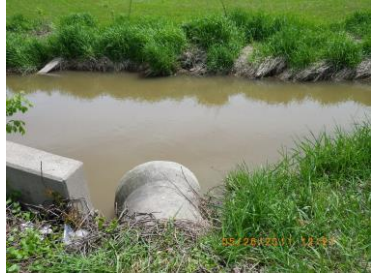
o20110526112114.jpg

Inspection Date: 5/26/2011 12:21:00 PM		Type: Repeat	Flow: Submerged, indeterminate	Previous Rainfall (hrs): 72+
Illicit Discharge Potential: Obvious		Inspector: JCW	Notes	
Submerged: Partially Depth (in):			Complaint follow-up. Strong chlorine smell inside pipe. Chemical interference with chlorine test. Limited screening conducted.	
Sampling Results			Condition Assessment	
Sample Location: Pool	Floatables:		Graffiti:	
Total Chlorine: -- ppm	Odor:	Noticeable from a dist	Erosion:	
Free Chlorine: -- ppm	Turbidity:		Deposition: in.	
Ammonia: -- ppm	Color:		Damage:	
pH: -- units	Gross Solids:			
Temperature -- °F	Vegetation:			
Conductivity: -- µS/cm	Benthic Growth:			
Detergents: -- mg/L	Stains:			
	Non-illicit:

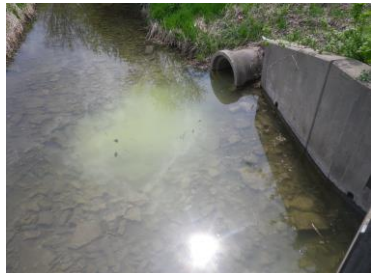
o20110512133142.jpg

Inspection Date: 5/12/2011 1:03:00 PM		Type: Complaint	Flow: Submerged, indeterminate	Previous Rainfall (hrs): 72+
Illicit Discharge Potential: Obvious		Inspector: JCW	Notes	
Submerged: Partially Depth (in):			Responded to complaint about discharge from pipe. Outfall partially submerged. Yellow pool at end of pipe. Chemical smell inside pipe.	
Sampling Results			Condition Assessment	
Sample Location: Pool	Floatables:		Graffiti:	
Total Chlorine: 2 ppm	Odor:	Noticeable from a dist	Erosion:	
Free Chlorine: 2 ppm	Turbidity:		Deposition: in.	
Ammonia: 2 ppm	Color:	Clearly visible in flow	Damage:	
pH: -- units	Gross Solids:			
Temperature -- °F	Vegetation:			
Conductivity: -- µS/cm	Benthic Growth:			
Detergents: -- mg/L	Stains:			
	Non-illicit:	None

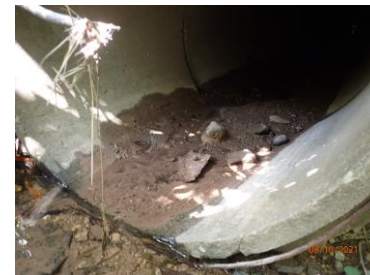
o20210816124938.JPG

Deposition: Minor Depth (in): 1

Damage: Minor ☒ Displacement ☐ Undercut ☐ Crushed☐ Corrosion ☐ Cracks/Structural Damage

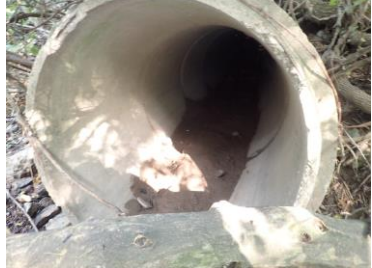
o20200924093736.JPG 2020

<div style="display: flex; justify-content: space-between;"> <div> <p>Notes</p> <p>Sediment damp, but no flow at time of inspection. 4" joint displacement.</p> </div> <div> <p>Condition Assessment</p> <table border="1" style="width:100%; border-collapse: collapse;"> <tr><td>Graffiti:</td><td>None</td></tr> <tr><td>Erosion:</td><td>None</td></tr> <tr><td>Deposition:</td><td>Minor 4 in.</td></tr> <tr><td>Damage:</td><td>Minor</td></tr> </table> </div> </div>			Graffiti:	None	Erosion:	None	Deposition:	Minor 4 in.	Damage:	Minor																										
Graffiti:	None																																					
Erosion:	None																																					
Deposition:	Minor 4 in.																																					
Damage:	Minor

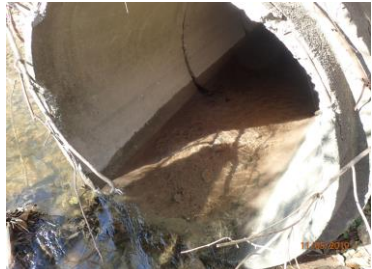
o20191105123320.JPG 2019

<div style="display: flex; justify-content: space-between;"> <div> <p>Notes</p> <p>Follow-up inspection for sampling - limited screening conducted. No detergent in follow-up sample.</p> </div> <div> <p>Condition Assessment</p> <table border="1" style="width:100%; border-collapse: collapse;"> <tr><td>Graffiti:</td><td>None</td></tr> <tr><td>Erosion:</td><td>None</td></tr> <tr><td>Deposition:</td><td>Minor 1 in.</td></tr> <tr><td>Damage:</td><td>Minor</td></tr> </table> </div> </div>			Graffiti:	None	Erosion:	None	Deposition:	Minor 1 in.	Damage:	Minor																										
Graffiti:	None																																					
Erosion:	None																																					
Deposition:	Minor 1 in.																																					
Damage:	Minor

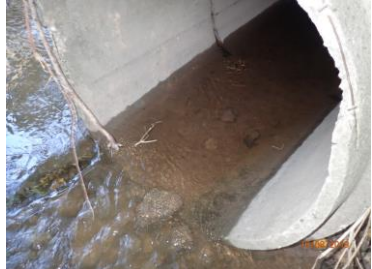
o20191008064438.JPG 2019

<div style="display: flex; justify-content: space-between;"> <div> <p>Notes</p> <p>Sample collected from submerged flow at end of pipe. 2" joint displacement. Detergent detected.</p> </div> <div> <p>Condition Assessment</p> <table border="1" style="width:100%; border-collapse: collapse;"> <tr><td>Graffiti:</td><td>None</td></tr> <tr><td>Erosion:</td><td>None</td></tr> <tr><td>Deposition:</td><td>Minor 1 in.</td></tr> <tr><td>Damage:</td><td>Minor</td></tr> </table> </div> </div>			Graffiti:	None	Erosion:	None	Deposition:	Minor 1 in.	Damage:	Minor																										
Graffiti:	None																																					
Erosion:	None																																					
Deposition:	Minor 1 in.																																					
Damage:	Minor

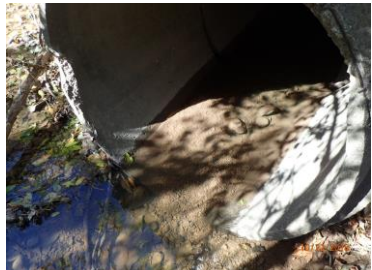
o20181022130156.JPG 2018

<div style="display: flex; justify-content: space-between;"> <div> <p>Notes</p> <p>Sample collected from submerged flow at end of pipe. 4" joint displacement.</p> </div> <div> <p>Condition Assessment</p> <table border="1" style="width:100%; border-collapse: collapse;"> <tr><td>Graffiti:</td><td>None</td></tr> <tr><td>Erosion:</td><td>None</td></tr> <tr><td>Deposition:</td><td>Minor 1 in.</td></tr> <tr><td>Damage:</td><td>Moderate</td></tr> </table> </div> </div>			Graffiti:	None	Erosion:	None	Deposition:	Minor 1 in.	Damage:	Moderate																										
Graffiti:	None																																					
Erosion:	None																																					
Deposition:	Minor 1 in.																																					
Damage:	Moderate

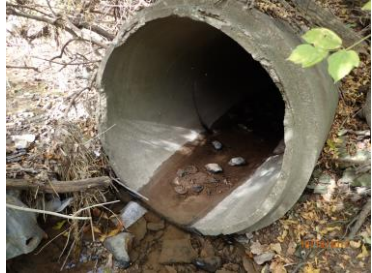
<p style="text-align: center;">o20171019115316.JPG</p> <p style="text-align: center; font-size: 24pt; font-weight: bold;">2017</p>

Inspection Date: 10/19/2017 11:55:23 AM		Type: Ongoing	Flow: Submerged, indeterminate	Previous Rainfall (hrs): 72+																											
Illicit Discharge Potential: Unlikely		Inspector: JCW	Notes																												
Submerged: Partially		Depth (in): 2	Upstream manhole dry - sample collected from submerged pool at end of pipe. 3" joint displacement and damaged concrete.																												
<table border="1" style="width:100%; border-collapse: collapse;"> <tr> <td colspan="2">Sampling Results</td> <td>Floatables: None</td> </tr> <tr> <td>Sample Location:</td> <td>Flow</td> <td>Odor: None</td> </tr> <tr> <td>Total Chlorine:</td> <td>0 ppm</td> <td>Turbidity: None</td> </tr> <tr> <td>Free Chlorine:</td> <td>0 ppm</td> <td>Color: None</td> </tr> <tr> <td>Ammonia:</td> <td>0 ppm</td> <td>Gross Solids: None</td> </tr> <tr> <td>pH:</td> <td>8.1 units</td> <td>Vegetation: None</td> </tr> <tr> <td>Temperature:</td> <td>62 °F</td> <td>Benthic Growth: Slight</td> </tr> <tr> <td>Conductivity:</td> <td>725 µS/cm</td> <td>Stains: None</td> </tr> <tr> <td>Detergents:</td> <td>0 mg/L</td> <td>Non-illicit: None</td> </tr> </table>					Sampling Results		Floatables: None	Sample Location:	Flow	Odor: None	Total Chlorine:	0 ppm	Turbidity: None	Free Chlorine:	0 ppm	Color: None	Ammonia:	0 ppm	Gross Solids: None	pH:	8.1 units	Vegetation: None	Temperature:	62 °F	Benthic Growth: Slight	Conductivity:	725 µS/cm	Stains: None	Detergents:	0 mg/L	Non-illicit: None

Condition Assessment																															
Graffiti:	None																														
Erosion:	None																														
Deposition:	None in.																														
Damage:	Moderate

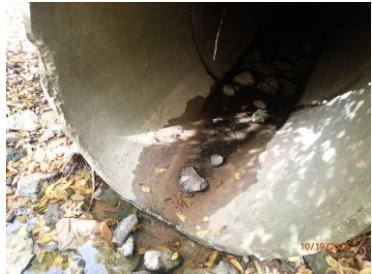
<p style="text-align: center;">o20161019130908.JPG</p> <p style="text-align: center; font-size: 24pt; font-weight: bold;">2016</p>

Inspection Date: 10/19/2016 1:11:20 PM		Type: Ongoing	Flow: Trickle	Previous Rainfall (hrs): 72+																											
Illicit Discharge Potential: Unlikely		Inspector: JCW	Notes																												
Submerged: None		Depth (in):	Last pipe segment displaced 4" at joint.																												
<table border="1" style="width:100%; border-collapse: collapse;"> <tr> <td colspan="2">Sampling Results</td> <td>Floatables: None</td> </tr> <tr> <td>Sample Location:</td> <td>Flow</td> <td>Odor: None</td> </tr> <tr> <td>Total Chlorine:</td> <td>0 ppm</td> <td>Turbidity: None</td> </tr> <tr> <td>Free Chlorine:</td> <td>0 ppm</td> <td>Color: Faint in bottle</td> </tr> <tr> <td>Ammonia:</td> <td>0 ppm</td> <td>Gross Solids: None</td> </tr> <tr> <td>pH:</td> <td>8.24 units</td> <td>Vegetation: None</td> </tr> <tr> <td>Temperature:</td> <td>65 °F</td> <td>Benthic Growth: Slight</td> </tr> <tr> <td>Conductivity:</td> <td>765 µS/cm</td> <td>Stains: None</td> </tr> <tr> <td>Detergents:</td> <td>0 mg/L</td> <td>Non-illicit: None</td> </tr> </table>					Sampling Results		Floatables: None	Sample Location:	Flow	Odor: None	Total Chlorine:	0 ppm	Turbidity: None	Free Chlorine:	0 ppm	Color: Faint in bottle	Ammonia:	0 ppm	Gross Solids: None	pH:	8.24 units	Vegetation: None	Temperature:	65 °F	Benthic Growth: Slight	Conductivity:	765 µS/cm	Stains: None	Detergents:	0 mg/L	Non-illicit: None

Condition Assessment																															
Graffiti:	None																														
Erosion:	None																														
Deposition:	None in.																														
Damage:	Minor

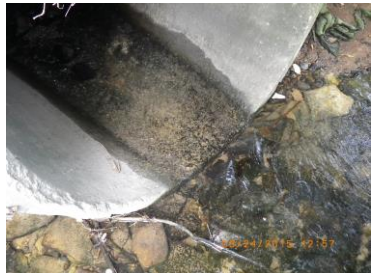
<p style="text-align: center;">o20150924115728.JPG</p> <p style="text-align: center; font-size: 24pt; font-weight: bold;">2015</p>

Inspection Date: 9/24/2015 12:55:30 PM		Type: Ongoing	Flow: Moderate	Previous Rainfall (hrs): 72+																											
Illicit Discharge Potential: Unlikely		Inspector: JCW	Notes																												
Submerged: None		Depth (in):	4" joint displacement.																												
<table border="1" style="width:100%; border-collapse: collapse;"> <tr> <td colspan="2">Sampling Results</td> <td>Floatables: None</td> </tr> <tr> <td>Sample Location:</td> <td>Flow</td> <td>Odor: None</td> </tr> <tr> <td>Total Chlorine:</td> <td>0 ppm</td> <td>Turbidity: None</td> </tr> <tr> <td>Free Chlorine:</td> <td>0 ppm</td> <td>Color: None</td> </tr> <tr> <td>Ammonia:</td> <td>0 ppm</td> <td>Gross Solids: None</td> </tr> <tr> <td>pH:</td> <td>8.17 units</td> <td>Vegetation: None</td> </tr> <tr> <td>Temperature:</td> <td>72 °F</td> <td>Benthic Growth: None</td> </tr> <tr> <td>Conductivity:</td> <td>1595 µS/cm</td> <td>Stains: Slight</td> </tr> <tr> <td>Detergents:</td> <td>0 mg/L</td> <td>Non-illicit: None</td> </tr> </table>					Sampling Results		Floatables: None	Sample Location:	Flow	Odor: None	Total Chlorine:	0 ppm	Turbidity: None	Free Chlorine:	0 ppm	Color: None	Ammonia:	0 ppm	Gross Solids: None	pH:	8.17 units	Vegetation: None	Temperature:	72 °F	Benthic Growth: None	Conductivity:	1595 µS/cm	Stains: Slight	Detergents:	0 mg/L	Non-illicit: None

Condition Assessment																															
Graffiti:	None																														
Erosion:	None																														
Deposition:	None in.																														
Damage:	Moderate

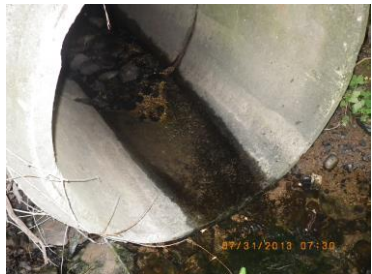
<p style="text-align: center;">o20130731063036.JPG</p> <p style="text-align: center; font-size: 24pt; font-weight: bold;">2013</p>

Inspection Date: 7/31/2013 7:27:16 AM		Type: Ongoing	Flow: Trickle	Previous Rainfall (hrs): 72+																											
Illicit Discharge Potential: Unlikely		Inspector: JCW	Notes																												
Submerged: None		Depth (in):	End section displaced 4".																												
<table border="1" style="width:100%; border-collapse: collapse;"> <tr> <td colspan="2">Sampling Results</td> <td>Floatables: None</td> </tr> <tr> <td>Sample Location:</td> <td>Flow</td> <td>Odor: None</td> </tr> <tr> <td>Total Chlorine:</td> <td>0 ppm</td> <td>Turbidity: None</td> </tr> <tr> <td>Free Chlorine:</td> <td>0 ppm</td> <td>Color: None</td> </tr> <tr> <td>Ammonia:</td> <td>0 ppm</td> <td>Gross Solids: None</td> </tr> <tr> <td>pH:</td> <td>8.05 units</td> <td>Vegetation: None</td> </tr> <tr> <td>Temperature:</td> <td>71 °F</td> <td>Benthic Growth: None</td> </tr> <tr> <td>Conductivity:</td> <td>1865 µS/cm</td> <td>Stains: Moderate</td> </tr> <tr> <td>Detergents:</td> <td>0 mg/L</td> <td>Non-illicit: None</td> </tr> </table>					Sampling Results		Floatables: None	Sample Location:	Flow	Odor: None	Total Chlorine:	0 ppm	Turbidity: None	Free Chlorine:	0 ppm	Color: None	Ammonia:	0 ppm	Gross Solids: None	pH:	8.05 units	Vegetation: None	Temperature:	71 °F	Benthic Growth: None	Conductivity:	1865 µS/cm	Stains: Moderate	Detergents:	0 mg/L	Non-illicit: None

Condition Assessment																															
Graffiti:	None																														
Erosion:	None																														
Deposition:	None in.																														
Damage:	Minor

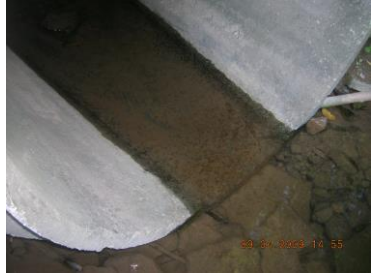
<p>Osh09_DSCN6570.JPG</p> <p>2009</p>	
Submerged: Partially		Depth (in): 1		End section of pipe separated.			
Sampling Results Sample Location: Pool Total Chlorine: 0 ppm Free Chlorine: 0 ppm Ammonia: -- ppm pH: 7.82 units Temperature: 73 °F Conductivity: -- µS/cm Detergents: 0 mg/L		Floatables: None Odor: None Turbidity: None Color: None Gross Solids: None Vegetation: Benthic Growth: Slight Stains: Non-illicit: None		Condition Assessment Graffiti: None Erosion: None Deposition: None 0 in. Damage: Moderate

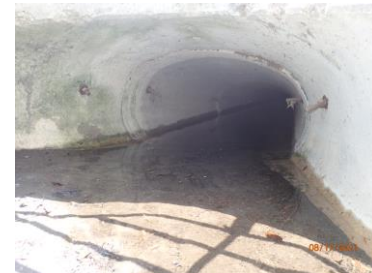
o20210817123346.JPG

Deposition: Minor Depth (in): 2
