IDDE Ongoing Screening Summary Report

2021 Inspection Year

City of Oshkosh

Westwood

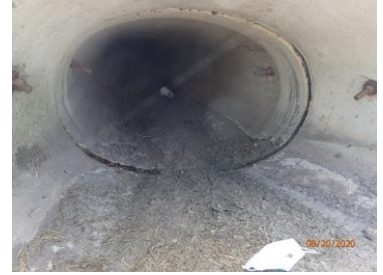
o20200820144034.JPG

Inspection Date: 8/20/2020 2:42:27 PM		Type: Ongoing	Flow: None	Previous Rainfall (hrs): 72+
Illicit Discharge Potential: Unlikely		Inspector: JCW		
Submerged: None		Depth (in):		
Sampling Results		Notes Pipe dry at time of inspection. End of pipe recently excavated.		
Sample Location:	Floatables:	None		
Total Chlorine: -- ppm	Odor:	None		
Free Chlorine: -- ppm	Turbidity:	None		
Ammonia: -- ppm	Color:	None		
pH: -- units	Gross Solids:	None		
Temperature -- °F	Vegetation:	None		
Conductivity: -- µS/cm	Benthic Growth:	None		
Detergents: -- mg/L	Stains:	None		
	Non-illicit:	None		
		Condition Assessment Graffiti: None Erosion: None Deposition: None in. Damage: None

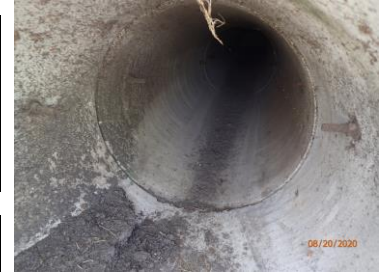
o20200820143100.JPG

Inspection Date: 8/20/2020 2:32:57 PM		Type: Ongoing	Flow: None	Previous Rainfall (hrs): 72+
Illicit Discharge Potential: Unlikely		Inspector: JCW		
Submerged: None		Depth (in):		
Sampling Results		Notes		
Sample Location:		Pipe dry at time of inspection. 3" of sediment on half of apron.		
Total Chlorine: -- ppm				
Free Chlorine: -- ppm				
Ammonia: -- ppm				
pH: -- units				
Temperature: -- °F				
Conductivity: -- µS/cm				
Detergents: -- mg/L				
Floatables:		Condition Assessment Graffiti: None Erosion: None Deposition: Minor 3 in. Damage: None		
Odor:				
Turbidity:				
Color:				
Gross Solids:				
Vegetation:				
Benthic Growth:				
Stains:				
Non-illicit:

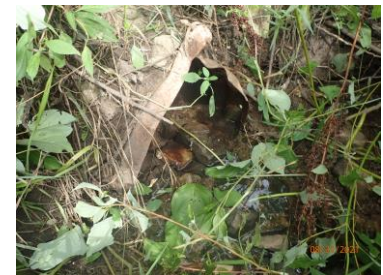
o20210831120416.JPG

Deposition: Minor Depth (in): 2

Damage: Minor ☐ Displacement ☐ Undercut ☒ Crushed☒ Corrosion ☐ Cracks/Structural Damage

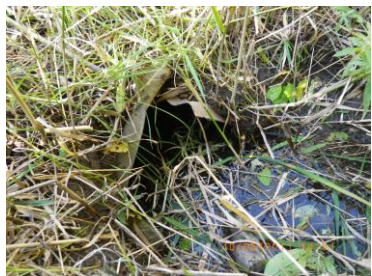
o20111005145114.JPG <div style="text-align: center; font-size: 24pt; font-weight: bold;">2011</div>
			Condition Assessment Graffiti: None Erosion: None Deposition: Minor 3 in. Damage: Minor

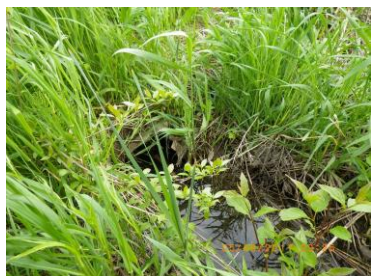
Inspection Date: 5/26/2011 9:25:00 AM		Type: Other	Flow: Submerged, indeterminate	Previous Rainfall (hrs): 72+
Illicit Discharge Potential: Unlikely		Inspector: JCW		
Submerged: Partially		Depth (in):		
Sampling Results Sample Location: _____ Total Chlorine: -- ppm Free Chlorine: -- ppm Ammonia: -- ppm pH: -- units Temperature -- °F Conductivity: -- µS/cm Detergents: -- mg/L		Floatables: _____ Odor: _____ Turbidity: _____ Color: _____ Gross Solids: _____ Vegetation: _____ Benthic Growth: _____ Stains: _____ Non-illicit: None	Notes Outfall partially submerged. Outfall screened upstream at 15-1219 US1.

o20110526092512.JPG <div style="text-align: center; font-size: 24pt; font-weight: bold;">2011</div>
			Condition Assessment Graffiti: None Erosion: None Deposition: None 0 in. Damage: Moderate

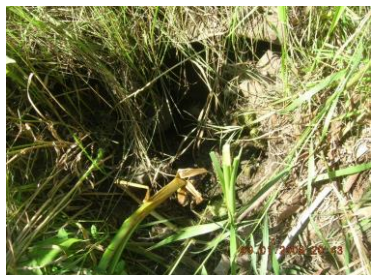
Inspection Date: 9/2/2009		Type: Initial	Flow: None	Previous Rainfall (hrs): 72+
Illicit Discharge Potential: Unlikely		Inspector: JCW		
Submerged: None		Depth (in): 0		
Sampling Results Sample Location: _____ Total Chlorine: -- ppm Free Chlorine: -- ppm Ammonia: -- ppm pH: -- units Temperature -- °F Conductivity: -- µS/cm Detergents: -- mg/L		Floatables: _____ Odor: _____ Turbidity: _____ Color: _____ Gross Solids: _____ Vegetation: _____ Benthic Growth: _____ Stains: _____ Non-illicit: None	Notes Wet, no flow

Osh09_DSCN6351.JPG <div style="text-align: center; font-size: 24pt; font-weight: bold;">2009</div>
			Condition Assessment Graffiti: None Erosion: None Deposition: 3 in. Damage: Minor

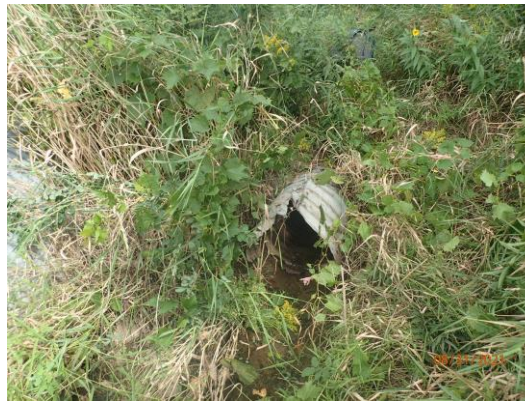
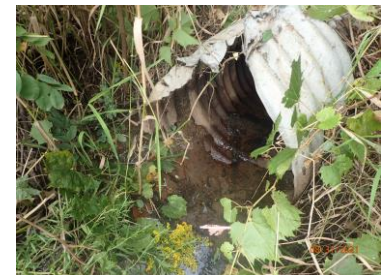
Notes: Sample collected from submerged flow in pipe. Metal pipe slightly crushed and damaged.

Damage: Moderate ☐ Displacement ☐ Undercut ☒ Crushed☒ Corrosion ☐ Cracks/Structural Damage

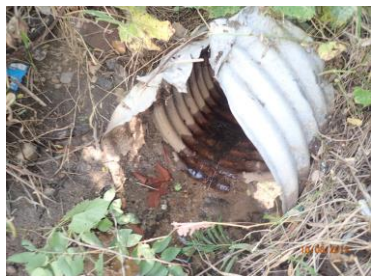
o20191008092808.JPG <div style="text-align: center; font-size: 24pt; font-weight: bold;">2019</div>
		Condition Assessment Graffiti: None Erosion: None Deposition: None in. Damage: Moderate

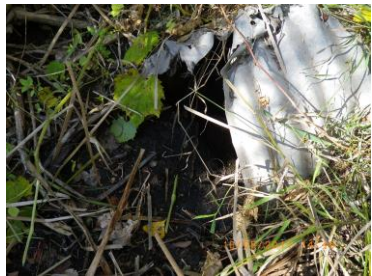
Inspection Date: 10/5/2011 2:46:18 PM		Type: Ongoing	Flow: None	Previous Rainfall (hrs): 72+
Illicit Discharge Potential: Unlikely		Inspector: JCW		
Submerged: None		Depth (in):		
Sampling Results Sample Location: Total Chlorine: -- ppm Free Chlorine: -- ppm Ammonia: -- ppm pH: -- units Temperature: -- °F Conductivity: -- µS/cm Detergents: -- mg/L		Floatables: None Odor: None Turbidity: None Color: None Gross Solids: None Vegetation: None Benthic Growth: Slight Stains: Slight Non-illicit: None	Notes Dirt wet but no flow leaving through outfall pipe.

o20111005144608.JPG <div style="text-align: center; font-size: 24pt; font-weight: bold;">2011</div>
		Condition Assessment Graffiti: None Erosion: None Deposition: Moderate 7 in. Damage: Minor

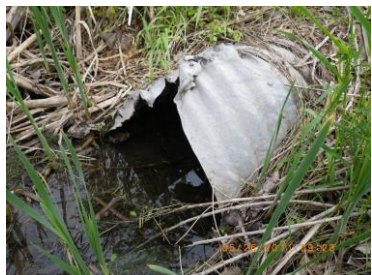
Inspection Date: 5/26/2011 9:23:00 AM		Type: Other	Flow: Submerged, indeterminate	Previous Rainfall (hrs): 72+
Illicit Discharge Potential: Unlikely		Inspector: JCW		
Submerged: Partially		Depth (in):		
Sampling Results Sample Location: Total Chlorine: -- ppm Free Chlorine: -- ppm Ammonia: -- ppm pH: -- units Temperature: -- °F Conductivity: -- µS/cm Detergents: -- mg/L		Floatables: Odor: Turbidity: Color: Gross Solids: Vegetation: Benthic Growth: Stains: Non-illicit: None	Notes Outfall partially submerged. Outfall screened upstream at 15-1219 US1.

o20110526092324.JPG <div style="text-align: center; font-size: 24pt; font-weight: bold;">2011</div>
		Condition Assessment Graffiti: None Erosion: None Deposition: None 0 in. Damage: Moderate

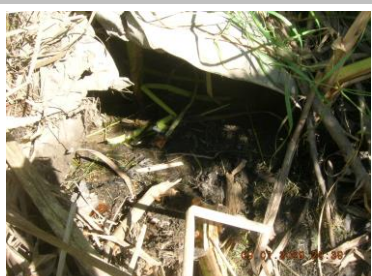
Inspection Date: 9/2/2009		Type: Initial	Flow: None	Previous Rainfall (hrs): 72+
Illicit Discharge Potential: Unlikely		Inspector: JCW		
Submerged: None		Depth (in): 0		
Sampling Results Sample Location: Total Chlorine: -- ppm Free Chlorine: -- ppm Ammonia: -- ppm pH: -- units Temperature: -- °F Conductivity: -- µS/cm Detergents: -- mg/L		Floatables: Odor: Turbidity: Color: Gross Solids: Vegetation: Benthic Growth: Stains: Non-illicit: None	Notes Wet, no flow

Osh09_DSCN6347.JPG <div style="text-align: center; font-size: 24pt; font-weight: bold;">2009</div>
		Condition Assessment Graffiti: None Erosion: None Deposition: 4 in. Damage: Minor

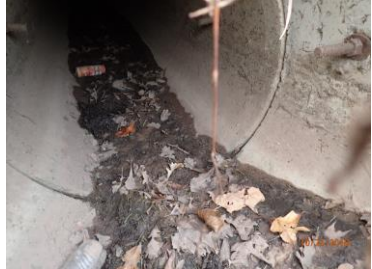
Sample Location:																																		
Total Chlorine:	-- ppm																																	
Free Chlorine:	-- ppm																																	
Ammonia:	-- ppm																																	
pH:	-- units																																	
Temperature:	-- °F																																	
Conductivity:	-- µS/cm																																	
Detergents:	-- mg/L																																	
Notes																																		
Sediment wet, but no collectable flow at time of inspection.																																		
Condition Assessment																																		
Graffiti:	None																																	
Erosion:	None																																	
Deposition:	Minor 1 in.																																	
Damage:	None

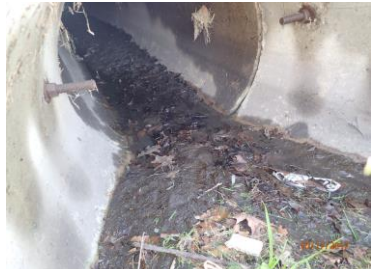
Sample Location:																																		
Total Chlorine:	-- ppm																																	
Free Chlorine:	-- ppm																																	
Ammonia:	-- ppm																																	
pH:	-- units																																	
Temperature:	-- °F																																	
Conductivity:	-- µS/cm																																	
Detergents:	-- mg/L																																	
Notes																																		
Saturated sediment on apron. Outfall partially submerged - screened upstream at 15-2409 US1.																																		
Condition Assessment																																		
Graffiti:	None																																	
Erosion:	None																																	
Deposition:	Minor 2 in.																																	
Damage:	None

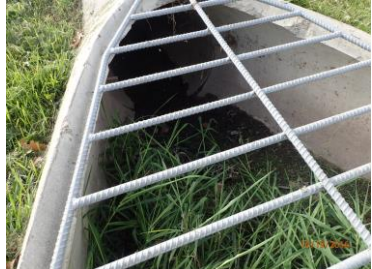
Sample Location:																																		
Total Chlorine:	-- ppm																																	
Free Chlorine:	-- ppm																																	
Ammonia:	-- ppm																																	
pH:	-- units																																	
Temperature:	-- °F																																	
Conductivity:	-- µS/cm																																	
Detergents:	-- mg/L																																	
Notes																																		
Sediment wet, but no flow at time of inspection.																																		
Condition Assessment																																		
Graffiti:	None																																	
Erosion:	None																																	
Deposition:	Minor 1 in.																																	
Damage:	None

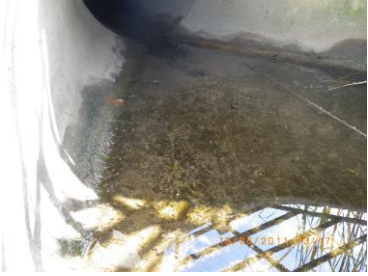
**Inspection Date:** 8/16/2021 10:19:15 AM**Inspector:** JCW**Inspection Type:** Ongoing**Previous Rainfall (hrs):** 72+**Flow Description:** Submerged, indeterminate

Location Map

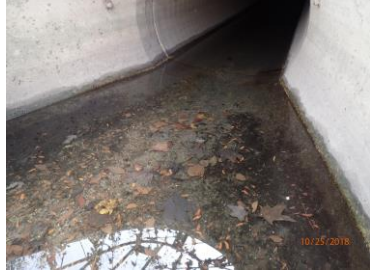
Closed Pipe Outfall

Priority Outfall

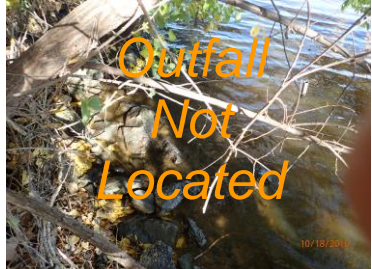
Upstream manhole located approx 53 ft WNW of outfall 02-309. Intermediate area consists of open space.

o20210816091640.JPG

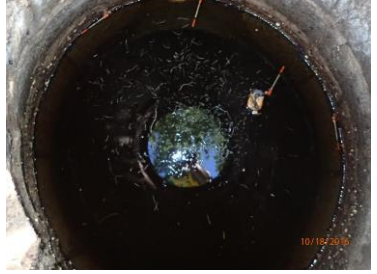
o20200820130258.JPG

Mapping Precison:

☒ Not Physically Located

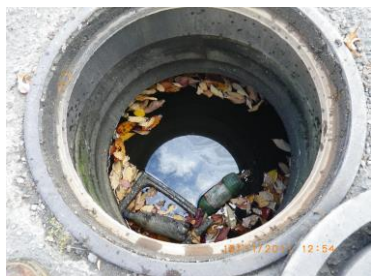
o20110510085154.JPG

Inspection Date: 5/10/2011 8:51:00 AM		Type: Other	Flow: Submerged, indeterminate	Previous Rainfall (hrs): 0-24
Illicit Discharge Potential: Potential		Inspector: JCW	Notes	
Submerged: Fully		Depth (in):	Limited screening conducted for upstream manhole prescreening.	
Sampling Results				
Sample Location:	Floatables:	None		
Total Chlorine: -- ppm	Odor:			
Free Chlorine: -- ppm	Turbidity:			
Ammonia: -- ppm	Color:			
pH: -- units	Gross Solids:	Severe		
Temperature -- °F	Vegetation:			
Conductivity: -- µS/cm	Benthic Growth:			
Detergents: -- mg/L	Stains:			
	Non-illicit:	None		
			Condition Assessment	
			Graffiti:	None
			Erosion:	None
			Deposition:	None 0 in.
			Damage:	None

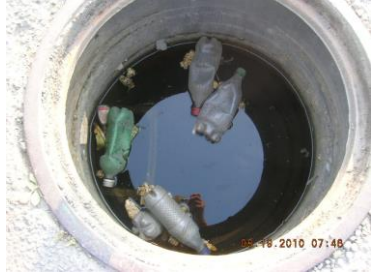
Pipe - Arch

Water of the State

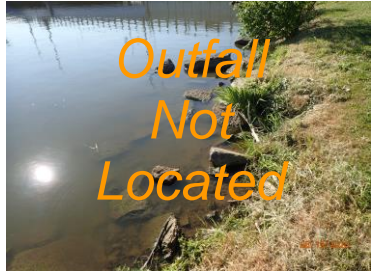
o20181022155222.JPG

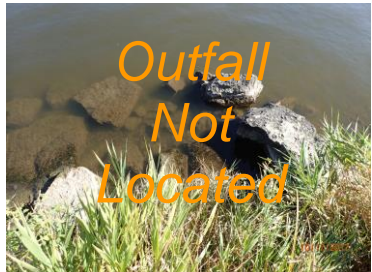
Inspection Date: 10/9/2014 9:47:52 AM		Type: Ongoing		Flow: Submerged (not located)		Previous Rainfall (hrs): 72+																																									
Illicit Discharge Potential: Potential		Inspector: JCW		Notes

o20150923065132.JPG

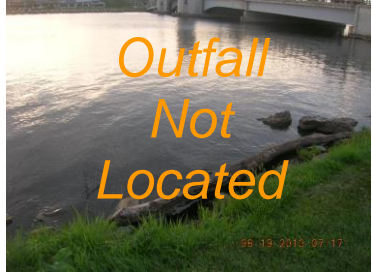
o20100819071708.JPG

Inspection Date: 8/19/2010 7:23:24 AM		Type: Ongoing	Flow: Submerged (not located)	Previous Rainfall (hrs): 72+
Illicit Discharge Potential: Unlikely		Inspector: JCW	Notes	
Submerged: Fully Depth (in):			Outfall fully submerged and not physically located. Outfall screened upstream at 16-594 US1.	
Sampling Results			Condition Assessment	
Sample Location:	Floatables:	None	Graffiti: None	
Total Chlorine: -- ppm	Odor:	None	Erosion: None	
Free Chlorine: -- ppm	Turbidity:	None	Deposition: None 0 in.	
Ammonia: -- ppm	Color:	None	Damage: None	
pH: -- units	Gross Solids:	None		
Temperature -- °F	Vegetation:	None		
Conductivity: -- µS/cm	Benthic Growth:	None		
Detergents: -- mg/L	Stains:	None		
	Non-illicit:	None

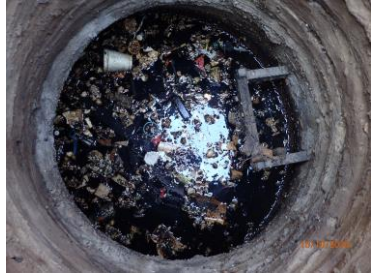
Inspection Date: 10/10/2016 2:07:20 PM		Type: Ongoing	Flow: Submerged, indeterminate	Previous Rainfall (hrs): 72+																																											
Illicit Discharge Potential: Potential		Inspector: JCW	Notes Potential illicit discharge due to gross solids.																																												
Submerged: Fully		Depth (in): 51

o20161010140454.JPG <div style="text-align: center; font-weight: bold; font-size: 1.2em;">2016</div>																																												
Sampling Results <table border="1" style="width: 100%; border-collapse: collapse;"> <tr> <td>Sample Location:</td> <td>Pool</td> <td>Floatables:</td> <td>Slight</td> </tr> <tr> <td>Total Chlorine:</td> <td>0 ppm</td> <td>Odor:</td> <td>Easily detected</td> </tr> <tr> <td>Free Chlorine:</td> <td>0 ppm</td> <td>Turbidity:</td> <td>None</td> </tr> <tr> <td>Ammonia:</td> <td>0.25 ppm</td> <td>Color:</td> <td>None</td> </tr> <tr> <td>pH:</td> <td>7.17 units</td> <td>Gross Solids:</td> <td>Moderate</td> </tr> <tr> <td>Temperature</td> <td>71 °F</td> <td>Vegetation:</td> <td>None</td> </tr> <tr> <td>Conductivity:</td> <td>831 µS/cm</td> <td>Benthic Growth:</td> <td>None</td> </tr> <tr> <td>Detergents:</td> <td>0 mg/L</td> <td>Stains:</td> <td>None</td> </tr> <tr> <td></td> <td></td> <td>Non-illicit:</td> <td>None</td> </tr> </table>		Sample Location:			Pool	Floatables:	Slight	Total Chlorine:	0 ppm	Odor:	Easily detected	Free Chlorine:	0 ppm	Turbidity:	None	Ammonia:	0.25 ppm	Color:	None	pH:	7.17 units	Gross Solids:	Moderate	Temperature	71 °F	Vegetation:	None	Conductivity:	831 µS/cm	Benthic Growth:	None	Detergents:	0 mg/L	Stains:	None			Non-illicit:	None	Condition Assessment <table border="1" style="width: 100%; border-collapse: collapse;"> <tr> <td>Graffiti:</td> <td>None</td> </tr> <tr> <td>Erosion:</td> <td>None</td> </tr> <tr> <td>Deposition:</td> <td>None in.</td> </tr> <tr> <td>Damage:</td> <td>None</td> </tr> </table>		Graffiti:	None	Erosion:	None	Deposition:	None in.

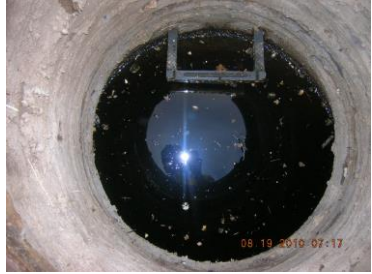
Inspection Date: 8/19/2010 7:26:35 AM		Type: Ongoing	Flow: Submerged, indeterminate	Previous Rainfall (hrs): 72+																																											
Illicit Discharge Potential: Unlikely		Inspector: JCW	Notes 2 small oil drops, likely from Oshkosh Ave runoff.																																												
Submerged: Fully		Depth (in): 51

o20100819071738.JPG <div style="text-align: center; font-weight: bold; font-size: 1.2em;">2010</div>																																												
Sampling Results <table border="1" style="width: 100%; border-collapse: collapse;"> <tr> <td>Sample Location:</td> <td>Pool</td> <td>Floatables:</td> <td>Slight</td> </tr> <tr> <td>Total Chlorine:</td> <td>0 ppm</td> <td>Odor:</td> <td>None</td> </tr> <tr> <td>Free Chlorine:</td> <td>0 ppm</td> <td>Turbidity:</td> <td>None</td> </tr> <tr> <td>Ammonia:</td> <td>0 ppm</td> <td>Color:</td> <td>Faint in bottle</td> </tr> <tr> <td>pH:</td> <td>7.44 units</td> <td>Gross Solids:</td> <td>Slight</td> </tr> <tr> <td>Temperature</td> <td>75 °F</td> <td>Vegetation:</td> <td>None</td> </tr> <tr> <td>Conductivity:</td> <td>-- µS/cm</td> <td>Benthic Growth:</td> <td>None</td> </tr> <tr> <td>Detergents:</td> <td>0 mg/L</td> <td>Stains:</td> <td>None</td> </tr> <tr> <td></td> <td></td> <td>Non-illicit:</td> <td>None</td> </tr> </table>		Sample Location:			Pool	Floatables:	Slight	Total Chlorine:	0 ppm	Odor:	None	Free Chlorine:	0 ppm	Turbidity:	None	Ammonia:	0 ppm	Color:	Faint in bottle	pH:	7.44 units	Gross Solids:	Slight	Temperature	75 °F	Vegetation:	None	Conductivity:	-- µS/cm	Benthic Growth:	None	Detergents:	0 mg/L	Stains:	None			Non-illicit:	None	Condition Assessment <table border="1" style="width: 100%; border-collapse: collapse;"> <tr> <td>Graffiti:</td> <td>None</td> </tr> <tr> <td>Erosion:</td> <td>None</td> </tr> <tr> <td>Deposition:</td> <td>None 0 in.</td> </tr> <tr> <td>Damage:</td> <td>None</td> </tr> </table>		Graffiti:	None	Erosion:	None	Deposition:	None 0 in.

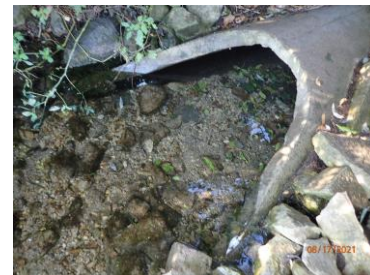
o20210817082858.JPG

Deposition: Minor Depth (in): 1

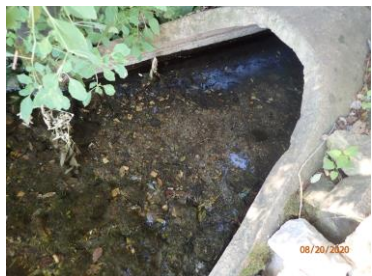
Odor:	None																					
Turbidity:	None																					
Color:	None																					
Gross Solids:	None																					
Vegetation:	None																					
Benthic Growth:	Severe																					
Stains:	Slight																					
Non-illicit:	None																					
<table border="1" style="width:100%; border-collapse: collapse;"> <tr><td>Sample Location:</td><td></td></tr> <tr><td>Total Chlorine:</td><td>-- ppm</td></tr> <tr><td>Free Chlorine:</td><td>-- ppm</td></tr> <tr><td>Ammonia:</td><td>-- ppm</td></tr> <tr><td>pH:</td><td>-- units</td></tr> <tr><td>Temperature:</td><td>-- °F</td></tr> <tr><td>Conductivity:</td><td>-- µS/cm</td></tr> <tr><td>Detergents:</td><td>-- mg/L</td></tr> </table>		Sample Location:		Total Chlorine:	-- ppm	Free Chlorine:	-- ppm	Ammonia:	-- ppm	pH:	-- units	Temperature:	-- °F	Conductivity:	-- µS/cm	Detergents:	-- mg/L	Notes Outfall partially submerged - screened upstream at 16-660 US1. Condition Assessment Graffiti: None Erosion: None Deposition: Minor 1 in. Damage: None

o20200820081850.JPG <div style="text-align: right; font-size: 24pt; font-weight: bold;">2020</div>

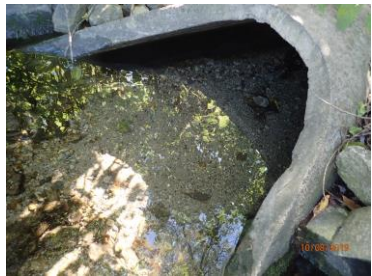
Inspection Date: 10/8/2019 2:42:09 PM		Type: Ongoing	Flow: Submerged, indeterminate	Previous Rainfall (hrs): 48-72																		
Illicit Discharge Potential: Potential		Inspector: JCW																				
Submerged: Partially		Depth (in): 16																				
Sampling Results		<table border="1" style="width:100%; border-collapse: collapse;"> <tr><td>Floatables:</td><td>None</td></tr> <tr><td>Odor:</td><td>None</td></tr> <tr><td>Turbidity:</td><td>None</td></tr> <tr><td>Color:</td><td>None</td></tr> <tr><td>Gross Solids:</td><td>None</td></tr> <tr><td>Vegetation:</td><td>None</td></tr> <tr><td>Benthic Growth:</td><td>Slight</td></tr> <tr><td>Stains:</td><td>None</td></tr> <tr><td>Non-illicit:</td><td>None</td></tr> </table>			Floatables:	None	Odor:	None	Turbidity:	None	Color:	None	Gross Solids:	None	Vegetation:	None	Benthic Growth:	Slight	Stains:	None	Non-illicit:	None
Floatables:	None

Odor:	None																					
Turbidity:	None																					
Color:	None																					
Gross Solids:	None																					
Vegetation:	None																					
Benthic Growth:	Slight																					
Stains:	None																					
Non-illicit:	None																					
<table border="1" style="width:100%; border-collapse: collapse;"> <tr><td>Sample Location:</td><td></td></tr> <tr><td>Total Chlorine:</td><td>-- ppm</td></tr> <tr><td>Free Chlorine:</td><td>-- ppm</td></tr> <tr><td>Ammonia:</td><td>-- ppm</td></tr> <tr><td>pH:</td><td>-- units</td></tr> <tr><td>Temperature:</td><td>-- °F</td></tr> <tr><td>Conductivity:</td><td>-- µS/cm</td></tr> <tr><td>Detergents:</td><td>-- mg/L</td></tr> </table>		Sample Location:		Total Chlorine:	-- ppm	Free Chlorine:	-- ppm	Ammonia:	-- ppm	pH:	-- units	Temperature:	-- °F	Conductivity:	-- µS/cm	Detergents:	-- mg/L	Notes Outfall partially submerged - screened upstream at 16-660 US1. Detergent detected in sample. Condition Assessment Graffiti: None Erosion: None Deposition: Minor 3 in. Damage: None

o20191008134040.JPG <div style="text-align: right; font-size: 24pt; font-weight: bold;">2019</div>

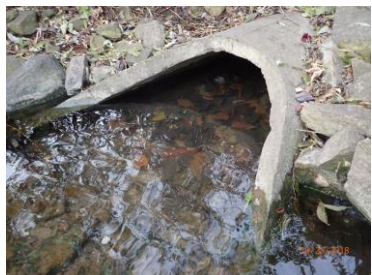
Inspection Date: 10/25/2018 8:13:23 AM		Type: Ongoing	Flow: Submerged, indeterminate	Previous Rainfall (hrs): 72+																		
Illicit Discharge Potential: Potential		Inspector: JCW																				
Submerged: Partially		Depth (in): 14																				
Sampling Results		<table border="1" style="width:100%; border-collapse: collapse;"> <tr><td>Floatables:</td><td>None</td></tr> <tr><td>Odor:</td><td>None</td></tr> <tr><td>Turbidity:</td><td>None</td></tr> <tr><td>Color:</td><td>None</td></tr> <tr><td>Gross Solids:</td><td>Slight</td></tr> <tr><td>Vegetation:</td><td>None</td></tr> <tr><td>Benthic Growth:</td><td>Moderate</td></tr> <tr><td>Stains:</td><td>Moderate</td></tr> <tr><td>Non-illicit:</td><td>None</td></tr> </table>			Floatables:	None	Odor:	None	Turbidity:	None	Color:	None	Gross Solids:	Slight	Vegetation:	None	Benthic Growth:	Moderate	Stains:	Moderate	Non-illicit:	None
Floatables:	None

Odor:	None																					
Turbidity:	None																					
Color:	None																					
Gross Solids:	Slight																					
Vegetation:	None																					
Benthic Growth:	Moderate																					
Stains:	Moderate																					
Non-illicit:	None																					
<table border="1" style="width:100%; border-collapse: collapse;"> <tr><td>Sample Location:</td><td></td></tr> <tr><td>Total Chlorine:</td><td>-- ppm</td></tr> <tr><td>Free Chlorine:</td><td>-- ppm</td></tr> <tr><td>Ammonia:</td><td>-- ppm</td></tr> <tr><td>pH:</td><td>-- units</td></tr> <tr><td>Temperature:</td><td>-- °F</td></tr> <tr><td>Conductivity:</td><td>-- µS/cm</td></tr> <tr><td>Detergents:</td><td>-- mg/L</td></tr> </table>		Sample Location:		Total Chlorine:	-- ppm	Free Chlorine:	-- ppm	Ammonia:	-- ppm	pH:	-- units	Temperature:	-- °F	Conductivity:	-- µS/cm	Detergents:	-- mg/L	Notes Outfall partially submerged - screened upstream at 16-660 US1. Detergent detected in sample. Condition Assessment Graffiti: None Erosion: None Deposition: None in. Damage: None

o20181025081252.JPG <div style="text-align: right; font-size: 24pt; font-weight: bold;">2018</div>

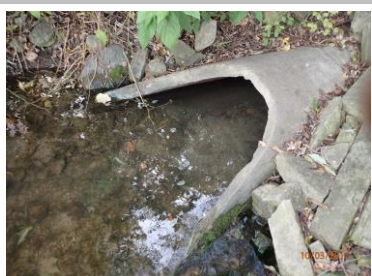
Inspection Date: 10/3/2017 11:03:37 AM		Type: Ongoing	Flow: Submerged, indeterminate	Previous Rainfall (hrs): 72+																		
Illicit Discharge Potential: Potential		Inspector: JCW																				
Submerged: Partially		Depth (in): 12																				
Sampling Results		<table border="1" style="width:100%; border-collapse: collapse;"> <tr><td>Floatables:</td><td>None</td></tr> <tr><td>Odor:</td><td>None</td></tr> <tr><td>Turbidity:</td><td>None</td></tr> <tr><td>Color:</td><td>None</td></tr> <tr><td>Gross Solids:</td><td>None</td></tr> <tr><td>Vegetation:</td><td>None</td></tr> <tr><td>Benthic Growth:</td><td>Moderate</td></tr> <tr><td>Stains:</td><td>Moderate</td></tr> <tr><td>Non-illicit:</td><td>None</td></tr> </table>			Floatables:	None	Odor:	None	Turbidity:	None	Color:	None	Gross Solids:	None	Vegetation:	None	Benthic Growth:	Moderate	Stains:	Moderate	Non-illicit:	None
Floatables:	None

Odor:	None																					
Turbidity:	None																					
Color:	None																					
Gross Solids:	None																					
Vegetation:	None																					
Benthic Growth:	Moderate																					
Stains:	Moderate																					
Non-illicit:	None																					
<table border="1" style="width:100%; border-collapse: collapse;"> <tr><td>Sample Location:</td><td></td></tr> <tr><td>Total Chlorine:</td><td>-- ppm</td></tr> <tr><td>Free Chlorine:</td><td>-- ppm</td></tr> <tr><td>Ammonia:</td><td>-- ppm</td></tr> <tr><td>pH:</td><td>-- units</td></tr> <tr><td>Temperature:</td><td>-- °F</td></tr> <tr><td>Conductivity:</td><td>-- µS/cm</td></tr> <tr><td>Detergents:</td><td>-- mg/L</td></tr> </table>		Sample Location:		Total Chlorine:	-- ppm	Free Chlorine:	-- ppm	Ammonia:	-- ppm	pH:	-- units	Temperature:	-- °F	Conductivity:	-- µS/cm	Detergents:	-- mg/L	Notes Outfall partially submerged - screened upstream at 16-660 US1. Detergent detected in sample. Condition Assessment Graffiti: None Erosion: None Deposition: None in. Damage: None

o20171003110156.JPG <div style="text-align: right; font-size: 24pt; font-weight: bold;">2017</div>

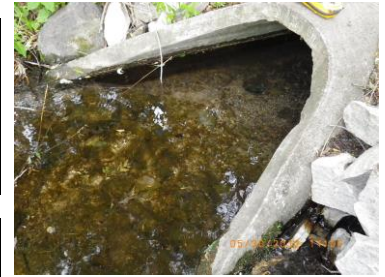
o20120530100048.JPG

Inspection Date: 5/30/2012 10:59:58 AM		Type: Ongoing	Flow: Submerged, indeterminate	Previous Rainfall (hrs): 72+																																				
Illicit Discharge Potential: Unlikely		Inspector: JCW																																						
Submerged: Partially		Depth (in): 10																																						
<table border="1"> <tr> <td colspan="2">Sampling Results</td> <td>Floatables:</td> <td>None</td> </tr> <tr> <td colspan="2">Sample Location:</td> <td>Odor:</td> <td>None</td> </tr> <tr> <td>Total Chlorine:</td> <td>-- ppm</td> <td>Turbidity:</td> <td>None</td> </tr> <tr> <td>Free Chlorine:</td> <td>-- ppm</td> <td>Color:</td> <td>None</td> </tr> <tr> <td>Ammonia:</td> <td>-- ppm</td> <td>Gross Solids:</td> <td>Slight</td> </tr> <tr> <td>pH:</td> <td>-- units</td> <td>Vegetation:</td> <td>None</td> </tr> <tr> <td>Temperature</td> <td>-- °F</td> <td>Benthic Growth:</td> <td>Moderate</td> </tr> <tr> <td>Conductivity:</td> <td>-- µS/cm</td> <td>Stains:</td> <td>Slight</td> </tr> <tr> <td>Detergents:</td> <td>-- mg/L</td> <td>Non-illicit:</td> <td>None</td> </tr> </table>					Sampling Results		Floatables:	None	Sample Location:		Odor:	None	Total Chlorine:	-- ppm	Turbidity:	None	Free Chlorine:	-- ppm	Color:	None	Ammonia:	-- ppm	Gross Solids:	Slight	pH:	-- units	Vegetation:	None	Temperature	-- °F	Benthic Growth:	Moderate	Conductivity:	-- µS/cm	Stains:	Slight	Detergents:	-- mg/L	Non-illicit:	None

Graffiti:	None																																							
Erosion:	None																																							
Deposition:	Minor 1 in.																																							
Damage:	None

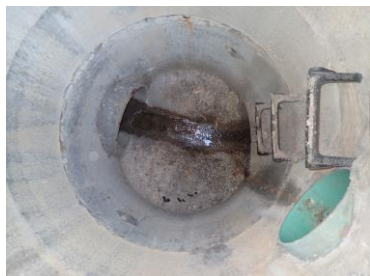
<div style="display: flex;"> <div style="flex: 1;"> <p>Notes</p> <p>Flowline damp, but no collectable flow at time of inspection.</p> </div> <div style="flex: 1;"> <p>Condition Assessment</p> <p>Graffiti: None</p> <p>Erosion: None</p> <p>Deposition: None in.</p> <p>Damage: None</p> </div> </div>

o20200820082306.JPG 2020

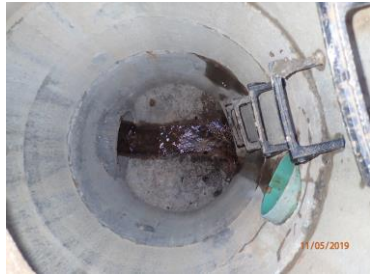
Inspection Date: 11/5/2019 2:41:00 PM		Type: Repeat	Flow: Moderate	Previous Rainfall (hrs): 48-72																																		
Illicit Discharge Potential: Potential		Inspector: JCW																																				
Submerged: None		Depth (in):																																				
Sampling Results		<div style="display: flex;"> <div style="flex: 1;"> <table border="1" style="width:100%; border-collapse: collapse;"> <tr><td>Floatables:</td><td>None</td></tr> <tr><td>Odor:</td><td>None</td></tr> <tr><td>Turbidity:</td><td>None</td></tr> <tr><td>Color:</td><td>None</td></tr> <tr><td>Gross Solids:</td><td>None</td></tr> <tr><td>Vegetation:</td><td>None</td></tr> <tr><td>Benthic Growth:</td><td>None</td></tr> <tr><td>Stains:</td><td>None</td></tr> <tr><td>Non-illicit:</td><td>None</td></tr> </table> </div> <div style="flex: 1;"> <table border="1" style="width:100%; border-collapse: collapse;"> <tr><td>Sample Location:</td><td>Flow</td></tr> <tr><td>Total Chlorine:</td><td>-- ppm</td></tr> <tr><td>Free Chlorine:</td><td>-- ppm</td></tr> <tr><td>Ammonia:</td><td>-- ppm</td></tr> <tr><td>pH:</td><td>-- units</td></tr> <tr><td>Temperature:</td><td>-- °F</td></tr> <tr><td>Conductivity:</td><td>-- µS/cm</td></tr> <tr><td>Detergents:</td><td>0.9 mg/L</td></tr> </table> </div> </div>			Floatables:	None	Odor:	None	Turbidity:	None	Color:	None	Gross Solids:	None	Vegetation:	None	Benthic Growth:	None	Stains:	None	Non-illicit:	None	Sample Location:	Flow	Total Chlorine:	-- ppm	Free Chlorine:	-- ppm	Ammonia:	-- ppm	pH:	-- units	Temperature:	-- °F	Conductivity:	-- µS/cm	Detergents:	0.9 mg/L

<div style="display: flex;"> <div style="flex: 1;"> <p>Notes</p> <p>Follow-up inspection for sampling - limited screening conducted.</p> </div> <div style="flex: 1;"> <p>Condition Assessment</p> <p>Graffiti: None</p> <p>Erosion: None</p> <p>Deposition: None in.</p> <p>Damage: None</p> </div> </div>

o20191105144026.JPG 2019

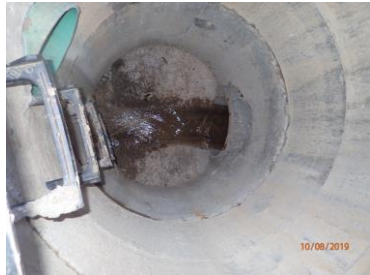
Inspection Date: 10/8/2019 2:44:41 PM		Type: Ongoing	Flow: Moderate	Previous Rainfall (hrs): 48-72																																		
Illicit Discharge Potential: Potential		Inspector: JCW																																				
Submerged: None		Depth (in):																																				
Sampling Results		<div style="display: flex;"> <div style="flex: 1;"> <table border="1" style="width:100%; border-collapse: collapse;"> <tr><td>Floatables:</td><td>None</td></tr> <tr><td>Odor:</td><td>None</td></tr> <tr><td>Turbidity:</td><td>None</td></tr> <tr><td>Color:</td><td>None</td></tr> <tr><td>Gross Solids:</td><td>None</td></tr> <tr><td>Vegetation:</td><td>None</td></tr> <tr><td>Benthic Growth:</td><td>None</td></tr> <tr><td>Stains:</td><td>None</td></tr> <tr><td>Non-illicit:</td><td>None</td></tr> </table> </div> <div style="flex: 1;"> <table border="1" style="width:100%; border-collapse: collapse;"> <tr><td>Sample Location:</td><td>Flow</td></tr> <tr><td>Total Chlorine:</td><td>0 ppm</td></tr> <tr><td>Free Chlorine:</td><td>0 ppm</td></tr> <tr><td>Ammonia:</td><td>0 ppm</td></tr> <tr><td>pH:</td><td>7.68 units</td></tr> <tr><td>Temperature:</td><td>65 °F</td></tr> <tr><td>Conductivity:</td><td>943 µS/cm</td></tr> <tr><td>Detergents:</td><td>0.5 mg/L</td></tr> </table> </div> </div>			Floatables:	None	Odor:	None	Turbidity:	None	Color:	None	Gross Solids:	None	Vegetation:	None	Benthic Growth:	None	Stains:	None	Non-illicit:	None	Sample Location:	Flow	Total Chlorine:	0 ppm	Free Chlorine:	0 ppm	Ammonia:	0 ppm	pH:	7.68 units	Temperature:	65 °F	Conductivity:	943 µS/cm	Detergents:	0.5 mg/L

<div style="display: flex;"> <div style="flex: 1;"> <p>Notes</p> <p>Sample collected from flow in manhole. Detergent detected in sample.</p> </div> <div style="flex: 1;"> <p>Condition Assessment</p> <p>Graffiti: None</p> <p>Erosion: None</p> <p>Deposition: None in.</p> <p>Damage: None</p> </div> </div>

o20191008134416.JPG 2019

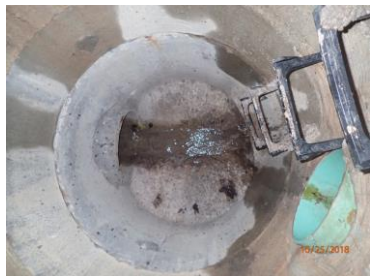
Inspection Date: 10/26/2018 12:20:38 PM		Type: Repeat	Flow: Trickle	Previous Rainfall (hrs): 72+																																		
Illicit Discharge Potential: Potential		Inspector: KMK																																				
Submerged: None		Depth (in):																																				
Sampling Results		<div style="display: flex;"> <div style="flex: 1;"> <table border="1" style="width:100%; border-collapse: collapse;"> <tr><td>Floatables:</td><td>None</td></tr> <tr><td>Odor:</td><td>None</td></tr> <tr><td>Turbidity:</td><td>None</td></tr> <tr><td>Color:</td><td>None</td></tr> <tr><td>Gross Solids:</td><td>None</td></tr> <tr><td>Vegetation:</td><td>None</td></tr> <tr><td>Benthic Growth:</td><td>None</td></tr> <tr><td>Stains:</td><td>None</td></tr> <tr><td>Non-illicit:</td><td>None</td></tr> </table> </div> <div style="flex: 1;"> <table border="1" style="width:100%; border-collapse: collapse;"> <tr><td>Sample Location:</td><td>Flow</td></tr> <tr><td>Total Chlorine:</td><td>0 ppm</td></tr> <tr><td>Free Chlorine:</td><td>0 ppm</td></tr> <tr><td>Ammonia:</td><td>0 ppm</td></tr> <tr><td>pH:</td><td>7.83 units</td></tr> <tr><td>Temperature:</td><td>56 °F</td></tr> <tr><td>Conductivity:</td><td>1063 µS/cm</td></tr> <tr><td>Detergents:</td><td>0.7 mg/L</td></tr> </table> </div> </div>			Floatables:	None	Odor:	None	Turbidity:	None	Color:	None	Gross Solids:	None	Vegetation:	None	Benthic Growth:	None	Stains:	None	Non-illicit:	None	Sample Location:	Flow	Total Chlorine:	0 ppm	Free Chlorine:	0 ppm	Ammonia:	0 ppm	pH:	7.83 units	Temperature:	56 °F	Conductivity:	1063 µS/cm	Detergents:	0.7 mg/L

<div style="display: flex;"> <div style="flex: 1;"> <p>Notes</p> <p>Detergent detection follow-up. Limited screening conducted beyond sampling.</p> </div> <div style="flex: 1;"> <p>Condition Assessment</p> <p>Graffiti: None</p> <p>Erosion: None</p> <p>Deposition: None in.</p> <p>Damage: None</p> </div> </div>

o20181025081632.JPG 2018

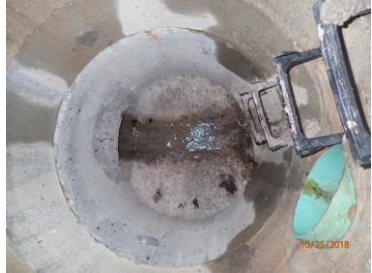
o20181025081632.JPG

Inspection Date: 10/17/2017 9:02:21 AM		Type: Repeat	Flow: Moderate	Previous Rainfall (hrs): 48-72	
Illicit Discharge Potential: Unlikely		Inspector: JCW	Notes		
Submerged: None		Depth (in):	Repeat inspection due to detergent. No detergent detected in manhole sample.		
Sampling Results		Floatables:	Condition Assessment Graffiti: None Erosion: None Deposition: None in. Damage: None		
Sample Location:	Flow	Odor:			None
Total Chlorine:	0 ppm	Turbidity:			None
Free Chlorine:	0 ppm	Color:			None
Ammonia:	0 ppm	Gross Solids:			None
pH:	7.78 units	Vegetation:			None
Temperature	61 °F	Benthic Growth:			Slight
Conductivity:	926 µS/cm	Stains:			None
Detergents:	0 mg/L	Non-illicit:			None

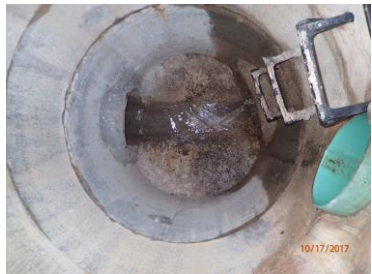
o20171017085628.JPG

Inspection Date: 10/3/2017 11:12:57 AM		Type: Ongoing	Flow: Trickle	Previous Rainfall (hrs): 72+	
Illicit Discharge Potential: Potential		Inspector: JCW	Notes		
Submerged: None		Depth (in):	Sample collected from flow in manhole. Detergent detected in sample.		
Sampling Results		Floatables:	Condition Assessment Graffiti: None Erosion: None Deposition: None in. Damage: None		
Sample Location:	Flow	Odor:			None
Total Chlorine:	0 ppm	Turbidity:			None
Free Chlorine:	0 ppm	Color:			None
Ammonia:	0 ppm	Gross Solids:			None
pH:	8.26 units	Vegetation:			None
Temperature	76 °F	Benthic Growth:			None
Conductivity:	845 µS/cm	Stains:			None
Detergents:	0.55 mg/L	Non-illicit:			None

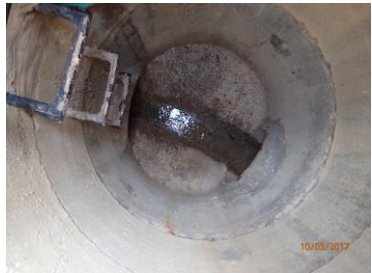
o20171003110702.JPG

Inspection Date: 5/30/2012 11:04:45 AM		Type: Ongoing	Flow: Trickle	Previous Rainfall (hrs): 72+	
Illicit Discharge Potential: Unlikely		Inspector: JCW	Notes		
Submerged: None		Depth (in):			
Sampling Results		Floatables:	Condition Assessment Graffiti: None Erosion: None Deposition: None in. Damage: None		
Sample Location:	Flow	Odor:			None
Total Chlorine:	0 ppm	Turbidity:			None
Free Chlorine:	0 ppm	Color:			None
Ammonia:	0 ppm	Gross Solids:			None
pH:	8.35 units	Vegetation:			None
Temperature	59 °F	Benthic Growth:			None
Conductivity:	1148 µS/cm	Stains:			None
Detergents:	0 mg/L	Non-illicit:			None

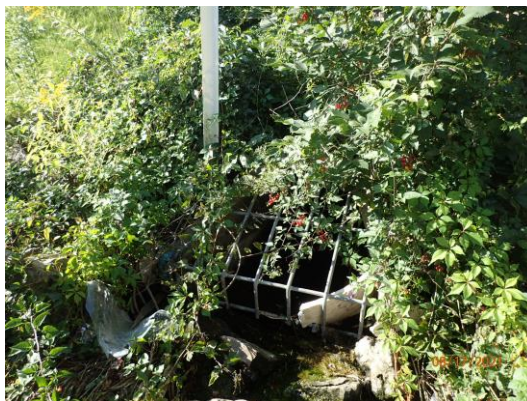
o20210817084408.JPG

Storm sewer from Koeller St discharges to stream from south.

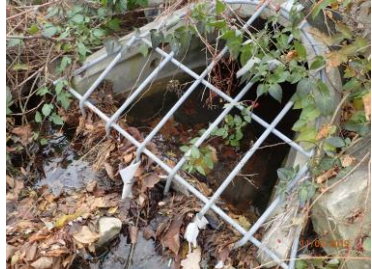
o20191105084324.JPG <div style="text-align: right; font-weight: bold; font-size: 1.2em;">2019</div>

Turbidity:	None																					
Color:	None																					
Gross Solids:	Slight																					
Vegetation:	None																					
Benthic Growth:	Slight																					
Stains:	None																					
Non-illicit:	None																					
<table border="1" style="width:100%; border-collapse: collapse;"> <tr><td colspan="2">Sample Location: Flow</td></tr> <tr><td>Total Chlorine:</td><td>-- ppm</td></tr> <tr><td>Free Chlorine:</td><td>-- ppm</td></tr> <tr><td>Ammonia:</td><td>-- ppm</td></tr> <tr><td>pH:</td><td>-- units</td></tr> <tr><td>Temperature:</td><td>-- °F</td></tr> <tr><td>Conductivity:</td><td>-- µS/cm</td></tr> <tr><td>Detergents:</td><td>0.8 mg/L</td></tr> </table>		Sample Location: Flow		Total Chlorine:	-- ppm	Free Chlorine:	-- ppm	Ammonia:	-- ppm	pH:	-- units	Temperature:	-- °F	Conductivity:	-- µS/cm	Detergents:	0.8 mg/L	Notes Follow-up inspection for sampling - limited screening conducted.

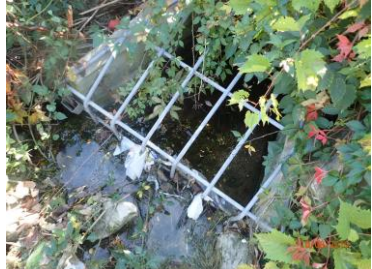
o20191008125814.JPG <div style="text-align: right; font-weight: bold; font-size: 1.2em;">2019</div>

Turbidity:	None																					
Color:	None																					
Gross Solids:	Slight																					
Vegetation:	None																					
Benthic Growth:	Slight																					
Stains:	None																					
Non-illicit:	None																					
<table border="1" style="width:100%; border-collapse: collapse;"> <tr><td colspan="2">Sample Location: Flow</td></tr> <tr><td>Total Chlorine:</td><td>0 ppm</td></tr> <tr><td>Free Chlorine:</td><td>0 ppm</td></tr> <tr><td>Ammonia:</td><td>0 ppm</td></tr> <tr><td>pH:</td><td>8.09 units</td></tr> <tr><td>Temperature:</td><td>66 °F</td></tr> <tr><td>Conductivity:</td><td>2640 µS/cm</td></tr> <tr><td>Detergents:</td><td>0.5 mg/L</td></tr> </table>		Sample Location: Flow		Total Chlorine:	0 ppm	Free Chlorine:	0 ppm	Ammonia:	0 ppm	pH:	8.09 units	Temperature:	66 °F	Conductivity:	2640 µS/cm	Detergents:	0.5 mg/L	Notes Sample collected from pipe flow. Detergent and elevated conductivity in sample.

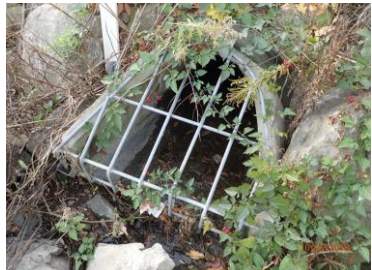
o20181025085152.JPG <div style="text-align: right; font-weight: bold; font-size: 1.2em;">2018</div>

Turbidity:	None																					
Color:	None																					
Gross Solids:	None																					
Vegetation:	None																					
Benthic Growth:	Moderate																					
Stains:	None																					
Non-illicit:	None																					
<table border="1" style="width:100%; border-collapse: collapse;"> <tr><td colspan="2">Sample Location: Flow</td></tr> <tr><td>Total Chlorine:</td><td>0 ppm</td></tr> <tr><td>Free Chlorine:</td><td>0 ppm</td></tr> <tr><td>Ammonia:</td><td>0 ppm</td></tr> <tr><td>pH:</td><td>8.19 units</td></tr> <tr><td>Temperature:</td><td>56 °F</td></tr> <tr><td>Conductivity:</td><td>3550 µS/cm</td></tr> <tr><td>Detergents:</td><td>0.5 mg/L</td></tr> </table>		Sample Location: Flow		Total Chlorine:	0 ppm	Free Chlorine:	0 ppm	Ammonia:	0 ppm	pH:	8.19 units	Temperature:	56 °F	Conductivity:	3550 µS/cm	Detergents:	0.5 mg/L	Notes Detergent detection follow-up. Limited screening conducted beyond sampling.

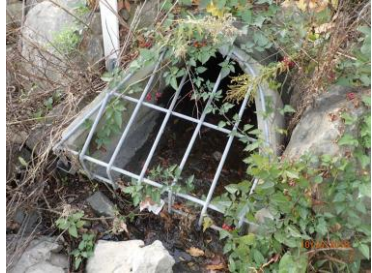
o20181025085152.JPG

Inspection Date: 10/25/2018 8:55:36 AM		Type: Ongoing	Flow: Trickle	Previous Rainfall (hrs): 72+
Illicit Discharge Potential: Potential		Inspector: JCW	Notes	
Submerged: None		Depth (in):	Sample collected from pipe flow. Detergent and elevated conductivity in sample.	
Sampling Results		Floatables:	Condition Assessment	
Sample Location: Flow		None	Graffiti: None	
Total Chlorine: 0 ppm		Odor: None	Erosion: None	
Free Chlorine: 0 ppm		Turbidity: None	Deposition: None in.	
Ammonia: 0 ppm		Color: None	Damage: None	
pH: 8.22 units		Gross Solids: None		
Temperature 52 °F		Vegetation: None		
Conductivity: 3300 µS/cm		Benthic Growth: Moderate		
Detergents: 0.45 mg/L		Stains: None		
		Non-illicit: None

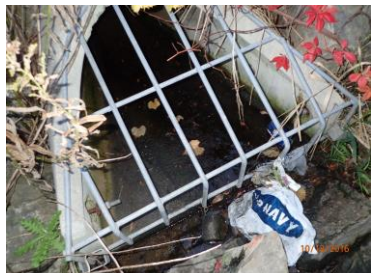
o20161018071712.JPG

Inspection Date: 10/18/2016 7:21:24 AM		Type: Ongoing	Flow: Trickle	Previous Rainfall (hrs): 72+
Illicit Discharge Potential: Unlikely		Inspector: JCW	Notes	
Submerged: None		Depth (in):	Elevated conductivity, but no other parameters out of range.	
Sampling Results		Floatables:	Condition Assessment	
Sample Location: Flow		None	Graffiti: None	
Total Chlorine: 0 ppm		Odor: Faint	Erosion: None	
Free Chlorine: 0 ppm		Turbidity: None	Deposition: None in.	
Ammonia: 0 ppm		Color: None	Damage: None	
pH: 8.29 units		Gross Solids: Slight		
Temperature 64 °F		Vegetation: None		
Conductivity: 3880 µS/cm		Benthic Growth: Moderate		
Detergents: 0 mg/L		Stains: None		
		Non-illicit: None

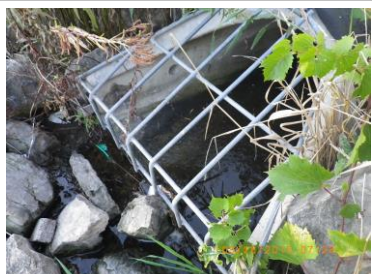
o20150928062340.JPG

Inspection Date: 9/28/2015 7:20:55 AM		Type: Ongoing	Flow: None	Previous Rainfall (hrs): 72+
Illicit Discharge Potential: Unlikely		Inspector: JCW	Notes	
Submerged: None		Depth (in):	Flowline wet, but no flow at time of inspection.	
Sampling Results		Floatables:	Condition Assessment	
Sample Location:		None	Graffiti: None	
Total Chlorine: -- ppm		Odor: None	Erosion: None	
Free Chlorine: -- ppm		Turbidity: None	Deposition: None in.	
Ammonia: -- ppm		Color: None	Damage: None	
pH: -- units		Gross Solids: Slight		
Temperature -- °F		Vegetation: None		
Conductivity: -- µS/cm		Benthic Growth: Moderate		
Detergents: -- mg/L		Stains: None		
		Non-illicit: None

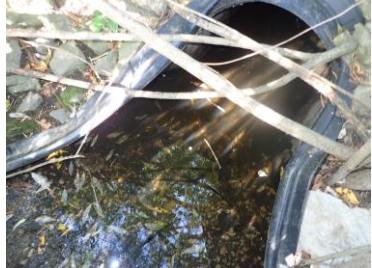
o20200820083238.JPG <div style="text-align: right; font-size: 1.5em; font-weight: bold;">2020</div>

Inspection Date: 8/20/2020 8:35:17 AM		Type: Ongoing	Flow: Submerged, indeterminate	Previous Rainfall (hrs): 72+
Illicit Discharge Potential: Unlikely		Inspector: JCW		
Submerged: Partially		Depth (in): 8		
Sampling Results		Notes 10 inch berm of roots blocking flow from apron. Outfall partially submerged - screened upstream at 16-995 US1.		
Sample Location:	Floatables:	None		
Total Chlorine: -- ppm	Odor:	None		
Free Chlorine: -- ppm	Turbidity:	None		
Ammonia: -- ppm	Color:	None		
pH: -- units	Gross Solids:	None		
Temperature -- °F	Vegetation:	None		
Conductivity: -- µS/cm	Benthic Growth:	None		
Detergents: -- mg/L	Stains:	None		
	Non-illicit:	None		
		Condition Assessment Graffiti: None Erosion: None Deposition: None in. Damage: None

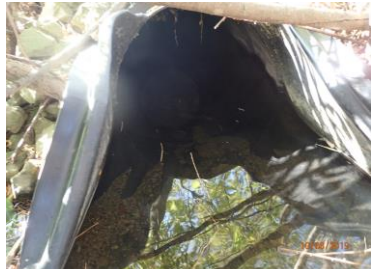
o20191008132854.JPG <div style="text-align: right; font-size: 1.5em; font-weight: bold;">2019</div>

Inspection Date: 10/8/2019 2:29:54 PM		Type: Ongoing	Flow: Submerged, indeterminate	Previous Rainfall (hrs): 48-72
Illicit Discharge Potential: Potential		Inspector: JCW		
Submerged: Partially		Depth (in): 18		
Sampling Results		Notes Outfall partially submerged - screened upstream at 16-995 US1. Detergent detected in sample.		
Sample Location:	Floatables:	None		
Total Chlorine: -- ppm	Odor:	None		
Free Chlorine: -- ppm	Turbidity:	None		
Ammonia: -- ppm	Color:	None		
pH: -- units	Gross Solids:	None		
Temperature -- °F	Vegetation:	None		
Conductivity: -- µS/cm	Benthic Growth:	Slight		
Detergents: -- mg/L	Stains:	None		
	Non-illicit:	None		
		Condition Assessment Graffiti: None Erosion: None Deposition: None in. Damage: None

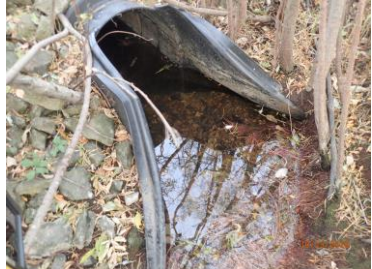
o20181025082506.JPG <div style="text-align: right; font-size: 1.5em; font-weight: bold;">2018</div>

Inspection Date: 10/25/2018 8:27:19 AM		Type: Ongoing	Flow: Submerged, indeterminate	Previous Rainfall (hrs): 72+
Illicit Discharge Potential: Potential		Inspector: JCW		
Submerged: Partially		Depth (in): 12		
Sampling Results		Notes Outfall partially submerged - screened upstream at 16-995 US1. Detergent detected in sample.		
Sample Location:	Floatables:	None		
Total Chlorine: -- ppm	Odor:	None		
Free Chlorine: -- ppm	Turbidity:	None		
Ammonia: -- ppm	Color:	None		
pH: -- units	Gross Solids:	Slight		
Temperature -- °F	Vegetation:	None		
Conductivity: -- µS/cm	Benthic Growth:	None		
Detergents: -- mg/L	Stains:	None		
	Non-illicit:	None		
		Condition Assessment Graffiti: None Erosion: None Deposition: None in. Damage: None

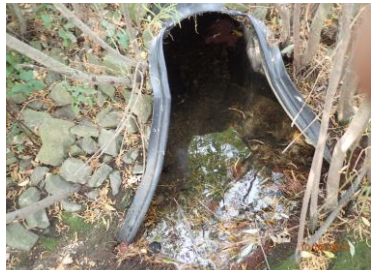
o20171003101614.JPG <div style="text-align: right; font-size: 1.5em; font-weight: bold;">2017</div>

Inspection Date: 10/3/2017 10:18:12 AM		Type: Ongoing	Flow: Submerged, indeterminate	Previous Rainfall (hrs): 72+
Illicit Discharge Potential: Potential		Inspector: JCW		
Submerged: Partially		Depth (in): 8		
Sampling Results		Notes Outfall partially submerged - screened upstream at 16-995 US1. Detergent detected in sample.		
Sample Location:	Floatables:	None		
Total Chlorine: -- ppm	Odor:	None		
Free Chlorine: -- ppm	Turbidity:	None		
Ammonia: -- ppm	Color:	None		
pH: -- units	Gross Solids:	None		
Temperature -- °F	Vegetation:	None		
Conductivity: -- µS/cm	Benthic Growth:	Slight		
Detergents: -- mg/L	Stains:	None		
	Non-illicit:	None		
		Condition Assessment Graffiti: None Erosion: None Deposition: Minor 1 in. Damage: None

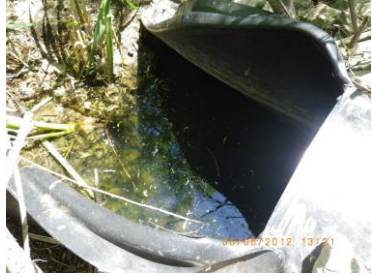
Inspection Date: 6/6/2012 1:21:40 PM		Type: Ongoing		Flow: Submerged, indeterminate		Previous Rainfall (hrs): 72+	
Illicit Discharge Potential: Unlikely		Inspector: JCW		Notes No flow leaving pool at end of outfall. Deposition in swale downstream. Screened upstream at 16-995 US1.

Submerged: Partially		Depth (in): 9					
Sampling Results Sample Location:		Floatables:	None	Condition Assessment Graffiti: None Erosion: None Deposition: Moderate 8 in. Damage: None

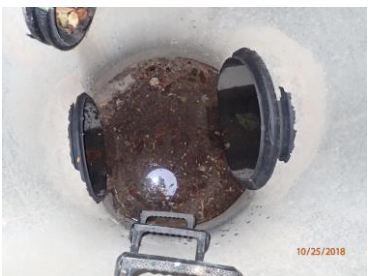
o20181025082910.JPG

Inspection Date: 10/25/2018 8:28:36 AM		Type: Ongoing	Flow: Submerged, indeterminate	Previous Rainfall (hrs): 72+
Illicit Discharge Potential: Potential		Inspector: JCW	Notes	
Submerged: Partially Depth (in): 2			Sample collected from submerged pool in outfall. Detergent detected in sample.	
Sampling Results		Floatables: None	Condition Assessment Graffiti: None Erosion: None Deposition: None in. Damage: None	
Sample Location: Pool		Odor: None		
Total Chlorine: 0 ppm		Turbidity: None		
Free Chlorine: 0 ppm		Color: None		
Ammonia: 0 ppm		Gross Solids: Slight		
pH: 7.86 units		Vegetation: None		
Temperature 50 °F		Benthic Growth: None		
Conductivity: 1011 µS/cm		Stains: None		
Detergents: 0.4 mg/L		Non-illicit: None

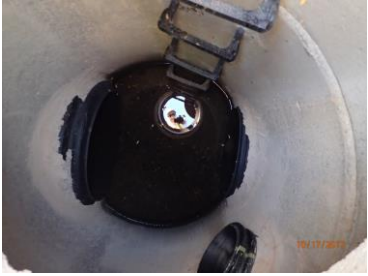
o20171017084622.JPG

Inspection Date: 10/17/2017 8:51:34 AM		Type: Repeat	Flow: Submerged, indeterminate	Previous Rainfall (hrs): 48-72
Illicit Discharge Potential: Potential		Inspector: JCW	Notes	
Submerged: Partially Depth (in): 7			Repeat inspection due to detergent. Detergent detected in manhole sample.	
Sampling Results		Floatables: None	Condition Assessment Graffiti: None Erosion: None Deposition: None in. Damage: None	
Sample Location: Pool		Odor: None		
Total Chlorine: 0 ppm		Turbidity: None		
Free Chlorine: 0 ppm		Color: None		
Ammonia: 0 ppm		Gross Solids: None		
pH: 7.54 units		Vegetation: None		
Temperature 61 °F		Benthic Growth: None		
Conductivity: 582 µS/cm		Stains: None		
Detergents: 0.8 mg/L		Non-illicit: None

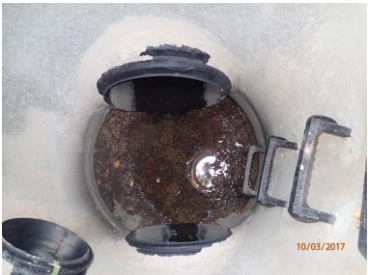
o20171003101932.JPG

Inspection Date: 10/3/2017 10:22:53 AM		Type: Ongoing	Flow: Submerged, indeterminate	Previous Rainfall (hrs): 72+
Illicit Discharge Potential: Potential		Inspector: JCW	Notes	
Submerged: Partially Depth (in): 3			Sample collected from submerged pool in outfall. Detergent detected in sample.	
Sampling Results		Floatables: None	Condition Assessment Graffiti: None Erosion: None Deposition: None in. Damage: None	
Sample Location: Pool		Odor: None		
Total Chlorine: 0 ppm		Turbidity: None		
Free Chlorine: 0 ppm		Color: None		
Ammonia: 0 ppm		Gross Solids: None		
pH: 7.45 units		Vegetation: None		
Temperature 72 °F		Benthic Growth: None		
Conductivity: 333 µS/cm		Stains: None		
Detergents: 1.3 mg/L		Non-illicit: None

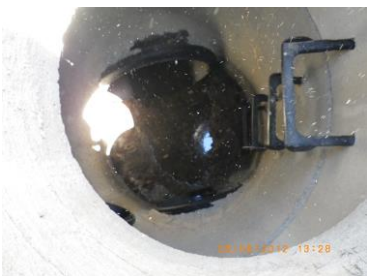
o20120606122856.JPG

Inspection Date: 6/6/2012 1:28:22 PM		Type: Ongoing	Flow: Submerged, no flow	Previous Rainfall (hrs): 72+
Illicit Discharge Potential: Unlikely		Inspector: JCW	Notes	
Submerged: None Depth (in): 1			Sample collected from pool in manhole. No flow entering either pipe.	
Sampling Results		Floatables: None	Condition Assessment Graffiti: None Erosion: None Deposition: None in. Damage: None	
Sample Location: Pool		Odor: Faint		
Total Chlorine: 0 ppm		Turbidity: None		
Free Chlorine: 0 ppm		Color: None		
Ammonia: 0 ppm		Gross Solids: Slight		
pH: 7.36 units		Vegetation: None		
Temperature 69 °F		Benthic Growth: None		
Conductivity: 411 µS/cm		Stains: Slight		
Detergents: 0 mg/L		Non-illicit: None

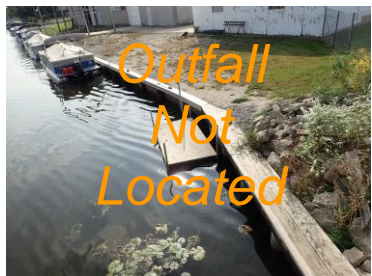
o20200924095628.JPG

Inspection Date: 9/24/2020 9:53:07 AM		Type: Ongoing	Flow: Submerged (not located)	Previous Rainfall (hrs): 72+
Illicit Discharge Potential: Potential		Inspector: QAL	Notes	
Submerged: Fully		Depth (in):	Outfall fully submerged and not located - screened upstream at 16-533 US1. Floating gross solids (litter) in upstream manhole.	
Sampling Results		Floatables:	Condition Assessment	
Sample Location:		Odor:		
Total Chlorine: -- ppm		Turbidity:	Gross Solids: None	
Free Chlorine: -- ppm		Color:	Vegetation: None	
Ammonia: -- ppm		Gross Solids:	Benthic Growth: None	
pH: -- units		Stains:	Deposition: None in.	
Temperature -- °F		Non-illicit:	Damage: None	
Conductivity: -- µS/cm				
Detergents: -- mg/L

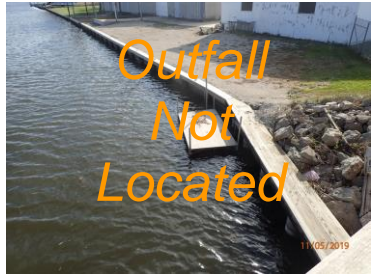
o20191105093616.JPG

Inspection Date: 11/5/2019 9:36:00 AM		Type: Repeat	Flow: Submerged (not located)	Previous Rainfall (hrs): 48-72
Illicit Discharge Potential: Unlikely		Inspector: JCW	Notes	
Submerged: Fully		Depth (in):	Outfall fully submerged and not located - screened upstream at 16-533 US1. Follow-up inspection for sampling - limited screening conducted.	
Sampling Results		Floatables:	Condition Assessment	
Sample Location:		Odor:		
Total Chlorine: -- ppm		Turbidity:	Gross Solids: None	
Free Chlorine: -- ppm		Color:	Vegetation: None	
Ammonia: -- ppm		Gross Solids:	Benthic Growth: None	
pH: -- units		Stains:	Deposition: None in.	
Temperature -- °F		Non-illicit:	Damage: None	
Conductivity: -- µS/cm				
Detergents: -- mg/L

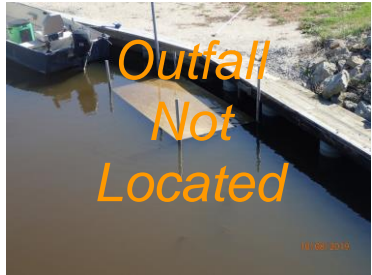
o20191008123600.JPG

Inspection Date: 10/8/2019 1:37:40 PM		Type: Ongoing	Flow: Submerged (not located)	Previous Rainfall (hrs): 48-72
Illicit Discharge Potential: Potential		Inspector: JCW	Notes	
Submerged: Fully		Depth (in):	Outfall fully submerged and not located - screened upstream at 16-533 US1. Floating gross solids (litter) and detergent in manhole.	
Sampling Results		Floatables:	Condition Assessment	
Sample Location:		Odor:		
Total Chlorine: -- ppm		Turbidity:	Gross Solids: None	
Free Chlorine: -- ppm		Color:	Vegetation: None	
Ammonia: -- ppm		Gross Solids:	Benthic Growth: None	
pH: -- units		Stains:	Deposition: None in.	
Temperature -- °F		Non-illicit:	Damage: None	
Conductivity: -- µS/cm				
Detergents: -- mg/L

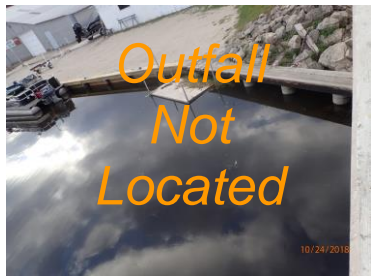
o20181024084514.JPG

Inspection Date: 10/24/2018 8:46:55 AM		Type: Ongoing	Flow: Submerged (not located)	Previous Rainfall (hrs): 72+
Illicit Discharge Potential: Potential		Inspector: JCW	Notes	
Submerged: Fully		Depth (in):	Outfall fully submerged and not located - screened upstream at 16-533 US1. Floating gross solids (litter) in manhole.	
Sampling Results		Floatables:	Condition Assessment	
Sample Location:		Odor:		
Total Chlorine: -- ppm		Turbidity:	Gross Solids: None	
Free Chlorine: -- ppm		Color:	Vegetation: None	
Ammonia: -- ppm		Gross Solids:	Benthic Growth: None	
pH: -- units		Stains:	Deposition: None in.	
Temperature -- °F		Non-illicit:	Damage: None	
Conductivity: -- µS/cm				
Detergents: -- mg/L

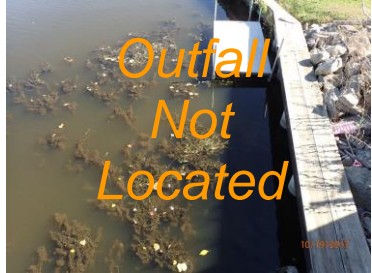
o20171019132622.JPG

Inspection Date: 10/19/2017 1:28:21 PM		Type: Ongoing	Flow: Submerged (not located)	Previous Rainfall (hrs): 72+
Illicit Discharge Potential: Unlikely		Inspector: JCW	Notes	
Submerged: Fully		Depth (in):	Outfall fully submerged and not located - screened upstream at 16-533 US1.	
Sampling Results		Floatables:	Condition Assessment Graffiti: None Erosion: None Deposition: None in. Damage: None	
Sample Location:		Odor:		
Total Chlorine: -- ppm		Turbidity:		
Free Chlorine: -- ppm		Color:		
Ammonia: -- ppm		Gross Solids:		
pH: -- units		Vegetation:		
Temperature -- °F		Benthic Growth:		
Conductivity: -- µS/cm		Stains:		
Detergents: -- mg/L		Non-illicit:

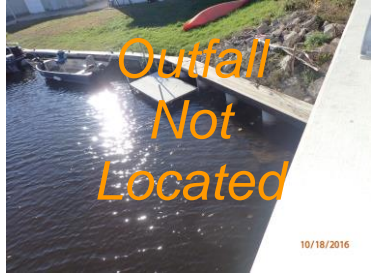
o20161018092038.JPG

Inspection Date: 10/18/2016 9:28:25 AM		Type: Ongoing	Flow: Submerged (not located)	Previous Rainfall (hrs): 72+
Illicit Discharge Potential: Potential		Inspector: JCW	Notes	
Submerged: Fully		Depth (in):	Outfall fully submerged and not located - screened upstream at 16-533 US1.	
Sampling Results		Floatables:	Condition Assessment Graffiti: None Erosion: None Deposition: None in. Damage: None	
Sample Location:		Odor:		
Total Chlorine: -- ppm		Turbidity:		
Free Chlorine: -- ppm		Color:		
Ammonia: -- ppm		Gross Solids:		
pH: -- units		Vegetation:		
Temperature -- °F		Benthic Growth:		
Conductivity: -- µS/cm		Stains:		
Detergents: -- mg/L		Non-illicit:

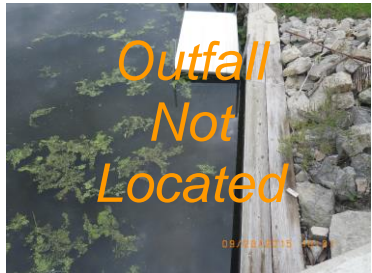
o20150923093118.JPG

Inspection Date: 9/23/2015 10:32:22 AM		Type: Ongoing	Flow: Submerged (not located)	Previous Rainfall (hrs): 72+
Illicit Discharge Potential: Potential		Inspector: JCW	Notes	
Submerged: Fully		Depth (in):	Outfall fully submerged and not located - screened at 16-533 US1.	
Sampling Results		Floatables:	Condition Assessment Graffiti: None Erosion: None Deposition: None in. Damage: None	
Sample Location:		Odor:		
Total Chlorine: -- ppm		Turbidity:		
Free Chlorine: -- ppm		Color:		
Ammonia: -- ppm		Gross Solids:		
pH: -- units		Vegetation:		
Temperature -- °F		Benthic Growth:		
Conductivity: -- µS/cm		Stains:		
Detergents: -- mg/L		Non-illicit:

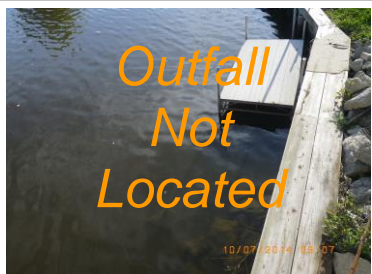
o20141007080736.JPG

Inspection Date: 10/7/2014 9:08:49 AM		Type: Ongoing	Flow: Submerged (not located)	Previous Rainfall (hrs): 48-72
Illicit Discharge Potential: Potential		Inspector: JCW	Notes	
Submerged: Fully		Depth (in):	Outfall fully submerged and not located - screened upstream at 16-533 US1.	
Sampling Results		Floatables:	Condition Assessment Graffiti: None Erosion: None Deposition: None in. Damage: None	
Sample Location:		Odor:		
Total Chlorine: -- ppm		Turbidity:		
Free Chlorine: -- ppm		Color:		
Ammonia: -- ppm		Gross Solids:		
pH: -- units		Vegetation:		
Temperature -- °F		Benthic Growth:		
Conductivity: -- µS/cm		Stains:		
Detergents: -- mg/L		Non-illicit:

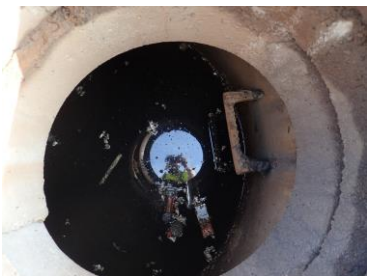
o20200924100816.JPG 2020

Floatables:	None	Odor:	None	Turbidity:	None	Color:	None	Gross Solids:	Moderate	Vegetation:	None	Benthic Growth:	None	Stains:	None	Non-illicit:	None
Floatables:	None																					
Odor:	None																					
Turbidity:	None																					
Color:	None																					
Gross Solids:	Moderate																					
Vegetation:	None																					
Benthic Growth:	None																					
Stains:	None																					
Non-illicit:	None																					
		Notes Sample collected from submerged pool in manhole. Floating gross solids (litter) in manhole.																				
		Condition Assessment Graffiti: None Erosion: None Deposition: None in. Damage: None

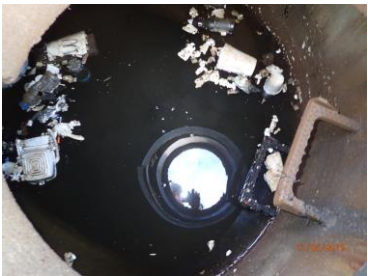
o20191105093642.JPG 2019

Floatables:	None	Odor:	None	Turbidity:	None	Color:	None	Gross Solids:	None	Vegetation:	None	Benthic Growth:	None	Stains:	None	Non-illicit:	None
Floatables:	None																					
Odor:	None																					
Turbidity:	None																					
Color:	None																					
Gross Solids:	None																					
Vegetation:	None																					
Benthic Growth:	None																					
Stains:	None																					
Non-illicit:	None																					
		Notes Follow-up inspection for sampling - limited screening conducted.																				
		Condition Assessment Graffiti: None Erosion: None Deposition: None in. Damage: None

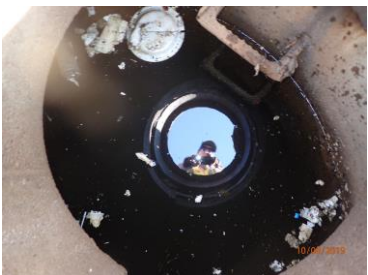
o20191008123830.JPG 2019

Floatables:	None	Odor:	None	Turbidity:	None	Color:	None	Gross Solids:	Moderate	Vegetation:	None	Benthic Growth:	None	Stains:	None	Non-illicit:	None
Floatables:	None																					
Odor:	None																					
Turbidity:	None																					
Color:	None																					
Gross Solids:	Moderate																					
Vegetation:	None																					
Benthic Growth:	None																					
Stains:	None																					
Non-illicit:	None																					
		Notes Sample collected from submerged pool in manhole. Floating gross solids (litter) in manhole. Detergent detected in sample.																				
		Condition Assessment Graffiti: None Erosion: None Deposition: None in. Damage: None

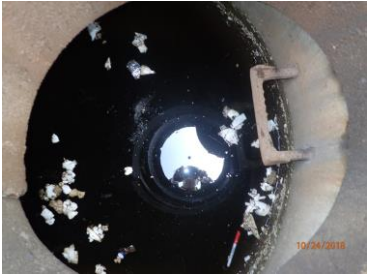
o20181024084850.JPG 2018

Floatables:	None	Odor:	None	Turbidity:	None	Color:	None	Gross Solids:	Slight	Vegetation:	None	Benthic Growth:	None	Stains:	None	Non-illicit:	None
Floatables:	None																					
Odor:	None																					
Turbidity:	None																					
Color:	None																					
Gross Solids:	Slight																					
Vegetation:	None																					
Benthic Growth:	None																					
Stains:	None																					
Non-illicit:	None																					
		Notes Sample collected from submerged pool in manhole. Floating gross solids (litter) in manhole.																				
		Condition Assessment Graffiti: None Erosion: None Deposition: None in. Damage: None
