IDDE Ongoing Screening Summary Report

2021 Inspection Year

City of Oshkosh

Westwood

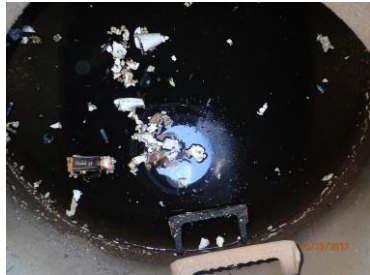
o20171019133054.JPG

Inspection Date: 10/19/2017 1:34:48 PM		Type: Ongoing	Flow: Submerged, indeterminate	Previous Rainfall (hrs): 72+
Illicit Discharge Potential: Unlikely		Inspector: JCW	Notes	
Submerged: Fully		Depth (in):	Sample collected from submerged pool in manhole.	
Sampling Results				
Sample Location:		Floatables:	Slight	
Total Chlorine: 0 ppm		Odor:	None	
Free Chlorine: 0 ppm		Turbidity:	None	
Ammonia: 0 ppm		Color:	None	
pH: 7.89 units		Gross Solids:	Slight	
Temperature 66 °F		Vegetation:	None	
Conductivity: 668 µS/cm		Benthic Growth:	None	
Detergents: 0 mg/L		Stains:	None	
		Non-illicit:	None	
			Condition Assessment	
			Graffiti: None	
			Erosion: None	
			Deposition: None in.	
			Damage: None

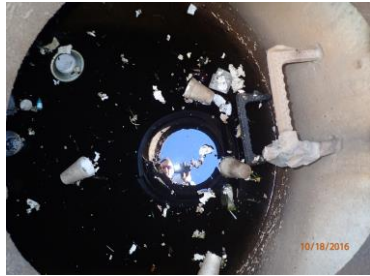
o20161018092516.JPG

Inspection Date: 10/18/2016 9:29:17 AM		Type: Ongoing	Flow: Submerged, indeterminate	Previous Rainfall (hrs): 72+
Illicit Discharge Potential: Potential		Inspector: JCW	Notes	
Submerged: Fully		Depth (in): 40	Potential illicit discharge due to gross solids.	
Sampling Results				
Sample Location: Pool		Floatables:	None	
Total Chlorine: 0 ppm		Odor:	None	
Free Chlorine: 0 ppm		Turbidity:	None	
Ammonia: 0 ppm		Color:	None	
pH: 7.94 units		Gross Solids:	Moderate	
Temperature 63 °F		Vegetation:	None	
Conductivity: 482 µS/cm		Benthic Growth:	None	
Detergents: 0 mg/L		Stains:	None	
		Non-illicit:	None	
			Condition Assessment	
			Graffiti: None	
			Erosion: None	
			Deposition: None in.	
			Damage: None

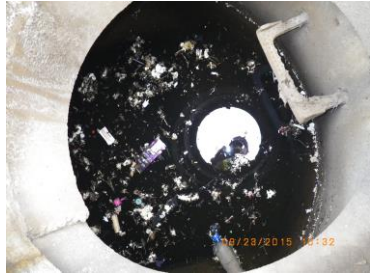
o20150923093204.JPG

Inspection Date: 9/23/2015 10:32:59 AM		Type: Ongoing	Flow: Submerged, indeterminate	Previous Rainfall (hrs): 72+
Illicit Discharge Potential: Potential		Inspector: JCW	Notes	
Submerged: Fully		Depth (in): 36	Floating gross solids (litter) - including syringe - in manhole.	
Sampling Results				
Sample Location: Pool		Floatables:	None	
Total Chlorine: 0 ppm		Odor:	None	
Free Chlorine: 0 ppm		Turbidity:	None	
Ammonia: 0 ppm		Color:	None	
pH: 7.95 units		Gross Solids:	Moderate	
Temperature 71 °F		Vegetation:	None	
Conductivity: 363 µS/cm		Benthic Growth:	Slight	
Detergents: 0 mg/L		Stains:	None	
		Non-illicit:	None	
			Condition Assessment	
			Graffiti: None	
			Erosion: None	
			Deposition: None in.	
			Damage: None

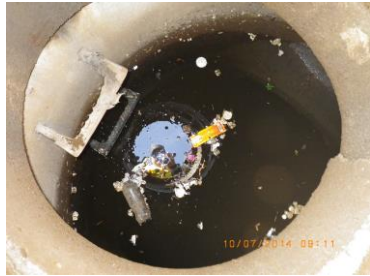
o20141007081140.JPG

Inspection Date: 10/7/2014 9:13:45 AM		Type: Ongoing	Flow: Submerged, indeterminate	Previous Rainfall (hrs): 48-72
Illicit Discharge Potential: Potential		Inspector: JCW	Notes	
Submerged: Fully		Depth (in): 34	Floating gross solids (litter) in manhole.	
Sampling Results				
Sample Location: Pool		Floatables:	None	
Total Chlorine: 0 ppm		Odor:	None	
Free Chlorine: 0 ppm		Turbidity:	None	
Ammonia: 0 ppm		Color:	None	
pH: 7.67 units		Gross Solids:	Moderate	
Temperature -- °F		Vegetation:	None	
Conductivity: 474 µS/cm		Benthic Growth:	None	
Detergents: 0 mg/L		Stains:	None	
		Non-illicit:	None	
			Condition Assessment	
			Graffiti: None	
			Erosion: None	
			Deposition: None in.	
			Damage: None

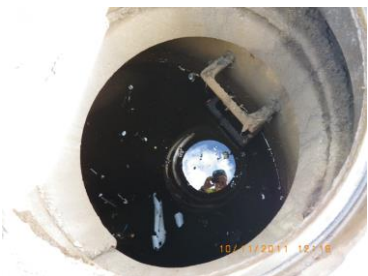
<small>o20111011121924.JPG</small> <div style="font-size: 24pt; font-weight: bold;">2011</div>

Inspection Date: 10/11/2011 12:22:21 PM		Type: Ongoing	Flow: Submerged, indeterminate	Previous Rainfall (hrs): 72+																																		
Illicit Discharge Potential: Unlikely		Inspector: JCW	<div style="border: 1px solid black; padding: 5px;"> Notes 2010 screening follow-up. Floatable debris significantly reduced. </div> <div style="border: 1px solid black; padding: 5px; margin-top: 10px;"> Condition Assessment Graffiti: None Erosion: None Deposition: None 0 in. Damage: None </div>																																			
Submerged: Fully Depth (in): 16																																						
<div style="display: flex; justify-content: space-between;"> <div style="width: 45%;"> Sampling Results <table border="1" style="width:100%; border-collapse: collapse;"> <tr><td>Sample Location:</td><td>Pool</td></tr> <tr><td>Total Chlorine:</td><td>0 ppm</td></tr> <tr><td>Free Chlorine:</td><td>0 ppm</td></tr> <tr><td>Ammonia:</td><td>0 ppm</td></tr> <tr><td>pH:</td><td>7.9 units</td></tr> <tr><td>Temperature:</td><td>70 °F</td></tr> <tr><td>Conductivity:</td><td>-- µS/cm</td></tr> <tr><td>Detergents:</td><td>-- mg/L</td></tr> </table> </div> <div style="width: 45%;"> <table border="1" style="width:100%; border-collapse: collapse;"> <tr><td>Floatables:</td><td>None</td></tr> <tr><td>Odor:</td><td>None</td></tr> <tr><td>Turbidity:</td><td>None</td></tr> <tr><td>Color:</td><td>None</td></tr> <tr><td>Gross Solids:</td><td>Moderate</td></tr> <tr><td>Vegetation:</td><td>None</td></tr> <tr><td>Benthic Growth:</td><td>None</td></tr> <tr><td>Stains:</td><td>None</td></tr> <tr><td>Non-illicit:</td><td>None</td></tr> </table> </div> </div>					Sample Location:	Pool	Total Chlorine:	0 ppm	Free Chlorine:	0 ppm	Ammonia:	0 ppm	pH:	7.9 units	Temperature:	70 °F	Conductivity:	-- µS/cm	Detergents:	-- mg/L	Floatables:	None	Odor:	None	Turbidity:	None	Color:	None	Gross Solids:	Moderate	Vegetation:	None	Benthic Growth:	None	Stains:	None	Non-illicit:	None

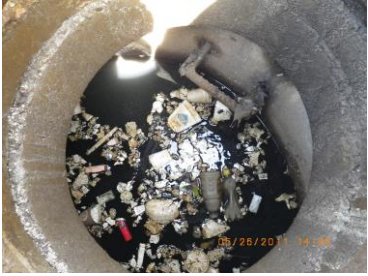
<small>o20110526143524.JPG</small> <div style="font-size: 24pt; font-weight: bold;">2011</div>

Inspection Date: 5/26/2011 2:35:00 PM		Type: Other	Flow: Submerged, indeterminate	Previous Rainfall (hrs): 72+																																		
Illicit Discharge Potential: Potential		Inspector: JCW	<div style="border: 1px solid black; padding: 5px;"> Notes Limited screening conducted to check for floatable debris. </div> <div style="border: 1px solid black; padding: 5px; margin-top: 10px;"> Condition Assessment Graffiti: None Erosion: None Deposition: None 0 in. Damage: None </div>																																			
Submerged: Fully Depth (in):																																						
<div style="display: flex; justify-content: space-between;"> <div style="width: 45%;"> Sampling Results <table border="1" style="width:100%; border-collapse: collapse;"> <tr><td>Sample Location:</td><td></td></tr> <tr><td>Total Chlorine:</td><td>-- ppm</td></tr> <tr><td>Free Chlorine:</td><td>-- ppm</td></tr> <tr><td>Ammonia:</td><td>-- ppm</td></tr> <tr><td>pH:</td><td>-- units</td></tr> <tr><td>Temperature:</td><td>-- °F</td></tr> <tr><td>Conductivity:</td><td>-- µS/cm</td></tr> <tr><td>Detergents:</td><td>-- mg/L</td></tr> </table> </div> <div style="width: 45%;"> <table border="1" style="width:100%; border-collapse: collapse;"> <tr><td>Floatables:</td><td>None</td></tr> <tr><td>Odor:</td><td></td></tr> <tr><td>Turbidity:</td><td></td></tr> <tr><td>Color:</td><td></td></tr> <tr><td>Gross Solids:</td><td>Moderate</td></tr> <tr><td>Vegetation:</td><td></td></tr> <tr><td>Benthic Growth:</td><td></td></tr> <tr><td>Stains:</td><td></td></tr> <tr><td>Non-illicit:</td><td>None</td></tr> </table> </div> </div>					Sample Location:		Total Chlorine:	-- ppm	Free Chlorine:	-- ppm	Ammonia:	-- ppm	pH:	-- units	Temperature:	-- °F	Conductivity:	-- µS/cm	Detergents:	-- mg/L	Floatables:	None	Odor:		Turbidity:		Color:		Gross Solids:	Moderate	Vegetation:		Benthic Growth:		Stains:		Non-illicit:	None

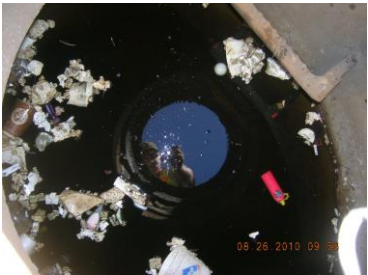
<small>o20100826095640.JPG</small> <div style="font-size: 24pt; font-weight: bold;">2010</div>

Inspection Date: 8/26/2010 10:01:38 AM		Type: Ongoing	Flow: Submerged, indeterminate	Previous Rainfall (hrs): 72+																																		
Illicit Discharge Potential: Potential		Inspector: JCW	<div style="border: 1px solid black; padding: 5px;"> Notes Floatable debris in manhole. </div> <div style="border: 1px solid black; padding: 5px; margin-top: 10px;"> Condition Assessment Graffiti: None Erosion: None Deposition: None 0 in. Damage: None </div>																																			
Submerged: Fully Depth (in): 36																																						
<div style="display: flex; justify-content: space-between;"> <div style="width: 45%;"> Sampling Results <table border="1" style="width:100%; border-collapse: collapse;"> <tr><td>Sample Location:</td><td>Pool</td></tr> <tr><td>Total Chlorine:</td><td>0 ppm</td></tr> <tr><td>Free Chlorine:</td><td>0 ppm</td></tr> <tr><td>Ammonia:</td><td>0 ppm</td></tr> <tr><td>pH:</td><td>7.23 units</td></tr> <tr><td>Temperature:</td><td>76 °F</td></tr> <tr><td>Conductivity:</td><td>-- µS/cm</td></tr> <tr><td>Detergents:</td><td>0 mg/L</td></tr> </table> </div> <div style="width: 45%;"> <table border="1" style="width:100%; border-collapse: collapse;"> <tr><td>Floatables:</td><td>None</td></tr> <tr><td>Odor:</td><td>None</td></tr> <tr><td>Turbidity:</td><td>None</td></tr> <tr><td>Color:</td><td>Faint in bottle</td></tr> <tr><td>Gross Solids:</td><td>Moderate</td></tr> <tr><td>Vegetation:</td><td>None</td></tr> <tr><td>Benthic Growth:</td><td>Slight</td></tr> <tr><td>Stains:</td><td>None</td></tr> <tr><td>Non-illicit:</td><td>None</td></tr> </table> </div> </div>					Sample Location:	Pool	Total Chlorine:	0 ppm	Free Chlorine:	0 ppm	Ammonia:	0 ppm	pH:	7.23 units	Temperature:	76 °F	Conductivity:	-- µS/cm	Detergents:	0 mg/L	Floatables:	None	Odor:	None	Turbidity:	None	Color:	Faint in bottle	Gross Solids:	Moderate	Vegetation:	None	Benthic Growth:	Slight	Stains:	None	Non-illicit:	None

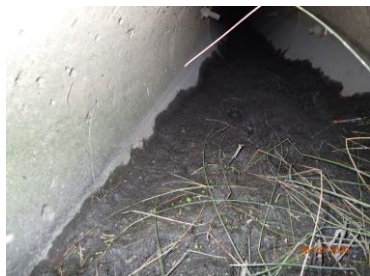
o20200820085150.JPG 2020

Sample Location:																																		
Total Chlorine:	-- ppm																																	
Free Chlorine:	-- ppm																																	
Ammonia:	-- ppm																																	
pH:	-- units																																	
Temperature:	-- °F																																	
Conductivity:	-- µS/cm																																	
Detergents:	-- mg/L																																	
Notes																																		
Sediment wet, but no flow at time of inspection. No flow entering pipe at upstream curb inlet.																																		
Condition Assessment																																		
Graffiti:	None																																	
Erosion:	None																																	
Deposition:	Minor 1 in.																																	
Damage:	None

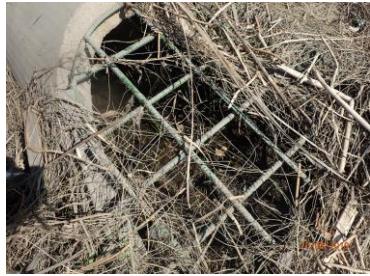
o20191008130940.JPG 2019

Sample Location:																																		
Total Chlorine:	-- ppm																																	
Free Chlorine:	-- ppm																																	
Ammonia:	-- ppm																																	
pH:	-- units																																	
Temperature:	-- °F																																	
Conductivity:	-- µS/cm																																	
Detergents:	-- mg/L																																	
Notes																																		
Outfall partially submerged - screened upstream at 16-1205 US1. Detergent detected in upstream manhole.																																		
Condition Assessment																																		
Graffiti:	None																																	
Erosion:	None																																	
Deposition:	Minor 2 in.																																	
Damage:	None

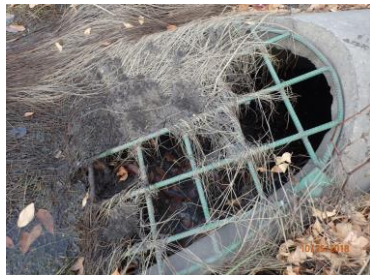
o20181025083538.JPG 2018

Sample Location:																																		
Total Chlorine:	-- ppm																																	
Free Chlorine:	-- ppm																																	
Ammonia:	-- ppm																																	
pH:	-- units																																	
Temperature:	-- °F																																	
Conductivity:	-- µS/cm																																	
Detergents:	-- mg/L																																	
Notes																																		
Outfall partially submerged - screened upstream at 16-1205 US1. Detergent detected in upstream manhole.																																		
Condition Assessment																																		
Graffiti:	None																																	
Erosion:	None																																	
Deposition:	Minor 2 in.																																	
Damage:	None

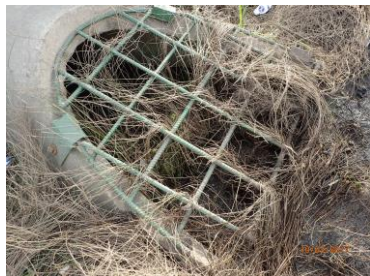
o20171003090114.JPG 2017

Sample Location:																																		
Total Chlorine:	-- ppm																																	
Free Chlorine:	-- ppm																																	
Ammonia:	-- ppm																																	
pH:	-- units																																	
Temperature:	-- °F																																	
Conductivity:	-- µS/cm																																	
Detergents:	-- mg/L																																	
Notes																																		
Outfall partially submerged - screened upstream at 16-1205 US1.																																		
Condition Assessment																																		
Graffiti:	None																																	
Erosion:	None																																	
Deposition:	Minor 1 in.																																	
Damage:	None

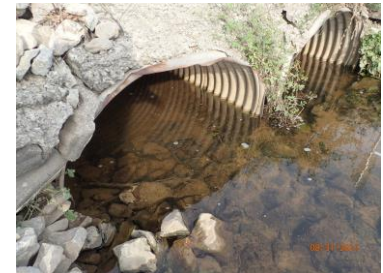
o20210831084650.JPG

Damage: Minor ☐ Displacement ☐ Undercut ☐ Crushed☒ Corrosion ☐ Cracks/Structural Damage

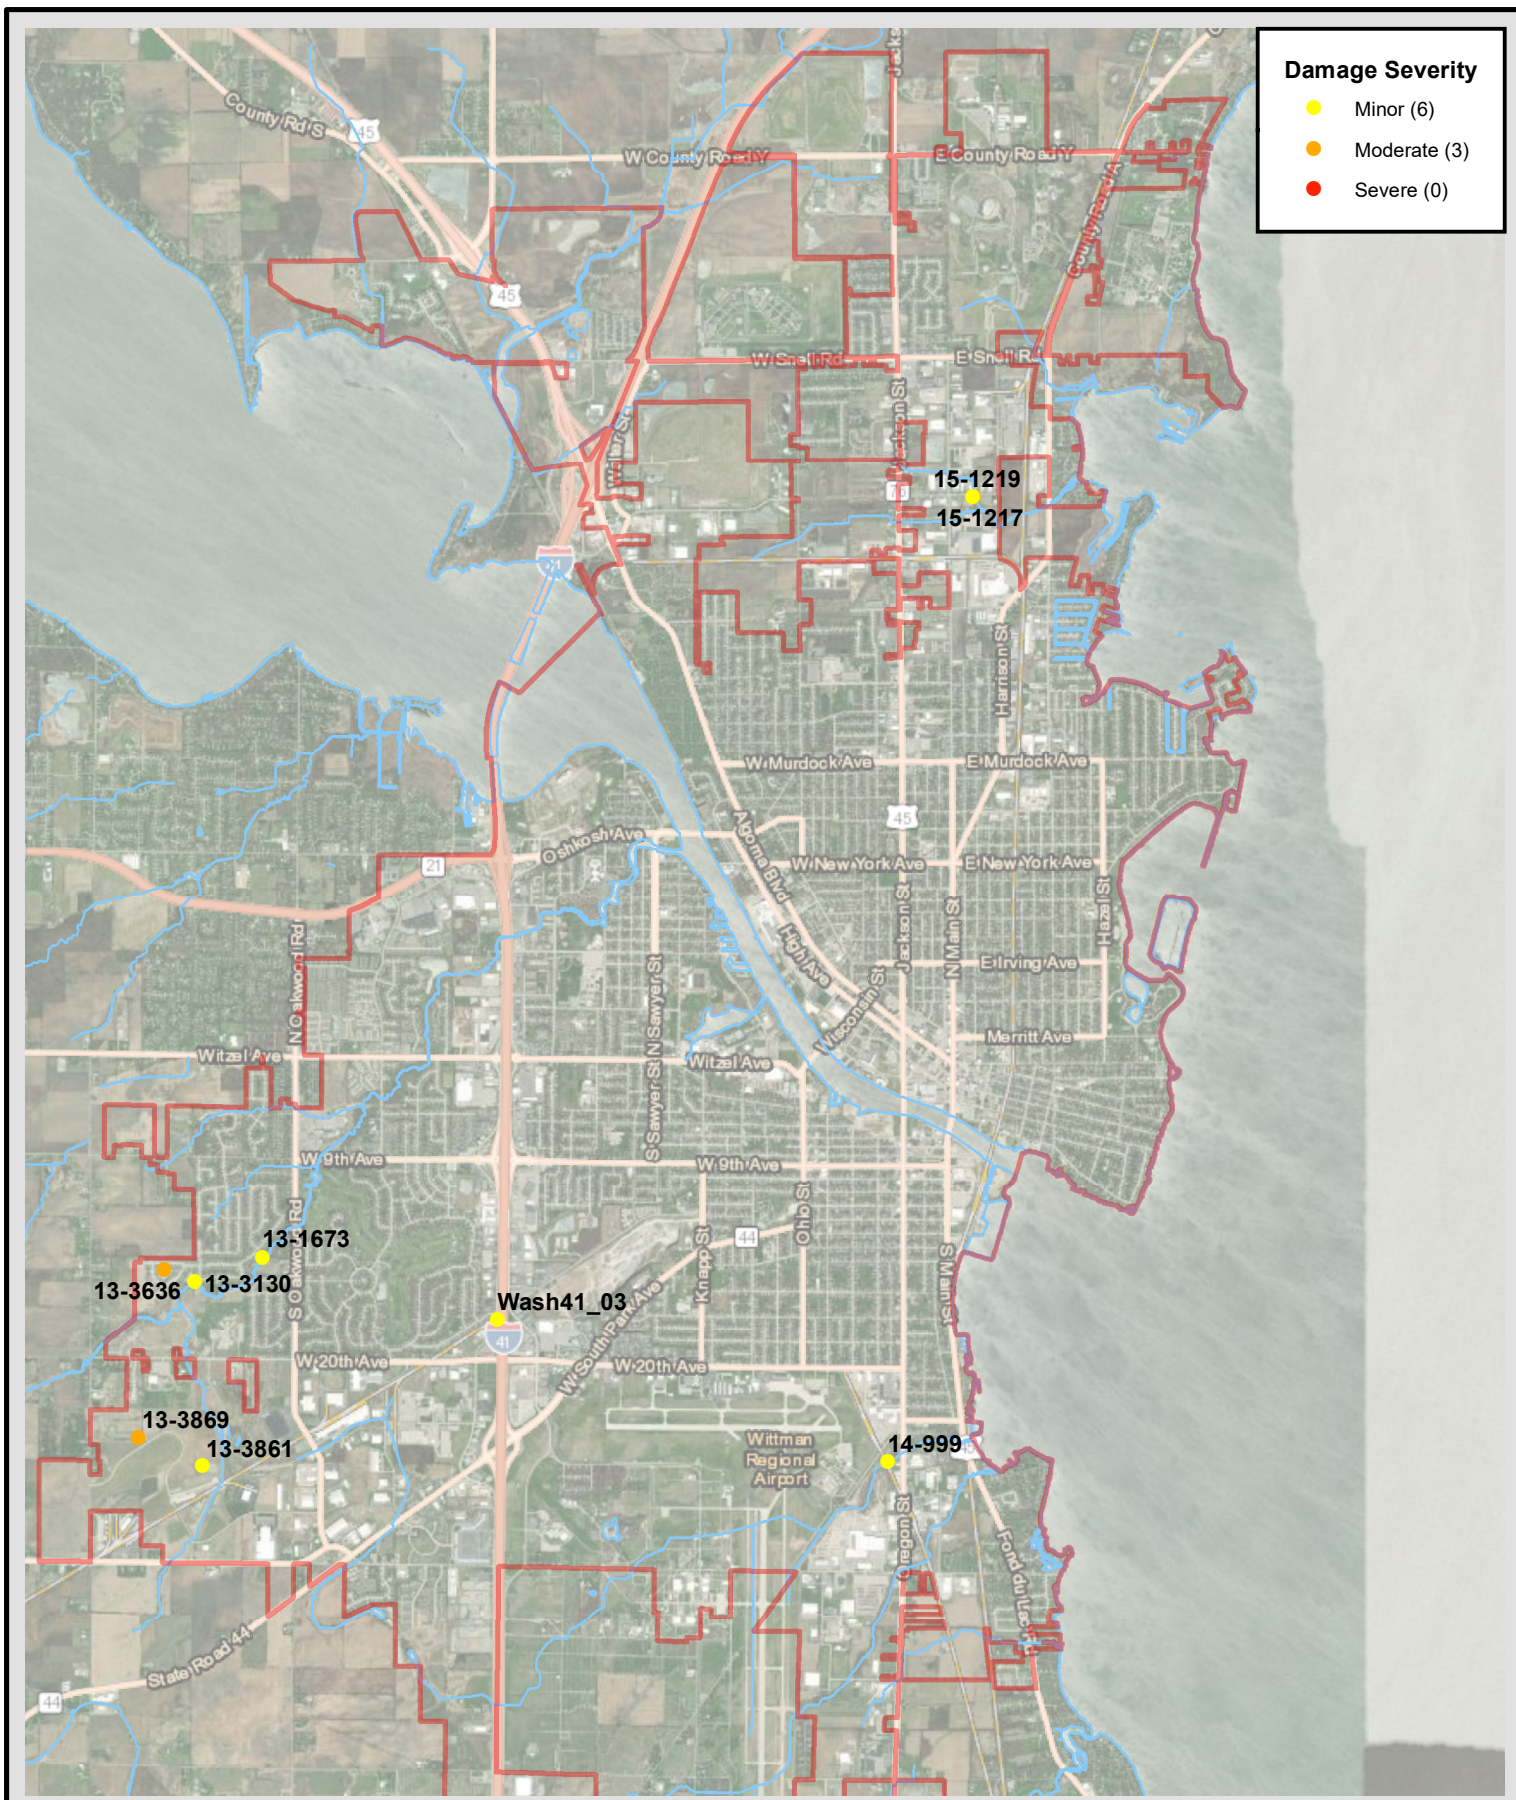
Damage Severity

- Minor (6)
- Moderate (3)
- Severe (0)

2021 IDDE ONGOING SCREENING PROGRAM OUTFALLS WITH DAMAGE

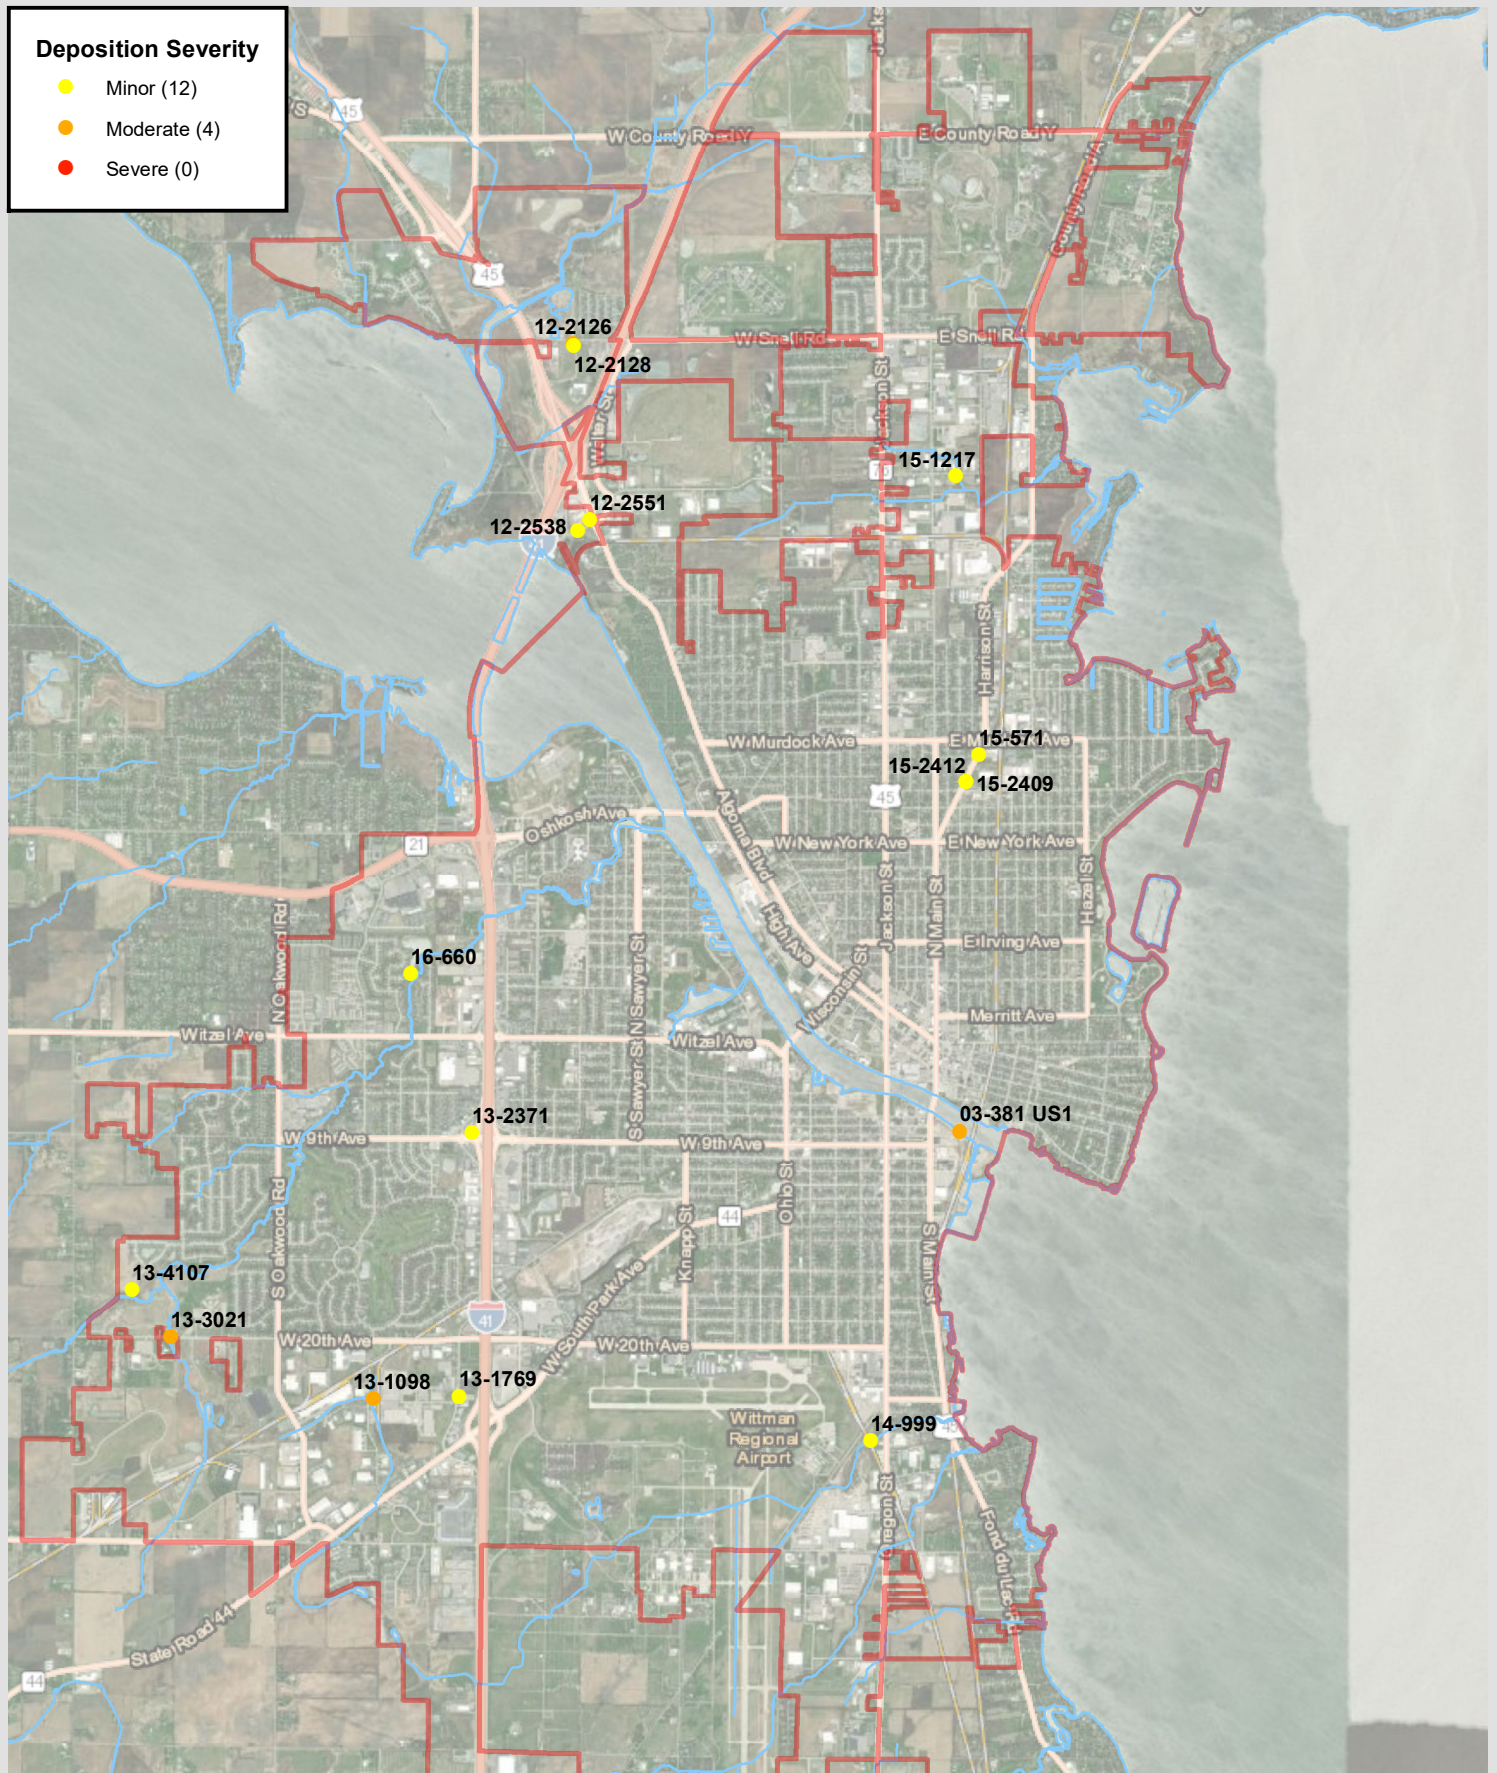
SCALE:
1" = 7,000'
PROJECT NO.
R3000958.00
FIGURE NO.
C-3

Deposition Severity

- Minor (12)
- Moderate (4)
- Severe (0)

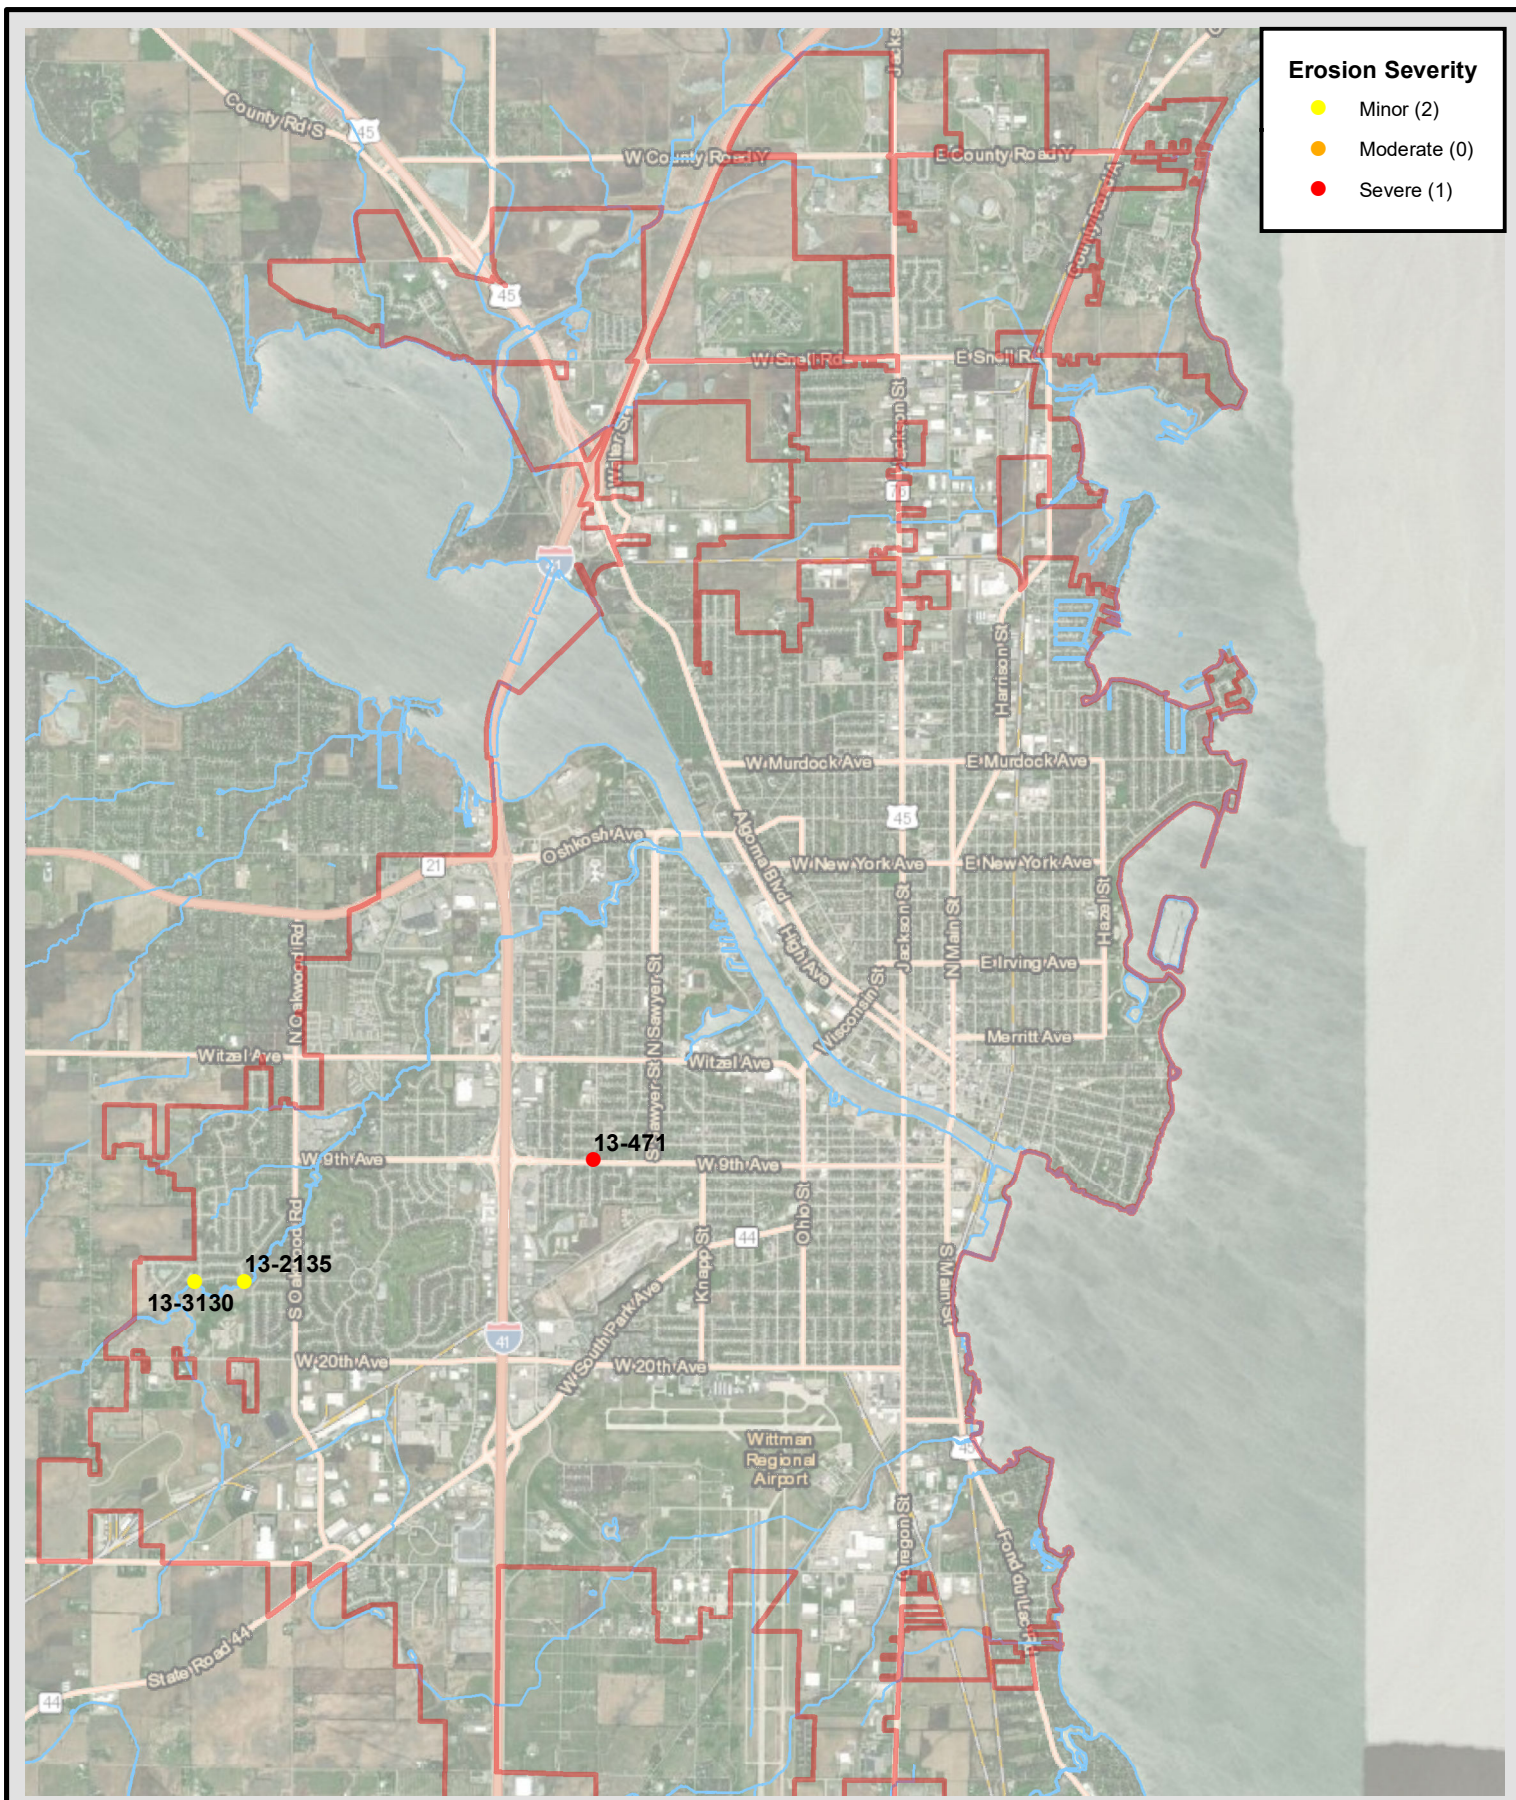
FIGURE NO.
C-4

Erosion Severity

- Minor (2)
- Moderate (0)
- Severe (1)

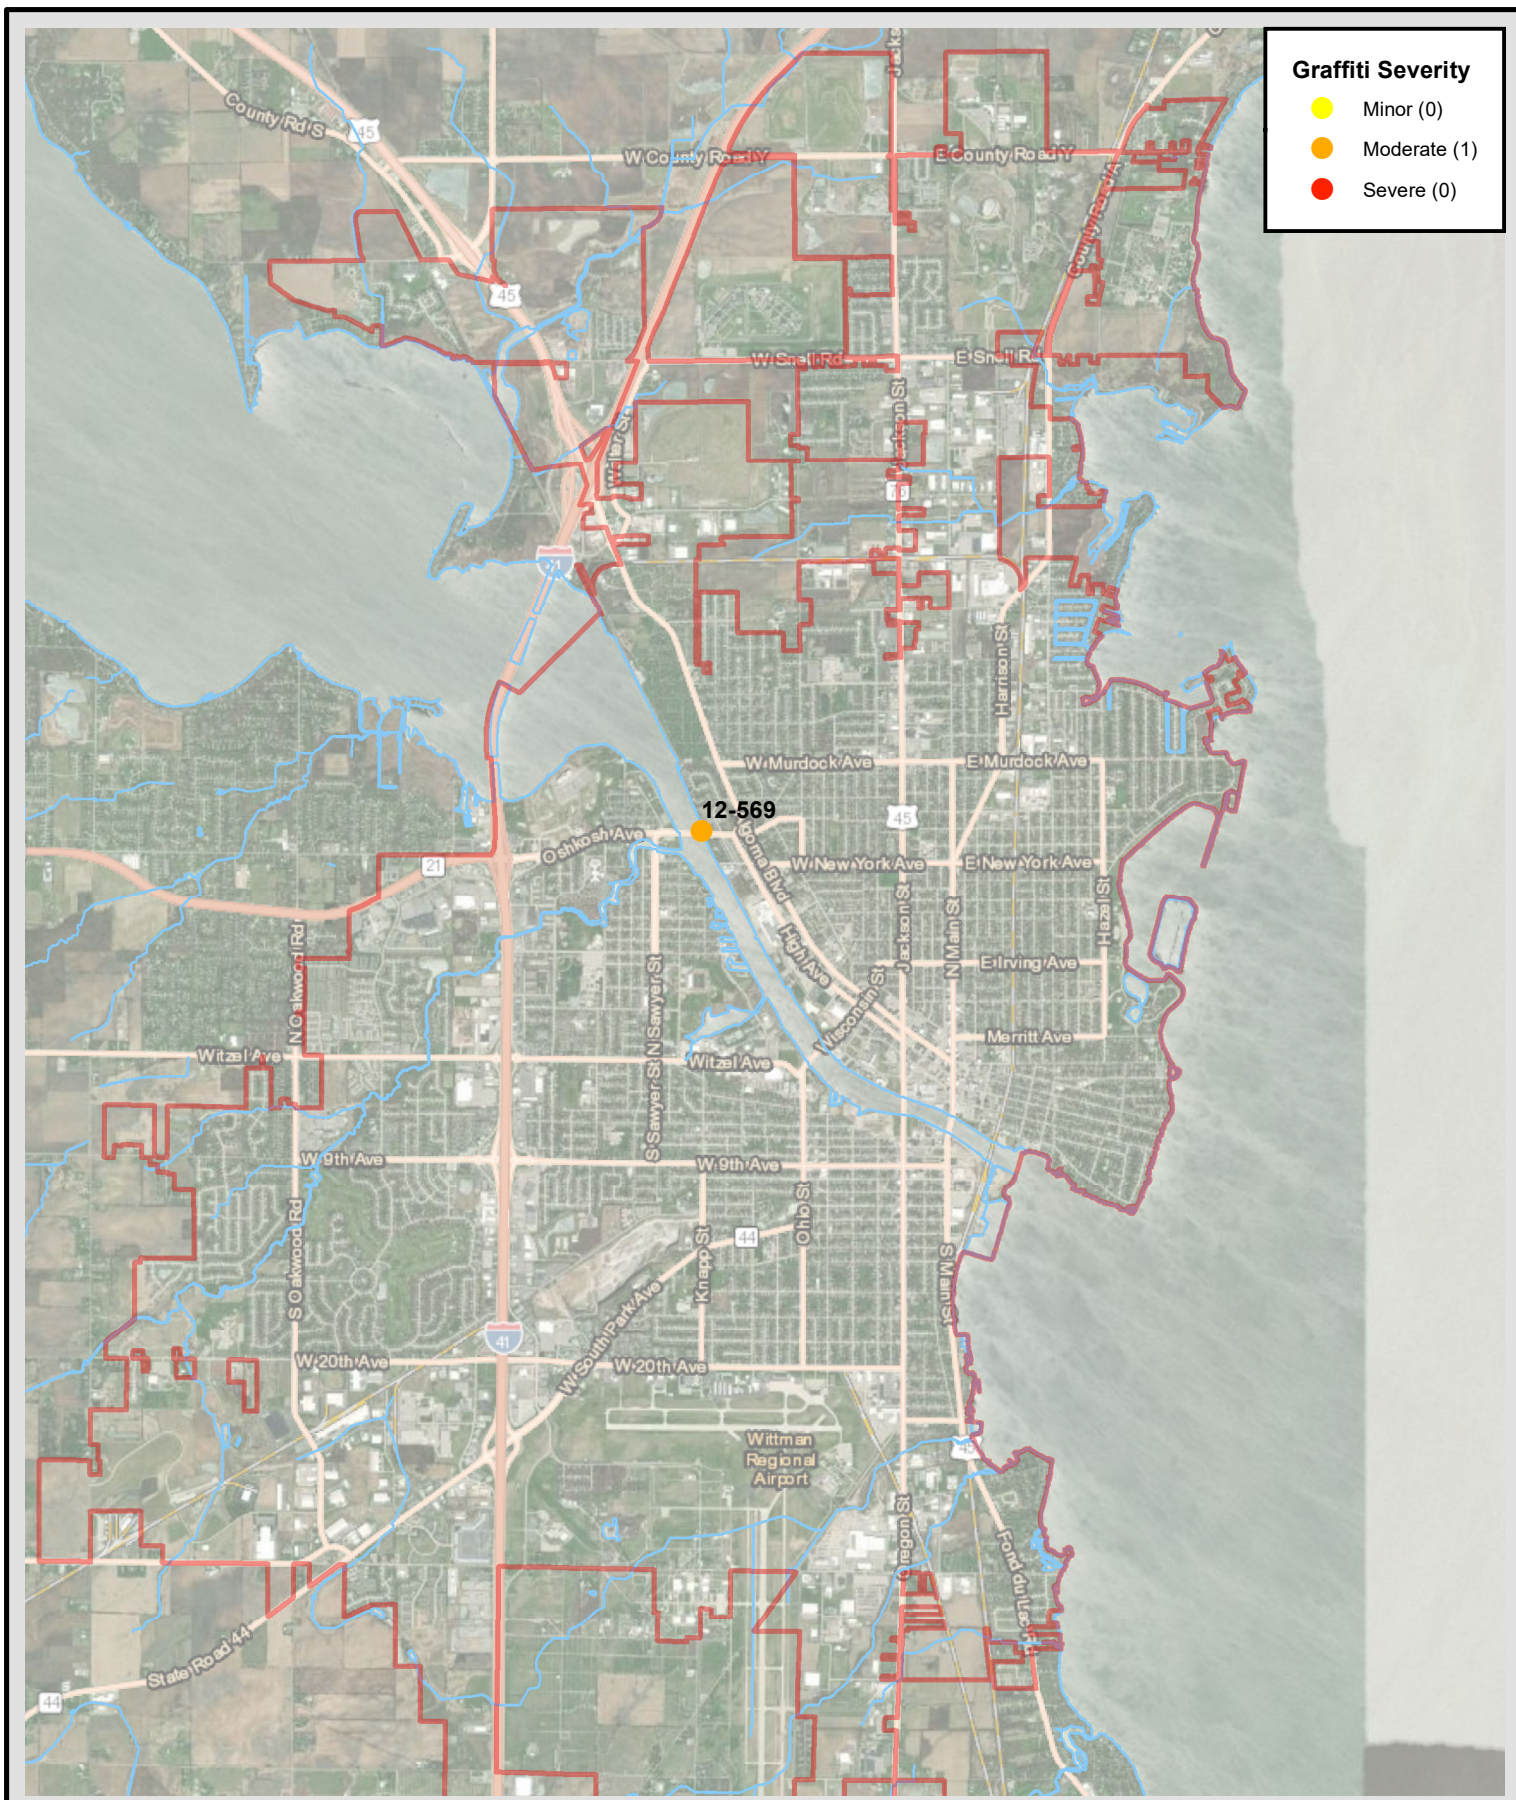
Graffiti Severity

- Minor (0)
- Moderate (1)
- Severe (0)

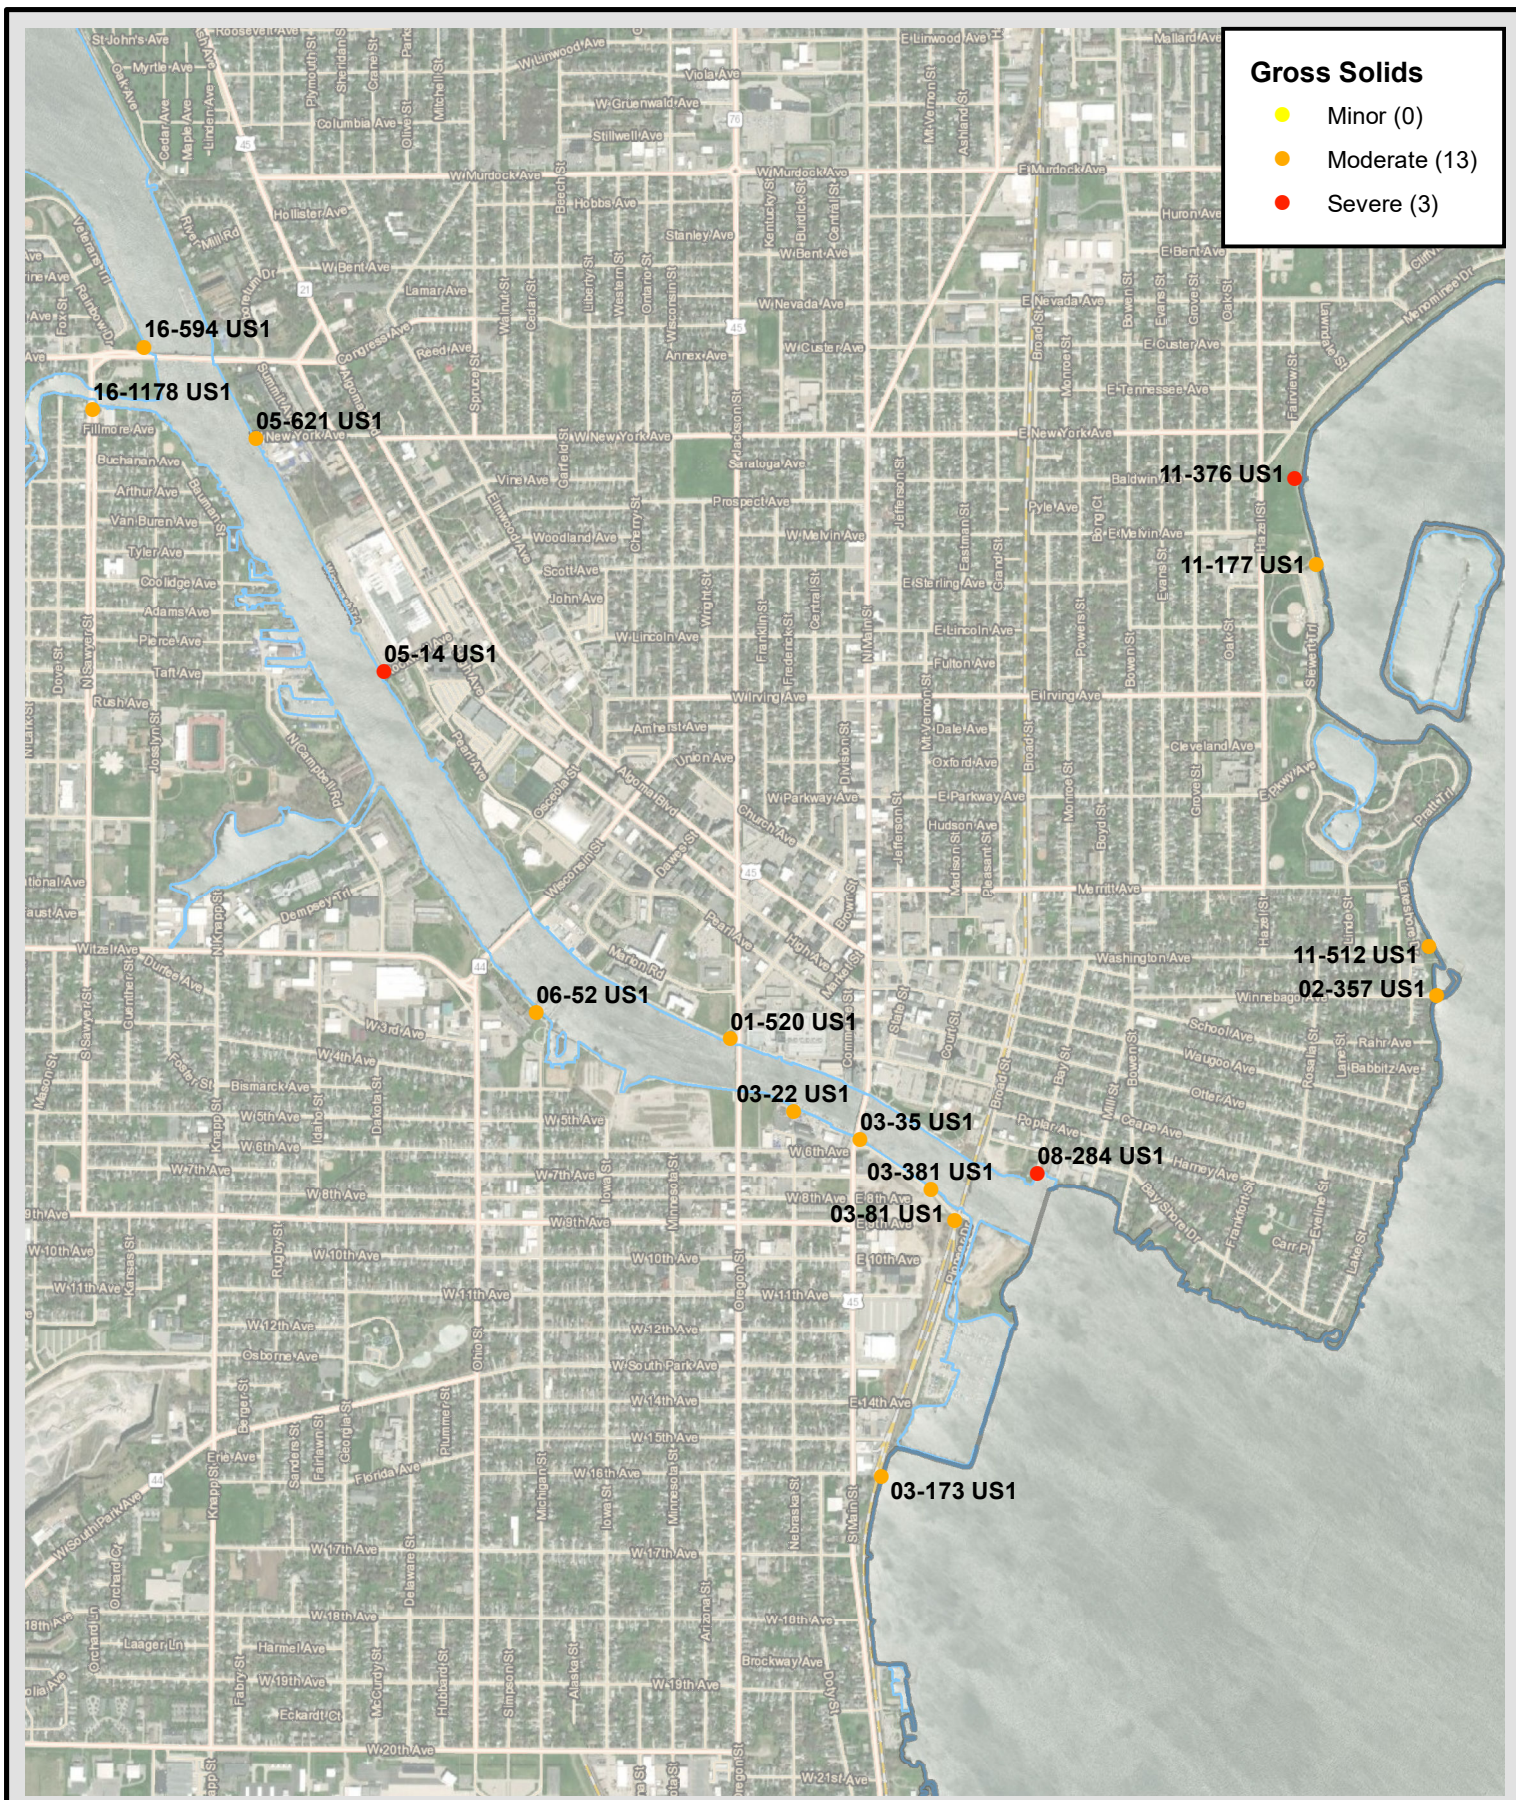
Project Manager:	SCALE: 1" = 1,932'
Project Engineer:	PROJECT NO. R3000958.00
Drawn By: JCW	FIGURE NO. D-1
Checked By:	
Date: 12/11/2020

Gross Solids

- Minor (0)
- Moderate (13)
- Severe (3)
