IDDE Ongoing Screening Summary Report

2022 Inspection Year

City of Oshkosh

Westwood

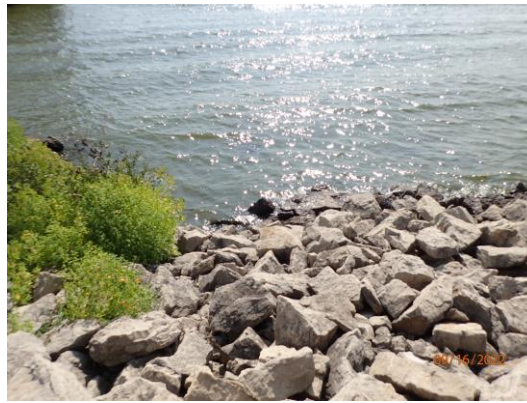
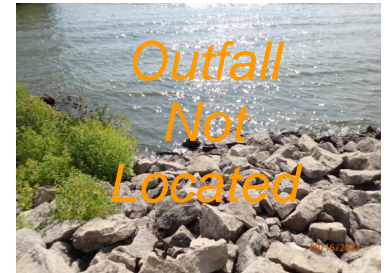
o20220916133918.JPG

Inspection Date: 8/16/2021 10:15:00 AM		Type: Ongoing	Flow: Submerged (not located)	Previous Rainfall (hrs): 72+
Illicit Discharge Potential: Potential		Inspector: JCW		
Submerged: Fully		Depth (in):		
Sampling Results Sample Location: _____ Total Chlorine: -- ppm Free Chlorine: -- ppm Ammonia: -- ppm pH: -- units Temperature: -- °F Conductivity: -- µS/cm Detergents: -- mg/L		Floatables: None Odor: None Turbidity: None Color: None Gross Solids: None Vegetation: None Benthic Growth: None Stains: None Non-illicit: None		
		Notes Outfall fully submerged and not located - screened upstream at 01-520 US1. Floating gross solids (litter) in upstream manhole.		
		Condition Assessment Graffiti: None Erosion: None Deposition: None in. Damage: None

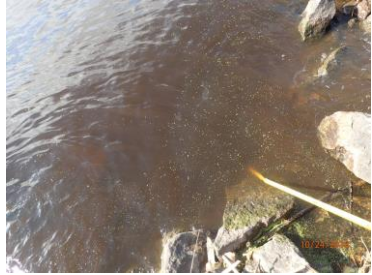
<p style="text-align: center;">o20181024110412.JPG</p> <p style="text-align: center; font-size: 24pt; font-weight: bold;">2018</p>	
Submerged: Fully		Depth (in):		Outfall fully submerged - screened upstream at 01-520 US1. Floating gross solids (litter) in manhole.			
Sampling Results				Condition Assessment			
Sample Location:		Floatables:		Graffiti:		None	
Total Chlorine: -- ppm		Odor:		Erosion:		None	
Free Chlorine: -- ppm		Turbidity:		Deposition:		None in.	
Ammonia: -- ppm		Color:		Damage:		None	
pH: -- units		Gross Solids:					
Temperature -- °F		Vegetation:					
Conductivity: -- µS/cm		Benthic Growth:					
Detergents: -- mg/L		Stains:					
		Non-illicit:

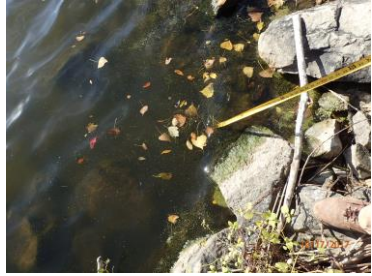
<p style="text-align: center;">o20171017151448.JPG</p> <p style="text-align: center; font-size: 24pt; font-weight: bold;">2017</p>	
Submerged: Fully		Depth (in): 39		Outfall fully submerged - screened upstream at 01-520 US1. Floating gross solids (litter) in manhole.			
Sampling Results				Condition Assessment			
Sample Location:		Floatables:		Graffiti:		None	
Total Chlorine: -- ppm		Odor:		Erosion:		None	
Free Chlorine: -- ppm		Turbidity:		Deposition:		None in.	
Ammonia: -- ppm		Color:		Damage:		None	
pH: -- units		Gross Solids:					
Temperature -- °F		Vegetation:					
Conductivity: -- µS/cm		Benthic Growth:					
Detergents: -- mg/L		Stains:					
		Non-illicit:

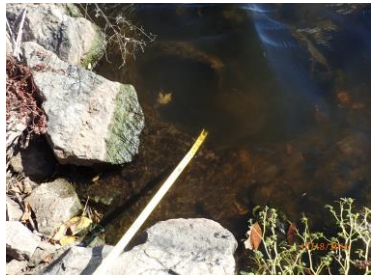
<p style="text-align: center;">o20161018153652.JPG</p> <p style="text-align: center; font-size: 24pt; font-weight: bold;">2016</p>	
Submerged: Fully		Depth (in): 33		Outfall fully submerged - screened upstream at 01-520 US1.			
Sampling Results				Condition Assessment			
Sample Location:		Floatables:		Graffiti:		None	
Total Chlorine: -- ppm		Odor:		Erosion:		None	
Free Chlorine: -- ppm		Turbidity:		Deposition:		None in.	
Ammonia: -- ppm		Color:		Damage:		None	
pH: -- units		Gross Solids:					
Temperature -- °F		Vegetation:					
Conductivity: -- µS/cm		Benthic Growth:					
Detergents: -- mg/L		Stains:					
		Non-illicit:

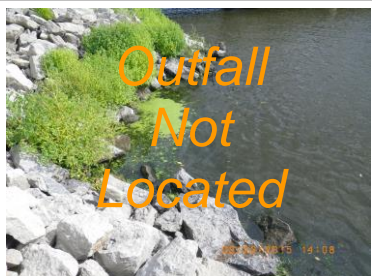
<p style="text-align: center;">o20150922130830.JPG</p> <p style="text-align: center; font-size: 24pt; font-weight: bold;">2015</p>	
Submerged: Fully		Depth (in):		Outfall fully submerged and not located during this screening - screened at 01-520 US1.			
Sampling Results				Condition Assessment			
Sample Location:		Floatables:		Graffiti:		None	
Total Chlorine: -- ppm		Odor:		Erosion:		None	
Free Chlorine: -- ppm		Turbidity:		Deposition:		None in.	
Ammonia: -- ppm		Color:		Damage:		None	
pH: -- units		Gross Solids:					
Temperature -- °F		Vegetation:					
Conductivity: -- µS/cm		Benthic Growth:					
Detergents: -- mg/L		Stains:					
		Non-illicit:

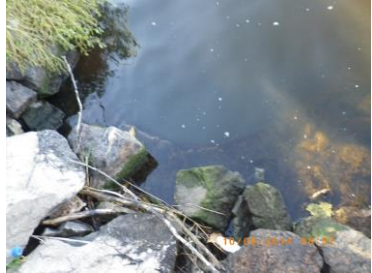
o20141009073704.JPG	
Submerged: Fully		Depth (in): 56					
Sampling Results		Floatables: None Odor: None Turbidity: None Color: None Gross Solids: None Vegetation: None Benthic Growth: Moderate Stains: None Non-illicit: None		Condition Assessment Graffiti: None Erosion: None Deposition: None in. Damage: None		<div style="text-align: center; font-size: 24pt; font-weight: bold;">2014</div>	
Sample Location: Total Chlorine: -- ppm Free Chlorine: -- ppm Ammonia: -- ppm pH: -- units Temperature: -- °F Conductivity: -- μS/cm Detergents: -- mg/L

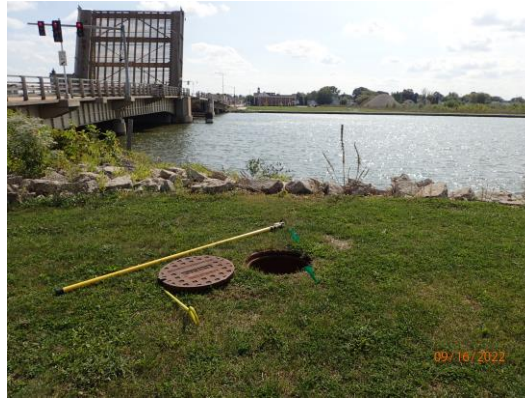
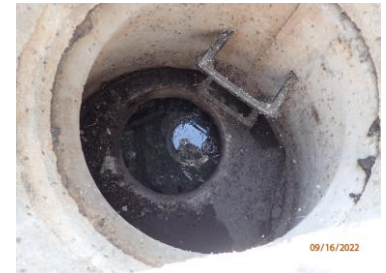
o20220916134136.JPG

**Inspection Date:** 9/16/2022 1:44:00 PM**Inspector:** EJK**Inspection Type:** Ongoing**Previous Rainfall (hrs):** 72+**Flow Description:** Submerged, indeterminate

Submerged: Partially Depth (in): 66

☐ Petrol. Sheen ☐ Suds ☐ Sewage ☒ Algae ☐ Other☐ Petroleum ☐ Musty ☐ Sewage ☐ Chlorine ☐ Other☐ VOC/Solvent ☐ Fishy ☐ Sulfur ☐ Fragrant☒ Litter ☐ Veg. Debris ☐ Sediment ☐ Other☐ Inhibited ☐ Excessive☐ Green ☐ Brown☐ Flow Line ☐ Oil ☐ Rust Stains☐ Paint ☐ Other☐ Natural Sheen ☐ Natural Suds/Foam**Physical Condition Assessment**

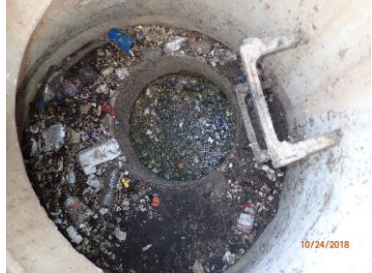
o20181024110538.JPG

Inspection Date: 10/24/2018 11:07:34 AM		Type: Ongoing	Flow: Submerged, indeterminate	Previous Rainfall (hrs): 72+
Illicit Discharge Potential: Potential		Inspector: JCW	Notes	
Submerged: Partially Depth (in): 70			Sample collected from submerged pool in manhole. Floating gross solids (litter) in manhole.	
Sampling Results		Floatables: None	Condition Assessment Graffiti: None Erosion: None Deposition: None in. Damage: None	
Sample Location: Pool		Odor: None		
Total Chlorine: 0 ppm		Turbidity: None		
Free Chlorine: 0 ppm		Color: None		
Ammonia: 0 ppm		Gross Solids: Severe		
pH: 8.02 units		Vegetation: None		
Temperature 49 °F		Benthic Growth: None		
Conductivity: 336 µS/cm		Stains: None		
Detergents: 0 mg/L		Non-illicit: None

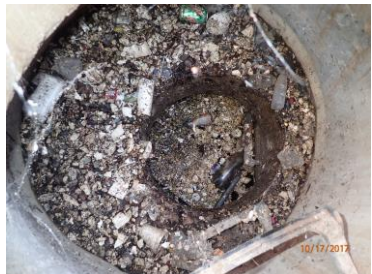
o20171017151640.JPG

Inspection Date: 10/17/2017 3:21:22 PM		Type: Ongoing	Flow: Submerged, indeterminate	Previous Rainfall (hrs): 48-72
Illicit Discharge Potential: Potential		Inspector: JCW	Notes	
Submerged: Fully Depth (in): 67			Sample collected from submerged pool in manhole. Floating gross solids (litter) in manhole.	
Sampling Results		Floatables: None	Condition Assessment Graffiti: None Erosion: None Deposition: None in. Damage: None	
Sample Location: Pool		Odor: None		
Total Chlorine: 0 ppm		Turbidity: None		
Free Chlorine: 0 ppm		Color: None		
Ammonia: 0 ppm		Gross Solids: Severe		
pH: 7.72 units		Vegetation: None		
Temperature 67 °F		Benthic Growth: None		
Conductivity: 896 µS/cm		Stains: None		
Detergents: 0 mg/L		Non-illicit: None

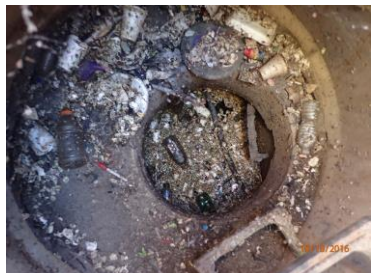
o20161018153916.JPG

Inspection Date: 10/18/2016 3:42:40 PM		Type: Ongoing	Flow: Submerged, indeterminate	Previous Rainfall (hrs): 72+
Illicit Discharge Potential: Potential		Inspector: JCW	Notes	
Submerged: Fully Depth (in): 67			Potential illicit discharge due to gross solids.	
Sampling Results		Floatables: None	Condition Assessment Graffiti: None Erosion: None Deposition: None in. Damage: None	
Sample Location: Pool		Odor: None		
Total Chlorine: 0 ppm		Turbidity: None		
Free Chlorine: 0 ppm		Color: Faint in bottle		
Ammonia: 0 ppm		Gross Solids: Severe		
pH: 8.16 units		Vegetation: None		
Temperature 66 °F		Benthic Growth: None		
Conductivity: 531 µS/cm		Stains: None		
Detergents: 0 mg/L		Non-illicit: None

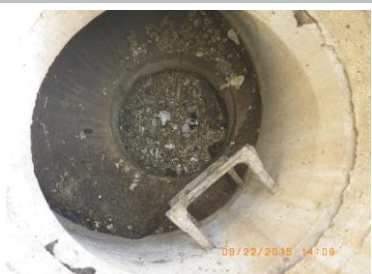
o20150922130946.JPG

Inspection Date: 9/22/2015 2:08:37 PM		Type: Ongoing	Flow: Submerged, indeterminate	Previous Rainfall (hrs): 72+
Illicit Discharge Potential: Potential		Inspector: JCW	Notes	
Submerged: Fully Depth (in): 70			Floating gross solids (litter) in manhole.	
Sampling Results		Floatables: None	Condition Assessment Graffiti: None Erosion: None Deposition: None in. Damage: None	
Sample Location: Pool		Odor: None		
Total Chlorine: 0 ppm		Turbidity: None		
Free Chlorine: 0 ppm		Color: None		
Ammonia: 0 ppm		Gross Solids: Severe		
pH: 8.1 units		Vegetation: None		
Temperature 76 °F		Benthic Growth: None		
Conductivity: 917 µS/cm		Stains: None		
Detergents: 0 mg/L		Non-illicit: None

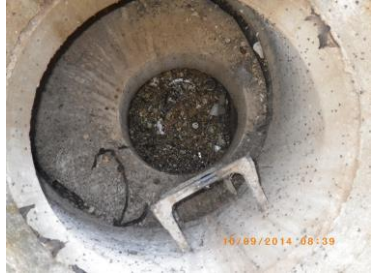
o20141009073910.JPG

Inspection Date: 10/9/2014 8:42:09 AM		Type: Ongoing	Flow: Submerged, indeterminate	Previous Rainfall (hrs): 72+
Illicit Discharge Potential: Potential		Inspector: JCW	Notes	
Submerged: Fully		Depth (in): 64	Floating gross solids (litter) inside manhole.	
Sampling Results		Floatables: None	Condition Assessment Graffiti: None Erosion: None Deposition: None in. Damage: None	
Sample Location: Pool	Odor: Faint			
Total Chlorine: 0 ppm	Turbidity: None			
Free Chlorine: 0 ppm	Color: None			
Ammonia: 0 ppm	Gross Solids: Severe			
pH: 7.84 units	Vegetation: None			
Temperature 57 °F	Benthic Growth: Slight			
Conductivity: 1318 µS/cm	Stains: None			
Detergents: 0 mg/L	Non-illicit: None

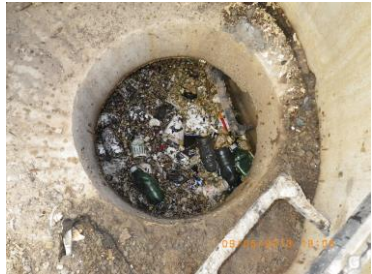
o20130905120924.JPG

Inspection Date: 9/5/2013 1:02:45 PM		Type: Ongoing	Flow: Submerged, indeterminate	Previous Rainfall (hrs): 72+
Illicit Discharge Potential: Potential		Inspector: JCW	Notes	
Submerged: Fully		Depth (in): 69	2012 screening follow-up. Significant gross solids in manhole - similar to previous years.	
Sampling Results		Floatables: None	Condition Assessment Graffiti: None Erosion: None Deposition: None in. Damage: None	
Sample Location: Pool	Odor: None			
Total Chlorine: 0 ppm	Turbidity: None			
Free Chlorine: 0 ppm	Color: None			
Ammonia: 0 ppm	Gross Solids: Severe			
pH: 8.51 units	Vegetation: None			
Temperature 76 °F	Benthic Growth: None			
Conductivity: 424 µS/cm	Stains: None			
Detergents: 0 mg/L	Non-illicit: None

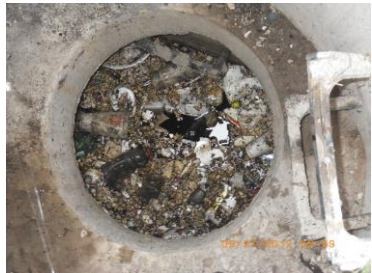
o20120927085918.JPG

Inspection Date: 9/27/2012 9:57:25 AM		Type: Ongoing	Flow: Submerged, indeterminate	Previous Rainfall (hrs): 72+
Illicit Discharge Potential: Potential		Inspector: JCW	Notes	
Submerged: Fully		Depth (in): 69	2011 gross solids follow-up.	
Sampling Results		Floatables: None	Condition Assessment Graffiti: None Erosion: None Deposition: None in. Damage: None	
Sample Location: Pool	Odor: None			
Total Chlorine: 0 ppm	Turbidity: None			
Free Chlorine: 0 ppm	Color: None			
Ammonia: 0.5 ppm	Gross Solids: Severe			
pH: 7.77 units	Vegetation: None			
Temperature 60 °F	Benthic Growth: None			
Conductivity: 542 µS/cm	Stains: Slight			
Detergents: 0 mg/L	Non-illicit: None

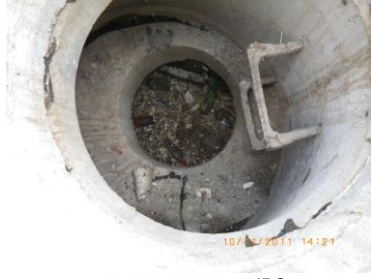
o20111011142110.JPG

Inspection Date: 10/11/2011 2:24:37 PM		Type: Ongoing	Flow: Submerged, indeterminate	Previous Rainfall (hrs): 72+
Illicit Discharge Potential: Potential		Inspector: JCW	Notes	
Submerged: Fully		Depth (in): 64	2010 screening follow-up. Floatable debris still present.	
Sampling Results				
Sample Location: Pool	Floatables:	None		
Total Chlorine: 0 ppm	Odor:	None		
Free Chlorine: 0 ppm	Turbidity:	None		
Ammonia: 0 ppm	Color:	None		
pH: 8.49 units	Gross Solids:	Severe		
Temperature 71 °F	Vegetation:	None		
Conductivity: -- µS/cm	Benthic Growth:	None		
Detergents: -- mg/L	Stains:	None		
	Non-illicit:	None		
		Condition Assessment		
		Graffiti:	None	
		Erosion:	None	
		Deposition:	None	0 in.
		Damage:	None

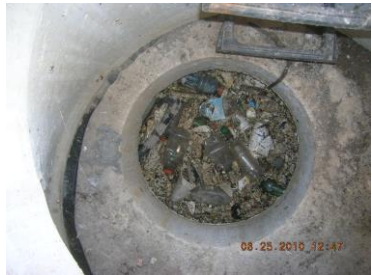
o20100825124708.JPG

Inspection Date: 8/25/2010 12:53:35 PM		Type: Ongoing	Flow: Submerged, indeterminate	Previous Rainfall (hrs): 72+
Illicit Discharge Potential: Potential		Inspector: JCW	Notes	
Submerged: Fully		Depth (in): 72	Significant floatable debris in manhole.	
Sampling Results				
Sample Location: Pool	Floatables:	None		
Total Chlorine: 0 ppm	Odor:	None		
Free Chlorine: 0 ppm	Turbidity:	None		
Ammonia: 0 ppm	Color:	Faint in bottle		
pH: 8.18 units	Gross Solids:	Severe		
Temperature 73 °F	Vegetation:	None		
Conductivity: -- µS/cm	Benthic Growth:	None		
Detergents: 0 mg/L	Stains:	None		
	Non-illicit:	None		
		Condition Assessment		
		Graffiti:	None	
		Erosion:	None	
		Deposition:	None	0 in.
		Damage:	None

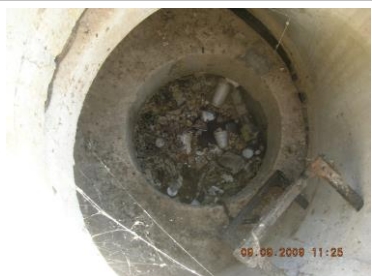
Osh09_DSCN6718.JPG

Inspection Date: 9/9/2009		Type: Initial	Flow: Submerged, indeterminate	Previous Rainfall (hrs): 72+
Illicit Discharge Potential: Potential		Inspector: JCW	Notes	
Submerged: Fully		Depth (in): 61	Abnormal detergent analysis result (bubbles). Significant floatables in manhole. Brown color.	
Sampling Results				
Sample Location: Pool	Floatables:	None		
Total Chlorine: 0 ppm	Odor:	None		
Free Chlorine: 0 ppm	Turbidity:	None		
Ammonia: -- ppm	Color:	Clearly visible in bottl		
pH: 8.6 units	Gross Solids:	Severe		
Temperature 78 °F	Vegetation:	None		
Conductivity: -- µS/cm	Benthic Growth:	None		
Detergents: 0 mg/L	Stains:	None		
	Non-illicit:	None		
		Condition Assessment		
		Graffiti:	None	
		Erosion:	None	
		Deposition:	None	0 in.
		Damage:	None

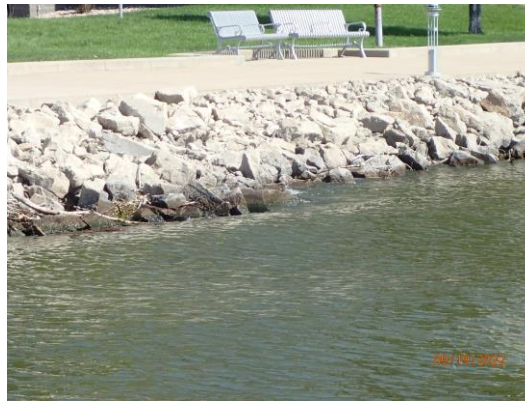
o20220919134604.JPG

Storm sewer from Marion Rd discharges to river from north.

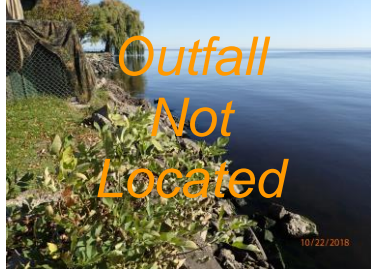
o20181022102328.JPG 2018

Inspection Date: 10/22/2018 10:23:45 AM		Type: Ongoing	Flow: Submerged (not located)	Previous Rainfall (hrs): 48-72																																		
Illicit Discharge Potential: Potential		Inspector: JCW																																				
Submerged: Fully		Depth (in):																																				
Sampling Results <table border="1" style="width:100%; border-collapse: collapse;"> <tr><td>Sample Location:</td><td></td></tr> <tr><td>Total Chlorine:</td><td>-- ppm</td></tr> <tr><td>Free Chlorine:</td><td>-- ppm</td></tr> <tr><td>Ammonia:</td><td>-- ppm</td></tr> <tr><td>pH:</td><td>-- units</td></tr> <tr><td>Temperature:</td><td>-- °F</td></tr> <tr><td>Conductivity:</td><td>-- µS/cm</td></tr> <tr><td>Detergents:</td><td>-- mg/L</td></tr> </table>		Sample Location:		Total Chlorine:	-- ppm	Free Chlorine:	-- ppm	Ammonia:	-- ppm	pH:	-- units	Temperature:	-- °F	Conductivity:	-- µS/cm	Detergents:	-- mg/L	<table border="1" style="width:100%; border-collapse: collapse;"> <tr><td>Floatables:</td><td>None</td></tr> <tr><td>Odor:</td><td>None</td></tr> <tr><td>Turbidity:</td><td>None</td></tr> <tr><td>Color:</td><td>None</td></tr> <tr><td>Gross Solids:</td><td>None</td></tr> <tr><td>Vegetation:</td><td>None</td></tr> <tr><td>Benthic Growth:</td><td>None</td></tr> <tr><td>Stains:</td><td>None</td></tr> <tr><td>Non-illicit:</td><td>None</td></tr> </table>	Floatables:	None	Odor:	None	Turbidity:	None	Color:	None	Gross Solids:	None	Vegetation:	None	Benthic Growth:	None	Stains:	None	Non-illicit:	None	Notes Outfall fully submerged and not located - screened upstream at 02-309 US1. Floating gross solids (litter) in manhole.

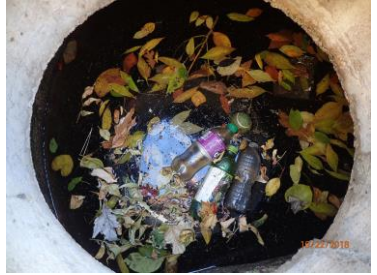
o20181022102412.JPG <div style="text-align: center; font-size: 24pt; font-weight: bold;">2018</div>

Inspection Date: 10/22/2018 10:26:35 AM		Type: Ongoing	Flow: Submerged, indeterminate	Previous Rainfall (hrs): 48-72
Illicit Discharge Potential: Potential		Inspector: JCW		
Submerged: Fully		Depth (in): 34		
Sampling Results Sample Location: Pool Total Chlorine: 0 ppm Free Chlorine: 0 ppm Ammonia: 0 ppm pH: 7.46 units Temperature: 58 °F Conductivity: 498 µS/cm Detergents: 0 mg/L		Floatables: None Odor: None Turbidity: None Color: None Gross Solids: Moderate Vegetation: None Benthic Growth: Slight Stains: None Non-illicit: None		
		Notes Sample collected from submerged pool in manhole. Floating gross solids (litter) in manhole.		
		Condition Assessment Graffiti: None Erosion: None Deposition: None in. Damage: None

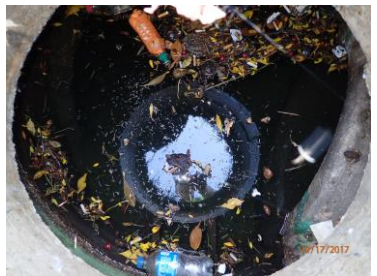
o20171017134106.JPG <div style="text-align: center; font-size: 24pt; font-weight: bold;">2017</div>

Inspection Date: 10/17/2017 1:45:07 PM		Type: Ongoing	Flow: Submerged, indeterminate	Previous Rainfall (hrs): 48-72
Illicit Discharge Potential: Potential		Inspector: JCW		
Submerged: Fully		Depth (in): 31		
Sampling Results Sample Location: Pool Total Chlorine: 0 ppm Free Chlorine: 0 ppm Ammonia: 0 ppm pH: 7.74 units Temperature: 69 °F Conductivity: 644 µS/cm Detergents: 0 mg/L		Floatables: None Odor: None Turbidity: None Color: None Gross Solids: Moderate Vegetation: None Benthic Growth: Moderate Stains: None Non-illicit: None		
		Notes Sample collected from submerged pool in manhole. Floating gross solids (litter) in manhole.		
		Condition Assessment Graffiti: None Erosion: None Deposition: None in. Damage: None

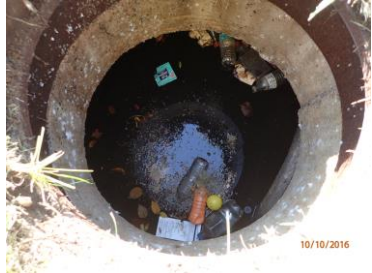
10/10/2016
o20161010103236.JPG

Inspection Date: 10/10/2016 10:35:02 AM		Type: Ongoing	Flow: Submerged, indeterminate	Previous Rainfall (hrs): 72+
Illicit Discharge Potential: Potential		Inspector: JCW	Notes	
Submerged: Fully		Depth (in): 28	Potential illicit discharge due to gross solids.	
Sampling Results		Condition Assessment		
Sample Location: Pool	Floatables: None	Graffiti: None	Erosion: None	in.
Total Chlorine: 0 ppm	Odor: None	Deposition: None	Damage: None	
Free Chlorine: 0 ppm	Turbidity: None			
Ammonia: 0 ppm	Color: None			
pH: 7.54 units	Gross Solids: Moderate			
Temperature 64 °F	Vegetation: None			
Conductivity: 592 µS/cm	Benthic Growth: None			
Detergents: 0 mg/L	Stains: None			
	Non-illicit: None

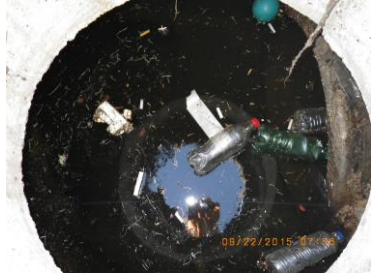
09/22/2015 07:50
o20150922065636.JPG

Inspection Date: 9/22/2015 7:50:50 AM		Type: Ongoing	Flow: Submerged, indeterminate	Previous Rainfall (hrs): 72+
Illicit Discharge Potential: Potential		Inspector: JCW	Notes	
Submerged: Fully		Depth (in): 28	Floating gross solids (litter) in manhole.	
Sampling Results		Condition Assessment		
Sample Location: Pool	Floatables: None	Graffiti: None	Erosion: None	in.
Total Chlorine: 0 ppm	Odor: None	Deposition: None	Damage: None	
Free Chlorine: 0 ppm	Turbidity: None			
Ammonia: 0 ppm	Color: None			
pH: 7.74 units	Gross Solids: Slight			
Temperature 66 °F	Vegetation: None			
Conductivity: 853 µS/cm	Benthic Growth: Slight			
Detergents: 0 mg/L	Stains: Slight			
	Non-illicit: None

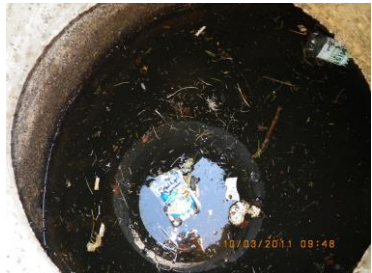
10/03/2011 09:48
o20111003094830.JPG

Inspection Date: 10/3/2011 9:47:42 AM		Type: Ongoing	Flow: Submerged, indeterminate	Previous Rainfall (hrs): 72+
Illicit Discharge Potential: Unlikely		Inspector: JCW	Notes	
Submerged: Fully		Depth (in): 32		
Sampling Results		Condition Assessment		
Sample Location: Pool	Floatables: None	Graffiti: None	Erosion: None	0 in.
Total Chlorine: 0 ppm	Odor: Faint	Deposition: None	Damage: None	
Free Chlorine: 0 ppm	Turbidity: None			
Ammonia: 0 ppm	Color: None			
pH: 7.71 units	Gross Solids: Slight			
Temperature 60 °F	Vegetation: None			
Conductivity: -- µS/cm	Benthic Growth: None			
Detergents: 0 mg/L	Stains: None			
	Non-illicit: None

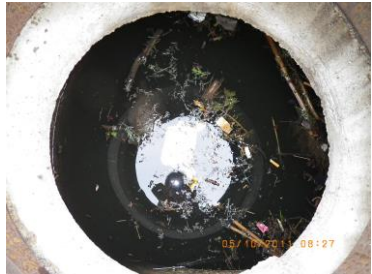
05/10/2011 08:27
o20110510082708.JPG

Inspection Date: 5/10/2011 8:27:00 AM		Type: Other	Flow: Submerged, indeterminate	Previous Rainfall (hrs): 0-24
Illicit Discharge Potential: Potential		Inspector: JCW	Notes	
Submerged: Fully		Depth (in):	Limited screening conducted for upstream manhole prescreening.	
Sampling Results		Condition Assessment		
Sample Location:	Floatables: None	Graffiti: None	Erosion: None	0 in.
Total Chlorine: -- ppm	Odor:	Deposition: None	Damage: None	
Free Chlorine: -- ppm	Turbidity:			
Ammonia: -- ppm	Color:			
pH: -- units	Gross Solids: Slight			
Temperature -- °F	Vegetation:			
Conductivity: -- µS/cm	Benthic Growth:			
Detergents: -- mg/L	Stains:			
	Non-illicit: None

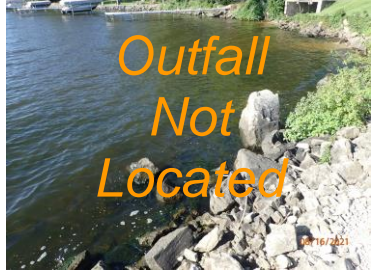
o20210816085746.JPG 2021

Inspection Date: 8/16/2021 8:57:00 AM		Type: Ongoing	Flow: Submerged (not located)	Previous Rainfall (hrs): 72+
Illicit Discharge Potential: Potential		Inspector: JCW		
Submerged: Fully		Depth (in):		
Sampling Results		Notes Outfall fully submerged and not located - screened upstream at 02-357 US1. Floating gross solids (litter) in upstream manhole.		
Sample Location:	Floatables:	None		
Total Chlorine: -- ppm	Odor:	None		
Free Chlorine: -- ppm	Turbidity:	None		
Ammonia: -- ppm	Color:	None		
pH: -- units	Gross Solids:	None		
Temperature -- °F	Vegetation:	None		
Conductivity: -- µS/cm	Benthic Growth:	None		
Detergents: -- mg/L	Stains:	None		
	Non-illicit:	None		
		Condition Assessment Graffiti: None Erosion: None Deposition: None in. Damage: None

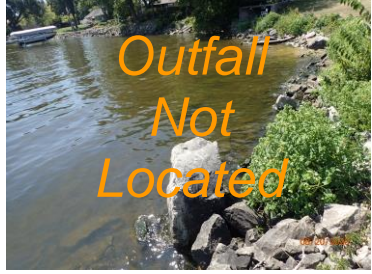
o20200820130304.JPG 2020

Inspection Date: 8/20/2020 1:04:00 PM		Type: Ongoing	Flow: Submerged (not located)	Previous Rainfall (hrs): 72+
Illicit Discharge Potential: Potential		Inspector: JCW		
Submerged: Fully		Depth (in):		
Sampling Results		Notes Outfall fully submerged and not located - screened upstream at 02-357 US1. Floating gross solids (litter) in upstream manhole.		
Sample Location:	Floatables:	None		
Total Chlorine: -- ppm	Odor:	None		
Free Chlorine: -- ppm	Turbidity:	None		
Ammonia: -- ppm	Color:	None		
pH: -- units	Gross Solids:	None		
Temperature -- °F	Vegetation:	None		
Conductivity: -- µS/cm	Benthic Growth:	None		
Detergents: -- mg/L	Stains:	None		
	Non-illicit:	None		
		Condition Assessment Graffiti: None Erosion: None Deposition: None in. Damage: None

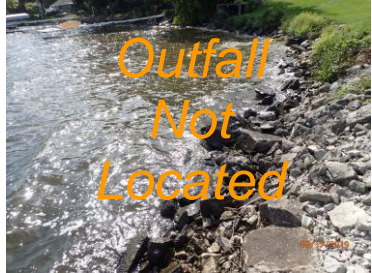
o20190917131538.JPG 2019

Inspection Date: 9/17/2019 2:15:46 PM		Type: Ongoing	Flow: Submerged (not located)	Previous Rainfall (hrs): 48-72
Illicit Discharge Potential: Potential		Inspector: JCW		
Submerged: Fully		Depth (in):		
Sampling Results		Notes Outfall fully submerged and not located - screened upstream at 02-357 US1. Floating gross solids (litter) in manhole.		
Sample Location:	Floatables:	None		
Total Chlorine: -- ppm	Odor:	None		
Free Chlorine: -- ppm	Turbidity:	None		
Ammonia: -- ppm	Color:	None		
pH: -- units	Gross Solids:	None		
Temperature -- °F	Vegetation:	None		
Conductivity: -- µS/cm	Benthic Growth:	None		
Detergents: -- mg/L	Stains:	None		
	Non-illicit:	None		
		Condition Assessment Graffiti: None Erosion: None Deposition: None in. Damage: None

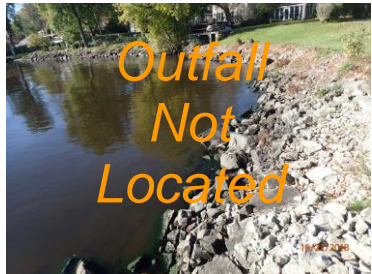
o20181022101158.JPG 2018

Inspection Date: 10/22/2018 10:13:07 AM		Type: Ongoing	Flow: Submerged (not located)	Previous Rainfall (hrs): 48-72
Illicit Discharge Potential: Potential		Inspector: JCW		
Submerged: Fully		Depth (in):		
Sampling Results		Notes Outfall fully submerged and not located - screened upstream at 02-357 US1. Floating gross solids (litter) in manhole.		
Sample Location:	Floatables:	None		
Total Chlorine: -- ppm	Odor:	None		
Free Chlorine: -- ppm	Turbidity:	None		
Ammonia: -- ppm	Color:	None		
pH: -- units	Gross Solids:	None		
Temperature -- °F	Vegetation:	None		
Conductivity: -- µS/cm	Benthic Growth:	None		
Detergents: -- mg/L	Stains:	None		
	Non-illicit:	None		
		Condition Assessment Graffiti: None Erosion: None Deposition: None in. Damage: None

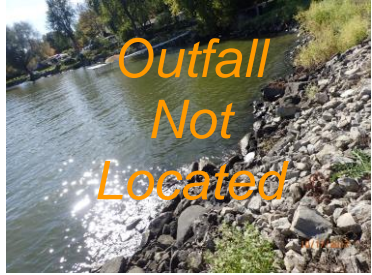
<small>o20171017133026.JPG</small> <div style="font-size: 24pt; font-weight: bold; color: black;">2017</div>

Inspection Date: 10/17/2017 1:32:28 PM		Type: Ongoing	Flow: Submerged (not located)	Previous Rainfall (hrs): 48-72
Illicit Discharge Potential: Potential		Inspector: JCW		<div style="border: 1px solid black; padding: 5px;"> Notes Outfall fully submerged and not located - screened upstream at 02-357 US1. Floating gross solids (litter) in manhole. </div> <div style="border: 1px solid black; padding: 5px; margin-top: 5px;"> Condition Assessment Graffiti: None Erosion: None Deposition: None in. Damage: None </div>
Submerged: Fully		Depth (in):		
<div style="border: 1px solid black; padding: 5px;"> Sampling Results Sample Location: Total Chlorine: -- ppm Free Chlorine: -- ppm Ammonia: -- ppm pH: -- units Temperature: -- °F Conductivity: -- µS/cm Detergents: -- mg/L </div>		<div style="border: 1px solid black; padding: 5px;"> Floatables: None Odor: None Turbidity: None Color: None Gross Solids: None Vegetation: None Benthic Growth: None Stains: None Non-illicit: None </div>

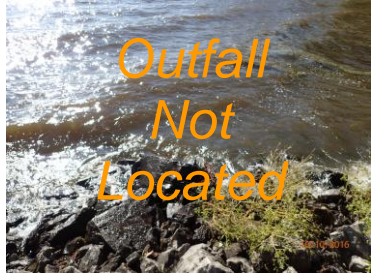
<small>o20161010105240.JPG</small> <div style="font-size: 24pt; font-weight: bold; color: black;">2016</div>

Inspection Date: 10/10/2016 10:53:43 AM		Type: Ongoing	Flow: Submerged (not located)	Previous Rainfall (hrs): 72+
Illicit Discharge Potential: Potential		Inspector: JCW		<div style="border: 1px solid black; padding: 5px;"> Notes Outfall fully submerged and not located - screened upstream at 02-357 US1. </div> <div style="border: 1px solid black; padding: 5px; margin-top: 5px;"> Condition Assessment Graffiti: None Erosion: None Deposition: None in. Damage: None </div>
Submerged: Fully		Depth (in):		
<div style="border: 1px solid black; padding: 5px;"> Sampling Results Sample Location: Total Chlorine: -- ppm Free Chlorine: -- ppm Ammonia: -- ppm pH: -- units Temperature: -- °F Conductivity: -- µS/cm Detergents: -- mg/L </div>		<div style="border: 1px solid black; padding: 5px;"> Floatables: None Odor: None Turbidity: None Color: None Gross Solids: None Vegetation: None Benthic Growth: None Stains: None Non-illicit: None </div>

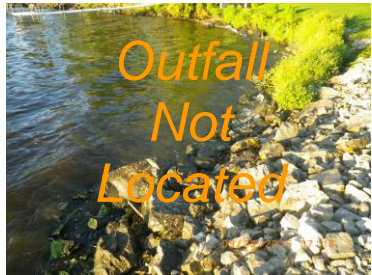
<small>o20150922061856.JPG</small> <div style="font-size: 24pt; font-weight: bold; color: black;">2015</div>

Inspection Date: 9/22/2015 7:14:30 AM		Type: Ongoing	Flow: Submerged (not located)	Previous Rainfall (hrs): 72+
Illicit Discharge Potential: Potential		Inspector: JCW		<div style="border: 1px solid black; padding: 5px;"> Notes Outfall fully submerged and not located - screened upstream at 02-357 US1. </div> <div style="border: 1px solid black; padding: 5px; margin-top: 5px;"> Condition Assessment Graffiti: None Erosion: None Deposition: None in. Damage: None </div>
Submerged: Fully		Depth (in):		
<div style="border: 1px solid black; padding: 5px;"> Sampling Results Sample Location: Total Chlorine: -- ppm Free Chlorine: -- ppm Ammonia: -- ppm pH: -- units Temperature: -- °F Conductivity: -- µS/cm Detergents: -- mg/L </div>		<div style="border: 1px solid black; padding: 5px;"> Floatables: None Odor: None Turbidity: None Color: None Gross Solids: None Vegetation: None Benthic Growth: None Stains: None Non-illicit: None </div>

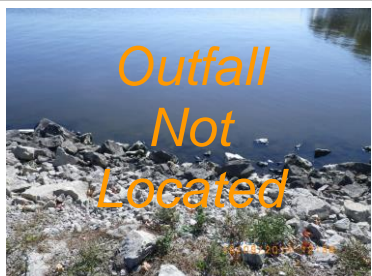
<small>o20141009113806.JPG</small> <div style="font-size: 24pt; font-weight: bold; color: black;">2014</div>

Inspection Date: 10/9/2014 12:37:08 PM		Type: Ongoing	Flow: Submerged (not located)	Previous Rainfall (hrs): 72+
Illicit Discharge Potential: Potential		Inspector: JCW		<div style="border: 1px solid black; padding: 5px;"> Notes Outfall fully submerged and not located - screened upstream at 02-357 US1. </div> <div style="border: 1px solid black; padding: 5px; margin-top: 5px;"> Condition Assessment Graffiti: None Erosion: None Deposition: None in. Damage: None </div>
Submerged: Fully		Depth (in):		
<div style="border: 1px solid black; padding: 5px;"> Sampling Results Sample Location: Total Chlorine: -- ppm Free Chlorine: -- ppm Ammonia: -- ppm pH: -- units Temperature: -- °F Conductivity: -- µS/cm Detergents: -- mg/L </div>		<div style="border: 1px solid black; padding: 5px;"> Floatables: None Odor: None Turbidity: None Color: None Gross Solids: None Vegetation: None Benthic Growth: None Stains: None Non-illicit: None </div>

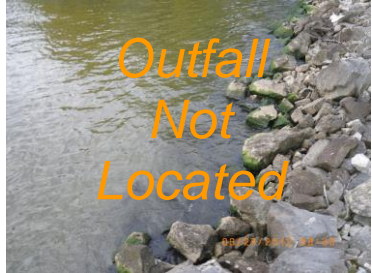
o20120927073330.JPG

Inspection Date: 9/27/2012 8:29:10 AM		Type: Ongoing	Flow: Submerged (not located)	Previous Rainfall (hrs): 72+
Illicit Discharge Potential: Unlikely		Inspector: JCW		
Submerged: Fully		Depth (in):		
Sampling Results		Notes		
Sample Location:	Floatables:	Outfall fully submerged; screened upstream at 02-357 US1. Condition Assessment Graffiti: None Erosion: None Deposition: None in. Damage: None		
Total Chlorine: -- ppm	Odor:			
Free Chlorine: -- ppm	Turbidity:			
Ammonia: -- ppm	Color:			
pH: -- units	Gross Solids:			
Temperature -- °F	Vegetation:			
Conductivity: -- µS/cm	Benthic Growth:			
Detergents: -- mg/L	Stains:			
	Non-illicit:

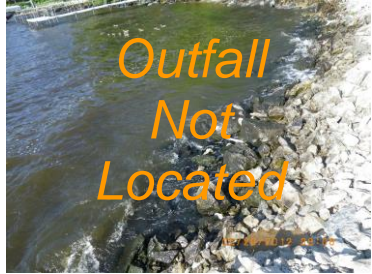
o20120620070830.JPG

Inspection Date: 6/20/2012 8:05:53 AM		Type: Other	Flow: Submerged (not located)	Previous Rainfall (hrs): 24-48
Illicit Discharge Potential: Unlikely		Inspector: JCW		
Submerged: Fully		Depth (in):		
Sampling Results		Notes		
Sample Location:	Floatables:	Gross solids pre-screening. Outfall fully submerged; screened upstream at 02-357 US1. Condition Assessment Graffiti: None Erosion: None Deposition: None in. Damage: None		
Total Chlorine: -- ppm	Odor:			
Free Chlorine: -- ppm	Turbidity:			
Ammonia: -- ppm	Color:			
pH: -- units	Gross Solids:			
Temperature -- °F	Vegetation:			
Conductivity: -- µS/cm	Benthic Growth:			
Detergents: -- mg/L	Stains:			
	Non-illicit:

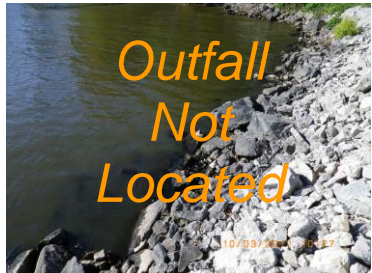
o20111003102714.JPG

Inspection Date: 10/3/2011 10:26:14 AM		Type: Ongoing	Flow: Submerged (not located)	Previous Rainfall (hrs): 72+
Illicit Discharge Potential: Potential		Inspector: JCW		
Submerged: Fully		Depth (in):		
Sampling Results		Notes		
Sample Location:	Floatables:	Outfall fully submerged and not physically located. Outfall screened upstream at 02-357 US1. Condition Assessment Graffiti: None Erosion: None Deposition: None 0 in. Damage: None		
Total Chlorine: -- ppm	Odor:			
Free Chlorine: -- ppm	Turbidity:			
Ammonia: -- ppm	Color:			
pH: -- units	Gross Solids:			
Temperature -- °F	Vegetation:			
Conductivity: -- µS/cm	Benthic Growth:			
Detergents: -- mg/L	Stains:			
	Non-illicit:

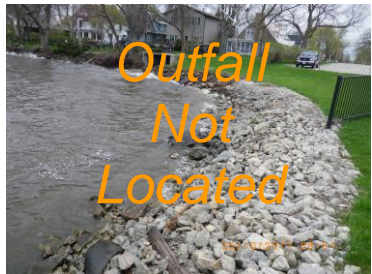
o20110510085116.JPG

Inspection Date: 5/10/2011 8:51:00 AM		Type: Other	Flow: Submerged (not located)	Previous Rainfall (hrs): 0-24
Illicit Discharge Potential: Potential		Inspector: JCW		
Submerged: Fully		Depth (in):		
Sampling Results		Notes		
Sample Location:	Floatables:	Outfall fully submerged and not physically located. Outfall screened upstream at 02-357 US1. Condition Assessment Graffiti: None Erosion: None Deposition: None 0 in. Damage: None		
Total Chlorine: -- ppm	Odor:			
Free Chlorine: -- ppm	Turbidity:			
Ammonia: -- ppm	Color:			
pH: -- units	Gross Solids:			
Temperature -- °F	Vegetation:			
Conductivity: -- µS/cm	Benthic Growth:			
Detergents: -- mg/L	Stains:			
	Non-illicit:

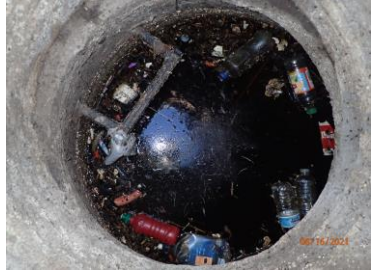
o20210816085830.JPG

Inspection Date: 8/16/2021 9:01:46 AM		Type: Ongoing	Flow: Submerged, indeterminate	Previous Rainfall (hrs): 72+
Illicit Discharge Potential: Potential		Inspector: JCW		
Submerged: Fully		Depth (in): 44		
Sampling Results		Notes Sample collected from submerged pool in manhole. Floating gross solids (litter) in manhole.		
Sample Location: Pool	Floatables: None	Condition Assessment Graffiti: None Erosion: None Deposition: None in. Damage: None		
Total Chlorine: 0 ppm	Odor: None			
Free Chlorine: 0 ppm	Turbidity: None			
Ammonia: 0 ppm	Color: None			
pH: 7.59 units	Gross Solids: Moderate			
Temperature 73 °F	Vegetation: None			
Conductivity: 392 µS/cm	Benthic Growth: None			
Detergents: 0 mg/L	Stains: None			
	Non-illicit: None

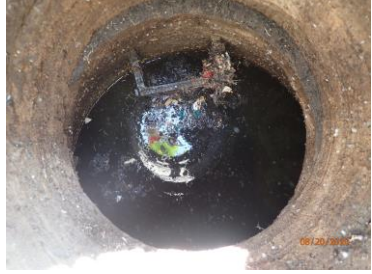
o20200820130342.JPG

Inspection Date: 8/20/2020 1:06:54 PM		Type: Ongoing	Flow: Submerged, indeterminate	Previous Rainfall (hrs): 72+
Illicit Discharge Potential: Potential		Inspector: JCW		
Submerged: Fully		Depth (in): 42		
Sampling Results		Notes Sample collected from submerged pool in manhole. Floating gross solids (litter) in manhole.		
Sample Location: Pool	Floatables: None	Condition Assessment Graffiti: None Erosion: None Deposition: None in. Damage: None		
Total Chlorine: 0 ppm	Odor: None			
Free Chlorine: 0 ppm	Turbidity: None			
Ammonia: 0 ppm	Color: None			
pH: 8.83 units	Gross Solids: Moderate			
Temperature 83 °F	Vegetation: None			
Conductivity: 404 µS/cm	Benthic Growth: None			
Detergents: 0 mg/L	Stains: None			
	Non-illicit: None

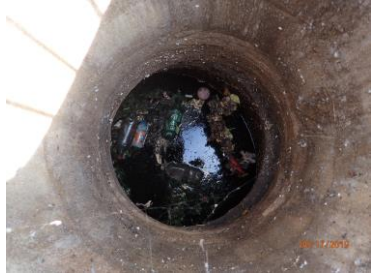
o20190917131642.JPG

Inspection Date: 9/17/2019 2:18:49 PM		Type: Ongoing	Flow: Submerged, indeterminate	Previous Rainfall (hrs): 48-72
Illicit Discharge Potential: Potential		Inspector: JCW		
Submerged: Fully		Depth (in): 42		
Sampling Results		Notes Sample collected from submerged pool in manhole. Floating gross solids (litter) in manhole.		
Sample Location: Pool	Floatables: None	Condition Assessment Graffiti: None Erosion: None Deposition: None in. Damage: None		
Total Chlorine: 0 ppm	Odor: None			
Free Chlorine: 0 ppm	Turbidity: None			
Ammonia: 0 ppm	Color: None			
pH: 8.03 units	Gross Solids: Moderate			
Temperature 76 °F	Vegetation: None			
Conductivity: 404 µS/cm	Benthic Growth: None			
Detergents: 0 mg/L	Stains: None			
	Non-illicit: None

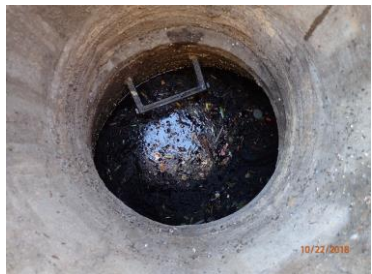
o20181022101258.JPG

Inspection Date: 10/22/2018 10:15:43 AM		Type: Ongoing	Flow: Submerged, indeterminate	Previous Rainfall (hrs): 48-72
Illicit Discharge Potential: Potential		Inspector: JCW		
Submerged: Fully		Depth (in): 43		
Sampling Results		Notes Sample collected from submerged pool in manhole. Floating gross solids (litter) in manhole.		
Sample Location: Pool	Floatables: None	Condition Assessment Graffiti: None Erosion: None Deposition: None in. Damage: None		
Total Chlorine: 0 ppm	Odor: None			
Free Chlorine: 0 ppm	Turbidity: None			
Ammonia: 0 ppm	Color: None			
pH: 7.17 units	Gross Solids: Slight			
Temperature 60 °F	Vegetation: None			
Conductivity: 506 µS/cm	Benthic Growth: None			
Detergents: 0 mg/L	Stains: None			
	Non-illicit: None

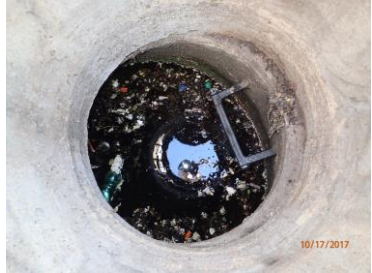
o20171017133104.JPG

Inspection Date: 10/17/2017 1:35:20 PM		Type: Ongoing	Flow: Submerged, indeterminate	Previous Rainfall (hrs): 48-72
Illicit Discharge Potential: Potential		Inspector: JCW	Notes	
Submerged: Fully		Depth (in): 39	Sample collected from submerged pool in manhole. Floating gross solids (litter) in manhole.	
Sampling Results		Condition Assessment		
Sample Location: Pool	Floatables: None	Graffiti: None	in.	
Total Chlorine: 0 ppm	Odor: None	Erosion: None		
Free Chlorine: 0 ppm	Turbidity: None	Deposition: None		
Ammonia: 0 ppm	Color: None	Damage: None		
pH: 7.57 units	Gross Solids: Moderate			
Temperature 67 °F	Vegetation: None			
Conductivity: 537 µS/cm	Benthic Growth: None			
Detergents: 0 mg/L	Stains: None			
	Non-illicit: None

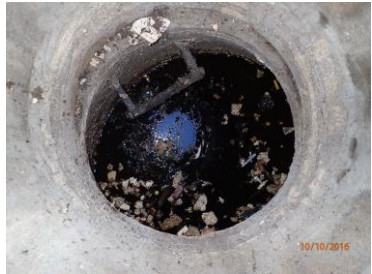
o20161010105436.JPG

Inspection Date: 10/10/2016 10:57:04 AM		Type: Ongoing	Flow: Submerged, indeterminate	Previous Rainfall (hrs): 72+
Illicit Discharge Potential: Potential		Inspector: JCW	Notes	
Submerged: Fully		Depth (in): 37	Potential illicit discharge due to gross solids.	
Sampling Results		Condition Assessment		
Sample Location: Pool	Floatables: None	Graffiti: None	in.	
Total Chlorine: 0 ppm	Odor: None	Erosion: None		
Free Chlorine: 0 ppm	Turbidity: None	Deposition: None		
Ammonia: 0 ppm	Color: None	Damage: None		
pH: 7.54 units	Gross Solids: Moderate			
Temperature 65 °F	Vegetation: None			
Conductivity: 654 µS/cm	Benthic Growth: None			
Detergents: 0 mg/L	Stains: None			
	Non-illicit: None

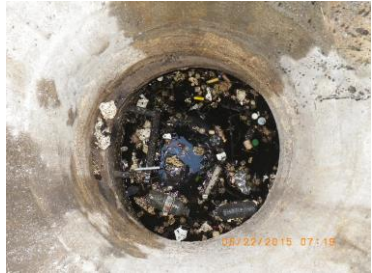
o20150922061944.JPG

Inspection Date: 9/22/2015 7:15:12 AM		Type: Ongoing	Flow: Submerged, indeterminate	Previous Rainfall (hrs): 72+
Illicit Discharge Potential: Potential		Inspector: JCW	Notes	
Submerged: Fully		Depth (in): 39	Floating gross solids (litter) in manhole.	
Sampling Results		Condition Assessment		
Sample Location: Pool	Floatables: None	Graffiti: None	in.	
Total Chlorine: 0 ppm	Odor: None	Erosion: None		
Free Chlorine: 0 ppm	Turbidity: None	Deposition: None		
Ammonia: 0 ppm	Color: None	Damage: None		
pH: 7.84 units	Gross Solids: Moderate			
Temperature 65 °F	Vegetation: None			
Conductivity: 459 µS/cm	Benthic Growth: None			
Detergents: 0 mg/L	Stains: None			
	Non-illicit: None

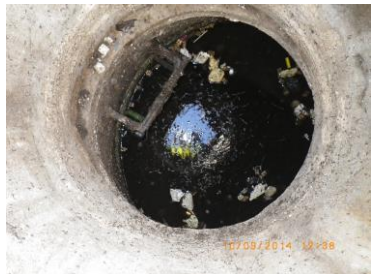
o20141009113842.JPG

Inspection Date: 10/9/2014 12:40:37 PM		Type: Ongoing	Flow: Submerged, indeterminate	Previous Rainfall (hrs): 72+
Illicit Discharge Potential: Potential		Inspector: JCW	Notes	
Submerged: Fully		Depth (in): 35	Floating gross solids (litter) in manhole.	
Sampling Results		Condition Assessment		
Sample Location: Pool	Floatables: None	Graffiti: None	in.	
Total Chlorine: 0 ppm	Odor: None	Erosion: None		
Free Chlorine: 0 ppm	Turbidity: None	Deposition: None		
Ammonia: 0 ppm	Color: None	Damage: None		
pH: 7.58 units	Gross Solids: Moderate			
Temperature 62 °F	Vegetation: None			
Conductivity: 707 µS/cm	Benthic Growth: None			
Detergents: 0 mg/L	Stains: None			
	Non-illicit: None

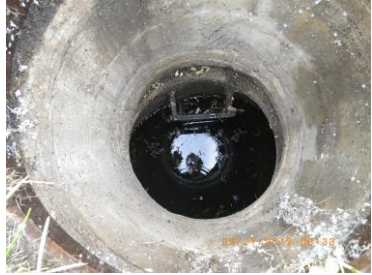
o20120927073352.JPG <div style="text-align: center; font-size: 24pt; font-weight: bold;">2012</div>

Sampling Results		Floatables:	None	Sample Location:	Pool	Odor:	None	Total Chlorine:	0 ppm	Turbidity:	None	Free Chlorine:	0 ppm	Color:	None	Ammonia:	0 ppm	Gross Solids:	Slight	pH:	7.73 units	Vegetation:	None	Temperature:	60 °F	Benthic Growth:	None	Conductivity:	518 µS/cm	Stains:	None	Detergents:	0 mg/L	Non-illicit:	None
Sampling Results		Floatables:	None																																					
Sample Location:	Pool	Odor:	None																																					
Total Chlorine:	0 ppm	Turbidity:	None																																					
Free Chlorine:	0 ppm	Color:	None																																					
Ammonia:	0 ppm	Gross Solids:	Slight																																					
pH:	7.73 units	Vegetation:	None																																					
Temperature:	60 °F	Benthic Growth:	None																																					
Conductivity:	518 µS/cm	Stains:	None																																					
Detergents:	0 mg/L	Non-illicit:	None																																					
			Condition Assessment Graffiti: None Erosion: None Deposition: None in. Damage: None

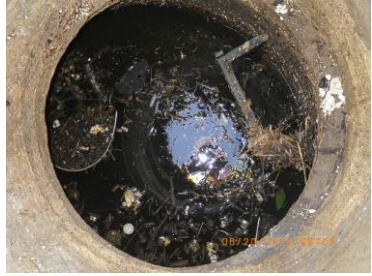
o20120620070908.JPG <div style="text-align: center; font-size: 24pt; font-weight: bold;">2012</div>

Inspection Date: 6/20/2012 8:08:37 AM		Type: Other	Flow: Submerged, indeterminate	Previous Rainfall (hrs): 24-48																																				
Illicit Discharge Potential: Unlikely		Inspector: JCW	Notes																																					
Submerged: Fully		Depth (in): 43	Gross solids pre-screening.

Sampling Results		Floatables:	None	Sample Location:		Odor:	None	Total Chlorine:	-- ppm	Turbidity:	None	Free Chlorine:	-- ppm	Color:	None	Ammonia:	-- ppm	Gross Solids:	Moderate	pH:	-- units	Vegetation:	None	Temperature:	-- °F	Benthic Growth:	Slight	Conductivity:	-- µS/cm	Stains:	None	Detergents:	-- mg/L	Non-illicit:	None
Sampling Results		Floatables:	None																																					
Sample Location:		Odor:	None																																					
Total Chlorine:	-- ppm	Turbidity:	None																																					
Free Chlorine:	-- ppm	Color:	None																																					
Ammonia:	-- ppm	Gross Solids:	Moderate																																					
pH:	-- units	Vegetation:	None																																					
Temperature:	-- °F	Benthic Growth:	Slight																																					
Conductivity:	-- µS/cm	Stains:	None																																					
Detergents:	-- mg/L	Non-illicit:	None																																					
			Condition Assessment Graffiti: None Erosion: None Deposition: None in. Damage: None

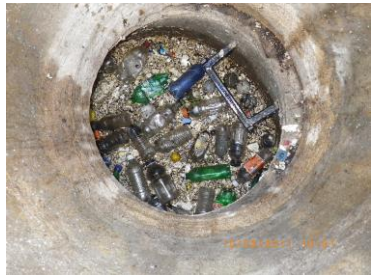
o20111003103104.JPG <div style="text-align: center; font-size: 24pt; font-weight: bold;">2011</div>

Inspection Date: 10/3/2011 10:30:08 AM		Type: Ongoing	Flow: Submerged, indeterminate	Previous Rainfall (hrs): 72+																																				
Illicit Discharge Potential: Potential		Inspector: JCW	Notes																																					
Submerged: Fully		Depth (in): 39	Significant floatable debris in manhole.

Sampling Results		Floatables:	None	Sample Location:	Pool	Odor:	None	Total Chlorine:	0 ppm	Turbidity:	None	Free Chlorine:	0 ppm	Color:	None	Ammonia:	0 ppm	Gross Solids:	Severe	pH:	7.1 units	Vegetation:	None	Temperature:	61 °F	Benthic Growth:	None	Conductivity:	-- µS/cm	Stains:	None	Detergents:	0 mg/L	Non-illicit:	None
Sampling Results		Floatables:	None																																					
Sample Location:	Pool	Odor:	None																																					
Total Chlorine:	0 ppm	Turbidity:	None																																					
Free Chlorine:	0 ppm	Color:	None																																					
Ammonia:	0 ppm	Gross Solids:	Severe																																					
pH:	7.1 units	Vegetation:	None																																					
Temperature:	61 °F	Benthic Growth:	None																																					
Conductivity:	-- µS/cm	Stains:	None																																					
Detergents:	0 mg/L	Non-illicit:	None																																					
			Condition Assessment Graffiti: None Erosion: None Deposition: None 0 in. Damage: None

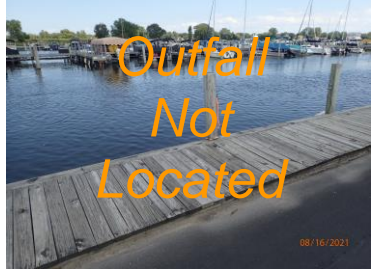
Inspection Date: 8/16/2021 1:21:13 PM		Type: Ongoing	Flow: Submerged (not located)	Previous Rainfall (hrs): 72+
Illicit Discharge Potential: Unlikely		Inspector: JCW		
Submerged: Fully		Depth (in):		
Sampling Results Sample Location: _____ Total Chlorine: -- ppm Free Chlorine: -- ppm Ammonia: -- ppm pH: -- units Temperature: -- °F Conductivity: -- µS/cm Detergents: -- mg/L		Floatables: None Odor: None Turbidity: None Color: None Gross Solids: None Vegetation: None Benthic Growth: None Stains: None Non-illicit: None	Notes Outfall fully submerged and not located - screened upstream at 03-119 US1.

o20210816131918.JPG 2021
		Condition Assessment Graffiti: None Erosion: None Deposition: None in. Damage: None

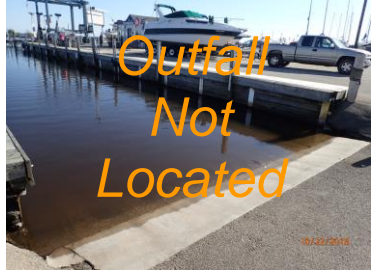
Inspection Date: 10/22/2018 2:02:38 PM		Type: Ongoing	Flow: Submerged (not located)	Previous Rainfall (hrs): 48-72
Illicit Discharge Potential: Unlikely		Inspector: JCW		
Submerged: Fully		Depth (in):		
Sampling Results Sample Location: _____ Total Chlorine: -- ppm Free Chlorine: -- ppm Ammonia: -- ppm pH: -- units Temperature: -- °F Conductivity: -- µS/cm Detergents: -- mg/L		Floatables: None Odor: None Turbidity: None Color: None Gross Solids: None Vegetation: None Benthic Growth: None Stains: None Non-illicit: None	Notes Outfall fully submerged and not located - screened upstream at 03-119 US1.

o20181022140104.JPG 2018
		Condition Assessment Graffiti: None Erosion: None Deposition: None in. Damage: None

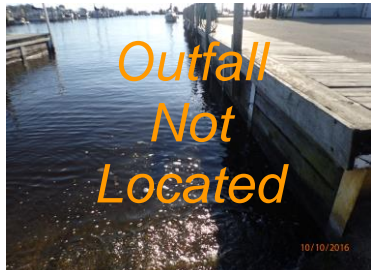
Inspection Date: 10/10/2016 8:46:57 AM		Type: Ongoing	Flow: Submerged (not located)	Previous Rainfall (hrs): 72+
Illicit Discharge Potential: Unlikely		Inspector: JCW		
Submerged: Fully		Depth (in):		
Sampling Results Sample Location: _____ Total Chlorine: -- ppm Free Chlorine: -- ppm Ammonia: -- ppm pH: -- units Temperature: -- °F Conductivity: -- µS/cm Detergents: -- mg/L		Floatables: None Odor: None Turbidity: None Color: None Gross Solids: None Vegetation: None Benthic Growth: None Stains: None Non-illicit: None	Notes Outfall fully submerged and not located - screened upstream at 03-119 US1.

o20161010084558.JPG 2016
		Condition Assessment Graffiti: None Erosion: None Deposition: None in. Damage: None

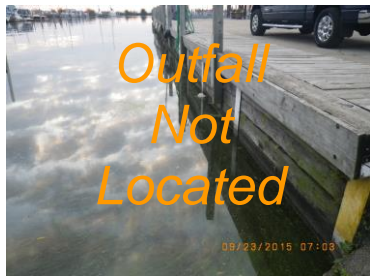
Inspection Date: 9/23/2015 7:00:50 AM		Type: Ongoing	Flow: Submerged (not located)	Previous Rainfall (hrs): 72+
Illicit Discharge Potential: Unlikely		Inspector: JCW		
Submerged: Fully		Depth (in):		
Sampling Results				
Sample Location:	Floatables:	None		
Total Chlorine: -- ppm	Odor:	None		
Free Chlorine: -- ppm	Turbidity:	None		
Ammonia: -- ppm	Color:	None		
pH: -- units	Gross Solids:	None		
Temperature -- °F	Vegetation:	None		
Conductivity: -- µS/cm	Benthic Growth:	None		
Detergents: -- mg/L	Stains:	None		
	Non-illicit:	None		
		Notes Outfall fully submerged and not located - screened at 03-119 US1.		
		Condition Assessment Graffiti: None Erosion: None Deposition: None in. Damage: None

o20150923060350.JPG <div style="text-align: center; font-weight: bold; font-size: 1.2em;">2015</div>

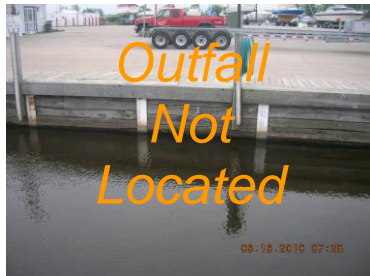
Inspection Date: 8/18/2010 7:32:47 AM		Type: Ongoing	Flow: Submerged (not located)	Previous Rainfall (hrs): 72+
Illicit Discharge Potential: Unlikely		Inspector: JCW		
Submerged: Fully		Depth (in):		
Sampling Results				
Sample Location:	Floatables:	None		
Total Chlorine: -- ppm	Odor:	None		
Free Chlorine: -- ppm	Turbidity:	None		
Ammonia: -- ppm	Color:	None		
pH: -- units	Gross Solids:	None		
Temperature -- °F	Vegetation:	None		
Conductivity: -- µS/cm	Benthic Growth:	None		
Detergents: -- mg/L	Stains:	None		
	Non-illicit:	None		
		Notes Outfall fully submerged and not physically located. Outfall screened upstream at 03-119 US1.		
		Condition Assessment Graffiti: None Erosion: None Deposition: None 0 in. Damage: None

o20100818072558.JPG <div style="text-align: center; font-weight: bold; font-size: 1.2em;">2010</div>

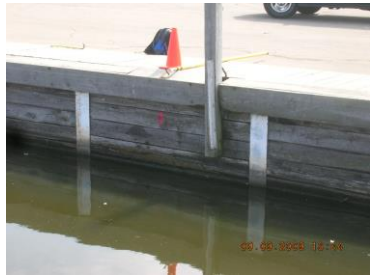
Inspection Date: 9/9/2009		Type: Initial	Flow: Submerged, indeterminate	Previous Rainfall (hrs): 72+
Illicit Discharge Potential: Unlikely		Inspector: JCW		
Submerged: Fully		Depth (in):		
Sampling Results				
Sample Location:	Floatables:			
Total Chlorine: -- ppm	Odor:			
Free Chlorine: -- ppm	Turbidity:			
Ammonia: -- ppm	Color:			
pH: -- units	Gross Solids:			
Temperature -- °F	Vegetation:			
Conductivity: -- µS/cm	Benthic Growth:			
Detergents: -- mg/L	Stains:			
	Non-illicit:	None		
		Notes		
		Condition Assessment Graffiti: None Erosion: None Deposition: None in. Damage: None

Osh09_DSCN6741.JPG <div style="text-align: center; font-weight: bold; font-size: 1.2em;">2009</div>

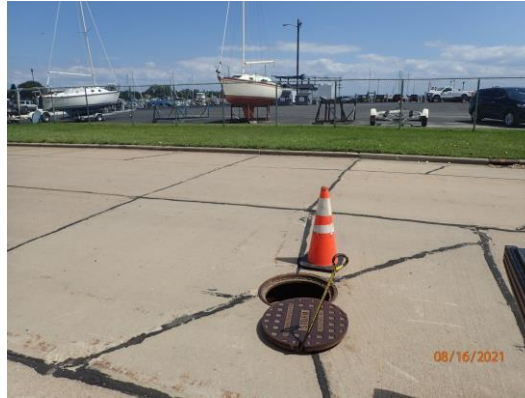
o20210816132338.JPG

Upstream manhole located approx 245 ft WSW of outfall 03-119. Intermediate area consists of street right-of-way and paved parking area with no observed inlets.

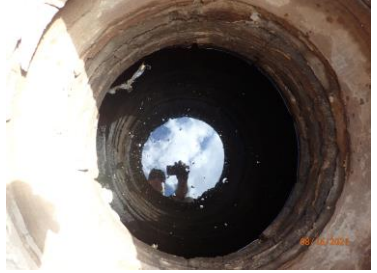
Inspection Date: 8/16/2021 1:26:50 PM		Type: Ongoing	Flow: Submerged, indeterminate	Previous Rainfall (hrs): 72+																																		
Illicit Discharge Potential: Unlikely		Inspector: JCW																																				
Submerged: Fully		Depth (in): 34																																				
Sampling Results <table border="1" style="width:100%; border-collapse: collapse;"> <tr><td>Sample Location:</td><td>Pool</td></tr> <tr><td>Total Chlorine:</td><td>0 ppm</td></tr> <tr><td>Free Chlorine:</td><td>0 ppm</td></tr> <tr><td>Ammonia:</td><td>0 ppm</td></tr> <tr><td>pH:</td><td>7.41 units</td></tr> <tr><td>Temperature:</td><td>79 °F</td></tr> <tr><td>Conductivity:</td><td>372 µS/cm</td></tr> <tr><td>Detergents:</td><td>0 mg/L</td></tr> </table>		Sample Location:	Pool	Total Chlorine:	0 ppm	Free Chlorine:	0 ppm	Ammonia:	0 ppm	pH:	7.41 units	Temperature:	79 °F	Conductivity:	372 µS/cm	Detergents:	0 mg/L	<table border="1" style="width:100%; border-collapse: collapse;"> <tr><td>Floatables:</td><td>None</td></tr> <tr><td>Odor:</td><td>None</td></tr> <tr><td>Turbidity:</td><td>None</td></tr> <tr><td>Color:</td><td>None</td></tr> <tr><td>Gross Solids:</td><td>None</td></tr> <tr><td>Vegetation:</td><td>None</td></tr> <tr><td>Benthic Growth:</td><td>None</td></tr> <tr><td>Stains:</td><td>None</td></tr> <tr><td>Non-illicit:</td><td>None</td></tr> </table>	Floatables:	None	Odor:	None	Turbidity:	None	Color:	None	Gross Solids:	None	Vegetation:	None	Benthic Growth:	None	Stains:	None	Non-illicit:	None	Notes Sample collected from submerged pool in manhole.

Sample Location:	Pool																																					
Total Chlorine:	0 ppm																																					
Free Chlorine:	0 ppm																																					
Ammonia:	0 ppm																																					
pH:	7.41 units																																					
Temperature:	79 °F																																					
Conductivity:	372 µS/cm																																					
Detergents:	0 mg/L																																					
Floatables:	None																																					
Odor:	None																																					
Turbidity:	None																																					
Color:	None																																					
Gross Solids:	None																																					
Vegetation:	None																																					
Benthic Growth:	None																																					
Stains:	None																																					
Non-illicit:	None

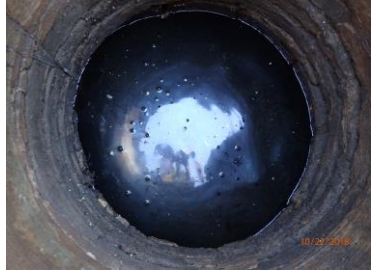
Inspection Date: 10/22/2018 2:06:18 PM		Type: Ongoing	Flow: Submerged, indeterminate	Previous Rainfall (hrs): 48-72																																		
Illicit Discharge Potential: Unlikely		Inspector: JCW																																				
Submerged: Partially		Depth (in): 32																																				
Sampling Results <table border="1" style="width:100%; border-collapse: collapse;"> <tr><td>Sample Location:</td><td>Pool</td></tr> <tr><td>Total Chlorine:</td><td>0 ppm</td></tr> <tr><td>Free Chlorine:</td><td>0 ppm</td></tr> <tr><td>Ammonia:</td><td>0.5 ppm</td></tr> <tr><td>pH:</td><td>6.72 units</td></tr> <tr><td>Temperature:</td><td>60 °F</td></tr> <tr><td>Conductivity:</td><td>773 µS/cm</td></tr> <tr><td>Detergents:</td><td>0 mg/L</td></tr> </table>		Sample Location:	Pool	Total Chlorine:	0 ppm	Free Chlorine:	0 ppm	Ammonia:	0.5 ppm	pH:	6.72 units	Temperature:	60 °F	Conductivity:	773 µS/cm	Detergents:	0 mg/L	<table border="1" style="width:100%; border-collapse: collapse;"> <tr><td>Floatables:</td><td>None</td></tr> <tr><td>Odor:</td><td>None</td></tr> <tr><td>Turbidity:</td><td>None</td></tr> <tr><td>Color:</td><td>None</td></tr> <tr><td>Gross Solids:</td><td>None</td></tr> <tr><td>Vegetation:</td><td>None</td></tr> <tr><td>Benthic Growth:</td><td>None</td></tr> <tr><td>Stains:</td><td>None</td></tr> <tr><td>Non-illicit:</td><td>Moderate</td></tr> </table>	Floatables:	None	Odor:	None	Turbidity:	None	Color:	None	Gross Solids:	None	Vegetation:	None	Benthic Growth:	None	Stains:	None	Non-illicit:	Moderate	Notes Sample collected from submerged pool in manhole.

Sample Location:	Pool																																					
Total Chlorine:	0 ppm																																					
Free Chlorine:	0 ppm																																					
Ammonia:	0.5 ppm																																					
pH:	6.72 units																																					
Temperature:	60 °F																																					
Conductivity:	773 µS/cm																																					
Detergents:	0 mg/L																																					
Floatables:	None																																					
Odor:	None																																					
Turbidity:	None																																					
Color:	None																																					
Gross Solids:	None																																					
Vegetation:	None																																					
Benthic Growth:	None																																					
Stains:	None																																					
Non-illicit:	Moderate

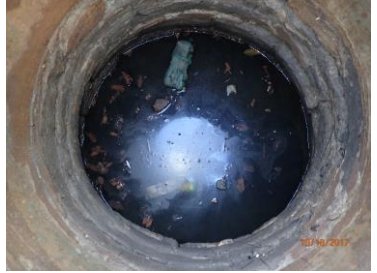
Inspection Date: 10/18/2017 2:45:31 PM		Type: Ongoing	Flow: Submerged, indeterminate	Previous Rainfall (hrs): 72+																																		
Illicit Discharge Potential: Unlikely		Inspector: JCW																																				
Submerged: Fully		Depth (in): 27																																				
Sampling Results <table border="1" style="width:100%; border-collapse: collapse;"> <tr><td>Sample Location:</td><td>Pool</td></tr> <tr><td>Total Chlorine:</td><td>0 ppm</td></tr> <tr><td>Free Chlorine:</td><td>0 ppm</td></tr> <tr><td>Ammonia:</td><td>0 ppm</td></tr> <tr><td>pH:</td><td>7.18 units</td></tr> <tr><td>Temperature:</td><td>67 °F</td></tr> <tr><td>Conductivity:</td><td>774 µS/cm</td></tr> <tr><td>Detergents:</td><td>0 mg/L</td></tr> </table>		Sample Location:	Pool	Total Chlorine:	0 ppm	Free Chlorine:	0 ppm	Ammonia:	0 ppm	pH:	7.18 units	Temperature:	67 °F	Conductivity:	774 µS/cm	Detergents:	0 mg/L	<table border="1" style="width:100%; border-collapse: collapse;"> <tr><td>Floatables:</td><td>None</td></tr> <tr><td>Odor:</td><td>None</td></tr> <tr><td>Turbidity:</td><td>None</td></tr> <tr><td>Color:</td><td>None</td></tr> <tr><td>Gross Solids:</td><td>Slight</td></tr> <tr><td>Vegetation:</td><td>None</td></tr> <tr><td>Benthic Growth:</td><td>None</td></tr> <tr><td>Stains:</td><td>None</td></tr> <tr><td>Non-illicit:</td><td>None</td></tr> </table>	Floatables:	None	Odor:	None	Turbidity:	None	Color:	None	Gross Solids:	Slight	Vegetation:	None	Benthic Growth:	None	Stains:	None	Non-illicit:	None	Notes Sample collected from submerged pool in manhole.

Sample Location:	Pool																																					
Total Chlorine:	0 ppm																																					
Free Chlorine:	0 ppm																																					
Ammonia:	0 ppm																																					
pH:	7.18 units																																					
Temperature:	67 °F																																					
Conductivity:	774 µS/cm																																					
Detergents:	0 mg/L																																					
Floatables:	None																																					
Odor:	None																																					
Turbidity:	None																																					
Color:	None																																					
Gross Solids:	Slight																																					
Vegetation:	None																																					
Benthic Growth:	None																																					
Stains:	None																																					
Non-illicit:	None

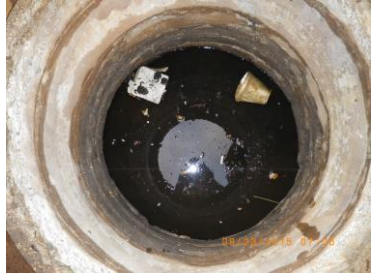
Inspection Date: 9/23/2015 7:05:01 AM		Type: Ongoing	Flow: Submerged, indeterminate	Previous Rainfall (hrs): 72+	
Illicit Discharge Potential: Unlikely		Inspector: JCW	Notes		
Submerged: Fully		Depth (in): 29

<p style="text-align: center;">o20150923060646.JPG</p> <p style="text-align: center; font-size: 24pt; font-weight: bold;">2015</p>		
Sampling Results					
Sample Location:	Pool	Floatables:			None
Total Chlorine:	0 ppm	Odor:			None
Free Chlorine:	0 ppm	Turbidity:			None
Ammonia:	0 ppm	Color:			None
pH:	7.44 units	Gross Solids:			Slight
Temperature	69 °F	Vegetation:			None
Conductivity:	516 µS/cm	Benthic Growth:			Moderate
Detergents:	0 mg/L	Stains:			None
		Non-illicit:	None		
			Condition Assessment Graffiti: None Erosion: None Deposition: None in. Damage: None

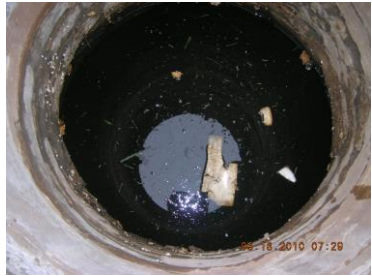
Inspection Date: 8/18/2010 7:36:59 AM		Type: Ongoing	Flow: Submerged, indeterminate	Previous Rainfall (hrs): 72+	
Illicit Discharge Potential: Unlikely		Inspector: JCW	Notes		
Submerged: Fully		Depth (in): 29

<p style="text-align: center;">o20100818072942.JPG</p> <p style="text-align: center; font-size: 24pt; font-weight: bold;">2010</p>		
Sampling Results					
Sample Location:	Pool	Floatables:			Slight
Total Chlorine:	0 ppm	Odor:			Faint
Free Chlorine:	0 ppm	Turbidity:			None
Ammonia:	0.5 ppm	Color:			Faint in bottle
pH:	7.06 units	Gross Solids:			Slight
Temperature	71 °F	Vegetation:			None
Conductivity:	-- µS/cm	Benthic Growth:			None
Detergents:	0 mg/L	Stains:			None
		Non-illicit:	Slight		
			Condition Assessment Graffiti: None Erosion: None Deposition: None 0 in. Damage: None

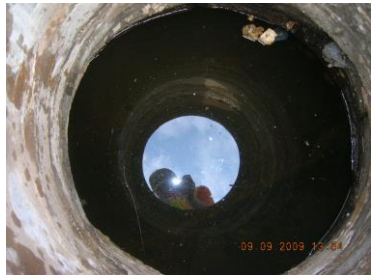
Inspection Date: 9/9/2009		Type: Initial	Flow: Submerged, indeterminate	Previous Rainfall (hrs): 72+	
Illicit Discharge Potential: Unlikely		Inspector: JCW	Notes		
Submerged: Fully		Depth (in): 27

<p style="text-align: center;">Osh09_DSCN6743.JPG</p> <p style="text-align: center; font-size: 24pt; font-weight: bold;">2009</p>		
Sampling Results					
Sample Location:	Pool	Floatables:			None
Total Chlorine:	0 ppm	Odor:			None
Free Chlorine:	0 ppm	Turbidity:			None
Ammonia:	-- ppm	Color:			None
pH:	7.87 units	Gross Solids:			None
Temperature	76 °F	Vegetation:			None
Conductivity:	-- µS/cm	Benthic Growth:			None
Detergents:	0 mg/L	Stains:			None
		Non-illicit:	None		
			Condition Assessment Graffiti: None Erosion: None Deposition: None 0 in. Damage: None
