IDDE Ongoing Screening Summary Report

2022 Inspection Year

City of Oshkosh

Westwood

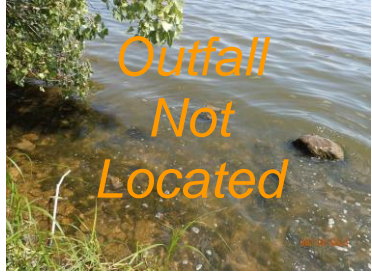
o20210816130634.JPG

Inspection Date: 8/16/2021 1:06:56 PM		Type: Ongoing	Flow: Submerged (not located)	Previous Rainfall (hrs): 72+
Illicit Discharge Potential: Potential		Inspector: JCW		
Submerged: Fully		Depth (in):		
Sampling Results		Notes		
Sample Location:	Floatables:	Outfall fully submerged and not located - screened upstream at 03-173 US1. Floating gross solids (litter) in upstream manhole.		
Total Chlorine: -- ppm	Odor:			
Free Chlorine: -- ppm	Turbidity:			
Ammonia: -- ppm	Color:			
pH: -- units	Gross Solids:			
Temperature -- °F	Vegetation:			
Conductivity: -- µS/cm	Benthic Growth:			
Detergents: -- mg/L	Stains:			
	Non-illicit:	Graffiti: None Erosion: None Deposition: None in. Damage: None

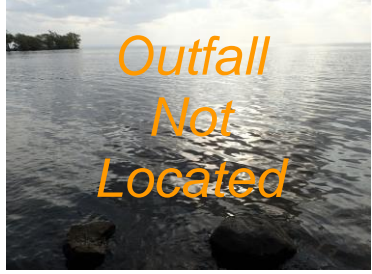
o20200924090116.JPG

Inspection Date: 9/24/2020 8:57:20 AM		Type: Ongoing	Flow: Submerged (not located)	Previous Rainfall (hrs): 72+
Illicit Discharge Potential: Potential		Inspector: QAL		
Submerged: Fully		Depth (in):		
Sampling Results		Notes		
Sample Location:	Floatables:	Outfall fully submerged and not located - screened upstream at 03-173 US1. Floating gross solids (litter) in upstream manhole.		
Total Chlorine: -- ppm	Odor:			
Free Chlorine: -- ppm	Turbidity:			
Ammonia: -- ppm	Color:			
pH: -- units	Gross Solids:			
Temperature -- °F	Vegetation:			
Conductivity: -- µS/cm	Benthic Growth:			
Detergents: -- mg/L	Stains:			
	Non-illicit:	Graffiti: None Erosion: None Deposition: None in. Damage: None

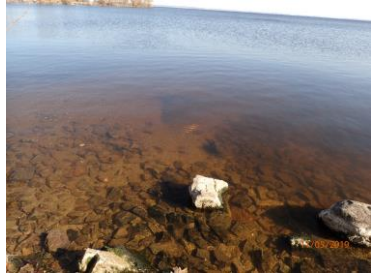
o20191105131408.JPG

Inspection Date: 11/5/2019 1:14:00 PM		Type: Repeat	Flow: Submerged, indeterminate	Previous Rainfall (hrs): 48-72
Illicit Discharge Potential: Potential		Inspector: JCW		
Submerged: Fully		Depth (in):		
Sampling Results		Notes		
Sample Location:	Floatables:	Outfall fully submerged - screened upstream at 03-173 US1. Follow-up inspection for sampling - limited screening conducted.		
Total Chlorine: -- ppm	Odor:			
Free Chlorine: -- ppm	Turbidity:			
Ammonia: -- ppm	Color:			
pH: -- units	Gross Solids:			
Temperature -- °F	Vegetation:			
Conductivity: -- µS/cm	Benthic Growth:			
Detergents: -- mg/L	Stains:			
	Non-illicit:	Graffiti: None Erosion: None Deposition: None in. Damage: None

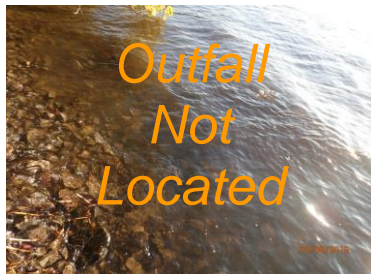
o20191008065912.JPG

Inspection Date: 10/8/2019 8:00:16 AM		Type: Ongoing	Flow: Submerged (not located)	Previous Rainfall (hrs): 48-72
Illicit Discharge Potential: Potential		Inspector: JCW		
Submerged: Fully		Depth (in):		
Sampling Results		Notes		
Sample Location:	Floatables:	Outfall fully submerged and not located - screened upstream at 03-173 US1. Floating gross solids (litter) in manhole. Detergent detected.		
Total Chlorine: -- ppm	Odor:			
Free Chlorine: -- ppm	Turbidity:			
Ammonia: -- ppm	Color:			
pH: -- units	Gross Solids:			
Temperature -- °F	Vegetation:			
Conductivity: -- µS/cm	Benthic Growth:			
Detergents: -- mg/L	Stains:			
	Non-illicit:	Graffiti: None Erosion: None Deposition: None in. Damage: None

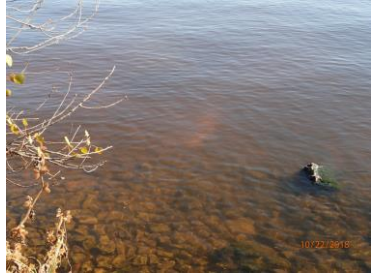
o20181022131820.JPG

Inspection Date: 10/22/2018 1:18:45 PM		Type: Ongoing	Flow: Submerged, indeterminate	Previous Rainfall (hrs): 48-72
Illicit Discharge Potential: Potential		Inspector: JCW	Notes	
Submerged: Fully		Depth (in):	Outfall fully submerged and not located - screened upstream at 03-173 US1. Floating gross solids (litter) in manhole.	
Sampling Results		Floatables:	Condition Assessment Graffiti: None Erosion: None Deposition: None in. Damage: None	
Sample Location:	Odor:	None		
Total Chlorine: -- ppm	Turbidity:	None		
Free Chlorine: -- ppm	Color:	None		
Ammonia: -- ppm	Gross Solids:	None		
pH: -- units	Vegetation:	None		
Temperature -- °F	Benthic Growth:	None		
Conductivity: -- µS/cm	Stains:	None		
Detergents: -- mg/L	Non-illicit:	None

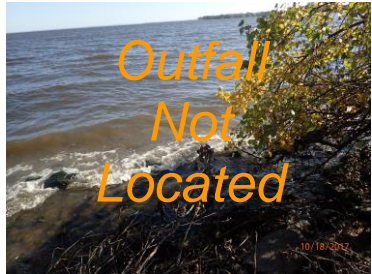
o20171018142348.JPG

Inspection Date: 10/18/2017 2:27:05 PM		Type: Ongoing	Flow: Submerged (not located)	Previous Rainfall (hrs): 72+
Illicit Discharge Potential: Potential		Inspector: JCW	Notes	
Submerged: Fully		Depth (in):	Outfall fully submerged and not located - screened upstream at 03-173 US2. Floating gross solids (litter) in manhole.	
Sampling Results		Floatables:	Condition Assessment Graffiti: None Erosion: None Deposition: None in. Damage: None	
Sample Location:	Odor:	None		
Total Chlorine: -- ppm	Turbidity:	None		
Free Chlorine: -- ppm	Color:	None		
Ammonia: -- ppm	Gross Solids:	None		
pH: -- units	Vegetation:	None		
Temperature -- °F	Benthic Growth:	None		
Conductivity: -- µS/cm	Stains:	None		
Detergents: -- mg/L	Non-illicit:	None

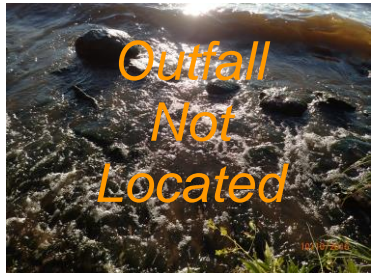
o20161010082552.JPG

Inspection Date: 10/10/2016 8:27:25 AM		Type: Ongoing	Flow: Submerged (not located)	Previous Rainfall (hrs): 72+
Illicit Discharge Potential: Potential		Inspector: JCW	Notes	
Submerged: Fully		Depth (in):	Outfall fully submerged and not located - screened upstream at 03-173 US2.	
Sampling Results		Floatables:	Condition Assessment Graffiti: None Erosion: None Deposition: None in. Damage: None	
Sample Location:	Odor:	None		
Total Chlorine: -- ppm	Turbidity:	None		
Free Chlorine: -- ppm	Color:	None		
Ammonia: -- ppm	Gross Solids:	None		
pH: -- units	Vegetation:	None		
Temperature -- °F	Benthic Growth:	None		
Conductivity: -- µS/cm	Stains:	None		
Detergents: -- mg/L	Non-illicit:	None

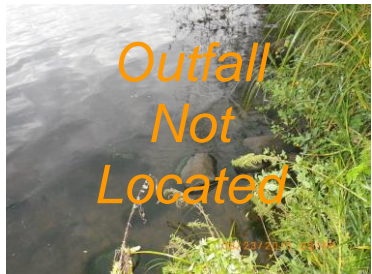
o20150923054658.JPG

Inspection Date: 9/23/2015 6:48:56 AM		Type: Ongoing	Flow: Submerged (not located)	Previous Rainfall (hrs): 72+
Illicit Discharge Potential: Potential		Inspector: JCW	Notes	
Submerged: Fully		Depth (in):	Outfall fully submerged and not located during this screening - screened at 13-173 US2.	
Sampling Results		Floatables:	Condition Assessment Graffiti: None Erosion: None Deposition: None in. Damage: None	
Sample Location:	Odor:	None		
Total Chlorine: -- ppm	Turbidity:	None		
Free Chlorine: -- ppm	Color:	None		
Ammonia: -- ppm	Gross Solids:	None		
pH: -- units	Vegetation:	None		
Temperature -- °F	Benthic Growth:	None		
Conductivity: -- µS/cm	Stains:	None		
Detergents: -- mg/L	Non-illicit:	None

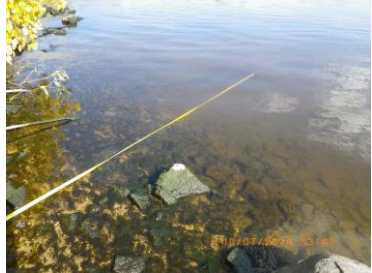
o20141007124746.JPG

Inspection Date: 10/7/2014 1:47:08 PM		Type: Ongoing	Flow: Submerged, indeterminate	Previous Rainfall (hrs): 48-72
Illicit Discharge Potential: Potential		Inspector: JCW	Notes	
Submerged: Fully		Depth (in):	Outfall fully submerged - screened upstream at 13-173 US2. Pipe approx 5" below water surface.	
Sampling Results		Floatables:	Condition Assessment Graffiti: None Erosion: None Deposition: None in. Damage: None	
Sample Location:		Odor:		
Total Chlorine: -- ppm		Turbidity:		
Free Chlorine: -- ppm		Color:		
Ammonia: -- ppm		Gross Solids:		
pH: -- units		Vegetation:		
Temperature -- °F		Benthic Growth:		
Conductivity: -- µS/cm		Stains:		
Detergents: -- mg/L		Non-illicit:

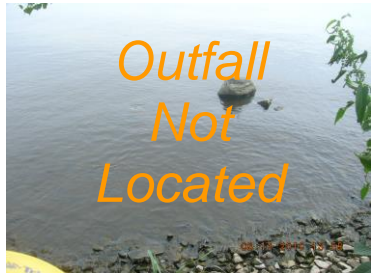
o20100817135838.JPG

Inspection Date: 8/17/2010 2:04:29 PM		Type: Ongoing	Flow: Submerged (not located)	Previous Rainfall (hrs): 72+
Illicit Discharge Potential: Potential		Inspector: JCW	Notes	
Submerged: Fully		Depth (in):	Outfall fully submerged and not physically located. Outfall screened upstream at 03-173 US2.	
Sampling Results		Floatables:	Condition Assessment Graffiti: None Erosion: None Deposition: None 0 in. Damage: None	
Sample Location:		Odor:		
Total Chlorine: -- ppm		Turbidity:		
Free Chlorine: -- ppm		Color:		
Ammonia: -- ppm		Gross Solids:		
pH: -- units		Vegetation:		
Temperature -- °F		Benthic Growth:		
Conductivity: -- µS/cm		Stains:		
Detergents: -- mg/L		Non-illicit:

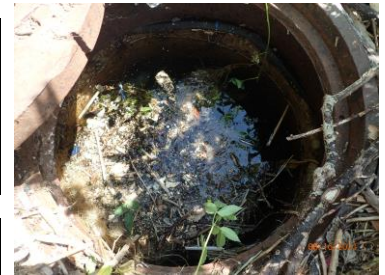
o20210816130728.JPG

Inspection Date: 8/16/2021 1:13:31 PM		Type: Ongoing	Flow: Submerged, indeterminate	Previous Rainfall (hrs): 72+
Illicit Discharge Potential: Potential		Inspector: JCW		
Submerged: Fully		Depth (in): 43		
Sampling Results		Notes Sample collected from submerged pool in manhole. Floating gross solids (litter) in manhole.		
Sample Location: Pool	Floatables: None	Condition Assessment Graffiti: None Erosion: None Deposition: None in. Damage: None		
Total Chlorine: 0 ppm	Odor: None			
Free Chlorine: 0 ppm	Turbidity: None			
Ammonia: 0 ppm	Color: None			
pH: 8.46 units	Gross Solids: Moderate			
Temperature 79 °F	Vegetation: None			
Conductivity: 337 µS/cm	Benthic Growth: None			
Detergents: 0 mg/L	Stains: None			
	Non-illicit: None

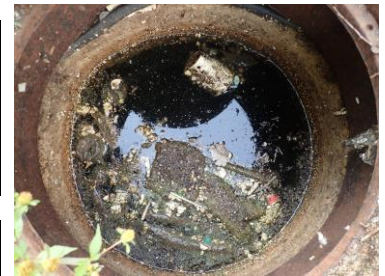
o20200924090226.JPG

Inspection Date: 9/24/2020 8:58:24 AM		Type: Ongoing	Flow: Submerged, no flow	Previous Rainfall (hrs): 72+
Illicit Discharge Potential: Potential		Inspector: QAL		
Submerged: Fully		Depth (in): 36		
Sampling Results		Notes Sample collected from submerged pool in manhole. Floating gross solids (litter) in manhole.		
Sample Location: Pool	Floatables: None	Condition Assessment Graffiti: None Erosion: None Deposition: None in. Damage: None		
Total Chlorine: 0 ppm	Odor: None			
Free Chlorine: 0 ppm	Turbidity: None			
Ammonia: 0 ppm	Color: Faint in bottle			
pH: 8.54 units	Gross Solids: Severe			
Temperature 68 °F	Vegetation: None			
Conductivity: 405 µS/cm	Benthic Growth: None			
Detergents: 0 mg/L	Stains: None			
	Non-illicit: None

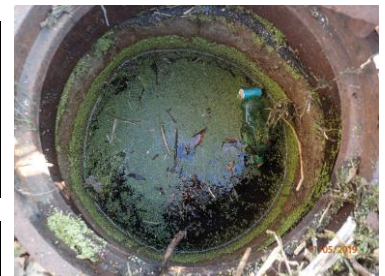
o20191105131426.JPG

Inspection Date: 11/5/2019 1:15:28 PM		Type: Repeat	Flow: Submerged, indeterminate	Previous Rainfall (hrs): 48-72
Illicit Discharge Potential: Potential		Inspector: JCW		
Submerged: Partially		Depth (in): 32		
Sampling Results		Notes Detergent detection follow-up. Limited screening conducted.		
Sample Location: Pool	Floatables: None	Condition Assessment Graffiti: None Erosion: None Deposition: None in. Damage: None		
Total Chlorine: -- ppm	Odor: None			
Free Chlorine: -- ppm	Turbidity: None			
Ammonia: -- ppm	Color: None			
pH: -- units	Gross Solids: None			
Temperature -- °F	Vegetation: None			
Conductivity: -- µS/cm	Benthic Growth: None			
Detergents: 0 mg/L	Stains: None			
	Non-illicit: None

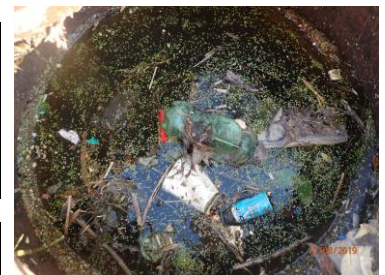
o20191008070022.JPG

Inspection Date: 10/8/2019 8:01:54 AM		Type: Ongoing	Flow: Submerged, indeterminate	Previous Rainfall (hrs): 48-72
Illicit Discharge Potential: Potential		Inspector: JCW		
Submerged: Partially		Depth (in): 38		
Sampling Results		Notes Manhole 03-173 US2 inaccessible (behind locked gate). Floating gross solids (litter) in manhole. Detergent detected.		
Sample Location: Pool	Floatables: Moderate	Condition Assessment Graffiti: None Erosion: None Deposition: Minor 4 in. Damage: None		
Total Chlorine: 0 ppm	Odor: None			
Free Chlorine: 0 ppm	Turbidity: None			
Ammonia: 0 ppm	Color: None			
pH: 7.64 units	Gross Solids: Moderate			
Temperature 53 °F	Vegetation: None			
Conductivity: 592 µS/cm	Benthic Growth: Slight			
Detergents: 1 mg/L	Stains: None			
	Non-illicit: None

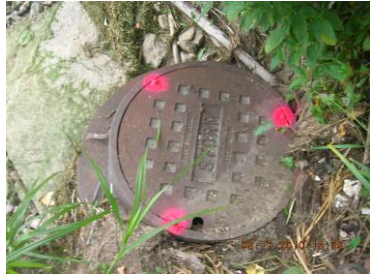
o20100817135854.JPG <div style="text-align: center; font-size: 24pt; font-weight: bold;">2010</div>

Inspection Date: 8/17/2010 2:07:11 PM		Type: Ongoing	Flow: Submerged, indeterminate	Previous Rainfall (hrs): 72+																																				
Illicit Discharge Potential: Potential		Inspector: JCW																																						
Submerged: Fully		Depth (in):																																						
<table border="1" style="width:100%; border-collapse: collapse;"> <tr> <td colspan="2">Sampling Results</td> <td>Floatables:</td> <td>None</td> </tr> <tr> <td>Sample Location:</td> <td></td> <td>Odor:</td> <td>None</td> </tr> <tr> <td>Total Chlorine:</td> <td>-- ppm</td> <td>Turbidity:</td> <td>None</td> </tr> <tr> <td>Free Chlorine:</td> <td>-- ppm</td> <td>Color:</td> <td>None</td> </tr> <tr> <td>Ammonia:</td> <td>-- ppm</td> <td>Gross Solids:</td> <td>None</td> </tr> <tr> <td>pH:</td> <td>-- units</td> <td>Vegetation:</td> <td>None</td> </tr> <tr> <td>Temperature</td> <td>-- °F</td> <td>Benthic Growth:</td> <td>None</td> </tr> <tr> <td>Conductivity:</td> <td>-- µS/cm</td> <td>Stains:</td> <td>None</td> </tr> <tr> <td>Detergents:</td> <td>-- mg/L</td> <td>Non-illicit:</td> <td>None</td> </tr> </table>					Sampling Results		Floatables:	None	Sample Location:		Odor:	None	Total Chlorine:	-- ppm	Turbidity:	None	Free Chlorine:	-- ppm	Color:	None	Ammonia:	-- ppm	Gross Solids:	None	pH:	-- units	Vegetation:	None	Temperature	-- °F	Benthic Growth:	None	Conductivity:	-- µS/cm	Stains:	None	Detergents:	-- mg/L	Non-illicit:	None

Sampling Results		Floatables:	None																																					
Sample Location:		Odor:	None																																					
Total Chlorine:	-- ppm	Turbidity:	None																																					
Free Chlorine:	-- ppm	Color:	None																																					
Ammonia:	-- ppm	Gross Solids:	None																																					
pH:	-- units	Vegetation:	None																																					
Temperature	-- °F	Benthic Growth:	None																																					
Conductivity:	-- µS/cm	Stains:	None																																					
Detergents:	-- mg/L	Non-illicit:	None																																					
		Notes Lid bolts rusted tight - could not access. Screened upstream at 03-173 US2.																																						
		Condition Assessment <table border="1" style="width:100%; border-collapse: collapse;"> <tr> <td>Graffiti:</td> <td>None</td> </tr> <tr> <td>Erosion:</td> <td>None</td> </tr> <tr> <td>Deposition:</td> <td>None 0 in.</td> </tr> <tr> <td>Damage:</td> <td>Moderate</td> </tr> </table>			Graffiti:	None	Erosion:	None	Deposition:	None 0 in.	Damage:	Moderate

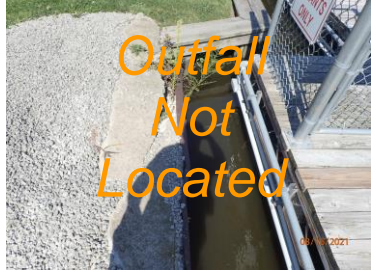
Inspection Date: 8/16/2021 10:33:32 AM		Type: Ongoing	Flow: Submerged (not located)	Previous Rainfall (hrs): 72+
Illicit Discharge Potential: Potential		Inspector: JCW		
Submerged: Fully		Depth (in):		
Sampling Results Sample Location: _____ Total Chlorine: -- ppm Free Chlorine: -- ppm Ammonia: -- ppm pH: -- units Temperature -- °F Conductivity: -- µS/cm Detergents: -- mg/L		Floatables: None Odor: None Turbidity: None Color: None Gross Solids: None Vegetation: None Benthic Growth: None Stains: None Non-illicit: None	Notes Outfall partially submerged - screened upstream at 03-22 US1. Floating gross solids (litter) in upstream manhole.

o20210816103158.JPG <div style="text-align: center; font-size: 24pt; font-weight: bold;">2021</div>
		Condition Assessment Graffiti: None Erosion: None Deposition: None in. Damage: None

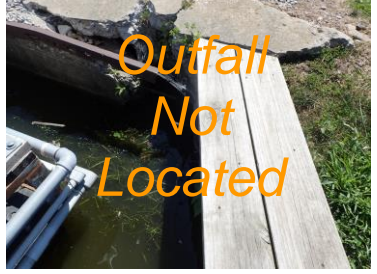
Inspection Date: 8/19/2020 2:03:43 PM		Type: Ongoing	Flow: Submerged (not located)	Previous Rainfall (hrs): 72+
Illicit Discharge Potential: Potential		Inspector: JCW		
Submerged: Fully		Depth (in):		
Sampling Results Sample Location: _____ Total Chlorine: -- ppm Free Chlorine: -- ppm Ammonia: -- ppm pH: -- units Temperature -- °F Conductivity: -- µS/cm Detergents: -- mg/L		Floatables: None Odor: None Turbidity: None Color: None Gross Solids: None Vegetation: None Benthic Growth: None Stains: None Non-illicit: None	Notes Outfall fully submerged and not located - screened upstream at 03-22 US1. Floating gross solids (litter) in upstream manhole.

o20200819140018.JPG <div style="text-align: center; font-size: 24pt; font-weight: bold;">2020</div>
		Condition Assessment Graffiti: None Erosion: None Deposition: None in. Damage: None

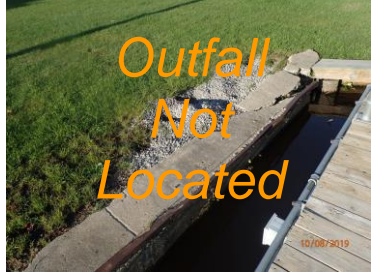
Inspection Date: 10/8/2019 8:34:00 AM		Type: Repeat	Flow: Submerged (not located)	Previous Rainfall (hrs): 48-72
Illicit Discharge Potential: Potential		Inspector: JCW		
Submerged: Fully		Depth (in):		
Sampling Results Sample Location: _____ Total Chlorine: -- ppm Free Chlorine: -- ppm Ammonia: -- ppm pH: -- units Temperature -- °F Conductivity: -- µS/cm Detergents: -- mg/L		Floatables: None Odor: None Turbidity: None Color: None Gross Solids: None Vegetation: None Benthic Growth: None Stains: None Non-illicit: None	Notes Outfall fully submerged and not located - screened upstream at 03-22 US1. Follow-up inspection for sampling - limited screening conducted.

o20191008073428.jpg <div style="text-align: center; font-size: 24pt; font-weight: bold;">2019</div>
		Condition Assessment Graffiti: None Erosion: None Deposition: None in. Damage: None

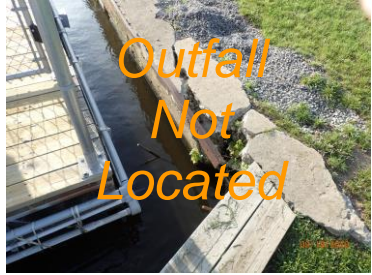
<p style="text-align: center;">o20190918071544.JPG</p> <p style="text-align: center; font-size: 1.5em; font-weight: bold;">2019</p>	
Submerged: Fully		Depth (in):		Outfall fully submerged and not located - screened upstream at 03-22 US1. Floating gross solids (litter) and detergent in manhole.			
Sampling Results				Condition Assessment			
Sample Location:		Floatables:	None	Graftiti:		None	in.
Total Chlorine: -- ppm		Odor:	None	Erosion:		None	
Free Chlorine: -- ppm		Turbidity:	None	Deposition:		None	
Ammonia: -- ppm		Color:	None	Damage:		None	
pH: -- units		Gross Solids:	None				
Temperature -- °F		Vegetation:	None				
Conductivity: -- µS/cm		Benthic Growth:	None				
Detergents: -- mg/L		Stains:	None				
		Non-illicit:	None

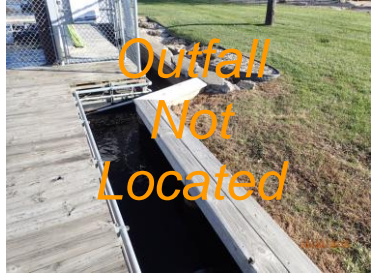
<p style="text-align: center;">o20181022155222.JPG</p> <p style="text-align: center; font-size: 1.5em; font-weight: bold;">2018</p>	
Submerged: Fully		Depth (in):		Outfall fully submerged and not located - screened upstream at 03-22 US1. Floating gross solids (litter) in manhole.			
Sampling Results				Condition Assessment			
Sample Location:		Floatables:	None	Graftiti:		None	in.
Total Chlorine: -- ppm		Odor:	None	Erosion:		None	
Free Chlorine: -- ppm		Turbidity:	None	Deposition:		None	
Ammonia: -- ppm		Color:	None	Damage:		None	
pH: -- units		Gross Solids:	None				
Temperature -- °F		Vegetation:	None				
Conductivity: -- µS/cm		Benthic Growth:	None				
Detergents: -- mg/L		Stains:	None				
		Non-illicit:	None

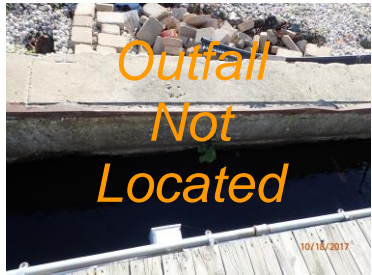
<p style="text-align: center;">o20171018151946.JPG</p> <p style="text-align: center; font-size: 1.5em; font-weight: bold;">2017</p>	
Submerged: Fully		Depth (in):		Outfall fully submerged and not located - screened upstream at 03-22 US1. Floating gross solids (litter) in manhole.			
Sampling Results				Condition Assessment			
Sample Location:		Floatables:	None	Graftiti:		None	in.
Total Chlorine: -- ppm		Odor:	None	Erosion:		None	
Free Chlorine: -- ppm		Turbidity:	None	Deposition:		None	
Ammonia: -- ppm		Color:	None	Damage:		None	
pH: -- units		Gross Solids:	None				
Temperature -- °F		Vegetation:	None				
Conductivity: -- µS/cm		Benthic Growth:	None				
Detergents: -- mg/L		Stains:	None				
		Non-illicit:	None

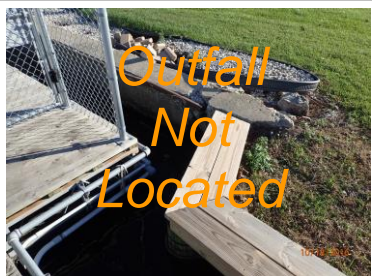
<p style="text-align: center;">o20161018160304.JPG</p> <p style="text-align: center; font-size: 1.5em; font-weight: bold;">2016</p>	
Submerged: Fully		Depth (in):		Outfall not located and assumed submerged - screened upstream at 03-22 US1.			
Sampling Results				Condition Assessment			
Sample Location:		Floatables:	None	Graftiti:		None	in.
Total Chlorine: -- ppm		Odor:	None	Erosion:		None	
Free Chlorine: -- ppm		Turbidity:	None	Deposition:		None	
Ammonia: -- ppm		Color:	None	Damage:		None	
pH: -- units		Gross Solids:	None				
Temperature -- °F		Vegetation:	None				
Conductivity: -- µS/cm		Benthic Growth:	None				
Detergents: -- mg/L		Stains:	None				
		Non-illicit:	None

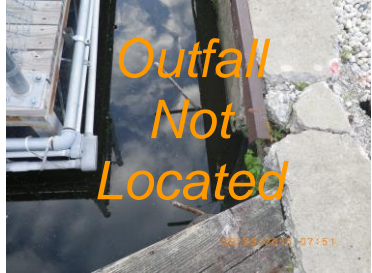
o20150923065132.JPG

Inspection Date: 9/23/2015 7:47:01 AM		Type: Ongoing	Flow: Submerged (not located)	Previous Rainfall (hrs): 72+
Illicit Discharge Potential: Potential		Inspector: JCW		
Submerged: Fully		Depth (in):		
Sampling Results		Notes		
Sample Location:	Floatables:	Significant sinking above suspected pipe. Outfall not located - screened at 03-22 US1.		
Total Chlorine: -- ppm	Odor:			
Free Chlorine: -- ppm	Turbidity:			
Ammonia: -- ppm	Color:			
pH: -- units	Gross Solids:	Condition Assessment		
Temperature -- °F	Vegetation:	Graffiti: None		
Conductivity: -- µS/cm	Benthic Growth:	Erosion: None		
Detergents: -- mg/L	Stains:	Deposition: None	in.	
	Non-illicit:	Damage: Severe

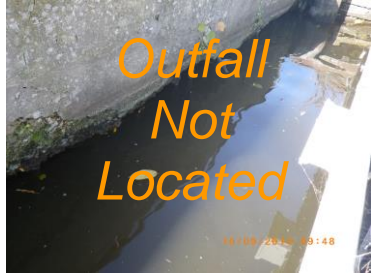
o20141009084834.JPG

Inspection Date: 10/9/2014 9:47:52 AM		Type: Ongoing	Flow: Submerged (not located)	Previous Rainfall (hrs): 72+
Illicit Discharge Potential: Potential		Inspector: JCW		
Submerged: Fully		Depth (in):		
Sampling Results		Notes		
Sample Location:	Floatables:	Outfall fully submerged and not located - screened upstream at 03-22 US1.		
Total Chlorine: -- ppm	Odor:			
Free Chlorine: -- ppm	Turbidity:			
Ammonia: -- ppm	Color:			
pH: -- units	Gross Solids:	Condition Assessment		
Temperature -- °F	Vegetation:	Graffiti: None		
Conductivity: -- µS/cm	Benthic Growth:	Erosion: None		
Detergents: -- mg/L	Stains:	Deposition: None	in.	
	Non-illicit:	Damage: None

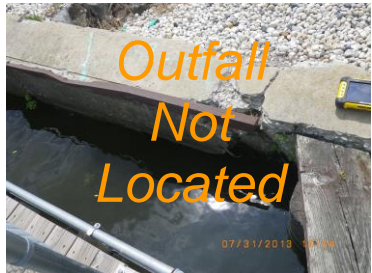
o20130731114434.JPG

Inspection Date: 7/31/2013 12:40:04 PM		Type: Ongoing	Flow: Submerged (not located)	Previous Rainfall (hrs): 72+
Illicit Discharge Potential: Potential		Inspector: JCW		
Submerged: Fully		Depth (in):		
Sampling Results		Notes		
Sample Location:	Floatables:	2012 screening follow-up. Outfall not located. Outfall screened upstream at 03-22 US1. Gross solids in upstream mh.		
Total Chlorine: -- ppm	Odor:			
Free Chlorine: -- ppm	Turbidity:			
Ammonia: -- ppm	Color:			
pH: -- units	Gross Solids:	Condition Assessment		
Temperature -- °F	Vegetation:	Graffiti: None		
Conductivity: -- µS/cm	Benthic Growth:	Erosion: None		
Detergents: -- mg/L	Stains:	Deposition: None	in.	
	Non-illicit:	Damage: None

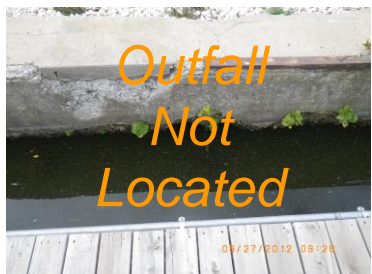
o20120927082846.JPG

Inspection Date: 9/27/2012 9:26:54 AM		Type: Ongoing	Flow: Submerged (not located)	Previous Rainfall (hrs): 72+
Illicit Discharge Potential: Potential		Inspector: JCW		
Submerged: Fully		Depth (in):		
Sampling Results		Notes		
Sample Location:	Floatables:	Outfall fully submerged; screened upstream at 03-22 US1.		
Total Chlorine: -- ppm	Odor:			
Free Chlorine: -- ppm	Turbidity:			
Ammonia: -- ppm	Color:			
pH: -- units	Gross Solids:	Condition Assessment		
Temperature -- °F	Vegetation:	Graffiti: None		
Conductivity: -- µS/cm	Benthic Growth:	Erosion: None		
Detergents: -- mg/L	Stains:	Deposition: None	in.	
	Non-illicit:	Damage: None

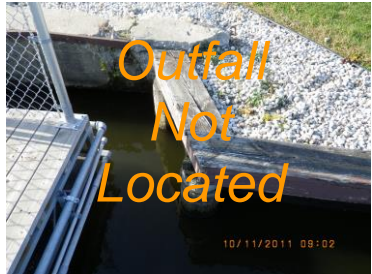
o20111011090250.JPG <div style="text-align: right; font-weight: bold; font-size: 1.2em;">2011</div>

Inspection Date: 10/11/2011 9:03:10 AM		Type: Ongoing	Flow: Submerged (not located)	Previous Rainfall (hrs): 72+																																				
Illicit Discharge Potential: Potential		Inspector: JCW	Notes																																					
Submerged: Fully		Depth (in):	2010 screening follow-up. Outfall fully submerged and not physically located. Outfall screened upstream at 03-22 US1.

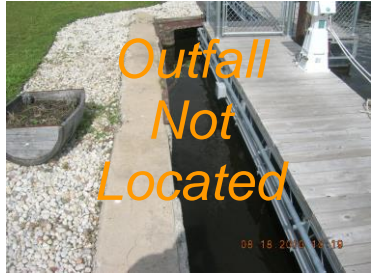
o20100818101918.JPG <div style="text-align: right; font-weight: bold; font-size: 1.2em;">2010</div>

Inspection Date: 8/18/2010 10:26:01 AM		Type: Ongoing	Flow: Submerged (not located)	Previous Rainfall (hrs): 72+																																				
Illicit Discharge Potential: Potential		Inspector: JCW	Notes																																					
Submerged: Fully		Depth (in):	Outfall fully submerged and not physically located. Outfall screened upstream at 03-22 US1.

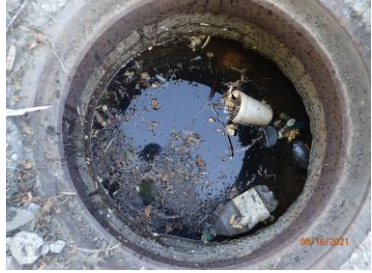
o20210816103330.JPG

Inspection Date: 8/16/2021 10:36:24 AM		Type: Ongoing	Flow: Submerged, indeterminate	Previous Rainfall (hrs): 72+
Illicit Discharge Potential: Potential		Inspector: JCW		
Submerged: Fully		Depth (in): 49		
Sampling Results		Notes Sample collected from submerged pool in manhole. Floating gross solids (litter) in manhole.		
Sample Location: Pool	Floatables: None	Condition Assessment Graffiti: None Erosion: None Deposition: None in. Damage: None		
Total Chlorine: 0 ppm	Odor: Faint			
Free Chlorine: 0 ppm	Turbidity: None			
Ammonia: 0 ppm	Color: None			
pH: 7.74 units	Gross Solids: Moderate			
Temperature 76 °F	Vegetation: None			
Conductivity: 322 µS/cm	Benthic Growth: None			
Detergents: 0 mg/L	Stains: None			
	Non-illicit: None

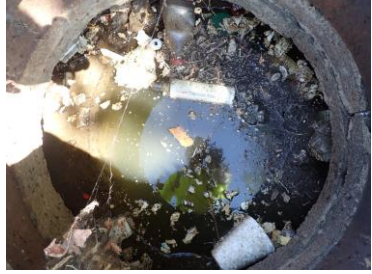
o20200819140108.JPG

Inspection Date: 8/19/2020 2:04:58 PM		Type: Ongoing	Flow: Submerged, indeterminate	Previous Rainfall (hrs): 72+
Illicit Discharge Potential: Potential		Inspector: JCW		
Submerged: Fully		Depth (in): 47		
Sampling Results		Notes Sample collected from submerged pool in manhole. Floating gross solids (litter) in manhole. Elevated pH seemed widespread in river.		
Sample Location: Pool	Floatables: None	Condition Assessment Graffiti: None Erosion: None Deposition: None in. Damage: None		
Total Chlorine: 0 ppm	Odor: None			
Free Chlorine: 0 ppm	Turbidity: None			
Ammonia: 0 ppm	Color: None			
pH: 9.13 units	Gross Solids: Severe			
Temperature 84 °F	Vegetation: None			
Conductivity: 338 µS/cm	Benthic Growth: None			
Detergents: 0 mg/L	Stains: None			
	Non-illicit: None

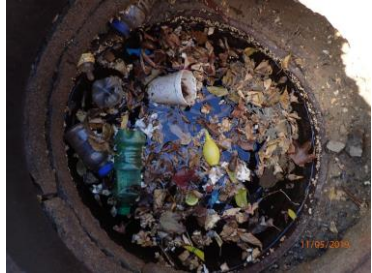
o20191105112834.JPG

Inspection Date: 11/5/2019 11:28:50 AM		Type: Repeat	Flow: Submerged, indeterminate	Previous Rainfall (hrs): 48-72
Illicit Discharge Potential: Potential		Inspector: JCW		
Submerged: Partially		Depth (in): 47		
Sampling Results		Notes Follow-up inspection for sampling - limited screening conducted. Floating gross solids (litter) in manhole.		
Sample Location: Pool	Floatables: None	Condition Assessment Graffiti: None Erosion: None Deposition: None in. Damage: None		
Total Chlorine: -- ppm	Odor: None			
Free Chlorine: -- ppm	Turbidity: None			
Ammonia: -- ppm	Color: None			
pH: -- units	Gross Solids: Severe			
Temperature -- °F	Vegetation: None			
Conductivity: -- µS/cm	Benthic Growth: None			
Detergents: 0 mg/L	Stains: None			
	Non-illicit: None

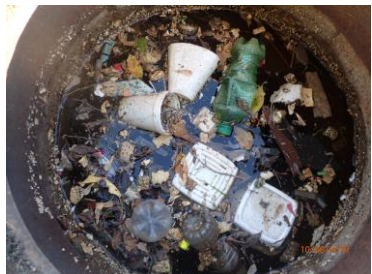
o20191008073520.jpg

Inspection Date: 10/8/2019 8:35:00 AM		Type: Repeat	Flow: Submerged, indeterminate	Previous Rainfall (hrs): 48-72
Illicit Discharge Potential: Potential		Inspector: JCW		
Submerged: Partially		Depth (in): 47		
Sampling Results		Notes Follow-up inspection for sampling - limited screening conducted. Floating gross solids (litter) in manhole.		
Sample Location: Pool	Floatables: None	Condition Assessment Graffiti: None Erosion: None Deposition: None in. Damage: None		
Total Chlorine: 0 ppm	Odor: None			
Free Chlorine: 0 ppm	Turbidity: None			
Ammonia: 0 ppm	Color: None			
pH: 7.58 units	Gross Solids: Severe			
Temperature 56 °F	Vegetation: None			
Conductivity: 381 µS/cm	Benthic Growth: None			
Detergents: 1.2 mg/L	Stains: None			
	Non-illicit: None

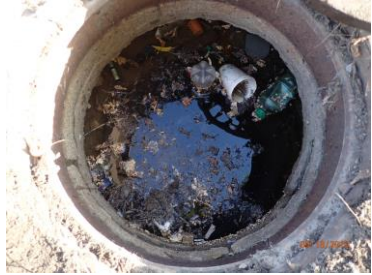
o20190918071726.JPG																											
Submerged: Fully		Depth (in): 49		Sample collected from submerged pool in manhole. Floating gross solids (litter) and detergent in manhole.																													
Sampling Results		<table border="1" style="width:100%; border-collapse: collapse;"> <tr><td>Floatables:</td><td>None</td></tr> <tr><td>Odor:</td><td>None</td></tr> <tr><td>Turbidity:</td><td>None</td></tr> <tr><td>Color:</td><td>None</td></tr> <tr><td>Gross Solids:</td><td>Moderate</td></tr> <tr><td>Vegetation:</td><td>None</td></tr> <tr><td>Benthic Growth:</td><td>None</td></tr> <tr><td>Stains:</td><td>None</td></tr> <tr><td>Non-illicit:</td><td>None</td></tr> </table>		Floatables:	None	Odor:	None	Turbidity:	None	Color:	None	Gross Solids:	Moderate	Vegetation:	None	Benthic Growth:	None	Stains:	None	Non-illicit:	None	Condition Assessment <table border="1" style="width:100%; border-collapse: collapse;"> <tr><td>Graffiti:</td><td>None</td></tr> <tr><td>Erosion:</td><td>None</td></tr> <tr><td>Deposition:</td><td>None in.</td></tr> <tr><td>Damage:</td><td>None</td></tr> </table>		Graffiti:	None	Erosion:	None	Deposition:	None in.	Damage:	None	<div style="text-align: center; font-size: 24pt; font-weight: bold;">2019</div>

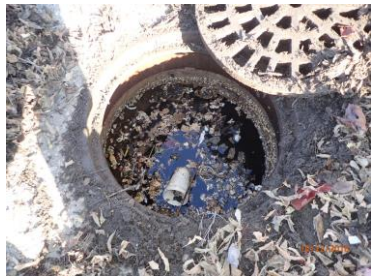
o20181022155408.JPG																											
Submerged: Fully		Depth (in): 49		Sample collected from submerged pool in manhole. Floating gross solids (litter) in manhole.																													
Sampling Results		<table border="1" style="width:100%; border-collapse: collapse;"> <tr><td>Floatables:</td><td>None</td></tr> <tr><td>Odor:</td><td>None</td></tr> <tr><td>Turbidity:</td><td>None</td></tr> <tr><td>Color:</td><td>None</td></tr> <tr><td>Gross Solids:</td><td>Moderate</td></tr> <tr><td>Vegetation:</td><td>None</td></tr> <tr><td>Benthic Growth:</td><td>None</td></tr> <tr><td>Stains:</td><td>None</td></tr> <tr><td>Non-illicit:</td><td>None</td></tr> </table>		Floatables:	None	Odor:	None	Turbidity:	None	Color:	None	Gross Solids:	Moderate	Vegetation:	None	Benthic Growth:	None	Stains:	None	Non-illicit:	None	Condition Assessment <table border="1" style="width:100%; border-collapse: collapse;"> <tr><td>Graffiti:</td><td>None</td></tr> <tr><td>Erosion:</td><td>None</td></tr> <tr><td>Deposition:</td><td>None in.</td></tr> <tr><td>Damage:</td><td>None</td></tr> </table>		Graffiti:	None	Erosion:	None	Deposition:	None in.	Damage:	None	<div style="text-align: center; font-size: 24pt; font-weight: bold;">2018</div>

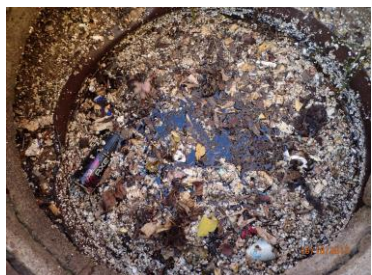
o20171018152158.JPG																											
Submerged: Fully		Depth (in): 44		Sample collected from submerged pool in manhole. Floating gross solids (litter) in manhole.																													
Sampling Results		<table border="1" style="width:100%; border-collapse: collapse;"> <tr><td>Floatables:</td><td>None</td></tr> <tr><td>Odor:</td><td>None</td></tr> <tr><td>Turbidity:</td><td>None</td></tr> <tr><td>Color:</td><td>None</td></tr> <tr><td>Gross Solids:</td><td>Moderate</td></tr> <tr><td>Vegetation:</td><td>None</td></tr> <tr><td>Benthic Growth:</td><td>None</td></tr> <tr><td>Stains:</td><td>None</td></tr> <tr><td>Non-illicit:</td><td>None</td></tr> </table>		Floatables:	None	Odor:	None	Turbidity:	None	Color:	None	Gross Solids:	Moderate	Vegetation:	None	Benthic Growth:	None	Stains:	None	Non-illicit:	None	Condition Assessment <table border="1" style="width:100%; border-collapse: collapse;"> <tr><td>Graffiti:</td><td>None</td></tr> <tr><td>Erosion:</td><td>None</td></tr> <tr><td>Deposition:</td><td>None in.</td></tr> <tr><td>Damage:</td><td>None</td></tr> </table>		Graffiti:	None	Erosion:	None	Deposition:	None in.	Damage:	None	<div style="text-align: center; font-size: 24pt; font-weight: bold;">2017</div>

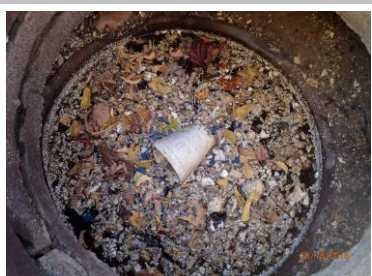
o20161018160430.JPG																											
Submerged: Fully		Depth (in): 44		Potential illicit discharge due to gross solids.																													
Sampling Results		<table border="1" style="width:100%; border-collapse: collapse;"> <tr><td>Floatables:</td><td>None</td></tr> <tr><td>Odor:</td><td>None</td></tr> <tr><td>Turbidity:</td><td>None</td></tr> <tr><td>Color:</td><td>Faint in bottle</td></tr> <tr><td>Gross Solids:</td><td>Severe</td></tr> <tr><td>Vegetation:</td><td>None</td></tr> <tr><td>Benthic Growth:</td><td>None</td></tr> <tr><td>Stains:</td><td>None</td></tr> <tr><td>Non-illicit:</td><td>None</td></tr> </table>		Floatables:	None	Odor:	None	Turbidity:	None	Color:	Faint in bottle	Gross Solids:	Severe	Vegetation:	None	Benthic Growth:	None	Stains:	None	Non-illicit:	None	Condition Assessment <table border="1" style="width:100%; border-collapse: collapse;"> <tr><td>Graffiti:</td><td>None</td></tr> <tr><td>Erosion:</td><td>None</td></tr> <tr><td>Deposition:</td><td>None in.</td></tr> <tr><td>Damage:</td><td>None</td></tr> </table>		Graffiti:	None	Erosion:	None	Deposition:	None in.	Damage:	None	<div style="text-align: center; font-size: 24pt; font-weight: bold;">2016</div>

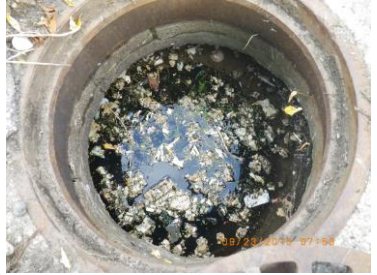
o20150923065324.JPG 2015

Inspection Date: 9/23/2015 7:51:33 AM		Type: Ongoing		Flow: Submerged, indeterminate		Previous Rainfall (hrs): 72+																											
Illicit Discharge Potential: Potential		Inspector: JCW		Notes Floating gross solids (litter) in manhole.

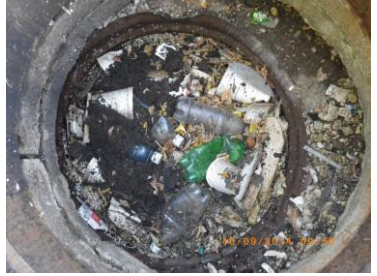
Inspection Date: 10/9/2014 9:52:24 AM		Type: Ongoing		Flow: Submerged, indeterminate		Previous Rainfall (hrs): 72+																											
Illicit Discharge Potential: Potential		Inspector: JCW		Notes Floatable litter in catchbasin.

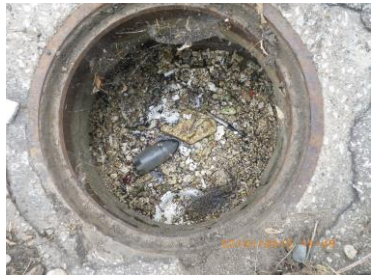
o20130731114610.JPG 2013

Inspection Date: 7/31/2013 12:42:35 PM		Type: Ongoing		Flow: Submerged, indeterminate		Previous Rainfall (hrs): 72+																											
Illicit Discharge Potential: Potential		Inspector: JCW		Notes 2012 screening follow-up. Significant gross solids - similar to previous years.

Submerged: Fully		Depth (in): 44																															
Sampling Results		<table border="1" style="width:100%; border-collapse: collapse;"> <tr><td>Floatables:</td><td>None</td></tr> <tr><td>Odor:</td><td>Faint</td></tr> <tr><td>Turbidity:</td><td>None</td></tr> <tr><td>Color:</td><td>Faint in bottle</td></tr> <tr><td>Gross Solids:</td><td>Severe</td></tr> <tr><td>Vegetation:</td><td>None</td></tr> <tr><td>Benthic Growth:</td><td>None</td></tr> <tr><td>Stains:</td><td>None</td></tr> <tr><td>Non-illicit:</td><td>None</td></tr> </table>		Floatables:	None	Odor:	Faint	Turbidity:	None	Color:	Faint in bottle	Gross Solids:	Severe	Vegetation:	None	Benthic Growth:	None	Stains:	None	Non-illicit:	None	Condition Assessment		<table border="1" style="width:100%; border-collapse: collapse;"> <tr><td>Graffiti:</td><td>None</td></tr> <tr><td>Erosion:</td><td>None</td></tr> <tr><td>Deposition:</td><td>None in.</td></tr> <tr><td>Damage:</td><td>None</td></tr> </table>		Graffiti:	None	Erosion:	None	Deposition:	None in.	Damage:	None

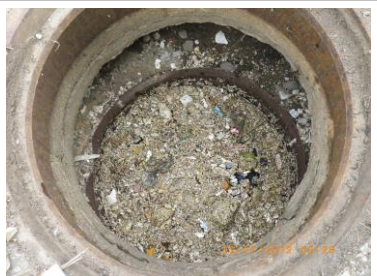
o20120927082922.JPG 2012

Inspection Date: 9/27/2012 9:27:45 AM		Type: Ongoing		Flow: Submerged, indeterminate		Previous Rainfall (hrs): 72+																											
Illicit Discharge Potential: Potential		Inspector: JCW		Notes 2011 gross solids follow-up.

Submerged: Fully		Depth (in): 39																															
Sampling Results		<table border="1" style="width:100%; border-collapse: collapse;"> <tr><td>Floatables:</td><td>None</td></tr> <tr><td>Odor:</td><td>None</td></tr> <tr><td>Turbidity:</td><td>None</td></tr> <tr><td>Color:</td><td>None</td></tr> <tr><td>Gross Solids:</td><td>Severe</td></tr> <tr><td>Vegetation:</td><td>None</td></tr> <tr><td>Benthic Growth:</td><td>None</td></tr> <tr><td>Stains:</td><td>None</td></tr> <tr><td>Non-illicit:</td><td>None</td></tr> </table>		Floatables:	None	Odor:	None	Turbidity:	None	Color:	None	Gross Solids:	Severe	Vegetation:	None	Benthic Growth:	None	Stains:	None	Non-illicit:	None	Condition Assessment		<table border="1" style="width:100%; border-collapse: collapse;"> <tr><td>Graffiti:</td><td>None</td></tr> <tr><td>Erosion:</td><td>None</td></tr> <tr><td>Deposition:</td><td>None in.</td></tr> <tr><td>Damage:</td><td>None</td></tr> </table>		Graffiti:	None	Erosion:	None	Deposition:	None in.	Damage:	None

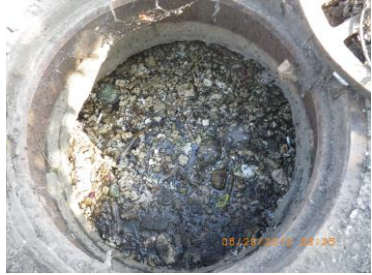
o20120620082508.JPG

Inspection Date: 6/20/2012 9:24:19 AM		Type: Other	Flow: Submerged, indeterminate	Previous Rainfall (hrs): 24-48
Illicit Discharge Potential: Potential		Inspector: JCW	Notes	
Submerged: Fully		Depth (in): 46	Gross solids pre-screening.	
Sampling Results				
Sample Location:	Floatables:	None		
Total Chlorine: -- ppm	Odor:	None		
Free Chlorine: -- ppm	Turbidity:	None		
Ammonia: -- ppm	Color:	None		
pH: -- units	Gross Solids:	Severe		
Temperature -- °F	Vegetation:	None		
Conductivity: -- µS/cm	Benthic Growth:	None		
Detergents: -- mg/L	Stains:	None		
	Non-illicit:	None		
			Condition Assessment	
			Graffiti:	None
			Erosion:	None
			Deposition:	None in.
			Damage:	None

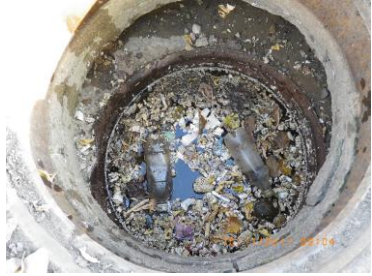
o20111011090446.JPG

Inspection Date: 10/11/2011 9:05:50 AM		Type: Ongoing	Flow: Submerged, indeterminate	Previous Rainfall (hrs): 72+
Illicit Discharge Potential: Potential		Inspector: JCW	Notes	
Submerged: Fully		Depth (in): 37	2010 screening follow-up. No significant change in volume of floatable debris.	
Sampling Results				
Sample Location: Pool	Floatables:	None		
Total Chlorine: 0 ppm	Odor:	None		
Free Chlorine: 0 ppm	Turbidity:	None		
Ammonia: 0 ppm	Color:	None		
pH: 8.13 units	Gross Solids:	Moderate		
Temperature 70 °F	Vegetation:	None		
Conductivity: -- µS/cm	Benthic Growth:	None		
Detergents: -- mg/L	Stains:	None		
	Non-illicit:	None		
			Condition Assessment	
			Graffiti:	None
			Erosion:	None
			Deposition:	None 0 in.
			Damage:	None

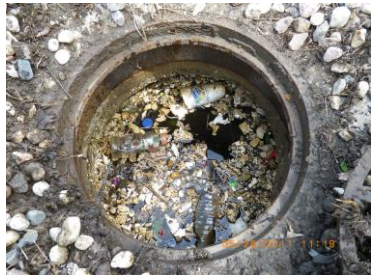
o20110526111930.JPG

Inspection Date: 5/26/2011 11:19:00 AM		Type: Other	Flow: Submerged, indeterminate	Previous Rainfall (hrs): 72+
Illicit Discharge Potential: Potential		Inspector: JCW	Notes	
Submerged: Fully		Depth (in):	Limited screening conducted to check for floatable debris.	
Sampling Results				
Sample Location:	Floatables:	None		
Total Chlorine: -- ppm	Odor:			
Free Chlorine: -- ppm	Turbidity:			
Ammonia: -- ppm	Color:			
pH: -- units	Gross Solids:	Moderate		
Temperature -- °F	Vegetation:			
Conductivity: -- µS/cm	Benthic Growth:			
Detergents: -- mg/L	Stains:			
	Non-illicit:	None		
			Condition Assessment	
			Graffiti:	None
			Erosion:	None
			Deposition:	None 0 in.
			Damage:	None

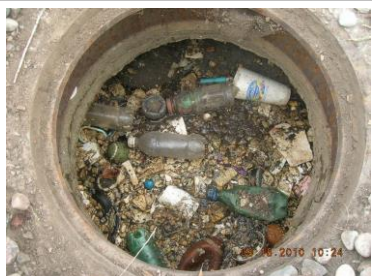
o20100818102410.JPG

Inspection Date: 8/18/2010 10:29:59 AM		Type: Ongoing	Flow: Submerged, indeterminate	Previous Rainfall (hrs): 72+
Illicit Discharge Potential: Potential		Inspector: JCW	Notes	
Submerged: Fully		Depth (in): 44	Severe floatable debris in catchbasin.	
Sampling Results				
Sample Location: Pool	Floatables:	None		
Total Chlorine: 0 ppm	Odor:	None		
Free Chlorine: 0 ppm	Turbidity:	None		
Ammonia: 0 ppm	Color:	Faint in bottle		
pH: 7.38 units	Gross Solids:	Severe		
Temperature 76 °F	Vegetation:	None		
Conductivity: -- µS/cm	Benthic Growth:	None		
Detergents: 0 mg/L	Stains:	None		
	Non-illicit:	None		
			Condition Assessment	
			Graffiti:	None
			Erosion:	None
			Deposition:	None 0 in.
			Damage:	None

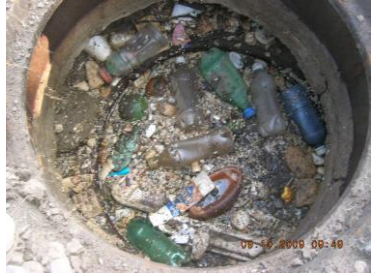
Inspection Date: 9/10/2009		Type: Initial		Flow: Submerged, indeterminate		Previous Rainfall (hrs): 72+	
Illicit Discharge Potential: Potential		Inspector: JCW		Notes Abnormal detergent analysis result (bubbles). Significant floatables in manhole.

Osh09_DSCN6768.JPG	
Submerged: Fully		Depth (in): 44					
Sampling Results		Floatables: None Odor: None Turbidity: None Color: None Gross Solids: Severe Vegetation: None Benthic Growth: None Stains: None Non-illicit: None		Condition Assessment Graffiti: None Erosion: None Deposition: None 0 in. Damage: None			
Sample Location: Pool Total Chlorine: 0 ppm Free Chlorine: 0 ppm Ammonia: -- ppm pH: 8.3 units Temperature: 75 °F Conductivity: -- µS/cm Detergents: 0 mg/L

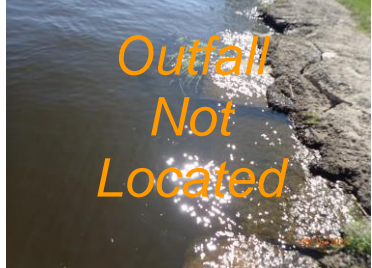
o20210816104428.JPG 2021

Inspection Date: 8/16/2021 10:47:35 AM		Type: Ongoing	Flow: Submerged (not located)	Previous Rainfall (hrs): 72+
Illicit Discharge Potential: Potential		Inspector: JCW		
Submerged: Fully		Depth (in):		
Sampling Results		Notes Outfall fully submerged and not located - screened upstream at 03-35 US1. Floating gross solids (litter) in upstream manhole.		
Sample Location:	Floatables:	None		
Total Chlorine: -- ppm	Odor:	None		
Free Chlorine: -- ppm	Turbidity:	None		
Ammonia: -- ppm	Color:	None		
pH: -- units	Gross Solids:	None		
Temperature -- °F	Vegetation:	None		
Conductivity: -- µS/cm	Benthic Growth:	None		
Detergents: -- mg/L	Stains:	None		
	Non-illicit:	None		
		Condition Assessment Graffiti: None Erosion: None Deposition: None in. Damage: None

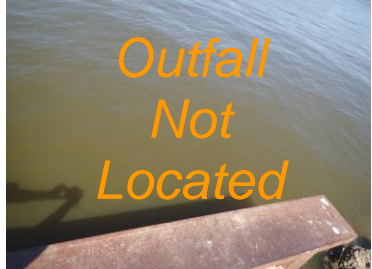
o20200819143634.JPG 2020

Inspection Date: 8/19/2020 2:40:57 PM		Type: Ongoing	Flow: Submerged (not located)	Previous Rainfall (hrs): 72+
Illicit Discharge Potential: Potential		Inspector: JCW		
Submerged: Fully		Depth (in):		
Sampling Results		Notes Outfall fully submerged and not located - screened upstream at 03-35 US1. Floating gross solids (litter) in upstream manhole.		
Sample Location:	Floatables:	None		
Total Chlorine: -- ppm	Odor:	None		
Free Chlorine: -- ppm	Turbidity:	None		
Ammonia: -- ppm	Color:	None		
pH: -- units	Gross Solids:	None		
Temperature -- °F	Vegetation:	None		
Conductivity: -- µS/cm	Benthic Growth:	None		
Detergents: -- mg/L	Stains:	None		
	Non-illicit:	None		
		Condition Assessment Graffiti: None Erosion: None Deposition: None in. Damage: None

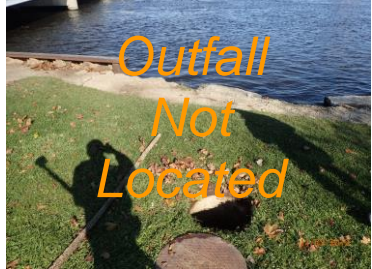
o20191105114512.JPG 2019

Inspection Date: 11/5/2019 11:44:00 AM		Type: Repeat	Flow: Submerged (not located)	Previous Rainfall (hrs): 48-72
Illicit Discharge Potential: Potential		Inspector: JCW		
Submerged: Fully		Depth (in):		
Sampling Results		Notes Follow-up inspection for sampling - limited screening conducted. Floating gross solids (litter) and detergent in manhole.		
Sample Location:	Floatables:	None		
Total Chlorine: -- ppm	Odor:	None		
Free Chlorine: -- ppm	Turbidity:	None		
Ammonia: -- ppm	Color:	None		
pH: -- units	Gross Solids:	None		
Temperature -- °F	Vegetation:	None		
Conductivity: -- µS/cm	Benthic Growth:	None		
Detergents: -- mg/L	Stains:	None		
	Non-illicit:	None		
		Condition Assessment Graffiti: None Erosion: None Deposition: None in. Damage: None

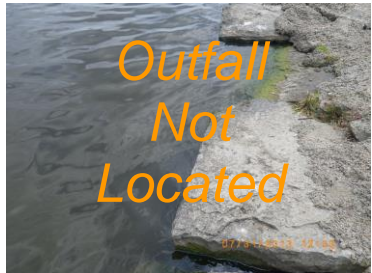
o20130731113304.JPG

Inspection Date: 7/31/2013 12:30:28 PM		Type: Ongoing	Flow: Submerged (not located)	Previous Rainfall (hrs): 72+
Illicit Discharge Potential: Potential		Inspector: JCW	Notes	
Submerged: Fully		Depth (in):	2012 screening follow-up. Outfall not located. Outfall screened upstream at 03-35 US1. Gross solids in upstream mh.	
Sampling Results		Condition Assessment		
Sample Location:	Floatables:	None		
Total Chlorine: -- ppm	Odor:	None		
Free Chlorine: -- ppm	Turbidity:	None		
Ammonia: -- ppm	Color:	None		
pH: -- units	Gross Solids:	None		
Temperature -- °F	Vegetation:	None		
Conductivity: -- µS/cm	Benthic Growth:	None		
Detergents: -- mg/L	Stains:	None		
	Non-illicit:	None		
		Graffiti:	None	
		Erosion:	None	
		Deposition:	None	in.
		Damage:	None

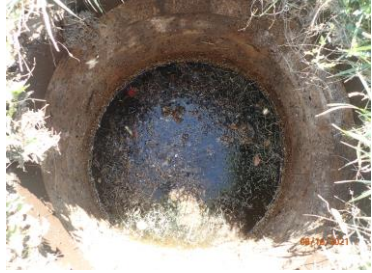
<p style="text-align: center;">o20210816104502.JPG</p> <p style="text-align: center; font-size: 24pt; font-weight: bold;">2021</p>	
Submerged: Fully		Depth (in): 39		Sample collected from submerged pool in manhole. Floating gross solids (litter) in manhole.			
Sampling Results							
Sample Location: Pool Total Chlorine: 0 ppm Free Chlorine: 0 ppm Ammonia: 0 ppm pH: 7.76 units Temperature: 77 °F Conductivity: 349 µS/cm Detergents: 0 mg/L		Floatables: None Odor: None Turbidity: None Color: None Gross Solids: Moderate Vegetation: None Benthic Growth: None Stains: None Non-illicit: None		Condition Assessment Graffiti: None Erosion: None Deposition: None in. Damage: None

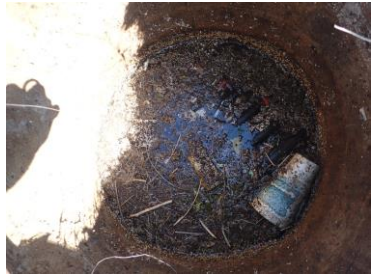
<p style="text-align: center;">o20200819143804.JPG</p> <p style="text-align: center; font-size: 24pt; font-weight: bold;">2020</p>	
Submerged: Fully		Depth (in): 36		Sample collected from submerged pool in manhole. Floating gross solids (litter) in manhole. Slightly elevated ammonia.			
Sampling Results							
Sample Location: Pool Total Chlorine: 0 ppm Free Chlorine: 0 ppm Ammonia: 0.5 ppm pH: 8.44 units Temperature: 85 °F Conductivity: 346 µS/cm Detergents: 0 mg/L		Floatables: None Odor: None Turbidity: None Color: None Gross Solids: Severe Vegetation: None Benthic Growth: None Stains: None Non-illicit: None		Condition Assessment Graffiti: None Erosion: None Deposition: None in. Damage: None

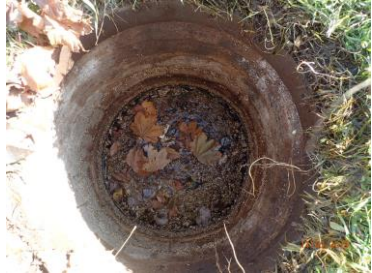
<p style="text-align: center;">o20191105114518.JPG</p> <p style="text-align: center; font-size: 24pt; font-weight: bold;">2019</p>	
Submerged: Partially		Depth (in): 30		Detergent detection follow-up. Limited screening conducted. Floating gross solids (litter) and detergent in manhole.			
Sampling Results							
Sample Location: Pool Total Chlorine: -- ppm Free Chlorine: -- ppm Ammonia: -- ppm pH: -- units Temperature: -- °F Conductivity: -- µS/cm Detergents: 0 mg/L		Floatables: None Odor: None Turbidity: None Color: None Gross Solids: Severe Vegetation: None Benthic Growth: None Stains: None Non-illicit: None		Condition Assessment Graffiti: None Erosion: None Deposition: None in. Damage: None

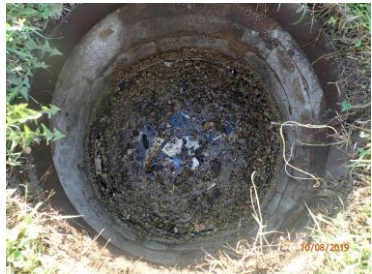
<p style="text-align: center;">o20191008072724.JPG</p> <p style="text-align: center; font-size: 24pt; font-weight: bold;">2019</p>	
Submerged: Partially		Depth (in): 42		Detergent detection follow-up. Limited screening conducted beyond sampling.			
Sampling Results							
Sample Location: Pool Total Chlorine: 0 ppm Free Chlorine: 0 ppm Ammonia: 0 ppm pH: 7.68 units Temperature: 55 °F Conductivity: 415 µS/cm Detergents: 1.3 mg/L		Floatables: None Odor: None Turbidity: None Color: None Gross Solids: Severe Vegetation: None Benthic Growth: None Stains: None Non-illicit: None		Condition Assessment Graffiti: None Erosion: None Deposition: None in. Damage: None

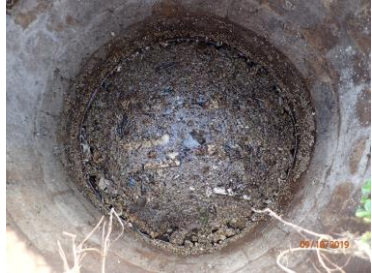
o20190918070320.JPG

Inspection Date: 9/18/2019 8:06:15 AM		Type: Ongoing	Flow: Submerged, indeterminate	Previous Rainfall (hrs): 72+
Illicit Discharge Potential: Potential		Inspector: JCW	Notes	
Submerged: Fully		Depth (in): 38	Sample collected from submerged pool in manhole. Floating gross solids (litter) and detergent in manhole.	
Sampling Results		Floatables: None	Condition Assessment Graffiti: None Erosion: None Deposition: None in. Damage: None	
Sample Location: Pool	Odor: None	Turbidity: None		
Total Chlorine: 0 ppm	Color: None	Gross Solids: Severe		
Free Chlorine: 0 ppm	Vegetation: None	Benthic Growth: None		
Ammonia: 0 ppm	Stains: None	Non-illicit: None		
pH: 8.47 units				
Temperature: 70 °F				
Conductivity: 389 µS/cm				
Detergents: 1.3 mg/L

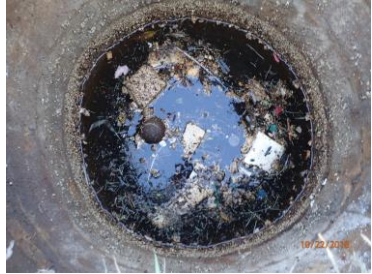
o20181022152746.JPG

Inspection Date: 10/22/2018 3:30:12 PM		Type: Ongoing	Flow: Submerged, indeterminate	Previous Rainfall (hrs): 48-72
Illicit Discharge Potential: Potential		Inspector: JCW	Notes	
Submerged: Fully		Depth (in): 41	Sample collected from submerged pool in manhole. Floating gross solids (litter) in manhole.	
Sampling Results		Floatables: None	Condition Assessment Graffiti: None Erosion: None Deposition: None in. Damage: None	
Sample Location: Pool	Odor: None	Turbidity: None		
Total Chlorine: 0 ppm	Color: None	Gross Solids: Moderate		
Free Chlorine: 0 ppm	Vegetation: None	Benthic Growth: None		
Ammonia: 0 ppm	Stains: None	Non-illicit: None		
pH: 7.81 units				
Temperature: 56 °F				
Conductivity: 338 µS/cm				
Detergents: 0 mg/L

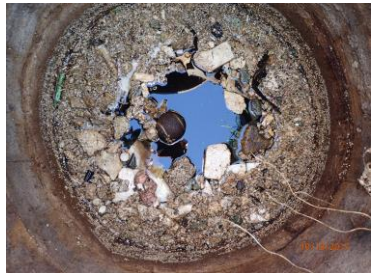
o20171018151012.JPG

Inspection Date: 10/18/2017 3:16:37 PM		Type: Ongoing	Flow: Submerged, indeterminate	Previous Rainfall (hrs): 72+
Illicit Discharge Potential: Potential		Inspector: JCW	Notes	
Submerged: Fully		Depth (in): 35	Sample collected from submerged pool in manhole. Floating gross solids (litter) in manhole.	
Sampling Results		Floatables: None	Condition Assessment Graffiti: None Erosion: None Deposition: None in. Damage: None	
Sample Location: Pool	Odor: None	Turbidity: None		
Total Chlorine: 0 ppm	Color: None	Gross Solids: Severe		
Free Chlorine: 0 ppm	Vegetation: None	Benthic Growth: None		
Ammonia: 0 ppm	Stains: None	Non-illicit: None		
pH: 7.94 units				
Temperature: 66 °F				
Conductivity: 554 µS/cm				
Detergents: 0 mg/L

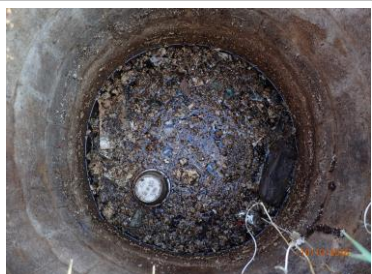
o20161010094958.JPG

Inspection Date: 10/10/2016 9:52:43 AM		Type: Ongoing	Flow: Submerged, indeterminate	Previous Rainfall (hrs): 72+
Illicit Discharge Potential: Potential		Inspector: JCW	Notes	
Submerged: Fully		Depth (in): 32	Potential illicit discharge due to gross solids.	
Sampling Results		Floatables: None	Condition Assessment Graffiti: None Erosion: None Deposition: None in. Damage: None	
Sample Location: Pool	Odor: Faint	Turbidity: None		
Total Chlorine: 0 ppm	Color: None	Gross Solids: Moderate		
Free Chlorine: 0 ppm	Vegetation: None	Benthic Growth: None		
Ammonia: 0 ppm	Stains: None	Non-illicit: None		
pH: 7.54 units				
Temperature: 63 °F				
Conductivity: 391 µS/cm				
Detergents: 0 mg/L

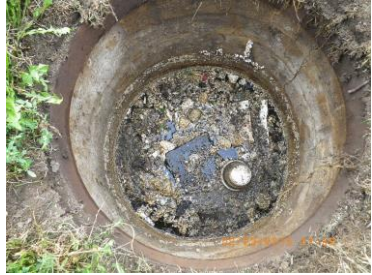
<p style="text-align: center;">o20150923063950.JPG</p> <p style="text-align: center; font-size: 1.5em; font-weight: bold;">2015</p>																																									
Submerged: Fully		Depth (in): 30		Floating gross solids (litter) in manhole.																																											
Sampling Results <table border="1" style="width:100%; border-collapse: collapse;"> <tr><td>Sample Location:</td><td>Pool</td></tr> <tr><td>Total Chlorine:</td><td>0 ppm</td></tr> <tr><td>Free Chlorine:</td><td>0 ppm</td></tr> <tr><td>Ammonia:</td><td>0 ppm</td></tr> <tr><td>pH:</td><td>8.64 units</td></tr> <tr><td>Temperature:</td><td>69 °F</td></tr> <tr><td>Conductivity:</td><td>359 µS/cm</td></tr> <tr><td>Detergents:</td><td>0 mg/L</td></tr> </table>		Sample Location:	Pool	Total Chlorine:	0 ppm			Free Chlorine:	0 ppm	Ammonia:	0 ppm	pH:	8.64 units	Temperature:	69 °F	Conductivity:	359 µS/cm	Detergents:	0 mg/L	<table border="1" style="width:100%; border-collapse: collapse;"> <tr><td>Floatables:</td><td>None</td></tr> <tr><td>Odor:</td><td>None</td></tr> <tr><td>Turbidity:</td><td>None</td></tr> <tr><td>Color:</td><td>Faint in bottle</td></tr> <tr><td>Gross Solids:</td><td>Moderate</td></tr> <tr><td>Vegetation:</td><td>None</td></tr> <tr><td>Benthic Growth:</td><td>None</td></tr> <tr><td>Stains:</td><td>None</td></tr> <tr><td>Non-illicit:</td><td>None</td></tr> </table>		Floatables:	None	Odor:	None	Turbidity:	None	Color:	Faint in bottle	Gross Solids:	Moderate	Vegetation:	None	Benthic Growth:	None	Stains:	None	Non-illicit:	None	Condition Assessment <table border="1" style="width:100%; border-collapse: collapse;"> <tr><td>Graffiti:</td><td>None</td></tr> <tr><td>Erosion:</td><td>None</td></tr> <tr><td>Deposition:</td><td>Minor 1 in.</td></tr> <tr><td>Damage:</td><td>None</td></tr> </table>		Graffiti:	None	Erosion:	None	Deposition:	Minor 1 in.

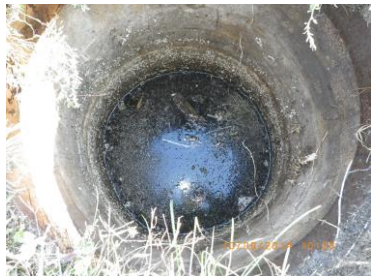
<p style="text-align: center;">o20141009093356.JPG</p> <p style="text-align: center; font-size: 1.5em; font-weight: bold;">2014</p>																																									
Submerged: Fully		Depth (in): 32		Vegetative debris in photo from opening lid.																																											
Sampling Results <table border="1" style="width:100%; border-collapse: collapse;"> <tr><td>Sample Location:</td><td>Pool</td></tr> <tr><td>Total Chlorine:</td><td>0 ppm</td></tr> <tr><td>Free Chlorine:</td><td>0 ppm</td></tr> <tr><td>Ammonia:</td><td>0 ppm</td></tr> <tr><td>pH:</td><td>7.86 units</td></tr> <tr><td>Temperature:</td><td>58 °F</td></tr> <tr><td>Conductivity:</td><td>476 µS/cm</td></tr> <tr><td>Detergents:</td><td>0 mg/L</td></tr> </table>		Sample Location:	Pool	Total Chlorine:	0 ppm			Free Chlorine:	0 ppm	Ammonia:	0 ppm	pH:	7.86 units	Temperature:	58 °F	Conductivity:	476 µS/cm	Detergents:	0 mg/L	<table border="1" style="width:100%; border-collapse: collapse;"> <tr><td>Floatables:</td><td>None</td></tr> <tr><td>Odor:</td><td>None</td></tr> <tr><td>Turbidity:</td><td>None</td></tr> <tr><td>Color:</td><td>Faint in bottle</td></tr> <tr><td>Gross Solids:</td><td>Slight</td></tr> <tr><td>Vegetation:</td><td>None</td></tr> <tr><td>Benthic Growth:</td><td>None</td></tr> <tr><td>Stains:</td><td>None</td></tr> <tr><td>Non-illicit:</td><td>None</td></tr> </table>		Floatables:	None	Odor:	None	Turbidity:	None	Color:	Faint in bottle	Gross Solids:	Slight	Vegetation:	None	Benthic Growth:	None	Stains:	None	Non-illicit:	None	Condition Assessment <table border="1" style="width:100%; border-collapse: collapse;"> <tr><td>Graffiti:</td><td>None</td></tr> <tr><td>Erosion:</td><td>None</td></tr> <tr><td>Deposition:</td><td>Minor 1 in.</td></tr> <tr><td>Damage:</td><td>None</td></tr> </table>		Graffiti:	None	Erosion:	None	Deposition:	Minor 1 in.

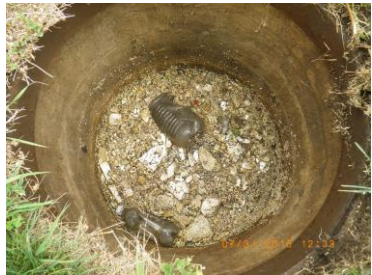
<p style="text-align: center;">o20130731113346.JPG</p> <p style="text-align: center; font-size: 1.5em; font-weight: bold;">2013</p>																																									
Submerged: Fully		Depth (in): 33		2012 screening follow-up. Significant gross solids. Similar to previous years.																																											
Sampling Results <table border="1" style="width:100%; border-collapse: collapse;"> <tr><td>Sample Location:</td><td>Pool</td></tr> <tr><td>Total Chlorine:</td><td>0 ppm</td></tr> <tr><td>Free Chlorine:</td><td>0 ppm</td></tr> <tr><td>Ammonia:</td><td>0 ppm</td></tr> <tr><td>pH:</td><td>8.47 units</td></tr> <tr><td>Temperature:</td><td>75 °F</td></tr> <tr><td>Conductivity:</td><td>425 µS/cm</td></tr> <tr><td>Detergents:</td><td>0 mg/L</td></tr> </table>		Sample Location:	Pool	Total Chlorine:	0 ppm			Free Chlorine:	0 ppm	Ammonia:	0 ppm	pH:	8.47 units	Temperature:	75 °F	Conductivity:	425 µS/cm	Detergents:	0 mg/L	<table border="1" style="width:100%; border-collapse: collapse;"> <tr><td>Floatables:</td><td>None</td></tr> <tr><td>Odor:</td><td>None</td></tr> <tr><td>Turbidity:</td><td>None</td></tr> <tr><td>Color:</td><td>Faint in bottle</td></tr> <tr><td>Gross Solids:</td><td>Severe</td></tr> <tr><td>Vegetation:</td><td>None</td></tr> <tr><td>Benthic Growth:</td><td>None</td></tr> <tr><td>Stains:</td><td>Moderate</td></tr> <tr><td>Non-illicit:</td><td>None</td></tr> </table>		Floatables:	None	Odor:	None	Turbidity:	None	Color:	Faint in bottle	Gross Solids:	Severe	Vegetation:	None	Benthic Growth:	None	Stains:	Moderate	Non-illicit:	None	Condition Assessment <table border="1" style="width:100%; border-collapse: collapse;"> <tr><td>Graffiti:</td><td>None</td></tr> <tr><td>Erosion:</td><td>None</td></tr> <tr><td>Deposition:</td><td>None in.</td></tr> <tr><td>Damage:</td><td>None</td></tr> </table>		Graffiti:	None	Erosion:	None	Deposition:	None in.

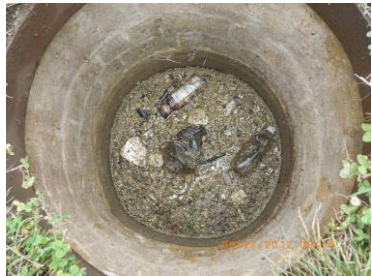
<p style="text-align: center;">o20120927081522.JPG</p> <p style="text-align: center; font-size: 1.5em; font-weight: bold;">2012</p>																																									
Submerged: Fully		Depth (in): 31		2011 gross solids follow-up.																																											
Sampling Results <table border="1" style="width:100%; border-collapse: collapse;"> <tr><td>Sample Location:</td><td>Pool</td></tr> <tr><td>Total Chlorine:</td><td>0 ppm</td></tr> <tr><td>Free Chlorine:</td><td>0 ppm</td></tr> <tr><td>Ammonia:</td><td>0 ppm</td></tr> <tr><td>pH:</td><td>8.42 units</td></tr> <tr><td>Temperature:</td><td>59 °F</td></tr> <tr><td>Conductivity:</td><td>723 µS/cm</td></tr> <tr><td>Detergents:</td><td>0 mg/L</td></tr> </table>		Sample Location:	Pool	Total Chlorine:	0 ppm			Free Chlorine:	0 ppm	Ammonia:	0 ppm	pH:	8.42 units	Temperature:	59 °F	Conductivity:	723 µS/cm	Detergents:	0 mg/L	<table border="1" style="width:100%; border-collapse: collapse;"> <tr><td>Floatables:</td><td>None</td></tr> <tr><td>Odor:</td><td>None</td></tr> <tr><td>Turbidity:</td><td>None</td></tr> <tr><td>Color:</td><td>None</td></tr> <tr><td>Gross Solids:</td><td>Severe</td></tr> <tr><td>Vegetation:</td><td>None</td></tr> <tr><td>Benthic Growth:</td><td>None</td></tr> <tr><td>Stains:</td><td>Slight</td></tr> <tr><td>Non-illicit:</td><td>None</td></tr> </table>		Floatables:	None	Odor:	None	Turbidity:	None	Color:	None	Gross Solids:	Severe	Vegetation:	None	Benthic Growth:	None	Stains:	Slight	Non-illicit:	None	Condition Assessment <table border="1" style="width:100%; border-collapse: collapse;"> <tr><td>Graffiti:</td><td>None</td></tr> <tr><td>Erosion:</td><td>None</td></tr> <tr><td>Deposition:</td><td>Minor 3 in.</td></tr> <tr><td>Damage:</td><td>None</td></tr> </table>		Graffiti:	None	Erosion:	None	Deposition:	Minor 3 in.

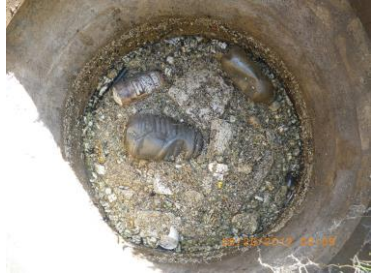
o20120620080918.JPG

Inspection Date: 6/20/2012 9:08:12 AM		Type: Other	Flow: Submerged, indeterminate	Previous Rainfall (hrs): 24-48
Illicit Discharge Potential: Potential		Inspector: JCW	Notes	
Submerged: Fully		Depth (in): 39	Gross solids pre-screening.	
Sampling Results				
Sample Location:	Floatables:	None		
Total Chlorine: -- ppm	Odor:	None		
Free Chlorine: -- ppm	Turbidity:	None		
Ammonia: -- ppm	Color:	None		
pH: -- units	Gross Solids:	Severe		
Temperature -- °F	Vegetation:	None		
Conductivity: -- µS/cm	Benthic Growth:	None		
Detergents: -- mg/L	Stains:	None		
	Non-illicit:	None		
			Condition Assessment	
			Graffiti:	None
			Erosion:	None
			Deposition:	None in.
			Damage:	None
