IDDE Ongoing Screening Summary Report

2022 Inspection Year

City of Oshkosh

Westwood

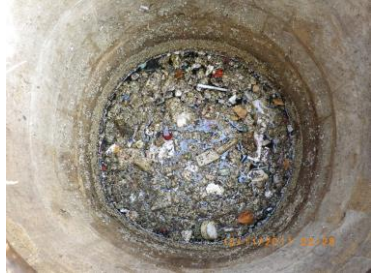
o20111011092832.JPG

Inspection Date: 10/11/2011 9:29:50 AM		Type: Ongoing	Flow: Submerged, indeterminate	Previous Rainfall (hrs): 72+
Illicit Discharge Potential: Potential		Inspector: JCW	Notes	
Submerged: Fully		Depth (in): 19	2010 screening follow-up. Floatable debris still present. Slight petroleum sheen.	
Sampling Results				
Sample Location: Pool	Floatables:	Severe		
Total Chlorine: 0 ppm	Odor:	None		
Free Chlorine: 0 ppm	Turbidity:	None		
Ammonia: 0 ppm	Color:	None		
pH: 8.01 units	Gross Solids:	Severe		
Temperature 71 °F	Vegetation:	None		
Conductivity: -- µS/cm	Benthic Growth:	None		
Detergents: -- mg/L	Stains:	None		
	Non-illicit:	None		
			Condition Assessment	
			Graffiti:	None
			Erosion:	None
			Deposition:	None 0 in.
			Damage:	None

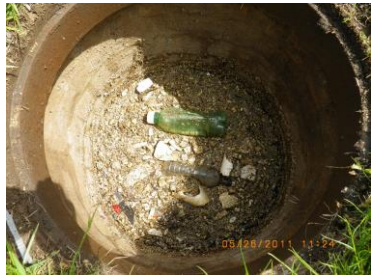
o20110526112400.JPG

Inspection Date: 5/26/2011 11:23:00 AM		Type: Other	Flow: Submerged, indeterminate	Previous Rainfall (hrs): 72+
Illicit Discharge Potential: Potential		Inspector: JCW	Notes	
Submerged: Fully		Depth (in):	Limited screening conducted to check for floatable debris.	
Sampling Results				
Sample Location:	Floatables:	None		
Total Chlorine: -- ppm	Odor:			
Free Chlorine: -- ppm	Turbidity:			
Ammonia: -- ppm	Color:			
pH: -- units	Gross Solids:	Severe		
Temperature -- °F	Vegetation:			
Conductivity: -- µS/cm	Benthic Growth:			
Detergents: -- mg/L	Stains:			
	Non-illicit:	None		
			Condition Assessment	
			Graffiti:	None
			Erosion:	None
			Deposition:	None 0 in.
			Damage:	None

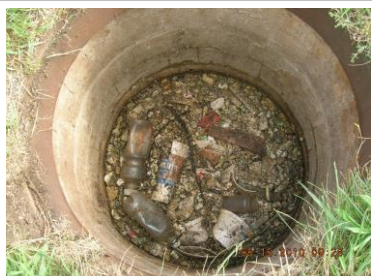
o20100818092304.JPG

Inspection Date: 8/18/2010 9:32:06 AM		Type: Ongoing	Flow: Submerged, indeterminate	Previous Rainfall (hrs): 72+
Illicit Discharge Potential: Potential		Inspector: JCW	Notes	
Submerged: Fully		Depth (in): 34	Severe floatable debris in catchbasin.	
Sampling Results				
Sample Location: Pool	Floatables:	None		
Total Chlorine: 0 ppm	Odor:	Faint		
Free Chlorine: 0 ppm	Turbidity:	None		
Ammonia: 0.5 ppm	Color:	Faint in bottle		
pH: 7.46 units	Gross Solids:	Severe		
Temperature 73 °F	Vegetation:	None		
Conductivity: -- µS/cm	Benthic Growth:	None		
Detergents: 0 mg/L	Stains:	None		
	Non-illicit:	None		
			Condition Assessment	
			Graffiti:	None
			Erosion:	None
			Deposition:	None 0 in.
			Damage:	None

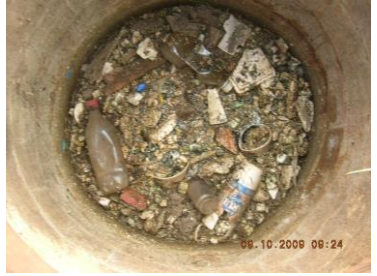
Inspection Date: 9/10/2009		Type: Initial		Flow: Submerged, indeterminate		Previous Rainfall (hrs): 72+	
Illicit Discharge Potential: Potential		Inspector: JCW		Notes Abnormal detergent analysis result (bubbles). Significant floatables in manhole.

Osh09_DSCN6763.JPG	
Submerged: Fully		Depth (in): 33					
Sampling Results Sample Location: Pool Total Chlorine: 0 ppm Free Chlorine: 0 ppm Ammonia: -- ppm pH: 8.23 units Temperature: 73 °F Conductivity: -- µS/cm Detergents: 0 mg/L		Floatables: None Odor: None Turbidity: None Color: None Gross Solids: Severe Vegetation: None Benthic Growth: None Stains: None Non-illicit: None		Condition Assessment Graffiti: None Erosion: None Deposition: None 0 in. Damage: None			
2009

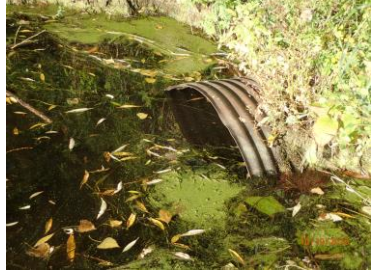
Inspection Date: 10/10/2016 8:37:23 AM		Type: Ongoing	Flow: Submerged, indeterminate	Previous Rainfall (hrs): 72+
Illicit Discharge Potential: Unlikely		Inspector: JCW		
Submerged: Partially		Depth (in): 31		
Sampling Results Sample Location: Total Chlorine: -- ppm Free Chlorine: -- ppm Ammonia: -- ppm pH: -- units Temperature -- °F Conductivity: -- µS/cm Detergents: -- mg/L		Floatables: None Odor: None Turbidity: None Color: None Gross Solids: None Vegetation: None Benthic Growth: None Stains: None Non-illicit: None		
		Notes Outfall partially submerged - screened upstream at 03-293 US1.		
		Condition Assessment Graffiti: None Erosion: None Deposition: None in. Damage: Minor

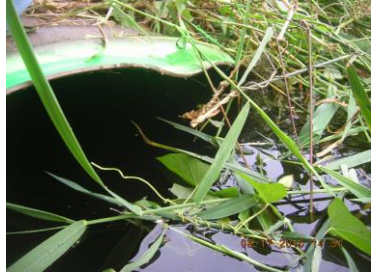
Inspection Date: 8/17/2010 3:02:36 PM		Type: Ongoing	Flow: Submerged, indeterminate	Previous Rainfall (hrs): 72+
Illicit Discharge Potential: Unlikely		Inspector: JCW		
Submerged: Partially		Depth (in): 38		
Sampling Results Sample Location: Total Chlorine: -- ppm Free Chlorine: -- ppm Ammonia: -- ppm pH: -- units Temperature -- °F Conductivity: -- µS/cm Detergents: -- mg/L		Floatables: None Odor: None Turbidity: None Color: None Gross Solids: None Vegetation: None Benthic Growth: None Stains: None Non-illicit: None		
		Notes Outfall partially submerged. Outfall screened upstream at 03-293 US1.		
		Condition Assessment Graffiti: None Erosion: None Deposition: None 0 in. Damage: Minor

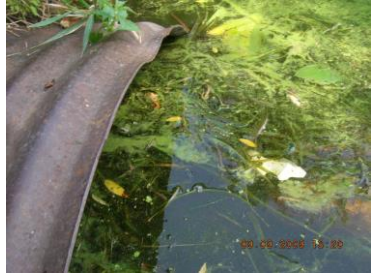
Osh09_DSCN6736.JPG <div style="text-align: right; font-size: 1.5em; font-weight: bold;">2009</div>

Inspection Date: 9/9/2009		Type: Initial	Flow: Submerged, indeterminate	Previous Rainfall (hrs): 72+
Illicit Discharge Potential: Potential		Inspector: JCW		
Submerged: Partially		Depth (in): 32		
Sampling Results Sample Location: Total Chlorine: -- ppm Free Chlorine: -- ppm Ammonia: -- ppm pH: -- units Temperature -- °F Conductivity: -- µS/cm Detergents: -- mg/L		Floatables: None Odor: None Turbidity: None Color: None Gross Solids: None Vegetation: None Benthic Growth: Slight Stains: None Non-illicit: None		
		Notes Outfall partially submerged. Outfall screened upstream at 03-293 US1.		
		Condition Assessment Graffiti: None Erosion: None Deposition: None 0 in. Damage: Minor

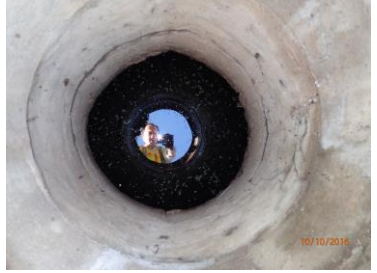
o20161010083910.JPG <div style="font-size: 24pt; font-weight: bold;">2016</div>

Inspection Date: 10/10/2016 8:41:32 AM		Type: Ongoing	Flow: Submerged, indeterminate	Previous Rainfall (hrs): 72+																															
Illicit Discharge Potential: Unlikely		Inspector: JCW																																	
Submerged: Fully		Depth (in): 33																																	
Sampling Results		<div style="border: 1px solid black; padding: 5px;">Notes</div> <div style="border: 1px solid black; padding: 5px; margin-top: 10px;"> Condition Assessment Graffiti: None Erosion: None Deposition: None in. Damage: None </div>																																	
<table border="1" style="width: 100%; border-collapse: collapse;"> <tr><td>Sample Location:</td><td>Pool</td></tr> <tr><td>Total Chlorine:</td><td>0 ppm</td></tr> <tr><td>Free Chlorine:</td><td>0 ppm</td></tr> <tr><td>Ammonia:</td><td>0 ppm</td></tr> <tr><td>pH:</td><td>7.46 units</td></tr> <tr><td>Temperature:</td><td>62 °F</td></tr> <tr><td>Conductivity:</td><td>386 µS/cm</td></tr> <tr><td>Detergents:</td><td>0 mg/L</td></tr> </table> <table border="1" style="width: 100%; border-collapse: collapse;"> <tr><td>Floatables:</td><td>None</td></tr> <tr><td>Odor:</td><td>None</td></tr> <tr><td>Turbidity:</td><td>None</td></tr> <tr><td>Color:</td><td>Faint in bottle</td></tr> <tr><td>Gross Solids:</td><td>None</td></tr> <tr><td>Vegetation:</td><td>None</td></tr> <tr><td>Benthic Growth:</td><td>None</td></tr> <tr><td>Stains:</td><td>None</td></tr> <tr><td>Non-illicit:</td><td>None</td></tr> </table>					Sample Location:	Pool	Total Chlorine:	0 ppm	Free Chlorine:	0 ppm	Ammonia:	0 ppm	pH:	7.46 units	Temperature:	62 °F	Conductivity:	386 µS/cm	Detergents:	0 mg/L	Floatables:	None	Odor:	None	Turbidity:	None	Color:	Faint in bottle	Gross Solids:	None	Vegetation:	None	Benthic Growth:	None	Stains:

Sample Location:	Pool																																		
Total Chlorine:	0 ppm																																		
Free Chlorine:	0 ppm																																		
Ammonia:	0 ppm																																		
pH:	7.46 units																																		
Temperature:	62 °F																																		
Conductivity:	386 µS/cm																																		
Detergents:	0 mg/L																																		
Floatables:	None																																		
Odor:	None																																		
Turbidity:	None																																		
Color:	Faint in bottle																																		
Gross Solids:	None																																		
Vegetation:	None																																		
Benthic Growth:	None																																		
Stains:	None																																		
Non-illicit:	None

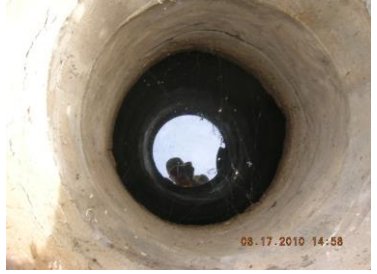
o20100817145804.JPG <div style="font-size: 24pt; font-weight: bold;">2010</div>

Inspection Date: 8/17/2010 3:05:51 PM		Type: Ongoing	Flow: Submerged, indeterminate	Previous Rainfall (hrs): 72+																															
Illicit Discharge Potential: Unlikely		Inspector: JCW																																	
Submerged: Fully		Depth (in): 36																																	
Sampling Results		<div style="border: 1px solid black; padding: 5px;">Notes</div> <div style="border: 1px solid black; padding: 5px; margin-top: 10px;"> Condition Assessment Graffiti: None Erosion: None Deposition: None 0 in. Damage: None </div>																																	
<table border="1" style="width: 100%; border-collapse: collapse;"> <tr><td>Sample Location:</td><td>Pool</td></tr> <tr><td>Total Chlorine:</td><td>0 ppm</td></tr> <tr><td>Free Chlorine:</td><td>0 ppm</td></tr> <tr><td>Ammonia:</td><td>0 ppm</td></tr> <tr><td>pH:</td><td>7.39 units</td></tr> <tr><td>Temperature:</td><td>76 °F</td></tr> <tr><td>Conductivity:</td><td>-- µS/cm</td></tr> <tr><td>Detergents:</td><td>0 mg/L</td></tr> </table> <table border="1" style="width: 100%; border-collapse: collapse;"> <tr><td>Floatables:</td><td>Slight</td></tr> <tr><td>Odor:</td><td>None</td></tr> <tr><td>Turbidity:</td><td>None</td></tr> <tr><td>Color:</td><td>None</td></tr> <tr><td>Gross Solids:</td><td>None</td></tr> <tr><td>Vegetation:</td><td>None</td></tr> <tr><td>Benthic Growth:</td><td>None</td></tr> <tr><td>Stains:</td><td>None</td></tr> <tr><td>Non-illicit:</td><td>Slight</td></tr> </table>					Sample Location:	Pool	Total Chlorine:	0 ppm	Free Chlorine:	0 ppm	Ammonia:	0 ppm	pH:	7.39 units	Temperature:	76 °F	Conductivity:	-- µS/cm	Detergents:	0 mg/L	Floatables:	Slight	Odor:	None	Turbidity:	None	Color:	None	Gross Solids:	None	Vegetation:	None	Benthic Growth:	None	Stains:

Sample Location:	Pool																																		
Total Chlorine:	0 ppm																																		
Free Chlorine:	0 ppm																																		
Ammonia:	0 ppm																																		
pH:	7.39 units																																		
Temperature:	76 °F																																		
Conductivity:	-- µS/cm																																		
Detergents:	0 mg/L																																		
Floatables:	Slight																																		
Odor:	None																																		
Turbidity:	None																																		
Color:	None																																		
Gross Solids:	None																																		
Vegetation:	None																																		
Benthic Growth:	None																																		
Stains:	None																																		
Non-illicit:	Slight

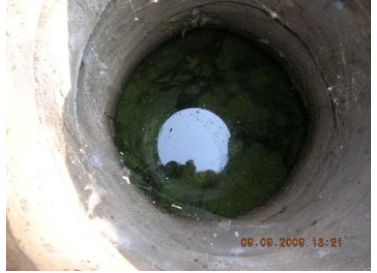
Osh09_DSCN6739.JPG <div style="font-size: 24pt; font-weight: bold;">2009</div>

Inspection Date: 9/9/2009		Type: Initial	Flow: Submerged, indeterminate	Previous Rainfall (hrs): 72+																															
Illicit Discharge Potential: Potential		Inspector: JCW																																	
Submerged: Partially		Depth (in):																																	
Sampling Results		<div style="border: 1px solid black; padding: 5px;">Notes</div> Abnormal detergent analysis result (bubbles)																																	
<table border="1" style="width: 100%; border-collapse: collapse;"> <tr><td>Sample Location:</td><td>Pool</td></tr> <tr><td>Total Chlorine:</td><td>0 ppm</td></tr> <tr><td>Free Chlorine:</td><td>0 ppm</td></tr> <tr><td>Ammonia:</td><td>-- ppm</td></tr> <tr><td>pH:</td><td>7.82 units</td></tr> <tr><td>Temperature:</td><td>78 °F</td></tr> <tr><td>Conductivity:</td><td>-- µS/cm</td></tr> <tr><td>Detergents:</td><td>0 mg/L</td></tr> </table> <table border="1" style="width: 100%; border-collapse: collapse;"> <tr><td>Floatables:</td><td>None</td></tr> <tr><td>Odor:</td><td>None</td></tr> <tr><td>Turbidity:</td><td>None</td></tr> <tr><td>Color:</td><td>None</td></tr> <tr><td>Gross Solids:</td><td>None</td></tr> <tr><td>Vegetation:</td><td>None</td></tr> <tr><td>Benthic Growth:</td><td>None</td></tr> <tr><td>Stains:</td><td>None</td></tr> <tr><td>Non-illicit:</td><td>None</td></tr> </table>					Sample Location:	Pool	Total Chlorine:	0 ppm	Free Chlorine:	0 ppm	Ammonia:	-- ppm	pH:	7.82 units	Temperature:	78 °F	Conductivity:	-- µS/cm	Detergents:	0 mg/L	Floatables:	None	Odor:	None	Turbidity:	None	Color:	None	Gross Solids:	None	Vegetation:	None	Benthic Growth:	None	Stains:

Sample Location:	Pool																																		
Total Chlorine:	0 ppm																																		
Free Chlorine:	0 ppm																																		
Ammonia:	-- ppm																																		
pH:	7.82 units																																		
Temperature:	78 °F																																		
Conductivity:	-- µS/cm																																		
Detergents:	0 mg/L																																		
Floatables:	None																																		
Odor:	None																																		
Turbidity:	None																																		
Color:	None																																		
Gross Solids:	None																																		
Vegetation:	None																																		
Benthic Growth:	None																																		
Stains:	None																																		
Non-illicit:	None																																		
		<div style="border: 1px solid black; padding: 5px; margin-top: 10px;"> Condition Assessment Graffiti: None Erosion: None Deposition: None 0 in. Damage: None </div>

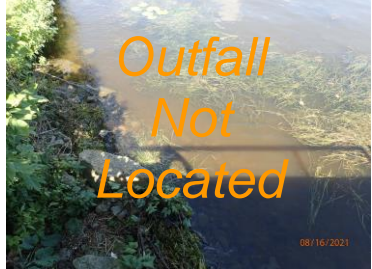
020210816110756.JPG

Inspection Date: 8/16/2021 11:09:51 AM		Type: Ongoing	Flow: Submerged (not located)	Previous Rainfall (hrs): 72+
Illicit Discharge Potential: Potential		Inspector: JCW		
Submerged: Fully		Depth (in):		
Sampling Results Sample Location: _____ Total Chlorine: -- ppm Free Chlorine: -- ppm Ammonia: -- ppm pH: -- units Temperature: -- °F Conductivity: -- µS/cm Detergents: -- mg/L		Floatables: None Odor: None Turbidity: None Color: None Gross Solids: None Vegetation: None Benthic Growth: None Stains: None Non-illicit: None	Notes Outfall fully submerged and not located - screened upstream at 03-81 US1. Floating gross solids (litter) in upstream manhole. Condition Assessment Graffiti: None Erosion: None Deposition: None in. Damage: None

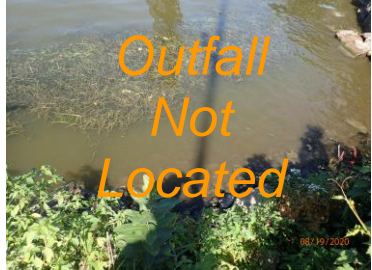
020200819141442.JPG

Inspection Date: 8/19/2020 2:16:29 PM		Type: Ongoing	Flow: Submerged (not located)	Previous Rainfall (hrs): 72+
Illicit Discharge Potential: Potential		Inspector: JCW		
Submerged: Fully		Depth (in):		
Sampling Results Sample Location: _____ Total Chlorine: -- ppm Free Chlorine: -- ppm Ammonia: -- ppm pH: -- units Temperature: -- °F Conductivity: -- µS/cm Detergents: -- mg/L		Floatables: None Odor: None Turbidity: None Color: None Gross Solids: None Vegetation: None Benthic Growth: None Stains: None Non-illicit: None	Notes Outfall fully submerged and not located - screened upstream at 03-81 US1. Floating gross solids (litter) in upstream manhole. Condition Assessment Graffiti: None Erosion: None Deposition: None in. Damage: None

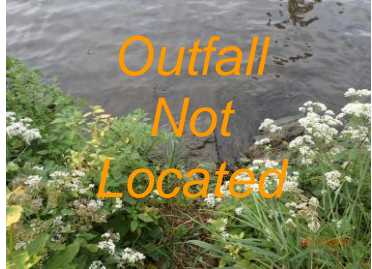
020190917135900.JPG

Inspection Date: 9/17/2019 3:00:32 PM		Type: Ongoing	Flow: Submerged (not located)	Previous Rainfall (hrs): 48-72
Illicit Discharge Potential: Potential		Inspector: JCW		
Submerged: Fully		Depth (in):		
Sampling Results Sample Location: _____ Total Chlorine: -- ppm Free Chlorine: -- ppm Ammonia: -- ppm pH: -- units Temperature: -- °F Conductivity: -- µS/cm Detergents: -- mg/L		Floatables: None Odor: None Turbidity: None Color: None Gross Solids: None Vegetation: None Benthic Growth: None Stains: None Non-illicit: None	Notes Outfall fully submerged and not located - screened upstream at 03-81 US1. Floating gross solids (litter) in manhole. Condition Assessment Graffiti: None Erosion: None Deposition: None in. Damage: None

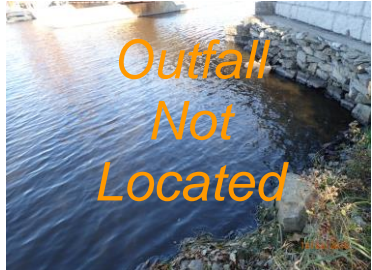
020181022151216.JPG

Inspection Date: 10/22/2018 3:13:39 PM		Type: Ongoing	Flow: Submerged (not located)	Previous Rainfall (hrs): 48-72
Illicit Discharge Potential: Potential		Inspector: JCW		
Submerged: Fully		Depth (in):		
Sampling Results Sample Location: _____ Total Chlorine: -- ppm Free Chlorine: -- ppm Ammonia: -- ppm pH: -- units Temperature: -- °F Conductivity: -- µS/cm Detergents: -- mg/L		Floatables: None Odor: None Turbidity: None Color: None Gross Solids: None Vegetation: None Benthic Growth: None Stains: None Non-illicit: None	Notes Outfall fully submerged and not located - screened upstream at 03-81 US1. Floating gross solids (litter) in manhole. Condition Assessment Graffiti: None Erosion: None Deposition: None in. Damage: None

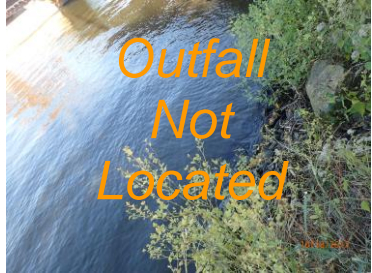
<p style="text-align: center;">o20171018144750.JPG</p> <p style="text-align: center; font-size: 1.5em; font-weight: bold;">2017</p>	
Submerged: Fully		Depth (in):		Outfall fully submerged and not located - screened upstream at 03-81 US1. Ammonia, detergent and sheen in upstream manhole.			
Sampling Results				Condition Assessment			
Sample Location:		Floatables:	None	Graffiti:		None	in.
Total Chlorine: -- ppm		Odor:	None	Erosion:		None	
Free Chlorine: -- ppm		Turbidity:	None	Deposition:		None	
Ammonia: -- ppm		Color:	None	Damage:		None	
pH: -- units		Gross Solids:	None				
Temperature -- °F		Vegetation:	None				
Conductivity: -- µS/cm		Benthic Growth:	None				
Detergents: -- mg/L		Stains:	None				
		Non-illicit:	None

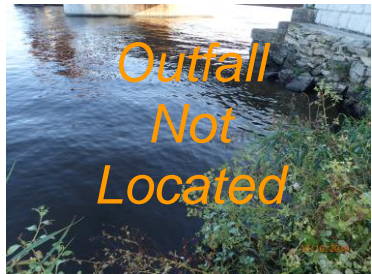
<p style="text-align: center;">o20161010085808.JPG</p> <p style="text-align: center; font-size: 1.5em; font-weight: bold;">2016</p>	
Submerged: Fully		Depth (in):		Outfall fully submerged and not located - screened upstream at 03-81 US1.			
Sampling Results				Condition Assessment			
Sample Location:		Floatables:	None	Graffiti:		None	in.
Total Chlorine: -- ppm		Odor:	None	Erosion:		None	
Free Chlorine: -- ppm		Turbidity:	None	Deposition:		None	
Ammonia: -- ppm		Color:	None	Damage:		None	
pH: -- units		Gross Solids:	None				
Temperature -- °F		Vegetation:	None				
Conductivity: -- µS/cm		Benthic Growth:	None				
Detergents: -- mg/L		Stains:	None				
		Non-illicit:	None

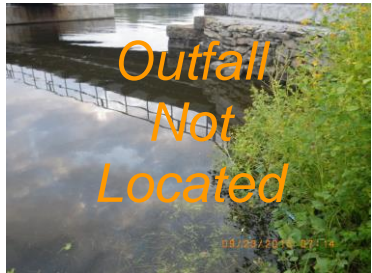
<p style="text-align: center;">o20150923061430.JPG</p> <p style="text-align: center; font-size: 1.5em; font-weight: bold;">2015</p>	
Submerged: Fully		Depth (in):		Outfall fully submerged and not located - screened at 03-81 US1.			
Sampling Results				Condition Assessment			
Sample Location:		Floatables:	None	Graffiti:		None	in.
Total Chlorine: -- ppm		Odor:	None	Erosion:		None	
Free Chlorine: -- ppm		Turbidity:	None	Deposition:		None	
Ammonia: -- ppm		Color:	None	Damage:		None	
pH: -- units		Gross Solids:	None				
Temperature -- °F		Vegetation:	None				
Conductivity: -- µS/cm		Benthic Growth:	None				
Detergents: -- mg/L		Stains:	None				
		Non-illicit:	None

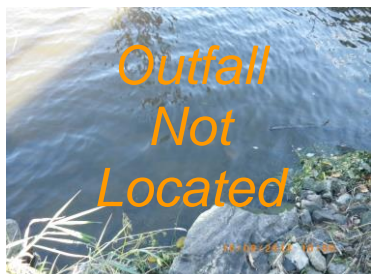
<p style="text-align: center;">o20141009090032.JPG</p> <p style="text-align: center; font-size: 1.5em; font-weight: bold;">2014</p>	
Submerged: Fully		Depth (in):		Outfall fully submerged and not located - screened upstream at 03-81 US1.			
Sampling Results				Condition Assessment			
Sample Location:		Floatables:	None	Graffiti:		None	in.
Total Chlorine: -- ppm		Odor:	None	Erosion:		None	
Free Chlorine: -- ppm		Turbidity:	None	Deposition:		None	
Ammonia: -- ppm		Color:	None	Damage:		None	
pH: -- units		Gross Solids:	None				
Temperature -- °F		Vegetation:	None				
Conductivity: -- µS/cm		Benthic Growth:	None				
Detergents: -- mg/L		Stains:	None				
		Non-illicit:	None

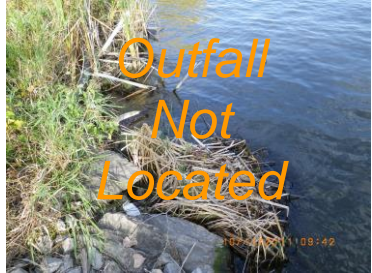
o20111011094236.JPG

Inspection Date: 10/11/2011 9:42:33 AM		Type: Ongoing	Flow: Submerged (not located)	Previous Rainfall (hrs): 72+
Illicit Discharge Potential: Unlikely		Inspector: JCW	Notes	
Submerged: Fully		Depth (in):	2010 screening follow-up. Outfall fully submerged and not physically located. Outfall screened upstream at 03-81 US1.	
Sampling Results		Floatables:	Condition Assessment Graffiti: None Erosion: None Deposition: None 0 in. Damage: None	
Sample Location:	Odor:	None		
Total Chlorine: -- ppm	Turbidity:	None		
Free Chlorine: -- ppm	Color:	None		
Ammonia: -- ppm	Gross Solids:	None		
pH: -- units	Vegetation:	None		
Temperature -- °F	Benthic Growth:	None		
Conductivity: -- µS/cm	Stains:	None		
Detergents: -- mg/L	Non-illicit:	None

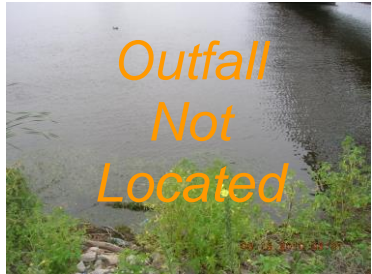
o20100818083116.JPG

Inspection Date: 8/18/2010 8:38:23 AM		Type: Ongoing	Flow: Submerged (not located)	Previous Rainfall (hrs): 72+
Illicit Discharge Potential: Potential		Inspector: JCW	Notes	
Submerged: Fully		Depth (in):	Outfall fully submerged and not physically located. Outfall screened upstream at 03-81 US1.	
Sampling Results		Floatables:	Condition Assessment Graffiti: None Erosion: None Deposition: None 0 in. Damage: None	
Sample Location:	Odor:	None		
Total Chlorine: -- ppm	Turbidity:	None		
Free Chlorine: -- ppm	Color:	None		
Ammonia: -- ppm	Gross Solids:	None		
pH: -- units	Vegetation:	None		
Temperature -- °F	Benthic Growth:	None		
Conductivity: -- µS/cm	Stains:	None		
Detergents: -- mg/L	Non-illicit:	None

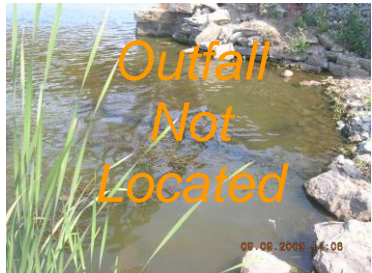
Osh09_DSCN6745.JPG

Inspection Date: 9/9/2009		Type: Initial	Flow: Submerged (not located)	Previous Rainfall (hrs): 72+
Illicit Discharge Potential: Obvious		Inspector: JCW	Notes	
Submerged: Fully		Depth (in):	Outfall fully submerged and not physically located. Outfall screened upstream at 03-81 US1.	
Sampling Results		Floatables:	Condition Assessment Graffiti: None Erosion: None Deposition: None 0 in. Damage: None	
Sample Location:	Odor:	None		
Total Chlorine: -- ppm	Turbidity:	None		
Free Chlorine: -- ppm	Color:	None		
Ammonia: -- ppm	Gross Solids:	None		
pH: -- units	Vegetation:	None		
Temperature -- °F	Benthic Growth:	None		
Conductivity: -- µS/cm	Stains:	None		
Detergents: -- mg/L	Non-illicit:	None

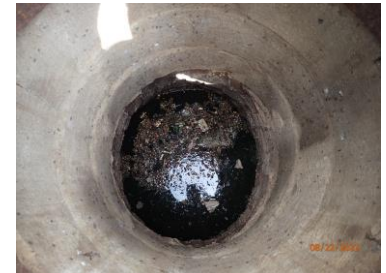
o20220822135248.JPG

☐ Petrol. Sheen ☐ Suds ☐ Sewage ☐ Algae ☐ Other☐ Petroleum ☐ Musty ☐ Sewage ☐ Chlorine ☐ Other☐ VOC/Solvent ☐ Fishy ☐ Sulfur ☐ Fragrant☒ Litter ☐ Veg. Debris ☐ Sediment ☐ Other☐ Inhibited ☐ Excessive☐ Green ☐ Brown☐ Flow Line ☐ Oil ☐ Rust Stains☐ Paint ☐ Other☐ Natural Sheen ☐ Natural Suds/Foam**Physical Condition Assessment**

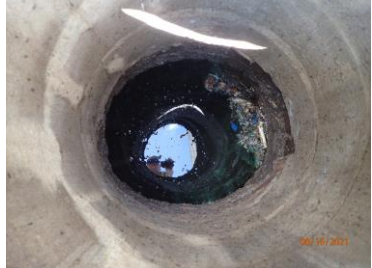
Sample Location:	Pool																																					
Total Chlorine:	0 ppm																																					
Free Chlorine:	0 ppm																																					
Ammonia:	0 ppm																																					
pH:	7.56 units																																					
Temperature:	77 °F																																					
Conductivity:	317 µS/cm																																					
Detergents:	0 mg/L																																					
Floatables:	None																																					
Odor:	None																																					
Turbidity:	None																																					
Color:	None																																					
Gross Solids:	Moderate																																					
Vegetation:	None																																					
Benthic Growth:	None																																					
Stains:	None																																					
Non-illicit:	None

<div style="display: flex;"> <div style="flex: 1;"> <p>Notes</p> <p>Sample collected from submerged pool in manhole. Floating gross solids (litter) in manhole.</p> </div> <div style="flex: 1;"> <p>Condition Assessment</p> <table border="1" style="width:100%; border-collapse: collapse;"> <tr><td>Graffiti:</td><td>None</td></tr> <tr><td>Erosion:</td><td>None</td></tr> <tr><td>Deposition:</td><td>None in.</td></tr> <tr><td>Damage:</td><td>None</td></tr> </table> </div> </div>			Graffiti:	None	Erosion:	None	Deposition:	None in.	Damage:	None																										
Graffiti:	None																																					
Erosion:	None																																					
Deposition:	None in.																																					
Damage:	None

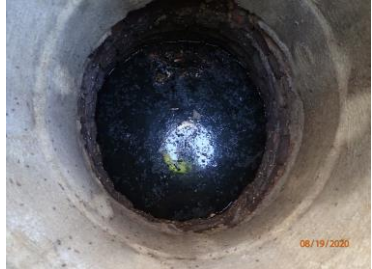
Sample Location:	Pool																																					
Total Chlorine:	0 ppm																																					
Free Chlorine:	0 ppm																																					
Ammonia:	0 ppm																																					
pH:	9.09 units																																					
Temperature:	84 °F																																					
Conductivity:	327 µS/cm																																					
Detergents:	0 mg/L																																					
Floatables:	None																																					
Odor:	None																																					
Turbidity:	None																																					
Color:	Faint in bottle																																					
Gross Solids:	Moderate																																					
Vegetation:	None																																					
Benthic Growth:	None																																					
Stains:	None																																					
Non-illicit:	None

<div style="display: flex;"> <div style="flex: 1;"> <p>Notes</p> <p>Sample collected from submerged pool in manhole. Floating gross solids (litter) in manhole. Elevated pH seemed widespread in river.</p> </div> <div style="flex: 1;"> <p>Condition Assessment</p> <table border="1" style="width:100%; border-collapse: collapse;"> <tr><td>Graffiti:</td><td>None</td></tr> <tr><td>Erosion:</td><td>None</td></tr> <tr><td>Deposition:</td><td>None in.</td></tr> <tr><td>Damage:</td><td>None</td></tr> </table> </div> </div>			Graffiti:	None	Erosion:	None	Deposition:	None in.	Damage:	None																										
Graffiti:	None																																					
Erosion:	None																																					
Deposition:	None in.																																					
Damage:	None

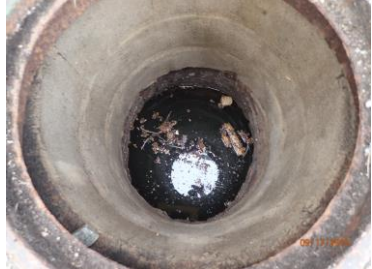
Sample Location:	Pool																																					
Total Chlorine:	0 ppm																																					
Free Chlorine:	0 ppm																																					
Ammonia:	0 ppm																																					
pH:	8.07 units																																					
Temperature:	75 °F																																					
Conductivity:	399 µS/cm																																					
Detergents:	0 mg/L																																					
Floatables:	None																																					
Odor:	None																																					
Turbidity:	None																																					
Color:	None																																					
Gross Solids:	Moderate																																					
Vegetation:	None																																					
Benthic Growth:	None																																					
Stains:	None																																					
Non-illicit:	None

<div style="display: flex;"> <div style="flex: 1;"> <p>Notes</p> <p>Sample collected from submerged pool in manhole. Floating gross solids (litter) in manhole.</p> </div> <div style="flex: 1;"> <p>Condition Assessment</p> <table border="1" style="width:100%; border-collapse: collapse;"> <tr><td>Graffiti:</td><td>None</td></tr> <tr><td>Erosion:</td><td>None</td></tr> <tr><td>Deposition:</td><td>None in.</td></tr> <tr><td>Damage:</td><td>None</td></tr> </table> </div> </div>			Graffiti:	None	Erosion:	None	Deposition:	None in.	Damage:	None																										
Graffiti:	None																																					
Erosion:	None																																					
Deposition:	None in.																																					
Damage:	None

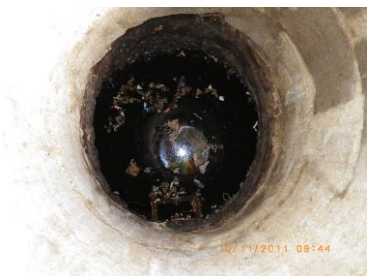
Odor: None

Color: None

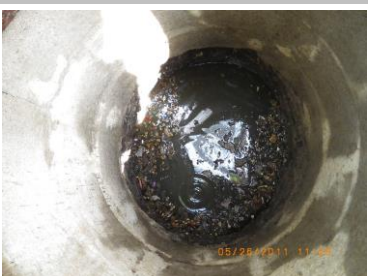
Stains: None

Vegetation: None

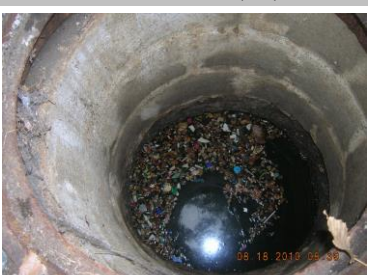
Erosion: None

Damage: None ☐ Displacement ☐ Undercut ☐ Crushed☐ Corrosion ☐ Cracks/Structural Damage

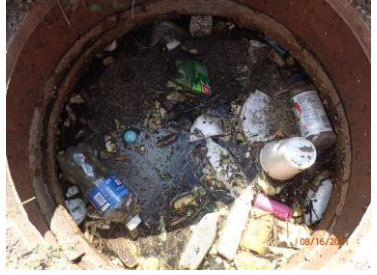
Floatables: Moderate

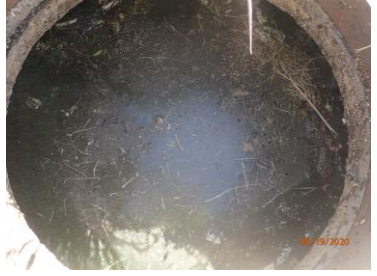
Vegetation: None

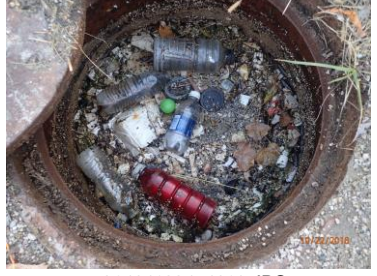
o20181022171308.JPG 2018

o20190918134540.JPG 2019	
Inspection Date: 10/22/2018 5:15:36 PM Illicit Discharge Potential: Potential Submerged: Fully Depth (in): 47		Type: Ongoing	Flow: Submerged, indeterminate	Previous Rainfall (hrs): 48-72
Inspector: JCW Sampling Results Sample Location: Pool Total Chlorine: 0 ppm Free Chlorine: 0 ppm Ammonia: 0 ppm pH: 7.59 units Temperature: 56 °F Conductivity: 361 µS/cm Detergents: 0 mg/L		Floatables: None Odor: None Turbidity: Cloudy Color: None Gross Solids: Severe Vegetation: None Benthic Growth: None Stains: None Non-illicit: None	Notes Sample collected from submerged pool in manhole. Floating gross solids (litter) in manhole.	
			Condition Assessment Graffiti: None Erosion: None Deposition: None in. Damage: None

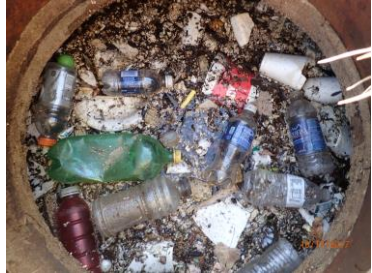
<p style="text-align: center;">o20171017155256.JPG</p> <p style="text-align: center; font-size: 24pt; font-weight: bold;">2017</p>

Inspection Date: 10/17/2017 3:58:36 PM		Type: Ongoing	Flow: Submerged, indeterminate	Previous Rainfall (hrs): 48-72																																		
Illicit Discharge Potential: Potential		Inspector: JCW																																				
Submerged: Fully		Depth (in): 40																																				
<div style="display: flex; justify-content: space-between;"> <div style="width: 45%;"> <p>Sampling Results</p> <table border="1" style="width:100%; border-collapse: collapse;"> <tr><td>Sample Location:</td><td>Pool</td></tr> <tr><td>Total Chlorine:</td><td>0 ppm</td></tr> <tr><td>Free Chlorine:</td><td>0 ppm</td></tr> <tr><td>Ammonia:</td><td>0 ppm</td></tr> <tr><td>pH:</td><td>7.93 units</td></tr> <tr><td>Temperature:</td><td>66 °F</td></tr> <tr><td>Conductivity:</td><td>886 µS/cm</td></tr> <tr><td>Detergents:</td><td>0 mg/L</td></tr> </table> </div> <div style="width: 45%;"> <table border="1" style="width:100%; border-collapse: collapse;"> <tr><td>Floatables:</td><td>None</td></tr> <tr><td>Odor:</td><td>None</td></tr> <tr><td>Turbidity:</td><td>None</td></tr> <tr><td>Color:</td><td>None</td></tr> <tr><td>Gross Solids:</td><td>Severe</td></tr> <tr><td>Vegetation:</td><td>None</td></tr> <tr><td>Benthic Growth:</td><td>None</td></tr> <tr><td>Stains:</td><td>None</td></tr> <tr><td>Non-illicit:</td><td>None</td></tr> </table> </div> </div>					Sample Location:	Pool	Total Chlorine:	0 ppm	Free Chlorine:	0 ppm	Ammonia:	0 ppm	pH:	7.93 units	Temperature:	66 °F	Conductivity:	886 µS/cm	Detergents:	0 mg/L	Floatables:	None	Odor:	None	Turbidity:	None	Color:	None	Gross Solids:	Severe	Vegetation:	None	Benthic Growth:	None	Stains:	None	Non-illicit:	None

<div style="display: flex; justify-content: space-between;"> <div style="width: 45%;"> <p>Notes</p> <p>Sample collected from submerged pool in manhole. Floating gross solids (litter) in manhole.</p> </div> <div style="width: 45%;"> <p>Condition Assessment</p> <table border="1" style="width:100%; border-collapse: collapse;"> <tr><td>Graffiti:</td><td>None</td></tr> <tr><td>Erosion:</td><td>None</td></tr> <tr><td>Deposition:</td><td>None in.</td></tr> <tr><td>Damage:</td><td>None</td></tr> </table> </div> </div>			Graffiti:	None	Erosion:	None	Deposition:	None in.	Damage:	None																										
Graffiti:	None																																					
Erosion:	None																																					
Deposition:	None in.																																					
Damage:	None

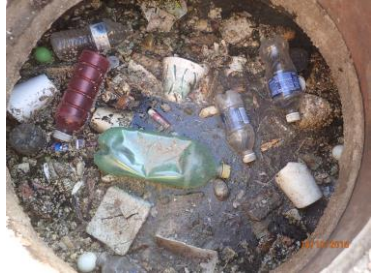
<p style="text-align: center;">o20161010154428.JPG</p> <p style="text-align: center; font-size: 24pt; font-weight: bold;">2016</p>

Inspection Date: 10/10/2016 3:46:48 PM		Type: Ongoing	Flow: Submerged, indeterminate	Previous Rainfall (hrs): 72+																																		
Illicit Discharge Potential: Potential		Inspector: JCW																																				
Submerged: Fully		Depth (in): 41																																				
<div style="display: flex; justify-content: space-between;"> <div style="width: 45%;"> <p>Sampling Results</p> <table border="1" style="width:100%; border-collapse: collapse;"> <tr><td>Sample Location:</td><td>Pool</td></tr> <tr><td>Total Chlorine:</td><td>0 ppm</td></tr> <tr><td>Free Chlorine:</td><td>0 ppm</td></tr> <tr><td>Ammonia:</td><td>0 ppm</td></tr> <tr><td>pH:</td><td>7.69 units</td></tr> <tr><td>Temperature:</td><td>70 °F</td></tr> <tr><td>Conductivity:</td><td>660 µS/cm</td></tr> <tr><td>Detergents:</td><td>0 mg/L</td></tr> </table> </div> <div style="width: 45%;"> <table border="1" style="width:100%; border-collapse: collapse;"> <tr><td>Floatables:</td><td>None</td></tr> <tr><td>Odor:</td><td>None</td></tr> <tr><td>Turbidity:</td><td>None</td></tr> <tr><td>Color:</td><td>None</td></tr> <tr><td>Gross Solids:</td><td>Severe</td></tr> <tr><td>Vegetation:</td><td>None</td></tr> <tr><td>Benthic Growth:</td><td>None</td></tr> <tr><td>Stains:</td><td>None</td></tr> <tr><td>Non-illicit:</td><td>None</td></tr> </table> </div> </div>					Sample Location:	Pool	Total Chlorine:	0 ppm	Free Chlorine:	0 ppm	Ammonia:	0 ppm	pH:	7.69 units	Temperature:	70 °F	Conductivity:	660 µS/cm	Detergents:	0 mg/L	Floatables:	None	Odor:	None	Turbidity:	None	Color:	None	Gross Solids:	Severe	Vegetation:	None	Benthic Growth:	None	Stains:	None	Non-illicit:	None

<div style="display: flex; justify-content: space-between;"> <div style="width: 45%;"> <p>Notes</p> <p>Potential illicit discharge due to gross solids.</p> </div> <div style="width: 45%;"> <p>Condition Assessment</p> <table border="1" style="width:100%; border-collapse: collapse;"> <tr><td>Graffiti:</td><td>None</td></tr> <tr><td>Erosion:</td><td>None</td></tr> <tr><td>Deposition:</td><td>None in.</td></tr> <tr><td>Damage:</td><td>None</td></tr> </table> </div> </div>			Graffiti:	None	Erosion:	None	Deposition:	None in.	Damage:	None																										
Graffiti:	None																																					
Erosion:	None																																					
Deposition:	None in.																																					
Damage:	None

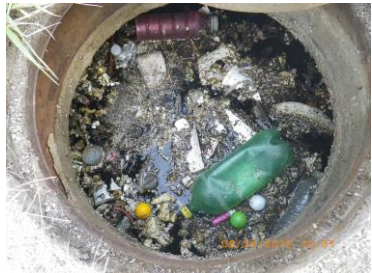
<p style="text-align: center;">o20150924093714.JPG</p> <p style="text-align: center; font-size: 24pt; font-weight: bold;">2015</p>

Inspection Date: 9/24/2015 10:36:18 AM		Type: Ongoing	Flow: Submerged, indeterminate	Previous Rainfall (hrs): 72+																																		
Illicit Discharge Potential: Potential		Inspector: JCW																																				
Submerged: Fully		Depth (in): 44																																				
<div style="display: flex; justify-content: space-between;"> <div style="width: 45%;"> <p>Sampling Results</p> <table border="1" style="width:100%; border-collapse: collapse;"> <tr><td>Sample Location:</td><td>Pool</td></tr> <tr><td>Total Chlorine:</td><td>0 ppm</td></tr> <tr><td>Free Chlorine:</td><td>0 ppm</td></tr> <tr><td>Ammonia:</td><td>0 ppm</td></tr> <tr><td>pH:</td><td>7.98 units</td></tr> <tr><td>Temperature:</td><td>70 °F</td></tr> <tr><td>Conductivity:</td><td>424 µS/cm</td></tr> <tr><td>Detergents:</td><td>0 mg/L</td></tr> </table> </div> <div style="width: 45%;"> <table border="1" style="width:100%; border-collapse: collapse;"> <tr><td>Floatables:</td><td>None</td></tr> <tr><td>Odor:</td><td>None</td></tr> <tr><td>Turbidity:</td><td>None</td></tr> <tr><td>Color:</td><td>None</td></tr> <tr><td>Gross Solids:</td><td>Severe</td></tr> <tr><td>Vegetation:</td><td>None</td></tr> <tr><td>Benthic Growth:</td><td>None</td></tr> <tr><td>Stains:</td><td>None</td></tr> <tr><td>Non-illicit:</td><td>None</td></tr> </table> </div> </div>					Sample Location:	Pool	Total Chlorine:	0 ppm	Free Chlorine:	0 ppm	Ammonia:	0 ppm	pH:	7.98 units	Temperature:	70 °F	Conductivity:	424 µS/cm	Detergents:	0 mg/L	Floatables:	None	Odor:	None	Turbidity:	None	Color:	None	Gross Solids:	Severe	Vegetation:	None	Benthic Growth:	None	Stains:	None	Non-illicit:	None

<div style="display: flex; justify-content: space-between;"> <div style="width: 45%;"> <p>Notes</p> <p>Floating gross solids (litter) in manhole.</p> </div> <div style="width: 45%;"> <p>Condition Assessment</p> <table border="1" style="width:100%; border-collapse: collapse;"> <tr><td>Graffiti:</td><td>None</td></tr> <tr><td>Erosion:</td><td>None</td></tr> <tr><td>Deposition:</td><td>None in.</td></tr> <tr><td>Damage:</td><td>None</td></tr> </table> </div> </div>			Graffiti:	None	Erosion:	None	Deposition:	None in.	Damage:	None																										
Graffiti:	None																																					
Erosion:	None																																					
Deposition:	None in.																																					
Damage:	None

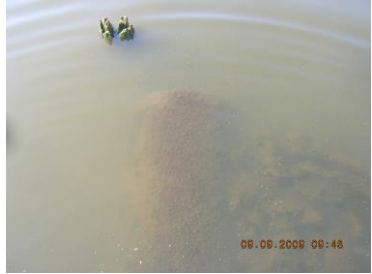
Inspection Date: 9/9/2009		Type: Initial		Flow: Submerged, indeterminate		Previous Rainfall (hrs): 72+	
Illicit Discharge Potential: Unlikely		Inspector: JCW		Notes Outfall fully submerged. Incorrectly screened upstream at water valve manhole.

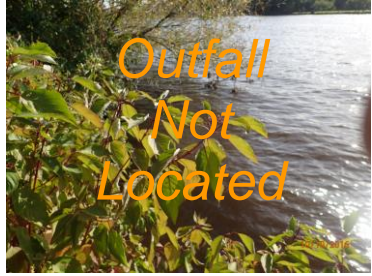
<p style="text-align: center;">o20161010154050.JPG</p> <p style="text-align: center; font-size: 1.5em; font-weight: bold;">2016</p>																																									
Submerged: Fully		Depth (in):		Outfall fully submerged and not located - screened upstream at 05-241 US1.																																											
Sampling Results <table border="1" style="width:100%; border-collapse: collapse;"> <tr><td>Sample Location:</td><td></td></tr> <tr><td>Total Chlorine:</td><td>-- ppm</td></tr> <tr><td>Free Chlorine:</td><td>-- ppm</td></tr> <tr><td>Ammonia:</td><td>-- ppm</td></tr> <tr><td>pH:</td><td>-- units</td></tr> <tr><td>Temperature:</td><td>-- °F</td></tr> <tr><td>Conductivity:</td><td>-- µS/cm</td></tr> <tr><td>Detergents:</td><td>-- mg/L</td></tr> </table>		Sample Location:		Total Chlorine:	-- ppm			Free Chlorine:	-- ppm	Ammonia:	-- ppm	pH:	-- units	Temperature:	-- °F	Conductivity:	-- µS/cm	Detergents:	-- mg/L	<table border="1" style="width:100%; border-collapse: collapse;"> <tr><td>Floatables:</td><td>None</td></tr> <tr><td>Odor:</td><td>None</td></tr> <tr><td>Turbidity:</td><td>None</td></tr> <tr><td>Color:</td><td>None</td></tr> <tr><td>Gross Solids:</td><td>None</td></tr> <tr><td>Vegetation:</td><td>None</td></tr> <tr><td>Benthic Growth:</td><td>None</td></tr> <tr><td>Stains:</td><td>None</td></tr> <tr><td>Non-illicit:</td><td>None</td></tr> </table>		Floatables:	None	Odor:	None	Turbidity:	None	Color:	None	Gross Solids:	None	Vegetation:	None	Benthic Growth:	None	Stains:	None	Non-illicit:	None	Condition Assessment <table border="1" style="width:100%; border-collapse: collapse;"> <tr><td>Graffiti:</td><td>None</td></tr> <tr><td>Erosion:</td><td>None</td></tr> <tr><td>Deposition:</td><td>None in.</td></tr> <tr><td>Damage:</td><td>None</td></tr> </table>		Graffiti:	None	Erosion:	None	Deposition:	None in.

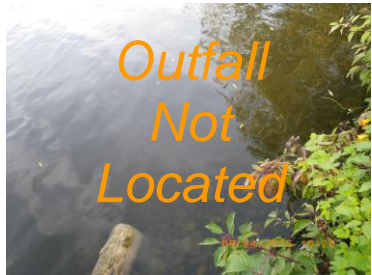
<p style="text-align: center;">o20150924092602.JPG</p> <p style="text-align: center; font-size: 1.5em; font-weight: bold;">2015</p>																																									
Submerged: Fully		Depth (in):		Outfall fully submerged and not located - screened at 05-241 US1.																																											
Sampling Results <table border="1" style="width:100%; border-collapse: collapse;"> <tr><td>Sample Location:</td><td></td></tr> <tr><td>Total Chlorine:</td><td>-- ppm</td></tr> <tr><td>Free Chlorine:</td><td>-- ppm</td></tr> <tr><td>Ammonia:</td><td>-- ppm</td></tr> <tr><td>pH:</td><td>-- units</td></tr> <tr><td>Temperature:</td><td>-- °F</td></tr> <tr><td>Conductivity:</td><td>-- µS/cm</td></tr> <tr><td>Detergents:</td><td>-- mg/L</td></tr> </table>		Sample Location:		Total Chlorine:	-- ppm			Free Chlorine:	-- ppm	Ammonia:	-- ppm	pH:	-- units	Temperature:	-- °F	Conductivity:	-- µS/cm	Detergents:	-- mg/L	<table border="1" style="width:100%; border-collapse: collapse;"> <tr><td>Floatables:</td><td>None</td></tr> <tr><td>Odor:</td><td>None</td></tr> <tr><td>Turbidity:</td><td>None</td></tr> <tr><td>Color:</td><td>None</td></tr> <tr><td>Gross Solids:</td><td>None</td></tr> <tr><td>Vegetation:</td><td>None</td></tr> <tr><td>Benthic Growth:</td><td>None</td></tr> <tr><td>Stains:</td><td>None</td></tr> <tr><td>Non-illicit:</td><td>None</td></tr> </table>		Floatables:	None	Odor:	None	Turbidity:	None	Color:	None	Gross Solids:	None	Vegetation:	None	Benthic Growth:	None	Stains:	None	Non-illicit:	None	Condition Assessment <table border="1" style="width:100%; border-collapse: collapse;"> <tr><td>Graffiti:</td><td>None</td></tr> <tr><td>Erosion:</td><td>None</td></tr> <tr><td>Deposition:</td><td>None in.</td></tr> <tr><td>Damage:</td><td>None</td></tr> </table>		Graffiti:	None	Erosion:	None	Deposition:	None in.

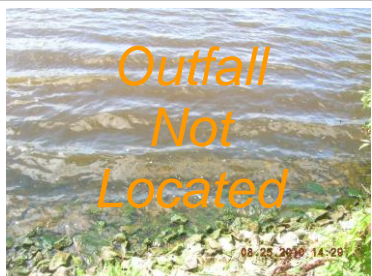
<p style="text-align: center;">o20100825142910.JPG</p> <p style="text-align: center; font-size: 1.5em; font-weight: bold;">2010</p>																																									
Submerged: Fully		Depth (in):		Outfall fully submerged and not physically located. Outfall screened upstream at 05-241 US2.																																											
Sampling Results <table border="1" style="width:100%; border-collapse: collapse;"> <tr><td>Sample Location:</td><td></td></tr> <tr><td>Total Chlorine:</td><td>-- ppm</td></tr> <tr><td>Free Chlorine:</td><td>-- ppm</td></tr> <tr><td>Ammonia:</td><td>-- ppm</td></tr> <tr><td>pH:</td><td>-- units</td></tr> <tr><td>Temperature:</td><td>-- °F</td></tr> <tr><td>Conductivity:</td><td>-- µS/cm</td></tr> <tr><td>Detergents:</td><td>-- mg/L</td></tr> </table>		Sample Location:		Total Chlorine:	-- ppm			Free Chlorine:	-- ppm	Ammonia:	-- ppm	pH:	-- units	Temperature:	-- °F	Conductivity:	-- µS/cm	Detergents:	-- mg/L	<table border="1" style="width:100%; border-collapse: collapse;"> <tr><td>Floatables:</td><td>None</td></tr> <tr><td>Odor:</td><td>None</td></tr> <tr><td>Turbidity:</td><td>None</td></tr> <tr><td>Color:</td><td>None</td></tr> <tr><td>Gross Solids:</td><td>None</td></tr> <tr><td>Vegetation:</td><td>None</td></tr> <tr><td>Benthic Growth:</td><td>None</td></tr> <tr><td>Stains:</td><td>None</td></tr> <tr><td>Non-illicit:</td><td>None</td></tr> </table>		Floatables:	None	Odor:	None	Turbidity:	None	Color:	None	Gross Solids:	None	Vegetation:	None	Benthic Growth:	None	Stains:	None	Non-illicit:	None	Condition Assessment <table border="1" style="width:100%; border-collapse: collapse;"> <tr><td>Graffiti:</td><td>None</td></tr> <tr><td>Erosion:</td><td>None</td></tr> <tr><td>Deposition:</td><td>None 0 in.</td></tr> <tr><td>Damage:</td><td>None</td></tr> </table>		Graffiti:	None	Erosion:	None	Deposition:	None 0 in.

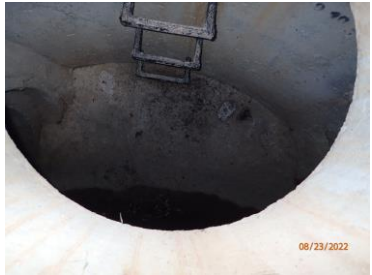
08/23/2022
o20220823142922.JPG

Inspection Date: 8/23/2022 2:31:00 PM		Inspector: EJK	Inspection Type: Ongoing	Previous Rainfall (hrs): 72+
Flow Description: None		Notes: Outfall pipe wet, but no collectable flow at time of inspection.		
Submerged: None	Depth (in):			
Illicit Discharge Potential: Unlikely				
Floatables: None	<input type="checkbox"/> Petrol. Sheen	<input type="checkbox"/> Suds	<input type="checkbox"/> Sewage	<input type="checkbox"/> Algae
Odor: None	<input type="checkbox"/> Petroleum	<input type="checkbox"/> Musty	<input type="checkbox"/> Sewage	<input type="checkbox"/> Chlorine
	<input type="checkbox"/> VOC/Solvent	<input type="checkbox"/> Fishy	<input type="checkbox"/> Sulfur	<input type="checkbox"/> Fragrant
Turbidity: None				
Color: None				
Gross Solids: None	<input type="checkbox"/> Litter	<input type="checkbox"/> Veg. Debris	<input type="checkbox"/> Sediment	<input type="checkbox"/> Other
Vegetation: None	<input type="checkbox"/> Inhibited	<input type="checkbox"/> Excessive

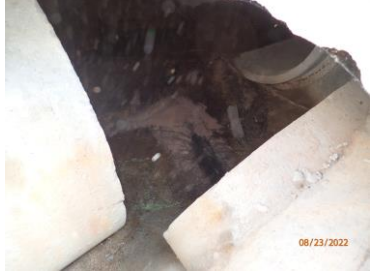
<small>o20220823142116.JPG</small>
---	--	---

Flow Description: None Submerged: None Depth (in): Illicit Discharge Potential: Unlikely	Notes: Manhole flowline wet, but no collectable flow at time of inspection.

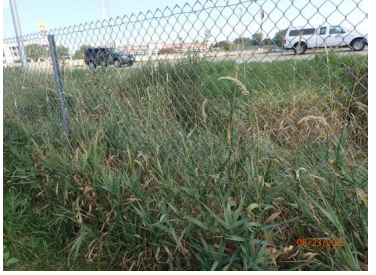
<small>o20220823141100.JPG</small>
---	---	---

Flow Description: None Submerged: None Depth (in): Illicit Discharge Potential: Unlikely	Notes: Outfall discharges inside IH-41 right-of-way and not located. Screened upstream at 06-1404 US1.

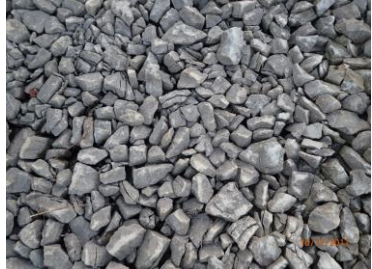
Inspection Date: 10/17/2017 7:29:48 AM		Type: Ongoing	Flow: None	Previous Rainfall (hrs): 48-72
Illicit Discharge Potential: Unlikely		Inspector: JCW		
Submerged: None		Depth (in):		
Sampling Results Sample Location: _____ Total Chlorine: -- ppm Free Chlorine: -- ppm Ammonia: -- ppm pH: -- units Temperature: -- °F Conductivity: -- µS/cm Detergents: -- mg/L		Floatables: None Odor: None Turbidity: None Color: None Gross Solids: None Vegetation: None Benthic Growth: None Stains: Slight Non-illicit: None	Notes Water level extends farther up riprap than normal, but no observed flow at time of inspection.

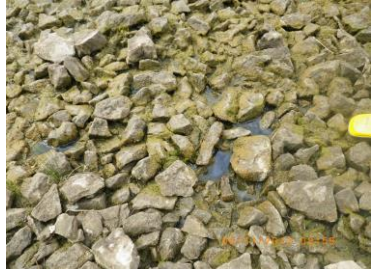
o20120611085940.JPG <div style="text-align: center; font-size: 24pt; font-weight: bold;">2012</div>
		Condition Assessment Graffiti: None Erosion: None Deposition: None in. Damage: None

Inspection Date: 6/11/2012 9:57:16 AM		Type: Ongoing	Flow: None	Previous Rainfall (hrs): 72+
Illicit Discharge Potential: Unlikely		Inspector: JCW		
Submerged: None		Depth (in):		
Sampling Results Sample Location: _____ Total Chlorine: -- ppm Free Chlorine: -- ppm Ammonia: -- ppm pH: -- units Temperature: -- °F Conductivity: -- µS/cm Detergents: -- mg/L		Floatables: Moderate Odor: None Turbidity: None Color: None Gross Solids: Slight Vegetation: None Benthic Growth: Moderate Stains: Moderate Non-illicit: Moderate	Notes

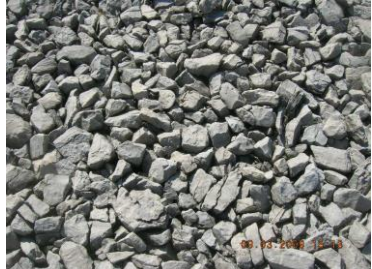
Osh09_DSCN6470.JPG <div style="text-align: center; font-size: 24pt; font-weight: bold;">2009</div>
		Condition Assessment Graffiti: None Erosion: None Deposition: None 0 in. Damage: None

Inspection Date: 9/3/2009		Type: Initial	Flow: None	Previous Rainfall (hrs): 72+
Illicit Discharge Potential: Unlikely		Inspector: JCW		
Submerged: None		Depth (in): 0		
Sampling Results Sample Location: _____ Total Chlorine: -- ppm Free Chlorine: -- ppm Ammonia: -- ppm pH: -- units Temperature: -- °F Conductivity: -- µS/cm Detergents: -- mg/L		Floatables: _____ Odor: _____ Turbidity: _____ Color: _____ Gross Solids: _____ Vegetation: _____ Benthic Growth: _____ Stains: _____ Non-illicit: None	Notes

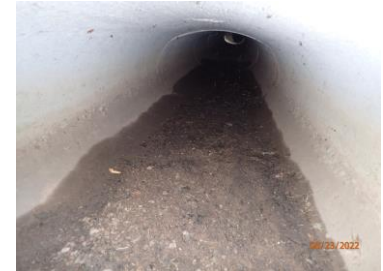
o20220823115044.JPG

Stains: Slight

Deposition: Minor Depth (in): 5

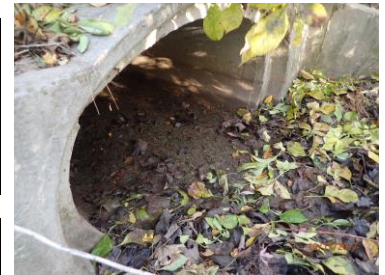
o20171017081720.JPG

Inspection Date: 10/17/2017 8:20:52 AM		Type: Ongoing	Flow: None	Previous Rainfall (hrs): 48-72
Illicit Discharge Potential: Unlikely		Inspector: JCW		
Submerged: None		Depth (in):		
Sampling Results		Notes		
Sample Location:		Sediment wet, but no flow at time of inspection.		
Total Chlorine:	-- ppm	Floatables:	None	
Free Chlorine:	-- ppm	Odor:	None	
Ammonia:	-- ppm	Turbidity:	None	
pH:	-- units	Color:	None	
Temperature	-- °F	Gross Solids:	None	
Conductivity:	-- µS/cm	Vegetation:	None	
Detergents:	-- mg/L	Benthic Growth:	None	
		Stains:	None	
		Non-illicit:	None	
		Condition Assessment		
		Graffiti:	None	
		Erosion:	None	
		Deposition:	Moderate	6 in.
		Damage:	None

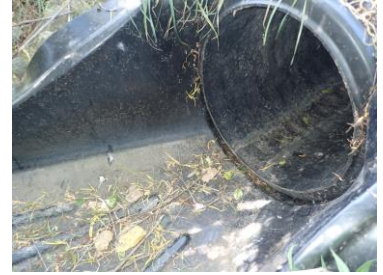
o20200820093038.JPG

Inspection Date: 8/20/2020 9:32:29 AM		Type: Ongoing	Flow: None	Previous Rainfall (hrs): 72+
Illicit Discharge Potential: Unlikely		Inspector: JCW		
Submerged: None		Depth (in):		
Sampling Results		Notes Pipe dry at time of inspection.		
Sample Location: Total Chlorine: -- ppm Free Chlorine: -- ppm Ammonia: -- ppm pH: -- units Temperature: -- °F Conductivity: -- µS/cm Detergents: -- mg/L		Floatables: None Odor: None Turbidity: None Color: None Gross Solids: None Vegetation: None Benthic Growth: None Stains: None Non-illicit: None		
		Condition Assessment Graffiti: None Erosion: None Deposition: None in. Damage: None

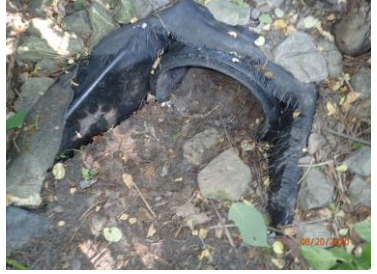
<p style="text-align: center;">o20200820094506.JPG</p> <p style="text-align: center; font-size: 24pt; font-weight: bold;">2020</p>

Inspection Date: 8/20/2020 9:47:10 AM		Type: Ongoing	Flow: None	Previous Rainfall (hrs): 72+																																			
Illicit Discharge Potential: Unlikely		Inspector: JCW																																					
Submerged: None		Depth (in):																																					
Sampling Results		Notes Pipe dry at time of inspection.																																					
<table border="1" style="width: 100%; border-collapse: collapse;"> <tr> <td style="width: 50%;">Sample Location:</td> <td style="width: 50%;">Floatables:</td> <td>None</td> </tr> <tr> <td>Total Chlorine: -- ppm</td> <td>Odor:</td> <td>None</td> </tr> <tr> <td>Free Chlorine: -- ppm</td> <td>Turbidity:</td> <td>None</td> </tr> <tr> <td>Ammonia: -- ppm</td> <td>Color:</td> <td>None</td> </tr> <tr> <td>pH: -- units</td> <td>Gross Solids:</td> <td>None</td> </tr> <tr> <td>Temperature -- °F</td> <td>Vegetation:</td> <td>None</td> </tr> <tr> <td>Conductivity: -- µS/cm</td> <td>Benthic Growth:</td> <td>None</td> </tr> <tr> <td>Detergents: -- mg/L</td> <td>Stains:</td> <td>None</td> </tr> <tr> <td></td> <td>Non-illicit:</td> <td>None</td> </tr> </table>					Sample Location:	Floatables:	None	Total Chlorine: -- ppm	Odor:	None	Free Chlorine: -- ppm	Turbidity:	None	Ammonia: -- ppm	Color:	None	pH: -- units	Gross Solids:	None	Temperature -- °F	Vegetation:	None	Conductivity: -- µS/cm	Benthic Growth:	None	Detergents: -- mg/L	Stains:	None		Non-illicit:	None	Condition Assessment <table border="1" style="width: 100%; border-collapse: collapse;"> <tr> <td style="width: 50%;">Graffiti:</td> <td style="width: 50%;">None</td> </tr> <tr> <td>Erosion:</td> <td>None</td> </tr> <tr> <td>Deposition:</td> <td>Moderate 3 in.</td> </tr> <tr> <td>Damage:</td> <td>None</td> </tr> </table>			Graffiti:	None	Erosion:	None	Deposition:

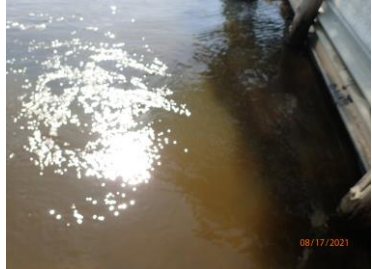
<p style="text-align: center;">o20210817104212.JPG</p> <p style="text-align: center; font-size: 24pt; font-weight: bold;">2021</p>

<div style="display: flex;"> <div style="flex: 1;"> <p>Notes</p> <p>Outfall fully submerged and not located - screened upstream at 06-1709 US1. Detergent detected in upstream manhole.</p> </div> <div style="flex: 1;"> <p>Condition Assessment</p> <table border="1" style="width:100%; border-collapse: collapse;"> <tr><td>Graffiti:</td><td>None</td></tr> <tr><td>Erosion:</td><td>None</td></tr> <tr><td>Deposition:</td><td>None in.</td></tr> <tr><td>Damage:</td><td>None</td></tr> </table> </div> </div>			Graffiti:	None	Erosion:	None	Deposition:	None in.	Damage:	None																										
Graffiti:	None																																					
Erosion:	None																																					
Deposition:	None in.																																					
Damage:	None

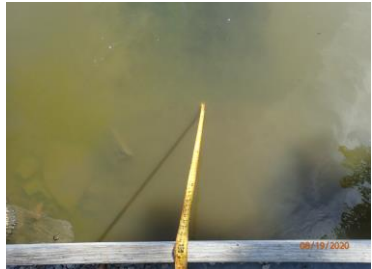
<p style="text-align: center;">o20200819102052.JPG</p> <p style="text-align: center; font-size: 24pt; font-weight: bold;">2020</p>

Inspection Date: 8/19/2020 10:22:53 AM		Type: Ongoing	Flow: Submerged, significant flow	Previous Rainfall (hrs): 72+																																		
Illicit Discharge Potential: Unlikely		Inspector: JCW																																				
Submerged: Fully		Depth (in): 38																																				
Sampling Results		<div style="display: flex;"> <div style="flex: 1;"> <table border="1" style="width:100%; border-collapse: collapse;"> <tr><td>Sample Location:</td><td></td></tr> <tr><td>Total Chlorine:</td><td>-- ppm</td></tr> <tr><td>Free Chlorine:</td><td>-- ppm</td></tr> <tr><td>Ammonia:</td><td>-- ppm</td></tr> <tr><td>pH:</td><td>-- units</td></tr> <tr><td>Temperature:</td><td>-- °F</td></tr> <tr><td>Conductivity:</td><td>-- µS/cm</td></tr> <tr><td>Detergents:</td><td>-- mg/L</td></tr> </table> </div> <div style="flex: 1;"> <table border="1" style="width:100%; border-collapse: collapse;"> <tr><td>Floatables:</td><td>None</td></tr> <tr><td>Odor:</td><td>None</td></tr> <tr><td>Turbidity:</td><td>None</td></tr> <tr><td>Color:</td><td>None</td></tr> <tr><td>Gross Solids:</td><td>None</td></tr> <tr><td>Vegetation:</td><td>None</td></tr> <tr><td>Benthic Growth:</td><td>None</td></tr> <tr><td>Stains:</td><td>None</td></tr> <tr><td>Non-illicit:</td><td>None</td></tr> </table> </div> </div>			Sample Location:		Total Chlorine:	-- ppm	Free Chlorine:	-- ppm	Ammonia:	-- ppm	pH:	-- units	Temperature:	-- °F	Conductivity:	-- µS/cm	Detergents:	-- mg/L	Floatables:	None	Odor:	None	Turbidity:	None	Color:	None	Gross Solids:	None	Vegetation:	None	Benthic Growth:	None	Stains:	None	Non-illicit:	None

<div style="display: flex;"> <div style="flex: 1;"> <p>Notes</p> <p>Outfall fully submerged - screened upstream at 06-253 US1.</p> </div> <div style="flex: 1;"> <p>Condition Assessment</p> <table border="1" style="width:100%; border-collapse: collapse;"> <tr><td>Graffiti:</td><td>None</td></tr> <tr><td>Erosion:</td><td>None</td></tr> <tr><td>Deposition:</td><td>None in.</td></tr> <tr><td>Damage:</td><td>None</td></tr> </table> </div> </div>			Graffiti:	None	Erosion:	None	Deposition:	None in.	Damage:	None																										
Graffiti:	None																																					
Erosion:	None																																					
Deposition:	None in.																																					
Damage:	None

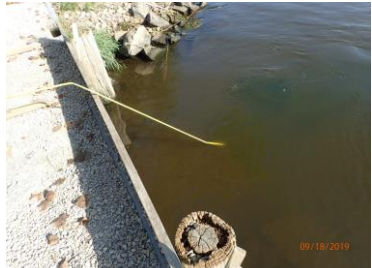
<p style="text-align: center;">o20190918082324.JPG</p> <p style="text-align: center; font-size: 24pt; font-weight: bold;">2019</p>

Inspection Date: 9/18/2019 9:25:08 AM		Type: Ongoing	Flow: Submerged, significant flow	Previous Rainfall (hrs): 72+																																		
Illicit Discharge Potential: Unlikely		Inspector: JCW																																				
Submerged: Fully		Depth (in):																																				
Sampling Results		<div style="display: flex;"> <div style="flex: 1;"> <table border="1" style="width:100%; border-collapse: collapse;"> <tr><td>Sample Location:</td><td></td></tr> <tr><td>Total Chlorine:</td><td>-- ppm</td></tr> <tr><td>Free Chlorine:</td><td>-- ppm</td></tr> <tr><td>Ammonia:</td><td>-- ppm</td></tr> <tr><td>pH:</td><td>-- units</td></tr> <tr><td>Temperature:</td><td>-- °F</td></tr> <tr><td>Conductivity:</td><td>-- µS/cm</td></tr> <tr><td>Detergents:</td><td>-- mg/L</td></tr> </table> </div> <div style="flex: 1;"> <table border="1" style="width:100%; border-collapse: collapse;"> <tr><td>Floatables:</td><td>None</td></tr> <tr><td>Odor:</td><td>None</td></tr> <tr><td>Turbidity:</td><td>None</td></tr> <tr><td>Color:</td><td>None</td></tr> <tr><td>Gross Solids:</td><td>None</td></tr> <tr><td>Vegetation:</td><td>None</td></tr> <tr><td>Benthic Growth:</td><td>None</td></tr> <tr><td>Stains:</td><td>None</td></tr> <tr><td>Non-illicit:</td><td>None</td></tr> </table> </div> </div>			Sample Location:		Total Chlorine:	-- ppm	Free Chlorine:	-- ppm	Ammonia:	-- ppm	pH:	-- units	Temperature:	-- °F	Conductivity:	-- µS/cm	Detergents:	-- mg/L	Floatables:	None	Odor:	None	Turbidity:	None	Color:	None	Gross Solids:	None	Vegetation:	None	Benthic Growth:	None	Stains:	None	Non-illicit:	None

<div style="display: flex;"> <div style="flex: 1;"> <p>Notes</p> <p>Outfall fully submerged, significant flow causing surface disturbance. Screened upstream at 06-253 US1.</p> </div> <div style="flex: 1;"> <p>Condition Assessment</p> <table border="1" style="width:100%; border-collapse: collapse;"> <tr><td>Graffiti:</td><td>None</td></tr> <tr><td>Erosion:</td><td>None</td></tr> <tr><td>Deposition:</td><td>None in.</td></tr> <tr><td>Damage:</td><td>None</td></tr> </table> </div> </div>			Graffiti:	None	Erosion:	None	Deposition:	None in.	Damage:	None																										
Graffiti:	None																																					
Erosion:	None																																					
Deposition:	None in.																																					
Damage:	None

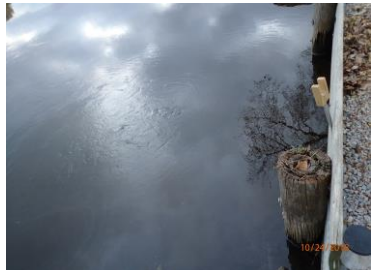
<p style="text-align: center;">o20181024072834.JPG</p> <p style="text-align: center; font-size: 24pt; font-weight: bold;">2018</p>

Inspection Date: 10/24/2018 7:29:02 AM		Type: Ongoing	Flow: Submerged, significant flow	Previous Rainfall (hrs): 72+																																		
Illicit Discharge Potential: Potential		Inspector: JCW																																				
Submerged: Fully		Depth (in):																																				
Sampling Results		<div style="display: flex;"> <div style="flex: 1;"> <table border="1" style="width:100%; border-collapse: collapse;"> <tr><td>Sample Location:</td><td></td></tr> <tr><td>Total Chlorine:</td><td>-- ppm</td></tr> <tr><td>Free Chlorine:</td><td>-- ppm</td></tr> <tr><td>Ammonia:</td><td>-- ppm</td></tr> <tr><td>pH:</td><td>-- units</td></tr> <tr><td>Temperature:</td><td>-- °F</td></tr> <tr><td>Conductivity:</td><td>-- µS/cm</td></tr> <tr><td>Detergents:</td><td>-- mg/L</td></tr> </table> </div> <div style="flex: 1;"> <table border="1" style="width:100%; border-collapse: collapse;"> <tr><td>Floatables:</td><td>None</td></tr> <tr><td>Odor:</td><td>None</td></tr> <tr><td>Turbidity:</td><td>None</td></tr> <tr><td>Color:</td><td>None</td></tr> <tr><td>Gross Solids:</td><td>None</td></tr> <tr><td>Vegetation:</td><td>None</td></tr> <tr><td>Benthic Growth:</td><td>None</td></tr> <tr><td>Stains:</td><td>None</td></tr> <tr><td>Non-illicit:</td><td>None</td></tr> </table> </div> </div>			Sample Location:		Total Chlorine:	-- ppm	Free Chlorine:	-- ppm	Ammonia:	-- ppm	pH:	-- units	Temperature:	-- °F	Conductivity:	-- µS/cm	Detergents:	-- mg/L	Floatables:	None	Odor:	None	Turbidity:	None	Color:	None	Gross Solids:	None	Vegetation:	None	Benthic Growth:	None	Stains:	None	Non-illicit:	None

<div style="display: flex;"> <div style="flex: 1;"> <p>Notes</p> <p>Outfall fully submerged, significant flow causing surface disturbance. Screened upstream at 06-253 US1. Elevated ammonia and conductivity in manhole.</p> </div> <div style="flex: 1;"> <p>Condition Assessment</p> <table border="1" style="width:100%; border-collapse: collapse;"> <tr><td>Graffiti:</td><td>None</td></tr> <tr><td>Erosion:</td><td>None</td></tr> <tr><td>Deposition:</td><td>None in.</td></tr> <tr><td>Damage:</td><td>None</td></tr> </table> </div> </div>			Graffiti:	None	Erosion:	None	Deposition:	None in.	Damage:	None																										
Graffiti:	None																																					
Erosion:	None																																					
Deposition:	None in.																																					
Damage:	None

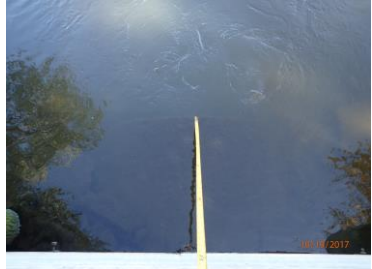
o20171019131334.JPG

Inspection Date: 10/19/2017 1:14:17 PM		Type: Ongoing	Flow: Submerged, significant flow	Previous Rainfall (hrs): 72+
Illicit Discharge Potential: Potential		Inspector: JCW	Notes	
Submerged: Fully		Depth (in):	Outfall fully submerged with significant flow causing surface disturbance. Screened upstream at 06-253 US1. Elevated ammonia in manhole.	
Sampling Results		Floatables:	Condition Assessment Graffiti: None Erosion: None Deposition: None in. Damage: None	
Sample Location:		Odor:		
Total Chlorine: -- ppm		Turbidity:		
Free Chlorine: -- ppm		Color:		
Ammonia: -- ppm		Gross Solids:		
pH: -- units		Vegetation:		
Temperature -- °F		Benthic Growth:		
Conductivity: -- µS/cm		Stains:		
Detergents: -- mg/L		Non-illicit:
