IDDE Ongoing Screening Summary Report

2022 Inspection Year

City of Oshkosh

Westwood

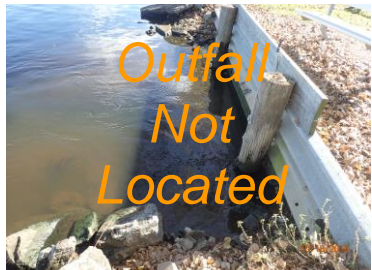
o20161018135746.JPG

Inspection Date: 10/18/2016 1:59:02 PM		Type: Ongoing	Flow: Submerged (not located)	Previous Rainfall (hrs): 72+
Illicit Discharge Potential: Unlikely		Inspector: JCW	Notes	
Submerged: Fully		Depth (in):	Outfall fully submerged and not located - screened upstream at 06-253 US1.	
Sampling Results		Floatables:	Condition Assessment Graffiti: None Erosion: None Deposition: None in. Damage: None	
Sample Location:		Odor:		
Total Chlorine: -- ppm		Turbidity:		
Free Chlorine: -- ppm		Color:		
Ammonia: -- ppm		Gross Solids:		
pH: -- units		Vegetation:		
Temperature -- °F		Benthic Growth:		
Conductivity: -- µS/cm		Stains:		
Detergents: -- mg/L		Non-illicit:

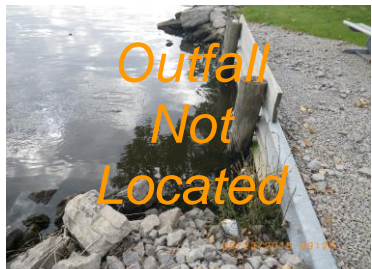
o20150923082910.JPG

Inspection Date: 9/23/2015 9:26:08 AM		Type: Ongoing	Flow: Submerged (not located)	Previous Rainfall (hrs): 72+
Illicit Discharge Potential: Unlikely		Inspector: JCW	Notes	
Submerged: Fully		Depth (in):	Outfall fully submerged and not located - screened at 06-253 US1.	
Sampling Results		Floatables:	Condition Assessment Graffiti: None Erosion: None Deposition: None in. Damage: None	
Sample Location:		Odor:		
Total Chlorine: -- ppm		Turbidity:		
Free Chlorine: -- ppm		Color:		
Ammonia: -- ppm		Gross Solids:		
pH: -- units		Vegetation:		
Temperature -- °F		Benthic Growth:		
Conductivity: -- µS/cm		Stains:		
Detergents: -- mg/L		Non-illicit:

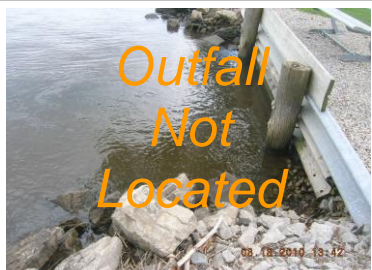
o20100818134248.JPG

Inspection Date: 8/18/2010 1:51:34 PM		Type: Ongoing	Flow: Submerged (not located)	Previous Rainfall (hrs): 72+
Illicit Discharge Potential: Unlikely		Inspector: JCW	Notes	
Submerged: Fully		Depth (in):	Outfall fully submerged and not physically located. Outfall screened upstream at 06-263 US1.	
Sampling Results		Floatables:	Condition Assessment Graffiti: None Erosion: None Deposition: None 0 in. Damage: None	
Sample Location:		Odor:		
Total Chlorine: -- ppm		Turbidity:		
Free Chlorine: -- ppm		Color:		
Ammonia: -- ppm		Gross Solids:		
pH: -- units		Vegetation:		
Temperature -- °F		Benthic Growth:		
Conductivity: -- µS/cm		Stains:		
Detergents: -- mg/L		Non-illicit:

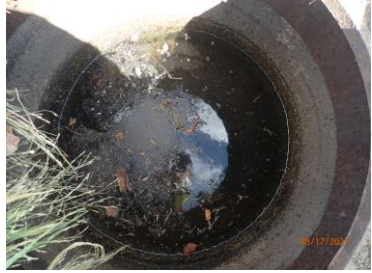
o20210817104756.JPG

Inspection Date: 8/17/2021 10:51:45 AM		Type: Ongoing	Flow: Submerged, significant flow	Previous Rainfall (hrs): 72+
Illicit Discharge Potential: Potential		Inspector: JCW		
Submerged: Fully		Depth (in): 48		
Sampling Results		Notes Sample collected from flow in catchbasin. Detergent detected in sample.		
Sample Location: Flow	Floatables: None	Condition Assessment Graffiti: None Erosion: None Deposition: None in. Damage: None		
Total Chlorine: 0 ppm	Odor: None			
Free Chlorine: 0 ppm	Turbidity: None			
Ammonia: 0 ppm	Color: None			
pH: 7.08 units	Gross Solids: None			
Temperature 80 °F	Vegetation: None			
Conductivity: 1154 µS/cm	Benthic Growth: Moderate			
Detergents: 0.4 mg/L	Stains: None			
	Non-illicit: None

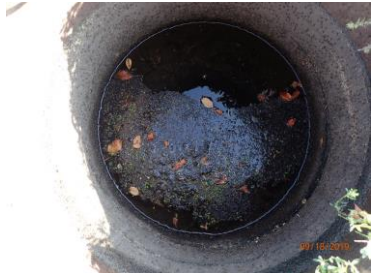
o20190918084446.JPG

Inspection Date: 9/18/2019 9:48:09 AM		Type: Ongoing	Flow: Submerged, slight flow	Previous Rainfall (hrs): 72+
Illicit Discharge Potential: Unlikely		Inspector: JCW		
Submerged: Fully		Depth (in): 45		
Sampling Results		Notes Sample collected from submerged flow in manhole. Floating gross solids (litter) in manhole.		
Sample Location: Pool	Floatables: None	Condition Assessment Graffiti: None Erosion: None Deposition: None in. Damage: None		
Total Chlorine: 0 ppm	Odor: None			
Free Chlorine: 0 ppm	Turbidity: None			
Ammonia: 0 ppm	Color: None			
pH: 7.38 units	Gross Solids: Slight			
Temperature 71 °F	Vegetation: None			
Conductivity: 1261 µS/cm	Benthic Growth: None			
Detergents: 0 mg/L	Stains: None			
	Non-illicit: None

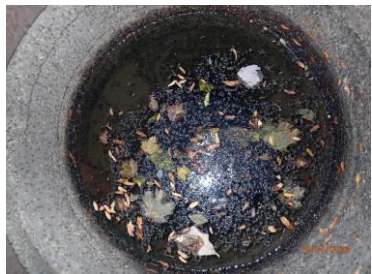
o20181024071720.JPG

Inspection Date: 10/24/2018 7:21:30 AM		Type: Ongoing	Flow: Submerged, indeterminate	Previous Rainfall (hrs): 72+
Illicit Discharge Potential: Potential		Inspector: JCW		
Submerged: Fully		Depth (in): 46		
Sampling Results		Notes Sample collected from submerged flow in manhole. Elevated ammonia and conductivity in sample.		
Sample Location: Pool	Floatables: None	Condition Assessment Graffiti: None Erosion: None Deposition: None in. Damage: None		
Total Chlorine: 0 ppm	Odor: None			
Free Chlorine: 0 ppm	Turbidity: None			
Ammonia: 3 ppm	Color: None			
pH: 7.27 units	Gross Solids: Slight			
Temperature 52 °F	Vegetation: None			
Conductivity: 2280 µS/cm	Benthic Growth: None			
Detergents: 0 mg/L	Stains: None			
	Non-illicit: None

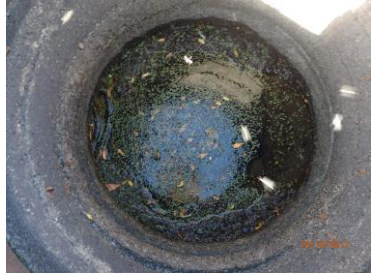
o20171019131708.JPG	
Submerged: Fully		Depth (in): 40		Sample collected from submerged flow in manhole. Elevated ammonia.			
Sampling Results Sample Location: Flow Total Chlorine: 0 ppm Free Chlorine: 0 ppm Ammonia: 3 ppm pH: 7.15 units Temperature: 68 °F Conductivity: 1990 µS/cm Detergents: 0 mg/L		Floatables: None Odor: None Turbidity: None Color: None Gross Solids: None Vegetation: None Benthic Growth: None Stains: None Non-illicit: None		Condition Assessment Graffiti: None Erosion: None Deposition: None in. Damage: None

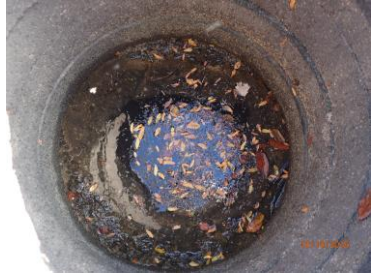
o20161018140148.JPG	
Submerged: Fully		Depth (in): 40		Strong current; significant flies in manhole.			
Sampling Results Sample Location: Flow Total Chlorine: 0 ppm Free Chlorine: 0 ppm Ammonia: 0 ppm pH: 7.01 units Temperature: 70 °F Conductivity: 1228 µS/cm Detergents: 0 mg/L		Floatables: None Odor: Faint Turbidity: None Color: None Gross Solids: None Vegetation: None Benthic Growth: None Stains: None Non-illicit: None		Condition Assessment Graffiti: None Erosion: None Deposition: None in. Damage: None

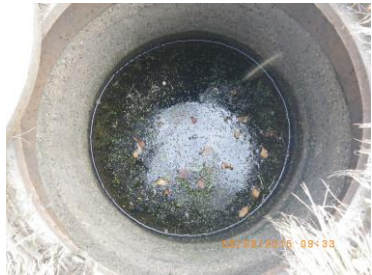
o20150923083310.JPG	
Submerged: Fully		Depth (in): 42		Significant current detected in pool. Many flies emerging from water.			
Sampling Results Sample Location: Pool Total Chlorine: 0 ppm Free Chlorine: 0 ppm Ammonia: 0 ppm pH: 7.53 units Temperature: 70 °F Conductivity: 1220 µS/cm Detergents: 0 mg/L		Floatables: None Odor: None Turbidity: None Color: None Gross Solids: Slight Vegetation: None Benthic Growth: Slight Stains: None Non-illicit: None		Condition Assessment Graffiti: None Erosion: None Deposition: None in. Damage: None

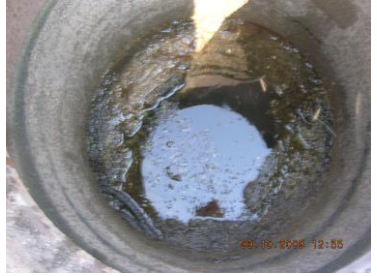
Inspection Date: 9/10/2009		Type: Initial		Flow: Submerged, slight flow		Previous Rainfall (hrs): 72+	
Illicit Discharge Potential: Unlikely		Inspector: JCW		Notes River fly swarm inside manhole.

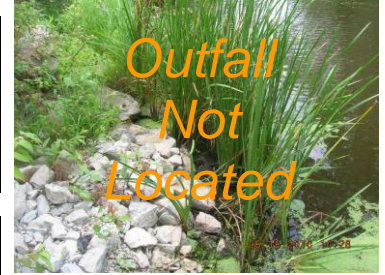
o20100818142820.JPG

Inspection Date: 8/18/2010 2:38:53 PM		Type: Ongoing	Flow: Submerged (not located)	Previous Rainfall (hrs): 72+
Illicit Discharge Potential: Potential		Inspector: JCW		
Submerged: Fully		Depth (in):		
Sampling Results		Notes Outfall fully submerged and not physically located. Outfall screened upstream at 06-221 US1.		
Sample Location:	Floatables:	None		
Total Chlorine: -- ppm	Odor:	None		
Free Chlorine: -- ppm	Turbidity:	None		
Ammonia: -- ppm	Color:	None		
pH: -- units	Gross Solids:	None		
Temperature -- °F	Vegetation:	None		
Conductivity: -- µS/cm	Benthic Growth:	None		
Detergents: -- mg/L	Stains:	None		
	Non-illicit:	None		
		Condition Assessment Graffiti: None Erosion: None Deposition: None 0 in. Damage: None

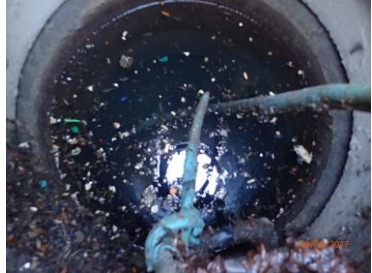
o20171018105550.JPG

Inspection Date: 10/18/2017 11:00:06 AM		Type: Ongoing	Flow: Submerged, indeterminate	Previous Rainfall (hrs): 72+
Illicit Discharge Potential: Potential		Inspector: JCW	Notes	
Submerged: Fully		Depth (in): 32	Sample collected from submerged pool in manhole. Floating gross solids (litter) in manhole.	
Sampling Results		Floatables: None	Condition Assessment	
Sample Location: Pool		Odor: None	Graffiti: None	
Total Chlorine: 0 ppm		Turbidity: None	Erosion: None	
Free Chlorine: 0 ppm		Color: None	Deposition: None in.	
Ammonia: 0 ppm		Gross Solids: Moderate	Damage: None	
pH: 7.24 units		Vegetation: None		
Temperature 66 °F		Benthic Growth: None		
Conductivity: 379 µS/cm		Stains: None		
Detergents: 0 mg/L		Non-illicit: None

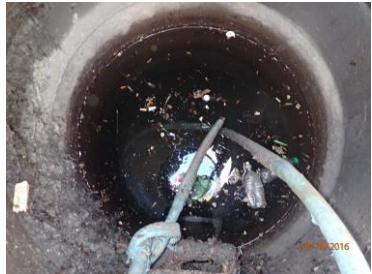
o20161018134038.JPG

Inspection Date: 10/18/2016 1:43:57 PM		Type: Ongoing	Flow: Submerged, indeterminate	Previous Rainfall (hrs): 72+
Illicit Discharge Potential: Potential		Inspector: JCW	Notes	
Submerged: Fully		Depth (in): 35	Casting displaced 2". Potential illicit discharge due to gross solids.	
Sampling Results		Floatables: None	Condition Assessment	
Sample Location: Pool		Odor: None	Graffiti: None	
Total Chlorine: 0 ppm		Turbidity: None	Erosion: None	
Free Chlorine: 0 ppm		Color: None	Deposition: None in.	
Ammonia: 0 ppm		Gross Solids: Moderate	Damage: Minor	
pH: 7.06 units		Vegetation: None		
Temperature 68 °F		Benthic Growth: None		
Conductivity: 460 µS/cm		Stains: None		
Detergents: 0 mg/L		Non-illicit: None

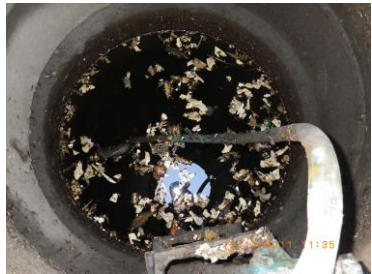
o20111011113522.JPG

Inspection Date: 10/11/2011 11:37:34 AM		Type: Ongoing	Flow: Submerged, indeterminate	Previous Rainfall (hrs): 72+
Illicit Discharge Potential: Potential		Inspector: JCW	Notes	
Submerged: Fully		Depth (in): 32	2010 screening follow-up. Floatable debris still present.	
Sampling Results		Floatables: None	Condition Assessment	
Sample Location: Pool		Odor: None	Graffiti: None	
Total Chlorine: 0 ppm		Turbidity: None	Erosion: None	
Free Chlorine: 0 ppm		Color: None	Deposition: None 0 in.	
Ammonia: 0 ppm		Gross Solids: Moderate	Damage: None	
pH: 7.5 units		Vegetation: None		
Temperature 71 °F		Benthic Growth: None		
Conductivity: -- µS/cm		Stains: None		
Detergents: -- mg/L		Non-illicit: None

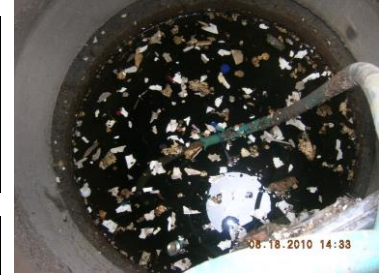
o20100818143354.JPG

Inspection Date: 8/18/2010 2:43:51 PM		Type: Ongoing	Flow: Submerged, indeterminate	Previous Rainfall (hrs): 72+																									
Illicit Discharge Potential: Potential		Inspector: JCW	Notes Torn paper and other floatable debris in manhole.																										
Submerged: Fully Depth (in): 36																													
Sampling Results <table border="1" style="width: 100%; border-collapse: collapse;"> <tr> <td style="width: 50%;">Sample Location: Pool</td> <td style="width: 50%;">Floatables: None</td> </tr> <tr> <td>Total Chlorine: 0 ppm</td> <td>Odor: None</td> </tr> <tr> <td>Free Chlorine: 0 ppm</td> <td>Turbidity: None</td> </tr> <tr> <td>Ammonia: 0 ppm</td> <td>Color: None</td> </tr> <tr> <td>pH: 7.21 units</td> <td>Gross Solids: Moderate</td> </tr> <tr> <td>Temperature: 79 °F</td> <td>Vegetation: None</td> </tr> <tr> <td>Conductivity: -- µS/cm</td> <td>Benthic Growth: None</td> </tr> <tr> <td>Detergents: 0 mg/L</td> <td>Stains: None</td> </tr> <tr> <td></td> <td>Non-illicit: None</td> </tr> </table>		Sample Location: Pool	Floatables: None	Total Chlorine: 0 ppm	Odor: None	Free Chlorine: 0 ppm	Turbidity: None	Ammonia: 0 ppm	Color: None	pH: 7.21 units	Gross Solids: Moderate	Temperature: 79 °F	Vegetation: None	Conductivity: -- µS/cm	Benthic Growth: None	Detergents: 0 mg/L	Stains: None		Non-illicit: None	Condition Assessment <table border="1" style="width: 100%; border-collapse: collapse;"> <tr> <td style="width: 50%;">Graffiti: None</td> <td style="width: 50%;"></td> </tr> <tr> <td>Erosion: None</td> <td></td> </tr> <tr> <td>Deposition: None</td> <td>0 in.</td> </tr> <tr> <td>Damage: None</td> <td></td> </tr> </table>		Graffiti: None		Erosion: None		Deposition: None	0 in.	Damage: None

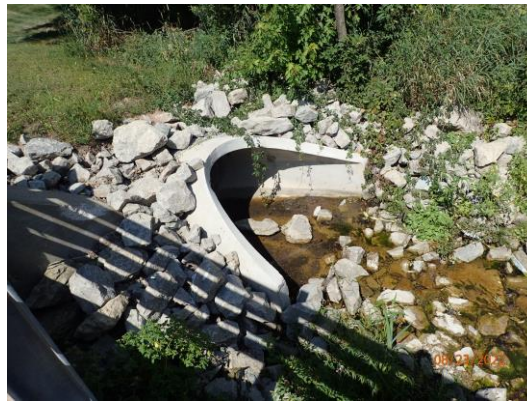
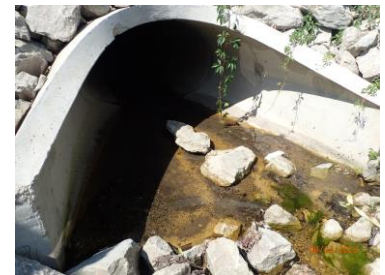
o20220823121036.JPG

Storm sewer from W. 9th Ave discharges to stream from west. Replaces outfall 06-1132 (2021).

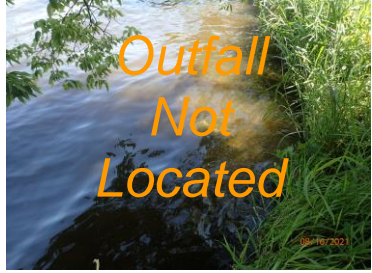
o20210816140546.JPG <div style="text-align: center; font-size: 24pt; font-weight: bold;">2021</div>
		Condition Assessment Graffiti: None Erosion: None Deposition: None in. Damage: None

Inspection Date: 8/16/2021 2:06:06 PM		Type: Ongoing	Flow: Submerged (not located)	Previous Rainfall (hrs): 72+
Illicit Discharge Potential: Potential		Inspector: JCW		
Submerged: Fully		Depth (in):		
Sampling Results Sample Location: _____ Total Chlorine: -- ppm Free Chlorine: -- ppm Ammonia: -- ppm pH: -- units Temperature: -- °F Conductivity: -- µS/cm Detergents: -- mg/L		Floatables: None Odor: None Turbidity: None Color: None Gross Solids: None Vegetation: None Benthic Growth: None Stains: None Non-illicit: None	Notes Outfall fully submerged and not located - screened upstream at 06-52 US1. Floating gross solids (litter) in upstream manhole.

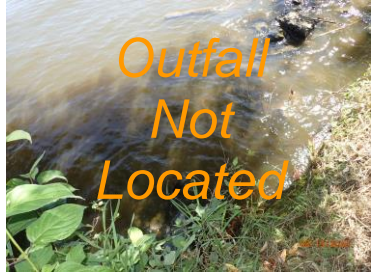
o20200819113108.JPG <div style="text-align: center; font-size: 24pt; font-weight: bold;">2020</div>
		Condition Assessment Graffiti: None Erosion: None Deposition: None in. Damage: None

Inspection Date: 8/19/2020 11:32:11 AM		Type: Ongoing	Flow: Submerged (not located)	Previous Rainfall (hrs): 72+
Illicit Discharge Potential: Potential		Inspector: JCW		
Submerged: Fully		Depth (in):		
Sampling Results Sample Location: _____ Total Chlorine: -- ppm Free Chlorine: -- ppm Ammonia: -- ppm pH: -- units Temperature: -- °F Conductivity: -- µS/cm Detergents: -- mg/L		Floatables: None Odor: None Turbidity: None Color: None Gross Solids: None Vegetation: None Benthic Growth: None Stains: None Non-illicit: None	Notes Outfall fully submerged and not located - screened upstream at 06-52 US1. Floating gross solids (litter) in upstream manhole.

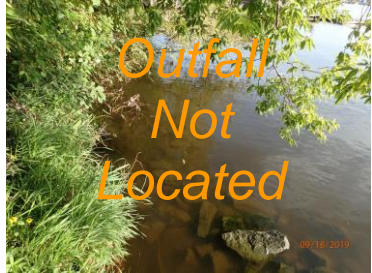
Inspection Date: 9/18/2019 8:43:23 AM		Type: Ongoing	Flow: Submerged (not located)	Previous Rainfall (hrs): 72+
Illicit Discharge Potential: Potential		Inspector: JCW		
Submerged: Fully		Depth (in):		
Sampling Results Sample Location: _____ Total Chlorine: -- ppm Free Chlorine: -- ppm Ammonia: -- ppm pH: -- units Temperature: -- °F Conductivity: -- µS/cm Detergents: -- mg/L		Floatables: None Odor: None Turbidity: None Color: None Gross Solids: None Vegetation: None Benthic Growth: None Stains: None Non-illicit: None	Notes Outfall fully submerged and not located - screened upstream at 06-52 US1. Floating gross solids (litter) in manhole.

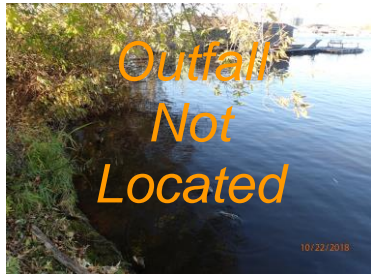
o20181022163054.JPG <div style="text-align: center; font-size: 24pt; font-weight: bold;">2018</div>
		Condition Assessment Graffiti: None Erosion: None Deposition: None in. Damage: None

Inspection Date: 10/22/2018 4:31:59 PM		Type: Ongoing	Flow: Submerged (not located)	Previous Rainfall (hrs): 48-72
Illicit Discharge Potential: Potential		Inspector: JCW		
Submerged: Fully		Depth (in):		
Sampling Results Sample Location: _____ Total Chlorine: -- ppm Free Chlorine: -- ppm Ammonia: -- ppm pH: -- units Temperature: -- °F Conductivity: -- µS/cm Detergents: -- mg/L		Floatables: None Odor: None Turbidity: None Color: None Gross Solids: None Vegetation: None Benthic Growth: None Stains: None Non-illicit: None	Notes Outfall fully submerged and not located - screened upstream at 06-52 US1. Floating gross solids (litter) in manhole.

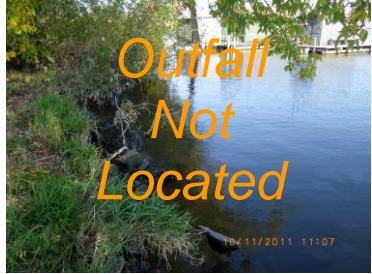
<p style="text-align: center;">o20111011110724.JPG</p> <p style="text-align: center; font-size: 24pt; font-weight: bold;">2011</p>

Inspection Date: 10/11/2011 11:06:46 AM		Type: Ongoing	Flow: Submerged (not located)	Previous Rainfall (hrs): 72+																																		
Illicit Discharge Potential: Unlikely		Inspector: JCW	<div style="border: 1px solid black; padding: 5px;"> Notes 2010 screening follow-up. Outfall fully submerged and not physically located. Outfall screened upstream at 06-52 US1. </div> <div style="border: 1px solid black; padding: 5px; margin-top: 5px;"> Condition Assessment Graffiti: None Erosion: None Deposition: None 0 in. Damage: None </div>																																			
Submerged: Fully Depth (in):																																						
<div style="display: flex; justify-content: space-between;"> <div style="width: 45%;"> Sampling Results <table border="1" style="width: 100%; border-collapse: collapse;"> <tr><td colspan="2">Sample Location:</td></tr> <tr><td>Total Chlorine:</td><td>-- ppm</td></tr> <tr><td>Free Chlorine:</td><td>-- ppm</td></tr> <tr><td>Ammonia:</td><td>-- ppm</td></tr> <tr><td>pH:</td><td>-- units</td></tr> <tr><td>Temperature:</td><td>-- °F</td></tr> <tr><td>Conductivity:</td><td>-- µS/cm</td></tr> <tr><td>Detergents:</td><td>-- mg/L</td></tr> </table> </div> <div style="width: 45%;"> <table border="1" style="width: 100%; border-collapse: collapse;"> <tr><td>Floatables:</td><td>None</td></tr> <tr><td>Odor:</td><td>None</td></tr> <tr><td>Turbidity:</td><td>None</td></tr> <tr><td>Color:</td><td>None</td></tr> <tr><td>Gross Solids:</td><td>None</td></tr> <tr><td>Vegetation:</td><td>None</td></tr> <tr><td>Benthic Growth:</td><td>None</td></tr> <tr><td>Stains:</td><td>None</td></tr> <tr><td>Non-illicit:</td><td>None</td></tr> </table> </div> </div>					Sample Location:		Total Chlorine:	-- ppm	Free Chlorine:	-- ppm	Ammonia:	-- ppm	pH:	-- units	Temperature:	-- °F	Conductivity:	-- µS/cm	Detergents:	-- mg/L	Floatables:	None	Odor:	None	Turbidity:	None	Color:	None	Gross Solids:	None	Vegetation:	None	Benthic Growth:	None	Stains:	None	Non-illicit:	None

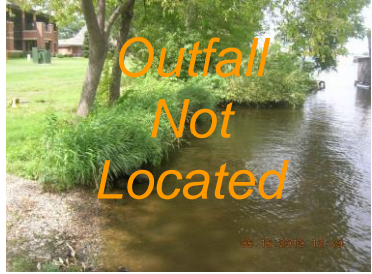
<p style="text-align: center;">o20100818124946.JPG</p> <p style="text-align: center; font-size: 24pt; font-weight: bold;">2010</p>

Inspection Date: 8/18/2010 12:57:36 PM		Type: Ongoing	Flow: Submerged (not located)	Previous Rainfall (hrs): 72+																																		
Illicit Discharge Potential: Potential		Inspector: JCW	<div style="border: 1px solid black; padding: 5px;"> Notes Outfall fully submerged and not physically located. Outfall screened upstream at 06-52 US1. </div> <div style="border: 1px solid black; padding: 5px; margin-top: 5px;"> Condition Assessment Graffiti: None Erosion: None Deposition: None 0 in. Damage: None </div>																																			
Submerged: Fully Depth (in):																																						
<div style="display: flex; justify-content: space-between;"> <div style="width: 45%;"> Sampling Results <table border="1" style="width: 100%; border-collapse: collapse;"> <tr><td colspan="2">Sample Location:</td></tr> <tr><td>Total Chlorine:</td><td>-- ppm</td></tr> <tr><td>Free Chlorine:</td><td>-- ppm</td></tr> <tr><td>Ammonia:</td><td>-- ppm</td></tr> <tr><td>pH:</td><td>-- units</td></tr> <tr><td>Temperature:</td><td>-- °F</td></tr> <tr><td>Conductivity:</td><td>-- µS/cm</td></tr> <tr><td>Detergents:</td><td>-- mg/L</td></tr> </table> </div> <div style="width: 45%;"> <table border="1" style="width: 100%; border-collapse: collapse;"> <tr><td>Floatables:</td><td>None</td></tr> <tr><td>Odor:</td><td>None</td></tr> <tr><td>Turbidity:</td><td>None</td></tr> <tr><td>Color:</td><td>None</td></tr> <tr><td>Gross Solids:</td><td>None</td></tr> <tr><td>Vegetation:</td><td>None</td></tr> <tr><td>Benthic Growth:</td><td>None</td></tr> <tr><td>Stains:</td><td>None</td></tr> <tr><td>Non-illicit:</td><td>None</td></tr> </table> </div> </div>					Sample Location:		Total Chlorine:	-- ppm	Free Chlorine:	-- ppm	Ammonia:	-- ppm	pH:	-- units	Temperature:	-- °F	Conductivity:	-- µS/cm	Detergents:	-- mg/L	Floatables:	None	Odor:	None	Turbidity:	None	Color:	None	Gross Solids:	None	Vegetation:	None	Benthic Growth:	None	Stains:	None	Non-illicit:	None

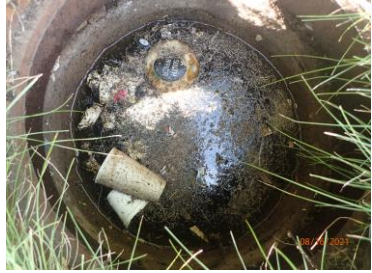
o20210816140640.JPG

Inspection Date: 8/16/2021 2:08:38 PM		Type: Ongoing	Flow: Submerged, indeterminate	Previous Rainfall (hrs): 72+
Illicit Discharge Potential: Potential		Inspector: JCW		
Submerged: Fully		Depth (in): 37		
Sampling Results		Notes Sample collected from submerged pool in manhole. Floating gross solids (litter) in manhole.		
Sample Location: Pool	Floatables: None	Condition Assessment Graffiti: None Erosion: None Deposition: None in. Damage: None		
Total Chlorine: 0 ppm	Odor: None			
Free Chlorine: 0 ppm	Turbidity: None			
Ammonia: 0 ppm	Color: None			
pH: 7.84 units	Gross Solids: Moderate			
Temperature 82 °F	Vegetation: None			
Conductivity: 347 µS/cm	Benthic Growth: Slight			
Detergents: 0 mg/L	Stains: None			
	Non-illicit: None

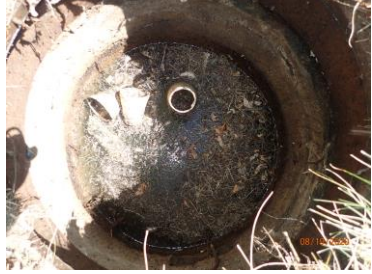
o20200819113240.JPG

Inspection Date: 8/19/2020 11:35:26 AM		Type: Ongoing	Flow: Submerged, indeterminate	Previous Rainfall (hrs): 72+
Illicit Discharge Potential: Potential		Inspector: JCW		
Submerged: Fully		Depth (in): 42		
Sampling Results		Notes Sample collected from submerged pool in manhole. Floating gross solids (litter) in manhole. Elevated pH seemed widespread in river.		
Sample Location: Pool	Floatables: None	Condition Assessment Graffiti: None Erosion: None Deposition: None in. Damage: None		
Total Chlorine: 0 ppm	Odor: None			
Free Chlorine: 0 ppm	Turbidity: None			
Ammonia: 0 ppm	Color: None			
pH: 9.11 units	Gross Solids: Moderate			
Temperature 81 °F	Vegetation: None			
Conductivity: 332 µS/cm	Benthic Growth: Moderate			
Detergents: 0 mg/L	Stains: None			
	Non-illicit: None

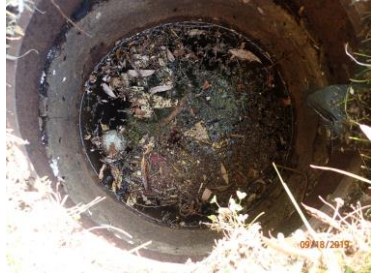
o20190918074352.JPG

Inspection Date: 9/18/2019 8:45:58 AM		Type: Ongoing	Flow: Submerged, no flow	Previous Rainfall (hrs): 72+
Illicit Discharge Potential: Potential		Inspector: JCW		
Submerged: Fully		Depth (in): 44		
Sampling Results		Notes Sample collected from submerged pool in manhole. Floating gross solids (litter) in manhole.		
Sample Location: Pool	Floatables: None	Condition Assessment Graffiti: None Erosion: None Deposition: None in. Damage: None		
Total Chlorine: 0 ppm	Odor: None			
Free Chlorine: 0 ppm	Turbidity: None			
Ammonia: 0 ppm	Color: None			
pH: 8.4 units	Gross Solids: Moderate			
Temperature 70 °F	Vegetation: None			
Conductivity: 391 µS/cm	Benthic Growth: None			
Detergents: 0 mg/L	Stains: None			
	Non-illicit: None

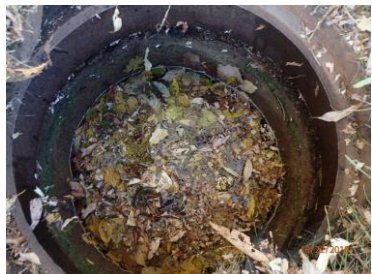
o20181022163150.JPG

Inspection Date: 10/22/2018 4:34:14 PM		Type: Ongoing	Flow: Submerged, indeterminate	Previous Rainfall (hrs): 48-72
Illicit Discharge Potential: Potential		Inspector: JCW		
Submerged: Fully		Depth (in): 44		
Sampling Results		Notes Sample collected from submerged pool in manhole. Floating gross solids (litter) in manhole.		
Sample Location: Pool	Floatables: None	Condition Assessment Graffiti: None Erosion: None Deposition: None in. Damage: None		
Total Chlorine: 0 ppm	Odor: None			
Free Chlorine: 0 ppm	Turbidity: None			
Ammonia: 0 ppm	Color: None			
pH: 7.77 units	Gross Solids: Moderate			
Temperature 54 °F	Vegetation: None			
Conductivity: 348 µS/cm	Benthic Growth: Slight			
Detergents: 0 mg/L	Stains: None			
	Non-illicit: None

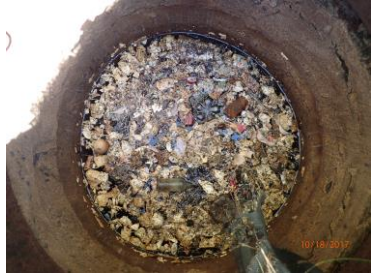
o20171018112938.JPG
2017

Inspection Date: 10/18/2017 11:33:33 AM		Type: Ongoing	Flow: Submerged, indeterminate	Previous Rainfall (hrs): 72+
Illicit Discharge Potential: Potential		Inspector: JCW	Notes	
Submerged: Fully		Depth (in): 40	Sample collected from submerged pool in manhole. Floating gross solids (litter) in manhole.	
Sampling Results		Floatables: None	Condition Assessment Graffiti: None Erosion: None Deposition: None in. Damage: None	
Sample Location: Pool	Odor: None			
Total Chlorine: 0 ppm	Turbidity: None			
Free Chlorine: 0 ppm	Color: None			
Ammonia: 0 ppm	Gross Solids: Severe			
pH: 8.39 units	Vegetation: None			
Temperature 65 °F	Benthic Growth: None			
Conductivity: 403 µS/cm	Stains: None			
Detergents: 0 mg/L	Non-illicit: None

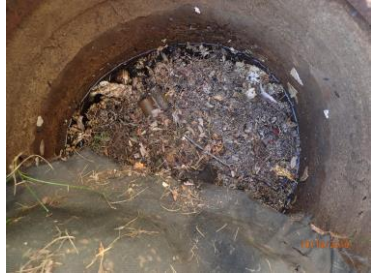
o20161018145924.JPG
2016

Inspection Date: 10/18/2016 3:00:00 PM		Type: Ongoing	Flow: Submerged, indeterminate	Previous Rainfall (hrs): 72+
Illicit Discharge Potential: Potential		Inspector: JCW	Notes	
Submerged: Fully		Depth (in):	Potential illicit discharge due to gross solids.	
Sampling Results		Floatables: None	Condition Assessment Graffiti: None Erosion: None Deposition: None 0 in. Damage: None	
Sample Location: Pool	Odor: None			
Total Chlorine: 0 ppm	Turbidity: None			
Free Chlorine: 0 ppm	Color: None			
Ammonia: 0 ppm	Gross Solids: Moderate			
pH: 8.02 units	Vegetation: None			
Temperature 67 °F	Benthic Growth: None			
Conductivity: 418 µS/cm	Stains: None			
Detergents: 0 mg/L	Non-illicit: None

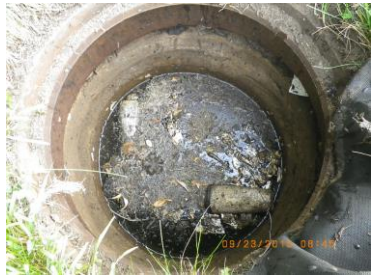
o20150923074542.JPG
2015

Inspection Date: 9/23/2015 8:42:53 AM		Type: Ongoing	Flow: Submerged, indeterminate	Previous Rainfall (hrs): 72+
Illicit Discharge Potential: Potential		Inspector: JCW	Notes	
Submerged: Fully		Depth (in): 44	Floating gross solids (litter) in manhole.	
Sampling Results		Floatables: None	Condition Assessment Graffiti: None Erosion: None Deposition: None in. Damage: None	
Sample Location: Pool	Odor: None			
Total Chlorine: 0 ppm	Turbidity: None			
Free Chlorine: 0 ppm	Color: None			
Ammonia: 0 ppm	Gross Solids: Moderate			
pH: 8.74 units	Vegetation: None			
Temperature 70 °F	Benthic Growth: None			
Conductivity: 351 µS/cm	Stains: None			
Detergents: 0 mg/L	Non-illicit: None

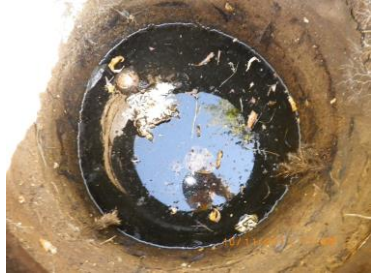
o20111011110824.JPG 2011

Inspection Date: 10/11/2011 11:09:29 AM		Type: Ongoing	Flow: Submerged, indeterminate	Previous Rainfall (hrs): 72+																																				
Illicit Discharge Potential: Unlikely		Inspector: JCW	Notes 2010 screening follow-up. Floatable debris significantly reduced.																																					
Submerged: Fully Depth (in): 35																																								
Sampling Results

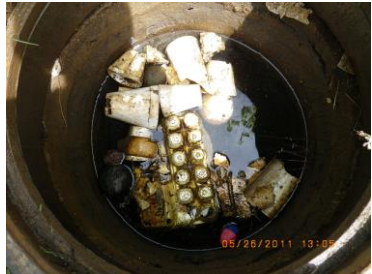
o20110526130522.JPG 2011

Inspection Date: 5/26/2011 1:05:00 PM		Type: Other	Flow: Submerged, indeterminate	Previous Rainfall (hrs): 72+																																				
Illicit Discharge Potential: Potential		Inspector: JCW	Notes Limited screening conducted to check for floatable debris.																																					
Submerged: Fully Depth (in):																																								
Sampling Results

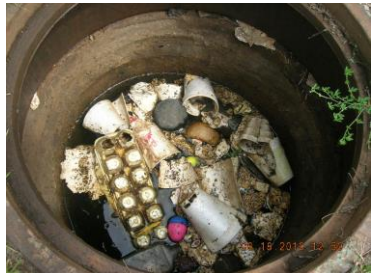
o20100818125018.JPG 2010

Inspection Date: 8/18/2010 1:00:07 PM		Type: Ongoing	Flow: Submerged, indeterminate	Previous Rainfall (hrs): 72+																																				
Illicit Discharge Potential: Potential		Inspector: JCW	Notes Significant floatable debris in manhole.																																					
Submerged: Fully Depth (in): 41																																								
Sampling Results

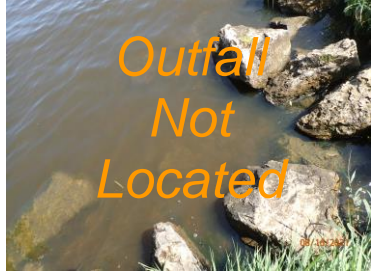
o20210816141900.JPG <div style="text-align: center; font-weight: bold; font-size: 1.2em;">2021</div>
		Condition Assessment Graffiti: None Erosion: None Deposition: None in. Damage: None

Inspection Date: 8/16/2021 2:19:36 PM		Type: Ongoing	Flow: Submerged (not located)	Previous Rainfall (hrs): 72+
Illicit Discharge Potential: Unlikely		Inspector: JCW		
Submerged: Fully		Depth (in):		
Sampling Results Sample Location: _____ Total Chlorine: -- ppm Free Chlorine: -- ppm Ammonia: -- ppm pH: -- units Temperature: -- °F Conductivity: -- µS/cm Detergents: -- mg/L		Floatables: None Odor: None Turbidity: None Color: None Gross Solids: None Vegetation: None Benthic Growth: None Stains: None Non-illicit: None	Notes Outfall fully submerged and not located - screened upstream at 06-810 US1.

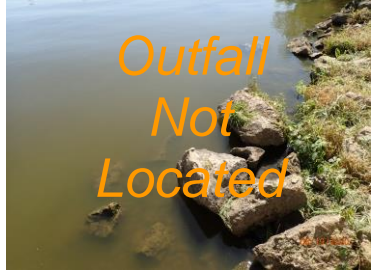
Inspection Date: 8/19/2020 11:18:34 AM		Type: Ongoing	Flow: Submerged (not located)	Previous Rainfall (hrs): 72+
Illicit Discharge Potential: Unlikely		Inspector: JCW		
Submerged: Fully		Depth (in):		
Sampling Results Sample Location: _____ Total Chlorine: -- ppm Free Chlorine: -- ppm Ammonia: -- ppm pH: -- units Temperature: -- °F Conductivity: -- µS/cm Detergents: -- mg/L		Floatables: None Odor: None Turbidity: None Color: None Gross Solids: None Vegetation: None Benthic Growth: None Stains: None Non-illicit: None	Notes Outfall fully submerged and not located - screened upstream at 06-810 US1.

o20200819111708.JPG <div style="text-align: center; font-weight: bold; font-size: 1.2em;">2020</div>
		Condition Assessment Graffiti: None Erosion: None Deposition: None in. Damage: None

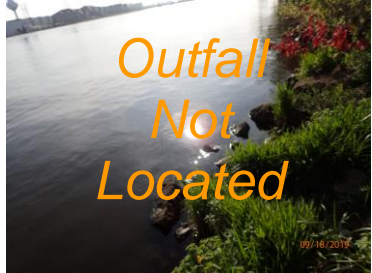
Inspection Date: 9/18/2019 9:09:25 AM		Type: Ongoing	Flow: Submerged (not located)	Previous Rainfall (hrs): 72+
Illicit Discharge Potential: Potential		Inspector: JCW		
Submerged: Fully		Depth (in):		
Sampling Results Sample Location: _____ Total Chlorine: -- ppm Free Chlorine: -- ppm Ammonia: -- ppm pH: -- units Temperature: -- °F Conductivity: -- µS/cm Detergents: -- mg/L		Floatables: None Odor: None Turbidity: None Color: None Gross Solids: None Vegetation: None Benthic Growth: None Stains: None Non-illicit: None	Notes Outfall fully submerged and not located - screened upstream at 06-810 US1. Floating gross solids (litter) in manhole.

o20190918080814.JPG <div style="text-align: center; font-weight: bold; font-size: 1.2em;">2019</div>
		Condition Assessment Graffiti: None Erosion: None Deposition: None in. Damage: None

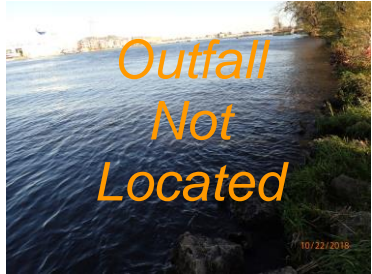
Inspection Date: 10/22/2018 4:42:27 PM		Type: Ongoing	Flow: Submerged (not located)	Previous Rainfall (hrs): 48-72
Illicit Discharge Potential: Potential		Inspector: JCW		
Submerged: Fully		Depth (in):		
Sampling Results Sample Location: _____ Total Chlorine: -- ppm Free Chlorine: -- ppm Ammonia: -- ppm pH: -- units Temperature: -- °F Conductivity: -- µS/cm Detergents: -- mg/L		Floatables: None Odor: None Turbidity: None Color: None Gross Solids: None Vegetation: None Benthic Growth: None Stains: None Non-illicit: None	Notes Outfall fully submerged and not located - screened upstream at 06-810 US1. Floating gross solids (litter) in manhole.

o20181022164110.JPG <div style="text-align: center; font-weight: bold; font-size: 1.2em;">2018</div>
		Condition Assessment Graffiti: None Erosion: None Deposition: None in. Damage: None

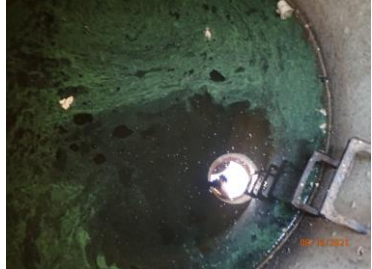
Inspection Date: 8/16/2021 2:20:40 PM		Type: Ongoing	Flow: Submerged, indeterminate	Previous Rainfall (hrs): 72+
Illicit Discharge Potential: Unlikely		Inspector: JCW		
Submerged: Fully		Depth (in): 58		
Sampling Results		<div style="display: flex; justify-content: space-between;"> <div> <p>Sample Location: Pool</p> <p>Total Chlorine: 0 ppm</p> <p>Free Chlorine: 0 ppm</p> <p>Ammonia: 0 ppm</p> <p>pH: 7.86 units</p> <p>Temperature: 82 °F</p> <p>Conductivity: 331 µS/cm</p> <p>Detergents: 0 mg/L</p> </div> <div> <p>Floatables: None</p> <p>Odor: None</p> <p>Turbidity: None</p> <p>Color: None</p> <p>Gross Solids: Slight</p> <p>Vegetation: None</p> <p>Benthic Growth: None</p> <p>Stains: None</p> <p>Non-illicit: None</p> </div> </div>		
		<div style="display: flex; justify-content: space-between;"> <div> <p>Notes</p> <p>Sample collected from submerged pool in manhole.</p> </div> <div> <p>Condition Assessment</p> <p>Graffiti: None</p> <p>Erosion: None</p> <p>Deposition: None in.</p> <p>Damage: None</p> </div> </div>

<p style="text-align: center;">o20210816142010.JPG</p> <p style="text-align: center; font-size: 24pt; font-weight: bold;">2021</p>

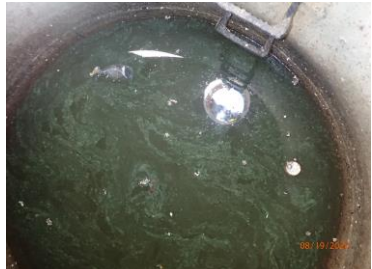
Inspection Date: 8/19/2020 11:21:56 AM		Type: Ongoing	Flow: Submerged, indeterminate	Previous Rainfall (hrs): 72+
Illicit Discharge Potential: Unlikely		Inspector: JCW		
Submerged: Fully		Depth (in): 36		
Sampling Results		<div style="display: flex; justify-content: space-between;"> <div> <p>Sample Location: Pool</p> <p>Total Chlorine: 0 ppm</p> <p>Free Chlorine: 0 ppm</p> <p>Ammonia: 0 ppm</p> <p>pH: 8.99 units</p> <p>Temperature: 80 °F</p> <p>Conductivity: 343 µS/cm</p> <p>Detergents: 0 mg/L</p> </div> <div> <p>Floatables: None</p> <p>Odor: None</p> <p>Turbidity: None</p> <p>Color: None</p> <p>Gross Solids: Slight</p> <p>Vegetation: None</p> <p>Benthic Growth: None</p> <p>Stains: None</p> <p>Non-illicit: None</p> </div> </div>		
		<div style="display: flex; justify-content: space-between;"> <div> <p>Notes</p> <p>Sample collected from submerged pool in manhole. Floating gross solids (litter) in manhole.</p> </div> <div> <p>Condition Assessment</p> <p>Graffiti: None</p> <p>Erosion: None</p> <p>Deposition: None in.</p> <p>Damage: None</p> </div> </div>

<p style="text-align: center;">o20200819111844.JPG</p> <p style="text-align: center; font-size: 24pt; font-weight: bold;">2020</p>

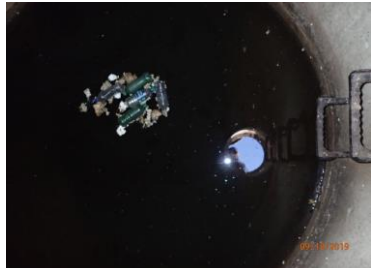
Inspection Date: 9/18/2019 9:12:03 AM		Type: Ongoing	Flow: Submerged, indeterminate	Previous Rainfall (hrs): 72+
Illicit Discharge Potential: Potential		Inspector: JCW		
Submerged: Fully		Depth (in): 57		
Sampling Results		<div style="display: flex; justify-content: space-between;"> <div> <p>Sample Location: Pool</p> <p>Total Chlorine: 0 ppm</p> <p>Free Chlorine: 0 ppm</p> <p>Ammonia: 0 ppm</p> <p>pH: 8.62 units</p> <p>Temperature: 71 °F</p> <p>Conductivity: 387 µS/cm</p> <p>Detergents: 0 mg/L</p> </div> <div> <p>Floatables: None</p> <p>Odor: None</p> <p>Turbidity: None</p> <p>Color: None</p> <p>Gross Solids: Slight</p> <p>Vegetation: None</p> <p>Benthic Growth: None</p> <p>Stains: None</p> <p>Non-illicit: None</p> </div> </div>		
		<div style="display: flex; justify-content: space-between;"> <div> <p>Notes</p> <p>Sample collected from submerged pool in manhole. Floating gross solids (litter) in manhole.</p> </div> <div> <p>Condition Assessment</p> <p>Graffiti: None</p> <p>Erosion: None</p> <p>Deposition: None in.</p> <p>Damage: None</p> </div> </div>

<p style="text-align: center;">o20190918080922.JPG</p> <p style="text-align: center; font-size: 24pt; font-weight: bold;">2019</p>

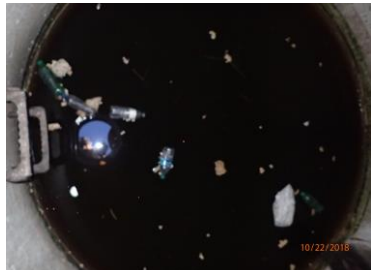
Inspection Date: 10/22/2018 4:45:48 PM		Type: Ongoing	Flow: Submerged, indeterminate	Previous Rainfall (hrs): 48-72
Illicit Discharge Potential: Potential		Inspector: JCW		
Submerged: Fully		Depth (in): 58		
Sampling Results		<div style="display: flex; justify-content: space-between;"> <div> <p>Sample Location: Pool</p> <p>Total Chlorine: 0 ppm</p> <p>Free Chlorine: 0 ppm</p> <p>Ammonia: 0 ppm</p> <p>pH: 7.7 units</p> <p>Temperature: 55 °F</p> <p>Conductivity: 370 µS/cm</p> <p>Detergents: 0 mg/L</p> </div> <div> <p>Floatables: None</p> <p>Odor: None</p> <p>Turbidity: None</p> <p>Color: None</p> <p>Gross Solids: Slight</p> <p>Vegetation: None</p> <p>Benthic Growth: None</p> <p>Stains: None</p> <p>Non-illicit: None</p> </div> </div>		
		<div style="display: flex; justify-content: space-between;"> <div> <p>Notes</p> <p>Sample collected from submerged pool in manhole. Floating gross solids (litter) in manhole.</p> </div> <div> <p>Condition Assessment</p> <p>Graffiti: None</p> <p>Erosion: None</p> <p>Deposition: None in.</p> <p>Damage: None</p> </div> </div>

<p style="text-align: center;">o20181022164226.JPG</p> <p style="text-align: center; font-size: 24pt; font-weight: bold;">2018</p>

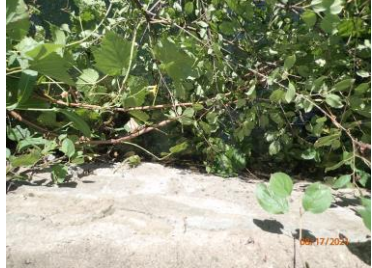
Inspection Date: 8/17/2021 10:19:04 AM		Type: Ongoing	Flow: Submerged, indeterminate	Previous Rainfall (hrs): 72+
Illicit Discharge Potential: Unlikely		Inspector: JCW		
Submerged: Fully		Depth (in): 43		
Sampling Results Sample Location: _____ Total Chlorine: -- ppm Free Chlorine: -- ppm Ammonia: -- ppm pH: -- units Temperature: -- °F Conductivity: -- µS/cm Detergents: -- mg/L		Floatables: None Odor: None Turbidity: None Color: None Gross Solids: None Vegetation: None Benthic Growth: None Stains: None Non-illicit: None	Notes Outfall fully submerged and not located - screened upstream at 06-829 US1.

o20210817101734.JPG
		Condition Assessment Graffiti: None Erosion: None Deposition: None in. Damage: None		2021

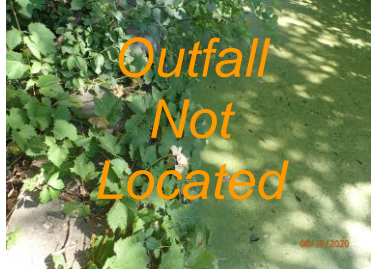
Inspection Date: 8/19/2020 10:50:40 AM		Type: Ongoing	Flow: Submerged (not located)	Previous Rainfall (hrs): 72+
Illicit Discharge Potential: Unlikely		Inspector: JCW		
Submerged: Fully		Depth (in):		
Sampling Results Sample Location: _____ Total Chlorine: -- ppm Free Chlorine: -- ppm Ammonia: -- ppm pH: -- units Temperature: -- °F Conductivity: -- µS/cm Detergents: -- mg/L		Floatables: None Odor: None Turbidity: None Color: None Gross Solids: None Vegetation: None Benthic Growth: None Stains: None Non-illicit: None	Notes Outfall fully submerged and not located - screened upstream at 06-829 US1.

o20200819105038.JPG
		Condition Assessment Graffiti: None Erosion: None Deposition: None in. Damage: None		2020

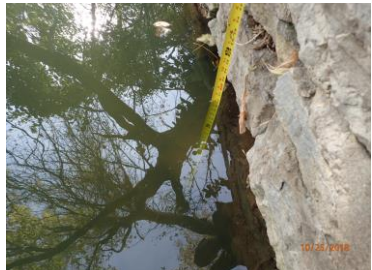
Inspection Date: 10/25/2018 1:36:22 PM		Type: Ongoing	Flow: Submerged, indeterminate	Previous Rainfall (hrs): 72+
Illicit Discharge Potential: Potential		Inspector: JCW		
Submerged: Fully		Depth (in):		
Sampling Results Sample Location: _____ Total Chlorine: -- ppm Free Chlorine: -- ppm Ammonia: -- ppm pH: -- units Temperature: -- °F Conductivity: -- µS/cm Detergents: -- mg/L		Floatables: None Odor: None Turbidity: None Color: None Gross Solids: None Vegetation: None Benthic Growth: None Stains: None Non-illicit: None	Notes Outfall fully submerged - screened upstream at 06-829 US1. Floating gross solids (litter) in manhole.

o20181025133432.JPG
		Condition Assessment Graffiti: None Erosion: None Deposition: None in. Damage: None		2018

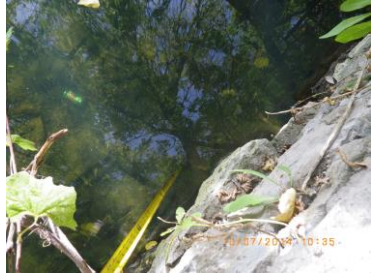
Northing: 471,413

Inspection Date: 10/7/2014 10:34:09 AM		Type: Ongoing	Flow: Submerged, indeterminate	Previous Rainfall (hrs): 48-72
Illicit Discharge Potential: Unlikely		Inspector: JCW	Notes	
Submerged: Fully		Depth (in): 42	Outfall fully submerged - screened upstream at 06-829 US1. Manhole lid in water near end of pipe.	
Sampling Results		Condition Assessment		
Sample Location:	Floatables:	None		
Total Chlorine: -- ppm	Odor:	None		
Free Chlorine: -- ppm	Turbidity:	None		
Ammonia: -- ppm	Color:	None		
pH: -- units	Gross Solids:	None		
Temperature -- °F	Vegetation:	None		
Conductivity: -- µS/cm	Benthic Growth:	Slight		
Detergents: -- mg/L	Stains:	None		
	Non-illicit:	None		
		Graffiti: None		
		Erosion: None		
		Deposition: None in.		
		Damage: None

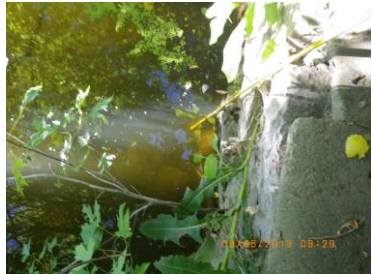
o20130905082920.JPG

Inspection Date: 9/5/2013 9:25:55 AM		Type: Ongoing	Flow: Submerged, indeterminate	Previous Rainfall (hrs): 72+
Illicit Discharge Potential: Potential		Inspector: JCW	Notes	
Submerged: Fully		Depth (in): 45	2012 screening follow-up. Outfall fully submerged. Outfall screened upstream at 06-829 US1. Gross solids in upstream mh.	
Sampling Results		Condition Assessment		
Sample Location:	Floatables:	None		
Total Chlorine: -- ppm	Odor:	None		
Free Chlorine: -- ppm	Turbidity:	None		
Ammonia: -- ppm	Color:	None		
pH: -- units	Gross Solids:	None		
Temperature -- °F	Vegetation:	None		
Conductivity: -- µS/cm	Benthic Growth:	None		
Detergents: -- mg/L	Stains:	None		
	Non-illicit:	None		
		Graffiti: None		
		Erosion: None		
		Deposition: None in.		
		Damage: None

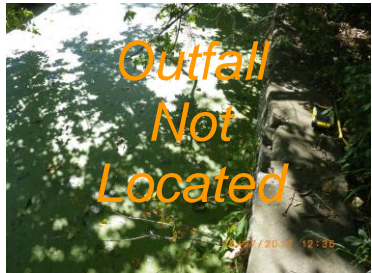
o20120927113654.JPG

Inspection Date: 9/27/2012 12:33:16 PM		Type: Ongoing	Flow: Submerged (not located)	Previous Rainfall (hrs): 72+
Illicit Discharge Potential: Potential		Inspector: JCW	Notes	
Submerged: Fully		Depth (in):	Outfall fully submerged; screened upstream at 06-829 US1.	
Sampling Results		Condition Assessment		
Sample Location:	Floatables:	None		
Total Chlorine: -- ppm	Odor:	None		
Free Chlorine: -- ppm	Turbidity:	None		
Ammonia: -- ppm	Color:	None		
pH: -- units	Gross Solids:	None		
Temperature -- °F	Vegetation:	None		
Conductivity: -- µS/cm	Benthic Growth:	None		
Detergents: -- mg/L	Stains:	None		
	Non-illicit:	None		
		Graffiti: None		
		Erosion: None		
		Deposition: None in.		
		Damage: None

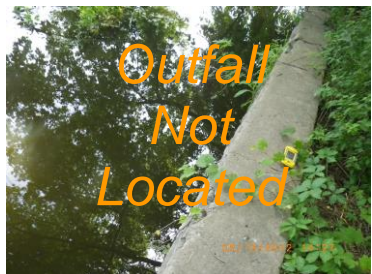
o20120613132730.JPG

Inspection Date: 6/13/2012 2:26:38 PM		Type: Other	Flow: Submerged (not located)	Previous Rainfall (hrs): 72+
Illicit Discharge Potential: Potential		Inspector: JCW	Notes	
Submerged: Fully		Depth (in):	Gross solids pre-screening.	
Sampling Results		Condition Assessment		
Sample Location:	Floatables:	None		
Total Chlorine: -- ppm	Odor:	None		
Free Chlorine: -- ppm	Turbidity:	None		
Ammonia: -- ppm	Color:	None		
pH: -- units	Gross Solids:	None		
Temperature -- °F	Vegetation:	None		
Conductivity: -- µS/cm	Benthic Growth:	None		
Detergents: -- mg/L	Stains:	None		
	Non-illicit:	None		
		Graffiti: None		
		Erosion: None		
		Deposition: None in.		
		Damage: None

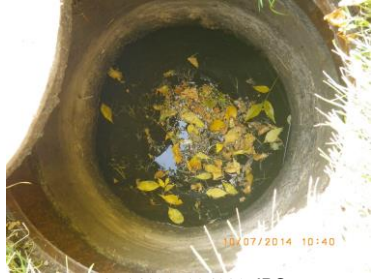
o20141007094030.JPG <div style="font-size: 24pt; font-weight: bold;">2014</div>

Inspection Date: 10/7/2014 10:41:53 AM		Type: Ongoing	Flow: Submerged, indeterminate	Previous Rainfall (hrs): 48-72
Illicit Discharge Potential: Unlikely		Inspector: JCW	Notes Vegetative debris from opening lid.	
Submerged: Fully Depth (in): 30				
Sampling Results Sample Location: Pool Total Chlorine: 0 ppm Free Chlorine: 0 ppm Ammonia: 0 ppm pH: 7.82 units Temperature: -- °F Conductivity: 1715 µS/cm Detergents: 0 mg/L		Floatables: None Odor: None Turbidity: None Color: None Gross Solids: None Vegetation: None Benthic Growth: Slight Stains: None Non-illicit: None	Condition Assessment Graffiti: None Erosion: None Deposition: None in. Damage: None

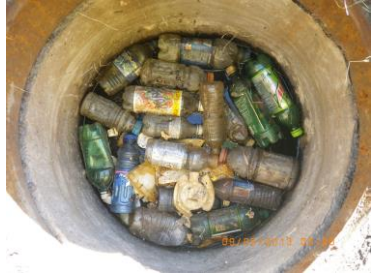
o20130905082002.JPG <div style="font-size: 24pt; font-weight: bold;">2013</div>

Inspection Date: 9/5/2013 9:16:05 AM		Type: Ongoing	Flow: Submerged, indeterminate	Previous Rainfall (hrs): 72+
Illicit Discharge Potential: Potential		Inspector: JCW	Notes 2012 screening follow-up. Significant gross solids in manhole - similar to previous years.	
Submerged: Fully Depth (in): 35				
Sampling Results Sample Location: Pool Total Chlorine: 0 ppm Free Chlorine: 0 ppm Ammonia: 0 ppm pH: 7.7 units Temperature: 71 °F Conductivity: 1666 µS/cm Detergents: 0 mg/L		Floatables: None Odor: None Turbidity: None Color: None Gross Solids: Severe Vegetation: None Benthic Growth: None Stains: Slight Non-illicit: None	Condition Assessment Graffiti: None Erosion: None Deposition: None in. Damage: None

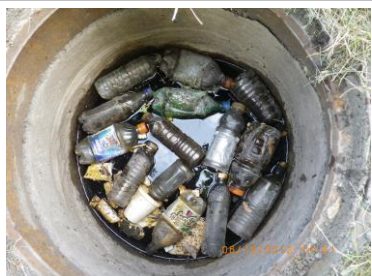
o20120613133100.JPG <div style="font-size: 24pt; font-weight: bold;">2012</div>

Inspection Date: 6/13/2012 2:30:25 PM		Type: Other	Flow: Submerged, indeterminate	Previous Rainfall (hrs): 72+
Illicit Discharge Potential: Potential		Inspector: JCW	Notes Gross solids pre-screening. Bottles in manhole.	
Submerged: Fully Depth (in): 37				
Sampling Results Sample Location: Pool Total Chlorine: 0 ppm Free Chlorine: 0 ppm Ammonia: 0 ppm pH: 7.58 units Temperature: 70 °F Conductivity: 1765 µS/cm Detergents: 0 mg/L		Floatables: None Odor: None Turbidity: None Color: None Gross Solids: Severe Vegetation: None Benthic Growth: Slight Stains: None Non-illicit: None	Condition Assessment Graffiti: None Erosion: None Deposition: None in. Damage: None

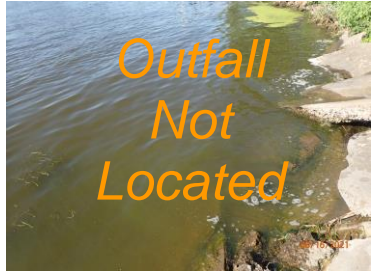
o20210816095056.JPG

Inspection Date: 8/16/2021 9:52:24 AM		Type: Ongoing	Flow: Submerged (not located)	Previous Rainfall (hrs): 72+
Illicit Discharge Potential: Potential		Inspector: JCW		
Submerged: Fully		Depth (in):		
Sampling Results		Notes		
Sample Location:	Floatables:	Outfall partially submerged - screened upstream at 08-284 US1. Floating gross solids (litter) in upstream manhole.		
Total Chlorine: -- ppm	Odor:			
Free Chlorine: -- ppm	Turbidity:			
Ammonia: -- ppm	Color:			
pH: -- units	Gross Solids:			
Temperature -- °F	Vegetation:			
Conductivity: -- µS/cm	Benthic Growth:			
Detergents: -- mg/L	Stains:			
	Non-illicit:

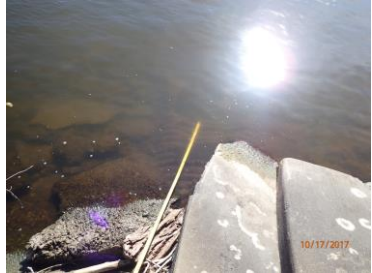
o20171017135302.JPG

Inspection Date: 10/17/2017 1:56:02 PM		Type: Ongoing	Flow: Submerged, indeterminate	Previous Rainfall (hrs): 48-72
Illicit Discharge Potential: Potential		Inspector: JCW	Notes	
Submerged: Fully Depth (in): 36			Outfall fully submerged with approx 9" of water over crown of pipe - screened upstream at 08-284 US1. Floating gross solids (litter) in manhole.	
Sampling Results			Condition Assessment	
Sample Location:	Floatables:	None	Graffiti: None Erosion: None Deposition: None in. Damage: None	
Total Chlorine: -- ppm	Odor:	None		
Free Chlorine: -- ppm	Turbidity:	None		
Ammonia: -- ppm	Color:	None		
pH: -- units	Gross Solids:	None		
Temperature -- °F	Vegetation:	None		
Conductivity: -- µS/cm	Benthic Growth:	None		
Detergents: -- mg/L	Stains:	None		
	Non-illicit:	None

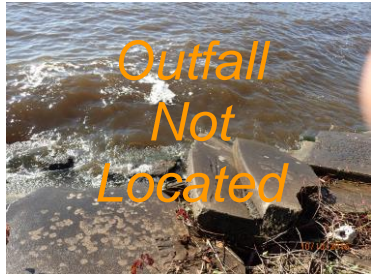
o20161010101832.JPG

Inspection Date: 10/10/2016 10:18:48 AM		Type: Ongoing	Flow: Submerged (not located)	Previous Rainfall (hrs): 72+
Illicit Discharge Potential: Potential		Inspector: JCW	Notes	
Submerged: Fully Depth (in):			Outfall fully submerged and not located - screened upstream at 08-284 US1.	
Sampling Results			Condition Assessment	
Sample Location:	Floatables:	None	Graffiti: None Erosion: None Deposition: None in. Damage: None	
Total Chlorine: -- ppm	Odor:	None		
Free Chlorine: -- ppm	Turbidity:	None		
Ammonia: -- ppm	Color:	None		
pH: -- units	Gross Solids:	None		
Temperature -- °F	Vegetation:	None		
Conductivity: -- µS/cm	Benthic Growth:	None		
Detergents: -- mg/L	Stains:	None		
	Non-illicit:	None

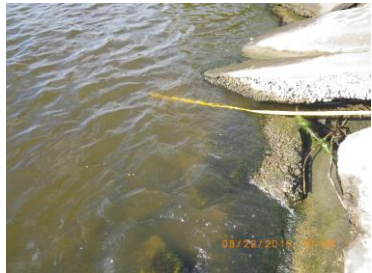
o20150922090932.JPG

Inspection Date: 9/22/2015 10:04:59 AM		Type: Ongoing	Flow: Submerged, indeterminate	Previous Rainfall (hrs): 72+
Illicit Discharge Potential: Potential		Inspector: JCW	Notes	
Submerged: Fully Depth (in): 30			Outfall fully submerged - screened at 08-284 US1.	
Sampling Results			Condition Assessment	
Sample Location:	Floatables:	None	Graffiti: None Erosion: None Deposition: None in. Damage: None	
Total Chlorine: -- ppm	Odor:	None		
Free Chlorine: -- ppm	Turbidity:	None		
Ammonia: -- ppm	Color:	None		
pH: -- units	Gross Solids:	None		
Temperature -- °F	Vegetation:	None		
Conductivity: -- µS/cm	Benthic Growth:	Moderate		
Detergents: -- mg/L	Stains:	None		
	Non-illicit:	None

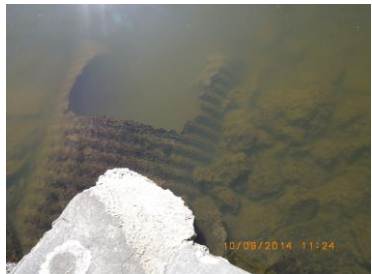
o20141009102400.JPG

Inspection Date: 10/9/2014 11:24:44 AM		Type: Ongoing	Flow: Submerged, indeterminate	Previous Rainfall (hrs): 72+
Illicit Discharge Potential: Potential		Inspector: JCW	Notes	
Submerged: Fully Depth (in): 29			Outfall fully submerged - screened upstream at 08-284 US1.	
Sampling Results			Condition Assessment	
Sample Location:	Floatables:	None	Graffiti: None Erosion: None Deposition: Minor 3 in. Damage: Minor	
Total Chlorine: -- ppm	Odor:	None		
Free Chlorine: -- ppm	Turbidity:	None		
Ammonia: -- ppm	Color:	None		
pH: -- units	Gross Solids:	None		
Temperature -- °F	Vegetation:	None		
Conductivity: -- µS/cm	Benthic Growth:	None		
Detergents: -- mg/L	Stains:	None		
	Non-illicit:	None

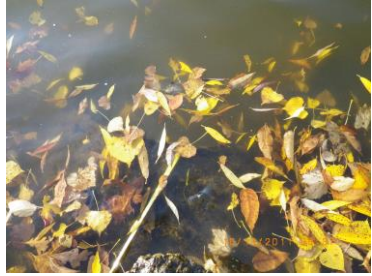
Inspection Date: 10/11/2011 8:37:04 AM		Type: Ongoing		Flow: Submerged, indeterminate		Previous Rainfall (hrs): 72+	
Illicit Discharge Potential: Unlikely		Inspector: JCW		Notes 2010 screening follow-up. Outfall fully submerged. Outfall screened upstream at 08-284 US1.

<small>o20111011083728.JPG</small>	
Submerged: Fully		Depth (in): 25					
Sampling Results		Floatables: None Odor: None Turbidity: None Color: None Gross Solids: None Vegetation: None Benthic Growth: None Stains: None Non-illicit: None		Condition Assessment Graffiti: None Erosion: None Deposition: None 0 in. Damage: None		<div style="text-align: center; font-size: 24pt; font-weight: bold;">2011</div>	
Sample Location: Total Chlorine: -- ppm Free Chlorine: -- ppm Ammonia: -- ppm pH: -- units Temperature -- °F Conductivity: -- µS/cm Detergents: -- mg/L

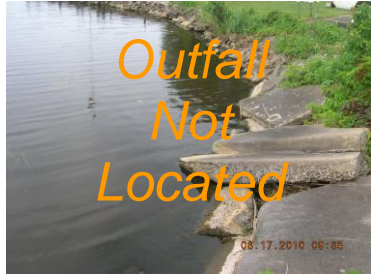
Inspection Date: 8/17/2010 9:35:00 AM		Type: Ongoing		Flow: Submerged (not located)		Previous Rainfall (hrs): 72+	
Illicit Discharge Potential: Potential		Inspector: JCW		Notes Outfall fully submerged and not physically located. Outfall screened upstream at 08-284 US1.

<small>o20100817093554.JPG</small>	
Submerged: Fully		Depth (in):					
Sampling Results		Floatables: None Odor: None Turbidity: None Color: None Gross Solids: None Vegetation: None Benthic Growth: None Stains: None Non-illicit: None		Condition Assessment Graffiti: None Erosion: None Deposition: None 0 in. Damage: None		<div style="text-align: center; font-size: 24pt; font-weight: bold;">2010</div>	
Sample Location: Total Chlorine: -- ppm Free Chlorine: -- ppm Ammonia: -- ppm pH: -- units Temperature -- °F Conductivity: -- µS/cm Detergents: -- mg/L

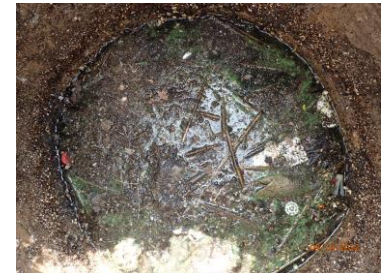
o20220916131222.JPG

**Inspection Date:** 9/16/2022 1:13:00 PM**Inspector:** EJK**Inspection Type:** Ongoing**Previous Rainfall (hrs):** 72+**Flow Description:** Submerged, indeterminate

Submerged: Partially Depth (in): 34

Non-illicit: Slight

☐ Petrol. Sheen ☐ Suds ☐ Sewage ☐ Algae ☐ Other☐ Petroleum ☐ Musty ☐ Sewage ☐ Chlorine ☐ Other☐ VOC/Solvent ☐ Fishy ☐ Sulfur ☐ Fragrant☒ Litter ☒ Veg. Debris ☐ Sediment ☐ Other☐ Inhibited ☐ Excessive☒ Green ☐ Brown☐ Flow Line ☐ Oil ☐ Rust Stains☐ Paint ☐ Other☒ Natural Sheen ☐ Natural Suds/Foam

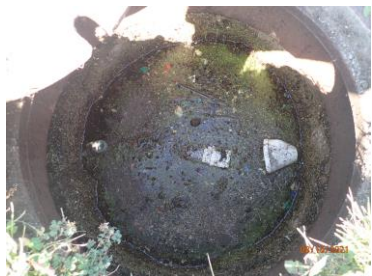
o20210816095220.JPG

Inspection Date: 8/16/2021 9:55:45 AM		Type: Ongoing	Flow: Submerged, indeterminate	Previous Rainfall (hrs): 72+
Illicit Discharge Potential: Potential		Inspector: JCW		
Submerged: Fully		Depth (in): 36		
Sampling Results		Notes		
Sample Location: Pool	Floatables: None	Sample collected from submerged pool in manhole. Floating gross solids (litter) in manhole.		
Total Chlorine: 0 ppm	Odor: None			
Free Chlorine: 0 ppm	Turbidity: None	Condition Assessment		
Ammonia: 0 ppm	Color: None			
pH: 7.14 units	Gross Solids: Severe	Graffiti: None	in.	
Temperature 77 °F	Vegetation: None	Erosion: None		
Conductivity: 328 µS/cm	Benthic Growth: None	Deposition: None		
Detergents: 0 mg/L	Stains: None	Damage: None		
	Non-illicit: None

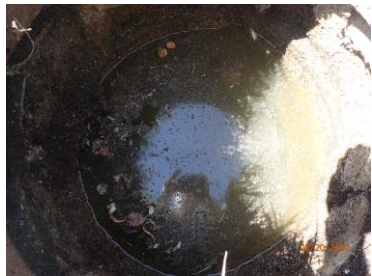
o20200820125256.JPG

Inspection Date: 8/20/2020 12:55:02 PM		Type: Ongoing	Flow: Submerged, indeterminate	Previous Rainfall (hrs): 72+
Illicit Discharge Potential: Potential		Inspector: JCW		
Submerged: Fully		Depth (in): 33		
Sampling Results		Notes		
Sample Location: Pool	Floatables: None	Sample collected from submerged pool in manhole. Floating gross solids (litter) in manhole. Elevated pH seemed widespread in river.		
Total Chlorine: 0 ppm	Odor: None			
Free Chlorine: 0 ppm	Turbidity: None	Condition Assessment		
Ammonia: 0 ppm	Color: None			
pH: 9.23 units	Gross Solids: Moderate	Graffiti: None	in.	
Temperature 82 °F	Vegetation: None	Erosion: None		
Conductivity: 320 µS/cm	Benthic Growth: Moderate	Deposition: None		
Detergents: 0 mg/L	Stains: None	Damage: None		
	Non-illicit: None

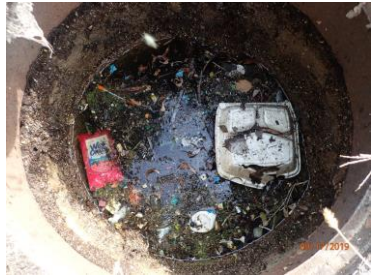
o20190917133856.JPG

Inspection Date: 9/17/2019 2:41:09 PM		Type: Ongoing	Flow: Submerged, indeterminate	Previous Rainfall (hrs): 48-72
Illicit Discharge Potential: Potential		Inspector: JCW		
Submerged: Fully		Depth (in): 34		
Sampling Results		Notes		
Sample Location: Pool	Floatables: None	Sample collected from submerged pool in outfall. Syringe and other floating gross solids (litter) in manhole.		
Total Chlorine: 0 ppm	Odor: None			
Free Chlorine: 0 ppm	Turbidity: None	Condition Assessment		
Ammonia: 0 ppm	Color: None			
pH: 8.79 units	Gross Solids: Severe	Graffiti: None	in.	
Temperature 76 °F	Vegetation: None	Erosion: None		
Conductivity: 341 µS/cm	Benthic Growth: None	Deposition: None		
Detergents: 0 mg/L	Stains: None	Damage: None		
	Non-illicit: None

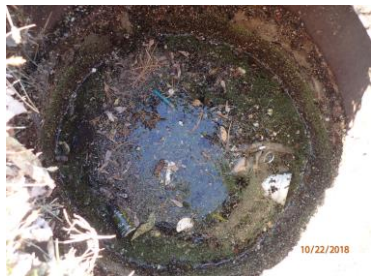
o20181022105156.JPG

Inspection Date: 10/22/2018 10:54:41 AM		Type: Ongoing	Flow: Submerged, indeterminate	Previous Rainfall (hrs): 48-72
Illicit Discharge Potential: Potential		Inspector: JCW		
Submerged: Fully		Depth (in): 34		
Sampling Results		Notes		
Sample Location: Pool	Floatables: None	Sample collected from submerged pool in outfall. Floating gross solids (litter) in manhole.		
Total Chlorine: 0 ppm	Odor: None			
Free Chlorine: 0 ppm	Turbidity: None	Condition Assessment		
Ammonia: 0 ppm	Color: Faint in bottle			
pH: 7.5 units	Gross Solids: Moderate	Graffiti: None	in.	
Temperature 54 °F	Vegetation: None	Erosion: None		
Conductivity: 314 µS/cm	Benthic Growth: Moderate	Deposition: None		
Detergents: 0 mg/L	Stains: None	Damage: None		
	Non-illicit: None

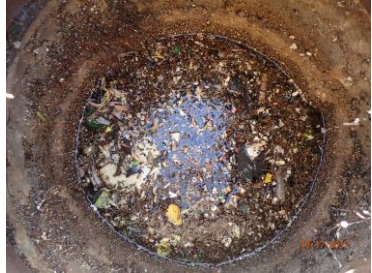
Inspection Date: 10/17/2017 1:59:35 PM		Type: Ongoing		Flow: Submerged, indeterminate		Previous Rainfall (hrs): 48-72																									
Illicit Discharge Potential: Potential		Inspector: JCW		Notes

<p style="text-align: center;">o20171017135518.JPG</p> <p style="text-align: center; font-size: 24pt; font-weight: bold;">2017</p>																									
Submerged: Fully		Depth (in): 30		Sample collected from submerged pool in outfall. Floating gross solids (litter) in manhole.																											
Sampling Results		<table border="1" style="width:100%; border-collapse: collapse;"> <tr><td>Floatables:</td><td>None</td></tr> <tr><td>Odor:</td><td>None</td></tr> <tr><td>Turbidity:</td><td>None</td></tr> <tr><td>Color:</td><td>None</td></tr> <tr><td>Gross Solids:</td><td>Moderate</td></tr> <tr><td>Vegetation:</td><td>None</td></tr> <tr><td>Benthic Growth:</td><td>None</td></tr> <tr><td>Stains:</td><td>None</td></tr> <tr><td>Non-illicit:</td><td>None</td></tr> </table>		Floatables:	None	Odor:	None	Turbidity:	None	Color:	None	Gross Solids:	Moderate	Vegetation:	None	Benthic Growth:	None	Stains:	None	Non-illicit:	None	Condition Assessment <table border="1" style="width:100%; border-collapse: collapse;"> <tr><td>Graffiti:</td><td>None</td></tr> <tr><td>Erosion:</td><td>None</td></tr> <tr><td>Deposition:</td><td>None in.</td></tr> <tr><td>Damage:</td><td>None</td></tr> </table>		Graffiti:	None	Erosion:	None	Deposition:	None in.	Damage:	None

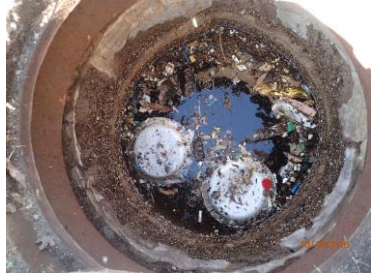
Inspection Date: 10/10/2016 10:21:35 AM		Type: Ongoing		Flow: Submerged, indeterminate		Previous Rainfall (hrs): 72+																									
Illicit Discharge Potential: Potential		Inspector: JCW		Notes

<p style="text-align: center;">o20161010101916.JPG</p> <p style="text-align: center; font-size: 24pt; font-weight: bold;">2016</p>																									
Submerged: Fully		Depth (in): 32		Potential illicit discharge due to gross solids.																											
Sampling Results		<table border="1" style="width:100%; border-collapse: collapse;"> <tr><td>Floatables:</td><td>None</td></tr> <tr><td>Odor:</td><td>None</td></tr> <tr><td>Turbidity:</td><td>None</td></tr> <tr><td>Color:</td><td>Clearly visible in bottl</td></tr> <tr><td>Gross Solids:</td><td>Moderate</td></tr> <tr><td>Vegetation:</td><td>None</td></tr> <tr><td>Benthic Growth:</td><td>None</td></tr> <tr><td>Stains:</td><td>None</td></tr> <tr><td>Non-illicit:</td><td>None</td></tr> </table>		Floatables:	None	Odor:	None	Turbidity:	None	Color:	Clearly visible in bottl	Gross Solids:	Moderate	Vegetation:	None	Benthic Growth:	None	Stains:	None	Non-illicit:	None	Condition Assessment <table border="1" style="width:100%; border-collapse: collapse;"> <tr><td>Graffiti:</td><td>None</td></tr> <tr><td>Erosion:</td><td>None</td></tr> <tr><td>Deposition:</td><td>None in.</td></tr> <tr><td>Damage:</td><td>None</td></tr> </table>		Graffiti:	None	Erosion:	None	Deposition:	None in.	Damage:	None
