IDDE Ongoing Screening Summary Report

2022 Inspection Year

City of Oshkosh

Westwood

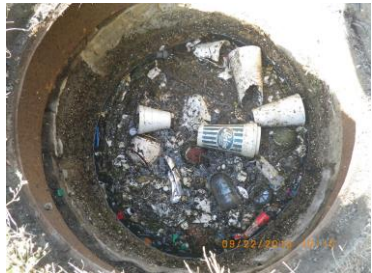
Inspection Date: 9/22/2015 10:09:39 AM		Type: Ongoing		Flow: Submerged, indeterminate		Previous Rainfall (hrs): 72+																									
Illicit Discharge Potential: Potential		Inspector: JCW		Notes

<p style="text-align: center;">o20150922091040.JPG</p> <p style="text-align: center; font-size: 24pt; font-weight: bold;">2015</p>																									
Submerged: Fully		Depth (in): 34		Floating gross solids (litter) in manhole.																											
Sampling Results		<table border="1" style="width:100%; border-collapse: collapse;"> <tr><td>Floatables:</td><td>None</td></tr> <tr><td>Odor:</td><td>None</td></tr> <tr><td>Turbidity:</td><td>None</td></tr> <tr><td>Color:</td><td>None</td></tr> <tr><td>Gross Solids:</td><td>Severe</td></tr> <tr><td>Vegetation:</td><td>None</td></tr> <tr><td>Benthic Growth:</td><td>None</td></tr> <tr><td>Stains:</td><td>None</td></tr> <tr><td>Non-illicit:</td><td>None</td></tr> </table>		Floatables:	None	Odor:	None	Turbidity:	None	Color:	None	Gross Solids:	Severe	Vegetation:	None	Benthic Growth:	None	Stains:	None	Non-illicit:	None	Condition Assessment <table border="1" style="width:100%; border-collapse: collapse;"> <tr><td>Graffiti:</td><td>None</td></tr> <tr><td>Erosion:</td><td>None</td></tr> <tr><td>Deposition:</td><td>None in.</td></tr> <tr><td>Damage:</td><td>None</td></tr> </table>		Graffiti:	None	Erosion:	None	Deposition:	None in.	Damage:	None

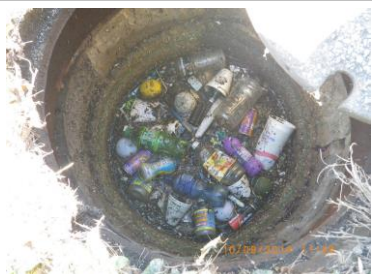
Inspection Date: 10/9/2014 11:28:19 AM		Type: Ongoing		Flow: Submerged, indeterminate		Previous Rainfall (hrs): 72+																									
Illicit Discharge Potential: Potential		Inspector: JCW		Notes

<p style="text-align: center;">o20141009102622.JPG</p> <p style="text-align: center; font-size: 24pt; font-weight: bold;">2014</p>																									
Submerged: Fully		Depth (in): 29		Floating gross solids (litter) in manhole.																											
Sampling Results		<table border="1" style="width:100%; border-collapse: collapse;"> <tr><td>Floatables:</td><td>None</td></tr> <tr><td>Odor:</td><td>None</td></tr> <tr><td>Turbidity:</td><td>None</td></tr> <tr><td>Color:</td><td>Faint in bottle</td></tr> <tr><td>Gross Solids:</td><td>Severe</td></tr> <tr><td>Vegetation:</td><td>None</td></tr> <tr><td>Benthic Growth:</td><td>None</td></tr> <tr><td>Stains:</td><td>None</td></tr> <tr><td>Non-illicit:</td><td>None</td></tr> </table>		Floatables:	None	Odor:	None	Turbidity:	None	Color:	Faint in bottle	Gross Solids:	Severe	Vegetation:	None	Benthic Growth:	None	Stains:	None	Non-illicit:	None	Condition Assessment <table border="1" style="width:100%; border-collapse: collapse;"> <tr><td>Graffiti:</td><td>None</td></tr> <tr><td>Erosion:</td><td>None</td></tr> <tr><td>Deposition:</td><td>None in.</td></tr> <tr><td>Damage:</td><td>None</td></tr> </table>		Graffiti:	None	Erosion:	None	Deposition:	None in.	Damage:	None

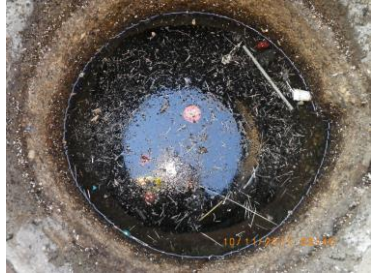
Inspection Date: 10/11/2011 8:41:22 AM		Type: Ongoing		Flow: Submerged, indeterminate		Previous Rainfall (hrs): 72+	
Illicit Discharge Potential: Unlikely		Inspector: JCW		Notes 2010 screening follow-up. Floatable debris significantly reduced.

o20111011084038.JPG	
Submerged: Fully		Depth (in): 18					
Sampling Results		Floatables: None Odor: None Turbidity: None Color: None Gross Solids: Slight Vegetation: None Benthic Growth: None Stains: None Non-illicit: None		Condition Assessment Graffiti: None Erosion: None Deposition: None 0 in. Damage: None		2011	
Sample Location: Pool Total Chlorine: 0 ppm Free Chlorine: 0 ppm Ammonia: 0 ppm pH: 8.11 units Temperature: 72 °F Conductivity: -- µS/cm Detergents: -- mg/L

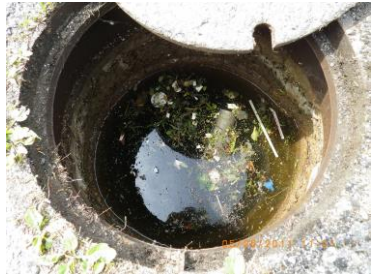
Inspection Date: 5/26/2011 11:01:00 AM		Type: Other		Flow: Submerged, indeterminate		Previous Rainfall (hrs): 72+	
Illicit Discharge Potential: Potential		Inspector: JCW		Notes Limited screening conducted to check for floatable debris.

o20110526110156.JPG	
Submerged: Fully		Depth (in):					
Sampling Results		Floatables: None Odor: Turbidity: Color: Gross Solids: Moderate Vegetation: Benthic Growth: Stains: Non-illicit: None		Condition Assessment Graffiti: None Erosion: None Deposition: None 0 in. Damage: None		2011	
Sample Location: Total Chlorine: -- ppm Free Chlorine: -- ppm Ammonia: -- ppm pH: -- units Temperature: -- °F Conductivity: -- µS/cm Detergents: -- mg/L

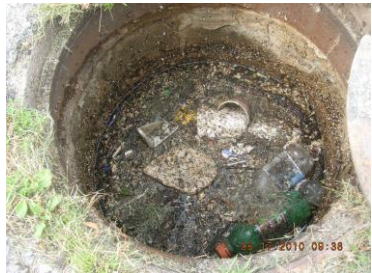
Inspection Date: 8/17/2010 9:47:15 AM		Type: Ongoing		Flow: Submerged, indeterminate		Previous Rainfall (hrs): 72+	
Illicit Discharge Potential: Potential		Inspector: JCW		Notes Significant floatable debris in manhole.

o20100817093838.JPG	
Submerged: Fully		Depth (in): 31					
Sampling Results		Floatables: None Odor: None Turbidity: None Color: Faint in bottle Gross Solids: Severe Vegetation: None Benthic Growth: None Stains: None Non-illicit: None		Condition Assessment Graffiti: None Erosion: None Deposition: None 0 in. Damage: None		2010	
Sample Location: Pool Total Chlorine: 0 ppm Free Chlorine: 0 ppm Ammonia: 0 ppm pH: 7.64 units Temperature: 74 °F Conductivity: -- µS/cm Detergents: 0 mg/L

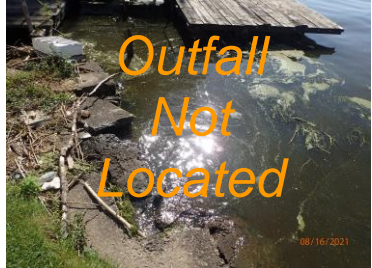
Inspection Date: 8/16/2021 10:01:15 AM		Type: Ongoing	Flow: Submerged (not located)	Previous Rainfall (hrs): 72+
Illicit Discharge Potential: Unlikely		Inspector: JCW		
Submerged: Fully		Depth (in):		
Sampling Results Sample Location: _____ Total Chlorine: -- ppm Free Chlorine: -- ppm Ammonia: -- ppm pH: -- units Temperature: -- °F Conductivity: -- µS/cm Detergents: -- mg/L		Floatables: None Odor: None Turbidity: None Color: None Gross Solids: None Vegetation: None Benthic Growth: None Stains: None Non-illicit: None	Notes Outfall fully submerged and not located - screened upstream at 08-347 US1. Condition Assessment Graffiti: None Erosion: None Deposition: None in. Damage: None

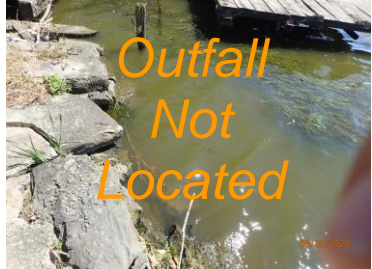
o20200820124230.JPG <div style="text-align: center; font-size: 24pt; font-weight: bold;">2020</div>

Inspection Date: 8/20/2020 12:42:50 PM		Type: Ongoing	Flow: Submerged (not located)	Previous Rainfall (hrs): 72+
Illicit Discharge Potential: Potential		Inspector: JCW		
Submerged: Fully		Depth (in):		
Sampling Results Sample Location: _____ Total Chlorine: -- ppm Free Chlorine: -- ppm Ammonia: -- ppm pH: -- units Temperature: -- °F Conductivity: -- µS/cm Detergents: -- mg/L		Floatables: None Odor: None Turbidity: None Color: None Gross Solids: None Vegetation: None Benthic Growth: None Stains: None Non-illicit: None	Notes Outfall fully submerged and not located - screened upstream at 08-347 US1. Floating gross solids (litter) in upstream manhole. Condition Assessment Graffiti: None Erosion: None Deposition: None in. Damage: None

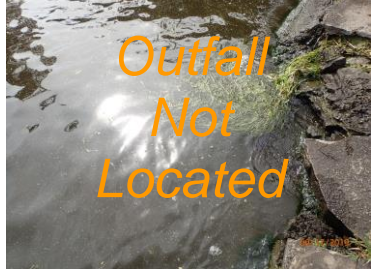
o20190917134640.JPG <div style="text-align: center; font-size: 24pt; font-weight: bold;">2019</div>

Inspection Date: 9/17/2019 2:47:00 PM		Type: Ongoing	Flow: Submerged (not located)	Previous Rainfall (hrs): 48-72
Illicit Discharge Potential: Unlikely		Inspector: JCW		
Submerged: Fully		Depth (in):		
Sampling Results Sample Location: _____ Total Chlorine: -- ppm Free Chlorine: -- ppm Ammonia: -- ppm pH: -- units Temperature: -- °F Conductivity: -- µS/cm Detergents: -- mg/L		Floatables: None Odor: None Turbidity: None Color: None Gross Solids: None Vegetation: None Benthic Growth: None Stains: None Non-illicit: None	Notes Outfall fully submerged and not located - screened upstream at 08-347 US1. Condition Assessment Graffiti: None Erosion: None Deposition: None in. Damage: None

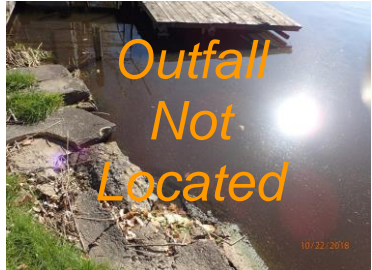
o20181022105820.JPG <div style="text-align: center; font-size: 24pt; font-weight: bold;">2018</div>

Inspection Date: 10/22/2018 10:59:46 AM		Type: Ongoing	Flow: Submerged (not located)	Previous Rainfall (hrs): 48-72
Illicit Discharge Potential: Potential		Inspector: JCW		
Submerged: Fully		Depth (in):		
Sampling Results Sample Location: _____ Total Chlorine: -- ppm Free Chlorine: -- ppm Ammonia: -- ppm pH: -- units Temperature: -- °F Conductivity: -- µS/cm Detergents: -- mg/L		Floatables: None Odor: None Turbidity: None Color: None Gross Solids: None Vegetation: None Benthic Growth: None Stains: None Non-illicit: None	Notes Outfall fully submerged and not located - screened upstream at 08-347 US1. Floating gross solids (litter) in manhole. Condition Assessment Graffiti: None Erosion: None Deposition: None in. Damage: None

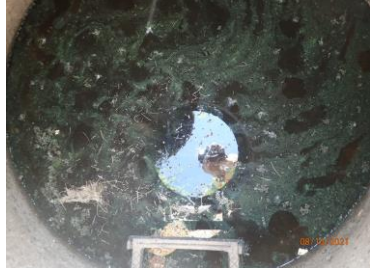
o20210816100142.JPG 2021

Sample Location:	Pool																																					
Total Chlorine:	0 ppm																																					
Free Chlorine:	0 ppm																																					
Ammonia:	0 ppm																																					
pH:	7.84 units																																					
Temperature:	76 °F																																					
Conductivity:	318 µS/cm																																					
Detergents:	0 mg/L																																					
Floatables:	None																																					
Odor:	None																																					
Turbidity:	None																																					
Color:	None																																					
Gross Solids:	Slight																																					
Vegetation:	None																																					
Benthic Growth:	None																																					
Stains:	None																																					
Non-illicit:	None

Notes Sample collected from submerged pool in manhole.																																				
		Condition Assessment <table border="1" style="width:100%; border-collapse: collapse;"> <tr><td>Graffiti:</td><td>None</td></tr> <tr><td>Erosion:</td><td>None</td></tr> <tr><td>Deposition:</td><td>None in.</td></tr> <tr><td>Damage:</td><td>None</td></tr> </table>			Graffiti:	None	Erosion:	None	Deposition:	None in.	Damage:	None																										
Graffiti:	None																																					
Erosion:	None																																					
Deposition:	None in.																																					
Damage:	None

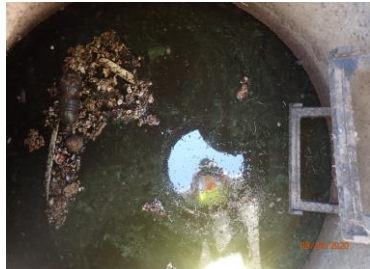
o20200820124306.JPG 2020

Sample Location:	Pool																																					
Total Chlorine:	0 ppm																																					
Free Chlorine:	0 ppm																																					
Ammonia:	0 ppm																																					
pH:	8.95 units																																					
Temperature:	82 °F																																					
Conductivity:	340 µS/cm																																					
Detergents:	0 mg/L																																					
Floatables:	None																																					
Odor:	None																																					
Turbidity:	None																																					
Color:	None																																					
Gross Solids:	Moderate																																					
Vegetation:	None																																					
Benthic Growth:	None																																					
Stains:	None																																					
Non-illicit:	None

Notes Sample collected from submerged pool in manhole. Floating gross solids (litter) in manhole.																																				
		Condition Assessment <table border="1" style="width:100%; border-collapse: collapse;"> <tr><td>Graffiti:</td><td>None</td></tr> <tr><td>Erosion:</td><td>None</td></tr> <tr><td>Deposition:</td><td>None in.</td></tr> <tr><td>Damage:</td><td>None</td></tr> </table>			Graffiti:	None	Erosion:	None	Deposition:	None in.	Damage:	None																										
Graffiti:	None																																					
Erosion:	None																																					
Deposition:	None in.																																					
Damage:	None

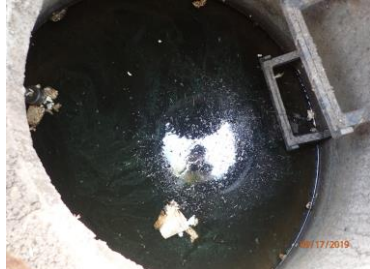
o20190917134722.JPG 2019

Sample Location:	Pool																																					
Total Chlorine:	0 ppm																																					
Free Chlorine:	0 ppm																																					
Ammonia:	0 ppm																																					
pH:	8.56 units																																					
Temperature:	75 °F																																					
Conductivity:	356 µS/cm																																					
Detergents:	0 mg/L																																					
Floatables:	None																																					
Odor:	None																																					
Turbidity:	None																																					
Color:	None																																					
Gross Solids:	Slight																																					
Vegetation:	None																																					
Benthic Growth:	None																																					
Stains:	None																																					
Non-illicit:	None

Notes Sample collected from submerged pool in manhole.																																				
		Condition Assessment <table border="1" style="width:100%; border-collapse: collapse;"> <tr><td>Graffiti:</td><td>None</td></tr> <tr><td>Erosion:</td><td>None</td></tr> <tr><td>Deposition:</td><td>None in.</td></tr> <tr><td>Damage:</td><td>None</td></tr> </table>			Graffiti:	None	Erosion:	None	Deposition:	None in.	Damage:	None																										
Graffiti:	None																																					
Erosion:	None																																					
Deposition:	None in.																																					
Damage:	None

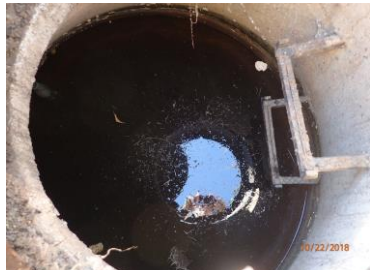
o20181022110036.JPG 2018

Sample Location:	Pool																																					
Total Chlorine:	0 ppm																																					
Free Chlorine:	0 ppm																																					
Ammonia:	0 ppm																																					
pH:	7.49 units																																					
Temperature:	55 °F																																					
Conductivity:	321 µS/cm																																					
Detergents:	0 mg/L																																					
Floatables:	None																																					
Odor:	None																																					
Turbidity:	None																																					
Color:	Faint in bottle																																					
Gross Solids:	Slight																																					
Vegetation:	None																																					
Benthic Growth:	Slight																																					
Stains:	None																																					
Non-illicit:	None

Notes Sample collected from submerged pool in manhole. Floating gross solids (litter) in manhole.																																				
		Condition Assessment <table border="1" style="width:100%; border-collapse: collapse;"> <tr><td>Graffiti:</td><td>None</td></tr> <tr><td>Erosion:</td><td>None</td></tr> <tr><td>Deposition:</td><td>None in.</td></tr> <tr><td>Damage:</td><td>None</td></tr> </table>			Graffiti:	None	Erosion:	None	Deposition:	None in.	Damage:	None																										
Graffiti:	None																																					
Erosion:	None																																					
Deposition:	None in.																																					
Damage:	None

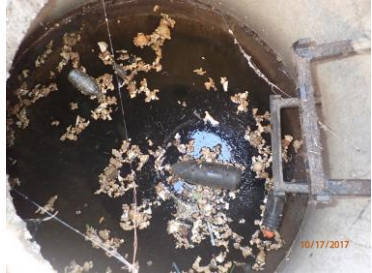
<p style="text-align: center;">o20171017140304.JPG</p> <p style="text-align: center; font-size: 24pt; font-weight: bold;">2017</p>

Sample Location:	Pool																																					
Total Chlorine:	0 ppm																																					
Free Chlorine:	0 ppm																																					
Ammonia:	0 ppm																																					
pH:	8.29 units																																					
Temperature:	66 °F																																					
Conductivity:	346 µS/cm																																					
Detergents:	0 mg/L																																					
Floatables:	None																																					
Odor:	None																																					
Turbidity:	None																																					
Color:	None																																					
Gross Solids:	Moderate																																					
Vegetation:	None																																					
Benthic Growth:	None																																					
Stains:	None																																					
Non-illicit:	None

<div style="display: flex; justify-content: space-between;"> <div style="width: 45%;"> <p>Notes</p> <p>Sample collected from submerged pool in manhole. Floating gross solids (litter) in manhole.</p> </div> <div style="width: 45%;"> <p>Condition Assessment</p> <table border="1" style="width:100%; border-collapse: collapse;"> <tr><td>Graffiti:</td><td>None</td></tr> <tr><td>Erosion:</td><td>None</td></tr> <tr><td>Deposition:</td><td>None in.</td></tr> <tr><td>Damage:</td><td>None</td></tr> </table> </div> </div>					Graffiti:	None	Erosion:	None	Deposition:	None in.	Damage:	None																										
Graffiti:	None																																					
Erosion:	None																																					
Deposition:	None in.																																					
Damage:	None

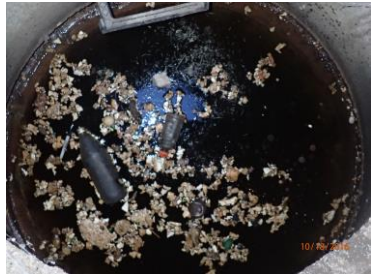
<p style="text-align: center;">o20161018170248.JPG</p> <p style="text-align: center; font-size: 24pt; font-weight: bold;">2016</p>

Sample Location:	Pool																																					
Total Chlorine:	0 ppm																																					
Free Chlorine:	0 ppm																																					
Ammonia:	0 ppm																																					
pH:	8.18 units																																					
Temperature:	66 °F																																					
Conductivity:	361 µS/cm																																					
Detergents:	0 mg/L																																					
Floatables:	None																																					
Odor:	None																																					
Turbidity:	None																																					
Color:	Faint in bottle																																					
Gross Solids:	Severe																																					
Vegetation:	None																																					
Benthic Growth:	None																																					
Stains:	None																																					
Non-illicit:	None

<div style="display: flex; justify-content: space-between;"> <div style="width: 45%;"> <p>Notes</p> <p>Potential illicit discharge due to gross solids.</p> </div> <div style="width: 45%;"> <p>Condition Assessment</p> <table border="1" style="width:100%; border-collapse: collapse;"> <tr><td>Graffiti:</td><td>None</td></tr> <tr><td>Erosion:</td><td>None</td></tr> <tr><td>Deposition:</td><td>None in.</td></tr> <tr><td>Damage:</td><td>None</td></tr> </table> </div> </div>					Graffiti:	None	Erosion:	None	Deposition:	None in.	Damage:	None																										
Graffiti:	None																																					
Erosion:	None																																					
Deposition:	None in.																																					
Damage:	None

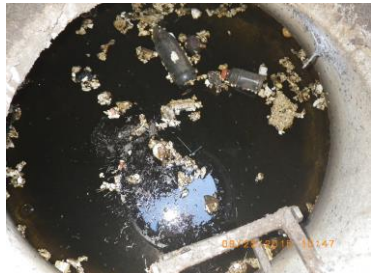
<p style="text-align: center;">o20150922094746.JPG</p> <p style="text-align: center; font-size: 24pt; font-weight: bold;">2015</p>

Sample Location:	Pool																																					
Total Chlorine:	0 ppm																																					
Free Chlorine:	0 ppm																																					
Ammonia:	0 ppm																																					
pH:	8.33 units																																					
Temperature:	73 °F																																					
Conductivity:	352 µS/cm																																					
Detergents:	0 mg/L																																					
Floatables:	None																																					
Odor:	None																																					
Turbidity:	None																																					
Color:	None																																					
Gross Solids:	Moderate																																					
Vegetation:	None																																					
Benthic Growth:	None																																					
Stains:	None																																					
Non-illicit:	None

<div style="display: flex; justify-content: space-between;"> <div style="width: 45%;"> <p>Notes</p> <p>Floating gross solids (litter) in manhole.</p> </div> <div style="width: 45%;"> <p>Condition Assessment</p> <table border="1" style="width:100%; border-collapse: collapse;"> <tr><td>Graffiti:</td><td>None</td></tr> <tr><td>Erosion:</td><td>None</td></tr> <tr><td>Deposition:</td><td>None in.</td></tr> <tr><td>Damage:</td><td>None</td></tr> </table> </div> </div>					Graffiti:	None	Erosion:	None	Deposition:	None in.	Damage:	None																										
Graffiti:	None																																					
Erosion:	None																																					
Deposition:	None in.																																					
Damage:	None

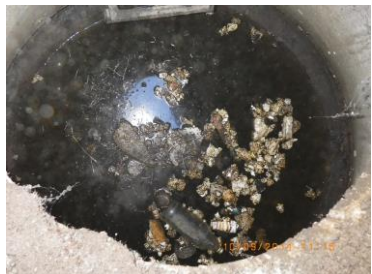
<p style="text-align: center;">o20141009101552.JPG</p> <p style="text-align: center; font-size: 24pt; font-weight: bold;">2014</p>

<div style="display: flex; justify-content: space-between;"> <div style="width: 45%;"> <p>Notes</p> <p>Floating gross solids (litter) in manhole.</p> </div> <div style="width: 45%;"> <p>Condition Assessment</p> <table border="1" style="width:100%; border-collapse: collapse;"> <tr><td>Graffiti:</td><td>None</td></tr> <tr><td>Erosion:</td><td>None</td></tr> <tr><td>Deposition:</td><td>None in.</td></tr> <tr><td>Damage:</td><td>None</td></tr> </table> </div> </div>					Graffiti:	None	Erosion:	None	Deposition:	None in.	Damage:	None																										
Graffiti:	None																																					
Erosion:	None																																					
Deposition:	None in.																																					
Damage:	None

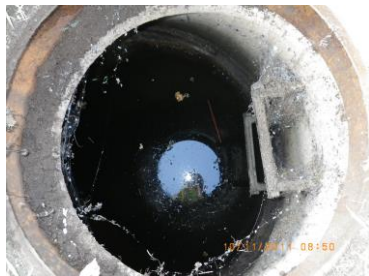
o20111011085018.JPG

Inspection Date: 10/11/2011 8:51:38 AM		Type: Ongoing	Flow: Submerged, indeterminate	Previous Rainfall (hrs): 72+
Illicit Discharge Potential: Unlikely		Inspector: JCW	Notes	
Submerged: Fully		Depth (in): 43	2010 screening follow-up. Floatable debris significantly reduced.	
Sampling Results		Condition Assessment		
Sample Location: Pool	Floatables:	None		
Total Chlorine: 0 ppm	Odor:	None		
Free Chlorine: 0 ppm	Turbidity:	None		
Ammonia: 0 ppm	Color:	Faint in bottle		
pH: 7.87 units	Gross Solids:	Slight		
Temperature 71 °F	Vegetation:	None		
Conductivity: -- µS/cm	Benthic Growth:	None		
Detergents: -- mg/L	Stains:	None		
	Non-illicit:	None		
		Graffiti:	None	
		Erosion:	None	
		Deposition:	None	0 in.
		Damage:	None

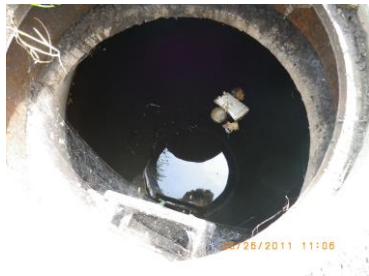
o20110526110604.JPG

Inspection Date: 5/26/2011 11:05:00 AM		Type: Other	Flow: Submerged, indeterminate	Previous Rainfall (hrs): 72+
Illicit Discharge Potential: Unlikely		Inspector: JCW	Notes	
Submerged: Fully		Depth (in):	Limited screening conducted to check for floatable debris.	
Sampling Results		Condition Assessment		
Sample Location:	Floatables:	None		
Total Chlorine: -- ppm	Odor:			
Free Chlorine: -- ppm	Turbidity:			
Ammonia: -- ppm	Color:			
pH: -- units	Gross Solids:	Slight		
Temperature -- °F	Vegetation:			
Conductivity: -- µS/cm	Benthic Growth:			
Detergents: -- mg/L	Stains:			
	Non-illicit:	None		
		Graffiti:	None	
		Erosion:	None	
		Deposition:	None	0 in.
		Damage:	None

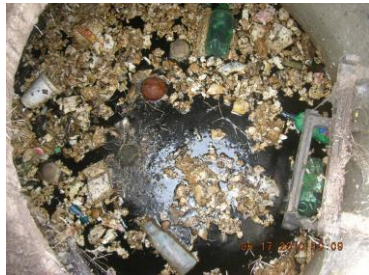
o20100817100950.JPG

Inspection Date: 8/17/2010 10:17:46 AM		Type: Ongoing	Flow: Submerged, indeterminate	Previous Rainfall (hrs): 72+
Illicit Discharge Potential: Potential		Inspector: JCW	Notes	
Submerged: Fully		Depth (in): 48	Significant floatable debris in manhole.	
Sampling Results		Condition Assessment		
Sample Location: Pool	Floatables:	None		
Total Chlorine: 0 ppm	Odor:	None		
Free Chlorine: 0 ppm	Turbidity:	None		
Ammonia: 0 ppm	Color:	None		
pH: 7.71 units	Gross Solids:	Severe		
Temperature 74 °F	Vegetation:	None		
Conductivity: -- µS/cm	Benthic Growth:	None		
Detergents: 0 mg/L	Stains:	None		
	Non-illicit:	None		
		Graffiti:	None	
		Erosion:	None	
		Deposition:	None	0 in.
		Damage:	None

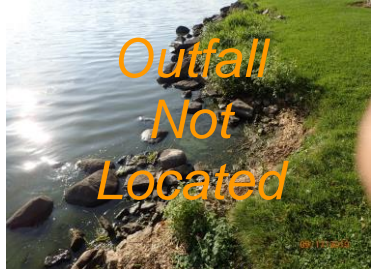
o20190917075538.JPG <div style="text-align: right; font-size: 24pt; font-weight: bold;">2019</div>

Inspection Date: 9/17/2019 8:55:55 AM		Type: Ongoing	Flow: Submerged (not located)	Previous Rainfall (hrs): 48-72
Illicit Discharge Potential: Potential		Inspector: JCW		
Submerged: Fully		Depth (in):		
Sampling Results Sample Location: _____ Total Chlorine: -- ppm Free Chlorine: -- ppm Ammonia: -- ppm pH: -- units Temperature: -- °F Conductivity: -- µS/cm Detergents: -- mg/L		Floatables: None Odor: None Turbidity: None Color: None Gross Solids: None Vegetation: None Benthic Growth: None Stains: None Non-illicit: None	Notes Outfall fully submerged and not physically located. Outfall screened upstream at 11-177 US1. Floating gross solids (litter) in manhole. Condition Assessment Graffiti: None Erosion: None Deposition: None in. Damage: None

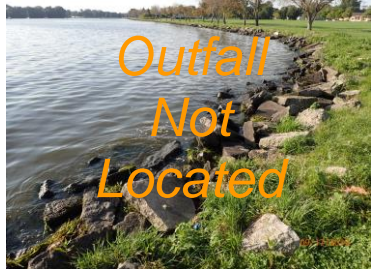
o20190917074332.JPG <div style="text-align: center; font-size: 24pt; font-weight: bold;">2019</div>

Inspection Date: 9/17/2019 8:43:35 AM		Type: Ongoing	Flow: Submerged (not located)	Previous Rainfall (hrs): 48-72
Illicit Discharge Potential: Potential		Inspector: JCW		
Submerged: Fully		Depth (in):		
Sampling Results Sample Location: _____ Total Chlorine: -- ppm Free Chlorine: -- ppm Ammonia: -- ppm pH: -- units Temperature: -- °F Conductivity: -- µS/cm Detergents: -- mg/L		Floatables: None Odor: None Turbidity: None Color: None Gross Solids: None Vegetation: None Benthic Growth: None Stains: None Non-illicit: None	Notes Outfall fully submerged and not located - screened upstream at 11-376 US1. Floating gross solids (litter) in manhole. Condition Assessment Graffiti: None Erosion: None Deposition: None in. Damage: None

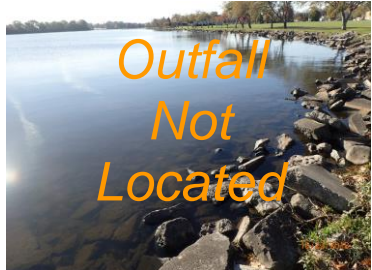
o20181022094126.JPG <div style="text-align: center; font-size: 24pt; font-weight: bold;">2018</div>

Inspection Date: 10/22/2018 9:42:07 AM		Type: Ongoing	Flow: Submerged (not located)	Previous Rainfall (hrs): 48-72
Illicit Discharge Potential: Potential		Inspector: JCW		
Submerged: Fully		Depth (in):		
Sampling Results Sample Location: _____ Total Chlorine: -- ppm Free Chlorine: -- ppm Ammonia: -- ppm pH: -- units Temperature: -- °F Conductivity: -- µS/cm Detergents: -- mg/L		Floatables: None Odor: None Turbidity: None Color: None Gross Solids: None Vegetation: None Benthic Growth: None Stains: None Non-illicit: None	Notes Outfall fully submerged and not located - screened upstream at 11-376 US1. Floating gross solids (litter) in manhole. Condition Assessment Graffiti: None Erosion: None Deposition: None in. Damage: None

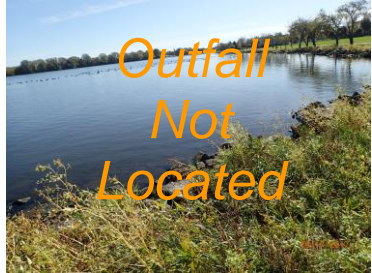
o20171017130204.JPG

Inspection Date: 10/17/2017 1:03:56 PM		Type: Ongoing	Flow: Submerged (not located)	Previous Rainfall (hrs): 48-72
Illicit Discharge Potential: Potential		Inspector: JCW	Notes	
Submerged: Fully Depth (in):			Outfall fully submerged and not located - screened upstream at 11-376 US1. Floating gross solids (litter) in manhole.	
Sampling Results			Condition Assessment	
Sample Location:	Floatables:	None	Graffiti: None Erosion: None Deposition: None in. Damage: None	
Total Chlorine: -- ppm	Odor:	None		
Free Chlorine: -- ppm	Turbidity:	None		
Ammonia: -- ppm	Color:	None		
pH: -- units	Gross Solids:	None		
Temperature -- °F	Vegetation:	None		
Conductivity: -- µS/cm	Benthic Growth:	None		
Detergents: -- mg/L	Stains:	None		
	Non-illicit:	None

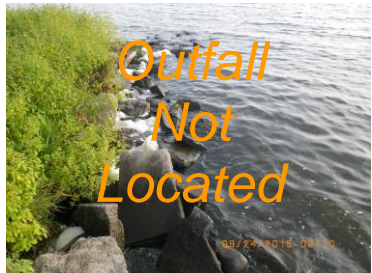
o20150924081044.JPG

Inspection Date: 9/24/2015 9:06:24 AM		Type: Ongoing	Flow: Submerged (not located)	Previous Rainfall (hrs): 72+
Illicit Discharge Potential: Potential		Inspector: JCW	Notes	
Submerged: Fully Depth (in):			Outfall fully submerged and not located - screened at 11-376 US1.	
Sampling Results			Condition Assessment	
Sample Location:	Floatables:	None	Graffiti: None Erosion: None Deposition: None in. Damage: None	
Total Chlorine: -- ppm	Odor:	None		
Free Chlorine: -- ppm	Turbidity:	None		
Ammonia: -- ppm	Color:	None		
pH: -- units	Gross Solids:	None		
Temperature -- °F	Vegetation:	None		
Conductivity: -- µS/cm	Benthic Growth:	None		
Detergents: -- mg/L	Stains:	None		
	Non-illicit:	Moderate

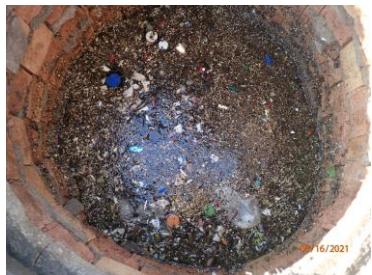
o20210816075758.JPG 2021
Sampling Results Sample Location: Pool Total Chlorine: 0 ppm Free Chlorine: 0 ppm Ammonia: 0 ppm pH: 7.67 units Temperature: 72 °F Conductivity: 572 µS/cm Detergents: 0 mg/L		Floatables: None Odor: None Turbidity: None Color: None Gross Solids: Severe Vegetation: None Benthic Growth: None Stains: None Non-illicit: None	Sample collected from submerged pool in manhole. Floating gross solids (litter) in manhole. Condition Assessment Graffiti: None Erosion: None Deposition: None in. Damage: None	
Inspection Date: 8/20/2020 2:10:47 PM		Type: Ongoing	Flow: Submerged, indeterminate	Previous Rainfall (hrs): 72+
Illicit Discharge Potential: Potential Submerged: Fully Depth (in): 81		Inspector: JCW	Notes

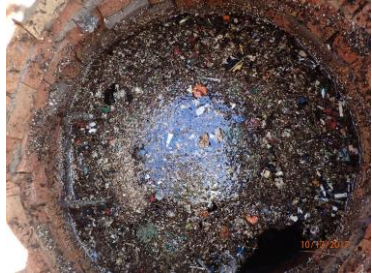
o20171017130258.JPG <div style="font-size: 24pt; font-weight: bold;">2017</div>

Inspection Date: 10/17/2017 1:07:06 PM		Type: Ongoing	Flow: Submerged, indeterminate	Previous Rainfall (hrs): 48-72
Illicit Discharge Potential: Potential		Inspector: JCW		Notes Sample collected from submerged pool in manhole. Floating gross solids (litter) in manhole.
Submerged: Fully Depth (in): 79				
Sampling Results Sample Location: Pool Total Chlorine: 0 ppm Free Chlorine: 0 ppm Ammonia: 0 ppm pH: 7.62 units Temperature: 67 °F Conductivity: 829 µS/cm Detergents: 0 mg/L		Floatables: None Odor: None Turbidity: None Color: None Gross Solids: Moderate Vegetation: None Benthic Growth: None Stains: None Non-illicit: None	Condition Assessment Graffiti: None Erosion: None Deposition: None in. Damage: None

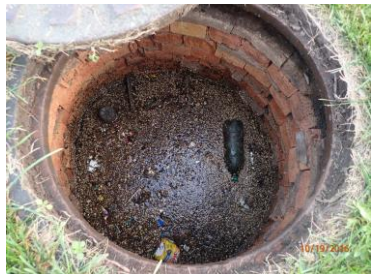
o20161019074410.JPG <div style="font-size: 24pt; font-weight: bold;">2016</div>

Inspection Date: 10/19/2016 7:46:56 AM		Type: Ongoing	Flow: Submerged, indeterminate	Previous Rainfall (hrs): 72+
Illicit Discharge Potential: Potential		Inspector: JCW		Notes Potential illicit discharge due to gross solids.
Submerged: Fully Depth (in): 79				
Sampling Results Sample Location: Pool Total Chlorine: 0 ppm Free Chlorine: 0 ppm Ammonia: 0 ppm pH: 7.89 units Temperature: 58 °F Conductivity: 357 µS/cm Detergents: 0 mg/L		Floatables: None Odor: Faint Turbidity: None Color: Faint in bottle Gross Solids: Severe Vegetation: None Benthic Growth: None Stains: None Non-illicit: None	Condition Assessment Graffiti: None Erosion: None Deposition: None in. Damage: None

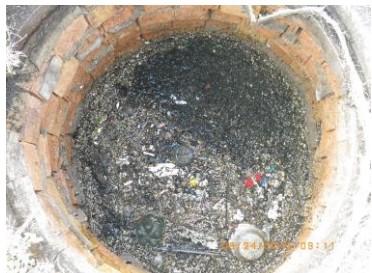
o20150924081150.JPG <div style="font-size: 24pt; font-weight: bold;">2015</div>

Inspection Date: 9/24/2015 9:10:22 AM		Type: Ongoing	Flow: Submerged, indeterminate	Previous Rainfall (hrs): 72+
Illicit Discharge Potential: Potential		Inspector: JCW		Notes Floating gross solids (litter) in manhole.
Submerged: Fully Depth (in): 81				
Sampling Results Sample Location: Pool Total Chlorine: 0 ppm Free Chlorine: 0 ppm Ammonia: 0 ppm pH: 7.88 units Temperature: 68 °F Conductivity: 397 µS/cm Detergents: 0 mg/L		Floatables: None Odor: Faint Turbidity: None Color: None Gross Solids: Severe Vegetation: None Benthic Growth: None Stains: None Non-illicit: None	Condition Assessment Graffiti: None Erosion: None Deposition: None in. Damage: None

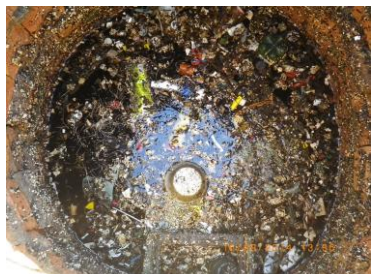
o20141009123616.JPG <div style="font-size: 24pt; font-weight: bold;">2014</div>

Inspection Date: 10/9/2014 1:36:18 PM		Type: Ongoing	Flow: Submerged, indeterminate	Previous Rainfall (hrs): 72+
Illicit Discharge Potential: Potential		Inspector: JCW		Notes Floating gross solids (litter) in manhole.
Submerged: Fully Depth (in): 74				
Sampling Results Sample Location: Pool Total Chlorine: 0 ppm Free Chlorine: 0 ppm Ammonia: 0 ppm pH: 7.76 units Temperature: 59 °F Conductivity: 381 µS/cm Detergents: 0 mg/L		Floatables: None Odor: None Turbidity: None Color: Faint in bottle Gross Solids: Severe Vegetation: None Benthic Growth: None Stains: None Non-illicit: None	Condition Assessment Graffiti: None Erosion: None Deposition: None in. Damage: None

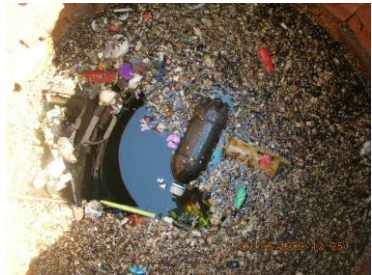
<p style="text-align: center;">Osh09_DSCN6622.JPG</p> <p style="text-align: center; font-size: 24pt; font-weight: bold;">2009</p>		
Sampling Results					
Sample Location:	Pool	Floatables:			None
Total Chlorine:	0 ppm	Odor:			
Free Chlorine:	0 ppm	Turbidity:			
Ammonia:	-- ppm	Color:			
pH:	7.82 units	Gross Solids:			Severe
Temperature	76 °F	Vegetation:			
Conductivity:	-- µS/cm	Benthic Growth:			
Detergents:	0 mg/L	Stains:			
		Non-illicit:	None	Condition Assessment Graffiti: None Erosion: None Deposition: None 0 in. Damage: None

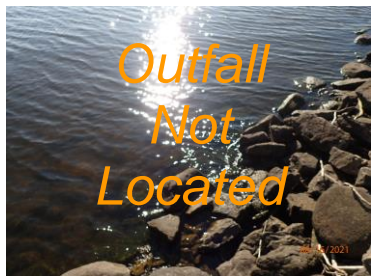
o20210816083746.JPG 2021

Inspection Date: 8/16/2021 8:42:01 AM		Type: Ongoing	Flow: Submerged (not located)	Previous Rainfall (hrs): 72+
Illicit Discharge Potential: Potential		Inspector: JCW		
Submerged: Fully		Depth (in):		
Sampling Results		Notes Outfall fully submerged and not located - screened upstream at 11-512 US1. Floating gross solids (litter) in upstream manhole.		
Sample Location:	Floatables:	None		
Total Chlorine: -- ppm	Odor:	None		
Free Chlorine: -- ppm	Turbidity:	None		
Ammonia: -- ppm	Color:	None		
pH: -- units	Gross Solids:	None		
Temperature -- °F	Vegetation:	None		
Conductivity: -- µS/cm	Benthic Growth:	None		
Detergents: -- mg/L	Stains:	None		
	Non-illicit:	None		
		Condition Assessment Graffiti: None Erosion: None Deposition: None in. Damage: None

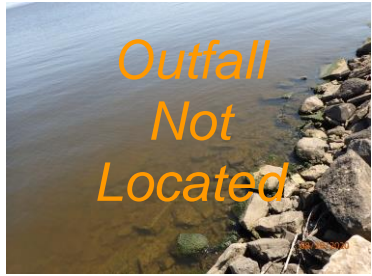
o20200820131742.JPG 2020

Inspection Date: 8/20/2020 1:20:27 PM		Type: Ongoing	Flow: Submerged (not located)	Previous Rainfall (hrs): 72+
Illicit Discharge Potential: Potential		Inspector: JCW		
Submerged: Fully		Depth (in):		
Sampling Results		Notes Outfall fully submerged and not located - screened upstream at 11-512 US1. Floating gross solids (litter) in upstream manhole.		
Sample Location:	Floatables:	None		
Total Chlorine: -- ppm	Odor:	None		
Free Chlorine: -- ppm	Turbidity:	None		
Ammonia: -- ppm	Color:	None		
pH: -- units	Gross Solids:	None		
Temperature -- °F	Vegetation:	None		
Conductivity: -- µS/cm	Benthic Growth:	None		
Detergents: -- mg/L	Stains:	None		
	Non-illicit:	None		
		Condition Assessment Graffiti: None Erosion: None Deposition: None in. Damage: None

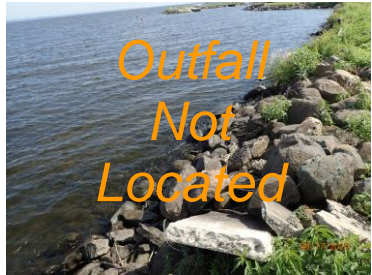
o20190917130514.JPG 2019

Inspection Date: 9/17/2019 2:05:48 PM		Type: Ongoing	Flow: Submerged (not located)	Previous Rainfall (hrs): 48-72
Illicit Discharge Potential: Potential		Inspector: JCW		
Submerged: Fully		Depth (in):		
Sampling Results		Notes Outfall fully submerged and not located - screened upstream at 11-512 US1. Floating gross solids (litter) in manhole.		
Sample Location:	Floatables:	None		
Total Chlorine: -- ppm	Odor:	None		
Free Chlorine: -- ppm	Turbidity:	None		
Ammonia: -- ppm	Color:	None		
pH: -- units	Gross Solids:	None		
Temperature -- °F	Vegetation:	None		
Conductivity: -- µS/cm	Benthic Growth:	None		
Detergents: -- mg/L	Stains:	None		
	Non-illicit:	None		
		Condition Assessment Graffiti: None Erosion: None Deposition: None in. Damage: None

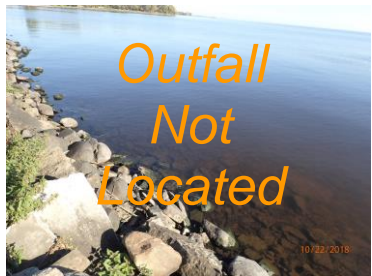
o20181022095658.JPG 2018

Inspection Date: 10/22/2018 9:59:38 AM		Type: Ongoing	Flow: Submerged (not located)	Previous Rainfall (hrs): 48-72
Illicit Discharge Potential: Potential		Inspector: JCW		
Submerged: Fully		Depth (in):		
Sampling Results		Notes Outfall fully submerged and not located - screened upstream at 11-512 US1. Floating gross solids (litter) in manhole.		
Sample Location:	Floatables:	None		
Total Chlorine: -- ppm	Odor:	None		
Free Chlorine: -- ppm	Turbidity:	None		
Ammonia: -- ppm	Color:	None		
pH: -- units	Gross Solids:	None		
Temperature -- °F	Vegetation:	None		
Conductivity: -- µS/cm	Benthic Growth:	None		
Detergents: -- mg/L	Stains:	None		
	Non-illicit:	None		
		Condition Assessment Graffiti: None Erosion: None Deposition: None in. Damage: None

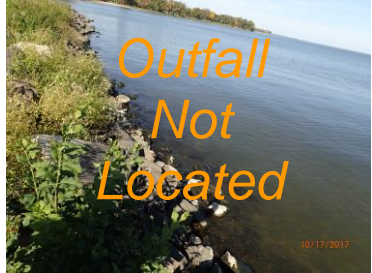
o20171017131910.JPG

Inspection Date: 10/17/2017 1:20:48 PM		Type: Ongoing	Flow: Submerged (not located)	Previous Rainfall (hrs): 48-72
Illicit Discharge Potential: Potential		Inspector: JCW	Notes	
Submerged: Fully		Depth (in):	Outfall fully submerged and not located - screened upstream at 11-512 US1. Floating gross solids (litter) in manhole.	
Sampling Results		Floatables:	Condition Assessment Graffiti: None Erosion: None Deposition: None in. Damage: None	
Sample Location:		Odor:		
Total Chlorine: -- ppm		Turbidity:		
Free Chlorine: -- ppm		Color:		
Ammonia: -- ppm		Gross Solids:		
pH: -- units		Vegetation:		
Temperature -- °F		Benthic Growth:		
Conductivity: -- µS/cm		Stains:		
Detergents: -- mg/L		Non-illicit:

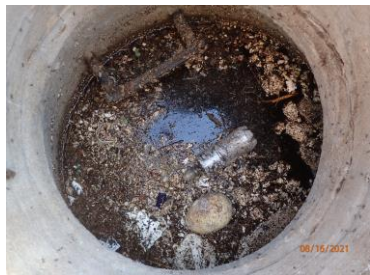
Inspection Date: 8/16/2021 8:42:51 AM		Type: Ongoing	Flow: Submerged, indeterminate	Previous Rainfall (hrs): 72+
Illicit Discharge Potential: Potential Submerged: Fully Depth (in): 41		Inspector: JCW	Notes Sample collected from submerged pool in manhole. Floating gross solids (litter) in manhole.	
Sampling Results Sample Location: Pool Total Chlorine: 0 ppm Free Chlorine: 0 ppm Ammonia: 0 ppm pH: 7.65 units Temperature: 73 °F Conductivity: 345 µS/cm Detergents: 0 mg/L		Floatables: None Odor: None Turbidity: None Color: None Gross Solids: Moderate Vegetation: None Benthic Growth: None Stains: None Non-illicit: None	Condition Assessment Graffiti: None Erosion: None Deposition: None in. Damage: None

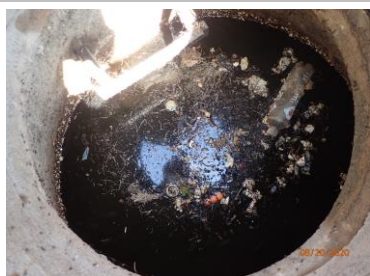
Inspector: JCW Sampling Results Sample Location: Pool Total Chlorine: 0 ppm Free Chlorine: 0 ppm Ammonia: 0 ppm pH: 9.07 units Temperature: 84 °F Conductivity: 347 µS/cm Detergents: 0 mg/L		Floatables: None Odor: None Turbidity: None Color: None Gross Solids: Moderate Vegetation: None Benthic Growth: Moderate Stains: None Non-illicit: None	Notes Sample collected from submerged pool in manhole. Floating gross solids (litter) in manhole. Elevated pH seemed widespread in river/lake.	
			Condition Assessment Graffiti: None Erosion: None Deposition: None in. Damage: None

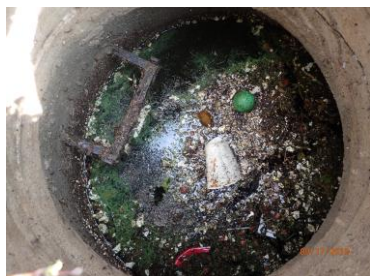
o20200820131802.JPG 2020	
Inspection Date: 9/17/2019 2:08:21 PM Illicit Discharge Potential: Potential Submerged: Fully Depth (in): 37		Type: Ongoing	Flow: Submerged, indeterminate	Previous Rainfall (hrs): 48-72
Inspector: JCW Sampling Results Sample Location: Pool Total Chlorine: 0 ppm Free Chlorine: 0 ppm Ammonia: 0 ppm pH: 8.23 units Temperature: 76 °F Conductivity: 333 µS/cm Detergents: 0 mg/L		Floatables: None Odor: None Turbidity: None Color: None Gross Solids: Severe Vegetation: None Benthic Growth: None Stains: None Non-illicit: None	Notes Sample collected from submerged pool in manhole. Floating gross solids (litter) in manhole.

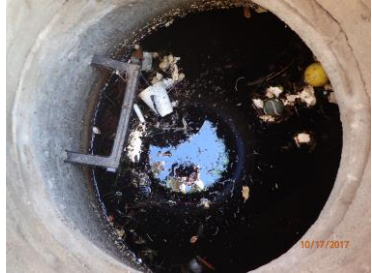
Inspection Date: 10/17/2017 1:23:39 PM		Type: Ongoing	Flow: Submerged, indeterminate	Previous Rainfall (hrs): 48-72
Illicit Discharge Potential: Potential		Inspector: JCW	Notes	
Submerged: Fully		Depth (in): 35	Sample collected from submerged pool in manhole. Floating gross solids (litter) in manhole.	
Sampling Results		Condition Assessment		
Sample Location: Pool	Floatables: None	Graffiti: None

o20171017131930.JPG 2017	
Total Chlorine: 0 ppm	Odor: None	Erosion: None		
Free Chlorine: 0 ppm	Turbidity: None	Deposition: None in.		
Ammonia: 0 ppm	Color: None	Damage: None		
pH: 7.47 units	Gross Solids: Moderate			
Temperature 67 °F	Vegetation: None			
Conductivity: 581 µS/cm	Benthic Growth: None			
Detergents: 0 mg/L	Stains: None			
	Non-illicit: None

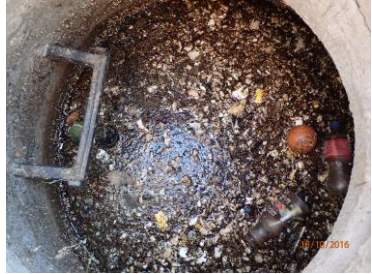
Inspection Date: 10/10/2016 11:07:16 AM		Type: Ongoing	Flow: Submerged, indeterminate	Previous Rainfall (hrs): 72+
Illicit Discharge Potential: Potential		Inspector: JCW	Notes	
Submerged: Fully		Depth (in): 35	Potential illicit discharge due to gross solids.	
Sampling Results		Condition Assessment		
Sample Location: Pool	Floatables: None	Graffiti: None

o20161010110444.JPG 2016	
Total Chlorine: 0 ppm	Odor: None	Erosion: None		
Free Chlorine: 0 ppm	Turbidity: None	Deposition: None in.		
Ammonia: 0 ppm	Color: None	Damage: None		
pH: 7.63 units	Gross Solids: Severe			
Temperature 65 °F	Vegetation: None			
Conductivity: 514 µS/cm	Benthic Growth: None			
Detergents: 0 mg/L	Stains: None			
	Non-illicit: None

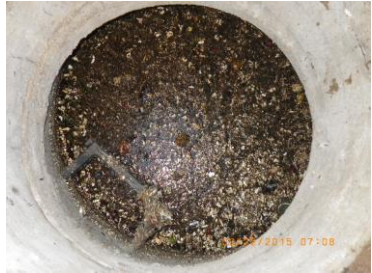
Inspection Date: 9/22/2015 7:04:46 AM		Type: Ongoing	Flow: Submerged, indeterminate	Previous Rainfall (hrs): 72+
Illicit Discharge Potential: Potential		Inspector: JCW	Notes	
Submerged: Fully		Depth (in): 37	Floating gross solids (litter) in manhole.	
Sampling Results		Condition Assessment		
Sample Location: Pool	Floatables: None	Graffiti: None

o20150922060832.JPG 2015	
Total Chlorine: 0 ppm	Odor: None	Erosion: None		
Free Chlorine: 0 ppm	Turbidity: None	Deposition: None in.		
Ammonia: 0 ppm	Color: None	Damage: None		
pH: 7.93 units	Gross Solids: Moderate			
Temperature 65 °F	Vegetation: None			
Conductivity: 1055 µS/cm	Benthic Growth: None			
Detergents: 0 mg/L	Stains: None			
	Non-illicit: None

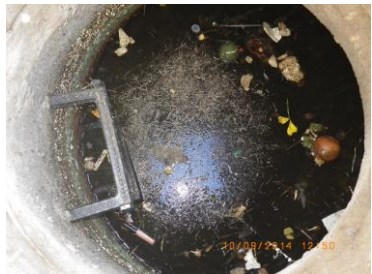
Inspection Date: 10/9/2014 12:52:08 PM		Type: Ongoing	Flow: Submerged, indeterminate	Previous Rainfall (hrs): 72+
Illicit Discharge Potential: Potential		Inspector: JCW	Notes	
Submerged: Fully		Depth (in): 39	Floating gross solids (litter) in manhole.	
Sampling Results		Condition Assessment		
Sample Location: Pool	Floatables: None	Graffiti: None

o20141009115024.JPG 2014	
Total Chlorine: 0 ppm	Odor: None	Erosion: None		
Free Chlorine: 0 ppm	Turbidity: Slight cloudiness	Deposition: None in.		
Ammonia: 0 ppm	Color: None	Damage: None		
pH: 7.57 units	Gross Solids: Moderate			
Temperature 62 °F	Vegetation: None			
Conductivity: 548 µS/cm	Benthic Growth: Slight			
Detergents: 0 mg/L	Stains: None			
	Non-illicit: None

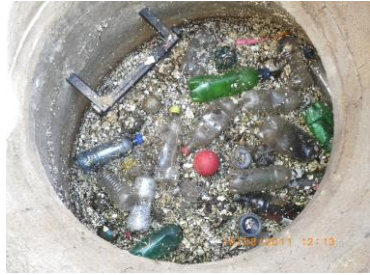
o20111003121302.JPG

Inspection Date: 10/3/2011 12:13:00 PM		Type: Ongoing	Flow: Submerged, indeterminate	Previous Rainfall (hrs): 72+
Illicit Discharge Potential: Potential		Inspector: JCW	Notes	
Submerged: Fully		Depth (in): 36	Significant floatable debris in manhole.	
Sampling Results				
Sample Location:	Pool	Floatables:	None	
Total Chlorine:	0 ppm	Odor:	None	
Free Chlorine:	0 ppm	Turbidity:	None	
Ammonia:	0 ppm	Color:	None	
pH:	7.39 units	Gross Solids:	Severe	
Temperature:	67 °F	Vegetation:	None	
Conductivity:	-- µS/cm	Benthic Growth:	None	
Detergents:	0 mg/L	Stains:	None	
		Non-illicit:	None	
			Condition Assessment	
			Graffiti:	None
			Erosion:	None
			Deposition:	None 0 in.
			Damage:	None

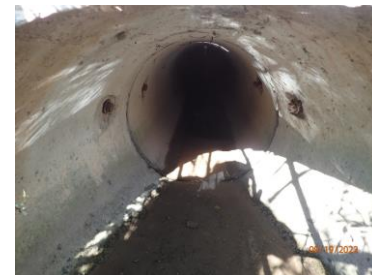
o20220919154512.JPG

Stains: Slight

☐ Petrol. Sheen ☐ Suds ☐ Sewage ☐ Algae ☐ Other☐ Petroleum ☐ Musty ☐ Sewage ☐ Chlorine ☐ Other☐ VOC/Solvent ☐ Fishy ☐ Sulfur ☐ Fragrant☐ Litter ☐ Veg. Debris ☐ Sediment ☐ Other☐ Inhibited ☐ Excessive☒ Green ☐ Brown☒ Flow Line ☐ Oil ☐ Rust Stains☐ Paint ☐ Other☐ Natural Sheen ☐ Natural Suds/Foam

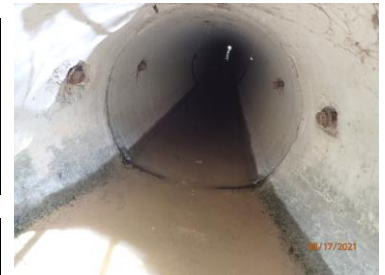
o20210817133706.JPG

Inspection Date: 8/17/2021 1:39:35 PM		Type: Ongoing	Flow: Submerged, slight flow	Previous Rainfall (hrs): 72+
Illicit Discharge Potential: Potential		Inspector: JCW		
Submerged: Partially		Depth (in): 3		
Sampling Results		Notes Sample collected from concentrated flow immediately downstream of outfall. Detergent detected in sample.		
Sample Location:	Flow	Floatables:	None	
Total Chlorine:	0 ppm	Odor:	None	
Free Chlorine:	0 ppm	Turbidity:	None	
Ammonia:	0 ppm	Color:	None	
pH:	7.57 units	Gross Solids:	None	
Temperature:	80 °F	Vegetation:	None	
Conductivity:	964 µS/cm	Benthic Growth:	Slight	
Detergents:	0.8 mg/L	Stains:	None	
		Non-illicit:	None	
		Condition Assessment Graffiti: None Erosion: None Deposition: None in. Damage: None

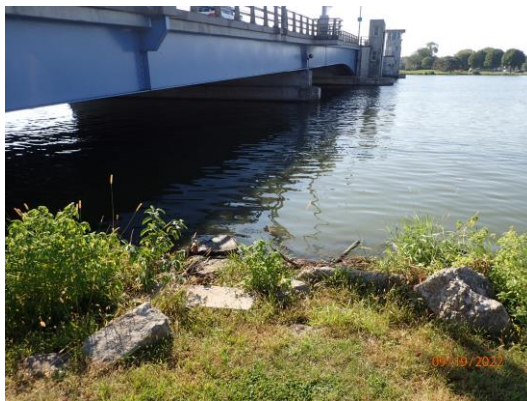
o20220919151702.JPG

Congress Ave storm sewer discharges to river from east. Outfall fully submerged and not physically located. GPS coordinates approximate. Pipe info from MS4 map.

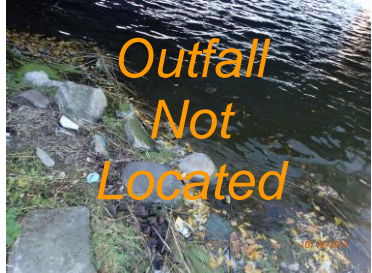
<p style="text-align: center;">o20171018101412.JPG</p> <p style="text-align: center; font-size: 1.5em; font-weight: bold;">2017</p>	
Submerged: Fully		Depth (in):		Outfall fully submerged and not located - screened upstream at 12-569 US1. Graffiti on nearby bridge abutment. Floating gross solids (litter) in MH.			
Sampling Results				Condition Assessment			
Sample Location:	Floatables:	None		Graffiti: Minor			
Total Chlorine: -- ppm	Odor:	None		Erosion: None			
Free Chlorine: -- ppm	Turbidity:	None		Deposition: None in.			
Ammonia: -- ppm	Color:	None		Damage: None			
pH: -- units	Gross Solids:	None					
Temperature -- °F	Vegetation:	None					
Conductivity: -- µS/cm	Benthic Growth:	None					
Detergents: -- mg/L	Stains:	None

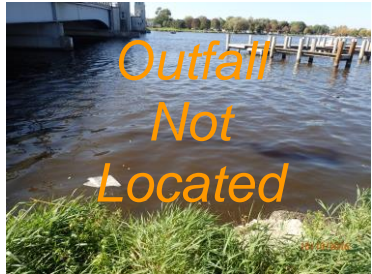
<p style="text-align: center;">o20161010132600.JPG</p> <p style="text-align: center; font-size: 1.5em; font-weight: bold;">2016</p>	
Submerged: Fully		Depth (in):		Graffiti on east bridge abutment. Outfall fully submerged and not located - screened upstream at 12-569 US1.			
Sampling Results				Condition Assessment			
Sample Location:	Floatables:	None		Graffiti: Minor			
Total Chlorine: -- ppm	Odor:	None		Erosion: None			
Free Chlorine: -- ppm	Turbidity:	None		Deposition: None in.			
Ammonia: -- ppm	Color:	None		Damage: None			
pH: -- units	Gross Solids:	None					
Temperature -- °F	Vegetation:	None					
Conductivity: -- µS/cm	Benthic Growth:	None					
Detergents: -- mg/L	Stains:	None					
	Non-illicit:	None

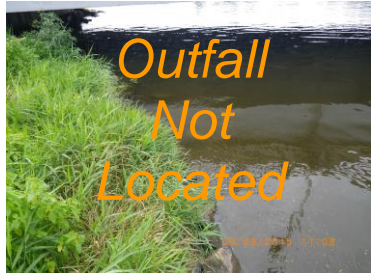
<p style="text-align: center;">o20150923100828.JPG</p> <p style="text-align: center; font-size: 1.5em; font-weight: bold;">2015</p>	
Submerged: Fully		Depth (in):		Outfall fully submerged and not located - screened at 12-569 US1.			
Sampling Results				Condition Assessment			
Sample Location:	Floatables:	None		Graffiti: Moderate			
Total Chlorine: -- ppm	Odor:	None		Erosion: None			
Free Chlorine: -- ppm	Turbidity:	None		Deposition: None in.			
Ammonia: -- ppm	Color:	None		Damage: None			
pH: -- units	Gross Solids:	None					
Temperature -- °F	Vegetation:	None					
Conductivity: -- µS/cm	Benthic Growth:	None					
Detergents: -- mg/L	Stains:	None					
	Non-illicit:	None

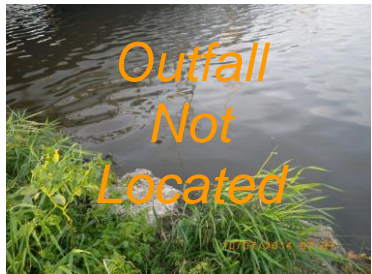
<p style="text-align: center;">o20141007063712.JPG</p> <p style="text-align: center; font-size: 1.5em; font-weight: bold;">2014</p>	
Submerged: Fully		Depth (in):		Outfall fully submerged and not located - screened upstream at 12-569 US1. Graffiti on east abutment.			
Sampling Results				Condition Assessment			
Sample Location:	Floatables:	None		Graffiti: Moderate			
Total Chlorine: -- ppm	Odor:	None		Erosion: None			
Free Chlorine: -- ppm	Turbidity:	None		Deposition: None in.			
Ammonia: -- ppm	Color:	None		Damage: None			
pH: -- units	Gross Solids:	None					
Temperature -- °F	Vegetation:	None					
Conductivity: -- µS/cm	Benthic Growth:	None					
Detergents: -- mg/L	Stains:	None					
	Non-illicit:	None

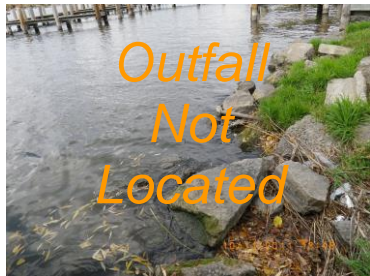
Inspection Date: 10/11/2011 1:49:07 PM		Type: Ongoing		Flow: Submerged (not located)		Previous Rainfall (hrs): 72+																									
Illicit Discharge Potential: Unlikely		Inspector: JCW		Notes 2010 screening follow-up. Outfall fully submerged and not physically located. Outfall screened upstream at 12-569 US1.

<small>o20111011134840.JPG</small> <div style="text-align: center; font-weight: bold; font-size: 1.2em;">2011</div>																									
Submerged: Fully		Depth (in):																													
Sampling Results <table border="1" style="width:100%; border-collapse: collapse;"> <tr> <td style="width:50%;">Sample Location:</td> <td style="width:50%;">Floatables:</td> </tr> <tr> <td>Total Chlorine: -- ppm</td> <td>Odor:</td> </tr> <tr> <td>Free Chlorine: -- ppm</td> <td>Turbidity:</td> </tr> <tr> <td>Ammonia: -- ppm</td> <td>Color:</td> </tr> <tr> <td>pH: -- units</td> <td>Gross Solids:</td> </tr> <tr> <td>Temperature -- °F</td> <td>Vegetation:</td> </tr> <tr> <td>Conductivity: -- µS/cm</td> <td>Benthic Growth:</td> </tr> <tr> <td>Detergents: -- mg/L</td> <td>Stains:</td> </tr> <tr> <td></td> <td>Non-illicit:</td> </tr> </table>		Sample Location:	Floatables:	Total Chlorine: -- ppm	Odor:	Free Chlorine: -- ppm	Turbidity:	Ammonia: -- ppm	Color:	pH: -- units	Gross Solids:	Temperature -- °F	Vegetation:	Conductivity: -- µS/cm	Benthic Growth:	Detergents: -- mg/L	Stains:		Non-illicit:	<table border="1" style="width:100%; border-collapse: collapse;"> <tr> <td colspan="2">Condition Assessment</td> </tr> <tr> <td>Graffiti:</td> <td>None</td> </tr> <tr> <td>Erosion:</td> <td>None</td> </tr> <tr> <td>Deposition:</td> <td>None 0 in.</td> </tr> <tr> <td>Damage:</td> <td>None</td> </tr> </table>		Condition Assessment		Graffiti:	None	Erosion:	None	Deposition:	None 0 in.	Damage:	None

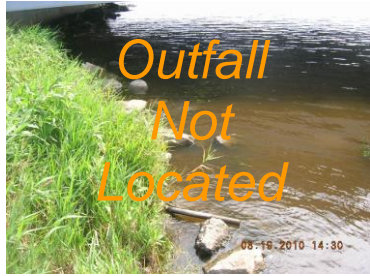
Inspection Date: 8/19/2010 2:37:50 PM		Type: Ongoing		Flow: Submerged (not located)		Previous Rainfall (hrs): 72+																									
Illicit Discharge Potential: Potential		Inspector: JCW		Notes Outfall fully submerged and not physically located. Outfall screened upstream at 12-569 US1.

<small>o20100819143022.JPG</small> <div style="text-align: center; font-weight: bold; font-size: 1.2em;">2010</div>																									
Submerged: Fully		Depth (in):																													
Sampling Results <table border="1" style="width:100%; border-collapse: collapse;"> <tr> <td style="width:50%;">Sample Location:</td> <td style="width:50%;">Floatables:</td> </tr> <tr> <td>Total Chlorine: -- ppm</td> <td>Odor:</td> </tr> <tr> <td>Free Chlorine: -- ppm</td> <td>Turbidity:</td> </tr> <tr> <td>Ammonia: -- ppm</td> <td>Color:</td> </tr> <tr> <td>pH: -- units</td> <td>Gross Solids:</td> </tr> <tr> <td>Temperature -- °F</td> <td>Vegetation:</td> </tr> <tr> <td>Conductivity: -- µS/cm</td> <td>Benthic Growth:</td> </tr> <tr> <td>Detergents: -- mg/L</td> <td>Stains:</td> </tr> <tr> <td></td> <td>Non-illicit:</td> </tr> </table>		Sample Location:	Floatables:	Total Chlorine: -- ppm	Odor:	Free Chlorine: -- ppm	Turbidity:	Ammonia: -- ppm	Color:	pH: -- units	Gross Solids:	Temperature -- °F	Vegetation:	Conductivity: -- µS/cm	Benthic Growth:	Detergents: -- mg/L	Stains:		Non-illicit:	<table border="1" style="width:100%; border-collapse: collapse;"> <tr> <td colspan="2">Condition Assessment</td> </tr> <tr> <td>Graffiti:</td> <td>None</td> </tr> <tr> <td>Erosion:</td> <td>None</td> </tr> <tr> <td>Deposition:</td> <td>None 0 in.</td> </tr> <tr> <td>Damage:</td> <td>None</td> </tr> </table>		Condition Assessment		Graffiti:	None	Erosion:	None	Deposition:	None 0 in.	Damage:	None

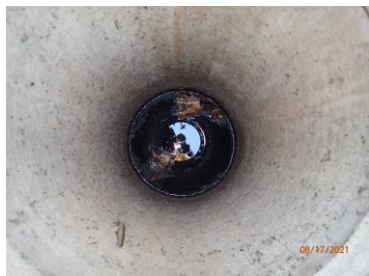
<p style="text-align: center;">o20210817091344.JPG</p> <p style="text-align: center; font-size: 24pt; font-weight: bold;">2021</p>																																									
Submerged: Fully		Depth (in): 38		Sample collected from submerged pool in manhole.																																											
Sampling Results <table border="1" style="width:100%; border-collapse: collapse;"> <tr><td>Sample Location:</td><td>Pool</td></tr> <tr><td>Total Chlorine:</td><td>0 ppm</td></tr> <tr><td>Free Chlorine:</td><td>0 ppm</td></tr> <tr><td>Ammonia:</td><td>0 ppm</td></tr> <tr><td>pH:</td><td>7.15 units</td></tr> <tr><td>Temperature:</td><td>77 °F</td></tr> <tr><td>Conductivity:</td><td>454 µS/cm</td></tr> <tr><td>Detergents:</td><td>0 mg/L</td></tr> </table>		Sample Location:	Pool	Total Chlorine:	0 ppm			Free Chlorine:	0 ppm	Ammonia:	0 ppm	pH:	7.15 units	Temperature:	77 °F	Conductivity:	454 µS/cm	Detergents:	0 mg/L	<table border="1" style="width:100%; border-collapse: collapse;"> <tr><td>Floatables:</td><td>None</td></tr> <tr><td>Odor:</td><td>None</td></tr> <tr><td>Turbidity:</td><td>None</td></tr> <tr><td>Color:</td><td>None</td></tr> <tr><td>Gross Solids:</td><td>Moderate</td></tr> <tr><td>Vegetation:</td><td>None</td></tr> <tr><td>Benthic Growth:</td><td>None</td></tr> <tr><td>Stains:</td><td>None</td></tr> <tr><td>Non-illicit:</td><td>None</td></tr> </table>		Floatables:	None	Odor:	None	Turbidity:	None	Color:	None	Gross Solids:	Moderate	Vegetation:	None	Benthic Growth:	None	Stains:	None	Non-illicit:	None	Condition Assessment <table border="1" style="width:100%; border-collapse: collapse;"> <tr><td>Graffiti:</td><td>None</td></tr> <tr><td>Erosion:</td><td>None</td></tr> <tr><td>Deposition:</td><td>None in.</td></tr> <tr><td>Damage:</td><td>None</td></tr> </table>		Graffiti:	None	Erosion:	None	Deposition:	None in.

Sample Location:	Pool																																														
Total Chlorine:	0 ppm																																														
Free Chlorine:	0 ppm																																														
Ammonia:	0 ppm																																														
pH:	7.15 units																																														
Temperature:	77 °F																																														
Conductivity:	454 µS/cm																																														
Detergents:	0 mg/L																																														
Floatables:	None																																														
Odor:	None																																														
Turbidity:	None																																														
Color:	None																																														
Gross Solids:	Moderate																																														
Vegetation:	None																																														
Benthic Growth:	None

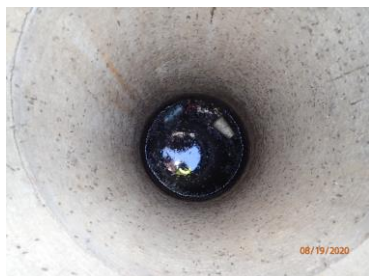
<p style="text-align: center;">o20200819084220.JPG</p> <p style="text-align: center; font-size: 24pt; font-weight: bold;">2020</p>																																									
Submerged: Partially		Depth (in): 38		Sample collected from submerged pool in manhole. Floating gross solids (litter) in manhole.																																											
Sampling Results <table border="1" style="width:100%; border-collapse: collapse;"> <tr><td>Sample Location:</td><td>Pool</td></tr> <tr><td>Total Chlorine:</td><td>0 ppm</td></tr> <tr><td>Free Chlorine:</td><td>0 ppm</td></tr> <tr><td>Ammonia:</td><td>0 ppm</td></tr> <tr><td>pH:</td><td>8.49 units</td></tr> <tr><td>Temperature:</td><td>73 °F</td></tr> <tr><td>Conductivity:</td><td>349 µS/cm</td></tr> <tr><td>Detergents:</td><td>0 mg/L</td></tr> </table>		Sample Location:	Pool	Total Chlorine:	0 ppm			Free Chlorine:	0 ppm	Ammonia:	0 ppm	pH:	8.49 units	Temperature:	73 °F	Conductivity:	349 µS/cm	Detergents:	0 mg/L	<table border="1" style="width:100%; border-collapse: collapse;"> <tr><td>Floatables:</td><td>None</td></tr> <tr><td>Odor:</td><td>Faint</td></tr> <tr><td>Turbidity:</td><td>None</td></tr> <tr><td>Color:</td><td>None</td></tr> <tr><td>Gross Solids:</td><td>Slight</td></tr> <tr><td>Vegetation:</td><td>None</td></tr> <tr><td>Benthic Growth:</td><td>None</td></tr> <tr><td>Stains:</td><td>None</td></tr> <tr><td>Non-illicit:</td><td>None</td></tr> </table>		Floatables:	None	Odor:	Faint	Turbidity:	None	Color:	None	Gross Solids:	Slight	Vegetation:	None	Benthic Growth:	None	Stains:	None	Non-illicit:	None	Condition Assessment <table border="1" style="width:100%; border-collapse: collapse;"> <tr><td>Graffiti:</td><td>None</td></tr> <tr><td>Erosion:</td><td>None</td></tr> <tr><td>Deposition:</td><td>None in.</td></tr> <tr><td>Damage:</td><td>None</td></tr> </table>		Graffiti:	None	Erosion:	None	Deposition:	None in.

Sample Location:	Pool																																														
Total Chlorine:	0 ppm																																														
Free Chlorine:	0 ppm																																														
Ammonia:	0 ppm																																														
pH:	8.49 units																																														
Temperature:	73 °F																																														
Conductivity:	349 µS/cm																																														
Detergents:	0 mg/L																																														
Floatables:	None																																														
Odor:	Faint																																														
Turbidity:	None																																														
Color:	None																																														
Gross Solids:	Slight																																														
Vegetation:	None																																														
Benthic Growth:	None
