IDDE Ongoing Screening Summary Report

2022 Inspection Year

City of Oshkosh

Westwood

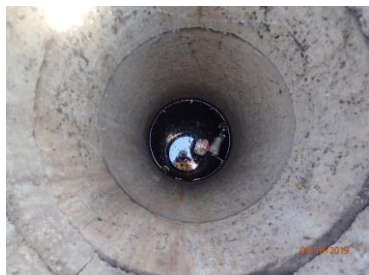
<p style="text-align: center;">o20190918101948.JPG</p> <p style="text-align: center; font-size: 24pt; font-weight: bold;">2019</p>																																									
Submerged: Fully		Depth (in): 42		Sample collected from submerged pool in manhole. Floating gross solids (litter) in manhole.																																											
Sampling Results <table border="1" style="width:100%; border-collapse: collapse;"> <tr><td>Sample Location:</td><td>Pool</td></tr> <tr><td>Total Chlorine:</td><td>0 ppm</td></tr> <tr><td>Free Chlorine:</td><td>0 ppm</td></tr> <tr><td>Ammonia:</td><td>0 ppm</td></tr> <tr><td>pH:</td><td>8.3 units</td></tr> <tr><td>Temperature:</td><td>74 °F</td></tr> <tr><td>Conductivity:</td><td>419 µS/cm</td></tr> <tr><td>Detergents:</td><td>0 mg/L</td></tr> </table>		Sample Location:	Pool	Total Chlorine:	0 ppm			Free Chlorine:	0 ppm	Ammonia:	0 ppm	pH:	8.3 units	Temperature:	74 °F	Conductivity:	419 µS/cm	Detergents:	0 mg/L	<table border="1" style="width:100%; border-collapse: collapse;"> <tr><td>Floatables:</td><td>None</td></tr> <tr><td>Odor:</td><td>None</td></tr> <tr><td>Turbidity:</td><td>None</td></tr> <tr><td>Color:</td><td>None</td></tr> <tr><td>Gross Solids:</td><td>Slight</td></tr> <tr><td>Vegetation:</td><td>None</td></tr> <tr><td>Benthic Growth:</td><td>None</td></tr> <tr><td>Stains:</td><td>None</td></tr> <tr><td>Non-illicit:</td><td>None</td></tr> </table>		Floatables:	None	Odor:	None	Turbidity:	None	Color:	None	Gross Solids:	Slight	Vegetation:	None	Benthic Growth:	None	Stains:	None	Non-illicit:	None	Condition Assessment <table border="1" style="width:100%; border-collapse: collapse;"> <tr><td>Graffiti:</td><td>None</td></tr> <tr><td>Erosion:</td><td>None</td></tr> <tr><td>Deposition:</td><td>None in.</td></tr> <tr><td>Damage:</td><td>None</td></tr> </table>		Graffiti:	None	Erosion:	None	Deposition:	None in.

Sample Location:	Pool																																														
Total Chlorine:	0 ppm																																														
Free Chlorine:	0 ppm																																														
Ammonia:	0 ppm																																														
pH:	8.3 units																																														
Temperature:	74 °F																																														
Conductivity:	419 µS/cm																																														
Detergents:	0 mg/L																																														
Floatables:	None																																														
Odor:	None																																														
Turbidity:	None																																														
Color:	None																																														
Gross Solids:	Slight																																														
Vegetation:	None																																														
Benthic Growth:	None

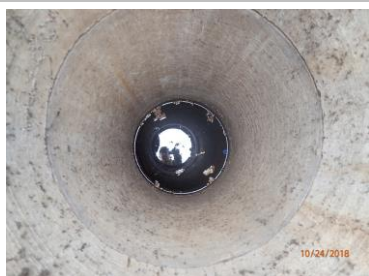
<p style="text-align: center;">o20181024092322.JPG</p> <p style="text-align: center; font-size: 24pt; font-weight: bold;">2018</p>																																									
Submerged: Fully		Depth (in): 44		Sample collected from submerged pool in manhole. Floating gross solids (litter) in manhole.																																											
Sampling Results <table border="1" style="width:100%; border-collapse: collapse;"> <tr><td>Sample Location:</td><td>Pool</td></tr> <tr><td>Total Chlorine:</td><td>0 ppm</td></tr> <tr><td>Free Chlorine:</td><td>0 ppm</td></tr> <tr><td>Ammonia:</td><td>0 ppm</td></tr> <tr><td>pH:</td><td>7.4 units</td></tr> <tr><td>Temperature:</td><td>52 °F</td></tr> <tr><td>Conductivity:</td><td>714 µS/cm</td></tr> <tr><td>Detergents:</td><td>0 mg/L</td></tr> </table>		Sample Location:	Pool	Total Chlorine:	0 ppm			Free Chlorine:	0 ppm	Ammonia:	0 ppm	pH:	7.4 units	Temperature:	52 °F	Conductivity:	714 µS/cm	Detergents:	0 mg/L	<table border="1" style="width:100%; border-collapse: collapse;"> <tr><td>Floatables:</td><td>None</td></tr> <tr><td>Odor:</td><td>None</td></tr> <tr><td>Turbidity:</td><td>None</td></tr> <tr><td>Color:</td><td>None</td></tr> <tr><td>Gross Solids:</td><td>Slight</td></tr> <tr><td>Vegetation:</td><td>None</td></tr> <tr><td>Benthic Growth:</td><td>None</td></tr> <tr><td>Stains:</td><td>None</td></tr> <tr><td>Non-illicit:</td><td>None</td></tr> </table>		Floatables:	None	Odor:	None	Turbidity:	None	Color:	None	Gross Solids:	Slight	Vegetation:	None	Benthic Growth:	None	Stains:	None	Non-illicit:	None	Condition Assessment <table border="1" style="width:100%; border-collapse: collapse;"> <tr><td>Graffiti:</td><td>None</td></tr> <tr><td>Erosion:</td><td>None</td></tr> <tr><td>Deposition:</td><td>None in.</td></tr> <tr><td>Damage:</td><td>None</td></tr> </table>		Graffiti:	None	Erosion:	None	Deposition:	None in.

Sample Location:	Pool																																														
Total Chlorine:	0 ppm																																														
Free Chlorine:	0 ppm																																														
Ammonia:	0 ppm																																														
pH:	7.4 units																																														
Temperature:	52 °F																																														
Conductivity:	714 µS/cm																																														
Detergents:	0 mg/L																																														
Floatables:	None																																														
Odor:	None																																														
Turbidity:	None																																														
Color:	None																																														
Gross Solids:	Slight																																														
Vegetation:	None																																														
Benthic Growth:	None

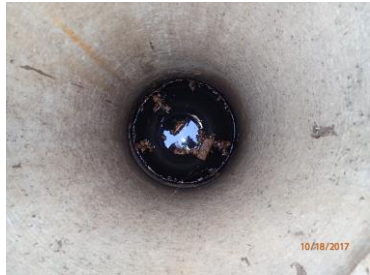
Inspection Date: 10/18/2017 10:20:25 AM		Type: Ongoing		Flow: Submerged, indeterminate		Previous Rainfall (hrs): 72+	
Illicit Discharge Potential: Potential		Inspector: JCW		Notes Sample collected from submerged pool in manhole. Floating gross solids (litter) in manhole.

o20171018101542.JPG	
Submerged: Fully		Depth (in): 39					
Sampling Results Sample Location: Pool Total Chlorine: 0 ppm Free Chlorine: 0 ppm Ammonia: 0 ppm pH: 7.44 units Temperature: 65 °F Conductivity: 1118 µS/cm Detergents: 0 mg/L		Floatables: None Odor: None Turbidity: None Color: None Gross Solids: Moderate Vegetation: None Benthic Growth: None Stains: None Non-illicit: None		Condition Assessment Graffiti: None Erosion: None Deposition: None in. Damage: None		<div style="text-align: center; font-size: 2em; font-weight: bold;">2017</div>

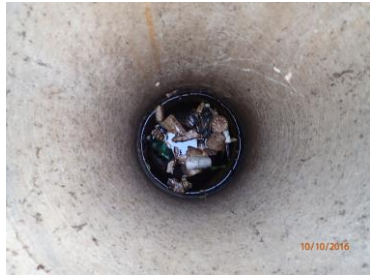
Inspection Date: 10/10/2016 1:30:04 PM		Type: Ongoing		Flow: Submerged, indeterminate		Previous Rainfall (hrs): 72+	
Illicit Discharge Potential: Potential		Inspector: JCW		Notes Potential illicit discharge due to gross solids.

o20161010132718.JPG	
Submerged: Fully		Depth (in): 38					
Sampling Results Sample Location: Pool Total Chlorine: 0 ppm Free Chlorine: 0 ppm Ammonia: 0 ppm pH: 7.41 units Temperature: 69 °F Conductivity: 616 µS/cm Detergents: 0 mg/L		Floatables: None Odor: None Turbidity: Slight cloudiness Color: Clearly visible in bottl Gross Solids: Moderate Vegetation: None Benthic Growth: None Stains: None Non-illicit: None		Condition Assessment Graffiti: None Erosion: None Deposition: None in. Damage: None		<div style="text-align: center; font-size: 2em; font-weight: bold;">2016</div>

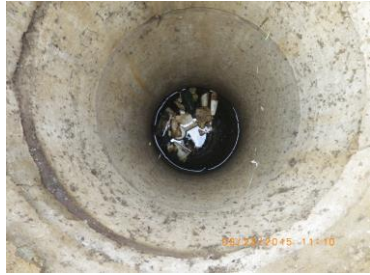
Inspection Date: 9/23/2015 11:06:51 AM		Type: Ongoing		Flow: Submerged, indeterminate		Previous Rainfall (hrs): 72+	
Illicit Discharge Potential: Potential		Inspector: JCW		Notes Floating gross solids (litter) in manhole.

o20150923101026.JPG	
Submerged: Fully		Depth (in): 40					
Sampling Results Sample Location: Pool Total Chlorine: 0 ppm Free Chlorine: 0 ppm Ammonia: 0 ppm pH: 7.5 units Temperature: 76 °F Conductivity: 441 µS/cm Detergents: 0 mg/L		Floatables: None Odor: None Turbidity: None Color: None Gross Solids: Moderate Vegetation: None Benthic Growth: Slight Stains: None Non-illicit: None		Condition Assessment Graffiti: None Erosion: None Deposition: None in. Damage: None		<div style="text-align: center; font-size: 2em; font-weight: bold;">2015</div>

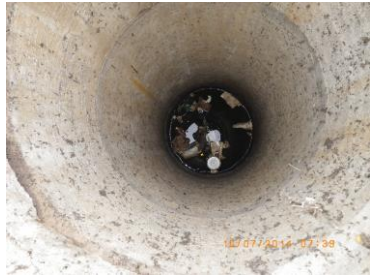
Inspection Date: 10/7/2014 7:39:34 AM		Type: Ongoing		Flow: Submerged, indeterminate		Previous Rainfall (hrs): 48-72	
Illicit Discharge Potential: Potential		Inspector: JCW		Notes Floating gross solids (litter) in manhole.

o20141007063948.JPG	
Submerged: Fully		Depth (in): 34					
Sampling Results Sample Location: Pool Total Chlorine: 0 ppm Free Chlorine: 0 ppm Ammonia: 0 ppm pH: 7.66 units Temperature: 59 °F Conductivity: 771 µS/cm Detergents: 0 mg/L		Floatables: None Odor: None Turbidity: None Color: None Gross Solids: Moderate Vegetation: None Benthic Growth: None Stains: None Non-illicit: None		Condition Assessment Graffiti: None Erosion: None Deposition: None in. Damage: None		<div style="text-align: center; font-size: 2em; font-weight: bold;">2014</div>

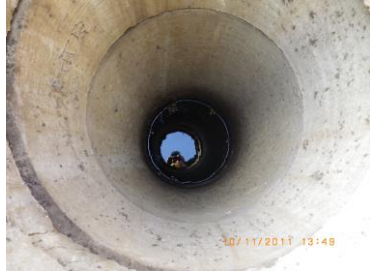
2011

Inspection Date: 10/11/2011 1:51:24 PM		Type: Ongoing	Flow: Submerged, indeterminate	Previous Rainfall (hrs): 72+
Illicit Discharge Potential: Unlikely		Inspector: JCW	Notes	
Submerged: Fully		Depth (in): 32	2010 screening follow-up. Floatable debris significantly reduced.	
Sampling Results		Condition Assessment		
Sample Location: Pool	Floatables:	None		
Total Chlorine: 0 ppm	Odor:	None		
Free Chlorine: 0 ppm	Turbidity:	None		
Ammonia: 0 ppm	Color:	None		
pH: 8.63 units	Gross Solids:	None		
Temperature 73 °F	Vegetation:	None		
Conductivity: -- µS/cm	Benthic Growth:	None		
Detergents: -- mg/L	Stains:	None		
	Non-illicit:	None		
		Graffiti:	None	
		Erosion:	None	
		Deposition:	None 0 in.	
		Damage:	None

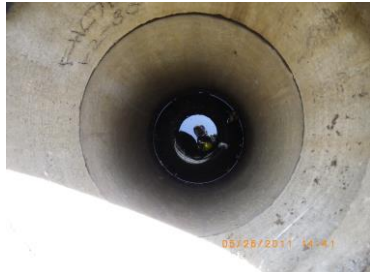
2011

Inspection Date: 5/26/2011 2:40:00 PM		Type: Other	Flow: Submerged, indeterminate	Previous Rainfall (hrs): 72+
Illicit Discharge Potential: Unlikely		Inspector: JCW	Notes	
Submerged: Fully		Depth (in):	Limited screening conducted to check for floatable debris.	
Sampling Results		Condition Assessment		
Sample Location:	Floatables:	None		
Total Chlorine: -- ppm	Odor:			
Free Chlorine: -- ppm	Turbidity:			
Ammonia: -- ppm	Color:			
pH: -- units	Gross Solids:	None		
Temperature -- °F	Vegetation:			
Conductivity: -- µS/cm	Benthic Growth:			
Detergents: -- mg/L	Stains:			
	Non-illicit:	None		
		Graffiti:	None	
		Erosion:	None	
		Deposition:	None 0 in.	
		Damage:	None

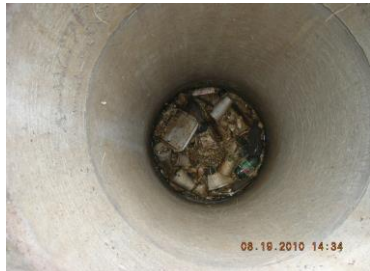
2010

Inspection Date: 8/19/2010 2:41:43 PM		Type: Ongoing	Flow: Submerged, indeterminate	Previous Rainfall (hrs): 72+
Illicit Discharge Potential: Potential		Inspector: JCW	Notes	
Submerged: Fully		Depth (in): 38	Severe floatable debris	
Sampling Results		Condition Assessment		
Sample Location: Pool	Floatables:	None		
Total Chlorine: 0 ppm	Odor:	None		
Free Chlorine: 0 ppm	Turbidity:	None		
Ammonia: 0 ppm	Color:	Faint in bottle		
pH: 7.59 units	Gross Solids:	Severe		
Temperature 79 °F	Vegetation:	None		
Conductivity: -- µS/cm	Benthic Growth:	None		
Detergents: 0 mg/L	Stains:	Slight		
	Non-illicit:	None		
		Graffiti:	None	
		Erosion:	None	
		Deposition:	None 0 in.	
		Damage:	None

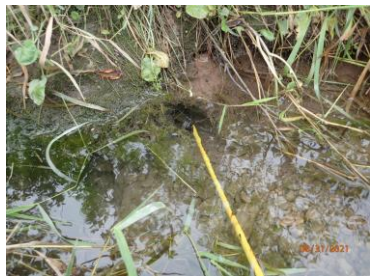
o20210831074728.JPG <div style="text-align: center; font-size: 24pt; font-weight: bold;">2021</div>

Inspection Date: 8/31/2021 7:49:46 AM		Type: Ongoing	Flow: Submerged, significant flow	Previous Rainfall (hrs): 48-72
Illicit Discharge Potential: Unlikely		Inspector: JCW		
Submerged: Fully		Depth (in):		
Sampling Results		<div style="display: flex; justify-content: space-between;"> <div> <p>Sample Location: Flow</p> <p>Total Chlorine: 0 ppm</p> <p>Free Chlorine: 0 ppm</p> <p>Ammonia: 0 ppm</p> <p>pH: 6.98 units</p> <p>Temperature: 71 °F</p> <p>Conductivity: 1980 µS/cm</p> <p>Detergents: 0 mg/L</p> </div> <div> <p>Floatables: None</p> <p>Odor: None</p> <p>Turbidity: None</p> <p>Color: None</p> <p>Gross Solids: None</p> <p>Vegetation: None</p> <p>Benthic Growth: Moderate</p> <p>Stains: None</p> <p>Non-illicit: None</p> </div> </div>		
		<div style="display: flex; justify-content: space-between;"> <div> <p>Notes</p> <p>Sample collected from concentrated flow immediately downstream of pipe.</p> </div> <div> <p>Condition Assessment</p> <p>Graffiti: None</p> <p>Erosion: None</p> <p>Deposition: Moderate 16 in.</p> <p>Damage: None</p> </div> </div>

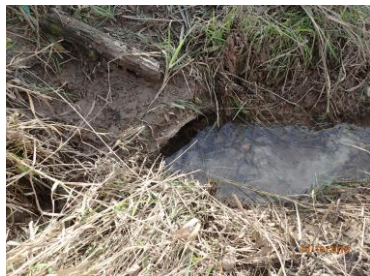
o20161019150326.JPG <div style="text-align: center; font-size: 24pt; font-weight: bold;">2016</div>

Inspection Date: 10/19/2016 3:04:11 PM		Type: Ongoing	Flow: Submerged, slight flow	Previous Rainfall (hrs): 72+
Illicit Discharge Potential: Unlikely		Inspector: JCW		
Submerged: Partially		Depth (in): 22		
Sampling Results		<div style="display: flex; justify-content: space-between;"> <div> <p>Sample Location:</p> <p>Total Chlorine: -- ppm</p> <p>Free Chlorine: -- ppm</p> <p>Ammonia: -- ppm</p> <p>pH: -- units</p> <p>Temperature: -- °F</p> <p>Conductivity: -- µS/cm</p> <p>Detergents: -- mg/L</p> </div> <div> <p>Floatables: None</p> <p>Odor: None</p> <p>Turbidity: None</p> <p>Color: None</p> <p>Gross Solids: None</p> <p>Vegetation: None</p> <p>Benthic Growth: None</p> <p>Stains: None</p> <p>Non-illicit: None</p> </div> </div>		
		<div style="display: flex; justify-content: space-between;"> <div> <p>Notes</p> <p>Outfall partially submerged - screened upstream at 13-1098 US1. End of pipe recently excavated.</p> </div> <div> <p>Condition Assessment</p> <p>Graffiti: None</p> <p>Erosion: None</p> <p>Deposition: Severe 16 in.</p> <p>Damage: None</p> </div> </div>

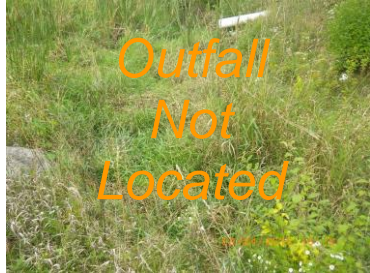
o20150924141536.JPG

Inspection Date: 9/24/2015 3:10:53 PM		Type: Ongoing	Flow: Submerged (not located)	Previous Rainfall (hrs): 72+
Illicit Discharge Potential: Unlikely		Inspector: JCW	Notes	
Submerged: None		Depth (in):	Outfall not located - screened at 13-1098 US1.	
Sampling Results		Condition Assessment		
Sample Location:	Floatables:	None		
Total Chlorine: -- ppm	Odor:	None		
Free Chlorine: -- ppm	Turbidity:	None		
Ammonia: -- ppm	Color:	None		
pH: -- units	Gross Solids:	None		
Temperature -- °F	Vegetation:	None		
Conductivity: -- µS/cm	Benthic Growth:	None		
Detergents: -- mg/L	Stains:	None		
	Non-illicit:	None		
		Graffiti:	None	
		Erosion:	None	
		Deposition:	None	in.
		Damage:	None

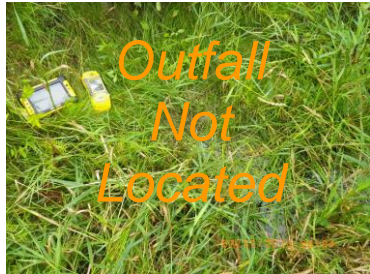
o20130730070410.JPG

Inspection Date: 7/30/2013 7:57:44 AM		Type: Ongoing	Flow: Submerged (not located)	Previous Rainfall (hrs): 72+
Illicit Discharge Potential: Unlikely		Inspector: JCW	Notes	
Submerged: Fully		Depth (in):	Pipe not located in grassy stream bank. Screened upstream at 13-1098 US1.	
Sampling Results		Condition Assessment		
Sample Location:	Floatables:	None		
Total Chlorine: -- ppm	Odor:	None		
Free Chlorine: -- ppm	Turbidity:	None		
Ammonia: -- ppm	Color:	None		
pH: -- units	Gross Solids:	None		
Temperature -- °F	Vegetation:	None		
Conductivity: -- µS/cm	Benthic Growth:	None		
Detergents: -- mg/L	Stains:	None		
	Non-illicit:	None		
		Graffiti:	None	
		Erosion:	None	
		Deposition:	None	in.
		Damage:	None

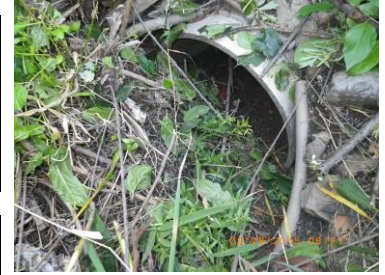
o20150928072150.JPG

Inspection Date: 9/28/2015 8:16:55 AM		Type: Ongoing	Flow: None	Previous Rainfall (hrs): 72+
Illicit Discharge Potential: Unlikely		Inspector: JCW		
Submerged: None		Depth (in):		
Sampling Results		Notes Flowline damp, but no flow at time of inspection. Sediment level with crown of pipe.		
Sample Location:	Floatables:	None		
Total Chlorine: -- ppm	Odor:	None		
Free Chlorine: -- ppm	Turbidity:	None		
Ammonia: -- ppm	Color:	None		
pH: -- units	Gross Solids:	None		
Temperature -- °F	Vegetation:	None		
Conductivity: -- µS/cm	Benthic Growth:	Slight		
Detergents: -- mg/L	Stains:	None		
	Non-illicit:	None		
		Condition Assessment Graffiti: None Erosion: None Deposition: Severe 18 in. Damage: None

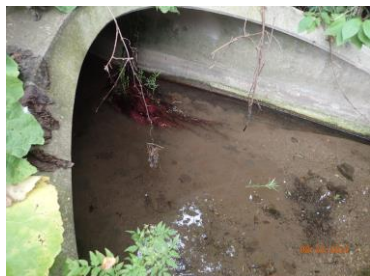
Inspection Date: 8/23/2021 9:30:00 AM		Type: Ongoing	Flow: Submerged, slight flow	Previous Rainfall (hrs): 72+
Illicit Discharge Potential: Unlikely		Inspector: JCW		
Submerged: Partially		Depth (in): 7		
Sampling Results Sample Location: Total Chlorine: 0 ppm Free Chlorine: 0 ppm Ammonia: 0 ppm pH: 7.63 units Temperature: 70 °F Conductivity: 1041 µS/cm Detergents: 0 mg/L		Floatables: None Odor: None Turbidity: None Color: None Gross Solids: None Vegetation: None Benthic Growth: Slight Stains: Slight Non-illicit: None	Notes Sample collected from submerged flow inside pipe. Condition Assessment Graffiti: None Erosion: None Deposition: None in. Damage: None

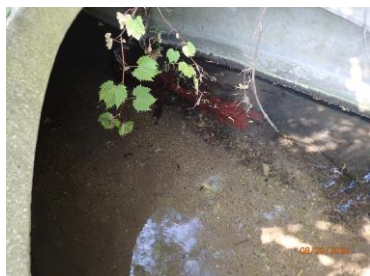
Inspection Date: 8/20/2020 10:49:39 AM		Type: Ongoing	Flow: Submerged, slight flow	Previous Rainfall (hrs): 72+
Illicit Discharge Potential: Unlikely		Inspector: JCW		
Submerged: Partially		Depth (in): 3		
Sampling Results Sample Location: Flow Total Chlorine: 0 ppm Free Chlorine: 0 ppm Ammonia: 0 ppm pH: 8.18 units Temperature: 76 °F Conductivity: 1219 µS/cm Detergents: 0 mg/L		Floatables: None Odor: None Turbidity: None Color: None Gross Solids: None Vegetation: None Benthic Growth: Moderate Stains: Slight Non-illicit: None	Notes Sample collected from concentrated flow immediately downstream from outfall. Condition Assessment Graffiti: None Erosion: None Deposition: None in. Damage: None

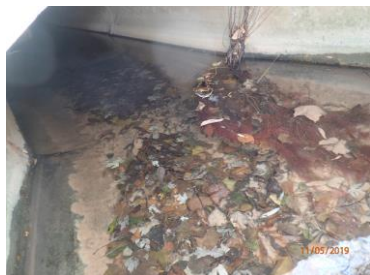
Inspection Date: 11/5/2019 2:05:00 PM		Type: Repeat	Flow: Submerged, indeterminate	Previous Rainfall (hrs): 48-72
Illicit Discharge Potential: Potential		Inspector: JCW		
Submerged: Partially		Depth (in): 19		
Sampling Results Sample Location: Total Chlorine: -- ppm Free Chlorine: -- ppm Ammonia: -- ppm pH: -- units Temperature: -- °F Conductivity: -- µS/cm Detergents: -- mg/L		Floatables: None Odor: None Turbidity: None Color: None Gross Solids: None Vegetation: None Benthic Growth: Slight Stains: None Non-illicit: Slight	Notes Outfall partially submerged - screened upstream at 13-2332 US1. Follow-up inspection for sampling - limited screening conducted. Condition Assessment Graffiti: None Erosion: None Deposition: None in. Damage: None

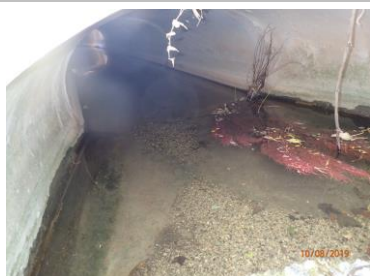
Inspection Date: 10/8/2019 3:09:23 PM		Type: Ongoing	Flow: Submerged, indeterminate	Previous Rainfall (hrs): 48-72
Illicit Discharge Potential: Potential		Inspector: JCW		
Submerged: Partially		Depth (in): 19		
Sampling Results Sample Location: Total Chlorine: -- ppm Free Chlorine: -- ppm Ammonia: -- ppm pH: -- units Temperature: -- °F Conductivity: -- µS/cm Detergents: -- mg/L		Floatables: None Odor: None Turbidity: None Color: None Gross Solids: None Vegetation: None Benthic Growth: Slight Stains: None Non-illicit: Slight	Notes Outfall partially submerged - screened upstream at 13-2332 US1. Detergent detected in upstream manhole. Condition Assessment Graffiti: None Erosion: None Deposition: None in. Damage: None

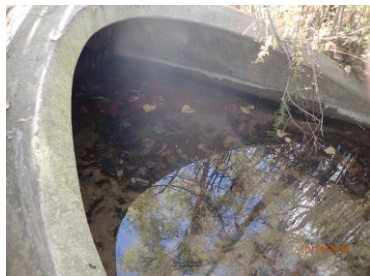
o20181024151710.JPG

Inspection Date: 10/24/2018 3:19:11 PM		Type: Ongoing	Flow: Submerged, slight flow	Previous Rainfall (hrs): 72+
Illicit Discharge Potential: Potential		Inspector: JCW	Notes	
Submerged: Partially Depth (in): 11			Outfall partially submerged - screened upstream at 13-2332 US1. Detergent detected in upstream manhole.	
Sampling Results			Condition Assessment	
Sample Location:	Floatables:	None	Graffiti: None Erosion: None Deposition: None in. Damage: None	
Total Chlorine: -- ppm	Odor:	Faint		
Free Chlorine: -- ppm	Turbidity:	None		
Ammonia: -- ppm	Color:	None		
pH: -- units	Gross Solids:	Moderate		
Temperature -- °F	Vegetation:	None		
Conductivity: -- µS/cm	Benthic Growth:	Slight		
Detergents: -- mg/L	Stains:	Moderate		
	Non-illicit:	None

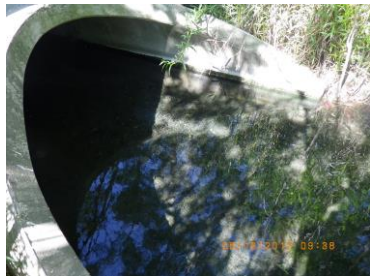
o20120612083850.JPG

Inspection Date: 6/12/2012 9:35:59 AM		Type: Ongoing	Flow: Submerged, slight flow	Previous Rainfall (hrs): 72+
Illicit Discharge Potential: Unlikely		Inspector: JCW	Notes	
Submerged: Partially Depth (in): 14			Outfall partially submerged; screened upstream at 13-2332 US1.	
Sampling Results			Condition Assessment	
Sample Location:	Floatables:	None	Graffiti: None Erosion: None Deposition: None in. Damage: None	
Total Chlorine: -- ppm	Odor:	None		
Free Chlorine: -- ppm	Turbidity:	None		
Ammonia: -- ppm	Color:	None		
pH: -- units	Gross Solids:	Slight		
Temperature -- °F	Vegetation:	None		
Conductivity: -- µS/cm	Benthic Growth:	Moderate		
Detergents: -- mg/L	Stains:	None		
	Non-illicit:	None

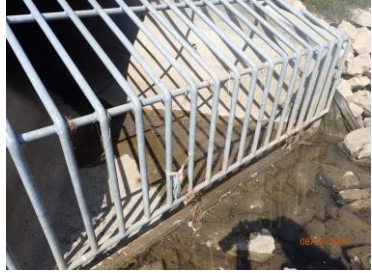
2017

Inspection Date: 8/23/2021 2:58:26 PM		Type: Ongoing	Flow: Trickle	Previous Rainfall (hrs): 72+
Illicit Discharge Potential: Unlikely		Inspector: JCW		
Submerged: None		Depth (in):		
Sampling Results		Notes		
Sample Location:		Sample collected from pipe flow.		
Total Chlorine:	0 ppm	Floatables:	None	
Free Chlorine:	0 ppm	Odor:	None	
Ammonia:	0 ppm	Turbidity:	None	
pH:	7.31 units	Color:	None	
Temperature:	82 °F	Gross Solids:	None	
Conductivity:	1720 µS/cm	Vegetation:	None	
Detergents:	0 mg/L	Benthic Growth:	Slight	
		Stains:	Slight	
		Non-illicit:	Slight	
		Condition Assessment		
		Graffiti:	None	
		Erosion:	None	
		Deposition:	None in.	
		Damage:	None

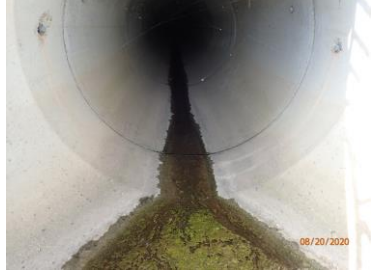
o20200820160626.JPG

Inspection Date: 8/20/2020 4:09:06 PM		Type: Ongoing	Flow: Trickle	Previous Rainfall (hrs): 72+
Illicit Discharge Potential: Unlikely		Inspector: JCW		
Submerged: None		Depth (in):		
Sampling Results		Notes		
Sample Location: Flow		Sample collected from pipe flow.		
Total Chlorine:	0 ppm	Floatables:	Moderate	
Free Chlorine:	0 ppm	Odor:	None	
Ammonia:	0 ppm	Turbidity:	None	
pH:	7.91 units	Color:	None	
Temperature:	79 °F	Gross Solids:	None	
Conductivity:	1889 µS/cm	Vegetation:	None	
Detergents:	0 mg/L	Benthic Growth:	Moderate	
		Stains:	Slight	
		Non-illicit:	None	
		Condition Assessment		
		Graffiti:	None	
		Erosion:	None	
		Deposition:	None in.	
		Damage:	None

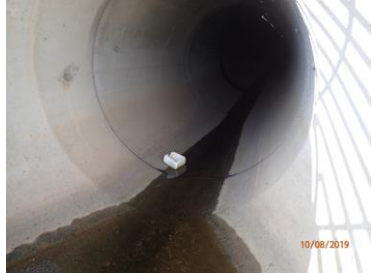
o20191008145924.JPG

Inspection Date: 10/8/2019 4:01:14 PM		Type: Ongoing	Flow: Moderate	Previous Rainfall (hrs): 48-72
Illicit Discharge Potential: Potential		Inspector: JCW		
Submerged: None		Depth (in):		
Sampling Results		Notes		
Sample Location: Flow		Sample collected from submerged flow at end of pipe. Elevated conductivity.		
Total Chlorine:	0 ppm	Floatables:	None	
Free Chlorine:	0 ppm	Odor:	None	
Ammonia:	0 ppm	Turbidity:	None	
pH:	7.66 units	Color:	None	
Temperature:	65 °F	Gross Solids:	None	
Conductivity:	2470 µS/cm	Vegetation:	None	
Detergents:	0 mg/L	Benthic Growth:	Moderate	
		Stains:	None	
		Non-illicit:	None	
		Condition Assessment		
		Graffiti:	None	
		Erosion:	None	
		Deposition:	None in.	
		Damage:	None

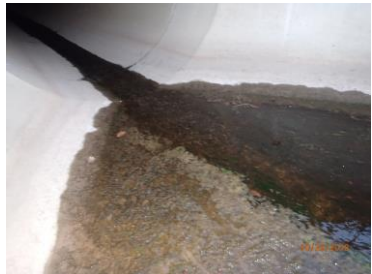
o20181025072226.JPG

Inspection Date: 10/26/2018 12:50:27 PM		Type: Repeat	Flow: Trickle	Previous Rainfall (hrs): 72+
Illicit Discharge Potential: Potential		Inspector: KMK		
Submerged: None		Depth (in):		
Sampling Results		Notes		
Sample Location: Flow		Detergent detection follow-up. Limited screening conducted beyond sampling.		
Total Chlorine:	0 ppm	Floatables:	Slight	
Free Chlorine:	0 ppm	Odor:	None	
Ammonia:	0 ppm	Turbidity:	None	
pH:	7.91 units	Color:	None	
Temperature:	56 °F	Gross Solids:	None	
Conductivity:	1745 µS/cm	Vegetation:	None	
Detergents:	0.85 mg/L	Benthic Growth:	None	
		Stains:	Slight	
		Non-illicit:	None	
		Condition Assessment		
		Graffiti:	None	
		Erosion:	None	
		Deposition:	None in.	
		Damage:	None

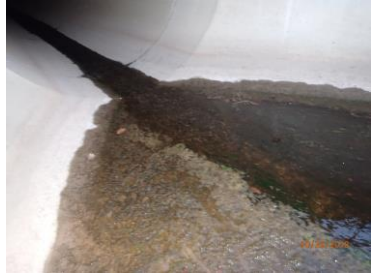
o20181025072226.JPG <div style="text-align: right; font-size: 24pt; font-weight: bold;">2018</div>

Inspection Date: 10/25/2018 7:24:13 AM		Type: Ongoing	Flow: Trickle	Previous Rainfall (hrs): 72+
Illicit Discharge Potential: Potential		Inspector: JCW	Notes	
Submerged: None		Depth (in):	Sample collected from submerged flow at end of pipe. Detergent detected.	
Sampling Results Sample Location: Flow Total Chlorine: 0 ppm Free Chlorine: 0 ppm Ammonia: 0 ppm pH: 7.94 units Temperature: 49 °F Conductivity: 1865 µS/cm Detergents: 0.45 mg/L		Floatables: Slight Odor: None Turbidity: None Color: None Gross Solids: None Vegetation: None Benthic Growth: Moderate Stains: Slight Non-illicit: None	Condition Assessment Graffiti: None Erosion: None Deposition: None in. Damage: None

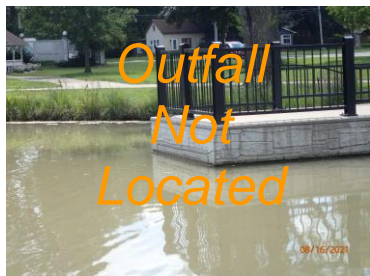
Inspection Date: 8/16/2021 1:47:39 PM		Type: Ongoing	Flow: Submerged (not located)	Previous Rainfall (hrs): 72+
Illicit Discharge Potential: Unlikely		Inspector: JCW		
Submerged: Fully		Depth (in):		
Sampling Results Sample Location: _____ Total Chlorine: -- ppm Free Chlorine: -- ppm Ammonia: -- ppm pH: -- units Temperature: -- °F Conductivity: -- µS/cm Detergents: -- mg/L		Floatables: None Odor: None Turbidity: None Color: None Gross Solids: None Vegetation: None Benthic Growth: None Stains: None Non-illicit: None	Notes Outfall fully submerged and not located - screened upstream at 13-4012 US1.

o20210816134612.JPG 2021
		Condition Assessment Graffiti: None Erosion: None Deposition: None in. Damage: None

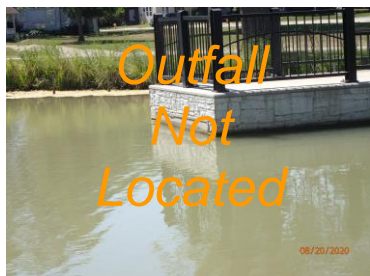
Inspection Date: 8/20/2020 12:23:12 PM		Type: Ongoing	Flow: Submerged (not located)	Previous Rainfall (hrs): 72+
Illicit Discharge Potential: Unlikely		Inspector: JCW		
Submerged: Fully		Depth (in):		
Sampling Results Sample Location: _____ Total Chlorine: -- ppm Free Chlorine: -- ppm Ammonia: -- ppm pH: -- units Temperature: -- °F Conductivity: -- µS/cm Detergents: -- mg/L		Floatables: None Odor: None Turbidity: None Color: None Gross Solids: None Vegetation: None Benthic Growth: None Stains: None Non-illicit: None	Notes Outfall fully submerged and not located - screened upstream at 13-2957 US1.

o20200820122132.JPG 2020
		Condition Assessment Graffiti: None Erosion: None Deposition: None in. Damage: None

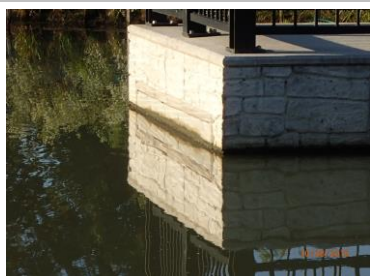
Inspection Date: 10/8/2019 8:14:46 AM		Type: Repeat	Flow: Submerged, indeterminate	Previous Rainfall (hrs): 48-72
Illicit Discharge Potential: Unlikely		Inspector: JCW		
Submerged: Fully		Depth (in):		
Sampling Results Sample Location: _____ Total Chlorine: -- ppm Free Chlorine: -- ppm Ammonia: -- ppm pH: -- units Temperature: -- °F Conductivity: -- µS/cm Detergents: -- mg/L		Floatables: None Odor: None Turbidity: None Color: None Gross Solids: None Vegetation: None Benthic Growth: None Stains: None Non-illicit: None	Notes Detergent detection follow-up. Limited screening conducted beyond sampling. No detergent in follow-up sample.

o20191008071216.JPG 2019
		Condition Assessment Graffiti: None Erosion: None Deposition: None in. Damage: None

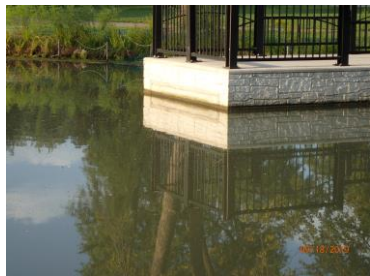
o20190918063134.JPG

Inspection Date: 9/18/2019 7:32:53 AM		Type: Ongoing	Flow: Submerged, indeterminate	Previous Rainfall (hrs): 72+
Illicit Discharge Potential: Potential		Inspector: JCW	Notes	
Submerged: Fully		Depth (in):	Outfall inaccessible - screened upstream at 13-2957 US1a. Detergent in upstream manhole.	
Sampling Results		Floatables:	Condition Assessment Graffiti: None Erosion: None Deposition: None in. Damage: None	
Sample Location:		Odor:		
Total Chlorine: -- ppm		Turbidity:		
Free Chlorine: -- ppm		Color:		
Ammonia: -- ppm		Gross Solids:		
pH: -- units		Vegetation:		
Temperature -- °F		Benthic Growth:		
Conductivity: -- µS/cm		Stains:		
Detergents: -- mg/L		Non-illicit:

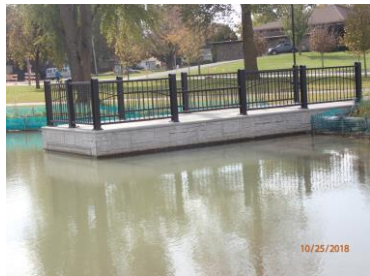
o20181025131742.JPG

Inspection Date: 10/25/2018 1:17:00 PM		Type: Ongoing	Flow: Submerged, indeterminate	Previous Rainfall (hrs): 72+
Illicit Discharge Potential: Unlikely		Inspector: JCW	Notes	
Submerged: Partially		Depth (in):	Outfall inaccessible - screened upstream at 13-2957 US1a.	
Sampling Results		Floatables:	Condition Assessment Graffiti: None Erosion: None Deposition: None in. Damage: None	
Sample Location:		Odor:		
Total Chlorine: -- ppm		Turbidity:		
Free Chlorine: -- ppm		Color:		
Ammonia: -- ppm		Gross Solids:		
pH: -- units		Vegetation:		
Temperature -- °F		Benthic Growth:		
Conductivity: -- µS/cm		Stains:		
Detergents: -- mg/L		Non-illicit:

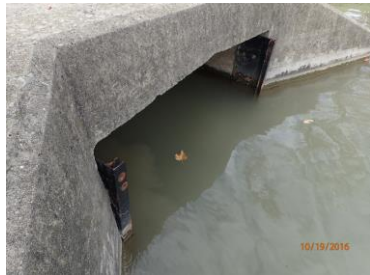
o20161019134018.JPG

Inspection Date: 10/19/2016 1:42:21 PM		Type: Ongoing	Flow: Submerged, indeterminate	Previous Rainfall (hrs): 72+
Illicit Discharge Potential: Unlikely		Inspector: JCW	Notes	
Submerged: Partially		Depth (in): 19	Outfall partially submerged - screened upstream at 13-2957 US1.	
Sampling Results		Floatables:	Condition Assessment Graffiti: None Erosion: None Deposition: None in. Damage: None	
Sample Location:		Odor:		
Total Chlorine: -- ppm		Turbidity:		
Free Chlorine: -- ppm		Color:		
Ammonia: -- ppm		Gross Solids:		
pH: -- units		Vegetation:		
Temperature -- °F		Benthic Growth:		
Conductivity: -- µS/cm		Stains:		
Detergents: -- mg/L		Non-illicit:

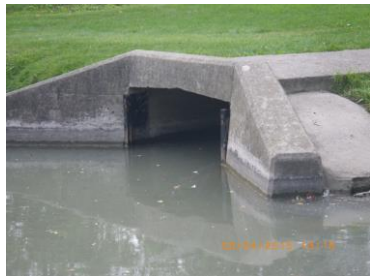
o20150924121536.JPG

Inspection Date: 9/24/2015 1:12:45 PM		Type: Ongoing	Flow: Submerged, indeterminate	Previous Rainfall (hrs): 72+
Illicit Discharge Potential: Unlikely		Inspector: JCW	Notes	
Submerged: Partially		Depth (in): 17	Outfall partially submerged - screened at 13-2957 US1.	
Sampling Results		Floatables:	Condition Assessment Graffiti: None Erosion: None Deposition: None in. Damage: None	
Sample Location:		Odor:		
Total Chlorine: -- ppm		Turbidity:		
Free Chlorine: -- ppm		Color:		
Ammonia: -- ppm		Gross Solids:		
pH: -- units		Vegetation:		
Temperature -- °F		Benthic Growth:		
Conductivity: -- µS/cm		Stains:		
Detergents: -- mg/L		Non-illicit:

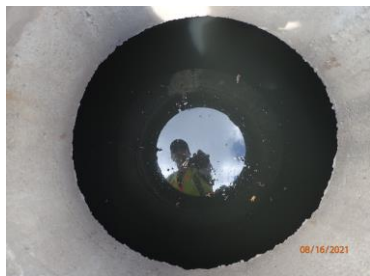
Inspection Date: 8/16/2021 1:50:23 PM		Type: Ongoing	Flow: Submerged, indeterminate	Previous Rainfall (hrs): 72+
Illicit Discharge Potential: Unlikely		Inspector: JCW		
Submerged: Fully		Depth (in): 72		
Sampling Results Sample Location: Pool Total Chlorine: 0 ppm Free Chlorine: 0 ppm Ammonia: 0 ppm pH: 7.4 units Temperature: 77 °F Conductivity: 1233 µS/cm Detergents: 0 mg/L		Floatables: None Odor: None Turbidity: Slight cloudiness Color: None Gross Solids: None Vegetation: None Benthic Growth: None Stains: None Non-illicit: None	Notes Sample collected from submerged pool in manhole.

o20210816134742.JPG <div style="text-align: center; font-size: 24pt; font-weight: bold;">2021</div>
			Condition Assessment Graffiti: None Erosion: None Deposition: None in. Damage: None

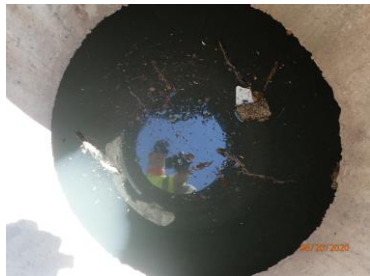
Inspection Date: 8/20/2020 12:29:26 PM		Type: Ongoing	Flow: Submerged, indeterminate	Previous Rainfall (hrs): 72+
Illicit Discharge Potential: Unlikely		Inspector: JCW		
Submerged: Fully		Depth (in): 57		
Sampling Results Sample Location: Pool Total Chlorine: 0 ppm Free Chlorine: 0 ppm Ammonia: 0 ppm pH: 7.88 units Temperature: 81 °F Conductivity: 1350 µS/cm Detergents: 0 mg/L		Floatables: None Odor: None Turbidity: None Color: None Gross Solids: Slight Vegetation: None Benthic Growth: None Stains: None Non-illicit: None	Notes Sample collected from submerged pool in manhole.

o20200820122308.JPG <div style="text-align: center; font-size: 24pt; font-weight: bold;">2020</div>
			Condition Assessment Graffiti: None Erosion: None Deposition: None in. Damage: None

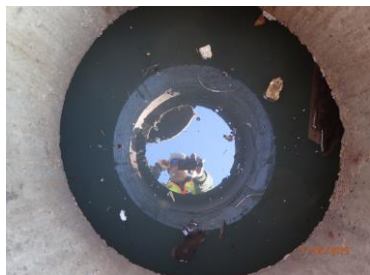
Inspection Date: 11/5/2019 1:33:38 PM		Type: Repeat	Flow: Submerged, indeterminate	Previous Rainfall (hrs): 48-72
Illicit Discharge Potential: Potential		Inspector: JCW		
Submerged: Partially		Depth (in): 71		
Sampling Results Sample Location: Pool Total Chlorine: -- ppm Free Chlorine: -- ppm Ammonia: -- ppm pH: -- units Temperature: -- °F Conductivity: -- µS/cm Detergents: 0.6 mg/L		Floatables: None Odor: None Turbidity: None Color: None Gross Solids: None Vegetation: None Benthic Growth: None Stains: None Non-illicit: None	Notes Follow-up inspection for sampling - limited screening conducted. Detergent in follow-up sample.

o20191105133254.JPG <div style="text-align: center; font-size: 24pt; font-weight: bold;">2019</div>
			Condition Assessment Graffiti: None Erosion: None Deposition: None in. Damage: None

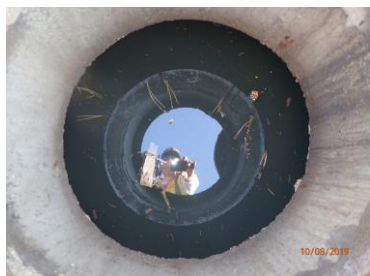
Inspection Date: 10/8/2019 8:16:29 AM		Type: Repeat	Flow: Submerged, indeterminate	Previous Rainfall (hrs): 48-72
Illicit Discharge Potential: Unlikely		Inspector: JCW		
Submerged: Partially		Depth (in): 72		
Sampling Results Sample Location: Flow Total Chlorine: 0 ppm Free Chlorine: 0 ppm Ammonia: 0 ppm pH: 7.65 units Temperature: 55 °F Conductivity: 1354 µS/cm Detergents: 0 mg/L		Floatables: None Odor: None Turbidity: None Color: None Gross Solids: Slight Vegetation: None Benthic Growth: None Stains: None Non-illicit: None	Notes Detergent detection follow-up. Limited screening conducted beyond sampling. No detergent in follow-up sample.

o20191008071514.JPG <div style="text-align: center; font-size: 24pt; font-weight: bold;">2019</div>
			Condition Assessment Graffiti: None Erosion: None Deposition: None in. Damage: None

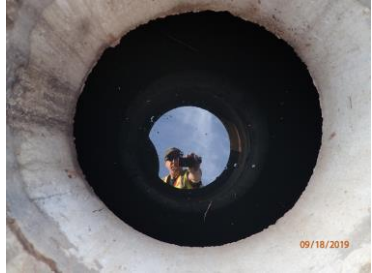
o20190918063424.JPG

Inspection Date: 9/18/2019 7:36:33 AM		Type: Ongoing	Flow: Submerged, indeterminate	Previous Rainfall (hrs): 72+
Illicit Discharge Potential: Potential		Inspector: JCW	Notes	
Submerged: Fully		Depth (in): 71	Sample collected from submerged pool in manhole. Detergent detected in sample.	
Sampling Results		Condition Assessment		
Sample Location: Pool	Floatables: None	Graffiti: None Erosion: None Deposition: None in. Damage: None		
Total Chlorine: 0 ppm	Odor: None			
Free Chlorine: 0 ppm	Turbidity: None			
Ammonia: 0 ppm	Color: None			
pH: 7.9 units	Gross Solids: None			
Temperature 70 °F	Vegetation: None			
Conductivity: 1265 µS/cm	Benthic Growth: None			
Detergents: 0.75 mg/L	Stains: None			
	Non-illicit: None

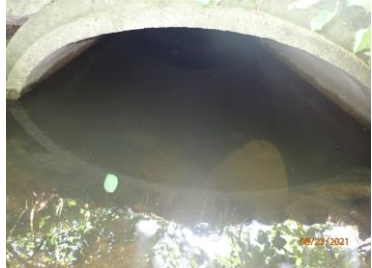
Inspection Date: 8/23/2021 3:10:59 PM		Type: Ongoing	Flow: Submerged, slight flow	Previous Rainfall (hrs): 72+
Illicit Discharge Potential: Potential		Inspector: JCW		
Submerged: Partially		Depth (in): 17		
Sampling Results Sample Location: Flow Total Chlorine: 0 ppm Free Chlorine: 0 ppm Ammonia: 0 ppm pH: 7.81 units Temperature: 79 °F Conductivity: 1140 µS/cm Detergents: 1 mg/L		Floatables: None Odor: None Turbidity: None Color: None Gross Solids: Slight Vegetation: None Benthic Growth: None Stains: None Non-illicit: None	Notes Severe channel erosion downstream of pipe. Sample collected from submerged flow. Detergent detected in sample.

o20210823151038.JPG
		Condition Assessment Graffiti: None Erosion: Severe Deposition: None in. Damage: None

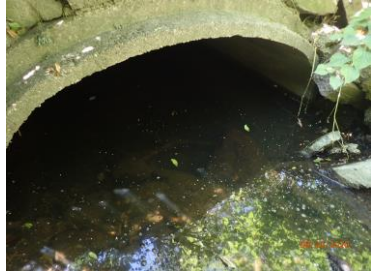
Inspection Date: 8/20/2020 12:09:18 PM		Type: Ongoing	Flow: Submerged, no flow	Previous Rainfall (hrs): 72+
Illicit Discharge Potential: Potential		Inspector: JCW		
Submerged: Partially		Depth (in): 24		
Sampling Results Sample Location: Pool Total Chlorine: 0 ppm Free Chlorine: 0 ppm Ammonia: 0 ppm pH: 7.76 units Temperature: 81 °F Conductivity: 453 µS/cm Detergents: 0.6 mg/L		Floatables: Moderate Odor: None Turbidity: None Color: None Gross Solids: None Vegetation: None Benthic Growth: Moderate Stains: None Non-illicit: None	Notes No flow appears to be leaving pool at end of outfall. Sample collected from pool -detergent detected.

o20200820121004.JPG
		Condition Assessment Graffiti: None Erosion: Moderate Deposition: Moderate 12 in. Damage: None

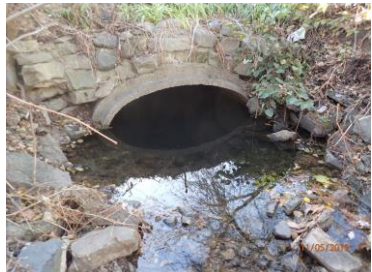
Inspection Date: 11/5/2019 2:27:14 PM		Type: Repeat	Flow: Submerged, indeterminate	Previous Rainfall (hrs): 48-72
Illicit Discharge Potential: Potential		Inspector: JCW		
Submerged: Partially		Depth (in): 20		
Sampling Results Sample Location: Pool Total Chlorine: -- ppm Free Chlorine: -- ppm Ammonia: -- ppm pH: 8.18 units Temperature: 45 °F Conductivity: 680 µS/cm Detergents: 0.8 mg/L		Floatables: None Odor: None Turbidity: None Color: None Gross Solids: None Vegetation: None Benthic Growth: None Stains: None Non-illicit: None	Notes Follow-up inspection for sampling - limited screening conducted. pH in normal range; detergent detected.

o20191105142746.JPG
		Condition Assessment Graffiti: None Erosion: None Deposition: None in. Damage: None

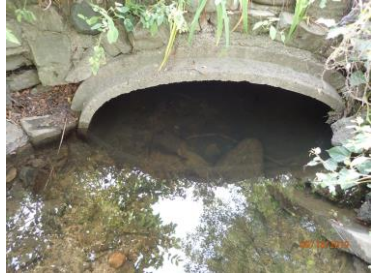
Inspection Date: 9/18/2019 3:16:56 PM		Type: Ongoing		Flow: Submerged, slight flow		Previous Rainfall (hrs): 72+	
Illicit Discharge Potential: Potential		Inspector: JCW		Notes

o20190918141444.JPG	
Submerged: Partially		Depth (in): 20		Downstream bank erosion. Sample collected from submerged flow in pipe. High pH detected.			
Sampling Results				Condition Assessment			
Sample Location: Flow		Floatables:	None	Graffiti: None		2019	
Total Chlorine: 0 ppm		Odor:	None	Erosion: Severe			
Free Chlorine: 0 ppm		Turbidity:	None	Deposition: None in.			
Ammonia: 0 ppm		Color:	None	Damage: None			
pH: 9.27 units		Gross Solids:	None				
Temperature 77 °F		Vegetation:	None				
Conductivity: 368 µS/cm		Benthic Growth:	Moderate				
Detergents: 0 mg/L		Stains:	Slight				
		Non-illicit:	None

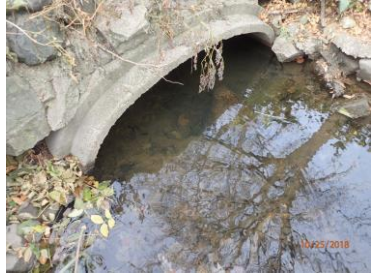
Inspection Date: 10/26/2018 1:26:25 PM		Type: Repeat		Flow: Submerged, significant flow		Previous Rainfall (hrs): 72+	
Illicit Discharge Potential: Potential		Inspector: KMK		Notes

o20181025093132.JPG	
Submerged: Partially		Depth (in): 26		Detergent detection follow-up. Limited screening conducted beyond sampling.			
Sampling Results				Condition Assessment			
Sample Location: Flow		Floatables:	None	Graffiti: None		2018	
Total Chlorine: 0 ppm		Odor:	None	Erosion: None			
Free Chlorine: 0 ppm		Turbidity:	None	Deposition: None in.			
Ammonia: 0 ppm		Color:	None	Damage: None			
pH: 8.18 units		Gross Solids:	Slight				
Temperature 54 °F		Vegetation:	None				
Conductivity: 1183 µS/cm		Benthic Growth:	Slight				
Detergents: 0.4 mg/L		Stains:	None				
		Non-illicit:	None

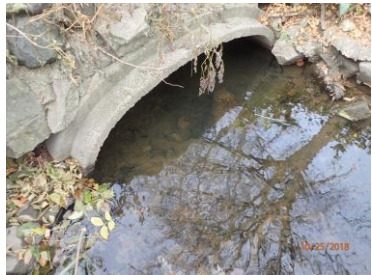
Inspection Date: 10/25/2018 9:33:47 AM		Type: Ongoing		Flow: Submerged, significant flow		Previous Rainfall (hrs): 72+	
Illicit Discharge Potential: Potential		Inspector: JCW		Notes

o20181025093132.JPG	
Submerged: Partially		Depth (in): 26		Downstream bank erosion. Sample collected from submerged flow in pipe. Detergent detected.			
Sampling Results				Condition Assessment			
Sample Location: Flow		Floatables:	None	Graffiti: None		2018	
Total Chlorine: 0 ppm		Odor:	None	Erosion: Moderate			
Free Chlorine: 0 ppm		Turbidity:	None	Deposition: None in.			
Ammonia: 0 ppm		Color:	None	Damage: None			
pH: 8.16 units		Gross Solids:	Slight				
Temperature 51 °F		Vegetation:	None				
Conductivity: 1209 µS/cm		Benthic Growth:	Moderate				
Detergents: 0.5 mg/L		Stains:	None				
		Non-illicit:	None

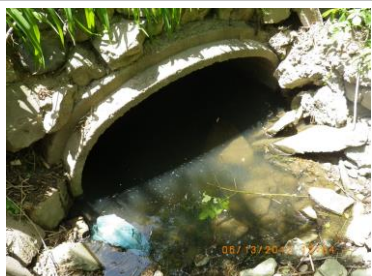
Inspection Date: 6/13/2012 12:53:24 PM		Type: Ongoing		Flow: Submerged, no flow		Previous Rainfall (hrs): 72+	
Illicit Discharge Potential: Unlikely		Inspector: JCW		Notes

o20120613115412.JPG	
Submerged: Partially		Depth (in): 19		No flow leaving pool on apron. Downstream channel dry. Sample collected from apron pool.			
Sampling Results				Condition Assessment			
Sample Location: Pool		Floatables:	None	Graffiti: None		2012	
Total Chlorine: 0 ppm		Odor:	None	Erosion: None			
Free Chlorine: 0 ppm		Turbidity:	Slight cloudiness	Deposition: None in.			
Ammonia: 0 ppm		Color:	None	Damage: None			
pH: 7.91 units		Gross Solids:	Slight				
Temperature 74 °F		Vegetation:	None				
Conductivity: 1579 µS/cm		Benthic Growth:	Slight				
Detergents: 0 mg/L		Stains:	None				
		Non-illicit:	None

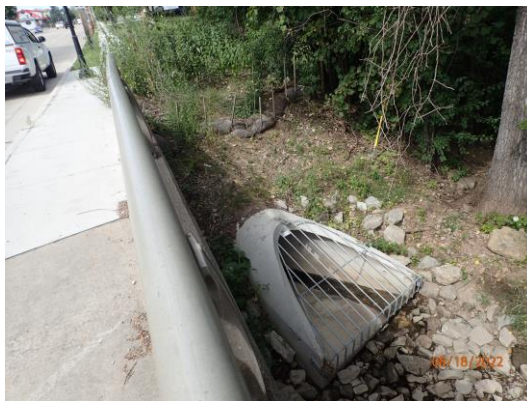
o20220818150802.JPG

Storm sewer from Oregon St discharges to stream from north. Replaces outfall 14-660 (2021).

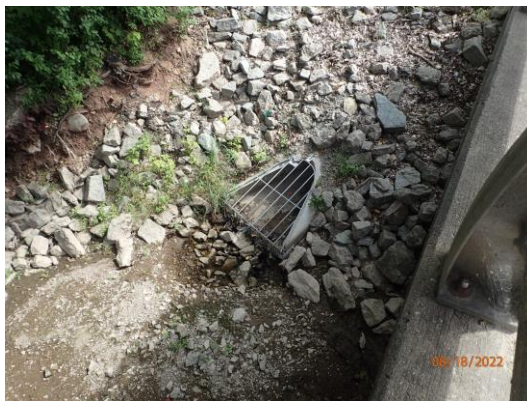
o20220818150540.JPG

Storm sewer from Oregon St. discharges to stream from south. Replaces outfall 14-659 (2021).

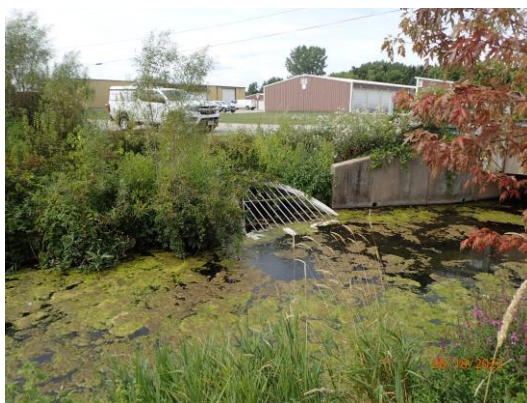
o20220818145424.JPG

Storm sewer from W 28th Ave discharges to stream from west. Replaces outfall 14-582 (2020).

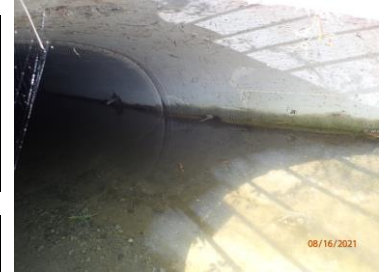
o20210816123040.JPG

Inspection Date: 8/16/2021 12:35:00 PM		Type: Ongoing	Flow: Submerged, slight flow	Previous Rainfall (hrs): 72+
Illicit Discharge Potential: Unlikely		Inspector: JCW		
Submerged: Partially		Depth (in): 17		
Sampling Results				
Sample Location: Flow		Floatables:	None	
Total Chlorine: 0 ppm		Odor:	None	
Free Chlorine: 0 ppm		Turbidity:	None	
Ammonia: 0 ppm		Color:	None	
pH: 7.37 units		Gross Solids:	None	
Temperature: 78 °F		Vegetation:	None	
Conductivity: 991 µS/cm		Benthic Growth:	Moderate	
Detergents: 0 mg/L		Stains:	None	
		Non-illicit:	None	
Notes				
New HECP. Sample collected from submerged flow in pipe.				
Condition Assessment				
Graffiti: None				
Erosion: None				
Deposition: None		in.		
Damage: None

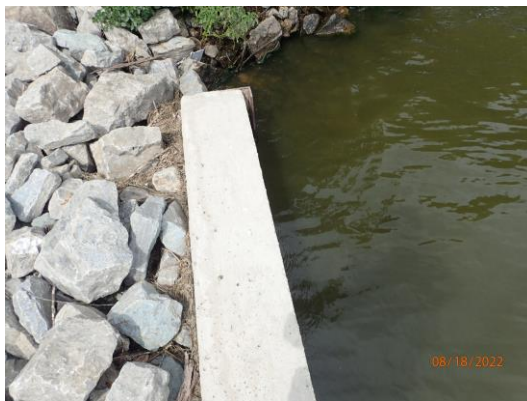
o20220818143614.JPG

Storm sewer from Waukau Ave discharges to lake from west. Replaces outfall 14-789 (2021).

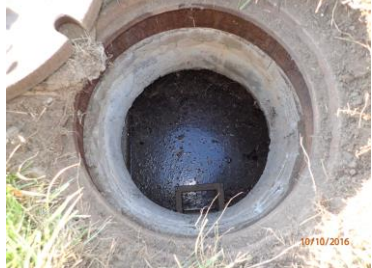
o20161010075814.JPG 2016

Notes Turbidity from manhole entry.																																				
		Condition Assessment <table border="1" style="width:100%; border-collapse: collapse;"> <tr><td>Graffiti:</td><td>None</td></tr> <tr><td>Erosion:</td><td>None</td></tr> <tr><td>Deposition:</td><td>None in.</td></tr> <tr><td>Damage:</td><td>None</td></tr> </table>			Graffiti:	None	Erosion:	None	Deposition:	None in.	Damage:	None																										
Graffiti:	None																																					
Erosion:	None																																					
Deposition:	None in.																																					
Damage:	None

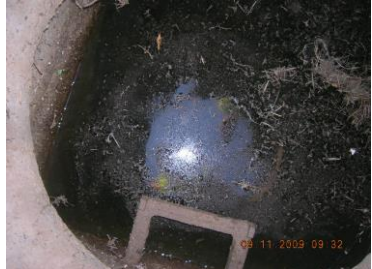
Osh09_DSCN6859.JPG 2009

Notes Slight green color.																																				
		Condition Assessment <table border="1" style="width:100%; border-collapse: collapse;"> <tr><td>Graffiti:</td><td>None</td></tr> <tr><td>Erosion:</td><td>None</td></tr> <tr><td>Deposition:</td><td>None 0 in.</td></tr> <tr><td>Damage:</td><td>None</td></tr> </table>			Graffiti:	None	Erosion:	None	Deposition:	None 0 in.	Damage:	None																										
Graffiti:	None																																					
Erosion:	None																																					
Deposition:	None 0 in.																																					
Damage:	None

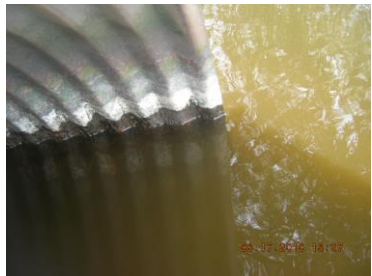
o20100817132746.JPG <div style="text-align: right; font-size: 24pt; font-weight: bold;">2010</div>

Inspection Date: 8/17/2010 1:35:34 PM		Type: Ongoing	Flow: Submerged, indeterminate	Previous Rainfall (hrs): 72+
Illicit Discharge Potential: Unlikely		Inspector: JCW		
Submerged: Partially		Depth (in): 17		
Sampling Results Sample Location: Total Chlorine: -- ppm Free Chlorine: -- ppm Ammonia: -- ppm pH: -- units Temperature: -- °F Conductivity: -- µS/cm Detergents: -- mg/L		Floatables: None Odor: None Turbidity: None Color: None Gross Solids: None Vegetation: None Benthic Growth: Moderate Stains: Moderate Non-illicit: None		
		Notes Outfall partially submerged. Outfall screened upstream at 14-400 US1.		
		Condition Assessment Graffiti: None Erosion: None Deposition: None 0 in. Damage: Minor

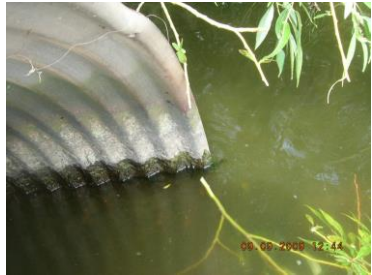
Osh09_DSCN6730.JPG <div style="text-align: right; font-size: 24pt; font-weight: bold;">2009</div>

Inspection Date: 9/9/2009		Type: Initial	Flow: Submerged, indeterminate	Previous Rainfall (hrs): 72+
Illicit Discharge Potential: Unlikely		Inspector: JCW		
Submerged: Partially		Depth (in): 14		
Sampling Results Sample Location: Total Chlorine: -- ppm Free Chlorine: -- ppm Ammonia: -- ppm pH: -- units Temperature: -- °F Conductivity: -- µS/cm Detergents: -- mg/L		Floatables: None Odor: None Turbidity: None Color: None Gross Solids: None Vegetation: None Benthic Growth: Slight Stains: Moderate Non-illicit: None		
		Notes Outfall partially submerged. Outfall screened upstream at 14-400 US1.		
		Condition Assessment Graffiti: None Erosion: None Deposition: None 0 in. Damage: Minor

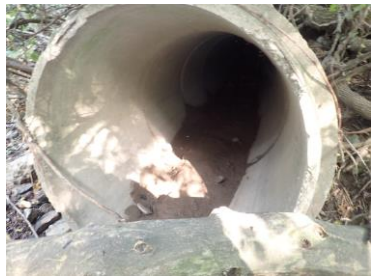
Upstream manhole located approx 25 ft N of outfall 01-520. Intermediate area consists of rip-rap shoreline. (OSH-9424 US1 in early reports.)

Northing: 472,419

Easting: 791,742

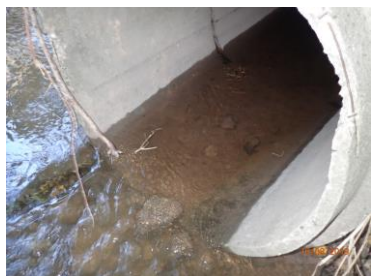
Submerged: Partially Depth (in): 66

Odor: None

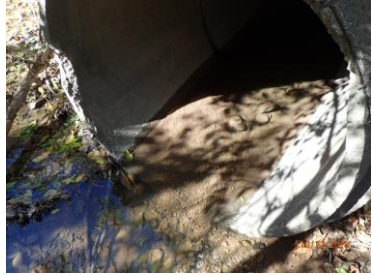
Color: None

Benthic Growth: None

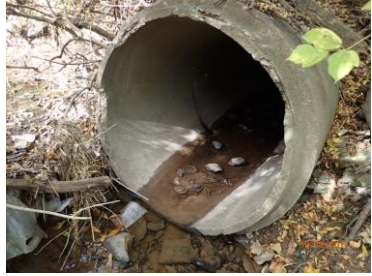
Non-illicit: None

Erosion: None

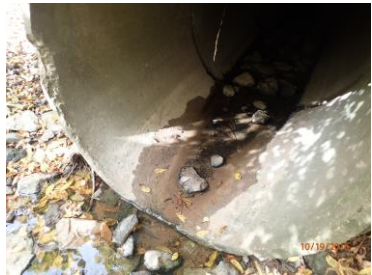
Damage: None ☐ Displacement ☐ Undercut ☐ Crushed☐ Corrosion ☐ Cracks/Structural Damage

2022**Sampling Results**

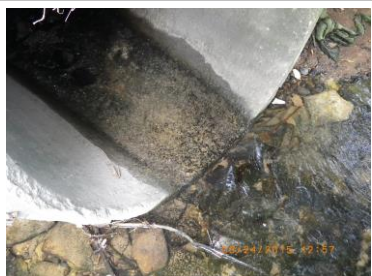
Sample ID: 220916-18

Time Collected: 13:45

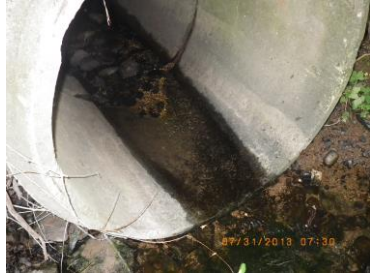
Free Chlorine (field): 0 ppm

pH (field): 7.61 units

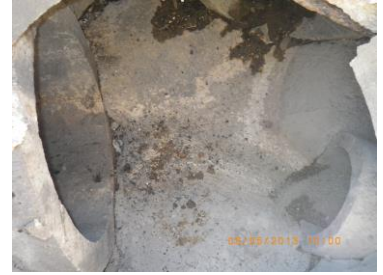
o20130905090002.JPG

Inspection Date: 9/5/2013 9:56:09 AM		Type: Ongoing	Flow: None	Previous Rainfall (hrs): 72+
Illicit Discharge Potential: Unlikely		Inspector: JCW		
Submerged: None		Depth (in):		
Sampling Results		Notes Manhole dry at time of inspection.		
Sample Location:	Floatables:	None		
Total Chlorine: -- ppm	Odor:	None		
Free Chlorine: -- ppm	Turbidity:	None		
Ammonia: -- ppm	Color:	None		
pH: -- units	Gross Solids:	None		
Temperature -- °F	Vegetation:	None		
Conductivity: -- µS/cm	Benthic Growth:	None		
Detergents: -- mg/L	Stains:	Slight		
	Non-illicit:	None		
		Condition Assessment Graffiti: None Erosion: None Deposition: None in. Damage: None

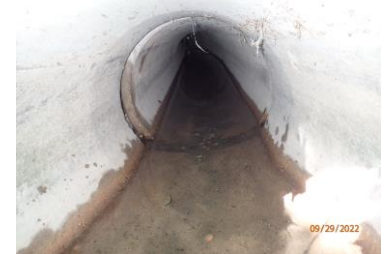
o20220929114700.JPG

Notes: Outfall partially submerged - screened upstream at 15-1817 US1.

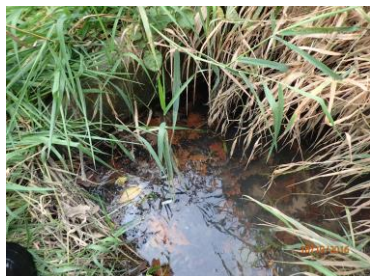
o20161019102752.JPG	
2016

Inspection Date: 10/19/2016 10:29:30 AM		Type: Ongoing	Flow: Submerged, indeterminate	Previous Rainfall (hrs): 72+
Illicit Discharge Potential: Unlikely		Inspector: JCW		
Submerged: Partially		Depth (in): 5		
Sampling Results Sample Location: Total Chlorine: -- ppm Free Chlorine: -- ppm Ammonia: -- ppm pH: -- units Temperature -- °F Conductivity: -- µS/cm Detergents: -- mg/L		Floatables: None Odor: None Turbidity: None Color: None Gross Solids: Moderate Vegetation: None Benthic Growth: Slight Stains: None Non-illicit: None		
		Notes Outfall partially submerged - screened upstream at 15-1817 US1.		
		Condition Assessment Graffiti: None Erosion: None Deposition: None in. Damage: None

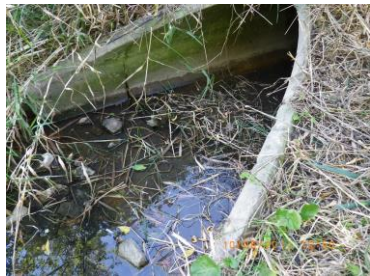
o20111006125050.JPG	
2011

Inspection Date: 10/6/2011 12:50:37 PM		Type: Ongoing	Flow: Submerged, indeterminate	Previous Rainfall (hrs): 72+
Illicit Discharge Potential: Unlikely		Inspector: JCW		
Submerged: Partially		Depth (in): 1		
Sampling Results Sample Location: Total Chlorine: -- ppm Free Chlorine: -- ppm Ammonia: -- ppm pH: -- units Temperature -- °F Conductivity: -- µS/cm Detergents: -- mg/L		Floatables: None Odor: None Turbidity: None Color: None Gross Solids: None Vegetation: None Benthic Growth: None Stains: Slight Non-illicit: None		
		Notes Concrete apron cracked. Outfall partially submerged. Outfall screened upstream at 15-1817 US1.		
		Condition Assessment Graffiti: None Erosion: None Deposition: None 0 in. Damage: Minor

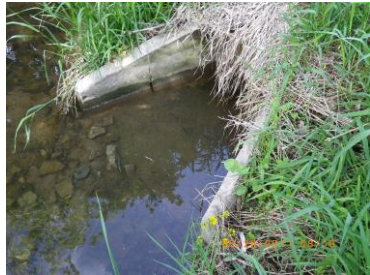
o20110526081916.JPG	
2011

Inspection Date: 5/26/2011 8:19:00 AM		Type: Other	Flow: Submerged, indeterminate	Previous Rainfall (hrs): 72+
Illicit Discharge Potential: Unlikely		Inspector: JCW		
Submerged: Partially		Depth (in):		
Sampling Results Sample Location: Total Chlorine: -- ppm Free Chlorine: -- ppm Ammonia: -- ppm pH: -- units Temperature -- °F Conductivity: -- µS/cm Detergents: -- mg/L		Floatables: Odor: Turbidity: Color: Gross Solids: Vegetation: Benthic Growth: Stains: Non-illicit: None		
		Notes Outfall partially submerged. Outfall screened upstream at 15-1817 US1.		
		Condition Assessment Graffiti: None Erosion: None Deposition: None 0 in. Damage: None

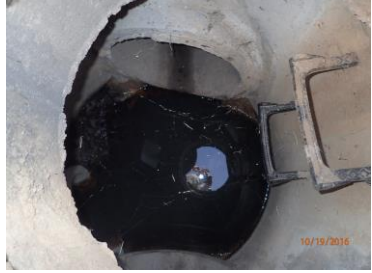
<p style="text-align: center;">o20161019104446.JPG</p> <p style="text-align: center; font-size: 24pt; font-weight: bold;">2016</p>

Sample Location: Pool																																		
Total Chlorine:	0 ppm																																	
Free Chlorine:	0 ppm																																	
Ammonia:	3 ppm																																	
pH:	7.47 units																																	
Temperature:	63 °F																																	
Conductivity:	423 µS/cm																																	
Detergents:	0 mg/L																																	
Notes																																		
Water level below outlet invert - no flow leaving pipe. Sample collected from pool.																																		
Condition Assessment																																		
Graffiti:	None																																	
Erosion:	None																																	
Deposition:	None in.																																	
Damage:	None

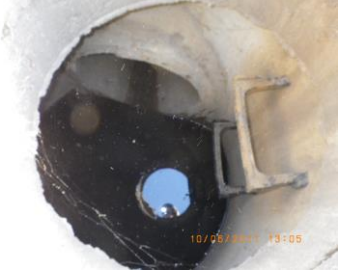
<p style="text-align: center;">o20111006130528.JPG</p> <p style="text-align: center; font-size: 24pt; font-weight: bold;">2011</p>

Sample Location: Pool																																		
Total Chlorine:	0 ppm																																	
Free Chlorine:	0 ppm																																	
Ammonia:	0 ppm																																	
pH:	7.46 units																																	
Temperature:	74 °F																																	
Conductivity:	-- µS/cm																																	
Detergents:	0 mg/L																																	
Notes																																		
Sample collected from sump. No flow leaving through outfall pipe.																																		
Condition Assessment																																		
Graffiti:	None																																	
Erosion:	None																																	
Deposition:	None 0 in.																																	
Damage:	None

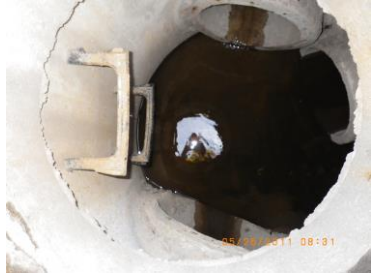
<p style="text-align: center;">o20110526083130.JPG</p> <p style="text-align: center; font-size: 24pt; font-weight: bold;">2011</p>

Sample Location:																																		
Total Chlorine:	-- ppm																																	
Free Chlorine:	-- ppm																																	
Ammonia:	-- ppm																																	
pH:	-- units																																	
Temperature:	-- °F																																	
Conductivity:	-- µS/cm																																	
Detergents:	-- mg/L																																	
Notes																																		
Limited screening conducted for upstream manhole prescreening.																																		
Condition Assessment																																		
Graffiti:	None																																	
Erosion:	None																																	
Deposition:	None 0 in.																																	
Damage:	None

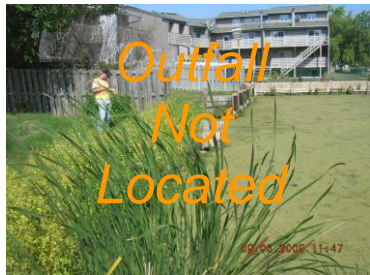
Color: None

Vegetation: None

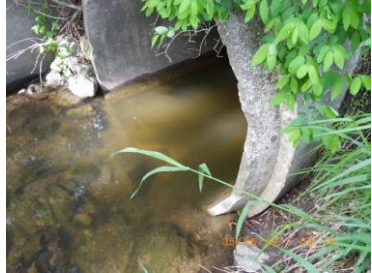
o20141009113842.JPG

Inspection Date: 10/9/2014 12:40:37 PM		Type: Ongoing	Flow: Submerged, indeterminate	Previous Rainfall (hrs): 72+
Illicit Discharge Potential: Potential		Inspector: JCW	Notes	
Submerged: Fully		Depth (in): 35	Floating gross solids (litter) in manhole.	
Sampling Results		Condition Assessment		
Sample Location: Pool	Floatables: None	Graffiti: None	in.	
Total Chlorine: 0 ppm	Odor: None	Erosion: None		
Free Chlorine: 0 ppm	Turbidity: None	Deposition: None		
Ammonia: 0 ppm	Color: None	Damage: None		
pH: 7.58 units	Gross Solids: Moderate			
Temperature 62 °F	Vegetation: None			
Conductivity: 707 µS/cm	Benthic Growth: None			
Detergents: 0 mg/L	Stains: None			
	Non-illicit: None

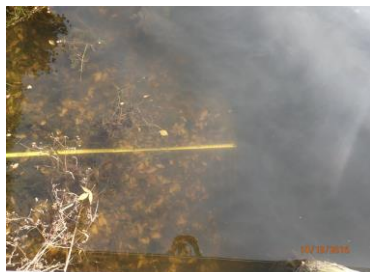
Inspection Date: 10/19/2016 9:46:48 AM		Type: Ongoing	Flow: Submerged, indeterminate	Previous Rainfall (hrs): 72+
Illicit Discharge Potential: Unlikely		Inspector: JCW		
Submerged: Fully		Depth (in): 60		
Sampling Results Sample Location: Total Chlorine: -- ppm Free Chlorine: -- ppm Ammonia: -- ppm pH: -- units Temperature -- °F Conductivity: -- µS/cm Detergents: -- mg/L		Floatables: None Odor: None Turbidity: None Color: None Gross Solids: None Vegetation: None Benthic Growth: None Stains: None Non-illicit: None	Notes Outfall fully submerged - screened upstream at 15-959 US1.

o20161019094524.JPG <div style="text-align: center; font-size: 24pt; font-weight: bold;">2016</div>
			Condition Assessment Graffiti: None Erosion: None Deposition: None in. Damage: None

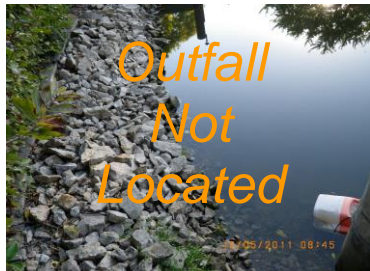
Inspection Date: 10/5/2011 8:45:12 AM		Type: Ongoing	Flow: Submerged (not located)	Previous Rainfall (hrs): 72+
Illicit Discharge Potential: Unlikely		Inspector: JCW		
Submerged: Fully		Depth (in):		
Sampling Results Sample Location: Total Chlorine: -- ppm Free Chlorine: -- ppm Ammonia: -- ppm pH: -- units Temperature -- °F Conductivity: -- µS/cm Detergents: -- mg/L		Floatables: None Odor: None Turbidity: None Color: None Gross Solids: None Vegetation: None Benthic Growth: None Stains: None Non-illicit: None	Notes Outfall fully submerged and not physically located. Outfall screened upstream at 15-959 US1.

o20111005084526.JPG <div style="text-align: center; font-size: 24pt; font-weight: bold;">2011</div>
			Condition Assessment Graffiti: None Erosion: None Deposition: None 0 in. Damage: None
