IDDE Ongoing Screening Summary Report

2022 Inspection Year

City of Oshkosh

Westwood

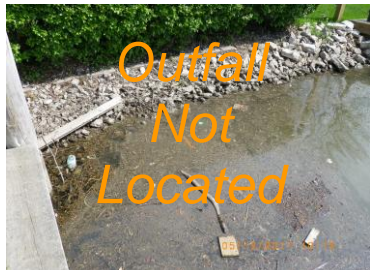
Inspection Date: 5/12/2011 10:12:00 AM		Type: Other	Flow: Submerged (not located)	Previous Rainfall (hrs): 48-72
Illicit Discharge Potential: Unlikely		Inspector: JCW		
Submerged: Fully		Depth (in):		
Sampling Results Sample Location: Total Chlorine: -- ppm Free Chlorine: -- ppm Ammonia: -- ppm pH: -- units Temperature -- °F Conductivity: -- µS/cm Detergents: -- mg/L		Floatables: Odor: Turbidity: Color: Gross Solids: Vegetation: Benthic Growth: Stains: Non-illicit: None	Notes Outfall fully submerged and not physically located. Outfall screened upstream at 15-959 US1.

o20110512101202.JPG <div style="text-align: center; font-size: 24pt; font-weight: bold;">2011</div>
			Condition Assessment Graffiti: None Erosion: None Deposition: None 0 in. Damage: None

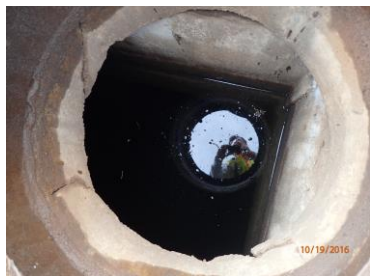
o20161019094812.JPG

Inspection Date: 10/19/2016 9:50:58 AM		Type: Ongoing	Flow: Submerged, indeterminate	Previous Rainfall (hrs): 72+
Illicit Discharge Potential: Unlikely		Inspector: JCW		
Submerged: Fully		Depth (in): 64		
Sampling Results		Notes		
Sample Location: Pool	Floatables: None	<div style="border: 1px solid black; padding: 5px;"> Condition Assessment Graffiti: None Erosion: None Deposition: None in. Damage: None </div>		
Total Chlorine: 0 ppm	Odor: None			
Free Chlorine: 0 ppm	Turbidity: None			
Ammonia: 0 ppm	Color: None			
pH: 7.69 units	Gross Solids: None			
Temperature 63 °F	Vegetation: None			
Conductivity: 786 µS/cm	Benthic Growth: Moderate			
Detergents: 0 mg/L	Stains: Moderate			
	Non-illicit: None

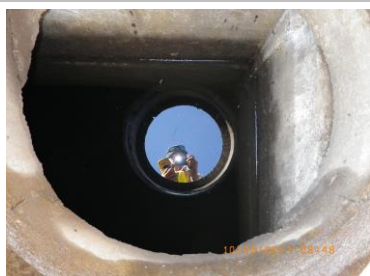
o20111005084830.JPG

Inspection Date: 10/5/2011 8:45:12 AM		Type: Ongoing	Flow: Submerged, indeterminate	Previous Rainfall (hrs): 72+
Illicit Discharge Potential: Unlikely		Inspector: JCW		
Submerged: Fully		Depth (in): 64		
Sampling Results		Notes		
Sample Location: Pool	Floatables: None	<div style="border: 1px solid black; padding: 5px;"> Condition Assessment Graffiti: None Erosion: None Deposition: None 0 in. Damage: None </div>		
Total Chlorine: 0 ppm	Odor: None			
Free Chlorine: 0 ppm	Turbidity: None			
Ammonia: 0 ppm	Color: None			
pH: 6.72 units	Gross Solids: None			
Temperature 62 °F	Vegetation: None			
Conductivity: -- µS/cm	Benthic Growth: None			
Detergents: 0 mg/L	Stains: Slight			
	Non-illicit: None

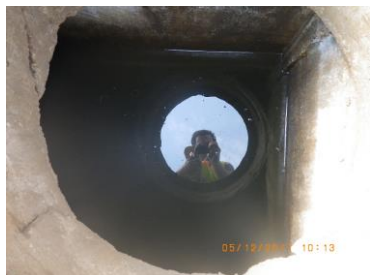
o20110512101300.JPG

Inspection Date: 5/12/2011 10:12:00 AM		Type: Other	Flow: Submerged, indeterminate	Previous Rainfall (hrs): 48-72
Illicit Discharge Potential: Unlikely		Inspector: JCW		
Submerged: Fully		Depth (in):		
Sampling Results		Notes		
Sample Location:	Floatables: None	<div style="border: 1px solid black; padding: 5px;"> Limited screening conducted for upstream manhole prescreening. Condition Assessment Graffiti: None Erosion: None Deposition: None 0 in. Damage: None </div>		
Total Chlorine: -- ppm	Odor:			
Free Chlorine: -- ppm	Turbidity:			
Ammonia: -- ppm	Color:			
pH: -- units	Gross Solids: None			
Temperature -- °F	Vegetation:			
Conductivity: -- µS/cm	Benthic Growth:			
Detergents: -- mg/L	Stains:			
	Non-illicit: None

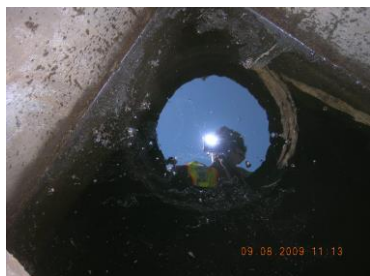
Osh09_DSCN6606.JPG

Inspection Date: 9/8/2009		Type: Initial	Flow: Submerged, indeterminate	Previous Rainfall (hrs): 72+
Illicit Discharge Potential: Unlikely		Inspector: JCW		
Submerged: Fully		Depth (in): 64		
Sampling Results		Notes		
Sample Location: Pool	Floatables:	<div style="border: 1px solid black; padding: 5px;"> Condition Assessment Graffiti: None Erosion: None Deposition: None 0 in. Damage: None </div>		
Total Chlorine: 0 ppm	Odor:			
Free Chlorine: 0 ppm	Turbidity:			
Ammonia: -- ppm	Color:			
pH: 8.2 units	Gross Solids:			
Temperature 75 °F	Vegetation:			
Conductivity: -- µS/cm	Benthic Growth:			
Detergents: 0 mg/L	Stains:			
	Non-illicit: None

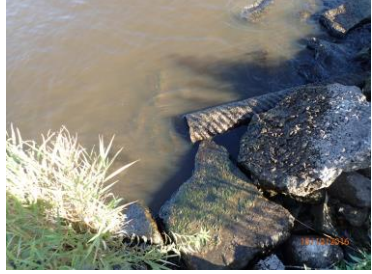
o20161010145414.JPG <div style="text-align: center; font-size: 24pt; font-weight: bold;">2016</div>

Inspection Date: 10/10/2016 2:55:26 PM		Type: Ongoing	Flow: Submerged, indeterminate	Previous Rainfall (hrs): 72+
Illicit Discharge Potential: Unlikely		Inspector: JCW		
Submerged: Partially		Depth (in): 5		
Sampling Results Sample Location: Total Chlorine: -- ppm Free Chlorine: -- ppm Ammonia: -- ppm pH: -- units Temperature: -- °F Conductivity: -- µS/cm Detergents: -- mg/L		Floatables: None Odor: None Turbidity: None Color: None Gross Solids: None Vegetation: None Benthic Growth: None Stains: None Non-illicit: None		
		Notes Outfall partially submerged - screened upstream at 16-1074 US1.		
		Condition Assessment Graffiti: None Erosion: None Deposition: None in. Damage: None

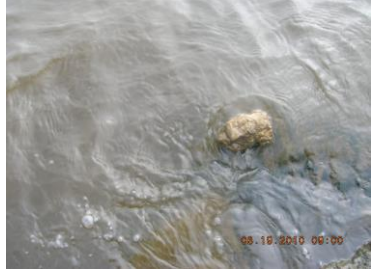
o20100819090004.JPG <div style="text-align: center; font-size: 24pt; font-weight: bold;">2010</div>

Inspection Date: 8/19/2010 9:04:14 AM		Type: Ongoing	Flow: Submerged, indeterminate	Previous Rainfall (hrs): 72+
Illicit Discharge Potential: Unlikely		Inspector: JCW		
Submerged: Fully		Depth (in): 8		
Sampling Results Sample Location: Total Chlorine: -- ppm Free Chlorine: -- ppm Ammonia: -- ppm pH: -- units Temperature: -- °F Conductivity: -- µS/cm Detergents: -- mg/L		Floatables: None Odor: None Turbidity: None Color: None Gross Solids: None Vegetation: None Benthic Growth: None Stains: None Non-illicit: None		
		Notes Lake level at crown of pipe. Outfall screened upstream at 16-1074 US1.		
		Condition Assessment Graffiti: None Erosion: None Deposition: None 0 in. Damage: None

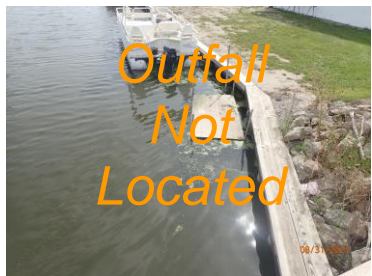
o20210831110724.JPG 2021

Inspection Date: 8/31/2021 11:09:30 AM		Type: Ongoing	Flow: Submerged (not located)	Previous Rainfall (hrs): 48-72
Illicit Discharge Potential: Potential		Inspector: JCW		
Submerged: Fully		Depth (in):		
Sampling Results		Notes Outfall partially submerged - screened upstream at 16-1178 US1. Floating gross solids (litter) in upstream manhole.		
Sample Location:	Floatables:	None		
Total Chlorine: -- ppm	Odor:	None		
Free Chlorine: -- ppm	Turbidity:	None		
Ammonia: -- ppm	Color:	None		
pH: -- units	Gross Solids:	None		
Temperature -- °F	Vegetation:	None		
Conductivity: -- µS/cm	Benthic Growth:	None		
Detergents: -- mg/L	Stains:	None		
	Non-illicit:	None		
		Condition Assessment Graffiti: None Erosion: None Deposition: None in. Damage: None

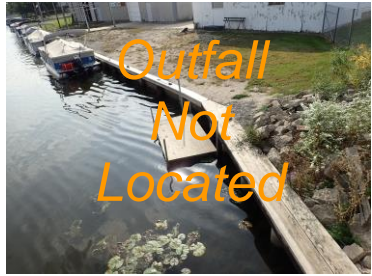
o20200924095628.JPG 2020

Inspection Date: 9/24/2020 9:53:07 AM		Type: Ongoing	Flow: Submerged (not located)	Previous Rainfall (hrs): 72+
Illicit Discharge Potential: Potential		Inspector: QAL		
Submerged: Fully		Depth (in):		
Sampling Results		Notes Outfall fully submerged and not located - screened upstream at 16-533 US1. Floating gross solids (litter) in upstream manhole.		
Sample Location:	Floatables:	None		
Total Chlorine: -- ppm	Odor:	None		
Free Chlorine: -- ppm	Turbidity:	None		
Ammonia: -- ppm	Color:	None		
pH: -- units	Gross Solids:	None		
Temperature -- °F	Vegetation:	None		
Conductivity: -- µS/cm	Benthic Growth:	None		
Detergents: -- mg/L	Stains:	None		
	Non-illicit:	None		
		Condition Assessment Graffiti: None Erosion: None Deposition: None in. Damage: None

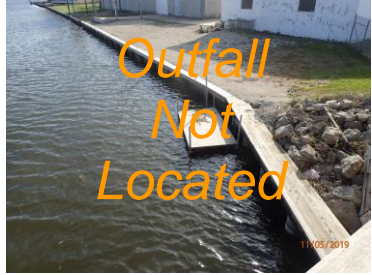
o20191105093616.JPG 2019

Inspection Date: 11/5/2019 9:36:00 AM		Type: Repeat	Flow: Submerged (not located)	Previous Rainfall (hrs): 48-72
Illicit Discharge Potential: Unlikely		Inspector: JCW		
Submerged: Fully		Depth (in):		
Sampling Results		Notes Outfall fully submerged and not located - screened upstream at 16-533 US1. Follow-up inspection for sampling - limited screening conducted.		
Sample Location:	Floatables:	None		
Total Chlorine: -- ppm	Odor:	None		
Free Chlorine: -- ppm	Turbidity:	None		
Ammonia: -- ppm	Color:	None		
pH: -- units	Gross Solids:	None		
Temperature -- °F	Vegetation:	None		
Conductivity: -- µS/cm	Benthic Growth:	None		
Detergents: -- mg/L	Stains:	None		
	Non-illicit:	None		
		Condition Assessment Graffiti: None Erosion: None Deposition: None in. Damage: None

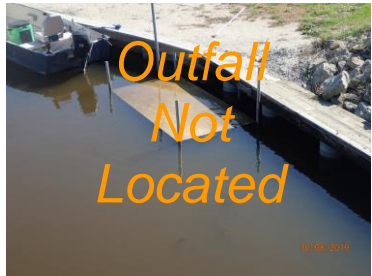
o20191008123600.JPG 2019

Inspection Date: 10/8/2019 1:37:40 PM		Type: Ongoing	Flow: Submerged (not located)	Previous Rainfall (hrs): 48-72
Illicit Discharge Potential: Potential		Inspector: JCW		
Submerged: Fully		Depth (in):		
Sampling Results		Notes Outfall fully submerged and not located - screened upstream at 16-533 US1. Floating gross solids (litter) and detergent in manhole.		
Sample Location:	Floatables:	None		
Total Chlorine: -- ppm	Odor:	None		
Free Chlorine: -- ppm	Turbidity:	None		
Ammonia: -- ppm	Color:	None		
pH: -- units	Gross Solids:	None		
Temperature -- °F	Vegetation:	None		
Conductivity: -- µS/cm	Benthic Growth:	None		
Detergents: -- mg/L	Stains:	None		
	Non-illicit:	None		
		Condition Assessment Graffiti: None Erosion: None Deposition: None in. Damage: None

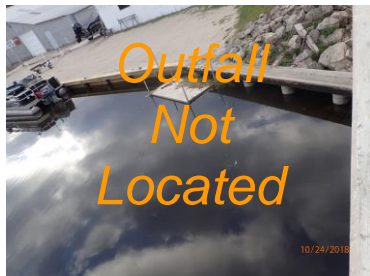
o20181024084514.JPG

Inspection Date: 10/24/2018 8:46:55 AM		Type: Ongoing	Flow: Submerged (not located)	Previous Rainfall (hrs): 72+
Illicit Discharge Potential: Potential		Inspector: JCW	Notes	
Submerged: Fully		Depth (in):	Outfall fully submerged and not located - screened upstream at 16-533 US1. Floating gross solids (litter) in manhole.	
Sampling Results		Floatables:	Condition Assessment Graffiti: None Erosion: None Deposition: None in. Damage: None	
Sample Location:		Odor:		
Total Chlorine: -- ppm		Turbidity:		
Free Chlorine: -- ppm		Color:		
Ammonia: -- ppm		Gross Solids:		
pH: -- units		Vegetation:		
Temperature -- °F		Benthic Growth:		
Conductivity: -- µS/cm		Stains:		
Detergents: -- mg/L		Non-illicit:

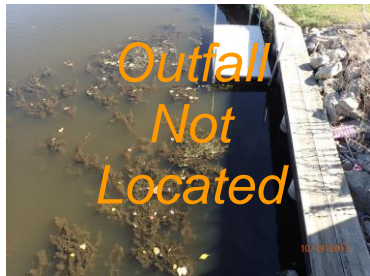
o20171019132622.JPG

Inspection Date: 10/19/2017 1:28:21 PM		Type: Ongoing	Flow: Submerged (not located)	Previous Rainfall (hrs): 72+
Illicit Discharge Potential: Unlikely		Inspector: JCW	Notes	
Submerged: Fully		Depth (in):	Outfall fully submerged and not located - screened upstream at 16-533 US1.	
Sampling Results		Floatables:	Condition Assessment Graffiti: None Erosion: None Deposition: None in. Damage: None	
Sample Location:		Odor:		
Total Chlorine: -- ppm		Turbidity:		
Free Chlorine: -- ppm		Color:		
Ammonia: -- ppm		Gross Solids:		
pH: -- units		Vegetation:		
Temperature -- °F		Benthic Growth:		
Conductivity: -- µS/cm		Stains:		
Detergents: -- mg/L		Non-illicit:

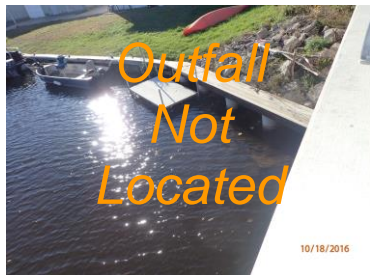
o20161018092038.JPG

Inspection Date: 10/18/2016 9:28:25 AM		Type: Ongoing	Flow: Submerged (not located)	Previous Rainfall (hrs): 72+
Illicit Discharge Potential: Potential		Inspector: JCW	Notes	
Submerged: Fully		Depth (in):	Outfall fully submerged and not located - screened upstream at 16-533 US1.	
Sampling Results		Floatables:	Condition Assessment Graffiti: None Erosion: None Deposition: None in. Damage: None	
Sample Location:		Odor:		
Total Chlorine: -- ppm		Turbidity:		
Free Chlorine: -- ppm		Color:		
Ammonia: -- ppm		Gross Solids:		
pH: -- units		Vegetation:		
Temperature -- °F		Benthic Growth:		
Conductivity: -- µS/cm		Stains:		
Detergents: -- mg/L		Non-illicit:

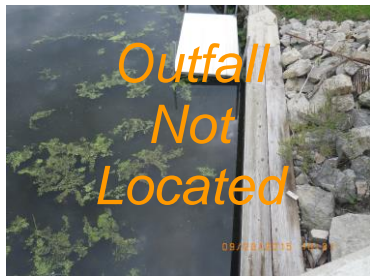
o20150923093118.JPG

Inspection Date: 9/23/2015 10:32:22 AM		Type: Ongoing	Flow: Submerged (not located)	Previous Rainfall (hrs): 72+
Illicit Discharge Potential: Potential		Inspector: JCW	Notes	
Submerged: Fully		Depth (in):	Outfall fully submerged and not located - screened at 16-533 US1.	
Sampling Results		Floatables:	Condition Assessment Graffiti: None Erosion: None Deposition: None in. Damage: None	
Sample Location:		Odor:		
Total Chlorine: -- ppm		Turbidity:		
Free Chlorine: -- ppm		Color:		
Ammonia: -- ppm		Gross Solids:		
pH: -- units		Vegetation:		
Temperature -- °F		Benthic Growth:		
Conductivity: -- µS/cm		Stains:		
Detergents: -- mg/L		Non-illicit:

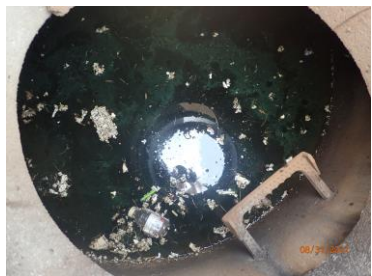
o20210831111218.JPG

Inspection Date: 8/31/2021 11:17:57 AM		Type: Ongoing	Flow: Submerged, indeterminate	Previous Rainfall (hrs): 48-72
Illicit Discharge Potential: Potential		Inspector: JCW		
Submerged: Fully		Depth (in): 40		
Sampling Results		Notes Sample collected from submerged pool in manhole. Floating gross solids (litter) in manhole.		
Sample Location: Pool	Floatables: None	Condition Assessment Graffiti: None Erosion: None Deposition: None in. Damage: None		
Total Chlorine: 0 ppm	Odor: None			
Free Chlorine: 0 ppm	Turbidity: None			
Ammonia: 0 ppm	Color: None			
pH: 7.29 units	Gross Solids: Moderate			
Temperature 78 °F	Vegetation: None			
Conductivity: 389 µS/cm	Benthic Growth: None			
Detergents: 0 mg/L	Stains: None			
	Non-illicit: None

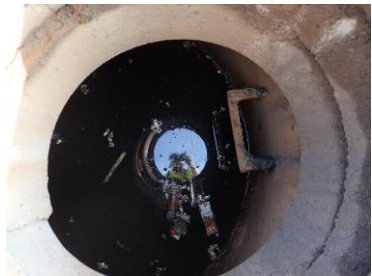
o20200924100816.JPG

Inspection Date: 9/24/2020 10:01:33 AM		Type: Ongoing	Flow: Submerged, indeterminate	Previous Rainfall (hrs): 72+
Illicit Discharge Potential: Potential		Inspector: QAL		
Submerged: Fully		Depth (in): 33		
Sampling Results		Notes Sample collected from submerged pool in manhole. Floating gross solids (litter) in manhole.		
Sample Location: Pool	Floatables: None	Condition Assessment Graffiti: None Erosion: None Deposition: None in. Damage: None		
Total Chlorine: 0 ppm	Odor: None			
Free Chlorine: 0 ppm	Turbidity: None			
Ammonia: 0 ppm	Color: None			
pH: 8.8 units	Gross Solids: Moderate			
Temperature 68 °F	Vegetation: None			
Conductivity: 433 µS/cm	Benthic Growth: None			
Detergents: 0 mg/L	Stains: None			
	Non-illicit: None

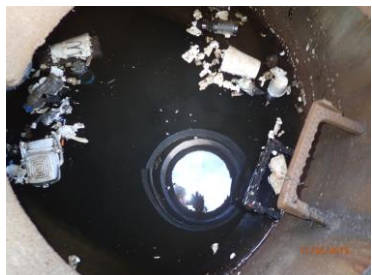
o20191105093642.JPG

Inspection Date: 11/5/2019 9:37:43 AM		Type: Repeat	Flow: Submerged, indeterminate	Previous Rainfall (hrs): 48-72
Illicit Discharge Potential: Unlikely		Inspector: JCW		
Submerged: Partially		Depth (in): 38		
Sampling Results		Notes Follow-up inspection for sampling - limited screening conducted.		
Sample Location: Pool	Floatables: None	Condition Assessment Graffiti: None Erosion: None Deposition: None in. Damage: None		
Total Chlorine: -- ppm	Odor: None			
Free Chlorine: -- ppm	Turbidity: None			
Ammonia: -- ppm	Color: None			
pH: -- units	Gross Solids: None			
Temperature -- °F	Vegetation: None			
Conductivity: -- µS/cm	Benthic Growth: None			
Detergents: 0 mg/L	Stains: None			
	Non-illicit: None

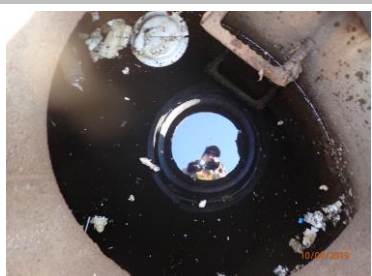
o20191008123830.JPG

Inspection Date: 10/8/2019 1:38:32 PM		Type: Ongoing	Flow: Submerged, indeterminate	Previous Rainfall (hrs): 48-72
Illicit Discharge Potential: Potential		Inspector: JCW		
Submerged: Partially		Depth (in): 38		
Sampling Results		Notes Sample collected from submerged pool in manhole. Floating gross solids (litter) in manhole. Detergent detected in sample.		
Sample Location: Pool	Floatables: None	Condition Assessment Graffiti: None Erosion: None Deposition: None in. Damage: None		
Total Chlorine: 0 ppm	Odor: None			
Free Chlorine: 0 ppm	Turbidity: None			
Ammonia: 0 ppm	Color: None			
pH: 7.34 units	Gross Solids: Moderate			
Temperature 66 °F	Vegetation: None			
Conductivity: 449 µS/cm	Benthic Growth: None			
Detergents: 0.5 mg/L	Stains: None			
	Non-illicit: None

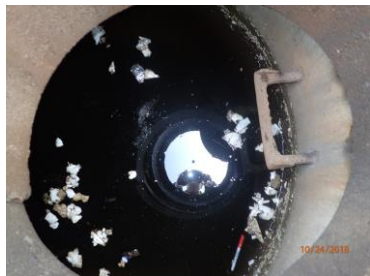
o20181024084850.JPG

Inspection Date: 10/24/2018 8:51:52 AM		Type: Ongoing	Flow: Submerged, indeterminate	Previous Rainfall (hrs): 72+
Illicit Discharge Potential: Potential		Inspector: JCW	Notes	
Submerged: Partially Depth (in): 46			Sample collected from submerged pool in manhole. Floating gross solids (litter) in manhole.	
Sampling Results		Floatables: None	Condition Assessment	
Sample Location: Pool		Odor: None	Graffiti: None	
Total Chlorine: 0 ppm		Turbidity: None	Erosion: None	
Free Chlorine: 0 ppm		Color: None	Deposition: None in.	
Ammonia: 0 ppm		Gross Solids: Slight	Damage: None	
pH: 7.75 units		Vegetation: None		
Temperature 48 °F		Benthic Growth: None		
Conductivity: 485 µS/cm		Stains: None		
Detergents: 0 mg/L		Non-illicit: None

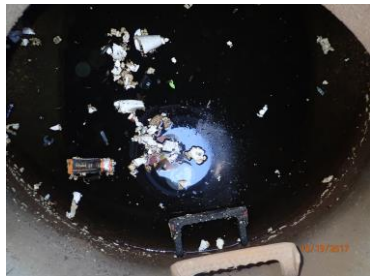
o20171019133054.JPG

Inspection Date: 10/19/2017 1:34:48 PM		Type: Ongoing	Flow: Submerged, indeterminate	Previous Rainfall (hrs): 72+
Illicit Discharge Potential: Unlikely		Inspector: JCW	Notes	
Submerged: Fully Depth (in):			Sample collected from submerged pool in manhole.	
Sampling Results		Floatables: Slight	Condition Assessment	
Sample Location:		Odor: None	Graffiti: None	
Total Chlorine: 0 ppm		Turbidity: None	Erosion: None	
Free Chlorine: 0 ppm		Color: None	Deposition: None in.	
Ammonia: 0 ppm		Gross Solids: Slight	Damage: None	
pH: 7.89 units		Vegetation: None		
Temperature 66 °F		Benthic Growth: None		
Conductivity: 668 µS/cm		Stains: None		
Detergents: 0 mg/L		Non-illicit: None

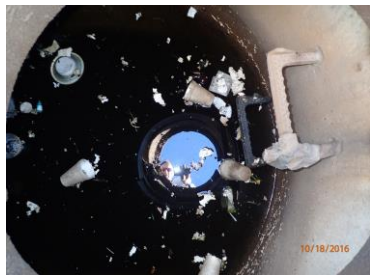
o20161018092516.JPG

Inspection Date: 10/18/2016 9:29:17 AM		Type: Ongoing	Flow: Submerged, indeterminate	Previous Rainfall (hrs): 72+
Illicit Discharge Potential: Potential		Inspector: JCW	Notes	
Submerged: Fully Depth (in): 40			Potential illicit discharge due to gross solids.	
Sampling Results		Floatables: None	Condition Assessment	
Sample Location: Pool		Odor: None	Graffiti: None	
Total Chlorine: 0 ppm		Turbidity: None	Erosion: None	
Free Chlorine: 0 ppm		Color: None	Deposition: None in.	
Ammonia: 0 ppm		Gross Solids: Moderate	Damage: None	
pH: 7.94 units		Vegetation: None		
Temperature 63 °F		Benthic Growth: None		
Conductivity: 482 µS/cm		Stains: None		
Detergents: 0 mg/L		Non-illicit: None

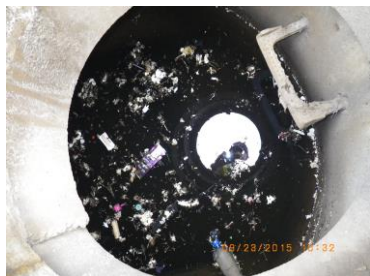
o20150923093204.JPG

Inspection Date: 9/23/2015 10:32:59 AM		Type: Ongoing	Flow: Submerged, indeterminate	Previous Rainfall (hrs): 72+
Illicit Discharge Potential: Potential		Inspector: JCW	Notes	
Submerged: Fully Depth (in): 36			Floating gross solids (litter) - including syringe - in manhole.	
Sampling Results		Floatables: None	Condition Assessment	
Sample Location: Pool		Odor: None	Graffiti: None	
Total Chlorine: 0 ppm		Turbidity: None	Erosion: None	
Free Chlorine: 0 ppm		Color: None	Deposition: None in.	
Ammonia: 0 ppm		Gross Solids: Moderate	Damage: None	
pH: 7.95 units		Vegetation: None		
Temperature 71 °F		Benthic Growth: Slight		
Conductivity: 363 µS/cm		Stains: None		
Detergents: 0 mg/L		Non-illicit: None

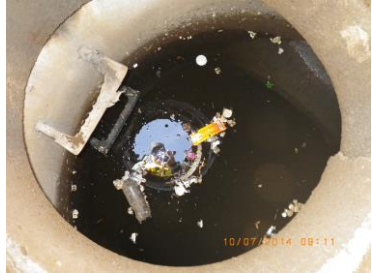
o20141007081140.JPG

Inspection Date: 10/7/2014 9:13:45 AM		Type: Ongoing	Flow: Submerged, indeterminate	Previous Rainfall (hrs): 48-72
Illicit Discharge Potential: Potential		Inspector: JCW	Notes	
Submerged: Fully		Depth (in): 34	Floating gross solids (litter) in manhole.	
Sampling Results				
Sample Location:	Pool	Floatables:	None	
Total Chlorine:	0 ppm	Odor:	None	
Free Chlorine:	0 ppm	Turbidity:	None	
Ammonia:	0 ppm	Color:	None	
pH:	7.67 units	Gross Solids:	Moderate	
Temperature	-- °F	Vegetation:	None	
Conductivity:	474 µS/cm	Benthic Growth:	None	
Detergents:	0 mg/L	Stains:	None	
		Non-illicit:	None	
			Condition Assessment	
			Graffiti:	None
			Erosion:	None
			Deposition:	None in.
			Damage:	None

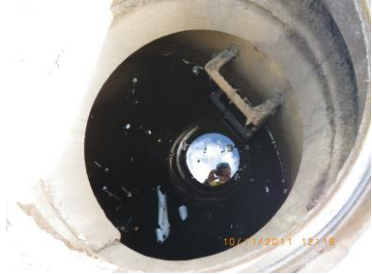
o20111011121924.JPG

Inspection Date: 10/11/2011 12:22:21 PM		Type: Ongoing	Flow: Submerged, indeterminate	Previous Rainfall (hrs): 72+
Illicit Discharge Potential: Unlikely		Inspector: JCW	Notes	
Submerged: Fully		Depth (in): 16	2010 screening follow-up. Floatable debris significantly reduced.	
Sampling Results				
Sample Location:	Pool	Floatables:	None	
Total Chlorine:	0 ppm	Odor:	None	
Free Chlorine:	0 ppm	Turbidity:	None	
Ammonia:	0 ppm	Color:	None	
pH:	7.9 units	Gross Solids:	Moderate	
Temperature	70 °F	Vegetation:	None	
Conductivity:	-- µS/cm	Benthic Growth:	None	
Detergents:	-- mg/L	Stains:	None	
		Non-illicit:	None	
			Condition Assessment	
			Graffiti:	None
			Erosion:	None
			Deposition:	None 0 in.
			Damage:	None

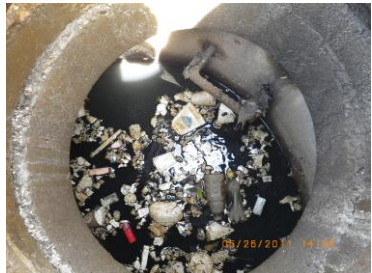
o20110526143524.JPG

Inspection Date: 5/26/2011 2:35:00 PM		Type: Other	Flow: Submerged, indeterminate	Previous Rainfall (hrs): 72+
Illicit Discharge Potential: Potential		Inspector: JCW	Notes	
Submerged: Fully		Depth (in):	Limited screening conducted to check for floatable debris.	
Sampling Results				
Sample Location:		Floatables:	None	
Total Chlorine:	-- ppm	Odor:		
Free Chlorine:	-- ppm	Turbidity:		
Ammonia:	-- ppm	Color:		
pH:	-- units	Gross Solids:	Moderate	
Temperature	-- °F	Vegetation:		
Conductivity:	-- µS/cm	Benthic Growth:		
Detergents:	-- mg/L	Stains:		
		Non-illicit:	None	
			Condition Assessment	
			Graffiti:	None
			Erosion:	None
			Deposition:	None 0 in.
			Damage:	None

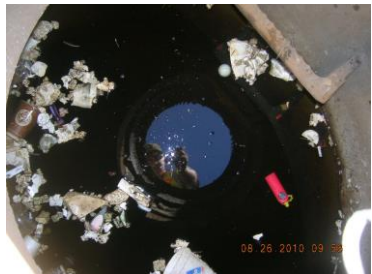
o20100826095640.JPG

Inspection Date: 8/26/2010 10:01:38 AM		Type: Ongoing	Flow: Submerged, indeterminate	Previous Rainfall (hrs): 72+
Illicit Discharge Potential: Potential		Inspector: JCW	Notes	
Submerged: Fully		Depth (in): 36	Floatable debris in manhole.	
Sampling Results				
Sample Location:	Pool	Floatables:	None	
Total Chlorine:	0 ppm	Odor:	None	
Free Chlorine:	0 ppm	Turbidity:	None	
Ammonia:	0 ppm	Color:	Faint in bottle	
pH:	7.23 units	Gross Solids:	Moderate	
Temperature	76 °F	Vegetation:	None	
Conductivity:	-- µS/cm	Benthic Growth:	Slight	
Detergents:	0 mg/L	Stains:	None	
		Non-illicit:	None	
			Condition Assessment	
			Graffiti:	None
			Erosion:	None
			Deposition:	None 0 in.
			Damage:	None

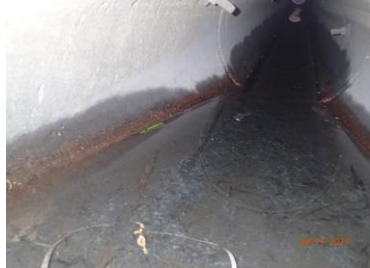
o20210817073912.JPG
2021

Inspection Date: 8/17/2021 7:41:43 AM		Type: Ongoing	Flow: Submerged, indeterminate	Previous Rainfall (hrs): 72+
Illicit Discharge Potential: Potential		Inspector: JCW		
Submerged: Partially		Depth (in): 3		
Sampling Results		Notes Outfall partially submerged. Traffic prevented screening of upstream inlet. Pond sample from end of pipe had detergent and elevated conductivity.		
Sample Location: Pool	Floatables: None	Condition Assessment Graffiti: None Erosion: None Deposition: None in. Damage: None		
Total Chlorine: 0 ppm	Odor: None			
Free Chlorine: 0 ppm	Turbidity: None			
Ammonia: 0 ppm	Color: None			
pH: 7.4 units	Gross Solids: None			
Temperature 72 °F	Vegetation: None			
Conductivity: 2580 µS/cm	Benthic Growth: Slight			
Detergents: 0.6 mg/L	Stains: Slight			
	Non-illicit: Slight

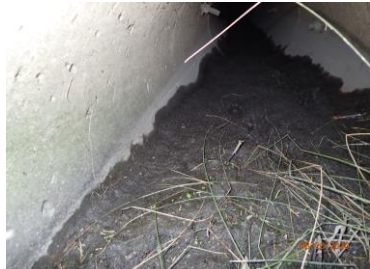
o20200820085150.JPG
2020

Inspection Date: 8/20/2020 8:54:14 AM		Type: Ongoing	Flow: None	Previous Rainfall (hrs): 72+
Illicit Discharge Potential: Unlikely		Inspector: JCW		
Submerged: None		Depth (in):		
Sampling Results		Notes Sediment wet, but no flow at time of inspection. No flow entering pipe at upstream curb inlet.		
Sample Location: --	Floatables: None	Condition Assessment Graffiti: None Erosion: None Deposition: Minor 1 in. Damage: None		
Total Chlorine: -- ppm	Odor: None			
Free Chlorine: -- ppm	Turbidity: None			
Ammonia: -- ppm	Color: None			
pH: -- units	Gross Solids: None			
Temperature -- °F	Vegetation: None			
Conductivity: -- µS/cm	Benthic Growth: Slight			
Detergents: -- mg/L	Stains: None			
	Non-illicit: None

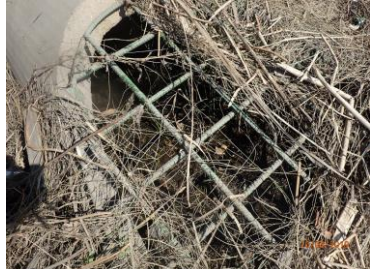
o20191008130940.JPG
2019

Inspection Date: 10/8/2019 2:11:11 PM		Type: Ongoing	Flow: Submerged, indeterminate	Previous Rainfall (hrs): 48-72
Illicit Discharge Potential: Potential		Inspector: JCW		
Submerged: Partially		Depth (in): 5		
Sampling Results		Notes Outfall partially submerged - screened upstream at 16-1205 US1. Detergent detected in upstream manhole.		
Sample Location: --	Floatables: None	Condition Assessment Graffiti: None Erosion: None Deposition: Minor 2 in. Damage: None		
Total Chlorine: -- ppm	Odor: None			
Free Chlorine: -- ppm	Turbidity: None			
Ammonia: -- ppm	Color: None			
pH: -- units	Gross Solids: Slight			
Temperature -- °F	Vegetation: None			
Conductivity: -- µS/cm	Benthic Growth: Slight			
Detergents: -- mg/L	Stains: None			
	Non-illicit: None

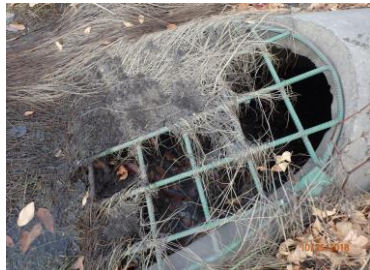
o20181025083538.JPG
2018

Inspection Date: 10/25/2018 8:41:00 AM		Type: Ongoing	Flow: Submerged, indeterminate	Previous Rainfall (hrs): 72+
Illicit Discharge Potential: Potential		Inspector: JCW		
Submerged: Partially		Depth (in): 5		
Sampling Results		Notes Outfall partially submerged - screened upstream at 16-1205 US1. Detergent detected in upstream manhole.		
Sample Location: --	Floatables: None	Condition Assessment Graffiti: None Erosion: None Deposition: Minor 2 in. Damage: None		
Total Chlorine: -- ppm	Odor: None			
Free Chlorine: -- ppm	Turbidity: None			
Ammonia: -- ppm	Color: None			
pH: -- units	Gross Solids: Slight			
Temperature -- °F	Vegetation: None			
Conductivity: -- µS/cm	Benthic Growth: None			
Detergents: -- mg/L	Stains: None			
	Non-illicit: None

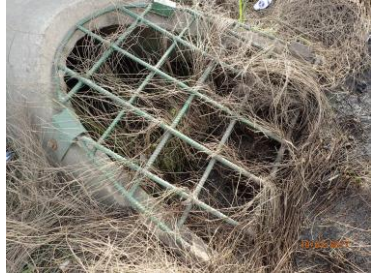
<p style="text-align: center;">o20171003090114.JPG</p> <p style="text-align: center; font-size: 24pt; font-weight: bold;">2017</p>	
Submerged: Partially		Depth (in): 1		Outfall partially submerged - screened upstream at 16-1205 US1.			
Sampling Results							
Sample Location:		Floatables:	None	Condition Assessment			
Total Chlorine: -- ppm		Odor:	None	Graffiti:		None	
Free Chlorine: -- ppm		Turbidity:	None	Erosion:		None	
Ammonia: -- ppm		Color:	None	Deposition:		Minor	1 in.
pH: -- units		Gross Solids:	Slight	Damage:		None	
Temperature -- °F		Vegetation:	None				
Conductivity: -- µS/cm		Benthic Growth:	None				
Detergents: -- mg/L		Stains:	None				
		Non-illicit:	None

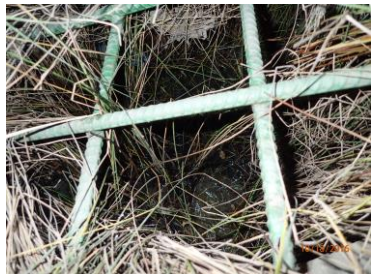
<p style="text-align: center;">o20161018070408.JPG</p> <p style="text-align: center; font-size: 24pt; font-weight: bold;">2016</p>	
Submerged: Partially		Depth (in): 2		Outfall partially submerged - screened upstream at 16-1205 US1.			
Sampling Results							
Sample Location:		Floatables:	None	Condition Assessment			
Total Chlorine: -- ppm		Odor:	None	Graffiti:		None	
Free Chlorine: -- ppm		Turbidity:	None	Erosion:		None	
Ammonia: -- ppm		Color:	None	Deposition:		None	in.
pH: -- units		Gross Solids:	None	Damage:		None	
Temperature -- °F		Vegetation:	None				
Conductivity: -- µS/cm		Benthic Growth:	Slight				
Detergents: -- mg/L		Stains:	None				
		Non-illicit:	None

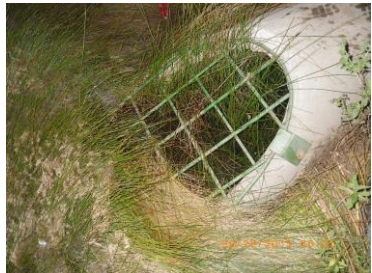
<p style="text-align: center;">o20150928053734.JPG</p> <p style="text-align: center; font-size: 24pt; font-weight: bold;">2015</p>	
Submerged: Partially		Depth (in): 3		Outfall partially submerged - screened at 16-1205 US1.			
Sampling Results							
Sample Location:		Floatables:	None	Condition Assessment			
Total Chlorine: -- ppm		Odor:	None	Graffiti:		None	
Free Chlorine: -- ppm		Turbidity:	None	Erosion:		None	
Ammonia: -- ppm		Color:	None	Deposition:		None	in.
pH: -- units		Gross Solids:	None	Damage:		None	
Temperature -- °F		Vegetation:	None				
Conductivity: -- µS/cm		Benthic Growth:	Slight				
Detergents: -- mg/L		Stains:	Slight				
		Non-illicit:	None

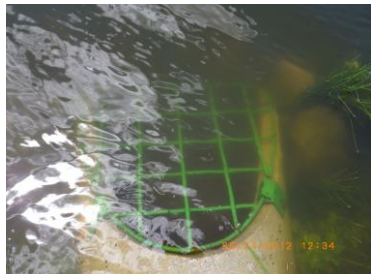
<p style="text-align: center;">o20120621113440.JPG</p> <p style="text-align: center; font-size: 24pt; font-weight: bold;">2012</p>	
Submerged: Fully		Depth (in): 21		Outfall fully submerged; screened upstream at 16-1205 US1.			
Sampling Results							
Sample Location:		Floatables:	None	Condition Assessment			
Total Chlorine: -- ppm		Odor:	None	Graffiti:		None	
Free Chlorine: -- ppm		Turbidity:	None	Erosion:		None	
Ammonia: -- ppm		Color:	None	Deposition:		None	in.
pH: -- units		Gross Solids:	None	Damage:		None	
Temperature -- °F		Vegetation:	None				
Conductivity: -- µS/cm		Benthic Growth:	None				
Detergents: -- mg/L		Stains:	None				
		Non-illicit:	None

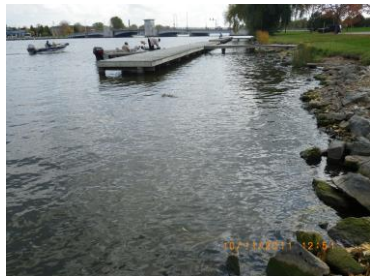
o20111011125132.JPG

Inspection Date: 10/11/2011 12:51:01 PM		Type: Ongoing	Flow: Submerged, indeterminate	Previous Rainfall (hrs): 72+
Illicit Discharge Potential: Potential		Inspector: JCW	Notes	
Submerged: Partially Depth (in):			2010 screening follow-up. Outfall partially submerged. Outfall screened upstream at 16-201 US1.	
Sampling Results			Condition Assessment	
Sample Location:	Floatables:	None	Graffiti: None	
Total Chlorine: -- ppm	Odor:	None	Erosion: None	
Free Chlorine: -- ppm	Turbidity:	None	Deposition: None 0 in.	
Ammonia: -- ppm	Color:	None	Damage: None	
pH: -- units	Gross Solids:	None		
Temperature -- °F	Vegetation:	None		
Conductivity: -- µS/cm	Benthic Growth:	None		
Detergents: -- mg/L	Stains:	None		
	Non-illicit:	None

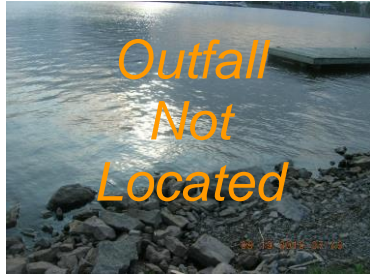
o20100819074346.JPG

Inspection Date: 8/19/2010 7:49:43 AM		Type: Ongoing	Flow: Submerged (not located)	Previous Rainfall (hrs): 72+
Illicit Discharge Potential: Potential		Inspector: JCW	Notes	
Submerged: Fully Depth (in):			Outfall fully submerged and not physically located. Outfall screened upstream at 16-201 US1.	
Sampling Results			Condition Assessment	
Sample Location:	Floatables:	None	Graffiti: None	
Total Chlorine: -- ppm	Odor:	None	Erosion: None	
Free Chlorine: -- ppm	Turbidity:	None	Deposition: None 0 in.	
Ammonia: -- ppm	Color:	None	Damage: None	
pH: -- units	Gross Solids:	None		
Temperature -- °F	Vegetation:	None		
Conductivity: -- µS/cm	Benthic Growth:	None		
Detergents: -- mg/L	Stains:	None		
	Non-illicit:	None

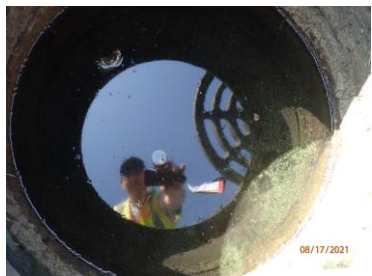
o20210817093056.JPG 2021

Sample Location:	Pool	Floatables:	Moderate																																				
Total Chlorine:	0 ppm	Odor:	Easily detected																																				
Free Chlorine:	0 ppm	Turbidity:	None																																				
Ammonia:	0 ppm	Color:	None																																				
pH:	7.5 units	Gross Solids:	Slight																																				
Temperature:	78 °F	Vegetation:	None																																				
Conductivity:	315 µS/cm	Benthic Growth:	Moderate																																				
Detergents:	0 mg/L	Stains:	None																																				
		Non-illicit:	None																																				
		Condition Assessment <table border="1" style="width:100%; border-collapse: collapse;"> <tr> <td>Graffiti:</td> <td>None</td> </tr> <tr> <td>Erosion:</td> <td>None</td> </tr> <tr> <td>Deposition:</td> <td>None in.</td> </tr> <tr> <td>Damage:</td> <td>None</td> </tr> </table>			Graffiti:	None	Erosion:	None	Deposition:	None in.	Damage:	None

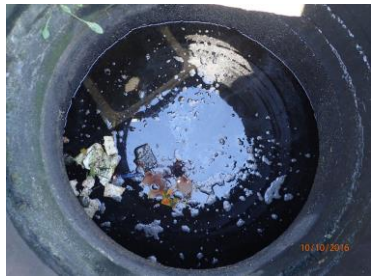
o20161010134816.JPG 2016

Inspection Date: 10/10/2016 1:50:41 PM		Type: Ongoing	Flow: Submerged, indeterminate	Previous Rainfall (hrs): 72+																																			
Illicit Discharge Potential: Potential		Inspector: JCW																																					
Submerged: Fully		Depth (in): 24																																					
Sampling Results <table border="1" style="width:100%; border-collapse: collapse;"> <tr> <td>Sample Location:</td> <td>Pool</td> <td>Floatables:</td> <td>Slight</td> </tr> <tr> <td>Total Chlorine:</td> <td>0 ppm</td> <td>Odor:</td> <td>Faint</td> </tr> <tr> <td>Free Chlorine:</td> <td>0 ppm</td> <td>Turbidity:</td> <td>None</td> </tr> <tr> <td>Ammonia:</td> <td>0 ppm</td> <td>Color:</td> <td>Faint in bottle</td> </tr> <tr> <td>pH:</td> <td>7.22 units</td> <td>Gross Solids:</td> <td>Moderate</td> </tr> <tr> <td>Temperature:</td> <td>69 °F</td> <td>Vegetation:</td> <td>None</td> </tr> <tr> <td>Conductivity:</td> <td>429 µS/cm</td> <td>Benthic Growth:</td> <td>None</td> </tr> <tr> <td>Detergents:</td> <td>0 mg/L</td> <td>Stains:</td> <td>None</td> </tr> <tr> <td></td> <td></td> <td>Non-illicit:</td> <td>None</td> </tr> </table>		Sample Location:	Pool	Floatables:	Slight	Total Chlorine:	0 ppm	Odor:	Faint	Free Chlorine:	0 ppm	Turbidity:	None	Ammonia:	0 ppm	Color:	Faint in bottle	pH:	7.22 units	Gross Solids:	Moderate	Temperature:	69 °F	Vegetation:	None	Conductivity:	429 µS/cm	Benthic Growth:	None	Detergents:	0 mg/L	Stains:	None			Non-illicit:	None	Notes Potential illicit discharge due to gross solids.

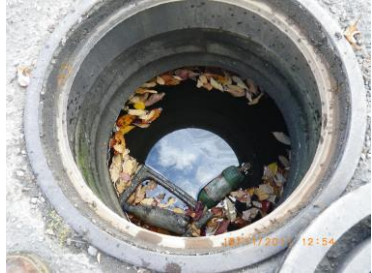
Inspection Date: 10/11/2011 12:54:49 PM		Type: Ongoing		Flow: Submerged, indeterminate		Previous Rainfall (hrs): 72+	
Illicit Discharge Potential: Potential		Inspector: JCW		Notes 2010 screening follow-up. Floatable debris still present. Slight petroleum sheen.

o20111011125430.JPG	
Submerged: Fully		Depth (in): 22					
Sampling Results		Floatables: Slight Odor: None Turbidity: None Color: None Gross Solids: Slight Vegetation: None Benthic Growth: None Stains: None Non-illicit: None		Condition Assessment Graffiti: None Erosion: None Deposition: None 0 in. Damage: None			
Sample Location: Pool Total Chlorine: 0 ppm Free Chlorine: 0 ppm Ammonia: 0 ppm pH: 8.44 units Temperature: 71 °F Conductivity: -- µS/cm Detergents: -- mg/L						2011

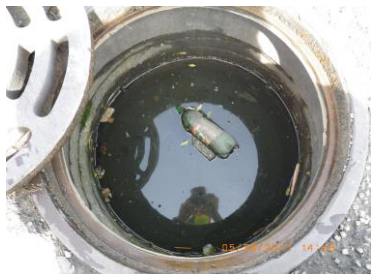
Inspection Date: 5/26/2011 2:48:00 PM		Type: Other		Flow: Submerged, indeterminate		Previous Rainfall (hrs): 72+	
Illicit Discharge Potential: Unlikely		Inspector: JCW		Notes Limited screening conducted to check for floatable debris.

o20110526144848.JPG	
Submerged: Fully		Depth (in):					
Sampling Results		Floatables: Slight Odor: Turbidity: Color: Gross Solids: Slight Vegetation: Benthic Growth: Stains: Non-illicit: None		Condition Assessment Graffiti: None Erosion: None Deposition: None 0 in. Damage: None			
Sample Location: Total Chlorine: -- ppm Free Chlorine: -- ppm Ammonia: -- ppm pH: -- units Temperature: -- °F Conductivity: -- µS/cm Detergents: -- mg/L						2011

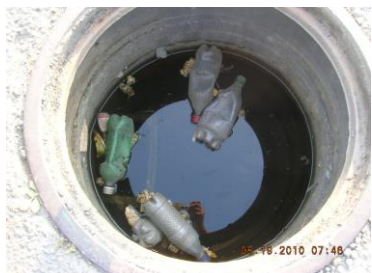
Inspection Date: 8/19/2010 7:54:51 AM		Type: Ongoing		Flow: Submerged, indeterminate		Previous Rainfall (hrs): 72+	
Illicit Discharge Potential: Potential		Inspector: JCW		Notes Moderate floatable debris in catchbasin.

o20100819074612.JPG	
Submerged: Fully		Depth (in): 29					
Sampling Results		Floatables: None Odor: None Turbidity: Slight cloudiness Color: Faint in bottle Gross Solids: Moderate Vegetation: None Benthic Growth: Slight Stains: None Non-illicit: None		Condition Assessment Graffiti: None Erosion: None Deposition: None 0 in. Damage: None			
Sample Location: Pool Total Chlorine: 0 ppm Free Chlorine: 0 ppm Ammonia: 0 ppm pH: 7.57 units Temperature: 74 °F Conductivity: -- µS/cm Detergents: 0 mg/L						2010

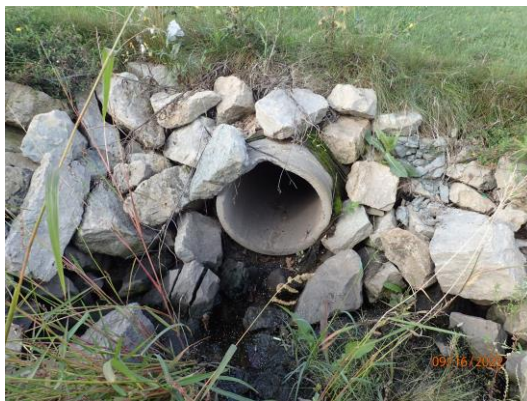
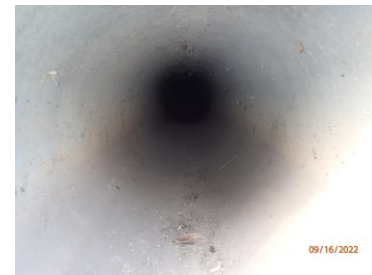
o20220916085226.JPG

Notes: No flow at time of inspection. Slight damage to end of concrete pipe.

Damage: Minor ☐ Displacement ☐ Undercut ☐ Crushed
☐ Corrosion ☒ Cracks/Structural Damage

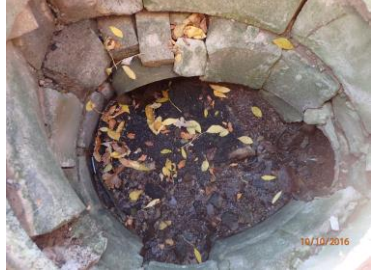
o20161010151142.JPG

Inspection Date: 10/10/2016 3:13:48 PM		Type: Ongoing	Flow: None	Previous Rainfall (hrs): 72+
Illicit Discharge Potential: Unlikely		Inspector: JCW		
Submerged: None		Depth (in):		
Sampling Results		Notes		
Sample Location:		Sediment in catchbasin wet, but no flow at time of inspection.		
Total Chlorine:	-- ppm	Floatables:	None	
Free Chlorine:	-- ppm	Odor:	None	
Ammonia:	-- ppm	Turbidity:	None	
pH:	-- units	Color:	None	
Temperature:	-- °F	Gross Solids:	None	
Conductivity:	-- µS/cm	Vegetation:	None	
Detergents:	-- mg/L	Benthic Growth:	None	
		Stains:	None	
		Non-illicit:	None	
		Condition Assessment		
		Graffiti:	None	
		Erosion:	None	
		Deposition:	Minor	3 in.
		Damage:	None

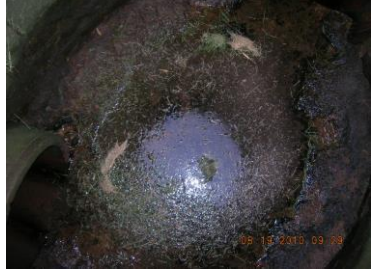
o20100819092912.JPG

Inspection Date: 8/19/2010 9:39:34 AM		Type: Ongoing	Flow: Submerged, no flow	Previous Rainfall (hrs): 72+
Illicit Discharge Potential: Unlikely		Inspector: JCW		
Submerged: Partially		Depth (in): 1		
Sampling Results		Notes		
Sample Location: Pool		Sample collected from pool at bottom of catchbasin.		
Total Chlorine:	0 ppm	Floatables:	None	
Free Chlorine:	0 ppm	Odor:	None	
Ammonia:	0 ppm	Turbidity:	None	
pH:	8.08 units	Color:	None	
Temperature:	80 °F	Gross Solids:	None	
Conductivity:	-- µS/cm	Vegetation:	None	
Detergents:	0 mg/L	Benthic Growth:	None	
		Stains:	None	
		Non-illicit:	None	
		Condition Assessment		
		Graffiti:	None	
		Erosion:	None	
		Deposition:	None	0 in.
		Damage:	None

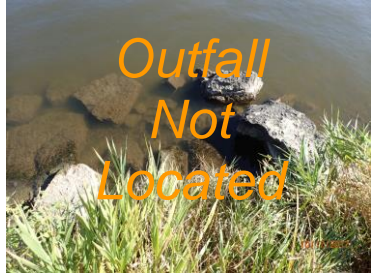
o20171017112242.JPG

Inspection Date: 10/17/2017 11:24:35 AM		Type: Ongoing	Flow: Submerged (not located)	Previous Rainfall (hrs): 48-72
Illicit Discharge Potential: Potential		Inspector: JCW	Notes	
Submerged: Fully Depth (in):			Outfall fully submerged and not located - screened upstream at 16-594 US1. Floating gross solids (litter) in manhole.	
Sampling Results			Condition Assessment	
Sample Location:	Floatables:	None	Graffiti:	None
Total Chlorine: -- ppm	Odor:	None	Erosion:	None
Free Chlorine: -- ppm	Turbidity:	None	Deposition:	None in.
Ammonia: -- ppm	Color:	None	Damage:	None
pH: -- units	Gross Solids:	None		
Temperature -- °F	Vegetation:	None		
Conductivity: -- µS/cm	Benthic Growth:	None		
Detergents: -- mg/L	Stains:	None		
	Non-illicit:	None

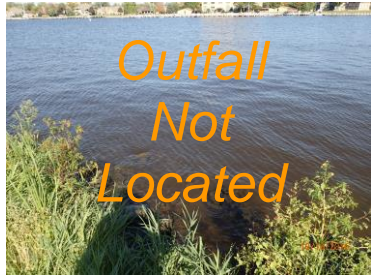
o20161010140356.JPG

Inspection Date: 10/10/2016 2:04:49 PM		Type: Ongoing	Flow: Submerged (not located)	Previous Rainfall (hrs): 72+
Illicit Discharge Potential: Potential		Inspector: JCW	Notes	
Submerged: Fully Depth (in):			Outfall fully submerged and not located -screened upstream at 16-594 US1.	
Sampling Results			Condition Assessment	
Sample Location:	Floatables:	None	Graffiti:	None
Total Chlorine: -- ppm	Odor:	None	Erosion:	None
Free Chlorine: -- ppm	Turbidity:	None	Deposition:	None in.
Ammonia: -- ppm	Color:	None	Damage:	None
pH: -- units	Gross Solids:	None		
Temperature -- °F	Vegetation:	None		
Conductivity: -- µS/cm	Benthic Growth:	None		
Detergents: -- mg/L	Stains:	None		
	Non-illicit:	None

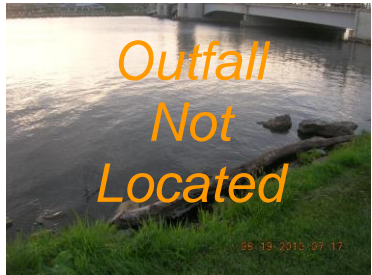
o20100819071708.JPG

Inspection Date: 8/19/2010 7:23:24 AM		Type: Ongoing	Flow: Submerged (not located)	Previous Rainfall (hrs): 72+
Illicit Discharge Potential: Unlikely		Inspector: JCW	Notes	
Submerged: Fully Depth (in):			Outfall fully submerged and not physically located. Outfall screened upstream at 16-594 US1.	
Sampling Results			Condition Assessment	
Sample Location:	Floatables:	None	Graffiti:	None
Total Chlorine: -- ppm	Odor:	None	Erosion:	None
Free Chlorine: -- ppm	Turbidity:	None	Deposition:	None 0 in.
Ammonia: -- ppm	Color:	None	Damage:	None
pH: -- units	Gross Solids:	None		
Temperature -- °F	Vegetation:	None		
Conductivity: -- µS/cm	Benthic Growth:	None		
Detergents: -- mg/L	Stains:	None		
	Non-illicit:	None

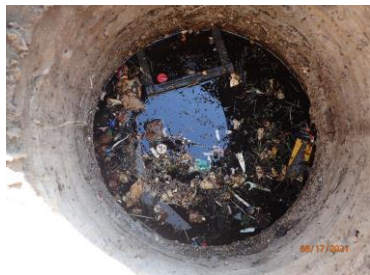
Inspection Date: 8/17/2021 9:42:48 AM		Type: Ongoing	Flow: Submerged, indeterminate	Previous Rainfall (hrs): 72+
Illicit Discharge Potential: Potential Submerged: Fully Depth (in): 59		Inspector: JCW	Notes Sample collected from submerged pool in manhole. Floating gross solids (litter) in manhole.	
Sampling Results Sample Location: Pool Total Chlorine: 0 ppm Free Chlorine: 0 ppm Ammonia: 0 ppm pH: 7.66 units Temperature: 79 °F Conductivity: 205 µS/cm Detergents: 0 mg/L		Floatables: None Odor: None Turbidity: None Color: None Gross Solids: Moderate Vegetation: None Benthic Growth: None Stains: None Non-illicit: None	Condition Assessment Graffiti: None Erosion: None Deposition: None in. Damage: None

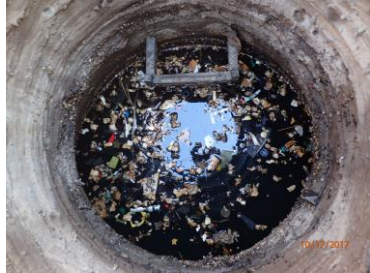
o20171017112318.JPG

Inspection Date: 10/17/2017 11:27:30 AM		Type: Ongoing	Flow: Submerged, indeterminate	Previous Rainfall (hrs): 48-72
Illicit Discharge Potential: Potential		Inspector: JCW	Notes	
Submerged: Fully		Depth (in): 51	Sample collected from submerged pool in manhole. Floating gross solids (litter) in manhole.	
Sampling Results		Condition Assessment		
Sample Location: Pool	Floatables: None	Graffiti: None Erosion: None Deposition: None in. Damage: None		
Total Chlorine: 0 ppm	Odor: None			
Free Chlorine: 0 ppm	Turbidity: None			
Ammonia: 0 ppm	Color: None			
pH: 6.98 units	Gross Solids: Moderate			
Temperature 68 °F	Vegetation: None			
Conductivity: 741 µS/cm	Benthic Growth: None			
Detergents: 0 mg/L	Stains: None			
	Non-illicit: None

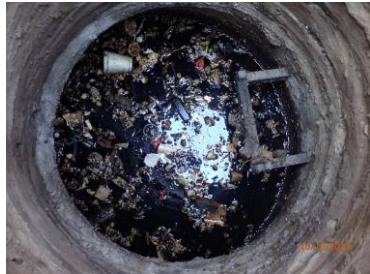
o20161010140454.JPG

Inspection Date: 10/10/2016 2:07:20 PM		Type: Ongoing	Flow: Submerged, indeterminate	Previous Rainfall (hrs): 72+
Illicit Discharge Potential: Potential		Inspector: JCW	Notes	
Submerged: Fully		Depth (in): 51	Potential illicit discharge due to gross solids.	
Sampling Results		Condition Assessment		
Sample Location: Pool	Floatables: Slight	Graffiti: None Erosion: None Deposition: None in. Damage: None		
Total Chlorine: 0 ppm	Odor: Easily detected			
Free Chlorine: 0 ppm	Turbidity: None			
Ammonia: 0.25 ppm	Color: None			
pH: 7.17 units	Gross Solids: Moderate			
Temperature 71 °F	Vegetation: None			
Conductivity: 831 µS/cm	Benthic Growth: None			
Detergents: 0 mg/L	Stains: None			
	Non-illicit: None

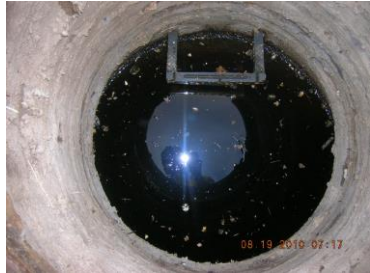
o20100819071738.JPG

Inspection Date: 8/19/2010 7:26:35 AM		Type: Ongoing	Flow: Submerged, indeterminate	Previous Rainfall (hrs): 72+
Illicit Discharge Potential: Unlikely		Inspector: JCW	Notes	
Submerged: Fully		Depth (in): 51	2 small oil drops, likely from Oshkosh Ave runoff.	
Sampling Results		Condition Assessment		
Sample Location: Pool	Floatables: Slight	Graffiti: None Erosion: None Deposition: None 0 in. Damage: None		
Total Chlorine: 0 ppm	Odor: None			
Free Chlorine: 0 ppm	Turbidity: None			
Ammonia: 0 ppm	Color: Faint in bottle			
pH: 7.44 units	Gross Solids: Slight			
Temperature 75 °F	Vegetation: None			
Conductivity: -- µS/cm	Benthic Growth: None			
Detergents: 0 mg/L	Stains: None			
	Non-illicit: None

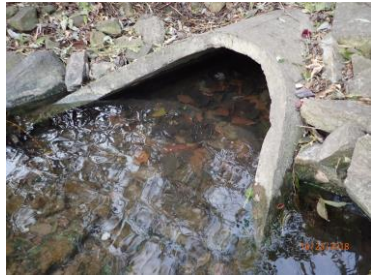
o20181025081252.JPG

Outfall partially submerged - screened upstream at 16-660 US1. Detergent detected in sample. Condition Assessment Graffiti: None Erosion: None Deposition: None in. Damage: None																																			
2018

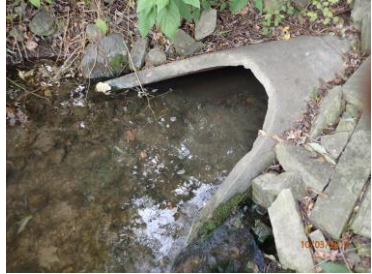
o20171003110156.JPG

Inspection Date: 10/3/2017 11:03:37 AM		Type: Ongoing	Flow: Submerged, indeterminate	Previous Rainfall (hrs): 72+
Illicit Discharge Potential: Potential		Inspector: JCW	Notes	
Submerged: Partially Depth (in): 12			Outfall partially submerged - screened upstream at 16-660 US1. Detergent detected in sample.	
Sampling Results			Condition Assessment	
Sample Location:	Floatables:	None	Graffiti: None Erosion: None Deposition: None in. Damage: None	
Total Chlorine: -- ppm	Odor:	None		
Free Chlorine: -- ppm	Turbidity:	None		
Ammonia: -- ppm	Color:	None		
pH: -- units	Gross Solids:	None		
Temperature -- °F	Vegetation:	None		
Conductivity: -- µS/cm	Benthic Growth:	Moderate		
Detergents: -- mg/L	Stains:	Moderate		
	Non-illicit:	None

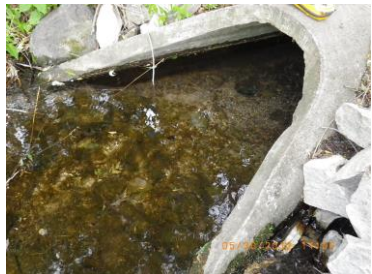
o20120530100048.JPG

Inspection Date: 5/30/2012 10:59:58 AM		Type: Ongoing	Flow: Submerged, indeterminate	Previous Rainfall (hrs): 72+
Illicit Discharge Potential: Unlikely		Inspector: JCW	Notes	
Submerged: Partially Depth (in): 10			Outfall partially submerged. Outfall screened upstream at 16-660.	
Sampling Results			Condition Assessment	
Sample Location:	Floatables:	None	Graffiti: None Erosion: None Deposition: Minor 1 in. Damage: None	
Total Chlorine: -- ppm	Odor:	None		
Free Chlorine: -- ppm	Turbidity:	None		
Ammonia: -- ppm	Color:	None		
pH: -- units	Gross Solids:	Slight		
Temperature -- °F	Vegetation:	None		
Conductivity: -- µS/cm	Benthic Growth:	Moderate		
Detergents: -- mg/L	Stains:	Slight		
	Non-illicit:	None

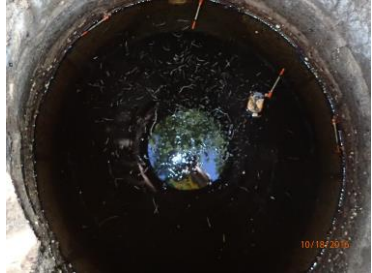
o20161018122930.JPG 2016

Notes Potential illicit discharge due to gross solids. Four syringes removed from manhole.																																				
		Condition Assessment <table border="1" style="width:100%; border-collapse: collapse;"> <tr><td>Graffiti:</td><td>None</td></tr> <tr><td>Erosion:</td><td>None</td></tr> <tr><td>Deposition:</td><td>None in.</td></tr> <tr><td>Damage:</td><td>None</td></tr> </table>			Graffiti:	None	Erosion:	None	Deposition:	None in.	Damage:	None																										
Graffiti:	None																																					
Erosion:	None																																					
Deposition:	None in.																																					
Damage:	None

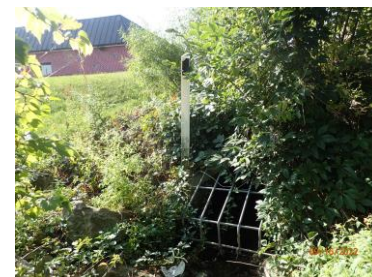
o20220916094346.JPG

☐ Petrol. Sheen ☐ Suds ☐ Sewage ☐ Algae ☐ Other☐ Petroleum ☐ Musty ☐ Sewage ☐ Chlorine ☐ Other☐ VOC/Solvent ☐ Fishy ☐ Sulfur ☐ Fragrant☒ Litter ☐ Veg. Debris ☐ Sediment ☐ Other☐ Inhibited ☐ Excessive☒ Green ☐ Brown☒ Flow Line ☐ Oil ☐ Rust Stains☐ Paint ☐ Other☐ Natural Sheen ☐ Natural Suds/Foam

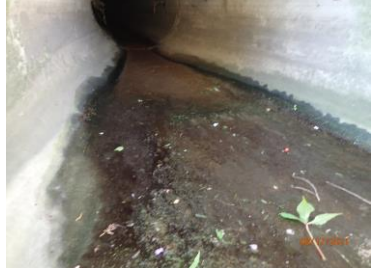
o20210817084532.JPG <div style="text-align: center; font-size: 24pt; font-weight: bold;">2021</div>

Sample Location:	Flow																																					
Total Chlorine:	0 ppm																																					
Free Chlorine:	0 ppm																																					
Ammonia:	0 ppm																																					
pH:	8.14 units																																					
Temperature:	76 °F																																					
Conductivity:	1990 µS/cm																																					
Detergents:	0.65 mg/L																																					
Floatables:	None																																					
Odor:	None																																					
Turbidity:	None																																					
Color:	None																																					
Gross Solids:	Slight																																					
Vegetation:	None																																					
Benthic Growth:	Severe																																					
Stains:	Moderate																																					
Non-illicit:	None

<div style="display: flex;"> <div style="flex: 1;"> <p>Notes</p> <p>Sample collected from pipe flow. Detergent detected in sample.</p> </div> <div style="flex: 1;"> <p>Condition Assessment</p> <table border="1" style="width:100%; border-collapse: collapse;"> <tr><td>Graffiti:</td><td>None</td></tr> <tr><td>Erosion:</td><td>None</td></tr> <tr><td>Deposition:</td><td>None in.</td></tr> <tr><td>Damage:</td><td>None</td></tr> </table> </div> </div>			Graffiti:	None	Erosion:	None	Deposition:	None in.	Damage:	None																										
Graffiti:	None																																					
Erosion:	None																																					
Deposition:	None in.																																					
Damage:	None

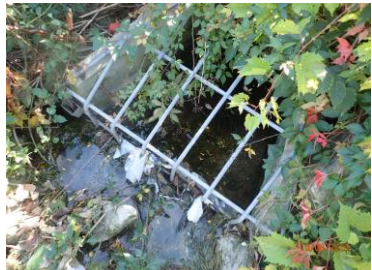
o20191008125814.JPG <div style="text-align: center; font-size: 24pt; font-weight: bold;">2019</div>

Sample Location:	Flow																																					
Total Chlorine:	0 ppm																																					
Free Chlorine:	0 ppm																																					
Ammonia:	0 ppm																																					
pH:	8.09 units																																					
Temperature:	66 °F																																					
Conductivity:	2640 µS/cm																																					
Detergents:	0.5 mg/L																																					
Floatables:	None																																					
Odor:	None																																					
Turbidity:	None																																					
Color:	None																																					
Gross Solids:	Slight																																					
Vegetation:	None																																					
Benthic Growth:	Slight																																					
Stains:	None																																					
Non-illicit:	None

<div style="display: flex;"> <div style="flex: 1;"> <p>Notes</p> <p>Sample collected from pipe flow. Detergent and elevated conductivity in sample.</p> </div> <div style="flex: 1;"> <p>Condition Assessment</p> <table border="1" style="width:100%; border-collapse: collapse;"> <tr><td>Graffiti:</td><td>None</td></tr> <tr><td>Erosion:</td><td>None</td></tr> <tr><td>Deposition:</td><td>None in.</td></tr> <tr><td>Damage:</td><td>None</td></tr> </table> </div> </div>			Graffiti:	None	Erosion:	None	Deposition:	None in.	Damage:	None																										
Graffiti:	None																																					
Erosion:	None																																					
Deposition:	None in.																																					
Damage:	None

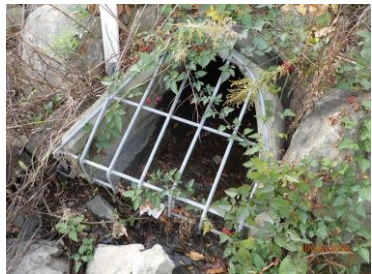
o20181025085152.JPG

Inspection Date: 10/25/2018 8:55:36 AM		Type: Ongoing	Flow: Trickle	Previous Rainfall (hrs): 72+
Illicit Discharge Potential: Potential		Inspector: JCW	Notes	
Submerged: None		Depth (in):	Sample collected from pipe flow. Detergent and elevated conductivity in sample.	
Sampling Results		Floatables: None	Condition Assessment	
Sample Location: Flow		Odor: None	Graffiti: None	
Total Chlorine: 0 ppm		Turbidity: None	Erosion: None	
Free Chlorine: 0 ppm		Color: None	Deposition: None in.	
Ammonia: 0 ppm		Gross Solids: None	Damage: None	
pH: 8.22 units		Vegetation: None		
Temperature 52 °F		Benthic Growth: Moderate		
Conductivity: 3300 µS/cm		Stains: None		
Detergents: 0.45 mg/L		Non-illicit: None

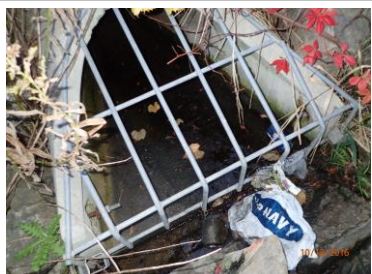
o20161018071712.JPG

Inspection Date: 10/18/2016 7:21:24 AM		Type: Ongoing	Flow: Trickle	Previous Rainfall (hrs): 72+
Illicit Discharge Potential: Unlikely		Inspector: JCW	Notes	
Submerged: None		Depth (in):	Elevated conductivity, but no other parameters out of range.	
Sampling Results		Floatables: None	Condition Assessment	
Sample Location: Flow		Odor: Faint	Graffiti: None	
Total Chlorine: 0 ppm		Turbidity: None	Erosion: None	
Free Chlorine: 0 ppm		Color: None	Deposition: None in.	
Ammonia: 0 ppm		Gross Solids: Slight	Damage: None	
pH: 8.29 units		Vegetation: None		
Temperature 64 °F		Benthic Growth: Moderate		
Conductivity: 3880 µS/cm		Stains: None		
Detergents: 0 mg/L		Non-illicit: None

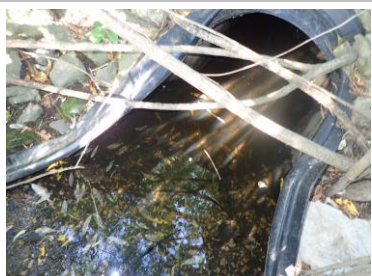
o20200820083238.JPG

Inspection Date: 8/20/2020 8:35:17 AM		Type: Ongoing	Flow: Submerged, indeterminate	Previous Rainfall (hrs): 72+																																		
Illicit Discharge Potential: Unlikely		Inspector: JCW																																				
Submerged: Partially		Depth (in): 8																																				
Sampling Results <table border="1" style="width:100%; border-collapse: collapse;"> <tr><td>Sample Location:</td><td></td></tr> <tr><td>Total Chlorine:</td><td>-- ppm</td></tr> <tr><td>Free Chlorine:</td><td>-- ppm</td></tr> <tr><td>Ammonia:</td><td>-- ppm</td></tr> <tr><td>pH:</td><td>-- units</td></tr> <tr><td>Temperature:</td><td>-- °F</td></tr> <tr><td>Conductivity:</td><td>-- µS/cm</td></tr> <tr><td>Detergents:</td><td>-- mg/L</td></tr> </table>		Sample Location:		Total Chlorine:	-- ppm	Free Chlorine:	-- ppm	Ammonia:	-- ppm	pH:	-- units	Temperature:	-- °F	Conductivity:	-- µS/cm	Detergents:	-- mg/L	<table border="1" style="width:100%; border-collapse: collapse;"> <tr><td>Floatables:</td><td>None</td></tr> <tr><td>Odor:</td><td>None</td></tr> <tr><td>Turbidity:</td><td>None</td></tr> <tr><td>Color:</td><td>None</td></tr> <tr><td>Gross Solids:</td><td>None</td></tr> <tr><td>Vegetation:</td><td>None</td></tr> <tr><td>Benthic Growth:</td><td>None</td></tr> <tr><td>Stains:</td><td>None</td></tr> <tr><td>Non-illicit:</td><td>None</td></tr> </table>	Floatables:	None	Odor:	None	Turbidity:	None	Color:	None	Gross Solids:	None	Vegetation:	None	Benthic Growth:	None	Stains:	None	Non-illicit:	None	Notes 10 inch berm of roots blocking flow from apron. Outfall partially submerged - screened upstream at 16-995 US1.

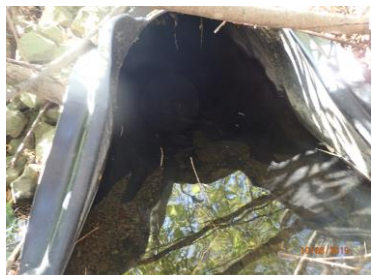
o20191008132854.JPG

Inspection Date: 10/8/2019 2:29:54 PM		Type: Ongoing	Flow: Submerged, indeterminate	Previous Rainfall (hrs): 48-72																																		
Illicit Discharge Potential: Potential		Inspector: JCW																																				
Submerged: Partially		Depth (in): 18																																				
Sampling Results <table border="1" style="width:100%; border-collapse: collapse;"> <tr><td>Sample Location:</td><td></td></tr> <tr><td>Total Chlorine:</td><td>-- ppm</td></tr> <tr><td>Free Chlorine:</td><td>-- ppm</td></tr> <tr><td>Ammonia:</td><td>-- ppm</td></tr> <tr><td>pH:</td><td>-- units</td></tr> <tr><td>Temperature:</td><td>-- °F</td></tr> <tr><td>Conductivity:</td><td>-- µS/cm</td></tr> <tr><td>Detergents:</td><td>-- mg/L</td></tr> </table>		Sample Location:		Total Chlorine:	-- ppm	Free Chlorine:	-- ppm	Ammonia:	-- ppm	pH:	-- units	Temperature:	-- °F	Conductivity:	-- µS/cm	Detergents:	-- mg/L	<table border="1" style="width:100%; border-collapse: collapse;"> <tr><td>Floatables:</td><td>None</td></tr> <tr><td>Odor:</td><td>None</td></tr> <tr><td>Turbidity:</td><td>None</td></tr> <tr><td>Color:</td><td>None</td></tr> <tr><td>Gross Solids:</td><td>None</td></tr> <tr><td>Vegetation:</td><td>None</td></tr> <tr><td>Benthic Growth:</td><td>Slight</td></tr> <tr><td>Stains:</td><td>None</td></tr> <tr><td>Non-illicit:</td><td>None</td></tr> </table>	Floatables:	None	Odor:	None	Turbidity:	None	Color:	None	Gross Solids:	None	Vegetation:	None	Benthic Growth:	Slight	Stains:	None	Non-illicit:	None	Notes Outfall partially submerged - screened upstream at 16-995 US1. Detergent detected in sample.

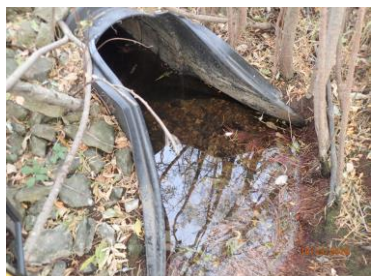
o20181025082506.JPG

Inspection Date: 10/25/2018 8:27:19 AM		Type: Ongoing	Flow: Submerged, indeterminate	Previous Rainfall (hrs): 72+																																		
Illicit Discharge Potential: Potential		Inspector: JCW																																				
Submerged: Partially		Depth (in): 12																																				
Sampling Results <table border="1" style="width:100%; border-collapse: collapse;"> <tr><td>Sample Location:</td><td></td></tr> <tr><td>Total Chlorine:</td><td>-- ppm</td></tr> <tr><td>Free Chlorine:</td><td>-- ppm</td></tr> <tr><td>Ammonia:</td><td>-- ppm</td></tr> <tr><td>pH:</td><td>-- units</td></tr> <tr><td>Temperature:</td><td>-- °F</td></tr> <tr><td>Conductivity:</td><td>-- µS/cm</td></tr> <tr><td>Detergents:</td><td>-- mg/L</td></tr> </table>		Sample Location:		Total Chlorine:	-- ppm	Free Chlorine:	-- ppm	Ammonia:	-- ppm	pH:	-- units	Temperature:	-- °F	Conductivity:	-- µS/cm	Detergents:	-- mg/L	<table border="1" style="width:100%; border-collapse: collapse;"> <tr><td>Floatables:</td><td>None</td></tr> <tr><td>Odor:</td><td>None</td></tr> <tr><td>Turbidity:</td><td>None</td></tr> <tr><td>Color:</td><td>None</td></tr> <tr><td>Gross Solids:</td><td>Slight</td></tr> <tr><td>Vegetation:</td><td>None</td></tr> <tr><td>Benthic Growth:</td><td>None</td></tr> <tr><td>Stains:</td><td>None</td></tr> <tr><td>Non-illicit:</td><td>None</td></tr> </table>	Floatables:	None	Odor:	None	Turbidity:	None	Color:	None	Gross Solids:	Slight	Vegetation:	None	Benthic Growth:	None	Stains:	None	Non-illicit:	None	Notes Outfall partially submerged - screened upstream at 16-995 US1. Detergent detected in sample.

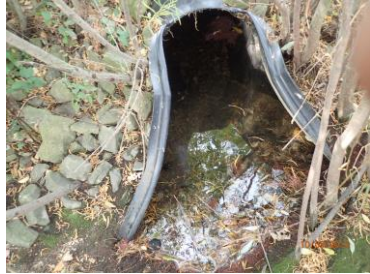
o20171003101614.JPG

Inspection Date: 10/3/2017 10:18:12 AM		Type: Ongoing	Flow: Submerged, indeterminate	Previous Rainfall (hrs): 72+
Illicit Discharge Potential: Potential		Inspector: JCW	Notes	
Submerged: Partially Depth (in): 8			Outfall partially submerged - screened upstream at 16-995 US1. Detergent detected in sample.	
Sampling Results			Condition Assessment	
Sample Location:	Floatables:	None	Graffiti: None Erosion: None Deposition: Minor 1 in. Damage: None	
Total Chlorine: -- ppm	Odor:	None		
Free Chlorine: -- ppm	Turbidity:	None		
Ammonia: -- ppm	Color:	None		
pH: -- units	Gross Solids:	None		
Temperature -- °F	Vegetation:	None		
Conductivity: -- µS/cm	Benthic Growth:	Slight		
Detergents: -- mg/L	Stains:	None		
	Non-illicit:	None

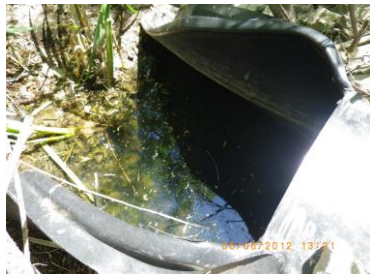
o20120606122140.JPG

Inspection Date: 6/6/2012 1:21:40 PM		Type: Ongoing	Flow: Submerged, indeterminate	Previous Rainfall (hrs): 72+
Illicit Discharge Potential: Unlikely		Inspector: JCW	Notes	
Submerged: Partially Depth (in): 9			No flow leaving pool at end of outfall. Deposition in swale downstream. Screened upstream at 16-995 US1.	
Sampling Results			Condition Assessment	
Sample Location:	Floatables:	None	Graffiti: None Erosion: None Deposition: Moderate 8 in. Damage: None	
Total Chlorine: -- ppm	Odor:	None		
Free Chlorine: -- ppm	Turbidity:	None		
Ammonia: -- ppm	Color:	None		
pH: -- units	Gross Solids:	Slight		
Temperature -- °F	Vegetation:	None		
Conductivity: -- µS/cm	Benthic Growth:	Slight		
Detergents: -- mg/L	Stains:	Slight		
	Non-illicit:	None
