IDDE Ongoing Screening Summary Report

2022 Inspection Year

City of Oshkosh

Westwood

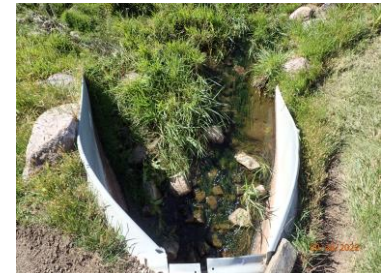
o20220928143850.JPG

Damage: Minor ☐ Displacement ☐ Undercut ☐ Crushed☒ Corrosion ☐ Cracks/Structural Damage

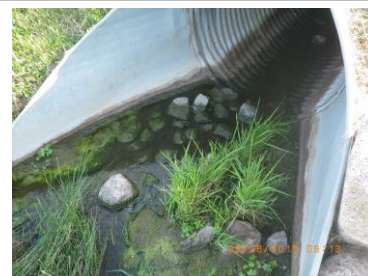
o20150928081322.JPG

Inspection Date: 9/28/2015 9:08:14 AM		Type: Ongoing	Flow: Trickle	Previous Rainfall (hrs): 72+
Illicit Discharge Potential: Unlikely		Inspector: JCW		
Submerged: None		Depth (in):		
Sampling Results		Notes Sample collected from incoming flow.		
Sample Location: Flow	Floatables:	Slight		
Total Chlorine: 0 ppm	Odor:	None		
Free Chlorine: 0 ppm	Turbidity:	None		
Ammonia: 0 ppm	Color:	None		
pH: 8.11 units	Gross Solids:	None		
Temperature 70 °F	Vegetation:	None		
Conductivity: 332 µS/cm	Benthic Growth:	Moderate		
Detergents: 0 mg/L	Stains:	None		
	Non-illicit:	None		
		Condition Assessment Graffiti: None Erosion: None Deposition: None in. Damage: Minor

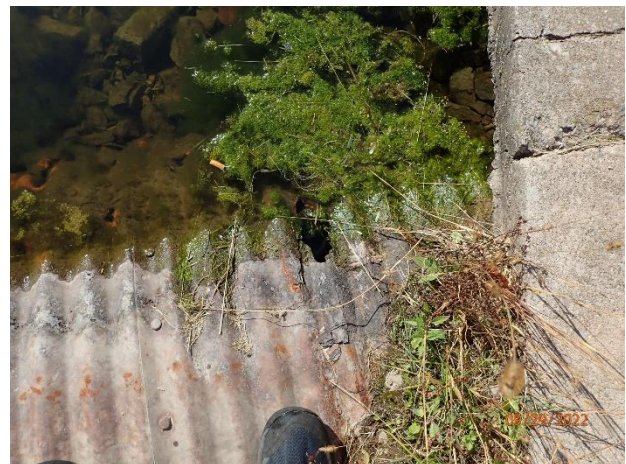
Outfall	Severity	Description
14-999	Minor	Pipe joints displaced 3”.
15-787	Minor	Surface corrosion on CMP.
16-2204	Minor	Broken concrete at end of pipe.
Wash41_01 US1	Minor	Corrosion on flowline of CMP.

Figure 2 – Outfall 15-787

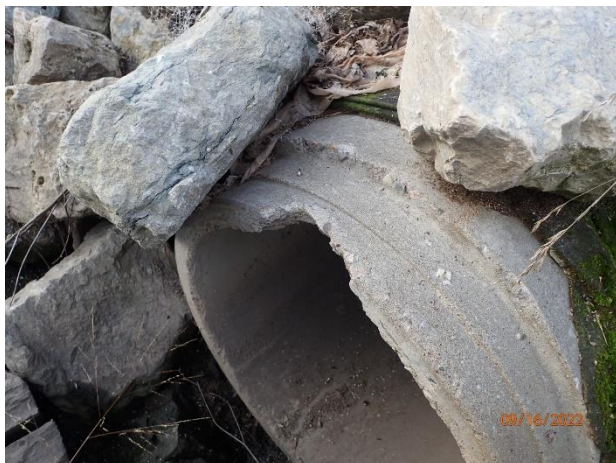
Figure 3 – Outfall 16-2204

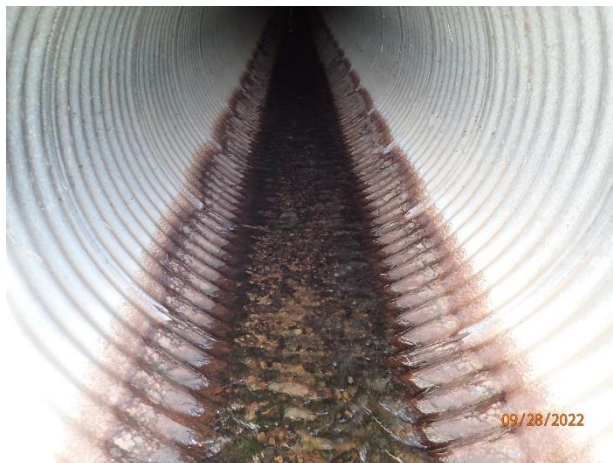
Figure 4 – Outfall Wash41_01 US1

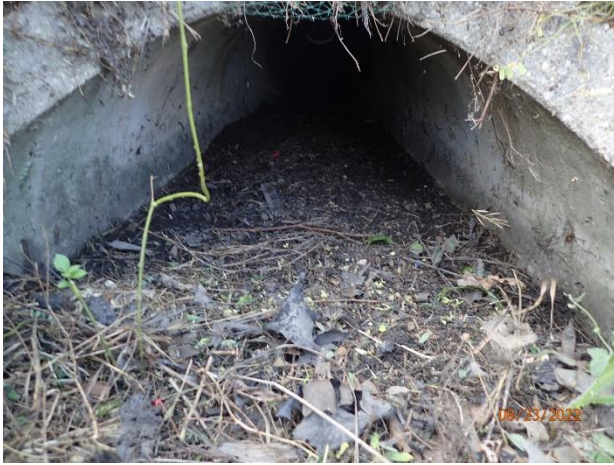
Outfall	Severity	Description
06-2804	Minor	2" of sediment in pipe and on apron
06-1601	Minor	5" of sediment in pipe and on apron
06-1633	Minor	2" of sediment in pipe
13-1098	Moderate	18" of sediment in pipe
14-2024	Minor	3" of sediment on one side of apron
14-999	Minor	3" of sediment in pipe
15-3373	Minor	1" of sediment in pipe

Figure 5 – Outfall 06-2804

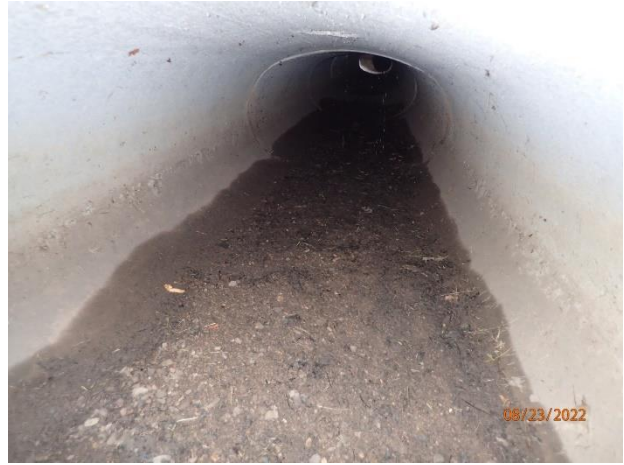
Figure 6 – Outfall 06-1601

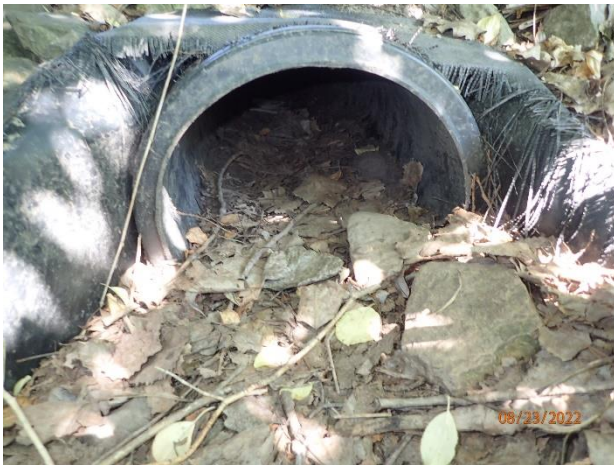
Figure 7 – Outfall 06-1633

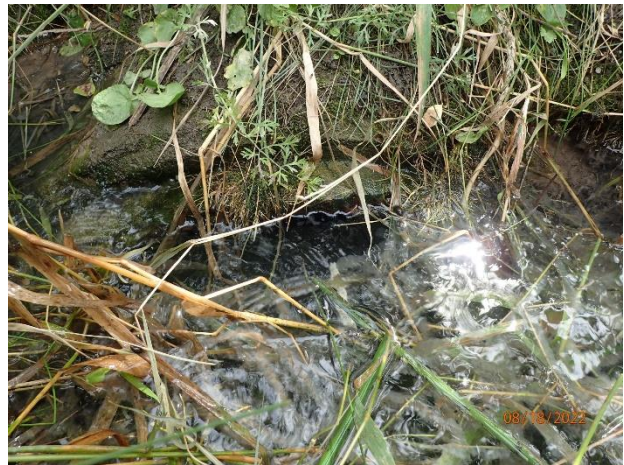
Figure 8 – Outfall 13-1098

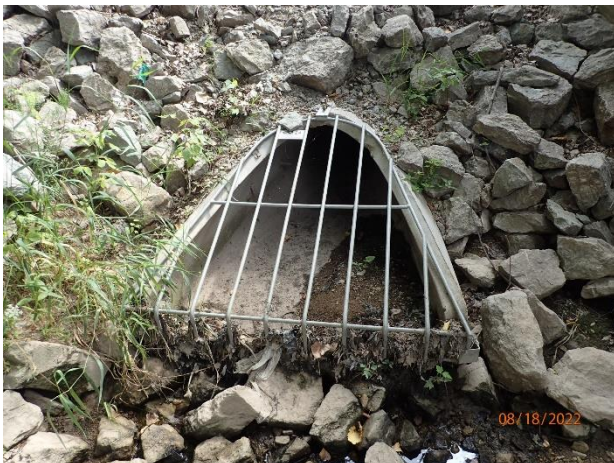
Figure 9 – Outfall 14-2024

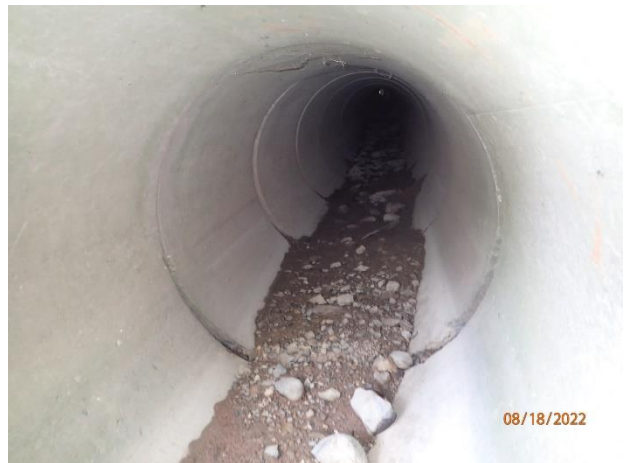
Figure 10 – Outfall 14-999

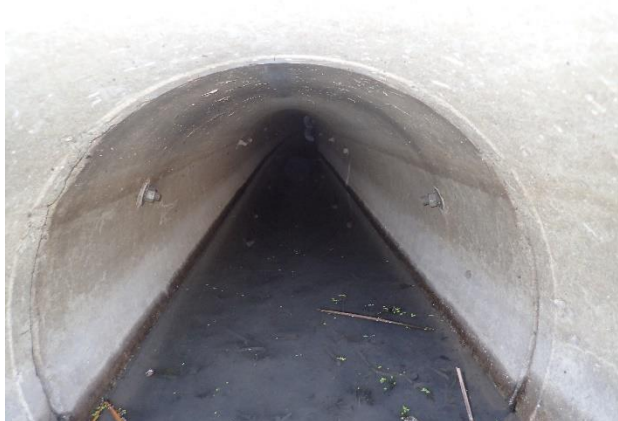
Figure 11 – Outfall 15-3373
