IDDE Ongoing Screening Summary Report

2024 Inspection Year

City of Oshkosh

Westwood

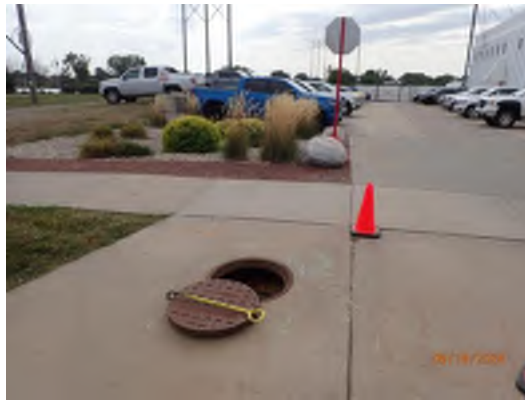
o20240919142410.JPG

Notes: Sample collected from submerged pool in manhole. Follow-up to spring petroleum sheen complaint. No petroleum observed.

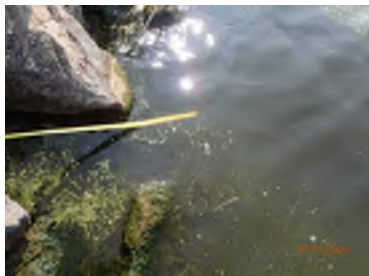
| | | | o20230717083628.JPG <div style="text-align: center; font-size: 24pt; font-weight: bold;">2023</div> | |

| Submerged: Fully Depth (in): | | | Outfall fully submerged - screened upstream at 01-520 US1. Floating gross solids (litter) in upstream manhole. | |

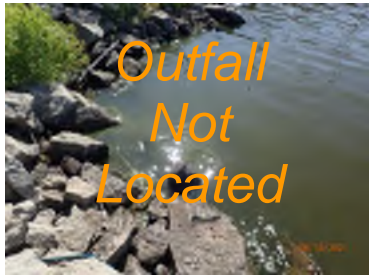
| | | | o20210816101510.JPG <div style="text-align: center; font-size: 24pt; font-weight: bold;">2021</div> | |

| Submerged: Fully Depth (in): | | | Outfall fully submerged and not located - screened upstream at 01-520 US1. Floating gross solids (litter) in upstream manhole. | |

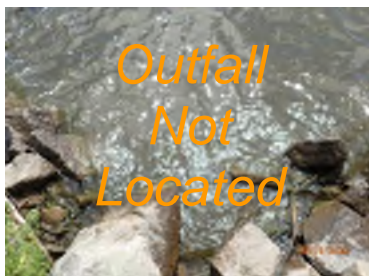
| | | | o20200819131544.JPG <div style="text-align: center; font-size: 24pt; font-weight: bold;">2020</div> | |

| Submerged: Fully Depth (in): | | | Outfall fully submerged and not located - screened upstream at 01-520 US1. Floating gross solids (litter) in upstream manhole. | |

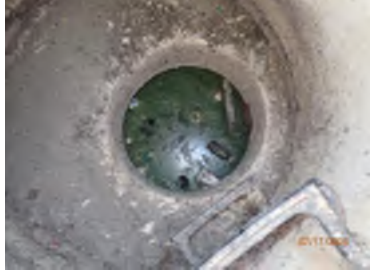
| Inspection Date: 7/17/2023 9:55:37 AM | | Type: Ongoing | Flow: Submerged, indeterminate | Previous Rainfall (hrs): 72+ |
|--|--|---|---|---|
| Sampling Results Sample Location: Pool Total Chlorine: 0 ppm Free Chlorine: 0 ppm Ammonia: 0 ppm pH: 8.79 units Temperature: 74 °F Conductivity: 442 µS/cm Detergents: 0 mg/L | | Floatables: None Odor: None Turbidity: None Color: None Gross Solids: Moderate Vegetation: None Benthic Growth: None Stains: None Non-illicit: None | Condition Assessment Graffiti: None Erosion: None Deposition: None in. Damage: None | |

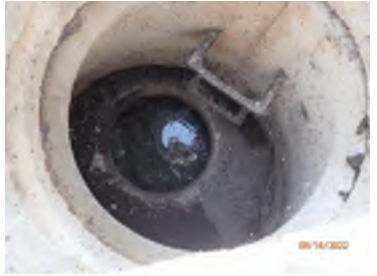
| Inspection Date: 7/17/2023 9:55:37 AM | | Type: Ongoing | Flow: Submerged, indeterminate | Previous Rainfall (hrs): 72+ |
|--|--|---|---|---|
| Inspector: EJK Notes Sample collected from submerged pool in manhole. | | Condition Assessment Graffiti: None Erosion: None Deposition: None in. Damage: None | o20220916134136.JPG 2022 | |
| Sampling Results Sample Location: Pool Total Chlorine: 0 ppm Free Chlorine: 0 ppm Ammonia: 0 ppm pH: 7.61 units Temperature: 74 °F Conductivity: 472 µS/cm Detergents: 0 mg/L | | | | Floatables: Slight Odor: None Turbidity: None Color: None Gross Solids: Slight Vegetation: None Benthic Growth: None Stains: None Non-illicit: None |

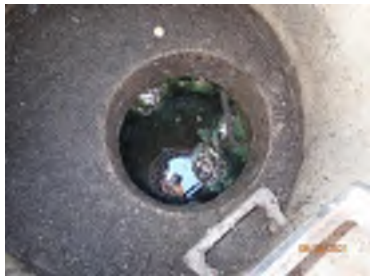
| Inspection Date: 7/17/2023 9:55:37 AM | | Type: Ongoing | Flow: Submerged, indeterminate | Previous Rainfall (hrs): 72+ |
|--|--|---|---|---|
| Inspector: JCW Notes Sample collected from submerged pool in manhole. Floating gross solids (litter) in manhole. | | Condition Assessment Graffiti: None Erosion: None Deposition: None in. Damage: None | o20210816101558.JPG 2021 | |

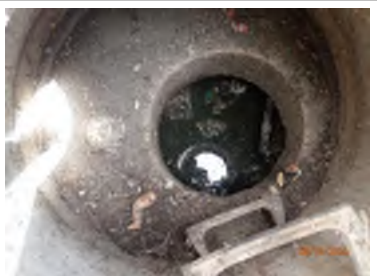
| Inspection Date: 7/17/2023 9:55:37 AM | | Type: Ongoing | Flow: Submerged, indeterminate | Previous Rainfall (hrs): 72+ |
|--|--|---|---|---|
| Inspector: JCW Notes Sample collected from submerged pool in manhole. Floating gross solids (litter) in manhole. Elevated pH seemed widespread in river. | | Condition Assessment Graffiti: None Erosion: None Deposition: None in. Damage: None | o20200819131610.JPG 2020 | |

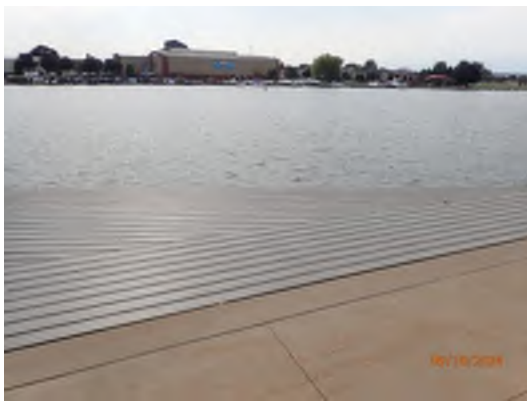
o20240910135750.JPG

Storm sewer from Commerce St discharges to river from north (under riverwalk). Replaces outfall 01-20 (2012).

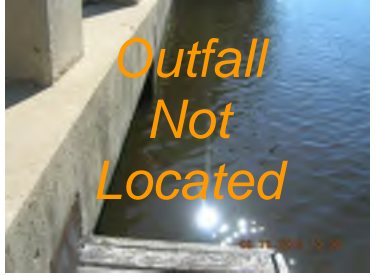
| Illicit Discharge Potential: Unlikely | | Inspector: JCW | | Notes | | <p>Outfall fully submerged and not physically located. Outfall screened upstream at 01-20 US2.</p> | |

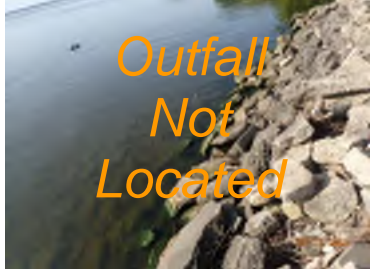
| | | Notes Outfall fully submerged and not located - screened upstream at 02-309 US1. | | |

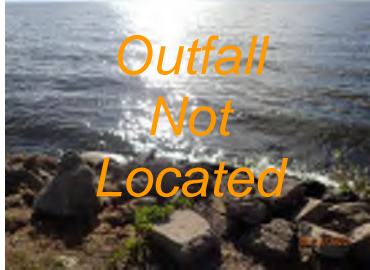
| | | Notes Outfall fully submerged and not located - screened upstream at 02-309 US1. | | |

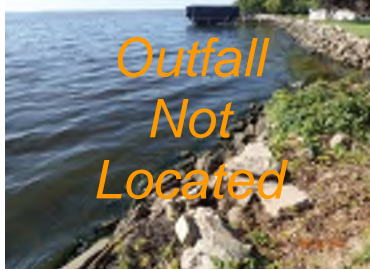
| | | Notes Outfall fully submerged and not located - screened upstream at 02-309 US1. | | |

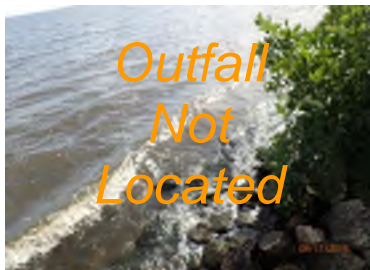
| | | Notes Outfall fully submerged and not located - screened upstream at 02-309 US1. | | |

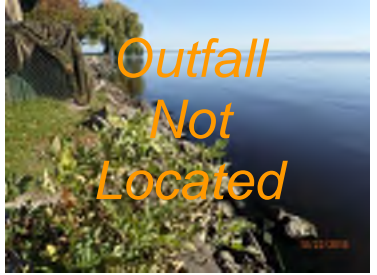
| | | Notes Outfall fully submerged and not located - screened upstream at 02-309 US1. Floating gross solids (litter) in manhole. | | |

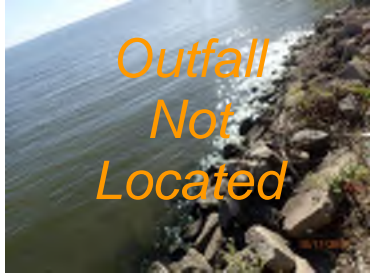
| | | Notes Outfall fully submerged and not located - screened upstream at 02-309 US1. Floating gross solids (litter) in manhole. | | |

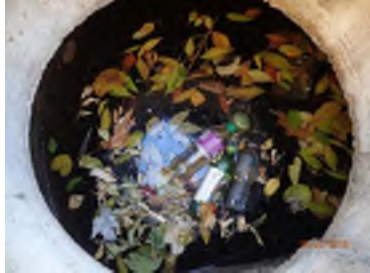
| Submerged: Fully | | Depth (in): 34 | | Sample collected from submerged pool in manhole. Floating gross solids (litter) in manhole. | | | |
| Sampling Results | | Floatables: None Odor: None Turbidity: None Color: None Gross Solids: Moderate Vegetation: None Benthic Growth: Slight Stains: None Non-illicit: None | | Condition Assessment Graffiti: None Erosion: None Deposition: None in. Damage: None | | | |

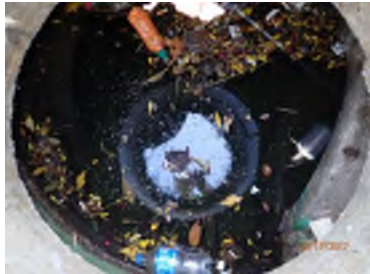
| Submerged: Fully | | Depth (in): 31 | | Sample collected from submerged pool in manhole. Floating gross solids (litter) in manhole. | | | |
| Sampling Results | | Floatables: None Odor: None Turbidity: None Color: None Gross Solids: Moderate Vegetation: None Benthic Growth: Moderate Stains: None Non-illicit: None | | Condition Assessment Graffiti: None Erosion: None Deposition: None in. Damage: None | | | |

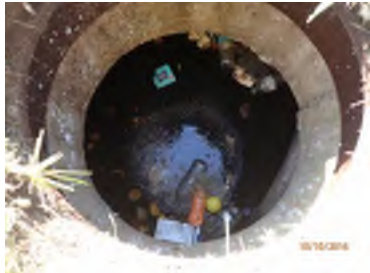
| Submerged: Fully | | Depth (in): 28 | | Potential illicit discharge due to gross solids. | | | |
| Sampling Results | | Floatables: None Odor: None Turbidity: None Color: None Gross Solids: Moderate Vegetation: None Benthic Growth: None Stains: None Non-illicit: None | | Condition Assessment Graffiti: None Erosion: None Deposition: None in. Damage: None | | | |

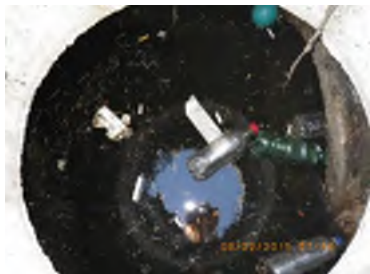
| Submerged: Fully | | Depth (in): 28 | | Floating gross solids (litter) in manhole. | | | |
| Sampling Results | | Floatables: None Odor: None Turbidity: None Color: None Gross Solids: Slight Vegetation: None Benthic Growth: Slight Stains: Slight Non-illicit: None | | Condition Assessment Graffiti: None Erosion: None Deposition: None in. Damage: None | | | |

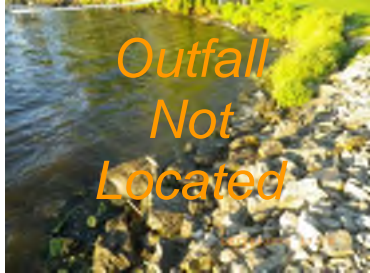
| Submerged: Fully | | Depth (in): | | Outfall fully submerged and not located - screened upstream at 02-357 US1. | | | |

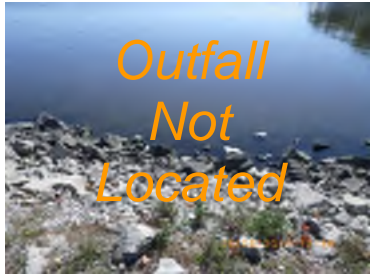
| Submerged: Fully | | Depth (in): | | Outfall fully submerged and not located - screened upstream at 02-357 US1. | | | |

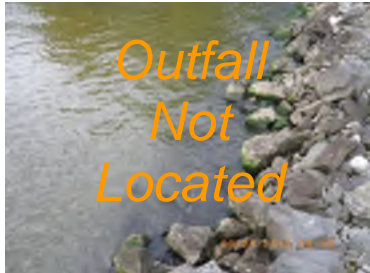
| Submerged: Fully | | Depth (in): | | Outfall fully submerged; screened upstream at 02-357 US1. | | | |

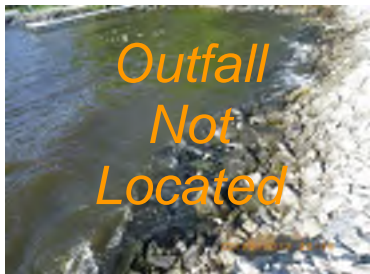
| Submerged: Fully | | Depth (in): | | Gross solids pre-screening. Outfall fully submerged; screened upstream at 02-357 US1. | | | |

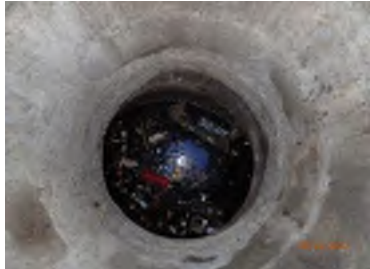
| | | Notes Sample collected from submerged pool in manhole. Floating gross solids (litter) in upstream manhole. | | |

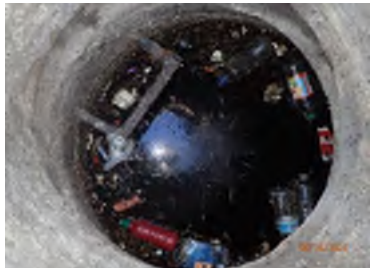
| | | Notes Sample collected from submerged pool in manhole. Floating gross solids (litter) in manhole. | | |

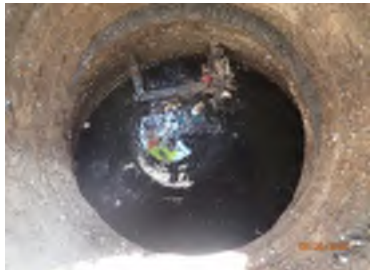
| | | Notes Sample collected from submerged pool in manhole. Floating gross solids (litter) in manhole. | | |

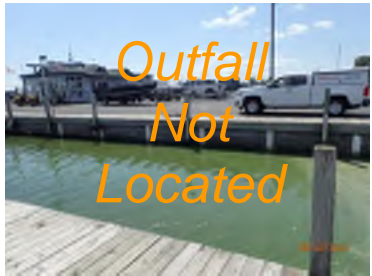
| Sampling Results Sample Location: _____ Total Chlorine: -- ppm Free Chlorine: -- ppm Ammonia: -- ppm pH: -- units Temperature: -- °F Conductivity: -- µS/cm Detergents: -- mg/L | | Floatables: None Odor: None Turbidity: None Color: None Gross Solids: None Vegetation: None Benthic Growth: None Stains: None Non-illicit: None | Notes Outfall fully submerged and not located - screened upstream at 03-119 US1. Detergent in upstream manhole. | o20220822115730.JPG <div style="text-align: center; font-size: 24pt; font-weight: bold;">2022</div> |
| | | Condition Assessment Graffiti: None Erosion: None Deposition: None in. Damage: None | | |

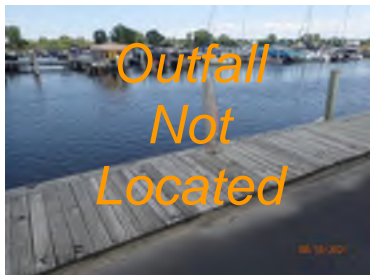
| Sampling Results Sample Location: _____ Total Chlorine: -- ppm Free Chlorine: -- ppm Ammonia: -- ppm pH: -- units Temperature: -- °F Conductivity: -- µS/cm Detergents: -- mg/L | | Floatables: None Odor: None Turbidity: None Color: None Gross Solids: None Vegetation: None Benthic Growth: None Stains: None Non-illicit: None | Notes Outfall fully submerged and not located - screened upstream at 03-119 US1. | o20210816131918.JPG <div style="text-align: center; font-size: 24pt; font-weight: bold;">2021</div> |
| | | Condition Assessment Graffiti: None Erosion: None Deposition: None in. Damage: None | | |

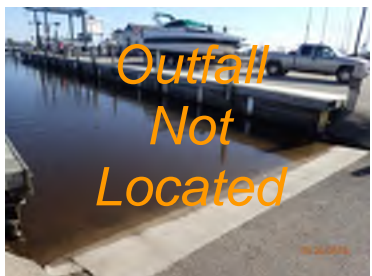
| Sampling Results Sample Location: _____ Total Chlorine: -- ppm Free Chlorine: -- ppm Ammonia: -- ppm pH: -- units Temperature: -- °F Conductivity: -- µS/cm Detergents: -- mg/L | | Floatables: None Odor: None Turbidity: None Color: None Gross Solids: None Vegetation: None Benthic Growth: None Stains: None Non-illicit: None | Notes Outfall fully submerged and not located - screened upstream at 03-119 US1. | o20181022140104.JPG <div style="text-align: center; font-size: 24pt; font-weight: bold;">2018</div> |
| | | Condition Assessment Graffiti: None Erosion: None Deposition: None in. Damage: None | | |

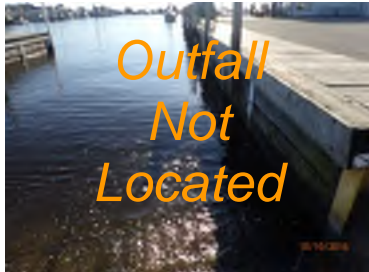
| | | Notes Outfall fully submerged and not located - screened upstream at 03-119 US1. | | |
| | | <p>Outfall Not Located</p> <p>2016</p> | | |

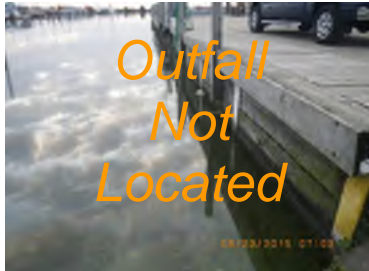
| | | Notes Outfall fully submerged and not located - screened at 03-119 US1. | | |
| | | <p>Outfall Not Located</p> <p>2015</p> | | |

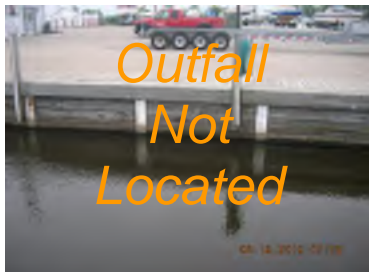
| | | Notes Outfall fully submerged and not physically located. Outfall screened upstream at 03-119 US1. | | |
| | | <p>Outfall Not Located</p> <p>2010</p> | | |

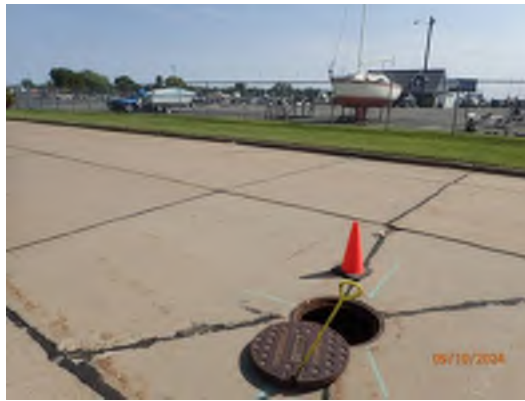
o20240910111332.JPG

Upstream manhole located approx 245 ft WSW of outfall 03-119. Intermediate area consists of street right-of-way and paved parking area with no observed inlets.

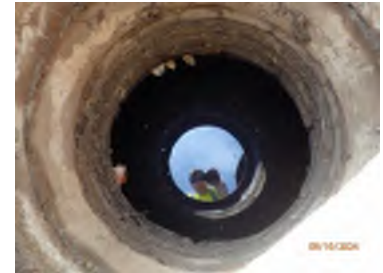
o20240910111338.JPG

☐ Petrol. Sheen ☐ Suds ☐ Sewage ☐ Algae ☐ Other☐ Petroleum ☐ Musty ☐ Sewage ☐ Chlorine ☐ Other☐ VOC/Solvent ☐ Fishy ☐ Sulfur ☐ Fragrant☒ Litter ☐ Veg. Debris ☐ Sediment ☐ Other☐ Inhibited ☐ Excessive☐ Green ☐ Brown☐ Flow Line ☐ Oil ☐ Rust Stains☐ Paint ☐ Other☐ Natural Sheen ☐ Natural Suds/Foam

Damage: None ☐ Displacement ☐ Undercut ☐ Crushed☐ Corrosion ☐ Cracks/Structural Damage

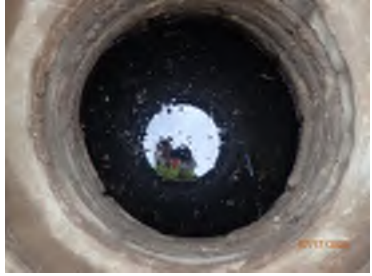
o20230717132712.JPG 2023 | | | | | | | | | | | | | | | | | | |

| | | Floatables: | None | Odor: | None | Turbidity: | None | Color: | None | Gross Solids: | Slight | Vegetation: | None | Benthic Growth: | None | Stains: | None | Non-illicit: | None |
| Floatables: | None | | | | | | | | | | | | | | | | | | | | | |
| Odor: | None | | | | | | | | | | | | | | | | | | | | | |
| Turbidity: | None | | | | | | | | | | | | | | | | | | | | | |
| Color: | None | | | | | | | | | | | | | | | | | | | | | |
| Gross Solids: | Slight | | | | | | | | | | | | | | | | | | | | | |
| Vegetation: | None | | | | | | | | | | | | | | | | | | | | | |
| Benthic Growth: | None | | | | | | | | | | | | | | | | | | | | | |
| Stains: | None | | | | | | | | | | | | | | | | | | | | | |
| Non-illicit: | None | | | | | | | | | | | | | | | | | | | | | |
| | | Notes Sample collected from submerged pool in manhole. | | | | | | | | | | | | | | | | | | | | |
| | | Condition Assessment Graffiti: None Erosion: None Deposition: None in. Damage: None | | | | | | | | | | | | | | | | | | | | |
| | | | |

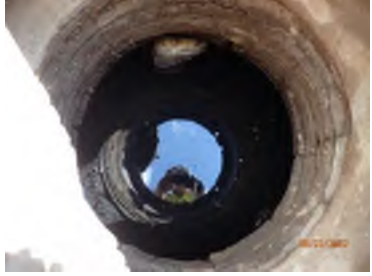
o20220822120016.JPG 2022 | | | | | | | | | | | | | | | | | | |

| | | Floatables: | None | Odor: | None | Turbidity: | None | Color: | None | Gross Solids: | Slight | Vegetation: | None | Benthic Growth: | None | Stains: | None | Non-illicit: | None |
| Floatables: | None | | | | | | | | | | | | | | | | | | | | | |
| Odor: | None | | | | | | | | | | | | | | | | | | | | | |
| Turbidity: | None | | | | | | | | | | | | | | | | | | | | | |
| Color: | None | | | | | | | | | | | | | | | | | | | | | |
| Gross Solids: | Slight | | | | | | | | | | | | | | | | | | | | | |
| Vegetation: | None | | | | | | | | | | | | | | | | | | | | | |
| Benthic Growth: | None | | | | | | | | | | | | | | | | | | | | | |
| Stains: | None | | | | | | | | | | | | | | | | | | | | | |
| Non-illicit: | None | | | | | | | | | | | | | | | | | | | | | |
| | | Notes Sample collected from submerged pool in manhole. Detergent detected in sample. | | | | | | | | | | | | | | | | | | | | |
| | | Condition Assessment Graffiti: None Erosion: None Deposition: None in. Damage: None | | | | | | | | | | | | | | | | | | | | |
| | | | |

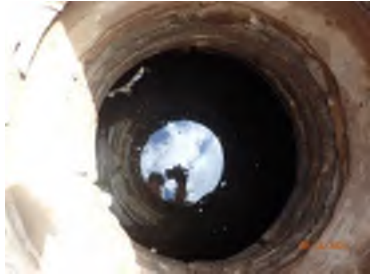
o20210816132344.JPG 2021 | | | | | | | | | | | | | | | | | | |

| | | Floatables: | None | Odor: | None | Turbidity: | None | Color: | None | Gross Solids: | None | Vegetation: | None | Benthic Growth: | None | Stains: | None | Non-illicit: | None |
| Floatables: | None | | | | | | | | | | | | | | | | | | | | | |
| Odor: | None | | | | | | | | | | | | | | | | | | | | | |
| Turbidity: | None | | | | | | | | | | | | | | | | | | | | | |
| Color: | None | | | | | | | | | | | | | | | | | | | | | |
| Gross Solids: | None | | | | | | | | | | | | | | | | | | | | | |
| Vegetation: | None | | | | | | | | | | | | | | | | | | | | | |
| Benthic Growth: | None | | | | | | | | | | | | | | | | | | | | | |
| Stains: | None | | | | | | | | | | | | | | | | | | | | | |
| Non-illicit: | None | | | | | | | | | | | | | | | | | | | | | |
| | | Notes Sample collected from submerged pool in manhole. | | | | | | | | | | | | | | | | | | | | |
| | | Condition Assessment Graffiti: None Erosion: None Deposition: None in. Damage: None | | | | | | | | | | | | | | | | | | | | |
| | | | |

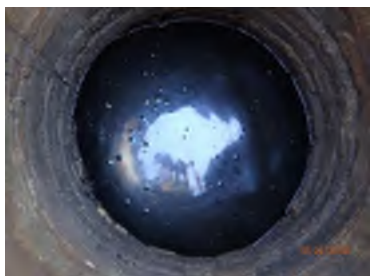
o20181022140340.JPG 2018 | | | | | | | | | | | | | | | | | | |

| | | Floatables: | None | Odor: | None | Turbidity: | None | Color: | None | Gross Solids: | None | Vegetation: | None | Benthic Growth: | None | Stains: | None | Non-illicit: | Moderate |
| Floatables: | None | | | | | | | | | | | | | | | | | | | | | |
| Odor: | None | | | | | | | | | | | | | | | | | | | | | |
| Turbidity: | None | | | | | | | | | | | | | | | | | | | | | |
| Color: | None | | | | | | | | | | | | | | | | | | | | | |
| Gross Solids: | None | | | | | | | | | | | | | | | | | | | | | |
| Vegetation: | None | | | | | | | | | | | | | | | | | | | | | |
| Benthic Growth: | None | | | | | | | | | | | | | | | | | | | | | |
| Stains: | None | | | | | | | | | | | | | | | | | | | | | |
| Non-illicit: | Moderate | | | | | | | | | | | | | | | | | | | | | |
| | | Notes Sample collected from submerged pool in manhole. | | | | | | | | | | | | | | | | | | | | |
| | | Condition Assessment Graffiti: None Erosion: None Deposition: None in. Damage: None | | | | | | | | | | | | | | | | | | | | |
| | | | |

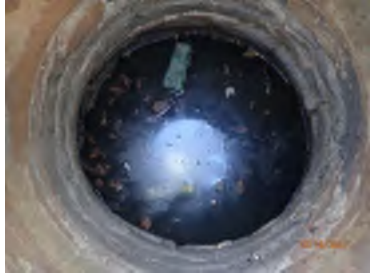
o20171018144002.JPG <div style="text-align: center; font-size: 24pt; font-weight: bold;">2017</div> | | | | | | | | | | | | | | | | | | | | | | | | | | | | | | | | | | | | | |

| | | | | Sampling Results | | Floatables: | None | Sample Location: | Pool | Odor: | None | Total Chlorine: | 0 ppm | Turbidity: | None | Free Chlorine: | 0 ppm | Color: | None | Ammonia: | 0 ppm | Gross Solids: | Slight | pH: | 7.18 units | Vegetation: | None | Temperature | 67 °F | Benthic Growth: | None | Conductivity: | 774 µS/cm | Stains: | None | Detergents: | 0 mg/L | Non-illicit: | None |
| Sampling Results | | Floatables: | None | | | | | | | | | | | | | | | | | | | | | | | | | | | | | | | | | | | | | |
| Sample Location: | Pool | Odor: | None | | | | | | | | | | | | | | | | | | | | | | | | | | | | | | | | | | | | | |
| Total Chlorine: | 0 ppm | Turbidity: | None | | | | | | | | | | | | | | | | | | | | | | | | | | | | | | | | | | | | | |
| Free Chlorine: | 0 ppm | Color: | None | | | | | | | | | | | | | | | | | | | | | | | | | | | | | | | | | | | | | |
| Ammonia: | 0 ppm | Gross Solids: | Slight | | | | | | | | | | | | | | | | | | | | | | | | | | | | | | | | | | | | | |
| pH: | 7.18 units | Vegetation: | None | | | | | | | | | | | | | | | | | | | | | | | | | | | | | | | | | | | | | |
| Temperature | 67 °F | Benthic Growth: | None | | | | | | | | | | | | | | | | | | | | | | | | | | | | | | | | | | | | | |
| Conductivity: | 774 µS/cm | Stains: | None | | | | | | | | | | | | | | | | | | | | | | | | | | | | | | | | | | | | | |
| Detergents: | 0 mg/L | Non-illicit: | None | | | | | | | | | | | | | | | | | | | | | | | | | | | | | | | | | | | | | |
| | | | Condition Assessment Graffiti: None Erosion: None Deposition: None in. Damage: None | | | | | | | | | | | | | | | | | | | | | | | | | | | | | | | | | | | | | |
| | | |

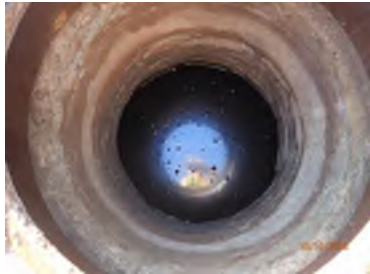
o20161010084816.JPG <div style="text-align: center; font-size: 24pt; font-weight: bold;">2016</div> | | | | | | | | | | | | | | | | | | | | | | | | | | | | | | | | | | | | | |

| | | | | Sampling Results | | Floatables: | None | Sample Location: | Pool | Odor: | None | Total Chlorine: | 0 ppm | Turbidity: | Slight cloudiness | Free Chlorine: | 0 ppm | Color: | None | Ammonia: | 0 ppm | Gross Solids: | None | pH: | 6.98 units | Vegetation: | None | Temperature | 63 °F | Benthic Growth: | None | Conductivity: | 781 µS/cm | Stains: | None | Detergents: | 0 mg/L | Non-illicit: | Slight |
| Sampling Results | | Floatables: | None | | | | | | | | | | | | | | | | | | | | | | | | | | | | | | | | | | | | | |
| Sample Location: | Pool | Odor: | None | | | | | | | | | | | | | | | | | | | | | | | | | | | | | | | | | | | | | |
| Total Chlorine: | 0 ppm | Turbidity: | Slight cloudiness | | | | | | | | | | | | | | | | | | | | | | | | | | | | | | | | | | | | | |
| Free Chlorine: | 0 ppm | Color: | None | | | | | | | | | | | | | | | | | | | | | | | | | | | | | | | | | | | | | |
| Ammonia: | 0 ppm | Gross Solids: | None | | | | | | | | | | | | | | | | | | | | | | | | | | | | | | | | | | | | | |
| pH: | 6.98 units | Vegetation: | None | | | | | | | | | | | | | | | | | | | | | | | | | | | | | | | | | | | | | |
| Temperature | 63 °F | Benthic Growth: | None | | | | | | | | | | | | | | | | | | | | | | | | | | | | | | | | | | | | | |
| Conductivity: | 781 µS/cm | Stains: | None | | | | | | | | | | | | | | | | | | | | | | | | | | | | | | | | | | | | | |
| Detergents: | 0 mg/L | Non-illicit: | Slight | | | | | | | | | | | | | | | | | | | | | | | | | | | | | | | | | | | | | |
| | | | Condition Assessment Graffiti: None Erosion: None Deposition: None in. Damage: None | | | | | | | | | | | | | | | | | | | | | | | | | | | | | | | | | | | | | |
| | | |

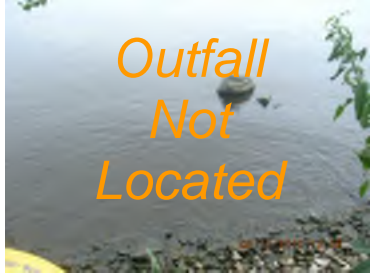
| | | | o20220916133918.JPG <div style="text-align: center; font-size: 24pt; font-weight: bold;">2022</div> | |

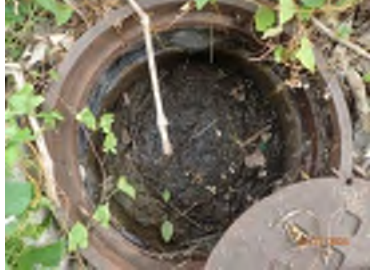
| Inspection Date: 7/17/2023 3:31:38 PM | | Type: Ongoing | Flow: Submerged, indeterminate | Previous Rainfall (hrs): 72+ |
|--|--|--|--|---|
| Illicit Discharge Potential: Potential Submerged: Fully Depth (in): 38 | | Inspector: JCW | Notes | 6" algae mat floating in manhole. Sample collected from submerged pool in manhole. High ammonia in sample. Strong odor from decomposing algae. |
| Sampling Results Sample Location: Pool Total Chlorine: 0 ppm Free Chlorine: 0 ppm Ammonia: 6 ppm pH: 8.07 units Temperature: 75 °F Conductivity: 481 µS/cm Detergents: 0 mg/L | | Floatables: Severe Odor: Easily detected Turbidity: None Color: None Gross Solids: Severe Vegetation: None Benthic Growth: None Stains: None Non-illicit: None | Condition Assessment Graffiti: None Erosion: None Deposition: None in. Damage: None | |

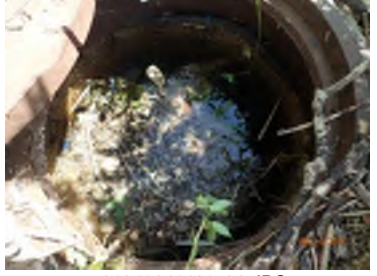
| Inspection Date: 7/17/2023 3:31:38 PM | | Type: Ongoing | Flow: Submerged, indeterminate | Previous Rainfall (hrs): 72+ |
|--|--|--|--|---|
| Illicit Discharge Potential: Potential Submerged: Fully Depth (in): | | Inspector: EJK | Notes | Sample collected from submerged pool in manhole. Floating gross solids (litter) in manhole. |

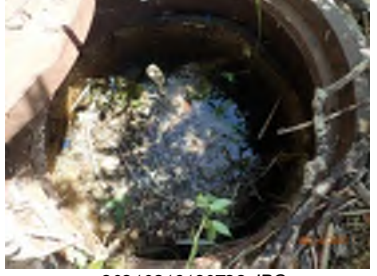
| Inspection Date: 7/17/2023 3:31:38 PM | | Type: Ongoing | Flow: Submerged, indeterminate | Previous Rainfall (hrs): 72+ |
|--|--|--|--|---|
| Illicit Discharge Potential: Potential Submerged: Fully Depth (in): 43 | | Inspector: JCW | Notes | Sample collected from submerged pool in manhole. Floating gross solids (litter) in manhole. |

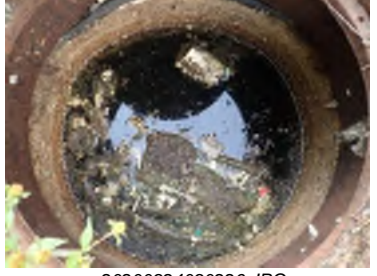
| Inspection Date: 7/17/2023 3:31:38 PM | | Type: Ongoing | Flow: Submerged, indeterminate | Previous Rainfall (hrs): 72+ |
|--|--|--|--|---|
| Illicit Discharge Potential: Potential Submerged: Fully Depth (in): 36 | | Inspector: QAL | Notes | Sample collected from submerged pool in manhole. Floating gross solids (litter) in manhole. |

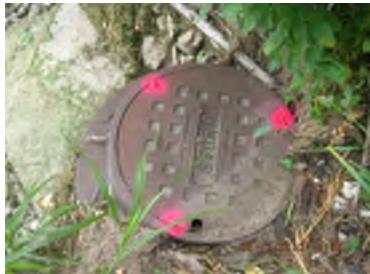
o20100817135854.JPG
2010

| Submerged: Fully Depth (in): | | | Lid bolts rusted tight - could not access. Screened upstream at 03-173 US2. | |
| Sampling Results | | Floatables: None | Condition Assessment Graffiti: None Erosion: None Deposition: None 0 in. Damage: Moderate | |

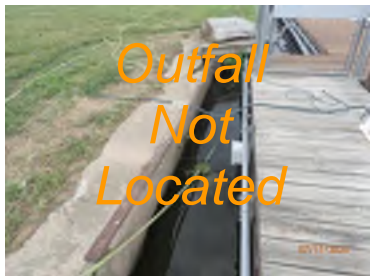
| Submerged: Fully | | Depth (in): | | Outfall fully submerged and not located - screened upstream at 03-22 US1. Floating gross solids (litter) in upstream manhole. | | | |

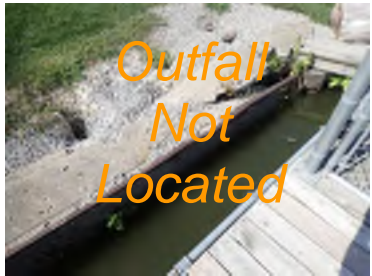
| Submerged: Fully | | Depth (in): | | Outfall fully submerged and not located - screened upstream at 03-22 US1. Floating gross solids (litter) in upstream manhole. | | | |

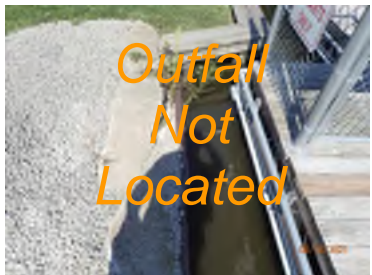
| Submerged: Fully | | Depth (in): | | Outfall partially submerged - screened upstream at 03-22 US1. Floating gross solids (litter) in upstream manhole. | | | |

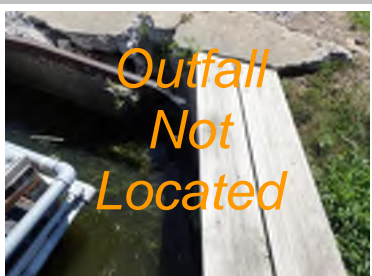
| Submerged: Fully | | Depth (in): | | Outfall fully submerged and not located - screened upstream at 03-22 US1. Floating gross solids (litter) in upstream manhole. | | | |

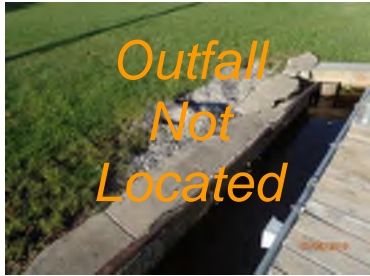
| Sampling Results | | Notes Outfall fully submerged and not located - screened upstream at 03-22 US1. Follow-up inspection for sampling - limited screening conducted. | | |

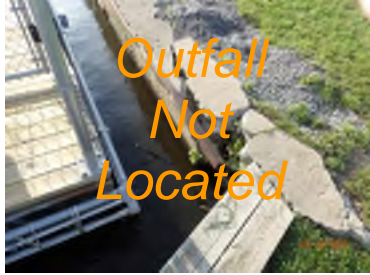
| Sampling Results | | Notes Outfall fully submerged and not located - screened upstream at 03-22 US1. Floating gross solids (litter) and detergent in manhole. | | |

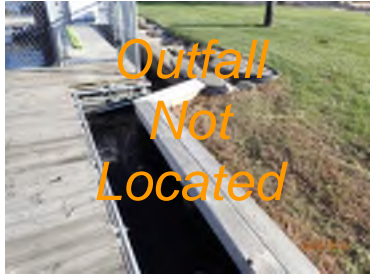
| Sampling Results | | Notes Outfall fully submerged and not located - screened upstream at 03-22 US1. Floating gross solids (litter) in manhole. | | |

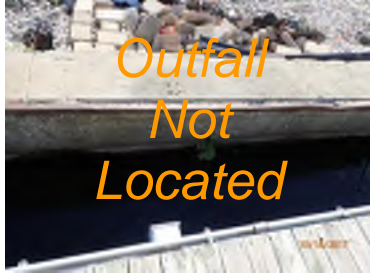
| Inspection Date: 10/18/2017 3:22:08 PM | | Type: Ongoing | Flow: Submerged (not located) | Previous Rainfall (hrs): 72+ |
|---|--|---|---|---|
| Illicit Discharge Potential: Potential Submerged: Fully Depth (in): | | Inspector: JCW | Notes Outfall fully submerged and not located - screened upstream at 03-22 US1. Floating gross solids (litter) in manhole. | |

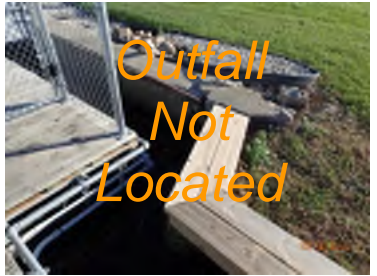
| Inspection Date: 10/18/2016 4:04:35 PM | | Type: Ongoing | Flow: Submerged (not located) | Previous Rainfall (hrs): 72+ |
|---|--|---|---|---|
| Illicit Discharge Potential: Potential Submerged: Fully Depth (in): | | Inspector: JCW | Notes Outfall not located and assumed submerged - screened upstream at 03-22 US1. | |

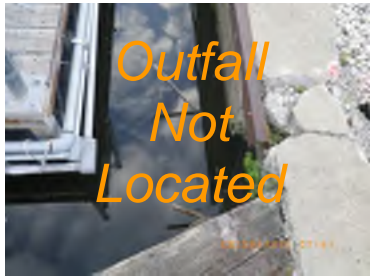
| Inspection Date: 9/23/2015 7:47:01 AM | | Type: Ongoing | Flow: Submerged (not located) | Previous Rainfall (hrs): 72+ |
|---|--|---|---|---|
| Illicit Discharge Potential: Potential Submerged: Fully Depth (in): | | Inspector: JCW | Notes Significant sinking above suspected pipe. Outfall not located - screened at 03-22 US1. | |
| Sampling Results Sample Location: | | Floatables: None Odor: None Turbidity: None Color: None Gross Solids: None Vegetation: None Benthic Growth: None Stains: None Non-illicit: None | Condition Assessment Graffiti: None Erosion: None Deposition: None in. Damage: Severe | |

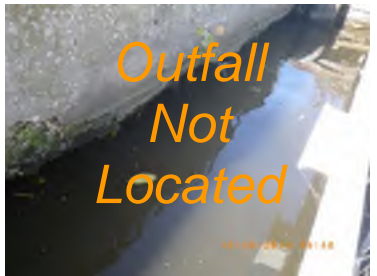
| Inspection Date: 10/9/2014 9:47:52 AM | | Type: Ongoing | Flow: Submerged (not located) | Previous Rainfall (hrs): 72+ |
|---|--|---|---|---|
| Illicit Discharge Potential: Potential Submerged: Fully Depth (in): | | Inspector: JCW | Notes Outfall fully submerged and not located - screened upstream at 03-22 US1. | |

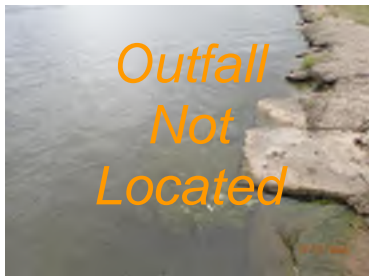
| Submerged: Fully | | Depth (in): | | Outfall fully submerged and not located - screened upstream at 03-35 US1. Floating gross solids (litter) in upstream manhole. | | | |

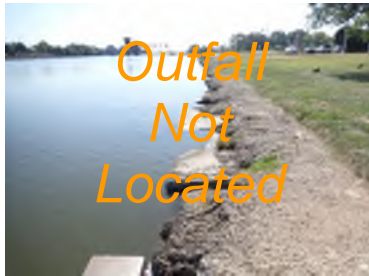
| Submerged: Fully | | Depth (in): | | Outfall fully submerged and not located - screened upstream at 03-35 US1. Floating gross solids (litter) in upstream manhole. | | | |

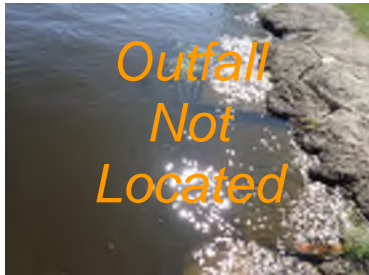
| Submerged: Fully | | Depth (in): | | Outfall fully submerged and not located - screened upstream at 03-35 US1. Floating gross solids (litter) in upstream manhole. | | | |

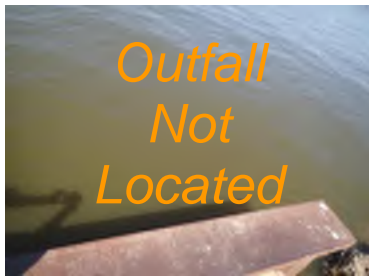
| Submerged: Fully | | Depth (in): | | Outfall fully submerged and not located - screened upstream at 03-35 US1. Floating gross solids (litter) in upstream manhole. | | | |

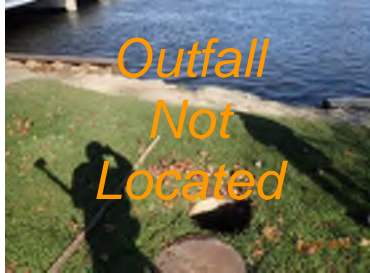
o20191105114512.JPG

| Illicit Discharge Potential: Potential | | Inspector: JCW | | <div style="border: 1px solid black; padding: 5px;"> Notes Follow-up inspection for sampling - limited screening conducted. Floating gross solids (litter) and detergent in manhole. </div> <div style="border: 1px solid black; padding: 5px; margin-top: 5px;"> Condition Assessment Graffiti: None Erosion: None Deposition: None in. Damage: None </div> | | | | | | | | | | | | | | | | | | |

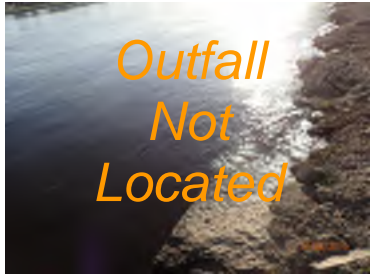
o20191008072714.JPG

| Illicit Discharge Potential: Potential | | Inspector: JCW | | <div style="border: 1px solid black; padding: 5px;"> Notes Detergent detection follow-up. Limited screening conducted beyond sampling. </div> <div style="border: 1px solid black; padding: 5px; margin-top: 5px;"> Condition Assessment Graffiti: None Erosion: None Deposition: None in. Damage: None </div> | | | | | | | | | | | | | | | | | | |

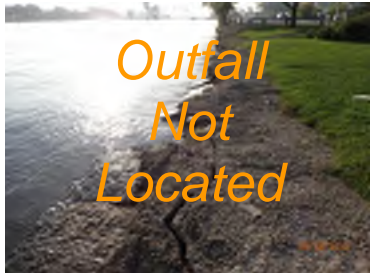
o20190918070310.JPG

| Illicit Discharge Potential: Potential | | Inspector: JCW | | <div style="border: 1px solid black; padding: 5px;"> Notes Outfall fully submerged and not located - screened upstream at 03-35 US1. Floating gross solids (litter) in manhole. </div> <div style="border: 1px solid black; padding: 5px; margin-top: 5px;"> Condition Assessment Graffiti: None Erosion: None Deposition: None in. Damage: None </div> | | | | | | | | | | | | | | | | | | |

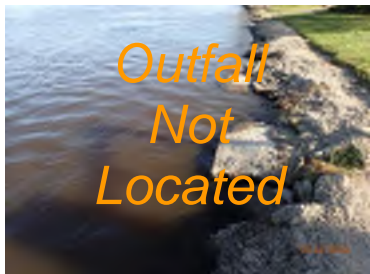
o20181022152608.JPG

| | | Notes Outfall fully submerged and not located - screened upstream at 03-35 US1. Floating gross solids (litter) in manhole. | | |

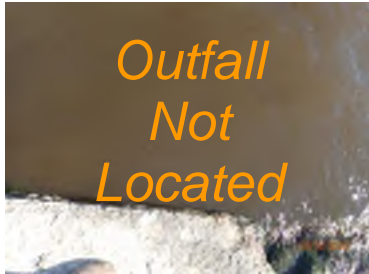
| | | o20161010094930.JPG <div style="text-align: center; font-size: 24pt; font-weight: bold;">2016</div> | | |

| | | Notes Outfall fully submerged and not located - screened upstream at 03-35 US1. | | |

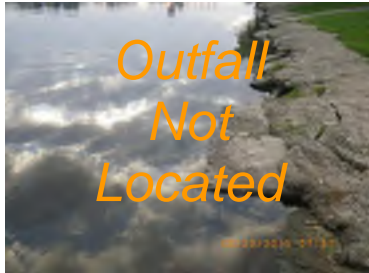
| | | o20150923063720.JPG <div style="text-align: center; font-size: 24pt; font-weight: bold;">2015</div> | | |

| | | Notes Outfall fully submerged and not located - screened at 03-35 US1. | | |

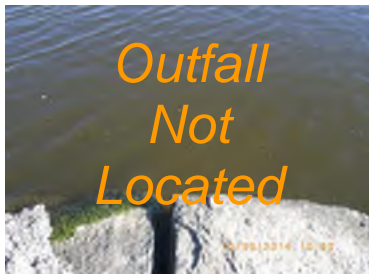
| | | o20141009093222.JPG <div style="text-align: center; font-size: 24pt; font-weight: bold;">2014</div> | | |

| | | Notes Outfall fully submerged and not located - screened upstream at 03-35 US1 | | |

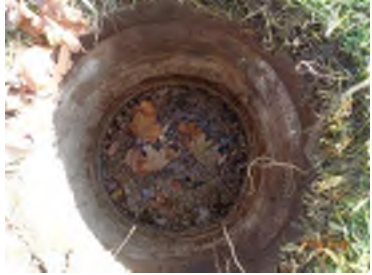
| o20191105114518.JPG 2019 | | | | |

| Illicit Discharge Potential: Potential | | Inspector: JCW | | Notes Detergent detection follow-up. Limited screening conducted. Floating gross solids (litter) and detergent in manhole. |
| Sampling Results Sample Location: Pool Total Chlorine: -- ppm Free Chlorine: -- ppm Ammonia: -- ppm pH: -- units Temperature: -- °F Conductivity: -- µS/cm Detergents: 0 mg/L | | Floatables: None Odor: None Turbidity: None Color: None Gross Solids: Severe Vegetation: None Benthic Growth: None Stains: None Non-illicit: None | Condition Assessment Graffiti: None Erosion: None Deposition: None in. Damage: None | |

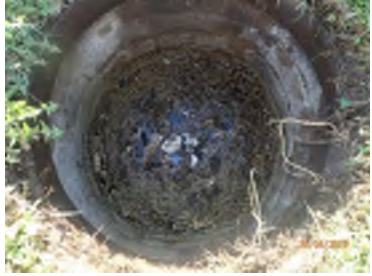
| o20191008072724.JPG 2019 | | | | |

| Illicit Discharge Potential: Potential | | Inspector: JCW | | Notes Detergent detection follow-up. Limited screening conducted beyond sampling. |
| Sampling Results Sample Location: Pool Total Chlorine: 0 ppm Free Chlorine: 0 ppm Ammonia: 0 ppm pH: 7.68 units Temperature: 55 °F Conductivity: 415 µS/cm Detergents: 1.3 mg/L | | Floatables: None Odor: None Turbidity: None Color: None Gross Solids: Severe Vegetation: None Benthic Growth: None Stains: None Non-illicit: None | Condition Assessment Graffiti: None Erosion: None Deposition: None in. Damage: None | |

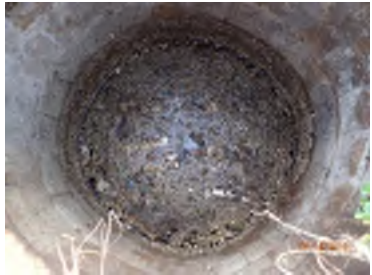
| o20190918070320.JPG 2019 | | | | |

| Illicit Discharge Potential: Potential | | Inspector: JCW | | Notes Sample collected from submerged pool in manhole. Floating gross solids (litter) and detergent in manhole. |
| Sampling Results Sample Location: Pool Total Chlorine: 0 ppm Free Chlorine: 0 ppm Ammonia: 0 ppm pH: 8.47 units Temperature: 70 °F Conductivity: 389 µS/cm Detergents: 1.3 mg/L | | Floatables: None Odor: None Turbidity: None Color: None Gross Solids: Severe Vegetation: None Benthic Growth: None Stains: None Non-illicit: None | Condition Assessment Graffiti: None Erosion: None Deposition: None in. Damage: None | |

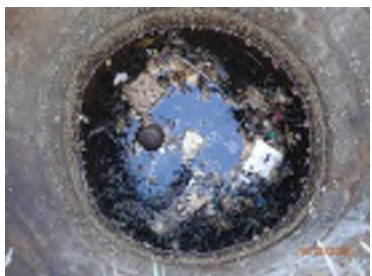
| o20181022152746.JPG 2018 | | | | |

| Illicit Discharge Potential: Potential | | Inspector: JCW | | Notes Sample collected from submerged pool in manhole. Floating gross solids (litter) in manhole. |
| Sampling Results Sample Location: Pool Total Chlorine: 0 ppm Free Chlorine: 0 ppm Ammonia: 0 ppm pH: 7.81 units Temperature: 56 °F Conductivity: 338 µS/cm Detergents: 0 mg/L | | Floatables: None Odor: None Turbidity: None Color: None Gross Solids: Moderate Vegetation: None Benthic Growth: None Stains: None Non-illicit: None | Condition Assessment Graffiti: None Erosion: None Deposition: None in. Damage: None | |

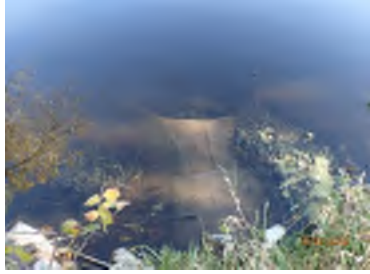
| | | | o20181022133918.JPG <div style="text-align: center; font-size: 24pt; font-weight: bold;">2018</div> | |

| | | Notes Outfall fully submerged - screened upstream at 03-306 US1. | | |

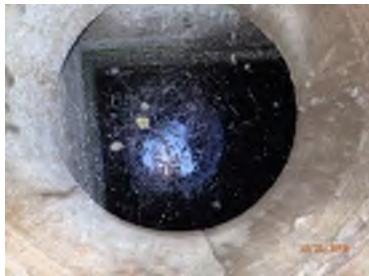
| | | Notes Broken manhole rings allow materials to enter manhole below casting. | | | | | | | | | | | | | | | | | | | | | | | | | | | | | | | | | | | | |
| Damage: | Minor | | | | | | | | | | | | | | | | | | | | | | | | | | | | | | | | | | | | | |

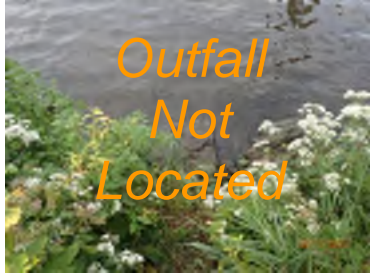
| Detergents: | 0 mg/L | Stains: | | | None |

| Illicit Discharge Potential: Potential | | Inspector: JCW | | <div style="border: 1px solid black; padding: 5px;"> Notes Outfall fully submerged and not located - screened upstream at 03-81 US1. Floating gross solids (litter) in manhole. </div> <div style="border: 1px solid black; padding: 5px; margin-top: 5px;"> Condition Assessment Graffiti: None Erosion: None Deposition: None in. Damage: None </div> | | | | | | | | | | | | | | | | | | |

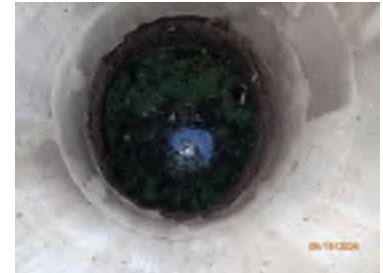
o20240919065040.JPG

Notes: Sample collected from submerged pool in manhole. Replacement lid too large for casting.

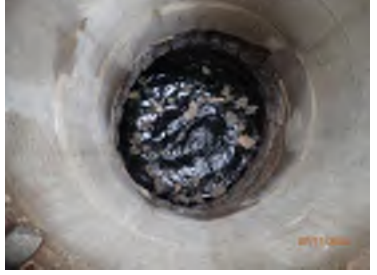
| Inspection Date: 7/17/2023 2:55:35 PM | | Type: Ongoing | Flow: Submerged, indeterminate | Previous Rainfall (hrs): 72+ |
|--|--|---|---|---|
| Sampling Results Sample Location: Pool Total Chlorine: 0 ppm Free Chlorine: 0 ppm Ammonia: 0 ppm pH: 8.69 units Temperature: 74 °F Conductivity: 401 µS/cm Detergents: 0 mg/L | | Floatables: None Odor: None Turbidity: None Color: None Gross Solids: Slight Vegetation: None Benthic Growth: None Stains: None Non-illicit: None | Sample collected from submerged pool in manhole. Replacement lid too large for casting. Condition Assessment Graffiti: None Erosion: None Deposition: None in. Damage: None | |

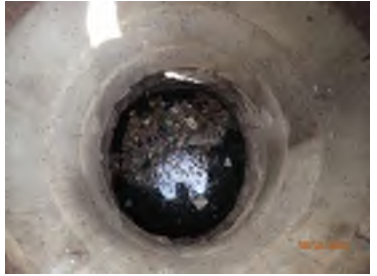
| Inspection Date: 7/17/2023 2:55:35 PM | | Type: Ongoing | Flow: Submerged, indeterminate | Previous Rainfall (hrs): 72+ |
|--|--|---|---|---|
| Floatables: None Odor: None Turbidity: None Color: None Gross Solids: Moderate Vegetation: None Benthic Growth: None Stains: None Non-illicit: None | | Sample collected from submerged pool in manhole. Floating gross solids (litter) in manhole. Condition Assessment Graffiti: None Erosion: None Deposition: None in. Damage: None | | |

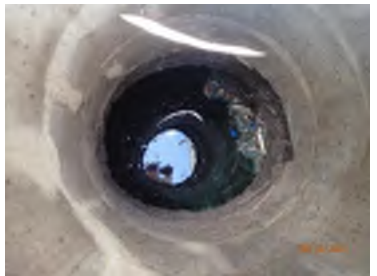
| Inspection Date: 7/17/2023 2:55:35 PM | | Type: Ongoing | Flow: Submerged, indeterminate | Previous Rainfall (hrs): 72+ |
|--|--|---|---|---|
| Floatables: None Odor: None Turbidity: None Color: None Gross Solids: Moderate Vegetation: None Benthic Growth: None Stains: None Non-illicit: None | | Sample collected from submerged pool in manhole. Floating gross solids (litter) in manhole. Condition Assessment Graffiti: None Erosion: None Deposition: None in. Damage: None | | |

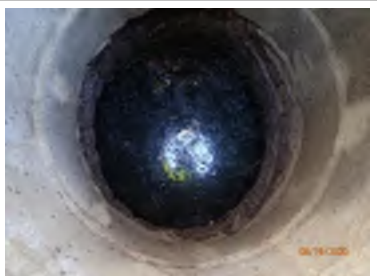
| Inspection Date: 7/17/2023 2:55:35 PM | | Type: Ongoing | Flow: Submerged, indeterminate | Previous Rainfall (hrs): 72+ |
|--|--|---|---|---|
| Sampling Results Sample Location: Pool Total Chlorine: 0 ppm Free Chlorine: 0 ppm Ammonia: 0 ppm pH: 9.09 units Temperature: 84 °F Conductivity: 327 µS/cm Detergents: 0 mg/L | | Inspector: JCW | Notes | o20200819141648.JPG 2020 |
| Floatables: None Odor: None Turbidity: None Color: Faint in bottle Gross Solids: Moderate Vegetation: None Benthic Growth: None Stains: None Non-illicit: None | | Sample collected from submerged pool in manhole. Floating gross solids (litter) in manhole. Elevated pH seemed widespread in river. Condition Assessment Graffiti: None Erosion: None Deposition: None in. Damage: None | | |

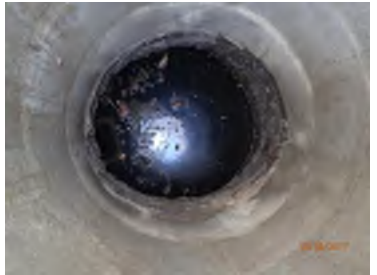
o20171018145016.JPG
2017

| Submerged: Fully | | Depth (in): 50 | Elevated ammonia and detergent in sample from manhole pool. Slight sheen observed on surface. | |

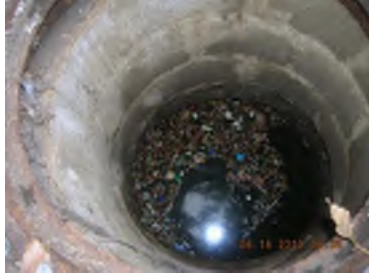
| Illicit Discharge Potential: Potential | | Inspector: JCW | Notes Petroleum odor likely from residual petroleum in pipes after 2009 jetting. | |
| Sampling Results Sample Location: Pool Total Chlorine: 0 ppm Free Chlorine: 0 ppm Ammonia: 0 ppm pH: 6.63 units Temperature: 71 °F Conductivity: -- µS/cm Detergents: 0 mg/L | | Floatables: None Odor: Faint Turbidity: None Color: None Gross Solids: Moderate Vegetation: None Benthic Growth: None Stains: Moderate Non-illicit: None | | |

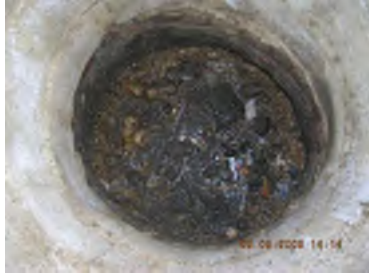
| Illicit Discharge Potential: Obvious | | Inspector: JCW | Notes Diesel/oil odor, sheen on surface. Floatables with grease. Brown/gray color. | |
| Sampling Results Sample Location: Pool Total Chlorine: 0 ppm Free Chlorine: 0 ppm Ammonia: -- ppm pH: 6.98 units Temperature: 73 °F Conductivity: -- µS/cm Detergents: 0 mg/L | | Floatables: Severe Odor: Easily detected Turbidity: None Color: Faint in bottle Gross Solids: Severe Vegetation: None Benthic Growth: None Stains: None Non-illicit: None | | |

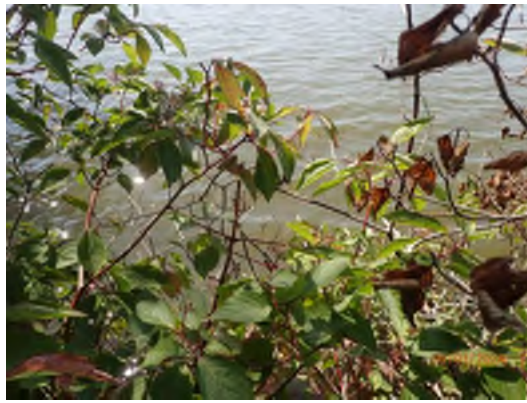
o20240903140710.JPG

Storm sewer from Rockwell Ave discharges to river from east. Outfall fully submerged and not physically located. GPS coordinates approximate. Pipe info from MS4 map.

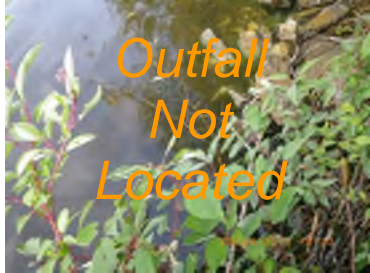
| Submerged: Fully | | Depth (in): | | Outfall fully submerged and not located - screened at 05-14 US1. Condition Assessment Graffiti: None Erosion: None Deposition: None in. Damage: None | | | |

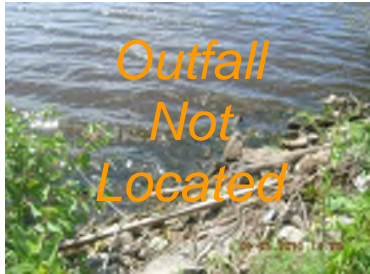
| Submerged: Fully | | Depth (in): | | Outfall fully submerged and not physically located. Outfall screened upstream at 05-14 US2. Condition Assessment Graffiti: None Erosion: None Deposition: None 0 in. Damage: None | | | |

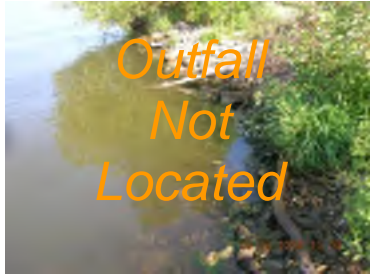
| Submerged: Fully | | Depth (in): | | Outfall fully submerged and not physically located. Outfall screened upstream at 05-14 US2. Condition Assessment Graffiti: None Erosion: None Deposition: None 0 in. Damage: None | | | |

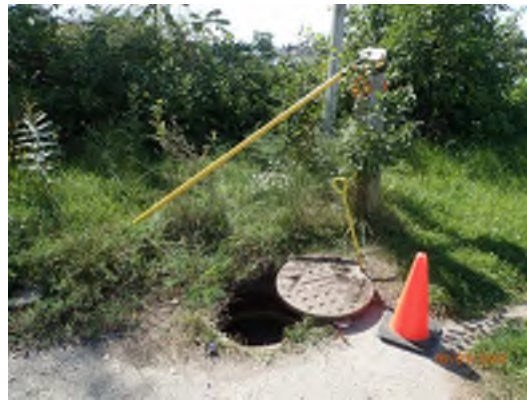
o20240903141252.JPG

Upstream manhole located approx 30 ft ENE of outfall 05-14. Intermediate area consists of street right-of-way and shoreline.

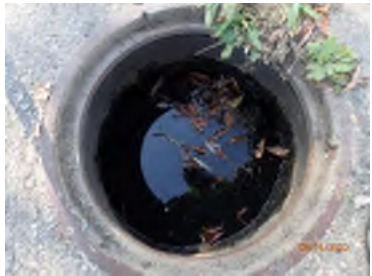
| Sampling Results Sample Location: Pool Total Chlorine: 0 ppm Free Chlorine: 0 ppm Ammonia: 0 ppm pH: 7.58 units Temperature: 73 °F Conductivity: 672 µS/cm Detergents: 0 mg/L | | Floatables: None Odor: None Turbidity: None Color: None Gross Solids: Slight Vegetation: None Benthic Growth: Slight Stains: None Non-illicit: Slight | Notes Sample collected from submerged pool in manhole. | o20220919141718.JPG <div style="text-align: center; font-size: 24pt; font-weight: bold;">2022</div> |
| | | | Condition Assessment Graffiti: None Erosion: None Deposition: None in. Damage: None | |

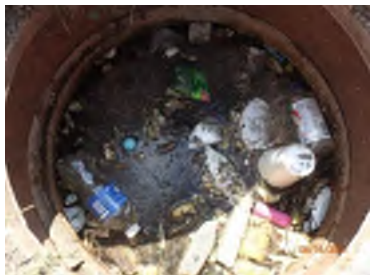
| Sampling Results Sample Location: Pool Total Chlorine: 0 ppm Free Chlorine: 0 ppm Ammonia: 0 ppm pH: 8 units Temperature: 85 °F Conductivity: 367 µS/cm Detergents: 0 mg/L | | Floatables: None Odor: None Turbidity: None Color: None Gross Solids: Severe Vegetation: None Benthic Growth: None Stains: None Non-illicit: None | Notes Sample collected from submerged pool in manhole. Floating gross solids (litter) in manhole. | o20210816151352.JPG <div style="text-align: center; font-size: 24pt; font-weight: bold;">2021</div> |
| | | | Condition Assessment Graffiti: None Erosion: None Deposition: None in. Damage: None | |

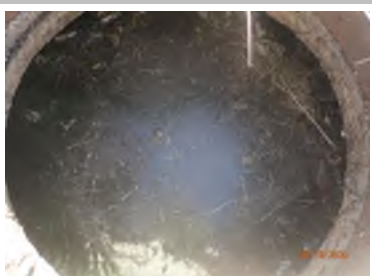
| Sampling Results Sample Location: Pool Total Chlorine: 0 ppm Free Chlorine: 0 ppm Ammonia: 0 ppm pH: 7.94 units Temperature: 87 °F Conductivity: 1577 µS/cm Detergents: 0 mg/L | | Floatables: None Odor: None Turbidity: None Color: None Gross Solids: Slight Vegetation: None Benthic Growth: None Stains: None Non-illicit: None | Notes Sample collected from submerged pool in manhole. Floating gross solids (litter) in manhole. | o20200819154014.JPG <div style="text-align: center; font-size: 24pt; font-weight: bold;">2020</div> |
| | | | Condition Assessment Graffiti: None Erosion: None Deposition: None in. Damage: None | |

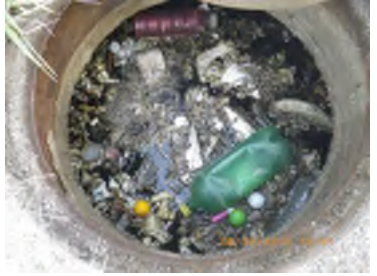
| Illicit Discharge Potential: Potential | | Inspector: JCW | Notes Floating gross solids (litter) in manhole. | | | | | | | | | | | | | | | | | | | | | | | | | | | | | | | | | |
| Submerged: Fully | | Depth (in): 44 | <p>o20150924093714.JPG</p> <p>2015</p> | | | | | | | | | | | | | | | | | | | | | | | | | | | | | | | | | |
| Sampling Results <table border="1"> <tr> <td>Sample Location:</td> <td>Pool</td> </tr> <tr> <td>Total Chlorine:</td> <td>0 ppm</td> </tr> <tr> <td>Free Chlorine:</td> <td>0 ppm</td> </tr> <tr> <td>Ammonia:</td> <td>0 ppm</td> </tr> <tr> <td>pH:</td> <td>7.98 units</td> </tr> <tr> <td>Temperature:</td> <td>70 °F</td> </tr> <tr> <td>Conductivity:</td> <td>424 µS/cm</td> </tr> <tr> <td>Detergents:</td> <td>0 mg/L</td> </tr> </table> | | Sample Location: | | | Pool | Total Chlorine: | 0 ppm | Free Chlorine: | 0 ppm | Ammonia: | 0 ppm | pH: | 7.98 units | Temperature: | 70 °F | Conductivity: | 424 µS/cm | Detergents: | 0 mg/L | <table border="1"> <tr> <td>Floatables:</td> <td>None</td> </tr> <tr> <td>Odor:</td> <td>None</td> </tr> <tr> <td>Turbidity:</td> <td>None</td> </tr> <tr> <td>Color:</td> <td>None</td> </tr> <tr> <td>Gross Solids:</td> <td>Severe</td> </tr> <tr> <td>Vegetation:</td> <td>None</td> </tr> <tr> <td>Benthic Growth:</td> <td>None</td> </tr> <tr> <td>Stains:</td> <td>None</td> </tr> <tr> <td>Non-illicit:</td> <td>None</td> </tr> </table> | Floatables: | None | Odor: | None | Turbidity: | None | Color: | None | Gross Solids: | Severe | Vegetation: | None | Benthic Growth: | None | Stains: | None |

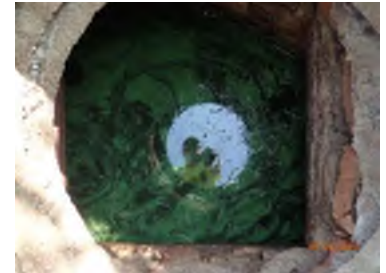
o20240903142658.JPG

☐ Petrol. Sheen ☐ Suds ☐ Sewage ☒ Algae ☐ Other☐ Petroleum ☐ Musty ☐ Sewage ☐ Chlorine ☐ Other☐ VOC/Solvent ☐ Fishy ☐ Sulfur ☐ Fragrant☐ Litter ☐ Veg. Debris ☐ Sediment ☐ Other☐ Inhibited ☐ Excessive☐ Green ☐ Brown☐ Flow Line ☐ Oil ☐ Rust Stains☐ Paint ☐ Other☐ Natural Sheen ☐ Natural Suds/Foam

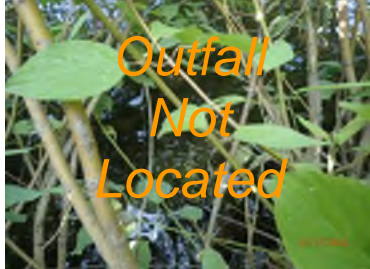
| | | Notes Outfall fully submerged and not located - screened upstream at 05-241 US1. | | |
| | | Condition Assessment Graffiti: None Erosion: None Deposition: None in. Damage: None | | |

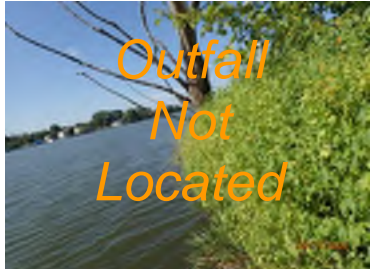
| | | Notes Outfall fully submerged and not located - screened upstream at 05-241 US1. | | |
| | | Condition Assessment Graffiti: None Erosion: None Deposition: None in. Damage: None | | |

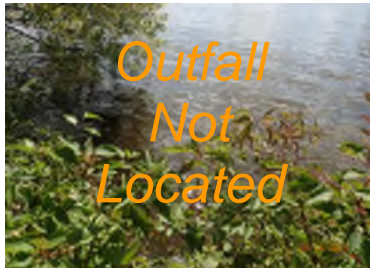
| | | Notes Outfall fully submerged and not located - screened upstream at 05-241 US1. | | |
| | | Condition Assessment Graffiti: None Erosion: None Deposition: None in. Damage: None | | |

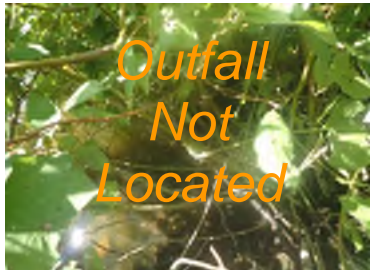
| | | Notes Outfall fully submerged and not located - screened upstream at 05-241 US1. | | |
| | | Condition Assessment Graffiti: None Erosion: None Deposition: None in. Damage: None | | |

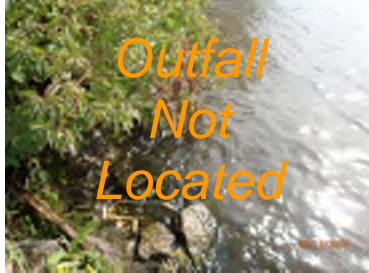
| Illicit Discharge Potential: Unlikely | | Inspector: JCW | | Notes | | <p style="text-align: center;">o20190918134402.JPG</p> <p style="text-align: center; font-size: 1.2em; font-weight: bold;">2019</p> | |
| Submerged: Fully | | Depth (in): | | Outfall fully submerged and not located - screened upstream at 05-241 US1. | | | |

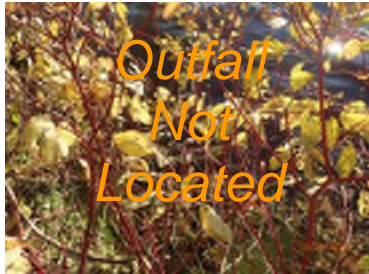
| Illicit Discharge Potential: Unlikely | | Inspector: JCW | | Notes | | <p style="text-align: center;">o20181022170952.JPG</p> <p style="text-align: center; font-size: 1.2em; font-weight: bold;">2018</p> | |
| Submerged: Fully | | Depth (in): | | Outfall fully submerged and not located - screened upstream at 05-241 US1. | | | |

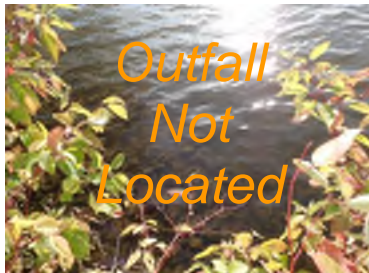
| Illicit Discharge Potential: Potential | | Inspector: JCW | | Notes | | <p style="text-align: center;">o20171017155038.JPG</p> <p style="text-align: center; font-size: 1.2em; font-weight: bold;">2017</p> | |
| Submerged: Fully | | Depth (in): | | Outfall fully submerged and not located - screened upstream at 05-241 US1. Detergent detected in upstream manhole. | | | |

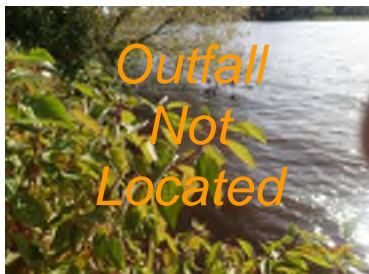
| Illicit Discharge Potential: Unlikely | | Inspector: JCW | | Notes | | <p style="text-align: center;">o20161010154050.JPG</p> <p style="text-align: center; font-size: 1.2em; font-weight: bold;">2016</p> | |
| Submerged: Fully | | Depth (in): | | Outfall fully submerged and not located - screened upstream at 05-241 US1. | | | |

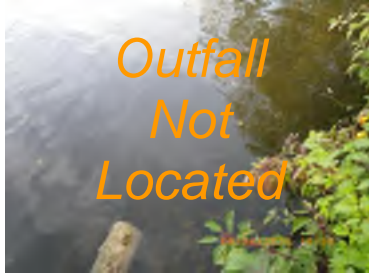
| | | Notes Outfall fully submerged and not located - screened at 05-241 US1. | | |
| | | Condition Assessment Graffiti: None Erosion: None Deposition: None in. Damage: None | | |
