IDDE Ongoing Screening Summary Report

2024 Inspection Year

City of Oshkosh

Westwood

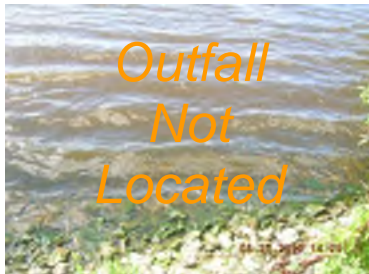
| | | Notes Outfall fully submerged and not physically located. Outfall screened upstream at 05-241 US2. | | |
| | | Condition Assessment Graffiti: None Erosion: None Deposition: None 0 in. Damage: None | | |

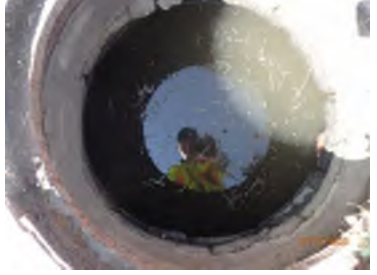
| | | Notes Sample collected from submerged pool in manhole. | | | | | | | | | | | | | | | | | | | | | | | | | | | | | | | | | | | | |
| | | Condition Assessment Graffiti: None Erosion: None Deposition: None in. Damage: None | | | | | | | | | | | | | | | | | | | | | | | | | | | | | | | | | | | | |

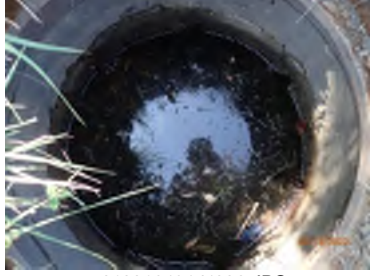
| | | Notes Sample collected from submerged pool in manhole. | | | | | | | | | | | | | | | | | | | | | | | | | | | | | | | | | | | | |
| | | Condition Assessment Graffiti: None Erosion: None Deposition: None in. Damage: None | | | | | | | | | | | | | | | | | | | | | | | | | | | | | | | | | | | | |

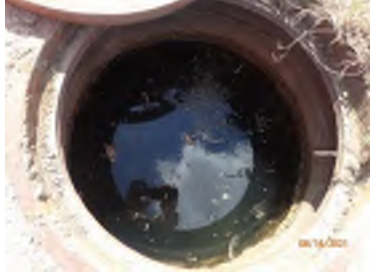
| | | Notes Sample collected from submerged pool in manhole. | | | | | | | | | | | | | | | | | | | | | | | | | | | | | | | | | | | | |
| | | Condition Assessment Graffiti: None Erosion: None Deposition: None in. Damage: None | | | | | | | | | | | | | | | | | | | | | | | | | | | | | | | | | | | | |

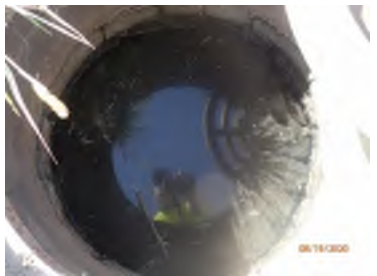
| | | Notes Sample collected from submerged pool in manhole. Elevated pH seemed widespread in river. | | | | | | | | | | | | | | | | | | | | | | | | | | | | | | | | | | | | |
| | | Condition Assessment Graffiti: None Erosion: None Deposition: None in. Damage: None | | | | | | | | | | | | | | | | | | | | | | | | | | | | | | | | | | | | |

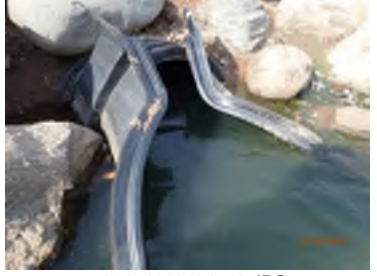
| Sampling Results Sample Location: Total Chlorine: -- ppm Free Chlorine: -- ppm Ammonia: -- ppm pH: -- units Temperature -- °F Conductivity: -- µS/cm Detergents: -- mg/L | | Floatables: None Odor: None Turbidity: None Color: None Gross Solids: None Vegetation: None Benthic Growth: None Stains: None Non-illicit: None | Notes Outfall partially submerged - screened upstream at 06-1495 US1. Apron clamp missing. | o20171003121718.JPG <div style="text-align: center; font-size: 24pt; font-weight: bold;">2017</div> |
| | | Condition Assessment Graffiti: None Erosion: None Deposition: None in. Damage: Minor | | |

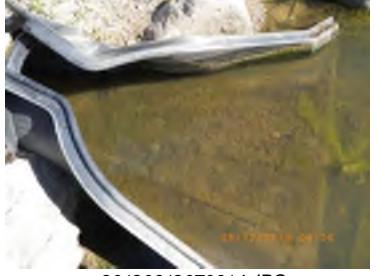
| Sampling Results Sample Location: Total Chlorine: -- ppm Free Chlorine: -- ppm Ammonia: -- ppm pH: -- units Temperature -- °F Conductivity: -- µS/cm Detergents: -- mg/L | | Floatables: None Odor: None Turbidity: None Color: None Gross Solids: None Vegetation: None Benthic Growth: Moderate Stains: Slight Non-illicit: None | Notes Outfall partially submerged; screened upstream at 06-1495 US1. | o20120612070614.JPG <div style="text-align: center; font-size: 24pt; font-weight: bold;">2012</div> |
| | | Condition Assessment Graffiti: None Erosion: None Deposition: None in. Damage: None | | |

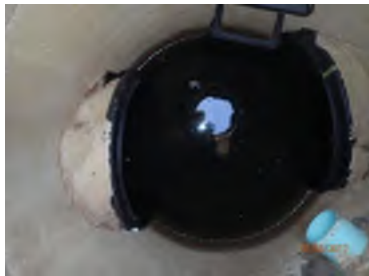
| | | Notes Sample collected from submerged pool in outfall. | | o20171003122158.JPG <div style="text-align: center; font-size: 24pt; font-weight: bold;">2017</div> | | | | | | | | | | | | | | | | | | | | | | | | | | | | | | | | | | |

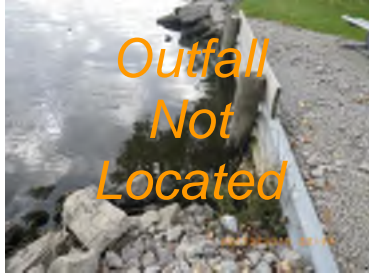
| | | Notes Outfall fully submerged and not located - screened at 06-253 US1. | | |

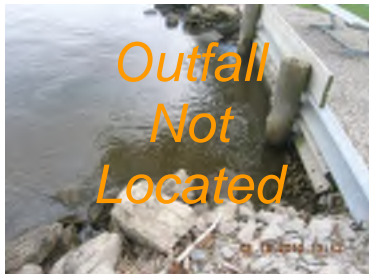
| | | Notes Outfall fully submerged and not physically located. Outfall screened upstream at 06-263 US1. | | |

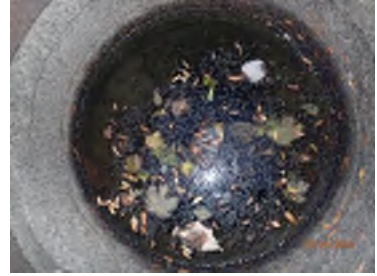
| Submerged: Fully | | Depth (in): 46 | | Sample collected from submerged flow in manhole. Elevated ammonia and conductivity in sample. | | | |
| Sample Location: Pool Total Chlorine: 0 ppm Free Chlorine: 0 ppm Ammonia: 3 ppm pH: 7.27 units Temperature: 52 °F Conductivity: 2280 µS/cm Detergents: 0 mg/L | | | | | | | |

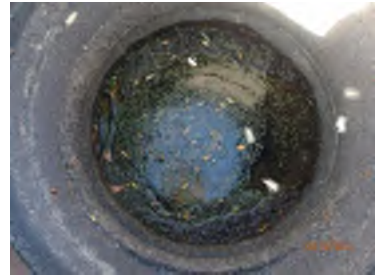
| Submerged: Fully | | Depth (in): 40 | | Sample collected from submerged flow in manhole. Elevated ammonia. | | | |
| Sample Location: Flow Total Chlorine: 0 ppm Free Chlorine: 0 ppm Ammonia: 3 ppm pH: 7.15 units Temperature: 68 °F Conductivity: 1990 µS/cm Detergents: 0 mg/L | | | | | | | |

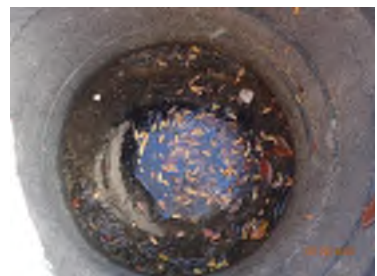
| Submerged: Fully | | Depth (in): 40 | | Strong current; significant flies in manhole. | | | |

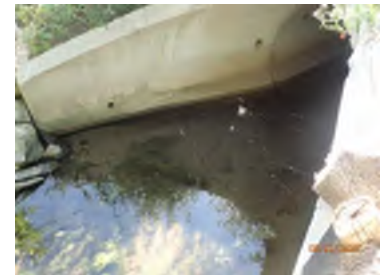
o20240822145810.JPG

Stains: Moderate

☐ Petrol. Sheen ☐ Suds ☐ Sewage ☐ Algae ☐ Other
☐ Petroleum ☐ Musty ☐ Sewage ☐ Chlorine ☐ Other
☐ VOC/Solvent ☐ Fishy ☐ Sulfur ☐ Fragrant☐ Litter ☐ Veg. Debris ☐ Sediment ☐ Other☐ Inhibited ☐ Excessive☒ Green ☐ Brown☒ Flow Line ☐ Oil ☐ Rust Stains☐ Paint ☐ Other☐ Natural Sheen ☐ Natural Suds/Foam

Damage: None ☐ Displacement ☐ Undercut ☐ Crushed
☐ Corrosion ☐ Cracks/Structural Damage

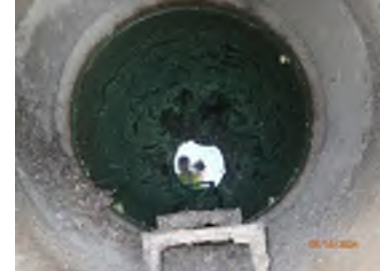
o20240910075130.JPG

☐ Petrol. Sheen ☐ Suds ☐ Sewage ☒ Algae ☐ Other☐ Petroleum ☐ Musty ☐ Sewage ☐ Chlorine ☐ Other☐ VOC/Solvent ☐ Fishy ☐ Sulfur ☐ Fragrant☒ Litter ☒ Veg. Debris ☐ Sediment ☐ Other☐ Inhibited ☐ Excessive☐ Green ☐ Brown☐ Flow Line ☐ Oil ☐ Rust Stains☐ Paint ☐ Other☐ Natural Sheen ☐ Natural Suds/Foam

Damage: None ☐ Displacement ☐ Undercut ☐ Crushed☐ Corrosion ☐ Cracks/Structural Damage

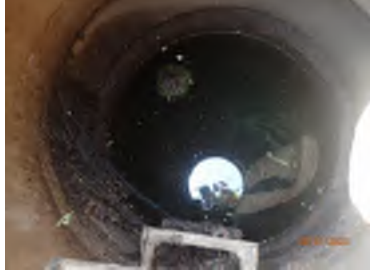
| Inspection Date: 8/1/2023 2:43:05 PM | | Type: Ongoing | Flow: Submerged, indeterminate | Previous Rainfall (hrs): 72+ |
|--|--|---|---|---|
| Sampling Results Sample Location: Pool Total Chlorine: 0 ppm Free Chlorine: 0 ppm Ammonia: 0.5 ppm pH: 7.46 units Temperature: 82 °F Conductivity: 423 µS/cm Detergents: 0 mg/L | | Floatables: Moderate Odor: None Turbidity: None Color: None Gross Solids: Slight Vegetation: None Benthic Growth: None Stains: None Non-illicit: None | Sample collected from submerged pool in manhole. Trace ammonia in sample. Condition Assessment Graffiti: None Erosion: None Deposition: None in. Damage: None | |

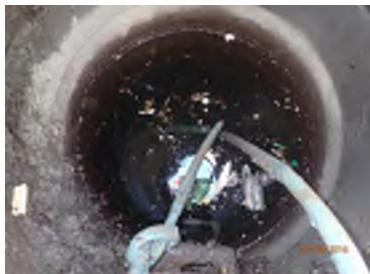
o20161018134038.JPG

| Ammonia: 0 ppm | | Gross Solids: Moderate | Stains: None | |
| | | | Damage: Minor | |

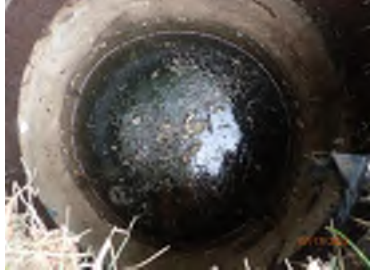
| Submerged: Fully | | Depth (in): 40 | | Sample collected from submerged pool in manhole. | | | | | | | | | | | | | | | | | | | | | | | | | |

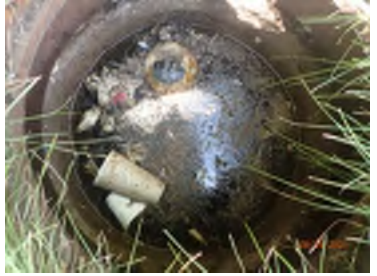
| Submerged: Fully | | Depth (in): 37 | | Sample collected from submerged pool in manhole. Floating gross solids (litter) in manhole. | | | | | | | | | | | | | | | | | | | | | | | | | |

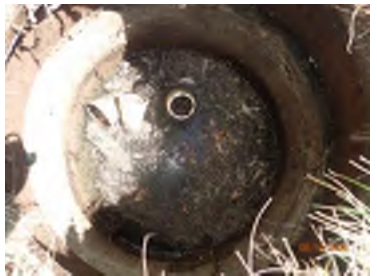
| Submerged: Fully | | Depth (in): 42 | | Sample collected from submerged pool in manhole. Floating gross solids (litter) in manhole. Elevated pH seemed widespread in river. | | | | | | | | | | | | | | | | | | | | | | | | | |

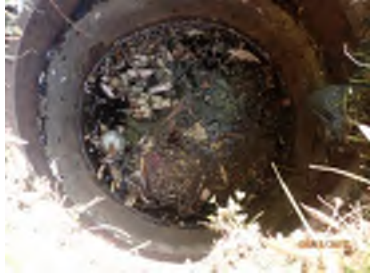
| Submerged: Fully | | Depth (in): 44 | | Sample collected from submerged pool in manhole. Floating gross solids (litter) in manhole. | | | |

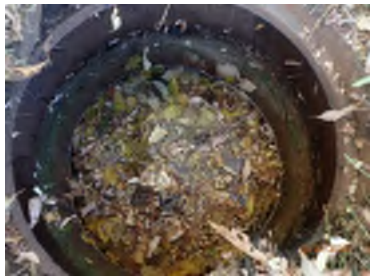
| Submerged: Fully | | Depth (in): 44 | | Sample collected from submerged pool in manhole. Floating gross solids (litter) in manhole. | | | |

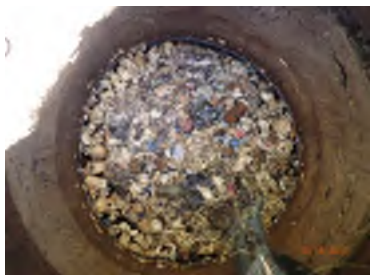
| Submerged: Fully | | Depth (in): 40 | | Sample collected from submerged pool in manhole. Floating gross solids (litter) in manhole. | | | |

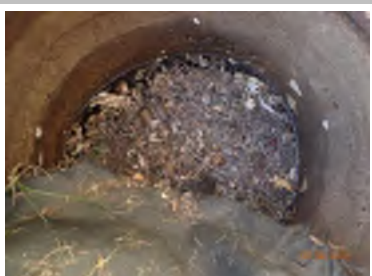
| Submerged: Fully | | Depth (in): | | Potential illicit discharge due to gross solids. | | | |

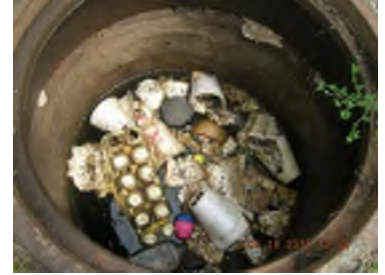
o20100818125018.JPG

| Sampling Results Sample Location: Pool Total Chlorine: 0 ppm Free Chlorine: 0 ppm Ammonia: 0 ppm pH: 7.98 units Temperature: 76 °F Conductivity: -- µS/cm Detergents: 0 mg/L | | Floatables: None Odor: None Turbidity: Slight cloudiness Color: Faint in bottle Gross Solids: Severe Vegetation: None Benthic Growth: None Stains: None Non-illicit: None | | |

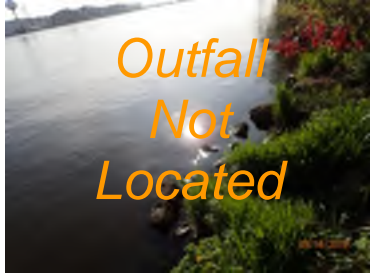
| Submerged: Fully | | Depth (in): | Outfall fully submerged and not located - screened upstream at 06-810 US1. Floating gross solids (litter) in manhole. | |

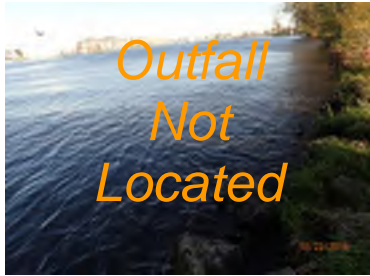
| Submerged: Fully | | Depth (in): | Outfall fully submerged and not located - screened upstream at 06-810 US1. Floating gross solids (litter) in manhole. | |

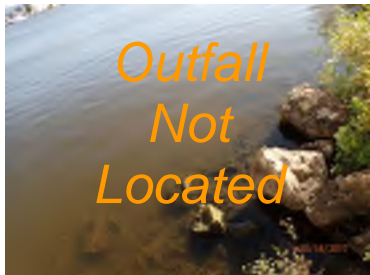
| Submerged: Fully | | Depth (in): | Outfall fully submerged and not located - screened upstream at 06-810 US1. | |

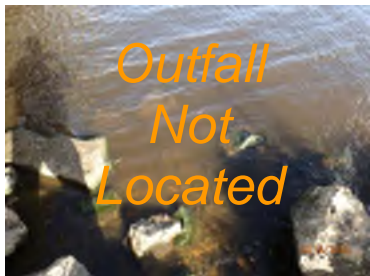
| Submerged: Fully | | Depth (in): | Outfall fully submerged and not located - screened upstream at 06-810 US1. | |

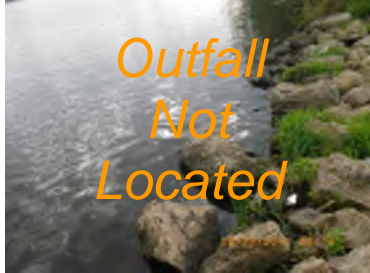
| | | Notes Outfall fully submerged and not located - screened at 06-810 US1. | | |

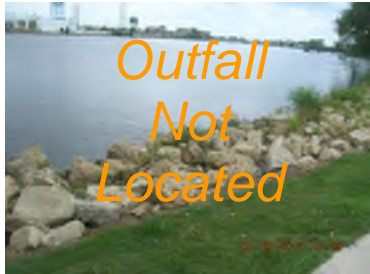
| | | Notes Outfall fully submerged and not physically located. Outfall screened upstream at 06-810 US1. | | |

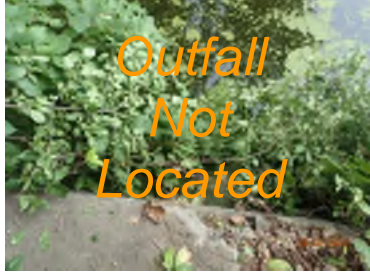
| | | Notes Outfall fully submerged and not located - screened upstream at 06-829 US1. Floating gross solids (litter) in manhole. | | |

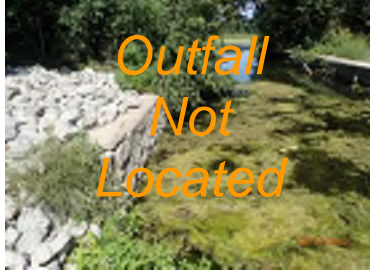
| | | Notes Outfall fully submerged and not located - screened upstream at 06-829 US1. | | |

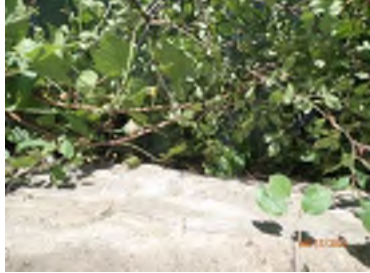
| | | Notes Outfall fully submerged and not located - screened upstream at 06-829 US1. | | |

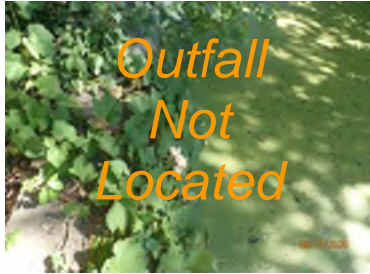
| | | Notes Outfall fully submerged and not located - screened upstream at 06-829 US1. | | |

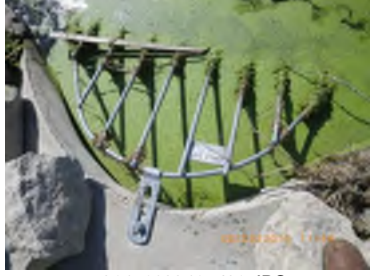
| | | o20150922105430.JPG 2015 | | |

| | | Notes Outfall partially submerged - screened at 08-1042 US1. | | |

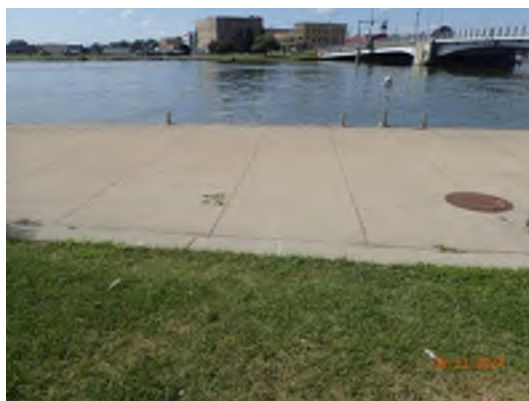
o20240822111434.JPG

Storm sewer from convention center parking lot discharges to river from north under riverwalk. GPS coordinates approximate. Pipe info from MS4 map. Replaces outfall 08-100 (2015).

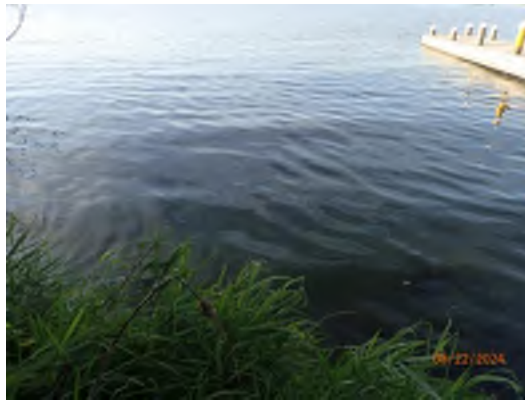
o20240822090412.JPG

Storm sewer from Mill St discharges to lake from north. Outfall fully submerged and not located - GPS coordinates approximate. Pipe info from MS4 map. Replaces outfall 08-395 (2016).

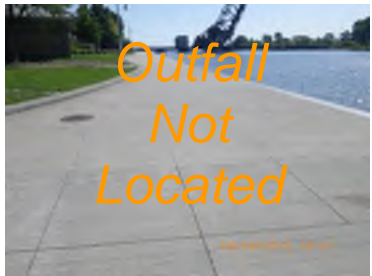
| | | | o20150922110148.JPG <div style="text-align: center; font-size: 24pt; font-weight: bold;">2015</div> | |

| | | Notes Outfall under walkway and not located - screened at 08-271 US1. | | |

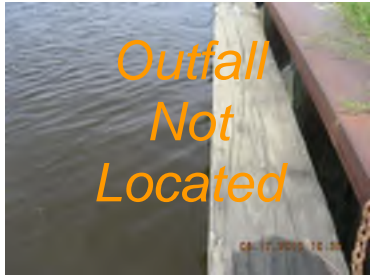
| | | | o201008171105524.JPG <div style="text-align: center; font-size: 24pt; font-weight: bold;">2010</div> | |

| | | Notes Outfall fully submerged and not physically located. Outfall screened upstream at 08-271 US1. | | |

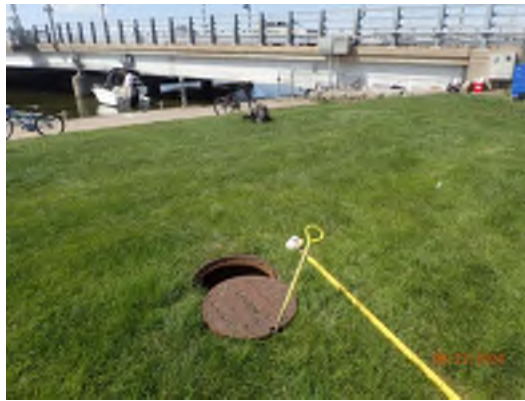
o20240822112218.JPG

Upstream manhole located approx 51 ft NE of outfall 08-279. Replaces original manhole closer to outfall (renamed 08-279 US1a).

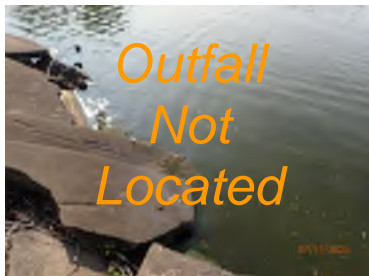
| Illicit Discharge Potential: Unlikely | | Inspector: JCW | | Notes Outfall fully submerged and not located - screened upstream at 08-284 US1. | | o20230717075542.JPG | |

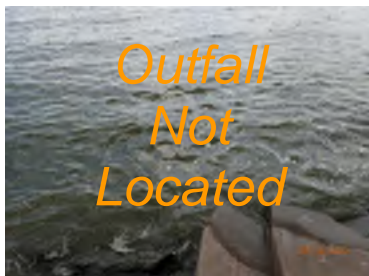
| Illicit Discharge Potential: Potential | | Inspector: EJK | | Notes Outfall partially submerged - screened upstream at 08-284 US1. Floating gross solids (litter) in upstream manhole. | | o20220916131014.JPG | |

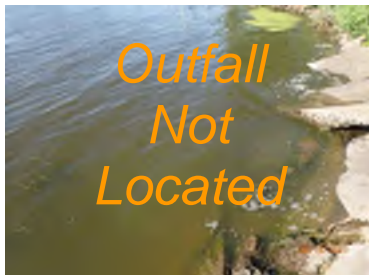
| Illicit Discharge Potential: Potential | | Inspector: JCW | | Notes Outfall partially submerged - screened upstream at 08-284 US1. Floating gross solids (litter) in upstream manhole. | | o20210816095056.JPG | |

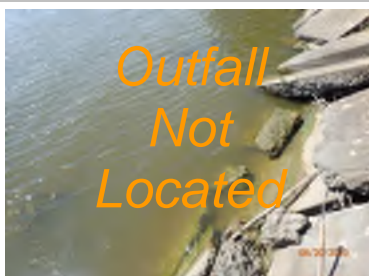
| Illicit Discharge Potential: Potential | | Inspector: JCW | | Notes Outfall fully submerged and not located - screened upstream at 08-284 US1. Floating gross solids (litter) in upstream manhole. | | o20200820125142.JPG | |

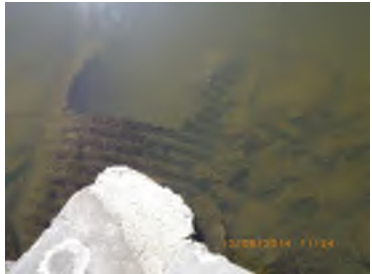
o20141009102400.JPG

| | | Deposition: | Minor 3 in. | |
| | | Damage: | Minor | |

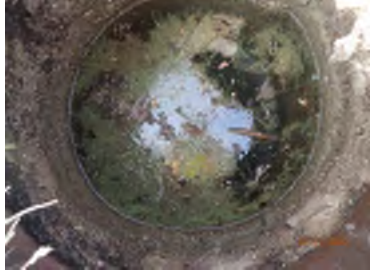
| Inspection Date: 7/17/2023 9:13:33 AM | | Type: Ongoing | Flow: Submerged, indeterminate | Previous Rainfall (hrs): 72+ |
|--|--|---|--|---|
| Illicit Discharge Potential: Unlikely Submerged: Fully Depth (in): 32 | | Inspector: JCW | Notes Sample collected from submerged pool in manhole. | o20230717075704.JPG 2023 |
| Sampling Results Sample Location: Pool Total Chlorine: 0 ppm Free Chlorine: 0 ppm Ammonia: 0 ppm pH: 8.52 units Temperature: 73 °F Conductivity: 401 µS/cm Detergents: 0 mg/L | | Floatables: Slight Odor: None Turbidity: None Color: None Gross Solids: Slight Vegetation: None Benthic Growth: None Stains: None Non-illicit: None | Condition Assessment Graffiti: None Erosion: None Deposition: None in. Damage: None | |

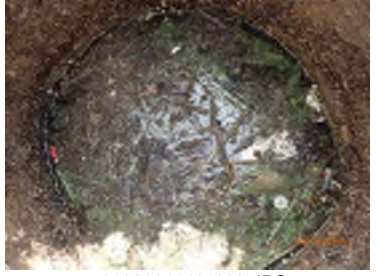
| Inspection Date: 7/17/2023 9:13:33 AM | | Type: Ongoing | Flow: Submerged, indeterminate | Previous Rainfall (hrs): 72+ |
|--|--|---|--|---|
| Illicit Discharge Potential: Potential Submerged: Partially Depth (in): 34 | | Inspector: EJK | Notes Sample collected from submerged pool in manhole. Floating gross solids (litter) in manhole. | o20220916131222.JPG 2022 |

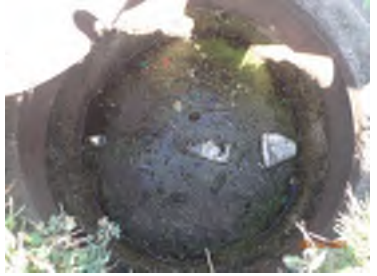
| Inspection Date: 7/17/2023 9:13:33 AM | | Type: Ongoing | Flow: Submerged, indeterminate | Previous Rainfall (hrs): 72+ |
|--|--|---|--|---|
| Illicit Discharge Potential: Potential Submerged: Fully Depth (in): 36 | | Inspector: JCW | Notes Sample collected from submerged pool in manhole. Floating gross solids (litter) in manhole. | o20210816095220.JPG 2021 |

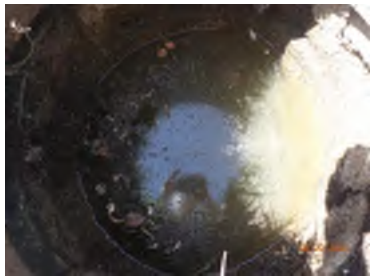
| Inspection Date: 7/17/2023 9:13:33 AM | | Type: Ongoing | Flow: Submerged, indeterminate | Previous Rainfall (hrs): 72+ |
|--|--|---|--|---|
| Illicit Discharge Potential: Potential Submerged: Fully Depth (in): 33 | | Inspector: JCW | Notes Sample collected from submerged pool in manhole. Floating gross solids (litter) in manhole. Elevated pH seemed widespread in river. | o20200820125256.JPG 2020 |

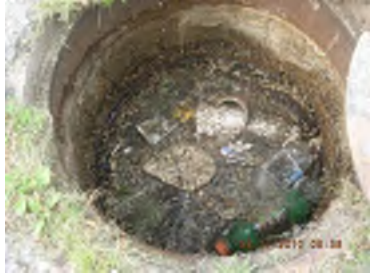
| Floatables: None Odor: None Turbidity: None Color: Faint in bottle Gross Solids: Severe Vegetation: None Benthic Growth: None Stains: None Non-illicit: None | | <p>o20100817093838.JPG</p> <p>2010</p> | | |

| Sampling Results | | Notes Significant floatable debris in manhole. | | |

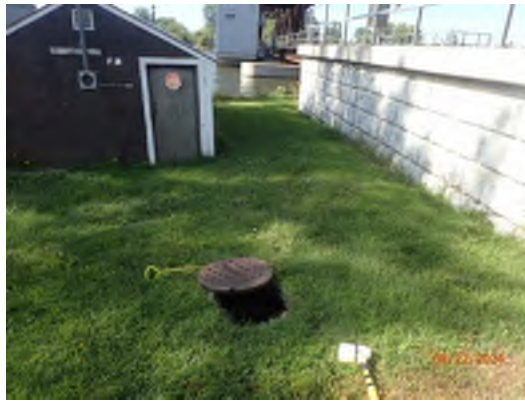
o20240822092608.JPG

Upstream manhole located approx 64 ft NNE of outfall 08-347. Intermediate area consists of gravel parking area and railroad storage shed.

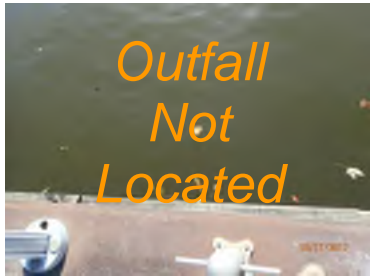
| Illicit Discharge Potential: Unlikely | | Inspector: JCW | Notes Outfall fully submerged and not located - screened upstream at 08-937 US1. | |

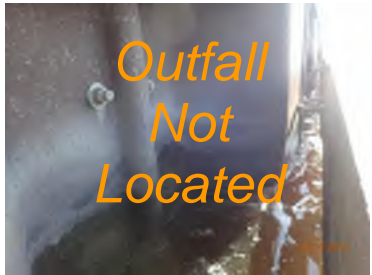
| Illicit Discharge Potential: Unlikely | | Inspector: JCW | Notes Outfall not located and assumed fully submerged - screened upstream at 08-937 US1. | |

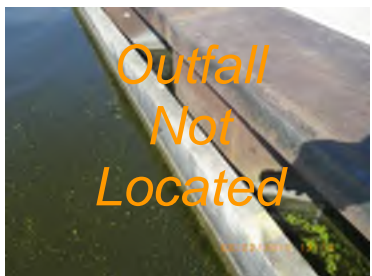
| Illicit Discharge Potential: Unlikely | | Inspector: JCW | Notes Outfall under walkway and not located - screened at 08-937 US1. | |

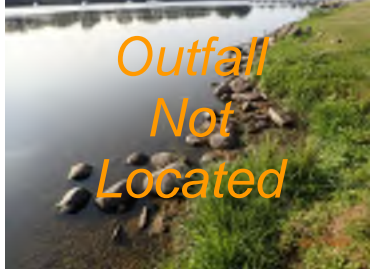
| Illicit Discharge Potential: Potential | | Inspector: JCW | | Notes | | <p style="text-align: center; color: orange; font-weight: bold; font-size: 1.2em;">Outfall Not Located</p> <p style="text-align: center; font-size: 0.8em;">o20230717063750.JPG</p> <p style="text-align: center; font-weight: bold; font-size: 1.5em;">2023</p> | |
| Submerged: None | | Depth (in): | | Outfall fully submerged and not located - screened upstream at 11-177 US1. Floating gross solids (litter) in upstream manhole. | | | |

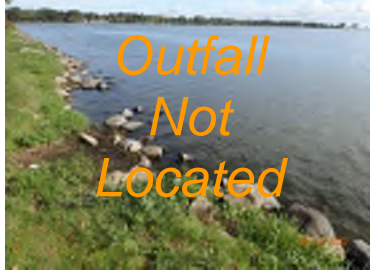
| Illicit Discharge Potential: Unlikely | | Inspector: EJK | | Notes | | <p style="text-align: center; color: orange; font-weight: bold; font-size: 1.2em;">Outfall Not Located</p> <p style="text-align: center; font-size: 0.8em;">o20220923100858.JPG</p> <p style="text-align: center; font-weight: bold; font-size: 1.5em;">2022</p> | |
| Submerged: Fully | | Depth (in): | | Outfall fully submerged and not located - screened upstream at 11-177 US1. | | | |

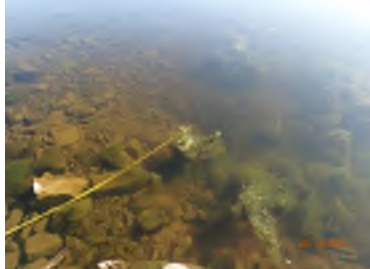
| Illicit Discharge Potential: Potential | | Inspector: JCW | | Notes | | <p style="text-align: center; color: orange; font-weight: bold; font-size: 1.2em;">Outfall Not Located</p> <p style="text-align: center; font-size: 0.8em;">o20210816080850.JPG</p> <p style="text-align: center; font-weight: bold; font-size: 1.5em;">2021</p> | |
| Submerged: Fully | | Depth (in): | | Outfall partially submerged - screened upstream at 11-177 US1. Floating gross solids (litter) in upstream manhole. | | | |

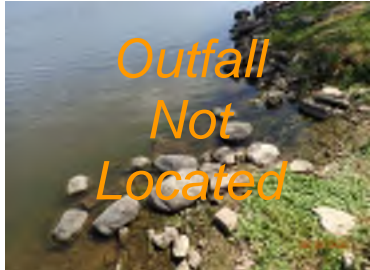
| Illicit Discharge Potential: Potential | | Inspector: JCW | | Notes | | <p style="text-align: center; color: orange; font-weight: bold; font-size: 1.2em;">Outfall Not Located</p> <p style="text-align: center; font-size: 0.8em;">o20200820135154.JPG</p> <p style="text-align: center; font-weight: bold; font-size: 1.5em;">2020</p> | |
| Submerged: Fully | | Depth (in): | | Outfall fully submerged and not located - screened upstream at 11-177 US1. Floating gross solids (litter) in upstream manhole. | | | |

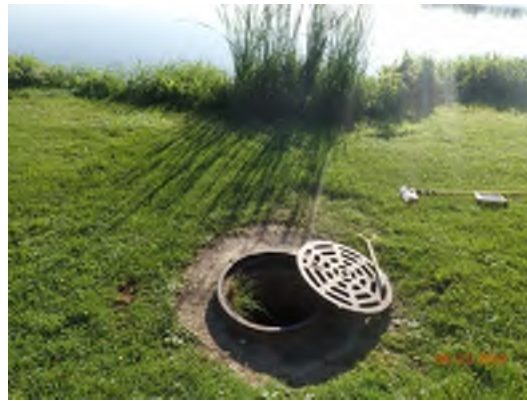
o20240822080910.JPG

Upstream catchbasin located approx 45 ft WSW of outfall 11-177. Intermediate area consists of open space.

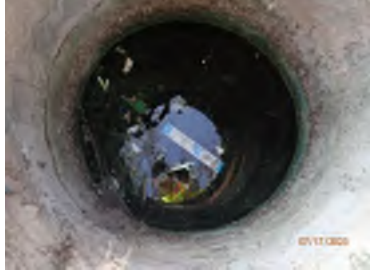
| Inspection Date: 7/17/2023 7:55:24 AM | | Type: Ongoing | Flow: Submerged, indeterminate | Previous Rainfall (hrs): 72+ |
|--|---|---|--|---|
| Illicit Discharge Potential: Potential Submerged: Fully Depth (in): 43 | | Inspector: JCW | Notes Sample collected from submerged pool in manhole. Floating gross solids (litter) in manhole. | o20230717063904.JPG 2023 |
| Sampling Results Sample Location: Pool Total Chlorine: 0 ppm Free Chlorine: 0 ppm Ammonia: 0 ppm pH: 8.93 units Temperature: 70 °F Conductivity: 382 µS/cm Detergents: 0 mg/L | Floatables: None Odor: None Turbidity: None Color: None Gross Solids: Moderate Vegetation: None Benthic Growth: Slight Stains: None Non-illicit: None | Condition Assessment Graffiti: None Erosion: None Deposition: None in. Damage: None | | |

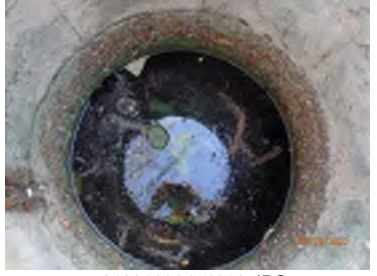
| Inspection Date: 7/17/2023 7:55:24 AM | | Type: Ongoing | Flow: Submerged, indeterminate | Previous Rainfall (hrs): 72+ |
|--|---|---|--|---|
| Illicit Discharge Potential: Unlikely Submerged: Partially Depth (in): 45 | | Inspector: EJK | Notes Sample collected from submerged pool in manhole. | o20220923101908.JPG 2022 |
| Sampling Results Sample Location: Pool Total Chlorine: 0 ppm Free Chlorine: 0 ppm Ammonia: 0 ppm pH: 7.88 units Temperature: 67 °F Conductivity: 409 µS/cm Detergents: 0 mg/L | Floatables: Slight Odor: None Turbidity: None Color: None Gross Solids: Slight Vegetation: None Benthic Growth: None Stains: None Non-illicit: None | Condition Assessment Graffiti: None Erosion: None Deposition: None in. Damage: None | | |

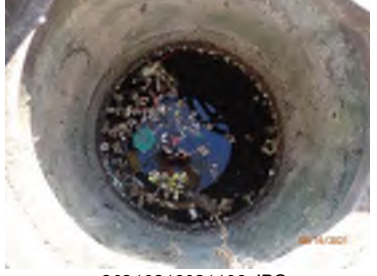
| Inspection Date: 7/17/2023 7:55:24 AM | | Type: Ongoing | Flow: Submerged, indeterminate | Previous Rainfall (hrs): 72+ |
|--|---|---|--|---|
| Illicit Discharge Potential: Potential Submerged: Fully Depth (in): 48 | | Inspector: JCW | Notes Sample collected from submerged pool in manhole. Floating gross solids (litter) in manhole. | o20210816081106.JPG 2021 |
| Sampling Results Sample Location: Pool Total Chlorine: 0 ppm Free Chlorine: 0 ppm Ammonia: 0 ppm pH: 8.11 units Temperature: 73 °F Conductivity: 372 µS/cm Detergents: 0 mg/L | Floatables: None Odor: None Turbidity: None Color: None Gross Solids: Moderate Vegetation: None Benthic Growth: Slight Stains: None Non-illicit: None | Condition Assessment Graffiti: None Erosion: None Deposition: None in. Damage: None | | |

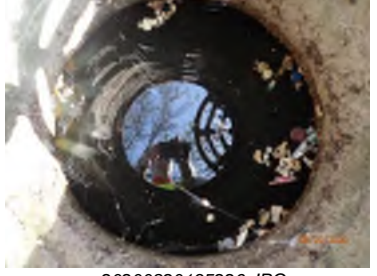
| Inspection Date: 7/17/2023 7:55:24 AM | | Type: Ongoing | Flow: Submerged, indeterminate | Previous Rainfall (hrs): 72+ |
|--|---|---|--|---|
| Illicit Discharge Potential: Potential Submerged: Fully Depth (in): 45 | | Inspector: JCW | Notes Sample collected from submerged pool in manhole. Floating gross solids (litter) in manhole. | o20200820135226.JPG 2020 |
| Sampling Results Sample Location: Pool Total Chlorine: 0 ppm Free Chlorine: 0 ppm Ammonia: 0 ppm pH: 8.85 units Temperature: 85 °F Conductivity: 342 µS/cm Detergents: 0 mg/L | Floatables: None Odor: None Turbidity: None Color: None Gross Solids: Moderate Vegetation: None Benthic Growth: None Stains: None Non-illicit: None | Condition Assessment Graffiti: None Erosion: None Deposition: None in. Damage: None | | |

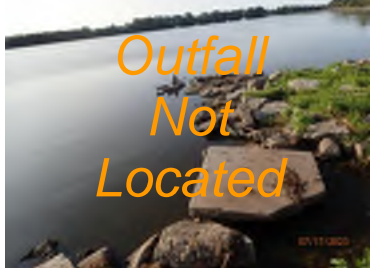
| | | o20230717062522.JPG <div style="text-align: center; font-size: 24pt; font-weight: bold;">2023</div> | | |

| | | Notes Outfall fully submerged and not located - screened upstream at 11-376 US1. Floating gross solids (litter) in upstream manhole. | | |

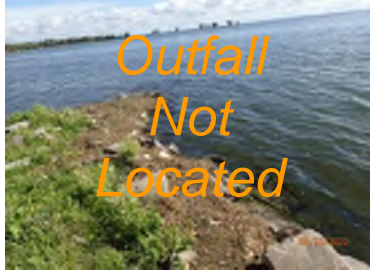
| | | o20220923105534.JPG <div style="text-align: center; font-size: 24pt; font-weight: bold;">2022</div> | | |

| | | Notes Outfall fully submerged and not located - screened upstream at 11-376 US1. Floating gross solids (litter) in upstream manhole. | | |

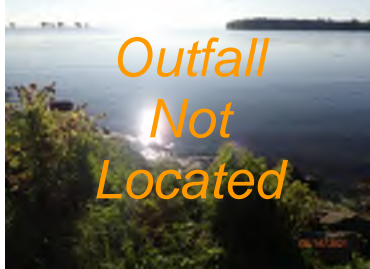
| | | o20210816075628.JPG <div style="text-align: center; font-size: 24pt; font-weight: bold;">2021</div> | | |

| | | Notes Outfall fully submerged and not located - screened upstream at 11-376 US1. Floating gross solids (litter) in upstream manhole. | | |

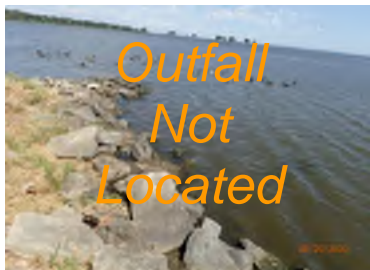
| | | o20200820140432.JPG <div style="text-align: center; font-size: 24pt; font-weight: bold;">2020</div> | | |

| | | Notes Outfall fully submerged and not located - screened upstream at 11-376 US1. Floating gross solids (litter) in upstream manhole. | | |

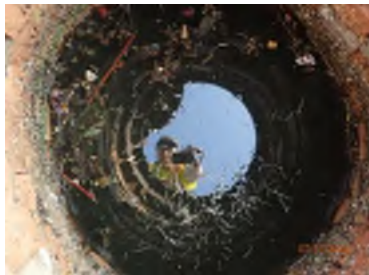
| Inspection Date: 7/17/2023 7:43:23 AM | | Type: Ongoing | Flow: Submerged, indeterminate | Previous Rainfall (hrs): 72+ |
|---|--|---|--|---|
| Illicit Discharge Potential: Potential Submerged: Fully Depth (in): 80 | | Inspector: JCW | Notes | o20230717062704.JPG 2023 |
| Sampling Results Sample Location: Pool Total Chlorine: 0 ppm Free Chlorine: 0 ppm Ammonia: 0 ppm pH: 8.22 units Temperature: 71 °F Conductivity: 1550 µS/cm Detergents: 0 mg/L | | Floatables: None Odor: None Turbidity: None Color: None Gross Solids: Moderate Vegetation: None Benthic Growth: None Stains: None Non-illicit: None | Sample collected from submerged pool in manhole. Floating gross solids (litter) in manhole. Condition Assessment Graffiti: None Erosion: None Deposition: None in. Damage: None | |

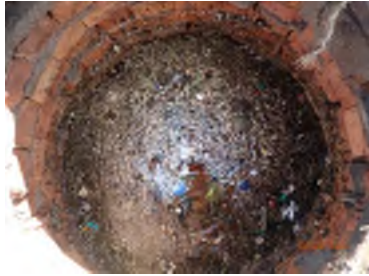
| Inspection Date: 7/17/2023 7:43:23 AM | | Type: Ongoing | Flow: Submerged, indeterminate | Previous Rainfall (hrs): 72+ |
|---|--|---|--|---|
| Illicit Discharge Potential: Potential Submerged: Partially Depth (in): 80 | | Inspector: EJK | Notes | o20220923105710.JPG 2022 |
| Sampling Results Sample Location: Pool Total Chlorine: 0 ppm Free Chlorine: 0 ppm Ammonia: 0.25 ppm pH: 7.16 units Temperature: 70 °F Conductivity: 648 µS/cm Detergents: 0 mg/L | | Floatables: None Odor: None Turbidity: None Color: None Gross Solids: Moderate Vegetation: None Benthic Growth: None Stains: None Non-illicit: None | Sample collected from submerged pool in manhole. Floating gross solids approx 5" thick. Slightly elevated ammonia. Condition Assessment Graffiti: None Erosion: None Deposition: None in. Damage: None | |

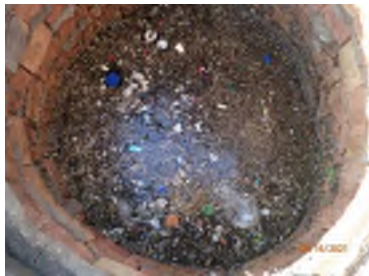
| Inspection Date: 7/17/2023 7:43:23 AM | | Type: Ongoing | Flow: Submerged, indeterminate | Previous Rainfall (hrs): 72+ |
|---|--|---|--|---|
| Illicit Discharge Potential: Potential Submerged: Fully Depth (in): 83 | | Inspector: JCW | Notes | o20210816075758.JPG 2021 |
| Sampling Results Sample Location: Pool Total Chlorine: 0 ppm Free Chlorine: 0 ppm Ammonia: 0 ppm pH: 7.67 units Temperature: 72 °F Conductivity: 572 µS/cm Detergents: 0 mg/L | | Floatables: None Odor: None Turbidity: None Color: None Gross Solids: Severe Vegetation: None Benthic Growth: None Stains: None Non-illicit: None | Sample collected from submerged pool in manhole. Floating gross solids (litter) in manhole. Condition Assessment Graffiti: None Erosion: None Deposition: None in. Damage: None | |

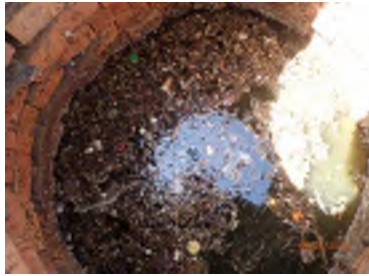
| Inspection Date: 7/17/2023 7:43:23 AM | | Type: Ongoing | Flow: Submerged, indeterminate | Previous Rainfall (hrs): 72+ |
|---|--|---|--|---|
| Illicit Discharge Potential: Potential Submerged: Fully Depth (in): 81 | | Inspector: JCW | Notes | o20200820140542.JPG 2020 |
| Sampling Results Sample Location: Pool Total Chlorine: 0 ppm Free Chlorine: 0 ppm Ammonia: 0 ppm pH: 8.64 units Temperature: 84 °F Conductivity: 382 µS/cm Detergents: 0 mg/L | | Floatables: None Odor: None Turbidity: None Color: None Gross Solids: Moderate Vegetation: None Benthic Growth: Moderate Stains: None Non-illicit: None | Sample collected from submerged pool in manhole. Floating gross solids (litter) in manhole. Condition Assessment Graffiti: None Erosion: None Deposition: None in. Damage: None | |

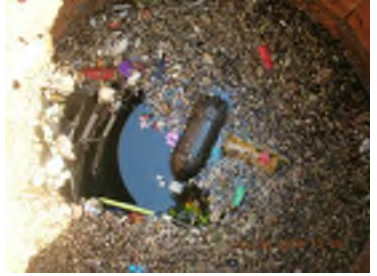
| Illicit Discharge Potential: Potential | | Inspector: JCW | | Notes Abnormal detergent analysis result (bubbles). Significant floating debris in manhole. | | Osh09_DSCN6622.JPG | |
| Sampling Results | | Floatables: None Odor: Turbidity: Color: Gross Solids: Severe Vegetation: Benthic Growth: Stains: Non-illicit: None | | Condition Assessment Graffiti: None Erosion: None Deposition: None 0 in. Damage: None | | 2009 | |

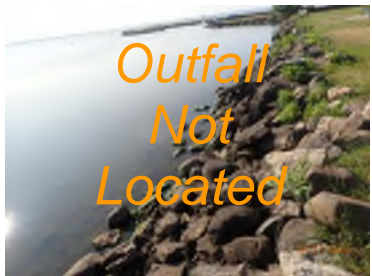
| Submerged: Fully | | Depth (in): | Outfall fully submerged and not located - screened upstream at 11-512 US1. Floating gross solids (litter) in upstream manhole. | | |

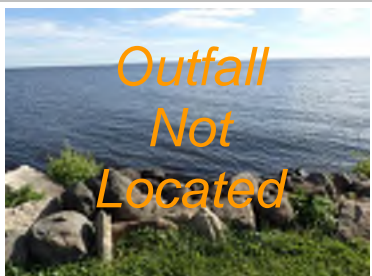
| Submerged: Fully | | Depth (in): | Outfall fully submerged and not located - screened upstream at 11-512 US1. Floating gross solids (litter) in upstream manhole. | | |

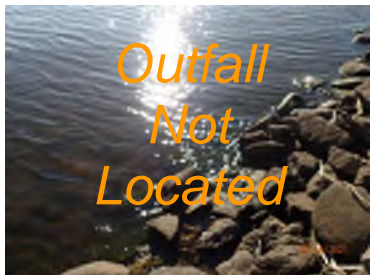
| Submerged: Fully | | Depth (in): | Outfall fully submerged and not located - screened upstream at 11-512 US1. Floating gross solids (litter) in upstream manhole. | | |

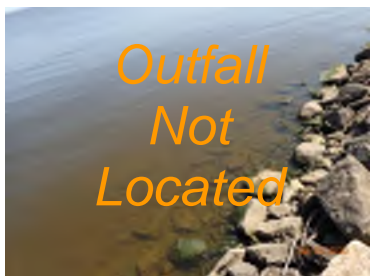
| Submerged: Fully | | Depth (in): | Outfall fully submerged and not located - screened upstream at 11-512 US1. Floating gross solids (litter) in upstream manhole. | | |

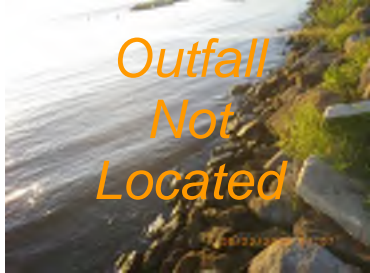
| Submerged: Fully | | Depth (in): | Outfall fully submerged and not located - screened upstream at 11-512 US1. | |

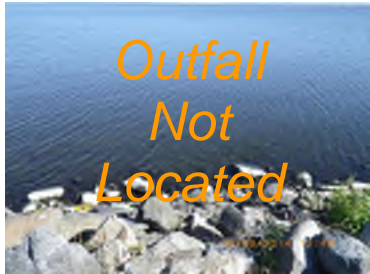
| Submerged: Fully | | Depth (in): | Outfall fully submerged and not located - screened upstream at 11-512 US1. | |

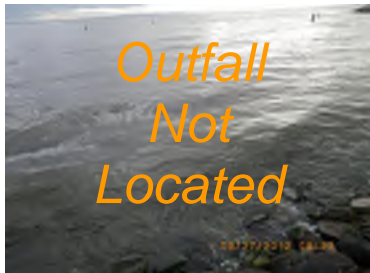
| Submerged: Fully | | Depth (in): | Outfall fully submerged; screened upstream at 11-512 US1. | |

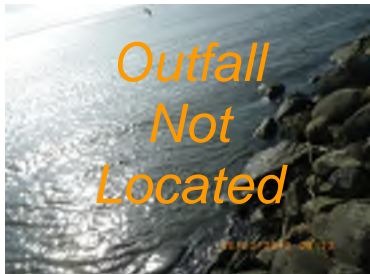
| Submerged: Fully | | Depth (in): | Gross solids pre-screening | |

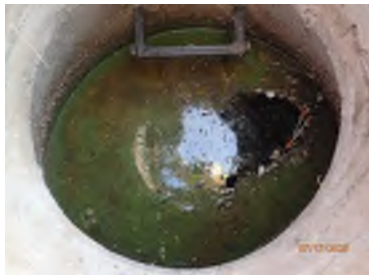
| Inspection Date: 7/17/2023 8:37:03 AM | | Type: Ongoing | Flow: Submerged, indeterminate | Previous Rainfall (hrs): 72+ |
|--|--|---|--|---|
| Illicit Discharge Potential: Potential Submerged: Fully Depth (in): 39 | | Inspector: JCW | Notes | o20230717072024.JPG 2023 |
| Sampling Results Sample Location: Pool Total Chlorine: 0 ppm Free Chlorine: 0 ppm Ammonia: 0 ppm pH: 7.15 units Temperature: 70 °F Conductivity: 205 µS/cm Detergents: 0 mg/L | | Floatables: Slight Odor: None Turbidity: None Color: None Gross Solids: Moderate Vegetation: None Benthic Growth: Moderate Stains: None Non-illicit: None | Sample collected from submerged pool in manhole. Floating gross solids (litter) in manhole, including two syringes. Condition Assessment Graffiti: None Erosion: None Deposition: None in. Damage: None | |

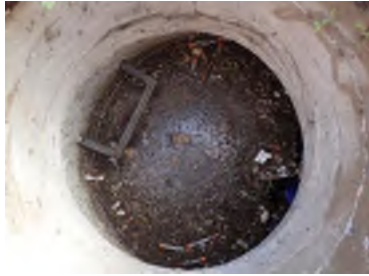
| Inspection Date: 7/17/2023 8:37:03 AM | | Type: Ongoing | Flow: Submerged, indeterminate | Previous Rainfall (hrs): 72+ |
|--|--|---|--|---|
| Illicit Discharge Potential: Potential Submerged: Partially Depth (in): 36 | | Inspector: EJK | Notes | o20220923092448.JPG 2022 |
| Sampling Results Sample Location: Pool Total Chlorine: 0 ppm Free Chlorine: 0 ppm Ammonia: 0 ppm pH: 7.84 units Temperature: 66 °F Conductivity: 460 µS/cm Detergents: 0 mg/L | | Floatables: None Odor: None Turbidity: None Color: None Gross Solids: Moderate Vegetation: None Benthic Growth: None Stains: None Non-illicit: None | Sample collected from submerged pool in manhole. Floating gross solids (litter) in upstream manhole. Condition Assessment Graffiti: None Erosion: None Deposition: None in. Damage: None | |

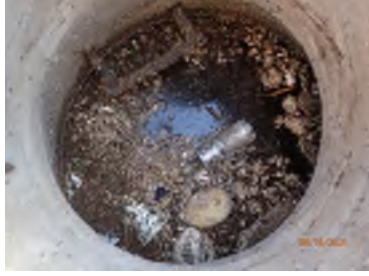
| Inspection Date: 7/17/2023 8:37:03 AM | | Type: Ongoing | Flow: Submerged, indeterminate | Previous Rainfall (hrs): 72+ |
|--|--|---|--|---|
| Illicit Discharge Potential: Potential Submerged: Fully Depth (in): 41 | | Inspector: JCW | Notes | o20210816083856.JPG 2021 |
| Sampling Results Sample Location: Pool Total Chlorine: 0 ppm Free Chlorine: 0 ppm Ammonia: 0 ppm pH: 7.65 units Temperature: 73 °F Conductivity: 345 µS/cm Detergents: 0 mg/L | | Floatables: None Odor: None Turbidity: None Color: None Gross Solids: Moderate Vegetation: None Benthic Growth: None Stains: None Non-illicit: None | Sample collected from submerged pool in manhole. Floating gross solids (litter) in manhole. Condition Assessment Graffiti: None Erosion: None Deposition: None in. Damage: None | |

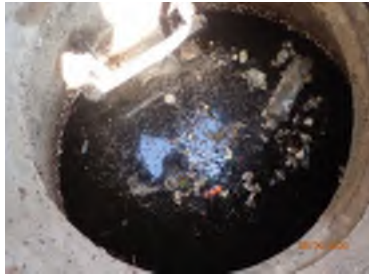
| Inspection Date: 7/17/2023 8:37:03 AM | | Type: Ongoing | Flow: Submerged, indeterminate | Previous Rainfall (hrs): 72+ |
|--|--|---|--|---|
| Illicit Discharge Potential: Potential Submerged: Fully Depth (in): 39 | | Inspector: JCW | Notes | o20200820131802.JPG 2020 |
| Sampling Results Sample Location: Pool Total Chlorine: 0 ppm Free Chlorine: 0 ppm Ammonia: 0 ppm pH: 9.07 units Temperature: 84 °F Conductivity: 347 µS/cm Detergents: 0 mg/L | | Floatables: None Odor: None Turbidity: None Color: None Gross Solids: Moderate Vegetation: None Benthic Growth: Moderate Stains: None Non-illicit: None | Sample collected from submerged pool in manhole. Floating gross solids (litter) in manhole. Elevated pH seemed widespread in river/lake. Condition Assessment Graffiti: None Erosion: None Deposition: None in. Damage: None | |

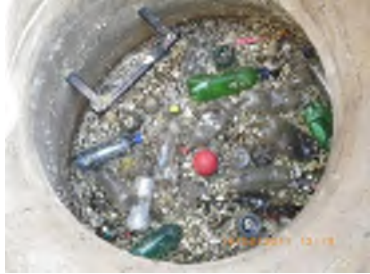
| Sampling Results Sample Location: Pool Total Chlorine: 0 ppm Free Chlorine: 0 ppm Ammonia: 0 ppm pH: 7.39 units Temperature: 67 °F Conductivity: -- µS/cm Detergents: 0 mg/L | | Floatables: None Odor: None Turbidity: None Color: None Gross Solids: Severe Vegetation: None Benthic Growth: None Stains: None Non-illicit: None | Condition Assessment Graffiti: None Erosion: None Deposition: None 0 in. Damage: None | |

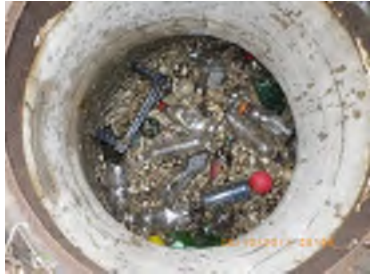
| Illicit Discharge Potential: Potential | | Inspector: JCW | Notes Limited screening conducted for upstream manhole prescreening. | |
| Sampling Results Sample Location: Total Chlorine: -- ppm Free Chlorine: -- ppm Ammonia: -- ppm pH: -- units Temperature: -- °F Conductivity: -- µS/cm Detergents: -- mg/L | | Floatables: None Odor: Turbidity: Color: Gross Solids: Severe Vegetation: Benthic Growth: Stains: Non-illicit: None | Condition Assessment Graffiti: None Erosion: None Deposition: None 0 in. Damage: None | |

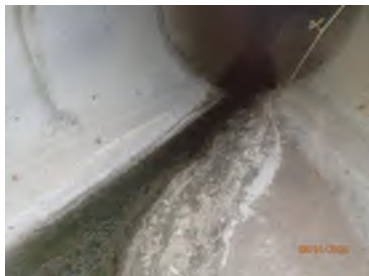
| Sampling Results Sample Location: _____ Total Chlorine: -- ppm Free Chlorine: -- ppm Ammonia: -- ppm pH: -- units Temperature: -- °F Conductivity: -- µS/cm Detergents: -- mg/L | | Floatables: None Odor: None Turbidity: None Color: None Gross Solids: Slight Vegetation: None Benthic Growth: Moderate Stains: Moderate Non-illicit: None | | |
| | | Notes Pipe wet, but no collectable flow at time of inspection. | | |

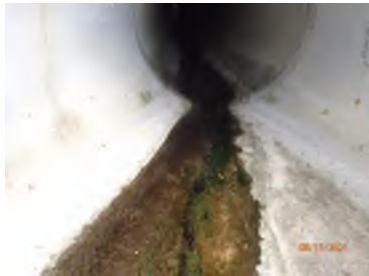
| Sampling Results Sample Location: Flow Total Chlorine: 0 ppm Free Chlorine: 0 ppm Ammonia: 0 ppm pH: 8.09 units Temperature: 78 °F Conductivity: 778 µS/cm Detergents: 0 mg/L | | Floatables: None Odor: None Turbidity: None Color: None Gross Solids: None Vegetation: None Benthic Growth: Moderate Stains: Slight Non-illicit: None | | |
| | | Notes Sample collected from pipe flow. | | |

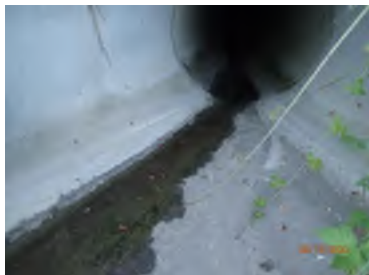
| Sampling Results Sample Location: _____ Total Chlorine: -- ppm Free Chlorine: -- ppm Ammonia: -- ppm pH: -- units Temperature: -- °F Conductivity: -- µS/cm Detergents: -- mg/L | | Floatables: None Odor: None Turbidity: None Color: None Gross Solids: None Vegetation: None Benthic Growth: Slight Stains: None Non-illicit: None | | |
| | | Notes Pipe wet, but no collectable flow at time of inspection. | | |

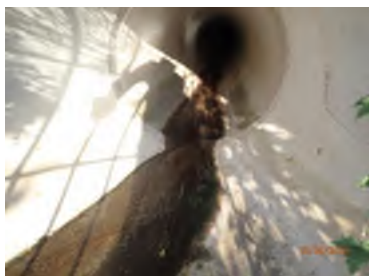
| Sampling Results Sample Location: Flow Total Chlorine: 0 ppm Free Chlorine: 0 ppm Ammonia: 0 ppm pH: 8.16 units Temperature: 65 °F Conductivity: 1014 µS/cm Detergents: 0 mg/L | | Floatables: None Odor: None Turbidity: None Color: None Gross Solids: None Vegetation: None Benthic Growth: Moderate Stains: None Non-illicit: Slight | | |
| | | Notes Outfall sampled from moderate flow. | | |

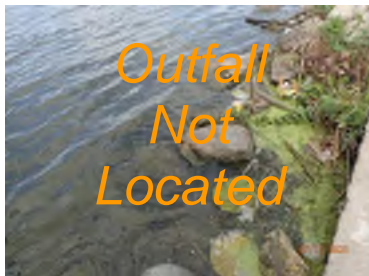
| Sampling Results Sample Location: _____ Total Chlorine: -- ppm Free Chlorine: -- ppm Ammonia: -- ppm pH: -- units Temperature: -- °F Conductivity: -- µS/cm Detergents: -- mg/L | | Floatables: None Odor: None Turbidity: None Color: None Gross Solids: None Vegetation: None Benthic Growth: None Stains: None Non-illicit: None | Notes Outfall fully submerged and not located - screened upstream at 12-569 US1. Graffiti on nearby bridge abutment. Condition Assessment Graffiti: Moderate Erosion: None Deposition: None in. Damage: None | o20230717095836.JPG 2023 |

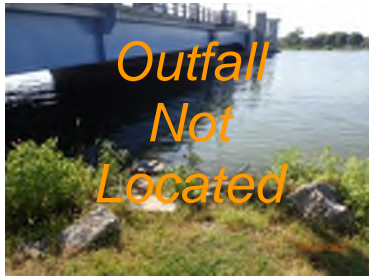
| Sampling Results Sample Location: _____ Total Chlorine: -- ppm Free Chlorine: -- ppm Ammonia: -- ppm pH: -- units Temperature: -- °F Conductivity: -- µS/cm Detergents: -- mg/L | | Floatables: None Odor: None Turbidity: None Color: None Gross Solids: None Vegetation: None Benthic Growth: None Stains: None Non-illicit: None | Notes Outfall fully submerged and not located - screened upstream at 12-569 US1. Condition Assessment Graffiti: Moderate Erosion: None Deposition: None in. Damage: None | o20220919151702.JPG 2022 |

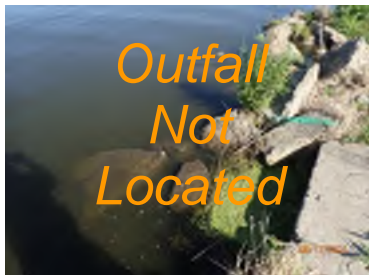
| Sampling Results Sample Location: _____ Total Chlorine: -- ppm Free Chlorine: -- ppm Ammonia: -- ppm pH: -- units Temperature: -- °F Conductivity: -- µS/cm Detergents: -- mg/L | | Floatables: None Odor: None Turbidity: None Color: None Gross Solids: None Vegetation: None Benthic Growth: None Stains: None Non-illicit: None | Notes Outfall fully submerged and not located - screened upstream at 12-569 US1. Graffiti on nearby bridge abutment. Condition Assessment Graffiti: Moderate Erosion: None Deposition: None in. Damage: None | o20210817091208.JPG 2021 |

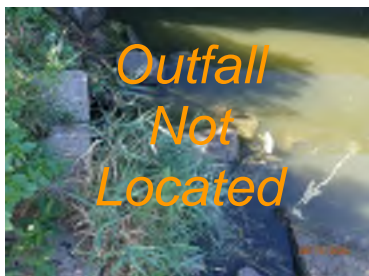
| Sampling Results Sample Location: _____ Total Chlorine: -- ppm Free Chlorine: -- ppm Ammonia: -- ppm pH: -- units Temperature: -- °F Conductivity: -- µS/cm Detergents: -- mg/L | | Floatables: None Odor: None Turbidity: None Color: None Gross Solids: None Vegetation: None Benthic Growth: None Stains: None Non-illicit: None | Notes Outfall fully submerged and not physically located - screened upstream at 12-569 US1. Graffiti on bridge abutment. Condition Assessment Graffiti: Moderate Erosion: None Deposition: None in. Damage: None | o20200819084114.JPG 2020 |

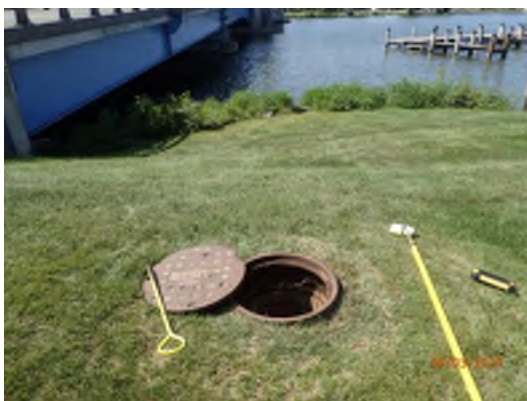
| Total Chlorine: 0 ppm | Color: None | Gross Solids: Slight | | |

| Ammonia: 0 ppm | Stains: None | Non-illicit: None | | |

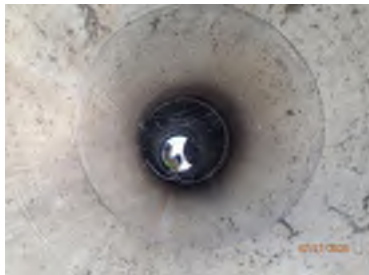
| Inspection Date: 7/17/2023 11:17:35 AM | | Type: Ongoing | Flow: Submerged, indeterminate | Previous Rainfall (hrs): 72+ |
|--|--|---|--|---|
| Illicit Discharge Potential: Unlikely Submerged: Fully Depth (in): 42 | | Inspector: JCW | Notes | o20230717100040.JPG 2023 |
| Sampling Results Sample Location: Pool Total Chlorine: 0 ppm Free Chlorine: 0 ppm Ammonia: 0 ppm pH: 8.39 units Temperature: 77 °F Conductivity: 435 µS/cm Detergents: 0 mg/L | | Floatables: None Odor: None Turbidity: None Color: None Gross Solids: None Vegetation: None Benthic Growth: None Stains: None Non-illicit: None | Sample collected from submerged pool in manhole. Condition Assessment Graffiti: None Erosion: None Deposition: None in. Damage: None | |

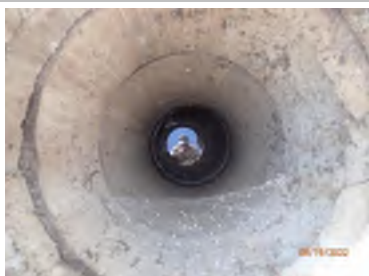
| Inspection Date: 7/17/2023 11:17:35 AM | | Type: Ongoing | Flow: Submerged, indeterminate | Previous Rainfall (hrs): 72+ |
|--|--|---|--|---|
| Illicit Discharge Potential: Unlikely Submerged: Partially Depth (in): 44 | | Inspector: EJK | Notes | o20220919152124.JPG 2022 |
| Sampling Results Sample Location: Pool Total Chlorine: 0 ppm Free Chlorine: 0 ppm Ammonia: 0 ppm pH: 7.5 units Temperature: 75 °F Conductivity: 484 µS/cm Detergents: 0 mg/L | | Floatables: None Odor: None Turbidity: None Color: None Gross Solids: Slight Vegetation: None Benthic Growth: None Stains: None Non-illicit: None | Sample collected from submerged pool in manhole. Condition Assessment Graffiti: None Erosion: None Deposition: None in. Damage: None | |

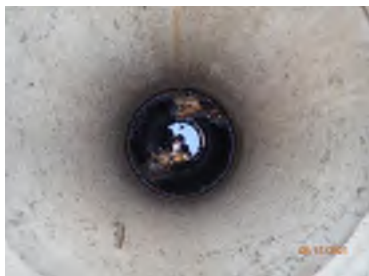
| Inspection Date: 7/17/2023 11:17:35 AM | | Type: Ongoing | Flow: Submerged, indeterminate | Previous Rainfall (hrs): 72+ |
|--|--|---|--|---|
| Illicit Discharge Potential: Unlikely Submerged: Fully Depth (in): 38 | | Inspector: JCW | Notes | o20210817091344.JPG 2021 |
| Sampling Results Sample Location: Pool Total Chlorine: 0 ppm Free Chlorine: 0 ppm Ammonia: 0 ppm pH: 7.15 units Temperature: 77 °F Conductivity: 454 µS/cm Detergents: 0 mg/L | | Floatables: None Odor: None Turbidity: None Color: None Gross Solids: Moderate Vegetation: None Benthic Growth: None Stains: None Non-illicit: None | Sample collected from submerged pool in manhole. Condition Assessment Graffiti: None Erosion: None Deposition: None in. Damage: None | |

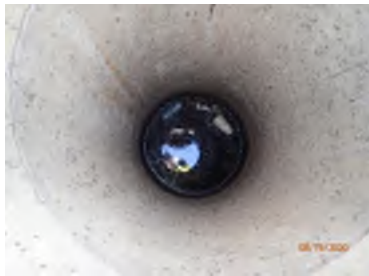
| Inspection Date: 7/17/2023 11:17:35 AM | | Type: Ongoing | Flow: Submerged, indeterminate | Previous Rainfall (hrs): 72+ |
|--|--|---|--|---|
| Illicit Discharge Potential: Unlikely Submerged: Partially Depth (in): 38 | | Inspector: JCW | Notes | o20200819084220.JPG 2020 |
| Sampling Results Sample Location: Pool Total Chlorine: 0 ppm Free Chlorine: 0 ppm Ammonia: 0 ppm pH: 8.49 units Temperature: 73 °F Conductivity: 349 µS/cm Detergents: 0 mg/L | | Floatables: None Odor: Faint Turbidity: None Color: None Gross Solids: Slight Vegetation: None Benthic Growth: None Stains: None Non-illicit: None | Sample collected from submerged pool in manhole. Floating gross solids (litter) in manhole. Condition Assessment Graffiti: None Erosion: None Deposition: None in. Damage: None | |

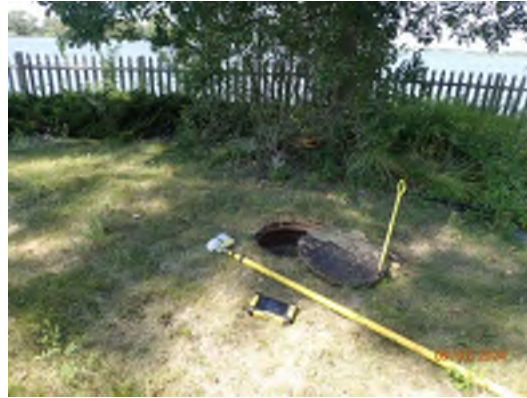
o20240903125352.JPG

Upstream manhole located approx 52 ft ENE of outfall 12-576. Intermediate area consists of residential lawn area and shoreline.

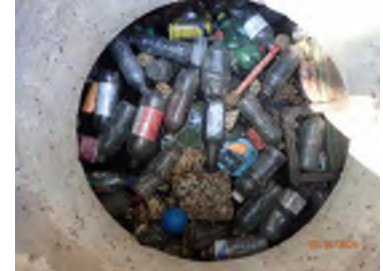
o20240903125400.JPG

Illicit Discharge Potential: Potential

Notes: Sample collected from submerged pool in manhole. Floating gross solids (litter) in manhole.

| Stains: | Moderate | <input checked="" type="checkbox"/> Flow Line | <input type="checkbox"/> Oil | <input type="checkbox"/> Rust Stains | | |

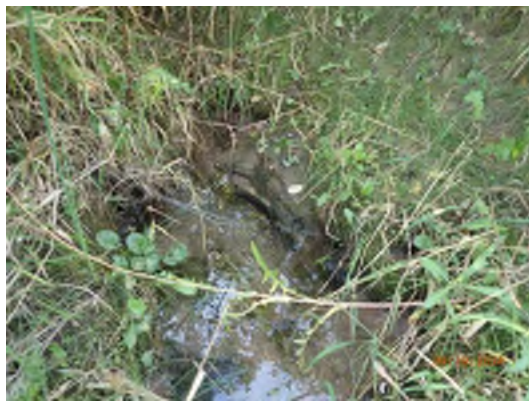
o20240919085006.JPG

Storm sewer from AmCor plant receiving area discharges to channel from south.

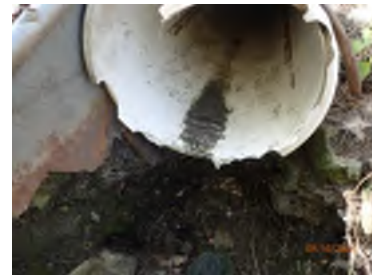
o20240910094248.JPG

Notes: Pipe dry at time of inspection. 12" underchut, broken PVC at end, metal endwall completely corroded.

Damage: Moderate ☐ Displacement ☒ Undercut ☐ Crushed☒ Corrosion ☒ Cracks/Structural Damage

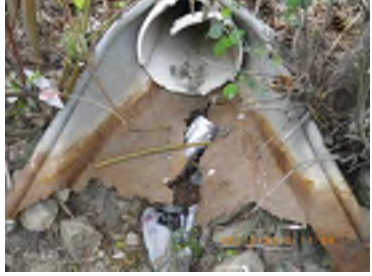
| | | o20120612103414.JPG | | |

| | | Notes Dry. End of pipe cracked. Apron undercut and corroded. | | |
| | | Condition Assessment Graffiti: None Erosion: None Deposition: None in. Damage: Moderate | | |

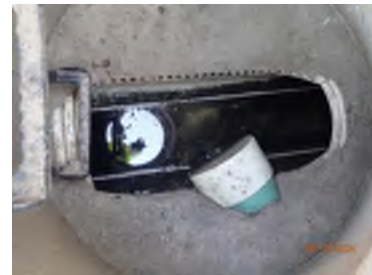
o20240910094840.JPG

Notes: Sample collected from submerged pool in manhole near incoming pipe. Dark staining on flowline. Slightly elevated ammonia - below action limit.

Stains: Severe

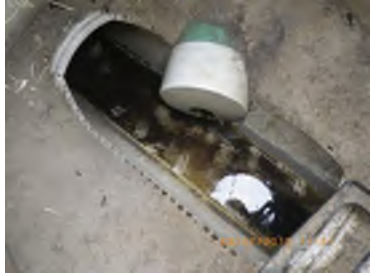
| Illicit Discharge Potential: Potential | | Inspector: JCW | Notes Black pool on flowline with petroleum odor. | | | | | | | | | | | | | | | | | | | | | | | | | | |

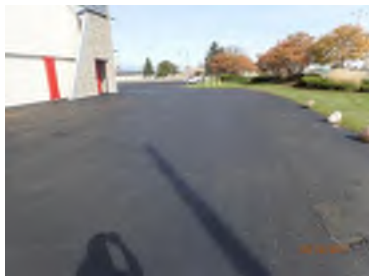
| | | Notes Outfall not located - screened upstream at 13-1718 US1. | | |

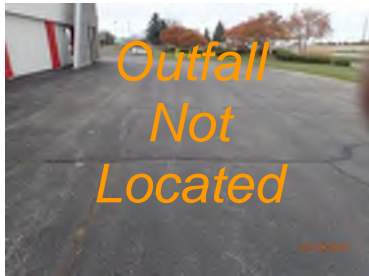
| | | Notes End of pipe/manhole not located - screened upstream at 13-1718 US1. | | |
