IDDE Ongoing Screening Summary Report

2024 Inspection Year

City of Oshkosh

Westwood

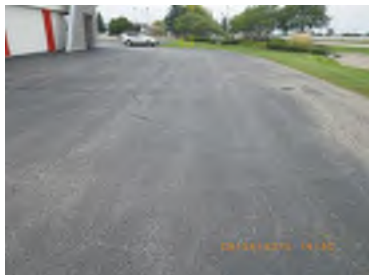
| | | Notes Outfall not located - screened at 13-1718 US1. | | |

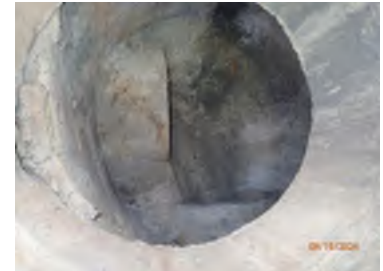
o20240919095512.JPG

Damage: Minor ☐ Displacement ☐ Undercut ☐ Crushed☐ Corrosion ☒ Cracks/Structural Damage

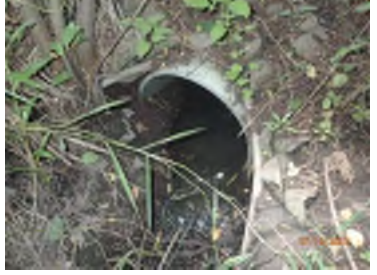
| Inspection Date: 7/19/2023 2:48:36 PM | | Type: Ongoing | Flow: Submerged, indeterminate | Previous Rainfall (hrs): 72+ |
|---|---|--|---|---|
| Illicit Discharge Potential: Unlikely Submerged: Partially Depth (in): 7 | | Inspector: JCW | Notes Outfall partially submerged - screened upstream at 13-1766 US1. | o20230719133228.JPG 2023 |
| Sampling Results Sample Location: Total Chlorine: -- ppm Free Chlorine: -- ppm Ammonia: -- ppm pH: -- units Temperature -- °F Conductivity: -- µS/cm Detergents: -- mg/L | Floatables: None Odor: None Turbidity: None Color: None Gross Solids: None Vegetation: None Benthic Growth: Moderate Stains: None Non-illicit: None | Condition Assessment Graffiti: None Erosion: None Deposition: Moderate 5 in. Damage: None | | |

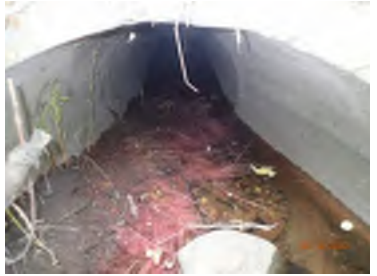
| Inspection Date: 7/19/2023 2:48:36 PM | | Type: Ongoing | Flow: Submerged, indeterminate | Previous Rainfall (hrs): 72+ |
|---|---|--|---|---|
| Illicit Discharge Potential: Unlikely Submerged: Partially Depth (in): 4 | | Inspector: EJK | Notes Sample collected from submerged flow at end of pipe. | o20220818134506.JPG 2022 |

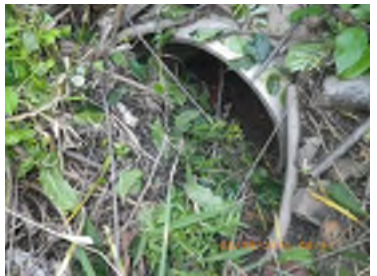
| Inspection Date: 7/19/2023 2:48:36 PM | | Type: Ongoing | Flow: Submerged, indeterminate | Previous Rainfall (hrs): 72+ |
|---|---|--|---|---|
| Illicit Discharge Potential: Unlikely Submerged: None Depth (in): | | Inspector: JCW | Notes Flowline damp, but no flow at time of inspection. Sediment level with crown of pipe. | o20150928072150.JPG 2015 |
| Sampling Results Sample Location: Total Chlorine: -- ppm Free Chlorine: -- ppm Ammonia: -- ppm pH: -- units Temperature -- °F Conductivity: -- µS/cm Detergents: -- mg/L | Floatables: None Odor: None Turbidity: None Color: None Gross Solids: None Vegetation: None Benthic Growth: Slight Stains: None Non-illicit: None | Condition Assessment Graffiti: None Erosion: None Deposition: Severe 18 in. Damage: None | | |

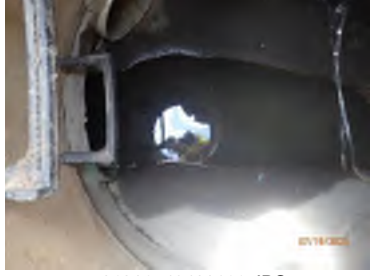
| | | <p>Notes</p> <p>Sample collected from submerged pool in manhole. Slightly elevated ammonia.</p> | | <p style="text-align: center; font-size: small;">o20230719133600.JPG</p> | | | | | | | | | | | | | | | | | | | | | | | | | | | | | | | | | | |
| | | <p>Condition Assessment</p> <table border="1" style="width: 100%; border-collapse: collapse;"> <tr> <td>Graffiti:</td> <td>None</td> </tr> <tr> <td>Erosion:</td> <td>None</td> </tr> <tr> <td>Deposition:</td> <td>Minor 2 in.</td> </tr> <tr> <td>Damage:</td> <td>None</td> </tr> </table> | | | Graffiti: | None | Erosion: | None | Deposition: | Minor 2 in. | Damage: | None | | | | | | | | | | | | | | | | | | | | | | | | | | |

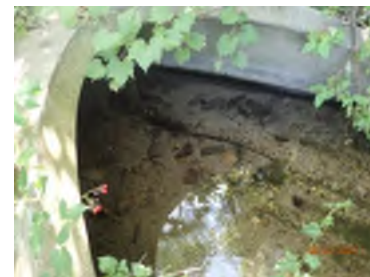
o20240822152644.JPG

Deposition: Minor Depth (in): 1

Damage: Minor ☒ Displacement ☐ Undercut ☐ Crushed☐ Corrosion ☐ Cracks/Structural Damage

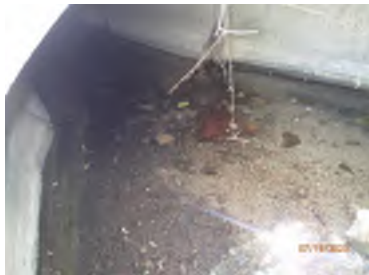
| Inspection Date: 7/19/2023 3:26:43 PM | | Type: Ongoing | Flow: Submerged, slight flow | Previous Rainfall (hrs): 72+ |
|---|--|---|--|---|
| Sampling Results Sample Location: Flow Total Chlorine: 0 ppm Free Chlorine: 0 ppm Ammonia: 0 ppm pH: 8.1 units Temperature: 78 °F Conductivity: 1291 µS/cm Detergents: 0 mg/L | | Floatables: None Odor: None Turbidity: None Color: None Gross Solids: Slight Vegetation: None Benthic Growth: Severe Stains: Severe Non-illicit: None | Sample collected from concentrated flow immediately downstream from pipe. 2" joint displacement. Downstream channel erosion. Condition Assessment Graffiti: None Erosion: Moderate Deposition: Minor 2 in. Damage: Minor | |

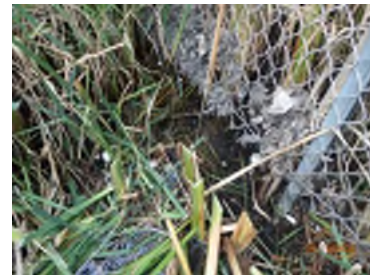
o20240919075748.JPG

☐ Petrol. Sheen ☐ Suds ☐ Sewage ☐ Algae ☐ Other☐ Petroleum ☐ Musty ☐ Sewage ☐ Chlorine ☐ Other☐ VOC/Solvent ☐ Fishy ☐ Sulfur ☐ Fragrant☒ Litter ☐ Veg. Debris ☐ Sediment ☐ Other☐ Inhibited ☐ Excessive☐ Green ☐ Brown☐ Flow Line ☐ Oil ☐ Rust Stains☐ Paint ☐ Other☐ Natural Sheen ☐ Natural Suds/Foam

Damage: None

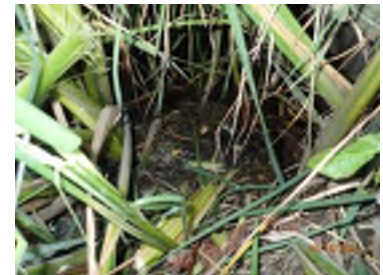
o20240919074036.JPG

☐ Displacement☐ Undercut☐ Crushed☐ Corrosion☐ Cracks/Structural Damage☐ Petrol. Sheen ☐ Suds ☐ Sewage ☐ Algae ☐ Other☐ Petroleum ☐ Musty ☐ Sewage ☐ Chlorine ☐ Other☐ VOC/Solvent ☐ Fishy ☐ Sulfur ☐ Fragrant☒ Litter ☐ Veg. Debris ☐ Sediment ☐ Other☐ Inhibited ☐ Excessive☒ Green ☐ Brown☐ Flow Line ☐ Oil ☐ Rust Stains☐ Paint ☐ Other☐ Natural Sheen ☐ Natural Suds/Foam

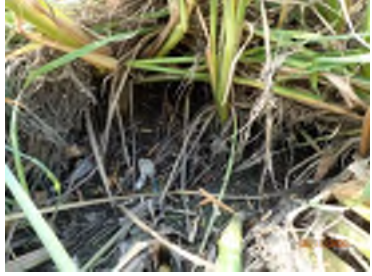
o20200915152730.JPG
2020

| | | Notes Sediment damp, but no flow at time of inspection. | | |
| | | Condition Assessment Graffiti: None Erosion: None Deposition: Moderate 12 in. Damage: None | | |

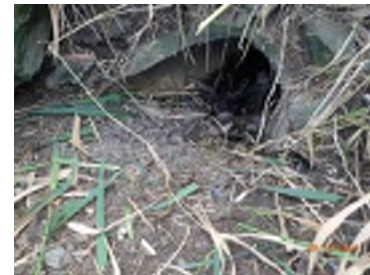
o20240919093516.JPG

☐ Petrol. Sheen ☐ Suds ☐ Sewage ☐ Algae ☐ Other
☐ Petroleum ☐ Musty ☐ Sewage ☐ Chlorine ☐ Other
☐ VOC/Solvent ☐ Fishy ☐ Sulfur ☐ Fragrant☒ Litter ☐ Veg. Debris ☐ Sediment ☐ Other☐ Inhibited ☐ Excessive☐ Green ☒ Brown☐ Flow Line ☐ Oil ☐ Rust Stains☐ Paint ☐ Other☐ Natural Sheen ☐ Natural Suds/Foam

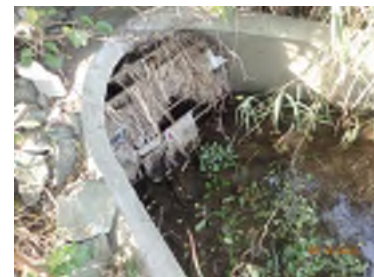
o20240919092924.JPG

Stains: Moderate

☒ Flow Line ☐ Oil ☐ Rust Stains

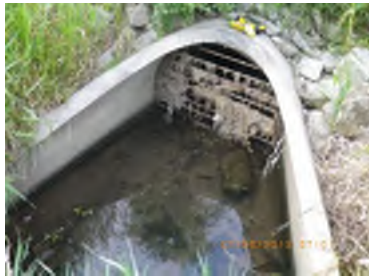
| | | Notes Outfall partially submerged. Outfall screened upstream at 13-2613 US1. | | |

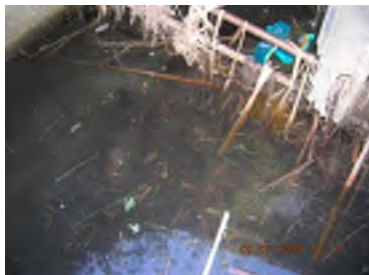
| | | Notes Thick layer of grass clippings in pipe and pool. | | |
| | | Condition Assessment Graffiti: None Erosion: None Deposition: None 0 in. Damage: None | | |

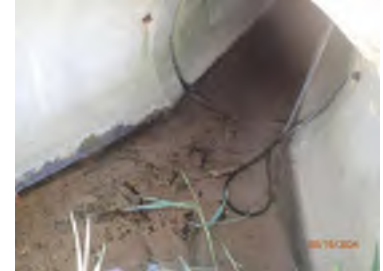
o20240919122812.JPG

Stains: Moderate

☐ Petrol. Sheen ☐ Suds ☐ Sewage ☐ Algae ☐ Other☐ Petroleum ☐ Musty ☐ Sewage ☐ Chlorine ☐ Other☐ VOC/Solvent ☐ Fishy ☐ Sulfur ☐ Fragrant☐ Litter ☐ Veg. Debris ☐ Sediment ☐ Other☐ Inhibited ☐ Excessive☒ Green ☐ Brown☒ Flow Line ☐ Oil ☐ Rust Stains☐ Paint ☐ Other☐ Natural Sheen ☐ Natural Suds/Foam

Damage: Minor ☒ Displacement ☐ Undercut ☐ Crushed☐ Corrosion ☐ Cracks/Structural Damage

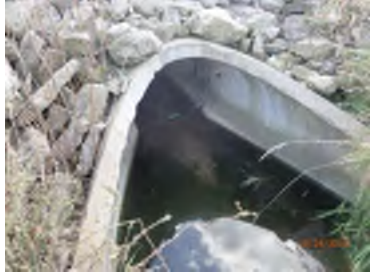
| Submerged: Partially Depth (in): 7 | | | | |
| Sampling Results Sample Location: Total Chlorine: -- ppm Free Chlorine: -- ppm Ammonia: -- ppm pH: -- units Temperature -- °F Conductivity: -- µS/cm Detergents: -- mg/L | | Floatables: None Odor: None Turbidity: None Color: None Gross Solids: None Vegetation: None Benthic Growth: Severe Stains: Slight Non-illicit: None | Notes Outfall partially submerged - screened upstream at 13-2872a US1. 3" joint displacement. | o20181024130804.JPG <div style="text-align: center; font-size: 24pt; font-weight: bold;">2018</div> |
| | | Condition Assessment Graffiti: None Erosion: None Deposition: None in. Damage: Minor | | |

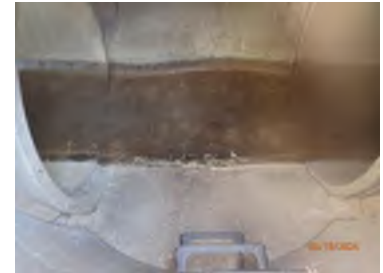
o20240919123118.JPG

Stains: Slight

☐ Petrol. Sheen ☐ Suds ☐ Sewage ☐ Algae ☐ Other☐ Petroleum ☐ Musty ☐ Sewage ☐ Chlorine ☐ Other☐ VOC/Solvent ☐ Fishy ☐ Sulfur ☐ Fragrant☐ Litter ☐ Veg. Debris ☐ Sediment ☐ Other☐ Inhibited ☐ Excessive☐ Green ☐ Brown☒ Flow Line ☐ Oil ☐ Rust Stains☐ Paint ☐ Other☐ Natural Sheen ☐ Natural Suds/Foam

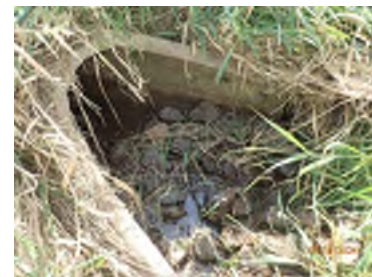
o20240919132540.JPG

Stains: Moderate

☐ Petrol. Sheen ☐ Suds ☐ Sewage ☐ Algae ☐ Other
☐ Petroleum ☐ Musty ☐ Sewage ☐ Chlorine ☐ Other
☐ VOC/Solvent ☐ Fishy ☐ Sulfur ☐ Fragrant☐ Litter ☐ Veg. Debris ☐ Sediment ☐ Other☐ Inhibited ☐ Excessive☒ Green ☒ Brown☒ Flow Line ☐ Oil ☐ Rust Stains☐ Paint ☐ Other☐ Natural Sheen ☐ Natural Suds/Foam

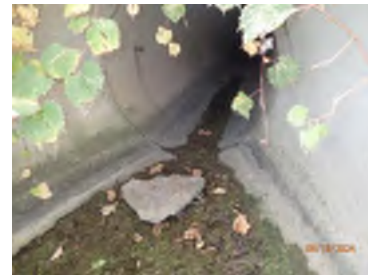
o20240919130550.JPG

Stains: Severe

☐ Displacement ☐ Undercut ☐ Crushed
☐ Corrosion ☐ Cracks/Structural Damage☐ Petrol. Sheen ☐ Suds ☐ Sewage ☒ Algae ☐ Other
☐ Petroleum ☐ Musty ☐ Sewage ☐ Chlorine ☐ Other
☐ VOC/Solvent ☐ Fishy ☐ Sulfur ☐ Fragrant☐ Litter ☐ Veg. Debris ☐ Sediment ☐ Other☐ Inhibited ☐ Excessive☒ Green ☐ Brown☒ Flow Line ☐ Oil ☐ Rust Stains☐ Paint ☐ Other☐ Natural Sheen ☐ Natural Suds/Foam

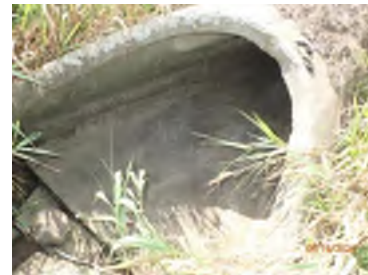
o20240919131756.JPG

Stains: Moderate

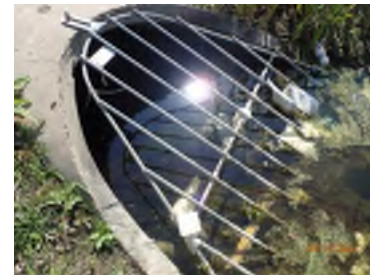
o20240919120030.JPG

Stains: Moderate

☐ Petrol. Sheen ☐ Suds ☐ Sewage ☐ Algae ☐ Other
☐ Petroleum ☐ Musty ☐ Sewage ☐ Chlorine ☐ Other
☐ VOC/Solvent ☐ Fishy ☐ Sulfur ☐ Fragrant☒ Litter ☐ Veg. Debris ☐ Sediment ☐ Other☐ Inhibited ☐ Excessive☒ Green ☐ Brown☒ Flow Line ☐ Oil ☐ Rust Stains☐ Paint ☐ Other☐ Natural Sheen ☐ Natural Suds/Foam

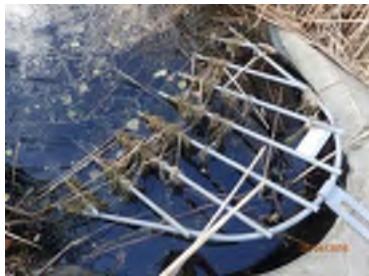
| | | Notes Outfall partially submerged - outfall screened upstream at 13-3488 US1. | | |

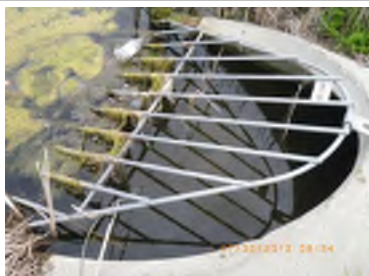
| | | Notes Outfall partially submerged. Outfall screened upstream at 13-3488 US1. | | |

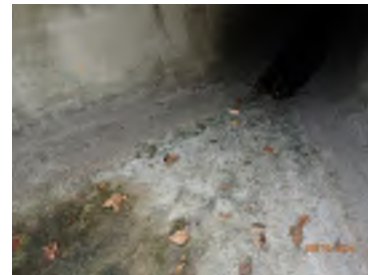
o20240919140258.JPG

Stains: Slight

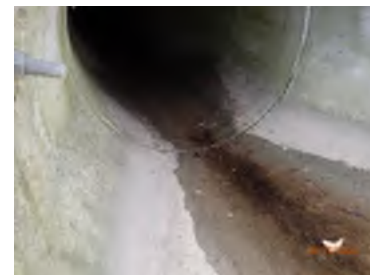
o20240919140006.JPG

Stains: Moderate

☐ Petrol. Sheen ☐ Suds ☐ Sewage ☐ Algae ☐ Other
☐ Petroleum ☐ Musty ☐ Sewage ☐ Chlorine ☐ Other
☐ VOC/Solvent ☐ Fishy ☐ Sulfur ☐ Fragrant☐ Litter ☐ Veg. Debris ☐ Sediment ☐ Other☐ Inhibited ☐ Excessive☒ Green ☐ Brown☒ Flow Line ☐ Oil ☐ Rust Stains☐ Paint ☐ Other☐ Natural Sheen ☐ Natural Suds/Foam

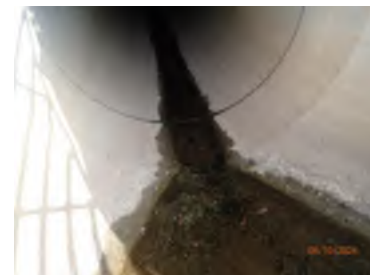
o20240910090934.JPG

Damage: Minor

☒ Displacement ☐ Undercut ☐ Crushed
☐ Corrosion ☐ Cracks/Structural Damage☐ Petrol. Sheen ☐ Suds ☐ Sewage ☐ Algae ☐ Other
☐ Petroleum ☐ Musty ☐ Sewage ☐ Chlorine ☐ Other
☐ VOC/Solvent ☐ Fishy ☐ Sulfur ☐ Fragrant☐ Litter ☐ Veg. Debris ☐ Sediment ☐ Other☐ Inhibited ☐ Excessive☒ Green ☒ Brown☒ Flow Line ☐ Oil ☐ Rust Stains☐ Paint ☐ Other☐ Natural Sheen ☐ Natural Suds/Foam

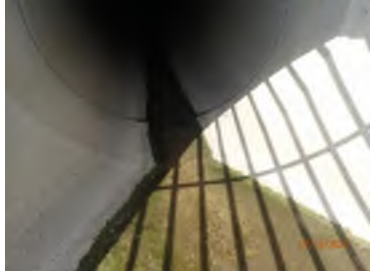
| Sampling Results Sample Location: Flow Total Chlorine: 0 ppm Free Chlorine: 0 ppm Ammonia: 0 ppm pH: 7.75 units Temperature: 78 °F Conductivity: 1013 µS/cm Detergents: 0 mg/L | | Floatables: Moderate Odor: None Turbidity: None Color: None Gross Solids: None Vegetation: None Benthic Growth: Moderate Stains: Slight Non-illicit: None | Notes Sample collected from pipe flow. 2" joint displacement. | o20230719131124.JPG <div style="text-align: center; font-size: 24pt; font-weight: bold;">2023</div> |
| | | | Condition Assessment Graffiti: None Erosion: None Deposition: None in. Damage: Minor | |

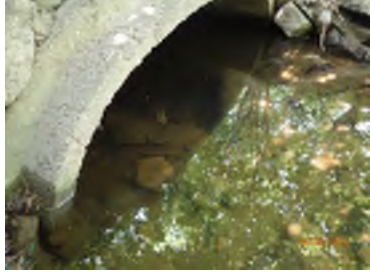
| Sampling Results Sample Location: _____ Total Chlorine: -- ppm Free Chlorine: -- ppm Ammonia: -- ppm pH: -- units Temperature: -- °F Conductivity: -- µS/cm Detergents: -- mg/L | | Floatables: None Odor: None Turbidity: None Color: None Gross Solids: None Vegetation: None Benthic Growth: None Stains: None Non-illicit: None | Notes Outfall fully submerged and not located - screened upstream at 02-357 US1. Floating gross solids (litter) in upstream manhole. Condition Assessment Graffiti: None Erosion: None Deposition: None in. Damage: None | |

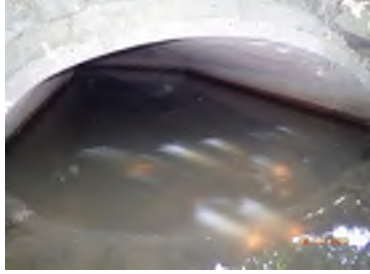
| Submerged: Fully | | Depth (in): | | |

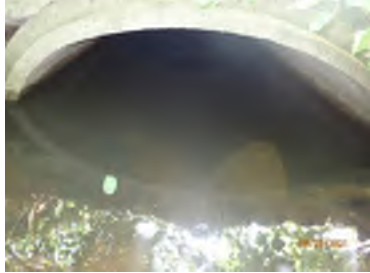
| Free Chlorine: -- ppm | Turbidity: | | | |

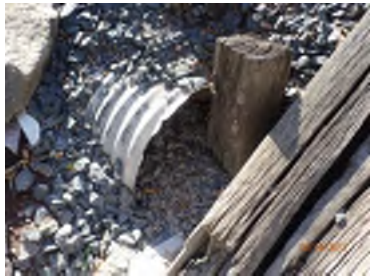
| Illicit Discharge Potential: Unlikely | | Inspector: JCW | Notes Dry railroad ballast inside pipe. No flow observed at time of inspection. | |

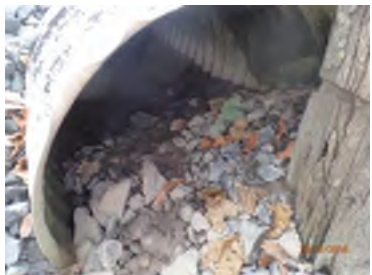
| Illicit Discharge Potential: Unlikely | | Inspector: JCW | Notes Corrugations wet, but no flow. 10" of stone in end of pipe. RR ties obstructing end. | |

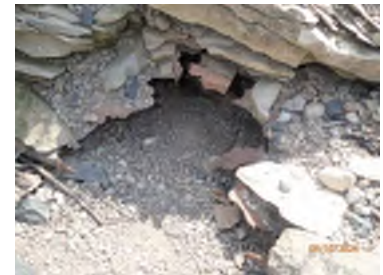
o20240910122840.JPG

Notes: Pipe dry at time of inspection. 18" of gravel in pipe, corrosion at end.

Damage: Moderate ☐ Displacement ☐ Undercut ☐ Crushed☒ Corrosion ☐ Cracks/Structural Damage

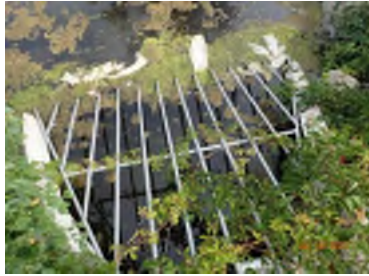
| Inspection Date: 7/19/2023 10:40:45 AM | | Type: Ongoing | Flow: Submerged, indeterminate | Previous Rainfall (hrs): 72+ |
|--|--|---|---|---|
| Illicit Discharge Potential: Unlikely Submerged: Partially Depth (in): 16 | | Inspector: EJK | Notes | Sample collected from submerged flow at end of pipe. Low pH reading due to probe malfunction. Retested 7.3. Condition Assessment Graffiti: None Erosion: None Deposition: None in. Damage: None |

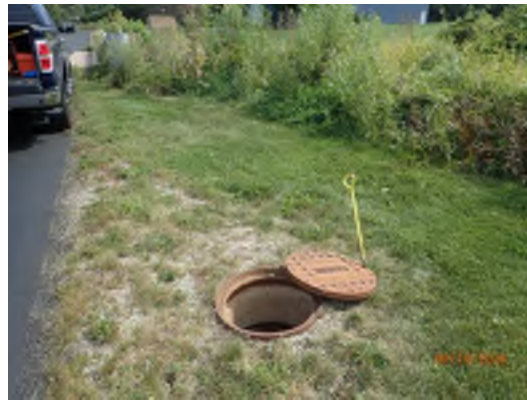
<table><tr> <td colspan="2">Sampling Results</td> <td>Floatables:</td> <td>None</td> </tr><tr> <td>Ammonia:</td> <td>0 ppm</td> <td>Gross Solids:</td> <td>None</td> </tr></table>

Upstream manhole located approx 27 ft WNW of outfall 14-2032 (formerly 14-582). Intermediate area consists of street right-of-way. Reconstructed 2020. Formerly 14-582 US1.

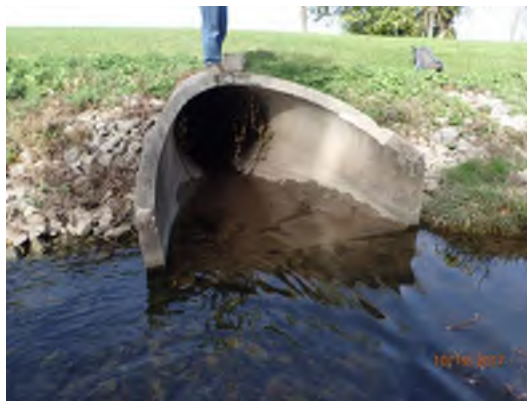
o20171019120112.JPG

Hughes St storm sewer discharges to stream from west. Inside Oshkosh Defense testing facility security fence.

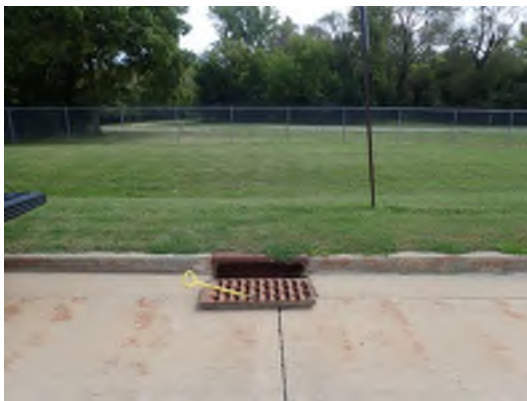
o20240910125326.JPG

Upstream curb inlet located approx 139 ft NW of outfall 14-996. Intermediate area consists of open space and wooded area.

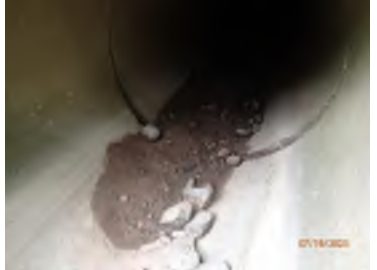
| Inspection Date: 7/19/2023 11:12:45 AM | | Type: Ongoing | Flow: None | Previous Rainfall (hrs): 72+ |
|--|--|---|---|---|
| Sampling Results Sample Location: Floatables: None Total Chlorine: -- ppm Odor: None Free Chlorine: -- ppm Turbidity: None Ammonia: -- ppm Color: None pH: -- units Gross Solids: None Temperature -- °F Vegetation: None Conductivity: -- µS/cm Benthic Growth: Slight Detergents: -- mg/L Stains: Moderate Non-illicit: None | | Condition Assessment | Graffiti: None Erosion: None Deposition: Minor 1 in. Damage: Minor | |

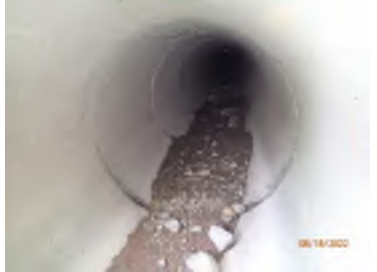
| Inspection Date: 7/19/2023 11:12:45 AM | | Type: Ongoing | Flow: None | Previous Rainfall (hrs): 72+ |
|--|--|---|---|---|
| Sampling Results Sample Location: Floatables: None Total Chlorine: -- ppm Odor: None Free Chlorine: -- ppm Turbidity: None Ammonia: -- ppm Color: None pH: -- units Gross Solids: None Temperature -- °F Vegetation: None Conductivity: -- µS/cm Benthic Growth: None Detergents: -- mg/L Stains: Slight Non-illicit: None | | Condition Assessment | Graffiti: None Erosion: None Deposition: Minor 3 in. Damage: Minor | |

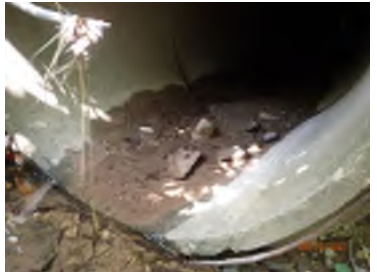
| Inspection Date: 7/19/2023 11:12:45 AM | | Type: Ongoing | Flow: None | Previous Rainfall (hrs): 72+ |
|--|--|---|---|---|
| Sampling Results Sample Location: Floatables: None Total Chlorine: -- ppm Odor: None Free Chlorine: -- ppm Turbidity: None Ammonia: -- ppm Color: None pH: -- units Gross Solids: None Temperature -- °F Vegetation: None Conductivity: -- µS/cm Benthic Growth: Slight Detergents: -- mg/L Stains: None Non-illicit: None | | Condition Assessment | Graffiti: None Erosion: None Deposition: Minor 1 in. Damage: Minor | |

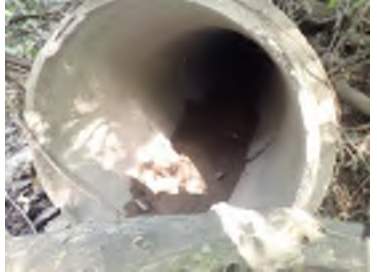
| Inspection Date: 7/19/2023 11:12:45 AM | | Type: Ongoing | Flow: None | Previous Rainfall (hrs): 72+ |
|--|--|---|---|---|
| Sampling Results Sample Location: Floatables: None Total Chlorine: -- ppm Odor: None Free Chlorine: -- ppm Turbidity: None Ammonia: -- ppm Color: None pH: -- units Gross Solids: None Temperature -- °F Vegetation: None Conductivity: -- µS/cm Benthic Growth: None Detergents: -- mg/L Stains: None Non-illicit: None | | Condition Assessment | Graffiti: None Erosion: None Deposition: Minor 4 in. Damage: Minor | |

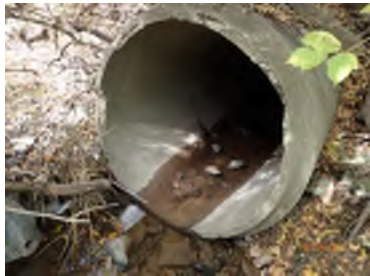
| Submerged: Partially Depth (in): 2 | | | Upstream manhole dry - sample collected from submerged pool at end of pipe. 3" joint displacement and damaged concrete. | | | | | | | | | | | | | | | | | | | | | | | | | | | | | | | | | | | | | | | | | | | | |
| Damage: | Moderate | | | | | | | | | | | | | | | | | | | | | | | | | | | | | | | | | | | | | | | | | | | | | | |

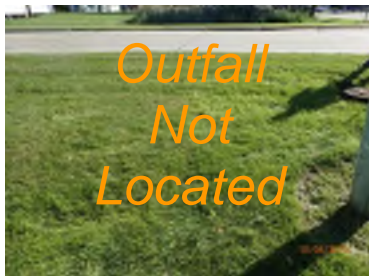
| | | Notes Outfall not located. Outfall screened upstream at 15-1032 US1. | | |

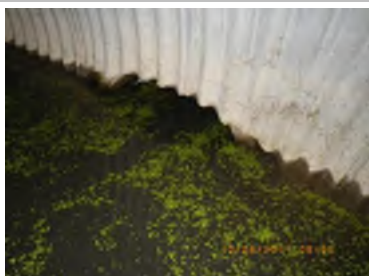
| | | Notes Outfall partially submerged. Outfall screened upstream at 15-1032 US1. | | |

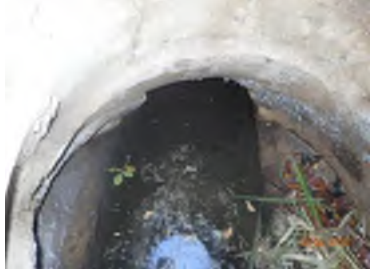
| Sampling Results Sample Location: Pool Total Chlorine: 0 ppm Free Chlorine: 0 ppm Ammonia: 0 ppm pH: 7.71 units Temperature: 61 °F Conductivity: 1068 µS/cm Detergents: 0 mg/L | | Floatables: None Odor: None Turbidity: None Color: None Gross Solids: Slight Vegetation: None Benthic Growth: None Stains: None Non-illicit: None | | |
| | | Notes: Sample collected from submerged pool in manhole. Condition Assessment: Graffiti: None Erosion: None Deposition: None in. Damage: None | | |

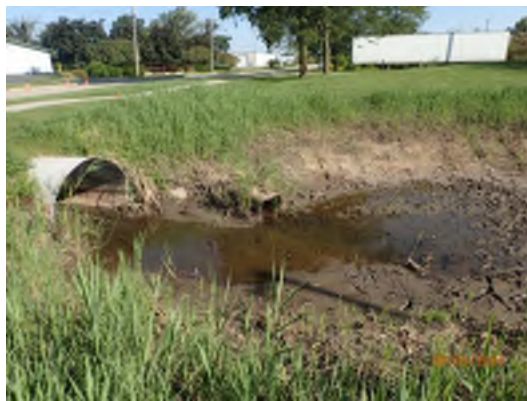
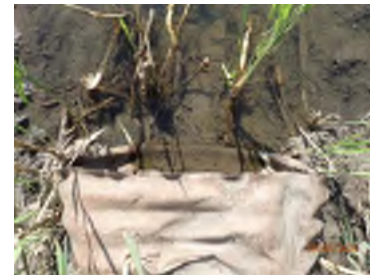
Notes: Corrosion on end 48" top and sides, with crushing. Sample collected from submerged flow inside pipe.

Damage: Moderate ☐ Displacement ☐ Undercut ☒ Crushed☒ Corrosion ☐ Cracks/Structural Damage

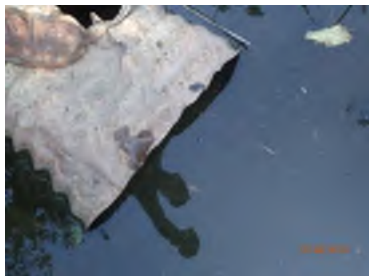
| | | Notes Outfall partially submerged. Outfall screened upstream at 15-1067 US1. Damaged metal pipe with holes. | | |
| | | Condition Assessment Graffiti: None Erosion: None Deposition: None in. Damage: Moderate | | |

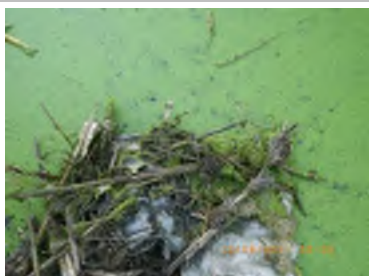
| | | Notes Outfall partially submerged. Outfall screened upstream at 15-1067 US1. | | |
| | | Condition Assessment Graffiti: None Erosion: None Deposition: Severe 16 in. Damage: Moderate | | |

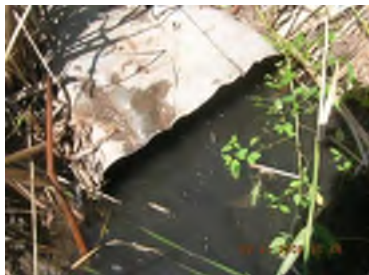
| | | Notes Crushed pipe. | | |
| | | Condition Assessment Graffiti: None Erosion: None Deposition: 5 in. Damage: Minor | | |

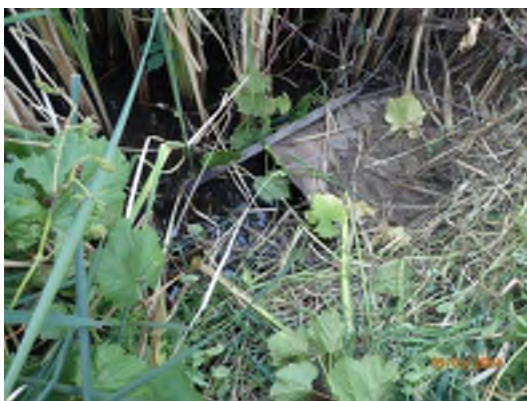
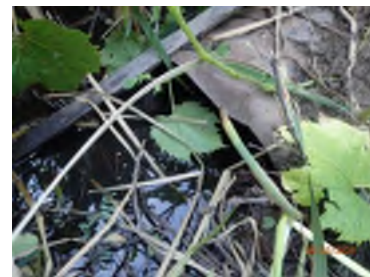
Damage: Minor

☐ Displacement ☐ Undercut ☒ Crushed
☐ Corrosion ☐ Cracks/Structural Damage☐ Petrol. Sheen ☐ Suds ☐ Sewage ☐ Algae ☐ Other
☐ Petroleum ☐ Musty ☐ Sewage ☐ Chlorine ☐ Other
☐ VOC/Solvent ☐ Fishy ☐ Sulfur ☐ Fragrant☐ Litter ☐ Veg. Debris ☐ Sediment ☐ Other☐ Inhibited ☐ Excessive☒ Green ☐ Brown☐ Flow Line ☐ Oil ☐ Rust Stains☐ Paint ☐ Other☐ Natural Sheen ☐ Natural Suds/Foam

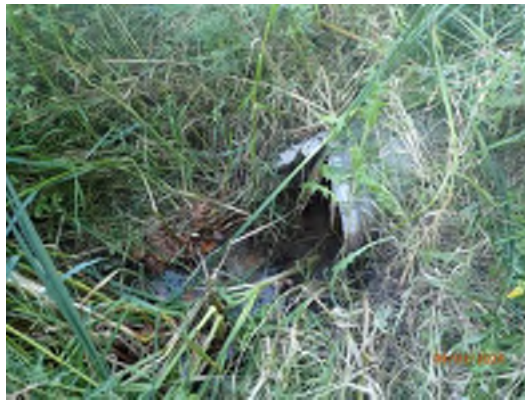
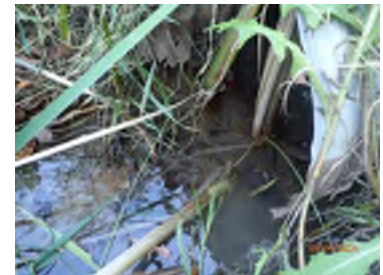
Notes: End 12" of invert missing due to corrosion. Sample collected from submerged flow inside pipe.

Damage: Moderate ☐ Displacement ☐ Undercut ☒ Crushed☒ Corrosion ☐ Cracks/Structural Damage

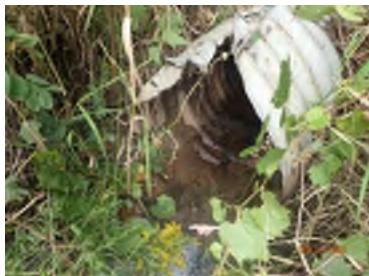
| Submerged: Partially Depth (in): 1 | | | Sample collected from submerged flow in pipe. Metal pipe slightly crushed and damaged. | |
| Sampling Results Sample Location: Flow Total Chlorine: 0 ppm Free Chlorine: 0 ppm Ammonia: 0 ppm pH: 7.16 units Temperature: 76 °F Conductivity: 936 µS/cm Detergents: 0 mg/L | | Floatables: None Odor: None Turbidity: None Color: None Gross Solids: None Vegetation: None Benthic Growth: None Stains: None Non-illicit: Slight | Condition Assessment Graffiti: None Erosion: None Deposition: None in. Damage: Moderate | |

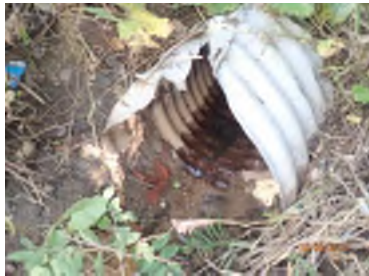
| Sampling Results Sample Location: Flow Total Chlorine: 0 ppm Free Chlorine: 0 ppm Ammonia: 0 ppm pH: 7.4 units Temperature: 62 °F Conductivity: 698 µS/cm Detergents: 0 mg/L | | Floatables: None Odor: None Turbidity: None Color: None Gross Solids: None Vegetation: None Benthic Growth: None Stains: None Non-illicit: None | Condition Assessment Graffiti: None Erosion: None Deposition: None in. Damage: Moderate | |

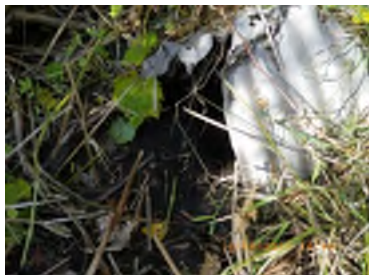
| Sampling Results Sample Location: Total Chlorine: -- ppm Free Chlorine: -- ppm Ammonia: -- ppm pH: -- units Temperature: -- °F Conductivity: -- µS/cm Detergents: -- mg/L | | Floatables: None Odor: None Turbidity: None Color: None Gross Solids: None Vegetation: None Benthic Growth: Slight Stains: Slight Non-illicit: None | Condition Assessment Graffiti: None Erosion: None Deposition: Moderate 7 in. Damage: Minor | |

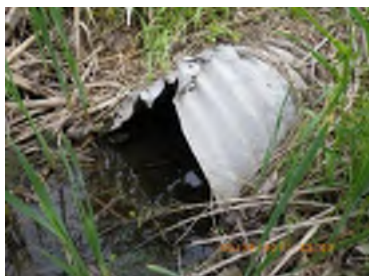
| Sampling Results Sample Location: Total Chlorine: -- ppm Free Chlorine: -- ppm Ammonia: -- ppm pH: -- units Temperature: -- °F Conductivity: -- µS/cm Detergents: -- mg/L | | Floatables: Odor: Turbidity: Color: Gross Solids: Vegetation: Benthic Growth: Stains: Non-illicit: None | Condition Assessment Graffiti: None Erosion: None Deposition: None 0 in. Damage: Moderate | |

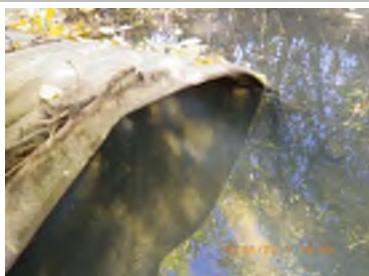
| Sampling Results Sample Location: Total Chlorine: -- ppm Free Chlorine: -- ppm Ammonia: -- ppm pH: -- units Temperature -- ° F Conductivity: -- µS/cm Detergents: -- mg/L | | Floatables: None Odor: None Turbidity: None Color: None Gross Solids: None Vegetation: None Benthic Growth: Slight Stains: Slight Non-illicit: None | Notes Outfall partially submerged. Outfall screened upstream at 15-1248 US1. | o20111005150508.JPG |
| | | Condition Assessment Graffiti: None Erosion: None Deposition: Moderate 11 in. Damage: Minor | | 2011 |

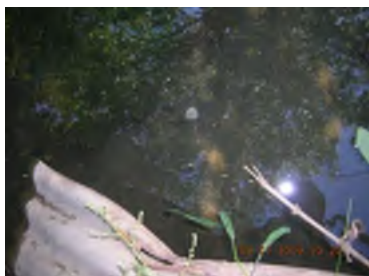
| Sampling Results Sample Location: Total Chlorine: -- ppm Free Chlorine: -- ppm Ammonia: -- ppm pH: -- units Temperature -- ° F Conductivity: -- µS/cm Detergents: -- mg/L | | Floatables: None Odor: None Turbidity: None Color: None Gross Solids: None Vegetation: Benthic Growth: Slight Stains: Non-illicit: None | Notes | Osh09_DSCN6341.JPG |
| | | Condition Assessment Graffiti: None Erosion: None Deposition: 8 in. Damage: None | | 2009 |

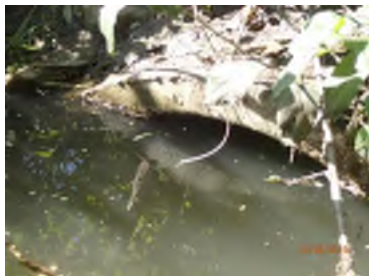
| Sampling Results Sample Location: Total Chlorine: -- ppm Free Chlorine: -- ppm Ammonia: -- ppm pH: -- units Temperature -- ° F Conductivity: -- µS/cm Detergents: -- mg/L | | Floatables: None Odor: None Turbidity: None Color: None Gross Solids: None Vegetation: None Benthic Growth: Moderate Stains: None Non-illicit: None | Notes Outfall partially submerged. Outfall screened upstream at 15-1263 US1. | o20191008102502.JPG <div style="text-align: center; font-size: 24pt; font-weight: bold;">2019</div> |

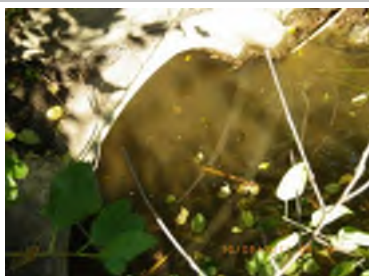
| Sampling Results Sample Location: Total Chlorine: -- ppm Free Chlorine: -- ppm Ammonia: -- ppm pH: -- units Temperature -- ° F Conductivity: -- µS/cm Detergents: -- mg/L | | Floatables: None Odor: None Turbidity: None Color: None Gross Solids: None Vegetation: None Benthic Growth: Slight Stains: Slight Non-illicit: None | Notes Outfall partially submerged. Outfall screened upstream at 15-1263 US1. | o20111006091914.JPG <div style="text-align: center; font-size: 24pt; font-weight: bold;">2011</div> |
| | | | Condition Assessment Graffiti: None Erosion: None Deposition: Moderate 16 in. Damage: None | |

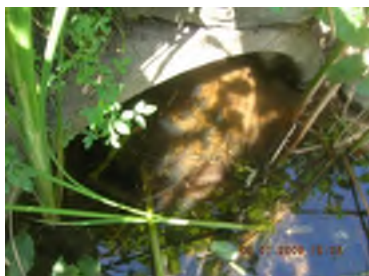
| Sampling Results Sample Location: Total Chlorine: -- ppm Free Chlorine: -- ppm Ammonia: -- ppm pH: -- units Temperature -- ° F Conductivity: -- µS/cm Detergents: -- mg/L | | Floatables: Odor: Turbidity: Color: Gross Solids: Vegetation: Benthic Growth: Slight Stains: Non-illicit: None | Notes | Osh09_DSCN6332.JPG <div style="text-align: center; font-size: 24pt; font-weight: bold;">2009</div> |
| | | | Condition Assessment Graffiti: None Erosion: None Deposition: 10 in. Damage: None | |

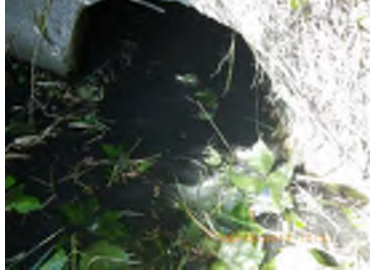
| Illicit Discharge Potential: Unlikely | | Inspector: JCW | | Notes | | <p>Outfall partially submerged. Outfall screened upstream at 15-1856 US1.</p> | |
| Submerged: Partially | | Depth (in): 7 | | | | | |

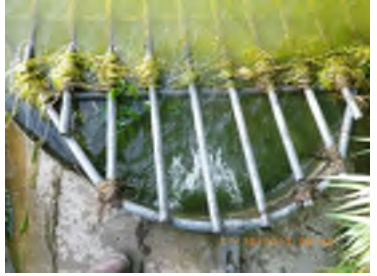
| Illicit Discharge Potential: Unlikely | | Inspector: JCW | | Notes Outfall partially submerged. Outfall screened upstream at 15-2477 US2. | | o20130716074040.JPG | |
| Sampling Results Sample Location: _____ Total Chlorine: -- ppm Free Chlorine: -- ppm Ammonia: -- ppm pH: -- units Temperature: -- °F Conductivity: -- µS/cm Detergents: -- mg/L | | Floatables: None Odor: None Turbidity: None Color: None Gross Solids: None Vegetation: None Benthic Growth: Moderate Stains: None Non-illicit: None | | Condition Assessment Graffiti: None Erosion: None Deposition: Moderate 9 in. Damage: None | | | |

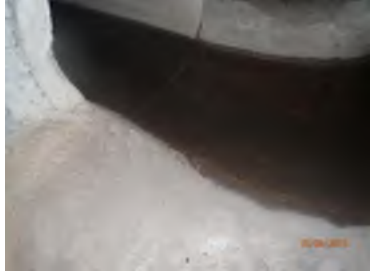
| Illicit Discharge Potential: Unlikely | | Inspector: JCW | | Notes | | <p>Sample collected from submerged pool in manhole.</p> | |

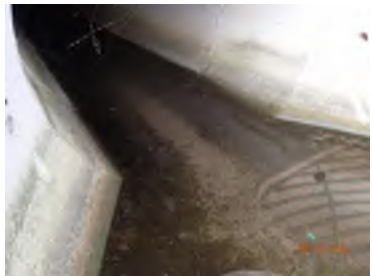
| Sampling Results Sample Location: Total Chlorine: -- ppm Free Chlorine: -- ppm Ammonia: -- ppm pH: -- units Temperature: -- °F Conductivity: -- µS/cm Detergents: -- mg/L | | Floatables: None Odor: None Turbidity: None Color: None Gross Solids: None Vegetation: None Benthic Growth: Moderate Stains: Moderate Non-illicit: None | | |
| | | Notes Outfall partially submerged - screened upstream at 15-3211 US1. | | |

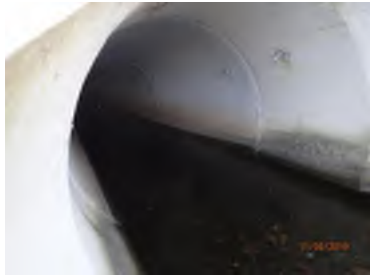
| Illicit Discharge Potential: Potential | | Inspector: JCW | | |
| Sampling Results Sample Location: Total Chlorine: -- ppm Free Chlorine: -- ppm Ammonia: -- ppm pH: -- units Temperature: -- °F Conductivity: -- µS/cm Detergents: -- mg/L | | Floatables: None Odor: None Turbidity: None Color: None Gross Solids: None Vegetation: None Benthic Growth: Moderate Stains: Slight Non-illicit: None | | |
| | | Notes Outfall partially submerged - screened upstream at 15-3211 US1. Detergent detected in upstream manhole. | | |

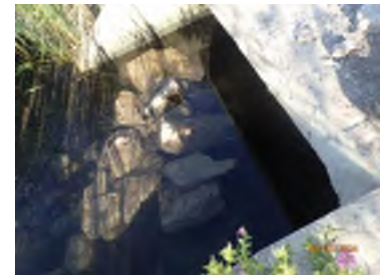
o20240903082230.JPG

Stains: Severe

☐ Petrol. Sheen ☐ Suds ☐ Sewage ☐ Algae ☐ Other☐ Petroleum ☐ Musty ☐ Sewage ☐ Chlorine ☐ Other☐ VOC/Solvent ☐ Fishy ☐ Sulfur ☐ Fragrant☐ Litter ☐ Veg. Debris ☐ Sediment ☐ Other☐ Inhibited ☐ Excessive☒ Green ☐ Brown☒ Flow Line ☐ Oil ☐ Rust Stains☐ Paint ☐ Other☒ Natural Sheen ☐ Natural Suds/Foam

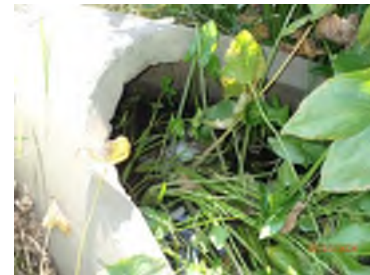
o20240903145732.JPG

Stains: Moderate

☐ Petrol. Sheen ☐ Suds ☐ Sewage ☐ Algae ☐ Other☐ Petroleum ☐ Musty ☐ Sewage ☐ Chlorine ☐ Other☐ VOC/Solvent ☐ Fishy ☐ Sulfur ☐ Fragrant☐ Litter ☐ Veg. Debris ☐ Sediment ☐ Other☐ Inhibited ☐ Excessive☒ Green ☐ Brown☒ Flow Line ☐ Oil ☐ Rust Stains☐ Paint ☐ Other☐ Natural Sheen ☐ Natural Suds/Foam

Damage: None

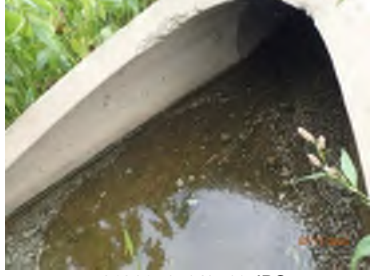
| | | | o20230717143516.JPG <div style="text-align: center; font-size: 24pt; font-weight: bold;">2023</div> | |

| Sampling Results Sample Location: --- Total Chlorine: -- ppm Free Chlorine: -- ppm Ammonia: -- ppm pH: -- units Temperature: -- °F Conductivity: -- µS/cm Detergents: -- mg/L | | Floatables: Slight Odor: None Turbidity: None Color: None Gross Solids: None Vegetation: None Benthic Growth: Slight Stains: Slight Non-illicit: None | | |
| | | Notes Outfall partially submerged - screened upstream at 15-3373 US1. Detergent detected in upstream manhole. | | |
| | | Condition Assessment Graffiti: None Erosion: None Deposition: None in. Damage: None | | |

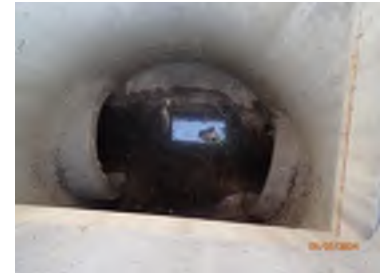
o20240903150120.JPG

Submerged: Partially Depth (in): 2

Stains: None

Damage: None ☐ Displacement ☐ Undercut ☐ Crushed☐ Corrosion ☐ Cracks/Structural Damage

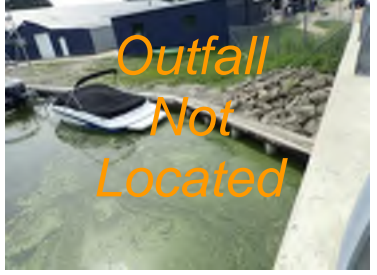
| Inspection Date: 8/9/2023 10:46:36 AM | | Type: Ongoing | Flow: Submerged (not located) | Previous Rainfall (hrs): 72+ |
|--|--|---|---|---|
| Illicit Discharge Potential: Potential Submerged: Fully Depth (in): | | Inspector: JCW | Notes | o20230809093408.JPG 2023 |
| Sampling Results Sample Location: Floatables: None Total Chlorine: -- ppm Odor: None Free Chlorine: -- ppm Turbidity: None Ammonia: -- ppm Color: None pH: -- units Gross Solids: None Temperature -- °F Vegetation: None Conductivity: -- µS/cm Benthic Growth: None Detergents: -- mg/L Stains: None Non-illicit: None | | | Condition Assessment Graffiti: None Erosion: None Deposition: None in. Damage: None | |

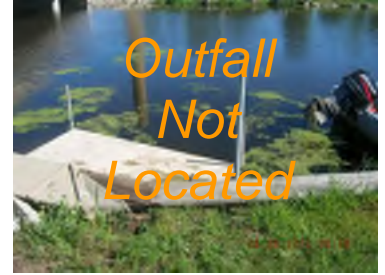
o20100826094912.JPG

| Sampling Results Sample Location: Total Chlorine: -- ppm Free Chlorine: -- ppm Ammonia: -- ppm pH: -- units Temperature: -- °F Conductivity: -- µS/cm Detergents: -- mg/L | | Floatables: None Odor: None Turbidity: None Color: None Gross Solids: None Vegetation: None Benthic Growth: None Stains: None Non-illicit: None | | |
| | | Notes Outfall fully submerged and not physically located. Outfall screened upstream at 16-533 US1. | | |
| | | Condition Assessment Graffiti: None Erosion: None Deposition: None 0 in. Damage: None | | |

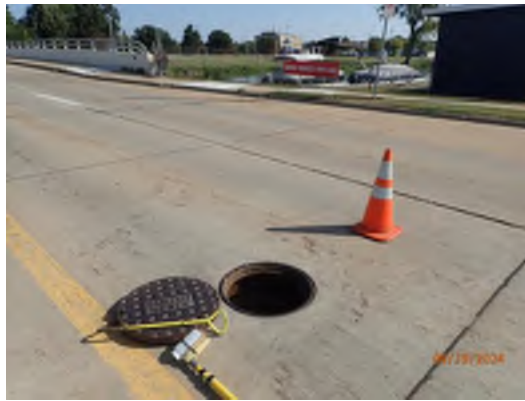
o20240919101508.JPG

Upstream manhole located approx 75 ft NE of outfall 16-1178 (formerly 16-533). Intermediate area consists of street right-of-way and commercial property.

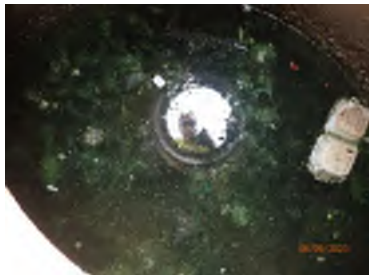
| Inspection Date: 8/9/2023 10:47:22 AM | | Type: Ongoing | Flow: Submerged, indeterminate | Previous Rainfall (hrs): 72+ |
|--|--|---|---|---|
| Illicit Discharge Potential: Potential Submerged: Fully Depth (in): 37 | | Inspector: JCW | Notes | o20230809094116.JPG 2023 |
| Sampling Results Sample Location: Pool Total Chlorine: 0 ppm Free Chlorine: 0 ppm Ammonia: 0.5 ppm pH: 7.72 units Temperature: 80 °F Conductivity: 456 µS/cm Detergents: 0 mg/L | | Floatables: None Odor: None Turbidity: None Color: None Gross Solids: Moderate Vegetation: None Benthic Growth: None Stains: None Non-illicit: None | Sample collected from submerged pool in manhole. Floating gross solids (litter) and trace ammonia in manhole. Condition Assessment Graffiti: None Erosion: None Deposition: None in. Damage: None | |

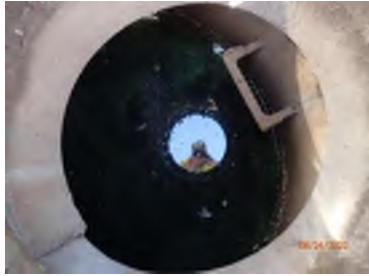
| Inspection Date: 8/9/2023 10:47:22 AM | | Type: Ongoing | Flow: Submerged, indeterminate | Previous Rainfall (hrs): 72+ |
|--|--|---|---|---|
| Illicit Discharge Potential: Unlikely Submerged: Fully Depth (in): | | Inspector: EJK | Notes | o20220824142446.JPG 2022 |
| Sampling Results Sample Location: Pool Total Chlorine: 0 ppm Free Chlorine: 0 ppm Ammonia: 0 ppm pH: 7.64 units Temperature: 81 °F Conductivity: 354 µS/cm Detergents: 0 mg/L | | Floatables: None Odor: None Turbidity: None Color: None Gross Solids: Slight Vegetation: None Benthic Growth: None Stains: None Non-illicit: None | Sample collected from submerged pool in manhole. Condition Assessment Graffiti: None Erosion: None Deposition: None in. Damage: None | |

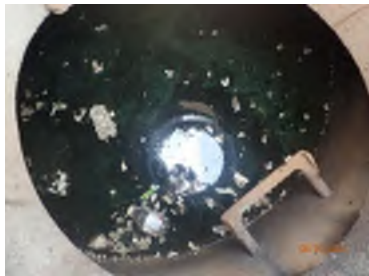
| Inspection Date: 8/9/2023 10:47:22 AM | | Type: Ongoing | Flow: Submerged, indeterminate | Previous Rainfall (hrs): 72+ |
|--|--|---|---|---|
| Illicit Discharge Potential: Potential Submerged: Fully Depth (in): 40 | | Inspector: JCW | Notes | o20210831111218.JPG 2021 |
| Sampling Results Sample Location: Pool Total Chlorine: 0 ppm Free Chlorine: 0 ppm Ammonia: 0 ppm pH: 7.29 units Temperature: 78 °F Conductivity: 389 µS/cm Detergents: 0 mg/L | | Floatables: None Odor: None Turbidity: None Color: None Gross Solids: Moderate Vegetation: None Benthic Growth: None Stains: None Non-illicit: None | Sample collected from submerged pool in manhole. Floating gross solids (litter) in manhole. Condition Assessment Graffiti: None Erosion: None Deposition: None in. Damage: None | |

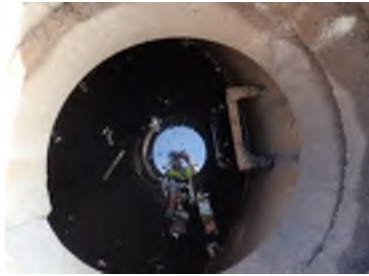
| Inspection Date: 8/9/2023 10:47:22 AM | | Type: Ongoing | Flow: Submerged, indeterminate | Previous Rainfall (hrs): 72+ |
|--|--|---|---|---|
| Illicit Discharge Potential: Potential Submerged: Fully Depth (in): 33 | | Inspector: QAL | Notes | o20200924100816.JPG 2020 |
| Sampling Results Sample Location: Pool Total Chlorine: 0 ppm Free Chlorine: 0 ppm Ammonia: 0 ppm pH: 8.8 units Temperature: 68 °F Conductivity: 433 µS/cm Detergents: 0 mg/L | | Floatables: None Odor: None Turbidity: None Color: None Gross Solids: Moderate Vegetation: None Benthic Growth: None Stains: None Non-illicit: None | Sample collected from submerged pool in manhole. Floating gross solids (litter) in manhole. Condition Assessment Graffiti: None Erosion: None Deposition: None in. Damage: None | |

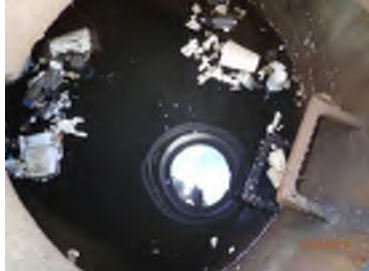
| | | <div style="display: flex; justify-content: space-between;"> <div style="width: 45%;"> <p>Notes</p> <p>Follow-up inspection for sampling - limited screening conducted.</p> </div> <div style="width: 45%;"> <p>Condition Assessment</p> <table border="1" style="width:100%; border-collapse: collapse;"> <tr><td>Graffiti:</td><td>None</td></tr> <tr><td>Erosion:</td><td>None</td></tr> <tr><td>Deposition:</td><td>None in.</td></tr> <tr><td>Damage:</td><td>None</td></tr> </table> </div> </div> | | | Graffiti: | None | Erosion: | None | Deposition: | None in. | Damage: | None | | | | | | | | | | | | | | | | | | | | | | | | | | |

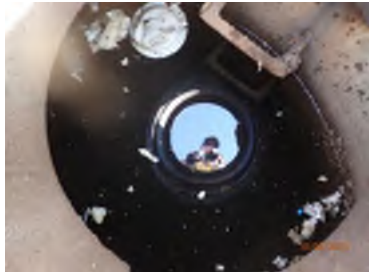
| | | <div style="display: flex; justify-content: space-between;"> <div style="width: 45%;"> <p>Notes</p> <p>Sample collected from submerged pool in manhole. Floating gross solids (litter) in manhole. Detergent detected in sample.</p> </div> <div style="width: 45%;"> <p>Condition Assessment</p> <table border="1" style="width:100%; border-collapse: collapse;"> <tr><td>Graffiti:</td><td>None</td></tr> <tr><td>Erosion:</td><td>None</td></tr> <tr><td>Deposition:</td><td>None in.</td></tr> <tr><td>Damage:</td><td>None</td></tr> </table> </div> </div> | | | Graffiti: | None | Erosion: | None | Deposition: | None in. | Damage: | None | | | | | | | | | | | | | | | | | | | | | | | | | | |

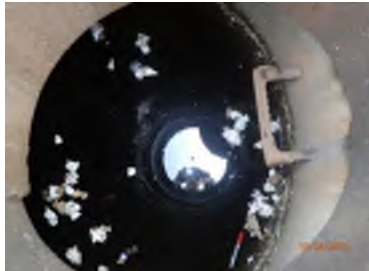
| | | <div style="display: flex; justify-content: space-between;"> <div style="width: 45%;"> <p>Notes</p> <p>Sample collected from submerged pool in manhole. Floating gross solids (litter) in manhole.</p> </div> <div style="width: 45%;"> <p>Condition Assessment</p> <table border="1" style="width:100%; border-collapse: collapse;"> <tr><td>Graffiti:</td><td>None</td></tr> <tr><td>Erosion:</td><td>None</td></tr> <tr><td>Deposition:</td><td>None in.</td></tr> <tr><td>Damage:</td><td>None</td></tr> </table> </div> </div> | | | Graffiti: | None | Erosion: | None | Deposition: | None in. | Damage: | None | | | | | | | | | | | | | | | | | | | | | | | | | | |

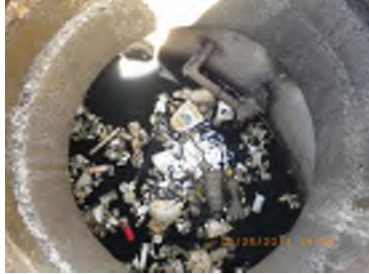
| Illicit Discharge Potential: Potential | | Inspector: JCW | Notes Limited screening conducted to check for floatable debris. | |
| Sampling Results Sample Location: _____ Total Chlorine: -- ppm Free Chlorine: -- ppm Ammonia: -- ppm pH: -- units Temperature: -- °F Conductivity: -- µS/cm Detergents: -- mg/L | | Floatables: None Odor: _____ Turbidity: _____ Color: _____ Gross Solids: Moderate Vegetation: _____ Benthic Growth: _____ Stains: _____ Non-illicit: None | | |

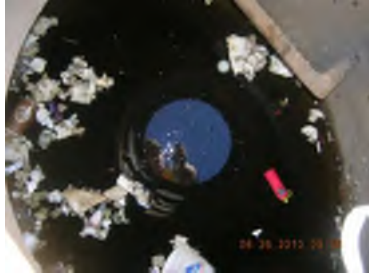
| Illicit Discharge Potential: Potential | | Inspector: JCW | Notes Floatable debris in manhole. | |
| Sampling Results Sample Location: Pool Total Chlorine: 0 ppm Free Chlorine: 0 ppm Ammonia: 0 ppm pH: 7.23 units Temperature: 76 °F Conductivity: -- µS/cm Detergents: 0 mg/L | | Floatables: None Odor: None Turbidity: None Color: Faint in bottle Gross Solids: Moderate Vegetation: None Benthic Growth: Slight Stains: None Non-illicit: None | | |

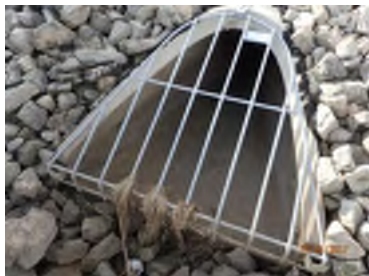
| | | Notes Pipe dry at time of inspection. | | |

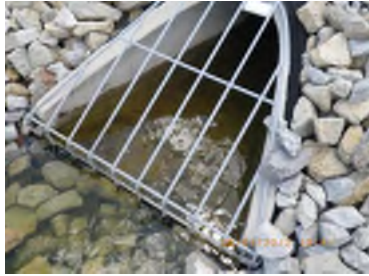
| | | Notes Outfall partially submerged. Sample not collected due to screening of upstream outfalls. | | |

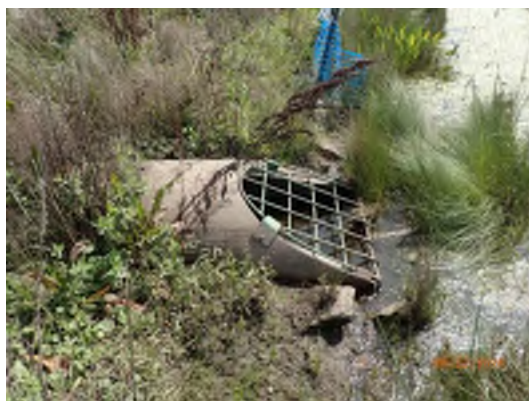
o20240822125452.JPG

Curb inlet from Washburn St discharges to northeast corner of detention basin.

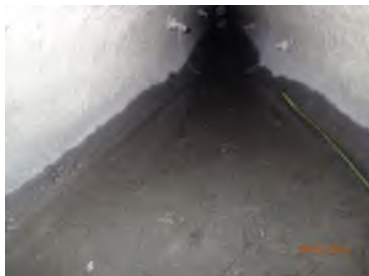
| Sampling Results Sample Location: Pool Total Chlorine: 0 ppm Free Chlorine: 0 ppm Ammonia: 0 ppm pH: 7.95 units Temperature: 74 °F Conductivity: 607 µS/cm Detergents: 0 mg/L | | Floatables: None Odor: None Turbidity: None Color: None Gross Solids: Slight Vegetation: None Benthic Growth: Severe Stains: None Non-illicit: None | Notes Outfall partially submerged. No water entering pipe in upstream curb inlet. Pond sample collected due to prior detergent detections. | o20230801084810.JPG <div style="text-align: center; font-size: 24pt; font-weight: bold;">2023</div> |
| | | Condition Assessment Graffiti: None Erosion: None Deposition: Minor 2 in. Damage: None | | |

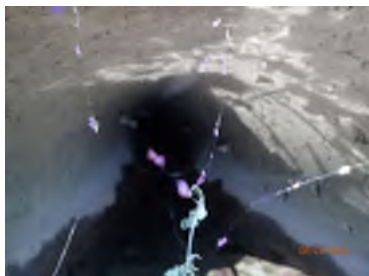
| Sampling Results Sample Location: Pool Total Chlorine: 0 ppm Free Chlorine: 0 ppm Ammonia: 0 ppm pH: 8.55 units Temperature: 82 °F Conductivity: 835 µS/cm Detergents: 2.5 mg/L | | Floatables: None Odor: Easily detected Turbidity: None Color: None Gross Solids: None Vegetation: None Benthic Growth: Severe Stains: Slight Non-illicit: Slight | Notes No flow escaping upstream curb inlet. Sample collected from outfall pool. Detergent in pond, possibly from car wash. | o20220823152424.JPG <div style="text-align: center; font-size: 24pt; font-weight: bold;">2022</div> |

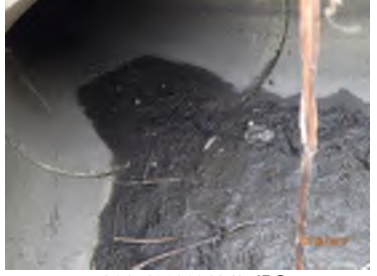
| | | Notes Wet sediment on apron; pipe dry 4 ft from end. No sample collected. | | |
| | | Condition Assessment Graffiti: None Erosion: None Deposition: Minor 1 in. Damage: None | | |

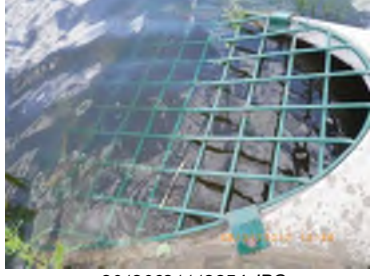
| | | Notes Outfall partially submerged; screened upstream at 16-1213 US1. | | |

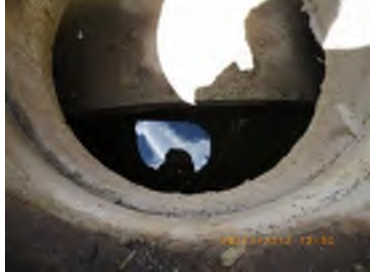
| Sampling Results Sample Location: Pool Total Chlorine: 0 ppm Free Chlorine: 0 ppm Ammonia: 0 ppm pH: 7.34 units Temperature: 66 °F Conductivity: 1227 µS/cm Detergents: 0 mg/L | | Floatables: None Odor: None Turbidity: None Color: None Gross Solids: None Vegetation: None Benthic Growth: None Stains: Moderate Non-illicit: None | | |
| | | Notes Apron submerged, but no upstream flow observed. Sampled from STH 21 apron pool. | | |
| | | Condition Assessment Graffiti: None Erosion: None Deposition: None in. Damage: None | | |

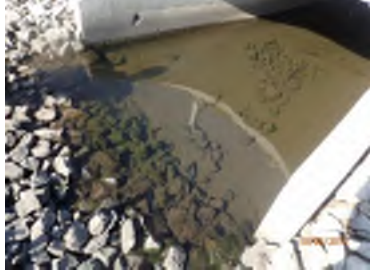
| Sampling Results Sample Location: Total Chlorine: -- ppm Free Chlorine: -- ppm Ammonia: -- ppm pH: -- units Temperature: -- °F Conductivity: -- µS/cm Detergents: -- mg/L | | Floatables: None Odor: None Turbidity: None Color: None Gross Solids: None Vegetation: None Benthic Growth: None Stains: None Non-illicit: None | | |
| | | Notes Apron submerged, but no upstream flow observed. | | |
| | | Condition Assessment Graffiti: None Erosion: None Deposition: Minor 3 in. Damage: None | | |

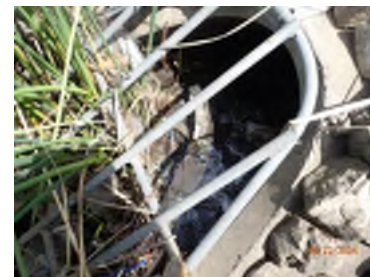
o20240822 124018.JPG

Stains: Moderate

☒ Flow Line ☐ Oil ☐ Rust Stains

Deposition: Moderate Depth (in): 3

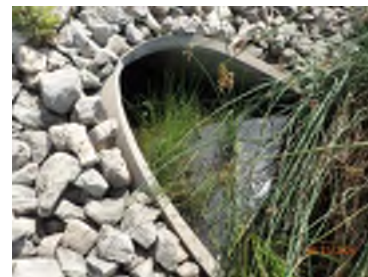
o20240822123410.JPG

Stains: Moderate

☐ Petrol. Sheen ☐ Suds ☐ Sewage ☐ Algae ☐ Other
☐ Petroleum ☐ Musty ☐ Sewage ☐ Chlorine ☐ Other
☐ VOC/Solvent ☐ Fishy ☐ Sulfur ☐ Fragrant☐ Litter ☐ Veg. Debris ☐ Sediment ☐ Other☐ Inhibited ☐ Excessive☐ Green ☒ Brown☒ Flow Line ☐ Oil ☐ Rust Stains☐ Paint ☐ Other☐ Natural Sheen ☐ Natural Suds/Foam

Deposition: Minor Depth (in): 1

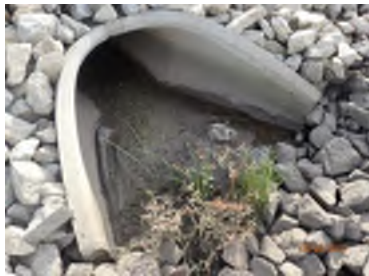
| Sampling Results Sample Location: Total Chlorine: -- ppm Free Chlorine: -- ppm Ammonia: -- ppm pH: -- units Temperature -- °F Conductivity: -- µS/cm Detergents: -- mg/L | | Floatables: None Odor: None Turbidity: None Color: None Gross Solids: Slight Vegetation: None Benthic Growth: None Stains: None Non-illicit: None | | |
| | | Notes Wet sediment on apron and in pipe. Outfall screened upstream at 16-1633 US1. | | |
| | | Condition Assessment Graffiti: None Erosion: None Deposition: Minor 1 in. Damage: None | | |

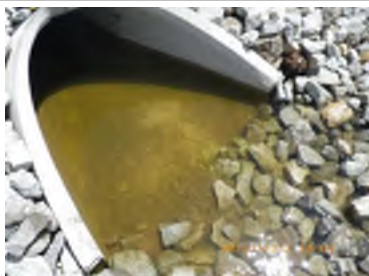
| Sampling Results Sample Location: Total Chlorine: -- ppm Free Chlorine: -- ppm Ammonia: -- ppm pH: -- units Temperature -- °F Conductivity: -- µS/cm Detergents: -- mg/L | | Floatables: None Odor: None Turbidity: None Color: None Gross Solids: None Vegetation: None Benthic Growth: Slight Stains: None Non-illicit: None | | |
| | | Notes Outfall partially submerged; screened upstream at 16-1200a US1. | | |
| | | Condition Assessment Graffiti: None Erosion: None Deposition: None in. Damage: None | | |

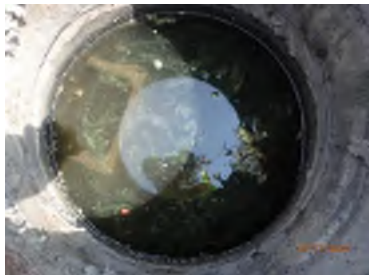
| Inspection Date: 7/17/2023 12:17:32 PM | | Type: Ongoing | Flow: Submerged, indeterminate | Previous Rainfall (hrs): 72+ |
|---|--|--|---|---|
| Illicit Discharge Potential: Unlikely Submerged: Partially Depth (in): 16 | | Inspector: JCW | Notes | o20230717105908.JPG 2023 |
| Sampling Results Sample Location: Pool Total Chlorine: 0 ppm Free Chlorine: 0 ppm Ammonia: 0 ppm pH: 8.9 units Temperature: 77 °F Conductivity: 391 µS/cm Detergents: 0 mg/L | | Floatables: Slight Odor: None Turbidity: None Color: None Gross Solids: Slight Vegetation: None Benthic Growth: Slight Stains: None Non-illicit: None | Sample collected from submerged pool in manhole. Condition Assessment Graffiti: None Erosion: None Deposition: None in. Damage: None | |

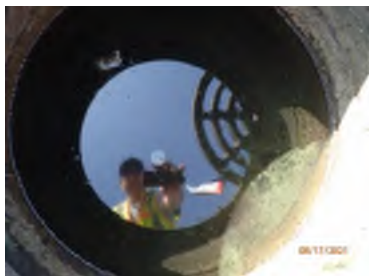
| Inspection Date: 7/17/2023 12:17:32 PM | | Type: Ongoing | Flow: Submerged, indeterminate | Previous Rainfall (hrs): 72+ |
|---|--|--|---|---|
| Inspection Date: 8/17/2021 9:33:51 AM Illicit Discharge Potential: Unlikely Submerged: Fully Depth (in): 29 | | Type: Ongoing | Flow: Submerged, indeterminate | |
| Inspector: JCW Sampling Results Sample Location: Pool Total Chlorine: 0 ppm Free Chlorine: 0 ppm Ammonia: 0 ppm pH: 7.5 units Temperature: 78 °F Conductivity: 315 µS/cm Detergents: 0 mg/L | | Floatables: Moderate Odor: Easily detected Turbidity: None Color: None Gross Solids: Slight Vegetation: None Benthic Growth: Moderate Stains: None Non-illicit: None | Notes Sample collected from submerged pool in manhole. Condition Assessment Graffiti: None Erosion: None Deposition: None in. Damage: None | o20210817093056.JPG 2021 |

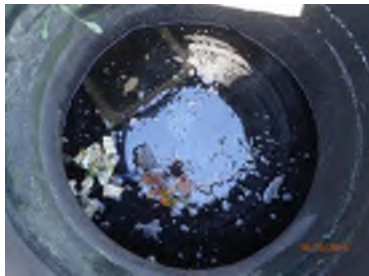
| Inspection Date: 7/17/2023 12:17:32 PM | | Type: Ongoing | Flow: Submerged, indeterminate | Previous Rainfall (hrs): 72+ |
|---|--|--|---|---|
| Inspection Date: 10/10/2016 1:50:41 PM Illicit Discharge Potential: Potential Submerged: Fully Depth (in): 24 | | Type: Ongoing | Flow: Submerged, indeterminate | |
| Inspector: JCW Sampling Results Sample Location: Pool Total Chlorine: 0 ppm Free Chlorine: 0 ppm Ammonia: 0 ppm pH: 7.22 units Temperature: 69 °F Conductivity: 429 µS/cm Detergents: 0 mg/L | | Floatables: Slight Odor: Faint Turbidity: None Color: Faint in bottle Gross Solids: Moderate Vegetation: None Benthic Growth: None Stains: None Non-illicit: None | Notes Potential illicit discharge due to gross solids. Condition Assessment Graffiti: None Erosion: None Deposition: None in. Damage: None | o20161010134816.JPG 2016 |

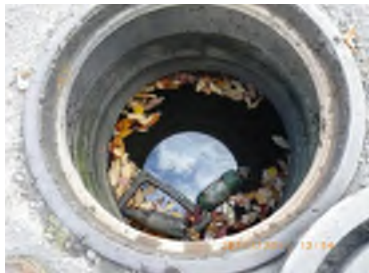
| Submerged: Fully | | Depth (in): 22 | o20111011125430.JPG <div style="text-align: center; font-weight: bold; font-size: 1.2em;">2011</div> | | |

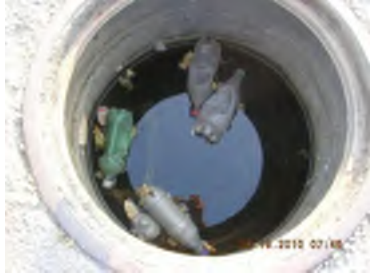
| Illicit Discharge Potential: Potential | | Inspector: JCW | Notes Moderate floatable debris in catchbasin. | | | | | | | | | | | | | | | | | | | | | | | | | | | | | | | | | |
| Submerged: Fully | | Depth (in): 29 | <p>o20100819074612.JPG</p> <p>2010</p> | | | | | | | | | | | | | | | | | | | | | | | | | | | | | | | | | |
