IDDE Ongoing Screening Summary Report

2024 Inspection Year

City of Oshkosh

Westwood

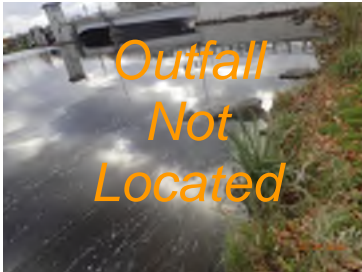
| Submerged: Fully | | Depth (in): | | Outfall fully submerged and not located - screened upstream at 16-594 US1. Floating gross solids (litter) in manhole. | | | |

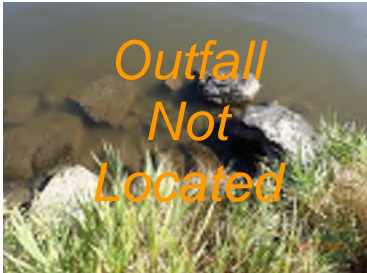
| Sampling Results Sample Location: Total Chlorine: -- ppm Free Chlorine: -- ppm Ammonia: -- ppm pH: -- units Temperature: -- °F Conductivity: -- µS/cm Detergents: -- mg/L | | Floatables: None Odor: None Turbidity: None Color: None Gross Solids: None Vegetation: None Benthic Growth: None Stains: None Non-illicit: None | Notes Outfall fully submerged and not located - screened upstream at 16-594 US1. Floating gross solids (litter) in manhole. | <p>o20171017112242.JPG</p> <p>2017</p> |

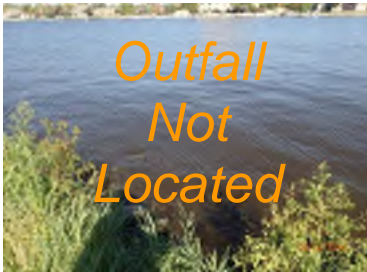
| | | Notes Outfall fully submerged and not located -screened upstream at 16-594 US1. | | |

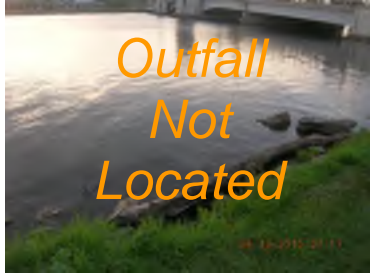
| | | Notes Outfall fully submerged and not physically located. Outfall screened upstream at 16-594 US1. | | |

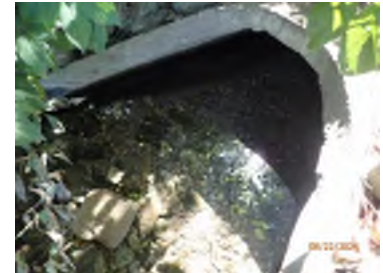
o20240822143530.JPG

Stains: Moderate

☐ Displacement ☐ Undercut ☐ Crushed
☐ Corrosion ☐ Cracks/Structural Damage☐ Petrol. Sheen ☐ Suds ☐ Sewage ☒ Algae ☐ Other
☐ Petroleum ☐ Musty ☐ Sewage ☐ Chlorine ☐ Other
☐ VOC/Solvent ☐ Fishy ☐ Sulfur ☐ Fragrant☐ Litter ☐ Veg. Debris ☐ Sediment ☐ Other☐ Inhibited ☐ Excessive☒ Green ☐ Brown☒ Flow Line ☐ Oil ☐ Rust Stains☐ Paint ☐ Other☐ Natural Sheen ☐ Natural Suds/Foam

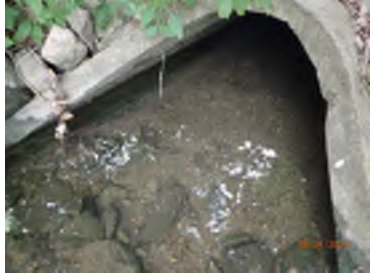
| Sampling Results Sample Location: Flow Total Chlorine: 0 ppm Free Chlorine: 0 ppm Ammonia: 0 ppm pH: 8.1 units Temperature: 74 °F Conductivity: 816 µS/cm Detergents: 0 mg/L | | Floatables: None Odor: None Turbidity: None Color: None Gross Solids: None Vegetation: None Benthic Growth: Moderate Stains: Slight Non-illicit: None | Notes Sample collected from submerged flow inside pipe. Upstream manhole wet, no flow. | o20230801093700.JPG <div style="text-align: center; font-size: 24pt; font-weight: bold;">2023</div> |
| | | | Condition Assessment Graffiti: None Erosion: None Deposition: Minor 1 in. Damage: None | |

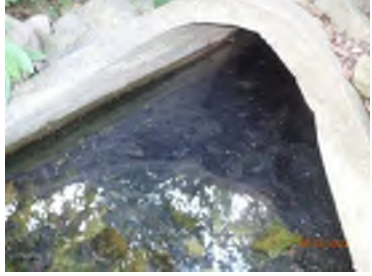
| Sampling Results Sample Location: Flow Total Chlorine: 0 ppm Free Chlorine: 0 ppm Ammonia: 0 ppm pH: 6.81 units Temperature: 73 °F Conductivity: 1058 µS/cm Detergents: 0 mg/L | | Floatables: None Odor: None Turbidity: None Color: None Gross Solids: None Vegetation: None Benthic Growth: Slight Stains: Slight Non-illicit: None | Notes Sample collected from submerged flow inside pipe. | o20220823145452.JPG <div style="text-align: center; font-size: 24pt; font-weight: bold;">2022</div> |
| | | | Condition Assessment Graffiti: None Erosion: None Deposition: None in. Damage: None | |

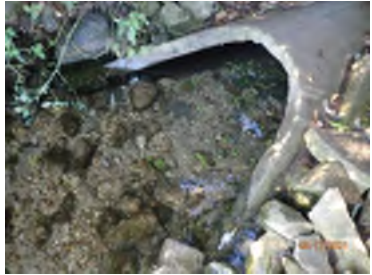
| Sampling Results Sample Location: -- Total Chlorine: -- ppm Free Chlorine: -- ppm Ammonia: -- ppm pH: -- units Temperature: -- °F Conductivity: -- µS/cm Detergents: -- mg/L | | Floatables: None Odor: None Turbidity: None Color: None Gross Solids: None Vegetation: None Benthic Growth: Moderate Stains: None Non-illicit: None | Notes Outfall partially submerged - screened upstream at 16-660 US1. Neighbor reported occasional sewage odor and suds at outfall. | o20210817082858.JPG <div style="text-align: center; font-size: 24pt; font-weight: bold;">2021</div> |
| | | | Condition Assessment Graffiti: None Erosion: None Deposition: Minor 1 in. Damage: None | |

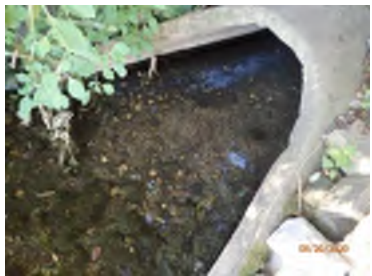
| Sampling Results Sample Location: -- Total Chlorine: -- ppm Free Chlorine: -- ppm Ammonia: -- ppm pH: -- units Temperature: -- °F Conductivity: -- µS/cm Detergents: -- mg/L | | Floatables: None Odor: None Turbidity: None Color: None Gross Solids: None Vegetation: None Benthic Growth: Severe Stains: Slight Non-illicit: None | Notes Outfall partially submerged - screened upstream at 16-660 US1. | o20200820081850.JPG <div style="text-align: center; font-size: 24pt; font-weight: bold;">2020</div> |
| | | | Condition Assessment Graffiti: None Erosion: None Deposition: Minor 1 in. Damage: None | |

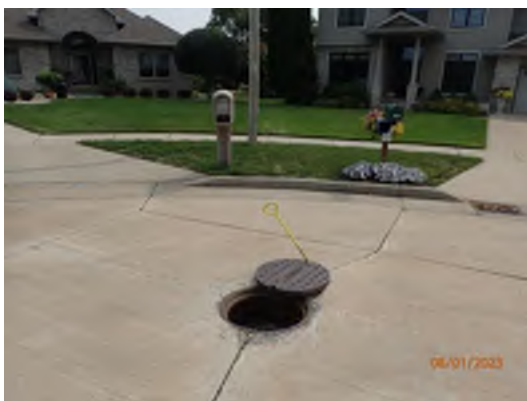
o20230801094224.JPG

Upstream manhole located approx 257 ft WSW of outfall 16-660. Intermediate area consists of residential property.

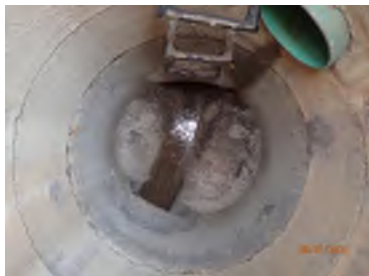
| Sampling Results Sample Location: _____ Total Chlorine: -- ppm Free Chlorine: -- ppm Ammonia: -- ppm pH: -- units Temperature: -- °F Conductivity: -- µS/cm Detergents: -- mg/L | | Floatables: None Odor: None Turbidity: None Color: None Gross Solids: None Vegetation: None Benthic Growth: None Stains: None Non-illicit: None | Notes Flowline wet, but no collectable flow at time of inspection. Sample collected from submerged flow in outfall. | o20230801094230.JPG <div style="text-align: center; font-size: 24pt; font-weight: bold;">2023</div> |
| | | Condition Assessment Graffiti: None Erosion: None Deposition: None in. Damage: None | | |

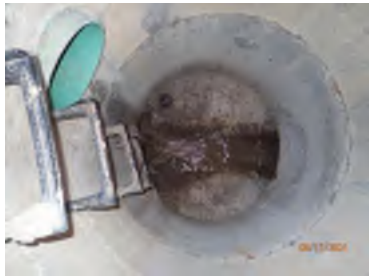
| Sampling Results Sample Location: Pool Total Chlorine: 0 ppm Free Chlorine: 0 ppm Ammonia: 0 ppm pH: 7.53 units Temperature: 73 °F Conductivity: 918 µS/cm Detergents: 0 mg/L | | Floatables: None Odor: None Turbidity: None Color: None Gross Solids: None Vegetation: None Benthic Growth: None Stains: None Non-illicit: None | Notes Sample collected from flow in manhole. | o20210817082014.JPG <div style="text-align: center; font-size: 24pt; font-weight: bold;">2021</div> |
| | | Condition Assessment Graffiti: None Erosion: None Deposition: None in. Damage: None | | |

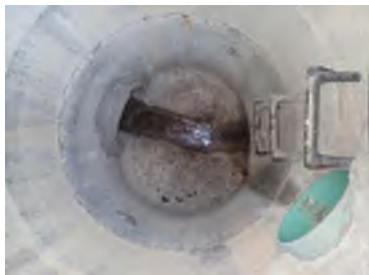
| Sampling Results Sample Location: _____ Total Chlorine: -- ppm Free Chlorine: -- ppm Ammonia: -- ppm pH: -- units Temperature: -- °F Conductivity: -- µS/cm Detergents: -- mg/L | | Floatables: None Odor: None Turbidity: None Color: None Gross Solids: None Vegetation: None Benthic Growth: None Stains: None Non-illicit: None | Notes Flowline damp, but no collectable flow at time of inspection. | o20200820082306.JPG <div style="text-align: center; font-size: 24pt; font-weight: bold;">2020</div> |
| | | Condition Assessment Graffiti: None Erosion: None Deposition: None in. Damage: None | | |

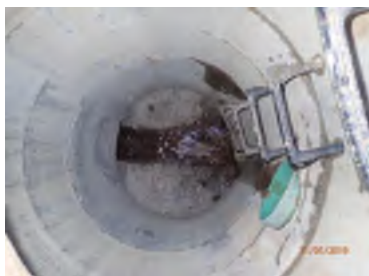
| Illicit Discharge Potential: Potential | | Inspector: JCW | | |
| Sampling Results Sample Location: Flow Total Chlorine: -- ppm Free Chlorine: -- ppm Ammonia: -- ppm pH: -- units Temperature: -- °F Conductivity: -- µS/cm Detergents: 0.9 mg/L | | Floatables: None Odor: None Turbidity: None Color: None Gross Solids: None Vegetation: None Benthic Growth: None Stains: None Non-illicit: None | Notes Follow-up inspection for sampling - limited screening conducted. | o20191105144026.JPG <div style="text-align: center; font-size: 24pt; font-weight: bold;">2019</div> |
| | | Condition Assessment Graffiti: None Erosion: None Deposition: None in. Damage: None | | |

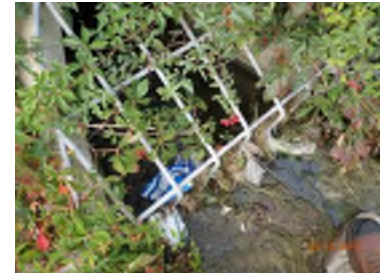
o20240910073502.JPG

Stains: Moderate

☐ Displacement ☐ Undercut ☐ Crushed
☐ Corrosion ☐ Cracks/Structural Damage☐ Petrol. Sheen ☐ Suds ☐ Sewage ☒ Algae ☐ Other
☐ Petroleum ☐ Musty ☐ Sewage ☐ Chlorine ☐ Other
☐ VOC/Solvent ☐ Fishy ☐ Sulfur ☐ Fragrant☒ Litter ☐ Veg. Debris ☐ Sediment ☐ Other☐ Inhibited ☐ Excessive☒ Green ☐ Brown☒ Flow Line ☐ Oil ☐ Rust Stains☐ Paint ☐ Other☐ Natural Sheen ☐ Natural Suds/Foam

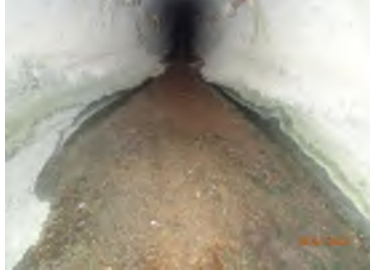
| Illicit Discharge Potential: Potential | | Inspector: JCW | | |
| Sampling Results Sample Location: Flow Total Chlorine: 0 ppm Free Chlorine: 0 ppm Ammonia: 0 ppm pH: 8.43 units Temperature: 76 °F Conductivity: 7200 µS/cm Detergents: 0 mg/L | | Floatables: None Odor: None Turbidity: None Color: None Gross Solids: Slight Vegetation: None Benthic Growth: Moderate Stains: Moderate Non-illicit: None | Notes Sample collected from pipe flow. Elevated conductivity. | o20230801103220.JPG <div style="text-align: center; font-size: 24pt; font-weight: bold;">2023</div> |
| | | | Condition Assessment Graffiti: None Erosion: None Deposition: None in. Damage: None | |

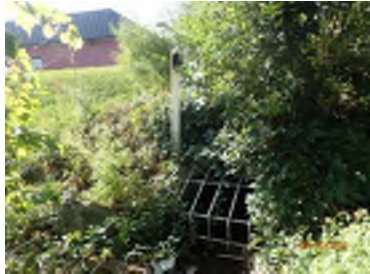
| Illicit Discharge Potential: Potential | | Inspector: EJK | | |
| Sampling Results Sample Location: Flow Total Chlorine: 0 ppm Free Chlorine: 0 ppm Ammonia: 0 ppm pH: 7.99 units Temperature: 70 °F Conductivity: 2310 µS/cm Detergents: 0 mg/L | | Floatables: None Odor: None Turbidity: None Color: None Gross Solids: Slight Vegetation: None Benthic Growth: Moderate Stains: Slight Non-illicit: None | Notes Sample collected from pipe flow. Elevated conductivity in sample. Tracked upstream without finding source. | o20220916094346.JPG <div style="text-align: center; font-size: 24pt; font-weight: bold;">2022</div> |
| | | | Condition Assessment Graffiti: None Erosion: None Deposition: None in. Damage: None | |

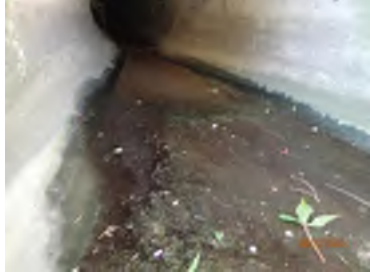
| Illicit Discharge Potential: Potential | | Inspector: JCW | | |
| Sampling Results Sample Location: Flow Total Chlorine: 0 ppm Free Chlorine: 0 ppm Ammonia: 0 ppm pH: 8.14 units Temperature: 76 °F Conductivity: 1990 µS/cm Detergents: 0.65 mg/L | | Floatables: None Odor: None Turbidity: None Color: None Gross Solids: Slight Vegetation: None Benthic Growth: Severe Stains: Moderate Non-illicit: None | Notes Sample collected from pipe flow. Detergent detected in sample. | o20210817084532.JPG <div style="text-align: center; font-size: 24pt; font-weight: bold;">2021</div> |
| | | | Condition Assessment Graffiti: None Erosion: None Deposition: None in. Damage: None | |

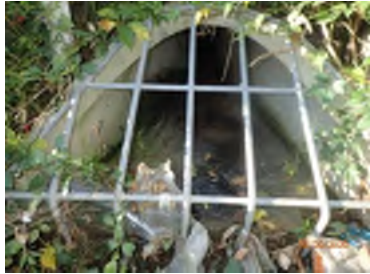
| Sampling Results Sample Location: -- Total Chlorine: -- ppm Free Chlorine: -- ppm Ammonia: -- ppm pH: -- units Temperature: -- °F Conductivity: -- µS/cm Detergents: -- mg/L | | Floatables: None Odor: None Turbidity: None Color: None Gross Solids: Moderate Vegetation: None Benthic Growth: Slight Stains: None Non-illicit: None | Notes Pipe wet, but no collectable flow at time of inspection. | o20200820075354.JPG <div style="text-align: center; font-size: 24pt; font-weight: bold;">2020</div> |
| | | | Condition Assessment Graffiti: None Erosion: None Deposition: None in. Damage: None | |

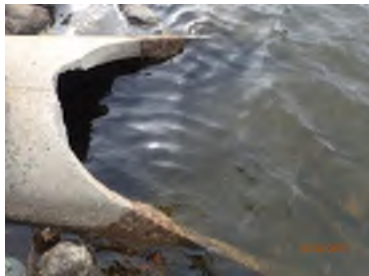
| | | Notes Outfall partially submerged - screened upstream at 16-941 US1. | | |
| | | Condition Assessment Graffiti: None Erosion: None Deposition: None in. Damage: Minor | | |

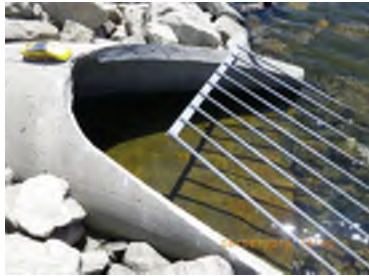
| | | Notes Grate detached from apron. Outfall partially submerged. Outfall screened upstream at 16-941 US1. | | |
| | | Condition Assessment Graffiti: None Erosion: None Deposition: None in. Damage: Minor | | |

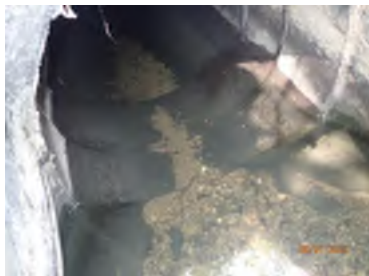
| Sampling Results Sample Location: _____ Total Chlorine: -- ppm Free Chlorine: -- ppm Ammonia: -- ppm pH: -- units Temperature: -- °F Conductivity: -- µS/cm Detergents: -- mg/L | | Floatables: None Odor: None Turbidity: None Color: None Gross Solids: None Vegetation: None Benthic Growth: Severe Stains: Slight Non-illicit: None | Notes Outfall partially submerged - screened upstream at 16-995 US1. Pipe clear, 15" berm at end of apron creating dam. | o20230801091314.JPG <div style="text-align: center; font-size: 24pt; font-weight: bold;">2023</div> |
| | | | Condition Assessment Graffiti: None Erosion: None Deposition: Moderate 15 in. Damage: None | |

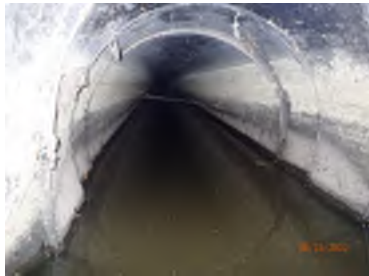
| Sampling Results Sample Location: Pool Total Chlorine: 0 ppm Free Chlorine: 0 ppm Ammonia: 0 ppm pH: 7.46 units Temperature: 73 °F Conductivity: 325 µS/cm Detergents: 3.5 mg/L | | Floatables: None Odor: None Turbidity: None Color: None Gross Solids: None Vegetation: None Benthic Growth: None Stains: Slight Non-illicit: None | Notes No flow leaving apron. Sample collected from apron pool. Detergent detected in sample. | o20220823151212.JPG <div style="text-align: center; font-size: 24pt; font-weight: bold;">2022</div> |

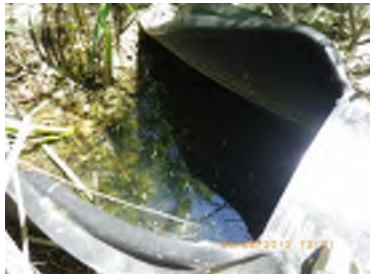
o20120606122140.JPG

| Detergents: -- mg/L | Stains: | Slight | | |
| | | Deposition: | Moderate 8 in. | |

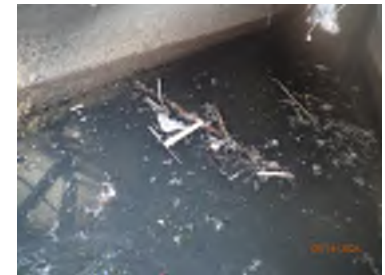
o20240919121542.JPG

Stains: Moderate

☐ Petrol. Sheen ☐ Suds ☐ Sewage ☐ Algae ☐ Other☐ Petroleum ☐ Musty ☐ Sewage ☐ Chlorine ☐ Other☐ VOC/Solvent ☐ Fishy ☐ Sulfur ☐ Fragrant☐ Litter ☐ Veg. Debris ☐ Sediment ☐ Other☐ Inhibited ☐ Excessive☒ Green ☐ Brown☒ Flow Line ☐ Oil ☐ Rust Stains☐ Paint ☐ Other☐ Natural Sheen ☐ Natural Suds/Foam
