# Initial Screening Summary Report

Illicit Discharge Detection and Elimination Program

City of Oshkosh

May 18, 2010

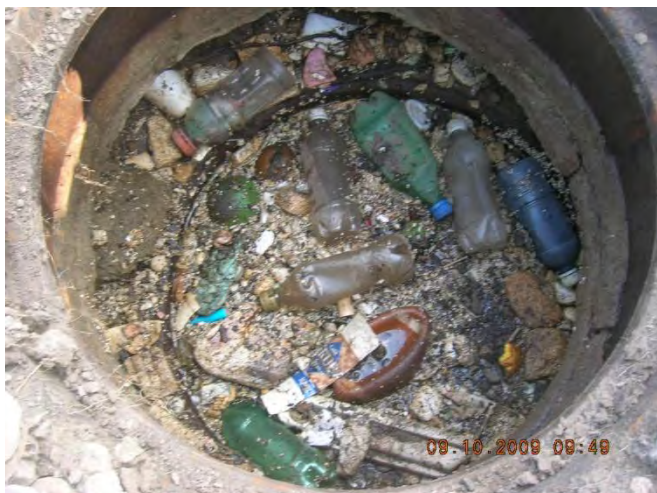
Eight upstream manholes contained significant amounts of floatable debris, including plastic bottles, foam packaging, and other solid waste. This effect was most pronounced at manholes upstream of a fully-submerged outfall, where the storm sewer pipes within the manhole were also fully-submerged. In these cases, any floatable debris traveling along the top of the storm sewer pipe will enter the manhole, and will remain suspended in the manhole pool, as they are not able to escape through the submerged outlet pipe. In these cases, the submerged manhole acts as a trap for much of the floatable debris.

**Figure 5 - Floatables in upstream manhole 03-22 US1**

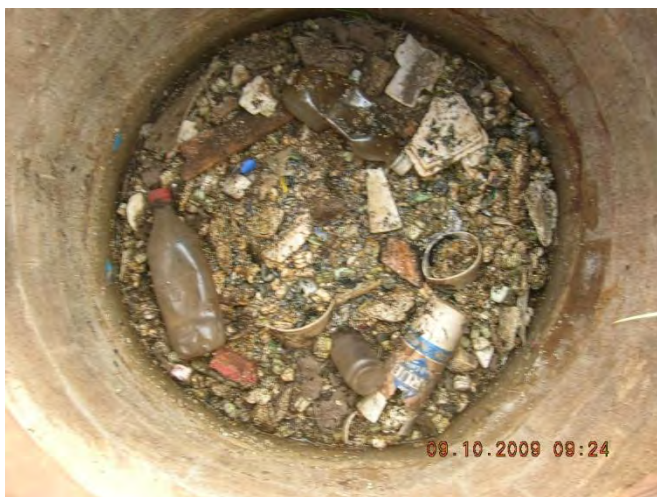
**Figure 6 - Floatables in upstream manhole 03-35 US1**

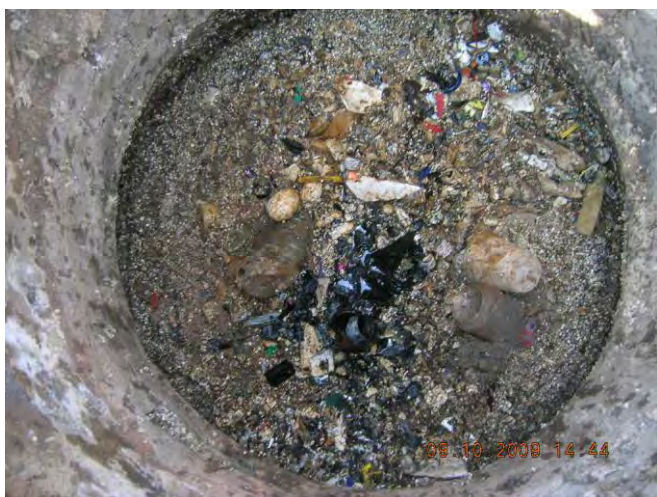
**Figure 7 - Floatables in upstream manhole 06-560 US1**

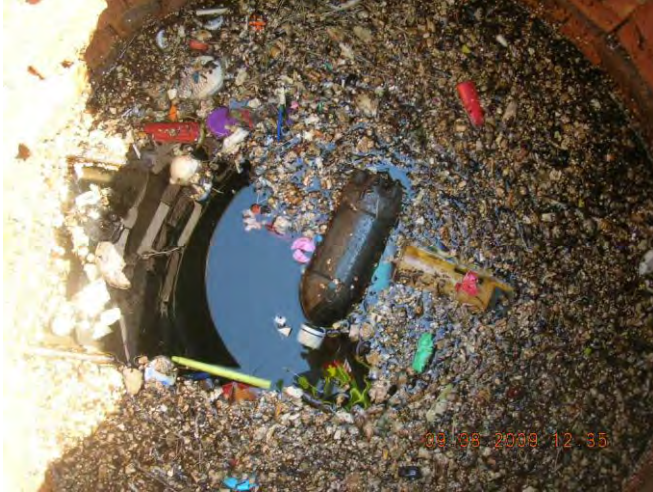
**Figure 8 - Floatables in upstream manhole 11-376 US1**

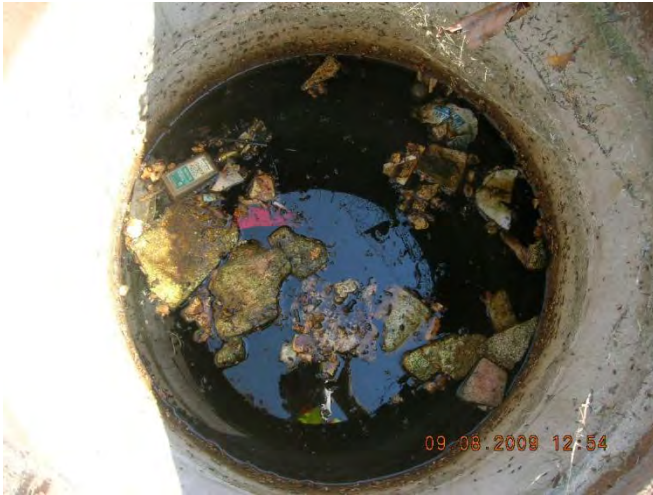
**Figure 9 - Floatables in upstream manhole 11-465 US1**

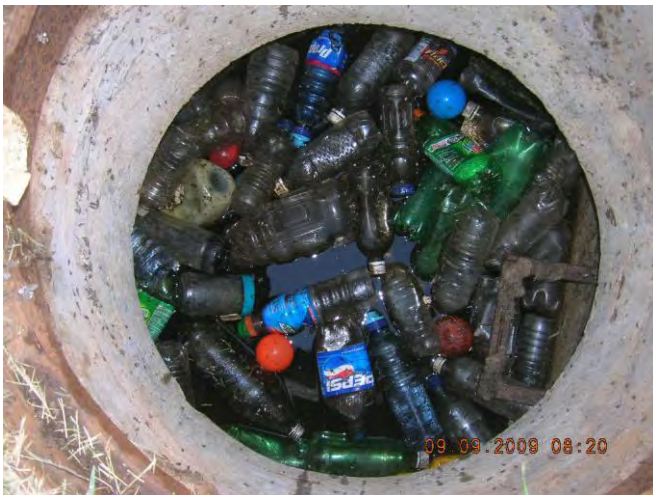
**Figure 10 - Floatables in upstream manhole 12-576 US1**

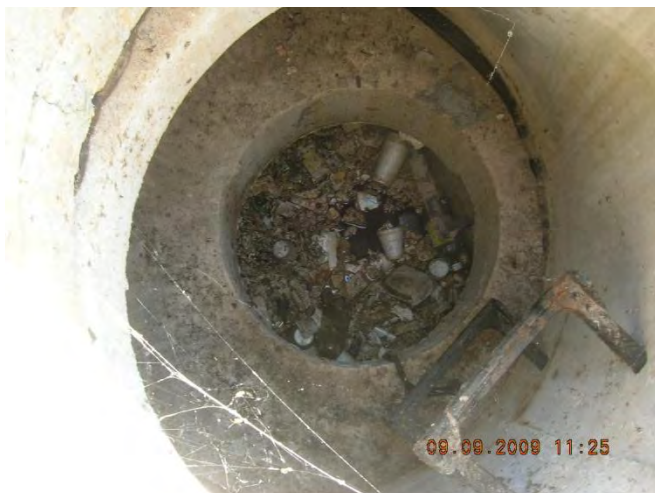
**Figure 11 - Floatables in upstream manhole OSH-9424 US1**

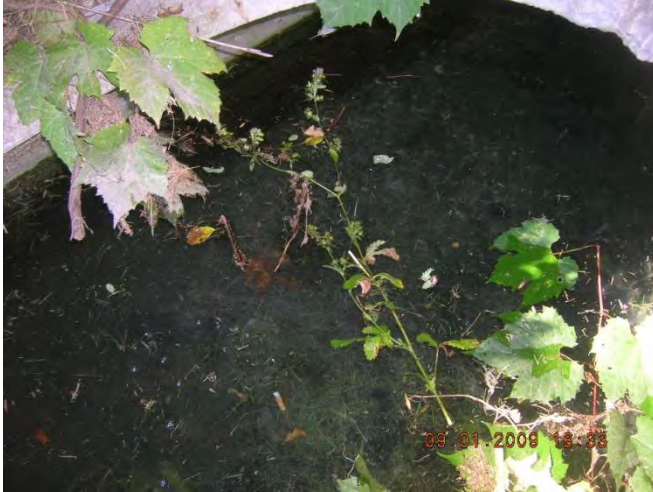
Outfall 15-1348 is located on the west border of Winnebago County Park. It receives flow from the residential area immediately west of the park. While conducting the screening at the outfall, a significant amount of grass clippings were submerged in the outfall pipe. The mat of grass clipping appeared to be approximately six inches thick. While some vegetation debris and grass clippings are typical in outfalls, especially those in residential areas, the amount in the outfall appeared excessive.

**Figure 18 – Grass clippings in outfall 15-1348**

If grass clippings continue to be a problem in this outfall, it may be necessary to target this neighborhood for an education campaign concerning the proper disposal of grass clippings and yard waste. It may also be necessary to conduct some maintenance at the outfall to remove the mat of grass clippings if they are not removed naturally.

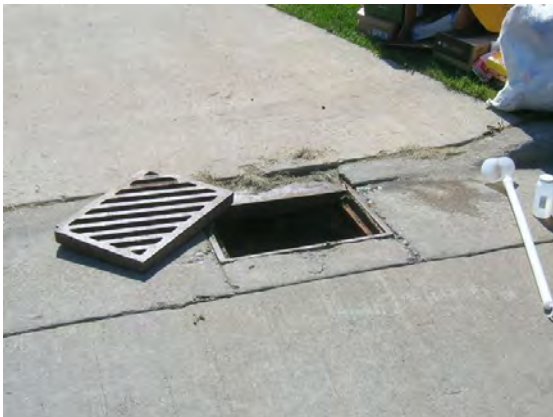
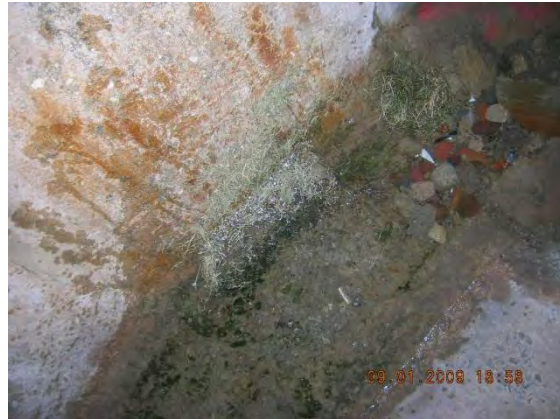
The first upstream manhole could not be located, as it appeared to be buried in a landscaped area. Because the storm sewer divided into two branches at this manhole, the next upstream manholes in each branch were screened. The upstream manhole for the south branch was a catchbasin located at the end of Chateau Terrace. This catchbasin had no flow, and showed no indicators of illicit discharge and almost no grass clippings. The upstream manhole for the north branch was a catchbasin located at the end of Prairie Court. This catchbasin also had no flow, but had more significant amounts of grass clippings in the catchbasin, as well as in the immediate area around the catchbasin.

**Figure 19 – Grass clippings in and around upstream manhole 15-1348 US2**

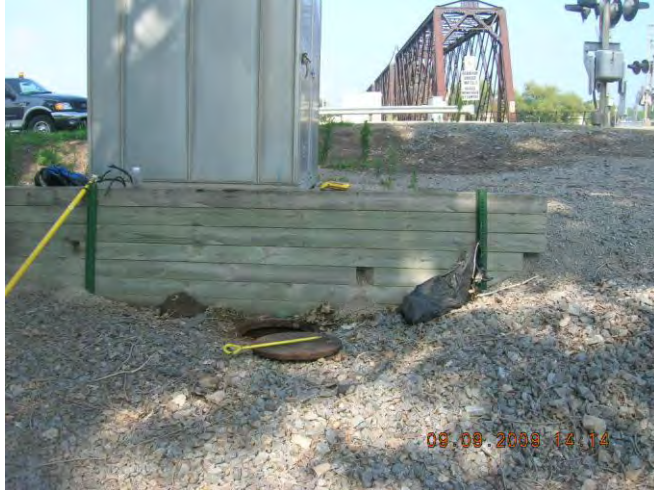
**Figure 20 – Upstream manhole 03-81 US1**

The first upstream manhole was located on the south side of Pioneer Drive, behind the railroad control shed. When the manhole was opened, a strong smell of diesel fuel was detected inside the manhole. The manhole was also submerged, and had a significant amount of floatable debris, which appeared to be coated with oil and grease.

A sample was collected from upstream manhole 03-81 US1. The sample had a grayish-black color, and had a strong odor of diesel fuel. The sampling equipment and container were coated in grease from penetrating the floatable debris. None of the typical sampling parameters tested positive. Because of the obvious odor of diesel fuel and appearance of grease, no additional VOC or oil/grease tests were run. The railroad track ballast in the area showed no signs of stains or other leaks, so a railroad spill seemed unlikely.

The City and OMNNI believe that the illicit discharge evidence for this outfall was not caused by one significant event. Rather, it was likely caused by a gradual buildup of diesel fuel and oil/grease over many years, which became trapped in the downstream manholes. Upon discovering the problem, the City vacuumed the upstream manholes. A follow-up inspection of manhole 03-81 US1 revealed that the manhole was still full-submerged, but the sample collected from the pool did not have a detectable odor.

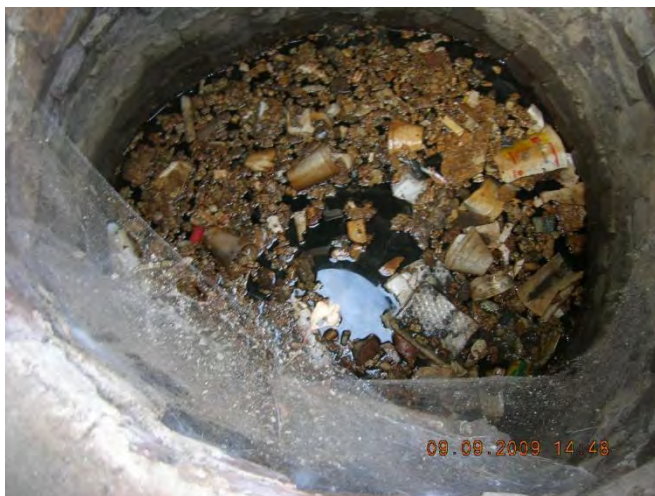
After receiving authorization from the City to use the contingency funds set aside for the project, additional upstream manholes were screened in an attempt to determine the extent of the contamination and the possible source. The first upstream manhole could not be located, as it was buried under the ballast in the railroad right-of-way. The second upstream manhole was located, also in the railroad right-of-way. This manhole (03-81 US2) also had oil-covered floatables, but the diesel odor was not as significant as in 03-81 US1.

**Figure 23 – Floatable debris in upstream manhole 03-81 US2**

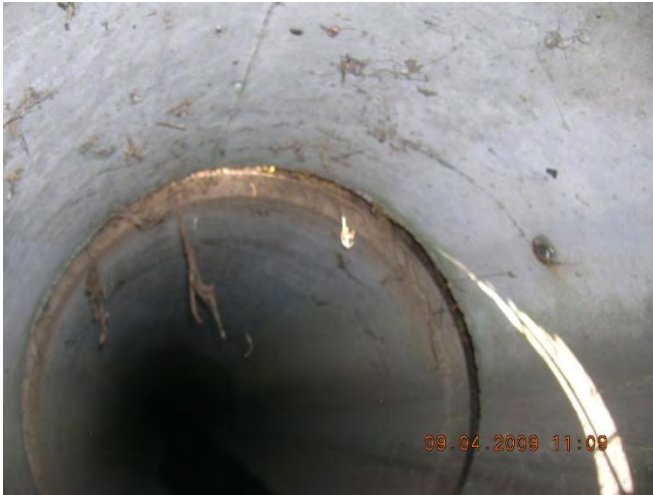
Eight outfalls showed signs of damage that may require attention in the near future. Several concrete pipes had dislocated end pipe sections (11-244 and 14-999) or aprons (13-1554, 14-659 and 14-660). Several corrugated metal pipes had ends that were crushed, with holes or tears at the end of the pipe (15-1067, 15-1217 and 15-1219). The damage is shown in the photos below.

**Figure 28 - Outfall 13-1554 displaced apron**

In addition, the initial screening identified three outfalls with graffiti, eight with structural damage, and none with severe erosion. While none of these posed an immediate danger, the City will likely want to address these issues as part of the regular storm sewer system maintenance.

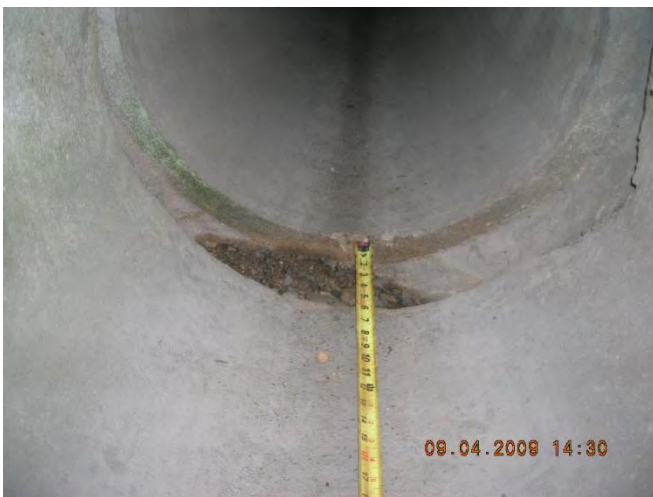
**Figure 29 - Outfall 14-659 displaced apron**

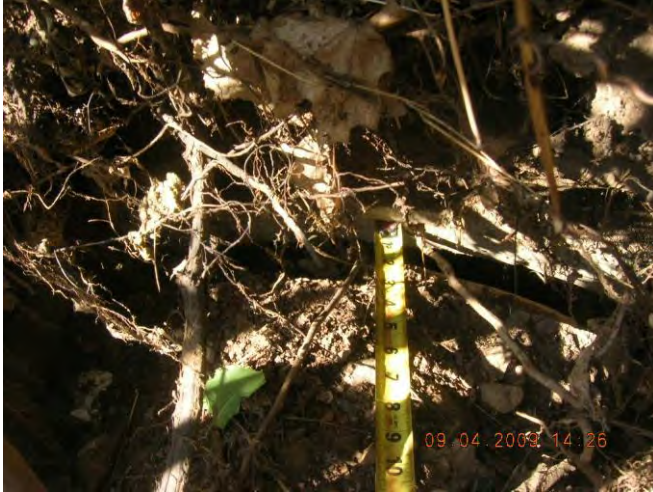
**Figure 30 - Outfall 14-660 displaced apron**

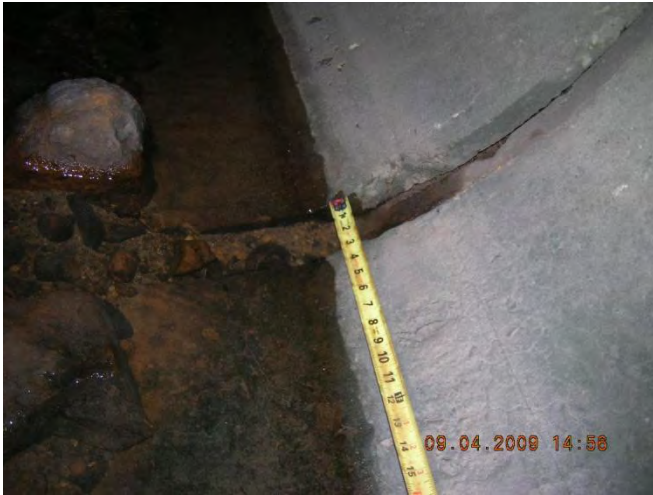
**Figure 31 - Outfall 14-999 displaced pipe section**

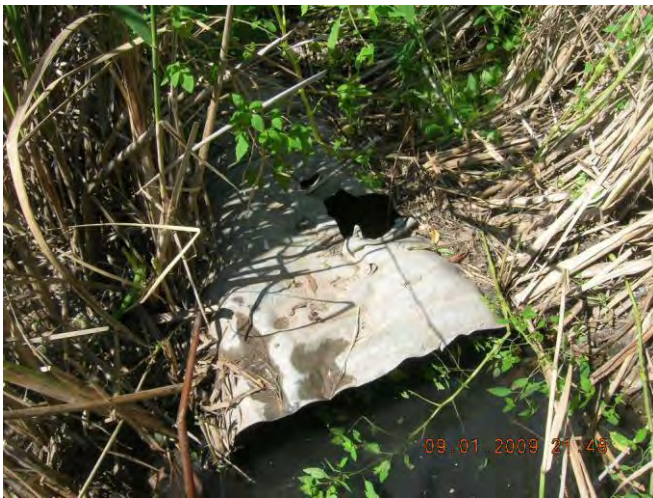
**Figure 32 - Outfall 15-1067 crushed CMP with holes**

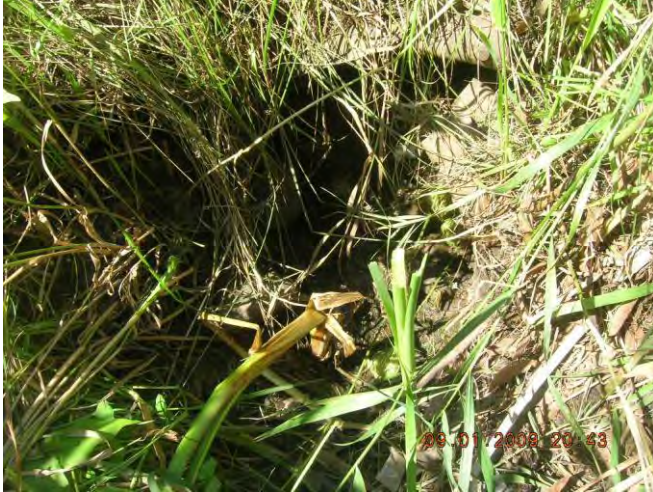
**Figure 33 - Outfall 15-1217 crushed CMP**

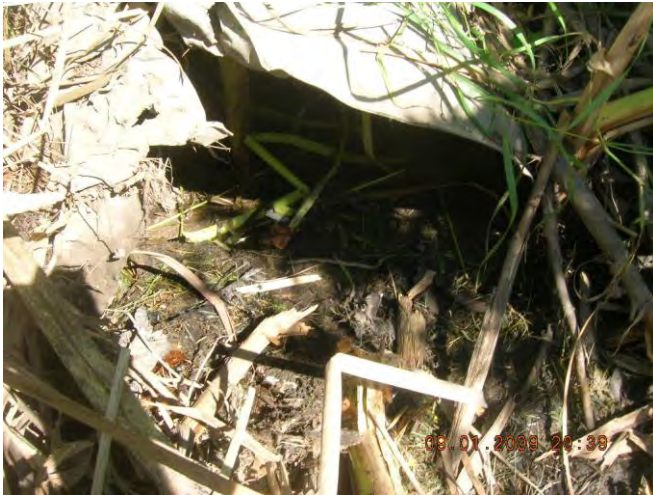
**Figure 34 - Outfall 15-1219 crushed CMP**

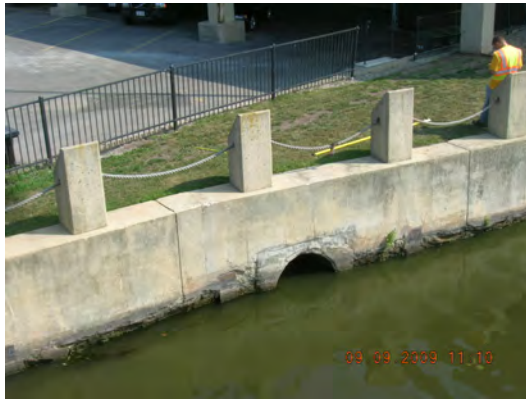
DSCN6708.JPG

Outfall partially submerged. Outfall screened upstream at 01-35 US1.

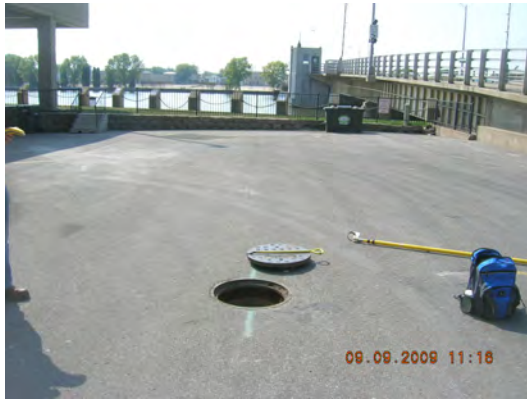
DSCN6711.JPG

Upstream manhole located approx 72 ft N of outfall 01-35. Intermediate area consists of paved parking area with no observed inlets.

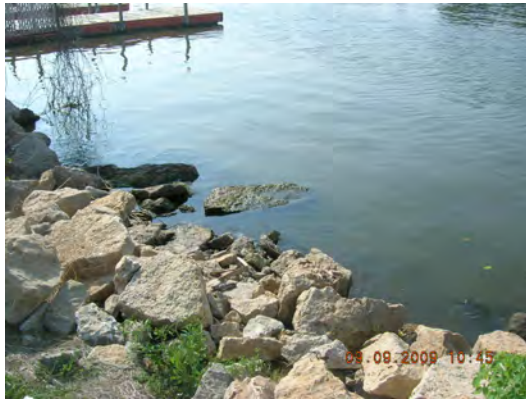
DSCN6704.JPG

Outfall fully submerged and not physically located.  
GPS coordinates approximate. Outfall screened  
upstream at 01-278 US1. Pipe info from MS4 map.

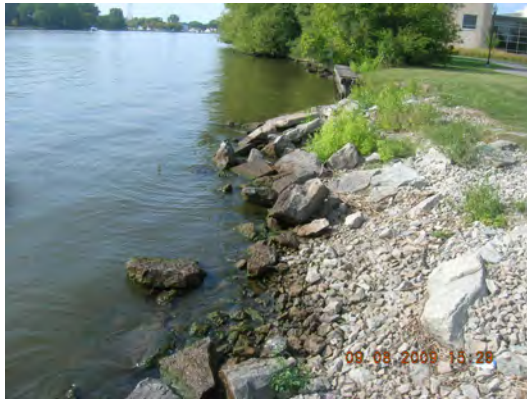
DSCN6665.JPG

Outfall fully submerged and not physically located.  
GPS coordinates approximate. Outfall screened  
upstream at 01-329 US1. Pipe info from MS4 map.

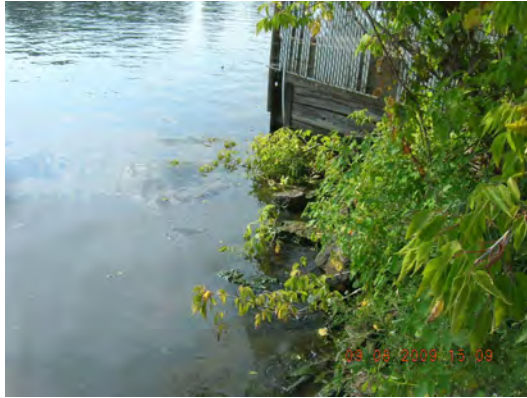
DSCN6661.JPG

Outfall fully submerged. Outfall screened upstream at 01-360 US1. Intermediate manholes inside fenced area on private property.

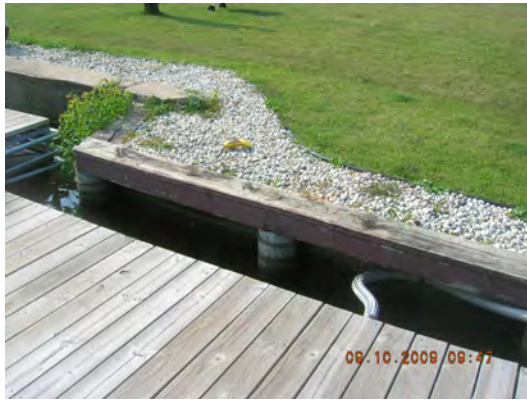
DSCN6765.JPG

Outfall fully submerged and not physically located.  
GPS coordinates approximate. Outfall screened  
upstream at 03-22 US1. Pipe info from MS4 map.

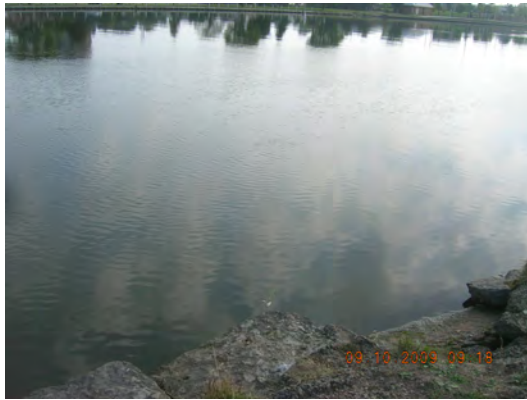
DSCN6761.JPG

Outfall fully submerged and not physically located.  
GPS coordinates approximate. Outfall screened  
upstream at 03-35 US1. Pipe info from MS4 map.

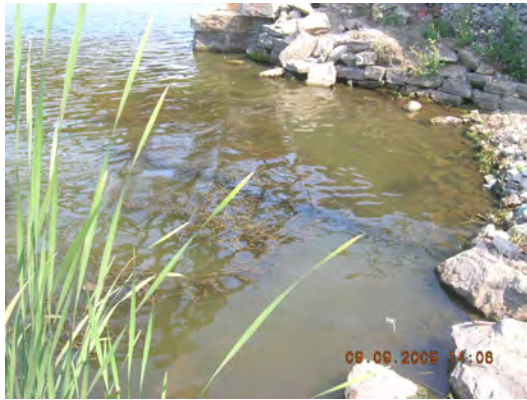
DSCN6745.JPG

Outfall fully submerged and not physically located.  
GPS coordinates approximate. Outfall screened  
upstream at 03-81 US1-5. Pipe info from MS4 map.

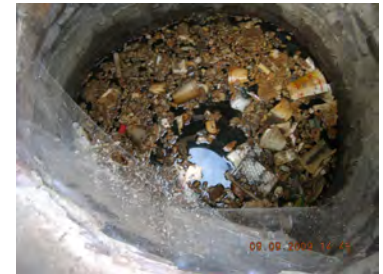
DSCN6751.JPG

Notes: Floatables with oil stains. Slight petroleum odor.

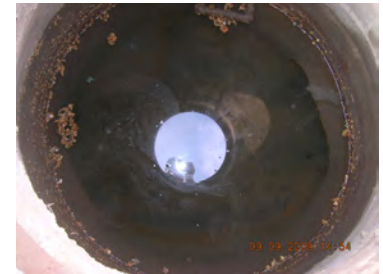
DSCN6754.JPG

Notes: Rust colored floatables and sheen on surface. Slight odor.

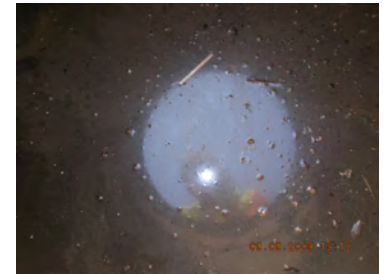
DSCN6757.JPG

Notes: Rust colored floatables and sheen on surface. Noticable non-petroleum odor. Rust color to water.

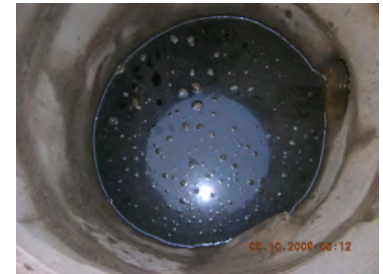
DSCN6760.JPG

Notes: Slight sheen with rust-colored water in manhole.

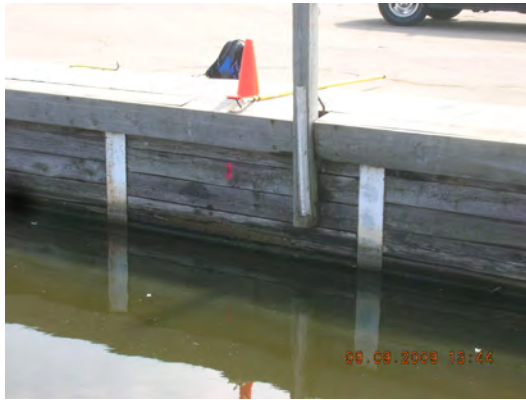
DSCN6741.JPG

Outfall fully submerged and not physically located.  
GPS coordinates approximate. Outfall screened  
upstream at 03-119 US1. Pipe info from MS4 map.

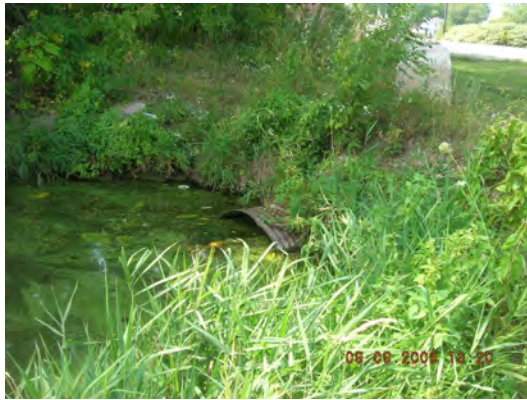
DSCN6735.JPG

Outfall partially submerged. Outfall screened upstream at 03-293 US1.

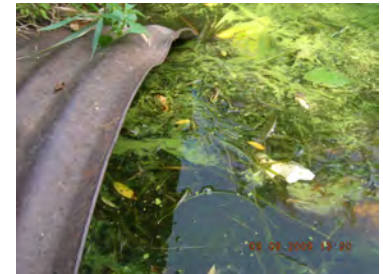
DSCN6736.JPG

- Outfall Damage** ☒ Corrosion ☐ Peeling Paint ☐ Spalling/Cracking/Chipping  
**Deposits/Stains** ☐ Oily ☐ Paint ☐ Flow Line ☐ Other:  
**Pipe Benthic Growth** ☐ Brown ☐ Orange ☒ Green ☐ Other:  
**Abnormal Vegetation** ☐ Inhibited ☐ Excessive  
**Poor Pool Quality** ☐ Odors ☐ Colors ☐ Oil Sheen ☐ Suds ☐ Floatables  
☒ Excessive Algae ☐ Other:

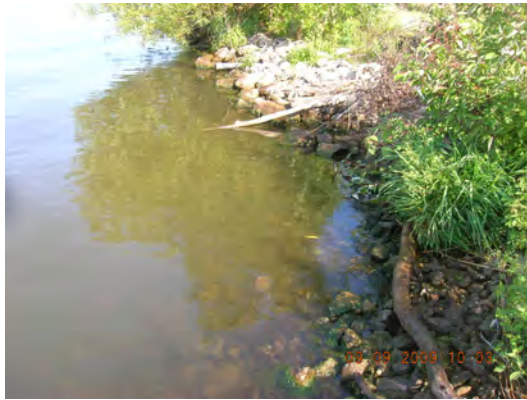
DSCN6696.JPG

Outfall fully submerged and not physically located.  
GPS coordinates approximate. Outfall screened  
upstream at 05-14 US1. Pipe info from MS4 map.

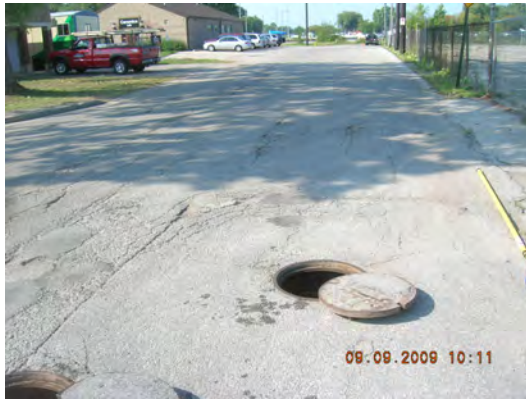
DSCN6700.JPG

Upstream manhole located approx 354 ft NE of outfall 05-14. Intermediate area consists of industrial parking area to north and commercial property to south.

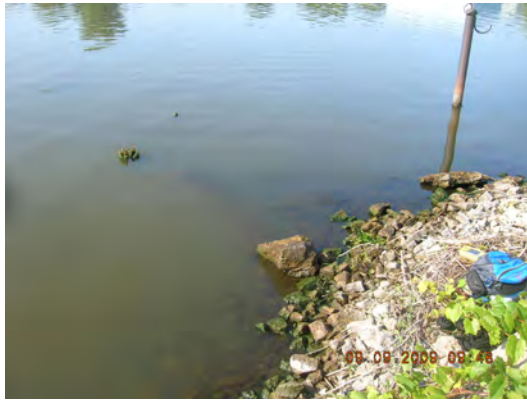
DSCN6690.JPG

Outfall fully submerged. Outfall screened upstream at 05-155 US1. Pipe info from MS4 map.

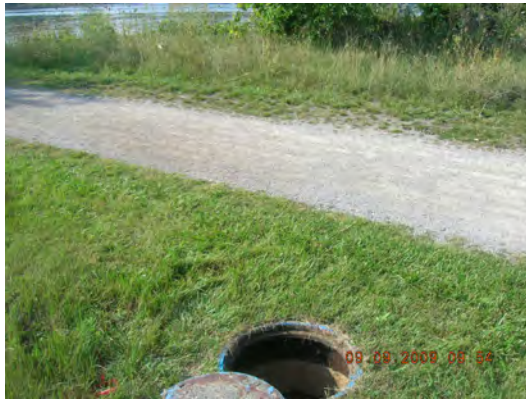
DSCN6693.JPG

Upstream manhole located approx 72 ft NNE of outfall 05-155. Intermediate area consists of open space.

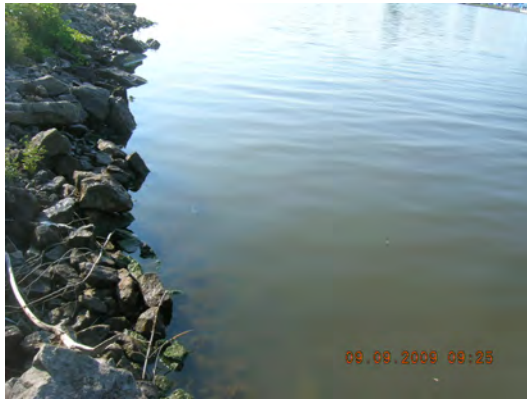
DSCN6685.JPG

Outfall fully submerged and not physically located.  
GPS coordinates approximate. Outfall screened  
upstream at 05-216 US1. Pipe info from MS4 map.

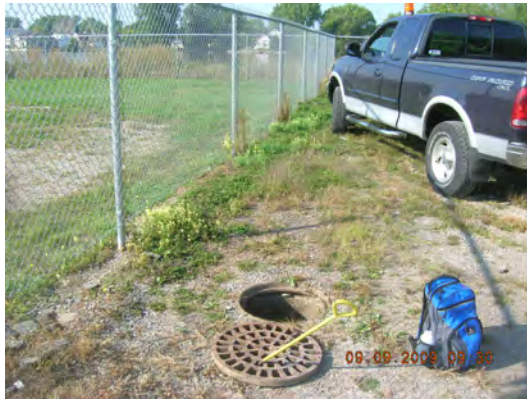
DSCN6686.JPG

Upstream manhole located approx 85 ft NE of outfall 05-216. Intermediate area consists of unpaved parking area near industrial facilities.

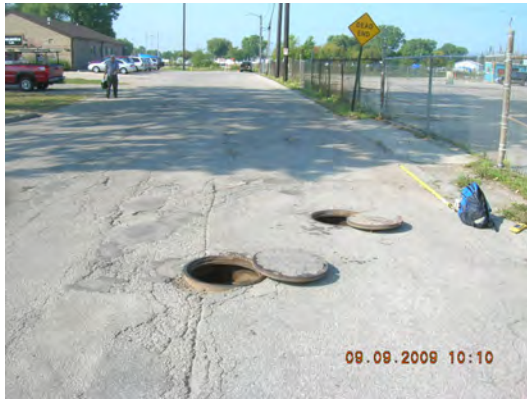
DSCN6697.JPG

Upstream manhole located approx 365 ft NE of outfall 05-241. Intermediate area consists of industrial parking area to north and commercial property to south.

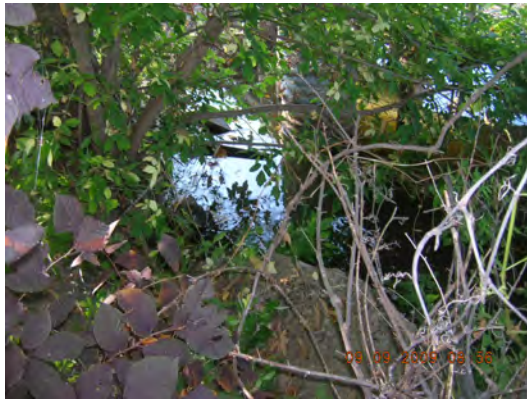
DSCN6680.JPG

Outfall fully submerged and not physically located.  
GPS coordinates approximate. Outfall screened  
upstream at 05-264 US1. Pipe info from MS4 map.

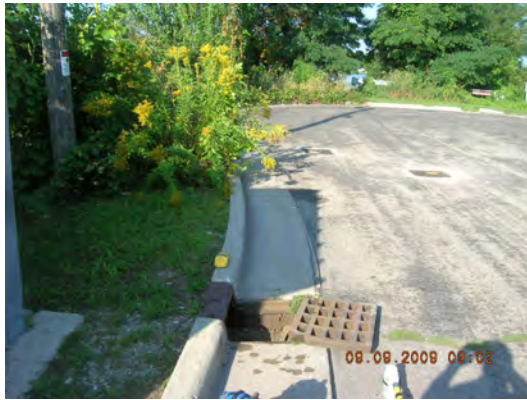
DSCN6681.JPG

Upstream manhole (inlet) located approx 89 ft E of outfall 05-264. Intermediate area consists of street right-of-way, with a marina to the south.

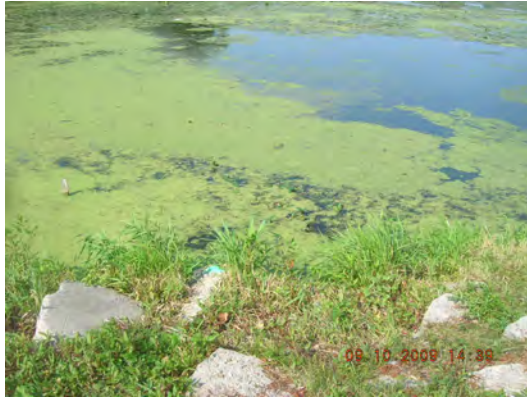
DSCN6804.JPG

Outfall fully submerged and not physically located.  
GPS coordinates approximate. Outfall screened  
upstream at 06-15 US1. Pipe info from MS4 map.

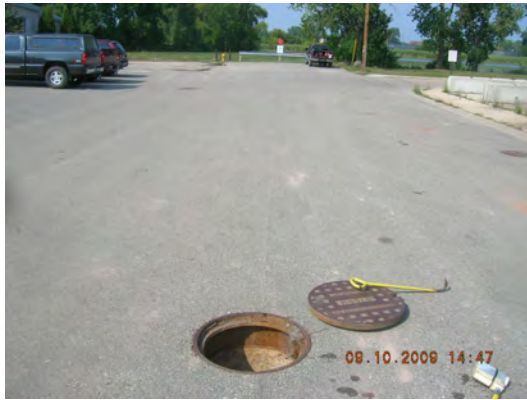
DSCN6808.JPG

Upstream manhole located approx 189 ft S of outfall 06-15. Intermediate area consists of paved road adjacent to wastewater treatment plant and industrial facilities.

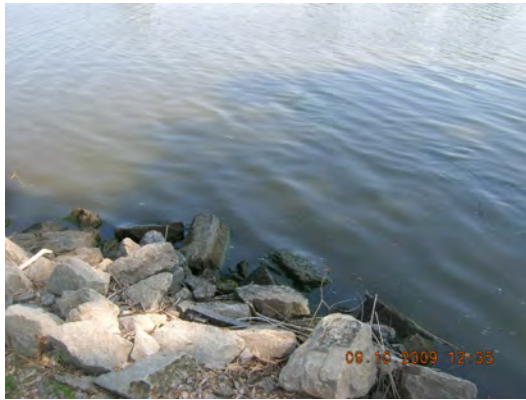
DSCN6784.JPG

Outfall fully submerged and not physically located.  
GPS coordinates approximate. Outfall screened  
upstream at 06-216 US1. Pipe info from MS4 map.

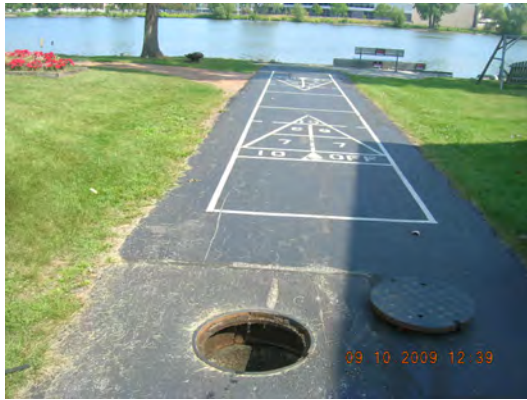
DSCN6787.JPG

Upstream manhole located approx 72 ft WSW of outfall 06-216. Intermediate area consists of open area east of multifamily residential property.

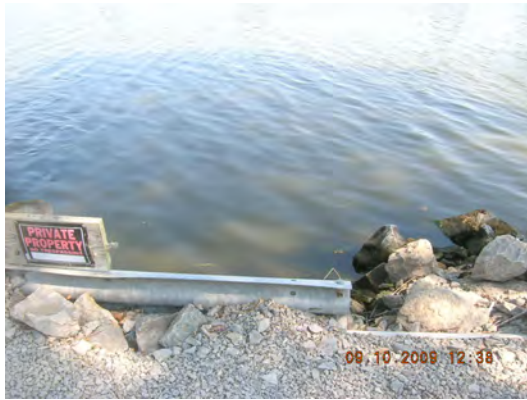
DSCN6785.JPG

Outfall fully submerged and not physically located.  
GPS coordinates approximate. Outfall screened  
upstream at 06-253 US1. Pipe info from MS4 map.

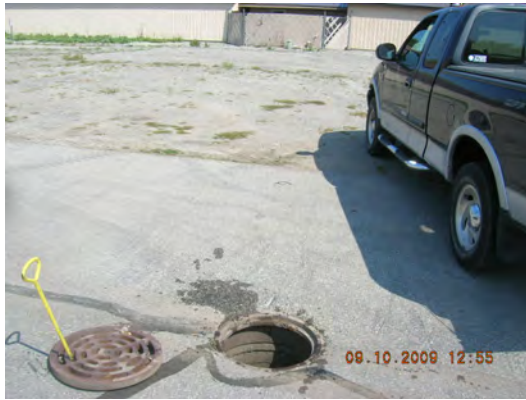
DSCN6790.JPG

Upstream manhole located approx 266 ft WSW of outfall 06-253. Intermediate area consists of multifamily residential buildings and parking.

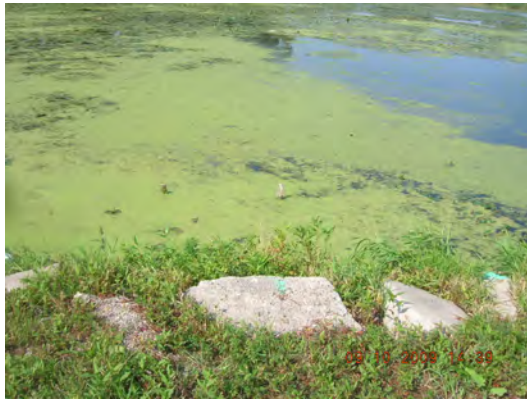
DSCN6803.JPG

Outfall fully submerged and not physically located.  
GPS coordinates approximate. Outfall screened  
upstream at 06-560 US1. Pipe info from MS4 map.

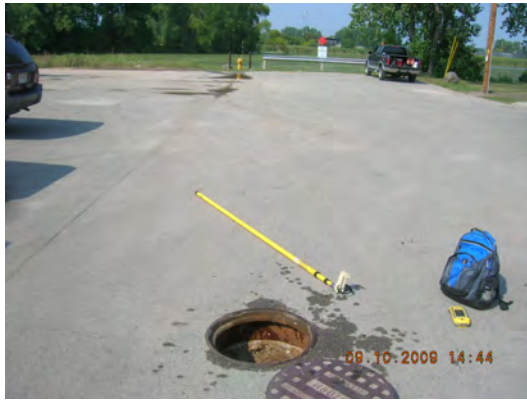
DSCN6805.JPG

Upstream manhole located approx 130 ft S of outfall 06-560. Intermediate area consists of paved road adjacent to wastewater treatment plant and industrial facilities.

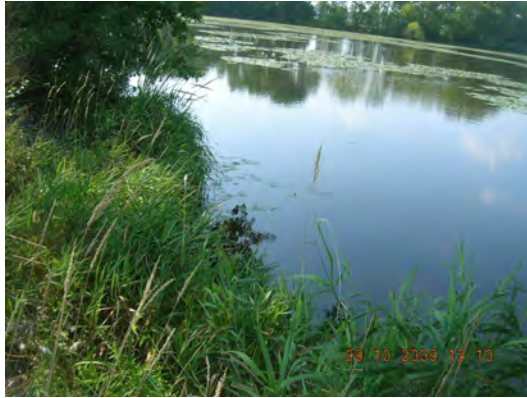
DSCN6817.JPG

Outfall fully submerged and not physically located.  
GPS coordinates approximate. Outfall screened  
upstream at 06-729 US1. Pipe info from MS4 map.

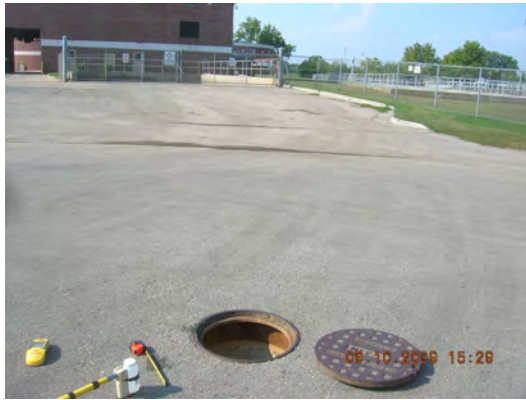
DSCN6818.JPG

Upstream manhole located approx 522 ft SSE of outfall 06-729. Intermediate manholes located inside wastewater treatment plant. Intermediate area consists of treatment plant and roads.

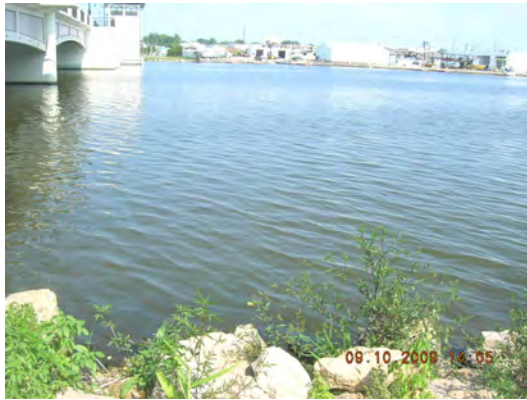
DSCN6798.JPG

Outfall fully submerged and not physically located.  
GPS coordinates approximate. Outfall screened  
upstream at 06-810 US1. Pipe info from MS4 map.

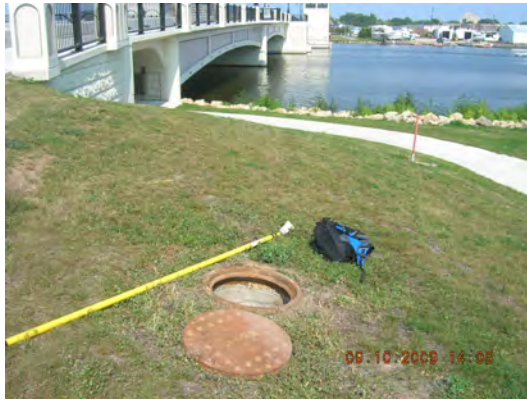
DSCN6800.JPG

Upstream manhole located approx 77 ft SW of outfall 06-810. Intermediate area consists of open area.

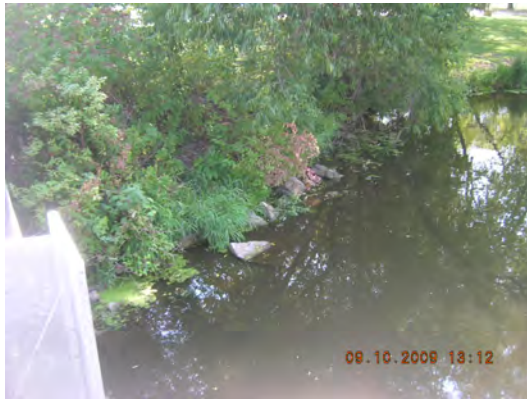
DSCN6793.JPG

Outfall fully submerged and not physically located.  
GPS coordinates approximate. Outfall screened  
upstream at 06-1028 US1. Pipe info from MS4 map.

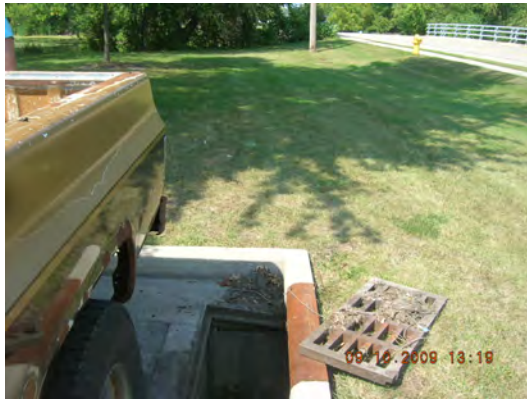
DSCN6795.JPG

Upstream manhole (inlet) located approx 122 ft SSE of outfall 06-1028. Intermediate area consists of open area and paved parking lot adjacent to wastewater treatment plant.

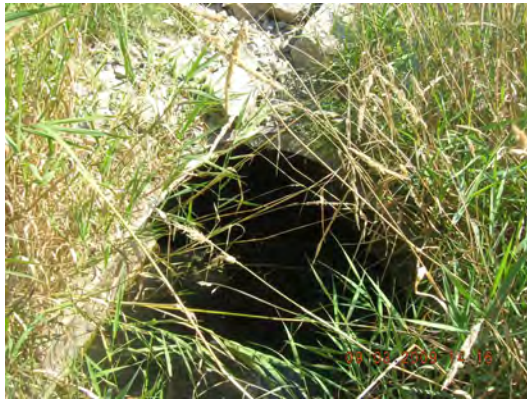
DSCN6459.JPG

Outfall partially submerged. Outfall screened upstream at 06-1136 US1.

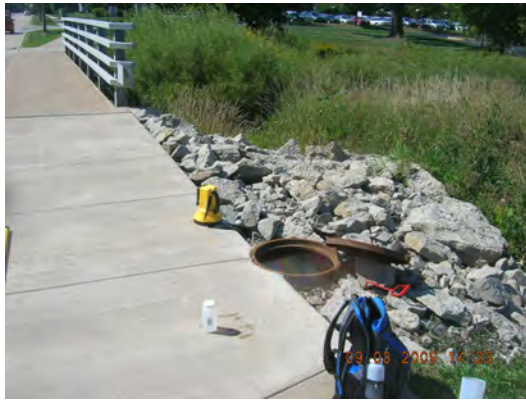
DSCN6462.JPG

Upstream manhole located approx 19 ft ESE of outfall 06-1136. Intermediate area consists of rip-rap embankment.

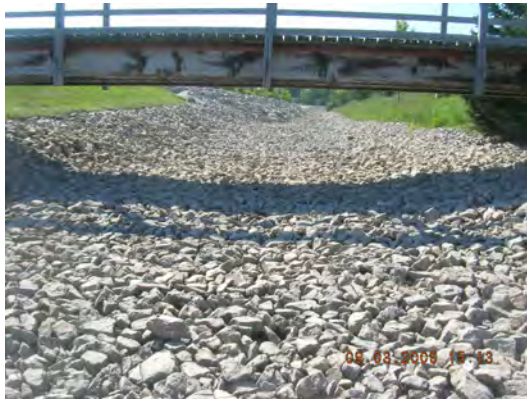
DSCN6469.JPG

Rip-rap channel into stormwater pond.

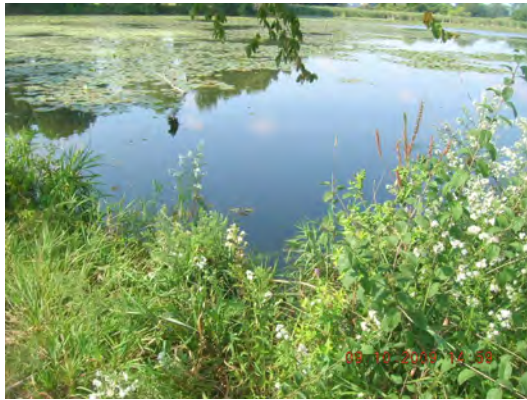
DSCN6811.JPG

Outfall fully submerged and not physically located.  
GPS coordinates approximate. Outfall screened  
upstream at 06-1694 US1. Pipe info from MS4 map.

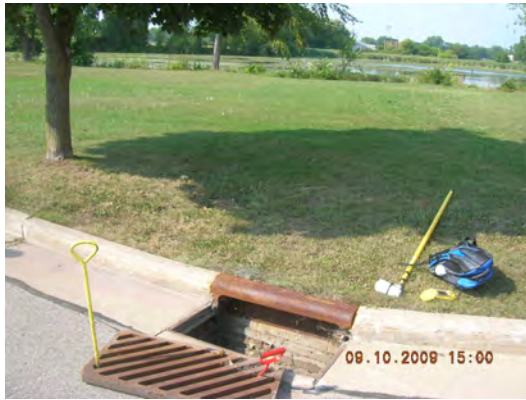
DSCN6813.JPG

Upstream manhole (inlet) located approx 109 ft S of outfall 06-1694. Intermediate area consists of open area north of wastewater treatment plant.

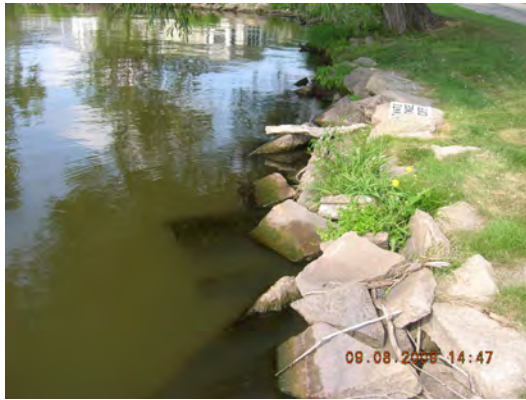
DSCN6655.JPG

Outfall fully submerged. Outfall screened upstream at 08-270 US1.

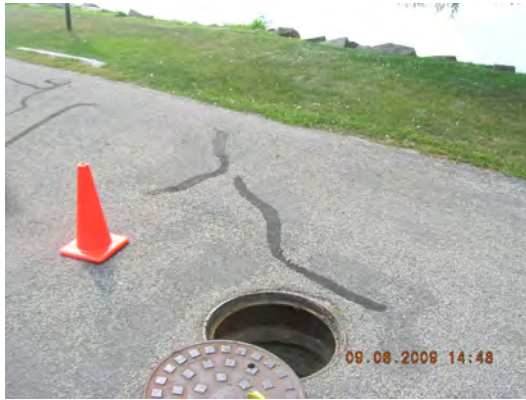
DSCN6657.JPG

Upstream manhole located approx 34 ft ENE of outfall 08-270. Intermediate area consists of road right-of-way and shoreline.

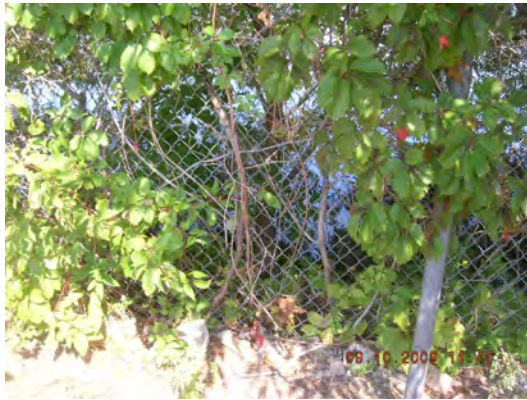
DSCN6782.JPG

Outfall not physically located - behind fence. GPS coordinates approximate. Outfall screened upstream at 09-32 US1. Pipe info from MS4 map.

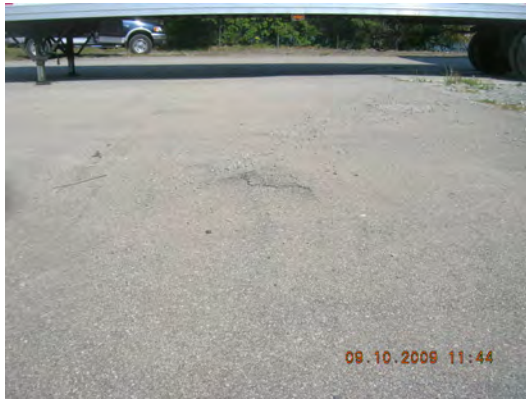
DSCN6783.JPG

Upstream manhole located approx 69 ft S of outfall 09-32. Inaccessible - paved over. No other manhole outside building.

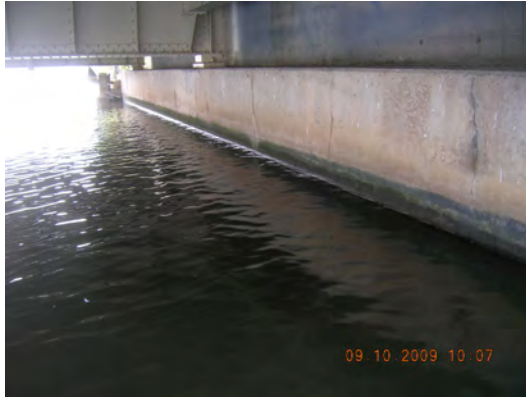
DSCN6770.JPG

Outfall fully submerged under bridge and not physically located. GPS coordinates approximate. Outfall screened upstream at 09-84 US1. Pipe info from MS4 map.

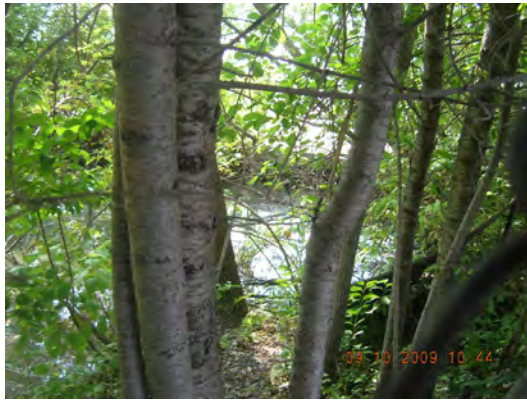
DSCN6774.JPG

Outfall not physically located - behind fence. May consist of three outfalls within one concrete box culvert. Outfall screened upstream at 09-101a US1.

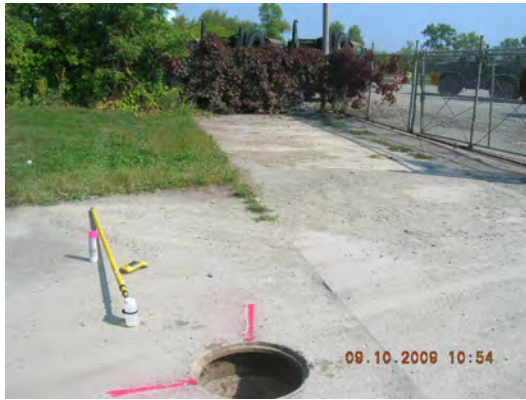
DSCN6776.JPG

Upstream manhole located approx 292 ft SSW of outfall 09-101a. Intermediate area consists of gravel parking area for industrial facility.

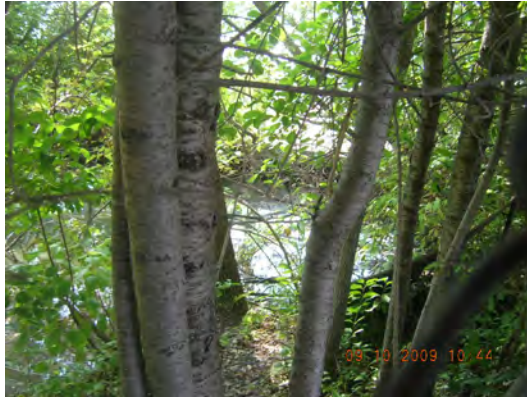
DSCN6774.JPG

Outfall not physically located - behind fence. May consist of three outfalls within one concrete box culvert. Outfall screened upstream at 09-101b US1.

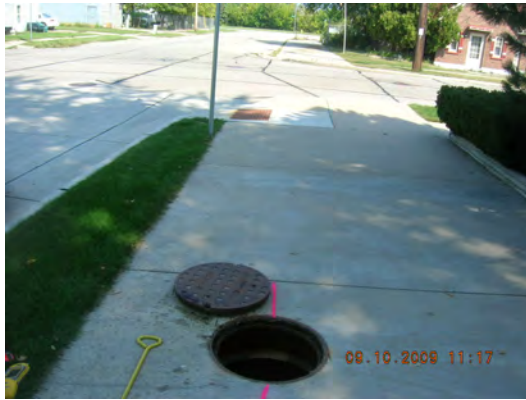
DSCN6779.JPG

Upstream manhole located approx 655 ft SSW of outfall 09-101b. Intermediate area consists of gravel parking area for industrial facility and residential streets.

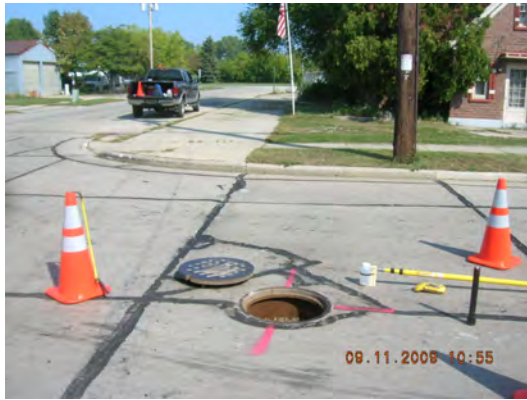
DSCN6890.JPG

Upstream manhole located approx 605 ft SSW of outfall 09-101c. Intermediate area consists of gravel parking area for industrial facility and residential streets.

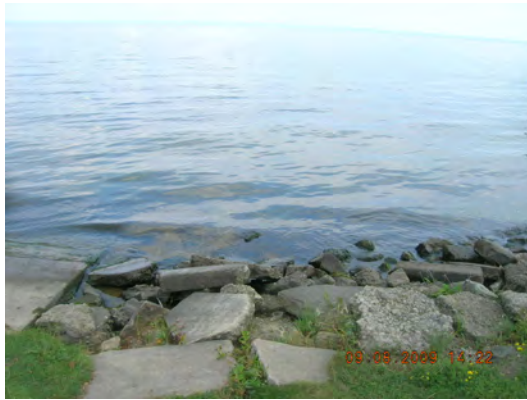
DSCN6651.JPG

Outfall fully submerged and not physically located.  
GPS coordinates approximate. Outfall screened  
upstream at 11-64 US1. Pipe info from MS4 map.

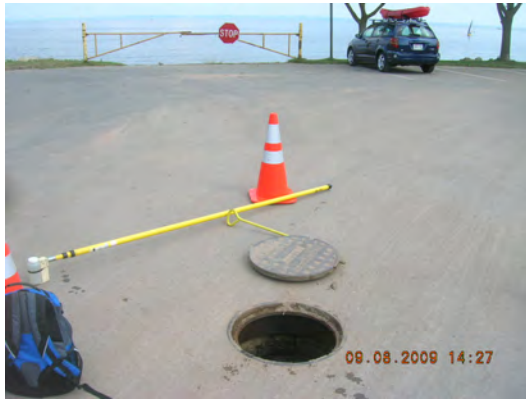
DSCN6652.JPG

Upstream manhole located approx 86 ft W of outfall 11-64. Intermediate area consists of paved parking area near beach and boat launch.

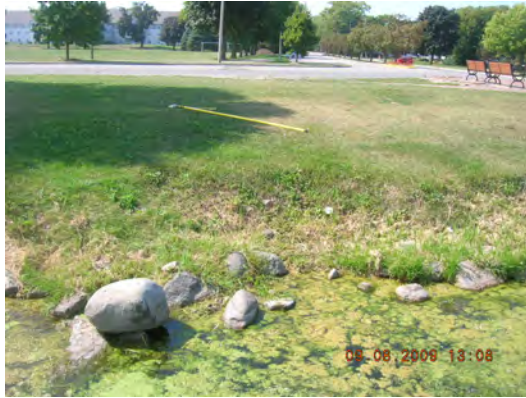
DSCN6628.JPG

Outfall fully submerged and not physically located.  
GPS coordinates approximate. Outfall screened  
upstream at 11-173 US1. Pipe info from MS4 map.

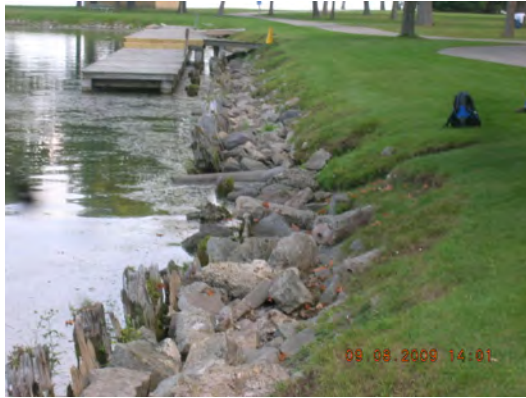
DSCN6644.JPG

Outfall fully submerged. Outfall screened upstream at 11-244 US1.

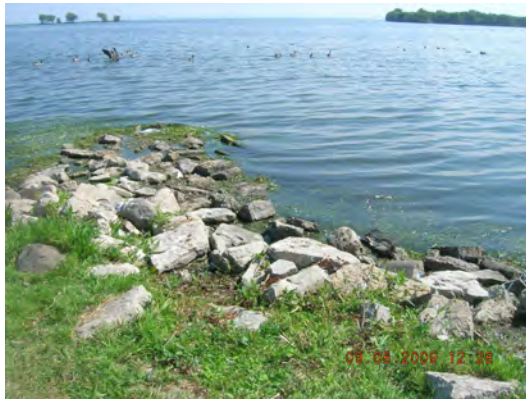
DSCN6620.JPG

Outfall fully submerged and not physically located.  
GPS coordinates approximate. Outfall screened  
upstream at 11-376 US1. Pipe info from MS4 map.

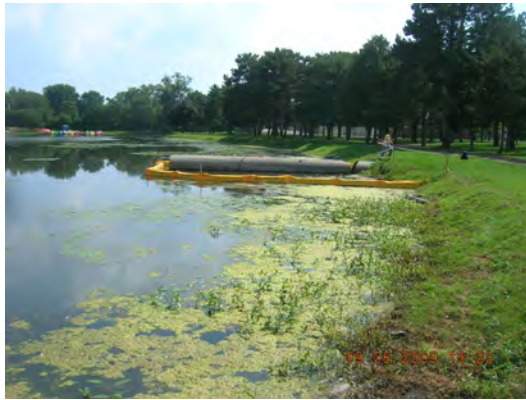
DSCN6632.JPG

Outfall partially submerged. Outfall screened upstream at 11-400 US1.

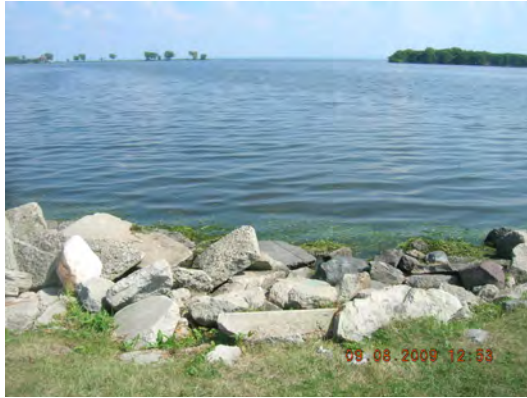
DSCN6624.JPG

Outfall fully submerged and not physically located.  
GPS coordinates approximate. Outfall screened  
upstream at 11-465 US1. Pipe info from MS4 map.

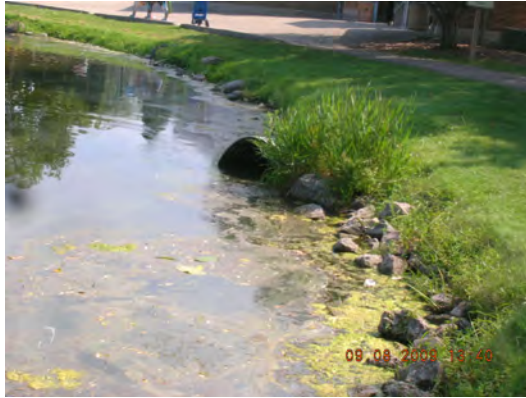
DSCN6638.JPG

Outfall partially submerged. Outfall screened upstream at 11-479 US1.

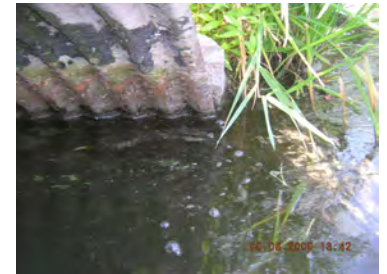
DSCN6639.JPG

- Outfall Damage** ☒ Corrosion ☐ Peeling Paint ☐ Spalling/Cracking/Chipping  
**Deposits/Stains** ☐ Oily ☐ Paint ☒ Flow Line ☐ Other:  
**Pipe Benthic Growth** ☐ Brown ☐ Orange ☒ Green ☐ Other:  
**Abnormal Vegetation** ☐ Inhibited ☐ Excessive  
**Poor Pool Quality** ☐ Odors ☐ Colors ☐ Oil Sheen ☐ Suds ☐ Floatables  
☐ Excessive Algae ☐ Other:

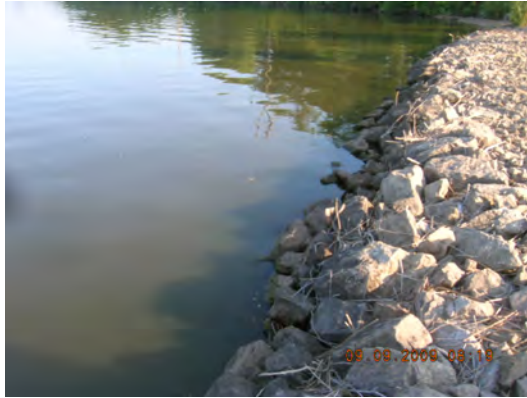
DSCN6673.JPG

Outfall fully submerged and not physically located.  
GPS coordinates approximate. Outfall screened  
upstream at 12-576 US1. Pipe info from MS4 map.
