# Initial Screening Summary Report

Illicit Discharge Detection and Elimination Program

City of Oshkosh

May 18, 2010

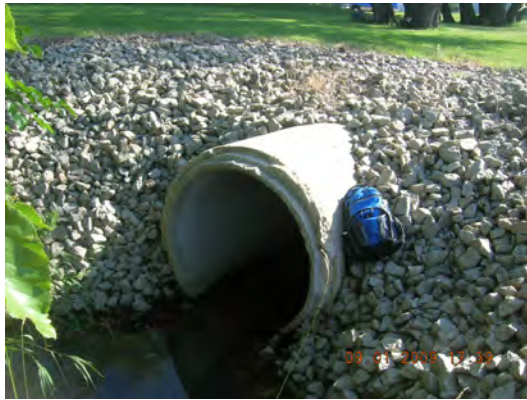
DSCN6304.JPG

Outfall partially submerged. Outfall screened upstream at 12-925 US1.

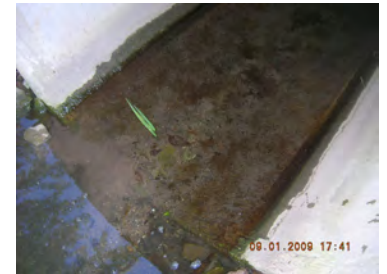
DSCN6305.JPG

- Outfall Damage** ☐ Corrosion ☐ Peeling Paint ☐ Spalling/Cracking/Chipping  
**Deposits/Stains** ☐ Oily ☐ Paint ☐ Flow Line ☐ Other:  
**Pipe Benthic Growth** ☒ Brown ☐ Orange ☒ Green ☐ Other:  
**Abnormal Vegetation** ☐ Inhibited ☐ Excessive  
**Poor Pool Quality** ☒ Odors ☐ Colors ☐ Oil Sheen ☐ Suds ☐ Floatables  
☐ Excessive Algae ☐ Other:

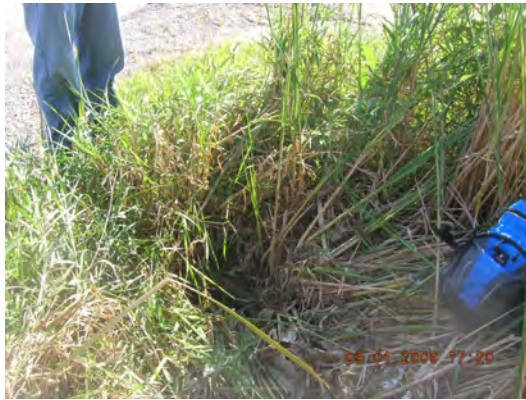
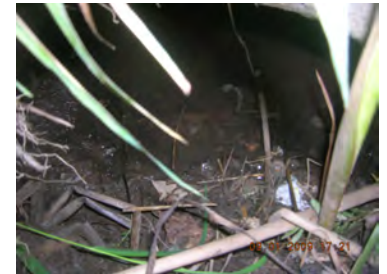
Size and shape not verified - half filled with sediment. Pipe info from MS4 map.

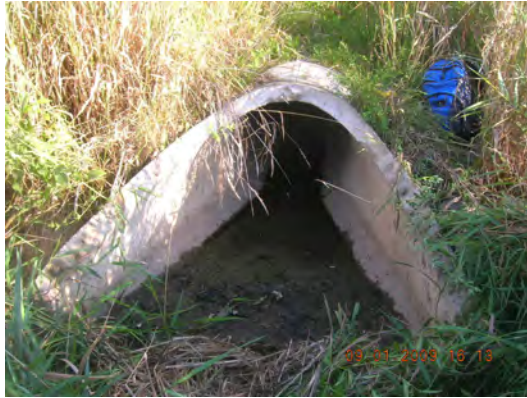
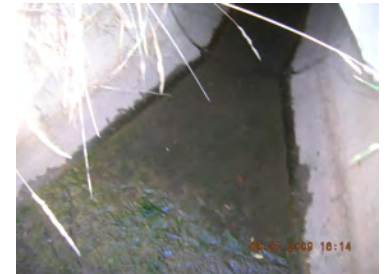
Inlet to stormwater pond.

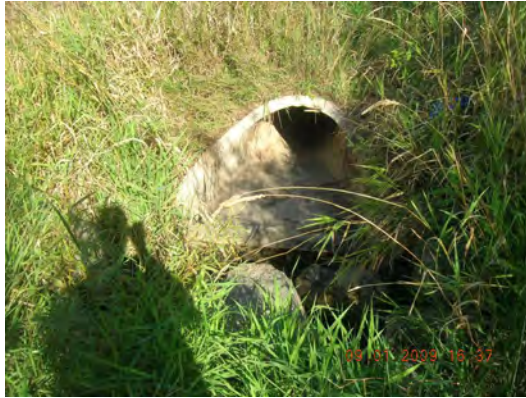
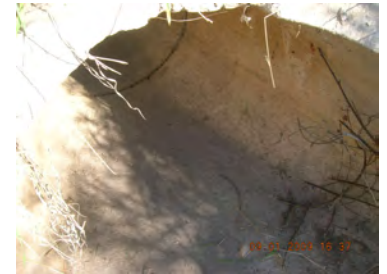
Inlet to stormwater pond.

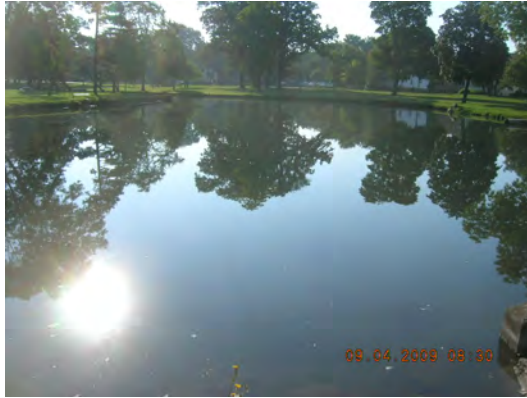
DSCN6488.JPG

Outfall fully submerged and not physically located.  
GPS coordinates approximate. Outfall screened  
upstream at 13-101 US1. Pipe info from MS4 map.

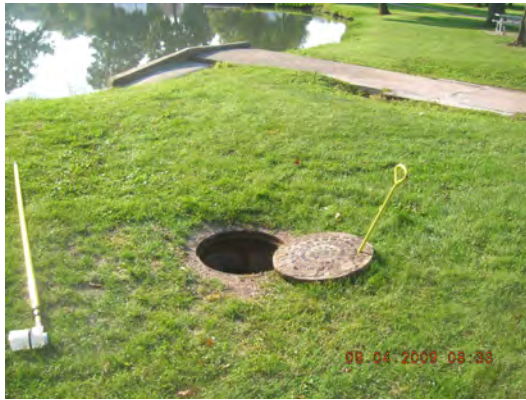
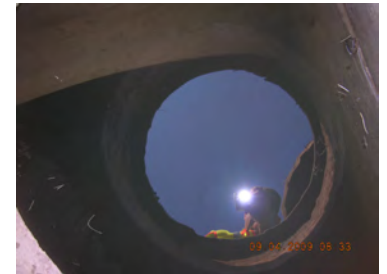
Upstream manhole located approx 43 ft NW of outfall 13-101. Intermediate area consists of open space in park.

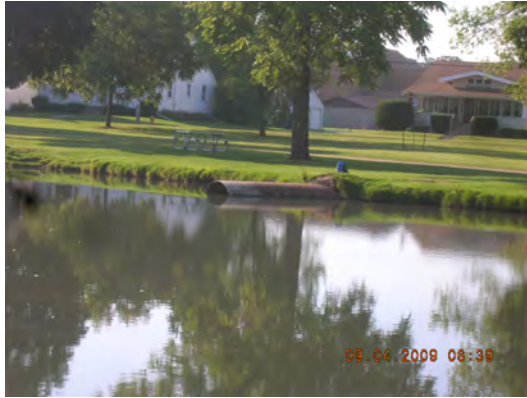
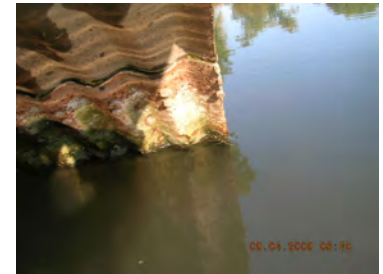
Outfall partially submerged. Outfall screened upstream at 13-337 US1. Pipe info from MS4 map.

- Outfall Damage** ☒ Corrosion ☐ Peeling Paint ☐ Spalling/Cracking/Chipping  
**Deposits/Stains** ☐ Oily ☐ Paint ☒ Flow Line ☐ Other:  
**Pipe Benthic Growth** ☐ Brown ☐ Orange ☒ Green ☐ Other:  
**Abnormal Vegetation** ☐ Inhibited ☐ Excessive  
**Poor Pool Quality** ☐ Odors ☐ Colors ☐ Oil Sheen ☐ Suds ☐ Floatables  
☐ Excessive Algae ☐ Other:

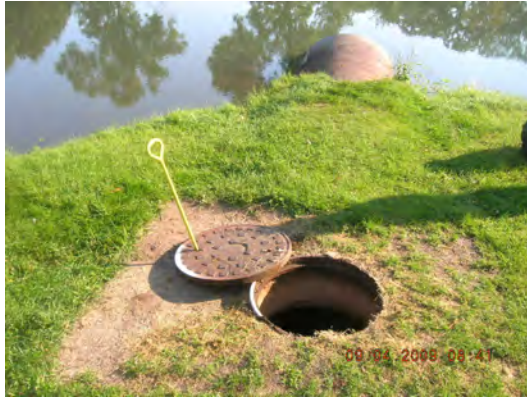
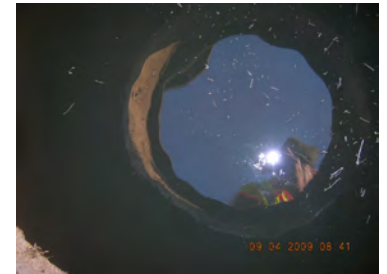
Upstream manhole located approx 20 ft SW of outfall 13-337. Intermediate area consists of open space in park.

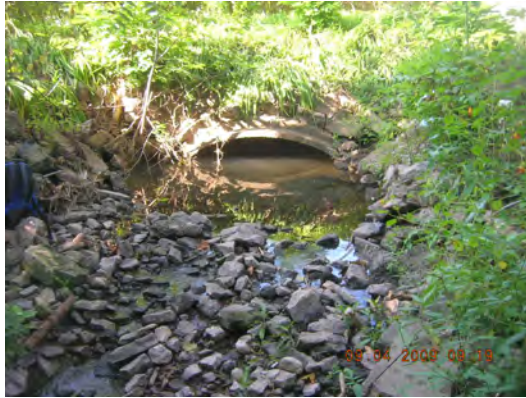
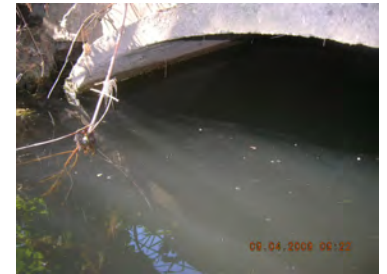
First upstream manhole buried under concrete sidewalk. Second upstream manhole buried under concrete street. Sample collected from pool by outfall. City may want to attempt to locate and access buried manholes.

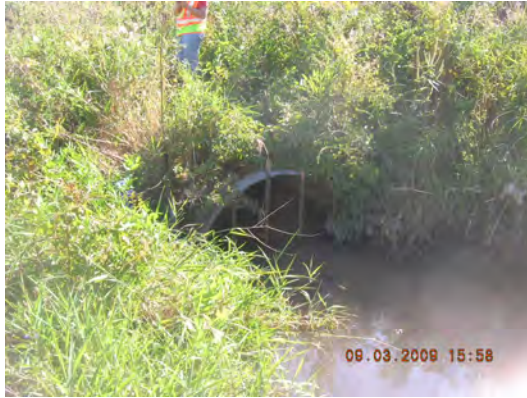
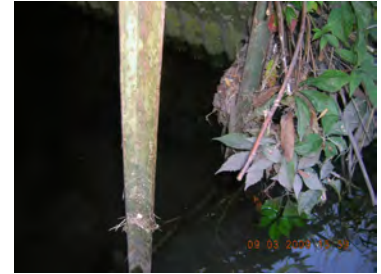
Outfall partially submerged. Outfall screened upstream at 13-875 US1.

<b>Outfall Damage</b>	<input checked="" type="checkbox"/> Corrosion	<input type="checkbox"/> Peeling Paint	<input type="checkbox"/> Spalling/Cracking/Chipping				
<b>Deposits/Stains</b>	<input type="checkbox"/> Oily	<input type="checkbox"/> Paint	<input type="checkbox"/> Flow Line	<input type="checkbox"/> Other:			
<b>Pipe Benthic Growth</b>	<input type="checkbox"/> Brown	<input type="checkbox"/> Orange	<input checked="" type="checkbox"/> Green	<input type="checkbox"/> Other:			
<b>Abnormal Vegetation</b>	<input type="checkbox"/> Inhibited	<input type="checkbox"/> Excessive					
<b>Poor Pool Quality</b>	<input type="checkbox"/> Odors	<input type="checkbox"/> Colors	<input type="checkbox"/> Oil Sheen	<input type="checkbox"/> Suds	<input type="checkbox"/> Floatables		
	<input type="checkbox"/> Excessive Algae	<input type="checkbox"/> Other:

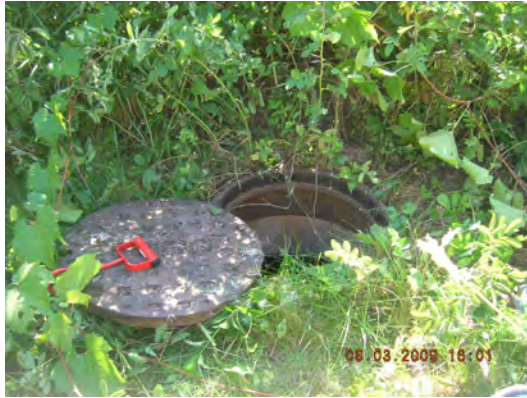
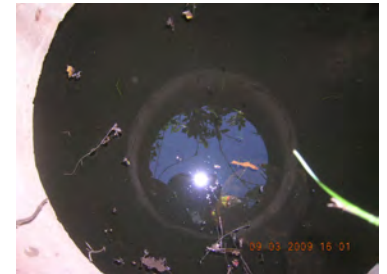
Upstream manhole located approx 10 ft S of outfall 13-875. Intermediate area consists of open space.

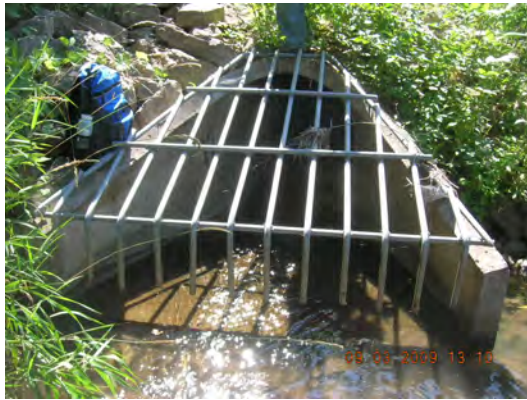
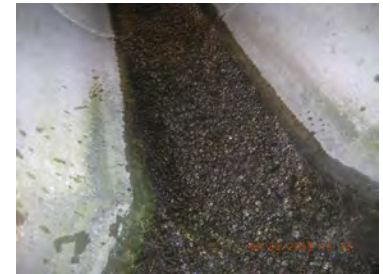
Outfall partially submerged. Outfall screened upstream at 13-948 US1.

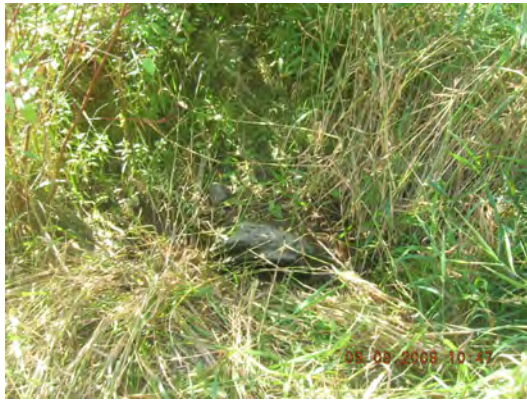
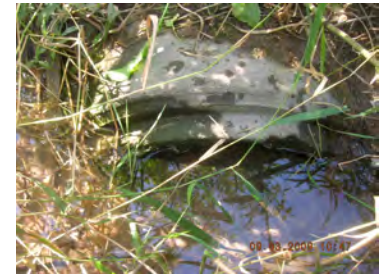
DSCN6425.JPG

Outfall partially submerged. Outfall screened upstream at 13-1098 US1.

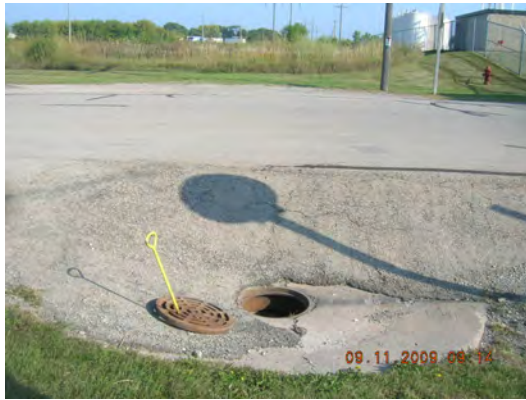
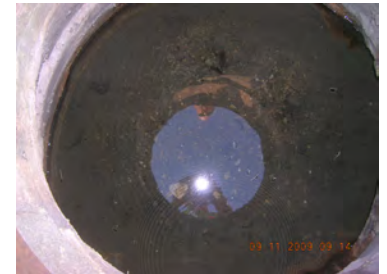
DSCN6852.JPG

Upstream manhole (inlet) located approx 103 ft S of outfall 13-1098. Intermediate area consists of driveway to industrial facility.

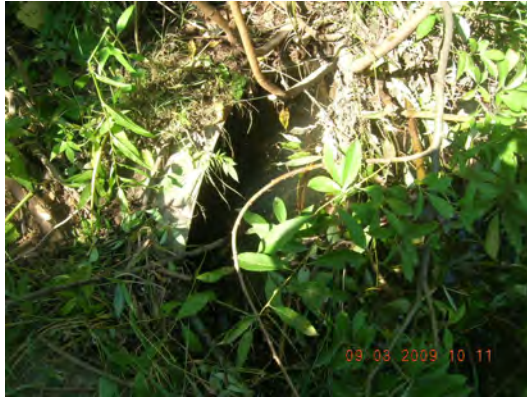
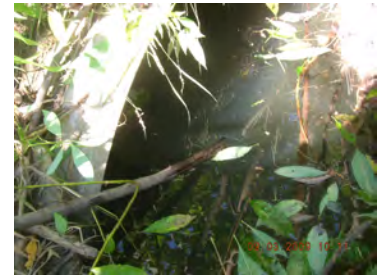
DSCN6419.JPG

Outfall partially submerged. Outfall screened upstream at 13-1174 US1. Pipe info from MS4 map.

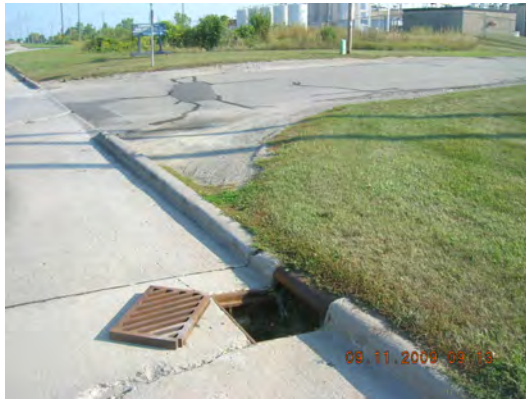
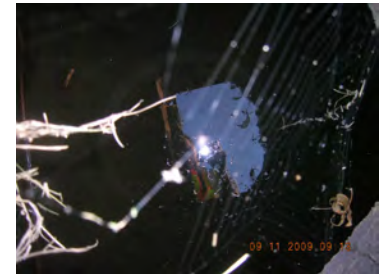
DSCN6849.JPG

Upstream manhole (inlet) located approx 112 ft SSW of outfall 13-1174. Intermediate area consists of driveway to industrial facility.

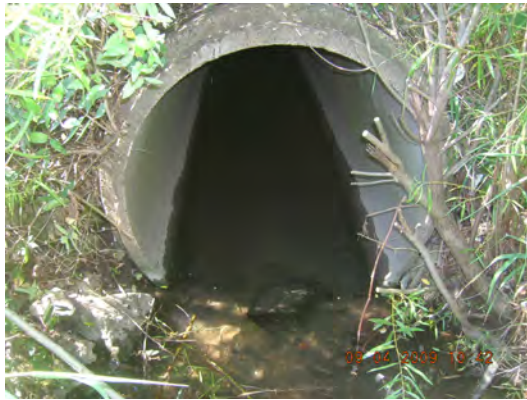
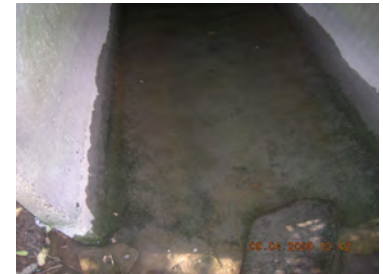
DSCN6507.JPG

Outfall partially submerged. Outfall screened upstream at 13-1219 US1.

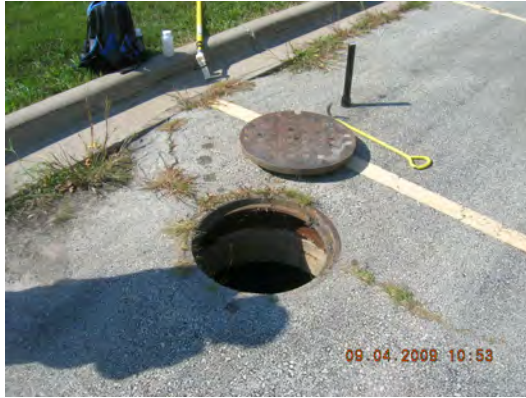
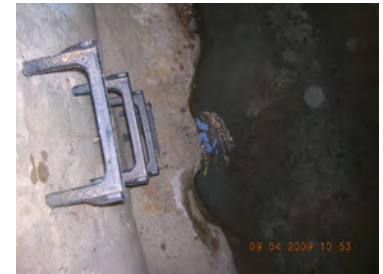
DSCN6510.JPG

Upstream manhole located approx 139 ft SW of outfall 13-1219. Intermediate area consists of paved commercial parking lot.

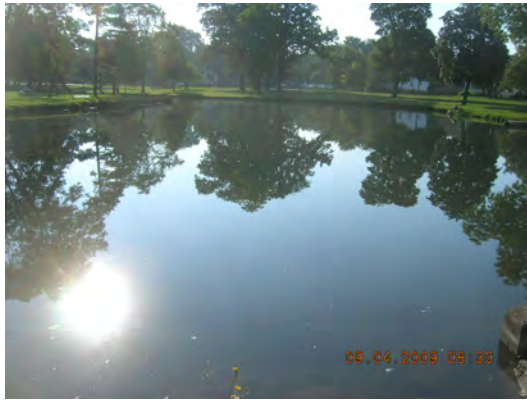
DSCN6488.JPG

Outfall fully submerged and not physically located.  
GPS coordinates approximate. Outfall screened  
upstream at 13-1242 US1. Pipe info from MS4 map.

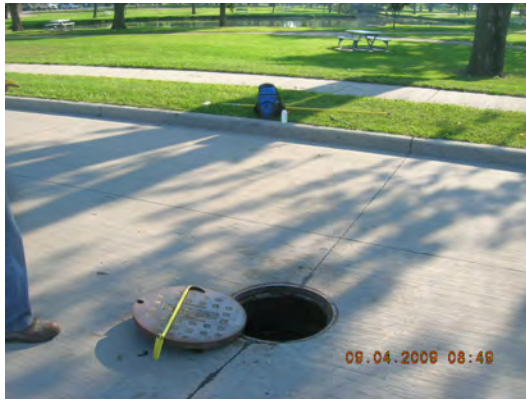
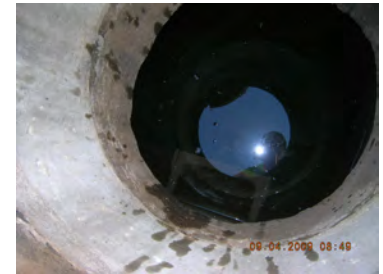
DSCN6499.JPG

Upstream manhole located approx 158 ft SW of outfall 13-1242. Intermediate area consists of open space in park and street right-of-way.

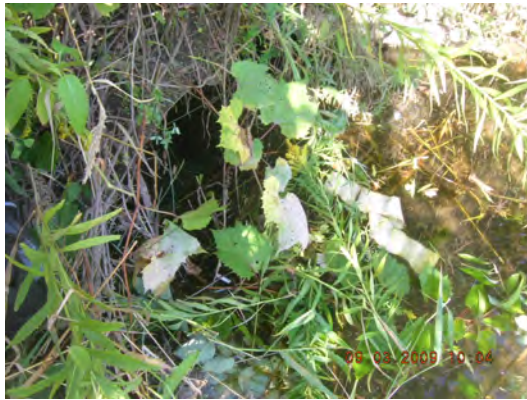
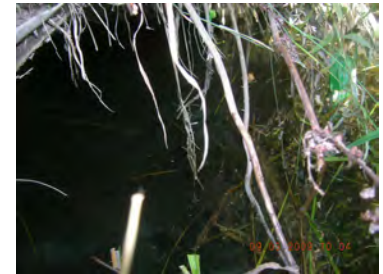
DSCN6416.JPG

Outfall partially submerged. Outfall screened upstream at 13-1283 US1. Pipe info from MS4 map.

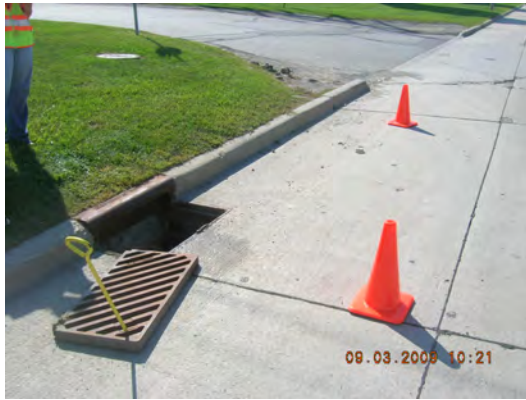
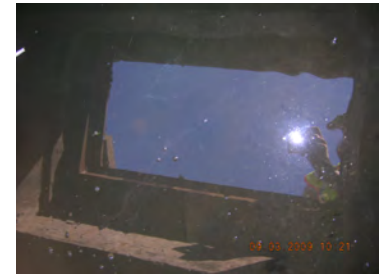
DSCN6422.JPG

Upstream manhole(inlet) located approx 112 ft SSW of outfall 13-1283. Intermediate area consists of street right-of-way.

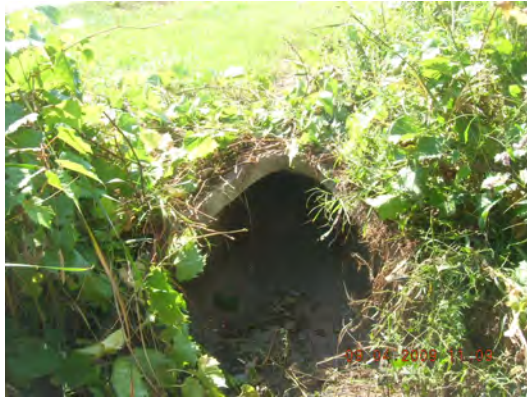
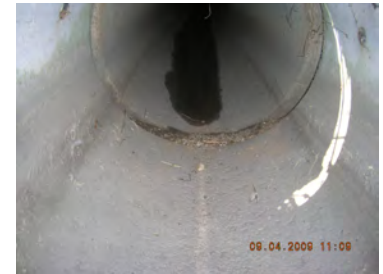
DSCN6513.JPG

Apron separated from pipe.

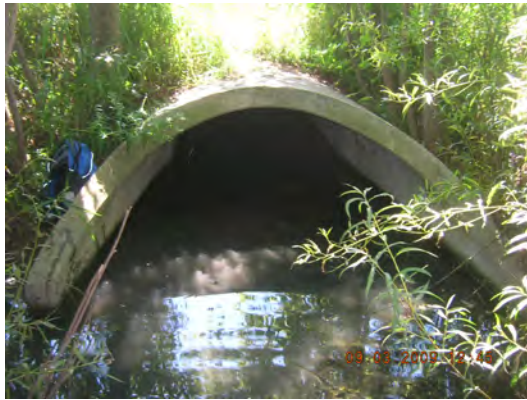
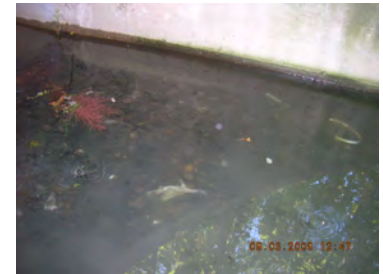
DSCN6436.JPG

Outfall partially submerged. Outfall screened upstream at 13-2332 US1.

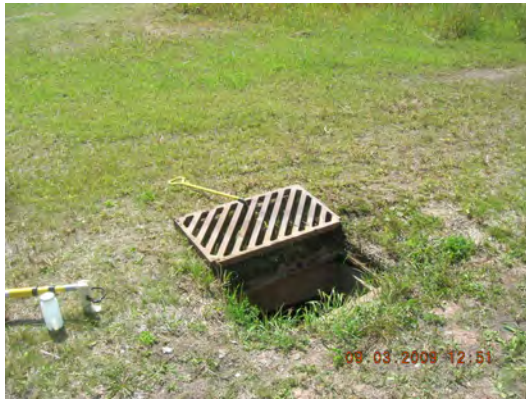
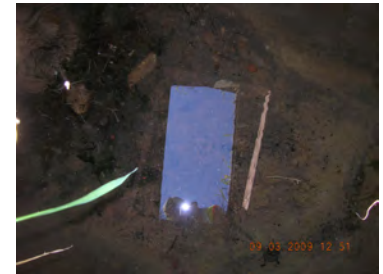
DSCN6439.JPG

Upstream manhole (inlet) located approx 30 ft S of outfall 13-2332. Intermediate area consists of open space.

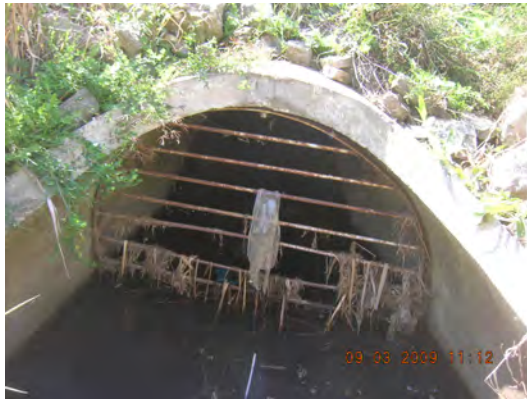
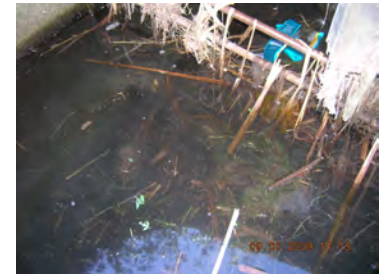
DSCN6429.JPG

Outfall partially submerged. Outfall screened upstream at 13-2613 US1.

- Outfall Damage** ☐ Corrosion ☐ Peeling Paint ☐ Spalling/Cracking/Chipping  
**Deposits/Stains** ☐ Oily ☐ Paint ☒ Flow Line ☐ Other:  
**Pipe Benthic Growth** ☐ Brown ☐ Orange ☒ Green ☐ Other:  
**Abnormal Vegetation** ☐ Inhibited ☐ Excessive  
**Poor Pool Quality** ☐ Odors ☐ Colors ☐ Oil Sheen ☐ Suds ☒ Floatables  
☒ Excessive Algae ☐ Other:

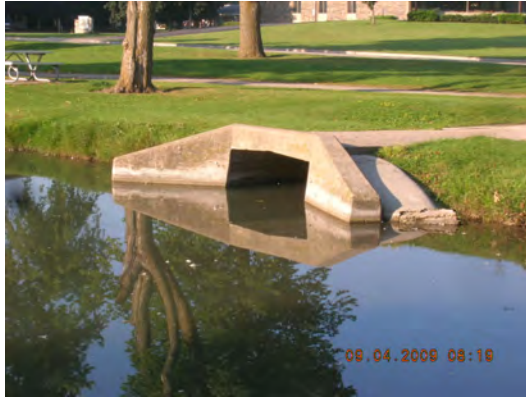
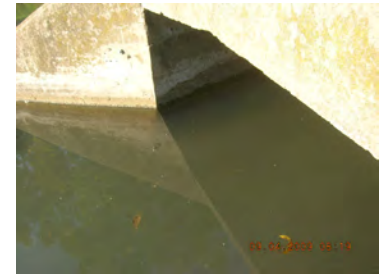
DSCN6482.JPG

Outfall partially submerged. Outfall screened upstream at 13-2957 US1.

- Outfall Damage** ☐ Corrosion ☐ Peeling Paint ☐ Spalling/Cracking/Chipping  
**Deposits/Stains** ☐ Oily ☐ Paint ☒ Flow Line ☐ Other:  
**Pipe Benthic Growth** ☒ Brown ☐ Orange ☐ Green ☐ Other:  
**Abnormal Vegetation** ☐ Inhibited ☐ Excessive  
**Poor Pool Quality** ☐ Odors ☐ Colors ☐ Oil Sheen ☐ Suds ☐ Floatables  
☐ Excessive Algae ☐ Other:

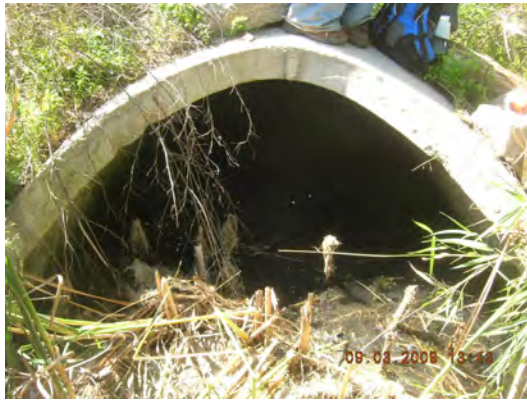
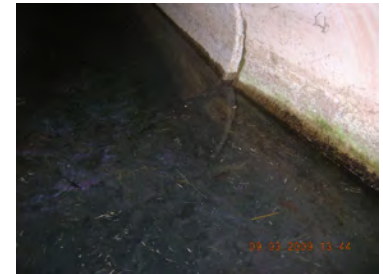
DSCN6448.JPG

Outfall partially submerged. Outfall screened upstream at 13-3099 US1. Pipe info from MS4 map.

### Illicit Discharge Potential: Potential

- Outfall Damage** ☐ Corrosion ☐ Peeling Paint ☐ Spalling/Cracking/Chipping  
**Deposits/Stains** ☐ Oily ☐ Paint ☒ Flow Line ☐ Other:  
**Pipe Benthic Growth** ☐ Brown ☐ Orange ☒ Green ☐ Other:  
**Abnormal Vegetation** ☐ Inhibited ☐ Excessive  
**Poor Pool Quality** ☒ Odors ☐ Colors ☒ Oil Sheen ☐ Suds ☐ Floatables  
☐ Excessive Algae ☐ Other:

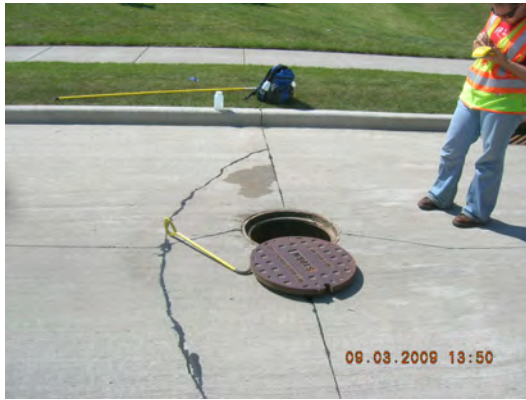
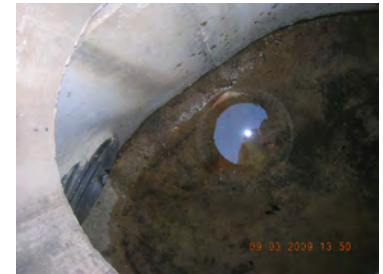
DSCN6453.JPG

Upstream manhole located approx 54 ft W of outfall 13-3099. Intermediate area consists of open space in park.

- ☐ Odors
- ☐ Colors
- ☒ Oil Sheen
- ☐ Suds
- ☐ Floatables
- ☐ Excessive Algae
- ☐ Other:

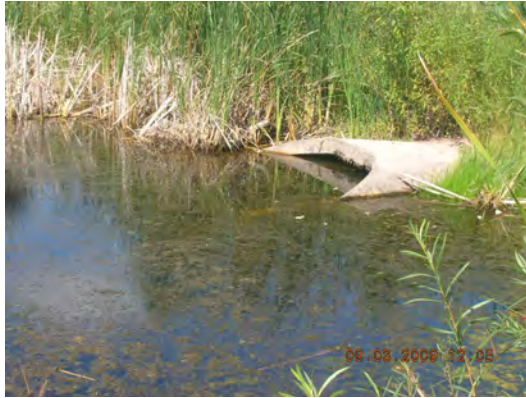
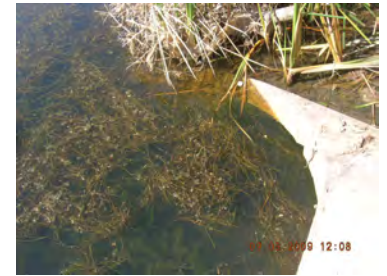
DSCN6433.JPG

- ☒ Office Follow-up Required  
☒ Field Follow-up Required  
☐ Damaged  
☐ Graffiti  
☐ Significant Erosion

Outfall partially submerged. Could not locate upstream manhole. Sample collected from pool.

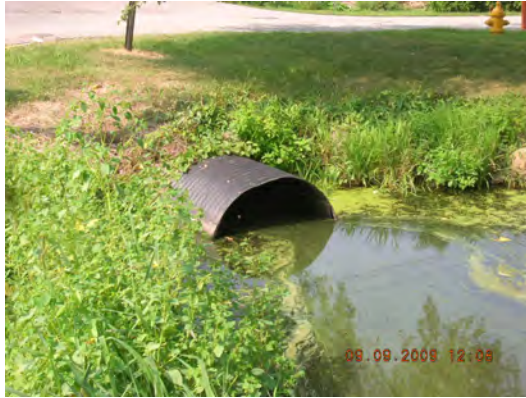
DSCN6720.JPG

Outfall partially submerged. Outfall screened upstream at 14-188 US1. Pipe info from MS4 map.

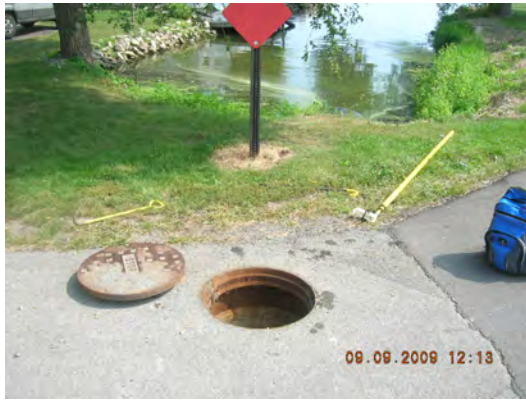
DSCN6723.JPG

Upstream manhole located approx 25 ft W of outfall 14-188. Intermediate area consists of paved driveway to parking area.

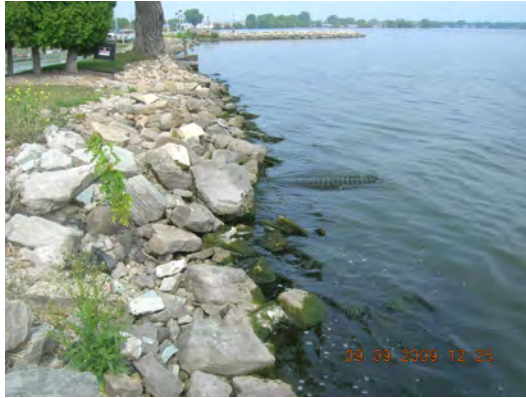
DSCN6726.JPG

Outfall almost fully submerged. Outfall screened upstream at 14-331 US1.

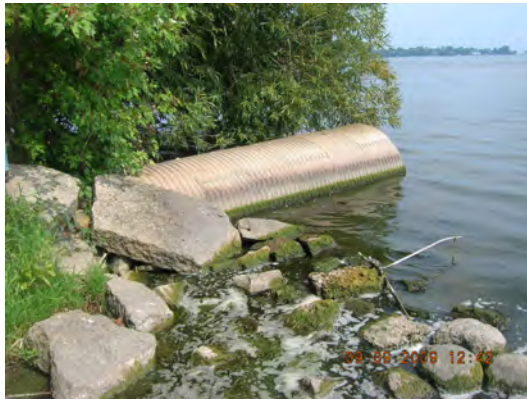
DSCN6729.JPG

Outfall partially submerged. Outfall screened upstream at 14-400 US1.

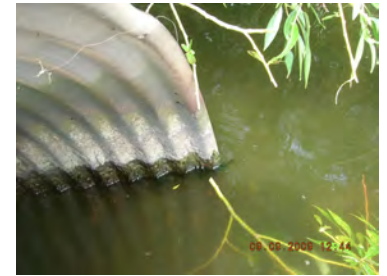
DSCN6730.JPG

- Outfall Damage** ☒ Corrosion ☐ Peeling Paint ☐ Spalling/Cracking/Chipping  
**Deposits/Stains** ☐ Oily ☐ Paint ☒ Flow Line ☐ Other:  
**Pipe Benthic Growth** ☐ Brown ☐ Orange ☒ Green ☐ Other:  
**Abnormal Vegetation** ☐ Inhibited ☐ Excessive  
**Poor Pool Quality** ☐ Odors ☐ Colors ☐ Oil Sheen ☐ Suds ☐ Floatables  
☐ Excessive Algae ☐ Other:

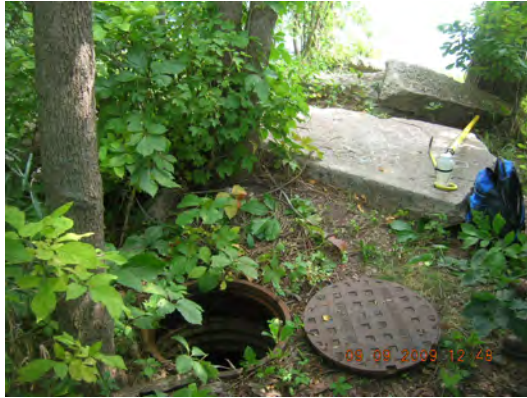
DSCN6732.JPG

Upstream manhole located approx 38 ft W of outfall 14-400. Intermediate area consists of wooded shoreline.

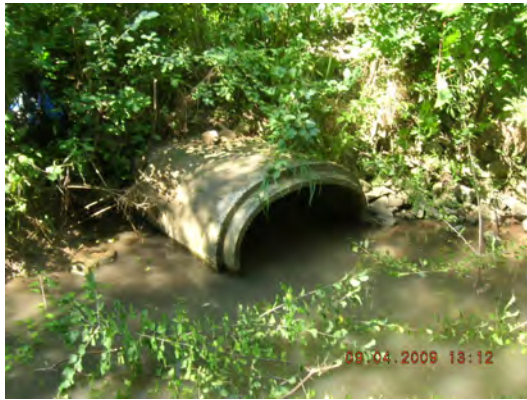
DSCN6530.JPG

Outfall partially submerged. Outfall screened upstream at 14-595 US1.

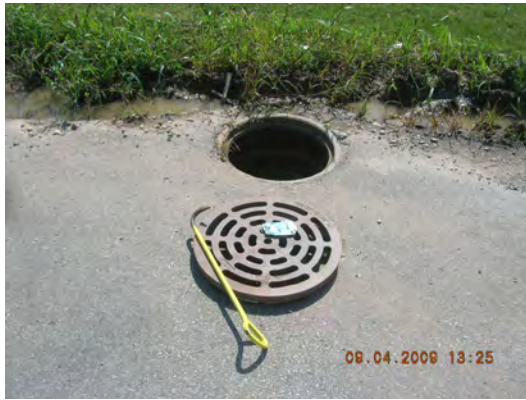
DSCN6534.JPG

Upstream manhole located approx 649 ft W of outfall 14-595. Intermediate area consists of open space and fenced stormwater pond, with paved parking area to north.

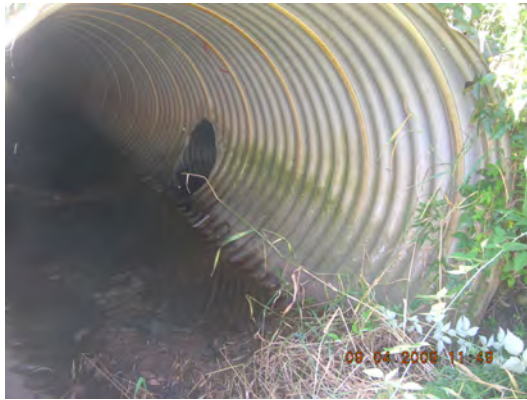
DSCN6527.JPG

24 inch CMP discharges into west culvert.

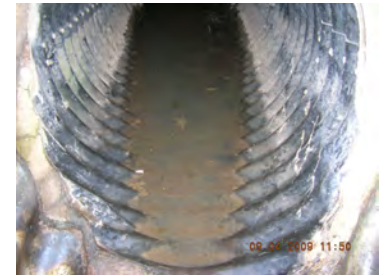
DSCN6528.JPG

- Outfall Damage** ☐ Corrosion ☒ Peeling Paint ☐ Spalling/Cracking/Chipping  
**Deposits/Stains** ☐ Oily ☐ Paint ☐ Flow Line ☐ Other:  
**Pipe Benthic Growth** ☐ Brown ☐ Orange ☐ Green ☐ Other:  
**Abnormal Vegetation** ☐ Inhibited ☐ Excessive  
**Poor Pool Quality** ☐ Odors ☐ Colors ☐ Oil Sheen ☐ Suds ☐ Floatables  
☐ Excessive Algae ☐ Other:

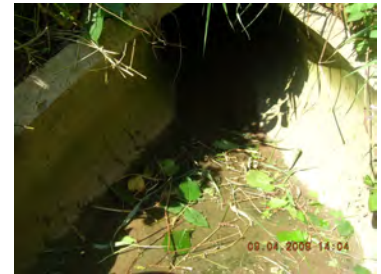
DSCN6547.JPG

- Outfall Damage** ☐ Corrosion ☐ Peeling Paint ☒ Spalling/Cracking/Chipping  
**Deposits/Stains** ☐ Oily ☐ Paint ☒ Flow Line ☐ Other:  
**Pipe Benthic Growth** ☐ Brown ☐ Orange ☐ Green ☐ Other:  
**Abnormal Vegetation** ☐ Inhibited ☐ Excessive  
**Poor Pool Quality** ☐ Odors ☐ Colors ☐ Oil Sheen ☐ Suds ☐ Floatables  
☐ Excessive Algae ☐ Other:

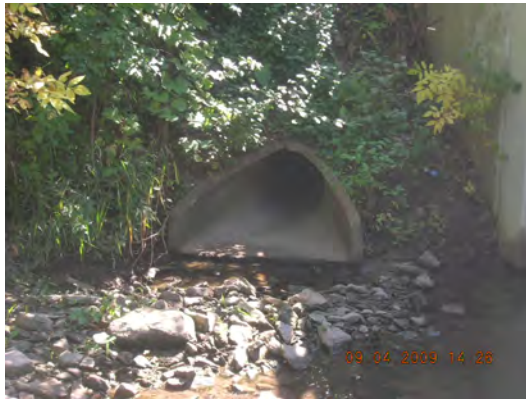
DSCN6558.JPG

- ☐ Office Follow-up Required  
☐ Field Follow-up Required  
☒ Damaged  
☒ Graffiti  
☐ Significant Erosion

Apron separated from pipe.

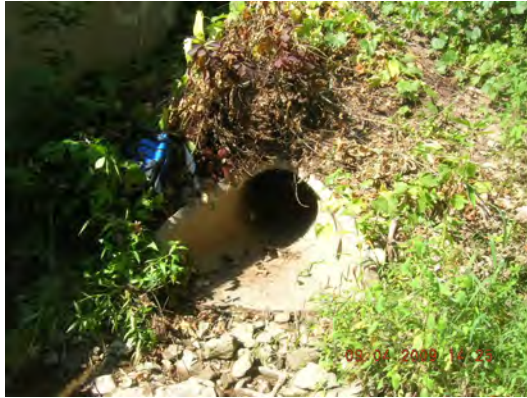
DSCN6552.JPG

- ☐ Office Follow-up Required  
☐ Field Follow-up Required  
☒ Damaged  
☒ Graffiti  
☐ Significant Erosion

Outfall Notes:  
Apron separated from pipe.

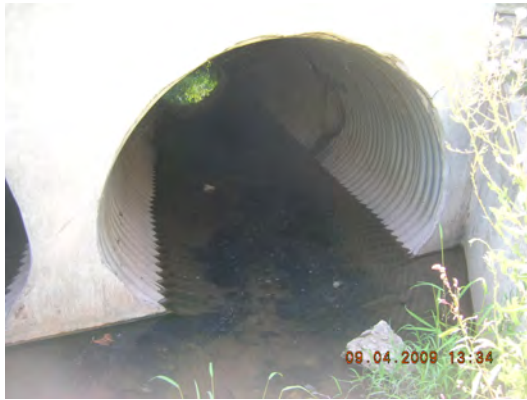
DSCN6537.JPG

30 inch CMP discharges into west culvert

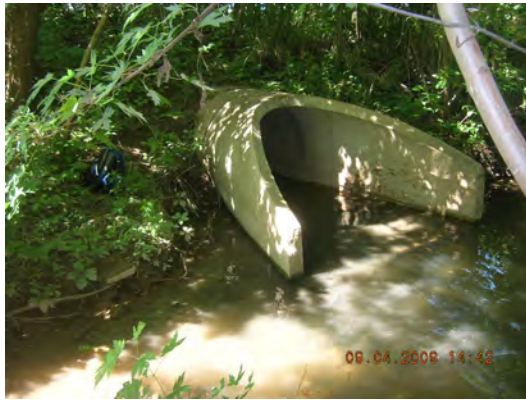
DSCN6563.JPG

Outfall partially submerged. Outfall screened upstream at 14-996 US1.

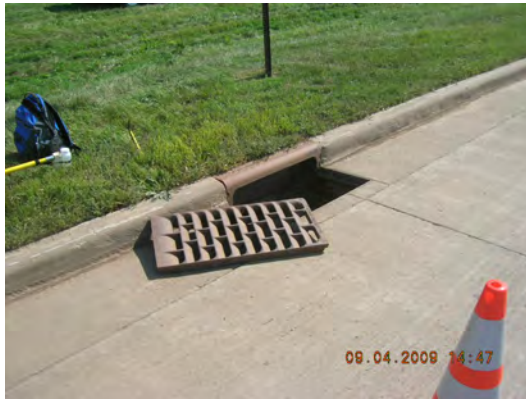
DSCN6566.JPG

Upstream manhole (inlet) located approx 139 ft NW of outfall 14-996. Intermediate area consists of open space and wooded shoreline.

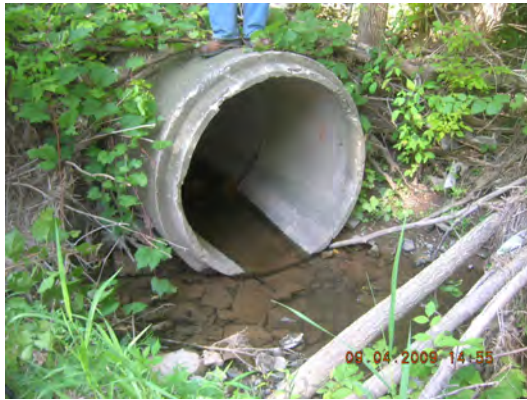
DSCN6569.JPG

Outfall partially submerged. Grate on upstream manhole (14-999 US1) could not be removed - sample collected from pool. End pipe section separated.

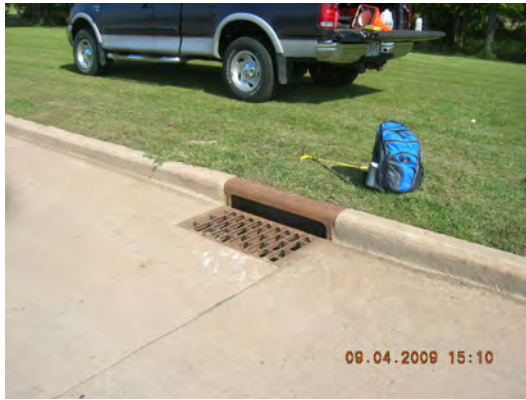
DSCN6573.JPG

Upstream manhole (inlet) located approx 322 ft NNW of outfall 14-999. Intermediate area consists of railroad right-of-way. Inlet grate could not be removed - screened from pool at outfall. City crews to open grate for future inspections.

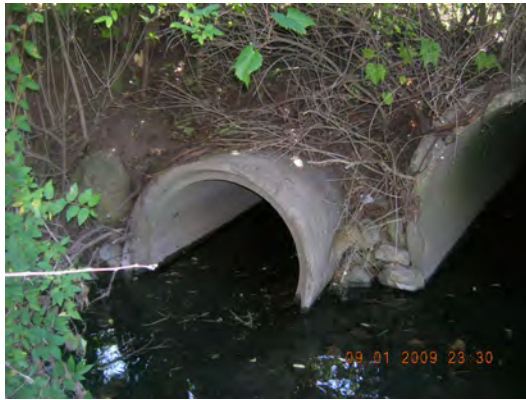
DSCN6390.JPG

Outfall partially submerged. Outfall screened upstream at 15-744 US1.

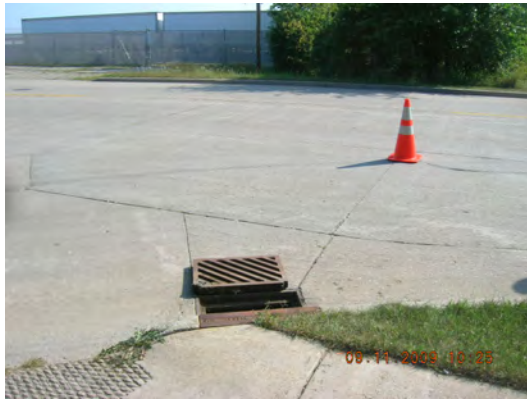
DSCN6885.JPG

Upstream manhole (inlet) located approx 48 ft W of outfall 15-744. Intermediate area consists of road right-of-way. Verify correct upstream location (vault for 36" pipe).

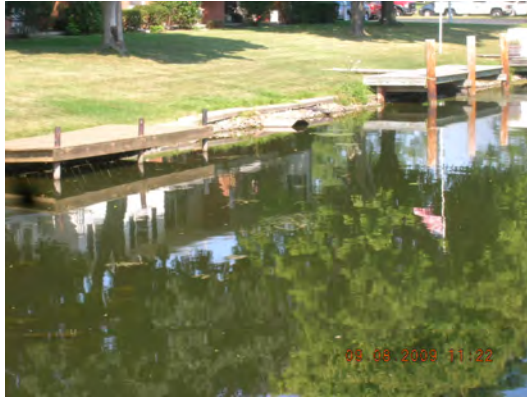
DSCN6608.JPG

Outfall partially submerged. Outfall screened upstream at 15-787 US1. Pipe info from MS4 map.

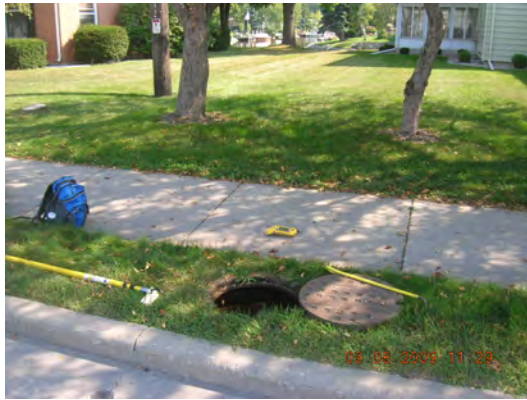
DSCN6611.JPG

Upstream manhole located approx 142 ft W of outfall 15-787. Intermediate area consists of residential property.

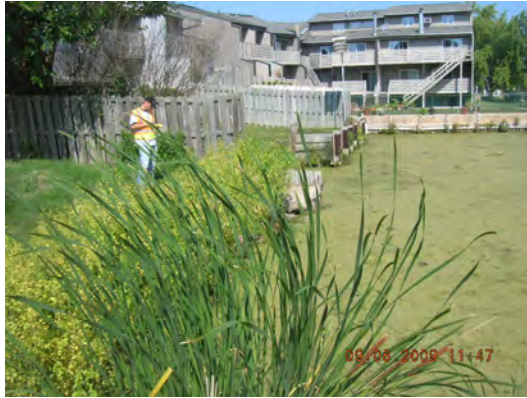
DSCN6616.JPG

Outfall fully submerged and not physically located.  
GPS coordinates approximate. Outfall screened  
upstream at 15-910 US1. Pipe info from MS4 map.

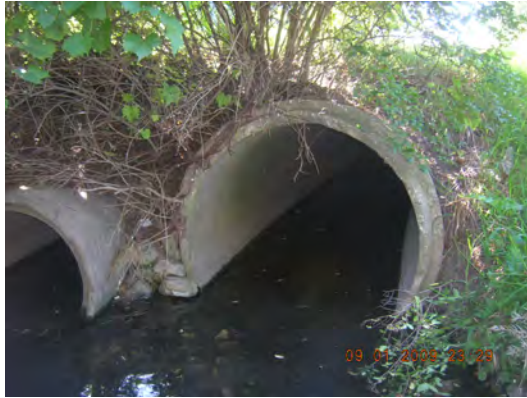
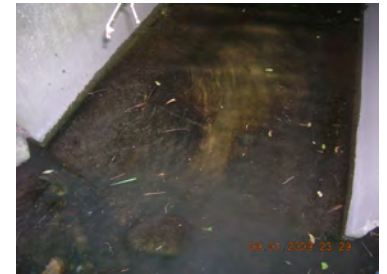
Outfall partially submerged. Outfall screened upstream at 15-940 US1.

Inspection Date: 9/2/2009 Inspector: JCW Flow Description: Submerged, slight flow Previous Rainfall (hrs): 72+

- Outfall Damage** ☐ Corrosion ☐ Peeling Paint ☐ Spalling/Cracking/Chipping  
**Deposits/Stains** ☐ Oily ☐ Paint ☐ Flow Line ☐ Other:  
**Pipe Benthic Growth** ☐ Brown ☐ Orange ☒ Green ☐ Other:  
**Abnormal Vegetation** ☐ Inhibited ☐ Excessive  
**Poor Pool Quality** ☐ Odors ☐ Colors ☐ Oil Sheen ☐ Suds ☐ Floatables  
☐ Excessive Algae ☐ Other:

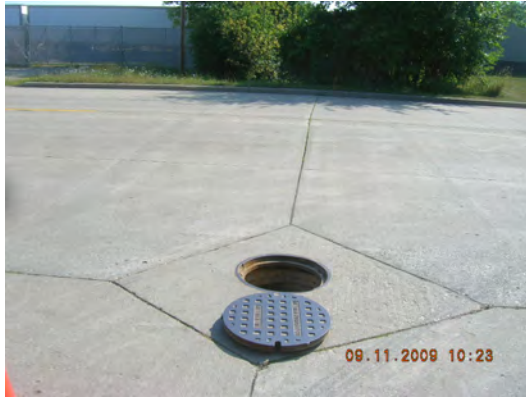
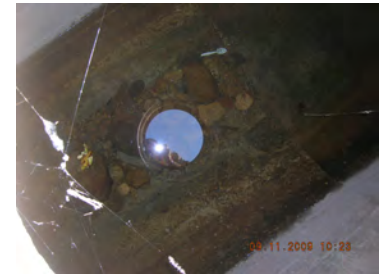
Upstream manhole located approx 47 ft W of outfall 15-940. Intermediate area consists of road right-of-way.

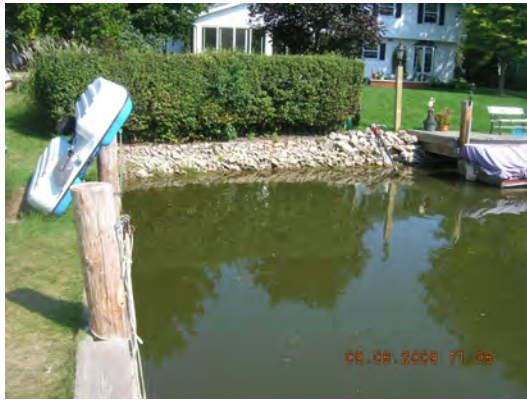
Outfall fully submerged and not physically located.  
GPS coordinates approximate. Outfall screened  
upstream at 15-959 US1. Pipe info from MS4 map.

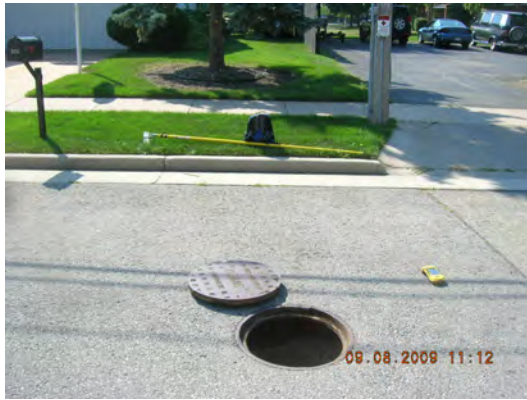
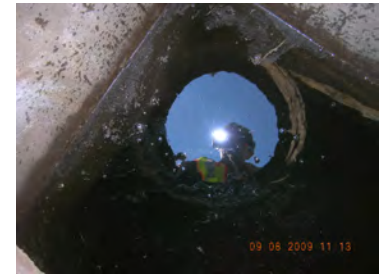
Upstream manhole located approx 100 ft N of outfall 13-100. Intermediate area consists of open space.

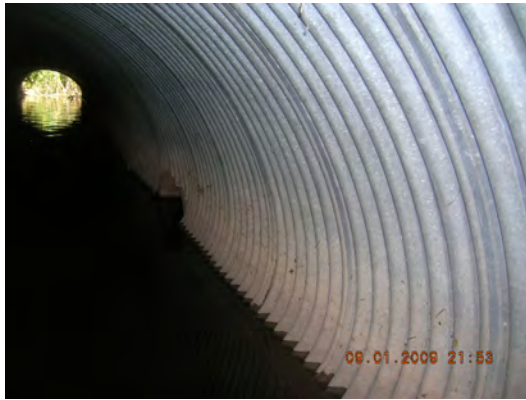
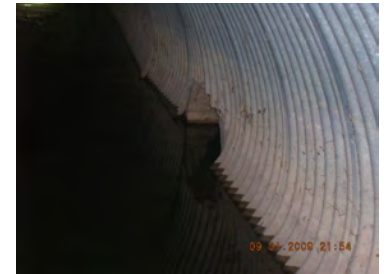
24 inch CMP discharging into culvert. Outfall partially submerged. Outfall screened upstream at 15-1032 US1.

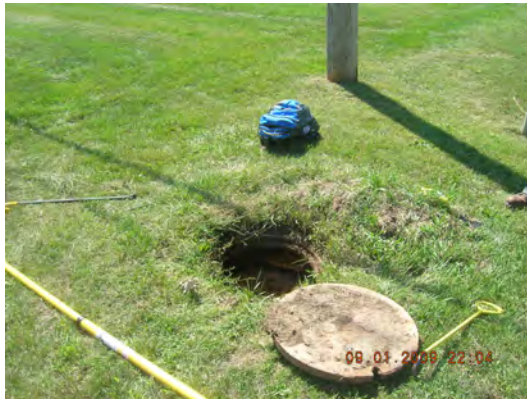
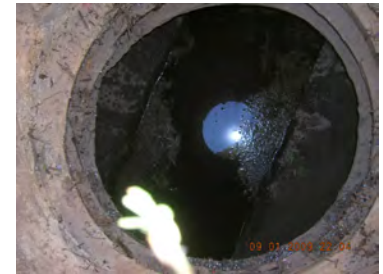
Upstream manhole located approx 9 ft SSW of outfall 15-1032. Intermediate area consists of open space in street right-of-way.

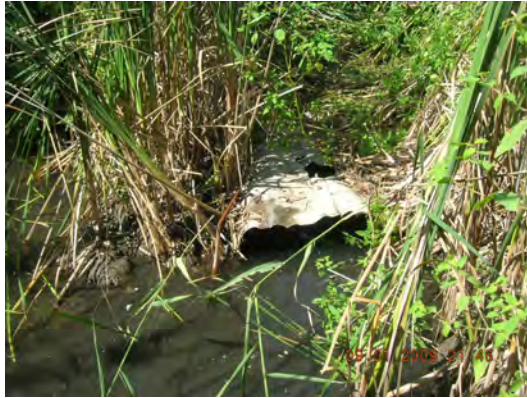
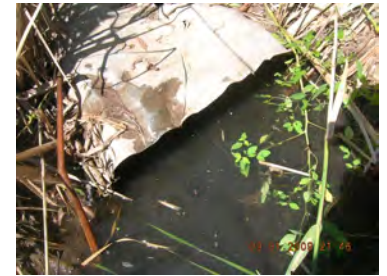
Outfall partially submerged. Outfall screened upstream at 15-1067 US1. CMP crushed, with holes.

- Outfall Damage** ☒ Corrosion ☐ Peeling Paint ☐ Spalling/Cracking/Chipping  
**Deposits/Stains** ☐ Oily ☐ Paint ☐ Flow Line ☐ Other:  
**Pipe Benthic Growth** ☐ Brown ☐ Orange ☐ Green ☐ Other:  
**Abnormal Vegetation** ☐ Inhibited ☐ Excessive  
**Poor Pool Quality** ☐ Odors ☐ Colors ☐ Oil Sheen ☐ Suds ☐ Floatables  
☐ Excessive Algae ☐ Other:

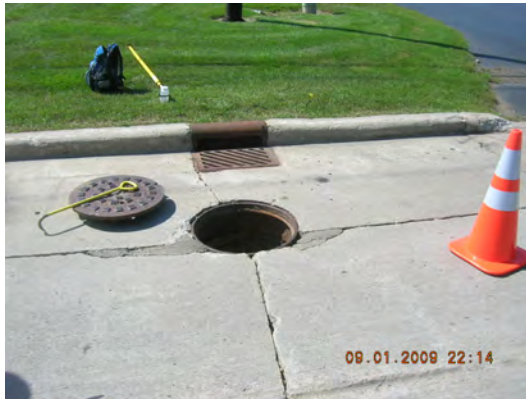
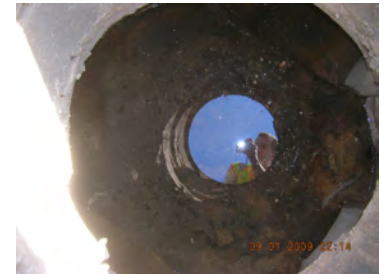
Upstream manhole located approx 365 ft NNW of outfall 15-1067. Intermediate area consists of Main Street and right-of-way. Intermediate manhole not found.

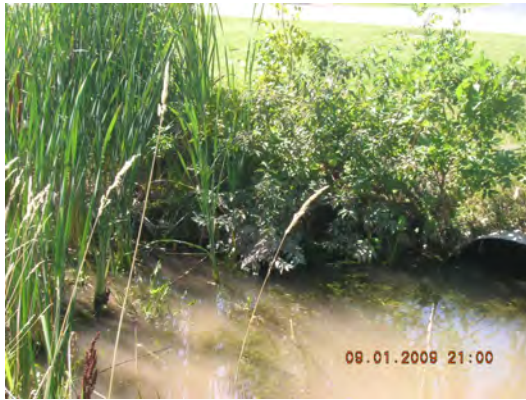
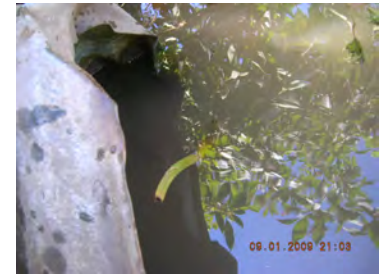
Outfall partially submerged. Outfall screened upstream at 15-1093 US1.

Illicit Discharge Potential: Potential

- Outfall Damage** ☒ Corrosion ☐ Peeling Paint ☐ Spalling/Cracking/Chipping  
**Deposits/Stains** ☐ Oily ☐ Paint ☒ Flow Line ☐ Other:  
**Pipe Benthic Growth** ☒ Brown ☐ Orange ☐ Green ☐ Other:  
**Abnormal Vegetation** ☐ Inhibited ☐ Excessive  
**Poor Pool Quality** ☐ Odors ☐ Colors ☐ Oil Sheen ☐ Suds ☐ Floatables  
☐ Excessive Algae ☐ Other:

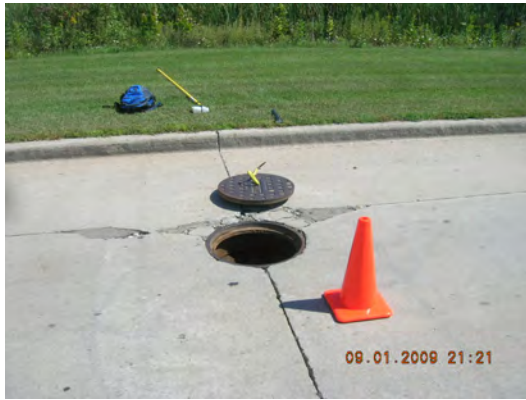
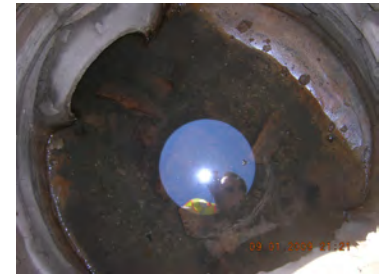
Upstream manhole located approx 88 ft SSW of outfall 15-1093. Intermediate area consists of Main Street and right-of-way.

| <b>Odor:</b> Faint | <input type="checkbox"/> Sewage | <input type="checkbox"/> Sulfide | <input type="checkbox"/> Rancid/Sour | <input type="checkbox"/> Petroleum | <input checked="" type="checkbox"/> Other: Ammonia-like burning odor |

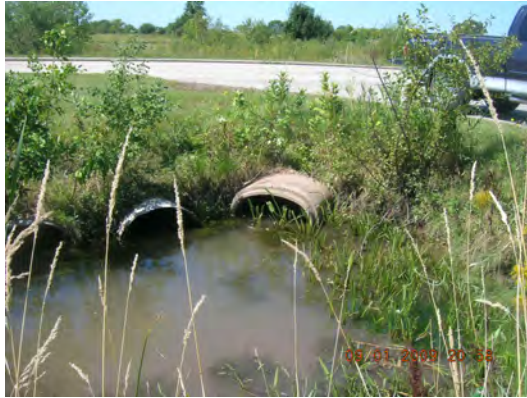
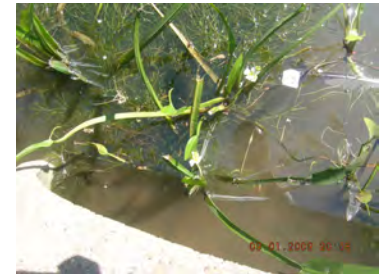
Outfall partially submerged. Outfall screened upstream at 15-1095 US1.

### Illicit Discharge Potential: Potential

- Outfall Damage** ☐ Corrosion ☐ Peeling Paint ☐ Spalling/Cracking/Chipping  
**Deposits/Stains** ☐ Oily ☐ Paint ☐ Flow Line ☐ Other:  
**Pipe Benthic Growth** ☐ Brown ☐ Orange ☒ Green ☐ Other:  
**Abnormal Vegetation** ☐ Inhibited ☐ Excessive  
**Poor Pool Quality** ☐ Odors ☐ Colors ☐ Oil Sheen ☐ Suds ☐ Floatables  
☐ Excessive Algae ☒ Other: milky sheen

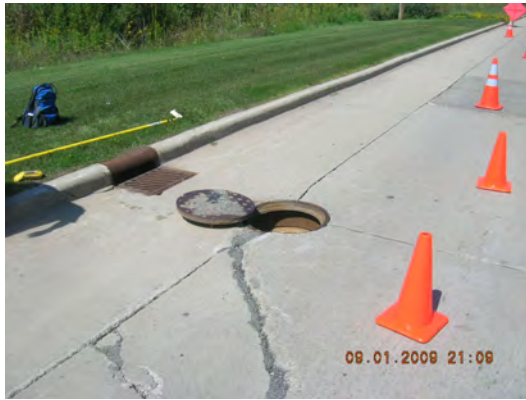
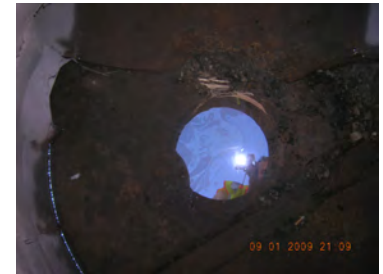
Upstream manhole located approx 92 ft NNW of outfall 15-1095. Intermediate area consists of Main Street and right-of-way.

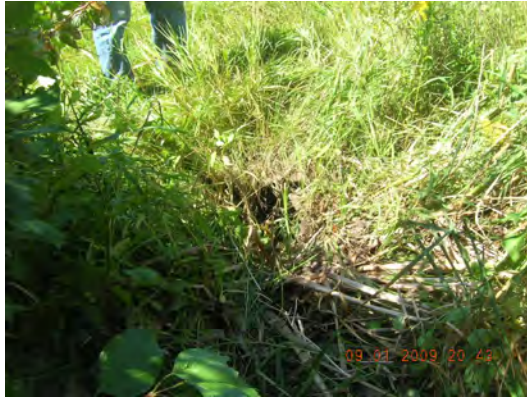
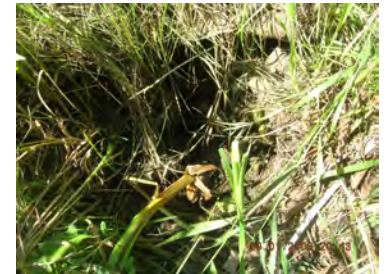
Outfall Notes:  
End of CMP crushed

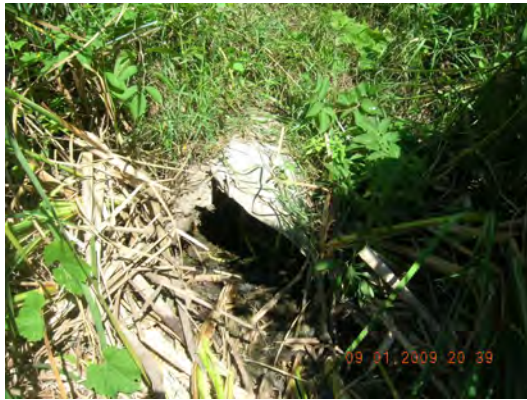
Outfall Notes:  
End of CMP crushed

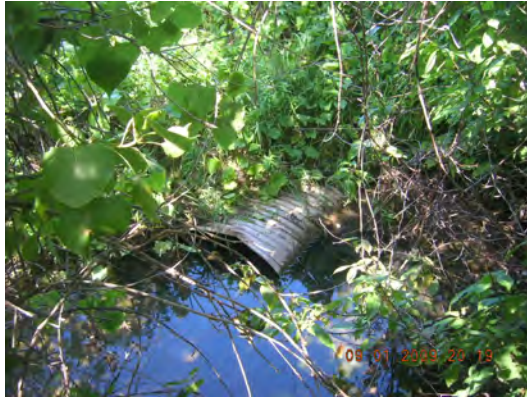
DSCN6340.JPG

Outfall partially submerged. Outfall screened upstream at 15-1248 US1.

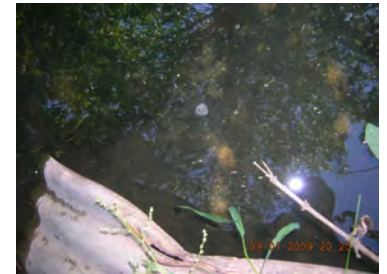
DSCN6341.JPG

- Outfall Damage** ☐ Corrosion ☐ Peeling Paint ☐ Spalling/Cracking/Chipping  
**Deposits/Stains** ☐ Oily ☐ Paint ☐ Flow Line ☐ Other:  
**Pipe Benthic Growth** ☐ Brown ☐ Orange ☒ Green ☐ Other:  
**Abnormal Vegetation** ☐ Inhibited ☐ Excessive  
**Poor Pool Quality** ☐ Odors ☐ Colors ☐ Oil Sheen ☐ Suds ☐ Floatables  
☐ Excessive Algae ☐ Other:

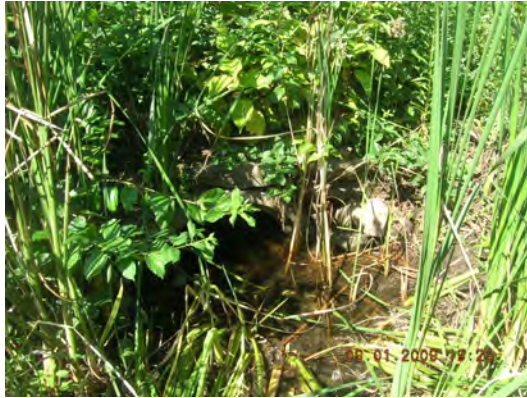
DSCN6331.JPG

Outfall partially submerged. Outfall screened upstream at 15-1263 US1 and US2.

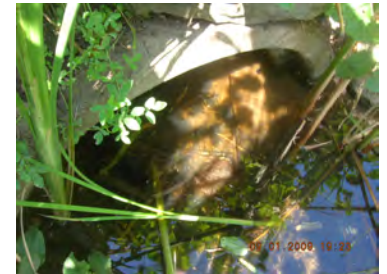
DSCN6332.JPG

- Outfall Damage** ☐ Corrosion ☐ Peeling Paint ☐ Spalling/Cracking/Chipping  
**Deposits/Stains** ☐ Oily ☐ Paint ☐ Flow Line ☐ Other:  
**Pipe Benthic Growth** ☒ Brown ☐ Orange ☐ Green ☐ Other:  
**Abnormal Vegetation** ☐ Inhibited ☐ Excessive  
**Poor Pool Quality** ☐ Odors ☐ Colors ☐ Oil Sheen ☐ Suds ☐ Floatables  
☐ Excessive Algae ☐ Other:

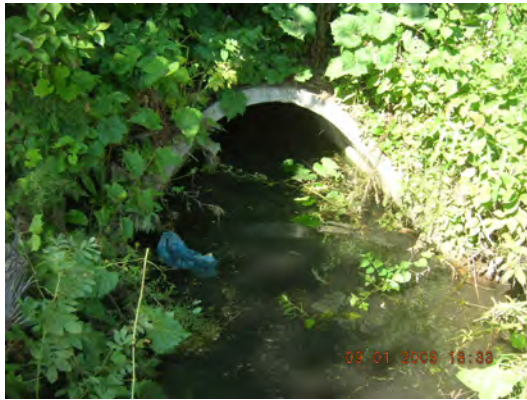
DSCN6310.JPG

Outfall partially submerged. Outfall screened upstream at 15-1348 US1 (south branch) and 15-1348 US2 (north branch)..

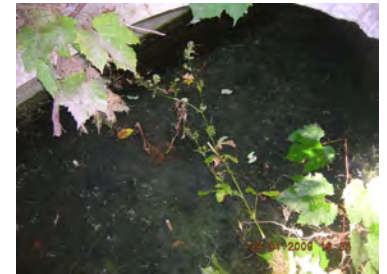
DSCN6311.JPG

Illicit Discharge Potential: **Suspect**

- Outfall Damage** ☐ Corrosion ☐ Peeling Paint ☐ Spalling/Cracking/Chipping  
**Deposits/Stains** ☐ Oily ☐ Paint ☒ Flow Line ☐ Other:  
**Pipe Benthic Growth** ☐ Brown ☐ Orange ☒ Green ☐ Other:  
**Abnormal Vegetation** ☐ Inhibited ☐ Excessive  
**Poor Pool Quality** ☐ Odors ☐ Colors ☐ Oil Sheen ☐ Suds ☐ Floatables  
☐ Excessive Algae ☒ Other: Grass clippings
