# Initial Screening Summary Report

Illicit Discharge Detection and Elimination Program

City of Oshkosh

May 18, 2010

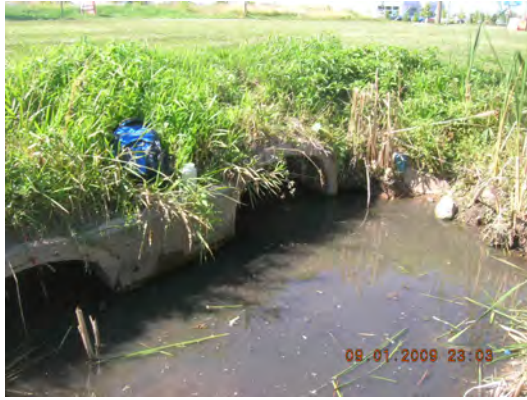
DSCN6384.JPG

Outfall partially submerged. Upstream manhole could not be located, so sample was collected from pool at outfall.

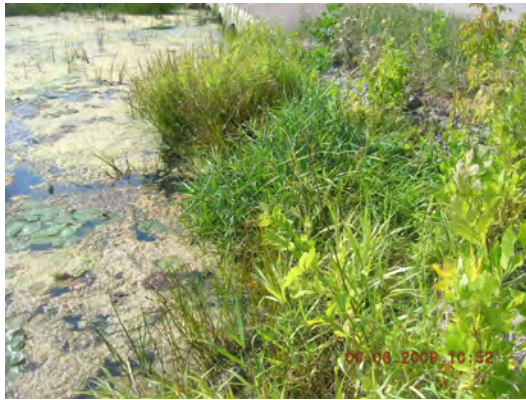
DSCN6599.JPG

Outfall fully submerged and not physically located.  
GPS coordinates approximate. Outfall screened  
upstream at 15-2243 US1. Pipe info from MS4 map.

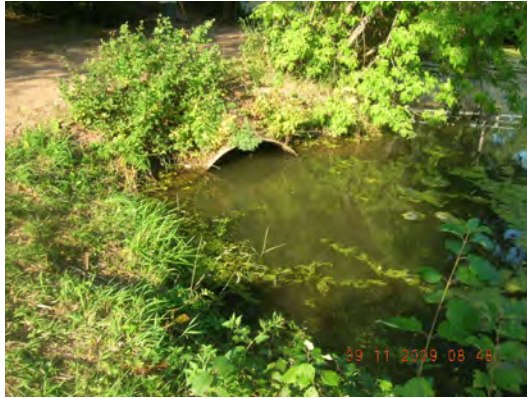
DSCN6843.JPG

Outfall partially submerged. Outfall screened upstream at 16-487 US1.

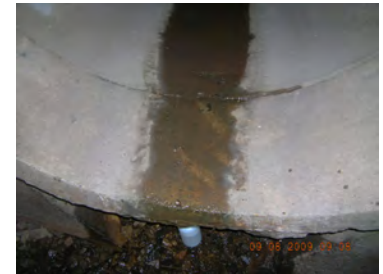
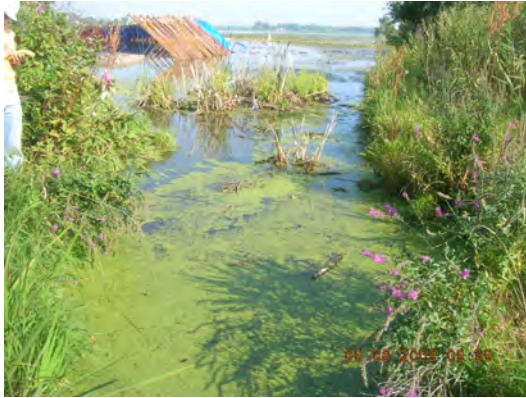
Swale from US HWY 41 corridor into Lake Butte des Morts (west side of highway). Outfall partially submerged. Outfall screened upstream at SW-01 US1.

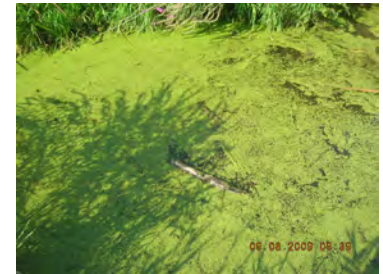
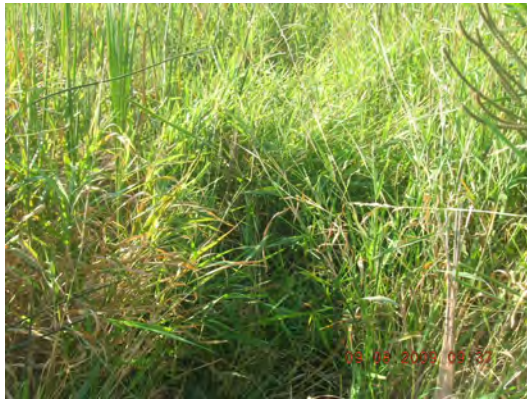
Swale from US HWY 41 corridor into Lake Butte des Morts (west side of highway). Upstream sample located approx 62 ft S of outfall SW-01. Intermediate area consists of highway right-of-way.

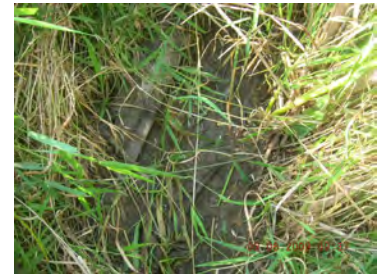
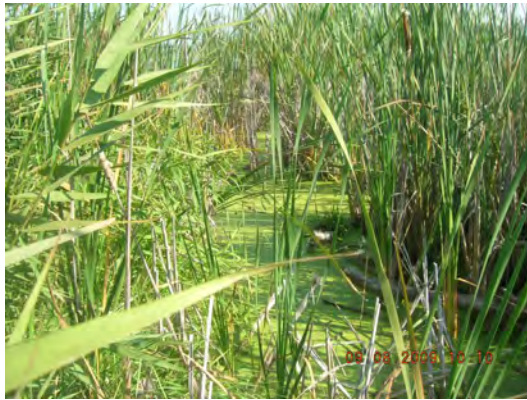
Swale from US HWY 41 corridor into Lake Butte des Morts (east side of highway). Outfall partially submerged. Outfall screened upstream at SW-02 US1.

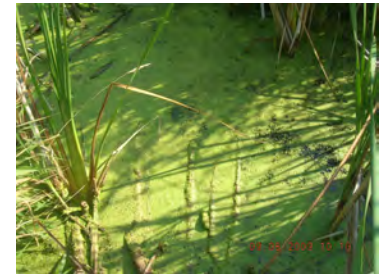
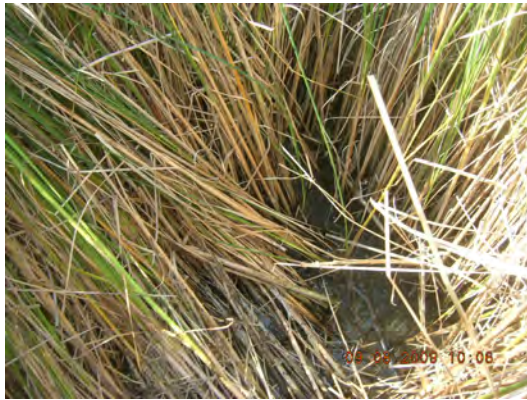
Swale from US HWY 41 corridor into Lake Butte des Morts (east side of highway). Upstream sample located approx 333 ft S of outfall SW-02. Intermediate area consists of highway right-of-way and golf course property.

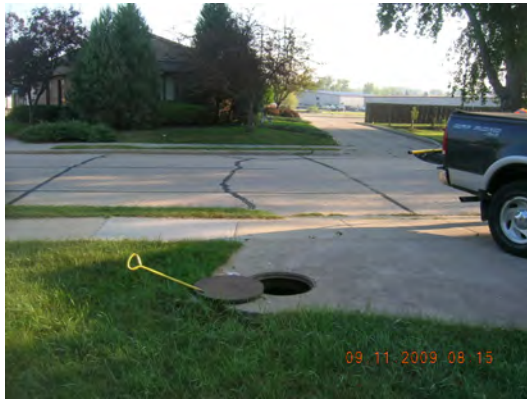
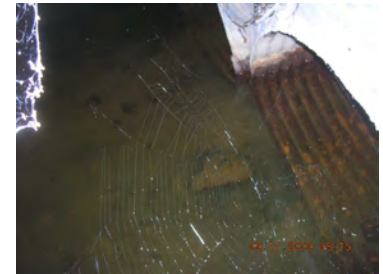
CMP discharges to concrete box culvert (west pipe)

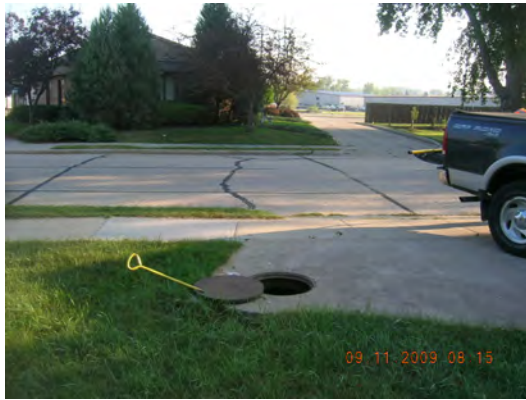
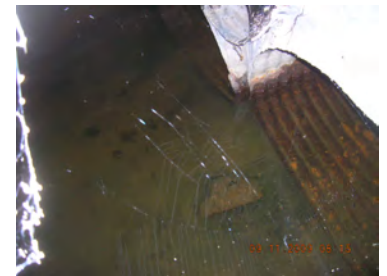
CMP discharges to concrete box culvert (east pipe)

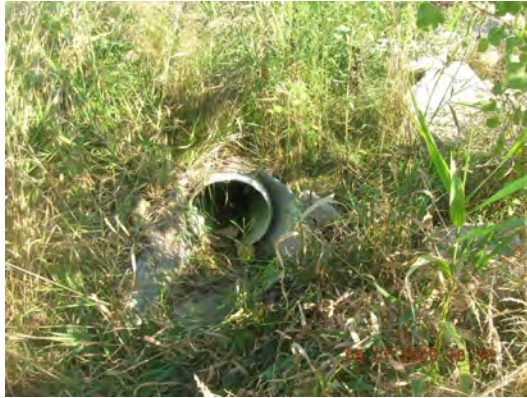
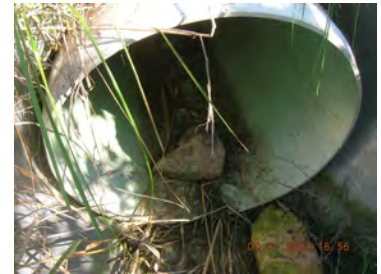
Outlet from stormwater pond south of W. Fernau Ave.

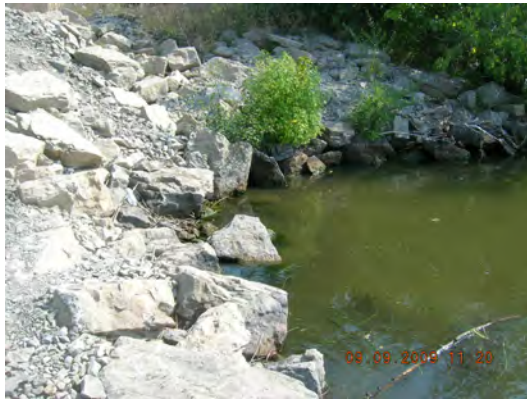
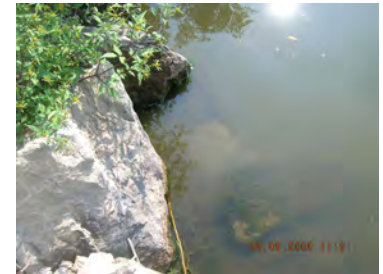
Outfall partially submerged. Outfall screened upstream at OSH--9424 US1.

Illicit Discharge Potential: Suspect

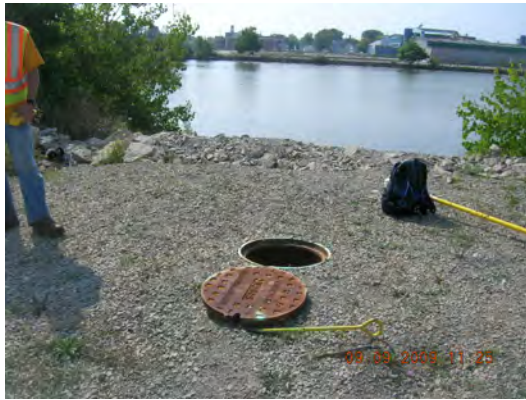
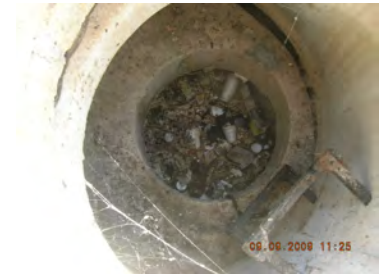
Upstream manhole located approx 28 ft N of outfall OSH--9424. Intermediate area consists of rip-rap shoreline.

### Illicit Discharge Potential: Suspect

Sample Location: Pool	Total Chlorine (field): 0 ppm	Phenol: 0 mg/L
Sample ID: 090909-57	Free Chlorine (field): 0 ppm	Detergents: 0 mg/L
Time Collected: 1130	Total Copper (field): 0 ppm	
	pH (field): 8.6 units	Temperature: 78 °F
