Ongoing Screening Summary Report 2010 Inspection Year

Illicit Discharge Detection and Elimination Program

City of Oshkosh

OMNNI Project No. N2029B10

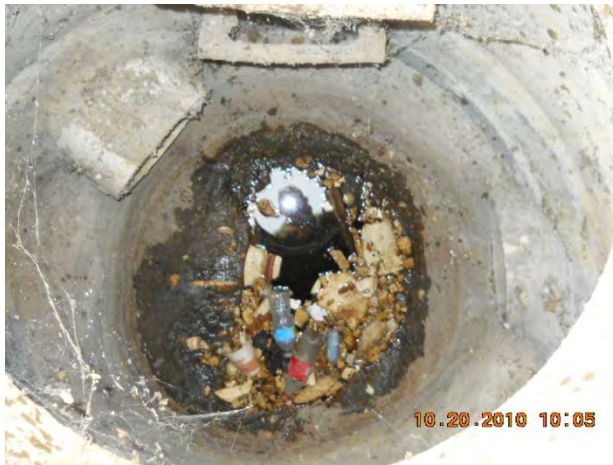
Figure 6 – Severe floatables in manhole 01-132 US1

It is recommended that the outfalls with significant floatable debris be reinspected during the 2011 ongoing screening program. These manholes should be cleaned several months prior to the next outfall screening. By doing this, it will be possible to determine if the debris is from a prior discharge, or if the problem is ongoing. If it is determined that it is an ongoing problem, upstream inlets, especially those located near dumpsters or other solid waste storage areas, should be closely examined in an attempt to locate the source of the discharge. These areas could then be targeted for public education campaigns.

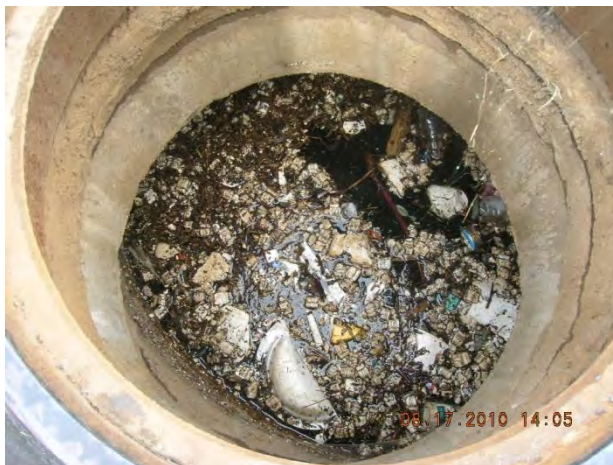
Figure 7 – Moderate floatables in manhole 03-173 US2

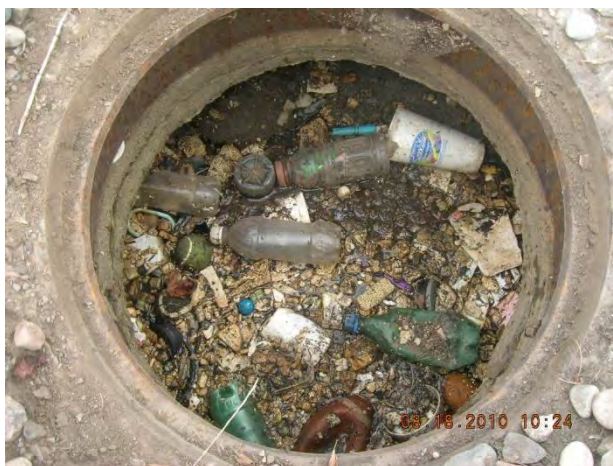
Figure 8 – Severe floatables in catchbasin 03-22 US1

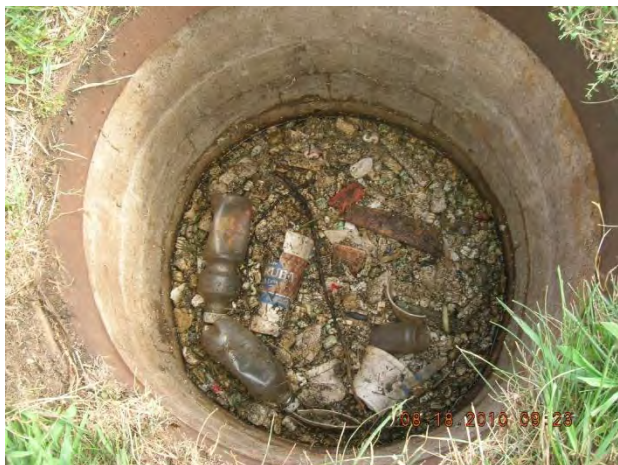
Figure 9 – Severe floatables in manhole 03-35 US1

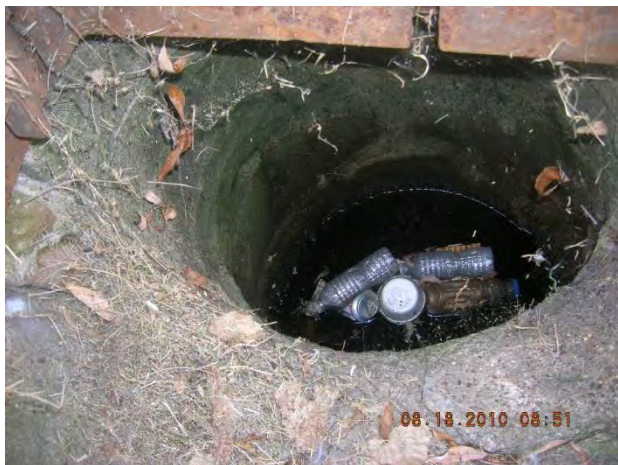
Figure 10 – Moderate floatables in curb inlet 03-381 US1

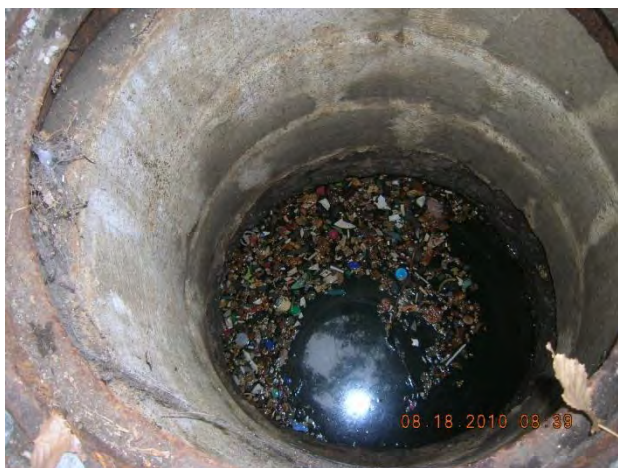
Figure 11 – Moderate floatables in manhole 03-81 US1

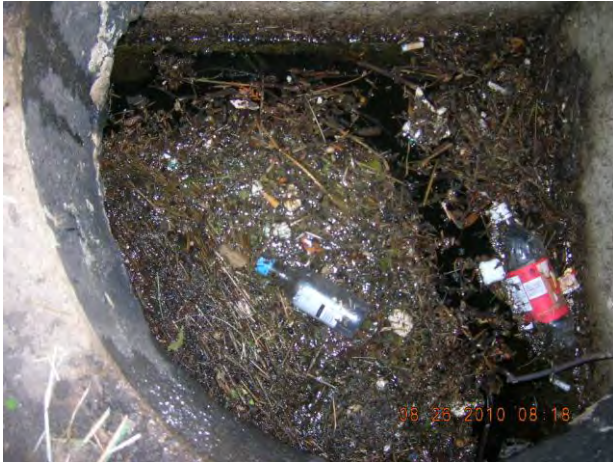
Figure 12 – Moderate floatables in manhole 05-264 US1

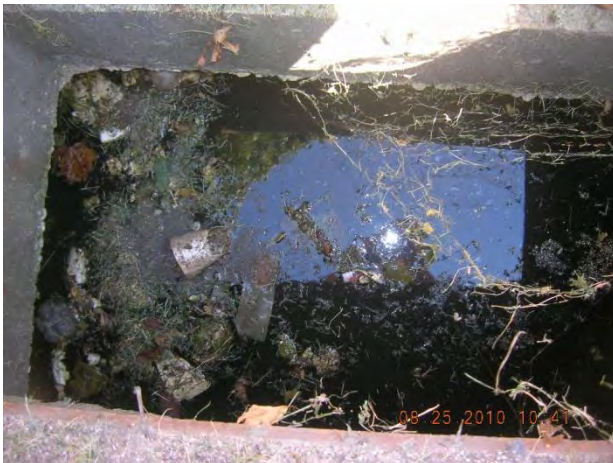
Figure 13 – Moderate floatables in curb inlet 06-1694 US1

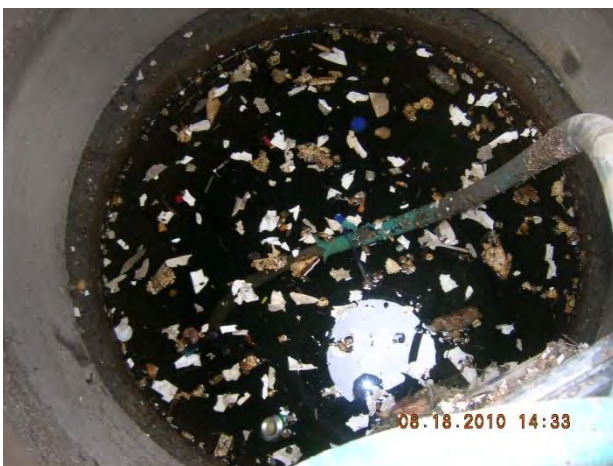
Figure 14 – Moderate floatables in manhole 06-221 US1

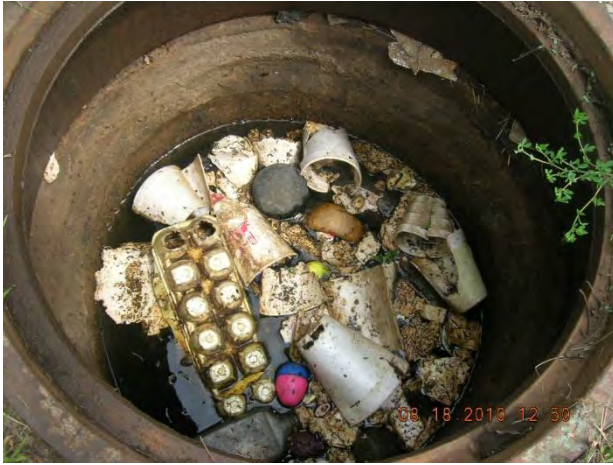
Figure 15 – Severe floatables in manhole 06-52 US1

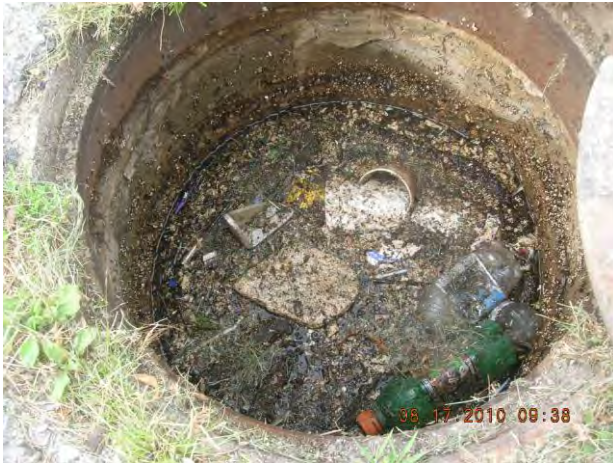
Figure 16 – Severe floatables in manhole 08-284 US1

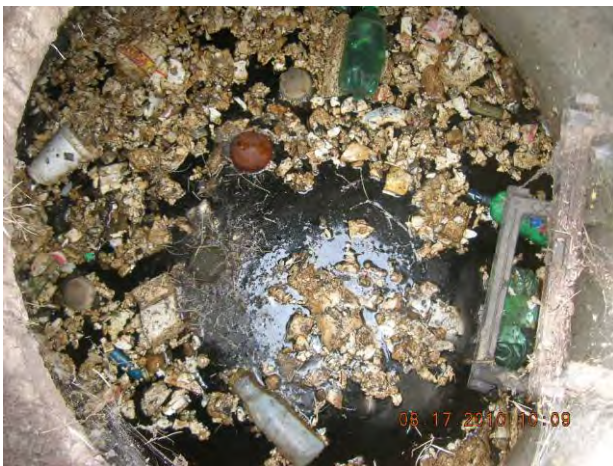
Figure 17 – Severe floatables in manhole 08-347 US1

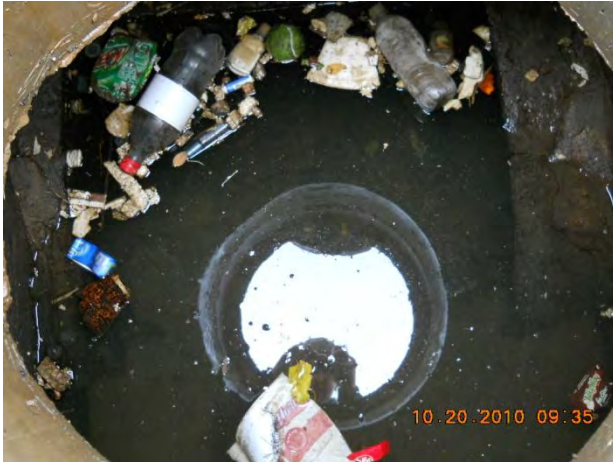
Figure 18 – Moderate floatables in manhole 09-101c US1

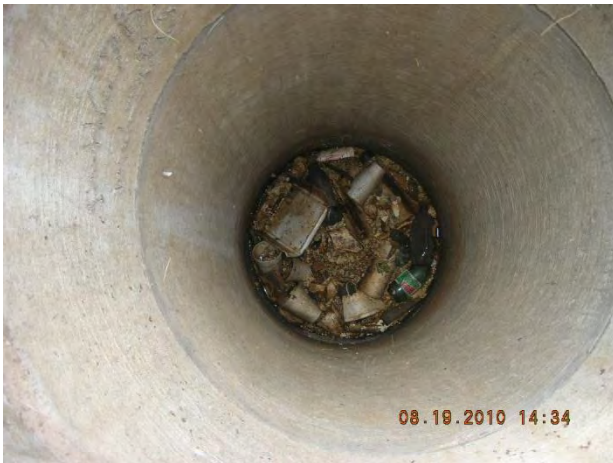
Figure 19 – Severe floatables in manhole 12-569 US1

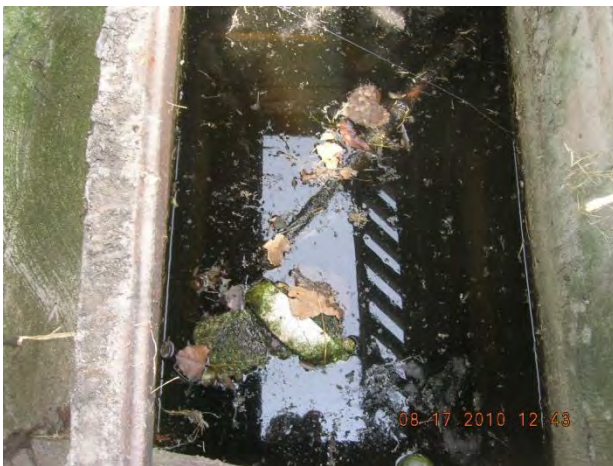
Figure 20 – Moderate floatables in curb inlet 14-1075 US1

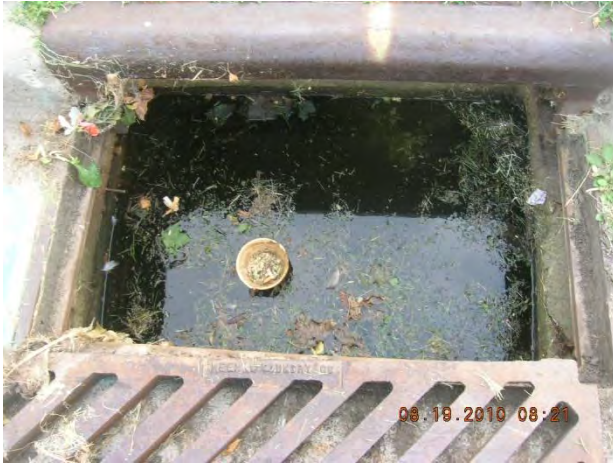
Figure 21 – Moderate floatables in curb inlet 16-142 US1

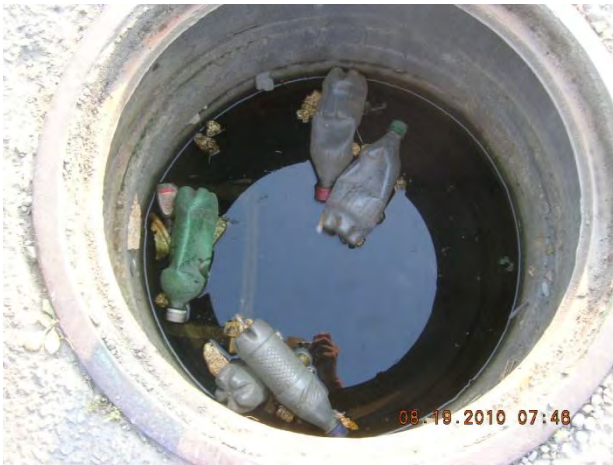
Figure 22 – Moderate floatables in catchbasin 16-201 US1

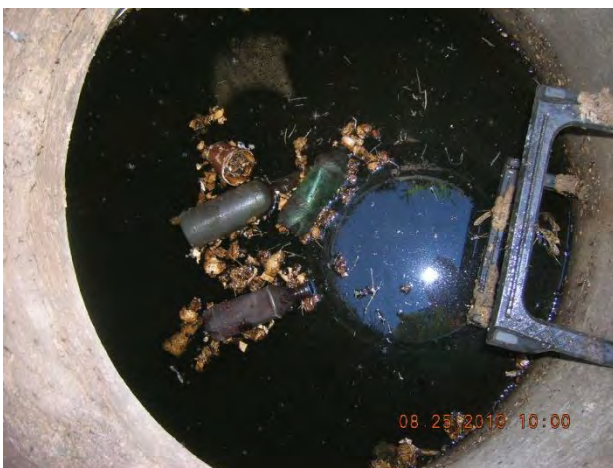
Figure 23 – Moderate floatables in manhole 16-396 US1

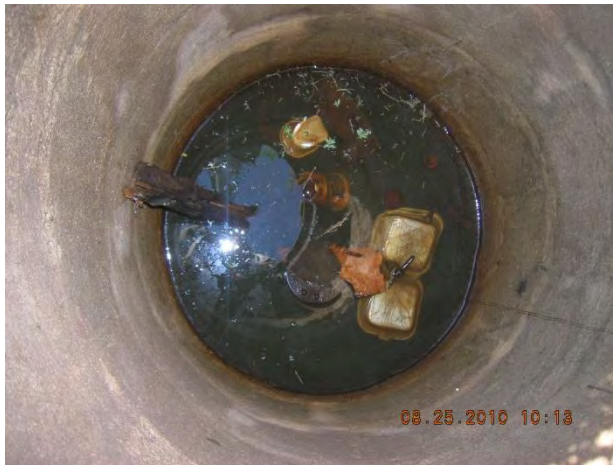
Figure 24 – Moderate floatables in manhole 16-436 US1

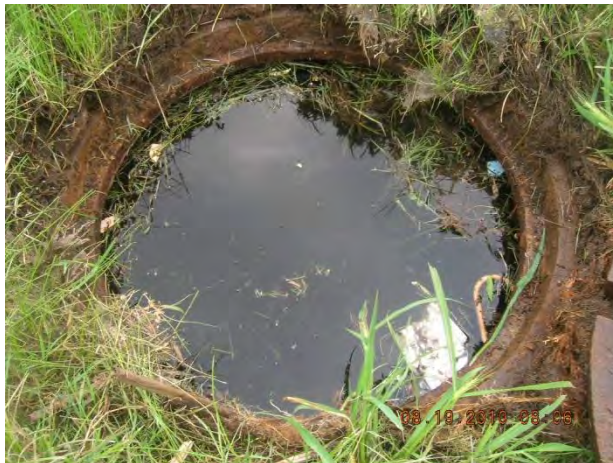
Figure 25 – Moderate floatables in manhole 16-463 US1

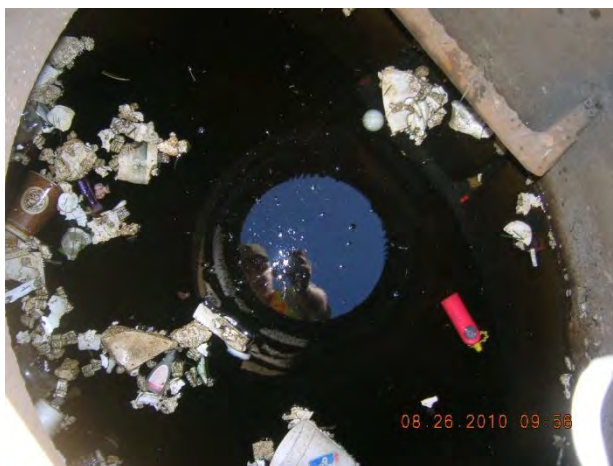
Figure 26 – Moderate floatables in manhole 16-533 US1

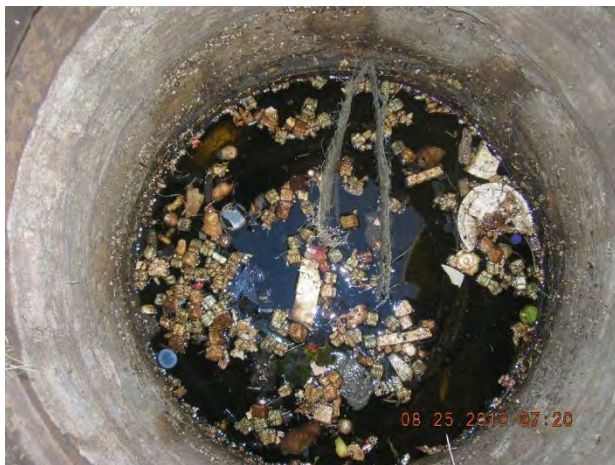
Figure 27 – Moderate floatables in manhole 16-551 US1

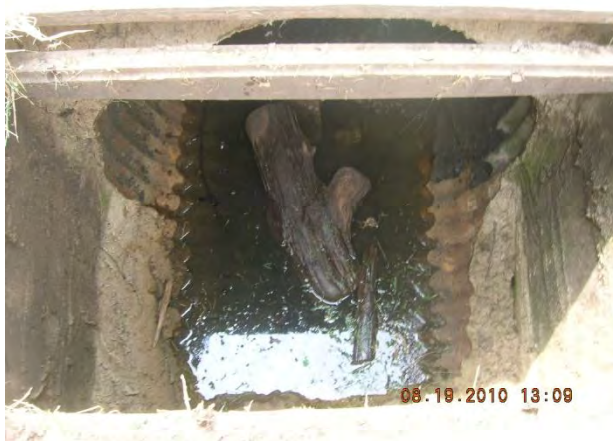
In all cases, the sheen was isolated to small patch on the surface of the pooled water, and was likely caused by trace amounts of oil from street runoff. The inlets with the oil sheen are shown in the photos below.

Figure 30 – Slight oil sheen in inlet 12-890 US1

Because the oil is in such limited quantities in each inlet, it is unlikely to identify an actual source of the discharge other than general street or parking lot runoff. If larger oil sheens are observed in the future, then additional screening may be warranted.

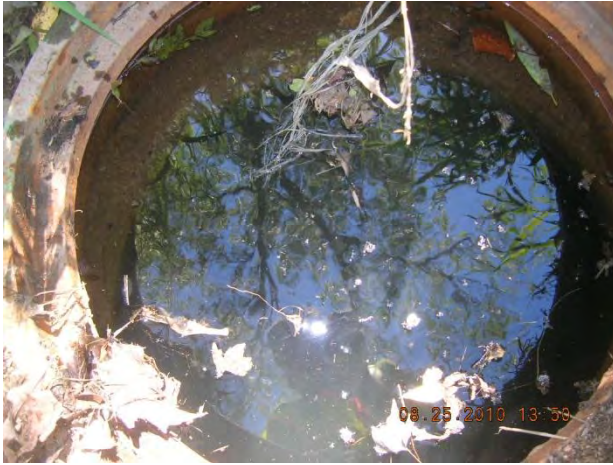
Figure 41 - Moderate deposition (4") in catchbasin 01-318 US1

Eight of the outfalls showed minor to moderate deposition at the end of the outfall pipe or manhole bottom. As deposition increases, flow may become restricted in the pipe or downstream channel. Outfalls with moderate or severe deposition may need to undergo maintenance to remove the deposited sediment and debris and maintain proper flow.

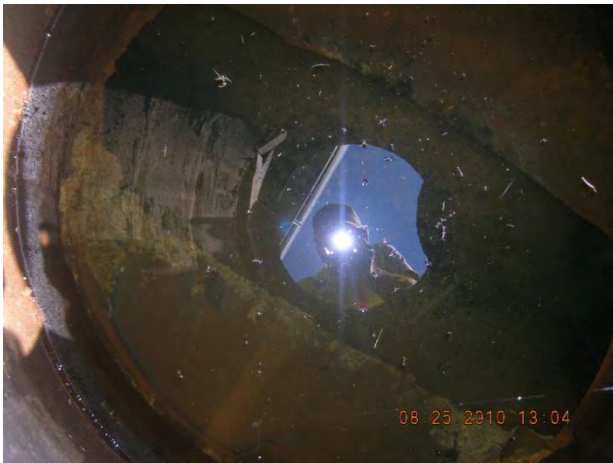
Figure 42 - Minor deposition (1") in manhole 01-360 US2

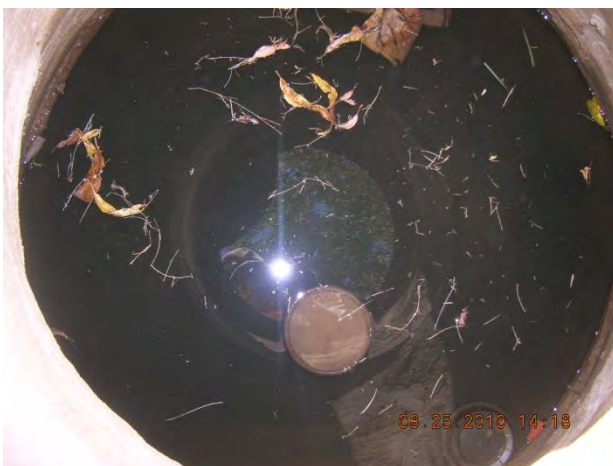
Figure 43 - Moderate deposition (12") in manhole 01-380 US1

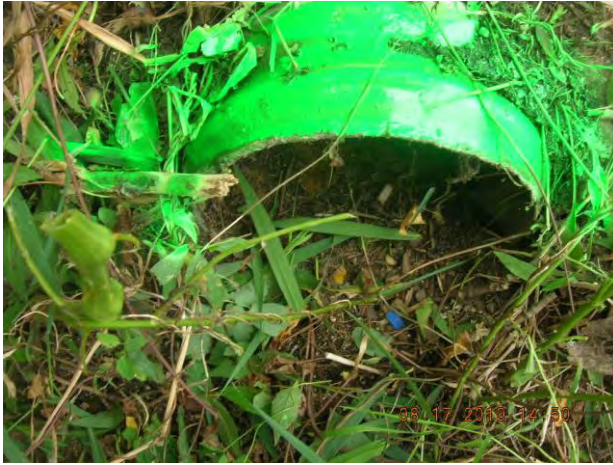
Figure 44 - Moderate deposition (3") at outfall 03-392

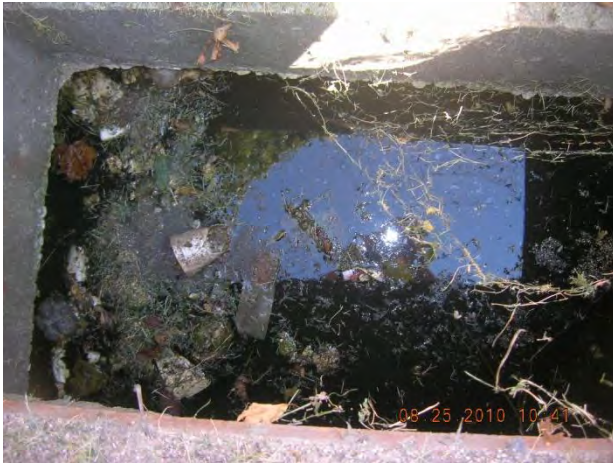
Figure 45 - Minor deposition (2") in inlet 06-1694 US1

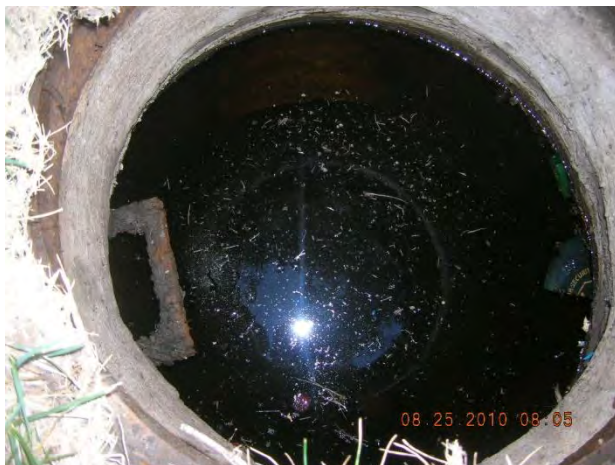
Figure 47 - Minor deposition (3") in manhole 16-164 US1

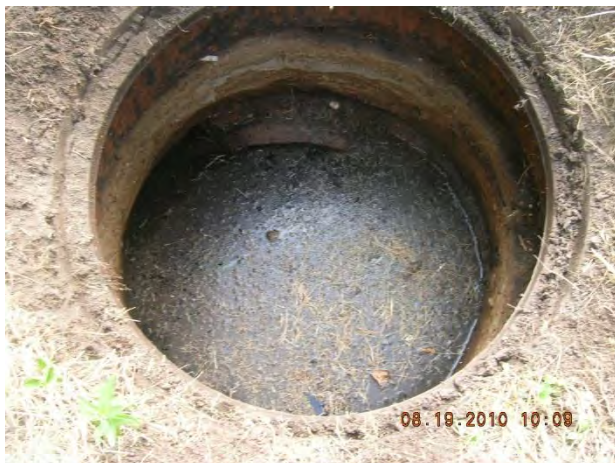
Figure 48 - Minor deposition (1") in manhole 16-362 US1

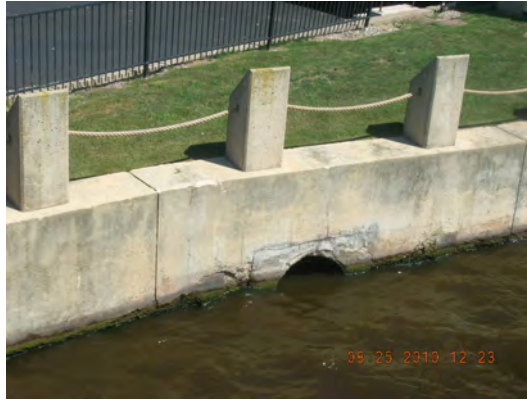
o20100825122338.JPG

Outfall partially submerged. Outfall screened upstream at 01-35 US1.

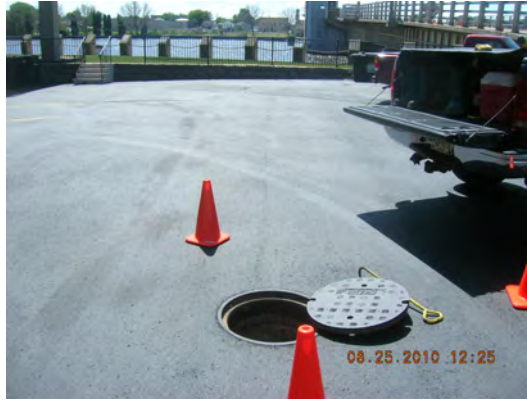
o20100825122536.JPG

Upstream manhole located approx 72 ft N of outfall 01-35. Intermediate area consists of paved parking area with no observed inlets.

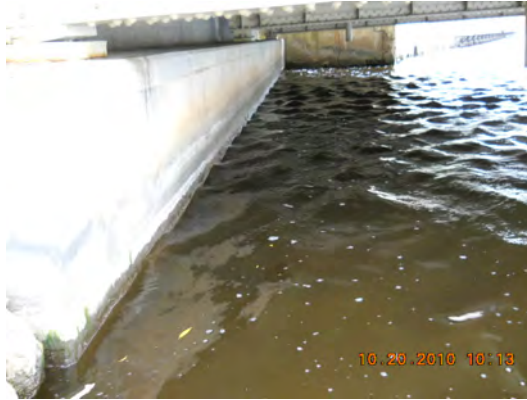
o20101020101356.jpg

Outfall fully submerged and not physically located. GPS coordinates approximate. Pipe info from MS4 map.

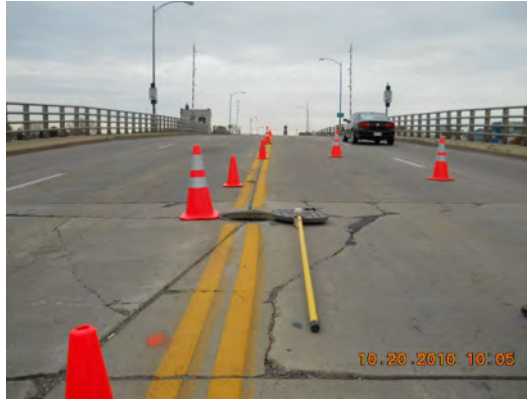
o20101020100512.jpg

Upstream manhole located approx 87 ft N of outfall 01-132. Intermediate area consists of street right-of-way.

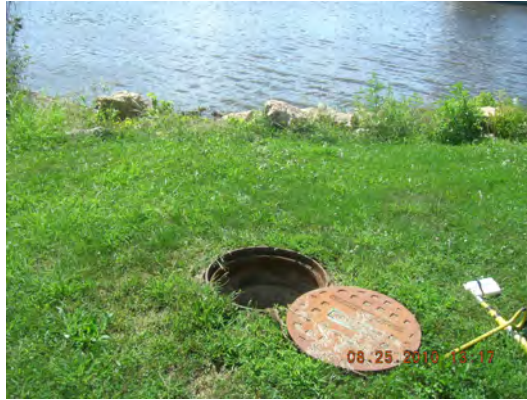
o20100825131754.JPG

Upstream manhole located approx 18 ft NE of outfall 01-278. Intermediate area consists of open space.

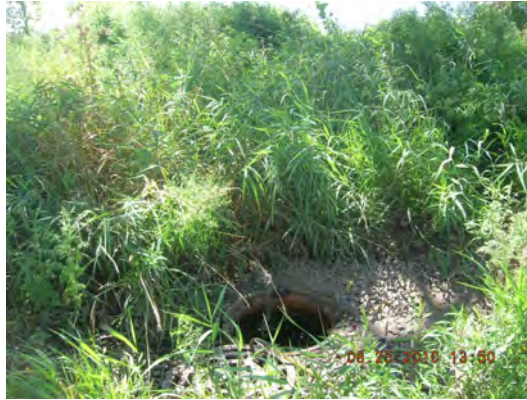
o20100825135002.JPG

Graffiti: None
Erosion: None
Deposition: Moderate Depth (in): 4
Damage: None ☐ Displacement ☐ Undercut ☐ Crushed
☐ Corrosion ☐ Concrete Damage

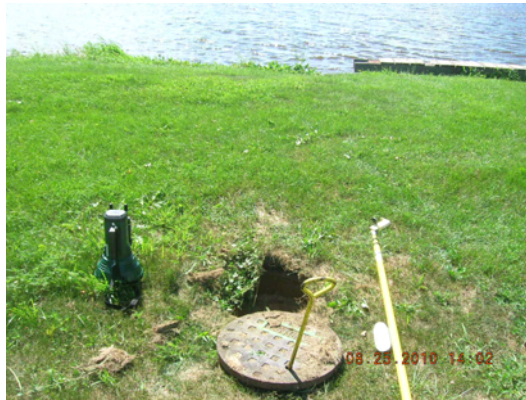
o20100825140232.JPG

Upstream manhole located approx 53 ft NNE of outfall 01-329. Intermediate area consists of open space.

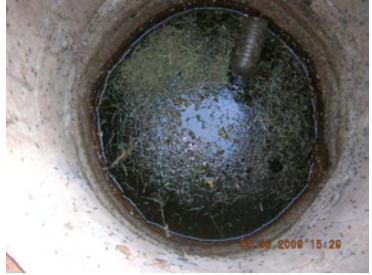
Osh09_DSCN6667.JPG							
Sampling Results							
Sample Location:		Pool

Inspection Date: 9/8/2009		Inspector: JCW		Inspection Type: Initial		Previous Rainfall (hrs): 72+	
Flow Description: Submerged, indeterminate				Notes: Abnormal detergent analysis result (bubbles)			
Submerged: Fully		Depth (in): 48					
Illicit Discharge Potential: Potential				<input type="checkbox"/> Field Follow-up		<input type="checkbox"/> Office Follow-up	
Floatables:	None	<input type="checkbox"/> Petroleum Sheen	<input type="checkbox"/> Suds	<input type="checkbox"/> Sewage	<input type="checkbox"/> Other		
		<input type="checkbox"/> Natural Sheen	<input type="checkbox"/> Algae	<input type="checkbox"/> Solid Waste/Debris			
Odor:	None	<input type="checkbox"/> Petroleum	<input type="checkbox"/> Musty	<input type="checkbox"/> Sewage	<input type="checkbox"/> Chlorine		
		<input type="checkbox"/> VOC/Solvent	<input type="checkbox"/> Fishy	<input type="checkbox"/> Sulfur	<input type="checkbox"/> Sour

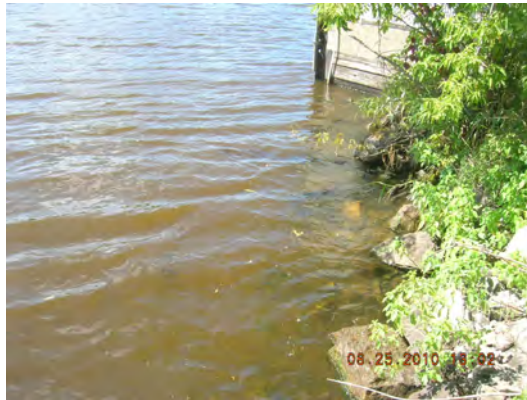
o20100825130230.JPG

Outfall fully submerged and not physically located. GPS coordinates approximate. Pipe info from MS4 map.

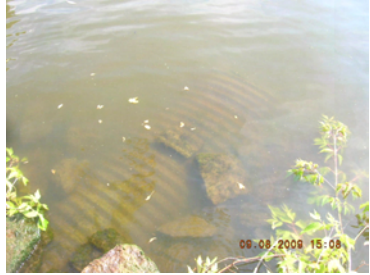
Outfall ID: 01-360

Inspection Date: 9/8/2009		Inspector: JCW		Inspection Type: Initial		Previous Rainfall (hrs): 72+	
Flow Description: Submerged, indeterminate		Notes: Outfall fully submerged and not physically located. Outfall screened upstream at 01-360 US3.

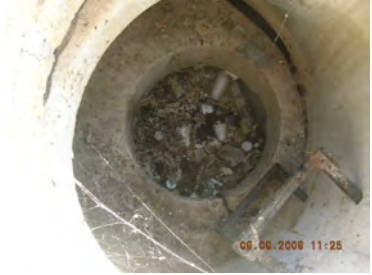
Outfall ID: 01-520 US1

Inspection Date: 9/9/2009		Inspector: JCW		Inspection Type: Initial		Previous Rainfall (hrs): 72+	
Flow Description: Submerged, indeterminate				Notes: Abnormal detergent analysis result (bubbles). Significant floatables in manhole. Brown color.			
Submerged: Fully		Depth (in): 61					
Illicit Discharge Potential: Potential				<input type="checkbox"/> Field Follow-up <input type="checkbox"/> Office Follow-up			
Floatables:	Severe	<input type="checkbox"/> Petroleum Sheen	<input type="checkbox"/> Suds	<input type="checkbox"/> Sewage	<input type="checkbox"/> Other

Turbidity:	None				<input type="checkbox"/> Othe		
Color:	Clearly visible in bottle	Brown					
Vegetation:	None	<input type="checkbox"/> Inhibited	<input type="checkbox"/> Excessive				
Benthic Growth:	None	<input type="checkbox"/> Green	<input type="checkbox"/> Brown	<input type="checkbox"/> Orange	<input type="checkbox"/> Other		
Stains:	None	<input type="checkbox"/> Flow Line	<input type="checkbox"/> Oil	<input type="checkbox"/> Rust Stains		Sampling Results Sample Location: Pool Sample ID: 090909-57 Time Collected 1130 Total Chlorine (field): 0 ppm Free Chlorine (field): 0 ppm Total Copper (field): 0 ppm Ammonia (field): ppm pH (field): 8.6 units Temperature: 78 °F Detergents: 0 mg/L Phenol: 0 mg/L	
		<input type="checkbox"/> Corrosion	<input type="checkbox"/> Paint	<input type="checkbox"/> Other			
Physical Condition Assessment							
Graffiti:	None						
Erosion:	None						
Deposition:	None	Depth (in): 0

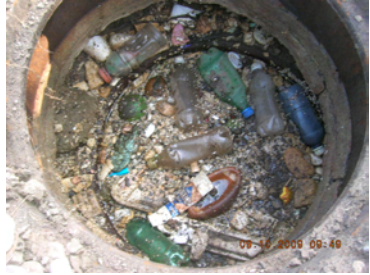
Osh09_DSCN6768.JPG							
Sampling Results

Inspection Date: 9/10/2009		Inspector: JCW		Inspection Type: Initial		Previous Rainfall (hrs): 72+	
Flow Description: Submerged, indeterminate				Notes: Abnormal detergent analysis result (bubbles). Significant floatables in manhole.			
Submerged: Fully		Depth (in): 44					
Illicit Discharge Potential: Potential				<input type="checkbox"/> Field Follow-up		<input type="checkbox"/> Office Follow-up	
Floatables: Severe		<input type="checkbox"/> Petroleum Sheen		<input type="checkbox"/> Suds		<input type="checkbox"/> Sewage	
		<input type="checkbox"/> Natural Sheen		<input type="checkbox"/> Algae		<input checked="" type="checkbox"/> Solid Waste/Debris	
Odor: None		<input type="checkbox"/> Petroleum		<input type="checkbox"/> Musty		<input type="checkbox"/> Sewage	
		<input type="checkbox"/> VOC/Solvent		<input type="checkbox"/> Fishy		<input type="checkbox"/> Sulfur	
Turbidity: None						<input type="checkbox"/> Chlorine

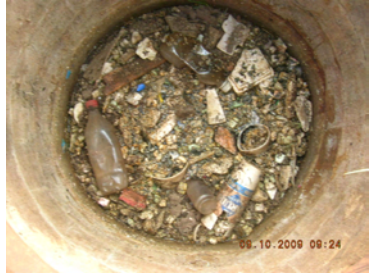
Osh09_DSCN6763.JPG							
Sampling Results

Inspection Date: 9/10/2009		Inspector: JCW		Inspection Type: Initial		Previous Rainfall (hrs): 72+	
Flow Description: Submerged, indeterminate				Notes: Abnormal detergent analysis result (bubbles). Significant floatables in manhole.			
Submerged: Fully		Depth (in): 33					
Illicit Discharge Potential: Potential				<input type="checkbox"/> Field Follow-up		<input type="checkbox"/> Office Follow-up	
Floatables: Severe		<input type="checkbox"/> Petroleum Sheen		<input type="checkbox"/> Suds		<input type="checkbox"/> Sewage	
		<input type="checkbox"/> Natural Sheen		<input type="checkbox"/> Algae		<input checked="" type="checkbox"/> Solid Waste/Debris	
Odor: None		<input type="checkbox"/> Petroleum		<input type="checkbox"/> Musty		<input type="checkbox"/> Sewage	
		<input type="checkbox"/> VOC/Solvent		<input type="checkbox"/> Fishy		<input type="checkbox"/> Sulfur	
Turbidity: None						<input type="checkbox"/> Chlorine

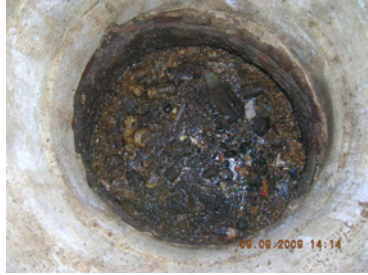
Outfall ID: 03-81 US1

Inspection Date: 9/9/2009		Inspector: JCW		Inspection Type: Initial		Previous Rainfall (hrs): 72+	
Flow Description: Submerged, indeterminate				Notes: Diesel/oil odor, sheen on surface. Floatables with grease. Brown/gray color.			
Submerged: Fully		Depth (in): 44					
Illicit Discharge Potential: Obvious				<input type="checkbox"/> Field Follow-up		<input type="checkbox"/> Office Follow-up	
Floatables:	Severe	<input checked="" type="checkbox"/> Petroleum Sheen	<input type="checkbox"/> Suds	<input type="checkbox"/> Sewage	<input type="checkbox"/> Other

Turbidity:	None				<input type="checkbox"/> Other		
Color:	Faint in bottle	Gray					
Vegetation:	None	<input type="checkbox"/> Inhibited	<input type="checkbox"/> Excessive				
Benthic Growth:	None	<input type="checkbox"/> Green	<input type="checkbox"/> Brown	<input type="checkbox"/> Orange	<input type="checkbox"/> Other		
Stains:	None	<input type="checkbox"/> Flow Line	<input type="checkbox"/> Oil	<input type="checkbox"/> Rust Stains			
		<input type="checkbox"/> Corrosion	<input type="checkbox"/> Paint	<input type="checkbox"/> Other			
Physical Condition Assessment							
Graffiti:	None						
Erosion:	None						
Deposition:	None	Depth (in): 0					
Damage:	None	<input type="checkbox"/> Displacement	<input type="checkbox"/> Undercut	<input type="checkbox"/> Crushed			
		<input type="checkbox"/> Corrosion	<input type="checkbox"/> Concrete Damage				
Sampling Results							
Sample Location:		Pool					
Sample ID:		090909-66

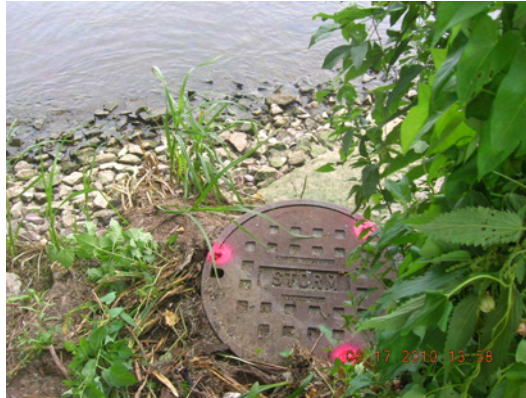
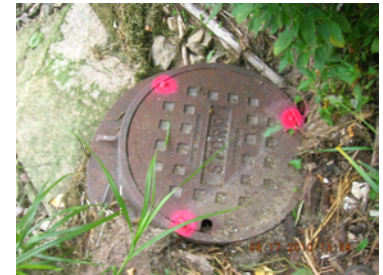
Notes: Lid bolts rusted tight - could not access. Screened upstream at 03-173 US2.

Damage: Moderate

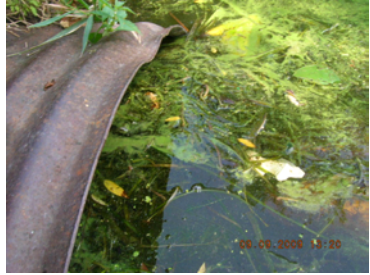
Osh09_DSCN6736.JPG

Inspection Date: 9/9/2009		Inspector: JCW		Inspection Type: Initial		Previous Rainfall (hrs): 72+	
Flow Description: Submerged, indeterminate				Notes: Outfall partially submerged. Outfall screened upstream at 03-293 US1.			
Submerged: Partially		Depth (in): 32					
Illicit Discharge Potential: Potential				<input type="checkbox"/> Field Follow-up		<input type="checkbox"/> Office Follow-up	
Floatables: None		<input type="checkbox"/> Petroleum Sheen	<input type="checkbox"/> Suds	<input type="checkbox"/> Sewage	<input type="checkbox"/> Other		
		<input type="checkbox"/> Natural Sheen	<input checked="" type="checkbox"/> Algae	<input type="checkbox"/> Solid Waste/Debris			
Odor: None		<input type="checkbox"/> Petroleum	<input type="checkbox"/> Musty	<input type="checkbox"/> Sewage	<input type="checkbox"/> Chlorine		
		<input type="checkbox"/> VOC/Solvent	<input type="checkbox"/> Fishy	<input type="checkbox"/> Sulfur	<input type="checkbox"/> Sour

Turbidity: None						<input type="checkbox"/> Other	
Color: None							
Vegetation: None		<input type="checkbox"/> Inhibited	<input type="checkbox"/> Excessive				
Benthic Growth: Slight		<input checked="" type="checkbox"/> Green	<input type="checkbox"/> Brown	<input type="checkbox"/> Orange	<input type="checkbox"/> Other		
Stains: None		<input type="checkbox"/> Flow Line	<input type="checkbox"/> Oil	<input type="checkbox"/> Rust Stains			
		<input checked="" type="checkbox"/> Corrosion	<input type="checkbox"/> Paint	<input type="checkbox"/> Other			
Physical Condition Assessment							
Graffiti: None							
Erosion: None							
Deposition: None		Depth (in): 0					
Damage: Minor		<input type="checkbox"/> Displacement	<input type="checkbox"/> Undercut	<input type="checkbox"/> Crushed			
		<input checked="" type="checkbox"/> Corrosion	<input type="checkbox"/> Concrete Damage

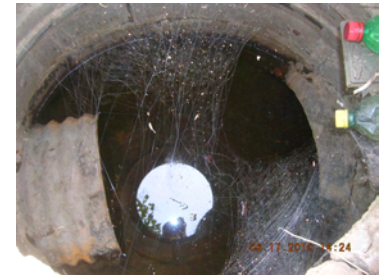
o20100817142402.JPG

Notes: Broken manhole rings allow materials to enter manhole below casting.

Slight ☒ Flow Line ☐ Oil ☐ Rust Stains

Damage: Minor ☐ Displacement ☒ Undercut ☐ Crushed

☐ Corrosion ☒ Concrete Damage

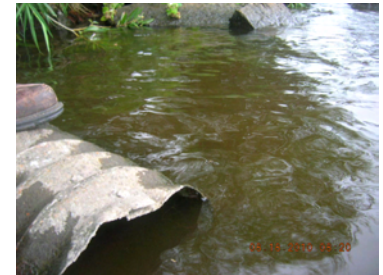
o20100818082054.JPG

☒ Corrosion

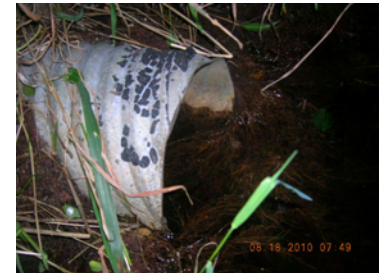
o20100818074924.JPG

☒ Corrosion

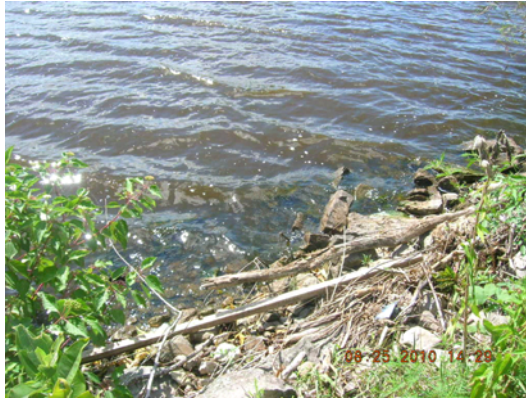
o20100825142900.JPG

Outfall fully submerged and not physically located. GPS coordinates approximate. Pipe info from MS4 map.

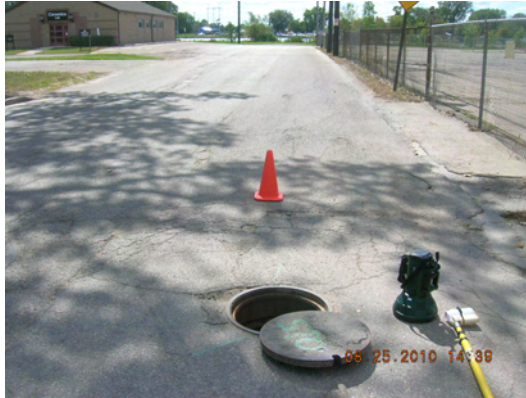
o20100825143904.JPG

Upstream manhole located approx 354 ft NE of outfall 05-14. Intermediate area consists of industrial parking area to north and institutional buildings to south.

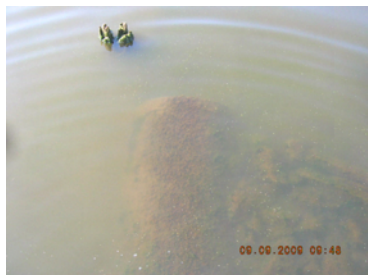
Inspection Date: 9/9/2009		Inspector: JCW		Inspection Type: Initial		Previous Rainfall (hrs): 72+		
Flow Description: Submerged, indeterminate		Notes: Outfall fully submerged. Incorrectly screened upstream at water valve manhole.

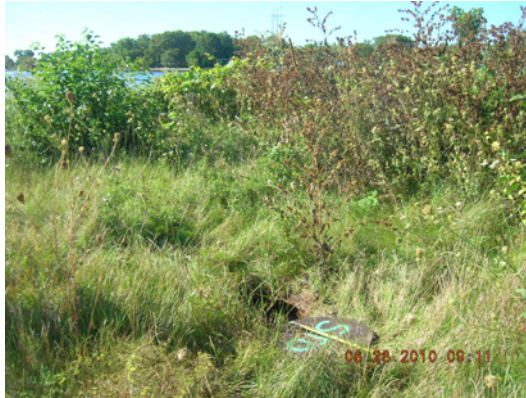
o20100826091110.JPG

Upstream manhole located approx 57 ft N of outfall 05-155. Intermediate area consists of open space on peninsula.

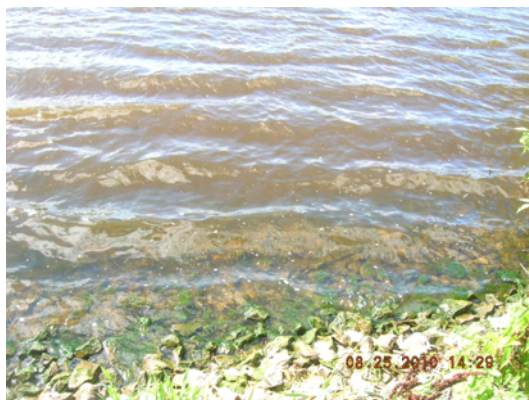
o20100825142910.JPG

Outfall fully submerged and not physically located. GPS coordinates approximate. Pipe info from MS4 map.

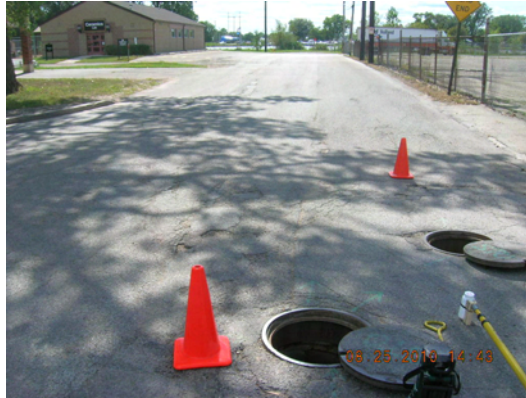
o20100825144300.JPG

Upstream manhole located approx 365 ft NE of outfall 05-241. Intermediate area consists of industrial parking area to north and institutional buildings to south.

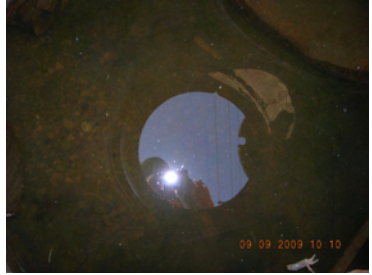
Inspection Date: 9/9/2009		Inspector: JCW		Inspection Type: Initial		Previous Rainfall (hrs): 72+	
Flow Description: Submerged, indeterminate				Notes: Abnormal detergent analysis result (bubbles)			
Submerged: Partially		Depth (in): 13					
Illicit Discharge Potential: Potential				<input type="checkbox"/> Field Follow-up		<input type="checkbox"/> Office Follow-up	
Floatables: None		<input type="checkbox"/> Petroleum Sheen	<input type="checkbox"/> Suds	<input type="checkbox"/> Sewage	<input type="checkbox"/> Other		
		<input type="checkbox"/> Natural Sheen	<input type="checkbox"/> Algae	<input type="checkbox"/> Solid Waste/Debris			
Odor: None		<input type="checkbox"/> Petroleum	<input type="checkbox"/> Musty	<input type="checkbox"/> Sewage	<input type="checkbox"/> Chlorine		
		<input type="checkbox"/> VOC/Solvent	<input type="checkbox"/> Fishy	<input type="checkbox"/> Sulfur	<input type="checkbox"/> Sour

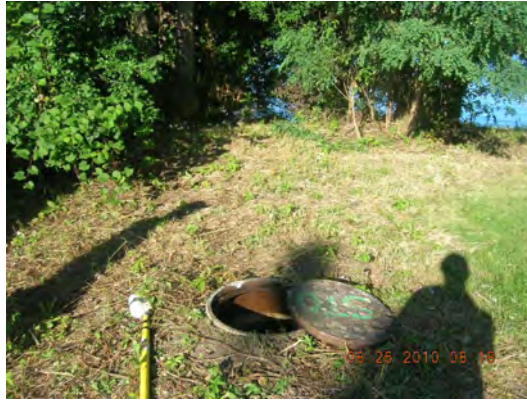
o20100826081830.JPG

Upstream manhole located approx 20 ft E of outfall 05-264. Intermediate area consists of open space.

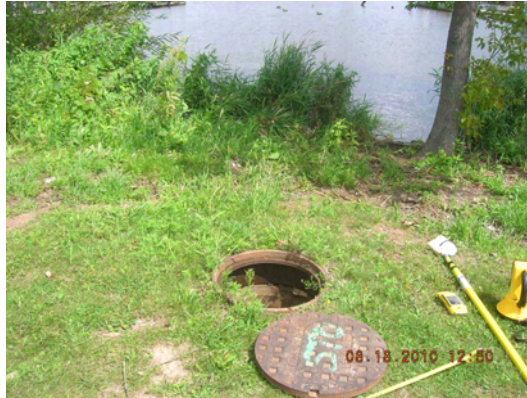
o20100818125006.JPG

Upstream manhole located approx 34 ft SW of outfall 06-52. Intermediate area consists of open space.

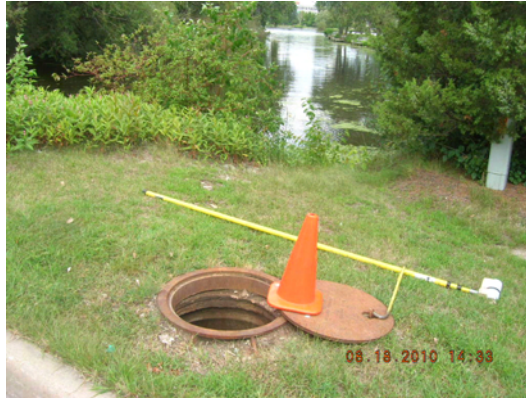
o20100818143346.JPG

Upstream manhole located approx 25 ft SSW of outfall 06-221. Intermediate area consists of open space. 1.5" hose through side of manhole - tied around steps

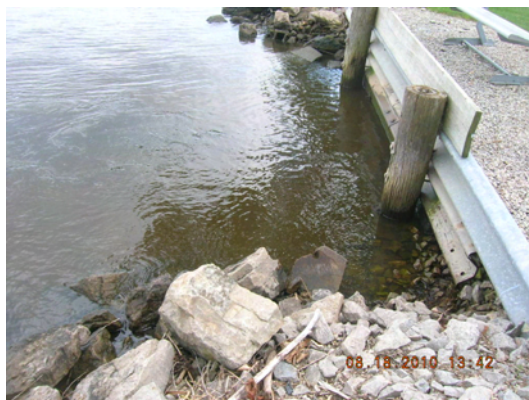
o20100818134248.JPG

Outfall fully submerged and not physically located. GPS coordinates approximate. Pipe info from MS4 map.

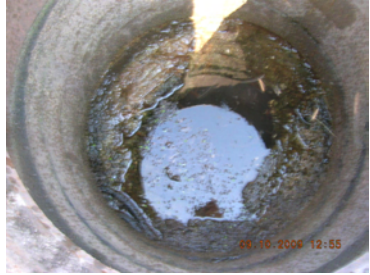
Osh09_DSCN6791.JPG							
Sampling Results							
Sample Location: Pool							
Sample ID: 090910-26

Inspection Date: 9/10/2009		Inspector: JCW		Inspection Type: Initial		Previous Rainfall (hrs): 72+	
Flow Description: Submerged, slight flow				Notes: River fly swarm inside manhole.			
Submerged: Fully		Depth (in): 38					
Illicit Discharge Potential: Unlikely				<input type="checkbox"/> Field Follow-up		<input type="checkbox"/> Office Follow-up	
Floatables: None		<input type="checkbox"/> Petroleum Sheen	<input type="checkbox"/> Suds	<input type="checkbox"/> Sewage	<input type="checkbox"/> Other		
		<input type="checkbox"/> Natural Sheen	<input type="checkbox"/> Algae	<input type="checkbox"/> Solid Waste/Debris			
Odor: None		<input type="checkbox"/> Petroleum	<input type="checkbox"/> Musty	<input type="checkbox"/> Sewage	<input type="checkbox"/> Chlorine		
		<input type="checkbox"/> VOC/Solvent	<input type="checkbox"/> Fishy	<input type="checkbox"/> Sulfur	<input type="checkbox"/> Sour		
Turbidity: None						<input type="checkbox"/> Other

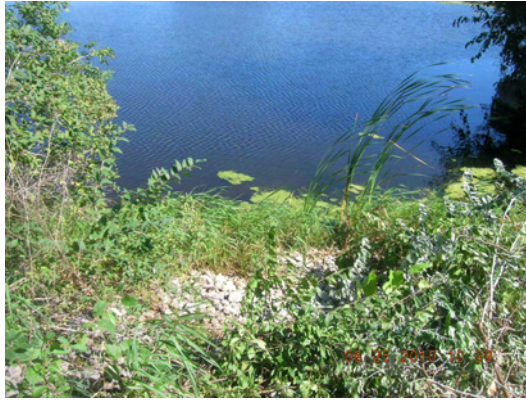
o20100825103932.JPG

Outfall fully submerged and not physically located. GPS coordinates approximate. Pipe info from MS4 map.

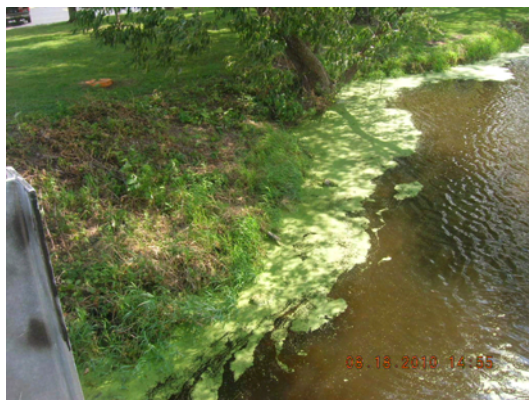
o20100818145512.JPG

Outfall fully submerged and not physically located. GPS coordinates approximate. Pipe info from MS4 map.

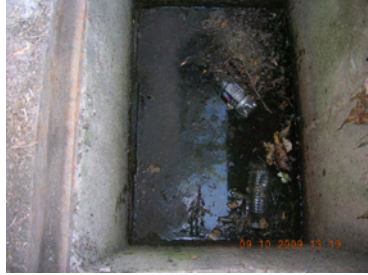
Osh09_DSCN6796.JPG							
Sampling Results

Inspection Date: 9/10/2009		Inspector: JCW		Inspection Type: Initial		Previous Rainfall (hrs): 72+	
Flow Description: Submerged, indeterminate				Notes: Slight sulfide odor.			
Submerged: Fully		Depth (in): 16					
Illicit Discharge Potential: Unlikely				<input type="checkbox"/> Field Follow-up		<input type="checkbox"/> Office Follow-up	
Floatables: Slight		<input type="checkbox"/> Petroleum Sheen		<input type="checkbox"/> Suds		<input type="checkbox"/> Sewage <input checked="" type="checkbox"/> Other	
		<input type="checkbox"/> Natural Sheen		<input type="checkbox"/> Algae		<input type="checkbox"/> Solid Waste/Debris	
Odor: None		<input type="checkbox"/> Petroleum		<input type="checkbox"/> Musty		<input type="checkbox"/> Sewage <input type="checkbox"/> Chlorine	
		<input type="checkbox"/> VOC/Solvent		<input type="checkbox"/> Fishy		<input checked="" type="checkbox"/> Sulfur <input type="checkbox"/> Sour

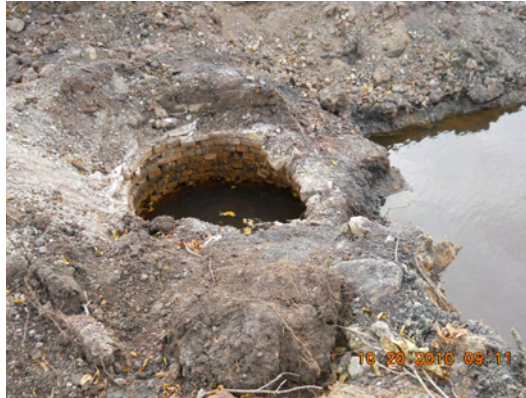
o20101020091150.jpg

Upstream manhole located approx 48 ft NNW of outfall 08-100. Intermediate area consists of open space. Area under excavation.

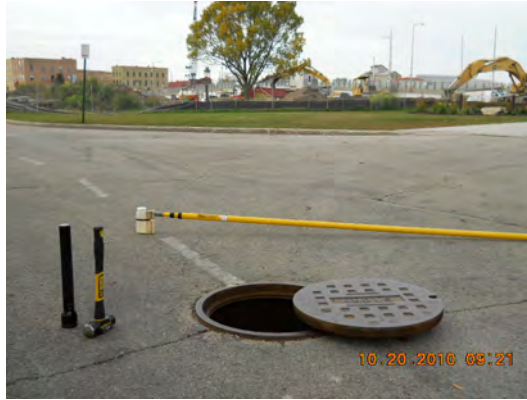
o20101020092102.jpg

Upstream manhole located approx 209 ft NNE of outfall 08-100. Intermediate area consists of open space and paved parking area.

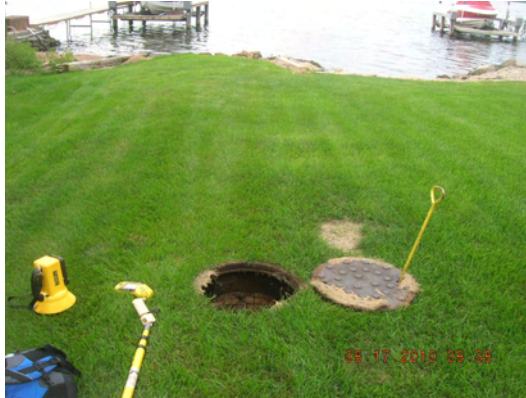
o20100817083802.JPG

Upstream manhole located approx 67 ft NNE of outfall 08-162. Intermediate area consists of open space.

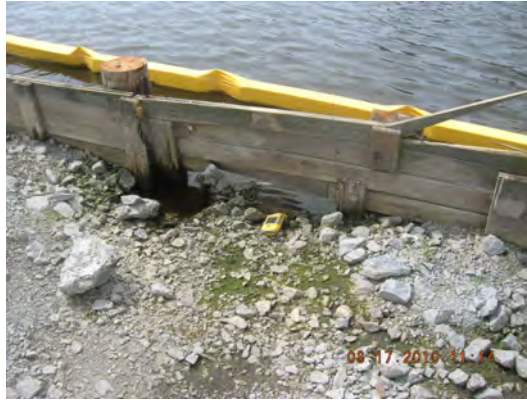
o20100817111406.JPG

Outfall partially submerged.

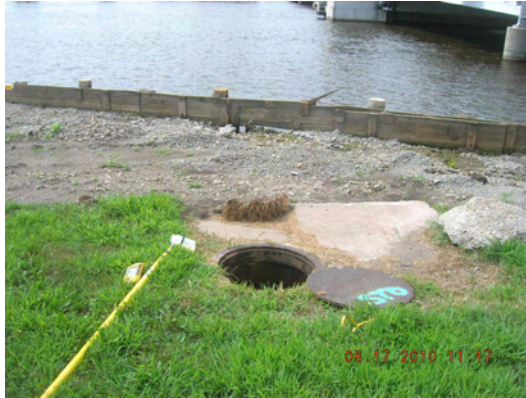
o20100817111740.JPG

Upstream manhole located approx 24 ft NNE of outfall 08-279. Intermediate area consists of open space under construction.

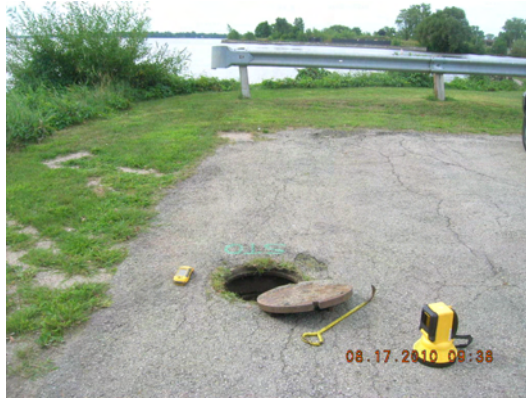
o20100817093830.JPG

Upstream manhole located approx 26 ft N of outfall 08-284. Intermediate area consists of street right-of-way and open space.

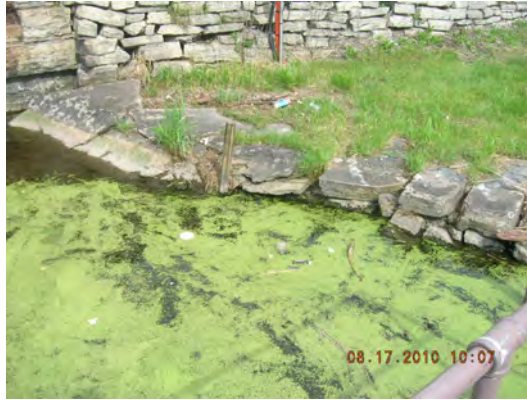
o20100817100702.JPG

Outfall fully submerged and not physically located. GPS coordinates approximate. Pipe info from MS4 map.

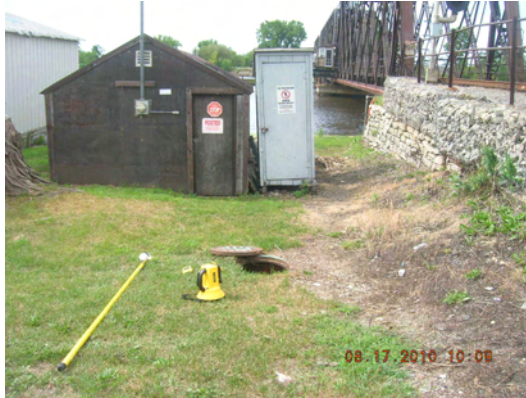
o20100817100938.JPG

Upstream manhole located approx 64 ft NNE of outfall 08-347. Intermediate area consists of gravel parking area and railroad storage shed.

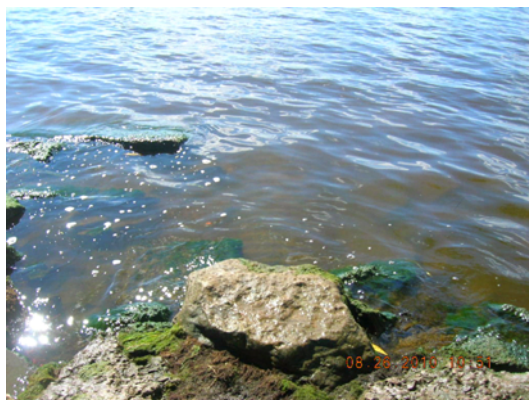
o20100826105100.JPG

Outfall fully submerged and not physically located. GPS coordinates approximate. Pipe info from MS4 map. Pipe larger than 18" shown on map.

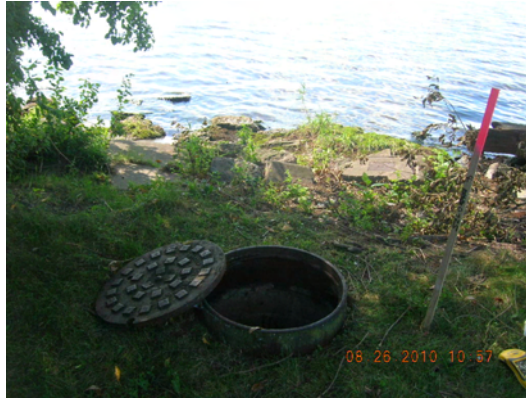
o20100826105736.JPG

Upstream manhole located approx 21 ft N of outfall 08-350. Intermediate area consists of open space.

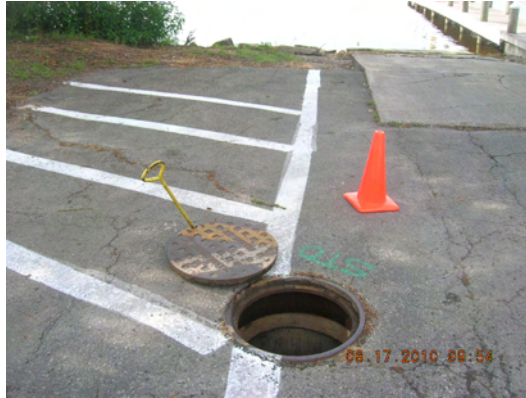
o20100817095412.JPG

Upstream manhole located approx 45 ft N of outfall 08-395. Intermediate area consists of paved parking and boat launch.

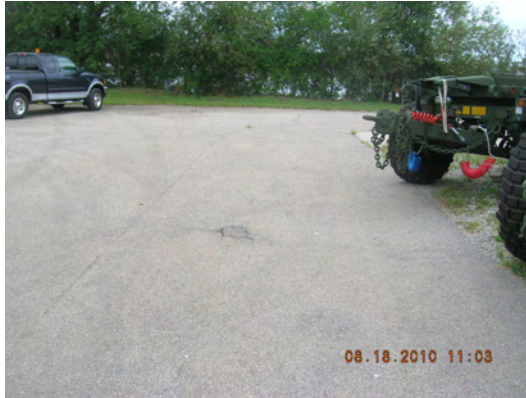
o20100818110338.JPG

Upstream manhole located approx 69 ft S of outfall 09-32. Inaccessible - paved over. No other manhole outside building.

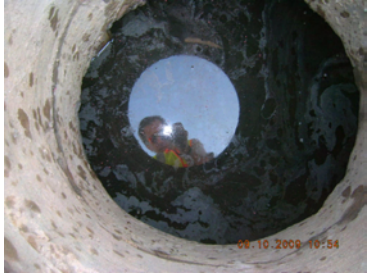
Outfall ID: 09-101a US1

Inspection Date: 9/10/2009		Inspector: JCW		Inspection Type: Initial		Previous Rainfall (hrs): 72+	
Flow Description: Submerged, indeterminate				Notes:			
Submerged: Fully Depth (in): 22							
Illicit Discharge Potential: Unlikely				<input type="checkbox"/> Field Follow-up <input type="checkbox"/> Office Follow-up			
Floatables: <input type="text" value="None"/>		<input type="checkbox"/> Petroleum Sheen	<input type="checkbox"/> Suds	<input type="checkbox"/> Sewage	<input type="checkbox"/> Other

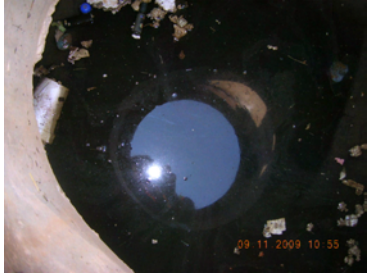
<i>Osh09_DSCN6891.JPG</i>			
Sampling Results							
Sample Location:				Pool			
Sample ID:				090911-71

Inspection Date: 9/11/2009		Inspector: JCW		Inspection Type: Initial		Previous Rainfall (hrs): 72+	
Flow Description: Submerged, indeterminate				Notes:			
Submerged: None		Depth (in):					
Illicit Discharge Potential: Potential				<input type="checkbox"/> Field Follow-up <input type="checkbox"/> Office Follow-up			
Floatables: Slight		<input checked="" type="checkbox"/> Petroleum Sheen		<input type="checkbox"/> Suds		<input type="checkbox"/> Sewage <input checked="" type="checkbox"/> Other	
		<input type="checkbox"/> Natural Sheen		<input type="checkbox"/> Algae		<input type="checkbox"/> Solid Waste/Debris	
Odor: None		<input type="checkbox"/> Petroleum		<input type="checkbox"/> Musty		<input type="checkbox"/> Sewage <input type="checkbox"/> Chlorine	
		<input type="checkbox"/> VOC/Solvent		<input type="checkbox"/> Fishy		<input type="checkbox"/> Sulfur <input type="checkbox"/> Sour	
Turbidity: None						<input type="checkbox"/> Other
