Ongoing Screening Summary Report 2010 Inspection Year

Illicit Discharge Detection and Elimination Program

City of Oshkosh

OMNNI Project No. N2029B10

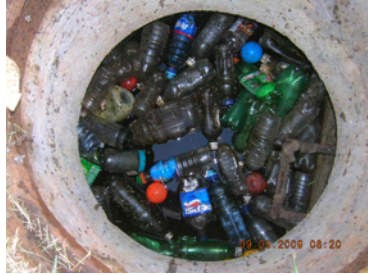
Outfall ID: 12-576 US1

Inspection Date: 9/9/2009		Inspector: JCW	Inspection Type: Initial	Previous Rainfall (hrs): 72+
Flow Description: Submerged, indeterminate		Notes: Abnormal detergent analysis result (bubbles). Significant floatables (bottles) in manhole.

Submerged: Fully Depth (in): 68				
Illicit Discharge Potential: Potential		<input type="checkbox"/> Field Follow-up <input type="checkbox"/> Office Follow-up		
Floatables: Severe	<input type="checkbox"/> Petroleum Sheen <input type="checkbox"/> Suds <input type="checkbox"/> Sewage <input type="checkbox"/> Other			
	<input type="checkbox"/> Natural Sheen <input type="checkbox"/> Algae <input checked="" type="checkbox"/> Solid Waste/Debris			
Odor: None	<input type="checkbox"/> Petroleum <input type="checkbox"/> Musty <input type="checkbox"/> Sewage <input type="checkbox"/> Chlorine			
	<input type="checkbox"/> VOC/Solvent <input type="checkbox"/> Fishy <input type="checkbox"/> Sulfur <input type="checkbox"/> Sour

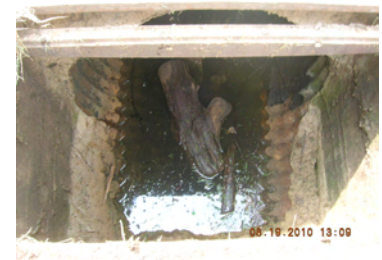
o20100819130900.JPG

Damage: Minor

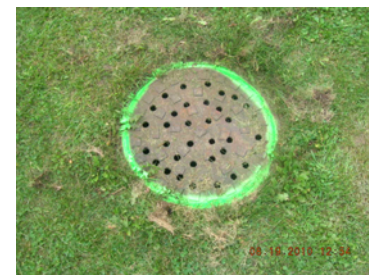
o20100819125440.JPG

Damage: Moderate ☐ Displacement ☐ Undercut ☐ Crushed

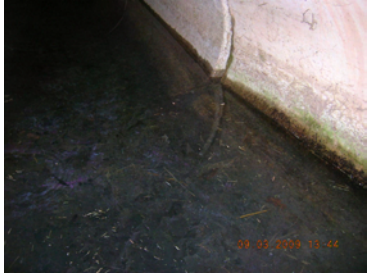
Osh09_DSCN6451.JPG</div>

Inspection Date: 9/3/2009		Inspector: JCW		Inspection Type: Initial		Previous Rainfall (hrs): 72+			
Flow Description: Submerged, indeterminate				Notes: Sulfide odor, slight oil sheen in pool.					
Submerged: Partially		Depth (in): 11							
Illicit Discharge Potential: Potential				<input type="checkbox"/> Field Follow-up <input type="checkbox"/> Office Follow-up					
Floatables: Slight		<input checked="" type="checkbox"/> Petroleum Sheen		<input type="checkbox"/> Suds		<input type="checkbox"/> Sewage		<input type="checkbox"/> Other	
		<input type="checkbox"/> Natural Sheen		<input type="checkbox"/> Algae		<input type="checkbox"/> Solid Waste/Debris			
Odor: Faint		<input type="checkbox"/> Petroleum		<input type="checkbox"/> Musty		<input type="checkbox"/> Sewage		<input type="checkbox"/> Chlorine	
		<input type="checkbox"/> VOC/Solvent		<input type="checkbox"/> Fishy		<input checked="" type="checkbox"/> Sulfur		<input type="checkbox"/> Sour

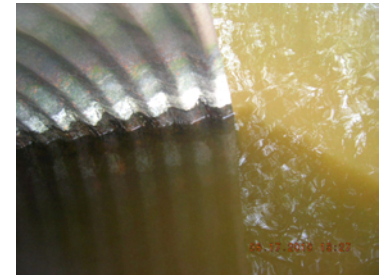
o20100817132746.JPG

☒ Corrosion

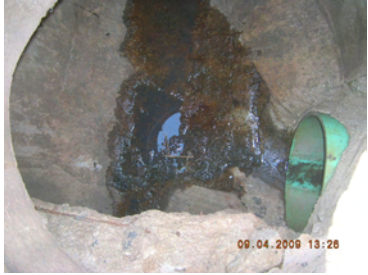
Inspection Date: 9/4/2009		Inspector: JCW		Inspection Type: Initial		Previous Rainfall (hrs): 72+	
Flow Description: None				Notes: Wet, no flow. Slight oil sheen in pool in manhole.			
Submerged: None		Depth (in): 0					
Illicit Discharge Potential: Potential				<input type="checkbox"/> Field Follow-up		<input type="checkbox"/> Office Follow-up	
Floatables:	<input type="text" value="Slight"/>	<input checked="" type="checkbox"/> Petroleum Sheen	<input type="checkbox"/> Suds	<input type="checkbox"/> Sewage	<input type="checkbox"/> Other

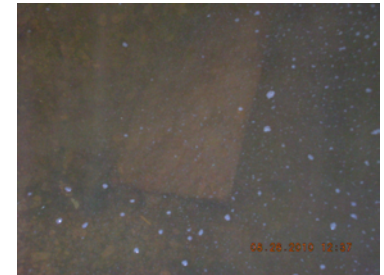
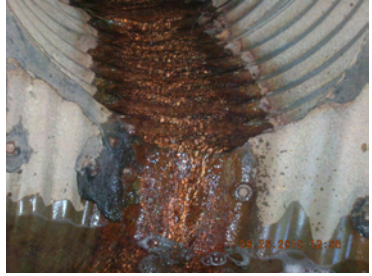
o20100826123758.JPG

Stains: Moderate

☒ Corrosion

Inspection Date: 8/26/2010 12:58:18 PM		Inspector: JCW		Inspection Type: Ongoing		Previous Rainfall (hrs): 72+	
Flow Description: Moderate				Notes: Persistent suds and gel-like sheen downstream			
Submerged: None		Depth (in):					
Illicit Discharge Potential: Potential				<input type="checkbox"/> Field Follow-up <input type="checkbox"/> Office Follow-up			
Floatables: Moderate		<input type="checkbox"/> Petroleum Sheen		<input checked="" type="checkbox"/> Suds		<input type="checkbox"/> Sewage <input checked="" type="checkbox"/> Other	
		<input type="checkbox"/> Natural Sheen		<input type="checkbox"/> Algae		<input type="checkbox"/> Solid Waste/Debris	
Odor: None		<input type="checkbox"/> Petroleum		<input type="checkbox"/> Musty		<input type="checkbox"/> Sewage <input type="checkbox"/> Chlorine	
		<input type="checkbox"/> VOC/Solvent		<input type="checkbox"/> Fishy		<input type="checkbox"/> Sulfur <input type="checkbox"/> Sour

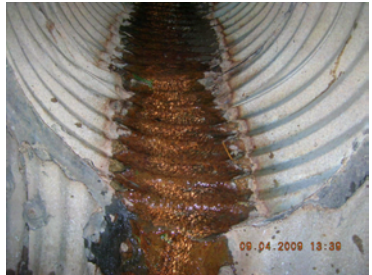
Osh09_DSCN6538.JPG

Inspection Date: 9/4/2009		Inspector: JCW		Inspection Type: Initial		Previous Rainfall (hrs): 72+	
Flow Description: Moderate				Notes: Sample 09090411 collected from pool (suds). No detergent detected.			
Submerged: None		Depth (in): 0					
Illicit Discharge Potential: Potential				<input type="checkbox"/> Field Follow-up <input type="checkbox"/> Office Follow-up			
Floatables: Moderate		<input type="checkbox"/> Petroleum Sheen		<input checked="" type="checkbox"/> Suds		<input type="checkbox"/> Sewage <input type="checkbox"/> Other	
		<input type="checkbox"/> Natural Sheen		<input type="checkbox"/> Algae		<input type="checkbox"/> Solid Waste/Debris	
Odor: None		<input type="checkbox"/> Petroleum		<input type="checkbox"/> Musty		<input type="checkbox"/> Sewage <input type="checkbox"/> Chlorine	
		<input type="checkbox"/> VOC/Solvent		<input type="checkbox"/> Fishy		<input type="checkbox"/> Sulfur <input type="checkbox"/> Sour

Turbidity: None						<input type="checkbox"/> Other	
Color: None							
Vegetation: None		<input type="checkbox"/> Inhibited		<input type="checkbox"/> Excessive			
Benthic Growth: None		<input type="checkbox"/> Green		<input type="checkbox"/> Brown		<input type="checkbox"/> Orange <input type="checkbox"/> Other	
Stains: Moderate		<input checked="" type="checkbox"/> Flow Line		<input type="checkbox"/> Oil		<input type="checkbox"/> Rust Stains	
		<input checked="" type="checkbox"/> Corrosion		<input type="checkbox"/> Paint		<input type="checkbox"/> Other	
Physical Condition Assessment							
Graffiti: None							
Erosion: None							
Deposition: None		Depth (in): 0					
Damage: Minor		<input type="checkbox"/> Displacement		<input type="checkbox"/> Undercut		<input type="checkbox"/> Crushed	
		<input checked="" type="checkbox"/> Corrosion		<input type="checkbox"/> Concrete Damage

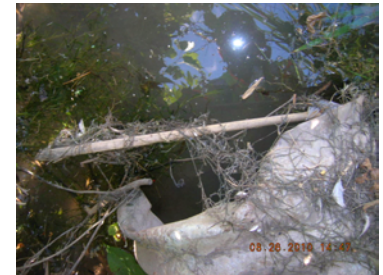
o20100826144742.JPG

Damage: Minor

☒ Corrosion

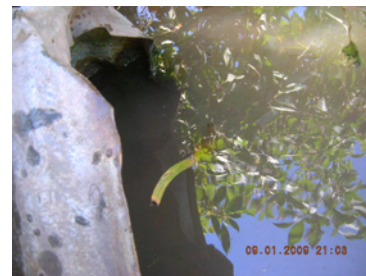
Osh09_DSCN6359.JPG

Turbidity:	<input type="text" value="Cloudy"/>				<input type="checkbox"/> Other		
Color:	<input type="text" value="None"/>						
Vegetation:	<input type="text" value="None"/>	<input type="checkbox"/> Inhibited	<input type="checkbox"/> Excessive				
Benthic Growth:	<input type="text" value="Slight"/>	<input type="checkbox"/> Green	<input checked="" type="checkbox"/> Brown	<input type="checkbox"/> Orange	<input type="checkbox"/> Other		
Stains:	<input type="text" value="None"/>	<input checked="" type="checkbox"/> Flow Line	<input type="checkbox"/> Oil	<input type="checkbox"/> Rust Stains			
		<input checked="" type="checkbox"/> Corrosion	<input type="checkbox"/> Paint	<input type="checkbox"/> Other			
Physical Condition Assessment							
Graffiti:	<input type="text" value="None"/>						
Erosion:	<input type="text" value="None"/>						
Deposition:	<input type="text" value="None"/>	Depth (in): 0

Damage:	<input type="text" value="Minor"/>	<input type="checkbox"/> Displacement	<input type="checkbox"/> Undercut	<input type="checkbox"/> Crushed			
		<input checked="" type="checkbox"/> Corrosion	<input type="checkbox"/> Concrete Damage				
							Sampling Results
							Sample Location:
							Sample ID:
							Time Collected:
							Total Chlorine (field): ppm
							Free Chlorine (field): ppm
							Total Copper (field): ppm
							Ammonia (field): ppm
							pH (field): units
							Temperature: °F
							Detergents: mg/L
							Phenol: mg/L

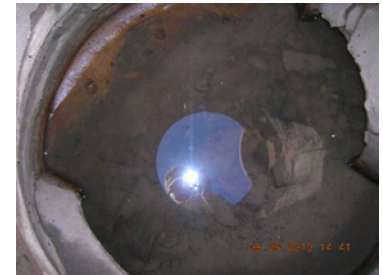
o20100826144124.JPG

Stains:

☒ Rust Stains

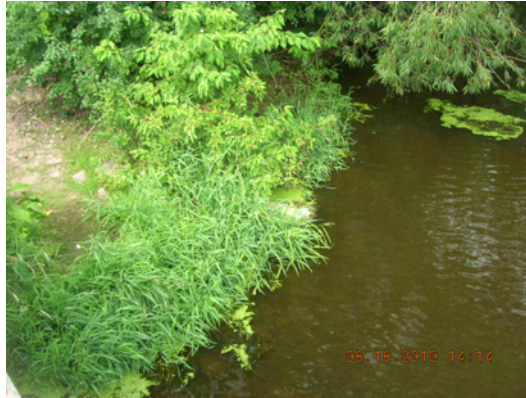
o20100818141424.JPG

Outfall fully submerged and not physically located. GPS coordinates approximate. Pipe info from MS4 map.

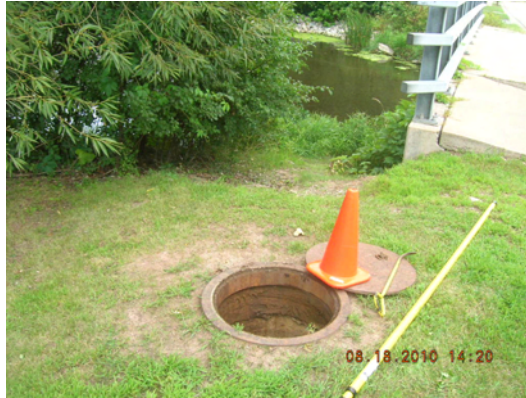
o20100818142000.JPG

Upstream manhole located approx 34 ft NW of outfall 16-28. Intermediate area consists of open space.

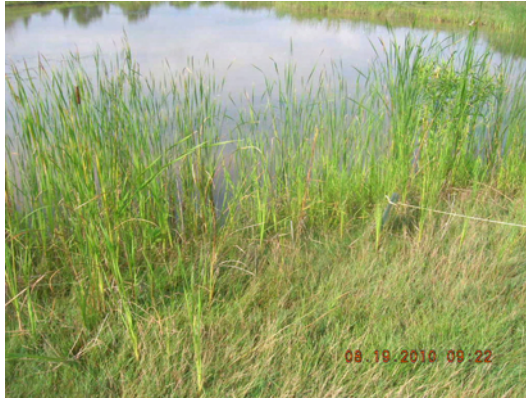
o20100819092252.JPG

Located in golf course pond. Outfall fully submerged and not physically located. GPS coordinates approximate. Pipe info from MS4 map.

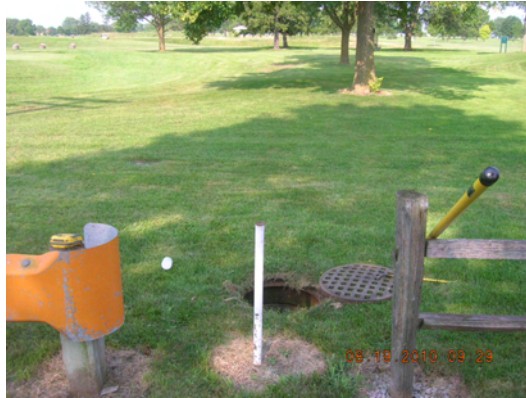
o20100819092904.JPG

Upstream catchbasin located approx 410 ft ESE of outfall 16-47. Intermediate area consists of open space in golf course. First upstream manhole not located.

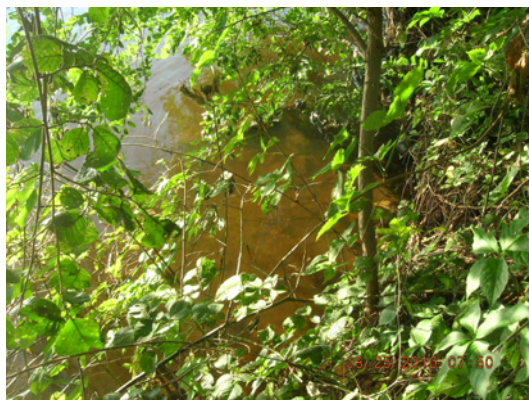
o20100825075024.JPG

Outfall fully submerged and not physically located. GPS coordinates approximate. Pipe info from MS4 map.

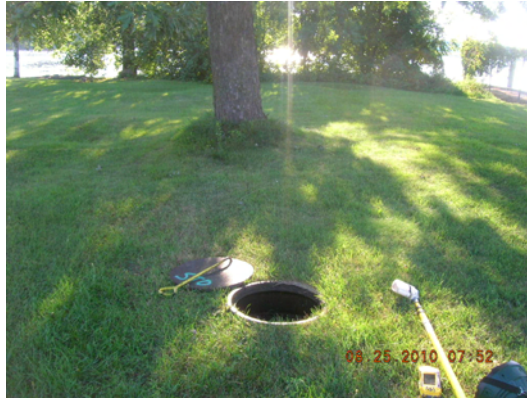
o20100825075224.JPG

Upstream manhole located approx 85 ft W of outfall 16-71. Intermediate area consists of open space.

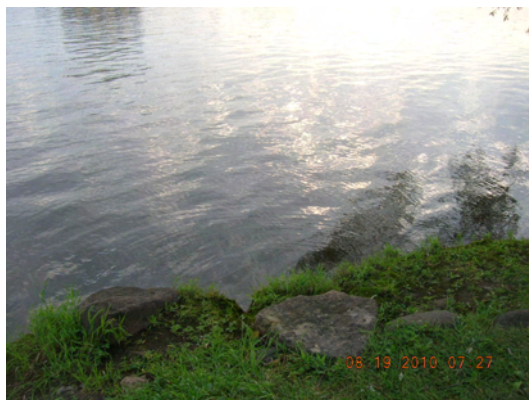
o20100819072722.JPG

Outfall fully submerged and not physically located. GPS coordinates approximate. Pipe info from MS4 map.

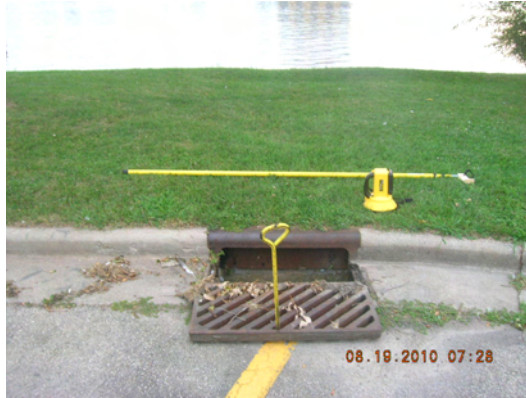
o20100819072802.JPG

Upstream curb inlet located approx 52 ft WSW of outfall 16-119. Intermediate area consists of open space between parking lot and shoreline.

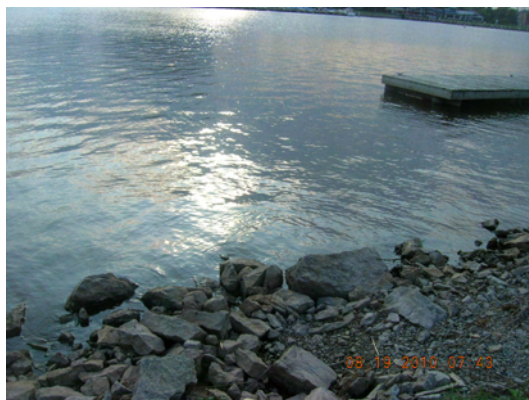
o20100819074346.JPG

Outfall fully submerged and not physically located. GPS coordinates approximate. Pipe info from MS4 map.

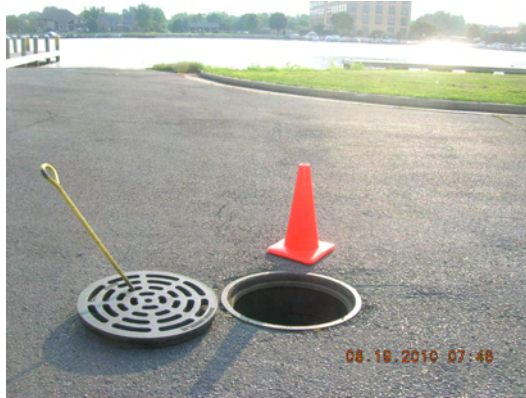
o20100819074604.JPG

Upstream catchbasin located approx 63 ft SW of outfall 16-201. Intermediate area consists of paved parking area and shoreline.

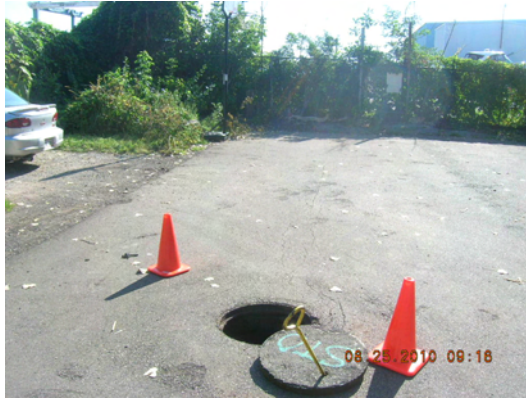
o20100825091610.JPG

Upstream manhole located approx 141ft SW of outfall 16-295. Intermediate area consists of street right-of-way and boat dry dock.

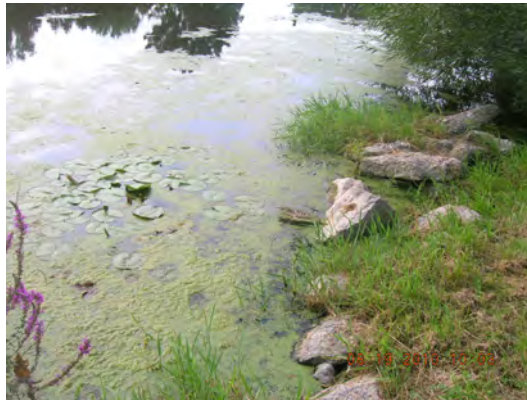
o20100819100322.JPG

Outfall fully submerged and not physically located. GPS coordinates approximate. Pipe info from MS4 map. 18" CMP in upstream manhole.

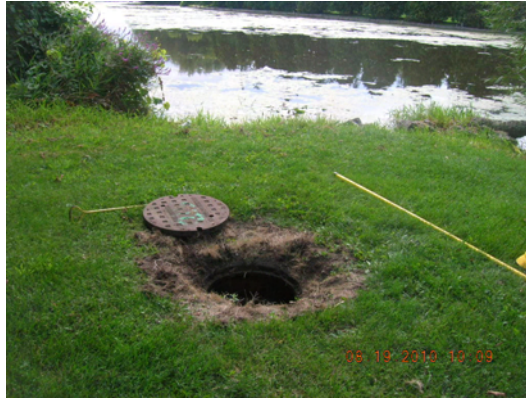
o20100819100912.JPG

Upstream manhole located approx 28 ft NW of outfall 16-362. Intermediate area consists of open space. 18" CMP discharges to SE.

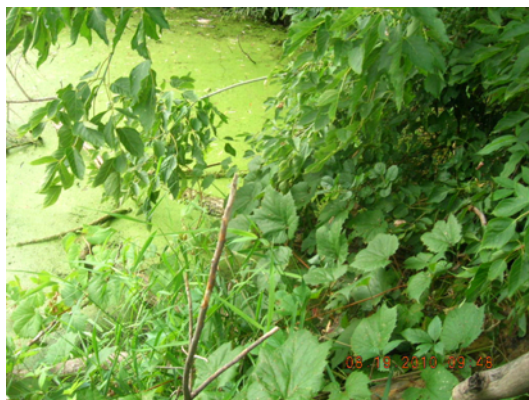
o20100819094846.JPG

Outfall fully submerged and not physically located. GPS coordinates approximate. Pipe info from MS4 map.

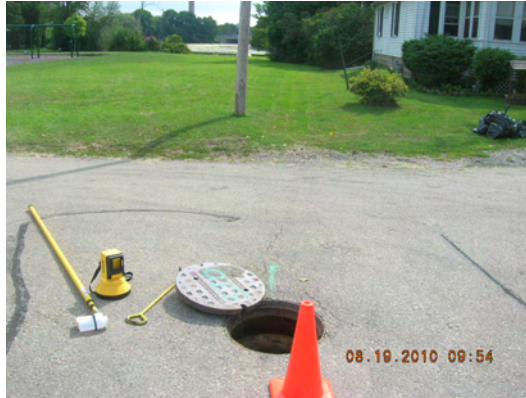
o20100819095404.JPG

Upstream manhole located approx 193 ft W of outfall 16-368. Intermediate area consists of street right-of-way, residential property and park space.

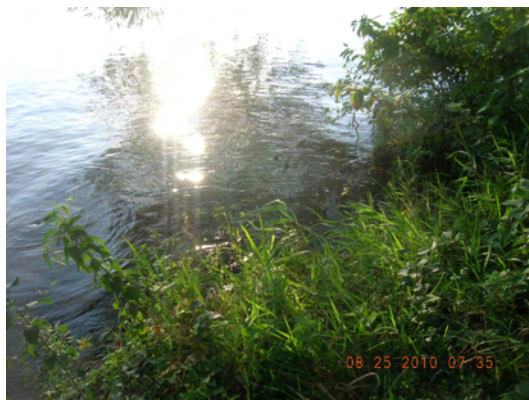
o20100825073518.JPG

Outfall fully submerged and not physically located. GPS coordinates approximate. Pipe info from MS4 map.

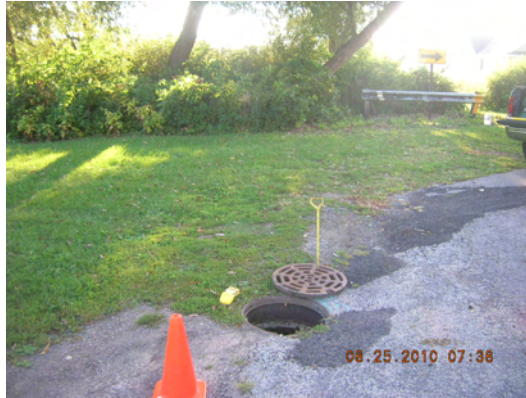
o20100825073858.JPG

Upstream catchbasin located approx 172 ft W of outfall 16-386. Intermediate area consists of open space and wooded area.

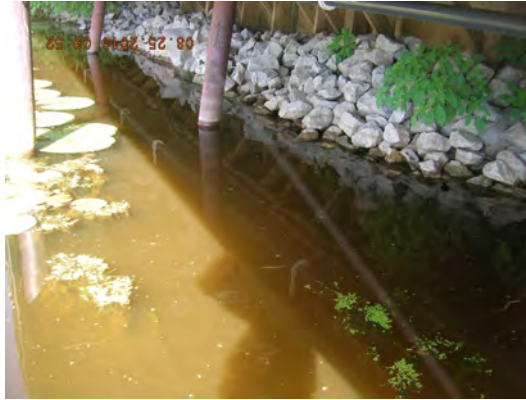
o20100825095256.JPG

Outfall fully submerged and not physically located. GPS coordinates approximate. Pipe info from MS4 map.

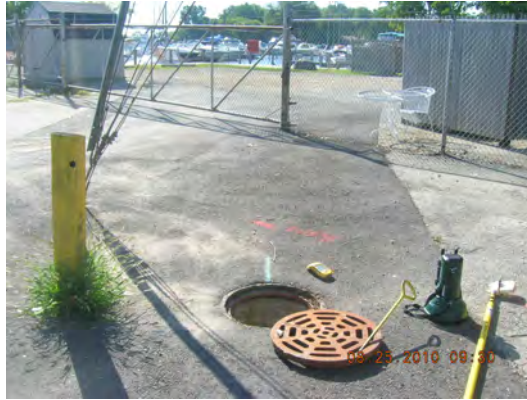
o20100825093000.JPG

Upstream catchbasin located approx 115 ft NW of outfall 16-389. Intermediate area consists of paved parking area.

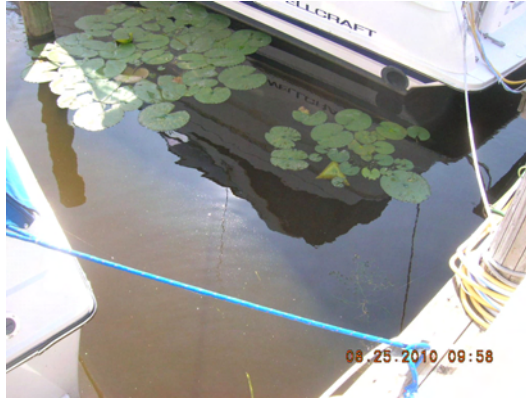
o20100825095832.JPG

Outfall fully submerged and not physically located. GPS coordinates approximate. Pipe info from MS4 map.

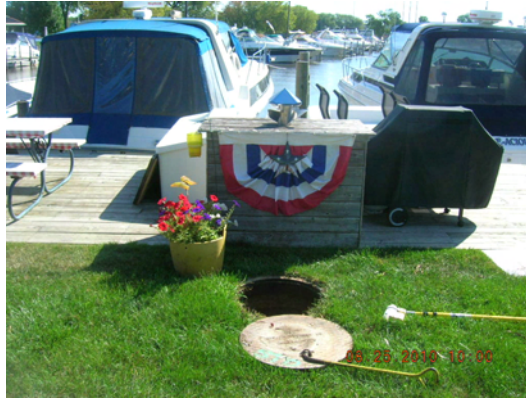
o20100825100024.JPG

Upstream manhole located approx 35 ft W of outfall 16-396. Intermediate area consists of boat slip.

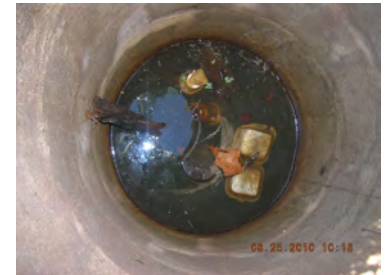
o20100825101302.JPG

Stains: Slight

☒ Rust Stains

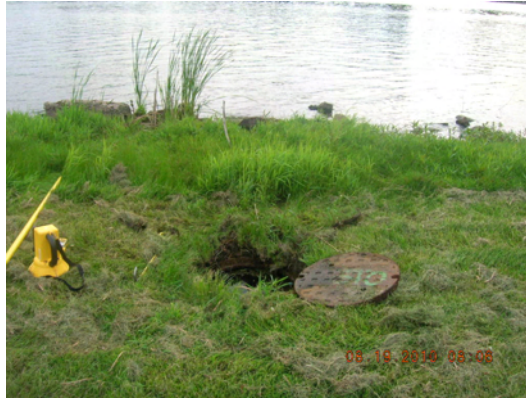
o20100819080604.JPG

Upstream manhole located approx 28 ft WSW of outfall 16-463. Intermediate area consists of open space along shoreline.

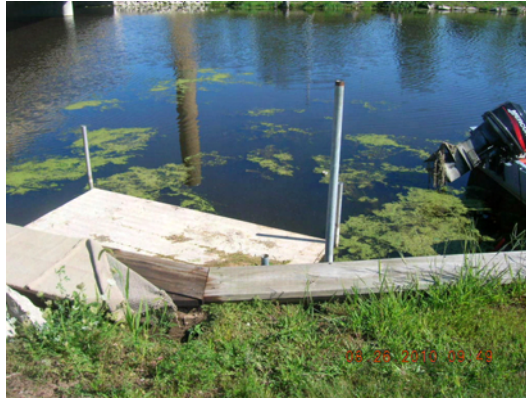
o20100826094912.JPG

Outfall fully submerged and not physically located. GPS coordinates approximate. Pipe info from MS4 map.

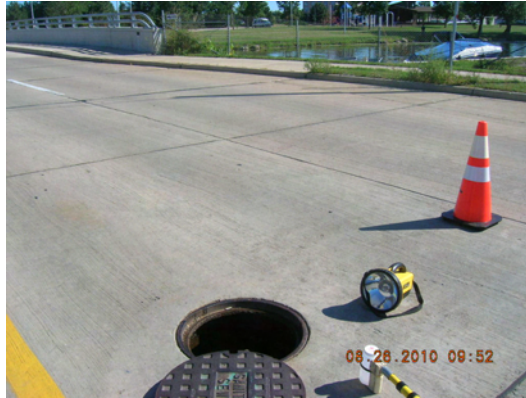
o20100826095220.JPG

Upstream manhole located approx 75 ft NE of outfall 16-533. Intermediate area consists of street right-of-way and commercial property.

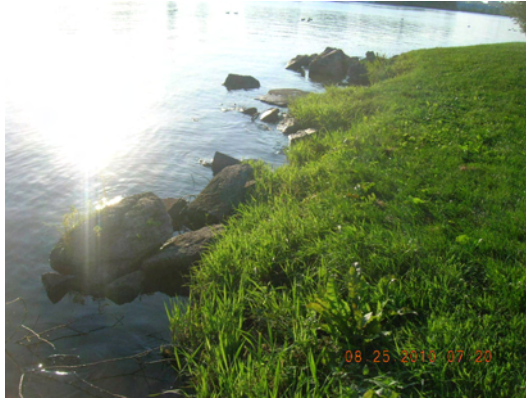
o20100825072000.JPG

Outfall fully submerged and not physically located. GPS coordinates approximate. Pipe info from MS4 map.

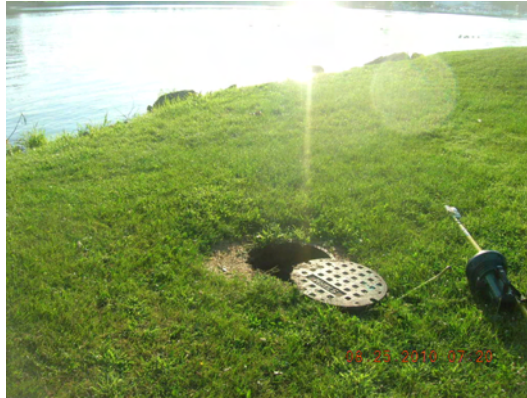
o20100825072012.JPG

Upstream manhole located approx 54 ft W of outfall 16-551. Intermediate area consists of open space in park.

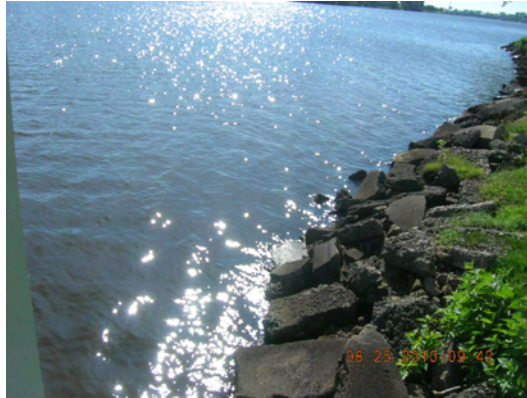
o20100825094258.JPG

Outfall fully submerged and not physically located. GPS coordinates approximate. Pipe info from MS4 map. Identified on MS4 map, but may be private outfall.

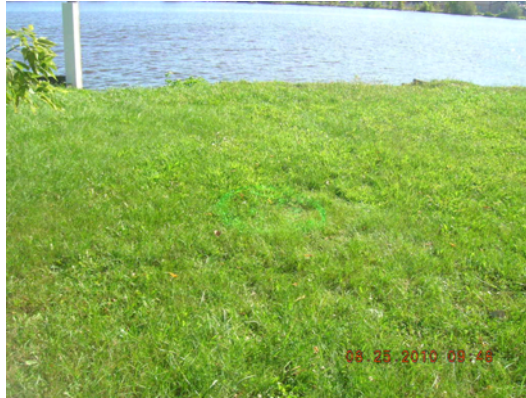
o20100825094812.JPG

Upstream manhole not located. Found probable location with metal detector and marked for City to expose.

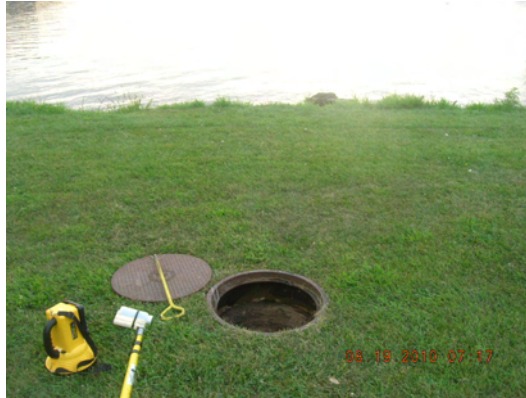
o20100819071728.JPG

Upstream manhole located approx 60 ft WSW of outfall 16-594. Intermediate area consists of open space in park.

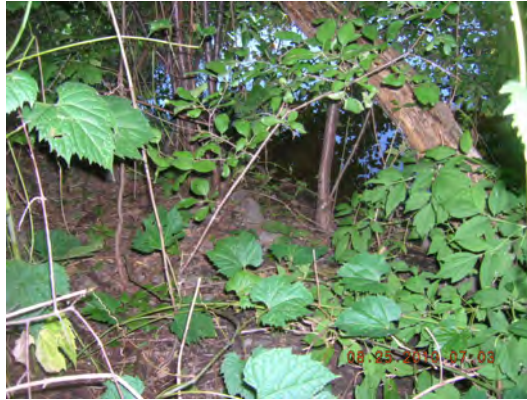
o20100825070344.JPG

Outfall fully submerged and not physically located. GPS coordinates approximate. Pipe info from MS4 map.

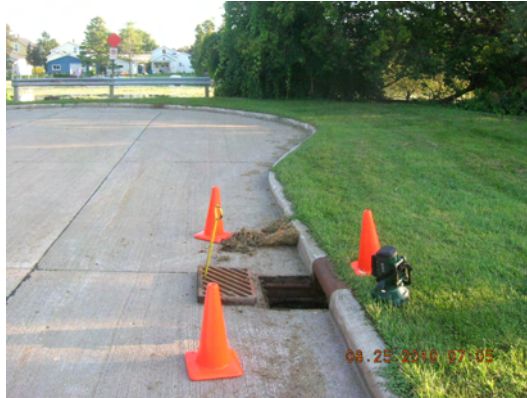
o20100825070540.JPG

Upstream curb inlet located approx 95 ft S of outfall 16-719. Intermediate area consists of street right-of-way and open space.

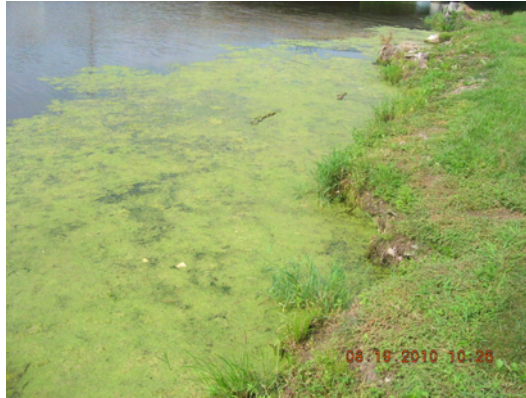
o20100819102648.JPG

Outfall fully submerged and not physically located. GPS coordinates approximate. 12" CMP leaving upstream curb inlet.

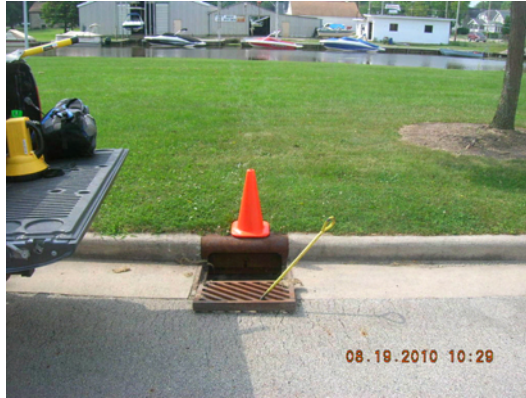
o20100819102924.JPG

Upstream curb inlet located approx 100 ft N of outfall 16-871. Intermediate area consists of open space in park.

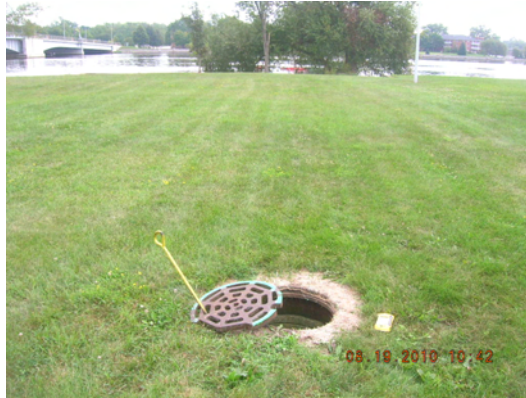
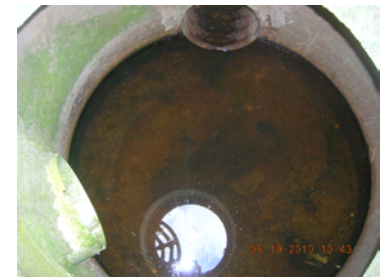
o20100819104256.JPG

Notes: 11" of water in sump, but below invert of outfall pipe. Rust stains from 4" pipe from SW.

Damage: Minor

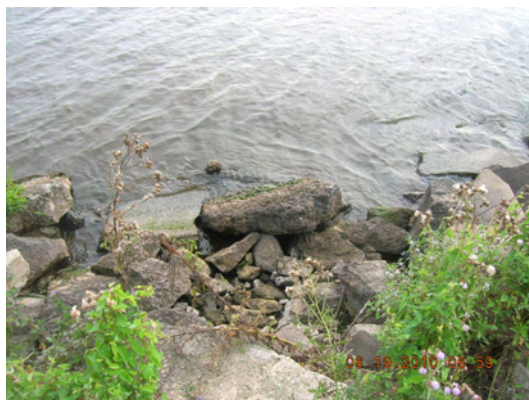
o20100819085940.JPG

Outfall fully submerged. Pipe info from MS4 map.

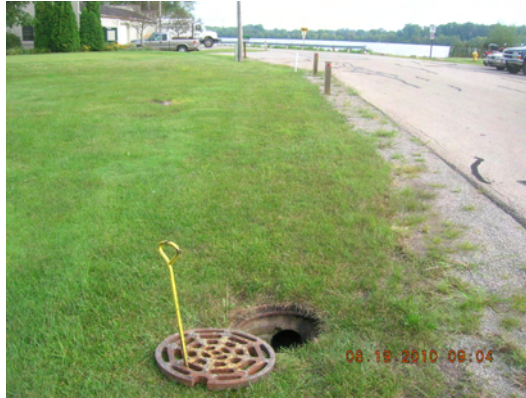
o20100819090430.JPG

Upstream catchbasin located approx 277 ft S of outfall 16-1074. Intermediate area consists of street right-of-way adjacent to golf course.

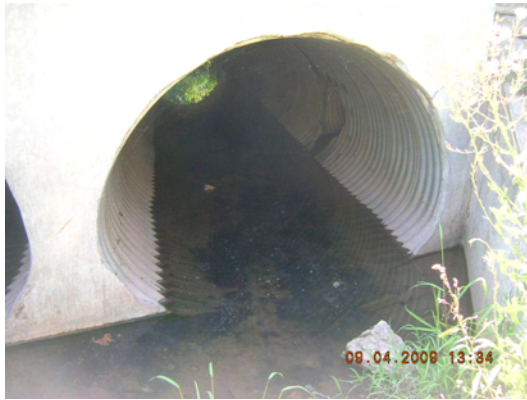
DSCN6537.JPG

30 inch CMP discharges into west culvert

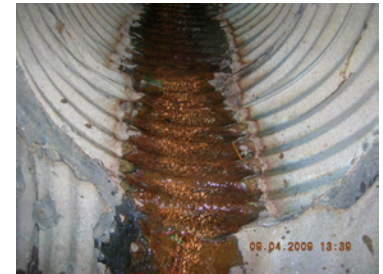
DSCN6538.JPG

- Outfall Damage** ☒ Corrosion ☐ Peeling Paint ☐ Spalling/Cracking/Chipping
Deposits/Stains ☐ Oily ☐ Paint ☒ Flow Line ☐ Other:
Pipe Benthic Growth ☐ Brown ☐ Orange ☐ Green ☐ Other:
Abnormal Vegetation ☐ Inhibited ☐ Excessive
Poor Pool Quality ☐ Odors ☐ Colors ☐ Oil Sheen ☒ Suds ☐ Floatables
☐ Excessive Algae ☐ Other:

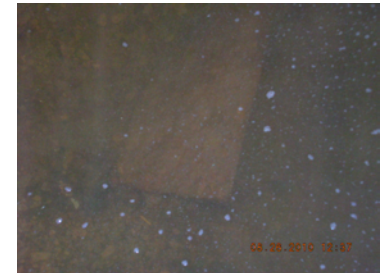
o20100826123758.JPG

30 inch CMP discharges into west culvert.

Stains: Moderate

☒ Corrosion

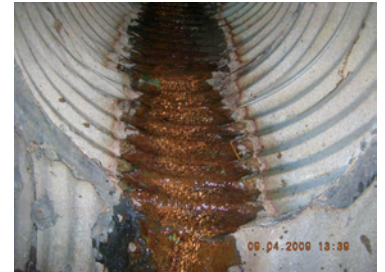
Osh09_DSCN6538.JPG

Inspection Date: 9/4/2009		Inspector: JCW		Inspection Type: Initial		Previous Rainfall (hrs): 72+	
Flow Description: Moderate				Notes: Sample 09090411 collected from pool (suds). No detergent detected.			
Submerged: None		Depth (in): 0					
Illicit Discharge Potential: Potential				<input type="checkbox"/> Field Follow-up <input type="checkbox"/> Office Follow-up			
Floatables: Moderate		<input type="checkbox"/> Petroleum Sheen		<input checked="" type="checkbox"/> Suds		<input type="checkbox"/> Sewage <input type="checkbox"/> Other	
		<input type="checkbox"/> Natural Sheen		<input type="checkbox"/> Algae		<input type="checkbox"/> Solid Waste/Debris	
Odor: None		<input type="checkbox"/> Petroleum		<input type="checkbox"/> Musty		<input type="checkbox"/> Sewage <input type="checkbox"/> Chlorine	
		<input type="checkbox"/> VOC/Solvent		<input type="checkbox"/> Fishy		<input type="checkbox"/> Sulfur <input type="checkbox"/> Sour
