Ongoing Screening Summary Report 2020 Inspection Year

Illicit Discharge Detection and Elimination Program City of Oshkosh

Ongoing Screening Summary Report

OMNNI Associates One Systems Drive Appleton, WI 54914-1654 (T) 920/735-6900 (F) 920/830-6100 www.omnni.com

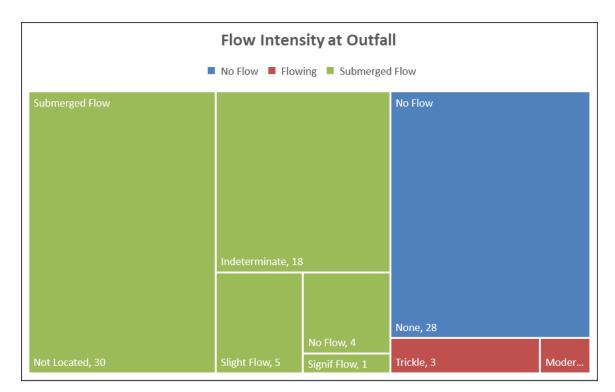
To meet the requirement of dry weather screening, outfalls were typically screened at least 48 hours after the previous runoff-producing rainfall event. In general, a minimum of 72 hours was used when possible. The distribution of the flow intensity of the outfalls (not including upstream sampling points) is shown in Figure 1.

Figure 1 – Flow intensity at outfall

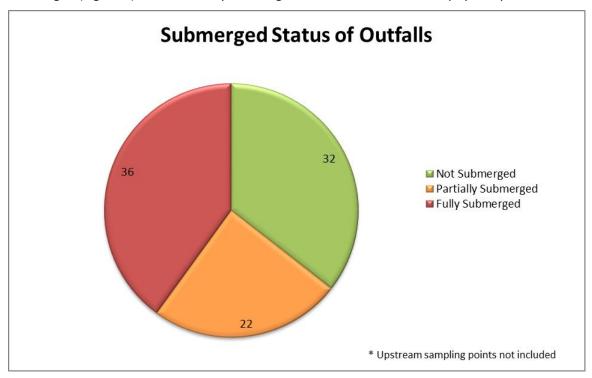
Most of the outfalls in the City were located at or below the normal levels of their respective receiving waters. Of the 90 inspected outfalls, 22 were partially submerged, and 36 were fully submerged (Figure 2). Of the 36 fully submerged outfalls, 30 could not be physically located.

Figure 2 - Submerged status of outfalls

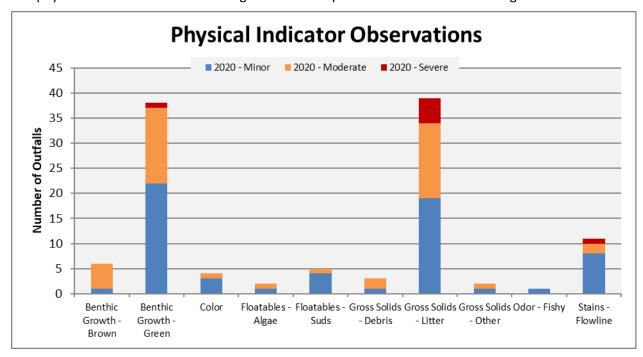
Figure 3 – Physical indicator observations

Benthic growth (green and/or brown) and flowline stains were prevalent at many of the outfalls. These conditions are fairly common and are not typically considered strong indicators of recurring illicit discharges unless they are particularly severe or occur in conjunction with other indicators.

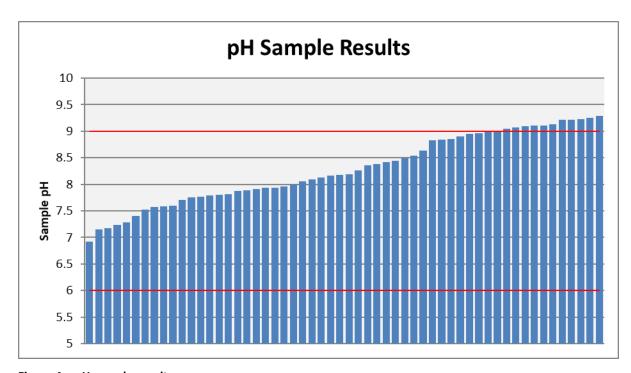
Figure 4 – pH sample results

The pH values ranged from 6.92 to 9.29. Several samples from outfall pools adjacent to the lake or river had pH values above 9.0. Because of this widespread occurrence of slightly elevated pH adjacent to open bodies of water during the 2020 screening, along with the absence of any other chemical indicator parameters exceedances, these elevated pH values were not sufficient to classify any of these outfalls as potential illicit discharges.

The pH results for the pH samples are shown in Figure 4.

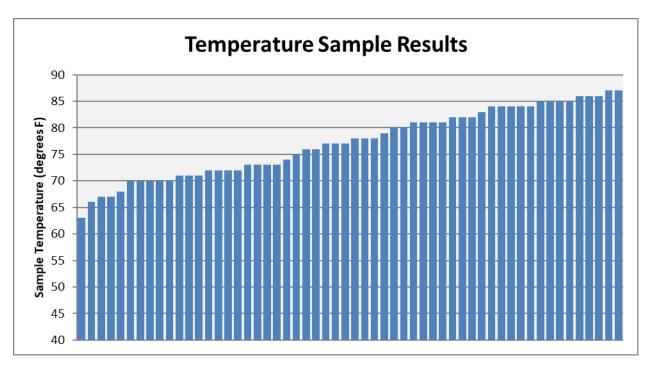
Figure 5 - Temperature sample results

The temperature values ranged from 63 to 87 °F. The samples with the highest temperatures were collected from locations that could be influenced by solar heating, so the upper values were not considered suspect. None of the samples exhibited abnormal temperatures, so none of the samples were considered suspect due to temperature.

The temperature results for the samples are shown in Figure 5.

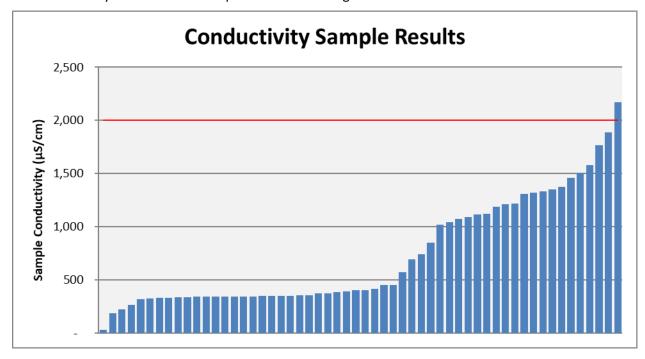
Figure 6 – Conductivity sample results

The conductivity values ranged from 26 to 2,170 μ S/cm. One sample was above the 2,000 μ S/cm action limit. Based on other factors, that outfall may or may not have been classified as a potential illicit discharge. The illicit discharge potential of the outfall with elevated conductivity is summarized in Table 2.

The conductivity results for the samples are shown in Figure 6.

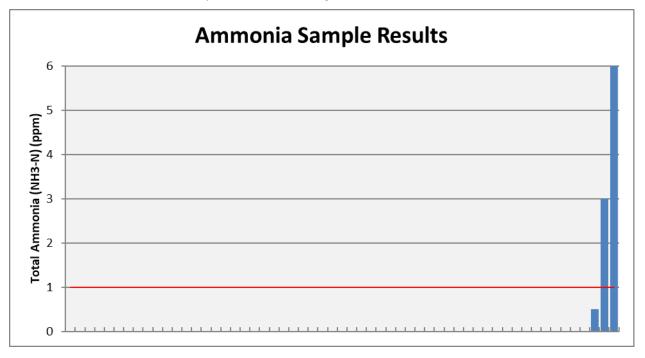
Figure 7 - Ammonia sample results

The ammonia values ranged from 0 to 6 ppm. Two samples were at or above the 1 ppm action limit. Based on other factors, these outfalls may or may not have been classified as potential illicit discharges. The illicit discharge potentials of the outfalls are summarized in Table 3.

The ammonia results for the samples are shown in Figure 7.

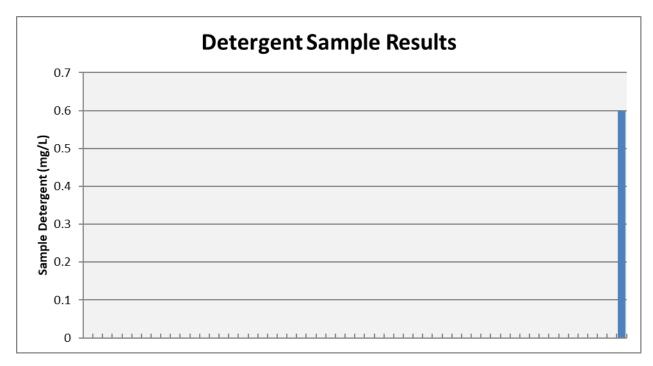
Figure 9 - Detergent sample results

The detergent values ranged from 0 to 0.6 mg/L, with one sample showing a positive detection of detergent. Based on other factors, this outfall may or may not have been classified as a potential illicit discharge. The illicit discharge potential of the outfall is summarized in Table 4.

The detergent results for the samples are shown in Figure 9.

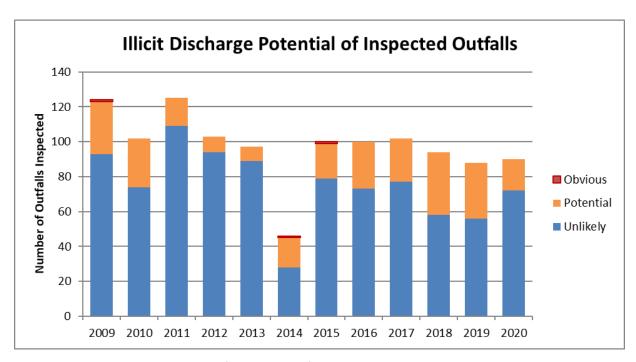
A chart showing the number of outfalls inspected over the past 12 years (starting with the initial screening in 2009) and the number of potential or obvious illicit discharges is shown in Figure 10.

Figure 10 - Illicit discharge potential of inspected outfalls

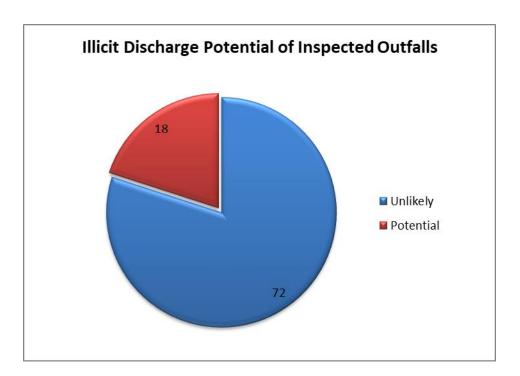
OMNNI assisted the City of Oshkosh with the 2020 ongoing screening of the MS4 outfalls, as required by the MS4 permit. A total of 90 outfalls were screened, along with upstream monitoring locations when necessary. Of those 90 outfalls, 72 exhibited unlikely potential of past illicit discharges, and 18 were classified as "potential." These results are summarized in Figure 57:

Figure 57 - Illicit discharge potential

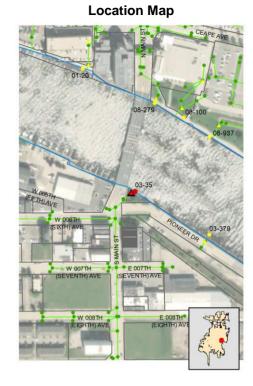
Upstream manhole located approx 20 ft WSW of outfall 03-35. Intermediate area consists of open space.

Inspection Date: 8/19/2020 2:41:48 PM Inspector: **JCW** Previous Rainfall (hrs): 72+ Inspection Type: Ongoing Flow Description: Sample collected from submerged pool in Submerged, indeterminate Notes: manhole. Floating gross solids (litter) in Submerged: Fully Depth (in): 36 manhole. Slightly elevated ammonia. Illicit Discharge Potential: Potential Petrol. Sheen Suds Other Floatables: None Sewage Algae Odor: None Petroleum Musty Sewage Chlorine Other ∇OC/Solvent Fishy Sulfur Fragrant Turbidity: None o20200819143804.JPG Color: None Gross Solids: Severe ✓ Litter ☐ Veg. Debris ☐ Sediment ☐ Other 2020 Vegetation: None Inhibited Excessive Sampling Results Benthic Growth: None Green Brown Sample Location: Pool Stains: Flow Line Oil None Rust Stains Sample ID: 200819-05 Paint Other Time Collected: 14:40 Natural Sheen Natural Suds/Foam Non-illicit: None Total Chlorine (field): 0 ppm Physical Condition Assessment Free Chlorine (field): 0 ppm Graffiti: None Ammonia (field): 0.5 ppm Erosion: pH (field): 8.44 units None ۰F Deposition: None Depth (in): Temperature (field): 85 Damage: None Conductivity (field): 346 μS/cm ☐ Displacement ☐ Undercut Crushed Detergents: 0 mg/L Cracks/Structural Damage Corrosion

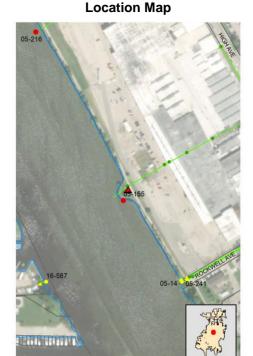
05-155 US1 City of Oshkosh

Inspection Date: 8/19/2020 4:03:15 PM Inspector: **JCW** Previous Rainfall (hrs): Inspection Type: Ongoing 72+ Flow Description: Sample collected from submerged pool in Submerged, indeterminate Notes: manhole Submerged: Fully Depth (in): 24 Illicit Discharge Potential: Unlikely Petrol. Sheen Suds ☐ Sewage ☐ Algae Other Floatables: None Odor: None Petroleum Musty Sewage Chlorine Other ∇OC/Solvent Fishy Sulfur Fragrant Turbidity: None o20200819160058.JPG Color: None Gross Solids: None Litter ☐ Veg. Debris ☐ Sediment ☐ Other 2020 Vegetation: None Inhibited Excessive Sampling Results Benthic Growth: None Green Brown Sample Location: Pool Stains: Flow Line Oil Rust Stains None Sample ID: 200819-81 Paint Other Time Collected: 16:02 Natural Sheen Natural Suds/Foam Non-illicit: None Total Chlorine (field): 0 ppm Physical Condition Assessment Free Chlorine (field): ppm Ammonia (field): Graffiti: None 0 ppm Erosion: pH (field): None 8.96 units ۰F Deposition: None Depth (in): Temperature (field): 87 Damage: None Conductivity (field): 417 μS/cm ☐ Displacement ☐ Undercut Crushed Detergents: 0 mg/L Corrosion Cracks/Structural Damage

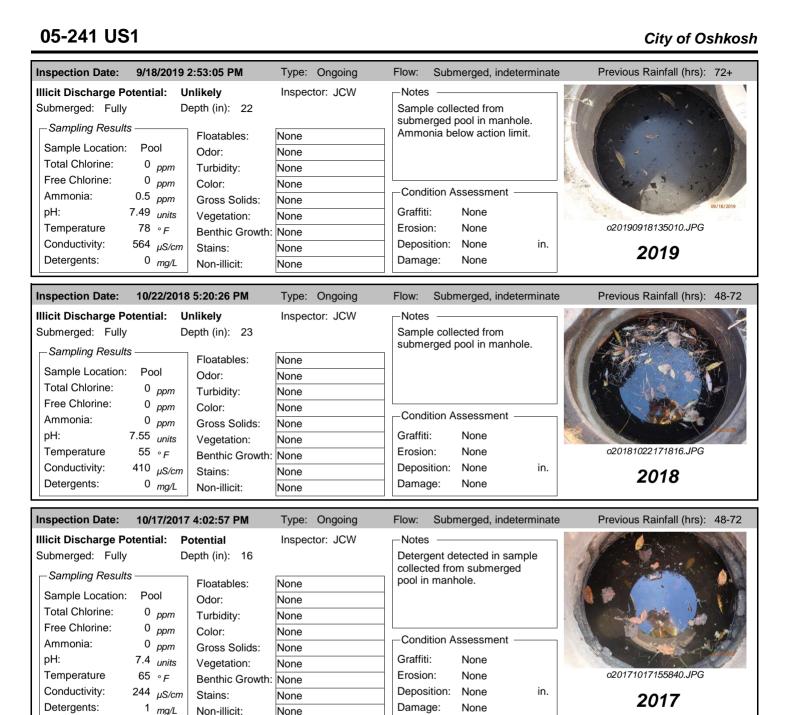
05-241 US1 City of Oshkosh

Trig/L	NOTI-IIIICIL.	None				
Inspection Date: 10/10/201	6 3:50:18 PM	Type: Ongoing	Flow: Su	bmerged, indeter	minate	Previous Rainfall (hrs): 72+
	Jnlikely	Inspector: JCW	Notes —			
	Depth (in): 17					
Sampling Results	Floatables:	None				
Sample Location: Pool	Odor:	None				
Total Chlorine: 0 ppm	Turbidity:	None				
Free Chlorine: 0 ppm	Color:	None	O a se all'ill a se	A 1		
Ammonia: 0 ppm	Gross Solids:	Moderate	Condition	Assessment —		Name of the last o
pH: 7.59 _{units}	Vegetation:	None	Graffiti:	None		10/10/2016
Temperature 69 ∘ F	Benthic Growth:	None	Erosion:	None		o20161010154822.JPG
Conductivity: 1551 µS/cm	Stains:	None	Deposition	: None	in.	2016
Detergents: 0 mg/L	Non-illicit:	Slight	Damage:	None		2010

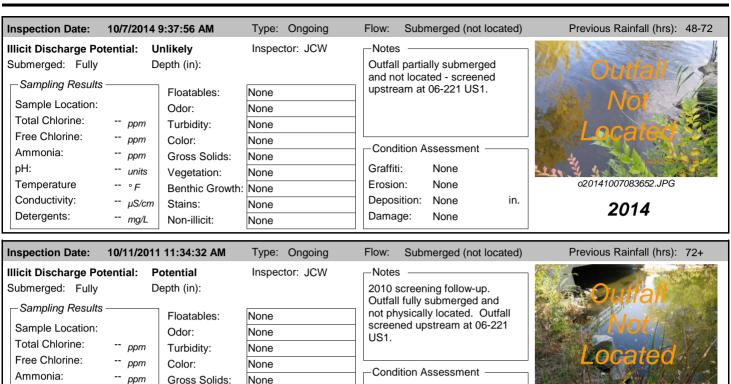
06-221 City of Oshkosh

Inspection Date:	8/18/2010 2	2:38:53 PM	Type: Ongoing	Flow:	Submerged (not l	located)	Previous Rainfall (hrs): 72+
Illicit Discharge Po Submerged: Fully	De	otential epth (in):	Inspector: JCW	Outfall fully submerged and not physically located. Outfall			Outfall
Sampling Results Sample Location:			None None		ned upstream at 06		Not
Total Chlorine:	ppm		None				a stock
Free Chlorine: Ammonia:	ppm ppm		None None	Cond	ition Assessment		
pH: Temperature	units	3	None	Graffit Erosio			o20100818142820.JPG
Conductivity:	μS/cm	Benthic Growth: Stains:	None None	Depos	sition: None	0 in.	2010
Detergents:	mg/L	Non-illicit:	None	Dama	ge: None		2370

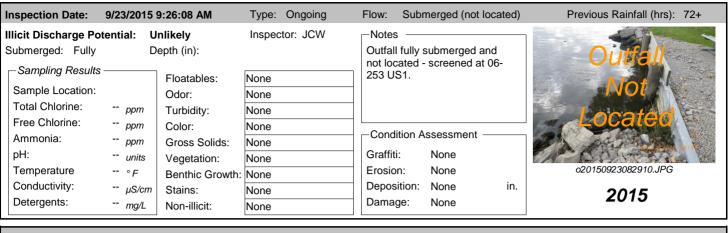
06-253 City of Oshkosh

Inspection Date:	8/18/2010	1:51:34 PM	Type: Ongoing	Flow:	Submerged (not lo	ocated)	Previous Rainfall (hrs): 72+
Illicit Discharge Pot Submerged: Fully Sampling Results Sample Location: Total Chlorine:	D	Odor:	None None None	not ph	s I fully submerged ar rysically located. Ou ned upstream at 06-	utfall	Outall
Free Chlorine: Ammonia: pH: Temperature Conductivity: Detergents:	ppm ppm units ° F μS/cm mg/L	Color: Gross Solids: Vegetation: Benthic Growth: Stains:	None None None	Cond Graffit Erosic Depos Dama	on: None sition: None	0 in.	020100818134248.JPG 2010

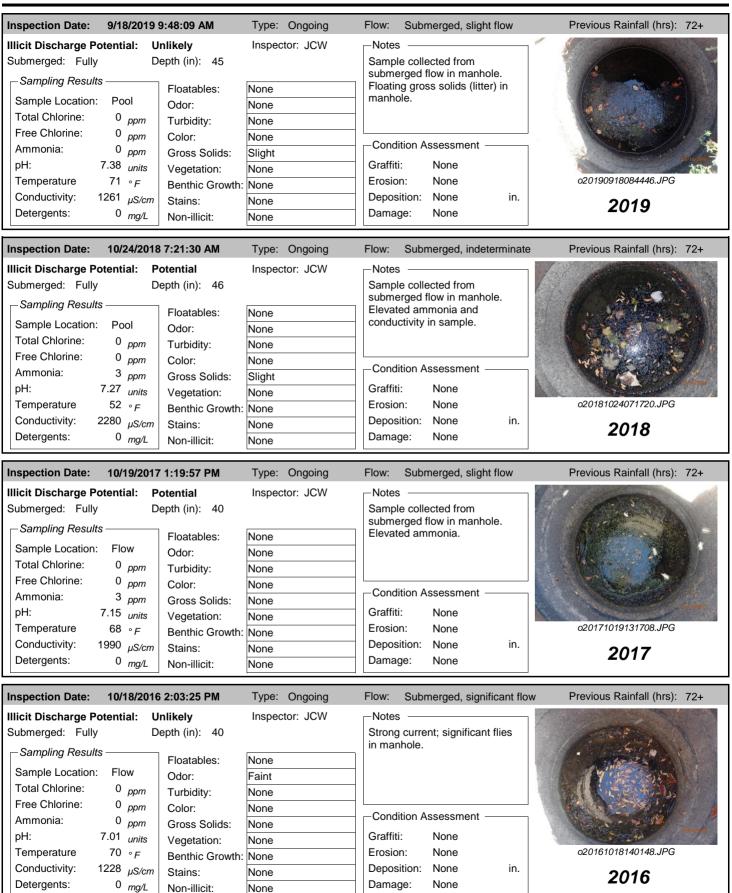
Inspection Date: 8/19/2020 10:28:37 AM Inspector: **JCW** Previous Rainfall (hrs): 72+ Inspection Type: Ongoing Flow Description: Sample collected from submerged flow in Submerged, significant flow Notes: manhole Submerged: Fully Depth (in): 42 Illicit Discharge Potential: Unlikely Petrol. Sheen Suds Sewage Algae Other Floatables: None Odor: None Petroleum Musty Sewage Chlorine Other ∇OC/Solvent Fishy Sulfur Fragrant Turbidity: None o20200819102530.JPG Color: None Gross Solids: None Litter ☐ Veg. Debris ☐ Sediment ☐ Other 2020 Vegetation: None Inhibited Excessive Sampling Results Benthic Growth: Moderate ✓ Green Brown Sample Location: Flow Stains: Flow Line Oil Rust Stains None Sample ID: 200819-61 Paint Other Time Collected: 10:28 Natural Sheen Natural Suds/Foam Non-illicit: None Total Chlorine (field): 0 ppm Physical Condition Assessment Free Chlorine (field): ppm Graffiti: None Ammonia (field): 0 ppm Erosion: pH (field): None 6.92 units ۰F Deposition: None Depth (in): Temperature (field): 76 Damage: None Conductivity (field): 1320 μS/cm ☐ Displacement ☐ Undercut Crushed Detergents: 0 mg/L Corrosion Cracks/Structural Damage

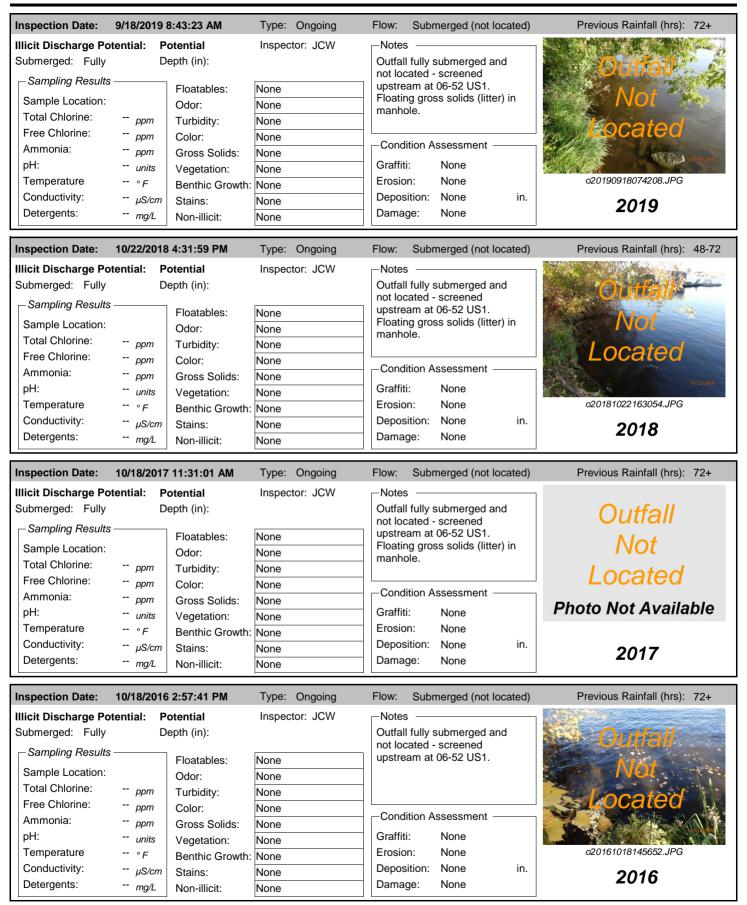
Inspection Date:	9/23/2015	8:40:05 AM	Type: Ongoing	Flow: Submerged (not located	d) Previous Rainfall (hrs): 72+
Illicit Discharge Po	tential: P	otential	Inspector: JCW	-Notes -	
Submerged: Fully		epth (in):	·	Outfall fully submerged and	Outfall
	·			not located - screened at 06-	Outal

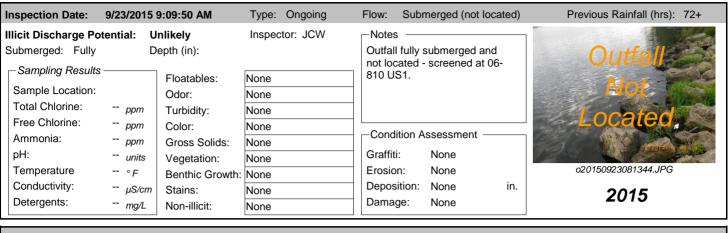
06-810 City of Oshkosh

Inspection Date:	8/18/2010	1:15:26 PM	Type: Ongoing	Flow: Submerged (not located)	Previous Rainfall (hrs): 72+
Illicit Discharge Po Submerged: Fully	D	nlikely epth (in):	Inspector: JCW	Notes Outfall fully submerged and not physically located. Outfall	Outfall
Sample Location:	,	Floatables: Odor:	None None	screened upstream at 06-810 US1.	Not
Total Chlorine:	ppm	Turbidity:	None	_	
Free Chlorine: Ammonia:	ppm	Color:	None	Condition Assessment	FO baltoU
pH:	ppm units	Gross Solids: Vegetation:	None None	Graffiti: None	Ser 18 3016 13 op
Temperature	∘ <i>F</i>	Benthic Growth:	None	Erosion: None	o20100818130938.JPG
Conductivity: Detergents:	μS/cm	Stains:	None	Deposition: None 0 in. Damage: None	2010
Detergents.	mg/L	Non-illicit:	None	Damage. 140He

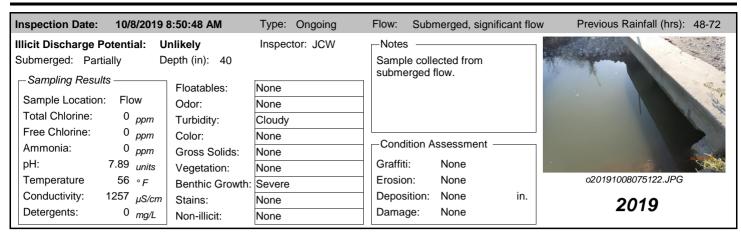
09-101 City of Oshkosh

Inspection I	Date: 8/19	/2020 12:48:19 PM	Inspector:	JCW	Inspection Type:	Ongoing	Previous Rainfall (hrs):	72+
Flow Descri Submerged:	•	Depth (in): al: Unlikely	Notes:	leaving	collected from subm culvert. Elevated pH ead in river.	•		
Floatables: Odor: Turbidity:	None None None	Pe	trol. Sheen troleum C/Solvent] Suds] Musty] Fishy	Sewage Cr	gae	020200819124	1636.JPG
Gross Solids Vegetation: Benthic Grov Stains:	None None	Gre	ibited	Veg. Debi Excessive Brown Oil Other		Other		v 819-38
Non-illicit: —Physical C Graffiti: Erosion: Deposition Damage:	None Condition Ass None None n: None None		tural Sheen Undercut Cracks/Str	c	al Suds/Foam Crushed amage		Time Collected: 12:5 Total Chlorine (field): Free Chlorine (field): Ammonia (field): pH (field): Temperature (field): Conductivity (field): Detergents:	0 ppm 0 ppm 0 ppm 9.29 units 86 ° F 326 μS/cm 0 mg/L

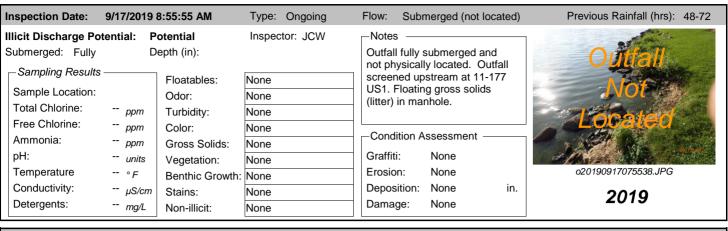
11-177 City of Oshkosh

Inspection	Date: 8/20/	2020 1:55:03 PM	Inspector:	JCW	Inspection Type:	Ongoing	Previous Rainfall (hrs):	72+
Flow Descr Submerged:	•	nerged (not located) Depth (in):	Notes:	screened i	y submerged and rupstream at 11-17 ds (litter) in upstrea	7 US1. Floating	Out	all
Illicit Dischar Floatables: Odor: Turbidity: Color:	None None None None	Peti	rol. SheenroleumC/Solvent	Suds [Musty [Fishy [Sewage Ch	gae Other Other Other agrant	0202008201351	54.JPG
Gross Solids Vegetation: Benthic Gro Stains:	None	Gre	bited E	Veg. Debris Excessive Brown Dil Other	Sediment Rust Stains		2020 Sampling Results Sample Location: Sample ID: Time Collected:	0
Non-illicit: —Physical (Graffiti: Erosion: Deposition: Damage:	None Condition Asso None None n: None None		ural Sheen Undercut Cracks/Str		Suds/Foam shed nage		Total Chlorine (field): Free Chlorine (field): Ammonia (field): pH (field): Temperature (field): Conductivity (field): Detergents:	ppm ppm ppm units ° F µS/cm mg/L

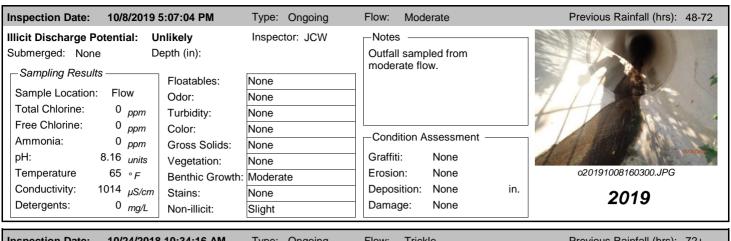
12-1328a City of Oshkosh

Inspection	Date: 8/1	19/2020 7:19:45 AM	Inspector: J	ICW Inspec	tion Type: C	Ongoing	Previous Rainfall (hrs):	72+
Flow Descri Submerged:	•	Depth (in):		Pipe wet, but no on spection.	collectable flo	w at time of		
Illicit Disch	arge Poten	tial: Unlikely						
Floatables:	None	Petro	l. Sheen 🗌 S	Suds Sewa	ige 🗌 Alga	e Other		
Odor:	None	Petro	oleum 🗌 M	Musty 🗌 Sewa	age 🗌 Chlo	rine Other

-	l	_ VOC	/Solvent F	ishy 🗌 Sulfu	r 🗌 Frag	rant		60/19/1026
Turbidity:	None						0202008190720	022 JPG
Color:	None			_				
Gross Solids	s: None	Litter	☐ Ve	g. Debris 🗌 Se	diment	Other	202	0
Vegetation:	None	Inhib	ited Exc	cessive		Г.	Sampling Results ———	
Benthic Grov	wth: Slight	✓ Gree	n 🗌 Bro	own			Sample Location:	
Stains:	None	Flow	Line Oil	☐ Ru	st Stains		Sample ID:	
		Paint	Oth	ner			Time Collected:	
Non-illicit:	None	☐ Natu	ral Sheen	Natural Suds/F	oam		Total Chlorine (field):	ppm
-Physical (Condition A	ssessment ———					Free Chlorine (field):	ppm
Graffiti:	None						Ammonia (field):	ppm
Erosion:	None						pH (field):	units
Deposition	n: None	Depth (in):					Temperature (field):	° <i>F</i>
Damage:	None	Displacement	Undercut	Crushed			Conductivity (field):	μS/cm
		Corrosion	Cracks/Struct	tural Damage			Detergents:	mg/L

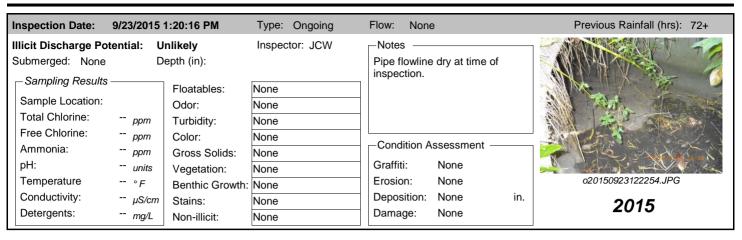
12-2042 City of Oshkosh

Graffiti:	None							Ammonia (field):	ppm
Erosion:	None							pH (field):	units
Depositio	n: Minor	Depth (in):	1					Temperature (field):	° <i>F</i>
Damage:	None	Displac	ement 🗌 U	ndercut		Crushed		Conductivity (field):	μS/cm
		Corrosi	on 🗌 C	racks/Str	uctural D	amage		Detergents:	mg/L

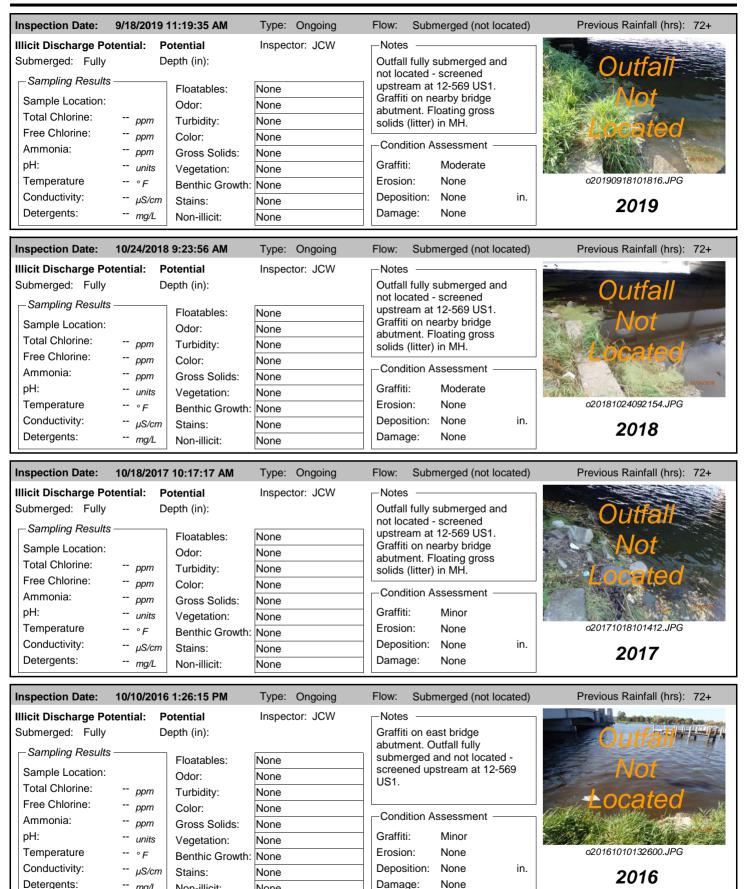
12-569 City of Oshkosh

Graffiti:	Mod	derate						Ammonia (field):	<i>ppm</i>
Erosion:	Non	-						pH (field):	units
Deposition		-1 - ()						Temperature (field):	° F
Damage:	Nor	Displace		Indercut racks/St	Cructural Dar	ushed mage		Conductivity (field): Detergents:	μS/cm mg/L

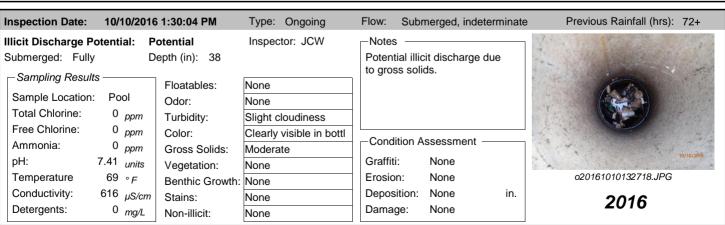
12-569 US1 City of Oshkosh

Inspection Date:	9/23/2015	11:06:51 AM	Type: Ongoing	Flow: Submerged, indeterminate	Previous Rainfall (hrs): 72+
Illicit Discharge P	otential: P	otential	Inspector: JCW	⊢Notes —	TO SHEET STATES
Submerged: Fully	y D	epth (in): 40		Floating gross solids (litter) in manhole.	
Sampling Result	ts —	Floatables:	None		R.G.
Sample Location:	: Pool	Odor:	None		
Total Chlorine:	0 _{ppm}	Turbidity:	None		
Free Chlorine:	0 _{ppm}	Color:	None		
Ammonia:	0 _{ppm}	Gross Solids:	Moderate	Condition Assessment	88/78/6045 11010
pH:	7.5 _{units}	Vegetation:	None	Graffiti: None	
Temperature	76 ∘ _F	Benthic Growth:	Slight	Erosion: None	o20150923101026.JPG
Conductivity:	441 _{μS/cm}	Stains:	None	Deposition: None in.	2015
Detergents:	0 _{mg/L}	Non-illicit:	None	Damage: None	2010
Inspection Date:	10/7/2014	7:39:34 AM	Type: Ongoing	Flow: Submerged, indeterminate	Previous Rainfall (hrs): 48-72
Illicit Discharge P		otential	Inspector: JCW	_Notes

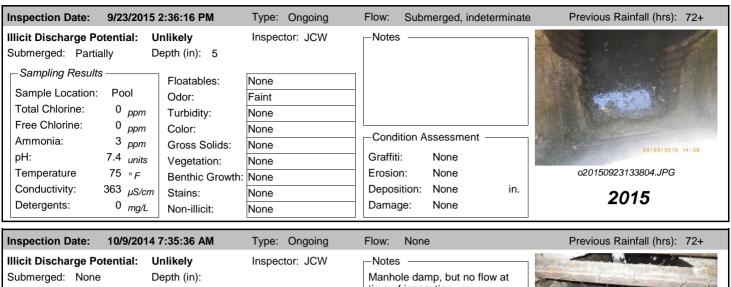
12-890 US1 City of Oshkosh

Inspection Date:	10/9/2014	7:35:36 AM	Type: Ongoing	Flow: None	Previous Rainfall (hrs): 72+
Illicit Discharge Pot	tential: U	nlikely	Inspector: JCW	-Notes -	
Submerged: None Depth (in):				Manhole damp, but no flow at time of inspection.	(A) (A)
Sampling Results		Floatables:	None		
Sample Location:		Odor:	None		
Total Chlorine:	ppm	Turbidity:	None		
Free Chlorine:	ppm	Color:	None		
Ammonia:	ppm	Gross Solids:	None	Condition Assessment —	
pH:	units	Vegetation:	None	Graffiti: None	10/10/2019
Temperature	∘ <i>F</i>	Benthic Growth:	None	Erosion: None	o20141009063122.JPG
Conductivity:	μS/cm	Stains:	None	Deposition: None in.	2014
Detergents:	mg/L	Non-illicit:	None	Damage: None	2014

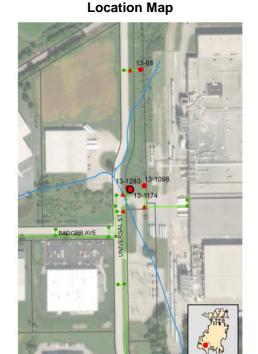
Inspection Date: 9/15/2020 2:19:39 PM Inspector: **JCW** Previous Rainfall (hrs): 72+ Inspection Type: Ongoing Flow Description: Submerged, slight flow Outfall partially submerged - screened Notes: upstream at 13-1174 US1. Submerged: Partially Depth (in): 21 Illicit Discharge Potential: Unlikely Other Petrol. Sheen 🗸 Suds ☐ Sewage ☐ Algae Floatables: Slight Odor: None Petroleum Musty Sewage Chlorine ∇OC/Solvent Fishy Sulfur Fragrant Turbidity: None o20200915141618.JPG Color: None Gross Solids: None Litter ☐ Veg. Debris ☐ Sediment ☐ Other 2020 Vegetation: None Inhibited Excessive Sampling Results Benthic Growth: Slight ✓ Green Brown Sample Location: Stains: Flow Line Oil None Rust Stains Sample ID: Paint Other Time Collected: Natural Sheen Natural Suds/Foam Non-illicit: None Total Chlorine (field): ppm Physical Condition Assessment Free Chlorine (field): ppm Ammonia (field): Graffiti: None ppm Erosion: pH (field): None units ۰F Deposition: Minor Depth (in): 2 Temperature (field): Damage: None Conductivity (field): μS/cm ☐ Displacement ☐ Undercut Crushed Detergents: mg/L Corrosion Cracks/Structural Damage

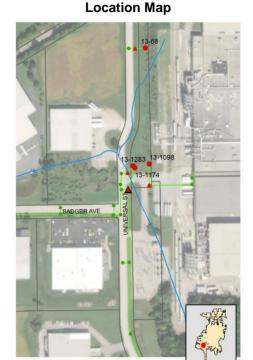
Inspection Date: 9/15/2020 2:31:37 PM Inspector: **JCW** Inspection Type: Ongoing 72+ Previous Rainfall (hrs): Flow Description: Submerged, slight flow Sample collected from submerged flow in Notes: manhole Submerged: Partially Depth (in): 18 Illicit Discharge Potential: Unlikely Other Petrol. Sheen 🗸 Suds Sewage Algae Floatables: Slight Odor: None Petroleum Musty Sewage Chlorine Other ∇OC/Solvent Fishy Sulfur Fragrant Turbidity: None o20200915142706.JPG Color: None Gross Solids: None Litter ☐ Veg. Debris ☐ Sediment ☐ Other 2020 Vegetation: None Inhibited Excessive Sampling Results Benthic Growth: None Green Brown Sample Location: Flow Stains: Flow Line Oil Rust Stains None Sample ID: 200915-49 Paint Other Time Collected: 14:28 Natural Sheen Natural Suds/Foam Non-illicit: None Total Chlorine (field): 0 ppm Physical Condition Assessment Free Chlorine (field): ppm Ammonia (field): Graffiti: None 0 ppm Erosion: pH (field): units None 8.00 ۰F Deposition: None Depth (in): Temperature (field): 73 Damage: None Conductivity (field): 1189 μS/cm ☐ Displacement ☐ Undercut Crushed Detergents: 0 mg/L Corrosion Cracks/Structural Damage

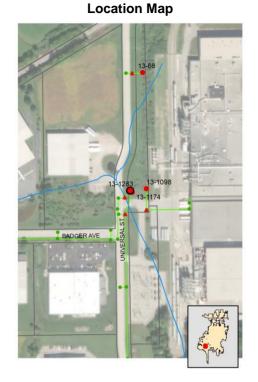
Inspection Date: 9/15/2020 2:24:09 PM Inspector: **JCW** Previous Rainfall (hrs): 72+ Inspection Type: Ongoing Flow Description: Submerged, indeterminate Outfall partially submerged - screened Notes: upstream at 13-1283 US1. Submerged: Partially Depth (in): 23 Illicit Discharge Potential: Unlikely Petrol. Sheen Suds Other Floatables: None Sewage Algae Odor: None Petroleum Musty Sewage Chlorine Other ∇OC/Solvent Fishy Sulfur Fragrant Turbidity: None o20200915142330.JPG Color: None Gross Solids: None Litter ☐ Veg. Debris ☐ Sediment ☐ Other 2020 Vegetation: None Inhibited Excessive Sampling Results Benthic Growth: None Green Brown Sample Location: Stains: Flow Line Oil Rust Stains None Sample ID: Paint Other Time Collected: Non-illicit: Natural Sheen Natural Suds/Foam None Total Chlorine (field): ppm Physical Condition Assessment Free Chlorine (field): ppm Graffiti: None Ammonia (field): ppm Erosion: None pH (field): units ۰F Deposition: Moderate Depth (in): 16 Temperature (field): Damage: Minor Conductivity (field): μS/cm ☐ Displacement ☐ Undercut Crushed Detergents: mg/L Cracks/Structural Damage ✓ Corrosion

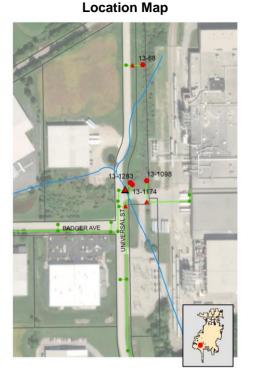
Inspection Date: 9/15/2020 2:37:15 PM Inspector: **JCW** Inspection Type: Ongoing Previous Rainfall (hrs): 72+ Flow Description: Submerged, indeterminate Sample collected from submerged pool in Notes: manhole Submerged: Partially Depth (in): 10 Illicit Discharge Potential: Unlikely Other Petrol. Sheen Suds Sewage Algae Floatables: None Odor: None Petroleum Musty Sewage Chlorine Other ∇OC/Solvent Fishy Sulfur Fragrant Turbidity: None o20200915143358.JPG Color: None Gross Solids: None Litter ☐ Veg. Debris ☐ Sediment ☐ Other 2020 Vegetation: None Inhibited Excessive Sampling Results Benthic Growth: None Green Brown Sample Location: Pool Stains: Flow Line Oil Rust Stains None Sample ID: 200915-54 Paint Other Time Collected: 14:34 Non-illicit: Natural Sheen Natural Suds/Foam None Total Chlorine (field): 0 ppm Physical Condition Assessment Free Chlorine (field): ppm Graffiti: None Ammonia (field): 0 ppm Erosion: pH (field): units None 7.52 ۰F Deposition: None Depth (in): Temperature (field): 73 Damage: None Conductivity (field): 851 μS/cm ☐ Displacement ☐ Undercut Crushed Detergents: 0 mg/L Corrosion Cracks/Structural Damage

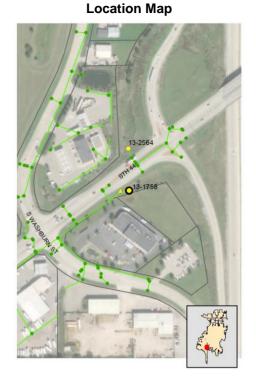
Inspection Date: 9/15/2020 11:23:06 AM Inspector: **JCW** Previous Rainfall (hrs): 72+ Inspection Type: Ongoing Flow Description: Sample collected from pipe flow. Moderate Notes: Submerged: None Depth (in): Illicit Discharge Potential: Unlikely Other Petrol. Sheen Suds Sewage Algae Floatables: None Odor: None Petroleum Musty Sewage Chlorine ∇OC/Solvent Fishy Sulfur Fragrant Turbidity: None o20200915112002.JPG Color: None Gross Solids: Slight ✓ Litter ☐ Veg. Debris ☐ Sediment ☐ Other 2020 Vegetation: None Inhibited Excessive Sampling Results Benthic Growth: Slight ✓ Green Brown Sample Location: Flow Stains: Flow Line Oil Rust Stains None Sample ID: 200915-69 Paint Other Time Collected: 11:21 Non-illicit: Slight ✓ Natural Sheen Natural Suds/Foam Total Chlorine (field): 0 ppm Physical Condition Assessment Free Chlorine (field): ppm Ammonia (field): ppm Graffiti: None 0 Erosion: None pH (field): units 7.60 ۰F Deposition: Minor Depth (in): 2 Temperature (field): 72 Damage: None Conductivity (field): 1332 μS/cm ☐ Displacement ☐ Undercut Crushed Detergents: 0 mg/L Corrosion Cracks/Structural Damage

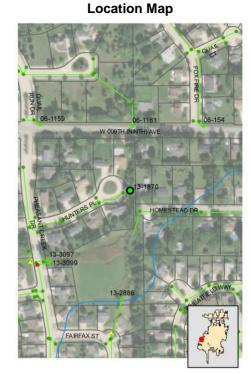
Inspection Da	ate: 8/20/2020 9:5	5:46 AM In	spector: JCV	Inspection Type	: Ongoing	Previous Rainfall (hrs):	72+
Flow Descrip	tion: None			iment wet, but no flow	at time of		
Submerged:	None Dept	n (in):	insp	ection.			
Illicit Dischar	ge Potential: Unlik	ely					
Odor: N Turbidity: N	one one one	Petrol. Petrole VOC/S		ty Sewage (Algae	020200820095-	410.JPG
Gross Solids:	None	Litter	☐ Veg. I	Debris Sediment	Other	202	0
Vegetation:	None	Inhibite			Γ	Sampling Results	
Benthic Growt Stains:	None	✓ Green ☐ Flow Li ☐ Paint	Brown Oil Other	Rust Stains		Sample Location: Sample ID: Time Collected:	
	None andition Assessment	☐ Natura	Sheen N	atural Suds/Foam		Total Chlorine (field): Free Chlorine (field):	ppm ppm
Graffiti: Erosion: Deposition: Damage:		olacement 🔲 L	Indercut [cracks/Structure	Crushed		Ammonia (field): pH (field): Temperature (field): Conductivity (field): Detergents:	ppm units °F μS/cm mg/L

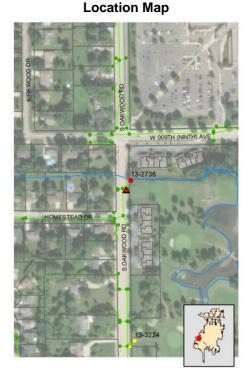
Inspection Date: 8/20/2020 10:20:25 AM **JCW** Inspection Type: Ongoing Previous Rainfall (hrs): 72+ Inspector: Flow Description: Submerged, indeterminate Sample collected from submerged pool in Notes: manhole Submerged: Partially Depth (in): 12 Illicit Discharge Potential: Unlikely Other Petrol. Sheen Suds Sewage Algae Floatables: None Odor: None Petroleum Musty Sewage Chlorine ∇OC/Solvent Fishy Sulfur Fragrant Turbidity: None o20200820101712.JPG Color: None Gross Solids: None Litter ☐ Veg. Debris ☐ Sediment ☐ Other 2020 Vegetation: None Inhibited Excessive Sampling Results Benthic Growth: None Green Brown Sample Location: Pool Stains: Flow Line Oil Rust Stains None Sample ID: 200820-29 Paint Other Time Collected: 10:18 Natural Sheen Natural Suds/Foam Non-illicit: None Total Chlorine (field): 0 ppm Physical Condition Assessment Free Chlorine (field): ppm Ammonia (field): Graffiti: None 0 ppm Erosion: pH (field): units None 8.26 ۰F Deposition: None Depth (in): Temperature (field): 77 Damage: None Conductivity (field): 1039 μS/cm ☐ Displacement ☐ Undercut Crushed Detergents: 0 mg/L Corrosion Cracks/Structural Damage

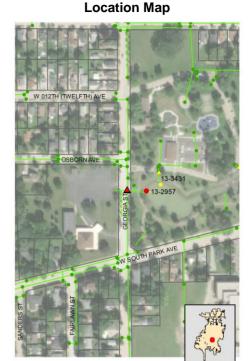
Inspection Date: 8/20/2020 12:29:26 PM **JCW** 72+ Inspector: Inspection Type: Ongoing Previous Rainfall (hrs): Flow Description: Sample collected from submerged pool in Submerged, indeterminate Notes: manhole Submerged: Fully Depth (in): 57 Illicit Discharge Potential: Unlikely Other Petrol. Sheen Suds Sewage Algae Floatables: None Odor: None Petroleum Musty Sewage Chlorine ∇OC/Solvent Fishy Sulfur Fragrant Turbidity: None o20200820122308.JPG Color: None Gross Solids: Slight ✓ Litter ☐ Veg. Debris ☐ Sediment ☐ Other 2020 Vegetation: None Inhibited Excessive Sampling Results Benthic Growth: None Green Brown Sample Location: Pool Stains: Flow Line Oil Rust Stains None Sample ID: 200820-14 Paint Other Time Collected: 12:24 Natural Sheen Natural Suds/Foam Non-illicit: None Total Chlorine (field): 0 ppm Physical Condition Assessment Free Chlorine (field): ppm Graffiti: None Ammonia (field): 0 ppm Erosion: pH (field): 7.88 units None ۰F Deposition: None Depth (in): Temperature (field): 81 Damage: None Conductivity (field): 1350 μS/cm ☐ Displacement ☐ Undercut Crushed Detergents: 0 mg/L Corrosion Cracks/Structural Damage

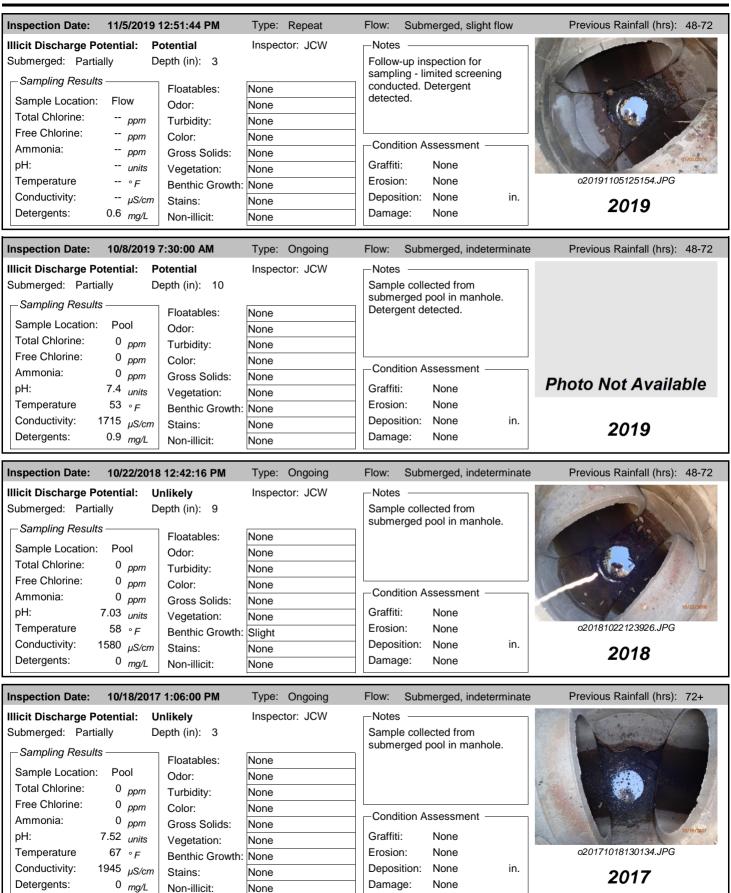
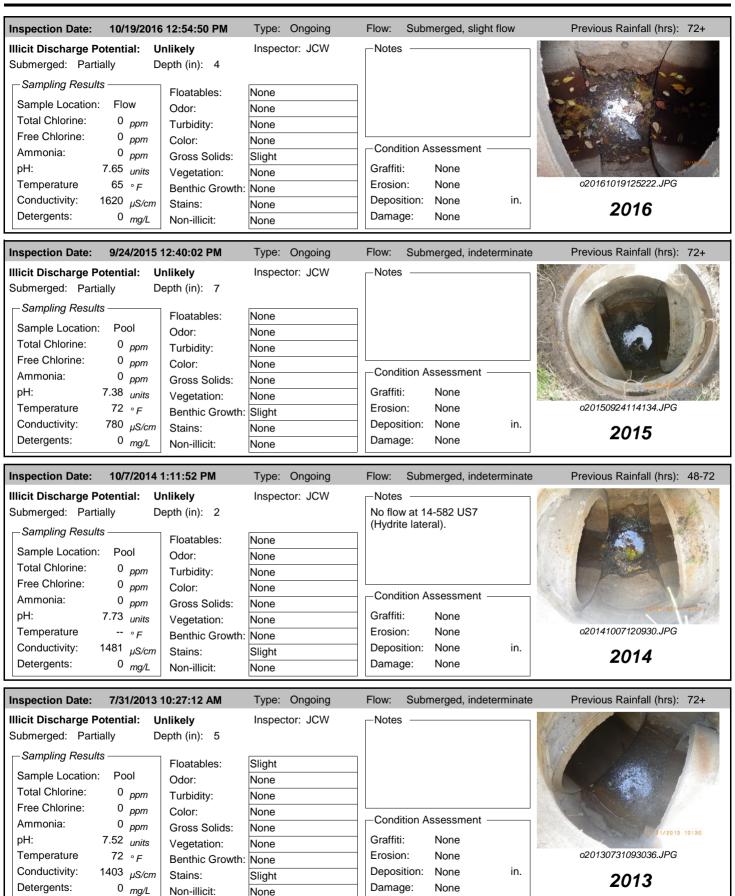
Inspection Date: 9/24/2020 9:17:59 AM Inspector: QAL Previous Rainfall (hrs): 72+ Inspection Type: Ongoing Flow Description: Submerged, indeterminate Sample collected from submerged pool in Notes: manhole Submerged: Partially Depth (in): 9 Illicit Discharge Potential: Unlikely Other Petrol. Sheen Suds Sewage Algae Floatables: None Odor: None Petroleum Musty Sewage Chlorine ∇OC/Solvent Fishy Sulfur Fragrant Turbidity: None o20200924092200.JPG Color: None Gross Solids: None Litter ☐ Veg. Debris ☐ Sediment ☐ Other 2020 Vegetation: None Inhibited Excessive Sampling Results Benthic Growth: None Green Brown Sample Location: Pool Stains: Flow Line Oil Rust Stains None Sample ID: 200924-74 Paint Other Time Collected: 09:19 Natural Sheen Natural Suds/Foam Non-illicit: None Total Chlorine (field): 0 ppm Physical Condition Assessment Free Chlorine (field): ppm Graffiti: None Ammonia (field): 0 ppm Erosion: pH (field): units None 7.81 ۰F Deposition: None Depth (in): Temperature (field): 66 Damage: None Conductivity (field): 1112 μS/cm ☐ Displacement ☐ Undercut Crushed Detergents: 0 mg/L Corrosion Cracks/Structural Damage

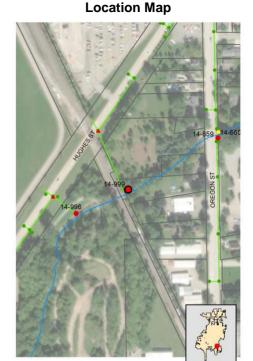
Hughes St storm sewer discharges to stream from north.

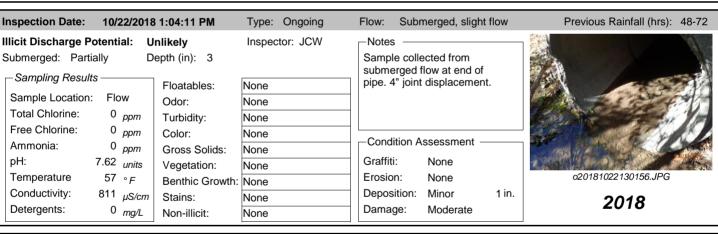
Inspection Date:	10/8/2019	7:44:51 AM	Type: Ongoing	Flow:	Submerged, signif	icant flo	w Previous Rainfall (hrs): 48-72
Illicit Discharge Po Submerged: Partia	ally D	otential epth (in): 5	Inspector: JCW	subme	e collected from erged flow at end of		
Sample Location: Total Chlorine:	Flow 0 _{ppm}	Odor:	None None None		" joint displacemen gent detected.	t.	
Free Chlorine: Ammonia: pH:	0 ppm 0 ppm 7.85 units	Gross Solids:	None None	- Cond Graffit	ition Assessment –		
Temperature	51 ∘ _F	Benthic Growth:	•	Erosio	n: None	41.	o20191008064438.JPG
Conductivity: Detergents:	741 _{μS/cm} 1 _{mg/L}		None None	Depos Dama		1 in.	2019

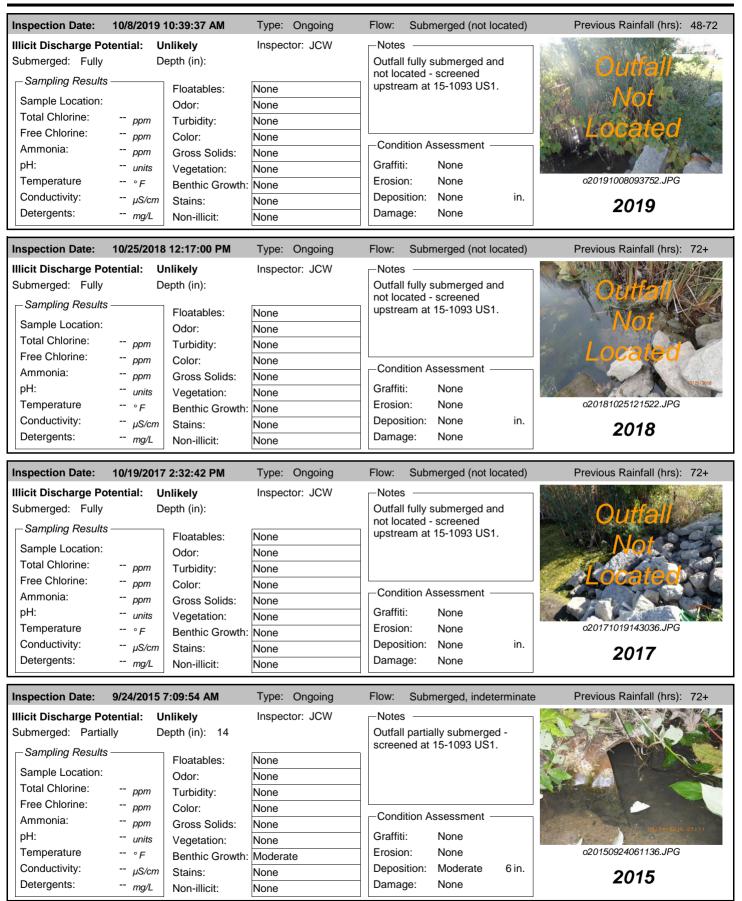
Inspection	Date:	9/15/2020 9:20:21 AM	Inspector:	JCW Inspe	ction Type:	Ongoing	Previous Rainfall (hrs):	72+
Flow Descr Submerged:		Submerged (not located) Depth (in):		Outfall fully subn screened upstream	0		000	
Illicit Disch	arge Po	tential: Unlikely						
Floatables:	None	Pet	rol. Sheen 🗌	Suds Sew	/age 🗌 Alg	gae		
Odor:	None	Pet	roleum	Musty Sew	vage 🗌 Ch	nlorine Other		
		VO	C/Solvent	Fishy Sulf	ur 🗌 Fra	agrant	and the state of t	N. W.
Turbidity:	None							9/45/2020
Color:	None						02020091509112	26_1.JPG
Gross Solids	s: Nor	ne Litte	er 🗌 Ve	eg. Debris 🗌 S	ediment [Other	202	0
Vegetation:	Nor	ne	bited E	xcessive			Sampling Results ———	
Benthic Gro	wth: Nor	ne Gre	en 🗌 B	rown			Sample Location:	
Stains:	Nor	ne	w Line 🔲 O	il 🗌 R	ust Stains		Sample ID:	
		Pai	nt 🗌 O	ther			·	
Non-illicit:	Nor	ne Nat	ural Sheen	Natural Suds/l	Foam		Time Collected:	
		n Assessment —			_		Total Chlorine (field):	<i>ppm</i>

Free Chlorine (field):	ppm
Graffiti: Erosion:	Nor Nor						Ammonia (field):	ppm
Depositio		-					pH (field): Temperature (field):	units ° F
Deposition Damage:	n. Nor		⊐				Conductivity (field):	μS/cm
Damage.	1401	Displacement Corrosion	Undercut Cracks/Stru	Crushed			Detergents:	mg/L

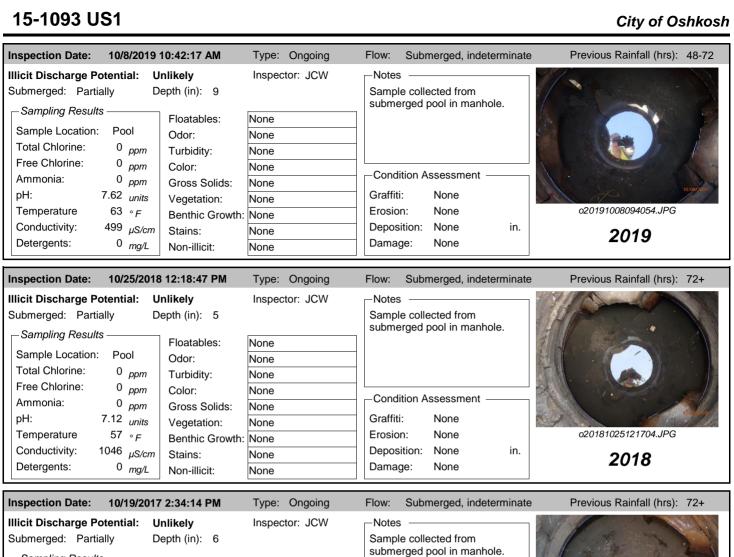
Inspection Date: 9/15/2020 9:21:20 AM Inspector: **JCW** Previous Rainfall (hrs): 72+ Inspection Type: Ongoing Flow Description: Submerged, indeterminate Sample collected from submerged pool in Notes: manhole Submerged: Partially Depth (in): 4 Illicit Discharge Potential: Unlikely Petrol. Sheen Suds Sewage Algae Other Floatables: None Odor: None Petroleum Musty Sewage Chlorine ∇OC/Solvent Fishy Sulfur Fragrant Turbidity: None o20200915091232.JPG Color: None Gross Solids: None Litter ☐ Veg. Debris ☐ Sediment ☐ Other 2020 Vegetation: None Inhibited Excessive Sampling Results Benthic Growth: None Green Brown Sample Location: Pool Stains: Flow Line Oil Rust Stains None Sample ID: 200915-81 Paint Other Time Collected: 09:16 Natural Sheen Natural Suds/Foam Non-illicit: None Total Chlorine (field): 0 ppm Physical Condition Assessment Free Chlorine (field): ppm Graffiti: None Ammonia (field): 0 ppm Erosion: pH (field): units None 7.24 ۰F Deposition: None Depth (in): Temperature (field): 70 Damage: None Conductivity (field): 184 μS/cm ☐ Displacement ☐ Undercut Crushed Detergents: 0 mg/L Corrosion Cracks/Structural Damage

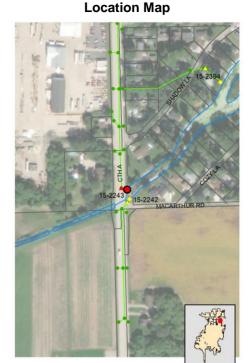
Storm sewer from CTH A discharges to stream from west.

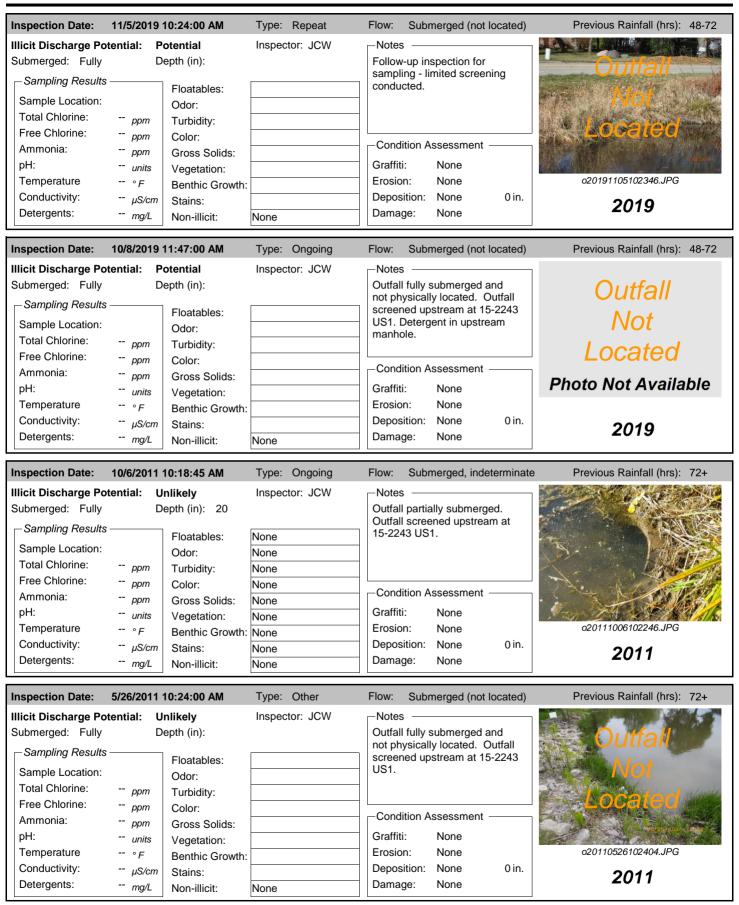
15-2243 City of Oshkosh

Inspection Date: 9/24/2020 8:36:06 AM Inspector: QAL Previous Rainfall (hrs): 72+ Inspection Type: Ongoing Flow Description: Notes: Outfall fully submerged and not located -Submerged (not located) screened upstream at 15-2243 US1. Submerged: Fully Depth (in): Illicit Discharge Potential: Unlikely Other Petrol. Sheen Suds ☐ Sewage ☐ Algae Floatables: None Odor: None Petroleum Musty Sewage Chlorine Other ∇OC/Solvent Fishy Sulfur Fragrant Turbidity: None o20200924083040.JPG Color: None Gross Solids: None Litter ☐ Veg. Debris ☐ Sediment ☐ Other 2020 Vegetation: None Inhibited Excessive Sampling Results Benthic Growth: None Green Brown Sample Location: Stains: Flow Line Oil Rust Stains None Sample ID: Paint Other Time Collected: Natural Sheen Natural Suds/Foam Non-illicit: None Total Chlorine (field): ppm Physical Condition Assessment Free Chlorine (field): ppm Graffiti: None Ammonia (field): ppm Erosion: pH (field): None units ۰F Deposition: None Depth (in): Temperature (field): Damage: None Conductivity (field): μS/cm ☐ Displacement ☐ Undercut Crushed Detergents: mg/L Corrosion Cracks/Structural Damage

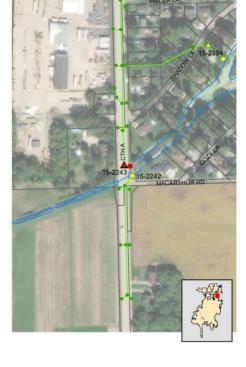
Upstream manhole located approx 31 ft WNW of outfall 15-2243. Intermediate area consists of county highway right-of-way.

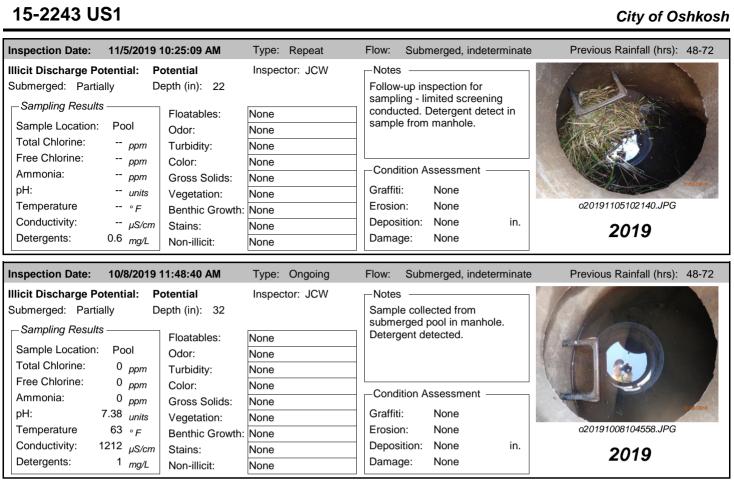
Inspection Date: 9/24/2020 8:35:00 AM **JCW** Previous Rainfall (hrs): 72+ Inspector: Inspection Type: Ongoing Flow Description: Submerged, indeterminate Sample collected from submerged pool in Notes: manhole. Depth not recorded. Depth (in): Submerged: Partially Illicit Discharge Potential: Unlikely Petrol. Sheen Suds Sewage Algae Other Floatables: None Odor: None Petroleum Musty Sewage Chlorine ∇OC/Solvent Fishy Sulfur Fragrant Turbidity: None o20200924083526.JPG Color: None Gross Solids: None Litter ☐ Veg. Debris ☐ Sediment ☐ Other 2020 Vegetation: None Inhibited Excessive Sampling Results Benthic Growth: None Green Brown Sample Location: Pool Stains: Flow Line Oil Rust Stains None Sample ID: 200924-56 Paint Other Time Collected: 08:36 Natural Sheen Natural Suds/Foam Non-illicit: None Total Chlorine (field): 0 ppm Physical Condition Assessment Free Chlorine (field): ppm Graffiti: None Ammonia (field): 0 ppm Erosion: pH (field): None 7.96 units ۰F Deposition: None Depth (in): Temperature (field): 67 Damage: None Conductivity (field): 1120 μS/cm ☐ Displacement ☐ Undercut Crushed Detergents: 0 mg/L Corrosion Cracks/Structural Damage

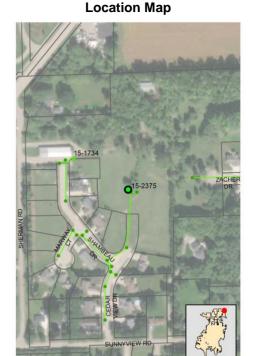
Storm sewer from Cedar View Dr discharges to south end of ravine.

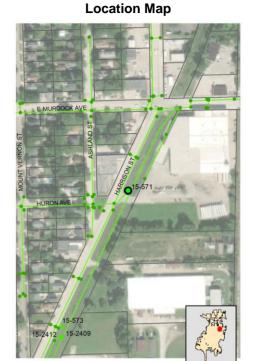
Storm sewer from Harrison St discharges to swale from south.

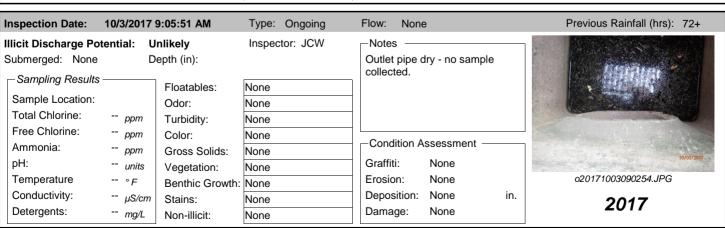
Inspection Date:	10/25/2018	8:41:51 AM	Type: Ongoing	Flow: None	Previous Rainfall (hrs): 72+
Illicit Discharge Po Submerged: None	D	otential epth (in):	Inspector: JCW	Notes Water below outlet pipe. Sample collected from sump.	
Sampling Results Sample Location: Total Chlorine:	Pool 0 _{ppm}	Odor:	None None None	Detergent detected.	
	0 _{ppm} 0 _{ppm} 7.68 _{units}	Vegetation:	None Slight None	Condition Assessment Graffiti: None Erosion: None	o20181025083908.JPG
Temperature Conductivity: Detergents:	50 ° F 661 μS/cm 0.55 mg/L		None None None	Deposition: None in. Damage: None	2018

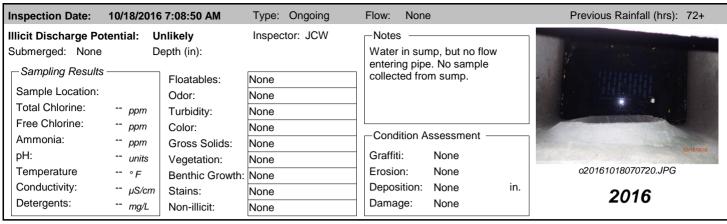
16-1205 US1 City of Oshkosh

Inspection Date:	9/28/2015	6:42:48 AM	Type: Ongoing	Flow: None	Previous Rainfall (hrs): 72+
Illicit Discharge Po Submerged: None	[Inlikely Depth (in):	Inspector: JCW	Water level below outlet pipe - no sample collected. 18" of	
Sampling Results Sample Location:	1		None None	water in sump, 2" of sediment.	
Total Chlorine:	ppm	Turbidity:	None		
Free Chlorine:	ppm	Color:	None	Condition Assessment	
Ammonia:	ppm	Gross Solids:	None		09/28/2015 06:43
pH:	units	Vegetation:	None	Graffiti: None	Y Lot
Temperature	∘ <i>F</i>	Benthic Growth:	None	Erosion: None	o20150928054310.JPG
Conductivity:	μS/cm	Stains:	None	Deposition: None in.	2015
Detergents:	mg/L	Non-illicit:	None	Damage: None	2010

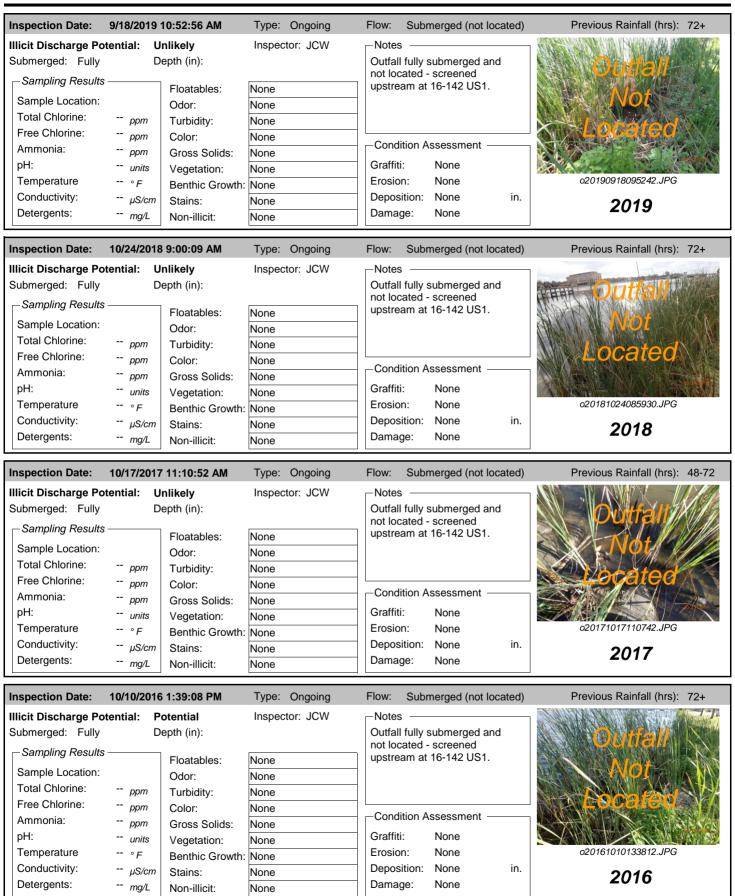
Inspection	Date: 8/19/	2020 8:54:17 AM Ir	nspector: JCW	Inspection Type:	Ongoing	Previous Rainfall (hrs):	72+
Flow Descr Submerged	-	merged (not located) Depth (in):		I fully submerged and ned upstream at 16-14		Out	a 112 3
	None None None	Petrol.	Sheen Suds eum Musty Solvent Fishy	Sewage C	gae Other	Loca	
Color:	None				7	0202008190852	
Gross Solid: Vegetation: Benthic Gro Stains:	None	☐ Litter ☐ Inhibite ☐ Green ☐ Flow L ☐ Paint	☐ Brown		Other	Sampling Results Sample Location: Sample ID: Time Collected:	0
Non-illicit: —Physical Graffiti: Erosion: Depositio Damage:		Depth (in):	Jndercut Cracks/Structural	ural Suds/Foam Crushed Damage		Total Chlorine (field): Free Chlorine (field): Ammonia (field): pH (field): Temperature (field): Conductivity (field): Detergents:	ppm ppm ppm units ° F μS/cm mg/L

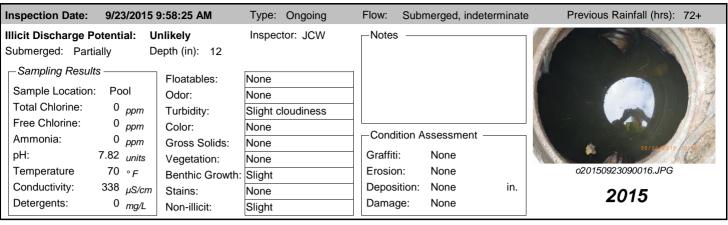
16-295 US1 City of Oshkosh

nspection Date:	8/25/2010 9	9:25:25 AM	Type: Ongoing	Flow:	Subm	erged, inde	terminate	Previous Rainfall (hrs): 72+
Ilicit Discharge Po Submerged: Partia —Sampling Results	ally De	nlikely epth (in): 15	Inspector: JCW	-Notes				
Sample Location: Total Chlorine:	Pool 0 _{ppm}	Odor:	None None Slight cloudiness					
Free Chlorine: Ammonia:	0 _{ppm} 0 _{ppm}		Faint in bottle	Condi	tion As	sessment -		
pH: Temperature	7.48 _{units}		None	Graffiti Erosio		None None		o20100825091620.JPG
Conductivity: Detergents:	μS/cm 0 _{mg/L}	Stains:	None None	Deposi Damag		None None	0 in.	2010
