Ongoing Screening Summary Report 2020 Inspection Year

Illicit Discharge Detection and Elimination Program City of Oshkosh

Ongoing Screening Summary Report

OMNNI Associates One Systems Drive Appleton, WI 54914-1654 (T) 920/735-6900 (F) 920/830-6100 www.omnni.com

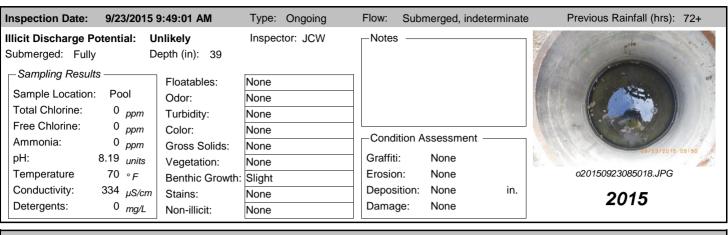
16-389 US1 City of Oshkosh

Inspection Date: 8/25/201	0 9:37:15 AM	Type: Ongoing	Flow:	Submerged, inde	eterminate	Previous Rainfall (hrs): 72+
Illicit Discharge Potential: Submerged: Fully	Unlikely Depth (in): 42	Inspector: JCW	Notes			
- Sampling Results		None				1//
Total Chlorine: 0 ppm	Odor: Turbidity:	Faint None				
Free Chlorine: 0 ppm	Color:	Faint in bottle	Condit	ion Assessment		
Ammonia: 0 _{ppm}	Gross Solids:	None	Condit	ion Assessment		28 23 2010 09:30
pH: 7.71 _{units}	Vegetation:	None	Graffiti:	None		3 2010 05:30
Temperature 73 ∘ _F	Benthic Growth:	None	Erosion	n: None		o20100825093008.JPG
Conductivity: µS/c	m Stains:	None	Deposi	tion: None	0 in.	2010
Detergents: 0 mg/L		None	Damag	e: None		2010

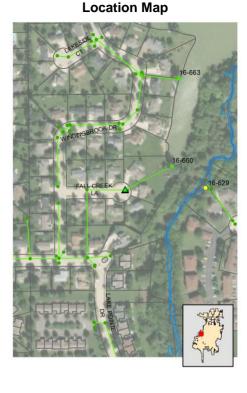
Upstream manhole located approx 257 ft WSW of outfall 16-660. Intermediate area consists of residential property.

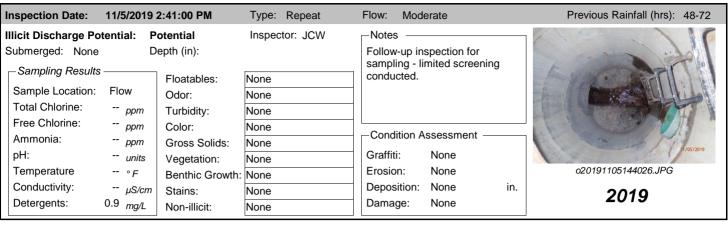
16-660 US1 City of Oshkosh

Inspection Date:	10/8/2019 2	2:44:41 PM	Type: Ongoing	Flow: Moderate	Previous Rainfall (hrs): 48-72
Illicit Discharge Po Submerged: None	De	otential epth (in):	Inspector: JCW	Notes Sample collected from flow in manhole. Detergent detected	
—Sampling Results Sample Location: Total Chlorine:	Flow 0 _{ppm}	Odor:	None None None	in sample.	
Free Chlorine: Ammonia: pH:	0 _{ppm} 0 _{ppm} 7.68 _{units}	Gross Solids:	None None	Condition Assessment Graffiti: None	10/08/2019
Temperature Conductivity: Detergents:	65 ∘ _F 943 _{μS/cm} 0.5 _{mg/L}		None None None	Erosion: None Deposition: None in. Damage: None	o20191008134416.JPG 2019

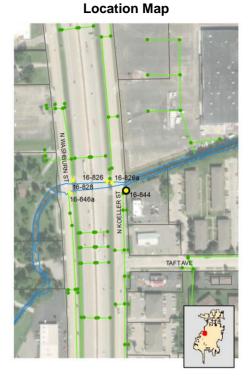
Storm sewer from Koeller St discharges to stream from south.

Inspection I	Date: 8/20/	2020 7:55:43 AM	nspector:	JCW Inspec	ction Type:	Ongoing	Previous Rainfall (hrs):	72+
•	iption: None		Notes:	Pipe wet, but no inspection.			Tievious Naimaii (iiis).	1. 6 K
Submerged:	None	Depth (in):		поросиот.				
Illicit Discha	arge Potentia	: Unlikely						
Floatables:	None	Petro	. Sheen _	Suds Sew	age 🗌 Al	lgae 🗌 Other		
Odor:	None	Petro	eum _	Musty Sew	age 🗌 C	hlorine Other		
		U VOC/	Solvent _	Fishy 🗌 Sulfu	ur 🗌 Fi	ragrant		
Turbidity:	None						DE LAND L	20,2020
Color:	None						020200820075	354.JPG
Gross Solids	: Moderate	✓ Litter		/eg. Debris 🗌 Se	ediment [Other	202	0
Vegetation:	None	Inhibi	ted 🗌 E	Excessive		Г	Sampling Results ———	
Benthic Grov	wth: Slight	✓ Green	n 🗌 E	Brown			Sample Location:	
Stains:	None	Flow	_ine 🔲 (Oil R	ust Stains		Sample ID:	
		☐ Paint		Other			·	
Non-illicit:	None	Natur	al Sheen	Natural Suds/F	oam		Time Collected:	
– Physical (Condition Asse	essment —			7		Total Chlorine (field):	ppm

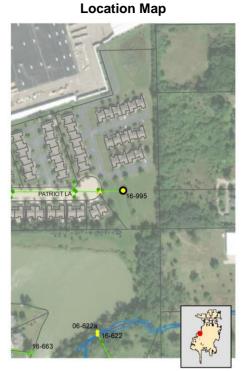
Storm sewer from Patriot Ln discharges to swale/dry pond that discharges to wet pond.

Inspection I	Date:	8/20/2020 8:35:17	AM In	spector:	JCW I	nspection Type:	Ongoing	Previous Rainfall (hrs):	72+
Flow Descri	iption:	Submerged, inde	terminate	Notes:		m of roots blocki	0		
Submerged:	Partial	lly Depth (in): 8			all partially subm ostream at 16-99		RIVA	
Illicit Discha	arge Pot	tential: Unlikely							
Floatables:	None		Petrol.	Sheen 🗌	Suds	Sewage A	lgae		
Odor:	None		Petrole	um 🗌	Musty	Sewage C	hlorine Other	X VI F F S	
			UOC/S	olvent 🗌	Fishy	Sulfur F	ragrant	7-402-3	
Turbidity:	None								
Color:	None							020200820083	238.JPG
Gross Solids	s: Nor	ne	Litter	\	/eg. Debris	Sediment	Other	202	0
Vegetation:	Nor	ne	Inhibite	d 🗌 E	Excessive			-Sampling Results ———	
Benthic Grov	wth: Nor	ne	Green	E	Brown			Sample Location:	
Stains:	Nor	ne	Flow Li	ne 🗌 C	Dil	Rust Stains		•	
			Paint		Other			Sample ID:	
Non-illicit:	Nor	10	Natural	Sheen	☐ Natural S	uds/Foam		Time Collected:	
			Natural	Oncon	rtatulal C	das/i dam		Total Chlorine (field):	<i>ppm</i>

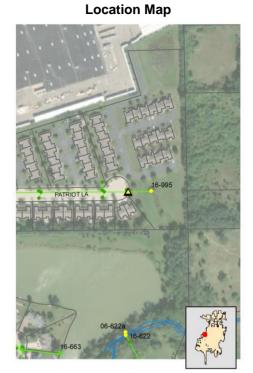
Inspection Date: 8/20/2020 8:38:07 AM Inspector: **JCW** Previous Rainfall (hrs): 72+ Inspection Type: Ongoing Flow Description: Flowline damp, but no collectable flow at None Notes: time of inspection. Submerged: None Depth (in): Illicit Discharge Potential: Unlikely Petrol. Sheen Suds Sewage Algae Other Floatables: None Odor: None Petroleum Musty Sewage Chlorine Other ∇OC/Solvent Fishy Sulfur Fragrant Turbidity: None o20200820083626.JPG Color: None Gross Solids: None Litter ☐ Veg. Debris ☐ Sediment ☐ Other 2020 Vegetation: None Inhibited Excessive Sampling Results Benthic Growth: None Green Brown Sample Location: Stains: Flow Line Oil Rust Stains None Sample ID: Paint Other Time Collected: Natural Sheen Natural Suds/Foam Non-illicit: None Total Chlorine (field): ppm Physical Condition Assessment Free Chlorine (field): ppm Ammonia (field): Graffiti: None ppm Erosion: pH (field): units None ۰F Deposition: None Depth (in): Temperature (field): Damage: None Conductivity (field): μS/cm ☐ Displacement ☐ Undercut Crushed Detergents: mg/L Corrosion Cracks/Structural Damage

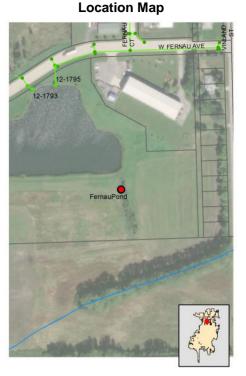
Detention basin discharges to stream from north via riprap channel.

Inspection Date: 8/19/2020 7:44:03 AM Inspector: **JCW** Previous Rainfall (hrs): 72+ Inspection Type: Ongoing Flow Description: Submerged, slight flow Sample collected from concentrated flow Notes: immediately downstream of outfall. Elevated Submerged: Partially Depth (in): 4 pH seemed widespread in open water. Illicit Discharge Potential: Unlikely Petrol. Sheen Suds Other Floatables: None Sewage Algae Odor: None Petroleum Musty Sewage Chlorine ∇OC/Solvent Fishy Sulfur Fragrant Turbidity: None o20200819074124.JPG Color: None Gross Solids: None Litter ☐ Veg. Debris ☐ Sediment ☐ Other 2020 Vegetation: None Inhibited Excessive Sampling Results Benthic Growth: Moderate ✓ Green Brown Sample Location: Flow Stains: Slight ✓ Flow Line Oil Rust Stains Sample ID: 200819-09 Paint Other Time Collected: 07:44 Natural Sheen Natural Suds/Foam Non-illicit: None Total Chlorine (field): 0 ppm Physical Condition Assessment Free Chlorine (field): ppm Ammonia (field): Graffiti: None 0 ppm Erosion: pH (field): None 9.25 units Deposition: None Depth (in): Temperature (field): 73 ۰F Damage: None Conductivity (field): 450 μS/cm ☐ Displacement ☐ Undercut Crushed Detergents: mg/L 0 Cracks/Structural Damage Corrosion

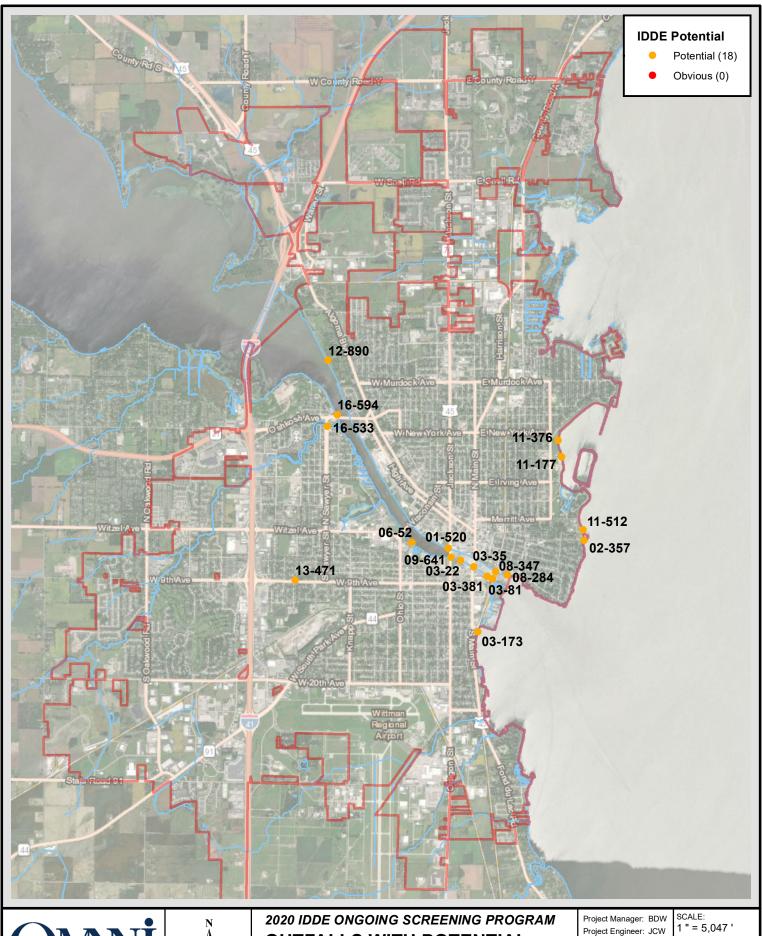
FIGURE NO. 12/11/2020 Date: C-1

- C-1 Outfalls with Potential Illicit Discharges
- C-2 Outfalls with Damage
- C-3 Outfalls with Deposition
- C-4 Outfalls with Erosion
- C-5 Outfalls with Graffiti
