# Ongoing Screening Summary Report 2013 Inspection Year

Illicit Discharge Detection and Elimination Program

City of Oshkosh

OMNNI Project No. N2029B13

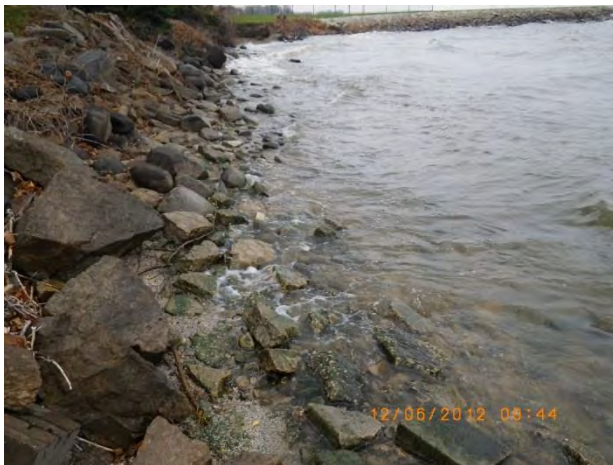
OMNNI met with the resident that reported the suds to the City. Some suds were present on the shoreline near the outfall. Samples of the suds and lake water were collected near the outfall and at two locations along the shoreline north of the outfall. Because the outfall was submerged, a sample was also collected from the pool in the upstream manhole.

**Figure 14 - Suds along shoreline north of outfall 02-184 (2012)**

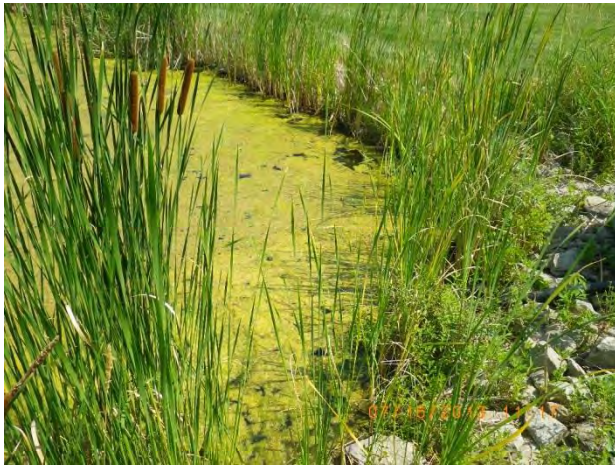
Outfall 12-1692 consists of a 24" reinforced concrete pipe that drains parts of Shore Preserve Drive and Wood Duck Court in the Edgewood Village subdivision. The pipe discharges to a detention basin west of Wood Duck Court. When the outfall was screened on July 16, 2013, the outfall pipe could not be located, as it was fully submerged, and covered with a dense mat of algae in the detention basin.

**Figure 17 - Approximate location of outfall 12-1692**

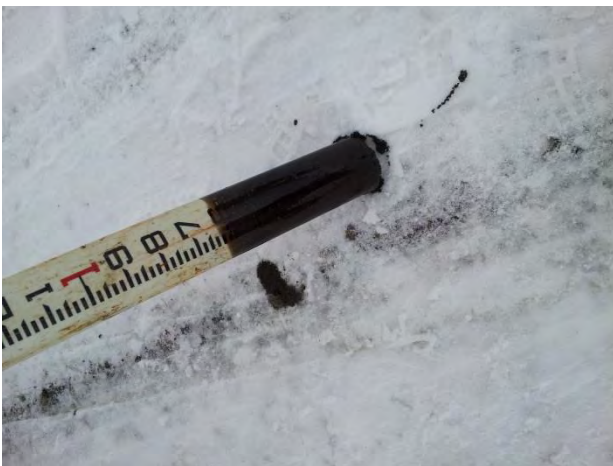
The City contacted OMNNI on December 11, 2012 to report that city crews had encountered oil in a storm sewer manhole while surveying the area around Washburn Street just south of STH 44, and requested that OMNNI assist with identifying the source of the oil. OMNNI conducted an investigation on December 12 to identify the source of the oil and define the downstream extent of the contamination.

**Figure 20 - Oil on survey rod from storm manhole 13-1743 (12/11/2012)**

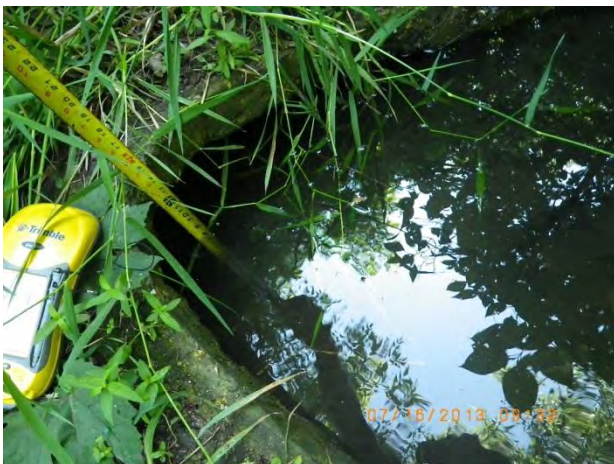
**Figure 37 - Moderate deposition at outfall 12-1245**

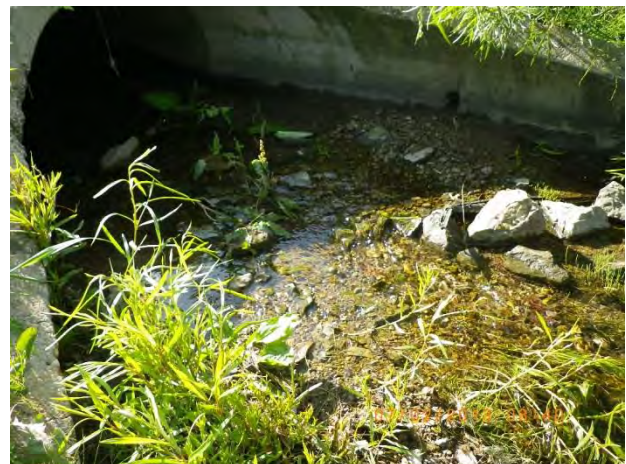
**Figure 38 - Minor deposition at outfall 12-1261**

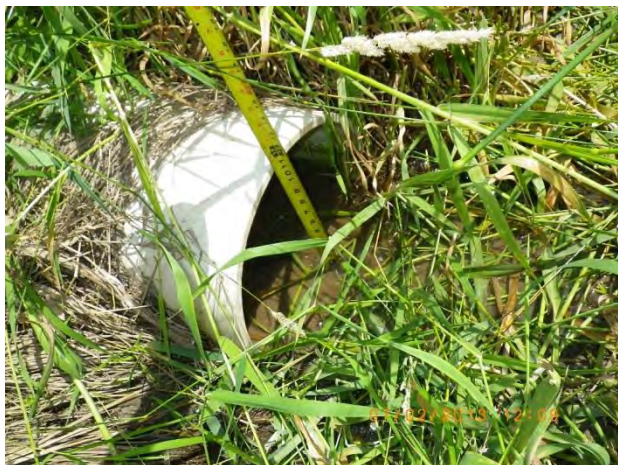
**Figure 39 - Moderate deposition at outfall 12-1676a**

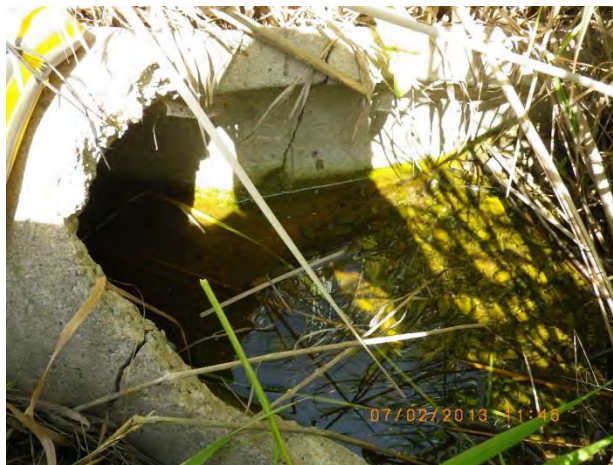
**Figure 40 - Minor deposition at outfall 12-1916**

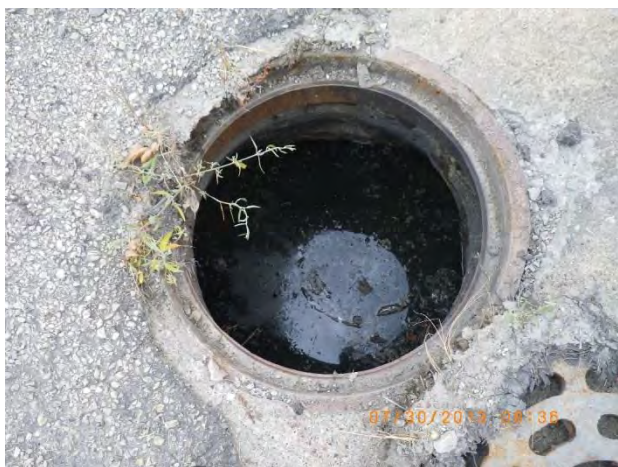
**Figure 41 - Minor deposition in manhole 13-1098 US1**

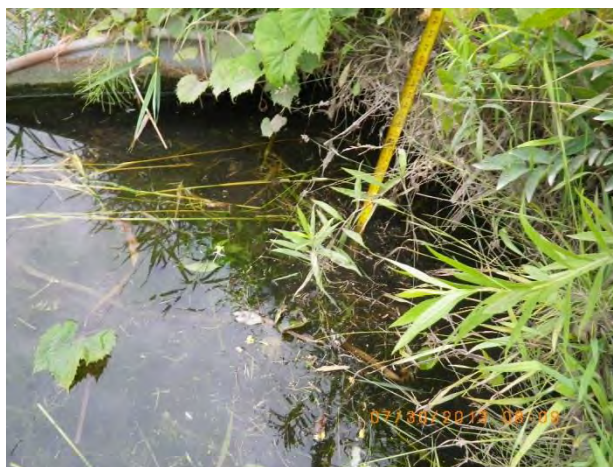
**Figure 42 - Moderate deposition at outfall 13-1283**

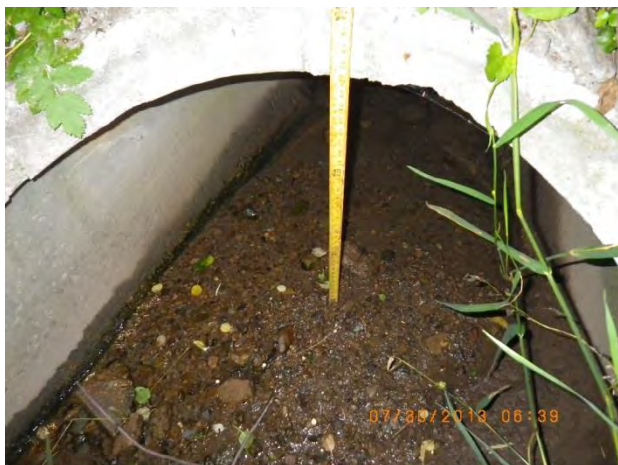
**Figure 43 - Minor deposition at outfall 13-1588**

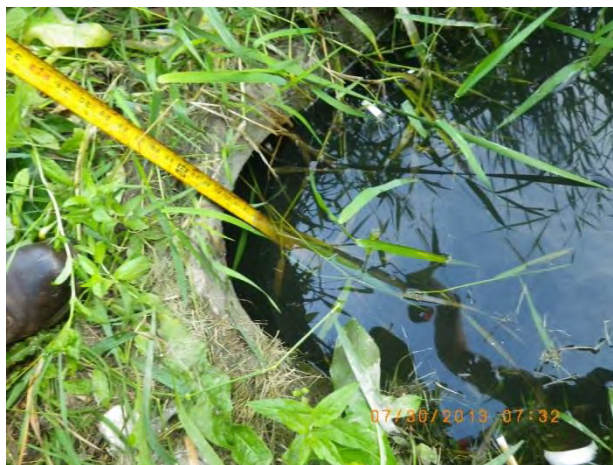
**Figure 44 - Moderate deposition at outfall 13-1758**

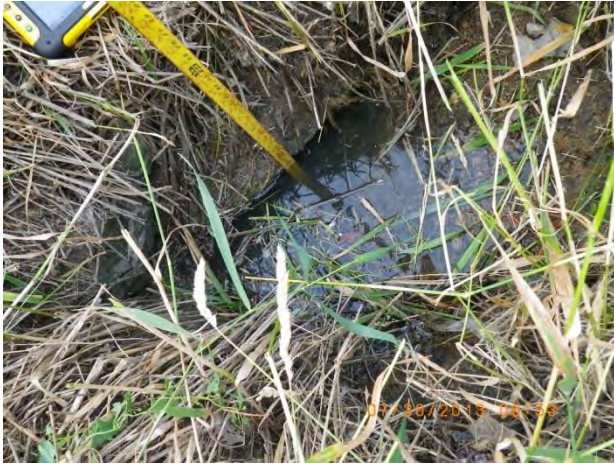
**Figure 45 - Moderate deposition at outfall 13-2611**

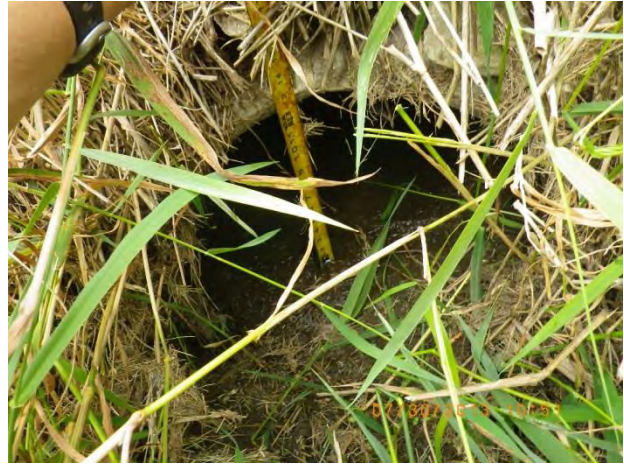
**Figure 46 - Minor deposition at outfall 13-2860**

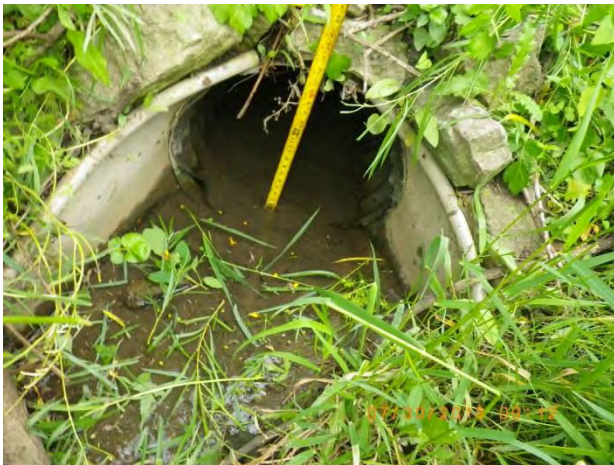
**Figure 47 - Minor deposition at outfall 13-68**

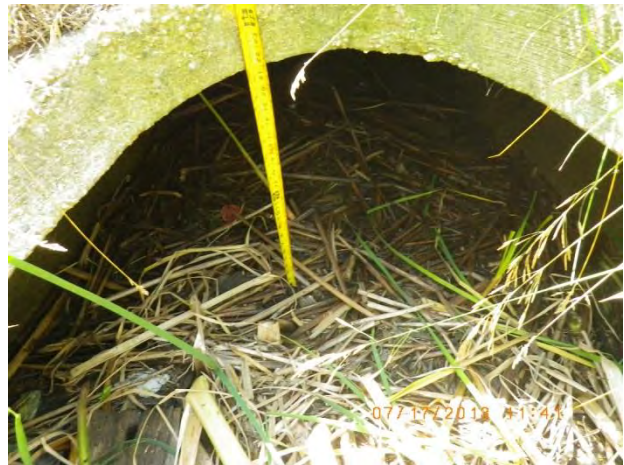
**Figure 48 - Minor deposition at outfall 14-1007**

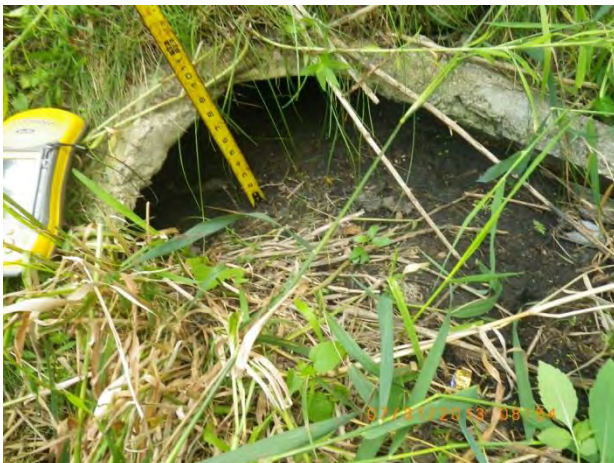
**Figure 49 - Severe deposition at outfall 14-1136**

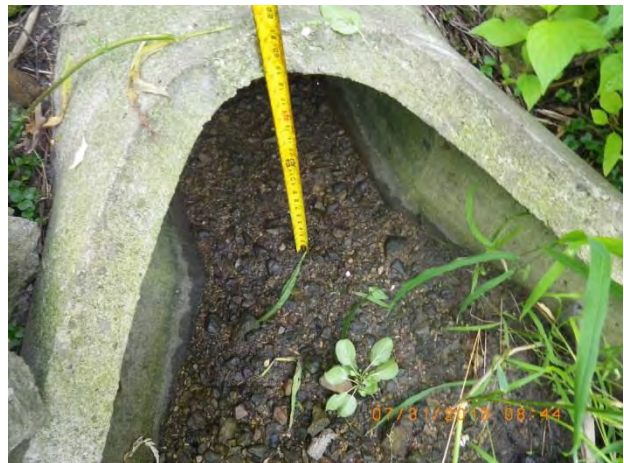
**Figure 50 - Minor deposition at outfall 14-1138**

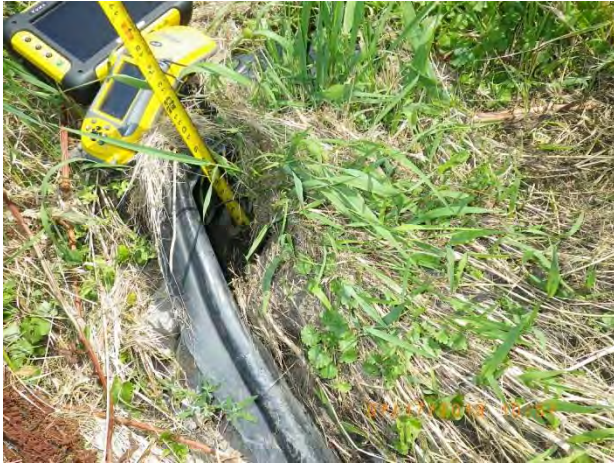
**Figure 51 - Severe deposition at outfall 14-1218**

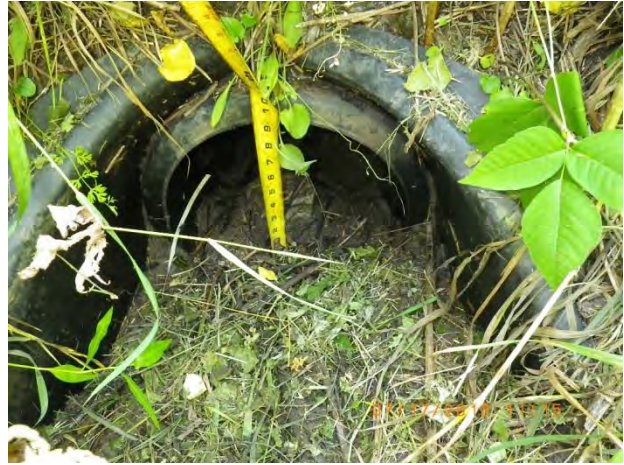
**Figure 52 - Minor deposition at outfall 14-1222**

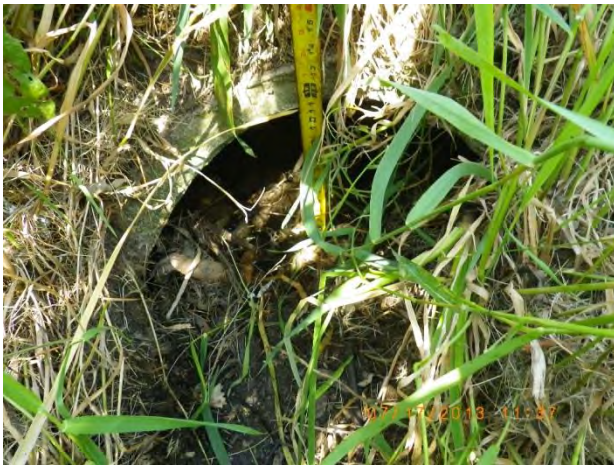
**Figure 53 - Moderate deposition at outfall 14-670**

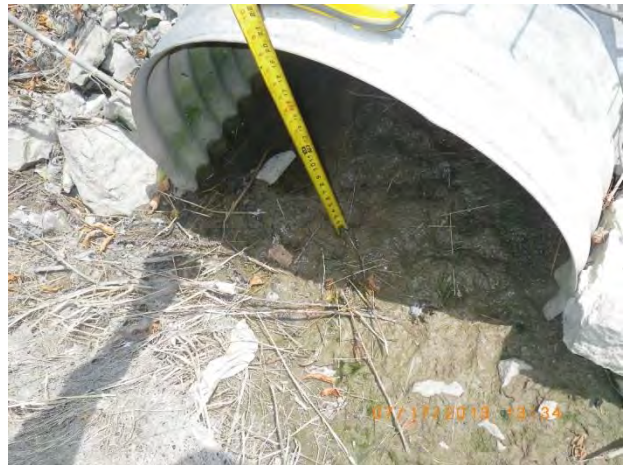
**Figure 54 - Moderate deposition at outfall 14-766**

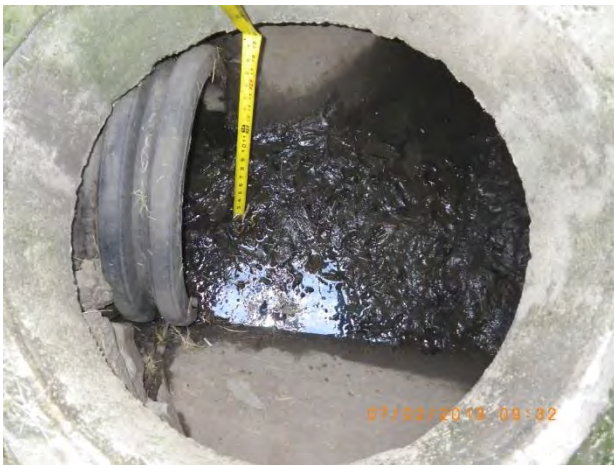
**Figure 55 - Minor deposition at manhole 15-1702 US1**

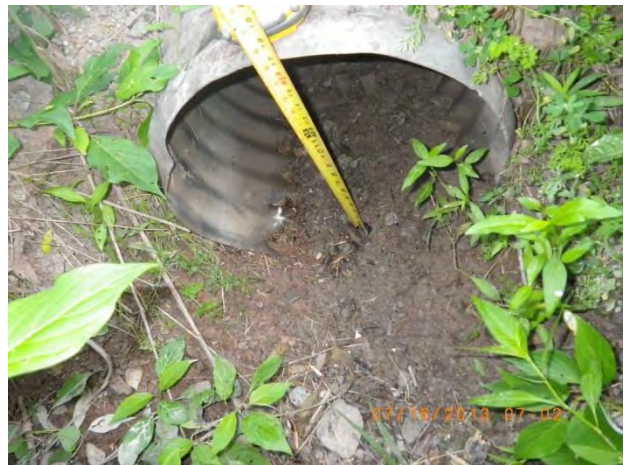
**Figure 56 - Minor deposition at outfall 15-1734**

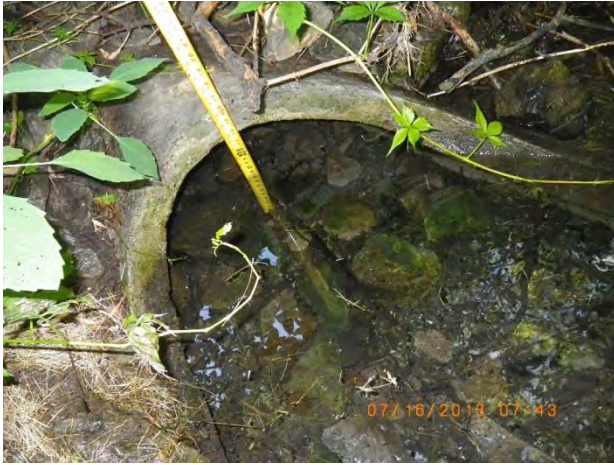
**Figure 57 - Minor deposition at outfall 15-1746**

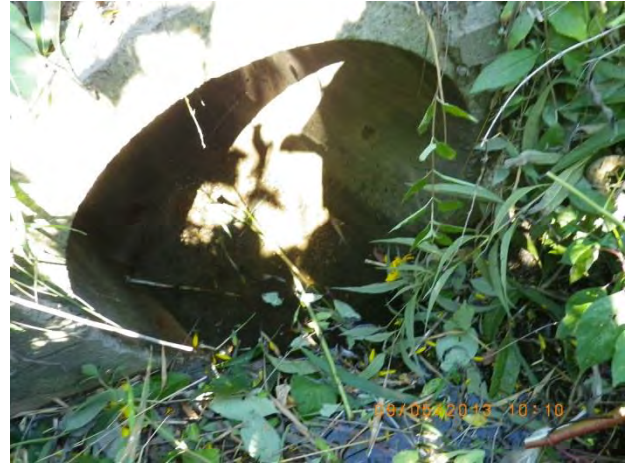
**Figure 58 - Minor deposition at outfall 15-1806**

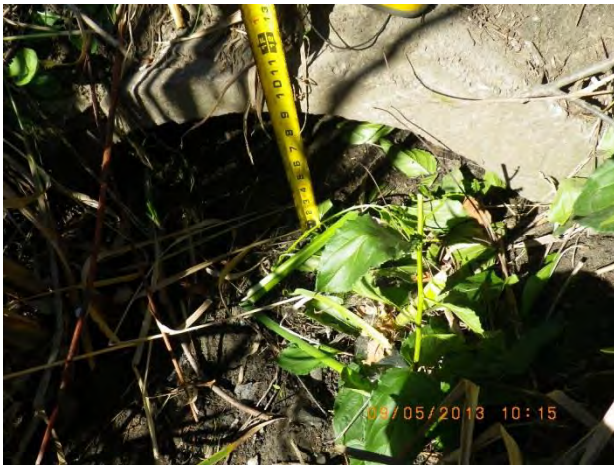
15-1856 US1	Minor	1" of sediment at bottom of manhole
15-1891	Severe	7" of sediment and vegetation at end of pipe
15-1891 US1	Minor	2" of sediment at bottom of manhole
15-1903	Severe	6" of sediment in pipe
15-2477	Moderate	9" of sediment on apron and in pipe

**Figure 59 - Severe deposition at outfall 15-1807**

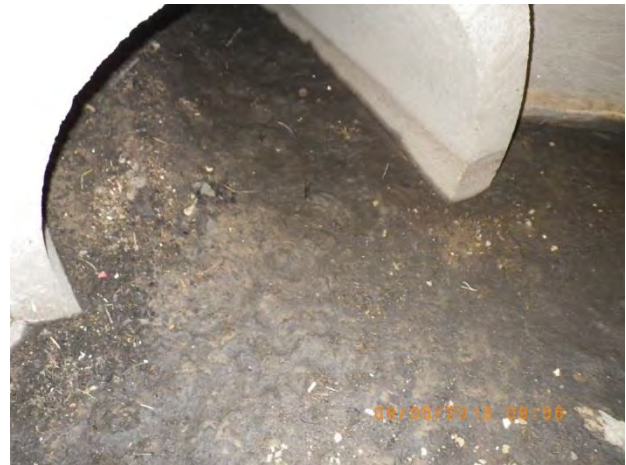
**Figure 60 - Moderate deposition at manhole 15-1807 US1**

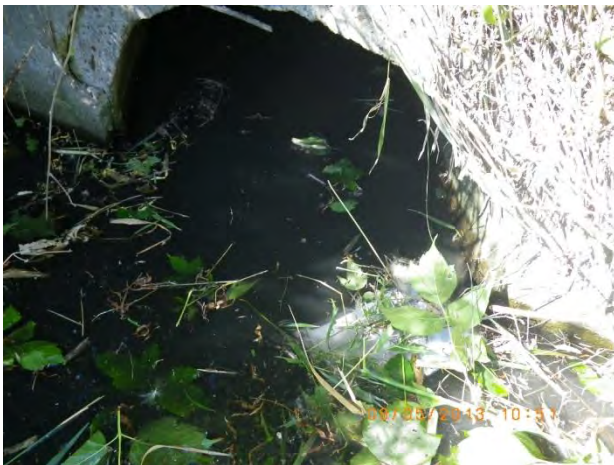
**Figure 61 - Moderate deposition at outfall 15-1856**

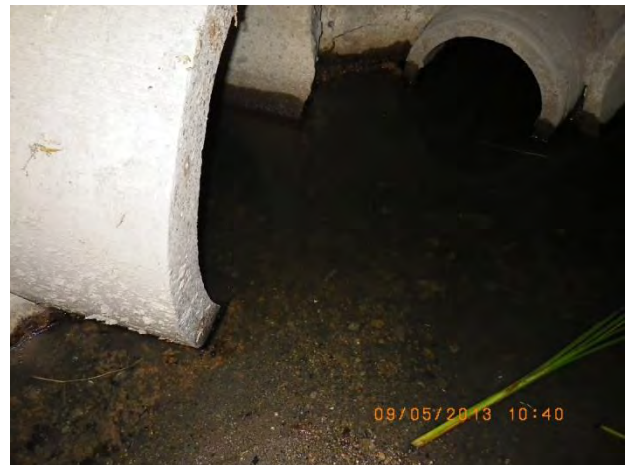
**Figure 62 - Minor deposition at manhole 15-1856 US1**

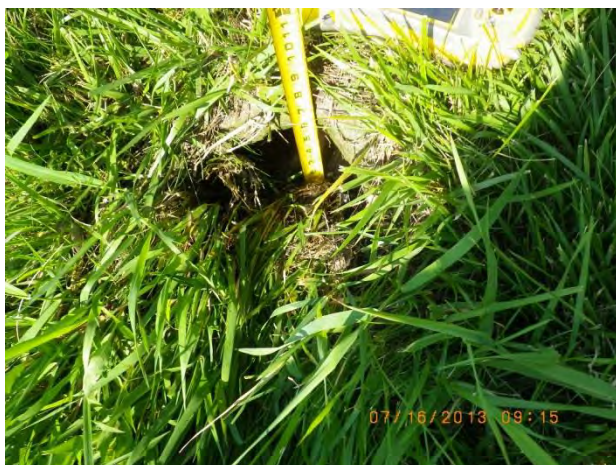
**Figure 63 - Severe deposition at outfall 15-1891**

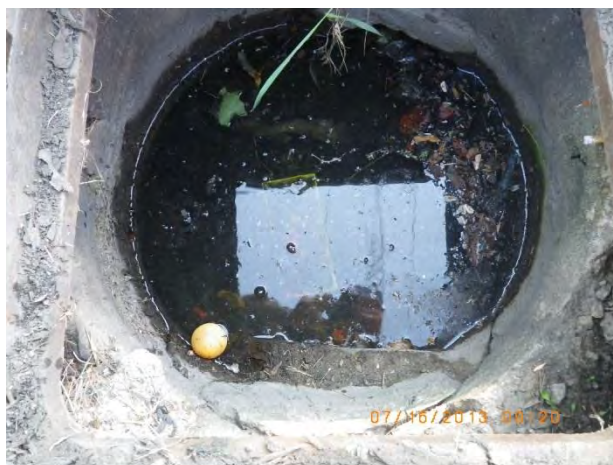
**Figure 64 - Minor deposition at manhole 15-1891 US1**

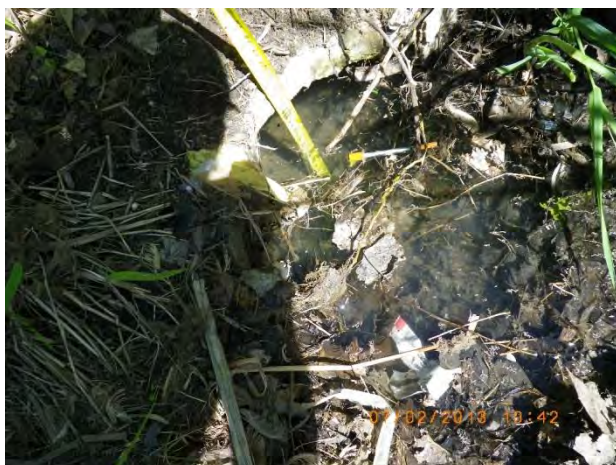
**Figure 65 - Severe deposition at outfall 15-1903**

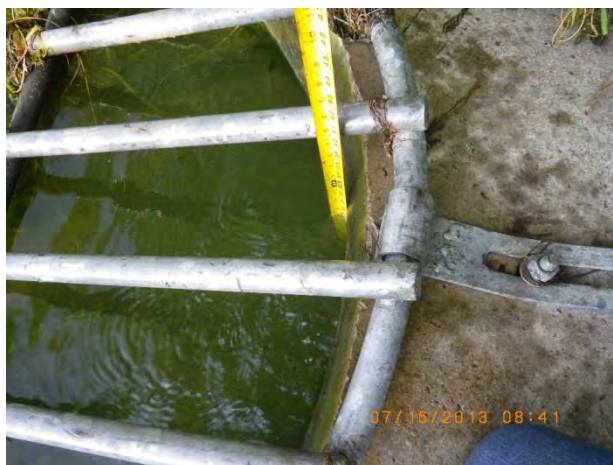
**Figure 66 - Moderate deposition at outfall 15-2477**

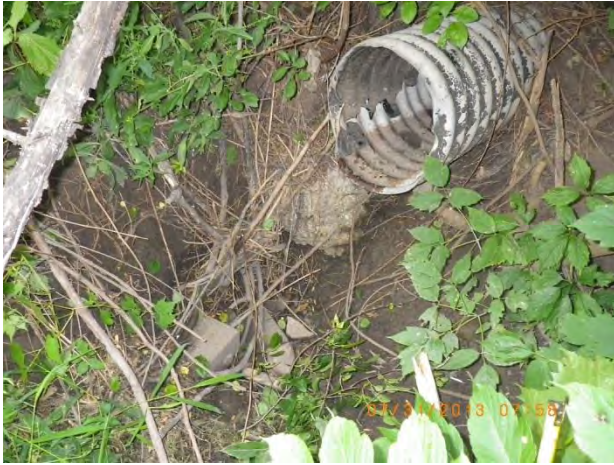
Outfall	Severity	Description
14-124	Minor	Minor erosion at end of pipe causing undercutting
14-660	Moderate	Sinkhole above displaced apron joint
15-1891	Minor	Channel erosion near outfall

Figure 67 - Minor erosion near outfall 14-124

Three of the outfalls showed signs of erosion at the end of the outfall pipe or channel. Most of the outfalls with minor erosion could be repaired with minor landscaping repairs. Those outfalls with moderate or severe erosion may need additional structural reinforcement, such as turf reinforcement mat or riprap.

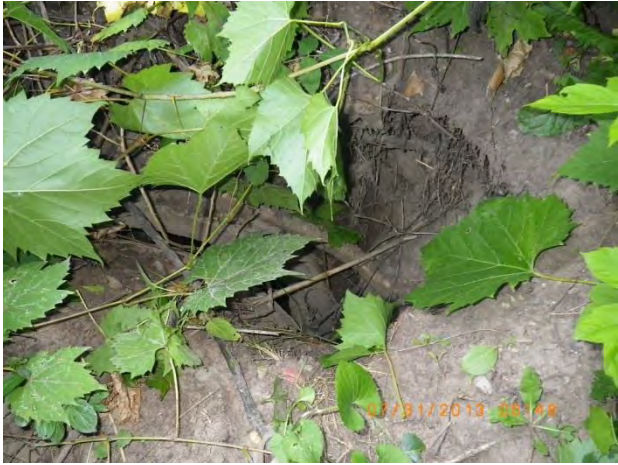
Figure 68 - Moderate erosion (sinkhole above joint) near outfall 14-660

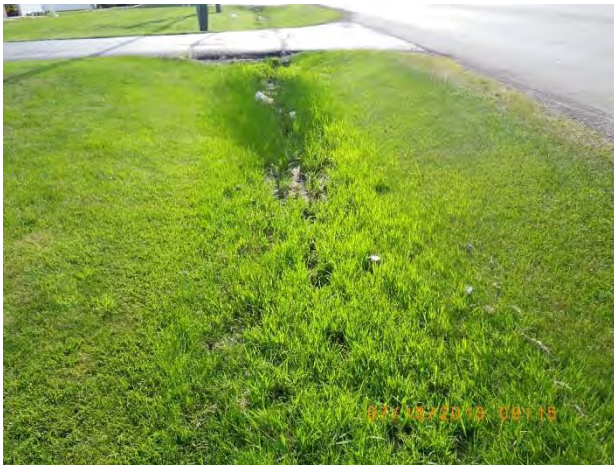
Figure 69 - Minor erosion near outfall 15-1891

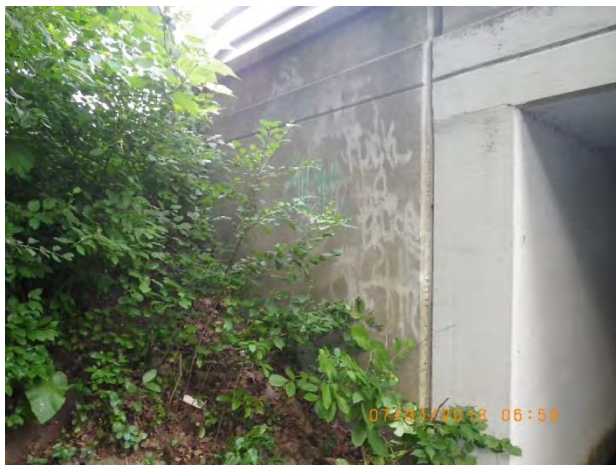
Graffiti was observed in or around one outfall. The graffiti was relatively minor, but should probably be monitored to make sure that it does not become more severe.

Outfall	Severity	Description
14-659	Minor	Graffiti on bridge abutment adjacent to outfall. Prior graffiti covered, with some new.

**Figure 70 - Graffiti near outfall 14-659**

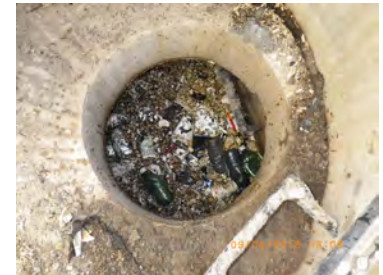
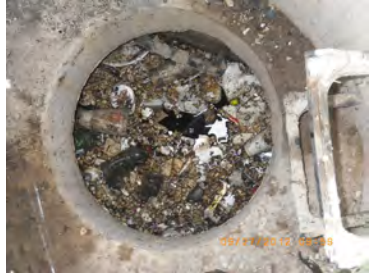
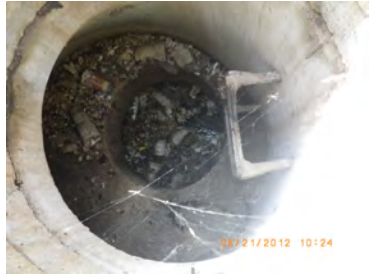
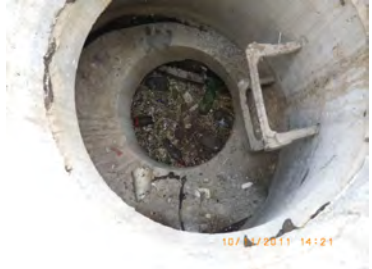
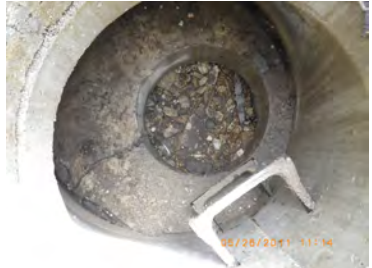
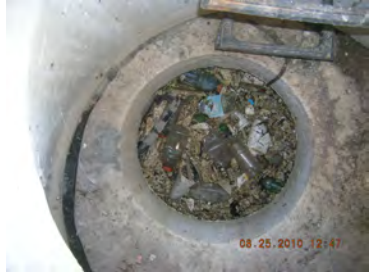
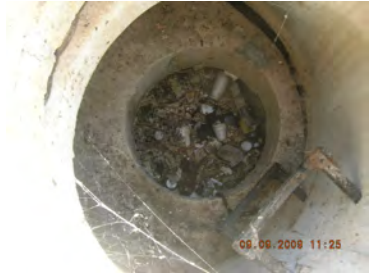
Color: None					
Gross Solids: Severe	<input checked="" type="checkbox"/> Litter	<input type="checkbox"/> Debris	<input type="checkbox"/> Sediment	<input type="checkbox"/> Other	
Vegetation: None	<input type="checkbox"/> Inhibited	<input type="checkbox"/> Excessive			
Benthic Growth: None	<input type="checkbox"/> Green	<input type="checkbox"/> Brown			
Stains: Slight	<input checked="" type="checkbox"/> Flow Line	<input type="checkbox"/> Oil	<input type="checkbox"/> Rust Stains		
	<input type="checkbox"/> Corrosion	<input type="checkbox"/> Paint	<input type="checkbox"/> Other		
Non-illicit: None	<input type="checkbox"/> Natural Sheen	<input type="checkbox"/> Natural Suds/Foam			
<b>Physical Condition Assessment</b>					
Graffiti: None					
Erosion: None					
Deposition: None	Depth (in):				
Damage: None	<input type="checkbox"/> Displacement	<input type="checkbox"/> Undercut	<input type="checkbox"/> Crushed

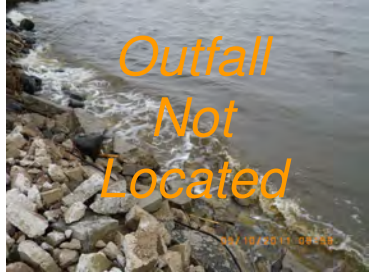
o20110510085930.JPG

<b>Inspection Date:</b> 5/10/2011 8:59:00 AM		<b>Inspector:</b> JCW	<b>Inspection Type:</b> Other	<b>Previous Rainfall (hrs):</b> 0-24		
<b>Flow Description:</b> Submerged (not located)		<b>Notes:</b> Outfall fully submerged and not physically located. Outfall screened upstream at 02-184 US1.				
Submerged: Fully      Depth (in):						
<b>Illicit Discharge Potential:</b> Unlikely		<input type="checkbox"/> Field Follow-up <input type="checkbox"/> Office Follow-up				
Floatables:		<input type="checkbox"/> Petrol. Sheen	<input type="checkbox"/> Suds	<input type="checkbox"/> Sewage	<input type="checkbox"/> Algae	<input type="checkbox"/> Other
Odor:		<input type="checkbox"/> Petroleum	<input type="checkbox"/> Musty	<input type="checkbox"/> Sewage	<input type="checkbox"/> Chlorine	<input type="checkbox"/> Other
		<input type="checkbox"/> VOC/Solvent	<input type="checkbox"/> Fishy	<input type="checkbox"/> Sulfur	<input type="checkbox"/> Fragrant

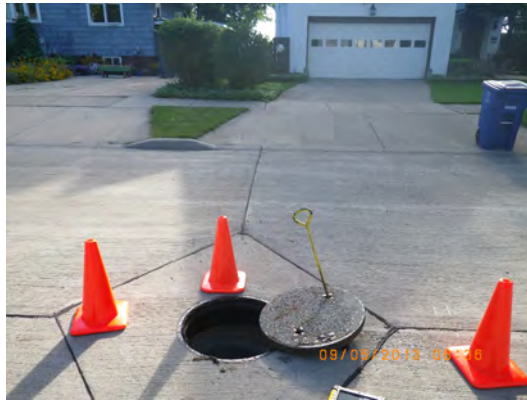
o20130905073606.JPG

Upstream manhole located approx 209 ft W of outfall 02-184. Intermediate area consists of residential lot.

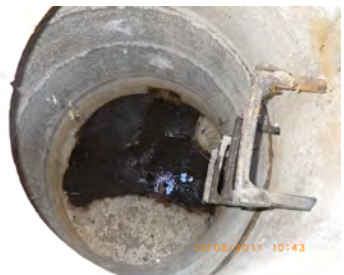
<b>Inspection Date:</b> 10/3/2011 10:43:48 AM		<b>Inspector:</b> JCW	<b>Inspection Type:</b> Ongoing	<b>Previous Rainfall (hrs):</b> 72+
<b>Flow Description:</b> Trickle		<b>Notes:</b> Significant mud on bottom of manhole. Slight flow through mud.		
Submerged: None      Depth (in):				
<b>Illicit Discharge Potential:</b> Unlikely		<input type="checkbox"/> Field Follow-up <input type="checkbox"/> Office Follow-up		
Floatables:	None	<input type="checkbox"/> Petrol. Sheen	<input type="checkbox"/> Suds	<input type="checkbox"/> Sewage <input type="checkbox"/> Algae <input type="checkbox"/> Other
Odor:	None	<input type="checkbox"/> Petroleum	<input type="checkbox"/> Musty	<input type="checkbox"/> Sewage <input type="checkbox"/> Chlorine <input type="checkbox"/> Other
		<input type="checkbox"/> VOC/Solvent	<input type="checkbox"/> Fishy	<input type="checkbox"/> Sulfur <input type="checkbox"/> Fragrant

o20111003104326.JPG				
<b>Sampling Results</b>				
Sample Location: Flow				
Sample ID: 111003-03				
Time Collected 10:50				
Total Chlorine (field): 0 ppm				
Free Chlorine (field): 0 ppm				
Total Copper (field): 0 ppm				
Ammonia (field): 0 ppm				
pH (field): 7.13 units				
Temperature (field): 61 °F				
Conductivity (field): -- µS/cm				
Detergents: 0 mg/L				
Phenol: -- mg/L

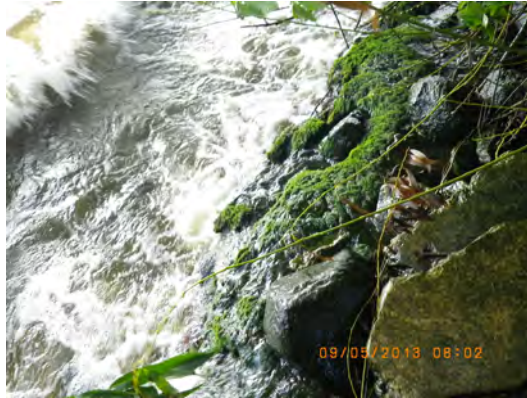
o20130905070204.JPG

Storm sewer from Rahr Ave discharges to lake from west. Outfall not located - pipe info from MS4 map.

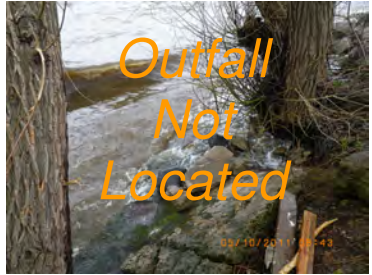
o20110510084330.JPG

<b>Inspection Date:</b> 5/10/2011 8:43:00 AM		<b>Inspector:</b> JCW	<b>Inspection Type:</b> Other	<b>Previous Rainfall (hrs):</b> 0-24		
<b>Flow Description:</b> Submerged (not located)		<b>Notes:</b> Outfall fully submerged and not physically located. Outfall screened upstream at 02-322 US1.				
Submerged: Fully      Depth (in):						
<b>Illicit Discharge Potential:</b> Unlikely		<input type="checkbox"/> Field Follow-up <input type="checkbox"/> Office Follow-up				
Floatables:		<input type="checkbox"/> Petrol. Sheen	<input type="checkbox"/> Suds	<input type="checkbox"/> Sewage	<input type="checkbox"/> Algae	<input type="checkbox"/> Other
Odor:		<input type="checkbox"/> Petroleum	<input type="checkbox"/> Musty	<input type="checkbox"/> Sewage	<input type="checkbox"/> Chlorine	<input type="checkbox"/> Other
		<input type="checkbox"/> VOC/Solvent	<input type="checkbox"/> Fishy	<input type="checkbox"/> Sulfur	<input type="checkbox"/> Fragrant

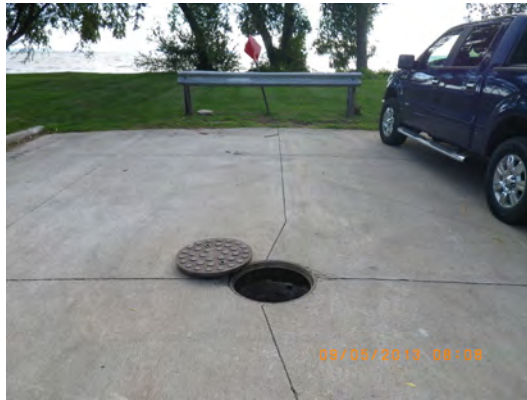
o20130905070816.JPG

Upstream manhole located approx 93 ft W of outfall 13-100. Intermediate area consists of street right-of-way and open space.

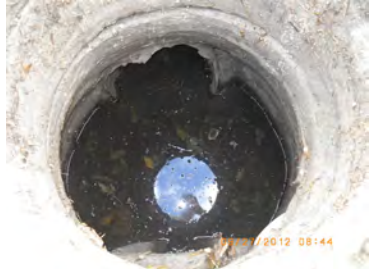
Turbidity: Opaque					
Color: Clearly visible in bottle	Dark/Black				
Gross Solids: Moderate	<input type="checkbox"/> Litter	<input checked="" type="checkbox"/> Debris	<input type="checkbox"/> Sediment	<input type="checkbox"/> Other	
Vegetation: None	<input type="checkbox"/> Inhibited	<input type="checkbox"/> Excessive			
Benthic Growth: None	<input type="checkbox"/> Green	<input type="checkbox"/> Brown			
Stains: None	<input type="checkbox"/> Flow Line	<input type="checkbox"/> Oil	<input type="checkbox"/> Rust Stains		
	<input type="checkbox"/> Corrosion	<input type="checkbox"/> Paint	<input type="checkbox"/> Other		
Non-illicit: Moderate	<input type="checkbox"/> Natural Sheen	<input checked="" type="checkbox"/> Natural Suds/Foam			
<b>Physical Condition Assessment</b>					
Graffiti: None					
Erosion: None					
Deposition: None	Depth (in):				
Damage: None	<input type="checkbox"/> Displacement	<input type="checkbox"/> Undercut	<input type="checkbox"/> Crushed

o20120927074434.JPG

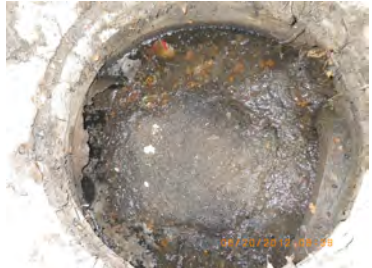
Turbidity: Cloudy					
Color: None					
Gross Solids: Severe	<input type="checkbox"/> Litter	<input checked="" type="checkbox"/> Debris	<input checked="" type="checkbox"/> Sediment	<input type="checkbox"/> Other	
Vegetation: None	<input type="checkbox"/> Inhibited	<input type="checkbox"/> Excessive			
Benthic Growth: None	<input type="checkbox"/> Green	<input type="checkbox"/> Brown			
Stains: None	<input type="checkbox"/> Flow Line	<input type="checkbox"/> Oil	<input type="checkbox"/> Rust Stains		
	<input type="checkbox"/> Corrosion	<input type="checkbox"/> Paint	<input type="checkbox"/> Other		
Non-illicit: None	<input type="checkbox"/> Natural Sheen	<input type="checkbox"/> Natural Suds/Foam			
<b>Physical Condition Assessment</b>					
Graffiti: None					
Erosion: None					
Deposition: Severe	Depth (in): 11				
Damage: None	<input type="checkbox"/> Displacement	<input type="checkbox"/> Undercut	<input type="checkbox"/> Crushed

o20120620073908.JPG

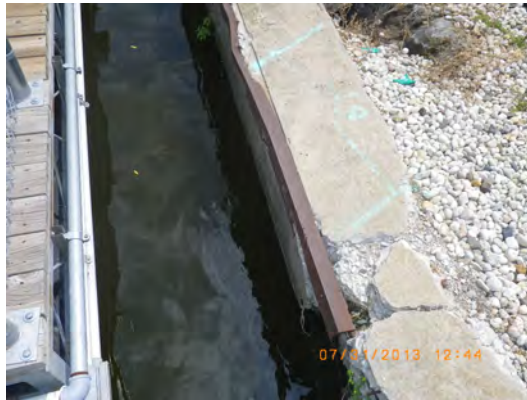
o20130731114428.JPG

Storm sewer from Nebraska St discharges to river from south. Outfall not located - pipe info from MS4 map.

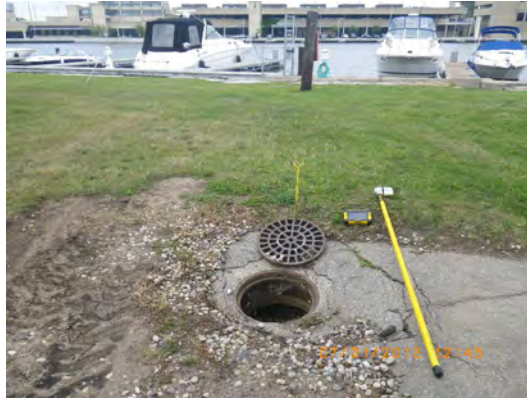
o20130731114604.JPG

Upstream catchbasin located approx 55 ft S of outfall 03-22. Intermediate area consists of open space.

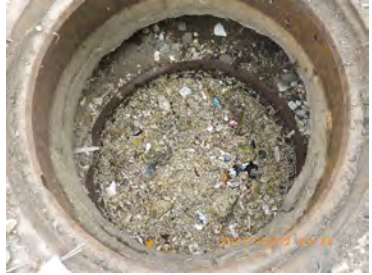
<b>Inspection Date:</b> 9/27/2012 9:27:45 AM		<b>Inspector:</b> JCW	<b>Inspection Type:</b> Ongoing	<b>Previous Rainfall (hrs):</b> 72+
<b>Flow Description:</b> Submerged, indeterminate		<b>Notes:</b> 2011 gross solids follow-up.		
Submerged: Fully      Depth (in): 39				
<b>Illicit Discharge Potential:</b> Potential		<input type="checkbox"/> Field Follow-up <input type="checkbox"/> Office Follow-up		
Floatables: None	<input type="checkbox"/> Petrol. Sheen	<input type="checkbox"/> Suds	<input type="checkbox"/> Sewage	<input type="checkbox"/> Algae <input type="checkbox"/> Other
Odor: None	<input type="checkbox"/> Petroleum	<input type="checkbox"/> Musty	<input type="checkbox"/> Sewage	<input type="checkbox"/> Chlorine <input type="checkbox"/> Other
	<input type="checkbox"/> VOC/Solvent	<input type="checkbox"/> Fishy	<input type="checkbox"/> Sulfur	<input type="checkbox"/> Fragrant
Turbidity: None

Color: None				
Gross Solids: Severe	<input checked="" type="checkbox"/> Litter	<input type="checkbox"/> Debris	<input type="checkbox"/> Sediment	<input type="checkbox"/> Other
Vegetation: None	<input type="checkbox"/> Inhibited	<input type="checkbox"/> Excessive		
Benthic Growth: None	<input type="checkbox"/> Green	<input type="checkbox"/> Brown		
Stains: None	<input type="checkbox"/> Flow Line	<input type="checkbox"/> Oil	<input type="checkbox"/> Rust Stains	
	<input type="checkbox"/> Corrosion	<input type="checkbox"/> Paint	<input type="checkbox"/> Other	
Non-illicit: None	<input type="checkbox"/> Natural Sheen	<input type="checkbox"/> Natural Suds/Foam		
<b>Physical Condition Assessment</b>				
Graffiti: None				
Erosion: None				
Deposition: None	Depth (in):			
Damage: None	<input type="checkbox"/> Displacement	<input type="checkbox"/> Undercut	<input type="checkbox"/> Crushed	
	<input type="checkbox"/> Corrosion	<input type="checkbox"/> Cracks/Structural Damage

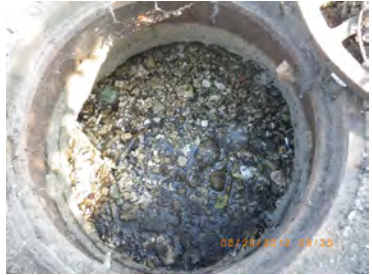
<b>Inspection Date:</b> 6/20/2012 9:24:19 AM		<b>Inspector:</b> JCW	<b>Inspection Type:</b> Other	<b>Previous Rainfall (hrs):</b> 24-48
<b>Flow Description:</b> Submerged, indeterminate		<b>Notes:</b> Gross solids pre-screening.		
Submerged: Fully      Depth (in): 46				
<b>Illicit Discharge Potential:</b> Potential		<input type="checkbox"/> Field Follow-up <input type="checkbox"/> Office Follow-up		
Floatables: None	<input type="checkbox"/> Petrol. Sheen	<input type="checkbox"/> Suds	<input type="checkbox"/> Sewage	<input type="checkbox"/> Algae <input type="checkbox"/> Other
Odor: None	<input type="checkbox"/> Petroleum	<input type="checkbox"/> Musty	<input type="checkbox"/> Sewage	<input type="checkbox"/> Chlorine <input type="checkbox"/> Other
	<input type="checkbox"/> VOC/Solvent	<input type="checkbox"/> Fishy	<input type="checkbox"/> Sulfur	<input type="checkbox"/> Fragrant
Turbidity: None

Color: None				
Gross Solids: Severe	<input checked="" type="checkbox"/> Litter	<input type="checkbox"/> Debris	<input type="checkbox"/> Sediment	<input type="checkbox"/> Other
Vegetation: None	<input type="checkbox"/> Inhibited	<input type="checkbox"/> Excessive		
Benthic Growth: None	<input type="checkbox"/> Green	<input type="checkbox"/> Brown		
Stains: None	<input type="checkbox"/> Flow Line	<input type="checkbox"/> Oil	<input type="checkbox"/> Rust Stains	
	<input type="checkbox"/> Corrosion	<input type="checkbox"/> Paint	<input type="checkbox"/> Other	
Non-illicit: None	<input type="checkbox"/> Natural Sheen	<input type="checkbox"/> Natural Suds/Foam		
<b>Physical Condition Assessment</b>				
Graffiti: None				
Erosion: None				
Deposition: None	Depth (in):			
Damage: None	<input type="checkbox"/> Displacement	<input type="checkbox"/> Undercut	<input type="checkbox"/> Crushed	
	<input type="checkbox"/> Corrosion	<input type="checkbox"/> Cracks/Structural Damage

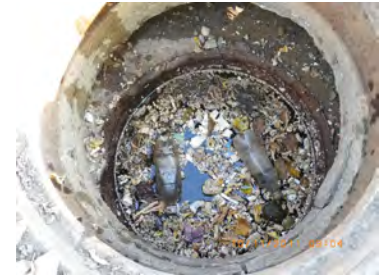
o20111011090446.JPG

Turbidity:	None						
Color:	None						
Gross Solids:	Moderate	<input checked="" type="checkbox"/> Litter	<input type="checkbox"/> Debris	<input type="checkbox"/> Sediment	<input type="checkbox"/> Other		
Vegetation:	None	<input type="checkbox"/> Inhibited	<input type="checkbox"/> Excessive				
Benthic Growth:	None	<input type="checkbox"/> Green	<input type="checkbox"/> Brown				
Stains:	None	<input type="checkbox"/> Flow Line	<input type="checkbox"/> Oil	<input type="checkbox"/> Rust Stains			
		<input type="checkbox"/> Corrosion	<input type="checkbox"/> Paint	<input type="checkbox"/> Other			
Non-illicit:	None	<input type="checkbox"/> Natural Sheen	<input type="checkbox"/> Natural Suds/Foam				
<b>Physical Condition Assessment</b>							
Graffiti:	None						
Erosion:	None						
Deposition:	None	Depth (in): 0					
Damage:	None	<input type="checkbox"/> Displacement	<input type="checkbox"/> Undercut	<input type="checkbox"/> Crushed

<input type="checkbox"/> Corrosion	<input type="checkbox"/> Cracks/Structural Damage				
				<b>Sampling Results</b>			
				Sample Location: Pool			
				Sample ID: 111011-09			
				Time Collected 09:05			
				Total Chlorine (field): 0 ppm			
				Free Chlorine (field): 0 ppm			
				Total Copper (field): 0 ppm			
				Ammonia (field): 0 ppm			
				pH (field): 8.13 units			
				Temperature (field): 70 °F			
				Conductivity (field): -- µS/cm			
				Detergents: -- mg/L			
				Phenol: -- mg/L

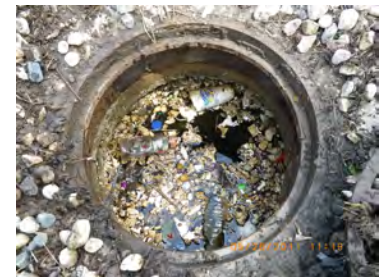
o20110526111930.JPG

<b>Inspection Date:</b> 5/26/2011 11:19:00 AM		<b>Inspector:</b> JCW		<b>Inspection Type:</b> Other		<b>Previous Rainfall (hrs):</b> 72+	
<b>Flow Description:</b> Submerged, indeterminate				<b>Notes:</b> Limited screening conducted to check for floatable debris.			
Submerged: Fully		Depth (in):					
<b>Illicit Discharge Potential:</b> Potential				<input type="checkbox"/> Field Follow-up		<input type="checkbox"/> Office Follow-up	
Floatables:	None	<input type="checkbox"/> Petrol. Sheen	<input type="checkbox"/> Suds	<input type="checkbox"/> Sewage	<input type="checkbox"/> Algae	<input type="checkbox"/> Other	
Odor:		<input type="checkbox"/> Petroleum	<input type="checkbox"/> Musty	<input type="checkbox"/> Sewage	<input type="checkbox"/> Chlorine	<input type="checkbox"/> Other	
		<input type="checkbox"/> VOC/Solvent	<input type="checkbox"/> Fishy	<input type="checkbox"/> Sulfur	<input type="checkbox"/> Fragrant

Turbidity:							
Color:							
Gross Solids:	Moderate	<input checked="" type="checkbox"/> Litter	<input type="checkbox"/> Debris	<input type="checkbox"/> Sediment	<input type="checkbox"/> Other		
Vegetation:		<input type="checkbox"/> Inhibited	<input type="checkbox"/> Excessive				
Benthic Growth:		<input type="checkbox"/> Green	<input type="checkbox"/> Brown				
Stains:		<input type="checkbox"/> Flow Line	<input type="checkbox"/> Oil	<input type="checkbox"/> Rust Stains			
		<input type="checkbox"/> Corrosion	<input type="checkbox"/> Paint	<input type="checkbox"/> Other			
Non-illicit:	None	<input type="checkbox"/> Natural Sheen	<input type="checkbox"/> Natural Suds/Foam				
<b>Physical Condition Assessment</b>							
Graffiti:	None						
Erosion:	None						
Deposition:	None	Depth (in): 0					
Damage:	None	<input type="checkbox"/> Displacement	<input type="checkbox"/> Undercut	<input type="checkbox"/> Crushed

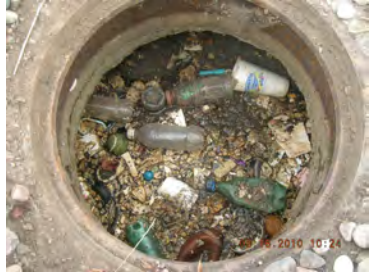
o20100818102410.JPG

Turbidity:	None					
Color:	Faint in bottle	Brown				
Gross Solids:	Severe	<input checked="" type="checkbox"/> Litter	<input type="checkbox"/> Debris	<input type="checkbox"/> Sediment	<input type="checkbox"/> Other	
Vegetation:	None	<input type="checkbox"/> Inhibited	<input type="checkbox"/> Excessive			
Benthic Growth:	None	<input type="checkbox"/> Green	<input type="checkbox"/> Brown			
Stains:	None	<input type="checkbox"/> Flow Line	<input type="checkbox"/> Oil	<input type="checkbox"/> Rust Stains		
		<input type="checkbox"/> Corrosion	<input type="checkbox"/> Paint	<input type="checkbox"/> Other		
Non-illicit:	None	<input type="checkbox"/> Natural Sheen	<input type="checkbox"/> Natural Suds/Foam			
<b>Physical Condition Assessment</b>						
Graffiti:	None					
Erosion:	None					
Deposition:	None	Depth (in): 0				
Damage:	None	<input type="checkbox"/> Displacement	<input type="checkbox"/> Undercut	<input type="checkbox"/> Crushed

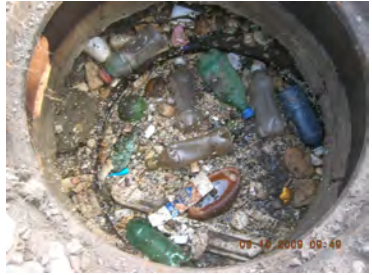
Osh09\_DSCN6768.JPG

Turbidity:	None					
Color:	None					
Gross Solids:	Severe	<input checked="" type="checkbox"/> Litter	<input type="checkbox"/> Debris	<input type="checkbox"/> Sediment	<input type="checkbox"/> Other	
Vegetation:	None	<input type="checkbox"/> Inhibited	<input type="checkbox"/> Excessive			
Benthic Growth:	None	<input type="checkbox"/> Green	<input type="checkbox"/> Brown			
Stains:	None	<input type="checkbox"/> Flow Line	<input type="checkbox"/> Oil	<input type="checkbox"/> Rust Stains		
		<input type="checkbox"/> Corrosion	<input type="checkbox"/> Paint	<input type="checkbox"/> Other		
Non-illicit:	None	<input type="checkbox"/> Natural Sheen	<input type="checkbox"/> Natural Suds/Foam			
<b>Physical Condition Assessment</b>						
Graffiti:	None					
Erosion:	None					
Deposition:	None	Depth (in): 0				
Damage:	None	<input type="checkbox"/> Displacement	<input type="checkbox"/> Undercut	<input type="checkbox"/> Crushed

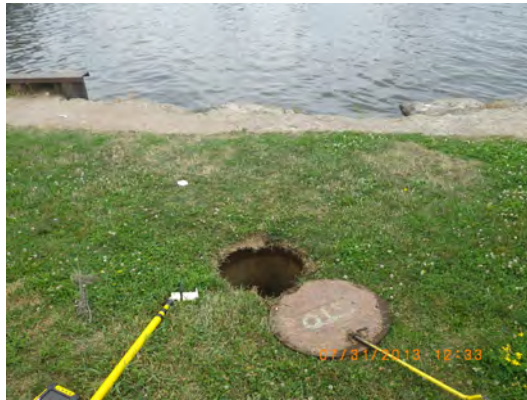
o20130731113340.JPG

Upstream manhole located approx 20 ft WSW of outfall 03-35. Intermediate area consists of open space.

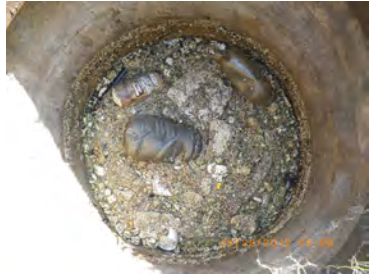
o20120620080918.JPG

<b>Inspection Date:</b> 6/20/2012 9:08:12 AM		<b>Inspector:</b> JCW	<b>Inspection Type:</b> Other	<b>Previous Rainfall (hrs):</b> 24-48		
<b>Flow Description:</b> Submerged, indeterminate		<b>Notes:</b> Gross solids pre-screening.				
Submerged: Fully      Depth (in): 39						
<b>Illicit Discharge Potential:</b> Potential		<input type="checkbox"/> Field Follow-up <input type="checkbox"/> Office Follow-up				
Floatables:	None	<input type="checkbox"/> Petrol. Sheen	<input type="checkbox"/> Suds	<input type="checkbox"/> Sewage	<input type="checkbox"/> Algae	<input type="checkbox"/> Other
Odor:	None	<input type="checkbox"/> Petroleum	<input type="checkbox"/> Musty	<input type="checkbox"/> Sewage	<input type="checkbox"/> Chlorine	<input type="checkbox"/> Other
		<input type="checkbox"/> VOC/Solvent	<input type="checkbox"/> Fishy	<input type="checkbox"/> Sulfur	<input type="checkbox"/> Fragrant	
Turbidity:	None

Color:	None					
Gross Solids:	Severe	<input checked="" type="checkbox"/> Litter	<input type="checkbox"/> Debris	<input type="checkbox"/> Sediment	<input type="checkbox"/> Other	
Vegetation:	None	<input type="checkbox"/> Inhibited	<input type="checkbox"/> Excessive			
Benthic Growth:	None	<input type="checkbox"/> Green	<input type="checkbox"/> Brown			
Stains:	None	<input type="checkbox"/> Flow Line	<input type="checkbox"/> Oil	<input type="checkbox"/> Rust Stains		
		<input type="checkbox"/> Corrosion	<input type="checkbox"/> Paint	<input type="checkbox"/> Other		
Non-illicit:	None	<input type="checkbox"/> Natural Sheen	<input type="checkbox"/> Natural Suds/Foam			
<b>Physical Condition Assessment</b>						
Graffiti:	None					
Erosion:	None					
Deposition:	None	Depth (in):				
Damage:	None	<input type="checkbox"/> Displacement	<input type="checkbox"/> Undercut	<input type="checkbox"/> Crushed		
		<input type="checkbox"/> Corrosion	<input type="checkbox"/> Cracks/Structural Damage

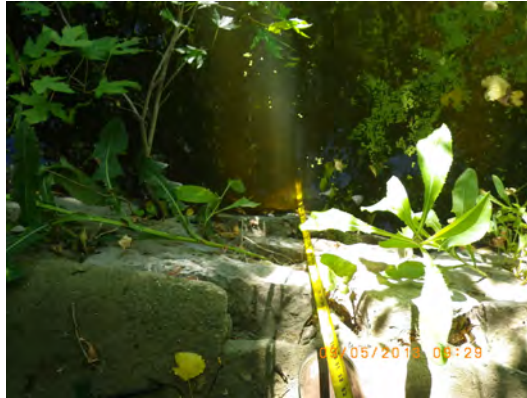
o20130905082908.JPG

Storm sewer from Josslyn St discharges to stream from west. Exits wall approx 9' north of fence.

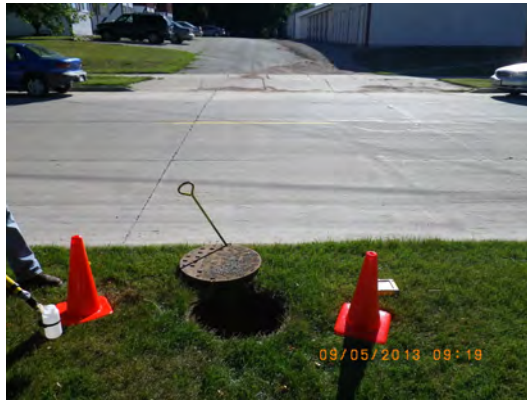
o20130905081956.JPG

Upstream manhole located approx 360 ft W of outfall 06-829. Intermediate area consists of multifamily residential and commercial properties. Two downstream manholes not located. High school located immediately upstream.

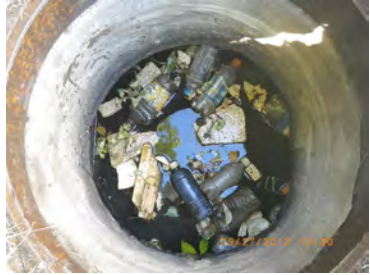
o20120927113044.JPG

<b>Inspection Date:</b> 9/27/2012 12:28:37 PM		<b>Inspector:</b> JCW	<b>Inspection Type:</b> Ongoing	<b>Previous Rainfall (hrs):</b> 72+		
<b>Flow Description:</b> Submerged, indeterminate		<b>Notes:</b>				
Submerged: Fully      Depth (in): 30						
<b>Illicit Discharge Potential:</b> Potential		<input type="checkbox"/> Field Follow-up <input type="checkbox"/> Office Follow-up				
Floatables:	None	<input type="checkbox"/> Petrol. Sheen	<input type="checkbox"/> Suds	<input type="checkbox"/> Sewage	<input type="checkbox"/> Algae	<input type="checkbox"/> Other
Odor:	None	<input type="checkbox"/> Petroleum	<input type="checkbox"/> Musty	<input type="checkbox"/> Sewage	<input type="checkbox"/> Chlorine	<input type="checkbox"/> Other
		<input type="checkbox"/> VOC/Solvent	<input type="checkbox"/> Fishy	<input type="checkbox"/> Sulfur	<input type="checkbox"/> Fragrant	
Turbidity:	None					
Color:	None

Gross Solids:	Moderate	<input checked="" type="checkbox"/> Litter	<input type="checkbox"/> Debris	<input type="checkbox"/> Sediment	<input type="checkbox"/> Other	
Vegetation:	None	<input type="checkbox"/> Inhibited	<input type="checkbox"/> Excessive			
Benthic Growth:	None	<input type="checkbox"/> Green	<input type="checkbox"/> Brown			
Stains:	Slight	<input checked="" type="checkbox"/> Flow Line	<input type="checkbox"/> Oil	<input type="checkbox"/> Rust Stains		
		<input type="checkbox"/> Corrosion	<input type="checkbox"/> Paint	<input type="checkbox"/> Other		
Non-illicit:	None	<input type="checkbox"/> Natural Sheen	<input type="checkbox"/> Natural Suds/Foam			
<b>Physical Condition Assessment</b>						
Graffiti:	None					
Erosion:	None					
Deposition:	None	Depth (in):				
Damage:	None	<input type="checkbox"/> Displacement	<input type="checkbox"/> Undercut	<input type="checkbox"/> Crushed		
		<input type="checkbox"/> Corrosion	<input type="checkbox"/> Cracks/Structural Damage

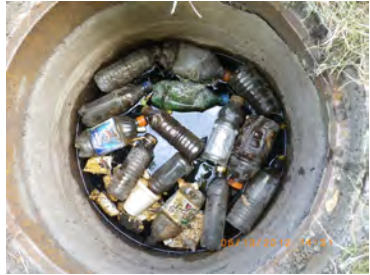
o20120613133100.JPG

Turbidity:	None					
Color:	None					
Gross Solids:	Severe	<input checked="" type="checkbox"/> Litter	<input type="checkbox"/> Debris	<input type="checkbox"/> Sediment	<input type="checkbox"/> Other	
Vegetation:	None	<input type="checkbox"/> Inhibited	<input type="checkbox"/> Excessive			
Benthic Growth:	Slight	<input checked="" type="checkbox"/> Green	<input type="checkbox"/> Brown			
Stains:	None	<input type="checkbox"/> Flow Line	<input type="checkbox"/> Oil	<input type="checkbox"/> Rust Stains		
		<input type="checkbox"/> Corrosion	<input type="checkbox"/> Paint	<input type="checkbox"/> Other		
Non-illicit:	None	<input type="checkbox"/> Natural Sheen	<input type="checkbox"/> Natural Suds/Foam			
<b>Physical Condition Assessment</b>						
Graffiti:	None					
Erosion:	None					
Deposition:	None	Depth (in):				
Damage:	None	<input type="checkbox"/> Displacement	<input type="checkbox"/> Undercut	<input type="checkbox"/> Crushed

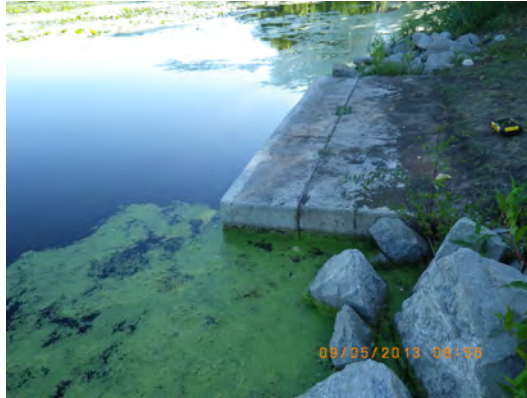
o20130905075636.JPG

Storm sewer from Knapp St discharges to stream from south. Replaces outfalls 06-15 and 06-560 (2011).

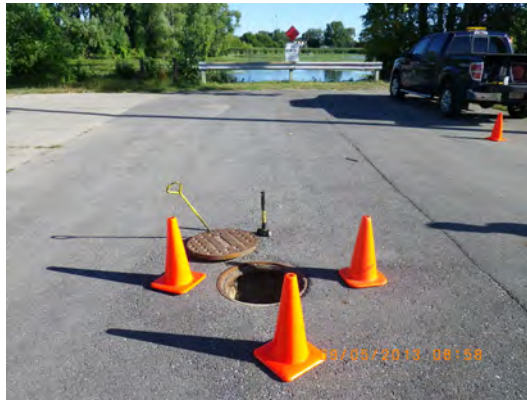
o20130905075850.JPG

Upstream manhole located approx 80 ft S of outfall 06-2241. Intermediate area consists of street right-of-way.

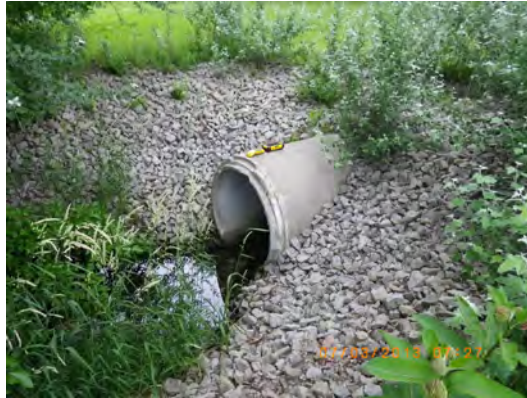
o20130703062722.JPG

Algoma Blvd storm sewer discharges to riprap channel from east.

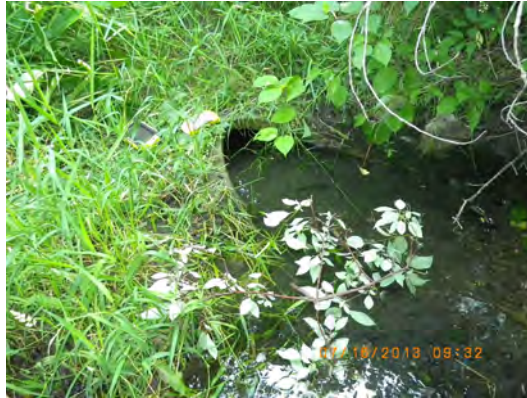
o20130716083202.JPG

Logan Dr storm sewer discharges to drainage swale from north.
