# Ongoing Screening Summary Report 2013 Inspection Year

Illicit Discharge Detection and Elimination Program

City of Oshkosh

OMNNI Project No. N2029B13

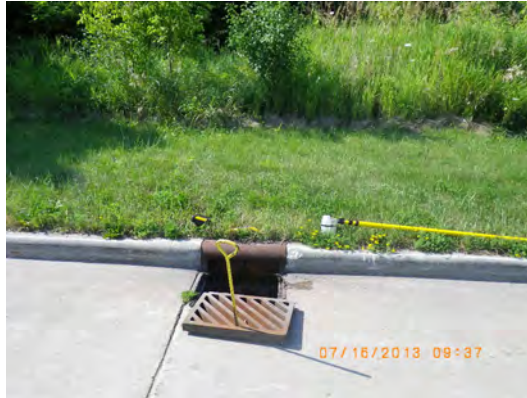
o20130716083706.JPG

Upstream curb inlet located approx 50 ft N of outfall 12-1245. Intermediate area consists of street right-of-way.

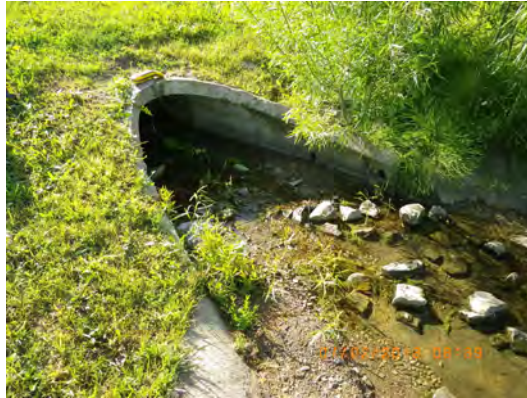
o20130702073950.JPG

Western Dr storm sewer discharges to concrete channel from east.

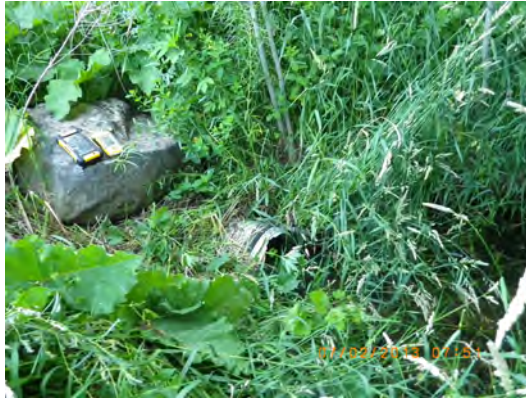
o20130702065152.JPG

Eichstadt Rd storm sewer discharges south to Town of Oshkosh via grass channel.

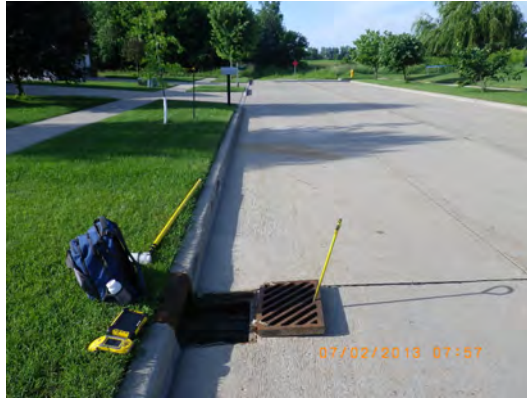
o20130702065700.JPG

Upstream curb inlet located approx 216 ft N of outfall 12-1414. Intermediate area consists of street right-of-way.

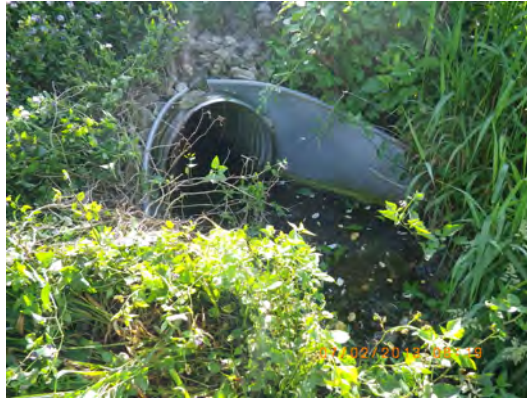
o20130702071940.JPG

Vinland St storm sewer discharges to swale in County landfill.

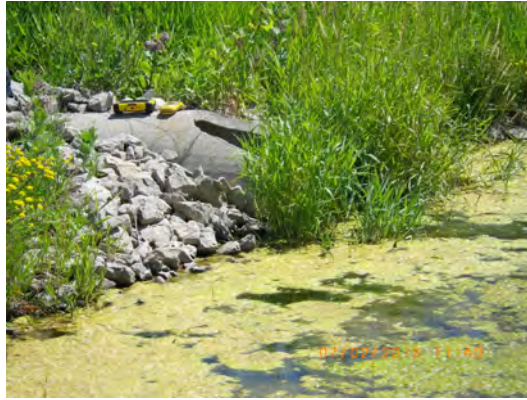
o20130702104058.JPG

Shore Preserve Dr storm sewer discharges to north side of detention basin.

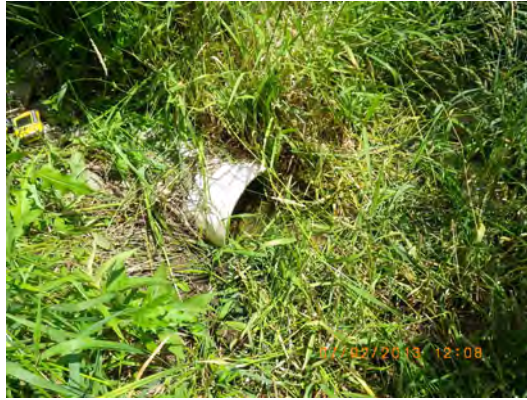
o20130702110828.JPG

Shorewood Preserve Dr detention basin discharges to stream from north.

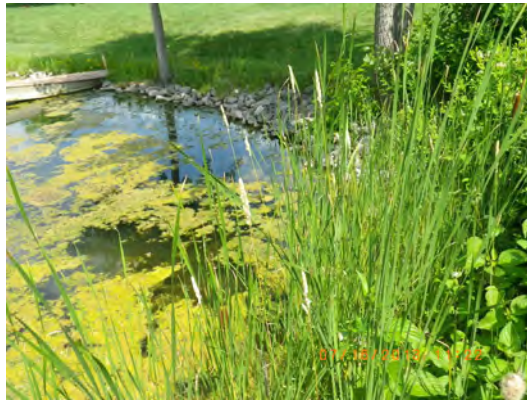
o20130716102228.JPG

Shore Preserve Dr storm sewer discharges to NE corner of detention basin. Outfall not located due to dense algae mat on pond.

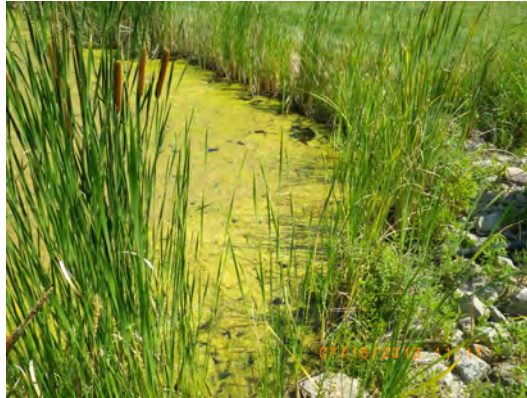
o20130716101704.JPG

Wood Duck Ct storm sewer discharges to SE corner of detention basin. Outfall not located due to dense algae mat on pond.

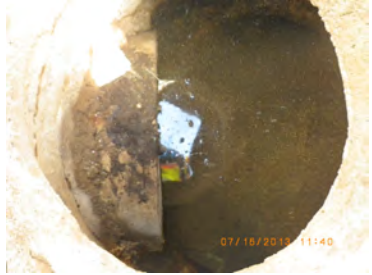
Outfall ID: 12-1692 US1

<b>Inspection Date:</b> 7/16/2013 11:38:06 AM		<b>Inspector:</b> JCW	<b>Inspection Type:</b> Ongoing	<b>Previous Rainfall (hrs):</b> 72+
<b>Flow Description:</b> Submerged, indeterminate		<b>Notes:</b> Detergent detection in manhole pool.

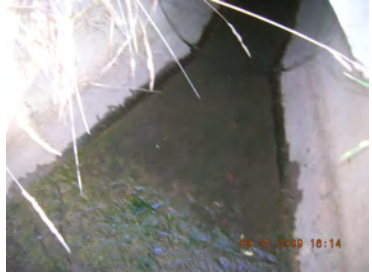
Outfall ID: 12-1781

<b>Inspection Date:</b> 9/2/2009		<b>Inspector:</b> JCW	<b>Inspection Type:</b> Initial	<b>Previous Rainfall (hrs):</b> 72+		
<b>Flow Description:</b> None		<b>Notes:</b> Wet, no flow.

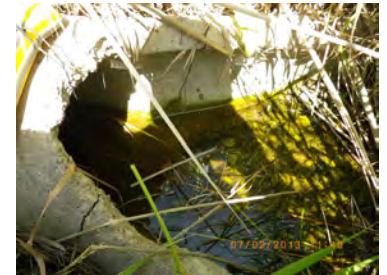
o20130702104638.JPG

Notes: Outfall partially submerged. Outfall screened upstream at 12-1916 US1. Minor crack on apron walls.

Damage: Minor

☐ Corrosion ☒ Cracks/Structural Damage

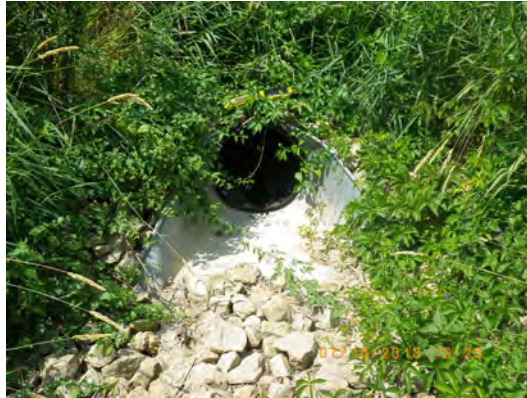
After examining the presence of physical indicators at each outfall and any chemical indicators present in the stormwater samples, each outfall was assigned one of the following classifications, in order of increasing likelihood of the presence of current or past illicit discharges:

Of the 97 inspected outfalls, 90 were classified as unlikely and 7 were classified as potential. The outfalls that were classified as anything other than “unlikely” are summarized in the table below and discussed in more detail in the following sections. A map showing the locations of these outfalls is included in Appendix C.

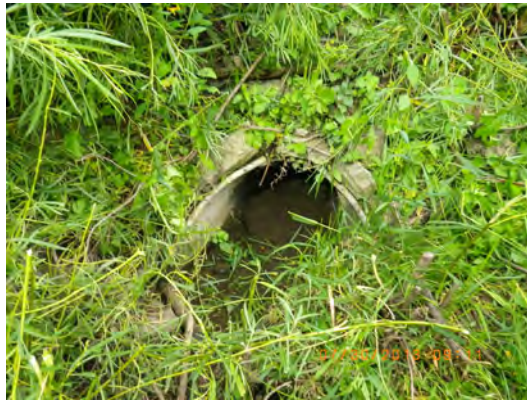
The detention basin, located between the discharge and the outfall, had a significant oil sheen at the time of the discharge. No sheen was observed on the surface of the pond during the re-screening.

**Figure 24 - Upstream detention basin (2013)**

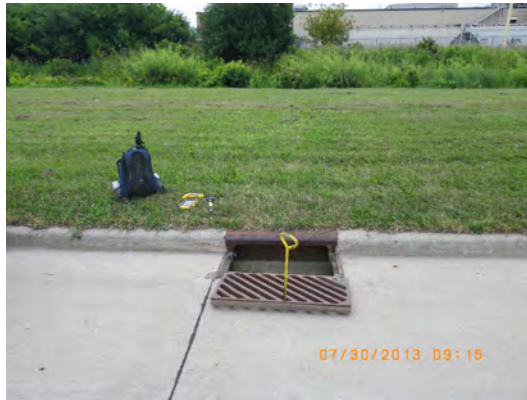
### Graffiti

The graffiti that was observed during the ongoing screening program is summarized in Table 9.

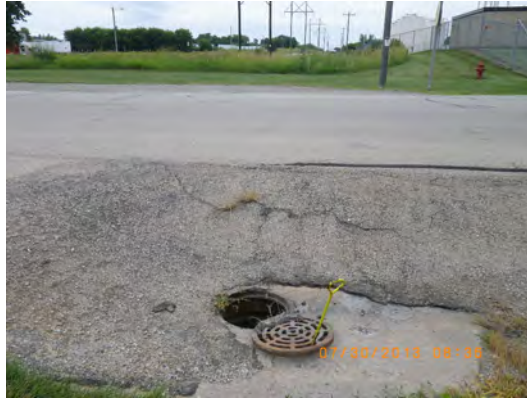
Outfall ID: 01-520

Turbidity: <input type="text" value="None"/>				
Color: <input type="text" value="None"/>				
Gross Solids: <input type="text" value="None"/>	<input type="checkbox"/> Litter	<input type="checkbox"/> Debris	<input type="checkbox"/> Sediment	<input type="checkbox"/> Other
Vegetation: <input type="text" value="None"/>	<input type="checkbox"/> Inhibited	<input type="checkbox"/> Excessive		
Benthic Growth: <input type="text" value="None"/>	<input type="checkbox"/> Green	<input type="checkbox"/> Brown		
Stains: <input type="text" value="None"/>	<input type="checkbox"/> Flow Line	<input type="checkbox"/> Oil	<input type="checkbox"/> Rust Stains	
	<input type="checkbox"/> Corrosion	<input type="checkbox"/> Paint	<input type="checkbox"/> Other	
Non-illicit: <input type="text" value="None"/>	<input type="checkbox"/> Natural Sheen	<input type="checkbox"/> Natural Suds/Foam		
<b>Physical Condition Assessment</b>

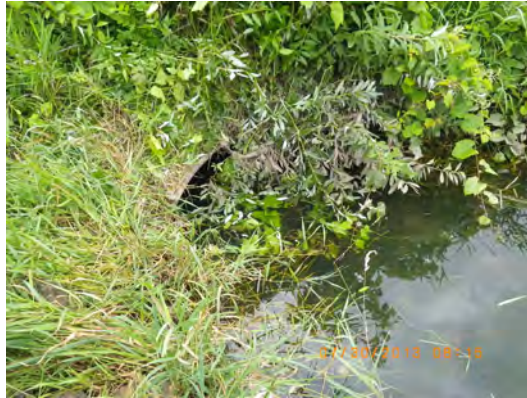
☐ Field Follow-up

Floatables: None

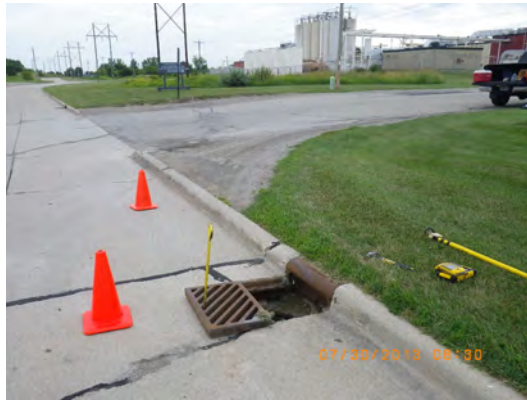
☐ Field Follow-up ☐ Office Follow-up

Odor:  ☐ Petroleum ☐ Musty ☐ Sewage ☐ Chlorine ☐ Other

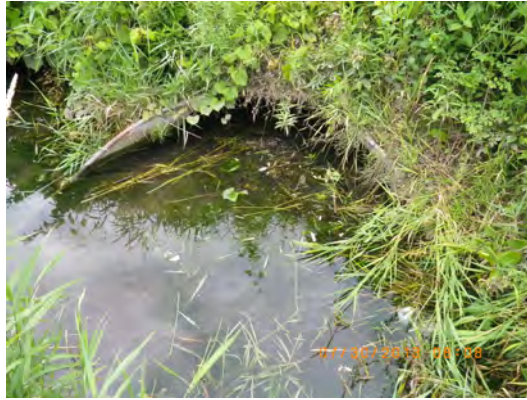
### Flow Description: Submerged, indeterminate

Depth (in): 6

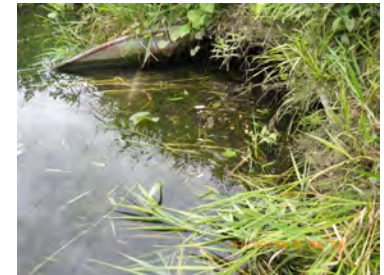
☐ Green

☐ Litter

☐ Debris

☐ Excessive

Benthic Growth:

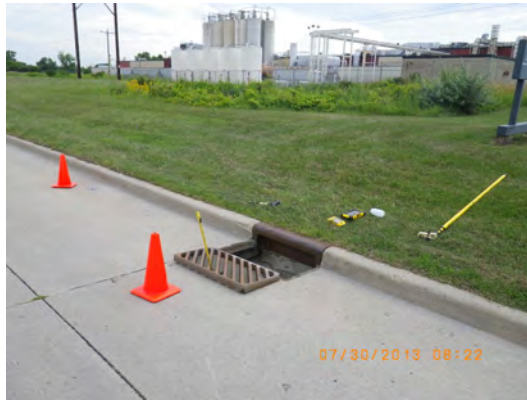
o20130730072300.JPG

Upstream manhole(inlet) located approx 112 ft SSW of outfall 13-1283. Intermediate area consists of street right-of-way. Drop inlet.

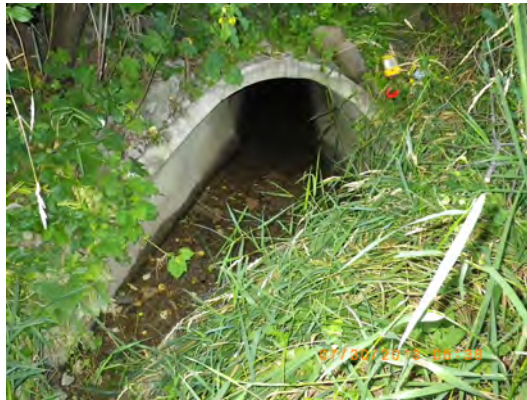
o20130730053858.JPG

Universal St storm sewer discharges to stream from east.

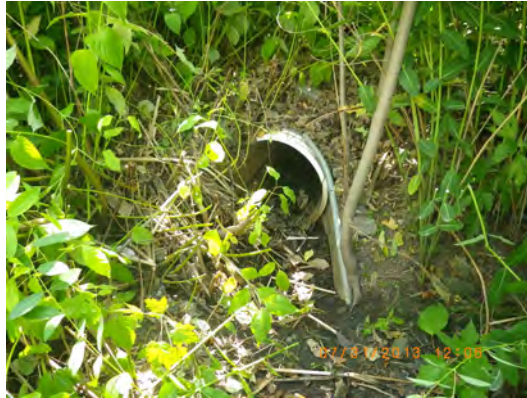
o20130731110616.JPG

Discharge pipe from south end of detention basin. Originally believed to be additional pond inlet.

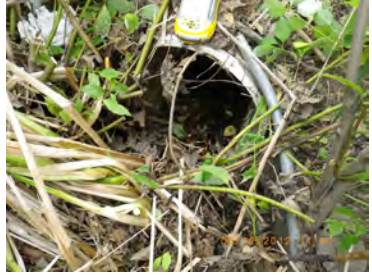
<b>Inspection Date:</b> 6/12/2012 11:38:57 AM		<b>Inspector:</b> JCW	<b>Inspection Type:</b> Ongoing	<b>Previous Rainfall (hrs):</b> 72+	
<b>Flow Description:</b> Submerged, indeterminate		<b>Notes:</b> Sediment and vegetation buildup on apron blocking flow. Screened upstream (downstream) at 13-1716 US1.			
Submerged: Partially      Depth (in): 2					
<b>Illicit Discharge Potential:</b> Potential		<input type="checkbox"/> Field Follow-up <input type="checkbox"/> Office Follow-up			
Floatables: None	<input type="checkbox"/> Petrol. Sheen	<input type="checkbox"/> Suds	<input type="checkbox"/> Sewage	<input type="checkbox"/> Algae	<input type="checkbox"/> Other
Odor: None	<input type="checkbox"/> Petroleum	<input type="checkbox"/> Musty	<input type="checkbox"/> Sewage	<input type="checkbox"/> Chlorine	<input type="checkbox"/> Other
	<input type="checkbox"/> VOC/Solvent	<input type="checkbox"/> Fishy	<input type="checkbox"/> Sulfur	<input type="checkbox"/> Fragrant

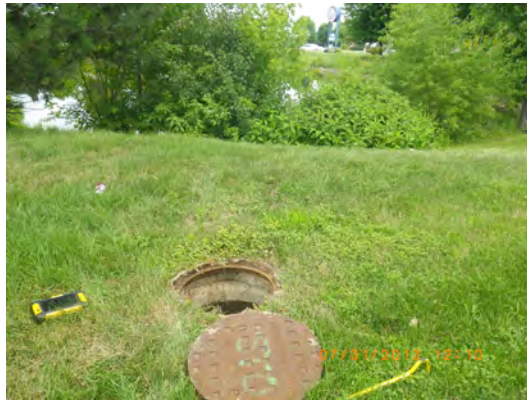
o2013073111008.JPG

Manhole located approx 17 ft S of outfall 13-1716.  
Determined to be located downstream of outfall.  
Pipe from car wash enters from east.

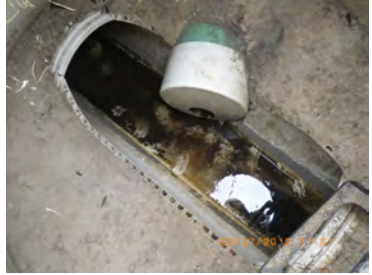
o20120927100116.JPG

<b>Sampling Results</b>	
Sample Location:	Pool
Sample ID:	120927-97
Time Collected	11:00
Total Chlorine (field):	0 ppm
Free Chlorine (field):	0 ppm
Total Copper (field):	0 ppm
Ammonia (field):	0 ppm
pH (field):	7.88 units
Temperature (field):	64 °F
Conductivity (field):	686 µS/cm
Detergents:	0 mg/L
Phenol:	-- mg/L

Turbidity: Cloudy					
Color: Clearly visible in bottle	Dark/Black				
Gross Solids: Slight	<input type="checkbox"/> Litter	<input checked="" type="checkbox"/> Debris	<input type="checkbox"/> Sediment	<input type="checkbox"/> Other	
Vegetation: None	<input type="checkbox"/> Inhibited	<input type="checkbox"/> Excessive			
Benthic Growth: None	<input type="checkbox"/> Green	<input type="checkbox"/> Brown			
Stains: Moderate	<input checked="" type="checkbox"/> Flow Line	<input type="checkbox"/> Oil	<input type="checkbox"/> Rust Stains		
	<input type="checkbox"/> Corrosion	<input type="checkbox"/> Paint	<input type="checkbox"/> Other		
Non-illicit: Moderate	<input checked="" type="checkbox"/> Natural Sheen	<input type="checkbox"/> Natural Suds/Foam			
<b>Physical Condition Assessment</b>					
Graffiti: None					
Erosion: None					
Deposition: None	Depth (in):				
Damage: None	<input type="checkbox"/> Displacement	<input type="checkbox"/> Undercut	<input type="checkbox"/> Crushed

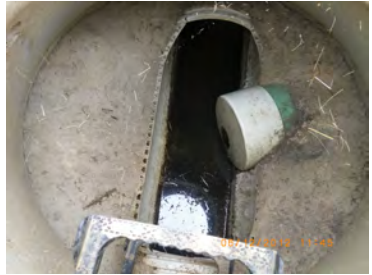
o20120612104548.JPG

<b>Sampling Results</b>	
Sample Location:	Pool
Sample ID:	120612-27
Time Collected	11:45
Total Chlorine (field):	0 ppm
Free Chlorine (field):	0 ppm
Total Copper (field):	0 ppm
Ammonia (field):	3 ppm
pH (field):	7.89 units
Temperature (field):	64 °F
Conductivity (field):	1011 µS/cm
Detergents:	1.3 mg/L
Phenol:	0 mg/L

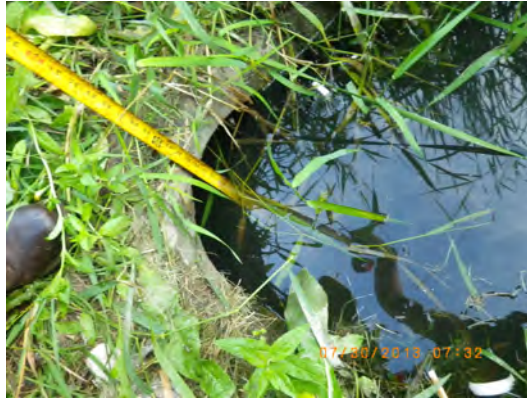
o20130730063254.JPG

STH 44 storm sewer discharges to USH 41 right-of-way from west.

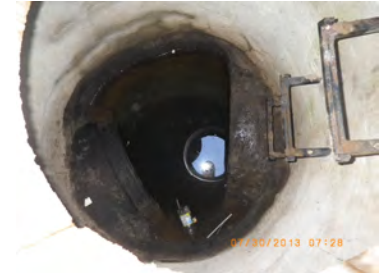
o20130730062844.JPG

Notes: Petroleum odor still present. Slight sheen observed.

Stains: Severe

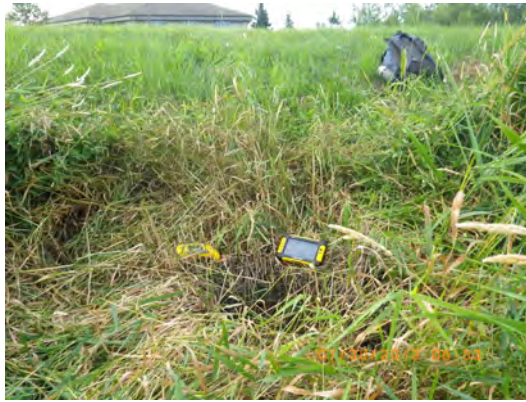
o20130730055300.JPG

STH 44 curb inlets discharge to stream from south. Possible outfall pool located, but actual pipe not found. Encountered rock/riprap.

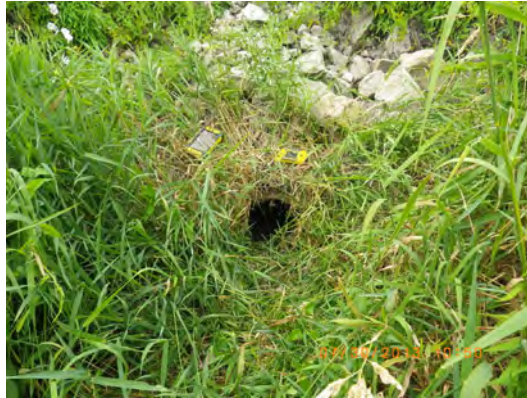
o20130730095044.JPG

Global Pkwy storm sewer discharges to detention basin via grass swale.

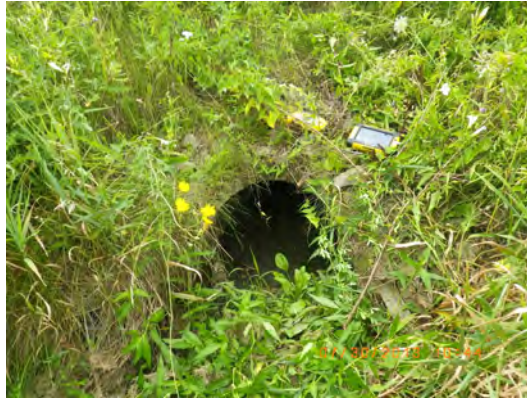
o20130730094430.JPG

Atlas Ave storm sewer discharges to detention basin via grass swale.

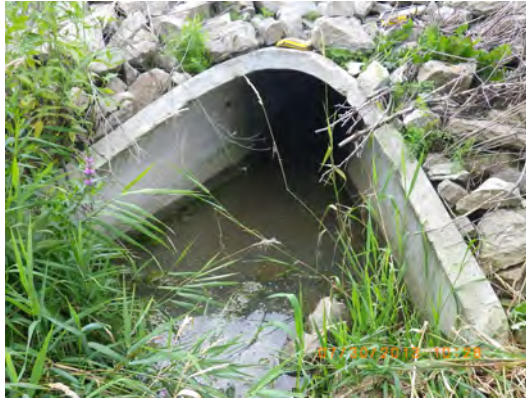
o20130730092820.JPG

Atlas Ave storm sewer discharges to detention basin via swale.

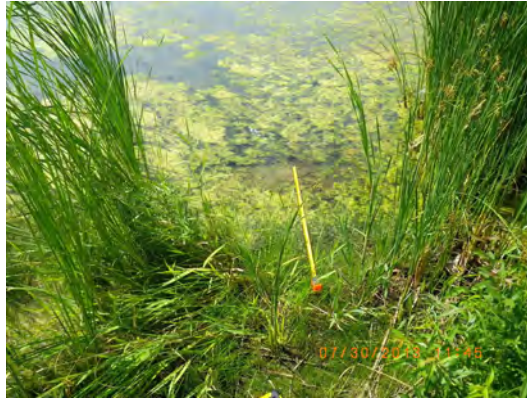
o20130730104502.JPG

White Tail Ln storm sewer discharges to NE corner of detention basin.

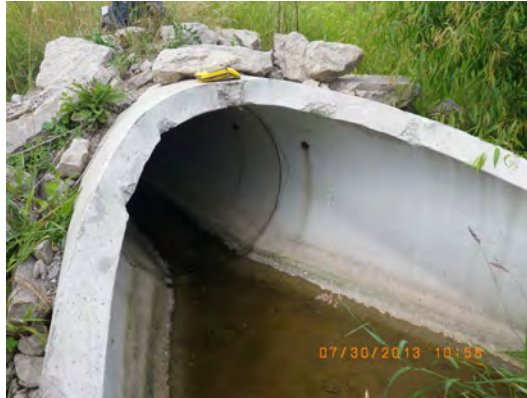
o20130730095852.JPG

Global Pkwy storm sewer discharges to SW corner of detention basin.

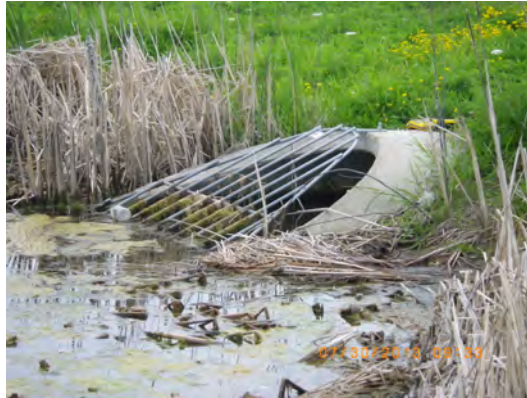
o20130730083352.JPG

Oakwood Rd storm sewer discharges to SE corner of detention basin.

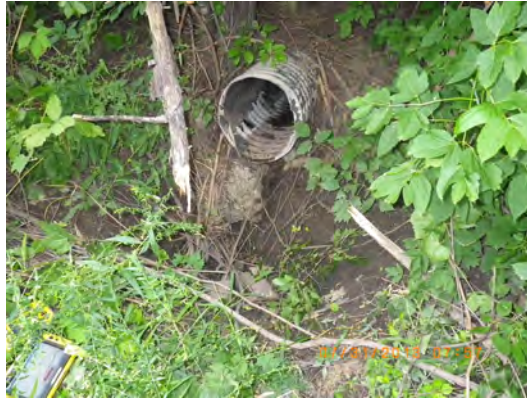
o20130731065746.JPG

25th Ave storm sewer discharges to stream from north. Location approximate - GPS not available in canopy.

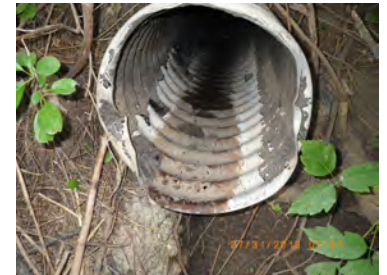
o20130731065754.JPG

Stains: Moderate

☒ Corrosion

Damage: Moderate

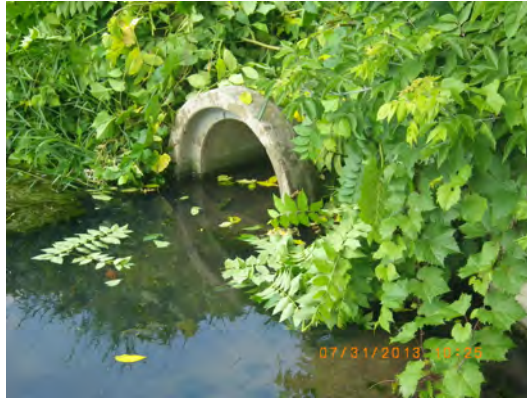
o20130731092548.JPG

W. 28th Street storm sewer discharges to stream from west.

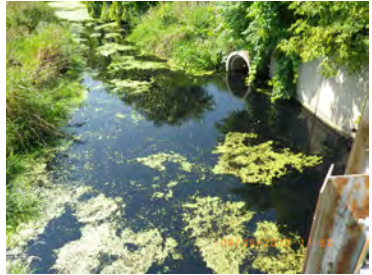
<b>Inspection Date:</b> 9/5/2012 11:52:00 AM		<b>Inspector:</b> JCW		<b>Inspection Type:</b> Complaint		<b>Previous Rainfall (hrs):</b> 72+	
<b>Flow Description:</b> Submerged, indeterminate				<b>Notes:</b> Dark black substance in water around outfall and bridge. Sample collected from stream.			
Submerged: Partially		Depth (in): 12					
<b>Illicit Discharge Potential:</b> Potential				<input type="checkbox"/> Field Follow-up		<input type="checkbox"/> Office Follow-up	
Floatables:	None	<input type="checkbox"/> Petrol. Sheen	<input type="checkbox"/> Suds	<input type="checkbox"/> Sewage	<input type="checkbox"/> Algae	<input type="checkbox"/> Other	
Odor:	Noticeable from a distance	<input type="checkbox"/> Petroleum	<input type="checkbox"/> Musty	<input checked="" type="checkbox"/> Sewage	<input type="checkbox"/> Chlorine	<input type="checkbox"/> Other	
		<input type="checkbox"/> VOC/Solvent	<input type="checkbox"/> Fishy	<input checked="" type="checkbox"/> Sulfur	<input type="checkbox"/> Fragrant

Turbidity:	Cloudy						
Color:	Clearly visible in flow	Dark/Black					
Gross Solids:	None	<input type="checkbox"/> Litter	<input type="checkbox"/> Debris	<input type="checkbox"/> Sediment	<input type="checkbox"/> Other		
Vegetation:	None	<input type="checkbox"/> Inhibited	<input type="checkbox"/> Excessive				
Benthic Growth:	Moderate	<input checked="" type="checkbox"/> Green	<input checked="" type="checkbox"/> Brown				
Stains:	None	<input type="checkbox"/> Flow Line	<input type="checkbox"/> Oil	<input type="checkbox"/> Rust Stains			
		<input type="checkbox"/> Corrosion	<input type="checkbox"/> Paint	<input type="checkbox"/> Other			
Non-illicit:	None	<input type="checkbox"/> Natural Sheen	<input type="checkbox"/> Natural Suds/Foam				
<b>Physical Condition Assessment</b>							
Graffiti:	None						
Erosion:	None						
Deposition:	None	Depth (in):					
Damage:	None	<input type="checkbox"/> Displacement	<input type="checkbox"/> Undercut	<input type="checkbox"/> Crushed

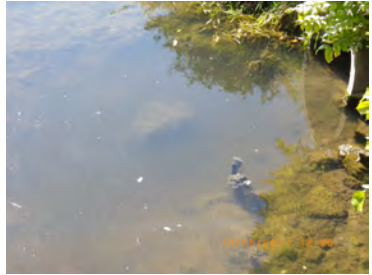
<b>Inspection Date:</b> 10/5/2011 12:26:00 PM		<b>Inspector:</b> JCW	<b>Inspection Type:</b> Repeat	<b>Previous Rainfall (hrs):</b> 72+
<b>Flow Description:</b> Submerged, indeterminate		<b>Notes:</b> Complaint follow-up. Outfall partially submerged. Outfall screened upstream at 14-585 US7. Limited screening conducted.		
Submerged: Partially      Depth (in):				
<b>Illicit Discharge Potential:</b> Obvious		<input type="checkbox"/> Field Follow-up <input type="checkbox"/> Office Follow-up		
Floatables:	<input type="checkbox"/> Petrol. Sheen	<input type="checkbox"/> Suds	<input type="checkbox"/> Sewage	<input type="checkbox"/> Algae <input type="checkbox"/> Other
Odor:	<input type="checkbox"/> Petroleum	<input type="checkbox"/> Musty	<input type="checkbox"/> Sewage	<input type="checkbox"/> Chlorine <input type="checkbox"/> Other
	<input type="checkbox"/> VOC/Solvent	<input type="checkbox"/> Fishy	<input type="checkbox"/> Sulfur	<input type="checkbox"/> Fragrant

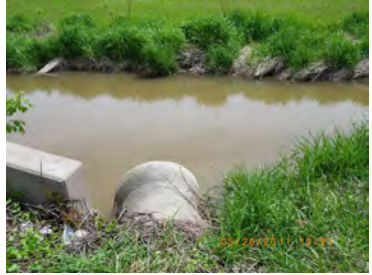
<b>Inspection Date:</b> 5/26/2011 12:21:00 PM		<b>Inspector:</b> JCW	<b>Inspection Type:</b> Repeat	<b>Previous Rainfall (hrs):</b> 72+		
<b>Flow Description:</b> Submerged, indeterminate		<b>Notes:</b> Complaint follow-up. Strong chlorine smell inside pipe. Chemical interference with chlorine test. Limited screening conducted.				
Submerged: Partially      Depth (in):						
<b>Illicit Discharge Potential:</b> Obvious		<input type="checkbox"/> Field Follow-up <input type="checkbox"/> Office Follow-up				
Floatables:		<input type="checkbox"/> Petrol. Sheen	<input type="checkbox"/> Suds	<input type="checkbox"/> Sewage	<input type="checkbox"/> Algae	<input type="checkbox"/> Other
Odor:	Noticeable from a distance	<input type="checkbox"/> Petroleum	<input type="checkbox"/> Musty	<input type="checkbox"/> Sewage	<input checked="" type="checkbox"/> Chlorine	<input type="checkbox"/> Other
		<input type="checkbox"/> VOC/Solvent	<input type="checkbox"/> Fishy	<input type="checkbox"/> Sulfur	<input type="checkbox"/> Fragrant

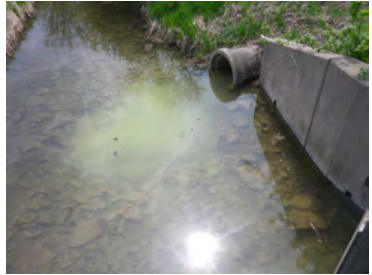
<b>Inspection Date:</b> 5/12/2011 1:03:00 PM		<b>Inspector:</b> JCW	<b>Inspection Type:</b> Complaint	<b>Previous Rainfall (hrs):</b> 72+		
<b>Flow Description:</b> Submerged, indeterminate		<b>Notes:</b> Responded to complaint about discharge from pipe. Outfall partially submerged. Yellow pool at end of pipe. Chemical smell				
Submerged: Partially      Depth (in):						
<b>Illicit Discharge Potential:</b> Obvious		<input type="checkbox"/> Field Follow-up <input type="checkbox"/> Office Follow-up				
Floatables:		<input type="checkbox"/> Petrol. Sheen	<input type="checkbox"/> Suds	<input type="checkbox"/> Sewage	<input type="checkbox"/> Algae	<input type="checkbox"/> Other
Odor:	Noticeable from a distance	<input type="checkbox"/> Petroleum	<input type="checkbox"/> Musty	<input type="checkbox"/> Sewage	<input checked="" type="checkbox"/> Chlorine	<input checked="" type="checkbox"/> Other
		<input type="checkbox"/> VOC/Solvent	<input type="checkbox"/> Fishy	<input type="checkbox"/> Sulfur	<input type="checkbox"/> Fragrant

Turbidity:						
Color:	Clearly visible in flow	Yellow				
Gross Solids:		<input type="checkbox"/> Litter	<input type="checkbox"/> Debris	<input type="checkbox"/> Sediment	<input type="checkbox"/> Other	
Vegetation:		<input type="checkbox"/> Inhibited	<input type="checkbox"/> Excessive			
Benthic Growth:		<input type="checkbox"/> Green	<input type="checkbox"/> Brown			
Stains:		<input type="checkbox"/> Flow Line	<input type="checkbox"/> Oil	<input type="checkbox"/> Rust Stains		
		<input type="checkbox"/> Corrosion	<input type="checkbox"/> Paint	<input type="checkbox"/> Other		
Non-illicit:	None	<input type="checkbox"/> Natural Sheen	<input type="checkbox"/> Natural Suds/Foam			
<b>Physical Condition Assessment</b>						
Graffiti:						
Erosion:						
Deposition:      Depth (in):						
Damage:						
<input type="checkbox"/> Displacement <input type="checkbox"/> Undercut <input type="checkbox"/> Crushed

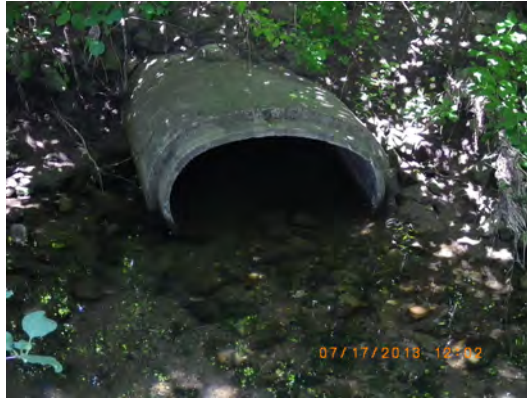
o20130717110224.JPG

33rd Ave storm sewer discharges to stream from west.

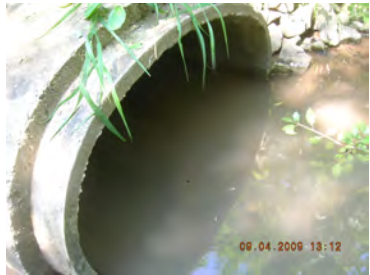
Osh09_DSCN6531.JPG				
<b>Sampling Results</b>				
Sample Location: Pool				
Sample ID: 090904-03

<b>Inspection Date:</b> 9/4/2009		<b>Inspector:</b> JCW	<b>Inspection Type:</b> Initial	<b>Previous Rainfall (hrs):</b> 72+
<b>Flow Description:</b> Submerged, indeterminate		<b>Notes:</b>		
Submerged: Partially	Depth (in): 7			
<b>Illicit Discharge Potential:</b> Potential		<input type="checkbox"/> Field Follow-up <input type="checkbox"/> Office Follow-up		
Floatables:		<input type="checkbox"/> Petrol. Sheen	<input type="checkbox"/> Suds	<input type="checkbox"/> Sewage <input type="checkbox"/> Algae <input type="checkbox"/> Other
Odor:		<input type="checkbox"/> Petroleum	<input type="checkbox"/> Musty	<input type="checkbox"/> Sewage <input type="checkbox"/> Chlorine <input type="checkbox"/> Other
		<input type="checkbox"/> VOC/Solvent	<input type="checkbox"/> Fishy	<input type="checkbox"/> Sulfur <input type="checkbox"/> Fragrant
Turbidity:				
Color:				
Gross Solids:		<input type="checkbox"/> Litter	<input type="checkbox"/> Debris	<input type="checkbox"/> Sediment <input type="checkbox"/> Other

Time Collected 13:15				
Total Chlorine (field): 0 ppm				
Free Chlorine (field): 0 ppm				
Total Copper (field): 0 ppm				
Ammonia (field): -- ppm				
pH (field): 7.57 units				
Temperature (field): 71 °F				
Conductivity (field): -- µS/cm				
Detergents: 0 mg/L				
Phenol: 0 mg/L

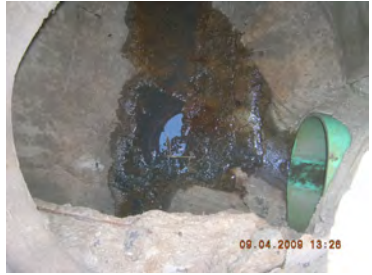
Osh09\_DSCN6535.JPG

<b>Inspection Date:</b> 9/4/2009		<b>Inspector:</b> JCW	<b>Inspection Type:</b> Initial	<b>Previous Rainfall (hrs):</b> 72+		
<b>Flow Description:</b> None		<b>Notes:</b> Wet, no flow. Slight oil sheen in pool in manhole.				
Submerged: None      Depth (in): 0						
<b>Illicit Discharge Potential:</b> Potential		<input type="checkbox"/> Field Follow-up <input type="checkbox"/> Office Follow-up				
Floatables:	Slight	<input checked="" type="checkbox"/> Petrol. Sheen	<input type="checkbox"/> Suds	<input type="checkbox"/> Sewage	<input type="checkbox"/> Algae	<input type="checkbox"/> Other
Odor:	None	<input type="checkbox"/> Petroleum	<input type="checkbox"/> Musty	<input type="checkbox"/> Sewage	<input type="checkbox"/> Chlorine	<input type="checkbox"/> Other
		<input type="checkbox"/> VOC/Solvent	<input type="checkbox"/> Fishy	<input type="checkbox"/> Sulfur	<input type="checkbox"/> Fragrant	
Turbidity:	None

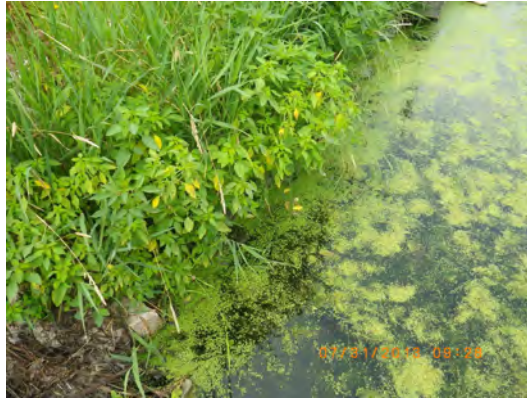
o20130731082824.JPG

Stoney Beach Rd storm sewer discharges to stream from south. Outfall not located.

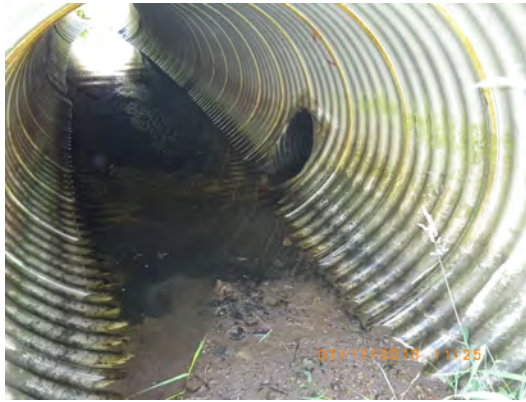
o20130717102530.JPG

35th Ave storm sewer discharges into west culvert.  
Location approximate - GPS not available in culvert.

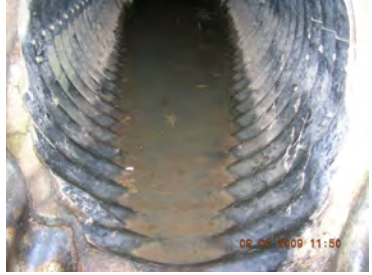
<b>Inspection Date:</b> 9/4/2009		<b>Inspector:</b> JCW	<b>Inspection Type:</b> Initial	<b>Previous Rainfall (hrs):</b> 72+
<b>Flow Description:</b> None		<b>Notes:</b> Water standing in pipe ribs - no flow. Black lining of pipe peeling.

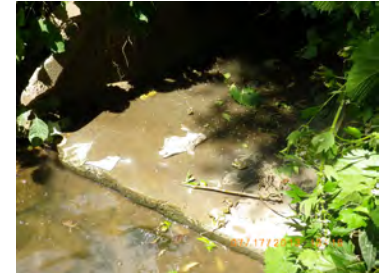
o20130717121624.JPG

Damage: Minor

☒ Displacement ☐ Undercut ☐ Crushed

☐ Corrosion ☒ Cracks/Structural Damage

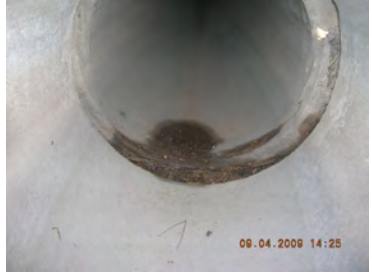
Outfall ID: 14-660

<b>Inspection Date:</b> 9/4/2009		<b>Inspector:</b> JCW	<b>Inspection Type:</b> Initial	<b>Previous Rainfall (hrs):</b> 72+		
<b>Flow Description:</b> None		<b>Notes:</b> Apron separating from pipe. Graffiti on bridge.

Damage: Moderate						
<input type="checkbox"/> Displacement <input type="checkbox"/> Undercut <input type="checkbox"/> Crushed						
<input type="checkbox"/> Corrosion <input type="checkbox"/> Cracks/Structural Damage						
<b>Sampling Results</b>						
Sample Location:						
Sample ID:						
Time Collected						
Total Chlorine (field):    --    ppm						
Free Chlorine (field):    --    ppm						
Total Copper (field):    --    ppm						
Ammonia (field):        --    ppm						
pH (field):                --    units						
Temperature (field):    --    °F						
Conductivity (field):    --    µS/cm						
Detergents:                --    mg/L						
Phenol:                    --    mg/L

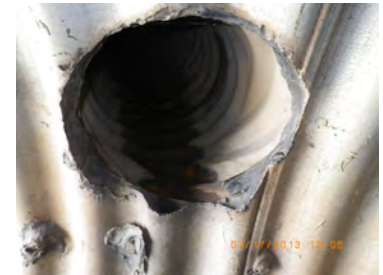
o20130717120604.JPG

Damage: Minor

☒ Corrosion

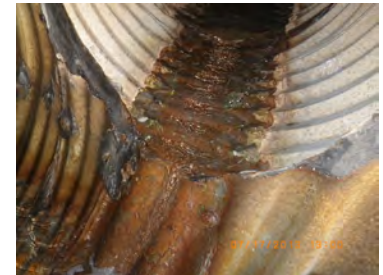
o20130717120006.JPG

Damage: Moderate

☒ Corrosion

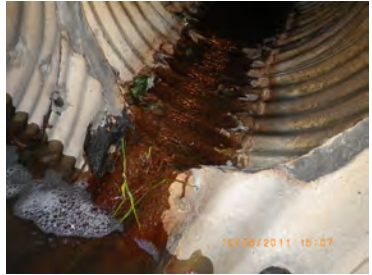
<b>Inspection Date:</b> 10/6/2011 3:04:00 PM		<b>Inspector:</b> JCW	<b>Inspection Type:</b> Ongoing	<b>Previous Rainfall (hrs):</b> 72+
<b>Flow Description:</b> Moderate		<b>Notes:</b> Persistent suds still present in mixing zone and downstream.		
Submerged: None      Depth (in):				
<b>Illicit Discharge Potential:</b> Potential		<input type="checkbox"/> Field Follow-up <input type="checkbox"/> Office Follow-up		
Floatables: Moderate	<input type="checkbox"/> Petrol. Sheen	<input checked="" type="checkbox"/> Suds	<input type="checkbox"/> Sewage	<input type="checkbox"/> Algae <input type="checkbox"/> Other
Odor: None	<input type="checkbox"/> Petroleum	<input type="checkbox"/> Musty	<input type="checkbox"/> Sewage	<input type="checkbox"/> Chlorine <input type="checkbox"/> Other
	<input type="checkbox"/> VOC/Solvent	<input type="checkbox"/> Fishy	<input type="checkbox"/> Sulfur	<input type="checkbox"/> Fragrant

<input checked="" type="checkbox"/> Corrosion	<input type="checkbox"/> Cracks/Structural Damage

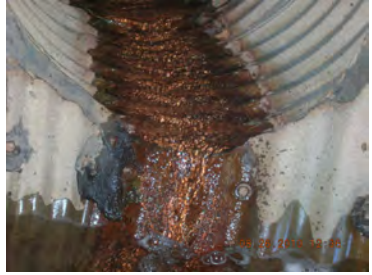
Outfall ID: 14-676

<b>Inspection Date:</b> 8/26/2010 12:58:18 PM		<b>Inspector:</b> JCW		<b>Inspection Type:</b> Ongoing		<b>Previous Rainfall (hrs):</b> 72+	
<b>Flow Description: Moderate</b>				<b>Notes:</b> Persistent suds and gel-like sheen downstream			
Submerged: None		Depth (in):					
<b>Illicit Discharge Potential: Potential</b>				<input type="checkbox"/> Field Follow-up		<input type="checkbox"/> Office Follow-up	
Floatables: Moderate	<input type="checkbox"/> Petrol. Sheen	<input checked="" type="checkbox"/> Suds	<input type="checkbox"/> Sewage	<input type="checkbox"/> Algae	<input checked="" type="checkbox"/> Other

Non-illicit: None	<input type="checkbox"/> Natural Sheen	<input type="checkbox"/> Natural Suds/Foam					
<b>Physical Condition Assessment</b> <hr/> Graffiti: None Erosion: None Deposition: None      Depth (in): 0 Damage: Moderate <input type="checkbox"/> Displacement <input type="checkbox"/> Undercut <input type="checkbox"/> Crushed <input checked="" type="checkbox"/> Corrosion <input type="checkbox"/> Cracks/Structural Damage

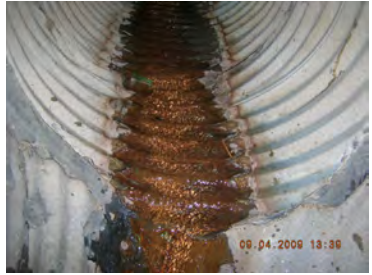
<b>Inspection Date:</b> 9/4/2009		<b>Inspector:</b> JCW		<b>Inspection Type:</b> Initial		<b>Previous Rainfall (hrs):</b> 72+	
<b>Flow Description: Moderate</b>				<b>Notes:</b> Sample 09090411 collected from pool (suds). No detergent detected.			
Submerged: None		Depth (in): 0					
<b>Illicit Discharge Potential: Potential</b>				<input type="checkbox"/> Field Follow-up		<input type="checkbox"/> Office Follow-up	
Floatables: Moderate	<input type="checkbox"/> Petrol. Sheen	<input checked="" type="checkbox"/> Suds	<input type="checkbox"/> Sewage	<input type="checkbox"/> Algae	<input type="checkbox"/> Other

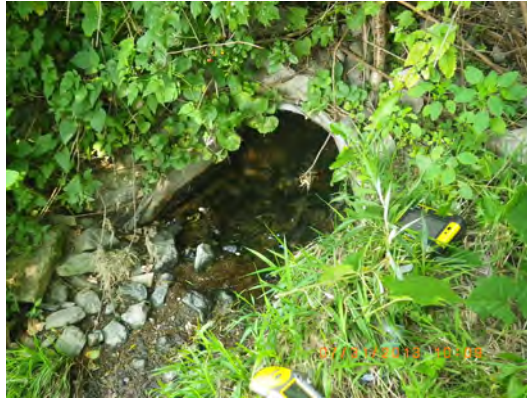
o20130731090940.JPG

Waukau Ave storm sewer discharges to lake from west.

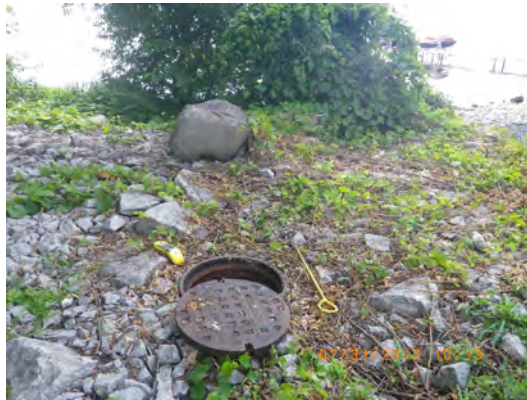
o20130731091346.JPG

Upstream manhole located approx 21 ft NW of outfall 14-789. Intermediate area consists of street right-of-way.

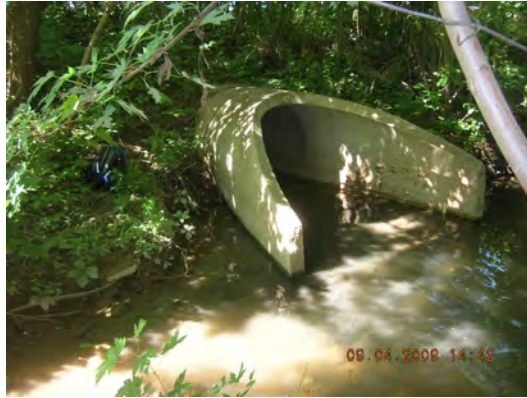
Osh09\_DSCN6563.JPG

Hughes St storm sewer discharges to stream from west. Inside Oshkosh Corporation security fence.

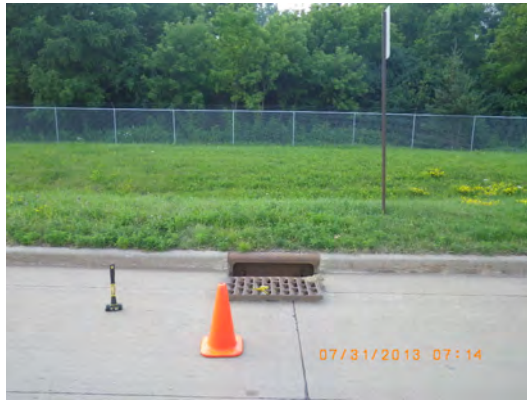
o20130731061448.JPG

Upstream curb inlet located approx 139 ft NW of outfall 14-996. Intermediate area consists of open space and wooded area.

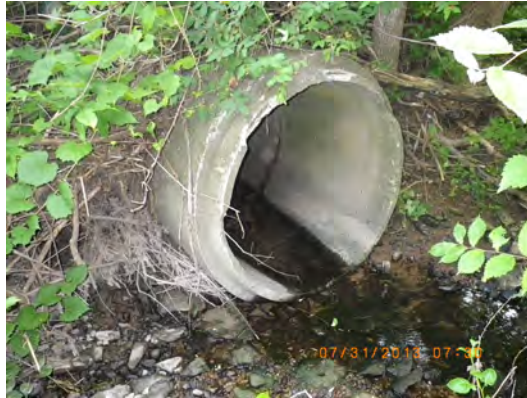
o20130731063028.JPG

Hughes St storm sewer discharges to stream from north.

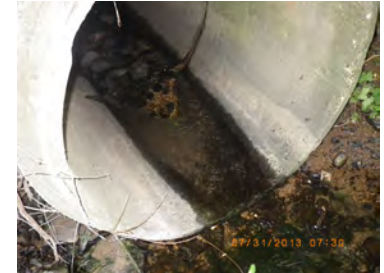
o20130731063036.JPG

Stains: Moderate

☒ Flow Line ☐ Oil ☐ Rust Stains

Damage: Minor

☒ Displacement ☐ Undercut ☐ Crushed

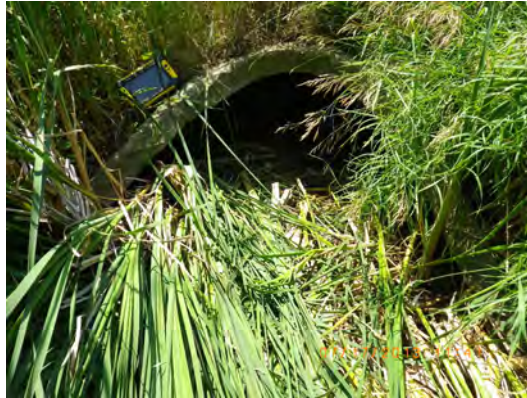
o20130717104104.JPG

Oregon St storm sewer discharges to east CTH I ditch.

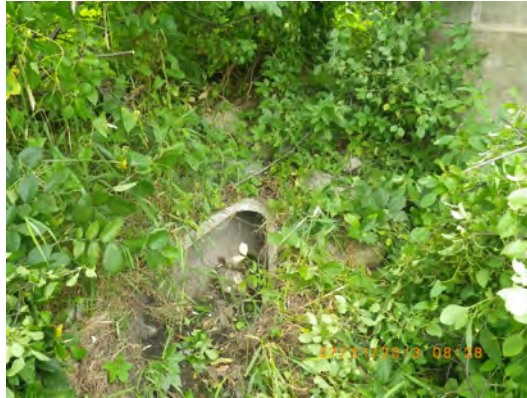
o20130731072850.JPG

Main St storm sewer discharges to stream from south.

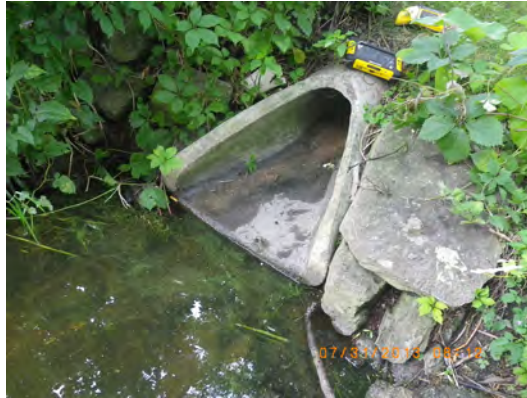
o20130731071258.JPG

Main St storm sewer discharges to stream from south.

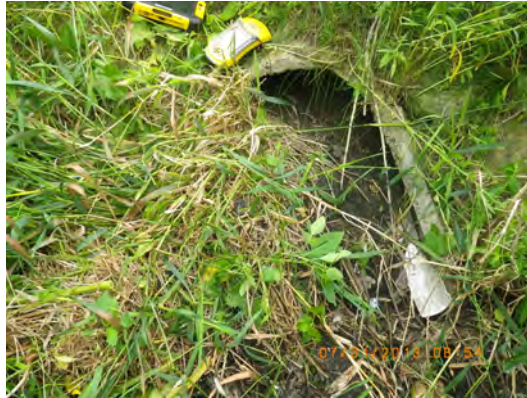
o20130731075420.JPG

Fond du Lac Rd curb inlets discharge to stream from north. Pipe diameter approximate due to deposition.

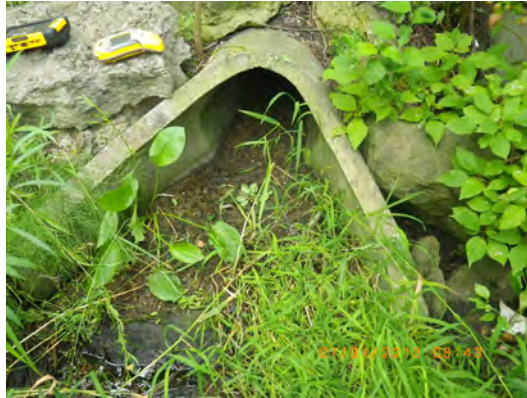
o20130731074334.JPG

Fond du Lac Rd curb inlet discharges to stream from south.

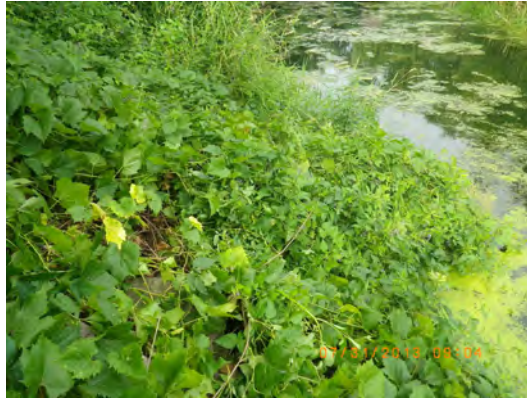
o20130731080446.JPG

Fond du Lac Rd storm sewer discharges to stream from south. Outfall information from MS4 map - outfall covered under brush.

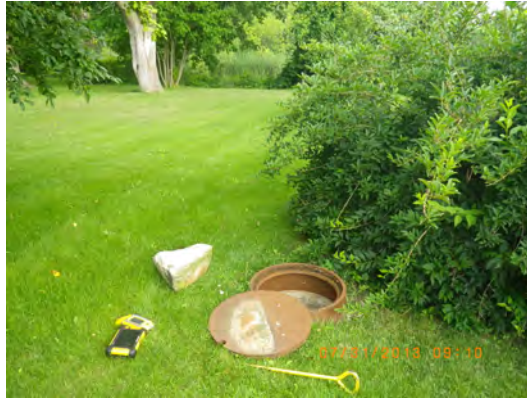
o20130731081054.JPG

Upstream manhole located approx 71 ft SSE of outfall 14-1139. Intermediate area consists of residential property and wooded area.

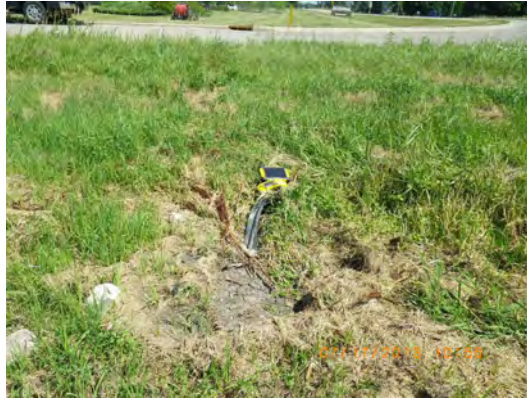
o20130717095626.JPG

Ripple Ave curb inlets discharge to swale on south side of road.

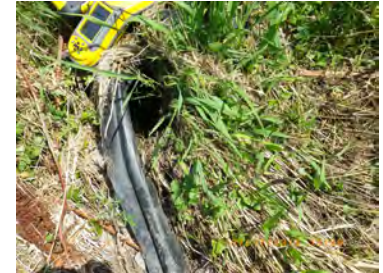
o20130717095634.JPG

Catchbasins from south ditch of Ripple Ave discharge to swale on south side of road.

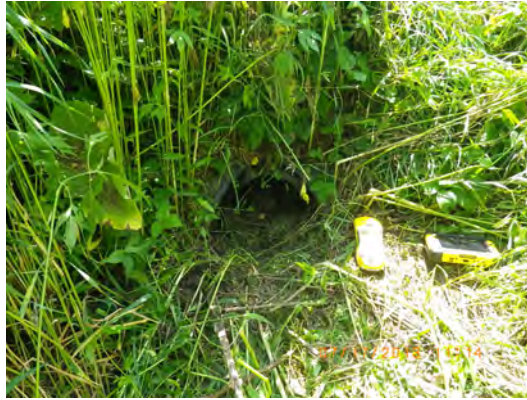
o20130717101432.JPG

Ripple Ave storm sewer discharges to swale from east.

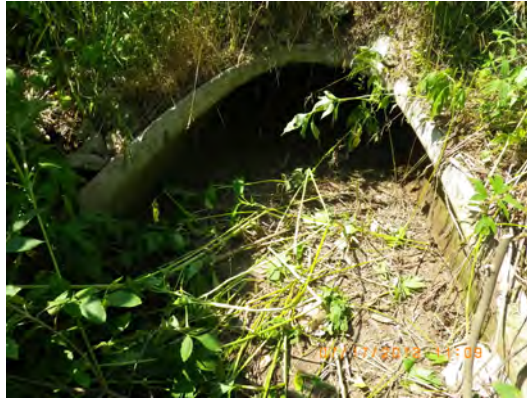
o20130717100904.JPG

Ripple Ave storms sewer discharges to swale from west.

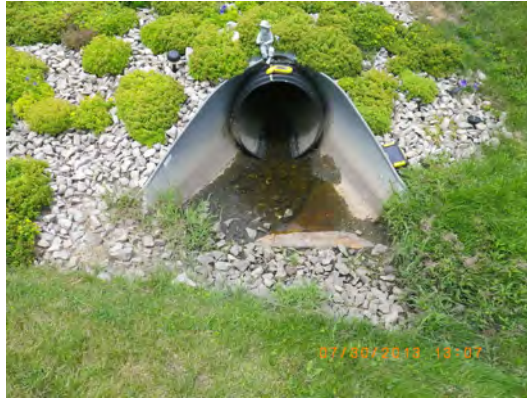
o20130730120714.JPG

Lilac Ln storm sewer discharges to NW corner of dry pond.

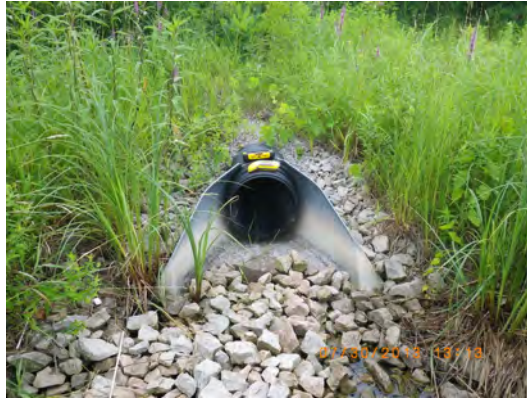
o20130730121336.JPG

Detention basin discharges to stream from north via grassy area.

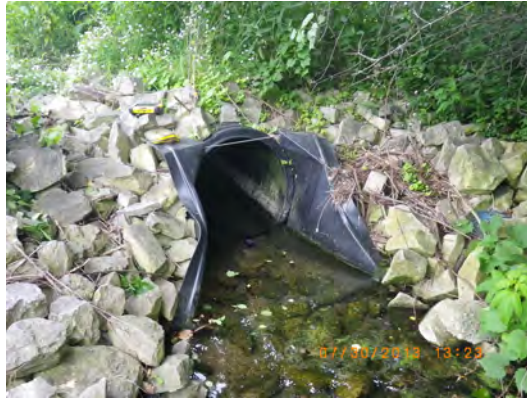
o20130730122354.JPG

Cherry Park Ct storm sewer discharges to stream from south.

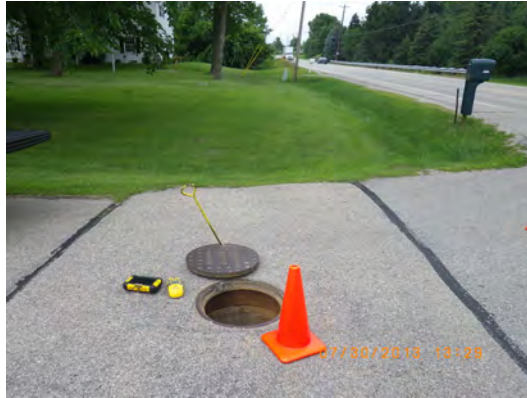
o20130730122942.JPG

Upstream manhole located approx 257 ft S of outfall 14-1387. Intermediate area consists of street right-of-way and residential property.

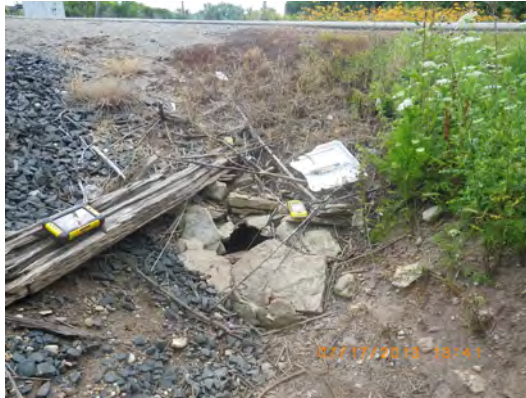
o20130717124108.JPG

Waukau Ave storm sewer discharges to railroad right-of-way from west.

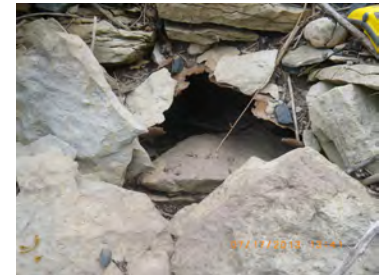
o20130717124114.JPG

Notes: Pipe dry at time of inspection. Significant corrosion of pipe.

Damage: Moderate ☐ Displacement ☐ Undercut ☐ Crushed

☒ Corrosion ☐ Cracks/Structural Damage

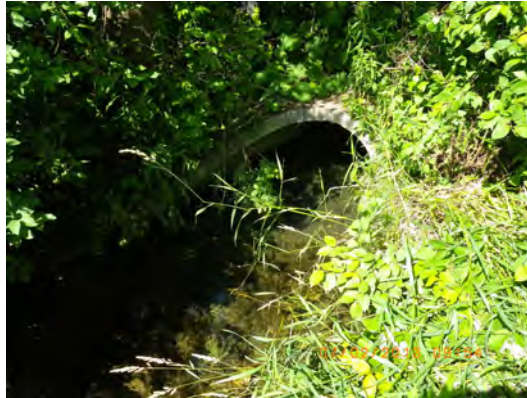
o20130702085424.JPG

Storm sewer discharges to Winnebago County Community Park from west.

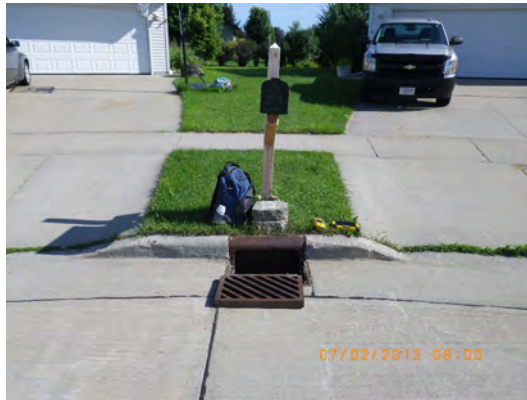
o20130702080038.JPG

Upstream curb inlet located approx 209 ft WSW of outfall 15-1348. Intermediate area consists of residential property.

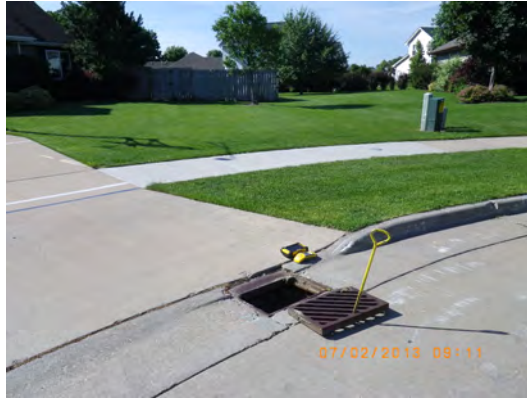
o20130702081142.JPG

Upstream curb inlet located approx 220 ft NW of outfall 15-1348. Intermediate area consists of residential property.

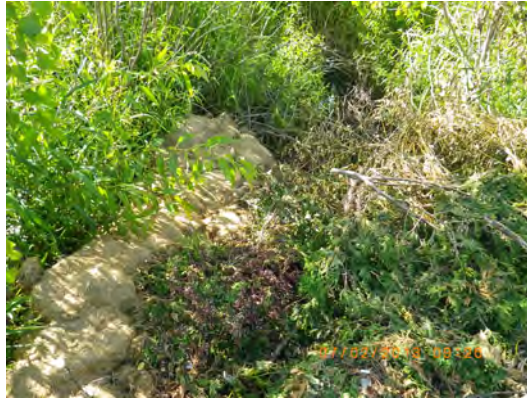
o20130702082622.JPG

Jacktar Rd storm sewer discharges to vacant property from north.

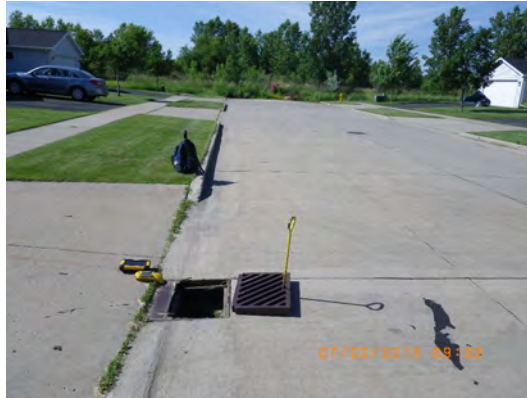
o20130702083212.JPG

Upstream curb inlet located approx 165 ft N of outfall 15-1702. Intermediate area consists of multifamily residential property.

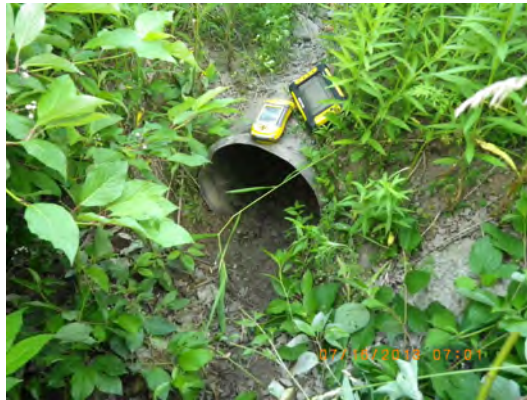
o20130716060136.JPG

Shambeau Dr storm sewer discharges to channel from west.

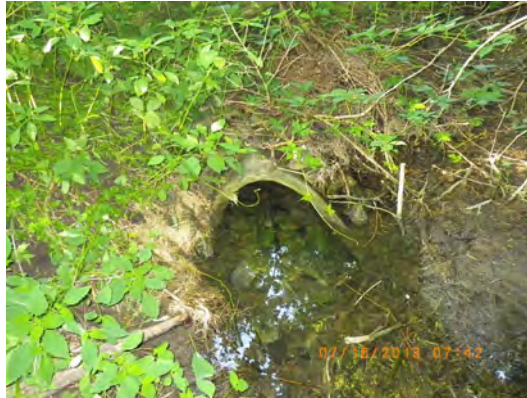
o20130716064250.JPG

Zacher Dr storm sewer discharges to channel from south. Location approximate - no GPS signal in canopy

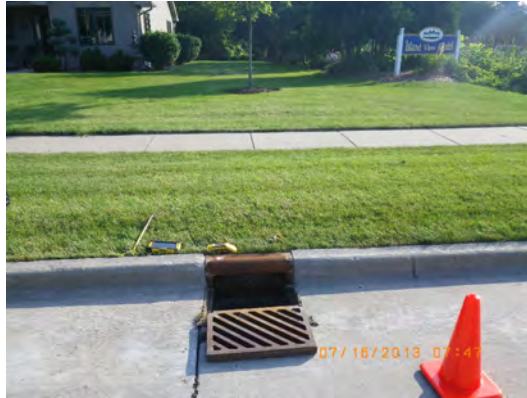
o20130716064758.JPG

Upstream curb inlet located approx 167 ft SSW of outfall 15-1746. Intermediate area consists of residential lot and wetlands in street right-of-way.

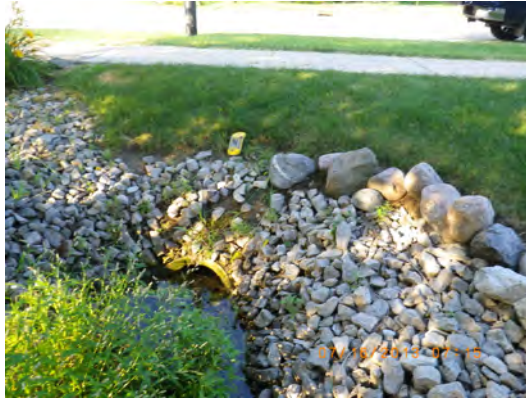
o20130716061550.JPG

Island Estates Ct curb inlets discharge to swale from south.
