# Ongoing Screening Summary Report 2013 Inspection Year

Illicit Discharge Detection and Elimination Program

City of Oshkosh

OMNNI Project No. N2029B13

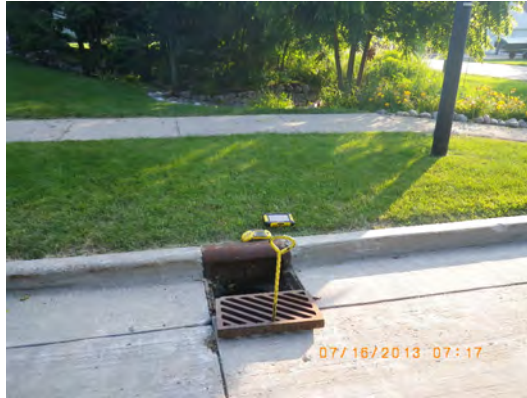
o20130716061752.JPG

Upstream curb inlet located approx 19 ft SW of outfall 15-1749. Intermediate area consists of street right-of-way.

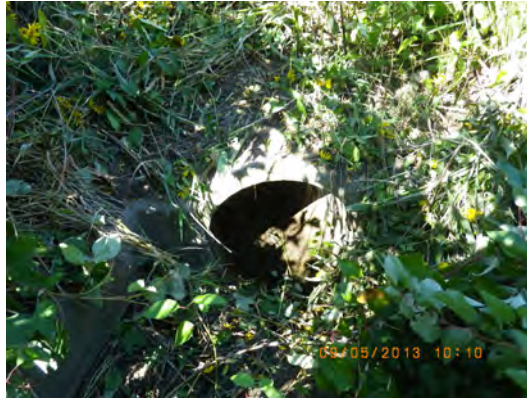
o20130905091004.JPG

Jackson St storm sewer discharges to stream from south.

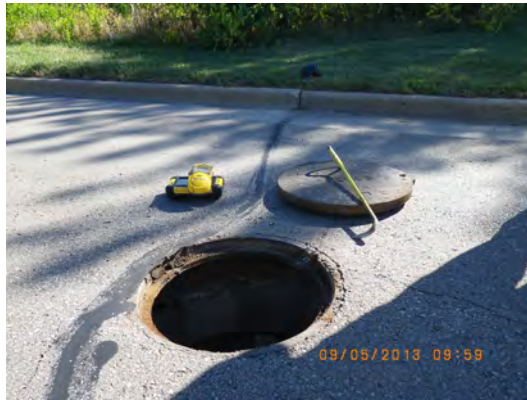
o20130905085950.JPG

Upstream manhole located approx 28 ft W of outfall 15-1806. Intermediate area consists of street right-of-way.

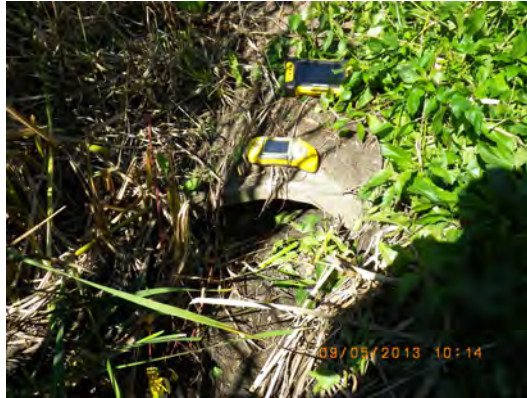
o20130905091444.JPG

Jackson St storm sewer discharges to stream from north. Dimensions approximate due to deposition.

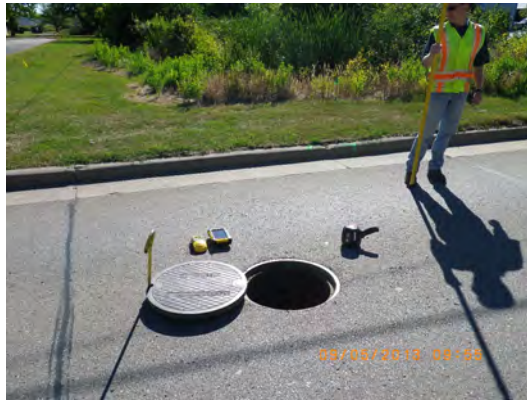
o20130905085526.JPG

Upstream manhole located approx 31 ft WNW of outfall 15-1807. Intermediate area consists of street right-of-way.

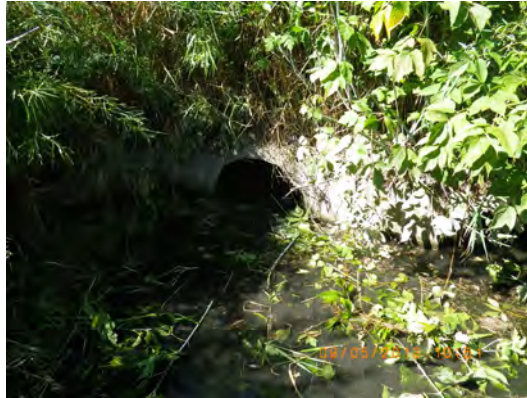
o20130905095104.JPG

Jackson St storm sewer discharges to stream from south.

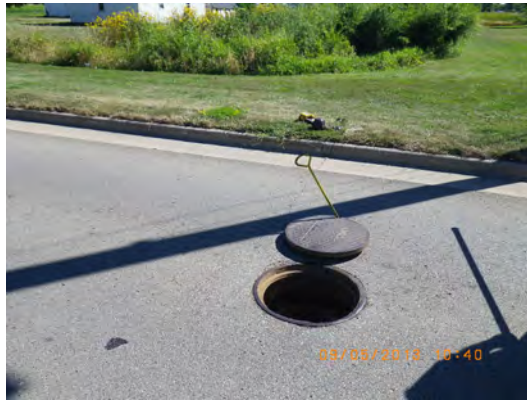
o20130905094002.JPG

Upstream manhole located approx 38 ft WSW of outfall 15-1856. Intermediate area consists of street right-of-way.

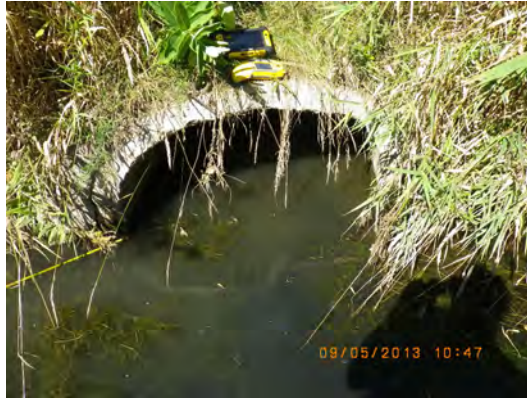
o20130905094742.JPG

Jackson St storm sewer discharges to stream from north.

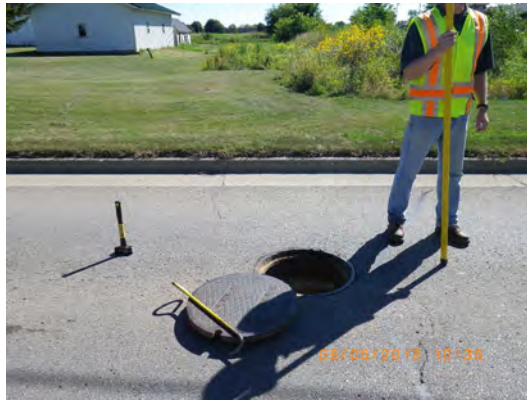
o20130905093528.JPG

Upstream manhole located approx 34 ft WNW of outfall 15-1889. Intermediate area consists of street right-of-way.

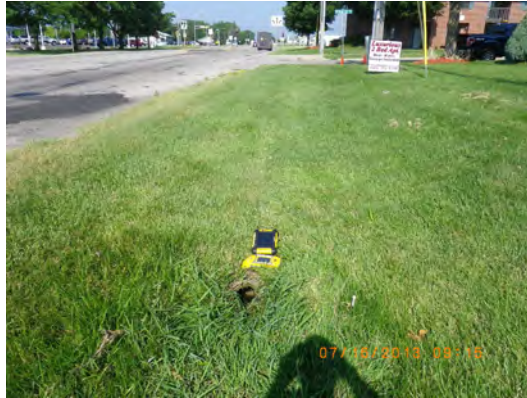
o20130716081518.JPG

Parkview Ct storm sewer discharges to north ditch of Snell Rd from west.

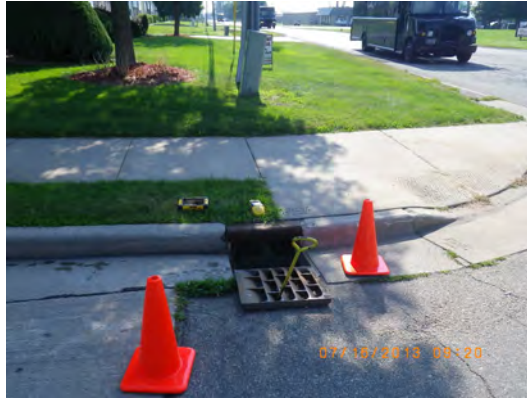
o20130716082022.JPG

Upstream curb inlet located approx 66 ft W of outfall 15-1891. Intermediate area consists of street right-of-way.

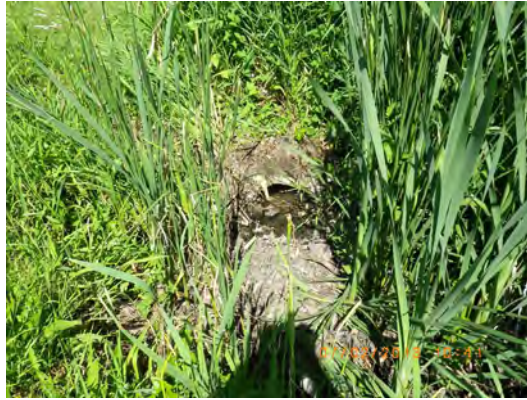
o20130702094124.JPG

Parkview Ct storm sewer discharges to north ditch of Snell Road from west.

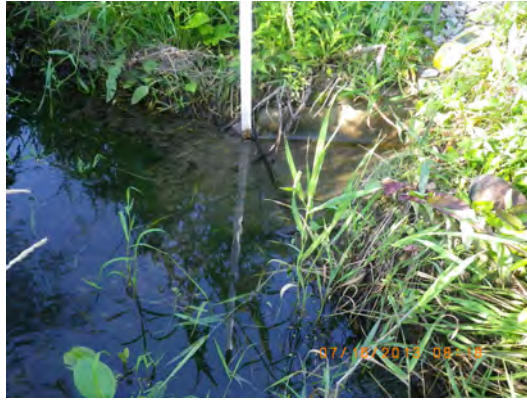
o20130716071838.JPG

CTH A curb inlets discharge to stream via swale on east side of road.

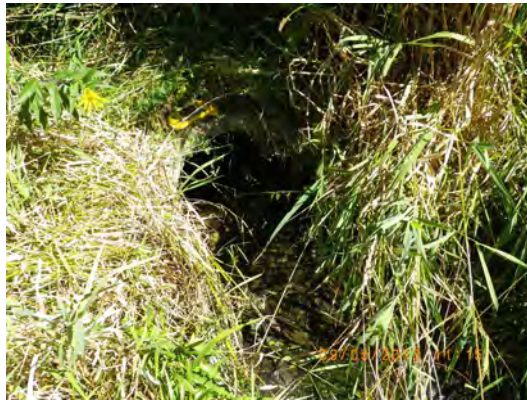
o20130905101540.JPG

CTH A storm sewer discharges to swale on east side of road. (Formerly A25)

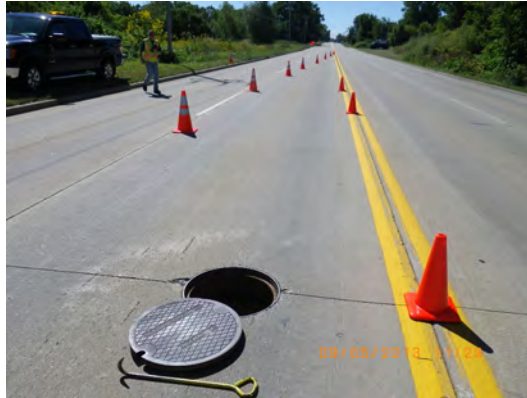
o20130905102910.JPG

Upstream manhole located approx 203 ft WNW of outfall 15-2297. Intermediate area consists of highway right-of-way.

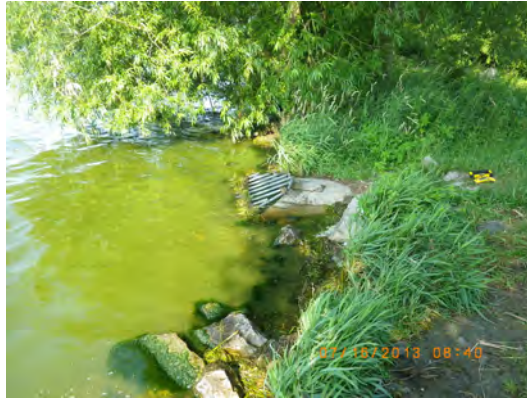
o20130716074026.JPG

Sherman Road storm sewer discharges to Asylum Bay from north.

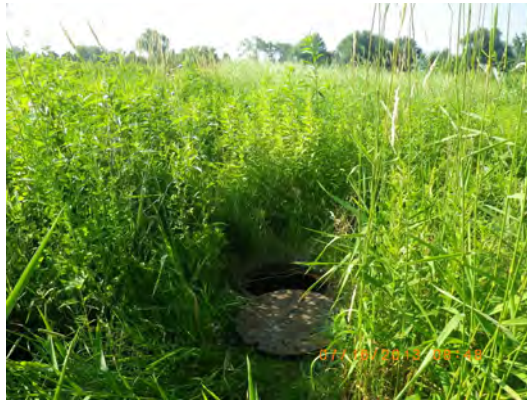
o20130716074846.JPG

Upstream manhole located approx 542 ft NNW of outfall 15-2477. Intermediate area consists of grassy field and gravel parking lot.

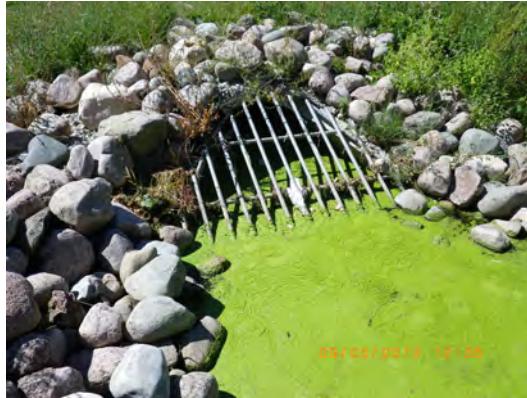
o20130905113652.JPG

Westfield St storm sewer discharges to stream from south. Replaces outfall 16-487 (2011).

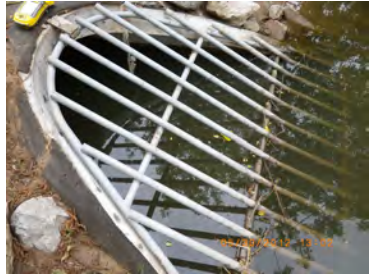
<b>Inspection Date:</b> 5/30/2012 1:02:54 PM		<b>Inspector:</b> JCW	<b>Inspection Type:</b> Ongoing	<b>Previous Rainfall (hrs):</b> 72+	
<b>Flow Description:</b> Submerged, indeterminate		<b>Notes:</b> Outfall partially submerged. Outfall screened upstream at 16-1508 US1.			
Submerged: Partially      Depth (in): 33					
<b>Illicit Discharge Potential:</b> Potential		<input type="checkbox"/> Field Follow-up <input type="checkbox"/> Office Follow-up			
Floatables: <input type="text" value="None"/>	<input type="checkbox"/> Petrol. Sheen	<input type="checkbox"/> Suds	<input type="checkbox"/> Sewage	<input type="checkbox"/> Algae	<input type="checkbox"/> Other
Odor: <input type="text" value="None"/>	<input type="checkbox"/> Petroleum	<input type="checkbox"/> Musty	<input type="checkbox"/> Sewage	<input type="checkbox"/> Chlorine	<input type="checkbox"/> Other
	<input type="checkbox"/> VOC/Solvent	<input type="checkbox"/> Fishy	<input type="checkbox"/> Sulfur	<input type="checkbox"/> Fragrant

Turbidity: <input type="text" value="None"/>					
Color: <input type="text" value="None"/>					
Gross Solids: <input type="text" value="Slight"/>	<input checked="" type="checkbox"/> Litter	<input type="checkbox"/> Debris	<input type="checkbox"/> Sediment	<input type="checkbox"/> Other	
Vegetation: <input type="text" value="None"/>	<input type="checkbox"/> Inhibited	<input type="checkbox"/> Excessive			
Benthic Growth: <input type="text" value="None"/>	<input type="checkbox"/> Green	<input type="checkbox"/> Brown			
Stains: <input type="text" value="None"/>	<input type="checkbox"/> Flow Line	<input type="checkbox"/> Oil	<input type="checkbox"/> Rust Stains		
	<input type="checkbox"/> Corrosion	<input type="checkbox"/> Paint	<input type="checkbox"/> Other		
Non-illicit: <input type="text" value="Slight"/>	<input checked="" type="checkbox"/> Natural Sheen	<input type="checkbox"/> Natural Suds/Foam

<b>Physical Condition Assessment</b>					
Graffiti: None					
Erosion: None					
Deposition: None      Depth (in):					
Damage: None <input type="checkbox"/> Displacement <input type="checkbox"/> Undercut <input type="checkbox"/> Crushed					
<input type="checkbox"/> Corrosion <input type="checkbox"/> Cracks/Structural Damage

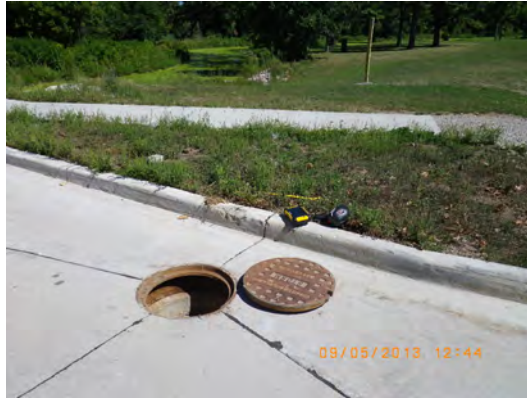
o20130905114406.JPG

Upstream manhole located approx 83 ft SW of outfall 16-487. Intermediate area consists of open space. Replaces 16-487 US1 (2011).

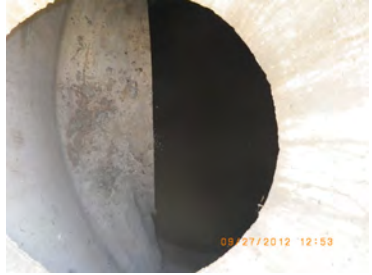
o20120927115358.JPG

<b>Inspection Date:</b> 9/27/2012 12:51:46 PM		<b>Inspector:</b> JCW	<b>Inspection Type:</b> Repeat	<b>Previous Rainfall (hrs):</b> 72+		
<b>Flow Description:</b> Submerged, indeterminate		<b>Notes:</b> Ammonia detection follow-up.				
Submerged: Partially      Depth (in): 9						
<b>Illicit Discharge Potential:</b> Potential		<input type="checkbox"/> Field Follow-up <input type="checkbox"/> Office Follow-up				
Floatables:	None	<input type="checkbox"/> Petrol. Sheen	<input type="checkbox"/> Suds	<input type="checkbox"/> Sewage	<input type="checkbox"/> Algae	<input type="checkbox"/> Other
Odor:	None	<input type="checkbox"/> Petroleum	<input type="checkbox"/> Musty	<input type="checkbox"/> Sewage	<input type="checkbox"/> Chlorine	<input type="checkbox"/> Other
		<input type="checkbox"/> VOC/Solvent	<input type="checkbox"/> Fishy	<input type="checkbox"/> Sulfur	<input type="checkbox"/> Fragrant	
Turbidity:	None

<b>Sampling Results</b>	
Sample Location:	Pool
Sample ID:	120927-48
Time Collected	12:52
Total Chlorine (field):	0 ppm
Free Chlorine (field):	0 ppm
Total Copper (field):	0 ppm
Ammonia (field):	3 ppm
pH (field):	7.8 units
Temperature (field):	65 °F
Conductivity (field):	1408 µS/cm
Detergents:	0 mg/L
Phenol:	-- mg/L

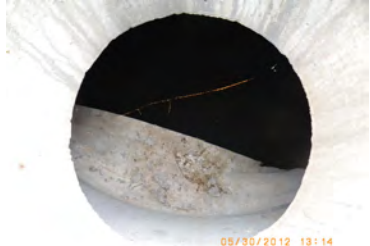
o20120530121440.JPG

<b>Inspection Date:</b> 5/30/2012 1:14:06 PM		<b>Inspector:</b> JCW	<b>Inspection Type:</b> Ongoing	<b>Previous Rainfall (hrs):</b> 72+		
<b>Flow Description:</b> Submerged, indeterminate		<b>Notes:</b>				
Submerged: Partially      Depth (in): 29						
<b>Illicit Discharge Potential:</b> Potential		<input type="checkbox"/> Field Follow-up <input type="checkbox"/> Office Follow-up				
Floatables:	None	<input type="checkbox"/> Petrol. Sheen	<input type="checkbox"/> Suds	<input type="checkbox"/> Sewage	<input type="checkbox"/> Algae	<input type="checkbox"/> Other
Odor:	None	<input type="checkbox"/> Petroleum	<input type="checkbox"/> Musty	<input type="checkbox"/> Sewage	<input type="checkbox"/> Chlorine	<input type="checkbox"/> Other
		<input type="checkbox"/> VOC/Solvent	<input type="checkbox"/> Fishy	<input type="checkbox"/> Sulfur	<input type="checkbox"/> Fragrant	
Turbidity:	None					
Color:	None

**Sampling Results**  
Sample Location: Pool  
Sample ID: 120530-97  
Time Collected 13:15  
Total Chlorine (field): 0 ppm  
Free Chlorine (field): 0 ppm  
Total Copper (field): 0 ppm  
Ammonia (field): 1 ppm  
pH (field): 7.9 units  
Temperature (field): 64 °F  
Conductivity (field): 1097 µS/cm  
Detergents: 0 mg/L  
Phenol: 0 mg/L

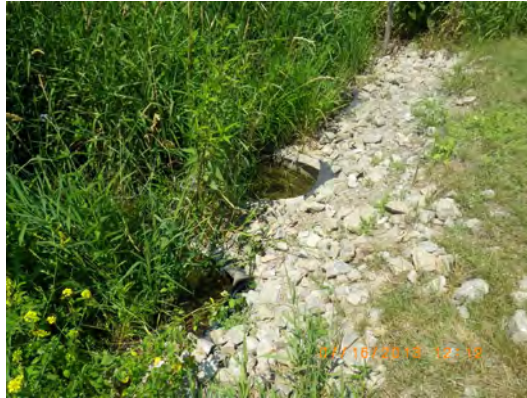
o20130716111222.JPG

Three outlet pipes for detention basin discharge to grassy wetland area.

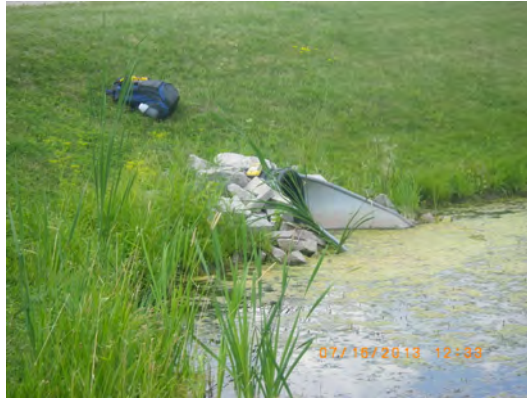
o20130716113306.JPG

Edgewood Ln ditches discharge to SW corner of detention basin through culvert.

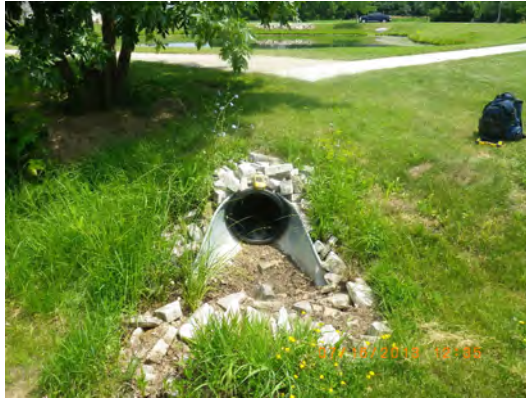
o20130716113558.JPG

Upstream end of Edgewood Lane culvert that discharges to detention basin.

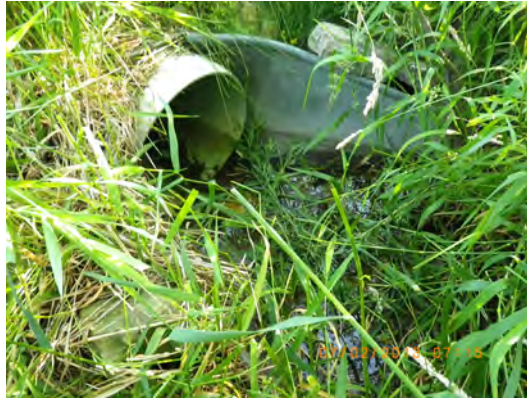
o20130702061548.JPG

Detention basin discharges to stream from north via riprap channel.

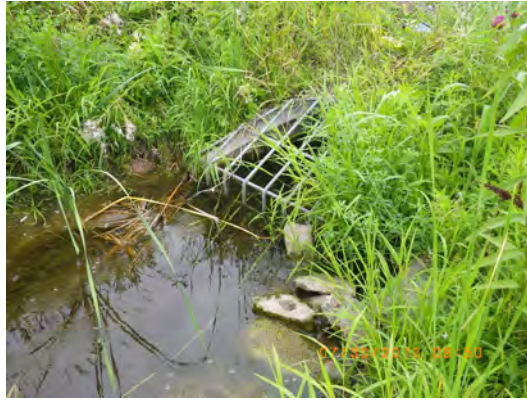
o20130730085028.JPG

Detention basin discharges to railroad right-of-way via grass swale.

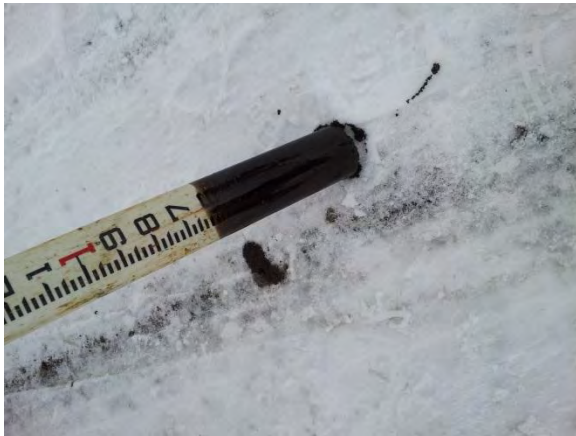
On December 11, 2012, a survey crew for the City of Oshkosh was working along S. Washburn Street, south of STH 44. While surveying storm sewer manhole 13-1743 on the south side of Washburn Street, they encountered an oily substance in the manhole. The manhole had approximately 0.6 feet of water trapped in it, with the oily substance floating on the water surface. The oil coated the survey rod with an opaque black film (Figure 1).

**Figure 1 – Oil on survey rod from storm manhole 13-1743**

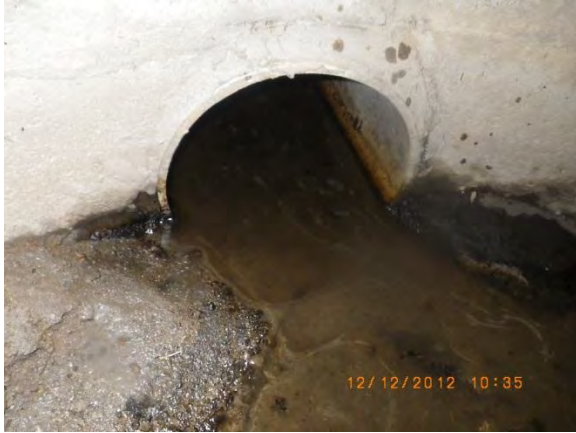
The branch on Washburn Street was investigated next. The manhole on the upstream end (13-1754) was inspected and found to be dry with no petroleum stains or odor. The next manhole (13-1749) was slightly submerged, and the flow appeared to be heading to the west (downstream). The flow entering from the east appeared to have a slight sheen, but did not have the dark, oily appearance that was observed at the end of the drainage swale.

**Figure 6 – Slight sheen in manhole 13-1749**

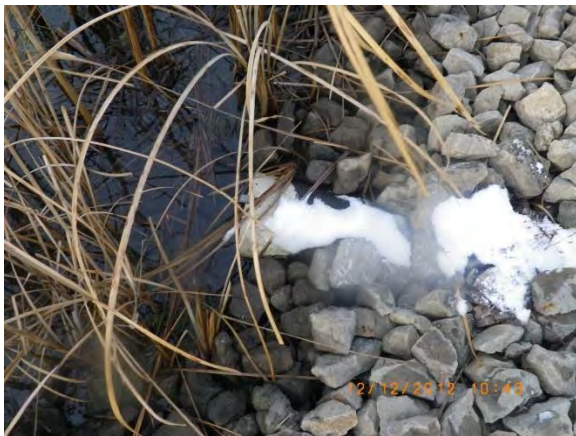
**Figure 7 – Detention pond inlet pipe**

An oil sheen was observed on the surface of the detention pond. Near the inlet pipe, the sheen appeared to consist of clear oil droplets. Near the pond's outlet pipe, near manhole/inlet 13-1743, the oil sheen was more opaque. The pond is likely designed to discharge to the storm sewer in Washburn Street. However, due to the partially-submerged condition at the outfall and the backed-up water in the storm sewer, the pond surface was at the same level as the storm sewer flow, and the water was free to flow between the storm sewer and the pond based on wind and other influences on flow.

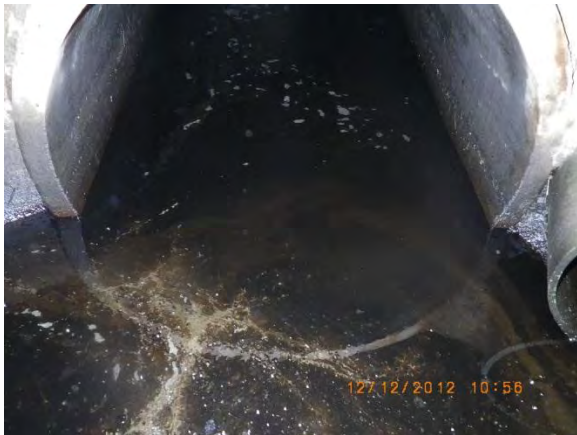
The junction of the detention pond and drainage swale with the storm sewer is located at manhole/inlet 13-1743. This inlet was inspected, and the opaque oil sheen observed in the drainage ditch was also observed in this inlet. No obvious source of the oil was identified, but there appeared to be a slight flow to the west (downstream).

**Figure 10 – Drainage swale pipe connection to manhole 13-1743**

A water sample was collected from this manhole. The water was ten inches deep, with an opaque film on the surface. The oily substance coated the sample pole and sample bottle. A strong petroleum odor was present.

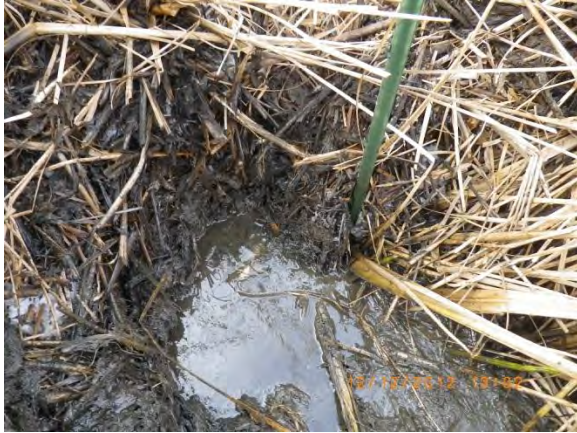
Based on the observations in the upstream manholes, the most likely source for the oil appeared to be the drainage swale south of Quent's Service Center. Starting at the downstream end of the swale, the surface flow was traced back up through the grass in the swale. Approximately 20 feet upstream from the end of the swale, the surface flow appeared to intensify from the north side of the swale. A metal fence post was located, which sometimes marks the location of a pipe. The area around the fence post was probed with a shovel, and a 4-inch PVC pipe was located. The pipe appeared to come from Quent's Service Center. When the area around the end of the pipe was cleared with the shovel, the pipe appeared to discharge the oily substance, which quickly flooded the area and submerged the pipe. Based on the appearance of the discharge and the strong odor that was present with the new discharge, this 4-inch PVC was identified as a probable source. The location of the pipe was marked with a lath, and the Illicit Discharge Coordinator was informed of the discovery.

**Figure 17 – 4-inch PVC pipe from Quent’s Service Center (submerged)**

Mr. Rabe investigated the site during the afternoon of December 12, 2012. Due to the severity of the contamination, he contacted the Fire Chief and asked to have the Hazardous Materials Response team deploy oil containment booms in the area. The Fire Chief spoke with the owner of Quent’s Service Center, who identified the PVC pipe as their sump pump discharge line. After investigating the inside of the building, oil was observed on the surface of the sump pit. The Fire Department will follow up with Quent’s Service Center on December 13.
